Hamilton Township (Mercer County)
Stormwater Outfall Assessment Summary
Addendum (Year 2)

Developed by the Rutgers Cooperative Extension Water Resources Program
Funded by Hamilton Township, Mercer County, New Jersey
December 2017

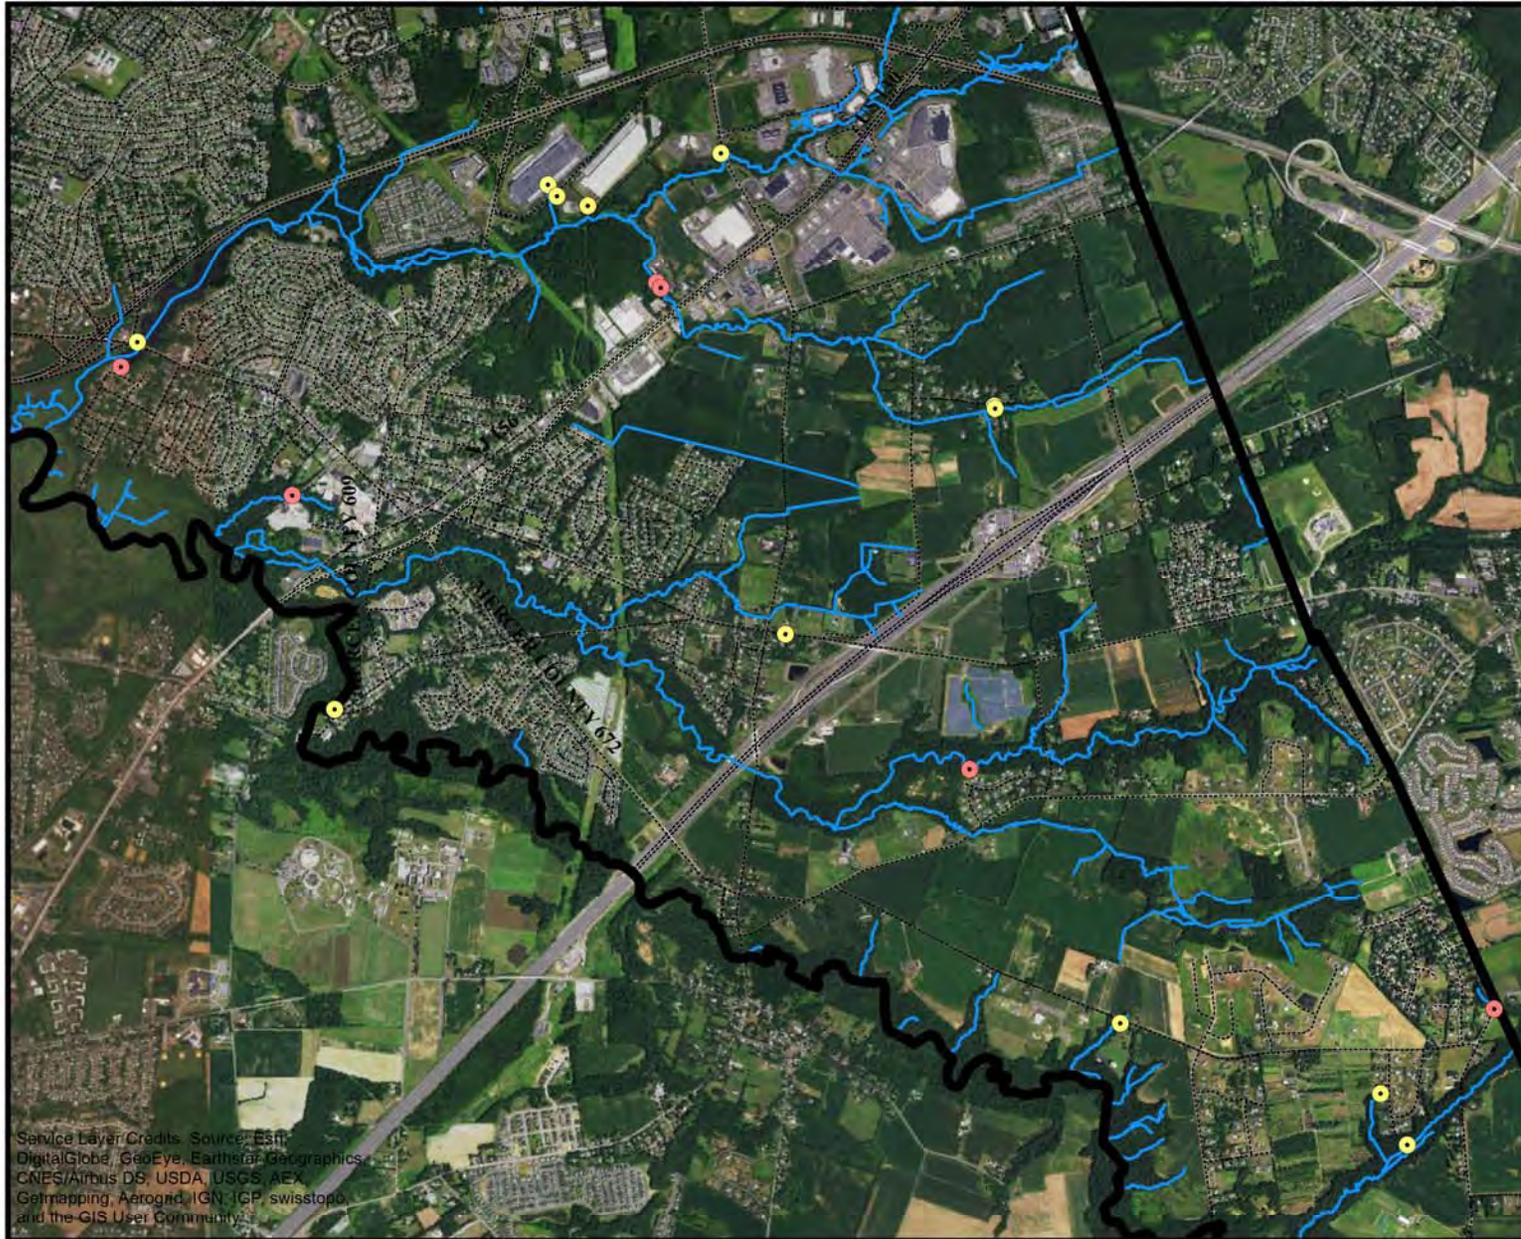
Outfall Maintenance Prioritization

- High: 6
- Medium: 13
- Low: 38

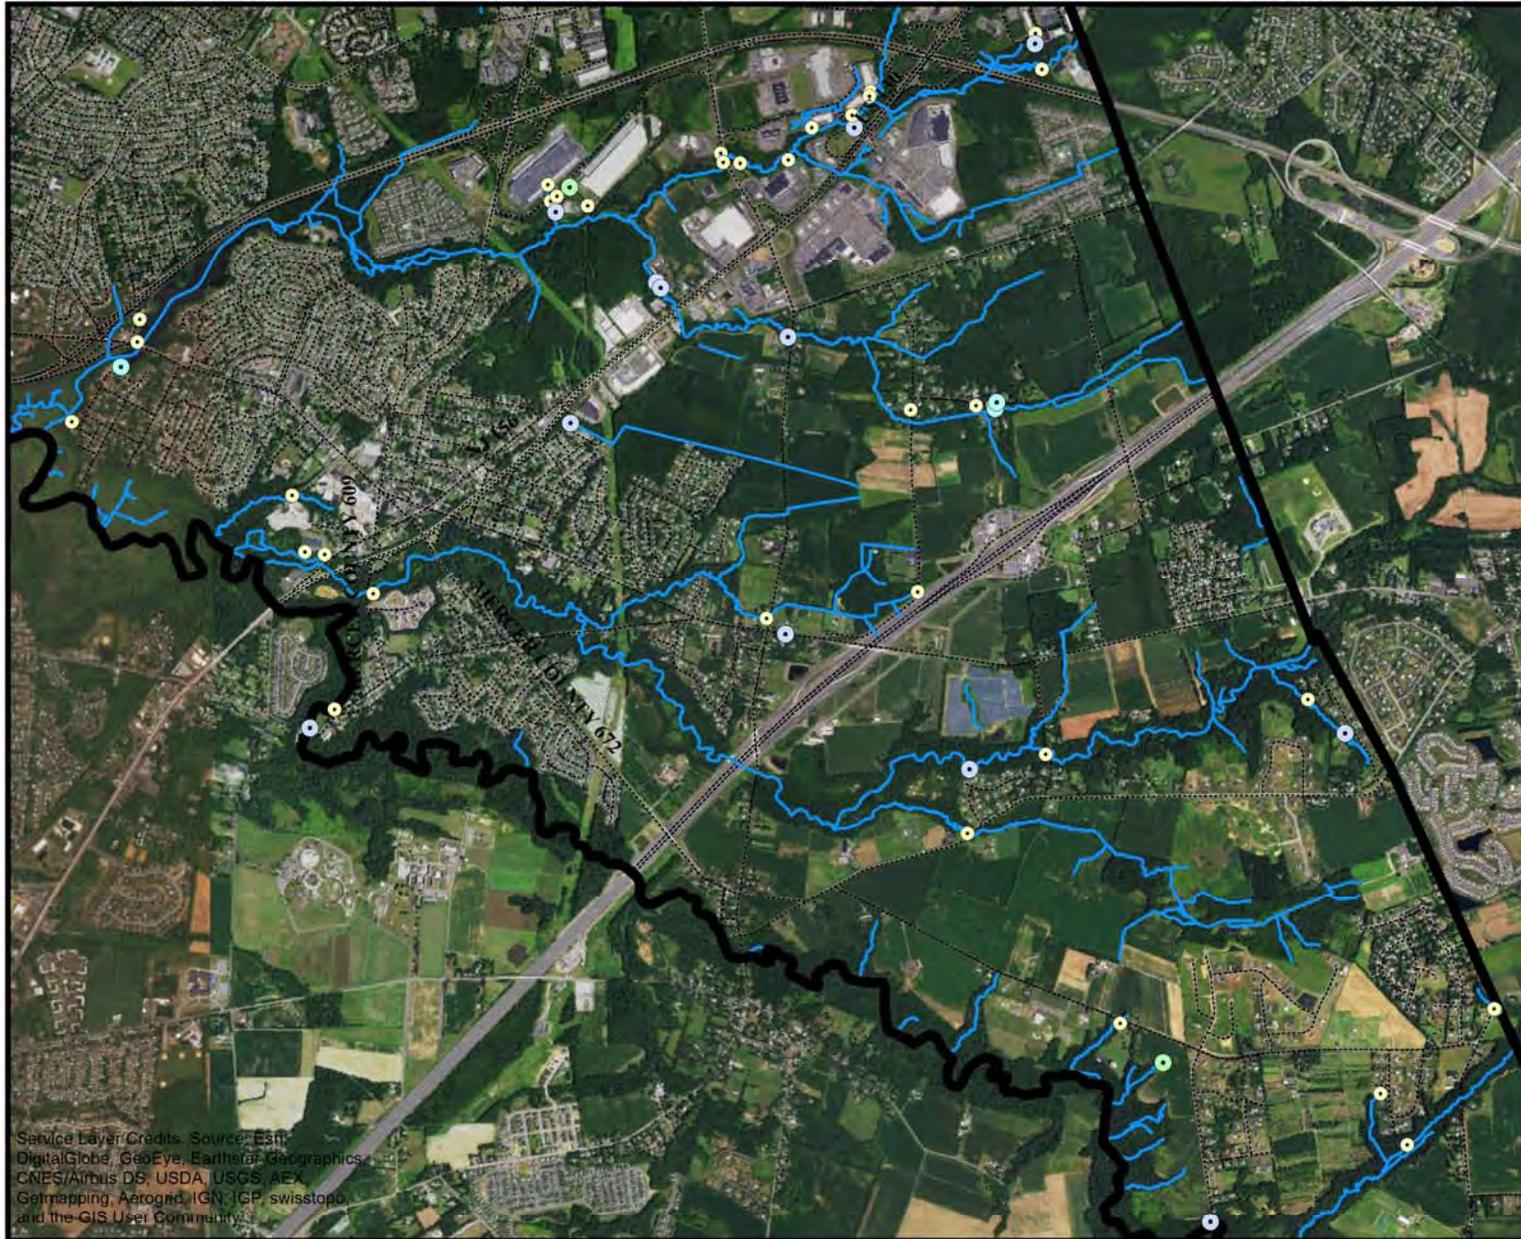
Outfall Pipe Condition

- Cracking: 13
- Peeling: 0
- Corrosion: 3
- Spalling: 3
- Normal: 38

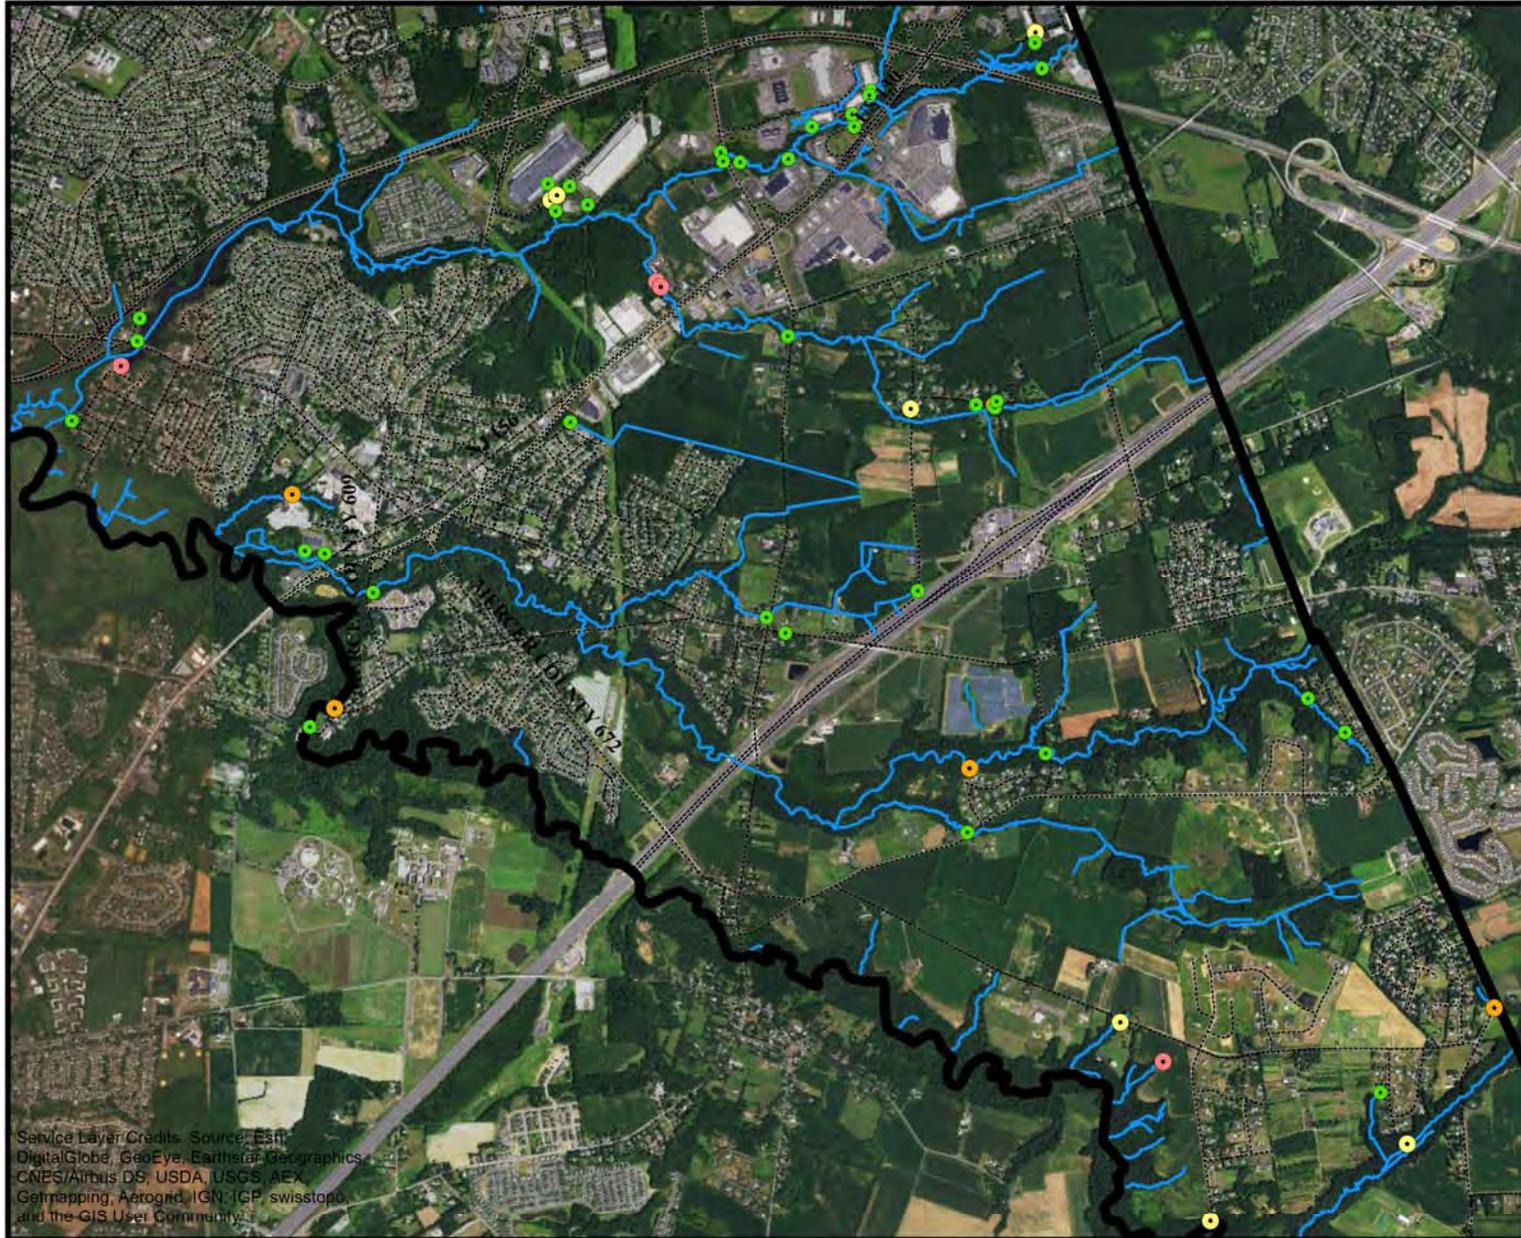
Outfall Erosion

- High: 4
- Medium: 5
- Low: 9
- None: 39

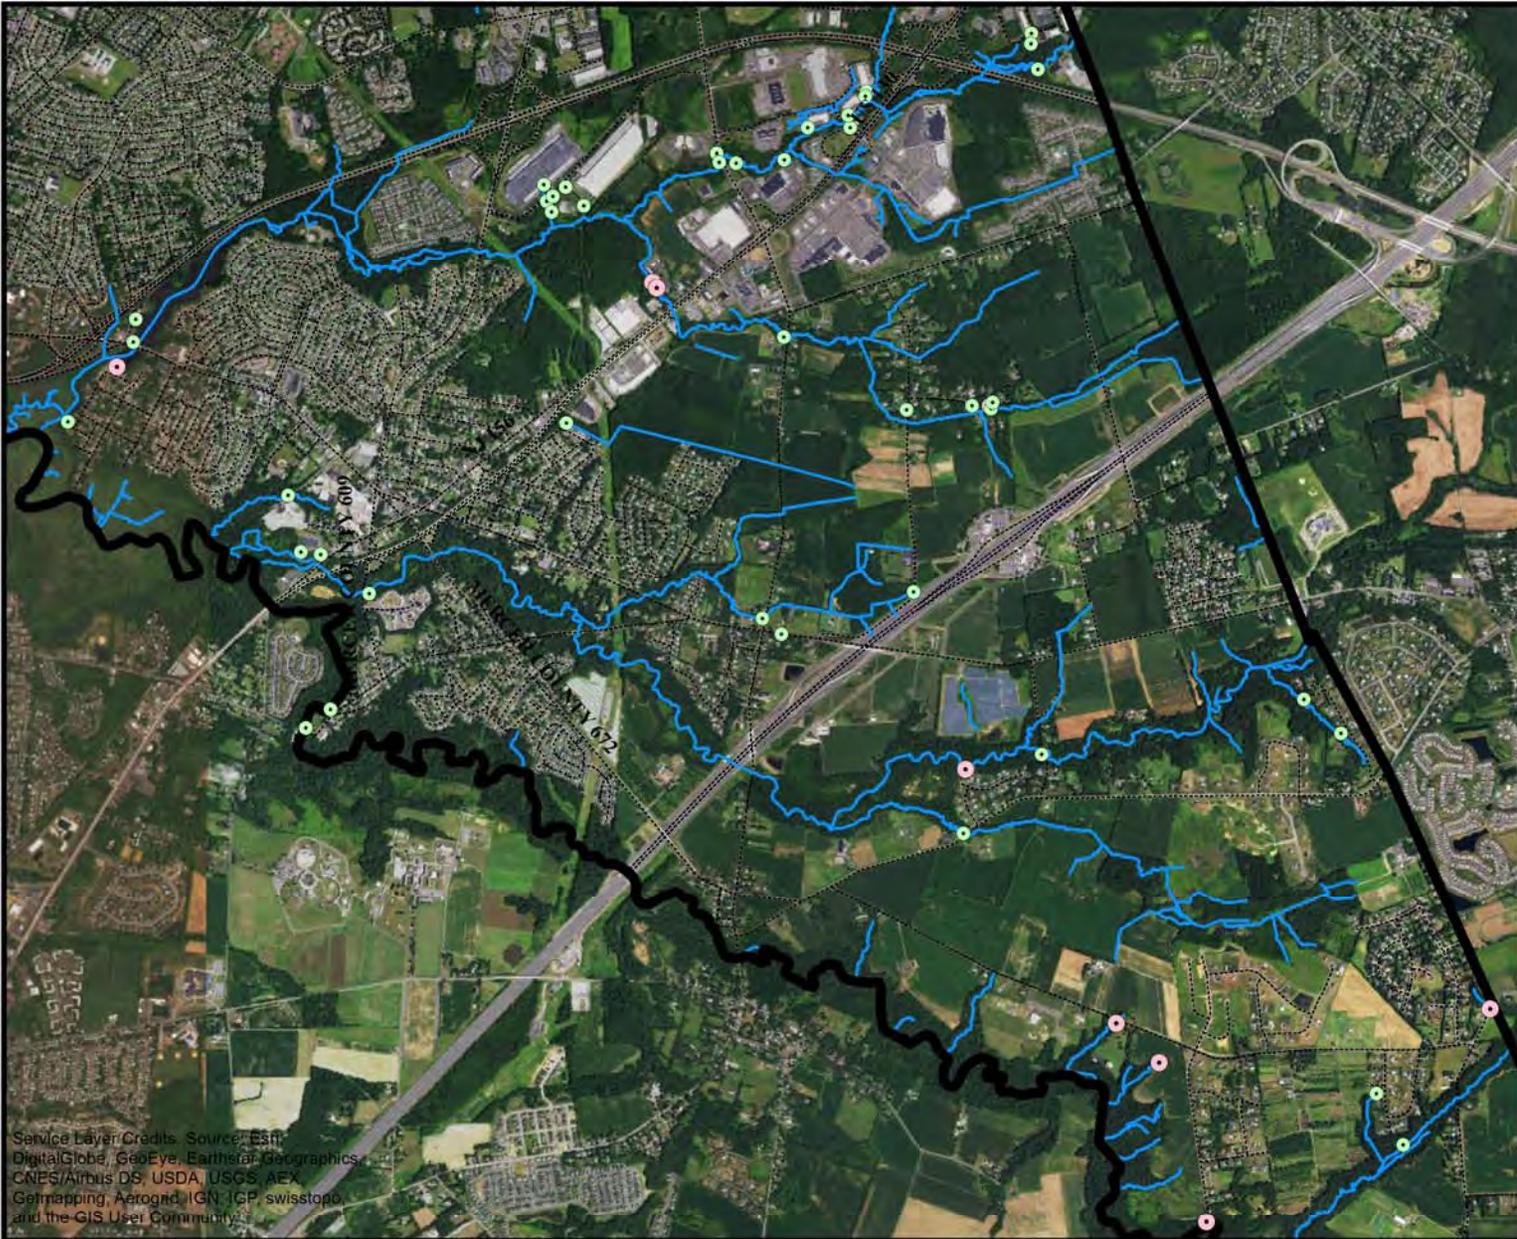
Outfall Stability

- Unstable: 10
- Stable: 47
