Hamilton Township in Mercer County

Stormwater Outfall Assessment

Developed by Rutgers Cooperative Extension Water Resources Program

December 2015

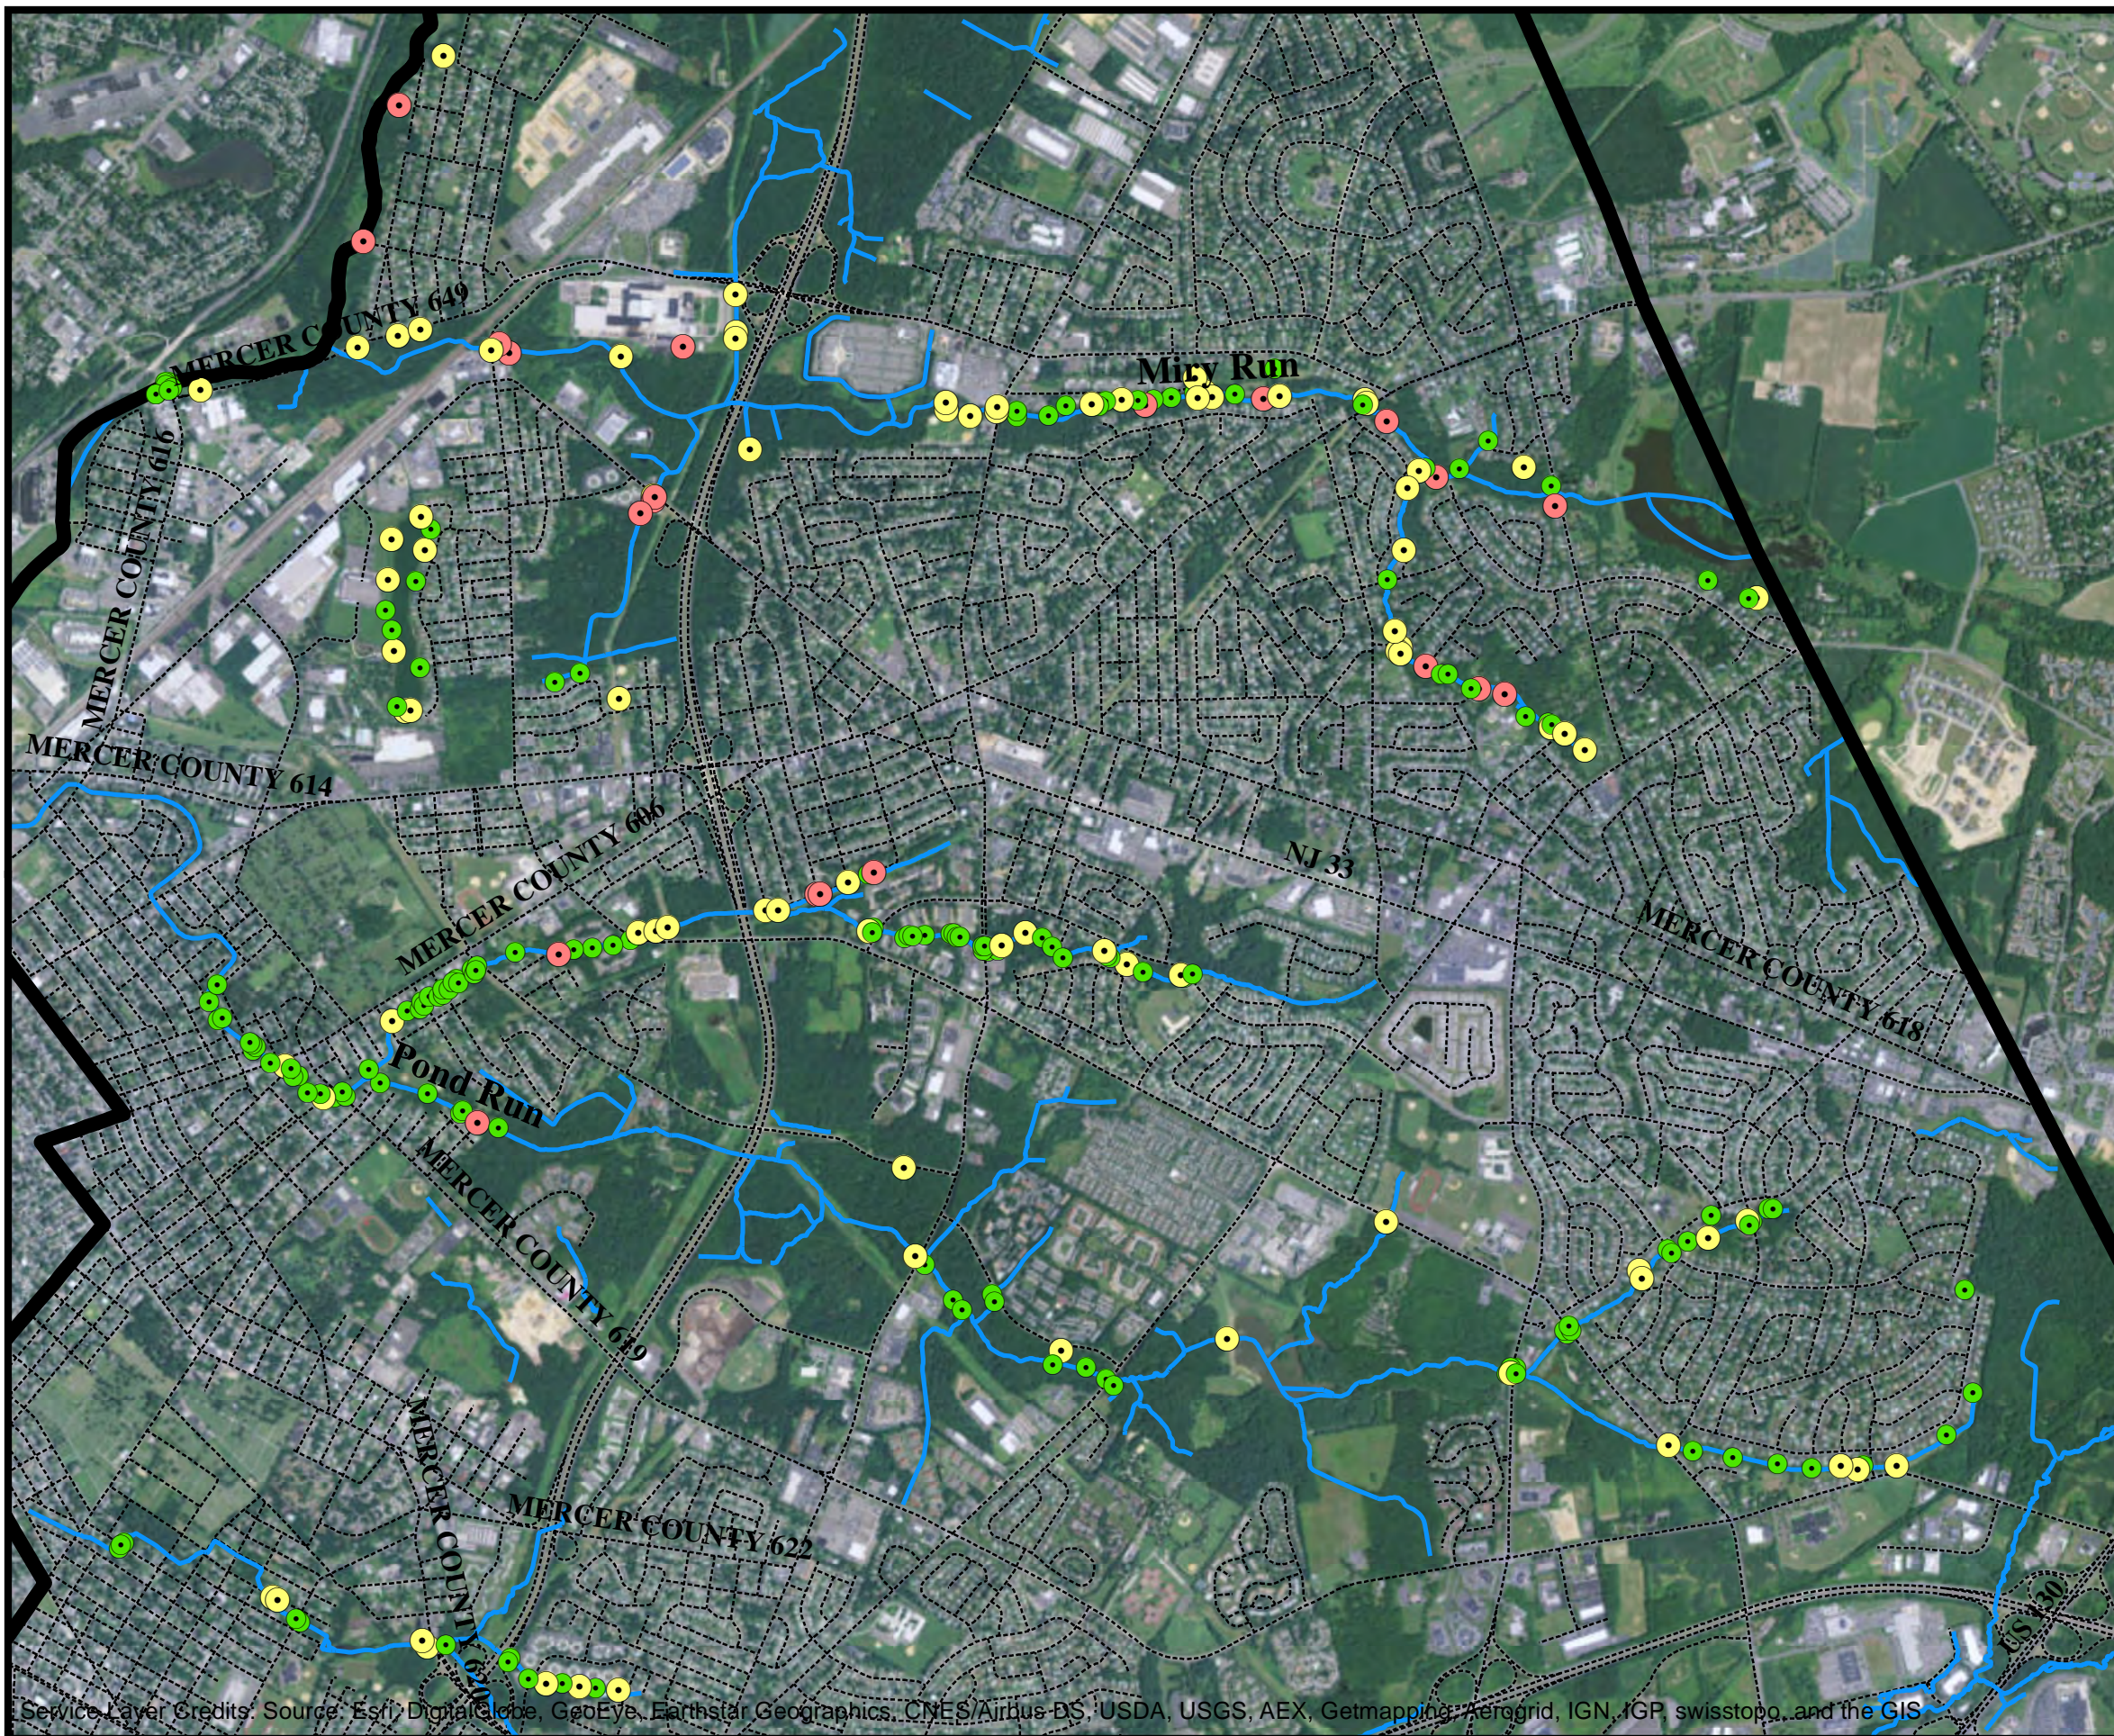
Outfall Maintenance Prioritization

A maintenance prioritization was developed using the field data collected for the 261 stormwater outfalls. Priority was given to outfalls that showed significant signs of deterioration, were causing downstream erosion, were unstable due to erosion, or showed signs of illicit connections. Consideration was also given to the amount of vegetation growth in and around the outfall, quantity of sediment deposits, areas of known commercial or industrial uses and other factors.

- High: 21
- Medium: 82
- Low: 158

1. The 21 outfalls identified as high priority for maintenance should be visited by Township personnel and a plan and schedule should be developed to take necessary corrective actions as soon as possible.
2. A complete maintenance plan and schedule should be developed for all stormwater outfalls to address the deficiencies noted in this assessment in a timely manner.

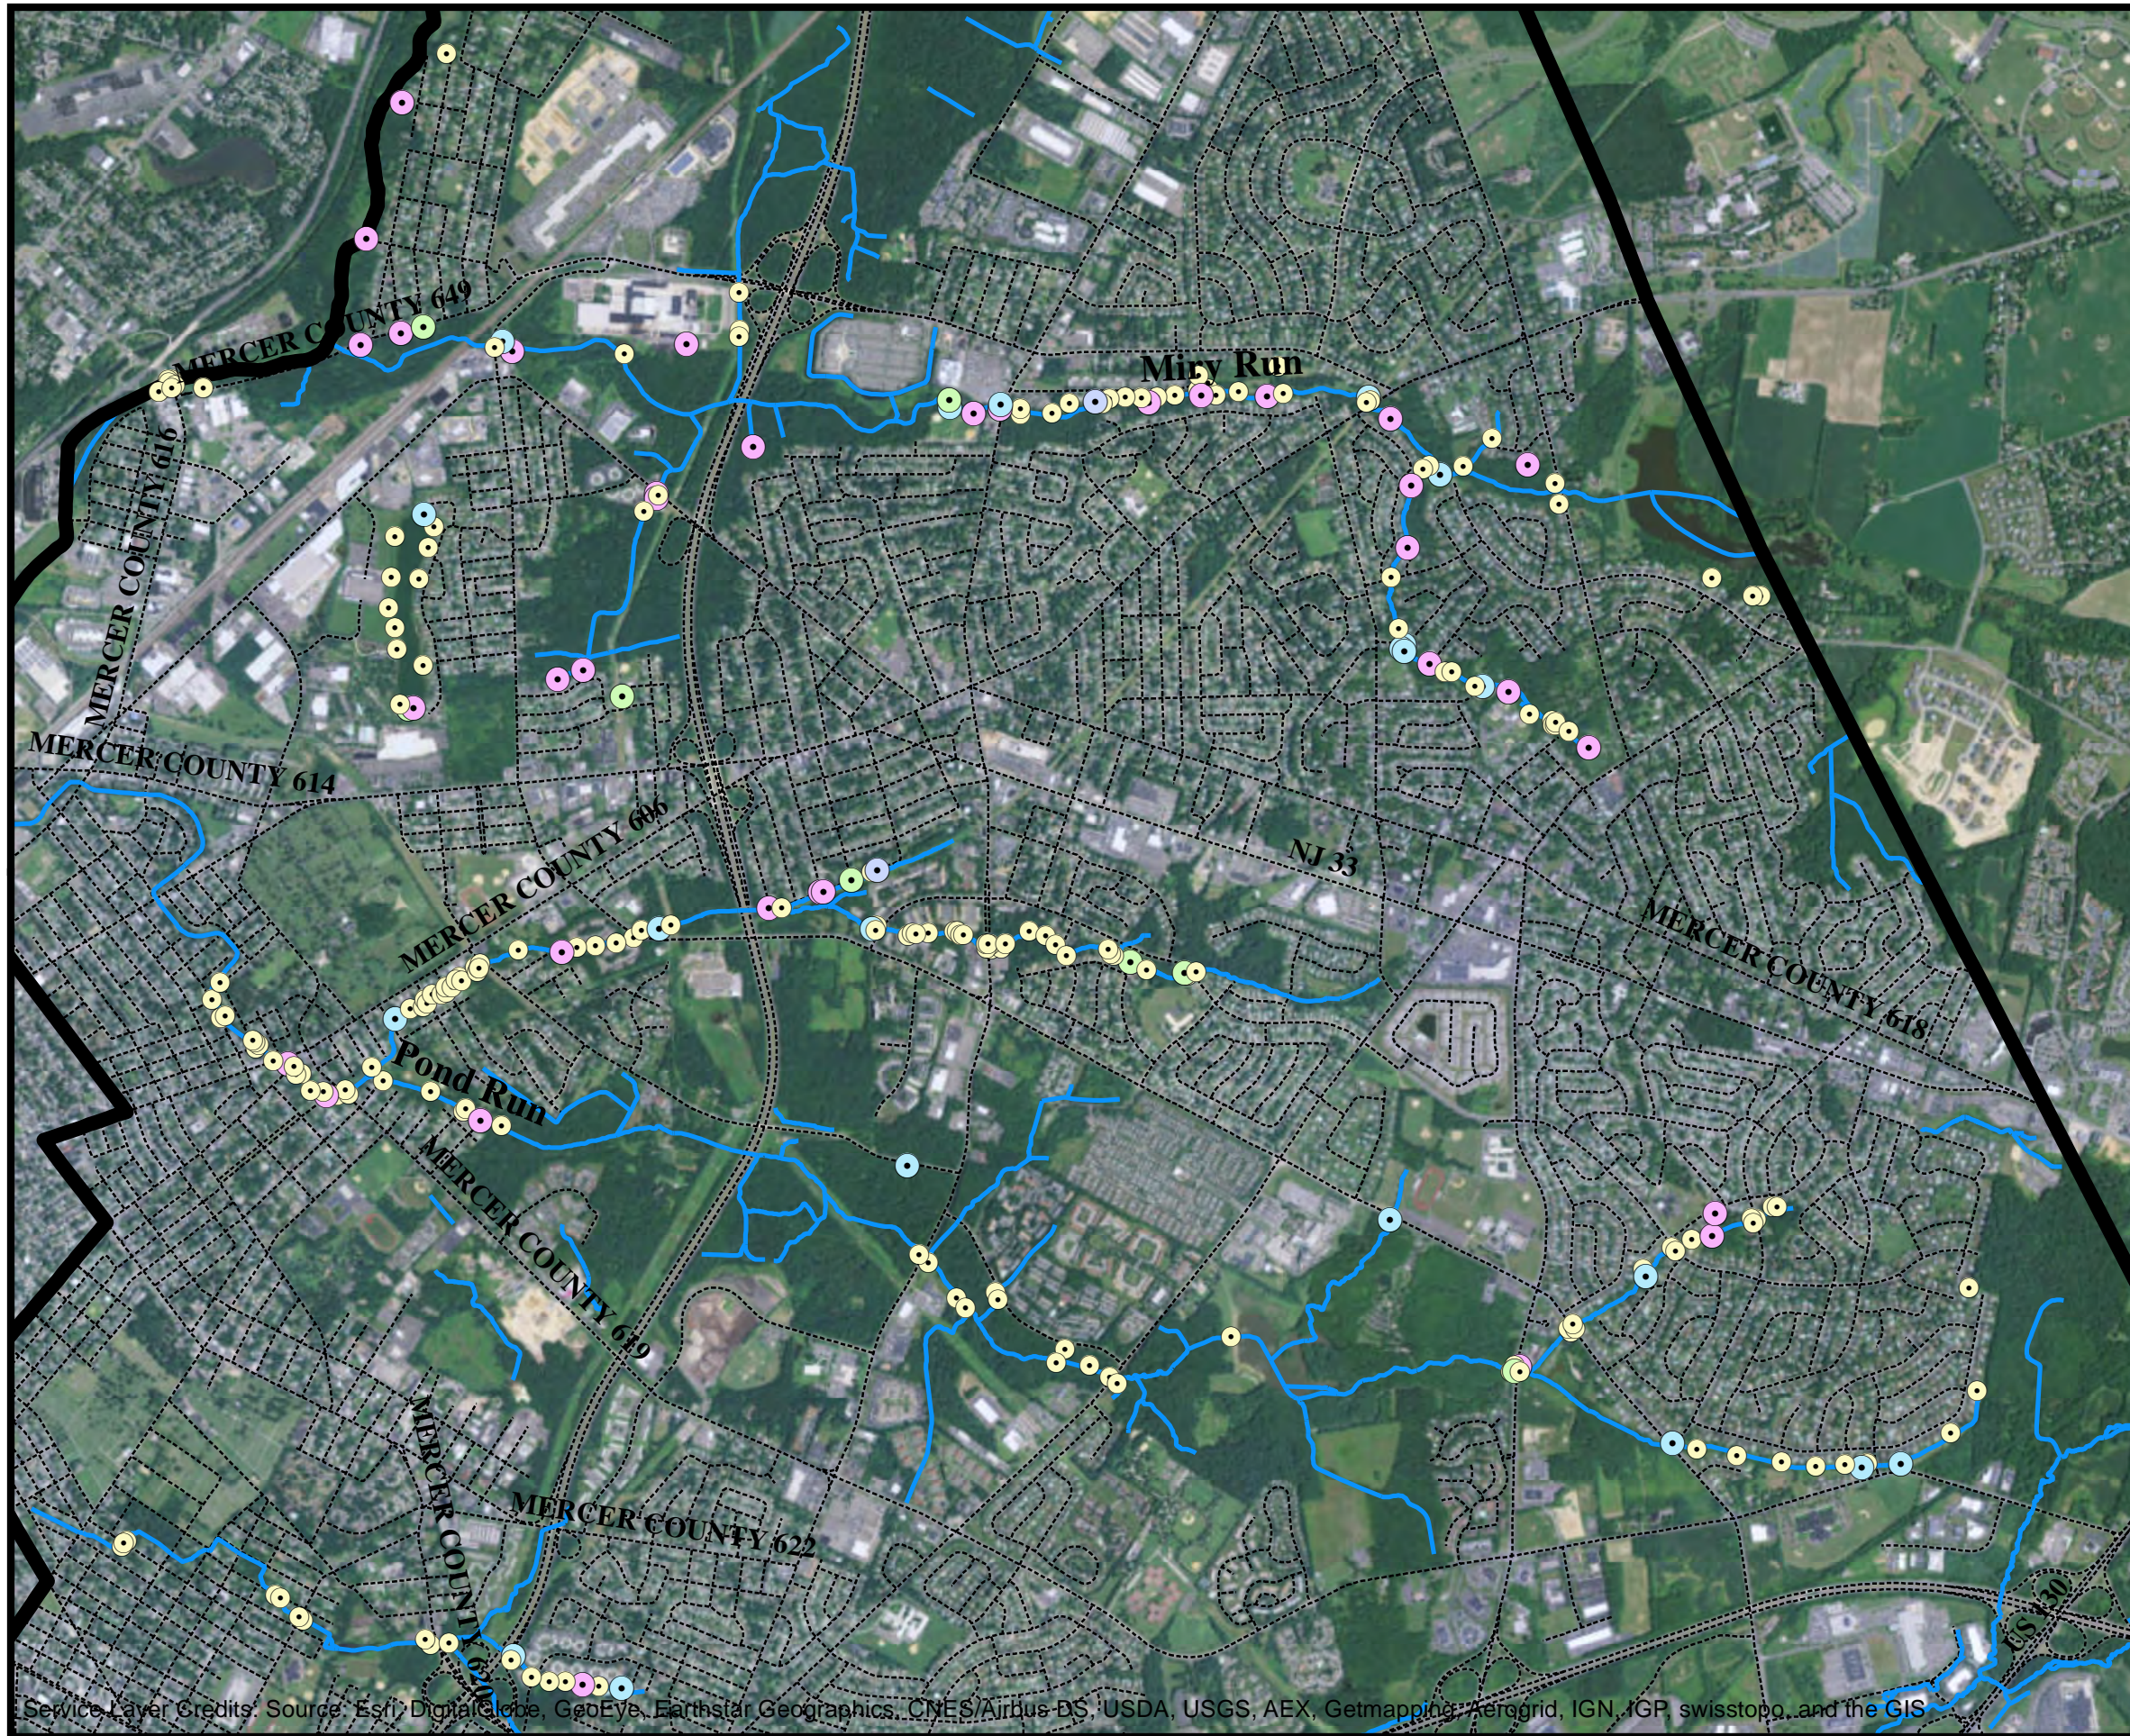
Outfall Pipe Condition

- Corrosion: 8
- Cracking: 34
- Peeling: 2
- Spalling: 21
- Normal: 198

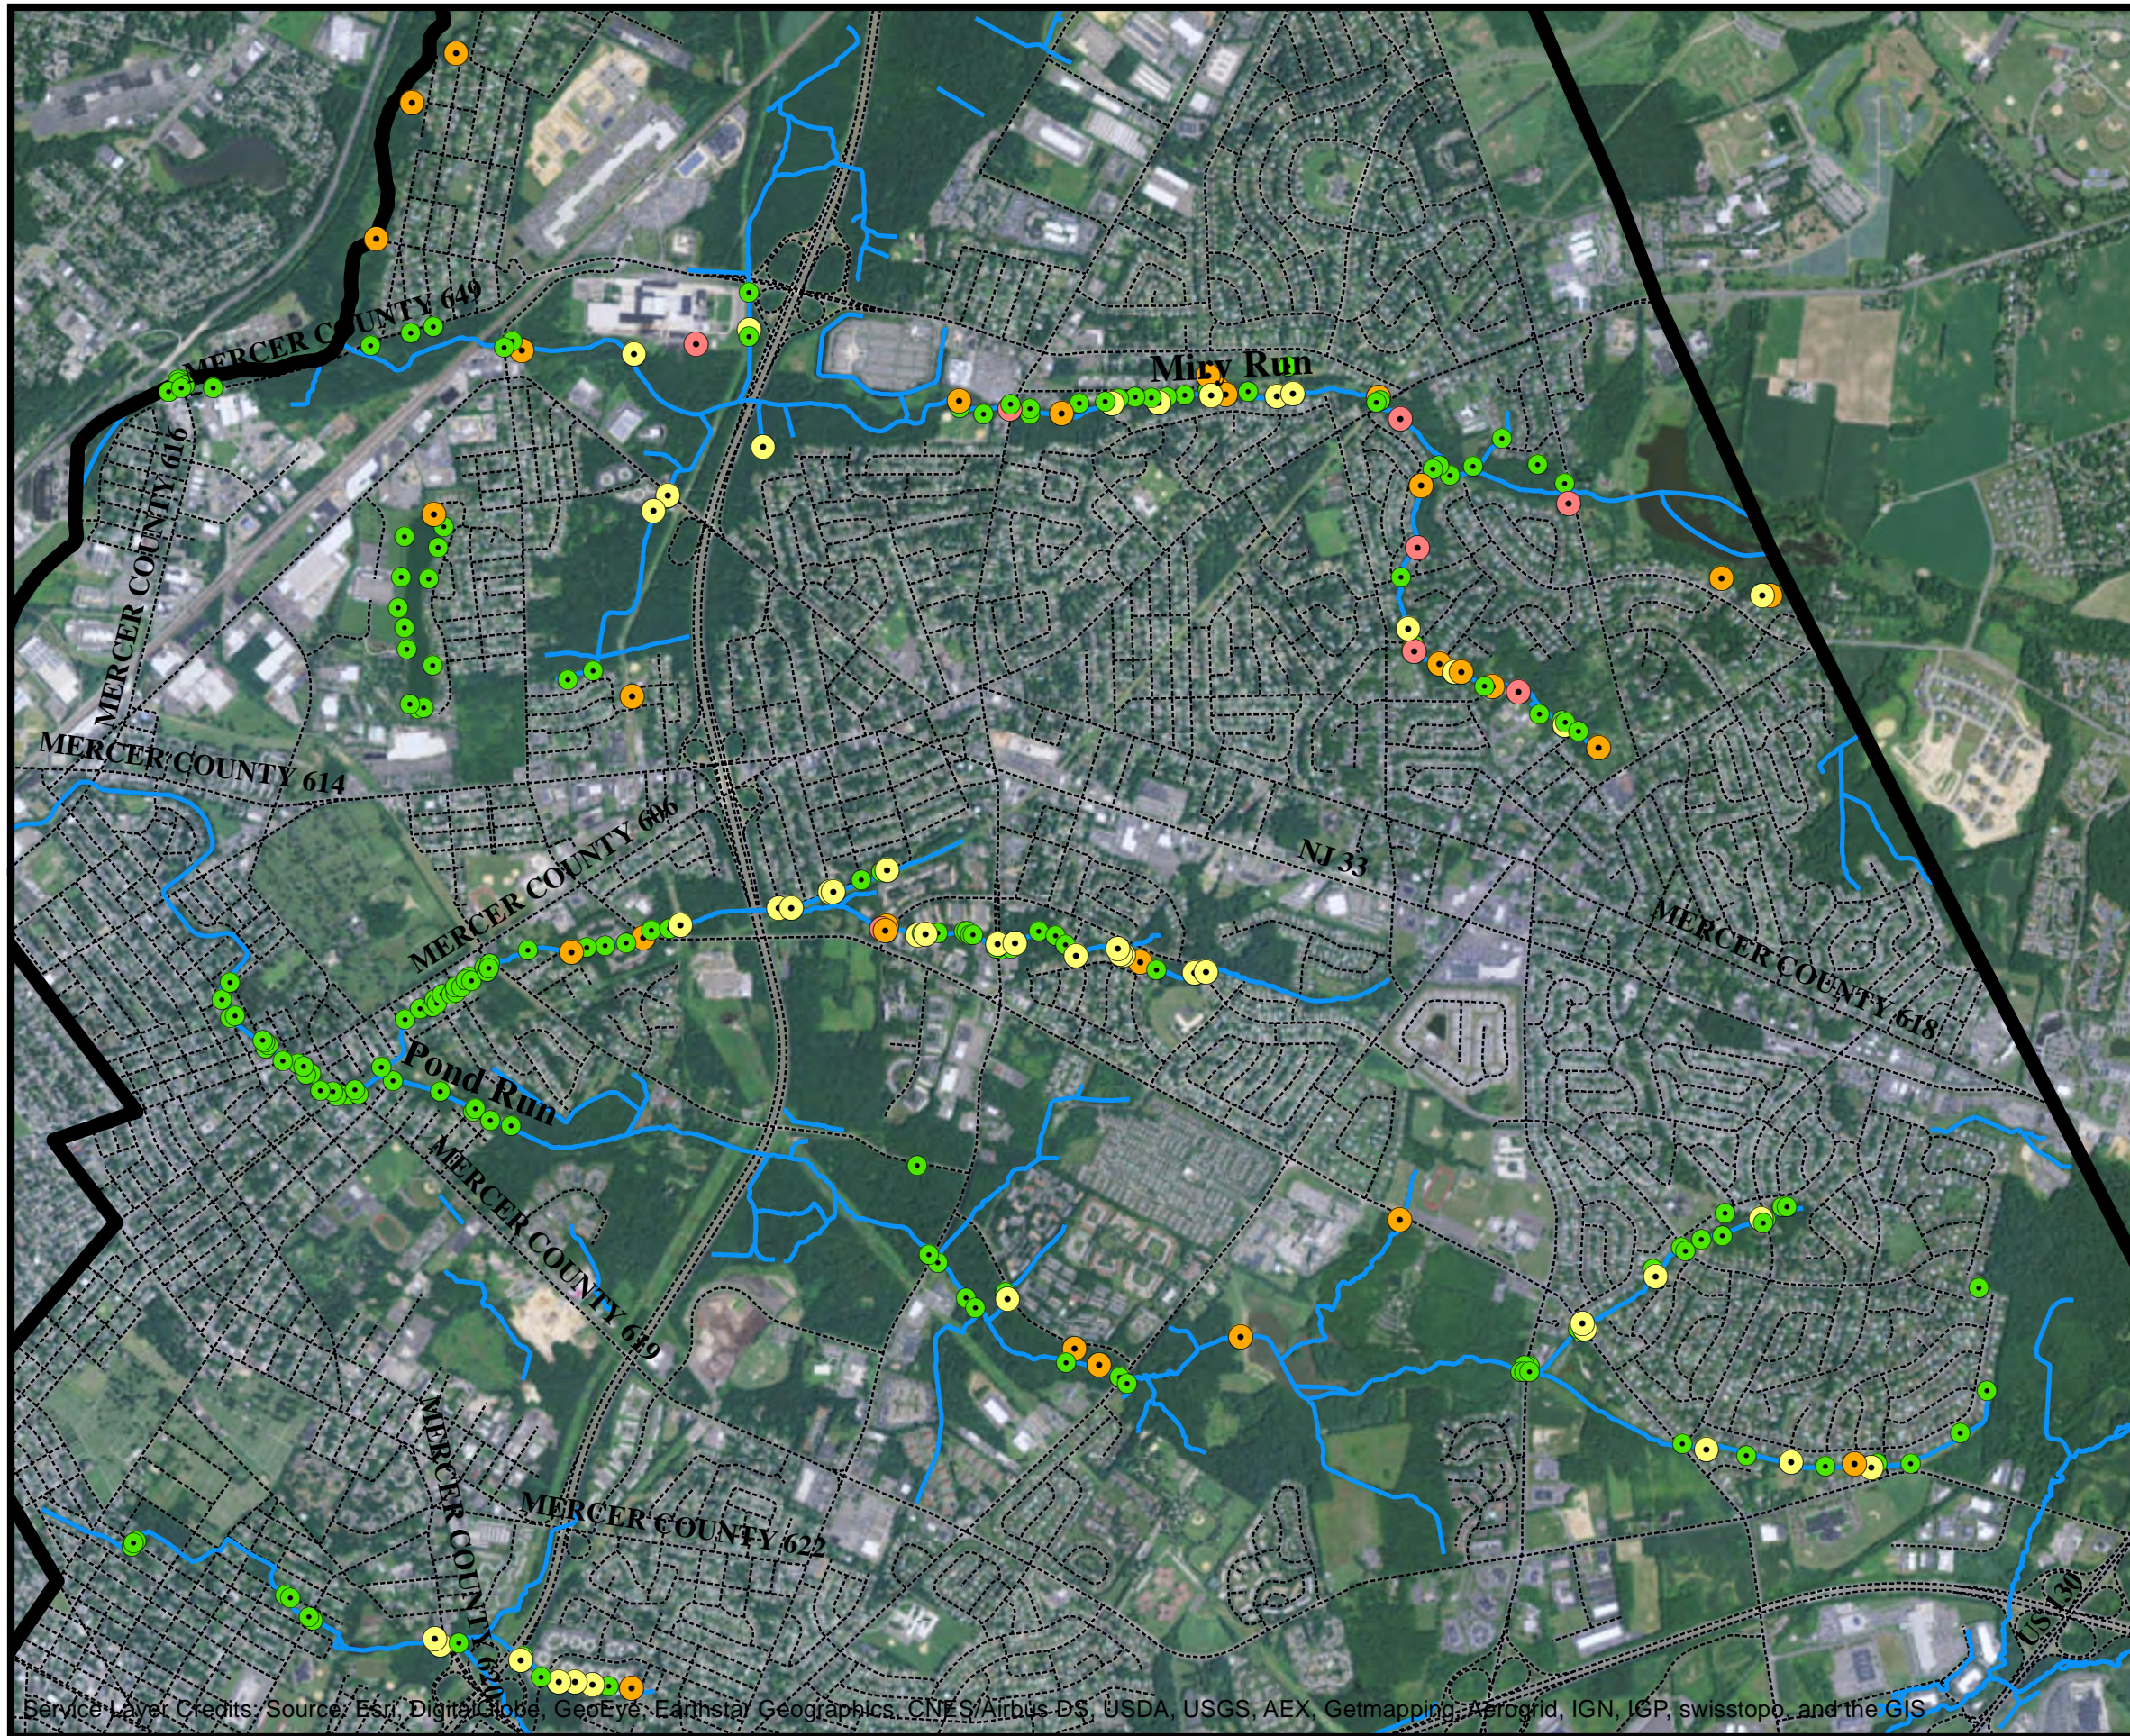
Downstream Erosion

- High: 8
- Medium: 30
- Low: 43
- None: 182

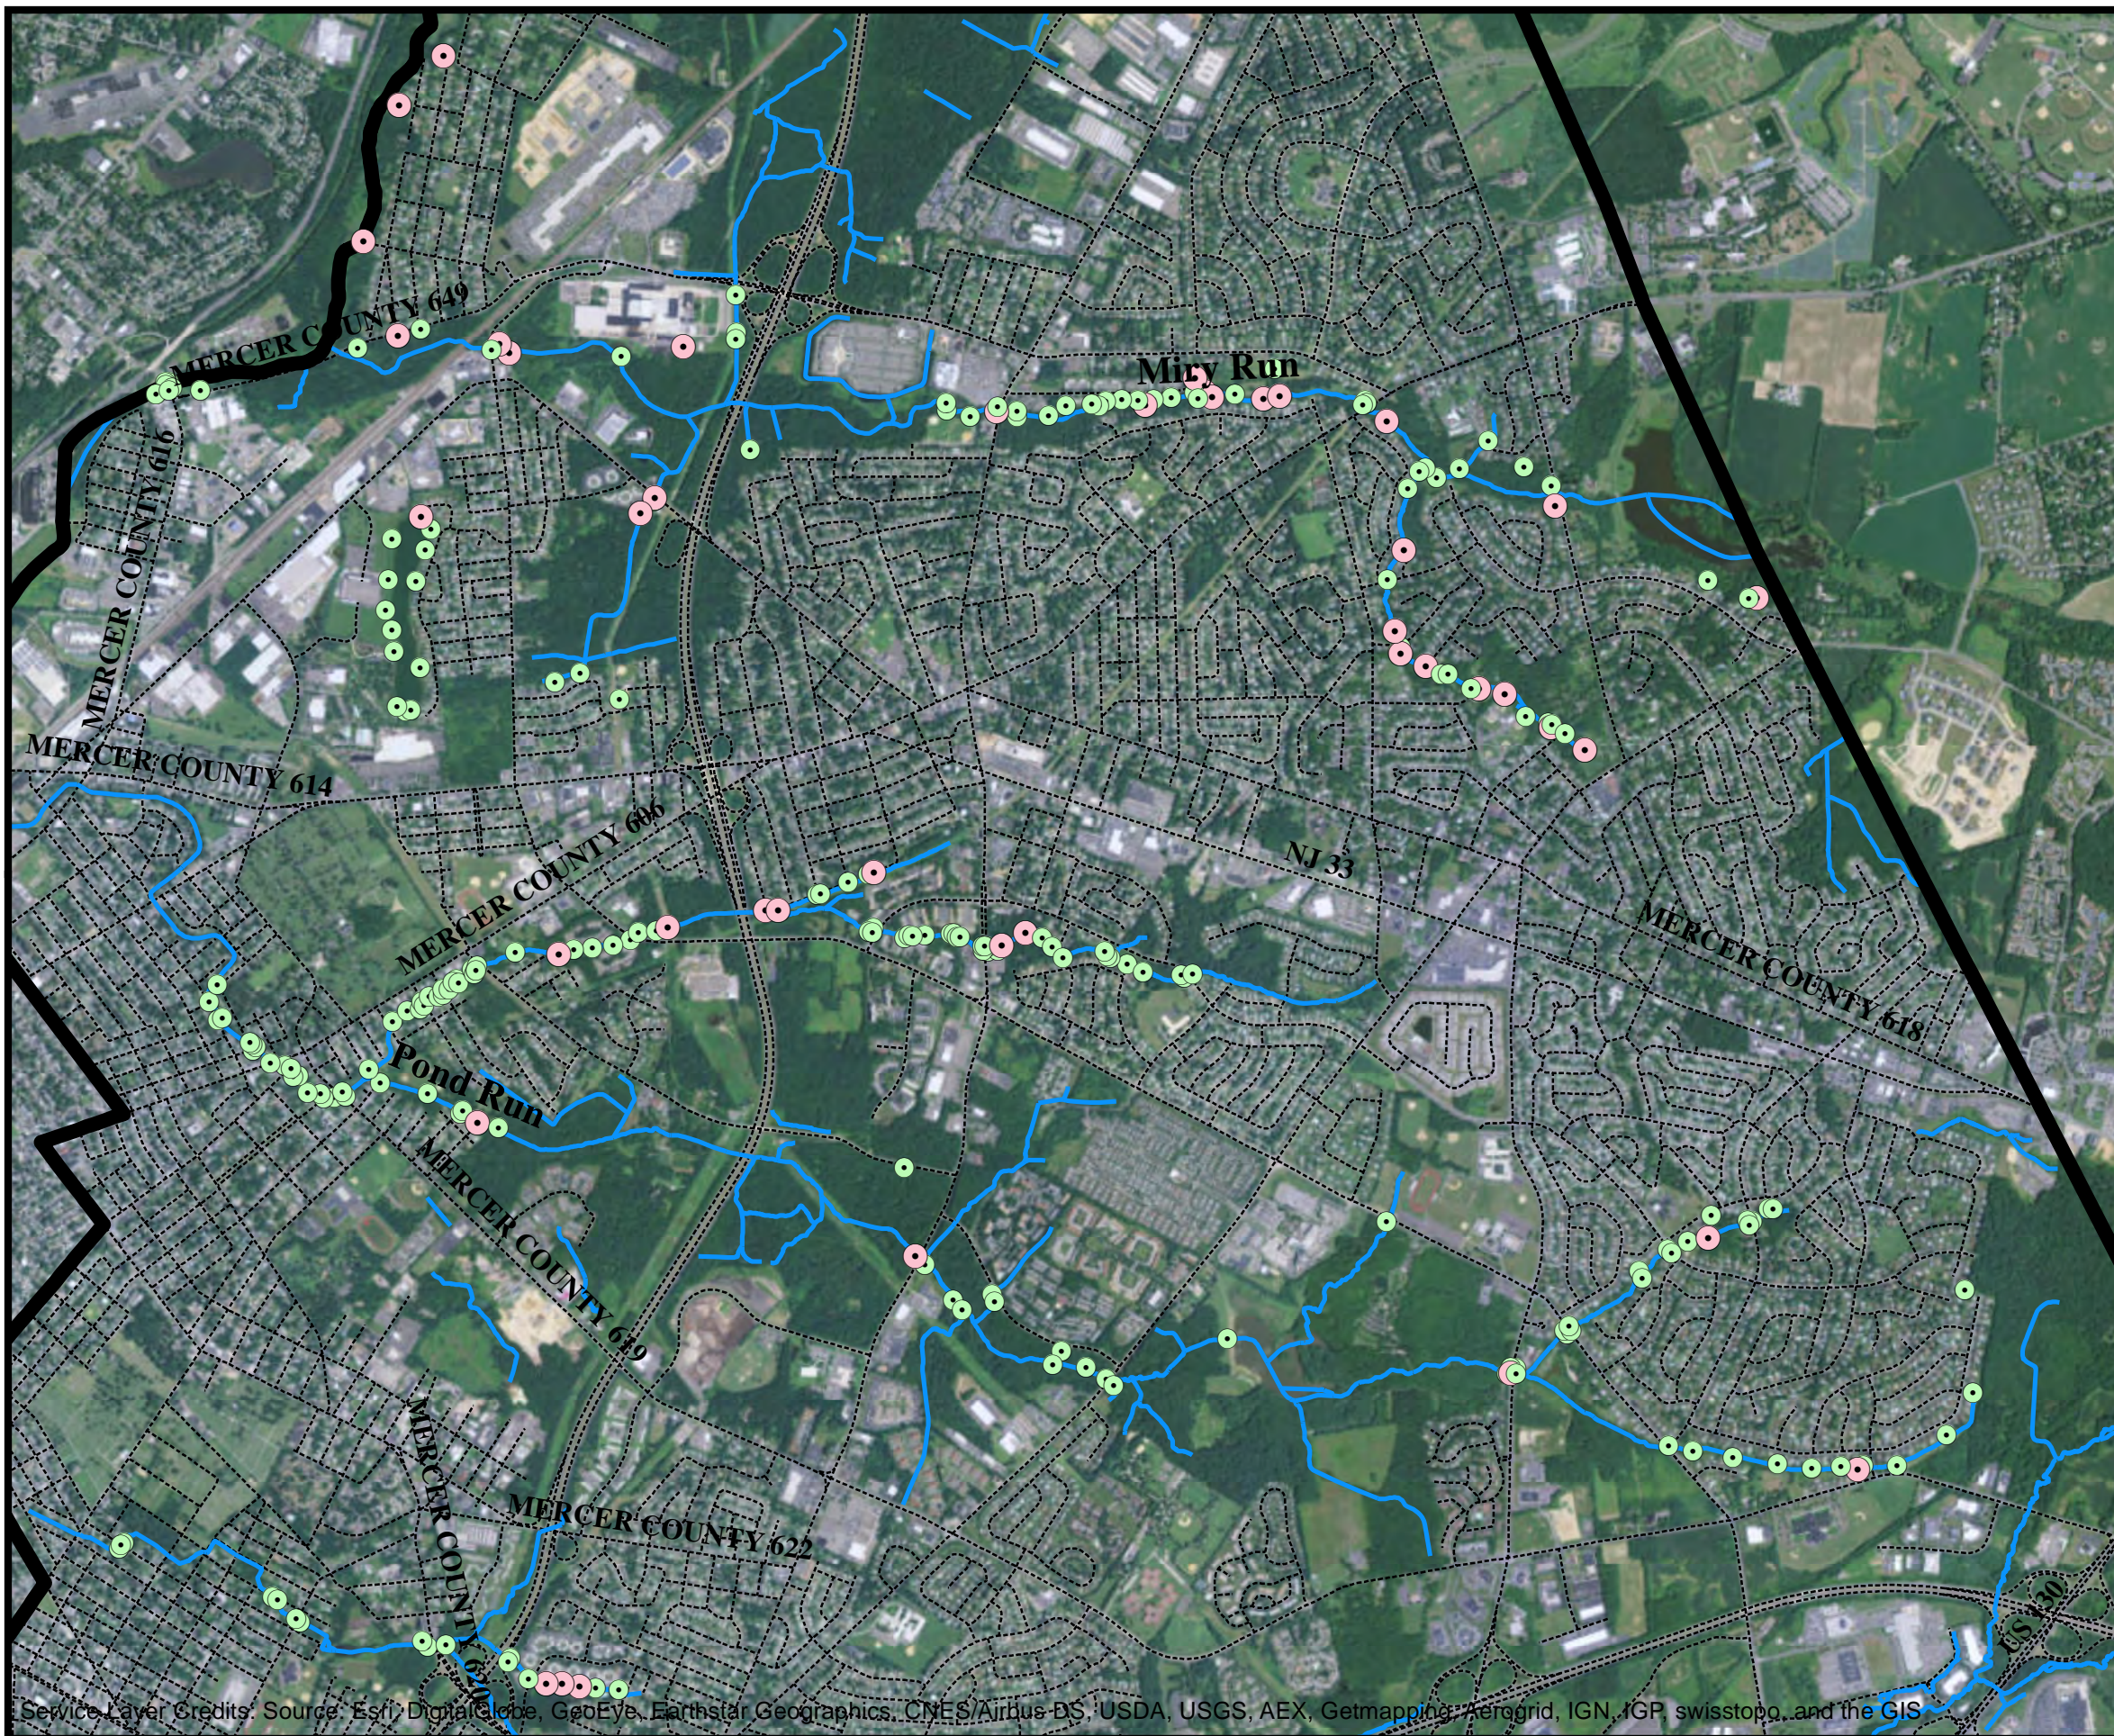
Outfall Stability

- ◉ Unstable: 43
- ◉ Stable: 218
