Appendix C
Concept Plans for Potential Green Infrastructure Projects

LAMINGTON RIVER WATERSHED: GREEN INFRASTRUCTURE SITES

1. CANFIELD AVENUE ELEMENTARY SCHOOL

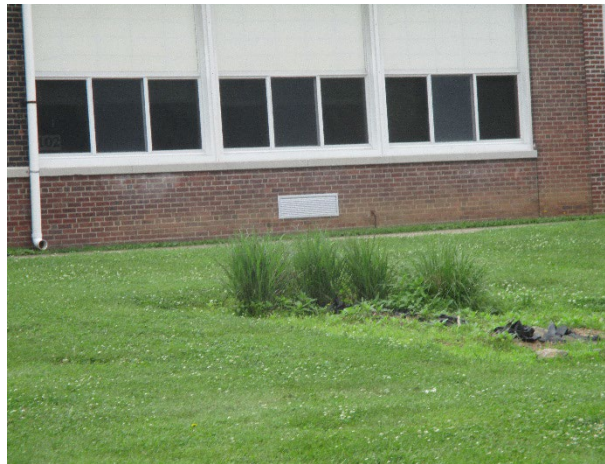
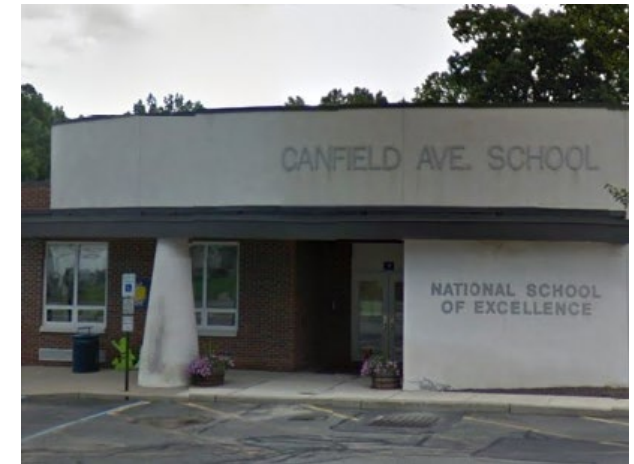
A rain garden can be installed near the disconnected downspouts to capture, treat, and infiltrate rooftop runoff. A preliminary soil assessment suggests that more soil testing would be required before determining the soil's suitability for green infrastructure.

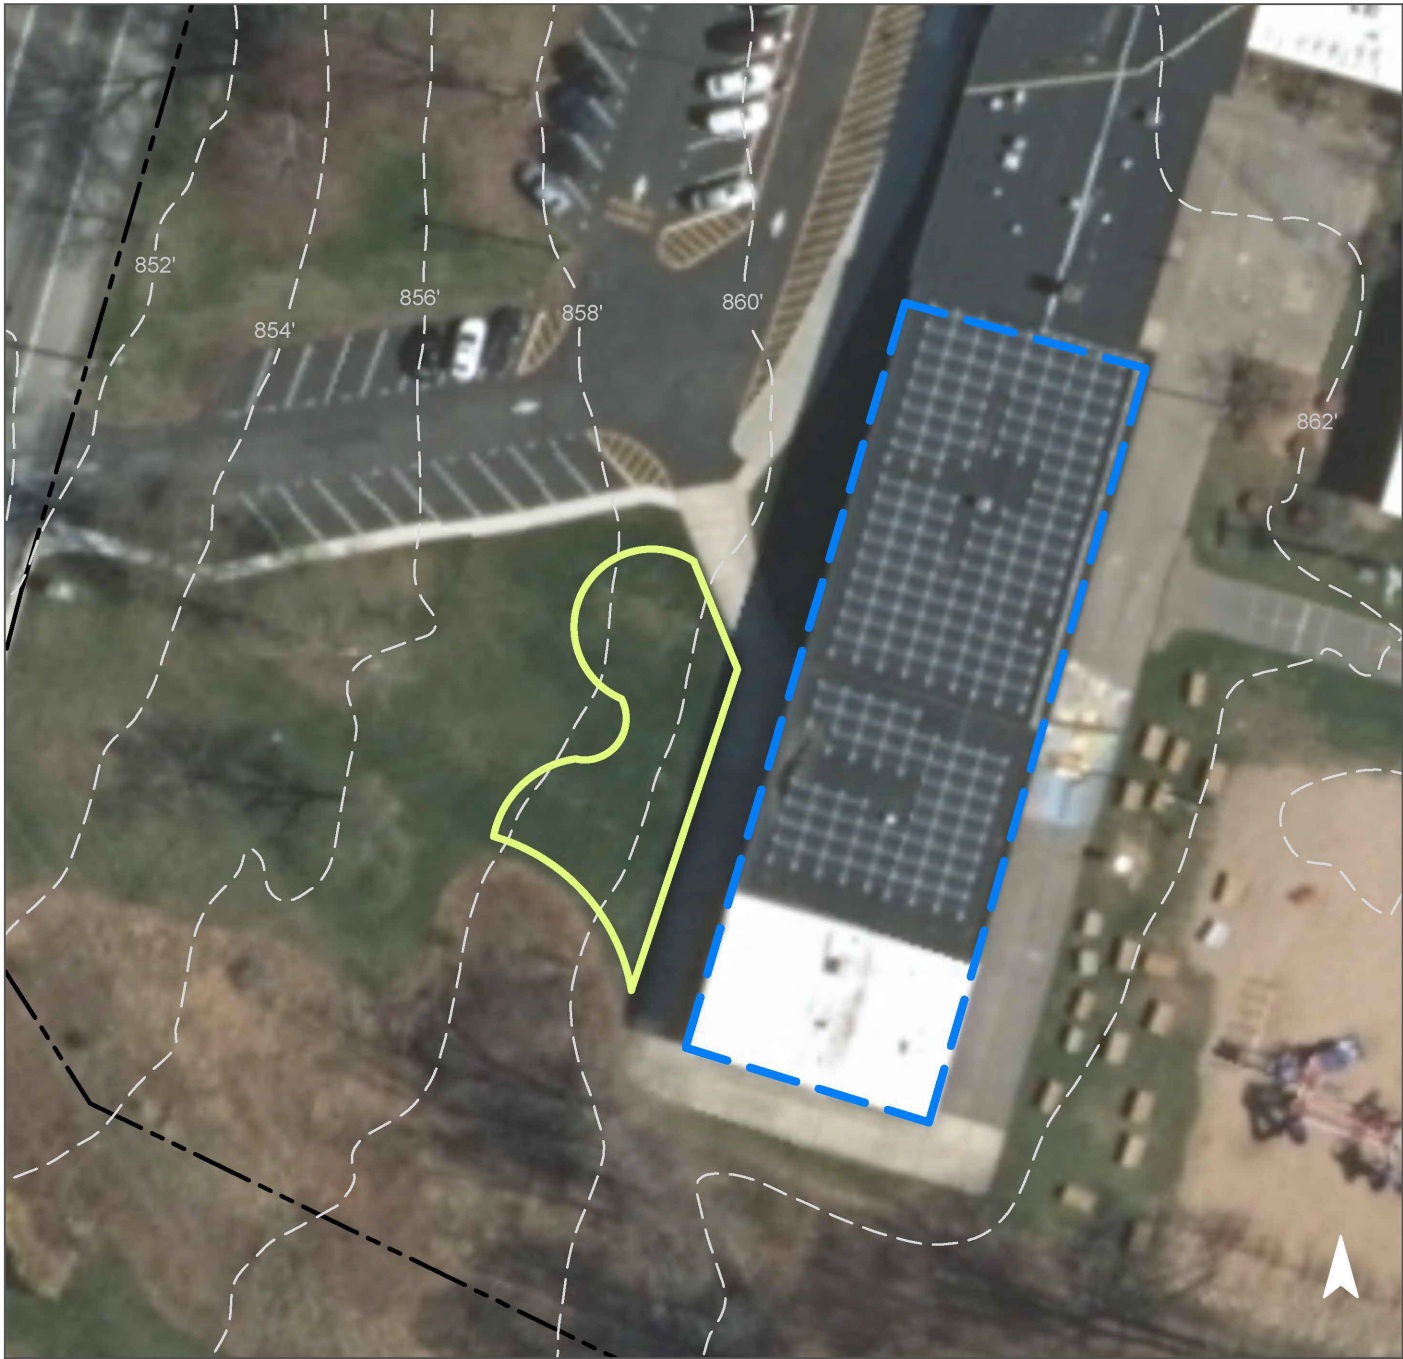
**Canfield Avenue
Elementary School**

bioretention system
-

drainage area
-

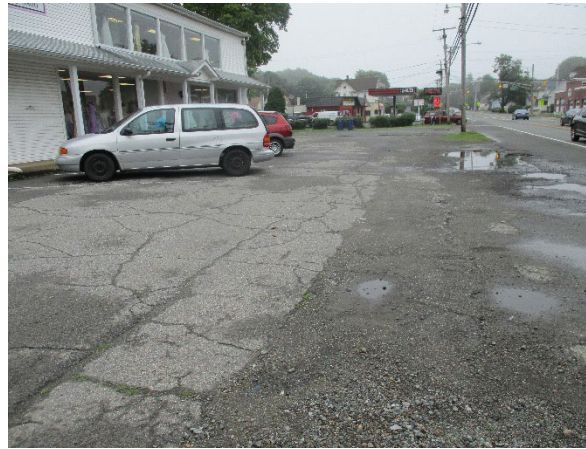
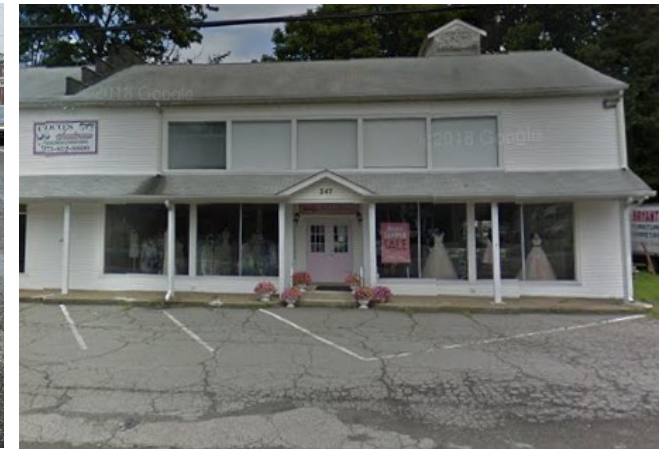
Pervious pavement can be installed on a parking strip south of the building to capture and infiltrate stormwater. A preliminary soil assessment suggests that the soils have suitable drainage characteristics for green infrastructure.

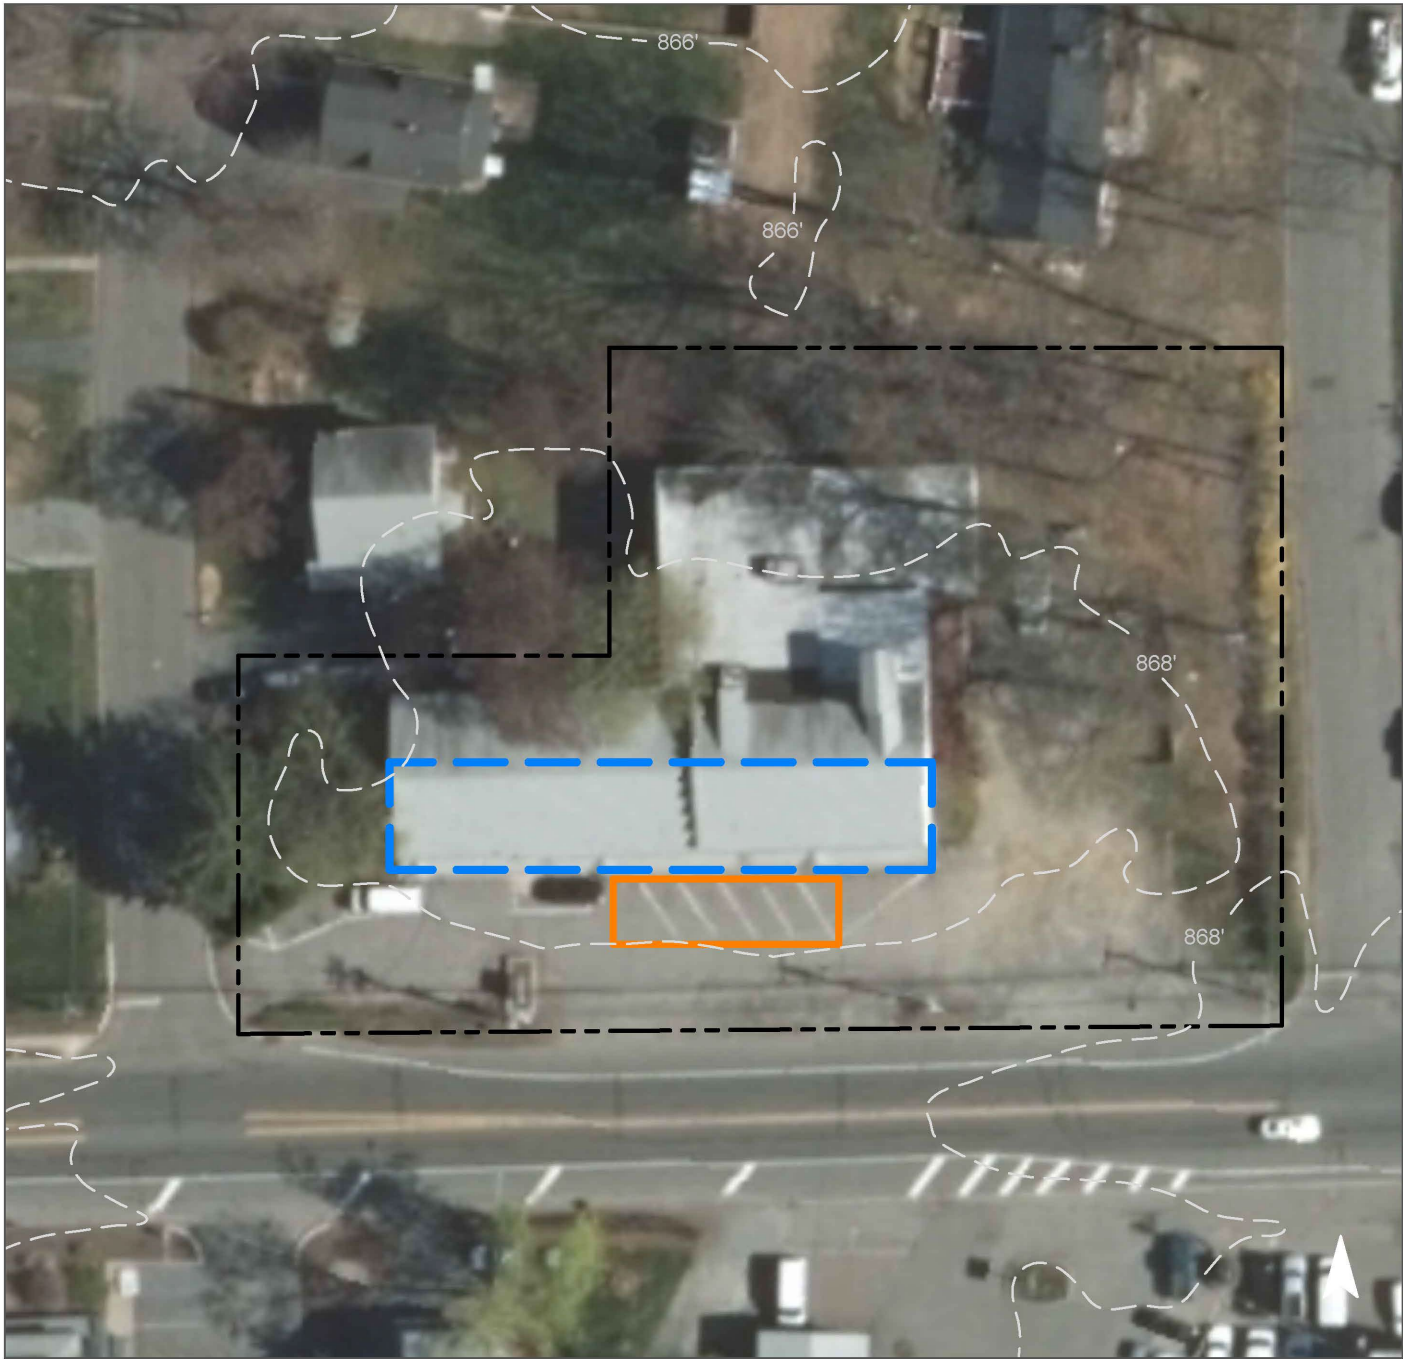
Coco's Chateau

pervious pavement
-

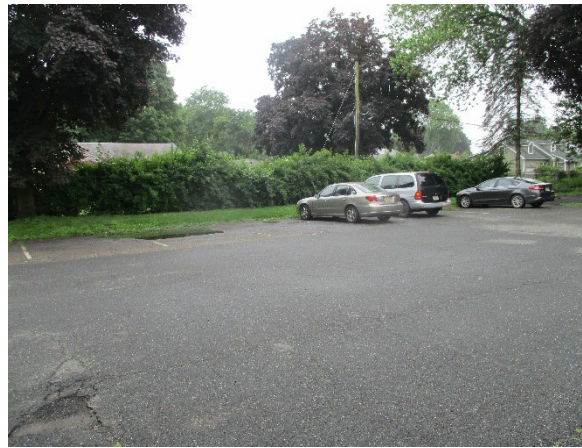
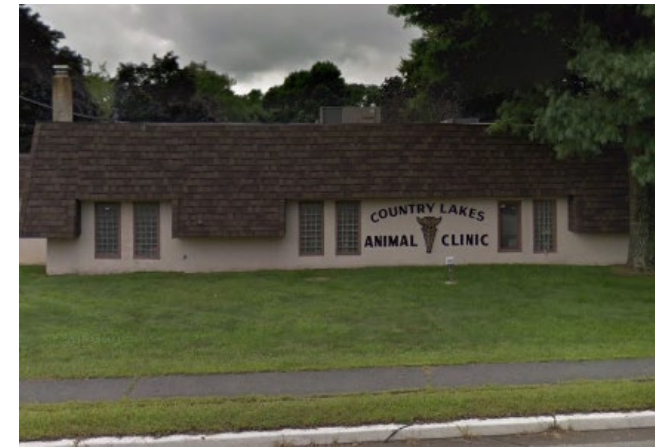
Parking spaces south of the building can be replaced with pervious pavement to capture and infiltrate stormwater. A preliminary soil assessment suggests that more soil testing would be required before determining the soil's suitability for green infrastructure.

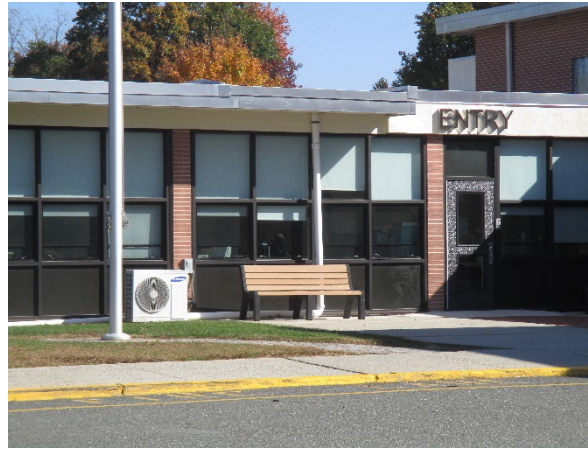
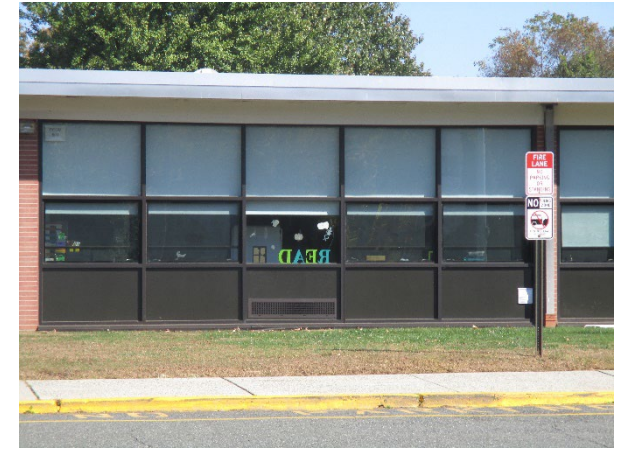
Rain gardens can be installed at the entrances of both buildings near downspouts to capture, treat, and infiltrate rooftop runoff. Another rain garden can be installed in the turfgrass area near a catch basin to capture water from the parking lot. A section of parking spaces can be converted to porous pavement to capture and infiltrate runoff from the parking lot. A preliminary soil assessment suggests that more soil testing would be required before determining the soil's suitability for green infrastructure.

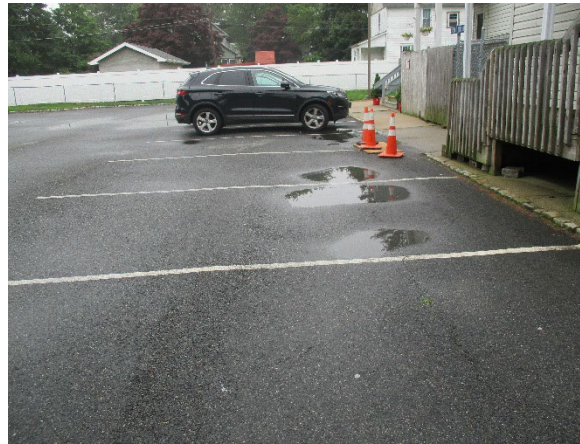
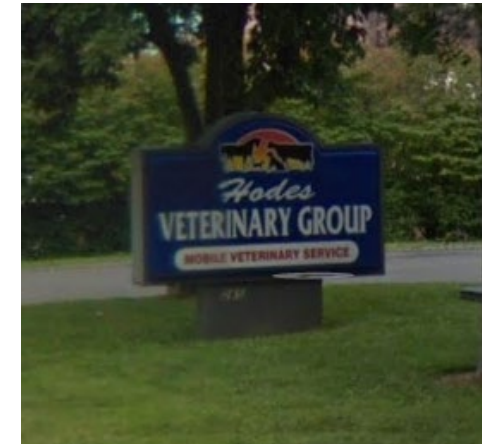
Pervious pavement can be installed on the north side of the building to capture and infiltrate stormwater. A preliminary soil assessment suggests that the soils have suitable drainage characteristics for green infrastructure.

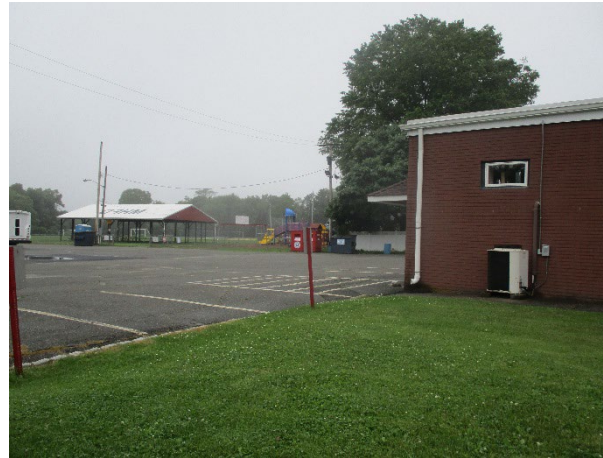
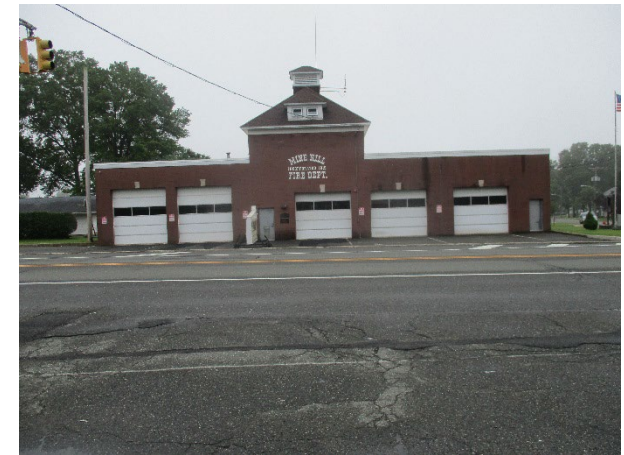
A rain garden can be installed on the west side of the building to capture, treat, and infiltrate rooftop runoff. Pervious pavement can be installed on the south parking strip to store stormwater runoff and allow it to slowly infiltrate into the ground. A cistern can be installed on the east side of the building near a disconnected downspout so the water can be used for watering gardens, washing vehicles, or for other non-potable uses. A preliminary soil assessment suggests that more soil testing would be required before determining the soil's suitability for green infrastructure.

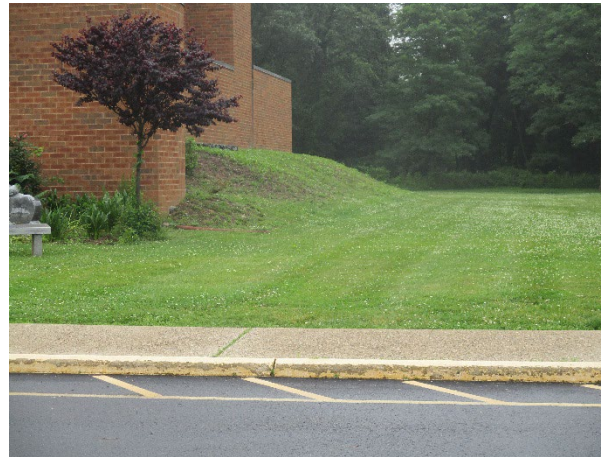
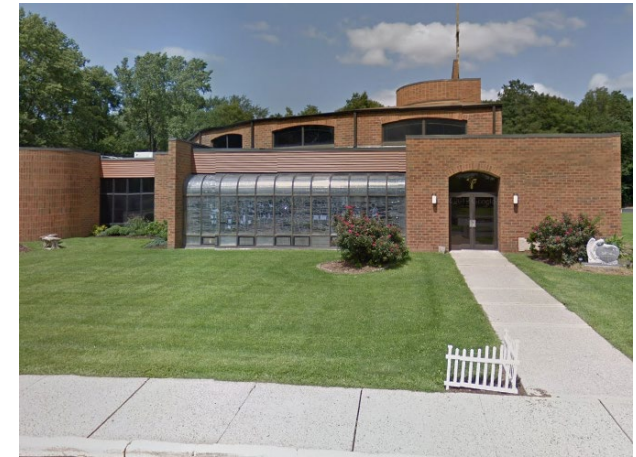
A rain garden can be installed on the east side of the building to capture, treat, and infiltrate rooftop runoff. A preliminary soil assessment suggests that more soil testing would be required before determining the soil's suitability for green infrastructure.

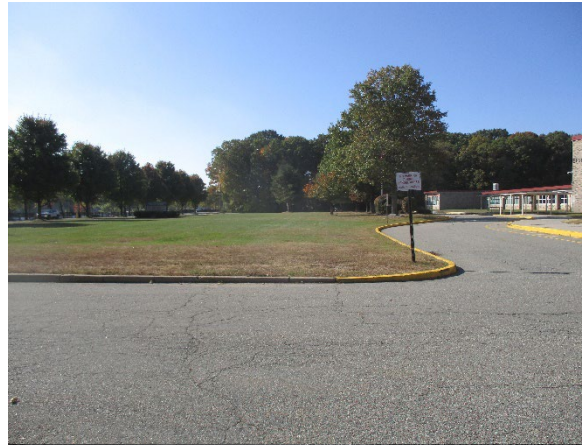
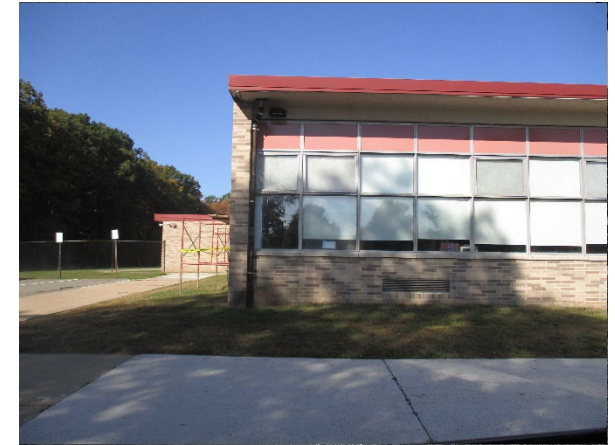
Three rain gardens can be installed to capture, treat, and infiltrate runoff from rooftops and paved areas. Parking spaces can be replaced with pervious pavement to capture and infiltrate stormwater runoff from the parking lot areas. A cistern can be installed to capture roof runoff from a maintenance shed. A preliminary soil assessment suggests that more soil testing would be required before determining the soil's suitability for green infrastructure.

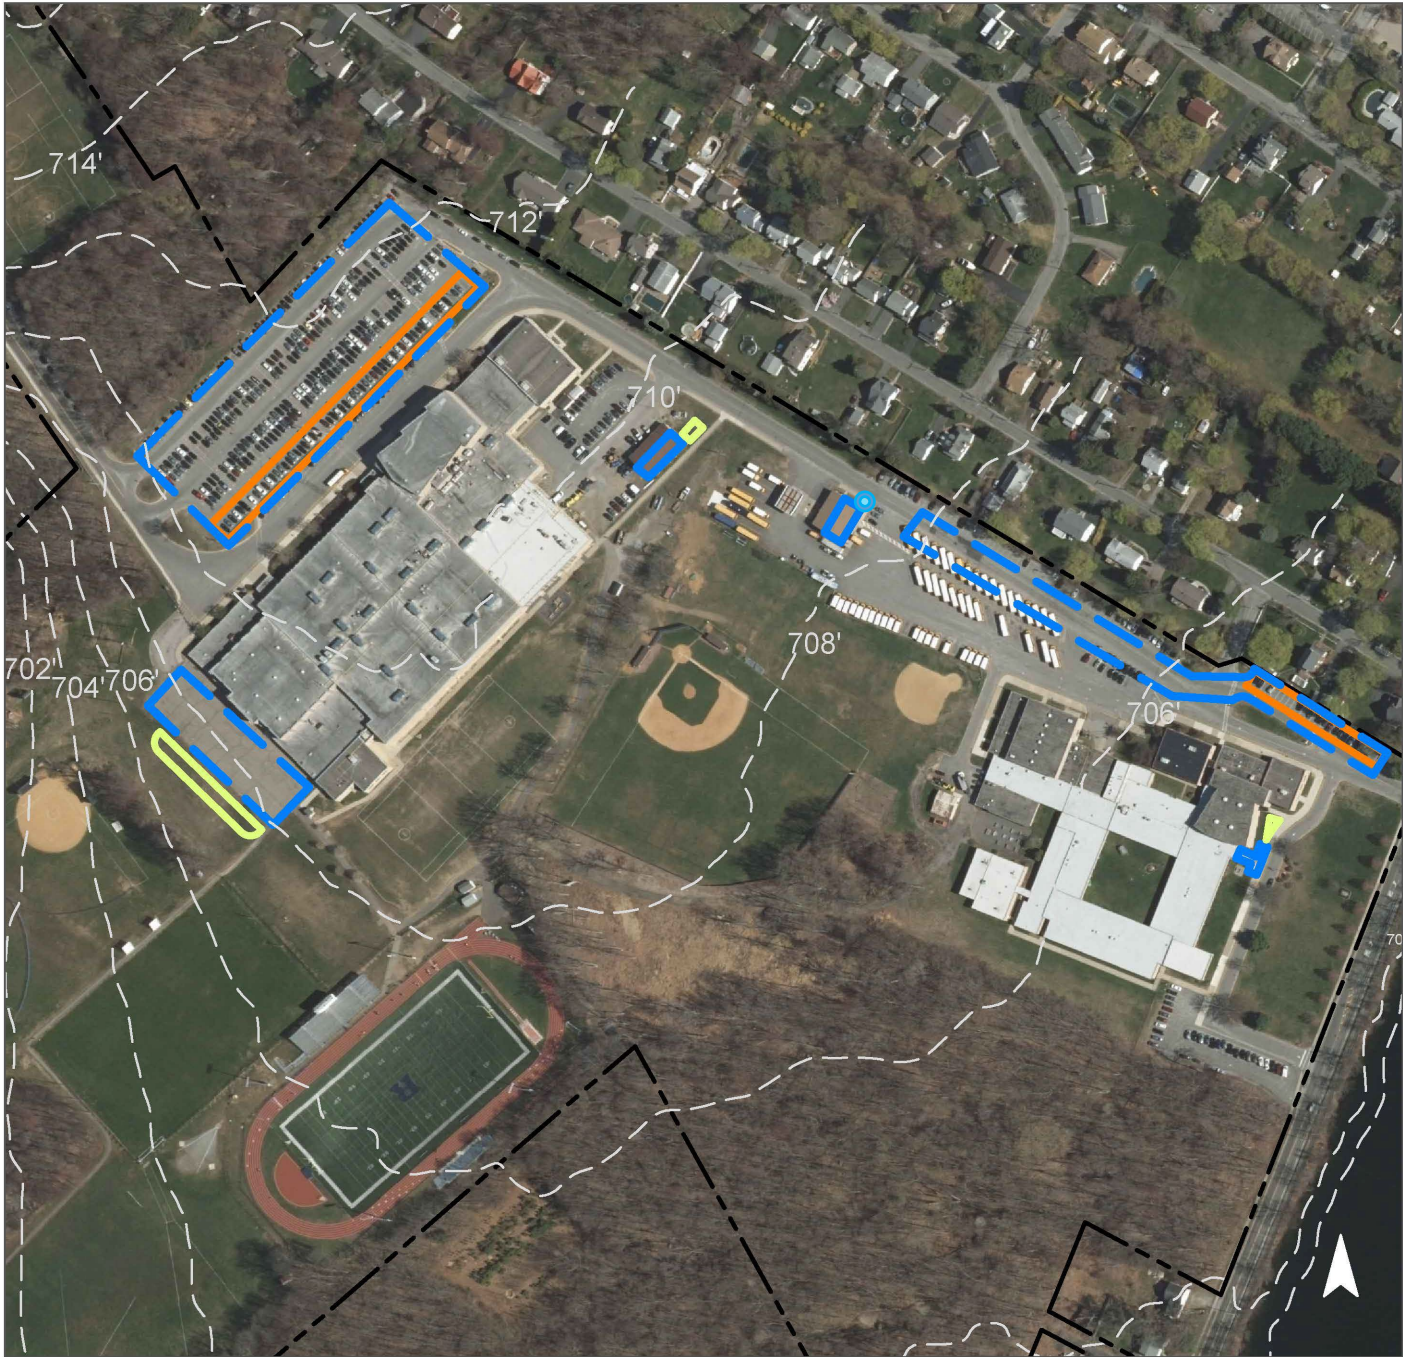
Eisenhower Middle School & Roxbury High School

- bioretention system
- pervious pavement
- rainwater harvesting
- drainage area
- property line
- 2015 Aerial: NJOIT, OGIS

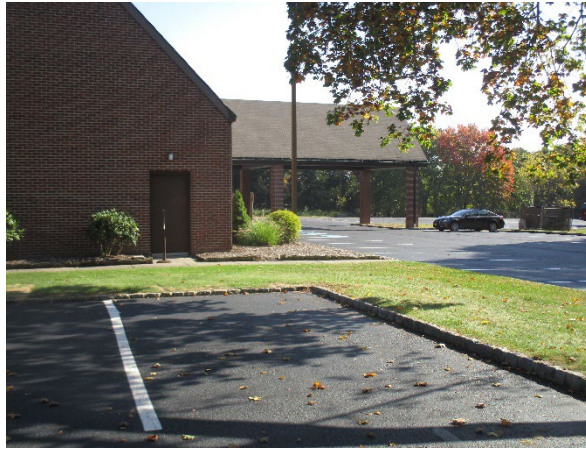
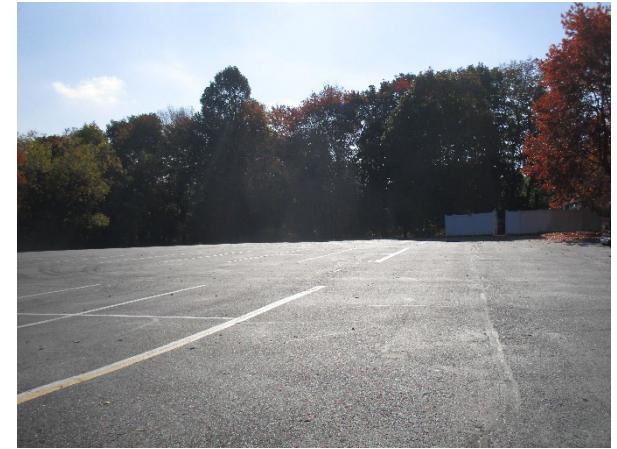
Rain gardens can be installed north and west of the building near downspouts to capture, treat, and infiltrate rooftop runoff. Another rain garden can be installed near the parking lot to capture runoff from the road. Parking spaces can be replaced with pervious pavement to capture and infiltrate stormwater runoff from the parking lot. A preliminary soil assessment suggests that more soil testing would be required before determining the soil's suitability for green infrastructure.

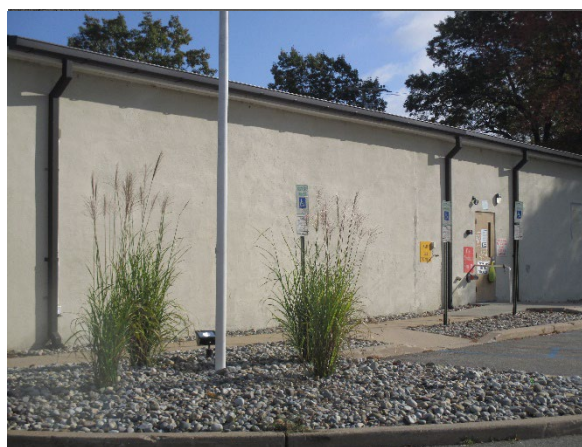
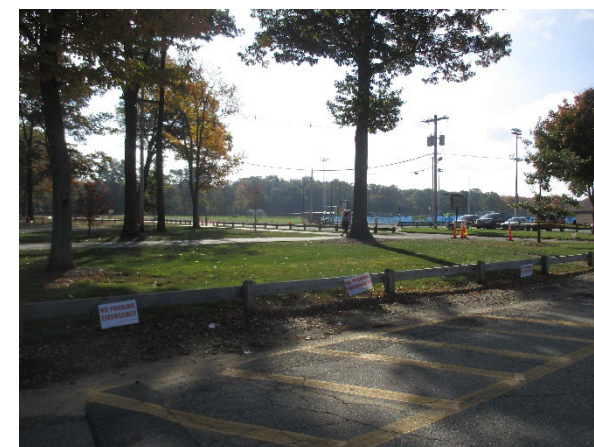
There are four downspouts along the north side of the building where downspout planter boxes can be installed. A rain garden can be installed at end of the parking lot that will capture stormwater from the parking lot. Another rain garden can be installed on the north side of the building near downspouts. Pervious pavement can be installed to capture and infiltrate runoff from the southern parking lot. A preliminary soil assessment suggests that more soil testing would be required before determining the soil's suitability for green infrastructure.

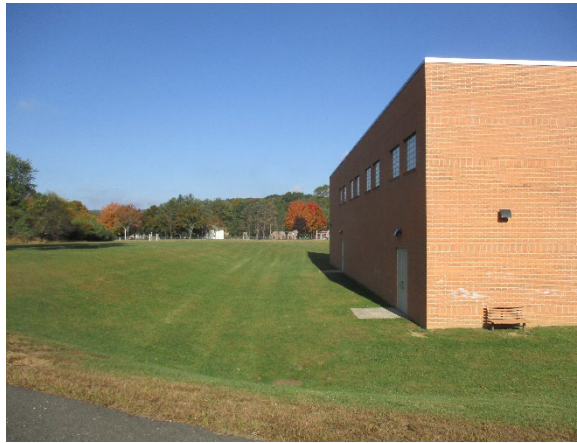
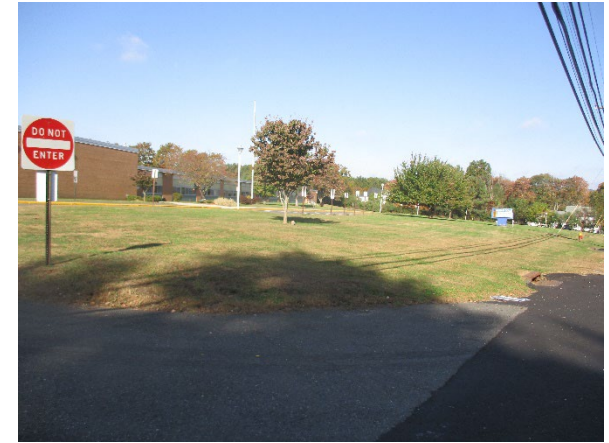
Two rains gardens can be installed in the turfgrass in front of the building to capture, treat, and infiltrate roadway runoff. Another rain garden can be installed south of the building to capture runoff from the basketball court. Pervious pavement can be installed in the parking lot to capture and infiltrate stormwater runoff from the parking lot. A preliminary soil assessment suggests that more soil testing would be required before determining the soil's suitability for green infrastructure.

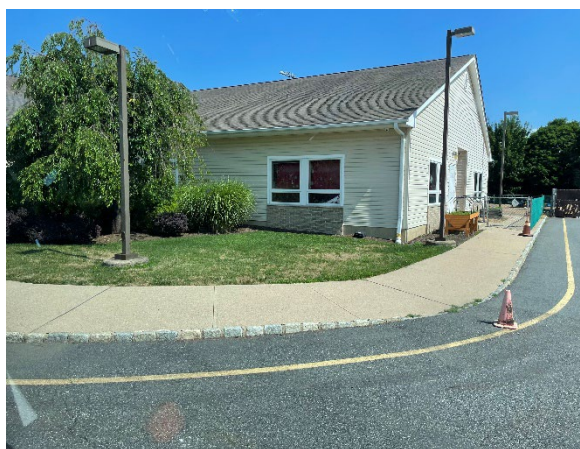
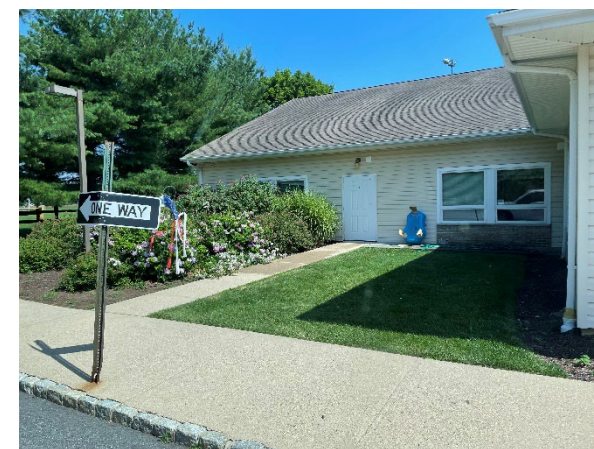
Parking spaces in the lot to the south of the building can be converted to porous pavement to capture and infiltrate stormwater runoff from the asphalt using trench drains for redirection. Two rain gardens requiring downspout disconnection can be installed in the grass areas near the entrance of the building to capture, treat, and infiltrate stormwater runoff from the roof. A rain garden with a curb cut can be installed in the grass area east of the building to capture, treat, and infiltrate stormwater runoff from the parking lot. A preliminary soil assessment suggests that the soils have suitable drainage characteristics for green infrastructure.

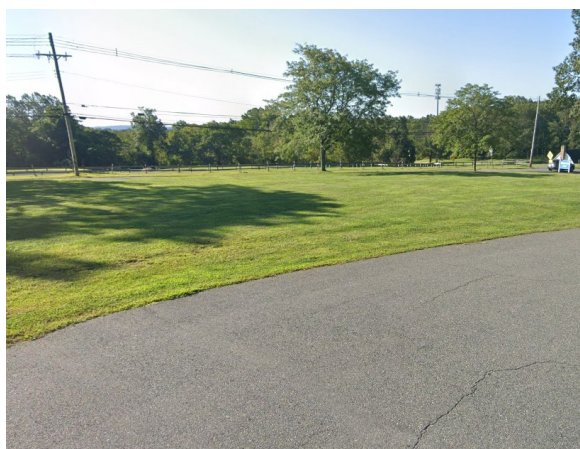
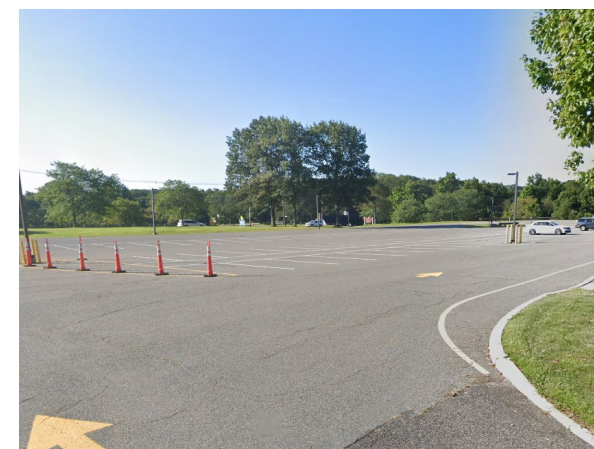
Rain gardens can be installed near the northern and southern parking lots to capture, treat, and infiltrate the stormwater runoff from the asphalt. This will require downspout disconnections. Existing parking spaces in the northern and southern lots can be converted into pervious pavement to capture and infiltrate the stormwater runoff from the asphalt. The basketball court to the north of the school can also be converted into pervious pavement. A preliminary soil assessment suggests that the soils have suitable drainage characteristics for green infrastructure.

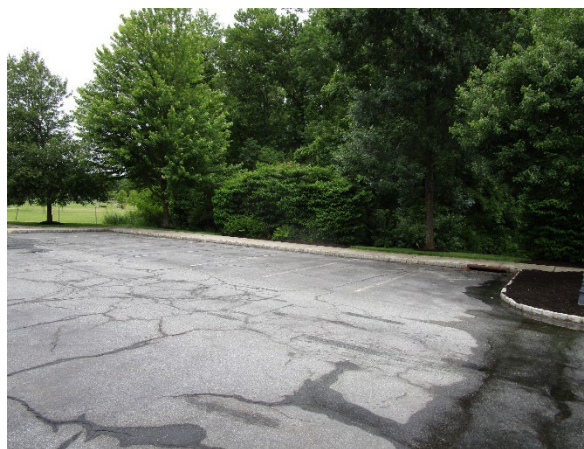
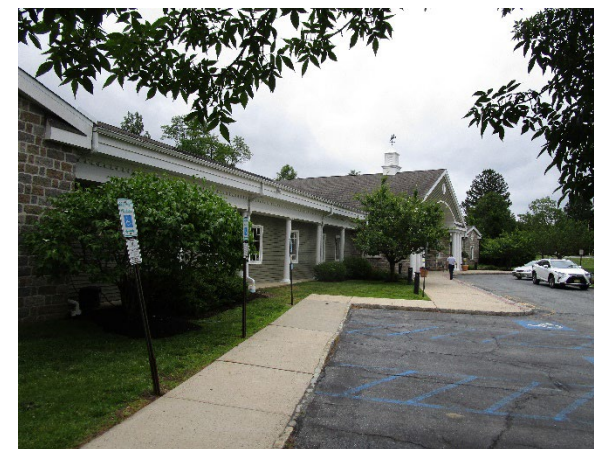
Parking spaces in the parking lot to the west of the building can be converted to porous pavement to capture and infiltrate stormwater runoff from the parking lot, before it enters the nearby storm drain. A rain garden can be installed south of the building to capture, filter, and infiltrate stormwater runoff from the roof if the front downspouts are disconnected. A preliminary soil assessment suggests that more soil testing would be required before determining the soil's suitability for green infrastructure.

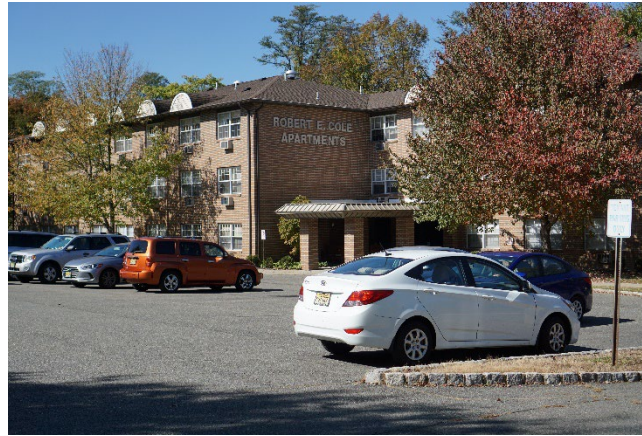
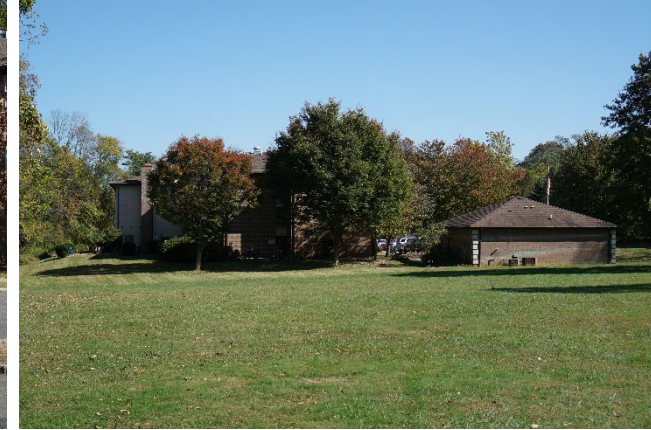
Two rain gardens can be installed west of the two buildings to accumulate and infiltrate stormwater runoff from the buildings. Additionally, porous pavement can be used to capture stormwater from the parking lot in front of the main building. A preliminary soil assessment suggests that more soil testing would be required before determining the soil's suitability for green infrastructure.

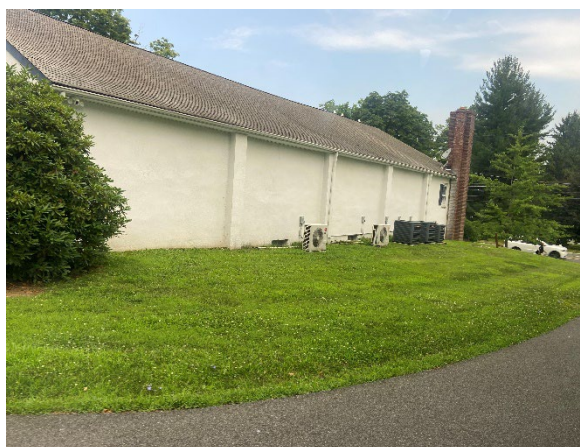
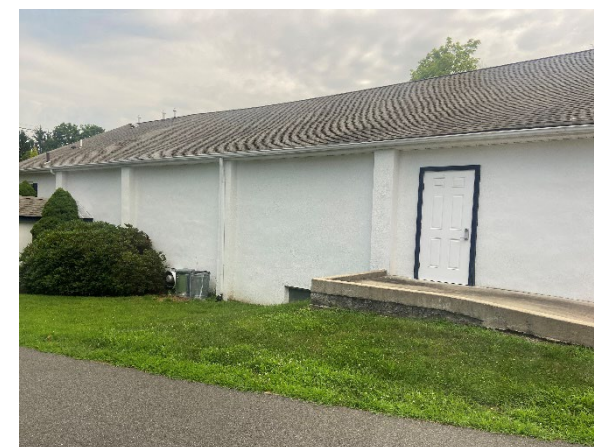
Rain gardens can be installed in multiple grass areas around the property to capture, treat, and infiltrate the stormwater runoff from the driveway and rooftop. This will require downspout disconnections, trench drains, and in some cases downspout redirection beneath the sidewalk. A cistern can be installed to the southwest of the building to divert and detain the stormwater runoff from the rooftop for later non-potable reuse such as watering a garden bed. A preliminary soil assessment suggests that the soils have suitable drainage characteristics for green infrastructure.

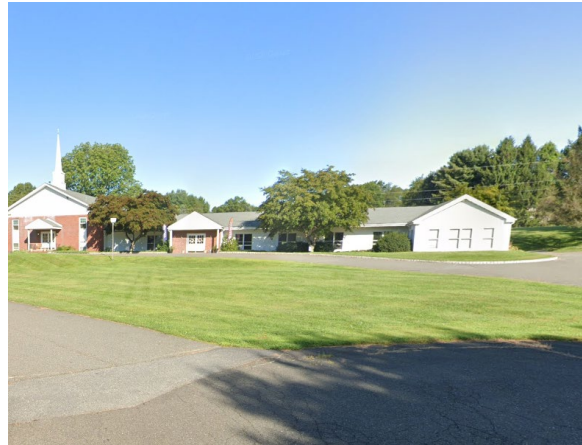
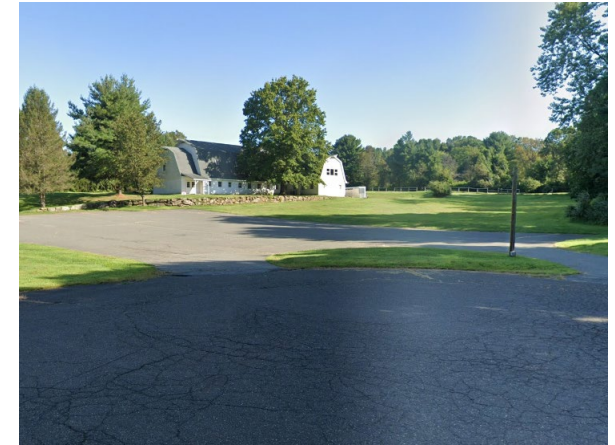
Rain gardens can be installed in multiple grass areas around the property to capture, treat, and infiltrate the stormwater runoff from the rooftop and driveways. This may require downspout disconnections, trench drains, and curb cuts. Existing parking spaces to the east of the building can be converted into pervious pavement to capture and infiltrate the stormwater runoff from the asphalt. This may require a trench drain. A preliminary soil assessment suggests that the soils have suitable drainage characteristics for green infrastructure.

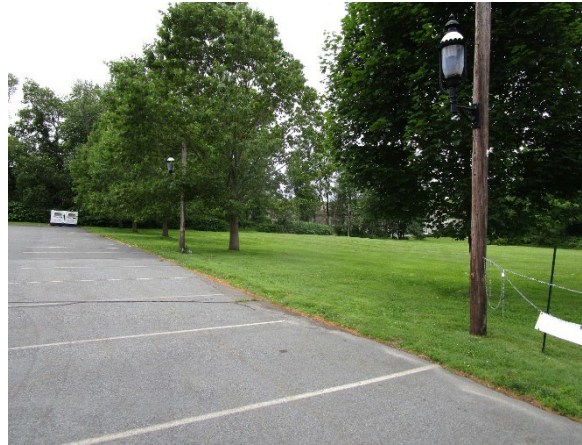
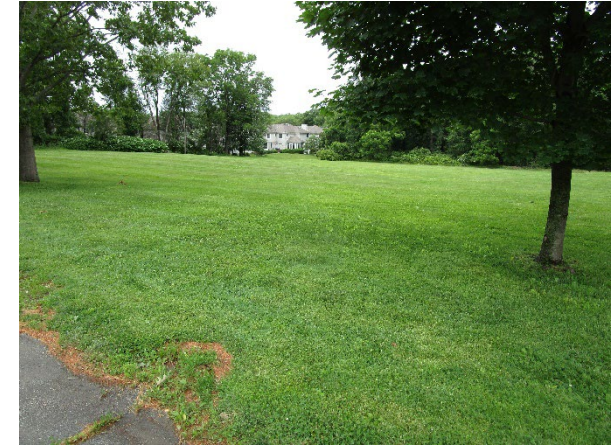
A rain garden can be installed west of the building behind the parking lot to capture, treat, and infiltrate stormwater runoff from the roof. A preliminary soil assessment suggests that the soils have suitable drainage characteristics for green infrastructure.

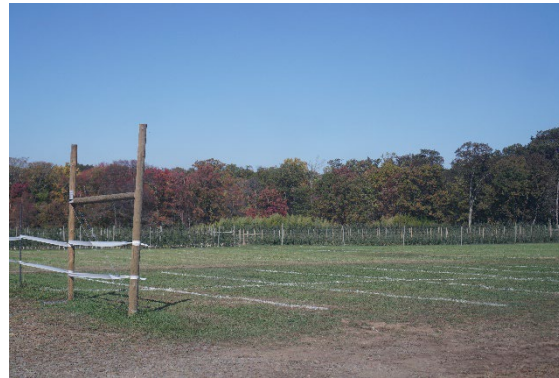
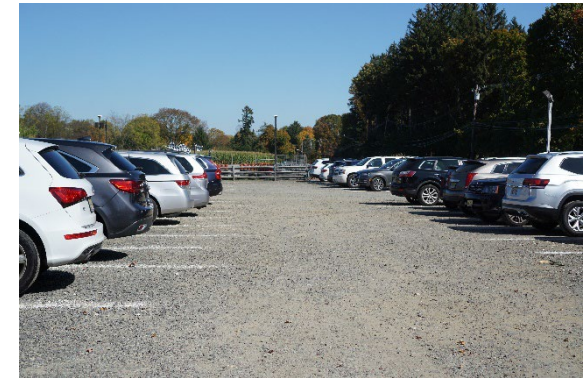
Pervious pavement can be installed in the parking lot to capture the stormwater runoff from the parking lot. A preliminary soil assessment suggests that the soils have suitable drainage characteristics for green infrastructure.

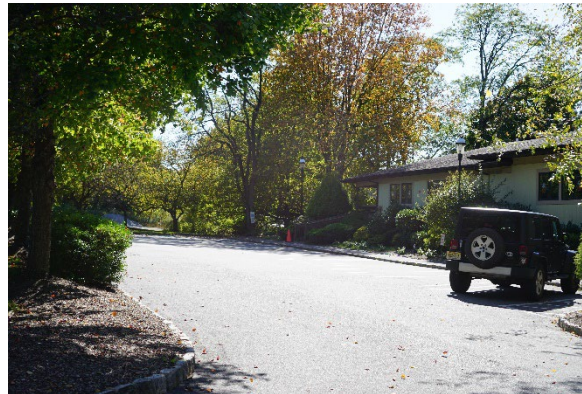
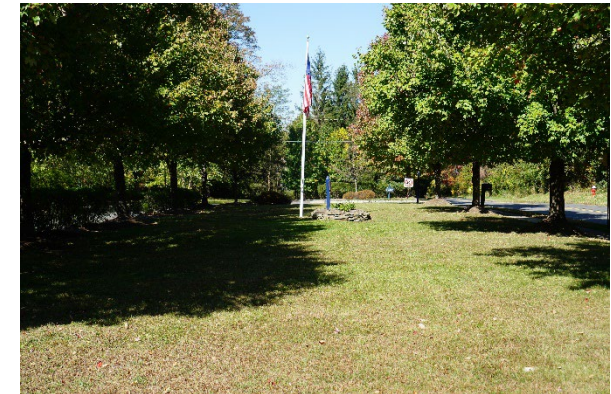
Parking spaces in the parking lot to the northeast of the building can be converted to porous pavement to capture and infiltrate stormwater runoff from the parking lot. A rain garden can be installed in the turfgrass area near the entrance of the building to capture, treat, and infiltrate stormwater runoff from the roof. A preliminary soil assessment suggests that the soils have suitable drainage characteristics for green infrastructure.

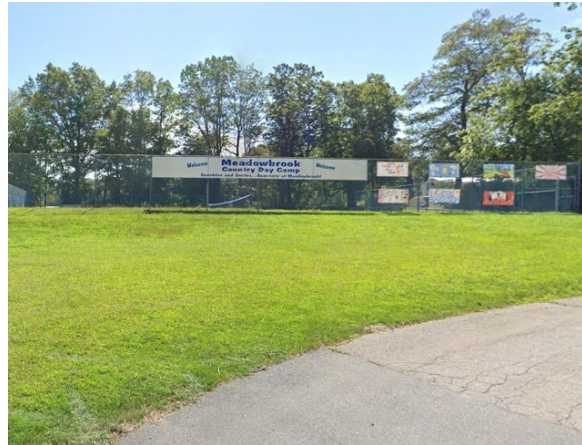
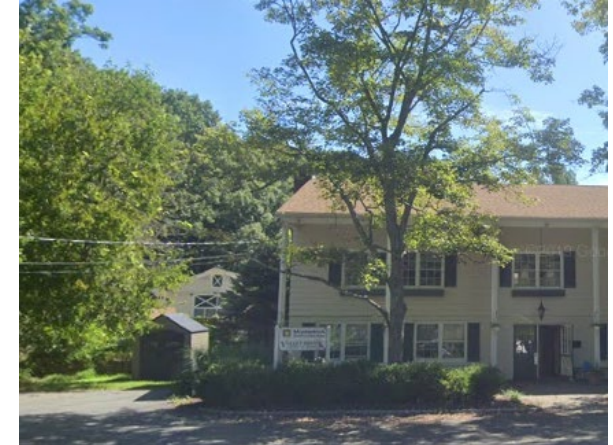
Rain gardens can be installed adjacent to buildings and impervious surfaces like the tennis courts to capture stormwater runoff. A preliminary soil assessment suggests that more soil testing would be required before determining the soil's suitability for green infrastructure.

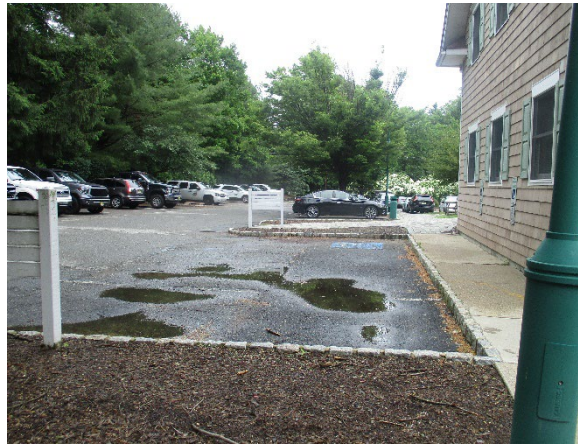
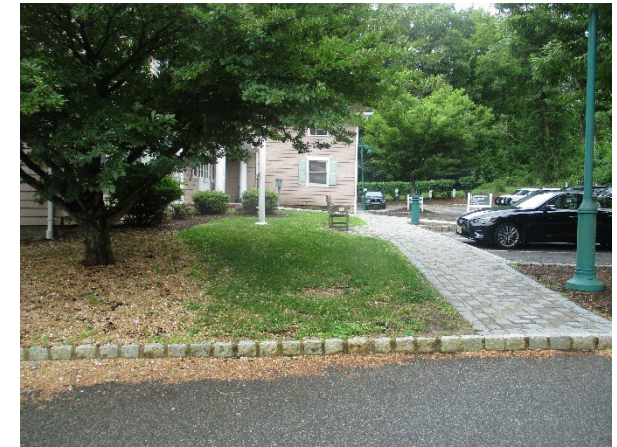
Pervious pavement can be installed in the parking spaces west of the building to capture and infiltrate stormwater. A rain garden can be installed to the northwest of the building to capture, treat, and infiltrate stormwater runoff from the roof. A preliminary soil assessment suggests that the soils have suitable drainage characteristics for green infrastructure.

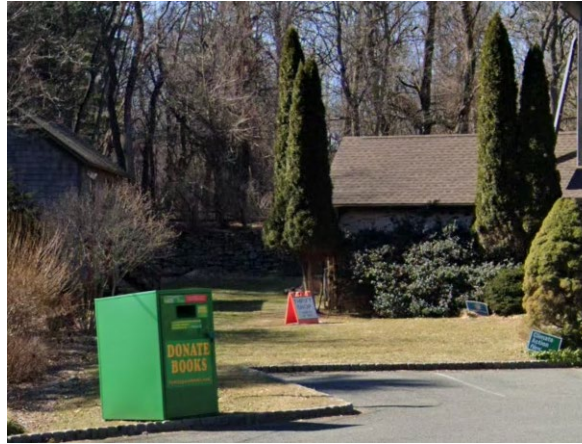
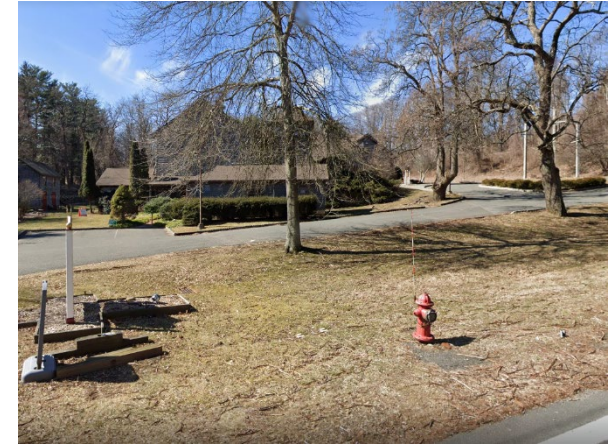
A rain garden can be installed near the south of the building using the disconnected downspouts to capture, treat, and infiltrate the stormwater runoff from the rooftop. Another rain garden can be installed around an existing catch basin near the driveway entrance to capture, treat, and infiltrate the stormwater runoff from the asphalt. A trench drain will be needed to intercept and redirect the driveway runoff. Existing parking spaces to the northwest of the building can be converted into pervious pavement to capture and infiltrate the stormwater runoff from the asphalt. The concrete walkway near the building entrance can be replaced with permeable pavers. A preliminary soil assessment suggests that the soils have suitable drainage characteristics for green infrastructure.

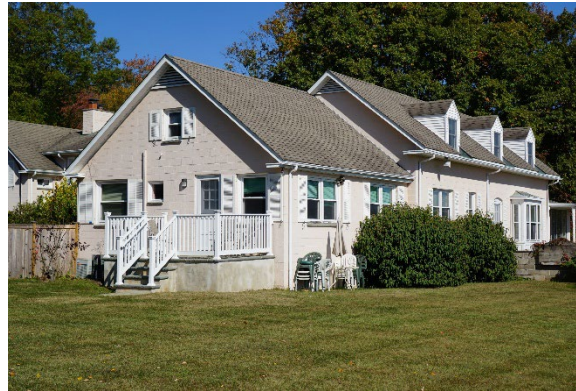
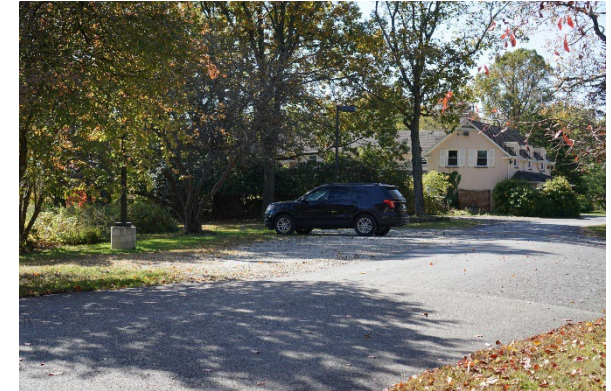
Pervious pavement can be installed in the parking spaces to capture the stormwater runoff from the pavement. A rain garden can be installed to capture and infiltrate stormwater runoff from the building's rooftop. A preliminary soil assessment suggests that the soils have suitable drainage characteristics for green infrastructure.

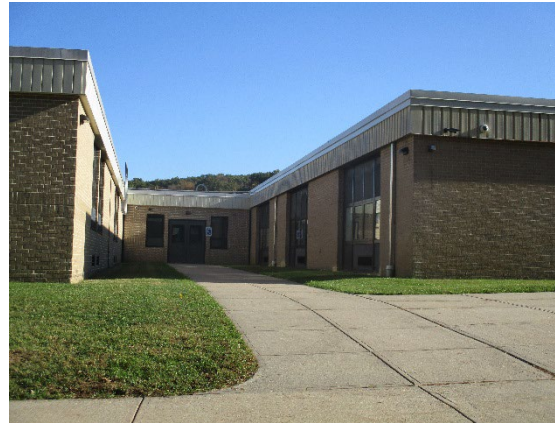
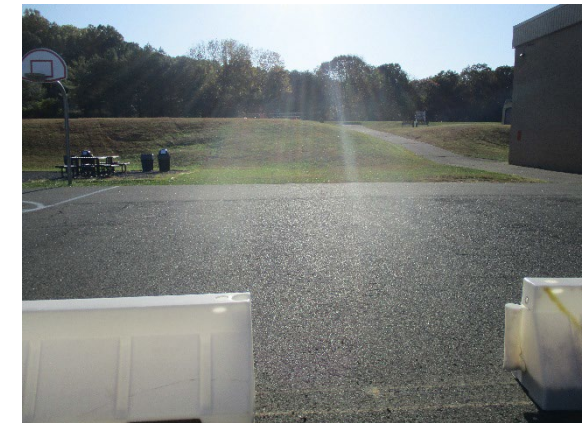
Two rain gardens can be installed adjacent to the entrance of the building and in the turfgrass south of the building to capture, treat, and infiltrate rooftop runoff. A section of parking spaces can be converted to pervious pavement to capture and infiltrate stormwater. A preliminary soil assessment suggests that more soil testing would be required before determining the soil's suitability for green infrastructure.

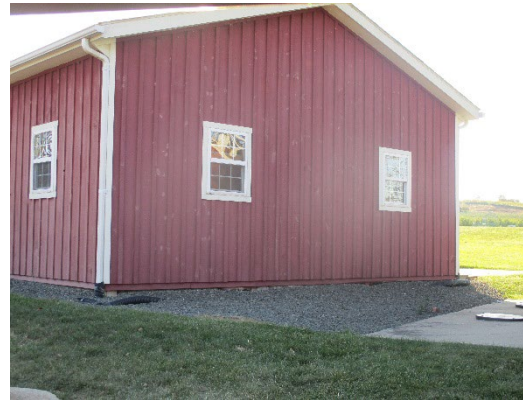
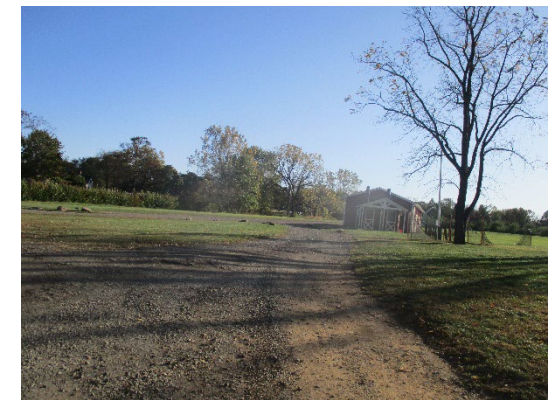
A cistern can be installed on the southern side of the building near a downspout to capture stormwater from the roof. The water can then be used for watering gardens, washing vehicles, or for other non-potable uses. Four downspout planter boxes can be constructed along the building to allow roof runoff to be reused. A preliminary soil assessment suggests that more soil testing would be required before determining the soil's suitability for green infrastructure.
