Appendix C
Concept Plans for Potential Green Infrastructure Projects

LAMINGTON RIVER WATERSHED: GREEN INFRASTRUCTURE SITES

1. CANFIELD AVENUE ELEMENTARY SCHOOL

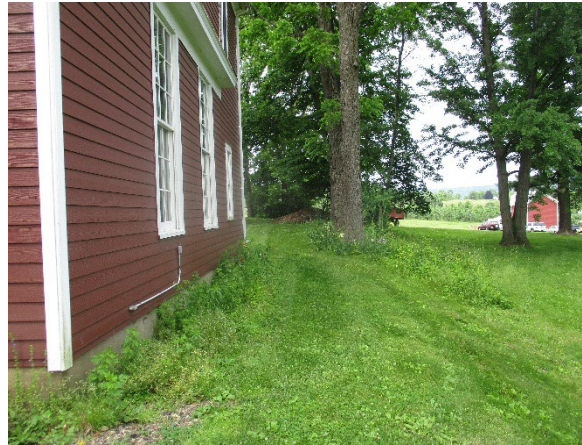
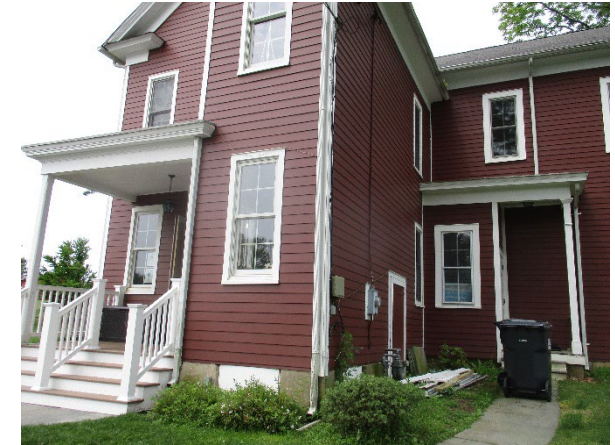
Two rain gardens can be used to capture, treat, and infiltrate rooftop runoff. A downspout planter box can be constructed along the building to allow roof runoff to be captured and reused. A preliminary soil assessment suggests that the soils have suitable drainage characteristics for green infrastructure.

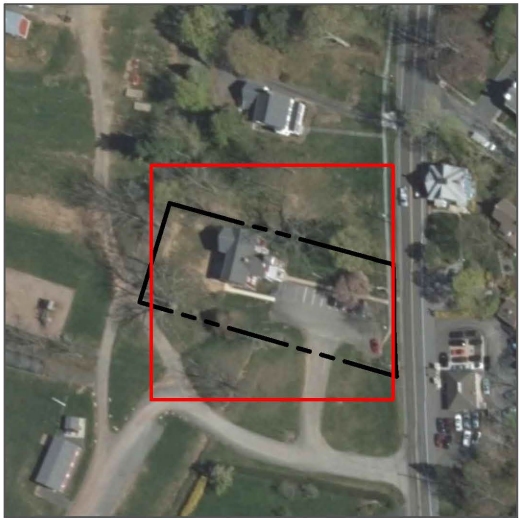
Tewksbury Township Library

Rain gardens can be installed in multiple locations around the property to capture, treat, and infiltrate stormwater runoff from the rooftops. Most of these will require downspout disconnection and redirection. A rain garden can be installed to the northwest of the property to capture, treat, and infiltrate runoff from the asphalt. A trench drain will be needed. Cisterns can be installed near multiple buildings to divert and detain runoff from the rooftops via downspouts for non-potable future use, such as washing vehicles or watering the landscaping vegetation. The police vehicle parking lot and sections of existing parking spots can be converted into pervious pavement to capture and infiltrate stormwater runoff from the asphalt and the rooftops. This will require downspout disconnections. A preliminary soil assessment suggests that more soil testing would be required before determining the soil's suitability for green infrastructure.

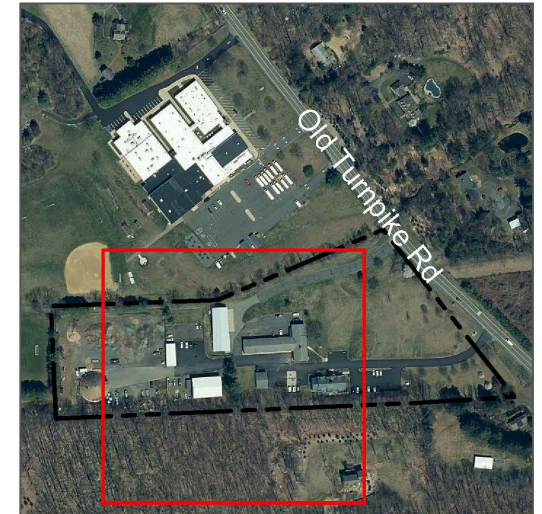
Tewksbury Township Municipal Buildings

Two rain gardens can be installed in the turfgrass areas adjacent to the building to capture, treat, and infiltrate stormwater runoff from the roof. Another rain garden can be installed in a parking lot island to capture, treat, and infiltrate stormwater runoff from the parking lot. A preliminary soil assessment suggests that more soil testing would be required before determining the soil's suitability for green infrastructure.

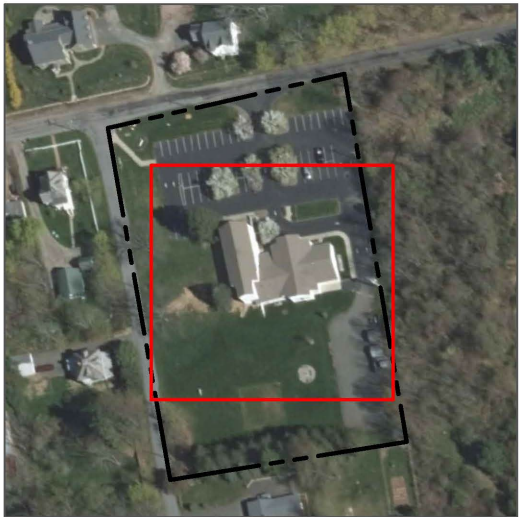
Zion Lutheran Church

A rain garden can be installed in the turfgrass area to capture, treat, and infiltrate stormwater runoff from the roof. Downspout planter boxes can be constructed along the building to allow roof runoff to be captured and reused. A preliminary soil assessment suggests that more soil testing would be required before determining the soil's suitability for green infrastructure.

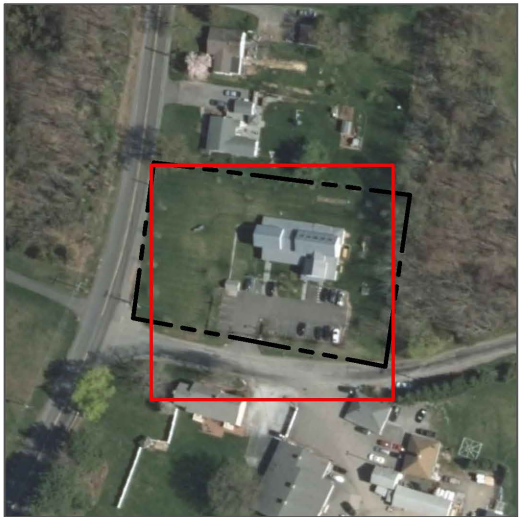
Oldwick Animal Hospital

A rain garden can be installed on the west side of the building to capture, treat, and infiltrate stormwater runoff from the roof. A preliminary soil assessment suggests that more soil testing would be required before determining the soil's suitability for green infrastructure.

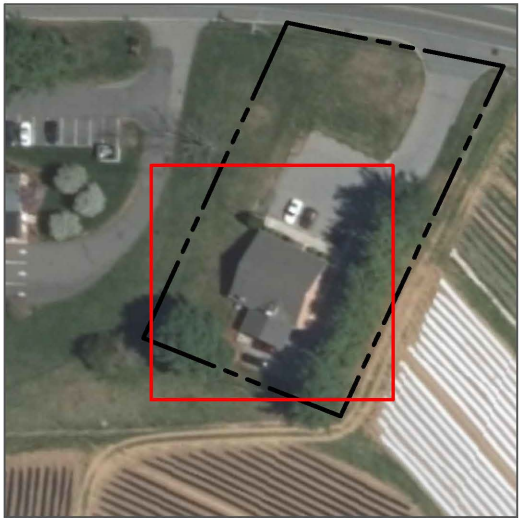
Oldwick Post Office

Rain gardens can be installed on the north side of the building and on the turfgrass area east of the parking lot to capture, treat, and infiltrate stormwater runoff from the roof. A preliminary soil assessment suggests that more soil testing would be required before determining the soil's suitability for green infrastructure.

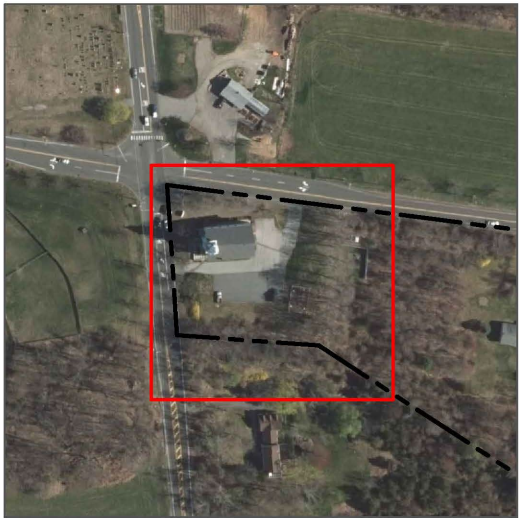
Fairmount United Methodist Church

A rain garden can be installed in the grass area to the east of the building to capture, treat, and infiltrate the stormwater runoff from the rooftop. This would require downspout disconnections. Cisterns can be installed to the northeast and southwest of the building to divert and detain the stormwater runoff from the rooftop for later non-potable reuse such as washing vehicles. A preliminary soil assessment suggests that the soils have suitable drainage characteristics for green infrastructure. An underdrain would be required.

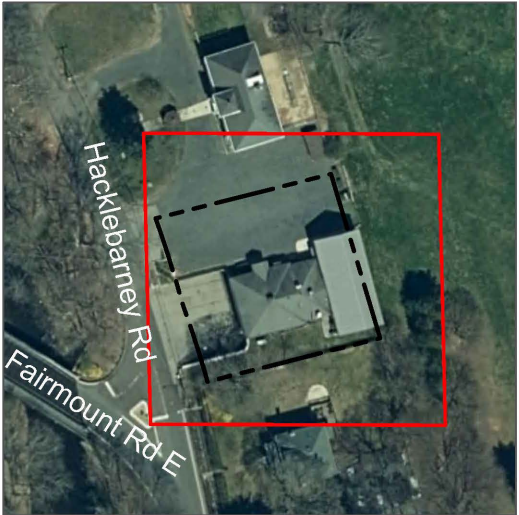
Pottersville Volunteer Fire Company

A rain garden can be installed in the turfgrass area on the west side of the building and on the turfgrass area in the parking lot to capture, treat, and infiltrate stormwater runoff from the roof. Parking spaces north of the building can be replaced with pervious pavement to capture and infiltrate stormwater runoff from the parking lot. A preliminary soil assessment suggests that more soil testing would be required before determining the soil's suitability for green infrastructure.
