## Bedminster Township

### Introduction

The purpose of this report is to provide a comprehensive understanding of key, defining features within the subwatersheds throughout Bedminster Township. This involves gathering, organizing, and presenting information about existing conditions and infrastructure within each subwatershed. It aims to serve as a tool for informed decision-making, planning, and implementation of sustainable watershed management strategies aimed to protect and enhance the health of the watershed, its associated ecosystems, and the surrounding communities.

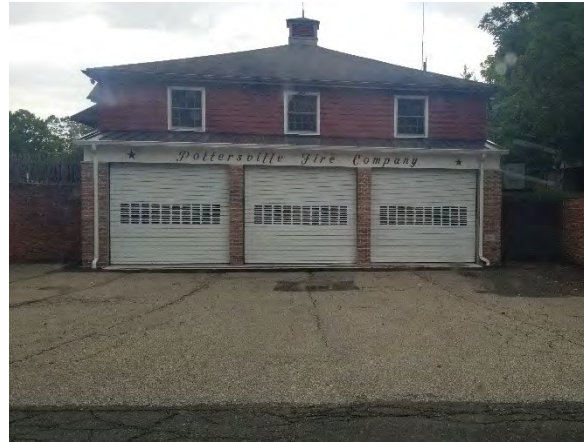
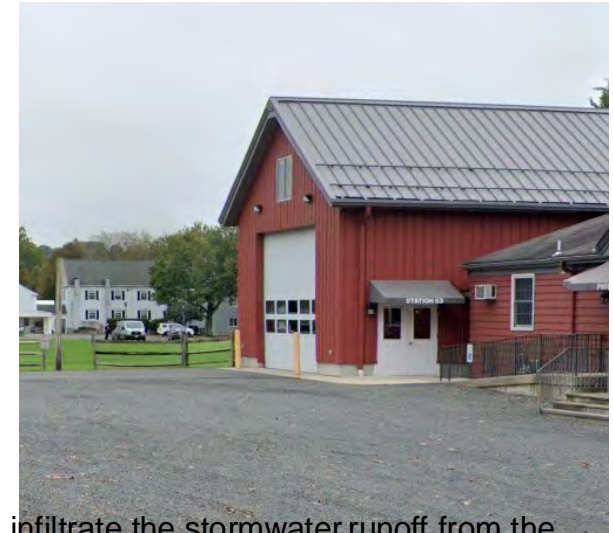
A rain garden can be installed in the grass area to the east of the building to capture, treat, and infiltrate the stormwater runoff from the rooftop. This would require downspout disconnections. Cisterns can be installed to the northeast and southwest of the building to divert and detain the stormwater runoff from the rooftop for later non-potable reuse such as washing vehicles. A preliminary soil assessment suggests that the soils have suitable drainage characteristics for green infrastructure. An underdrain would be required.

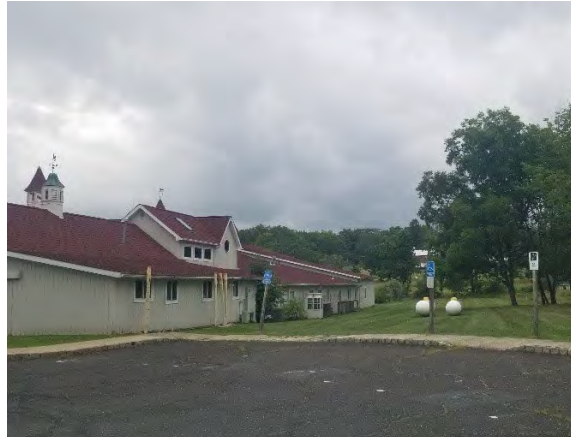
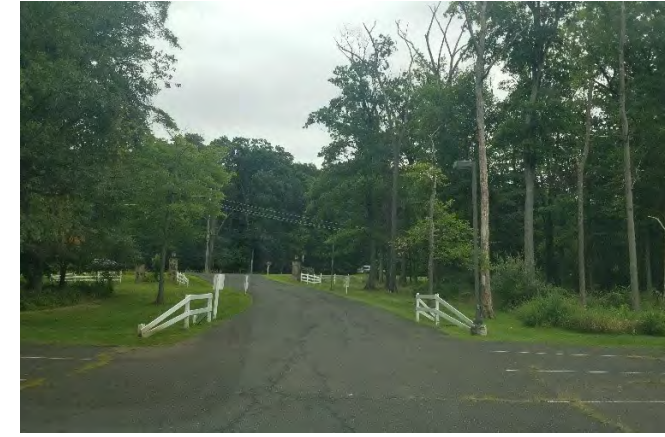
Multiple rain gardens can be installed in grass areas around the property to capture, treat, and infiltrate the stormwater runoff from the rooftops and driveway. This may require downspout disconnections, curb cuts, and trench drains. The existing eastern parking spaces can be converted into pervious pavement to capture and infiltrate the stormwater runoff from the driveway. A cistern can be installed to the south of the church building to divert and detain the stormwater runoff from the rooftop for later non-potable reuse such as watering a garden or washing a vehicle. A preliminary soil assessment suggests that more soil testing would be required before determining the soil's suitability for green infrastructure.

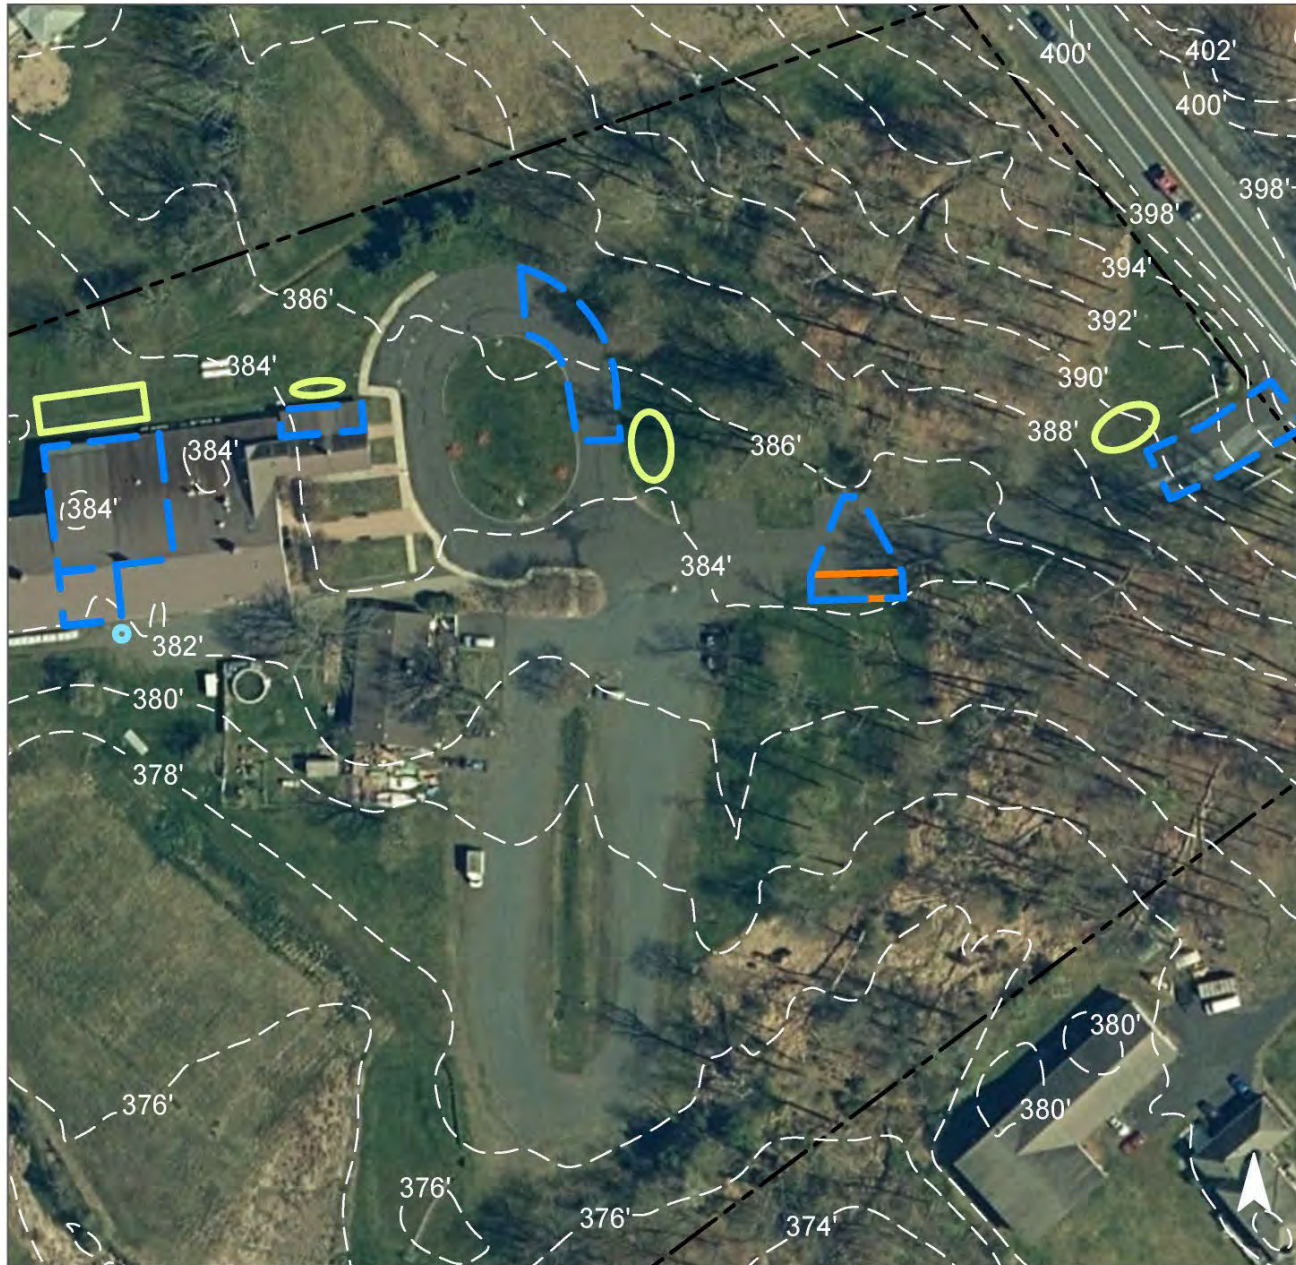
## Resurgent Church

- bioretention system
- pervious pavement
- rainwater harvesting
- captured drainage area
- property line
- 2020 Aerial: NJOIT, OGIS

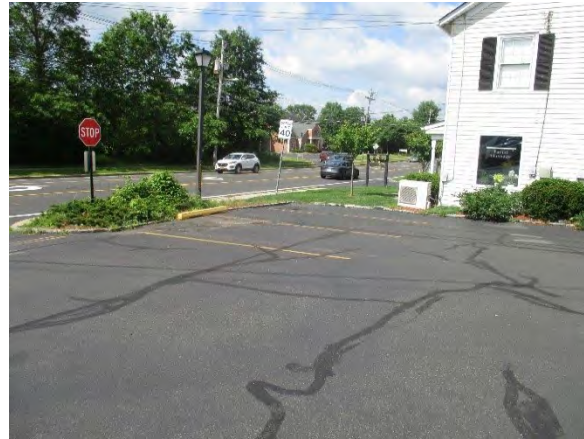
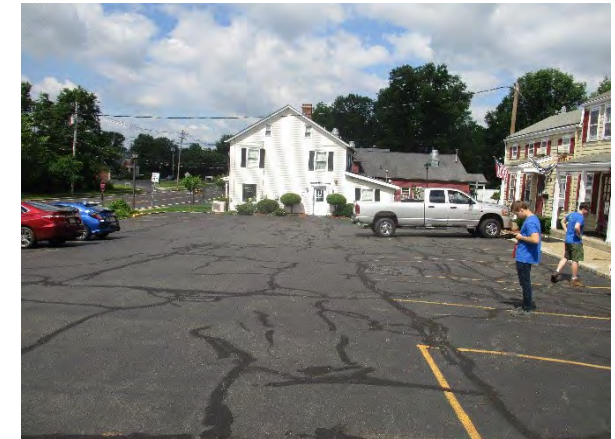
Parking spaces located in the south section of the parking lot can be replaced with pervious pavement to capture and infiltrate stormwater. Downspouts at Annie's Deli can be disconnected and directed into downspout planter boxes to capture and filter rooftop runoff. A preliminary soil assessment suggests that more soil testing would be required before determining the soil's suitability for green infrastructure.

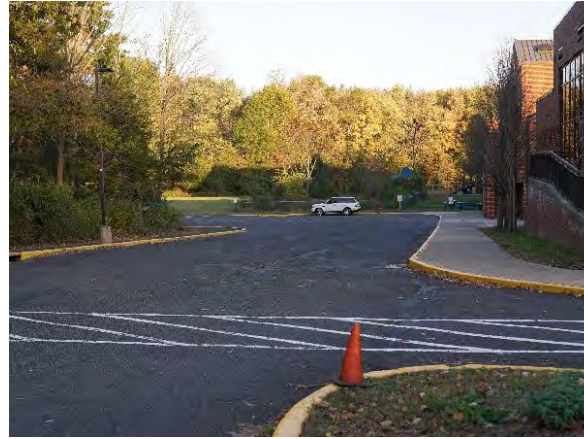
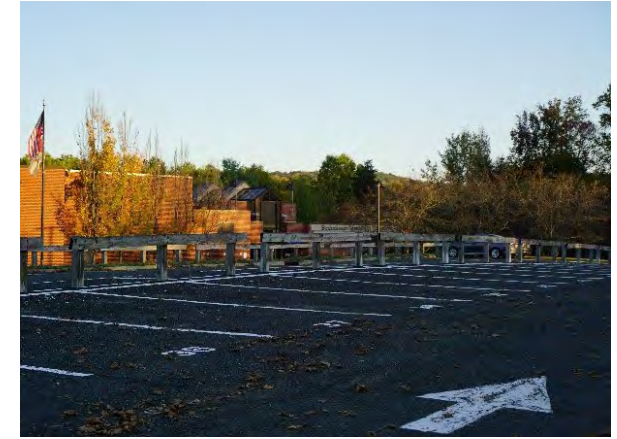
Pervious pavement can be installed in the front parking lot of the building to capture storm water runoff from the parking lot. A preliminary soil assessment suggests that the soil is suitable for green infrastructure implementations.

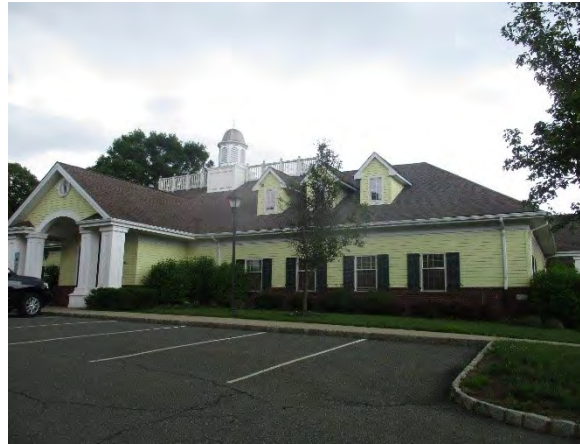
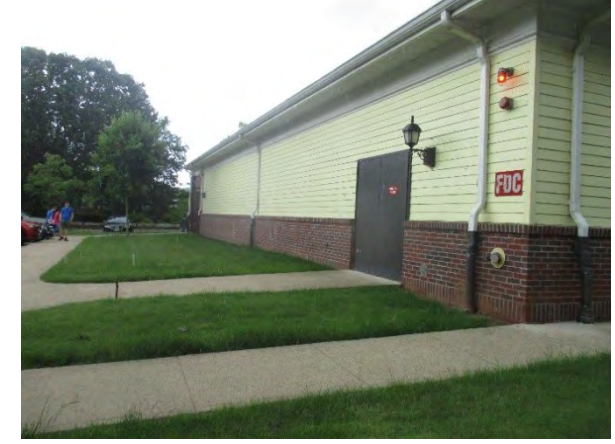
Bioretention systems can be installed to capture, treat, and infiltrate rooftop runoff on the north and south of the building. Pervious pavement can be installed in the southeast corner of the parking lot to capture and infiltrate stormwater. A preliminary soil assessment suggests that the soils have suitable drainage characteristics for green infrastructure.

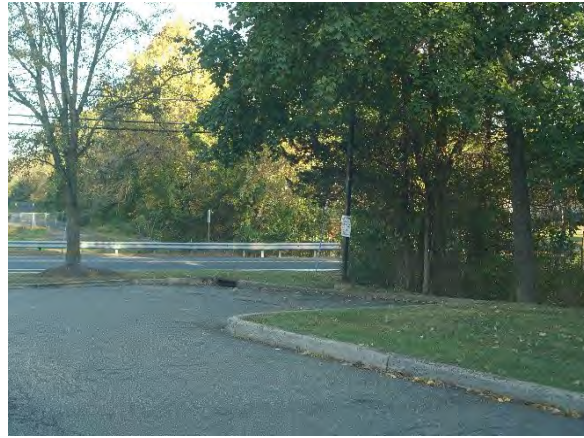
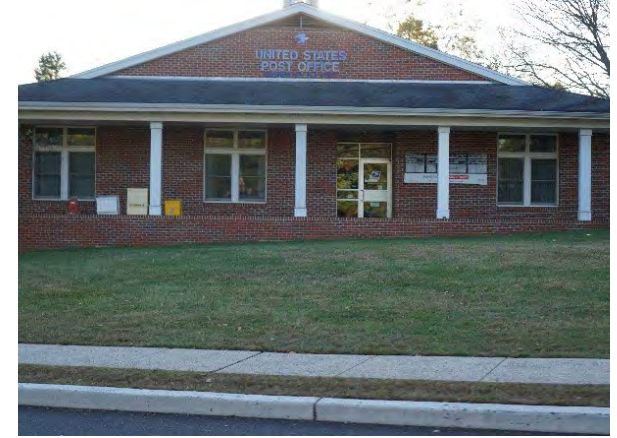
A rain garden can be installed east of the building to capture runoff from the building's roof. Additionally, pervious pavement can be installed in the parking lot to capture stormwater before it reaches the drain. A preliminary soil assessment suggests that more soil testing would be required before determining the soil's suitability for green infrastructure.

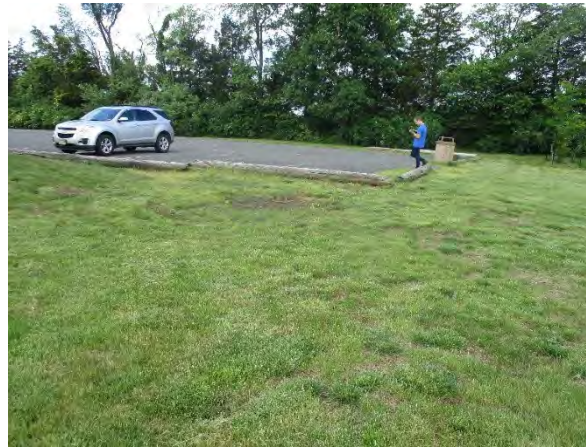
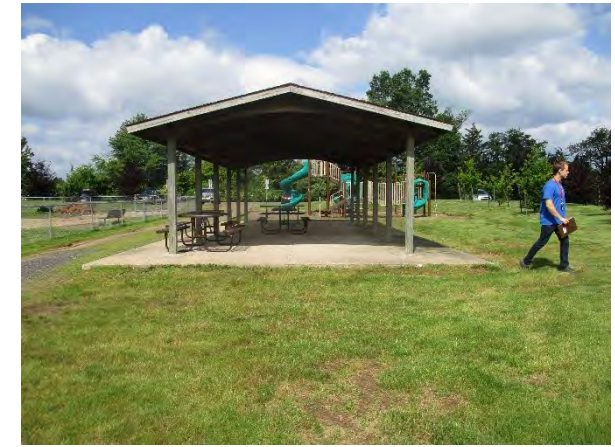
Bioretention systems can be installed to capture, treat, and infiltrate parking lot and rooftop runoff. Potential locations are in the northeast corner of the parking lot and the easternmost side of the structure shown in the above right image. Pervious pavement can be installed in the southwest corner of the parking lot to manage pavement runoff. A preliminary soil assessment suggests that more soil testing would be required before determining the soil's suitability for green infrastructure.

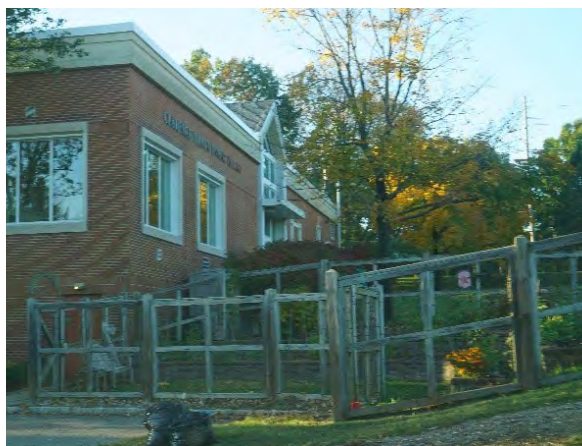
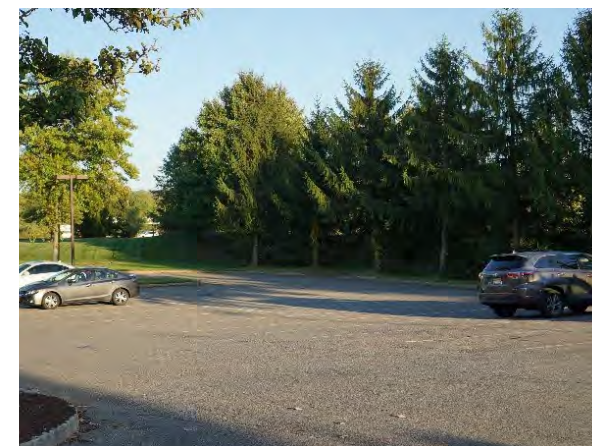
A rain garden can be installed on the eastern island in the parking lot to capture stormwater runoff from the impervious surface. A preliminary soil assessment suggests that more soil testing would be required before determining the soil's suitability for green infrastructure.

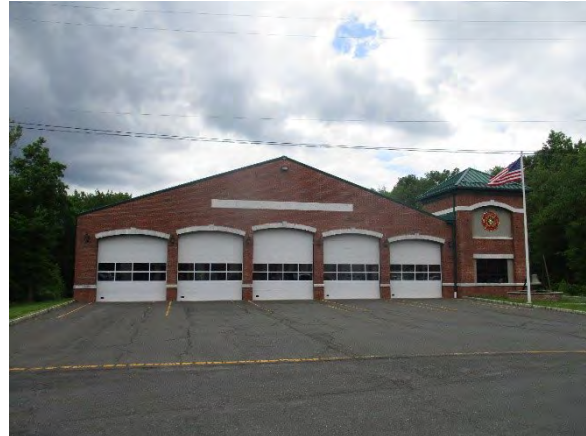
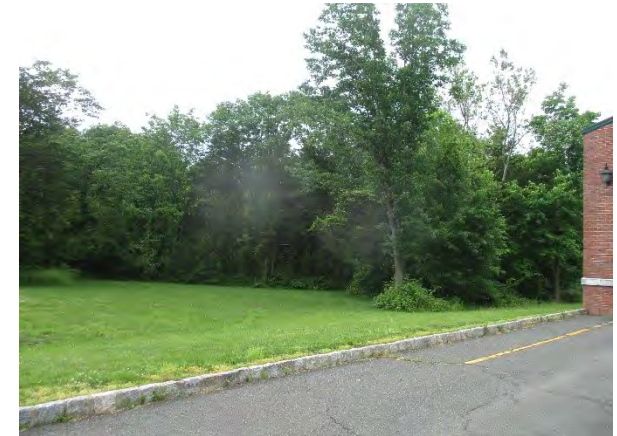
A cistern can be installed in the southwest corner of the building to allow roof runoff to be reused. A bioretention system can be installed at the northeast corner of the building to capture, treat, and infiltrate rooftop runoff. Pervious pavement can be installed in the parking spaces behind and south of the building to filter and infiltrate pavement runoff. A preliminary soil assessment suggests that more soil testing would be required before determining the soil's suitability for green infrastructure.

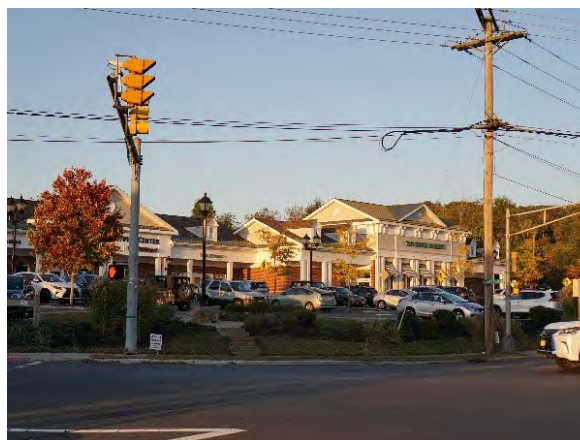
Pervious pavement can be installed within the parking lot to capture stormwater runoff from the impervious surfaces that surround the area. A preliminary soil assessment suggests that more soil testing would be required before determining the soil's suitability for green infrastructure.

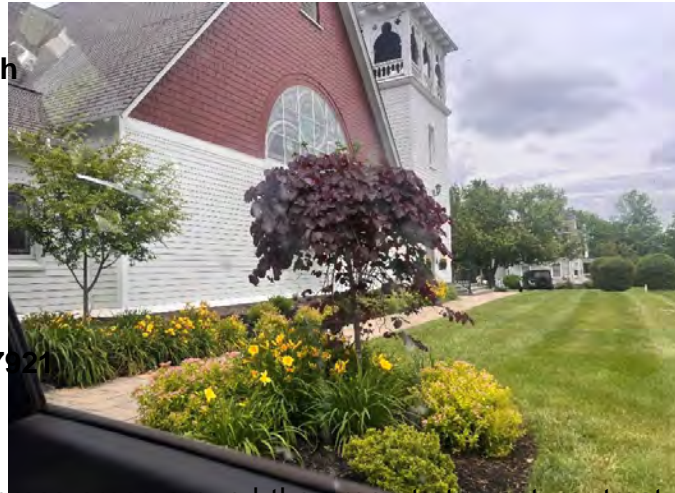
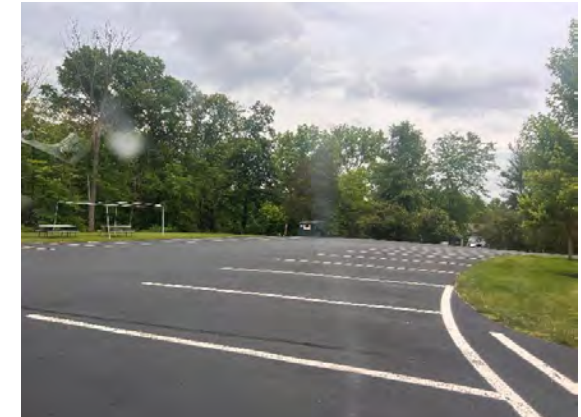
Multiple rain gardens can be installed in grass areas around the property to capture, treat, and infiltrate the stormwater runoff from the rooftops and driveway. This will require downspout disconnections. The existing northern, eastern, and western parking spaces can be converted into pervious pavement to capture and infiltrate the stormwater runoff from the driveway and parking lot. A cistern can be installed to the north of the church building to divert and detain the stormwater runoff from the rooftop for later non-potable reuse such as watering a garden. A preliminary soil assessment suggests that more soil testing would be required before determining the soil's suitability for green infrastructure.

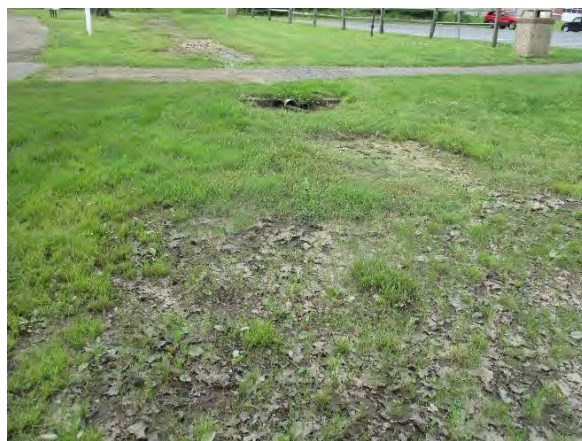
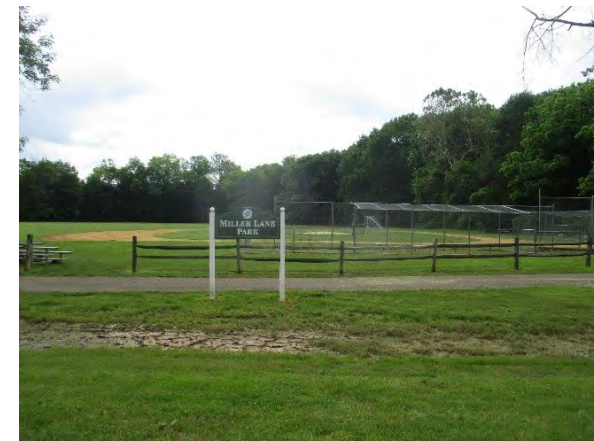
Connected bioretention systems can be installed on the eastern edge of the parking lot to capture, treat, and infiltrate runoff. The systems can be linked by pipes (already installed) shown in the above image. Pervious pavement can be installed in the parking spaces on the southern edge of the parking lot to filter and infiltrate pavement runoff. A preliminary soil assessment suggests that more soil testing would be required before determining the soil's suitability for green infrastructure.

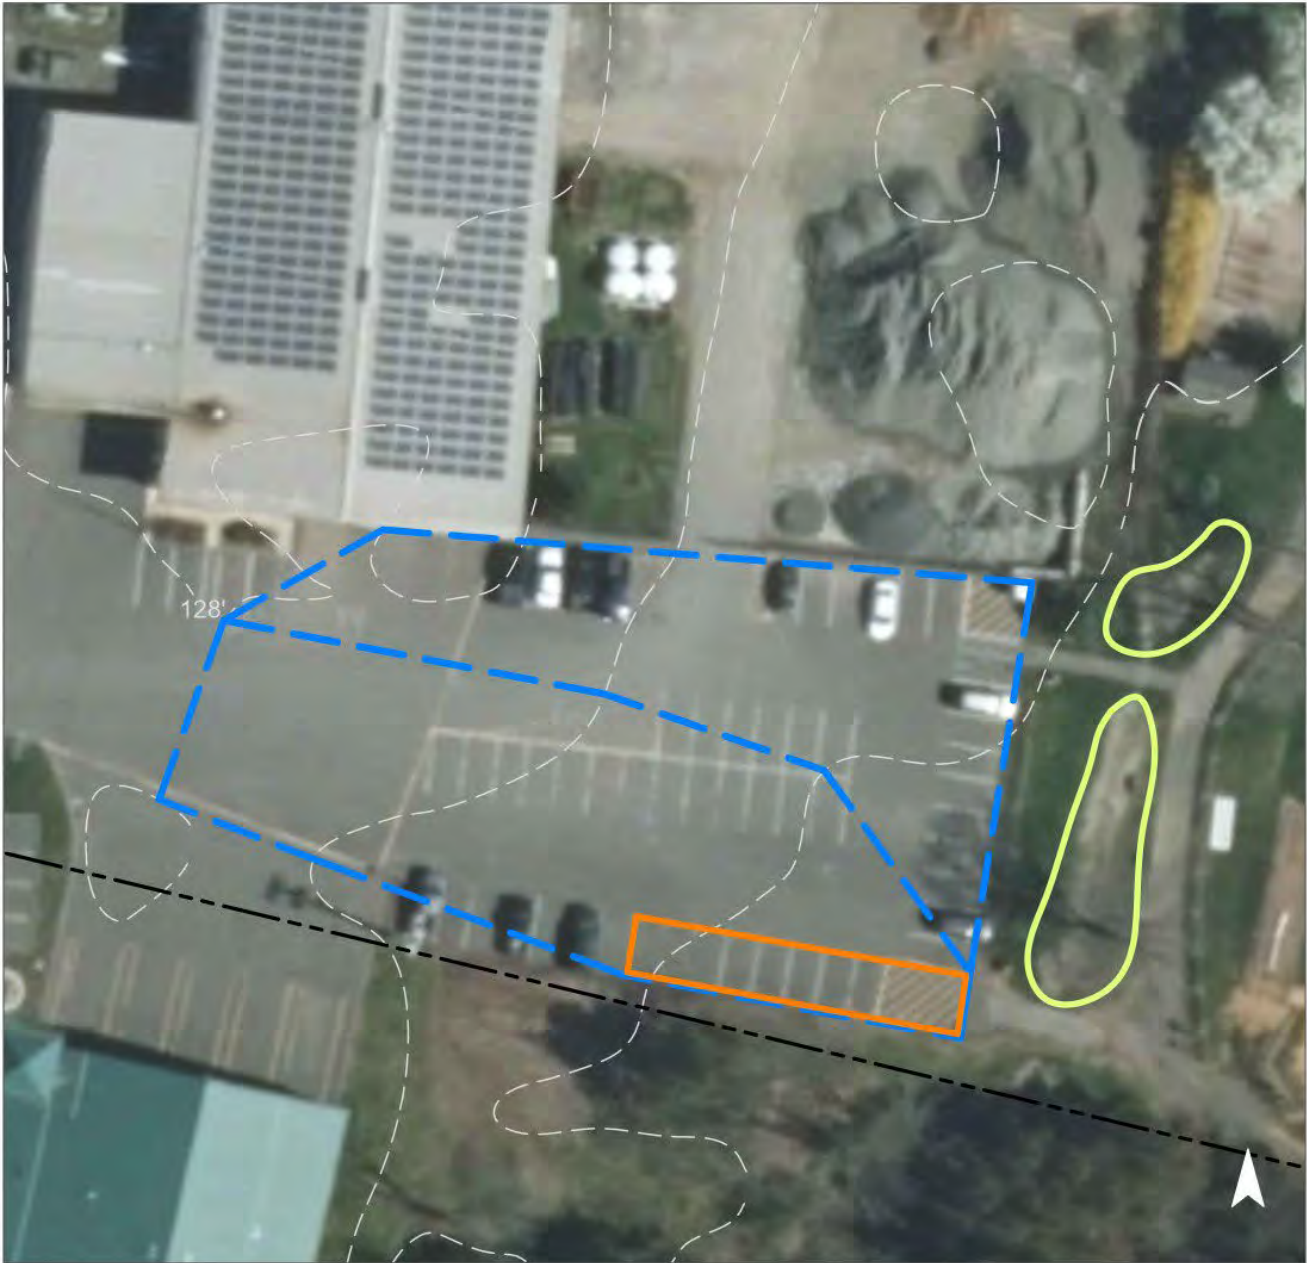
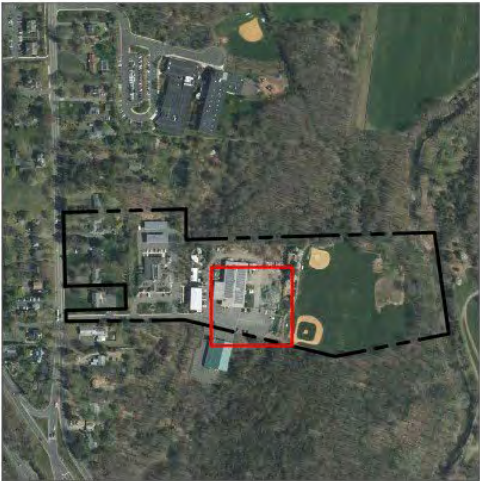
## Miller Lane Park

- bioretention system
- pervious pavement
- drainage area
- property line
- 2015 Aerial: NJOIT, OGIS

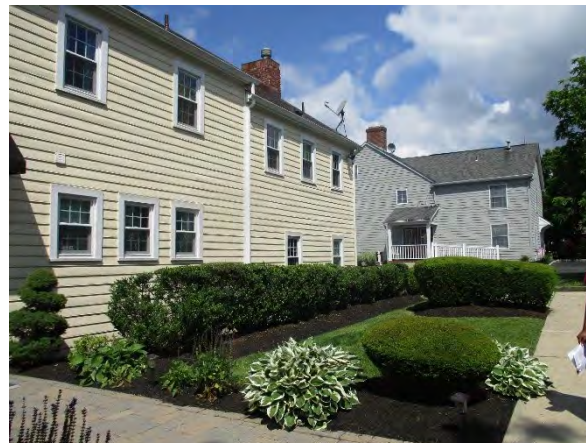
A bioretention system can be installed northeast of the building, adjacent to the parking lot, to capture, treat, and infiltrate rooftop runoff. The potential site location is shown in the above left image. Pervious pavement can be installed on the southwest side of the parking lot, adjacent to the sidewalk, to capture, filter, and infiltrate pavement runoff. A preliminary soil assessment suggests that more soil testing would be required before determining the soil's suitability for green infrastructure.

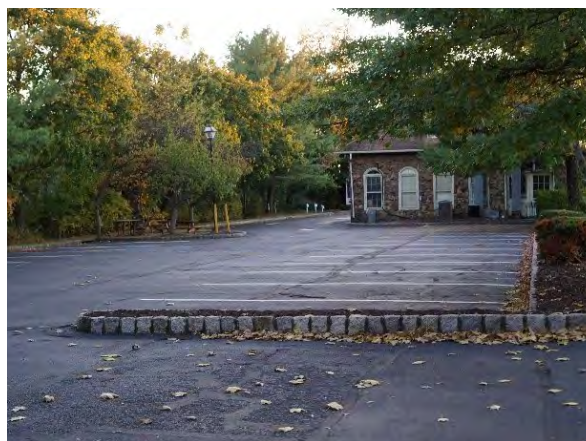
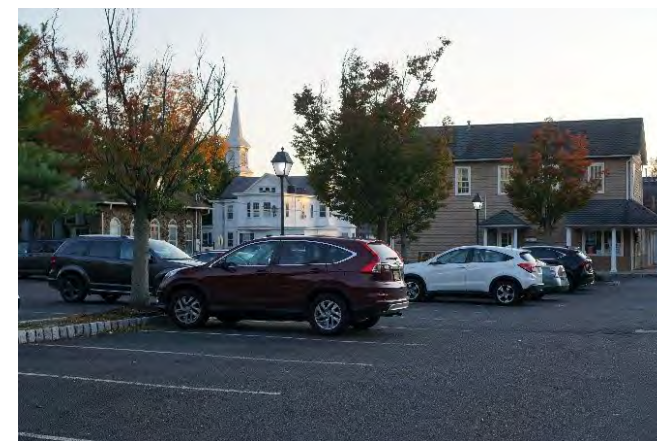
A rain garden can be installed north of the building to capture, treat, and infiltrate stormwater runoff from the rooftop of the building. Additionally, pervious pavement can be installed in the northeast parking lot to capture stormwater from the parking lot. A preliminary soil assessment suggests that more soil testing would be required before determining the soil's suitability for green infrastructure.

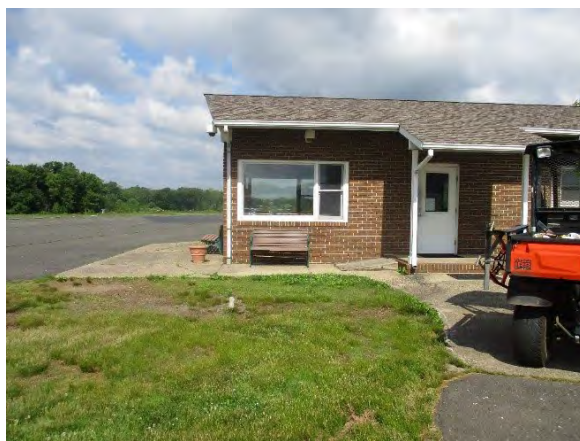
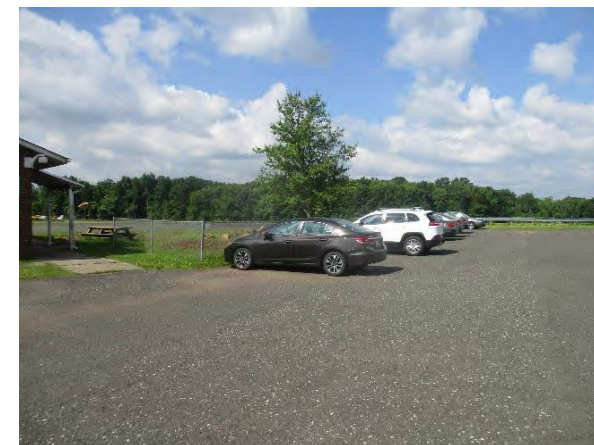
A bioretention system can be installed in the turfgrass located at the southeast corner of the building (shown in the above left image) to capture, treat, and infiltrate rooftop and pavement runoff. Parking spaces can be replaced with pervious pavement to filter and infiltrate stormwater runoff from the parking lot located north of the building shown. A preliminary soil assessment suggests that the soils have suitable drainage characteristics for green infrastructure.

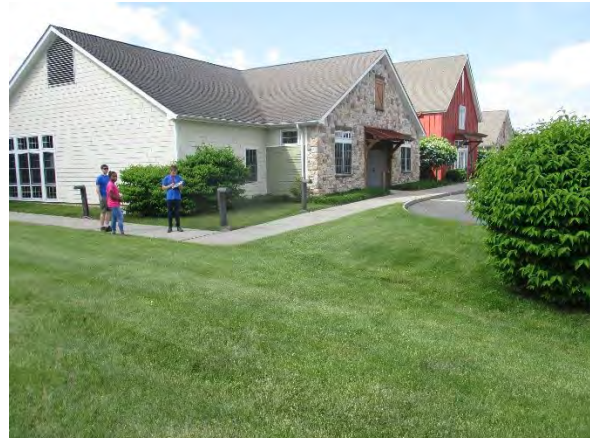
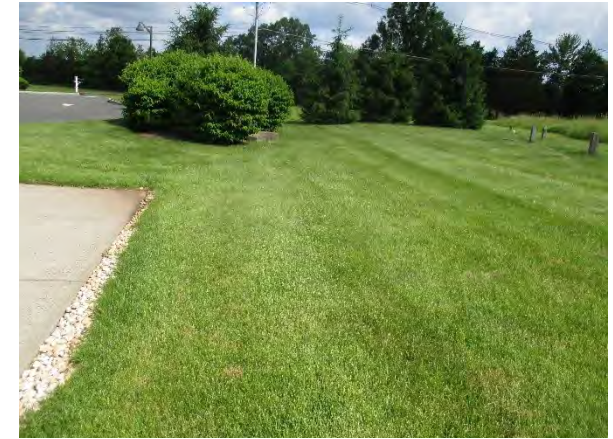
Bioretention systems can be installed at the northeast corner of the school (just beyond the corner of the sidewalk seen) and in the center of the courtyard to capture, treat, and infiltrate rooftop runoff. Pervious pavement can be installed at the western edge of the parking lot to manage pavement runoff. A preliminary soil assessment suggests that more soil testing would be required before determining the soil's suitability for green infrastructure.

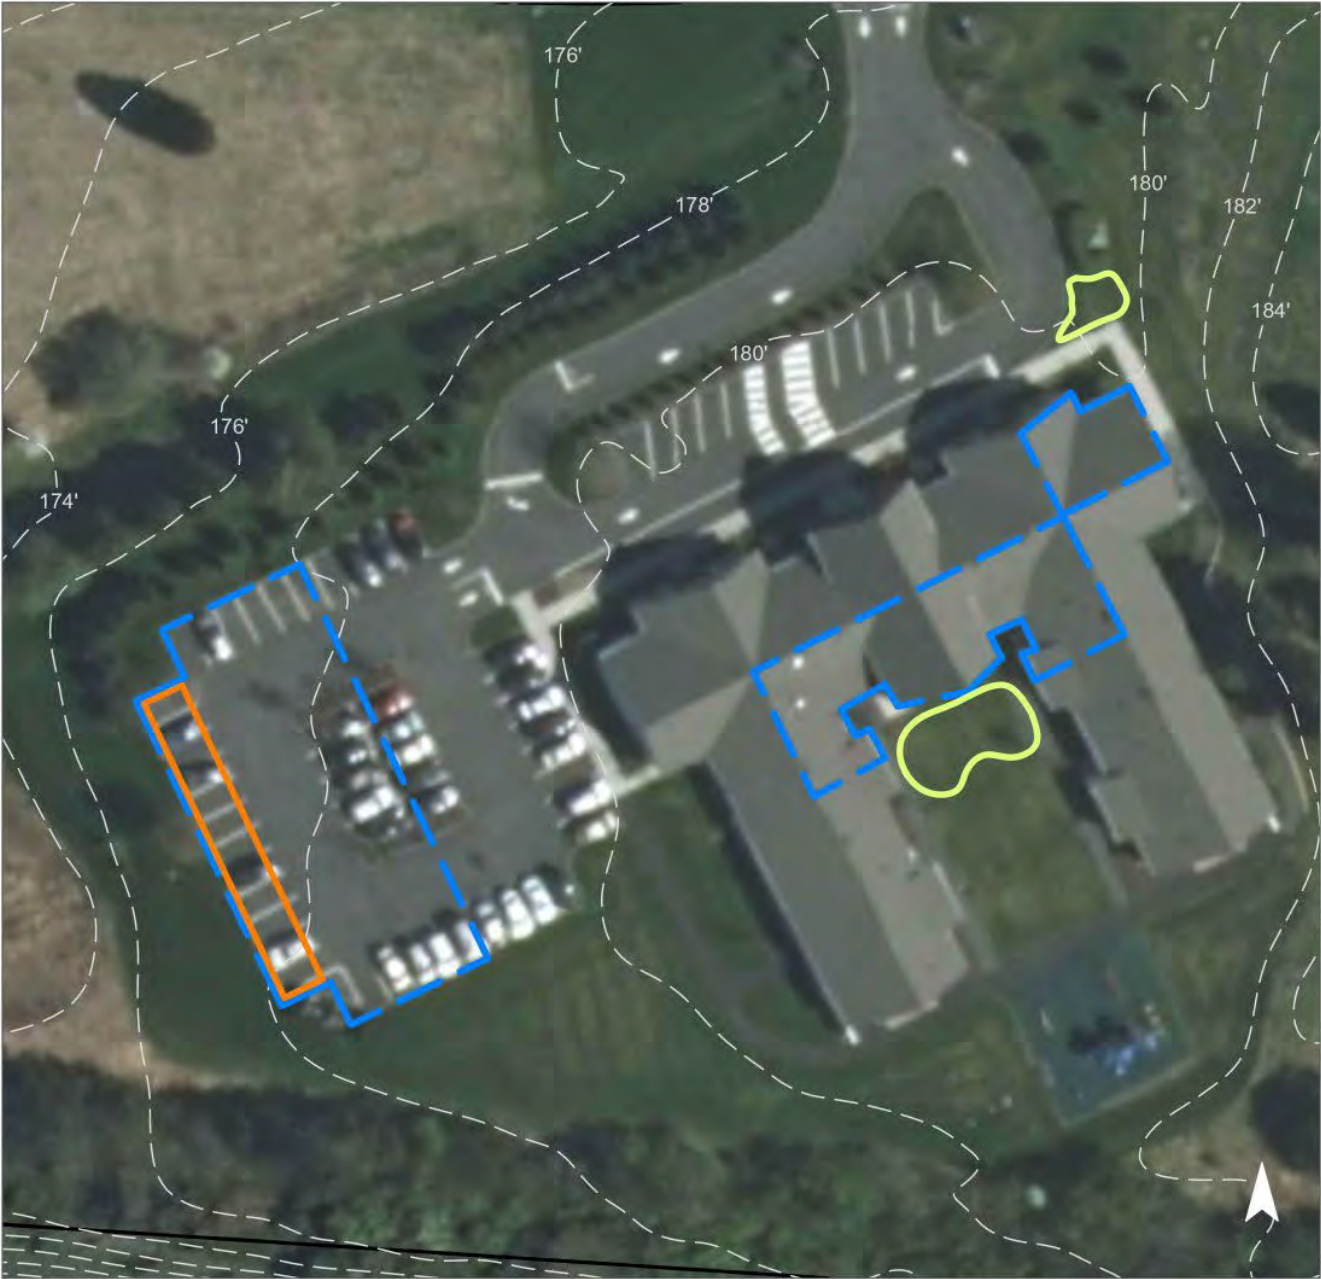
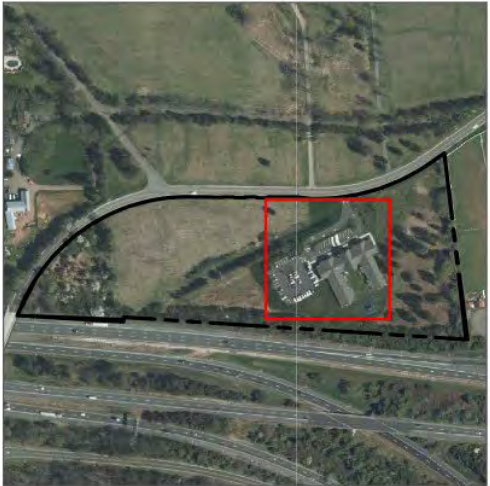
**Somerset Hills Learning Institute**

- bioretention system
- pervious pavement
- drainage area
- property line
- 2015 Aerial: NJOIT, OGIS

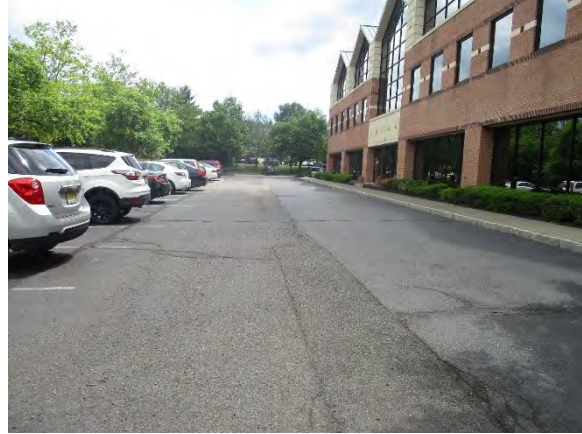
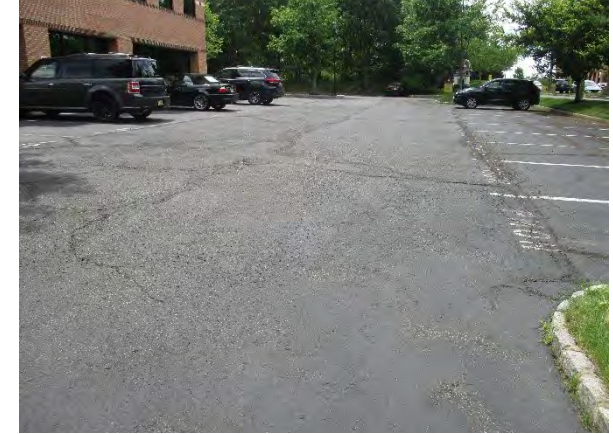
A bioretention system can be installed north of the road in front of the building to manage pavement runoff. Parking spaces north of the building can be replaced with pervious pavement to capture and infiltrate stormwater runoff from the parking lot. A preliminary soil assessment suggests that more soil testing would be required before determining the soil's suitability for green infrastructure.

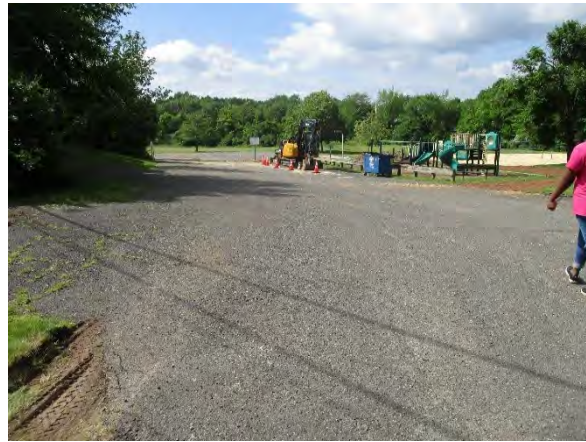
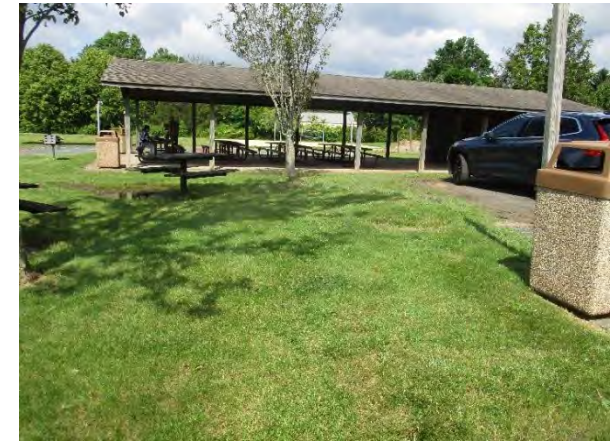
Bioretention systems can be installed southeast of the southernmost building and southeast of the tennis court to capture, treat, and infiltrate rooftop, tennis court, and parking lot runoff. Parking spaces located to the west of the northernmost building can be replaced with pervious pavement to capture and infiltrate stormwater. A preliminary soil assessment suggests that more soil testing would be required before determining the soil's suitability for green infrastructure.

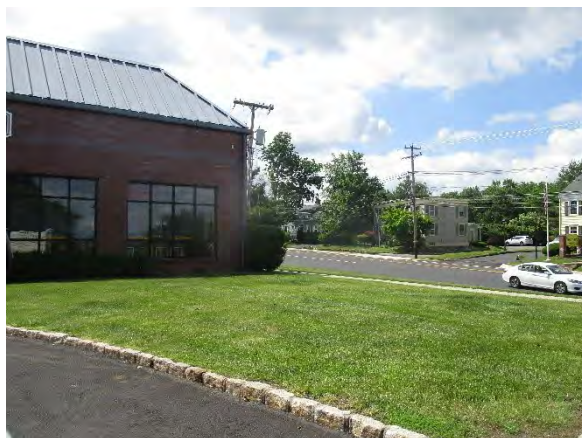
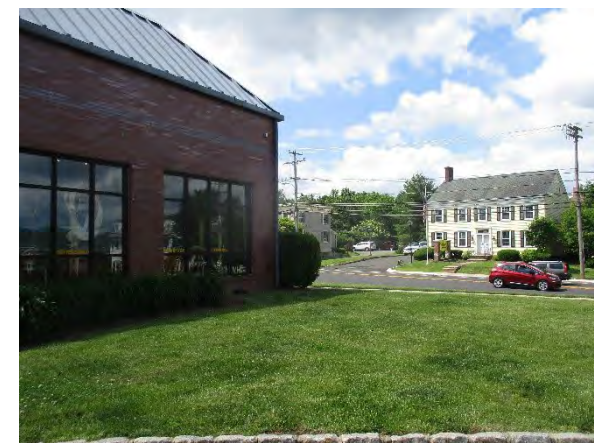
A bioretention system can be installed on the northwestern side of Pancheros Mexican Grill to capture, treat, and infiltrate rooftop runoff from Pancheros Mexican Grill located in the Hills Village Center. Pervious pavement can be installed in various locations on the northern side of the parking lot to filter and infiltrate pavement runoff. A preliminary soil assessment suggests that more soil testing would be required before determining the soil's suitability for green infrastructure.

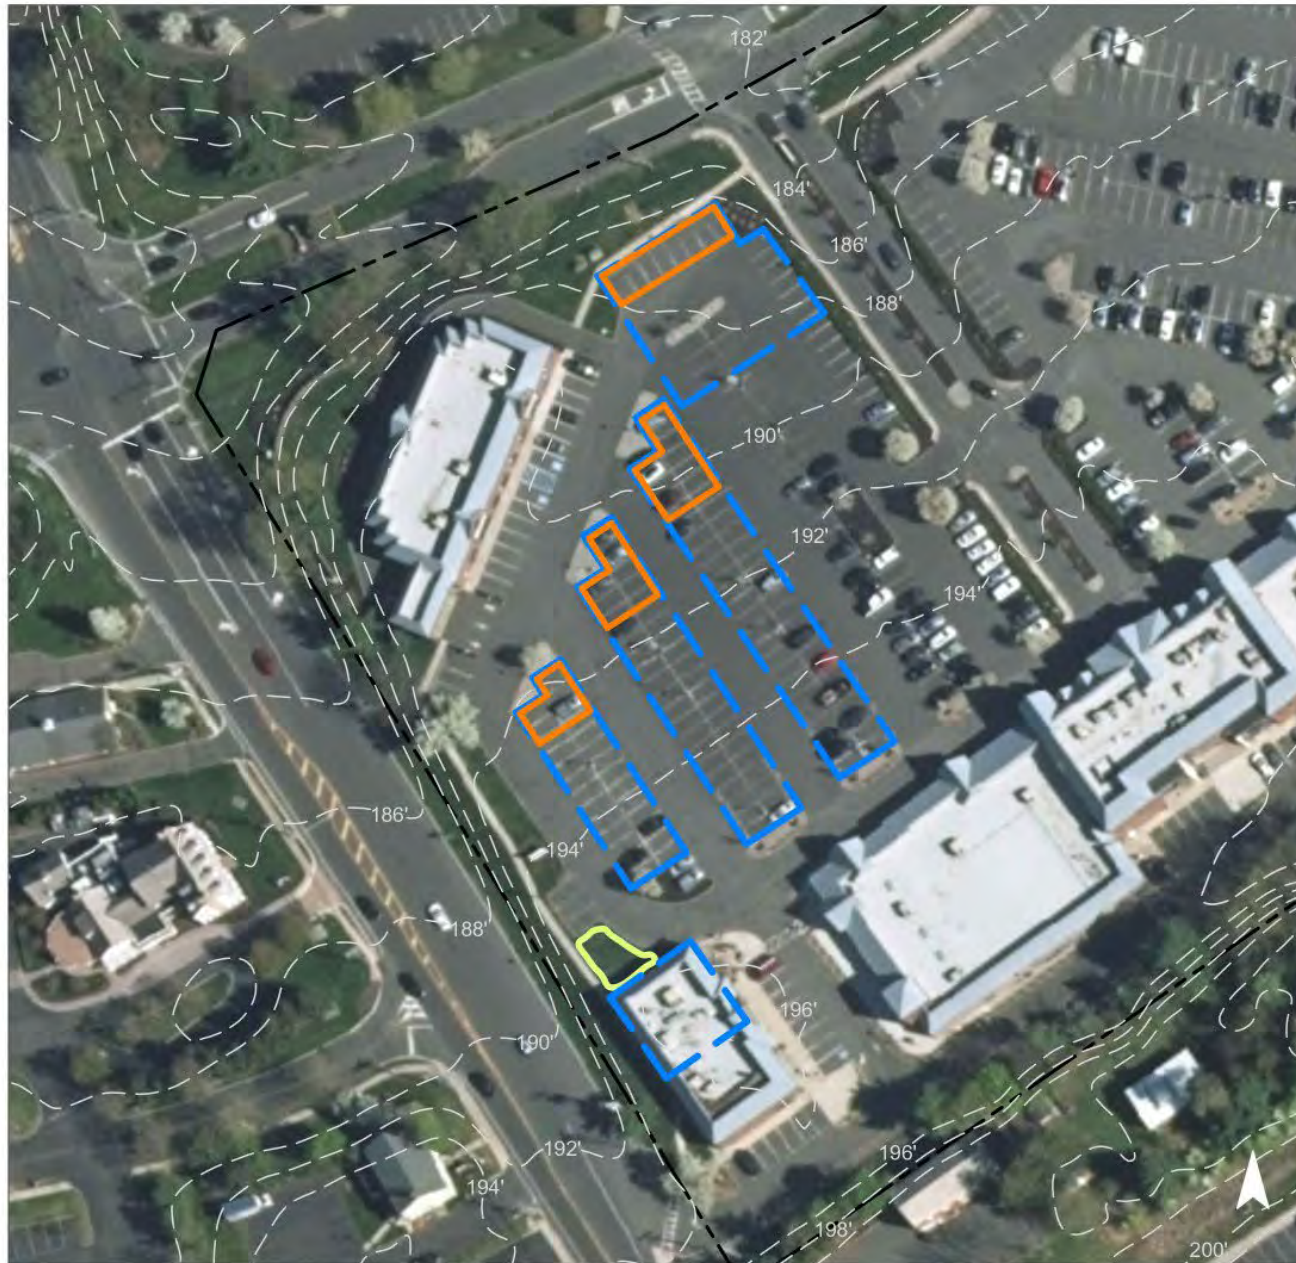
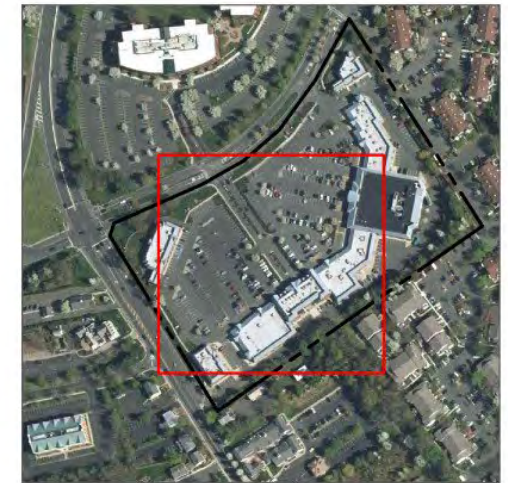
## The Hills Village Center

- bioretention system
- pervious pavement
- drainage area
- property line
- 2015 Aerial: NJOIT, OGIS

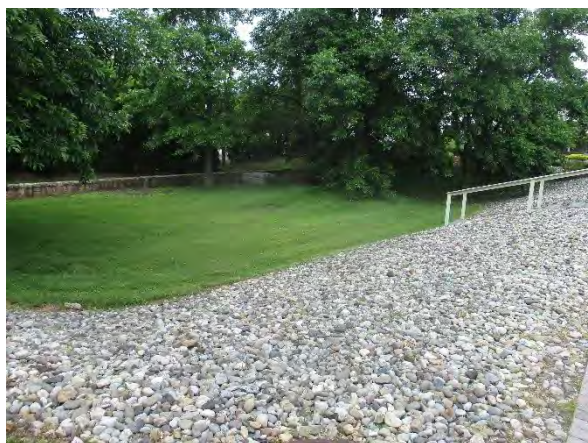
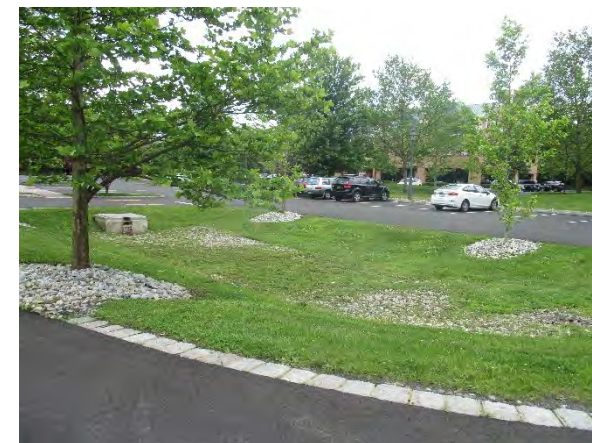
The detention basin in the center of the parking lot can be retrofitted to act as a bioretention system to capture, treat, and infiltrate parking lot runoff. An additional bioretention system can be installed north of the parking lot to capture, treat, and infiltrate additional parking lot runoff. Pervious pavement can be installed in the parking spaces in the northeastern side of the parking lot to infiltrate pavement runoff. A preliminary soil assessment suggests that more soil testing would be required before determining the soil's suitability for green infrastructure.

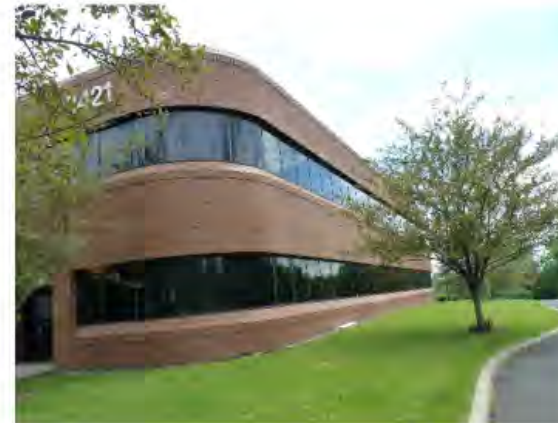
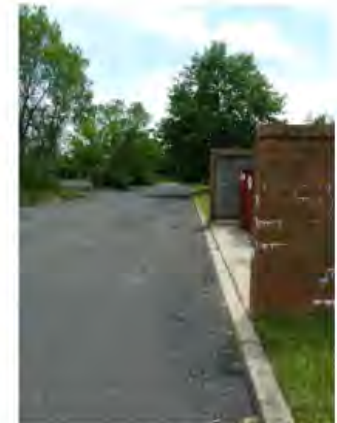
Parking spots on the south side of the building can be replaced with porous asphalt to capture and infiltrate stormwater runoff from the parking lot. A preliminary soil assessment suggests that the soils have suitable drainage characteristics for green infrastructure.

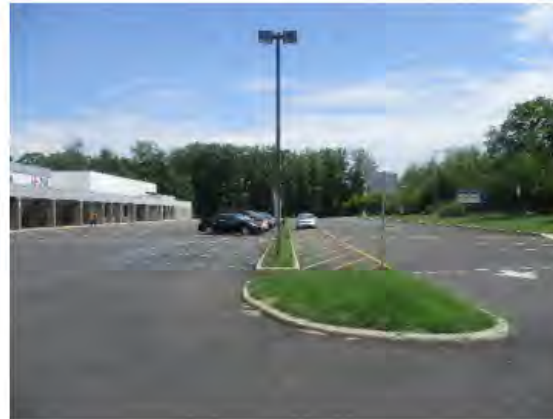
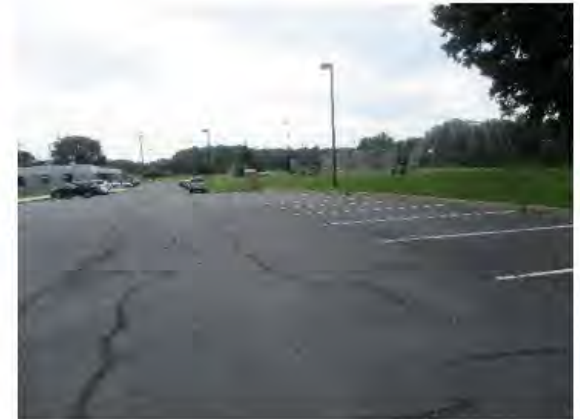
Parking spots on the south and west sides of the building can be replaced with porous asphalt to capture and infiltrate stormwater runoff from the parking lot. A preliminary soil assessment suggests that more soil testing would be required before determining the soil's suitability for green infrastructure.

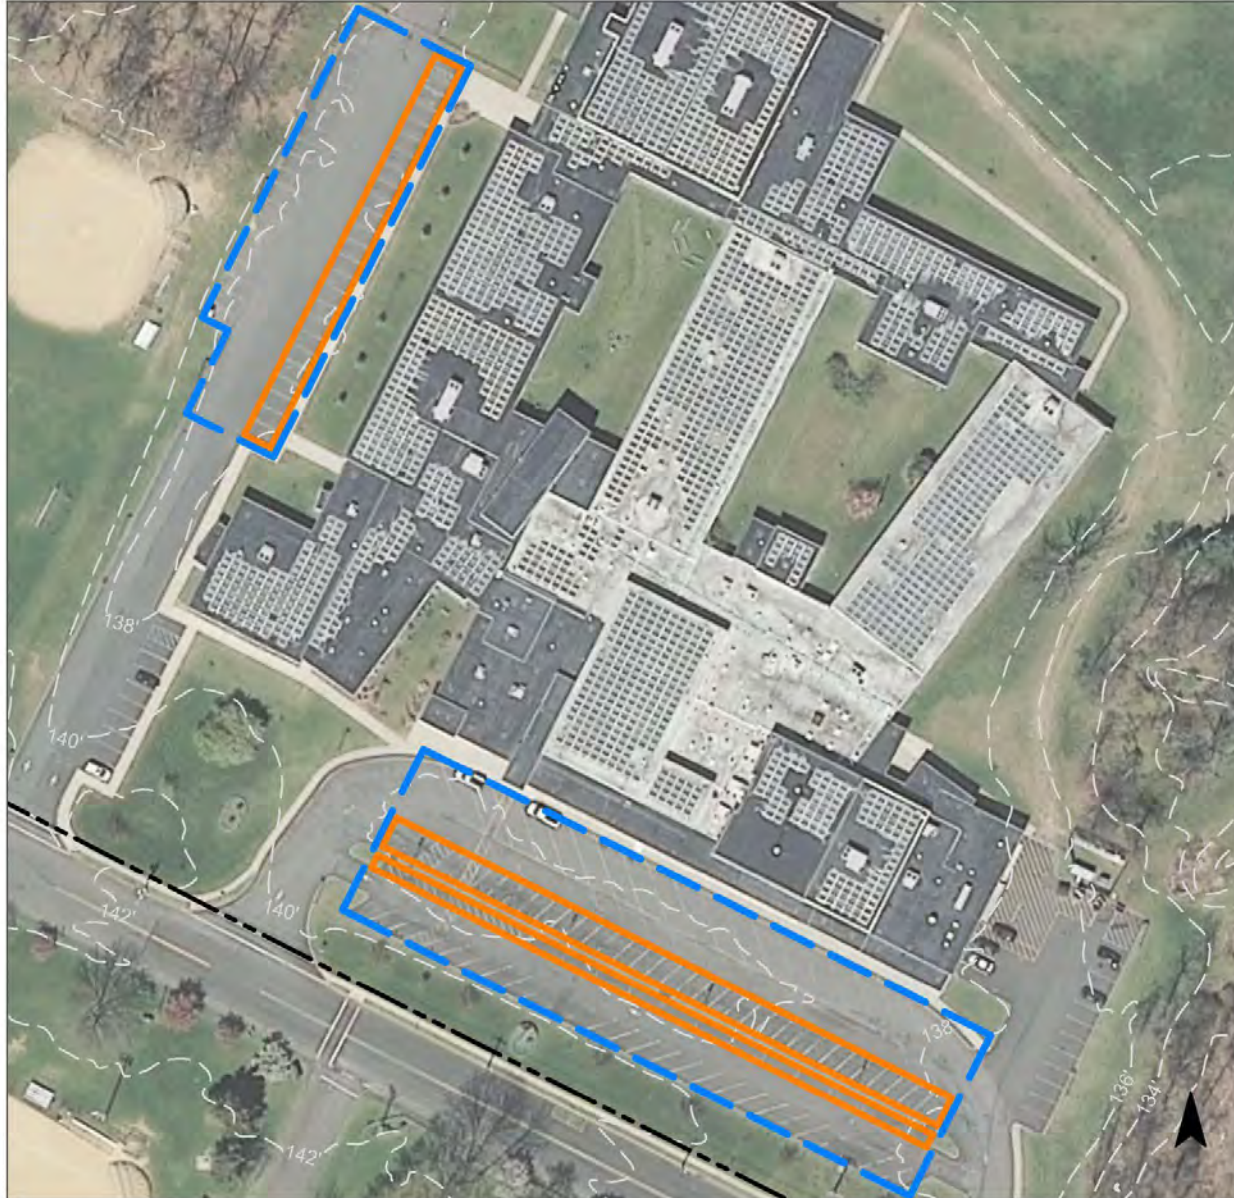
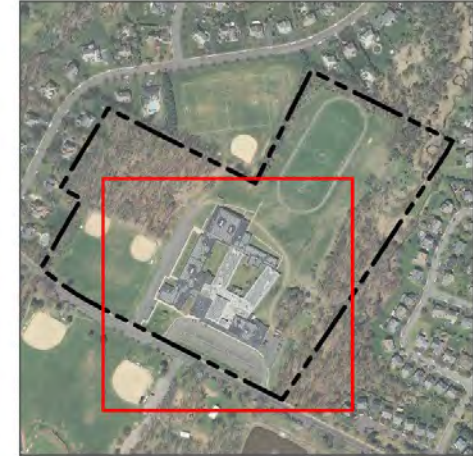
**Branchburg Central  
Middle School**

- pervious pavements
- drainage areas
- property line
- 2012 Aerial: NJOIT, OGIS
