## Bedminster Township

### Introduction

The purpose of this report is to provide a comprehensive understanding of key, defining features within the subwatersheds throughout Bedminster Township. This involves gathering, organizing, and presenting information about existing conditions and infrastructure within each subwatershed. It aims to serve as a tool for informed decision-making, planning, and implementation of sustainable watershed management strategies aimed to protect and enhance the health of the watershed, its associated ecosystems, and the surrounding communities.

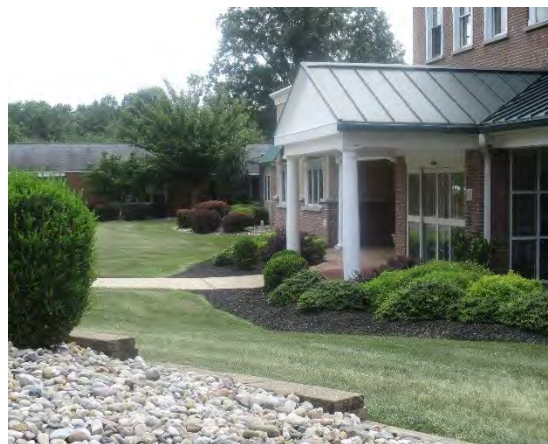
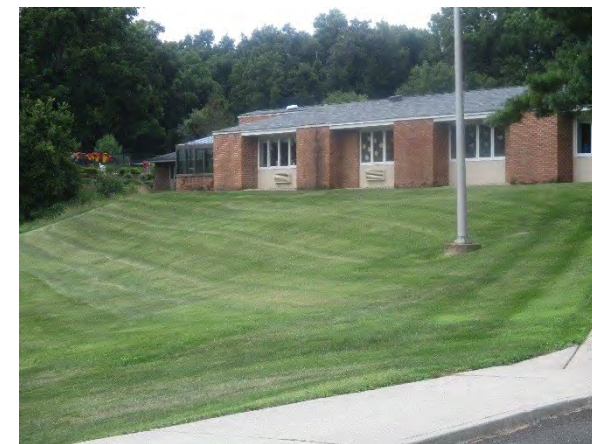
Parking spaces can be replaced with pervious pavement to infiltrate parking lot runoff. A rain garden can be installed to capture, treat, and infiltrate driveway runoff. A preliminary soil assessment suggests that the soils have suitable drainage characteristics for green infrastructure.

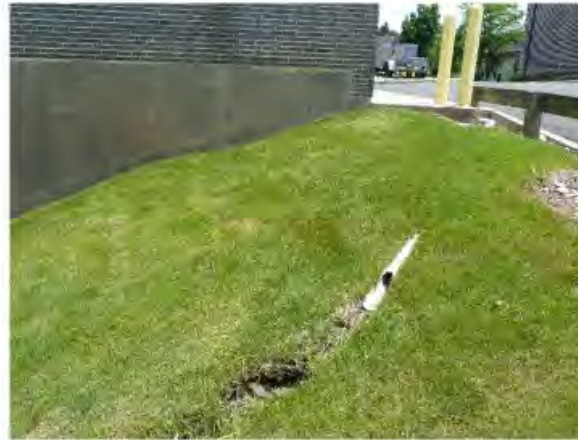
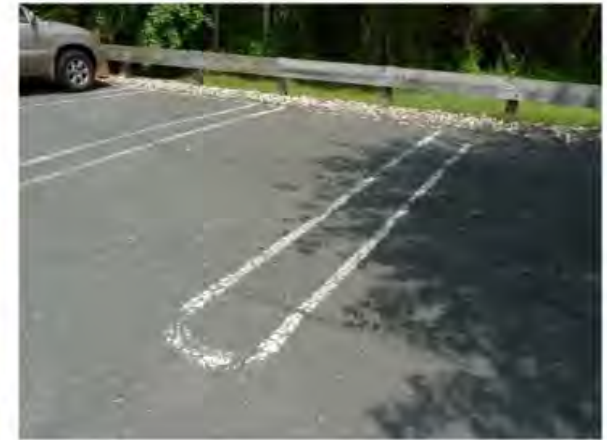
Parking spots on the east and west sides of the building can be replaced with porous asphalt to capture and infiltrate parking lot runoff. A preliminary soil assessment suggests that the soils have suitable drainage characteristics for green infrastructure.

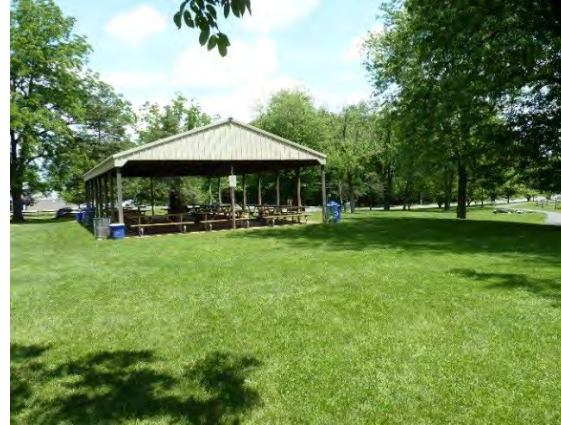
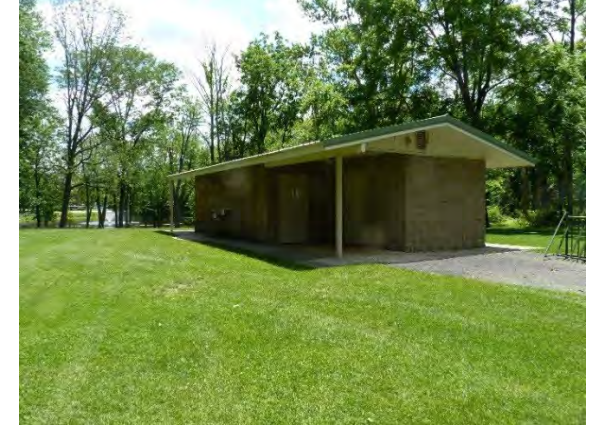
Rain gardens can be built to capture, treat, and infiltrate roof runoff. A preliminary soil assessment suggests that more soil testing would be required before determining the soil's suitability for green infrastructure.

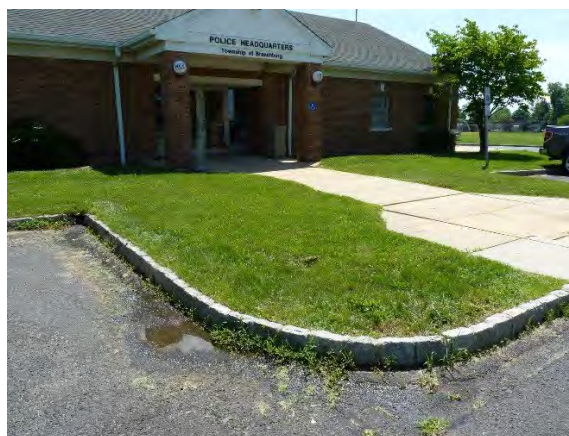
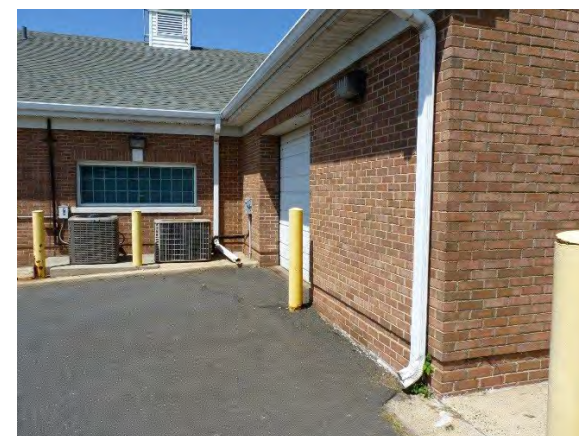
Parking spaces can be replaced with pervious pavement to infiltrate runoff. A rain garden can be installed to capture, treat, and infiltrate roof runoff. A preliminary soil assessment suggests that the soils have suitable drainage characteristics for green infrastructure.

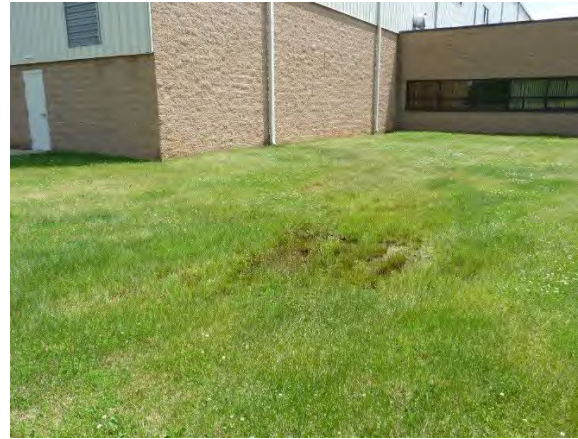
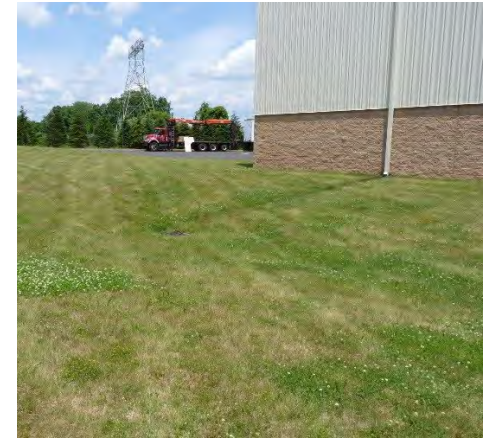
Bioretention systems can be installed to capture, treat, and infiltrate rooftop runoff. Parking spaces can be replaced with pervious pavement to infiltrate parking lot runoff. A preliminary soil assessment suggests that the soils have suitable drainage characteristics for green infrastructure.

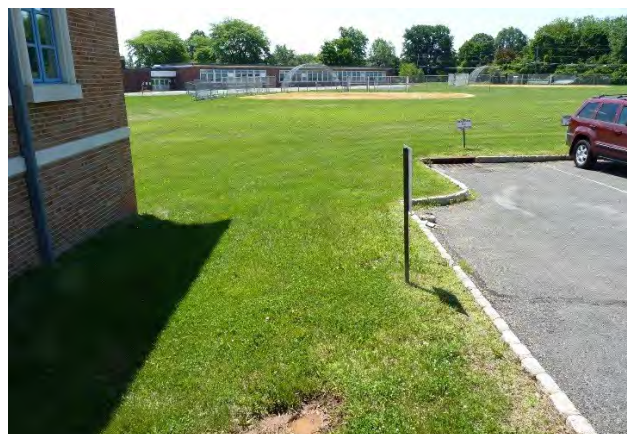
Parking spaces can be replaced with pervious pavement to infiltrate runoff. Bioretention systems can be installed to capture, treat, and infiltrate additional stormwater. A preliminary soil assessment suggests that more soil testing would be required before determining the soil's suitability for green infrastructure.

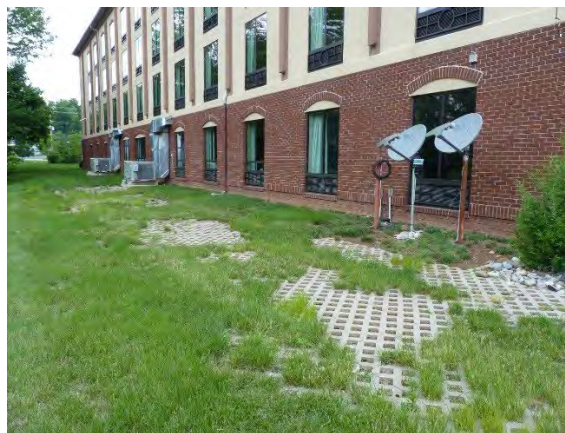
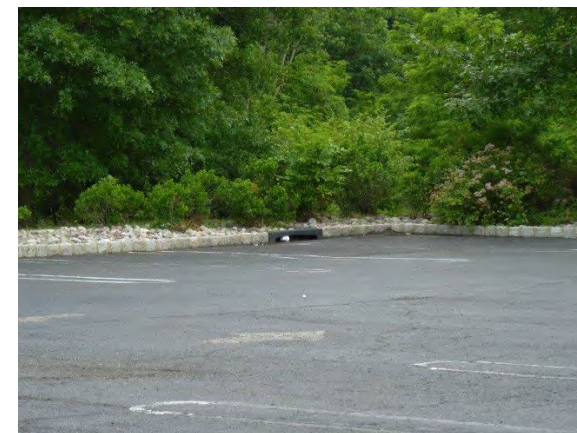
Existing pervious pavers surround the south and west sides of the buildings. Downspouts can be disconnected and directed into the pavers to capture and infiltrate roof runoff. Parking spaces can be replaced with porous asphalt to capture parking lot runoff. A preliminary soil assessment suggests that the soils have suitable drainage characteristics for green infrastructure.

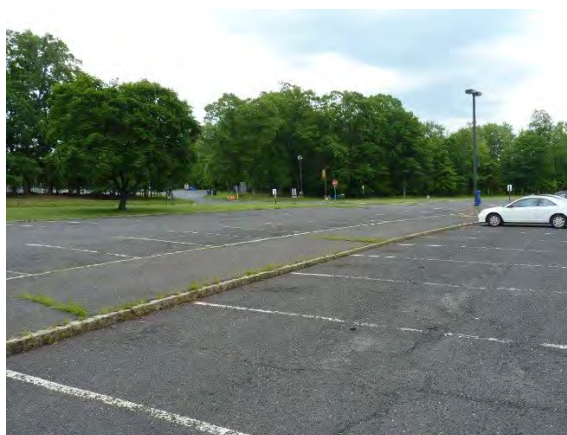
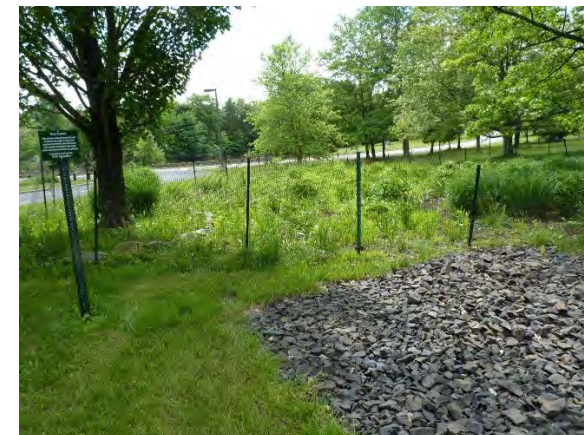
Two rain gardens can be installed in the parking lot to capture, treat, and infiltrate runoff from the parking lot. A preliminary soil assessment suggests that the soils have suitable drainage characteristics for green infrastructure.

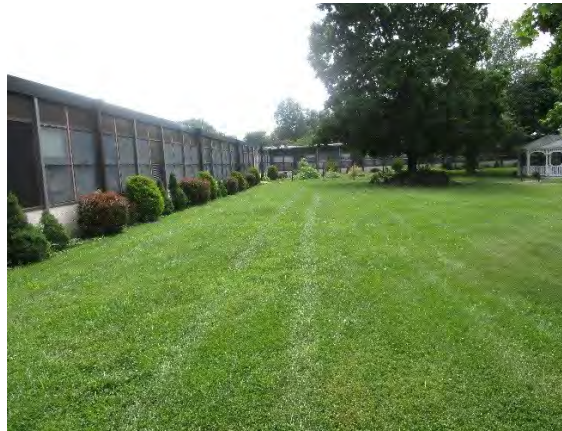
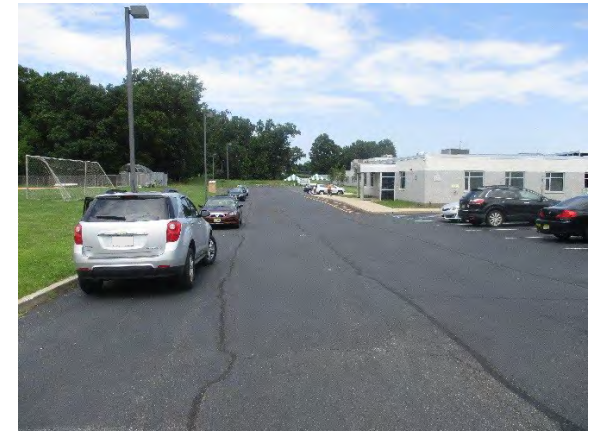
Parking spaces on the east and west sides of the school can be replaced with porous asphalt to capture and infiltrate stormwater runoff from the parking lot. Bioretention systems can be installed to capture, treat, and infiltrate rooftop runoff. A preliminary soil assessment suggests that the soils have suitable drainage characteristics for green infrastructure.

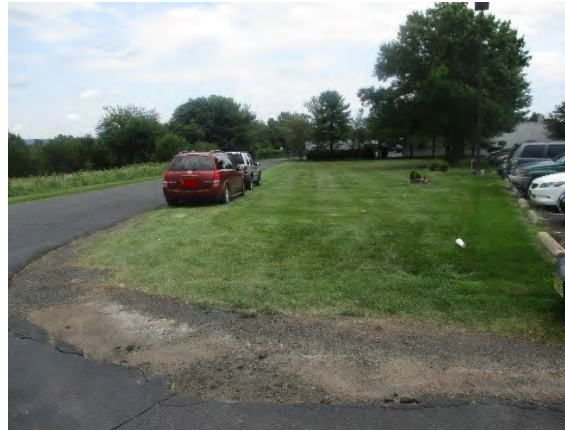
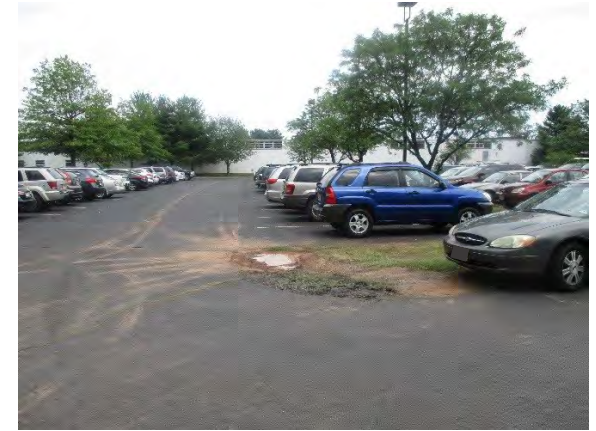
Parking spaces can be replaced with pervious pavement to infiltrate runoff. In the northwest corner of the site a rain garden can be installed to capture, treat, and infiltrate stormwater generated by the parking lot. A preliminary soil assessment suggests that the soils have suitable drainage characteristics for green infrastructure.

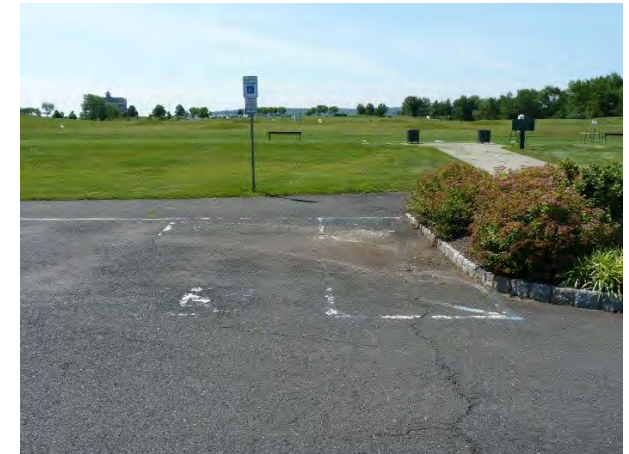
Parking spaces can be replaced with porous asphalt to capture and infiltrate runoff. Bioretention systems can also be installed to capture, treat, and infiltrate roof runoff. A preliminary soil assessment suggests that the soils have suitable drainage characteristics for green infrastructure.

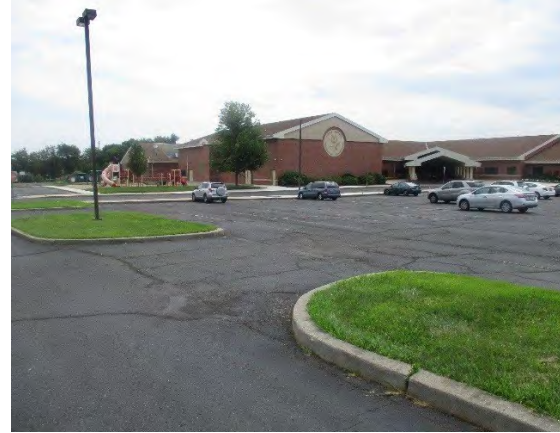
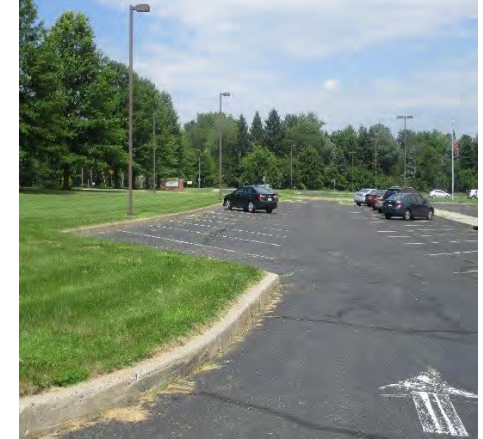
Bioretention systems can be built to capture, treat, and infiltrate parking lot runoff. Parking spaces can be replaced with pervious pavement. A preliminary soil assessment suggests that the soils have suitable drainage characteristics for green infrastructure.

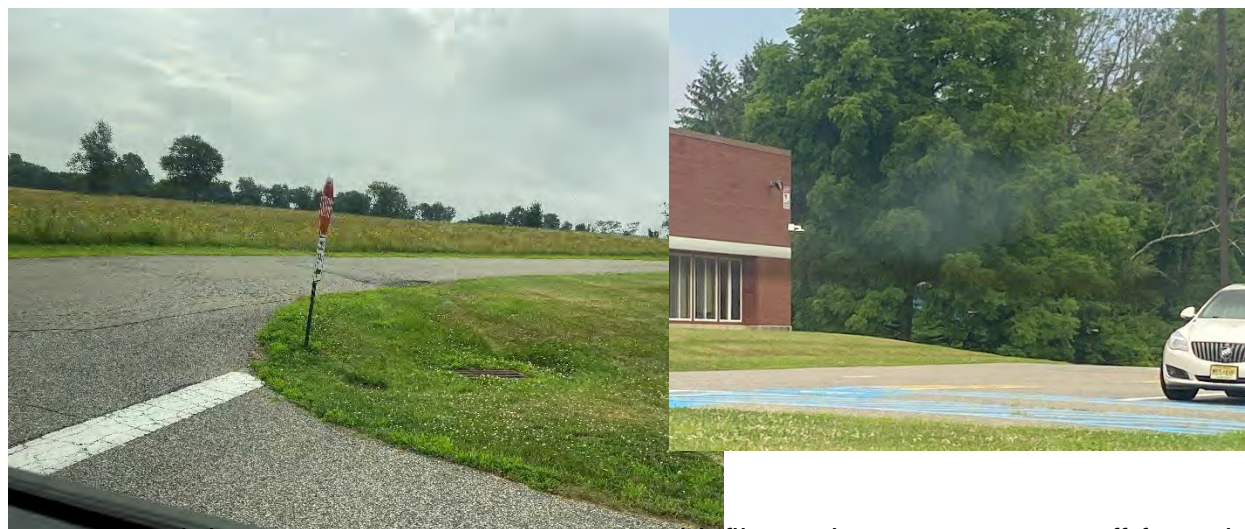
Rain gardens can be installed in multiple grass areas around the property to capture, treat, and infiltrate the stormwater runoff from the driveway and parking lot. Trench drains will be required for some of these gardens. Existing parking spaces in the northern and southern parking lots can be converted into pervious pavement to capture and infiltrate the stormwater runoff from the asphalt. A preliminary soil assessment suggests that the soils have suitable drainage characteristics for green infrastructure.

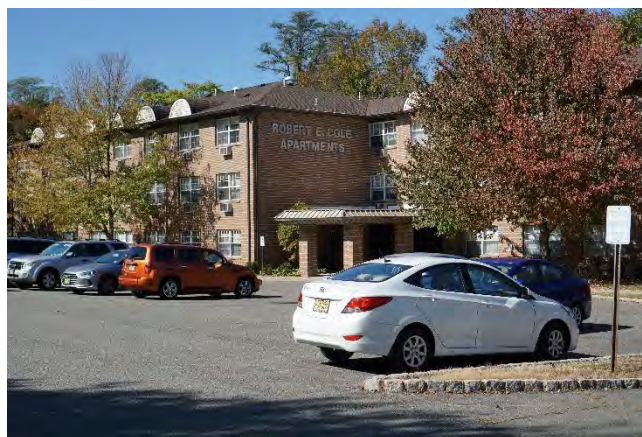
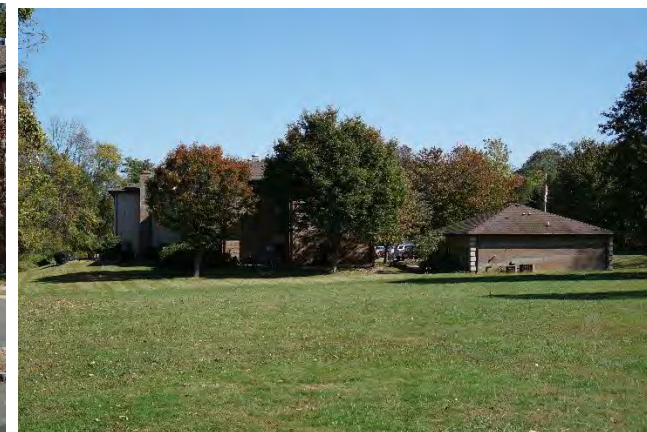
**Address:** 1 Cole Court  
Chester Borough, NJ 07930

Two rain gardens can be installed west of the two buildings to accumulate and infiltrate stormwater runoff from the buildings. Additionally, porous pavement can be used to capture stormwater from the parking lot in front of the main building. A preliminary soil assessment suggests that more soil testing would be required before determining the soil's suitability for green infrastructure.

Recommended Green Infrastructure Practices	Recharge Potential (Mgal/yr)	TSS Removal Potential (lbs/yr)	Maximum Volume Reduction Potential (gal/storm)	Peak Discharge Reduction Potential (cu. ft./second)	Estimated Size (sq. ft.)	Estimated Cost
Bioretention systems	0.042	7	2,980	0.11	405	\$2,025
Pervious pavement	0.178	30	12,640	0.48	1,450	\$36,250

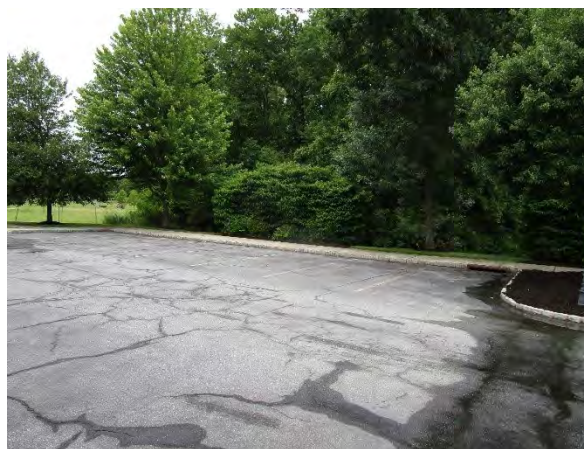
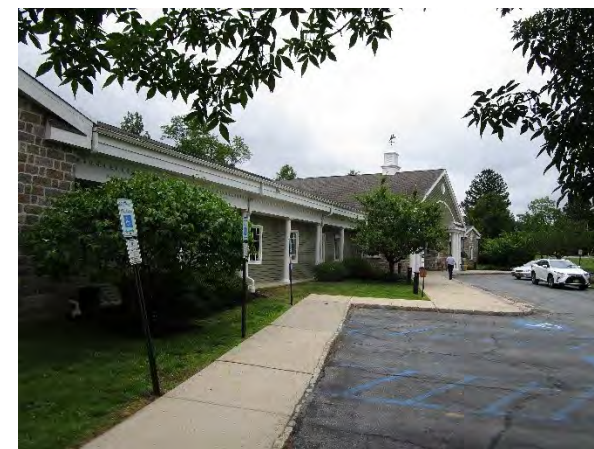
**Address:** 250 West Main Street  
Chester, NJ 07930

Parking spaces in the parking lot to the west of the building can be converted to porous pavement to capture and infiltrate stormwater runoff from the parking lot, before it enters the nearby storm drain. A rain garden can be installed south of the building to capture, filter, and infiltrate stormwater runoff from the roof if the front downspouts are disconnected. A preliminary soil assessment suggests that more soil testing would be required before determining the soil's suitability for green infrastructure.

Recommended Green Infrastructure Practices	Recharge Potential (Mgal/yr)	TSS Removal Potential (lbs/yr)	Maximum Volume Reduction Potential (gal/storm)	Peak Discharge Reduction Potential (cu. ft./second)	Estimated Size (sq. ft.)	Estimated Cost
Bioretention system	0.089	15	6,310	0.24	860	\$4,300
Pervious pavement	0.157	26	11,120	0.42	1,055	\$26,375

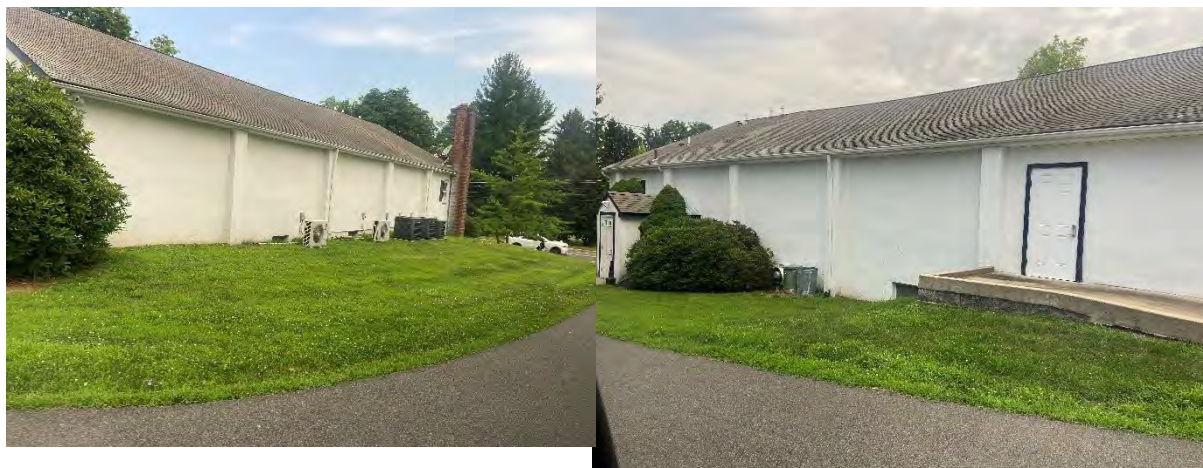
**Address:** 370 Main Street  
Chester, NJ 07930

Rain gardens can be installed in multiple grass areas around the property to capture, treat, and infiltrate the stormwater runoff from the driveway and rooftop. This will require downspout disconnections, trench drains, and in some cases downspout redirection beneath the sidewalk. A cistern can be installed to the southwest of the building to divert and detain the stormwater runoff from the rooftop for later non-potable reuse such as watering a garden bed. A preliminary soil assessment suggests that the soils have suitable drainage characteristics for green infrastructure.

Recommended Green Infrastructure Practices	Drainage Area (sq. ft.)	Recharge Potential (Mgal/yr)	TSS Removal Potential (lbs/yr)	Maximum Volume Reduction Potential (gal/storm)	Peak Discharge Reduction Potential (cu. ft./second)	Estimated Size (sq. ft.)	Estimated Cost
Bioretention system	12,090	0.358	53	25,220	0.95	3,025	\$30,250
Rainwater harvesting	430	0.013	2	350	N/A	350 (gal)	\$1,050

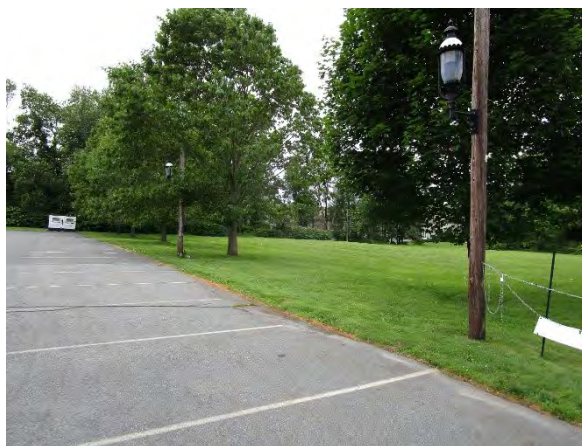
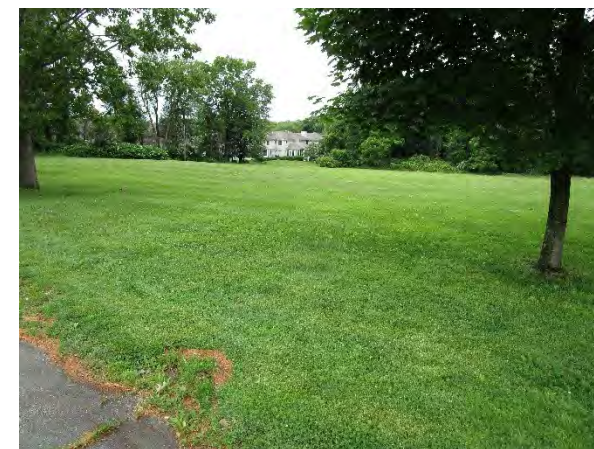
**Address:** 375 Main Street  
Chester, NJ 07930

A rain garden can be installed west of the building behind the parking lot to capture, treat, and infiltrate stormwater runoff from the roof. A preliminary soil assessment suggests that the soils have suitable drainage characteristics for green infrastructure.

Recommended Green Infrastructure Practices	Recharge Potential (Mgal/yr)	TSS Removal Potential (lbs/yr)	Maximum Volume Reduction Potential (gal/storm)	Peak Discharge Reduction Potential (cu. ft./second)	Estimated Size (sq. ft.)	Estimated Cost
Bioretention system	0.214	36	15,160	0.57	2,050	\$10,250

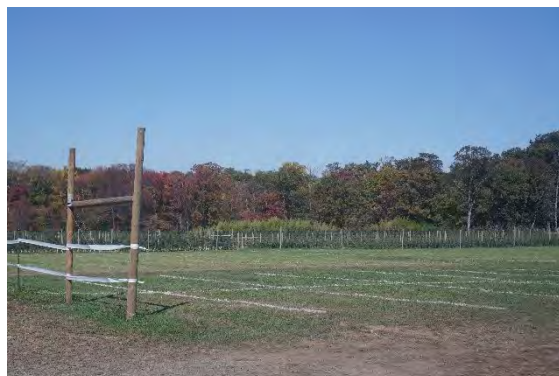
**Address:** 15 North Road  
Chester Borough, NJ 07930

Pervious pavement can be installed in the parking lot to capture the stormwater runoff from the parking lot. A preliminary soil assessment suggests that the soils have suitable drainage characteristics for green infrastructure.

Recommended Green Infrastructure Practices	Recharge Potential (Mgal/yr)	TSS Removal Potential (lbs/yr)	Maximum Volume Reduction Potential (gal/storm)	Peak Discharge Reduction Potential (cu. ft./second)	Estimated Size (sq. ft.)	Estimated Cost
Pervious pavement	0.316	53	22,460	0.84	2,700	\$67,500

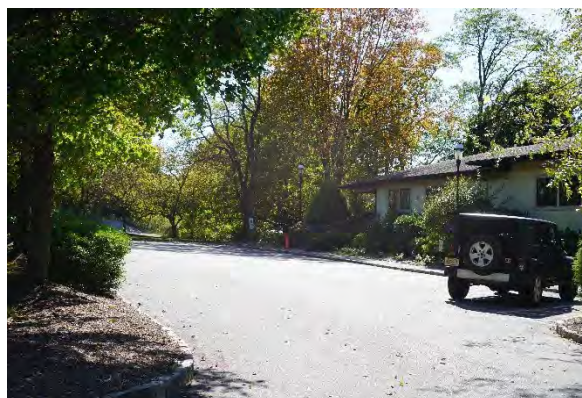
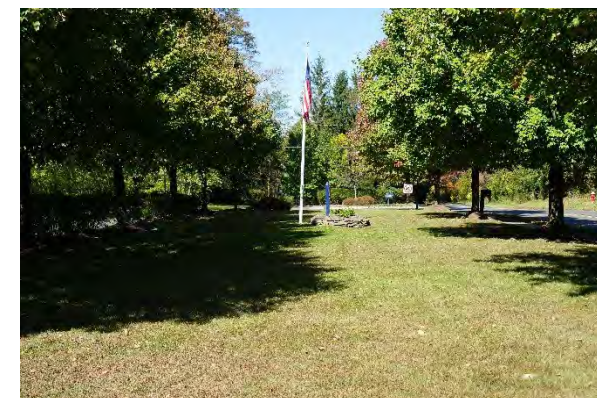
**Address:** 41 Oakdale Road  
Chester Borough, NJ 07930

Parking spaces in the parking lot to the northeast of the building can be converted to porous pavement to capture and infiltrate stormwater runoff from the parking lot. A rain garden can be installed in the turfgrass area near the entrance of the building to capture, treat, and infiltrate stormwater runoff from the roof. A preliminary soil assessment suggests that the soils have suitable drainage characteristics for green infrastructure.

Recommended Green Infrastructure Practices	Recharge Potential (Mgal/yr)	TSS Removal Potential (lbs/yr)	Maximum Volume Reduction Potential (gal/storm)	Peak Discharge Reduction Potential (cu. ft./second)	Estimated Size (sq. ft.)	Estimated Cost
Bioretention system	0.038	6	2,690	0.10	365	\$1,825
Pervious pavement	0.131	22	9,320	0.35	900	\$22,500

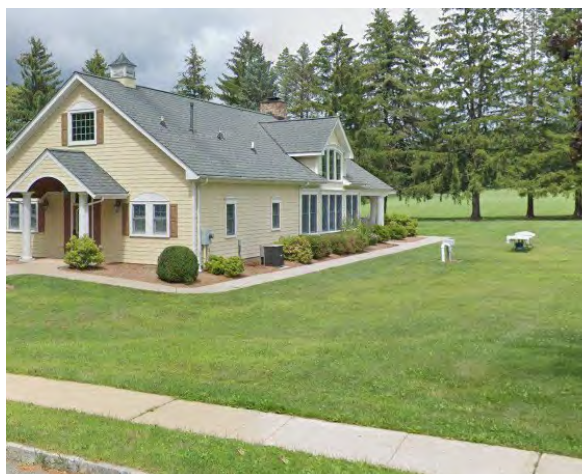
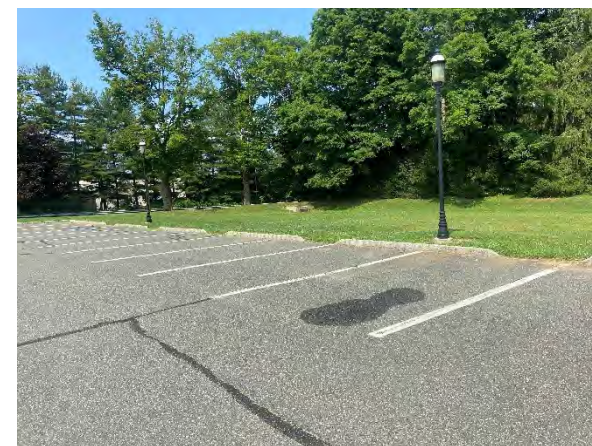
**Address:** 107 Seminary Avenue  
Chester, NJ 07930

Rain gardens can be installed to the northwest of the parking lot and to the southeast of the building to capture, treat, and infiltrate the stormwater runoff from the parking lot and building rooftop. This will require curb cuts and downspout redirection beneath the sidewalk. A preliminary soil assessment suggests that the soils have suitable drainage characteristics for green infrastructure.

Recommended Green Infrastructure Practices	Drainage Area (sq. ft.)	Recharge Potential (Mgal/yr)	TSS Removal Potential (lbs/yr)	Maximum Volume Reduction Potential (gal/storm)	Peak Discharge Reduction Potential (cu. ft./second)	Estimated Size (sq. ft.)	Estimated Cost
Bioretention system	8,915	0.264	38	18,600	0.70	2,230	\$22,300

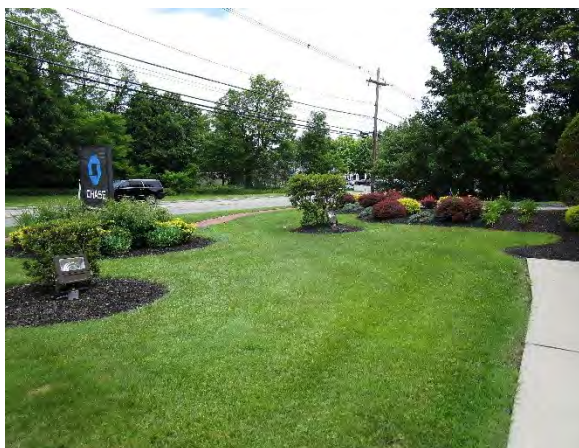
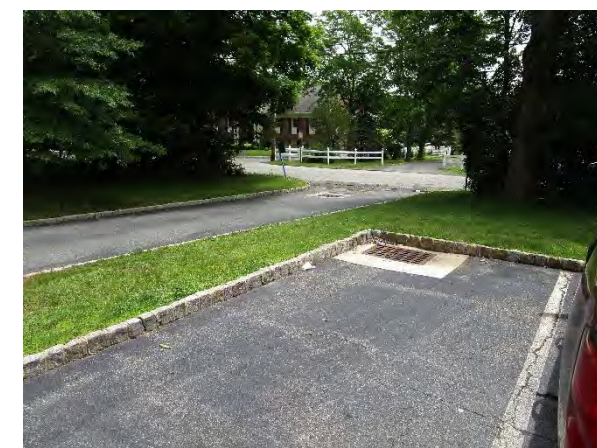
**Address:** 444 East Main Street  
Chester, NJ 07930

A rain garden can be installed north of the building to capture, treat, and infiltrate stormwater runoff from the roof and parking lot. Parking spaces near the catch basin in the rear parking lot can be converted to porous pavement to capture and infiltrate stormwater runoff from the parking lot. A preliminary soil assessment suggests that the soils have suitable drainage characteristics for green infrastructure.

Recommended Green Infrastructure Practices	Recharge Potential (Mgal/yr)	TSS Removal Potential (lbs/yr)	Maximum Volume Reduction Potential (gal/storm)	Peak Discharge Reduction Potential (cu. ft./second)	Estimated Size (sq. ft.)	Estimated Cost
Bioretention system	0.031	5	2,180	0.08	295	\$1,475
Pervious pavement	0.098	16	6,930	0.26	810	\$20,250

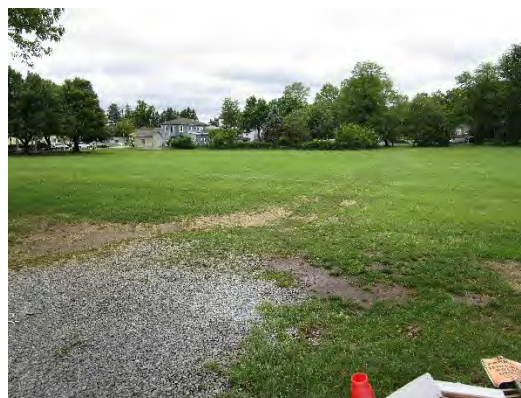
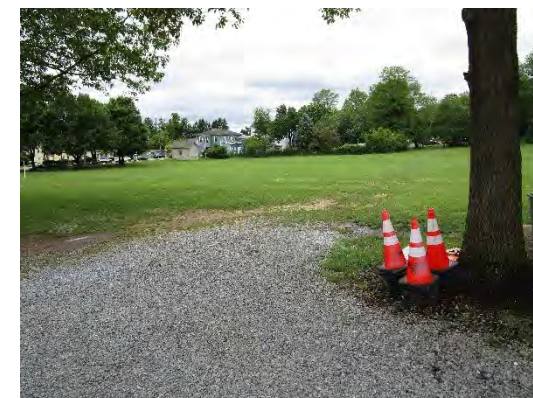
**Address:** 134 Main Street  
Chester Borough, NJ 07930

A rain garden can be installed to the west of the building nearby the baseball field. A preliminary soil assessment suggests that the soils have suitable drainage characteristics for green infrastructure.

Recommended Green Infrastructure Practices	Recharge Potential (Mgal/yr)	TSS Removal Potential (lbs/yr)	Maximum Volume Reduction Potential (gal/storm)	Peak Discharge Reduction Potential (cu. ft./second)	Estimated Size (sq. ft.)	Estimated Cost
Bioretention system	0.026	4	1,850	0.07	250	\$1,250

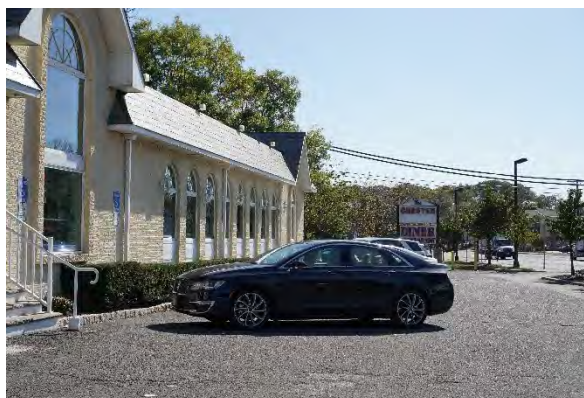
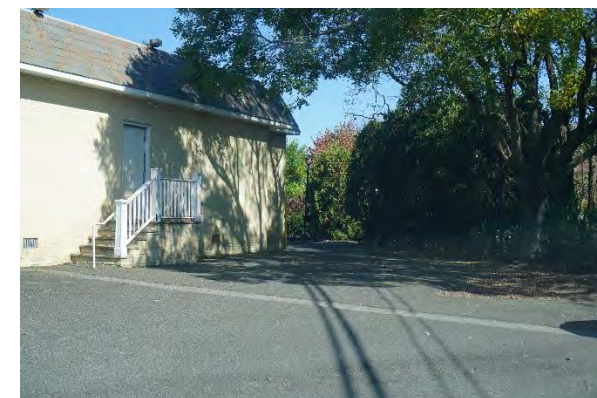
**Address:** 65 US-206  
Chester Borough, NJ 07930

Porous pavement can be installed on the west side of the building to capture and infiltrate stormwater runoff from the building and surrounding area. A preliminary soil assessment suggests that more soil testing would be required before determining the soil's suitability for green infrastructure.

Recommended Green Infrastructure Practices	Recharge Potential (Mgal/yr)	TSS Removal Potential (lbs/yr)	Maximum Volume Reduction Potential (gal/storm)	Peak Discharge Reduction Potential (cu. ft./second)	Estimated Size (sq. ft.)	Estimated Cost
Pervious pavement	0.155	26	11,000	0.41	1,080	\$27,000

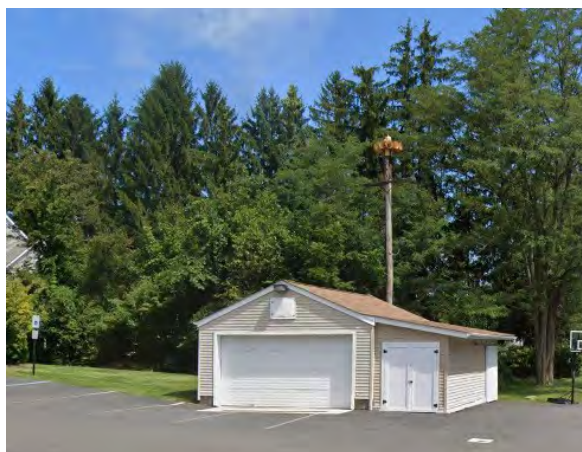
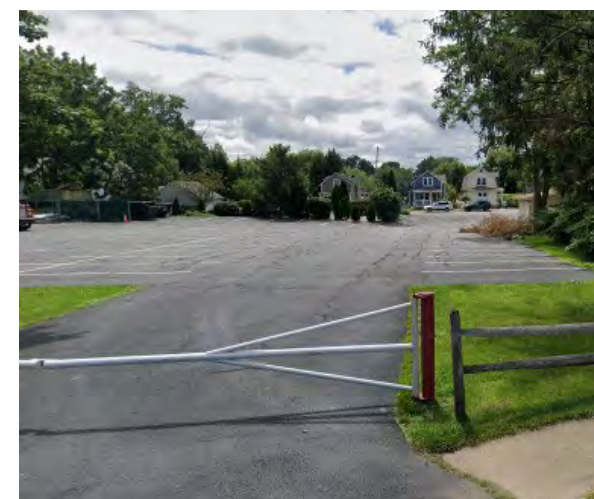
**Address:** 86 Main Street  
Chester, NJ 07930

A rain garden can be installed to the west of the shed to capture, treat, and infiltrate the stormwater runoff from the rooftop. This will require a downspout disconnection. The gutters on the eastern section of the shed can also be reworked and directed towards the raingarden to increase the treated drainage area. Existing parking spaces in the eastern parking lot can be converted into pervious pavement to capture and infiltrate the stormwater runoff from the asphalt. A preliminary soil assessment suggests that more soil testing would be required before determining the soil's suitability for green infrastructure.

Recommended Green Infrastructure Practices	Drainage Area (sq. ft.)	Recharge Potential (Mgal/yr)	TSS Removal Potential (lbs/yr)	Maximum Volume Reduction Potential (gal/storm)	Peak Discharge Reduction Potential (cu. ft./second)	Estimated Size (sq. ft.)	Estimated Cost
Bioretention system	810	0.024	4	1,690	0.06	205	\$2,050
Pervious pavement	18,255	0.541	80	38,070	1.43	4,155	\$103,875

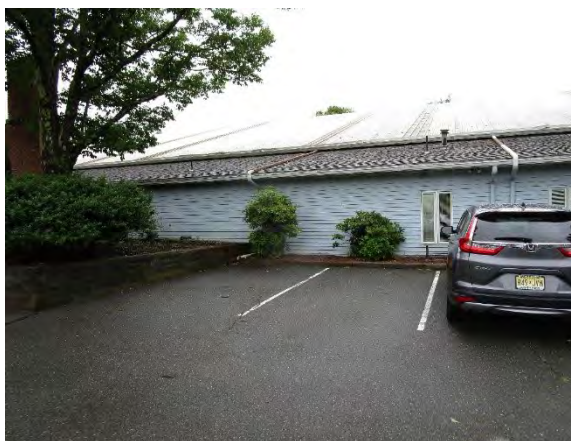
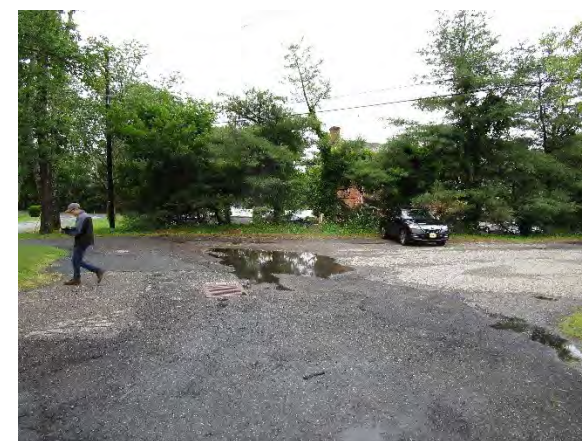
**Address:** 581 Main Street  
Chester, NJ 07930

Parking spaces in the parking lot to the south of the building can be converted to porous pavement to capture and infiltrate stormwater runoff from the roof via the downspouts, which are disconnected. A preliminary soil assessment suggests that more soil testing would be required before determining the soil's suitability for green infrastructure.

Recommended Green Infrastructure Practices	Recharge Potential (Mgal/yr)	TSS Removal Potential (lbs/yr)	Maximum Volume Reduction Potential (gal/storm)	Peak Discharge Reduction Potential (cu. ft./second)	Estimated Size (sq. ft.)	Estimated Cost
Pervious pavement	0.190	32	13,490	0.51	1,300	\$32,500

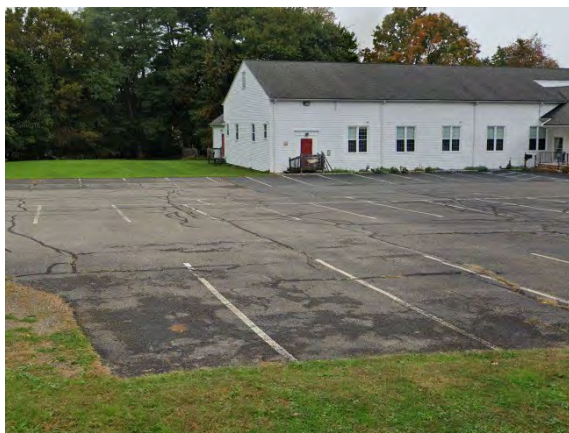
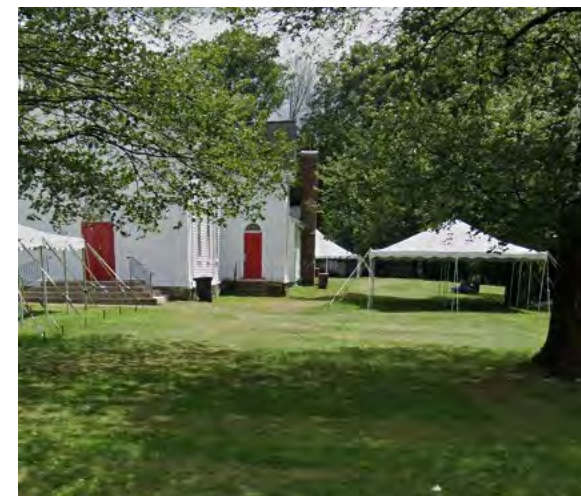
**Address:** 220 Main Street  
Chester, NJ 07930

Rain gardens can be installed in multiple grass areas around the property to capture, treat, and infiltrate the stormwater runoff from the rooftops and parking lot. This will require downspout redirection and disconnections. Existing parking spaces in western section of the parking lot can be converted into pervious pavement to capture and infiltrate the stormwater runoff from the asphalt. A cistern can be installed to the southeast of the building to divert and detain the stormwater runoff from the rooftop for later non-potable reuse such as watering a garden bed. A preliminary soil assessment suggests that the soils have suitable drainage characteristics for green infrastructure.

Recommended Green Infrastructure Practices	Drainage Area (sq. ft.)	Recharge Potential (Mgal/yr)	TSS Removal Potential (lbs/yr)	Maximum Volume Reduction Potential (gal/storm)	Peak Discharge Reduction Potential (cu. ft./second)	Estimated Size (sq. ft.)	Estimated Cost
Bioretention system	12,290	0.364	53	25,630	0.96	3,075	\$30,750
Pervious pavement	6,735	0.199	29	14,050	0.53	1,255	\$31,375
Rainwater harvesting	510	0.015	2	400	N/A	400 (gal)	\$1,200

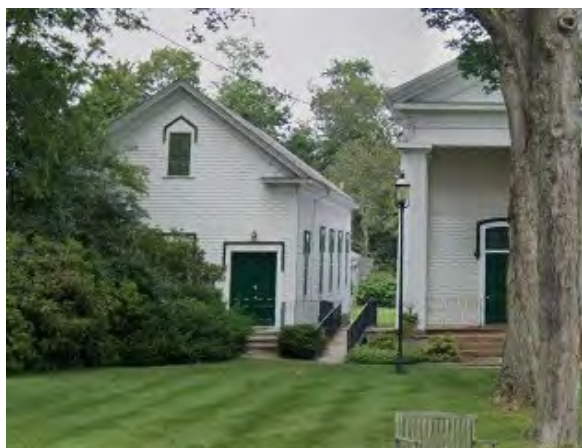
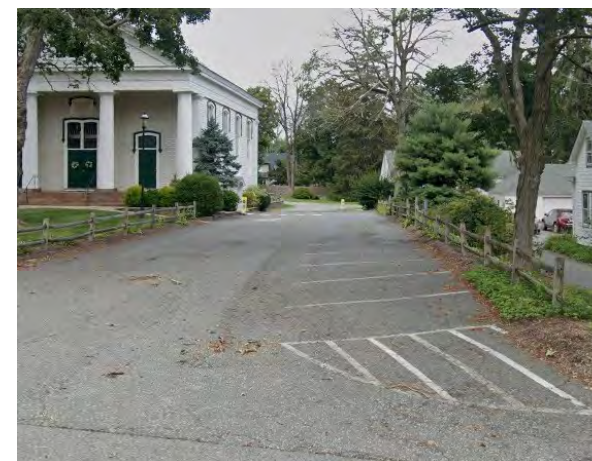
Rain gardens can be installed in multiple grass areas around the property to capture, treat, and infiltrate the stormwater runoff from the rooftops. This will require downspout disconnections, and in some cases downspout redirection underneath the sidewalk. Existing parking spaces in the eastern and western parking lots can be converted into pervious pavement to capture and infiltrate the stormwater runoff from the asphalt. A preliminary soil assessment suggests that more soil testing would be required before determining the soil's suitability for green infrastructure.

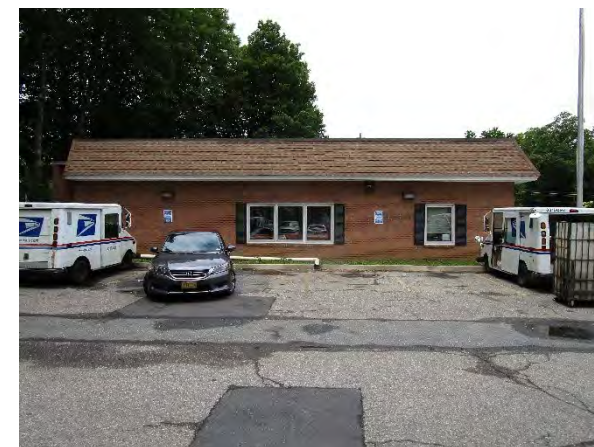
Parking spaces in the parking lot to the east of the building can be converted to porous pavement to capture and infiltrate stormwater runoff from the parking lot and the downspout. A septic system in the turfgrass area north of the building limits rain garden opportunities. A preliminary soil assessment suggests that the soils have suitable drainage characteristics for green infrastructure.

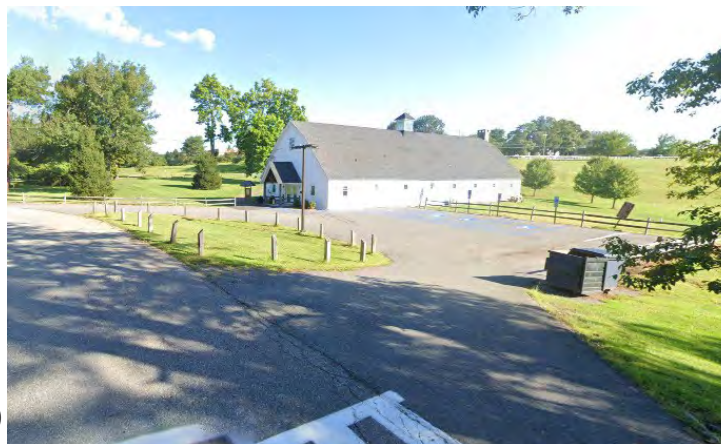
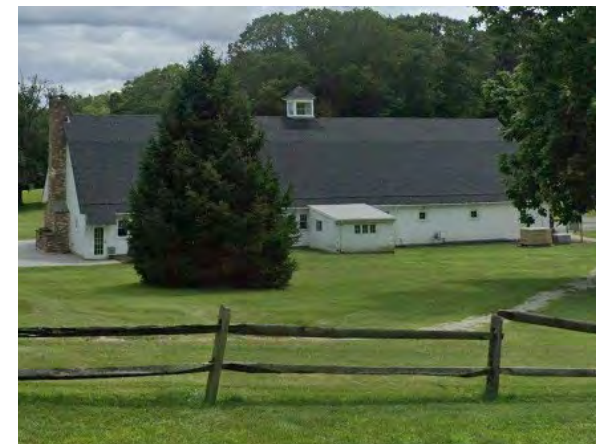
Rain gardens can be installed in multiple grass areas to capture, treat, and infiltrate the stormwater runoff from the building rooftop and from the asphalt driveway. This will require downspout disconnections. The existing parking spaces to the southeast of the park building can be converted into pervious pavement to capture and infiltrate the stormwater runoff from the asphalt. A preliminary soil assessment suggests that the soils have suitable drainage characteristics for green infrastructure.

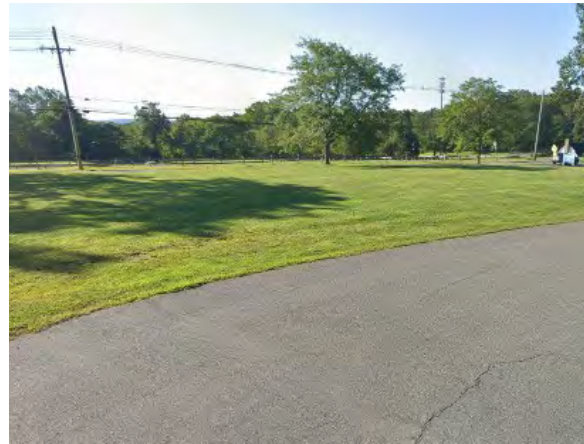
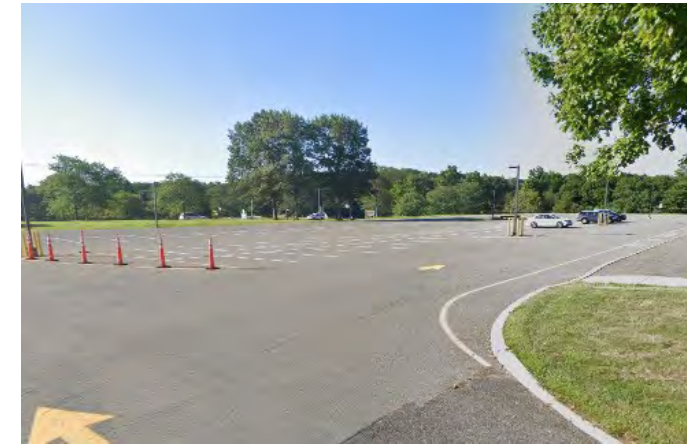
Rain gardens can be installed near the northern and southern parking lots to capture, treat, and infiltrate the stormwater runoff from the asphalt. This will require downspout disconnections. Existing parking spaces in the northern and southern lots can be converted into pervious pavement to capture and infiltrate the stormwater runoff from the asphalt. The basketball court to the north of the school can also be converted into pervious pavement. A preliminary soil assessment suggests that the soils have suitable drainage characteristics for green infrastructure.

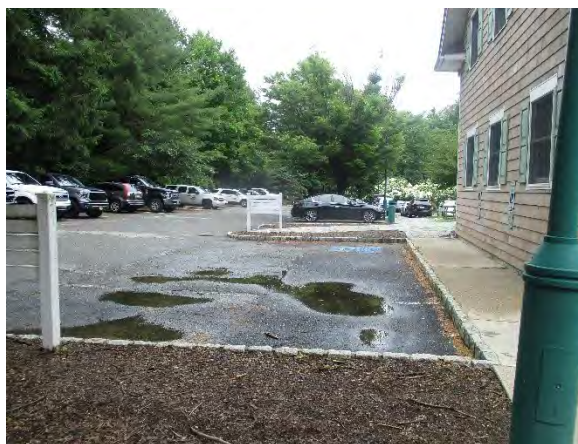
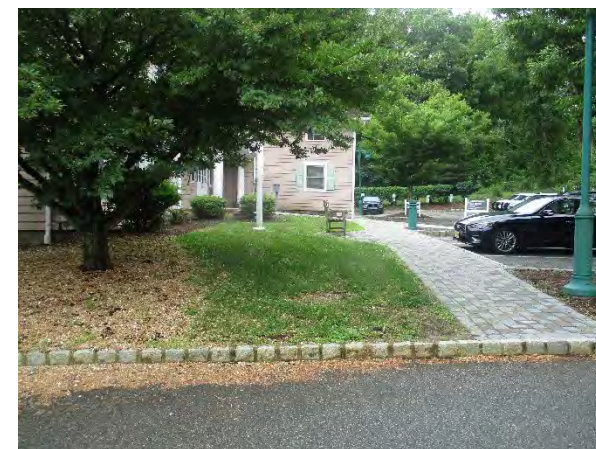
Pervious pavement can be installed in the parking spaces west of the building to capture and infiltrate stormwater. A rain garden can be installed to the northwest of the building to capture, treat, and infiltrate stormwater runoff from the roof. A preliminary soil assessment suggests that the soils have suitable drainage characteristics for green infrastructure.

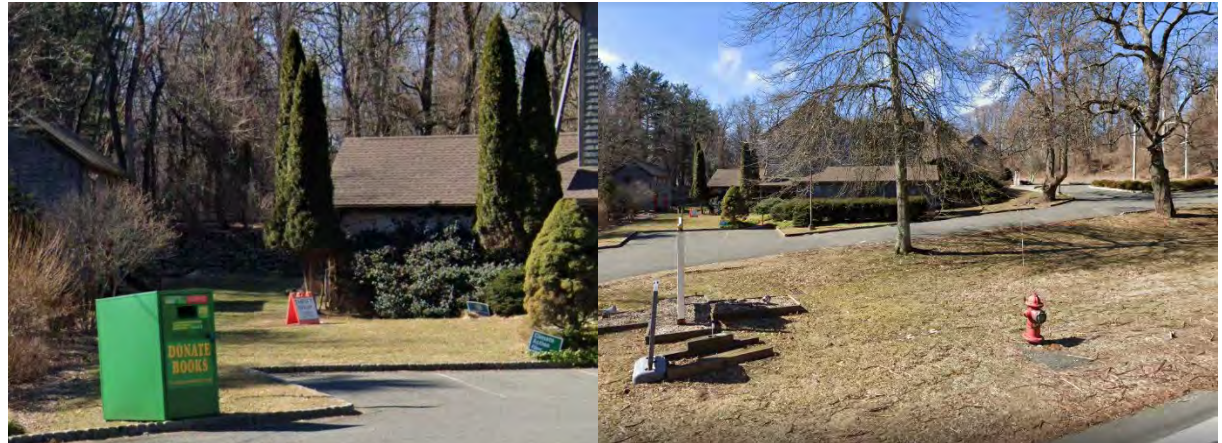
A rain garden can be installed near the south of the building using the disconnected downspouts to capture, treat, and infiltrate the stormwater runoff from the rooftop. Another rain garden can be installed around an existing catch basin near the driveway entrance to capture, treat, and infiltrate the stormwater runoff from the asphalt. A trench drain will be needed to intercept and redired the driveway runoff. Existing parking spaces to the northwest of the building can be converted into pervious pavement to capture and infiltrate the stormwater runoff from the asphalt. The concrete walkway near the building entrance can be replaced with permeable pavers. A preliminary soil assessment suggests that the soils have suitable drainage characteristics for green infrastructure.

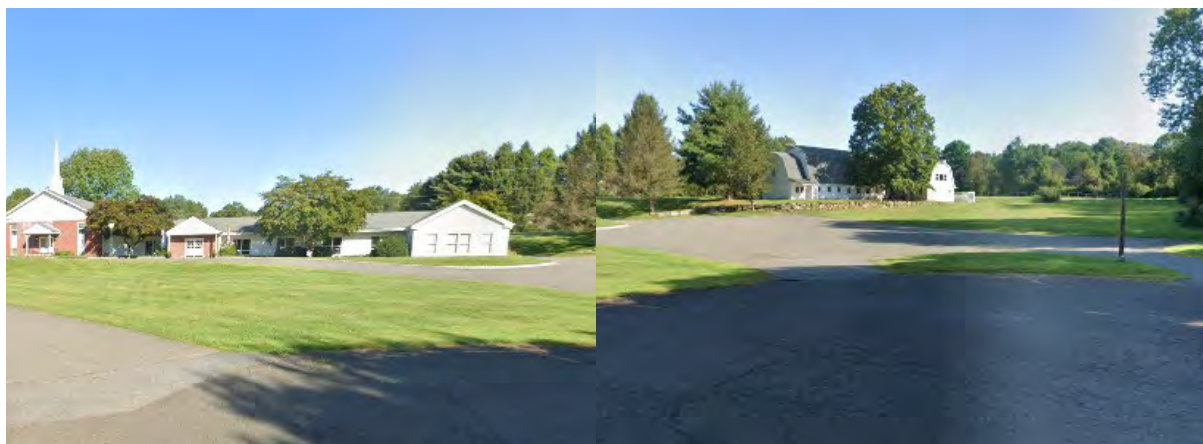
Rain gardens can be installed in multiple grass areas around the property to capture, treat, and infiltrate the stormwater runoff from the rooftop and driveways. This may require downspout disconnections, trench drains, and curb cuts. Existing parking spaces to the east of the building can be converted into pervious pavement to capture and infiltrate the stormwater runoff from the asphalt. This may require a trench drain. A preliminary soil assessment suggests that the soils have suitable drainage characteristics for green infrastructure.

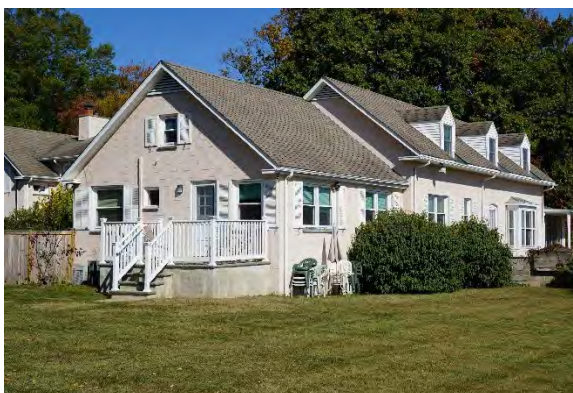
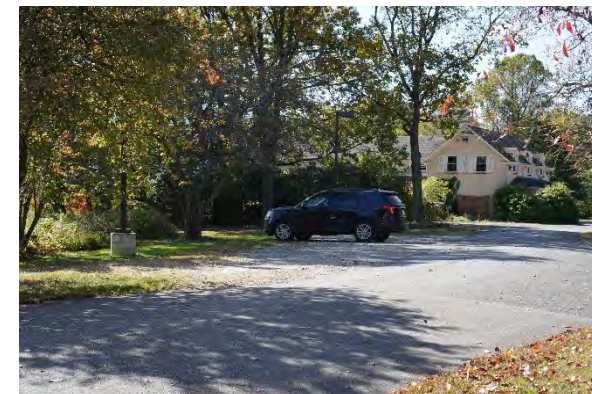
Pervious pavement can be installed in the parking spaces to capture the stormwater runoff from the pavement. A rain garden can be installed to capture and infiltrate stormwater runoff from the building's rooftop. A preliminary soil assessment suggests that the soils have suitable drainage characteristics for green infrastructure.

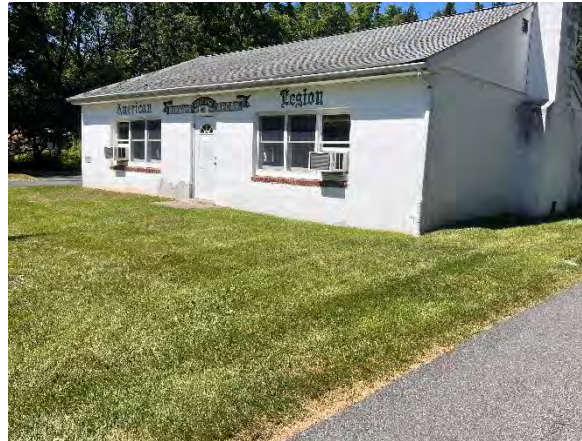
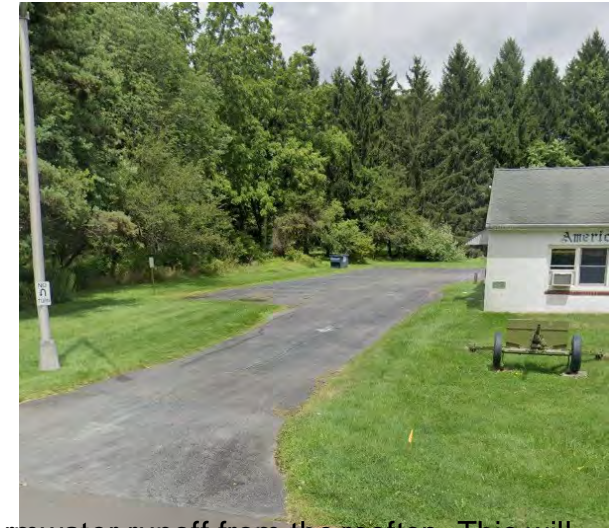
A rain garden can be installed to the south of the building to capture, treat, and infiltrate the stormwater runoff from the rooftop. This will require downspout disconnection. Another rain garden can be installed near the western driveway entrance to capture, treat, and infiltrate the stormwater runoff from the asphalt. This will require a trench drain. Existing parking spaces to the north and west of the building can be converted into pervious pavement to capture and infiltrate the stormwater runoff from the parking lot. This may require a trench drain. A preliminary soil assessment suggests that more soil testing would be required before determining the soil's suitability for green infrastructure.
