## Bedminster Township

### Introduction

The purpose of this report is to provide a comprehensive understanding of key, defining features within the subwatersheds throughout Bedminster Township. This involves gathering, organizing, and presenting information about existing conditions and infrastructure within each subwatershed. It aims to serve as a tool for informed decision-making, planning, and implementation of sustainable watershed management strategies aimed to protect and enhance the health of the watershed, its associated ecosystems, and the surrounding communities.

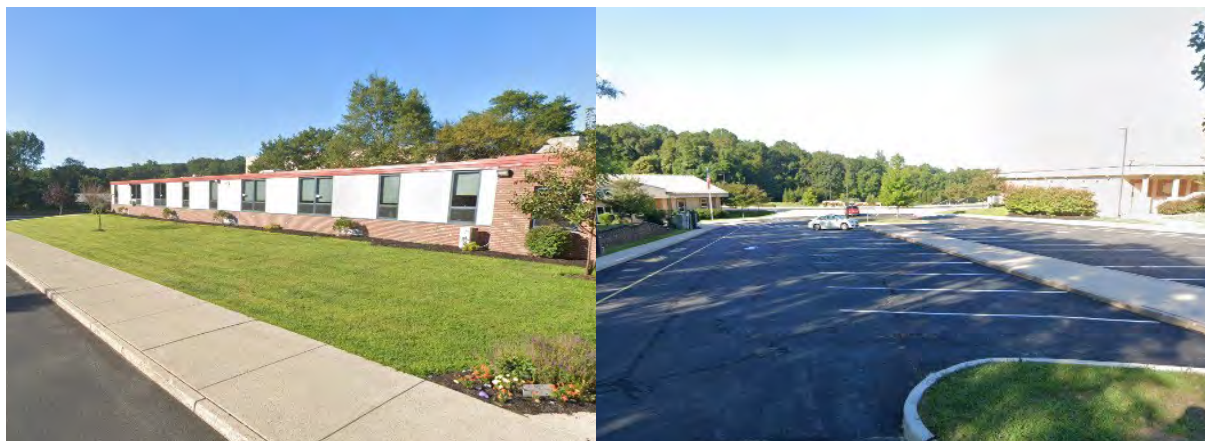
Rain gardens can be installed in multiple grass areas around the property to capture, treat, and infiltrate the stormwater runoff from the rooftops, parking lots, and driveways. This may require downspout disconnections, redirection of downspouts beneath sidewalks, trench drains, and curb cuts. Existing parking spaces in multiple lots can be converted into pervious pavement to capture and infiltrate the stormwater runoff from the asphalt. This may require trench drains in some locations. The basketball courts near each school building can also be converted into pervious pavement. The concrete walkway near the entrance of Bragg School can be replaced with permeable pavers. A preliminary soil assessment suggests that the soils have suitable drainage characteristics for green infrastructure.

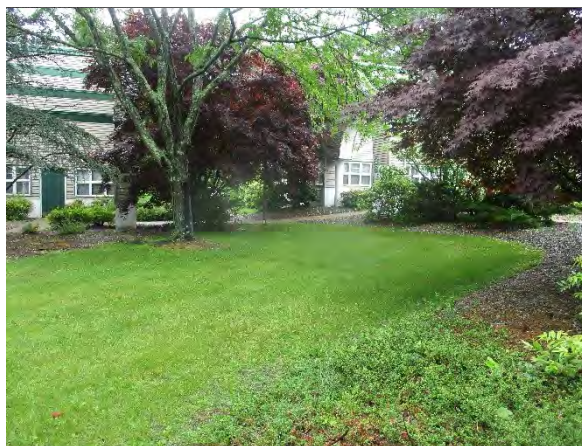
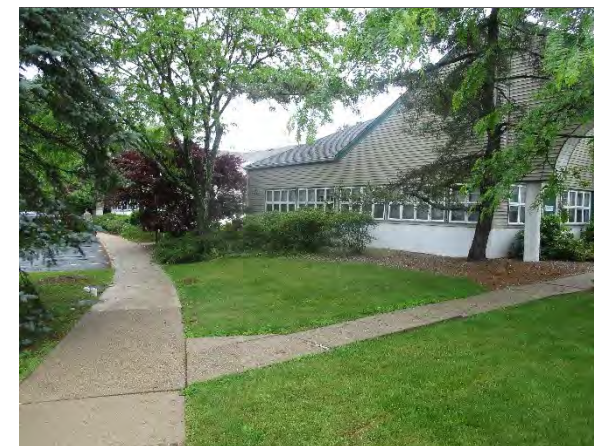
Rain gardens can be installed in the center courtyard and to the west of the building to capture rooftop runoff from multiple buildings. A preliminary soil assessment suggests that the soils have suitable drainage characteristics for green infrastructure.

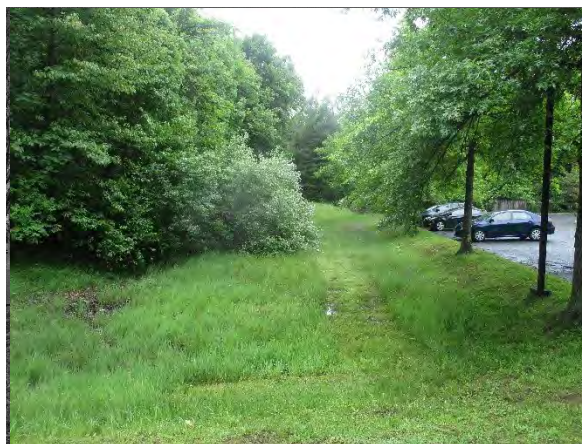
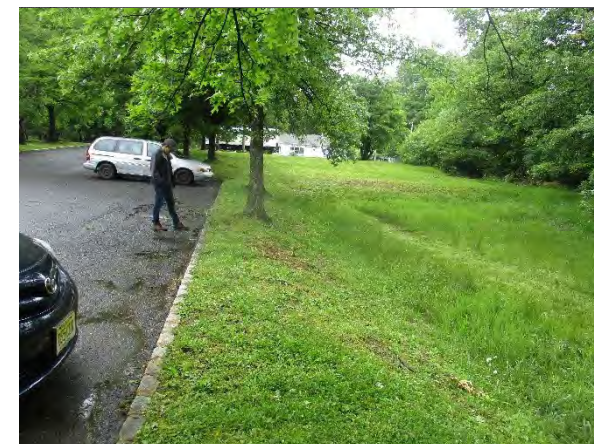
**Address:** 310 Route 24  
Chester, NJ 07930

A rain garden can be installed to reduce the flooding that occurs east of the parking lot. Pervious pavement can be installed in the parking lot row directly west of the building to capture stormwater runoff from both the parking lot and the rooftop. A preliminary soil assessment suggests that more soil testing would be required before determining the soil's suitability for green infrastructure.

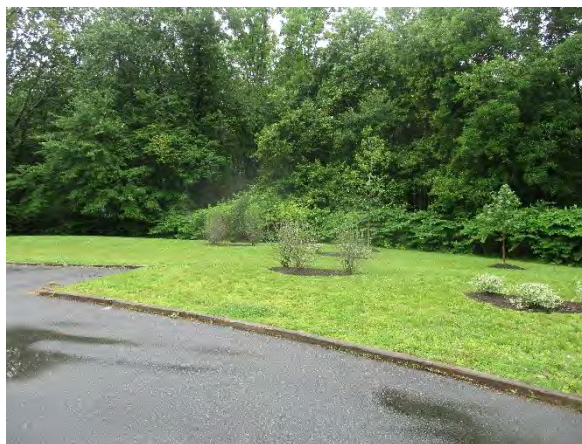
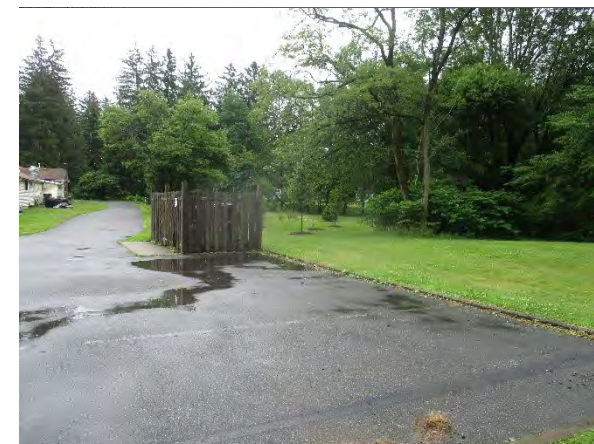
**Address:** 2631, 324 Route 24  
Chester, NJ 07930

Pervious pavement can be installed in the western corner of the parking lot to capture and infiltrate stormwater runoff from the parking lot. A rain garden can be installed along the roadway south of the building to capture stormwater runoff from the pavement. A preliminary soil assessment suggests that more soil testing would be required before determining the soil's suitability for green infrastructure.

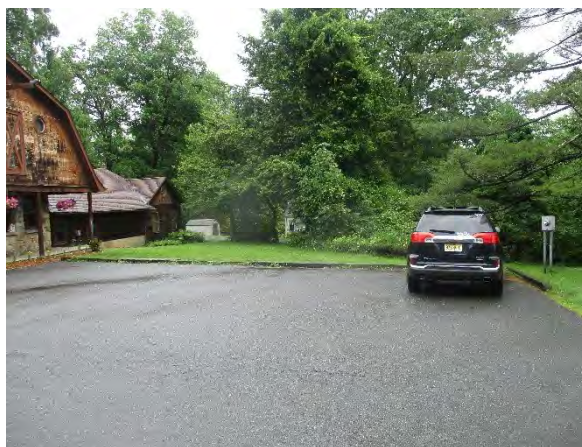
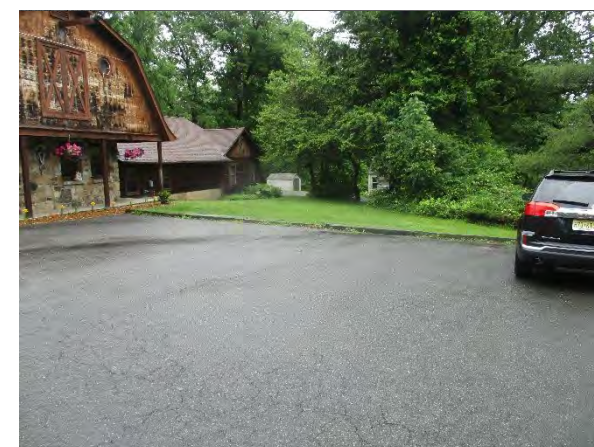
**Address:** 571 Route 24  
Mendham, NJ 07945

A rain garden can be installed south of the building to capture stormwater runoff from both the rooftop of the building as well as the parking lot. Downspout planter boxes can be installed in front of the building to capture the stormwater runoff from the western rooftop. A preliminary soil assessment suggests that the soils have suitable drainage characteristics for green infrastructure.

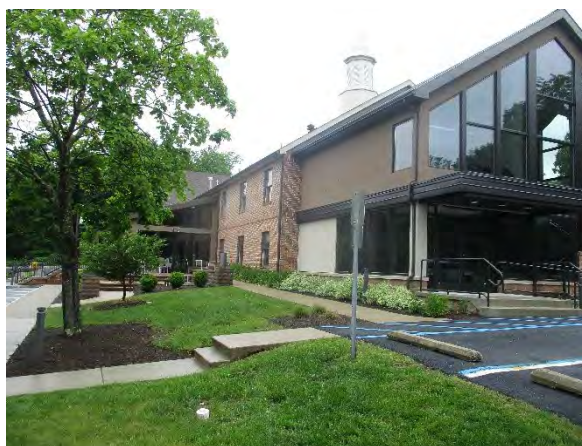
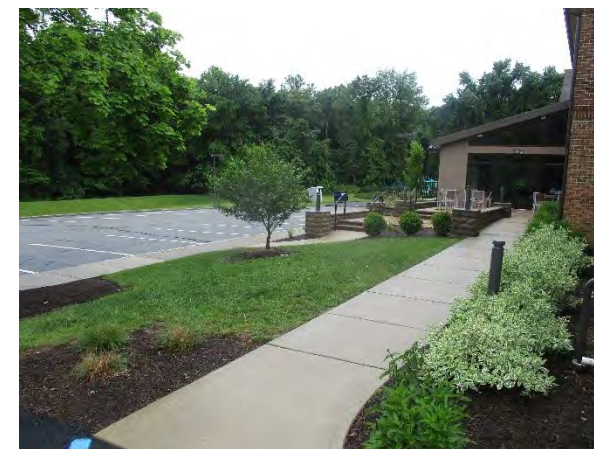
**Address:** 480 Route 24  
Chester, NJ 07930

A rain garden can be installed southwest of the building to capture, treat, and infiltrate the stormwater coming from the top of the building. Pervious pavement can be installed in the southeastern corner of the parking lot to capture stormwater runoff from the parking lot. A preliminary soil assessment suggests that the soils have suitable drainage characteristics for green infrastructure.

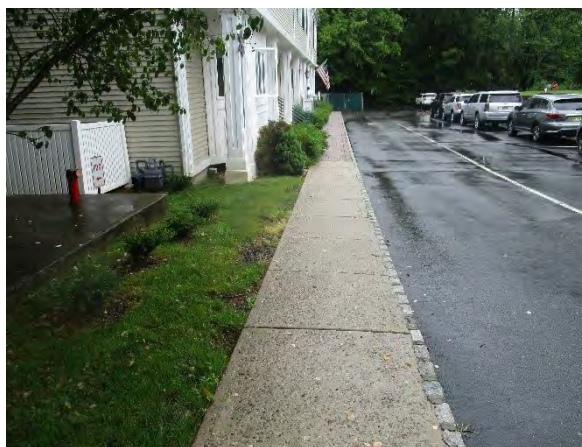
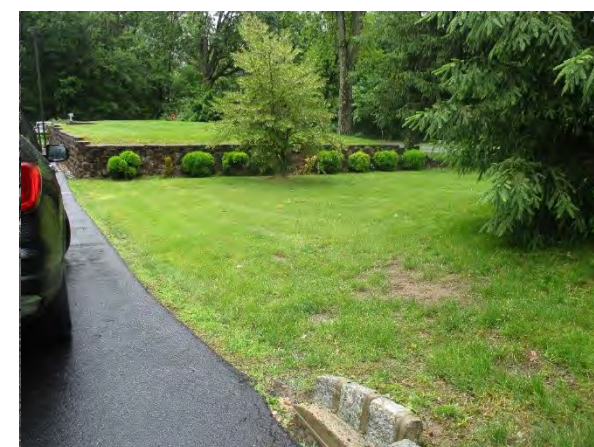
**Address:** 577 Route 24  
Mendham, NJ 07945

A rain garden can be installed south of the roadway to capture, treat, and infiltrate stormwater runoff from the pavement. Downspout planter boxes can be installed along the front, southern wall of the building to capture stormwater runoff from the rooftop. A preliminary soil assessment suggests that the soils have suitable drainage characteristics for green infrastructure.

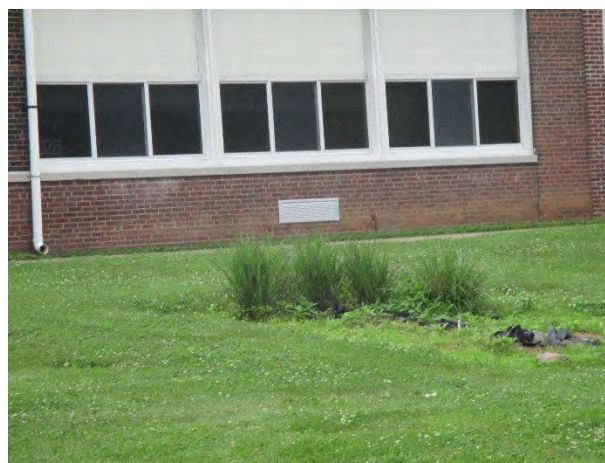
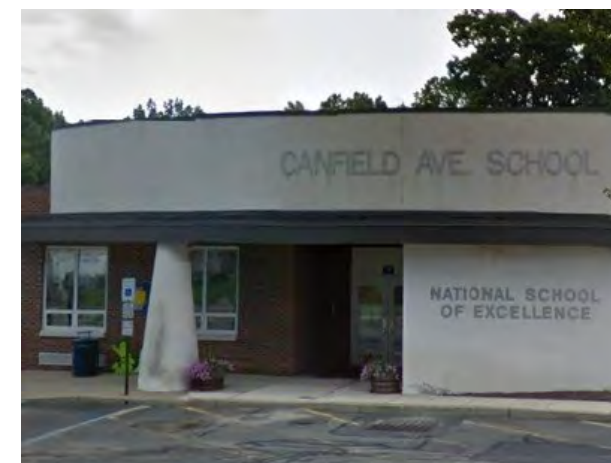
**Address:** 42 Canfield Avenue  
Mine Hill, NJ 07803

A rain garden can be installed near the disconnected downspouts to capture, treat, and infiltrate rooftop runoff. A preliminary soil assessment suggests that more soil testing would be required before determining the soil's suitability for green infrastructure.

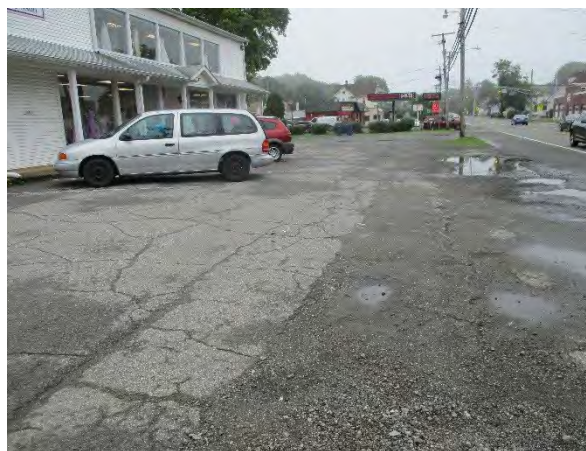
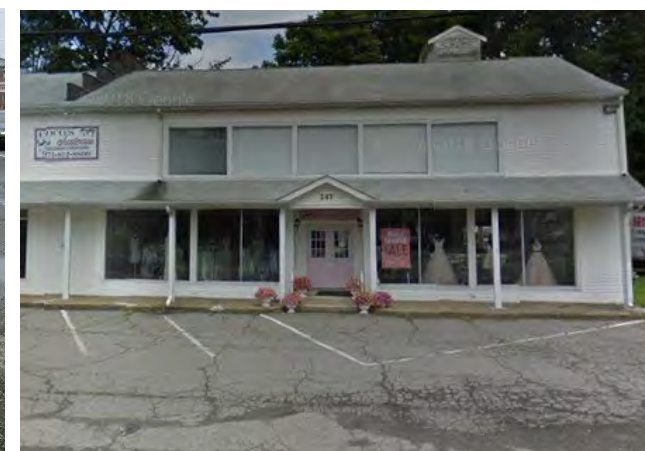
**Address:** 247 US-46  
Mine Hill, NJ 07803

Pervious pavement can be installed on a parking strip south of the building to capture and infiltrate stormwater. A preliminary soil assessment suggests that the soils have suitable drainage characteristics for green infrastructure.

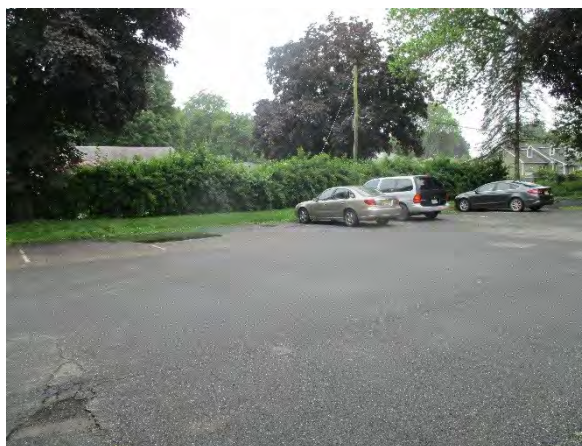
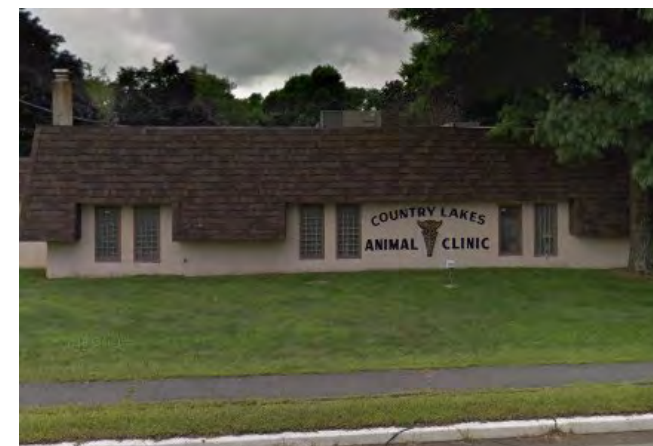
**Address:** 378 US-46  
Mine Hill, NJ 07803

Parking spaces south of the building can be replaced with pervious pavement to capture and infiltrate stormwater. A preliminary soil assessment suggests that more soil testing would be required before determining the soil's suitability for green infrastructure.

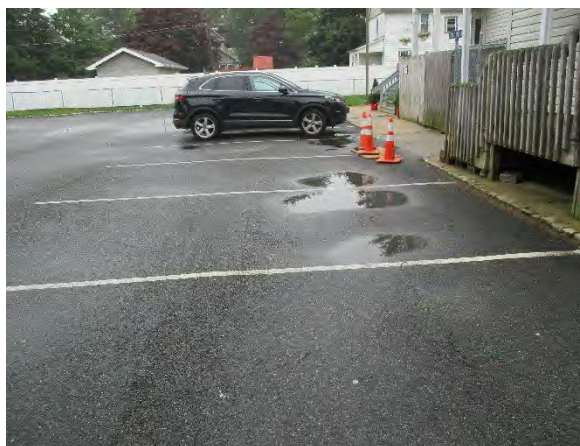
**Address:** 265 US-46  
Mine Hill, NJ 07803

Pervious pavement can be installed on the north side of the building to capture and infiltrate stormwater. A preliminary soil assessment suggests that the soils have suitable drainage characteristics for green infrastructure.

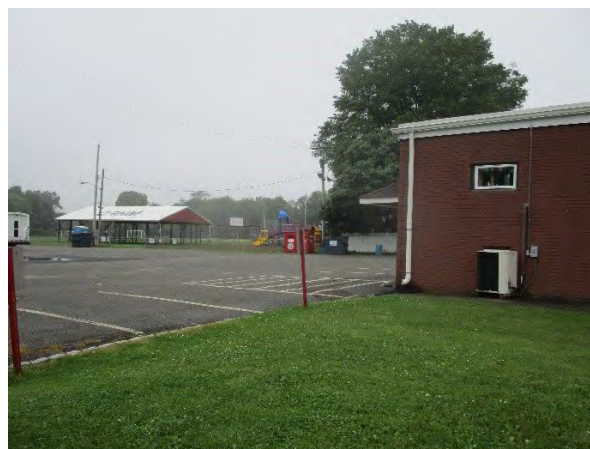
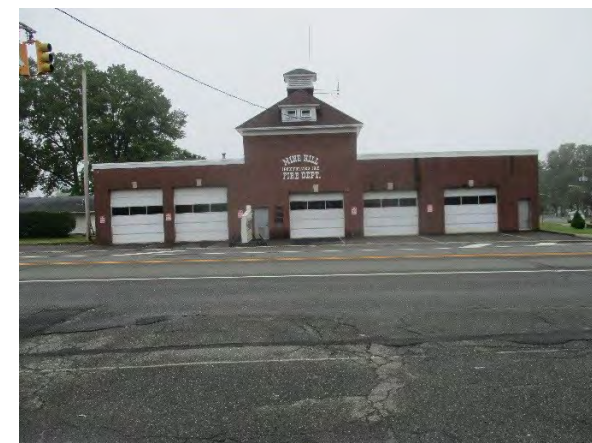
**Address:** 230 US-46  
Mine Hill, NJ 07803

A rain garden can be installed on the west side of the building to capture, treat, and infiltrate rooftop runoff. Pervious pavement can be installed on the south parking strip to store stormwater runoff and allow it to slowly infiltrate into the ground. A cistern can be installed on the east side of the building near a disconnected downspout so the water can be used for watering gardens, washing vehicles, or for other non-potable uses. A preliminary soil assessment suggests that more soil testing would be required before determining the soil's suitability for green infrastructure.

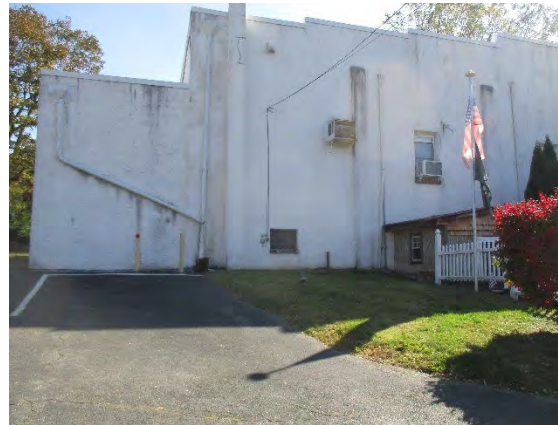
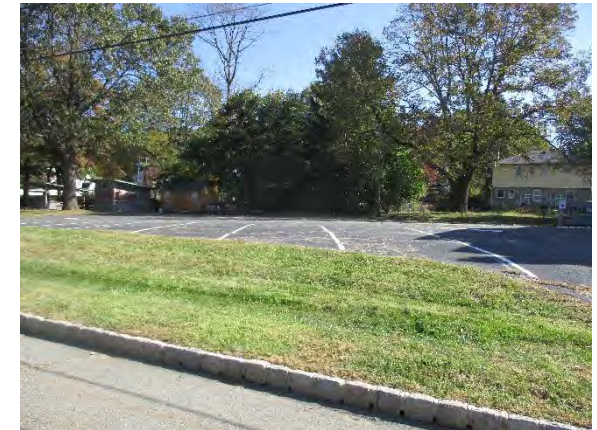
**Address:** 391 Maple Avenue  
Mine Hill, NJ 07803

Half of the building's rooftop runoff and part of the parking lot runoff, can be treated with pervious pavement in the east strip of the parking lot. A preliminary soil assessment suggests that more soil testing would be required before determining the soil's suitability for green infrastructure.

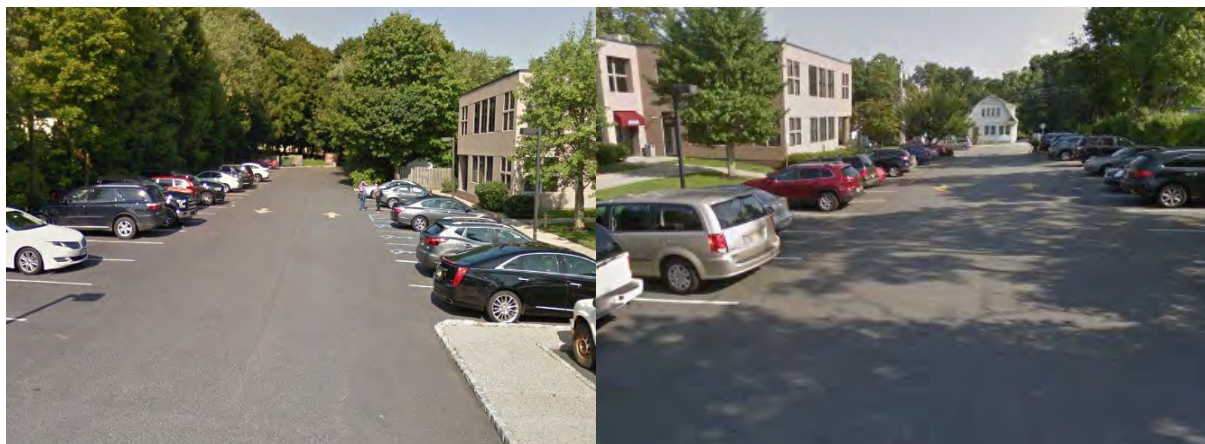
**Address:** 195 US-46 #101  
Mine Hill Township, NJ  
07803

Existing parking spaces to the north and west of the building can be converted into pervious pavement to capture and infiltrate the stormwater runoff from the parking lot. A trench drain may be required. A preliminary soil assessment suggests that the soils have suitable drainage characteristics for green infrastructure.

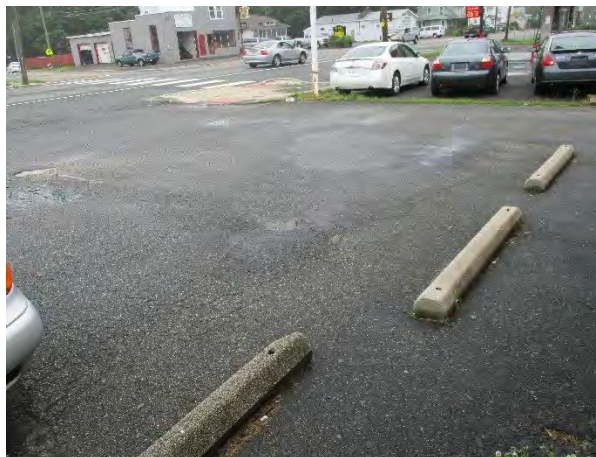
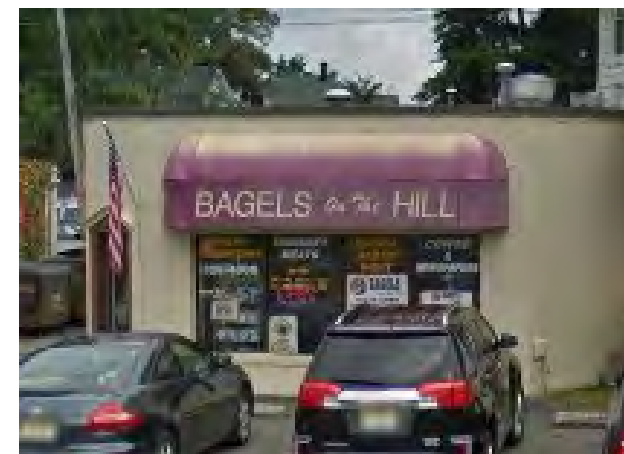
Pervious pavement can be installed south of the building to store stormwater runoff and allow it to slowly infiltrate into the ground. A preliminary soil assessment suggests that the soils have suitable drainage characteristics for green infrastructure.

Recommended Green Infrastructure Practices	Recharge Potential (Mgal/yr)	TSS Removal Potential (lbs/yr)	Maximum Volume Reduction Potential (gal/storm)	Peak Discharge Reduction Potential (cu. ft./second)	Estimated Size (sq. ft.)	Estimated Cost
Pervious pavement	0.062	10	4,550	0.17	630	\$15,750

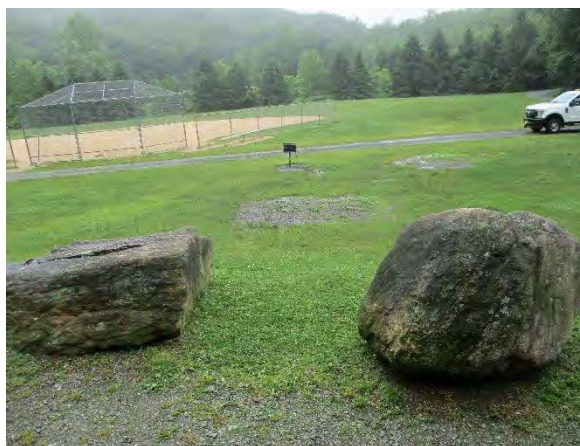
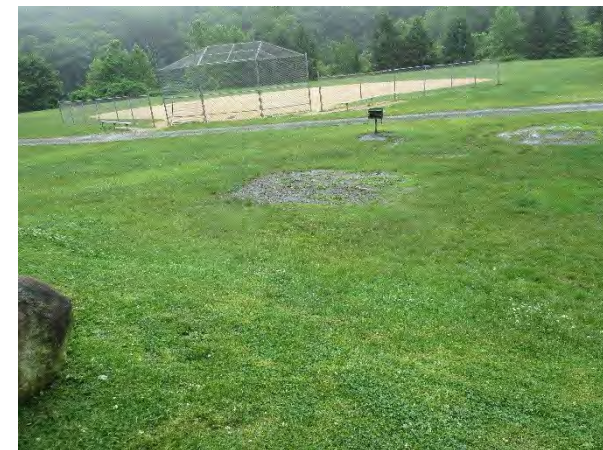
A rain garden can be installed in the turfgrass area on the north side of the park to capture, treat, and infiltrate stormwater runoff from the parking/roadway area. A preliminary soil assessment suggests that more soil testing would be required before determining the soil's suitability for green infrastructure.

Recommended Green Infrastructure Practices	Recharge Potential (Mgal/yr)	TSS Removal Potential (lbs/yr)	Maximum Volume Reduction Potential (gal/storm)	Peak Discharge Reduction Potential (cu. ft./second)	Estimated Size (sq. ft.)	Estimated Cost
Bioretention system	0.057	10	4,200	0.16	550	\$2,750

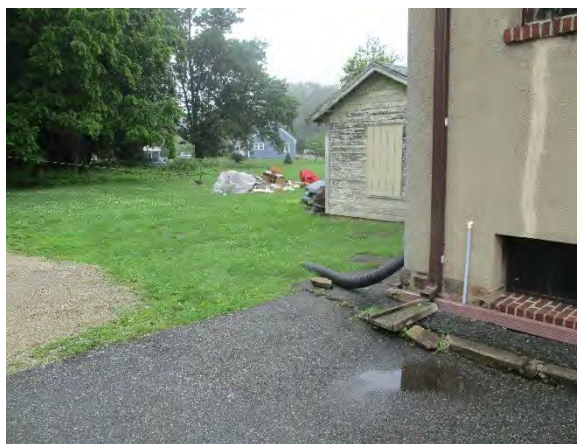
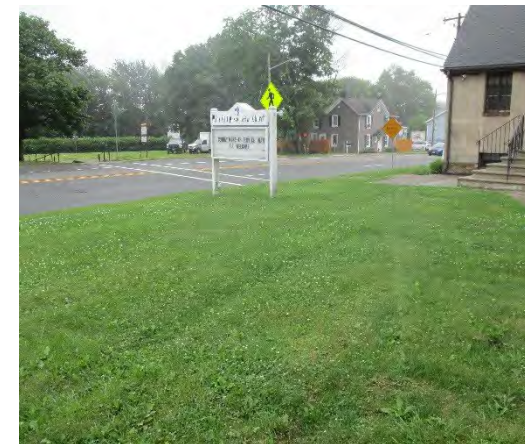
Rain gardens can be installed on the north, southeast, and south sides of the building near disconnected downspouts to capture, treat, and infiltrate rooftop runoff. A preliminary soil assessment suggests that the soils have suitable drainage characteristics for green infrastructure.

Recommended Green Infrastructure Practices	Recharge Potential (Mgal/yr)	TSS Removal Potential (lbs/yr)	Maximum Volume Reduction Potential (gal/storm)	Peak Discharge Reduction Potential (cu. ft./second)	Estimated Size (sq. ft.)	Estimated Cost
Bioretention systems	0.073	12	5,330	0.20	700	\$3,500

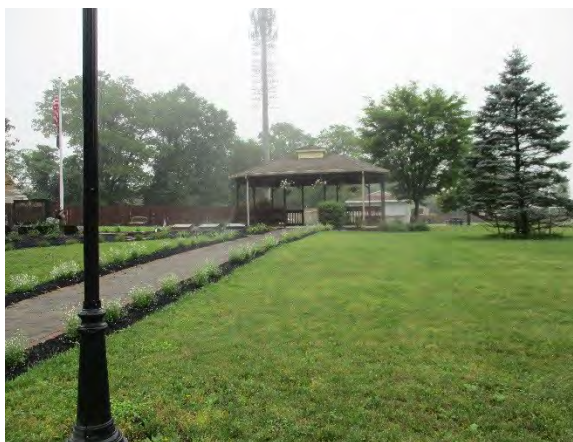
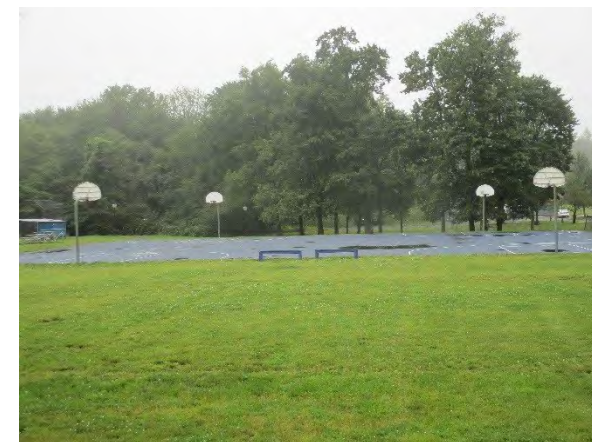
A rain garden can be installed south of the gazebo to capture, treat, and infiltrate rooftop runoff. Pervious pavement can be installed on the basketball court to store stormwater runoff and allow it to slowly infiltrate into the ground. A preliminary soil assessment suggests that more soil testing would be required before determining the soil's suitability for green infrastructure.

Recommended Green Infrastructure Practices	Recharge Potential (Mgal/yr)	TSS Removal Potential (lbs/yr)	Maximum Volume Reduction Potential (gal/storm)	Peak Discharge Reduction Potential (cu. ft./second)	Estimated Size (sq. ft.)	Estimated Cost
Bioretention system	0.013	2	970	0.04	125	\$625
Pervious pavement	0.358	60	26,280	0.99	13,750	\$343,750

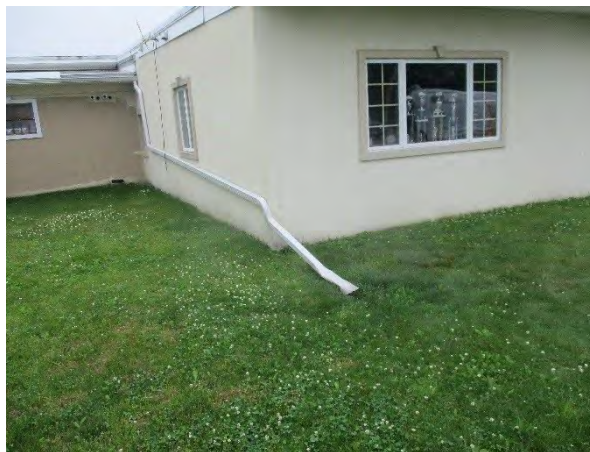
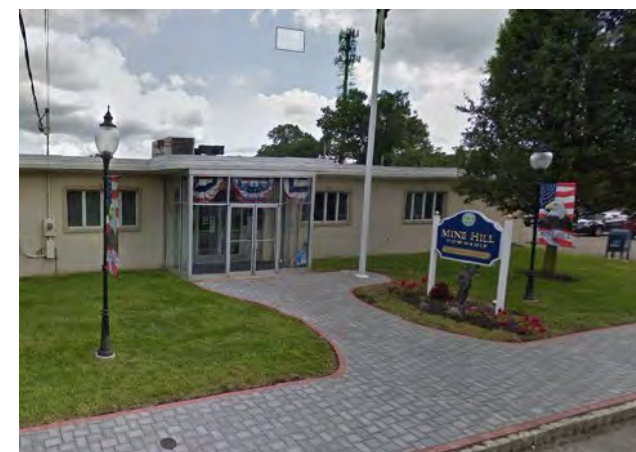
A rain garden can be installed in the turfgrass area near the building to capture, treat, and infiltrate rooftop runoff. A preliminary soil assessment suggests that more soil testing would be required before determining the soil's suitability for green infrastructure.

Recommended Green Infrastructure Practices	Recharge Potential (Mgal/yr)	TSS Removal Potential (lbs/yr)	Maximum Volume Reduction Potential (gal/storm)	Peak Discharge Reduction Potential (cu. ft./second)	Estimated Size (sq. ft.)	Estimated Cost
Bioretention system	0.123	21	9,010	0.34	376	\$1,880

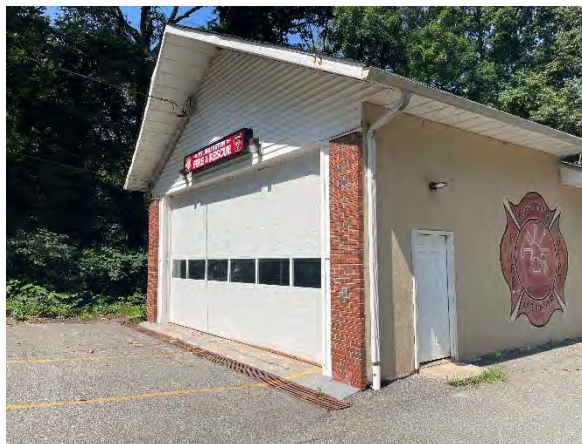
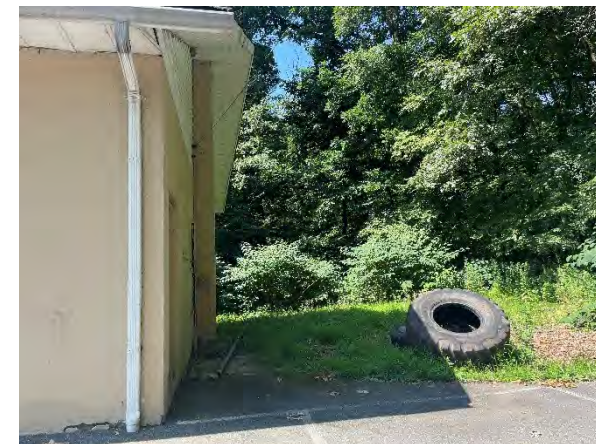
Cisterns can be installed to the northeast and southeast of the building to divert and detain the stormwater runoff from the rooftop for later non-potable reuse such as washing vehicles.

Recommended Green Infrastructure Practices	Drainage Area (sq. ft.)	Recharge Potential (Mgal/yr)	TSS Removal Potential (lbs/yr)	Maximum Volume Reduction Potential (gal/storm)	Peak Discharge Reduction Potential (cu. ft./second)	Estimated Size (sq. ft.)	Estimated Cost
Rainwater harvesting	1,295	0.038	6	1,100	0.04	1,100 (gal)	\$3,300

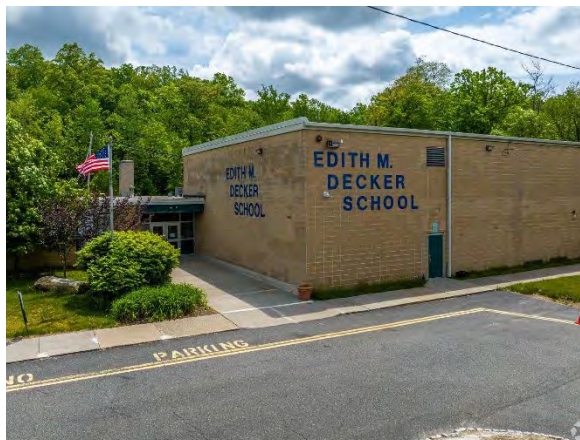
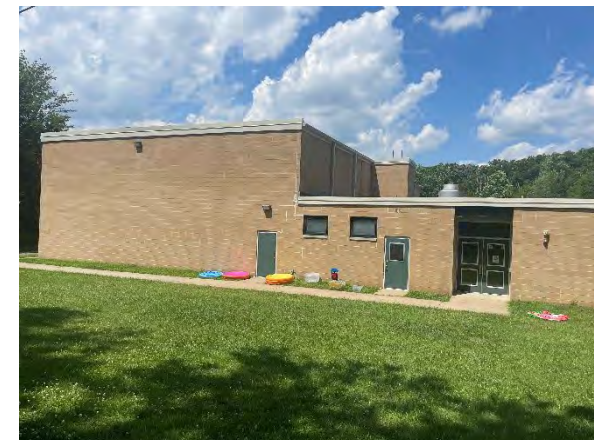
Rain gardens can be installed to the south and southwest of the building and to the west of the parking lot to capture, treat, and infiltrate stormwater runoff from the rooftop and asphalt. The rain garden to the southwest of the school will require downspout redirection and disconnection. The rain garden to the south of the school will require downspout redirection underneath the sidewalk. The existing parking spaces to the northwest of the lot can be converted into pervious pavement to capture and infiltrate the stormwater runoff from the asphalt. A preliminary soil assessment suggests that more soil testing would be required before determining the soil's suitability for green infrastructure.

Recommended Green Infrastructure Practices	Drainage Area (sq. ft.)	Recharge Potential (Mgal/yr)	TSS Removal Potential (lbs/yr)	Maximum Volume Reduction Potential (gal/storm)	Peak Discharge Reduction Potential (cu. ft./second)	Estimated Size (sq. ft.)	Estimated Cost
Bioretention system	7,220	0.214	32	15,060	0.57	1,800	\$18,000
Pervious pavement	7,800	0.231	34	16,270	0.61	2,175	\$54,375

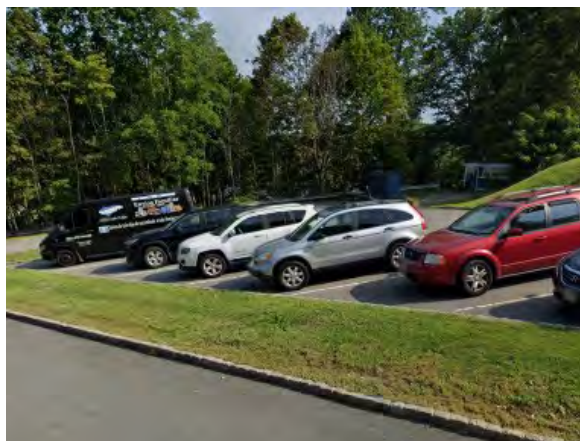
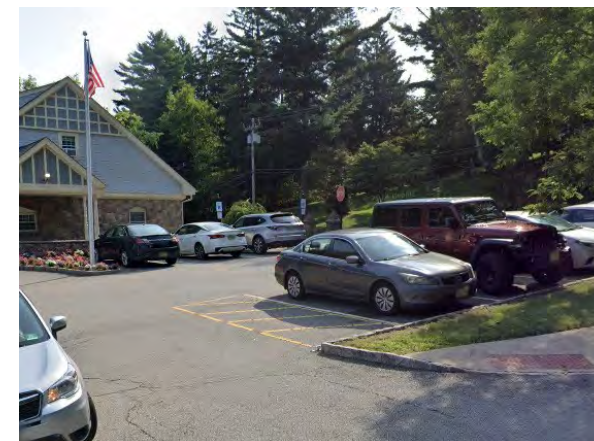
A rain garden can be installed to the east of the building to capture, treat, and infiltrate stormwater runoff from the rooftop. This will require a downspout redirection beneath the sidewalk. The existing parking spaces to the west of the building can be converted into pervious pavement to capture and infiltrate stormwater runoff from the asphalt. A trench drain will be required. A preliminary soil assessment suggests that more soil testing would be required before determining the soil's suitability for green infrastructure.

Recommended Green Infrastructure Practices	Drainage Area (sq. ft.)	Recharge Potential (Mgal/yr)	TSS Removal Potential (lbs/yr)	Maximum Volume Reduction Potential (gal/storm)	Peak Discharge Reduction Potential (cu. ft./second)	Estimated Size (sq. ft.)	Estimated Cost
Bioretention system	350	0.010	2	730	0.03	90	\$900
Pervious pavement	5,880	0.174	25	12,270	0.46	1,180	\$29,500

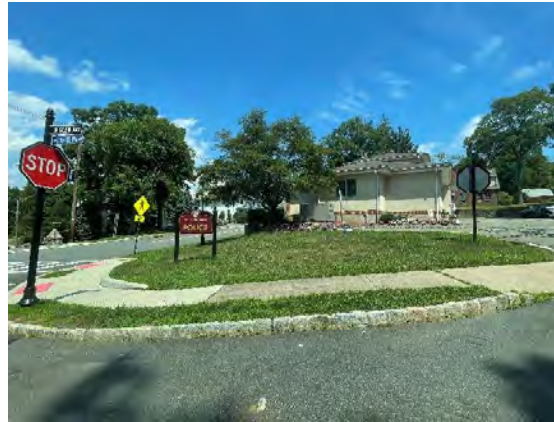
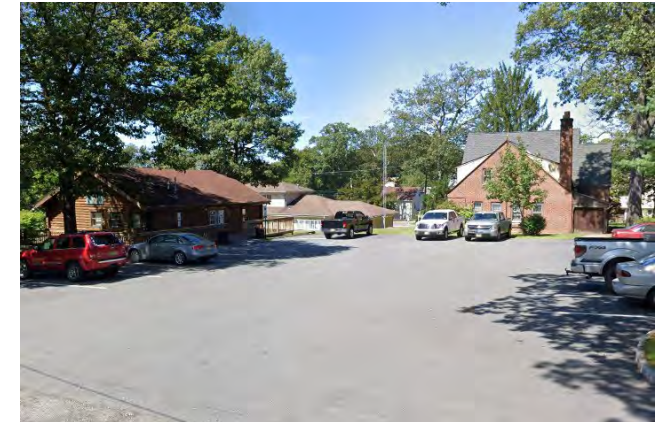
Rain gardens can be installed in multiple grass areas around the property to capture, treat, and infiltrate stormwater runoff from the building rooftops. Many of these will require downspout redirections and disconnections. The rain garden to the west of the police department will also manage stormwater runoff from the parking lot. This rain garden will require a downspout disconnection, a trench drain, and a curb cut. The existing parking spaces to the east of the civic center can be converted into pervious pavement to capture and infiltrate the stormwater runoff from the asphalt lot. The southeastern downspout can also be disconnected to the pervious pavement to manage rooftop runoff. A cistern can be installed to the south of the police department building to divert and detain stormwater runoff from the rooftop for later non-potable reuse such as watering the landscaping vegetation or washing vehicles. A preliminary soil assessment suggests that more soil testing would be required before determining the soil's suitability for green infrastructure.

Recommended Green Infrastructure Practices	Drainage Area (sq. ft.)	Recharge Potential (Mgal/yr)	TSS Removal Potential (lbs/yr)	Maximum Volume Reduction Potential (gal/storm)	Peak Discharge Reduction Potential (cu. ft./second)	Estimated Size (sq. ft.)	Estimated Cost
Bioretention system	3,470	0.103	15	7,240	0.27	860	\$8,600
Pervious pavement	8,425	0.249	36	17,570	0.66	1,725	\$43,125
Rainwater harvesting	420	0.012	2	400	0.01	400 (gal)	\$1,200

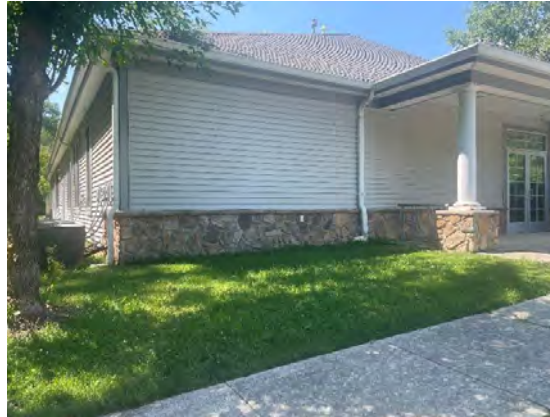
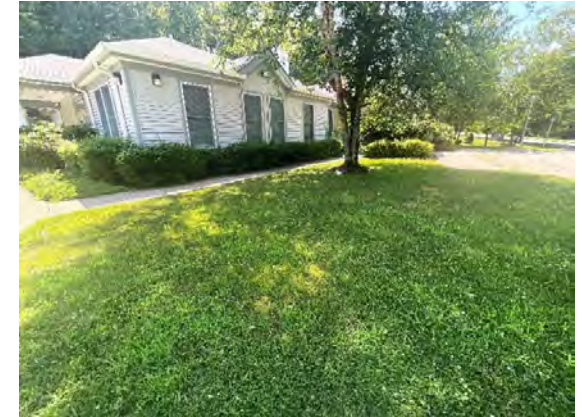
Rain gardens can be installed to the northeast and southeast corners of the building to capture, treat, and infiltrate stormwater runoff from the rooftop. This will require downspout disconnections. The northern rain garden will require downspout redirection beneath the sidewalk. The existing parking spaces to the east of the building can be converted into pervious pavement to capture and infiltrate stormwater runoff from the asphalt. A cistern can be installed to the southwest of the building to divert and detain stormwater runoff from the rooftop for later non-potable reuse such as watering the nearby garden beds. A preliminary soil assessment suggests that the soils have suitable drainage characteristics for green infrastructure.

Recommended Green Infrastructure Practices	Drainage Area (sq. ft.)	Recharge Potential (Mgal/yr)	TSS Removal Potential (lbs/yr)	Maximum Volume Reduction Potential (gal/storm)	Peak Discharge Reduction Potential (cu. ft./second)	Estimated Size (sq. ft.)	Estimated Cost
Bioretention system	1,130	0.033	6	2,360	0.09	285	\$2,850
Pervious pavement	4,740	0.140	21	9,890	0.37	1,310	\$32,750
Rainwater harvesting	530	0.016	2	500	0.02	500 (gal)	\$1,500

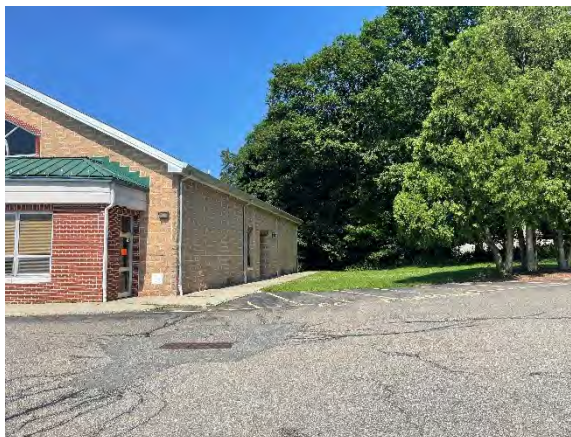
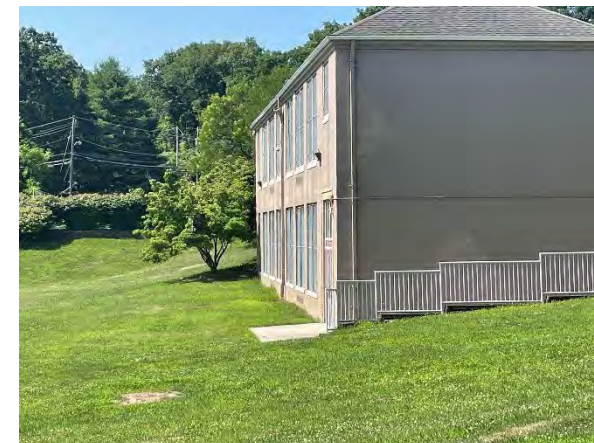
Rain gardens can be installed to the northwest and southeast corners of the building to capture, treat, and infiltrate stormwater runoff from the rooftop. The southeastern rain garden will require downspout disconnections. The northwestern rain garden will require downspout redirection beneath the sidewalk. Existing parking spaces to the north and northeast of the building can be converted into pervious pavement to capture and infiltrate the stormwater runoff from the asphalt. The southern basketball court can be converted into pervious pavement to capture and infiltrate stormwater runoff from the court. A preliminary soil assessment suggests that more soil testing would be required before determining the soil's suitability for green infrastructure.

Recommended Green Infrastructure Practices	Drainage Area (sq. ft.)	Recharge Potential (Mgal/yr)	TSS Removal Potential (lbs/yr)	Maximum Volume Reduction Potential (gal/storm)	Peak Discharge Reduction Potential (cu. ft./second)	Estimated Size (sq. ft.)	Estimated Cost
Bioretention system	3,625	0.107	15	7,560	0.28	905	\$9,050
Pervious pavement	33,635	0.996	146	70,150	2.64	11,600	\$290,000

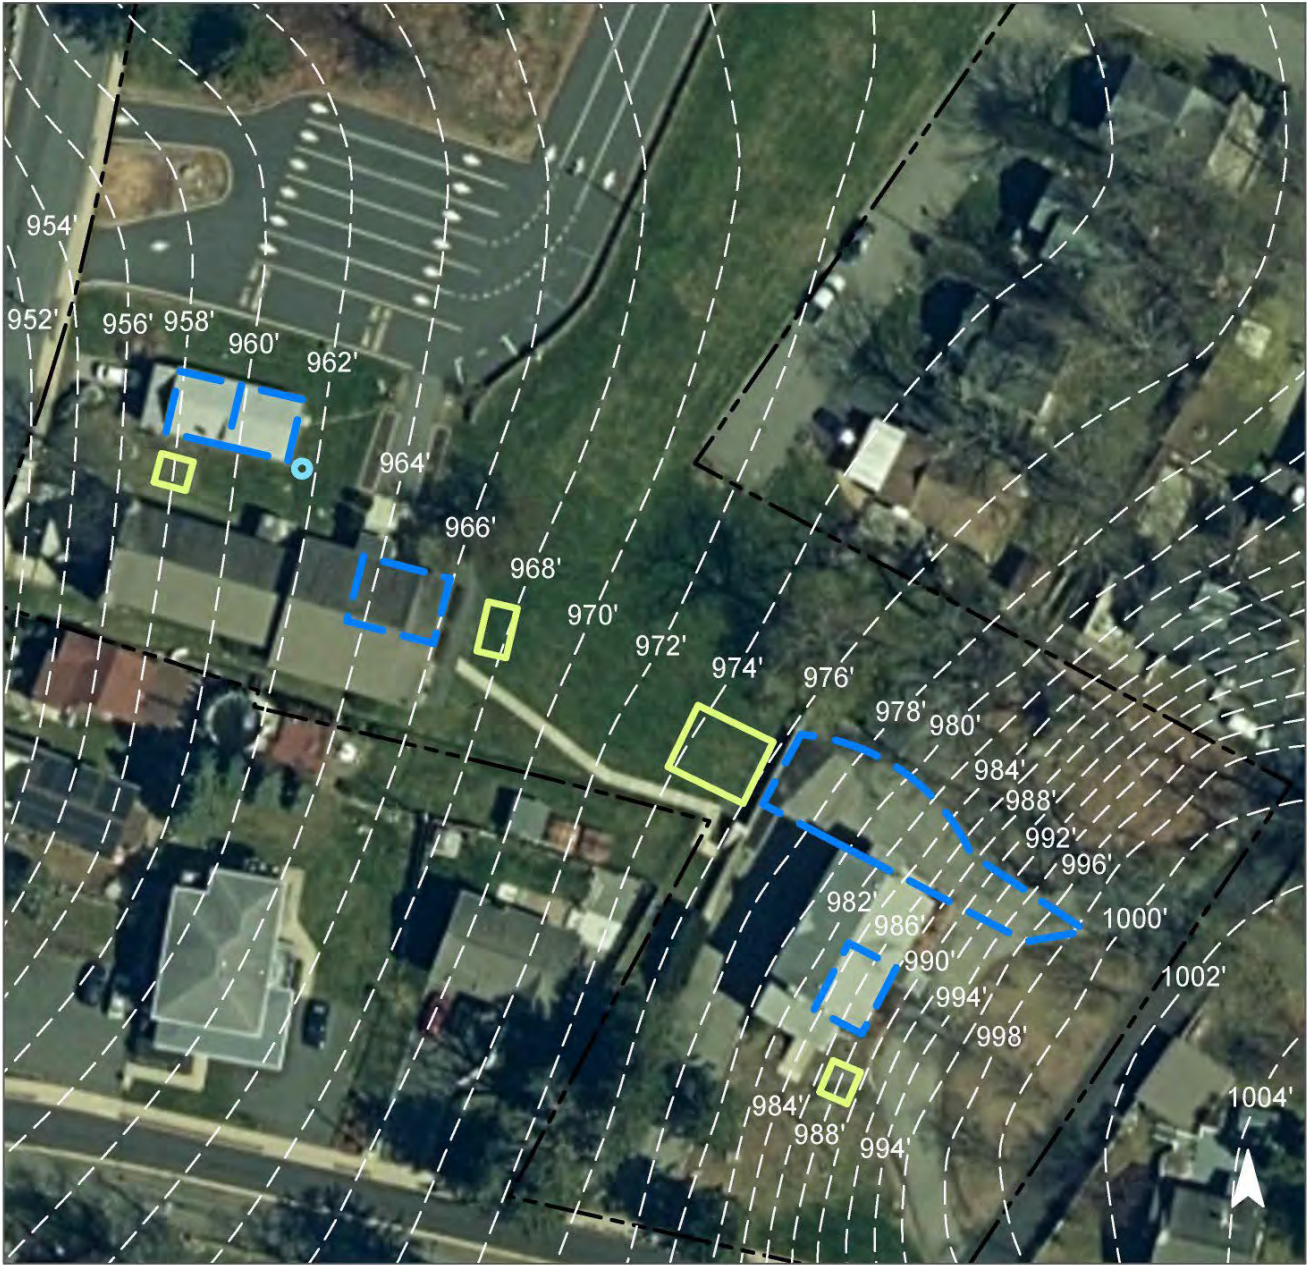
## Our Lady of the Lake Roman Catholic Church

Rain gardens can be installed in multiple grass areas around the church and rectory property to capture, treat, and infiltrate stormwater runoff from the rooftops and parking lot. Downspout redirections, disconnections, and redirection beneath a walkway will be required. The rain garden to the northwest of the rectory will require a trench drain and curb cuts. A cistern can be installed to the southeast of the northern church building to divert and detain the stormwater runoff from the rooftop for later non-potable reuse such as watering the landscaping vegetation. The two nearest downspouts can be redirected to the cistern to increase the managed drainage area. A preliminary soil assessment suggests that more soil testing would be required before determining the soil's suitability for green infrastructure.

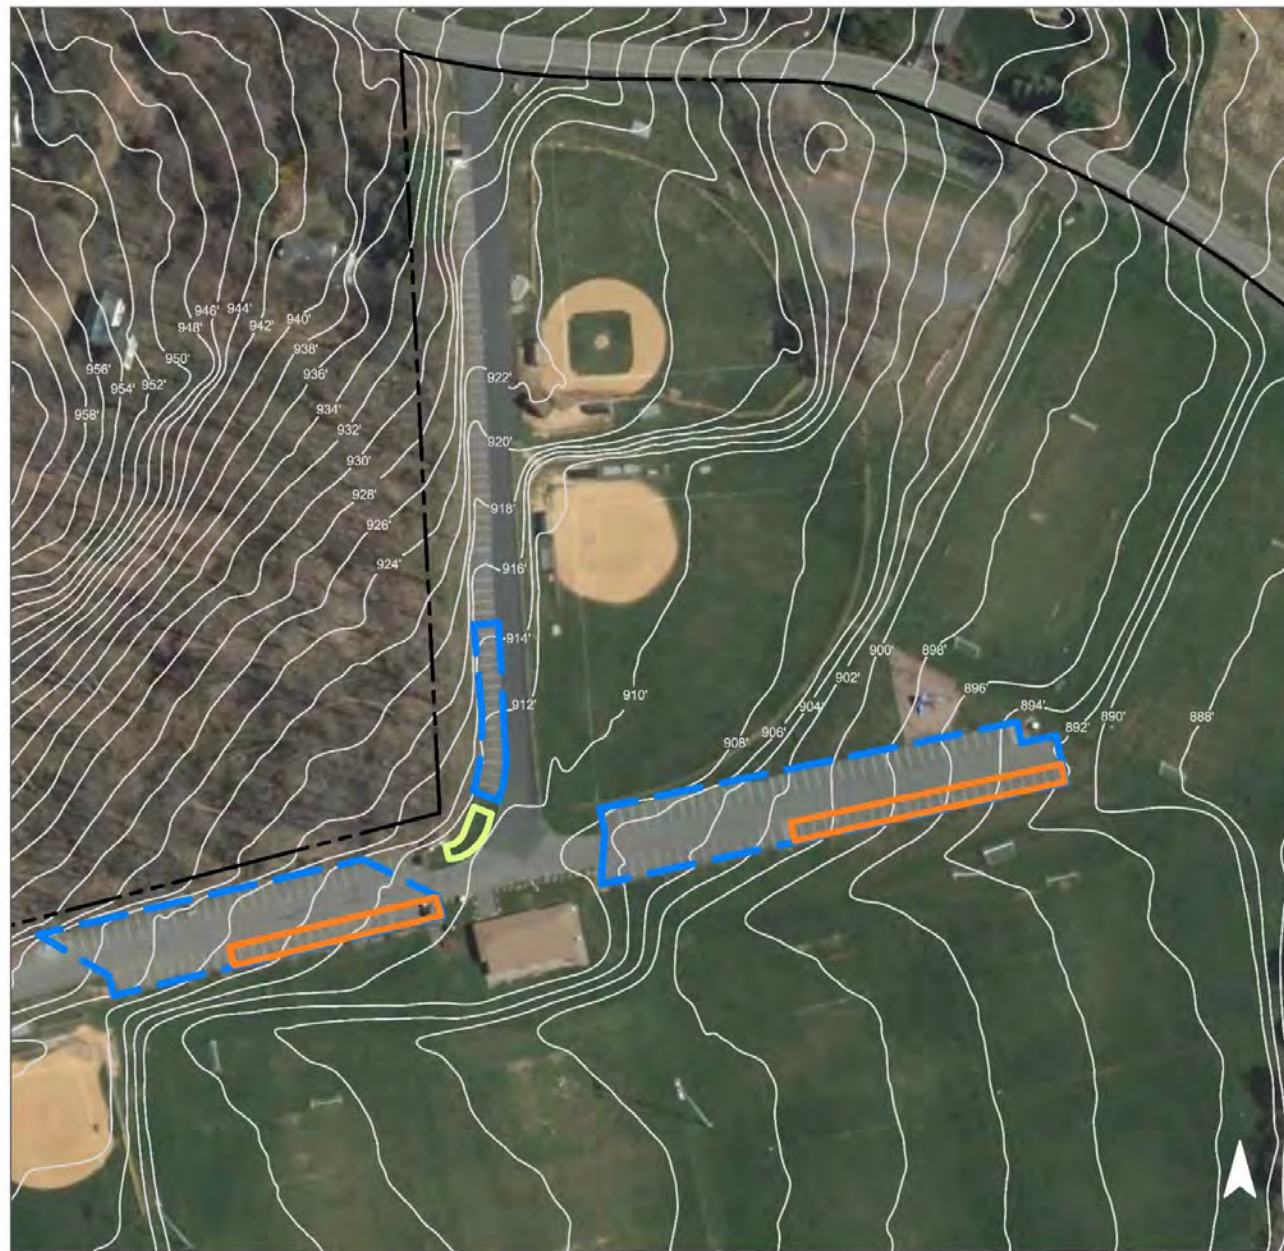
## Heistein Park

A bioretention system can be installed in the parking lot bump out to treat the parking lot drainage area. Pervious pavement can be installed in the east and west strips of the parking lot to manage additional runoff from the parking lot. A preliminary soil assessment suggests that the soils have suitable drainage characteristics for green infrastructure.

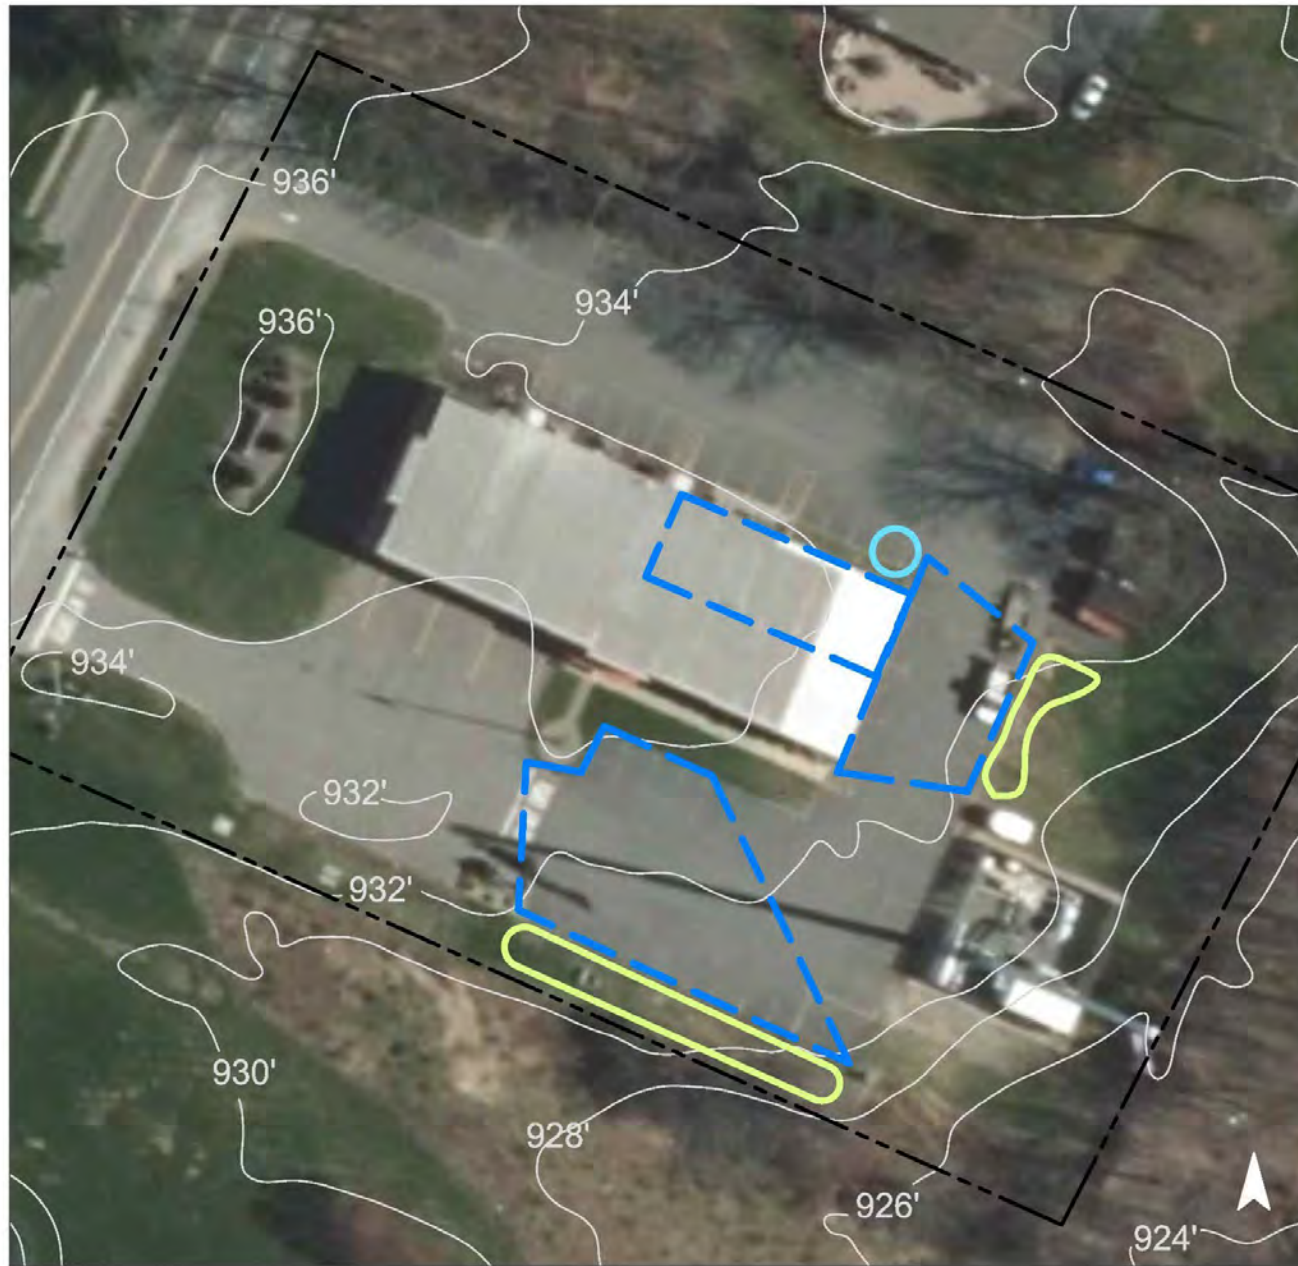
## Randolph Township Fire Department Company #4

A bioretention system can be installed in the east and south turfgrass areas to capture, treat, and infiltrate the runoff from the parking area. Additionally, a cistern can be installed on the northeast corner of the building to capture the rooftop drainage area that can be reused to wash the fire trucks and water the existing landscaping. A preliminary soil assessment suggests that the soils have suitable drainage characteristics for green infrastructure.

- bioretention system
- rainwater harvesting
- drainage area
- property line
- 2015 Aerial: NJOIT, OGIS
