## Bedminster Township

### Introduction

The purpose of this report is to provide a comprehensive understanding of key, defining features within the subwatersheds throughout Bedminster Township. This involves gathering, organizing, and presenting information about existing conditions and infrastructure within each subwatershed. It aims to serve as a tool for informed decision-making, planning, and implementation of sustainable watershed management strategies aimed to protect and enhance the health of the watershed, its associated ecosystems, and the surrounding communities.

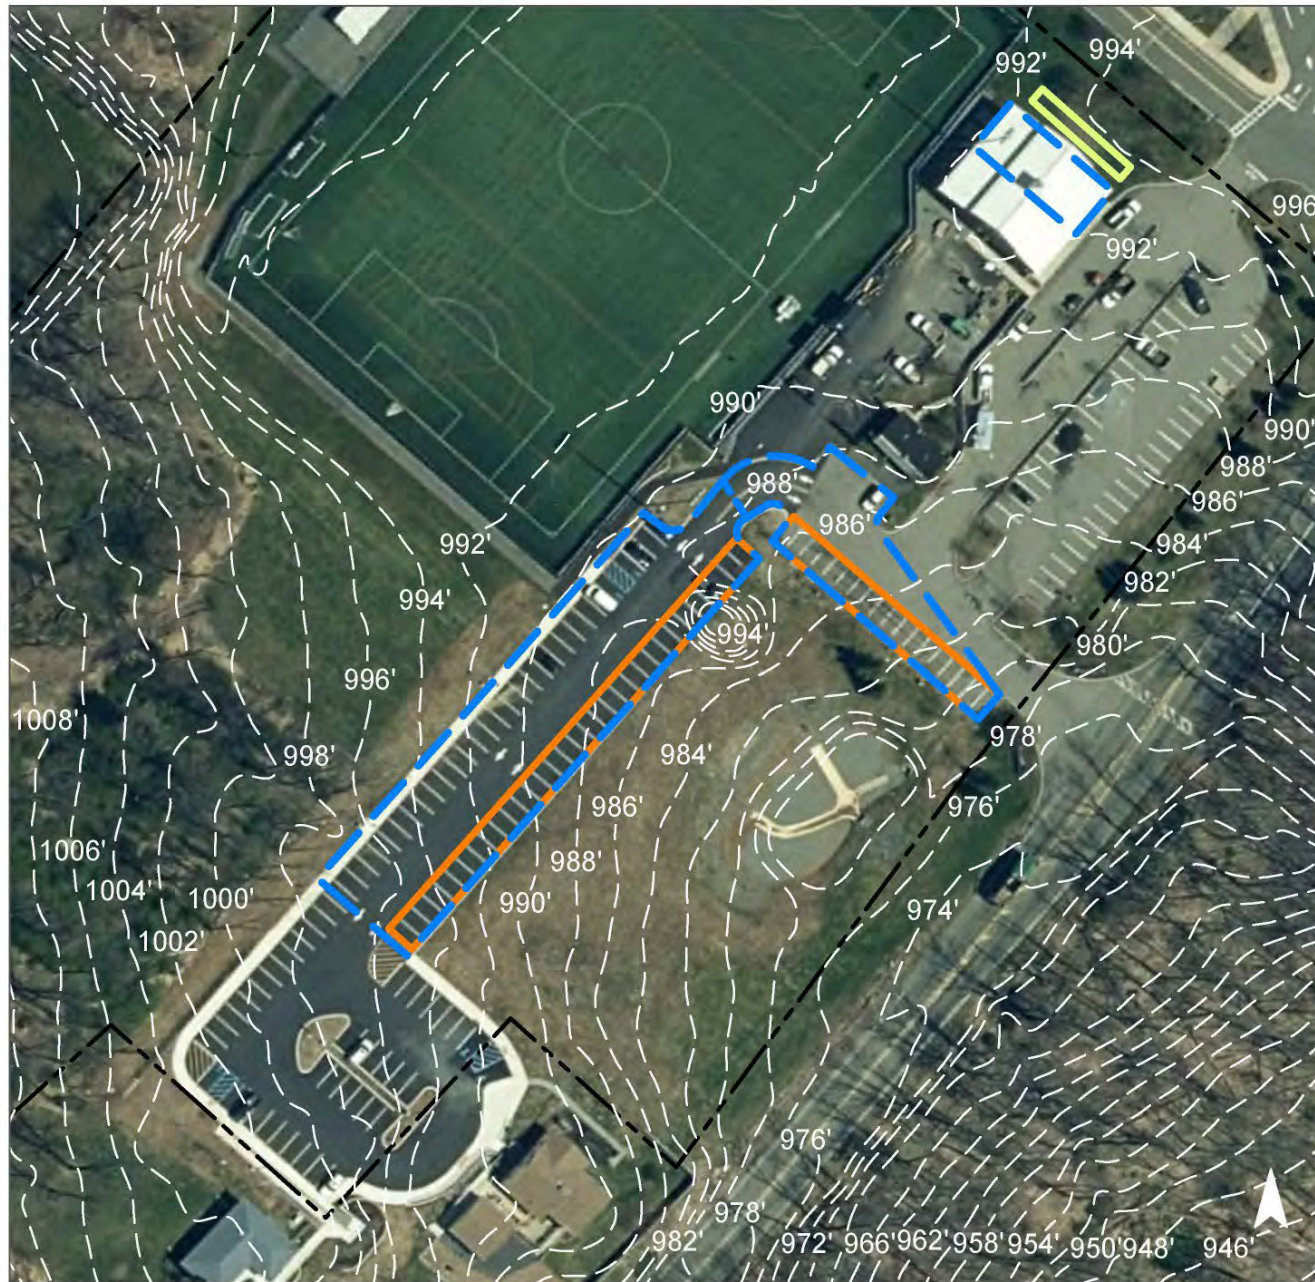
**John DaSilva Memorial Field**

A rain garden can be installed to the northeast of the garage to capture, treat, and infiltrate the stormwater runoff from the rooftop. This will require disconnecting downspouts. The existing parking spaces to the west of the entry driveway and in the western lot can be converted into pervious pavement to capture and infiltrate the stormwater runoff from the asphalt. A preliminary soil assessment suggests that the soils have suitable drainage characteristics for green infrastructure.

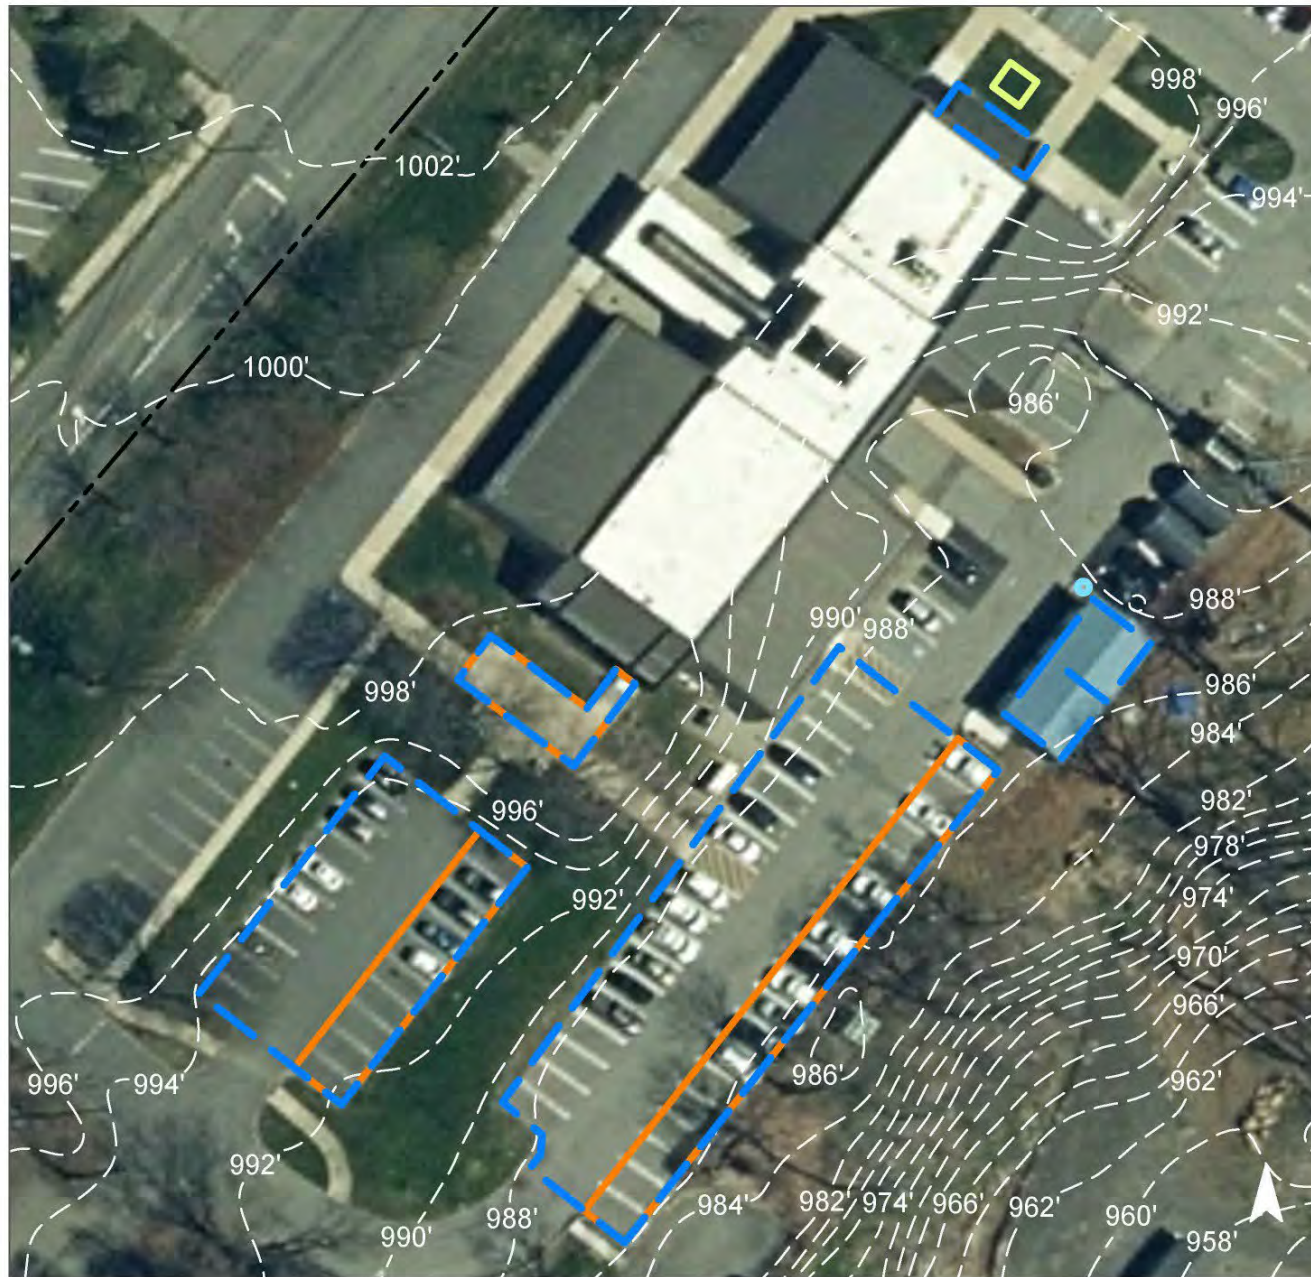
## Randolph Township Recreation

A rain garden can be installed to the northeast corner of the building to capture, treat, and infiltrate the stormwater runoff from the rooftop. This will require downspout disconnection and redirection. The concrete entry walkway to the southwest of the building can be replaced with permeable pavers. Existing parking spaces in the southeastern and southwestern lots can be converted into pervious pavement to capture and infiltrate stormwater runoff from the asphalt. The pervious pavement to the southeast will require a trench drain to intercept and redirect runoff. The downspouts on the southwest of the adjacent shed can be disconnected to the porous pavement to manage runoff from the rooftop. A cistern can be installed to the south of the shed to divert and detain the stormwater runoff from the rooftop for later non-potable reuse such as washing township vehicles. A preliminary soil assessment suggests that the soils have suitable drainage characteristics for green infrastructure.

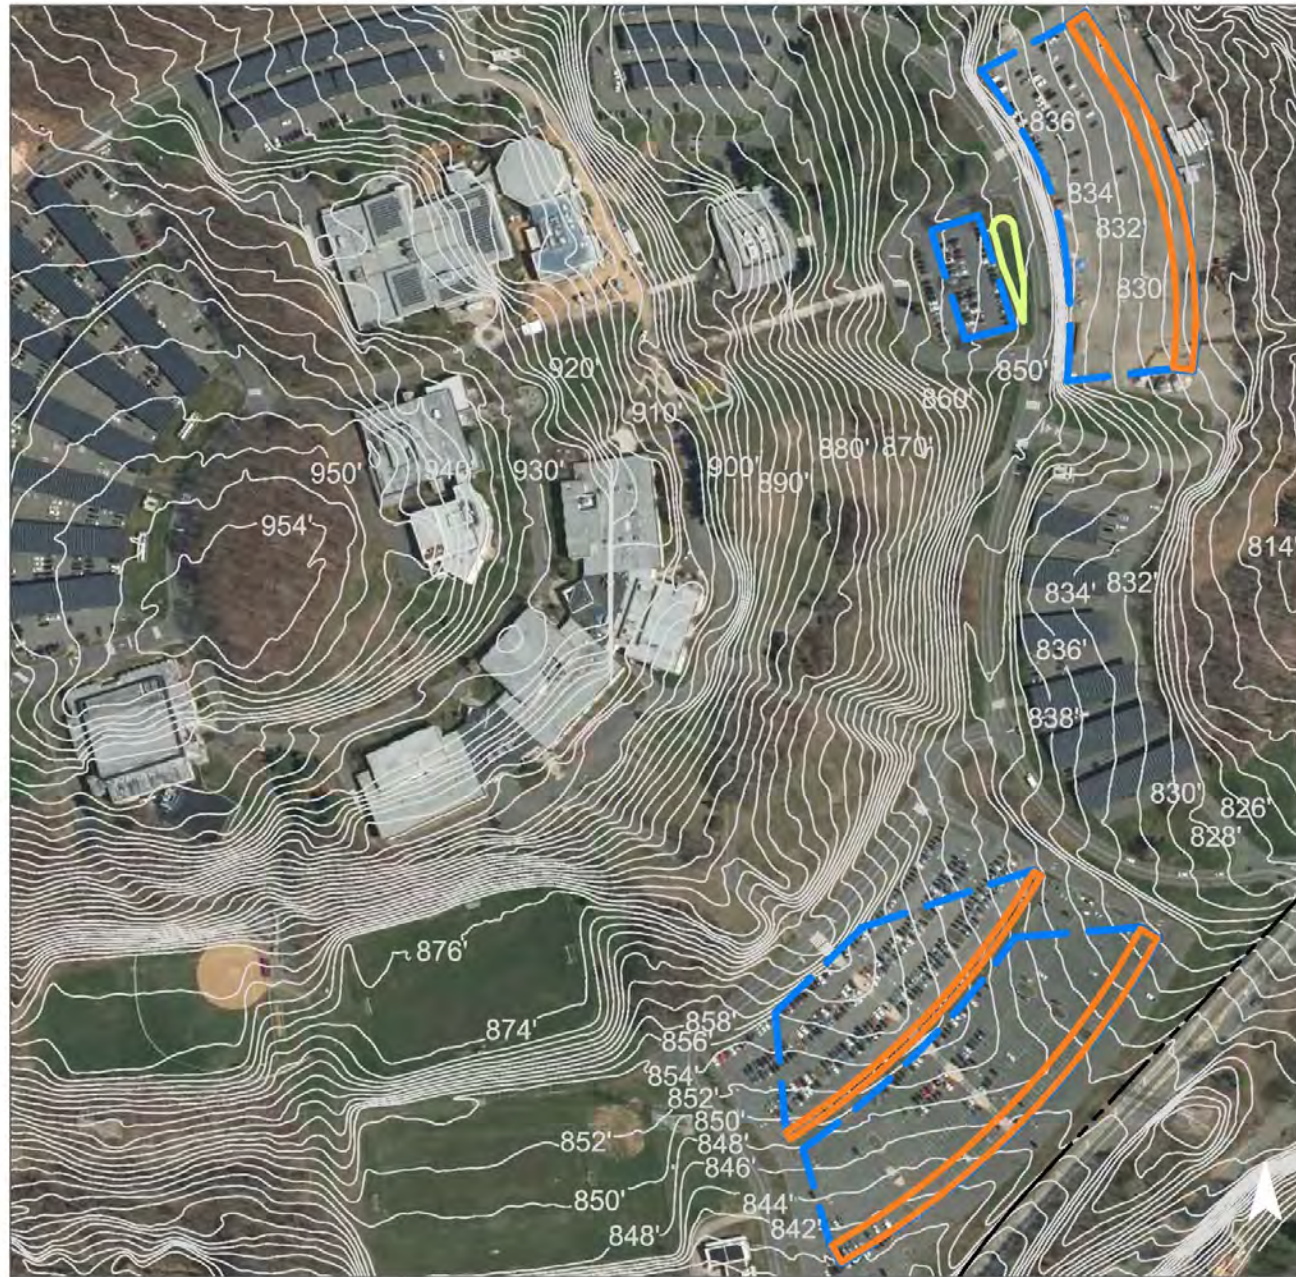
## County College of Morris

A bioretention system can be installed at the east end of the parking lot adjacent to Henderson Hall to treat the parking lot's drainage area. Pervious pavement can be installed in parking spaces throughout the campus to manage the large amount of stormwater runoff generated by the parking lot areas. A preliminary soil assessment suggests that more soil testing would be required before determining the soil's suitability for green infrastructure.

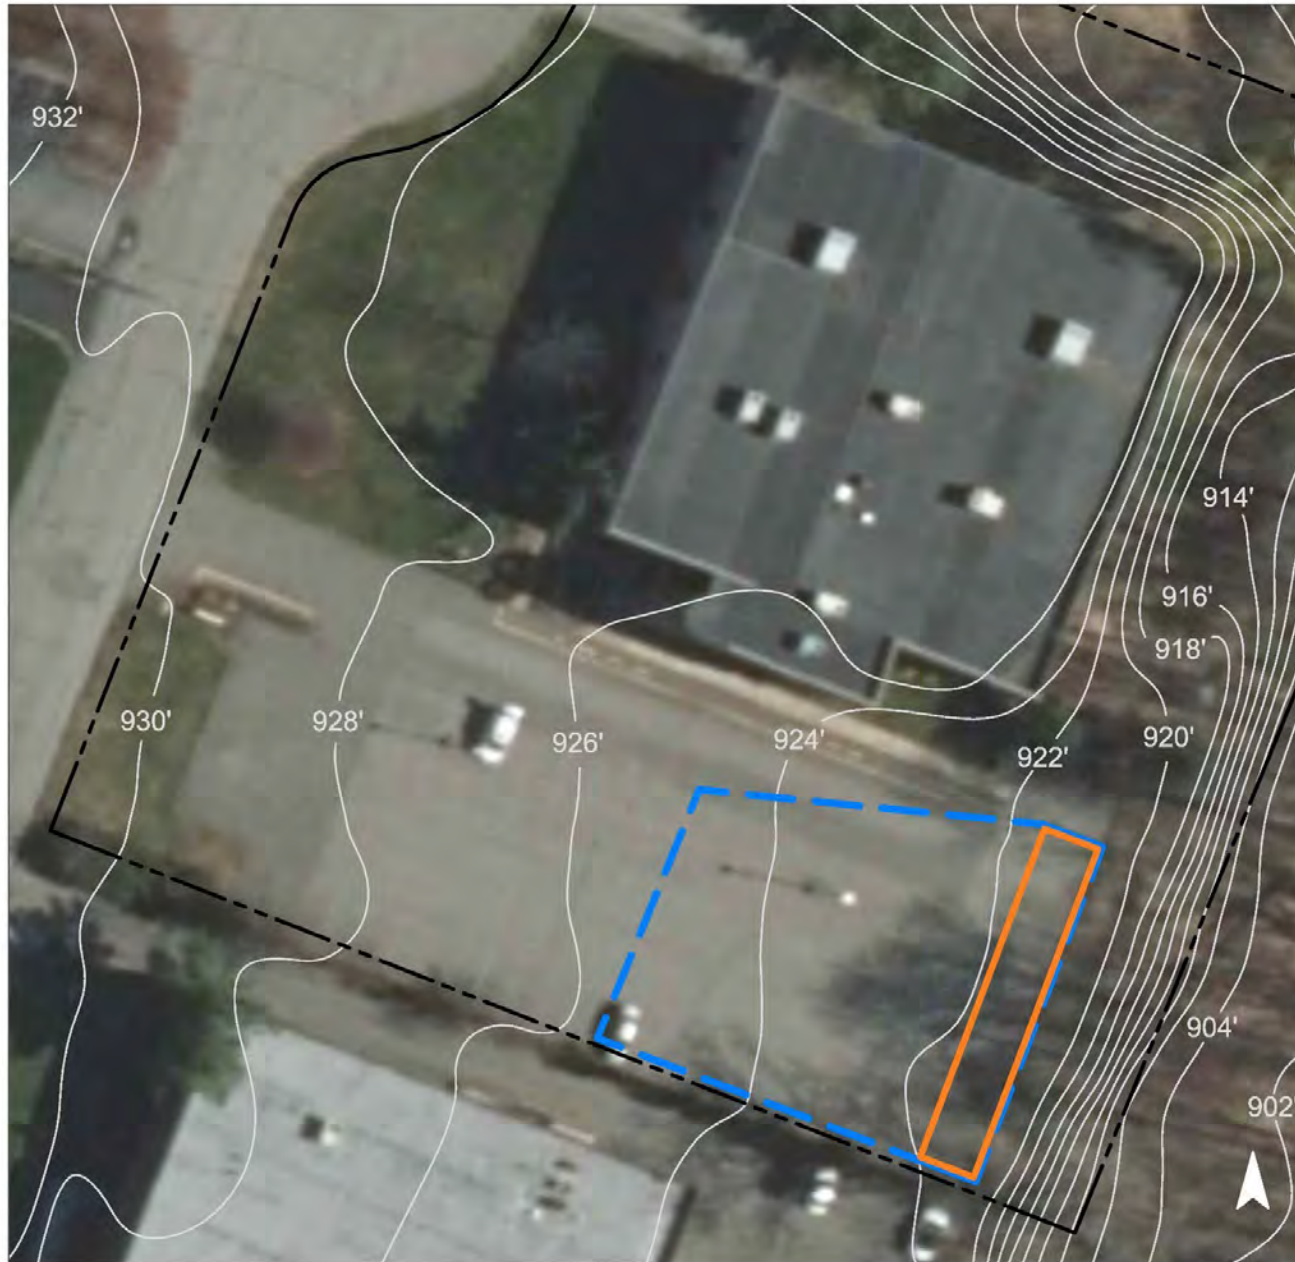
## Iglesia Alianza

Parking spaces at the southeast end of the parking lot can be converted to pervious pavement to capture and infiltrate stormwater from the parking lot. A preliminary soil assessment suggests that the soils have suitable drainage characteristics for green infrastructure.

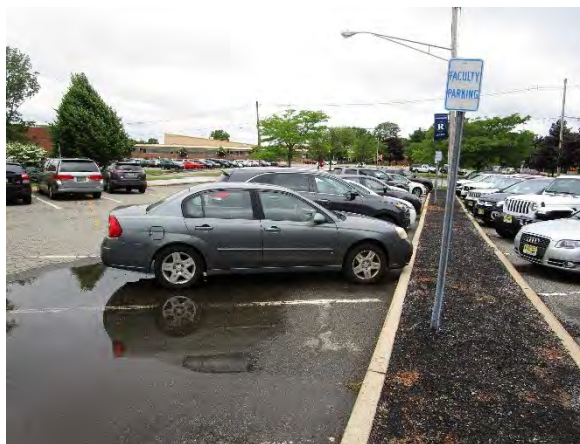
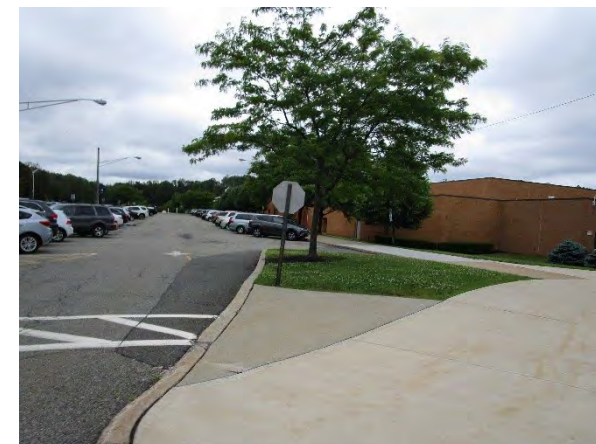
**Block and Lot:** Block 116 | Lot 30

Parking spaces in the parking lot to the southeast of the building can be converted to pervious pavement to capture and infiltrate stormwater runoff from the parking lot. Additional parking spaces throughout the site could be retrofitted as well. A small bioretention system can be installed adjacent to the shed to manage the rooftop runoff. A preliminary soil assessment suggests that the soils have suitable drainage characteristics for green infrastructure.

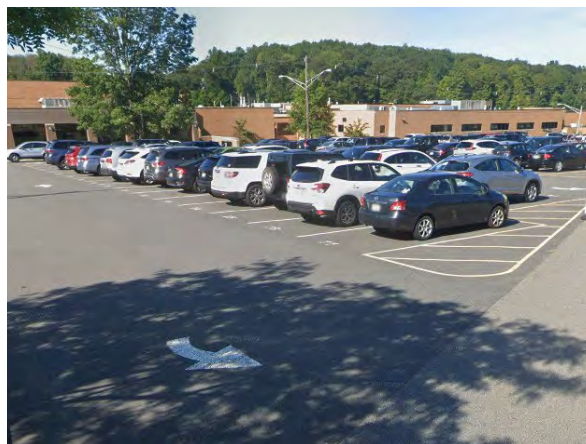
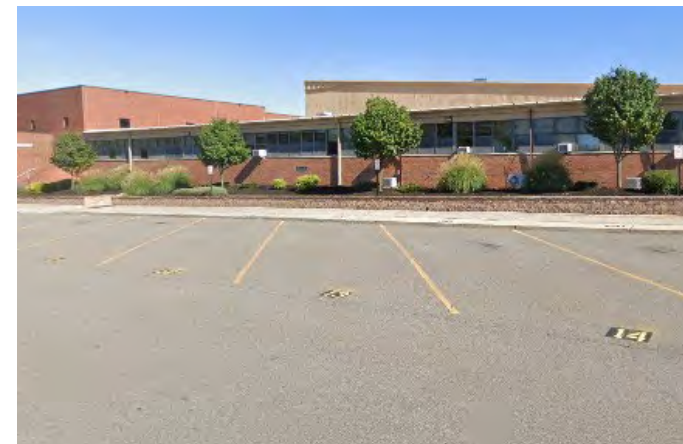
**Address:** 507 Millbrook Avenue  
Randolph, NJ 07869

The existing parking spaces to the south of the school can be converted into pervious pavement to capture and infiltrate the stormwater runoff from the asphalt. Trench drains will be required. The downspouts on the southern side of the building can also be disconnected to the pervious pavement to manage rooftop runoff. A preliminary soil assessment suggests that more soil testing would be required before determining the soil's suitability for green infrastructure.

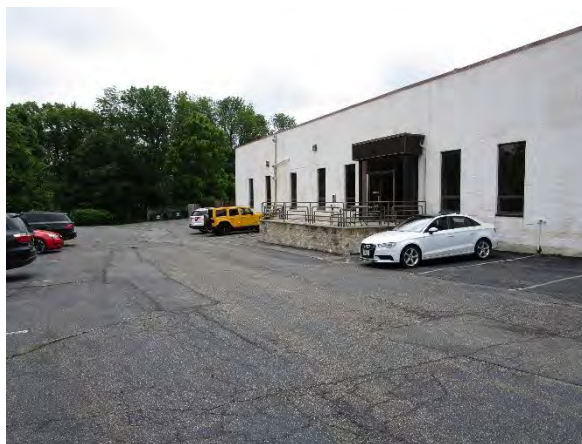
**Block and Lot:** Block 73 | Lot 56

Pervious pavement can be installed in the northeast portion of the parking lot to capture and infiltrate stormwater runoff from the parking area. A preliminary soil assessment suggests that the soils have suitable drainage characteristics for green infrastructure.

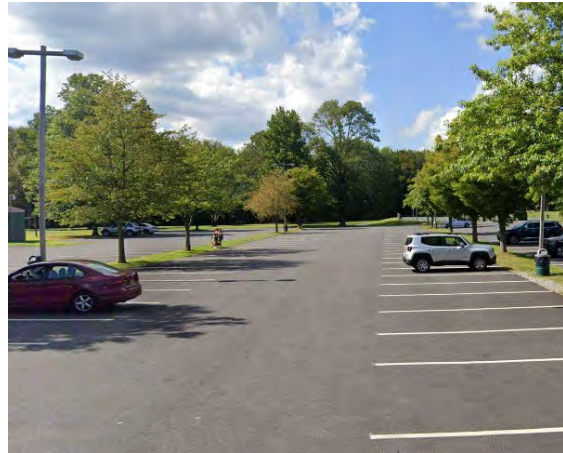
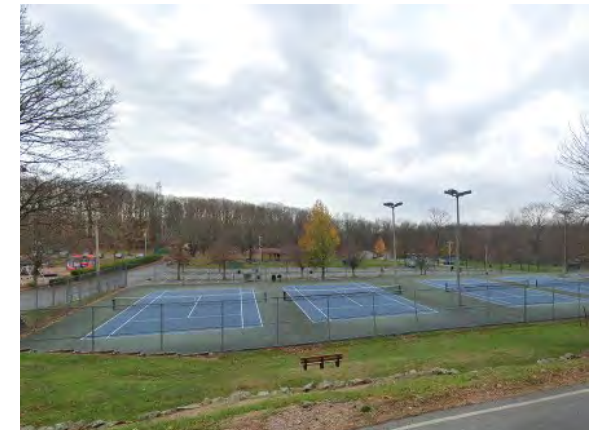
**Address:** 43 North Bungalow Lane  
Randolph, NJ 07869

Rain gardens can be installed in multiple grass areas around the property to capture, treat, and infiltrate stormwater runoff from the rooftops of the park buildings. This may require downspout redirections and disconnections. A gutter system will need to be installed on the pavilion for the northern rain garden. Existing parking spaces in the northern lot can be converted into pervious pavement to capture and infiltrate the stormwater runoff from the asphalt. The tennis and basketball courts can be converted into pervious pavement to capture and infiltrate the stormwater runoff from the courts. A cistern can be installed to the northeast of the southern park building to divert and detain the stormwater runoff from the rooftop for later non-potable reuse such as washing vehicles. A preliminary soil assessment suggests that the soils have suitable drainage characteristics for green infrastructure.

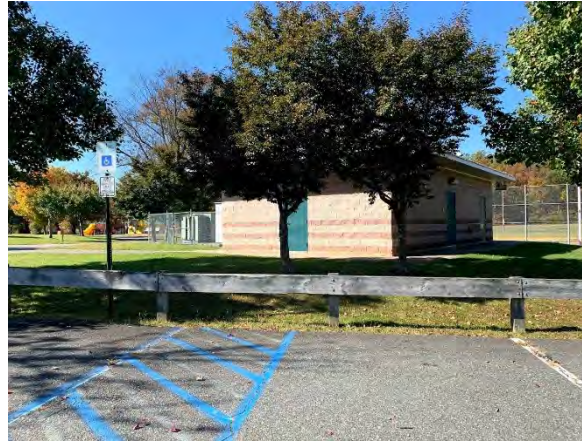
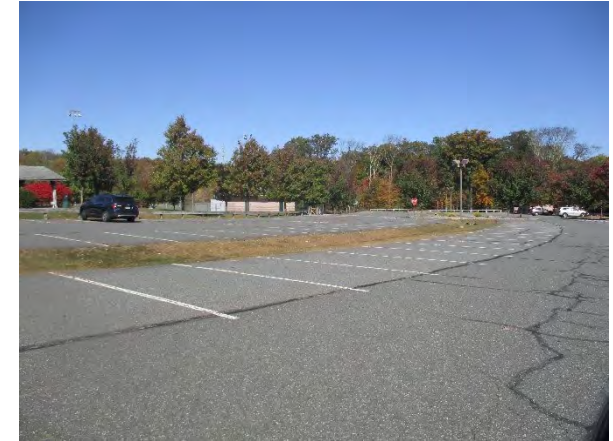
**Block and Lot:** Block 119 | Lot 15. 01,  
115.02, 101.01, 116.01

Bioretention systems can be installed near the park buildings to manage their rooftop areas. The existing swales in the center of the parking lot can be retrofitted with bioswales to enhance infiltration and slow down the stormwater runoff from the parking lot area. Pervious pavement can be installed in the northwest corner of the parking lot to capture additional stormwater runoff. A preliminary soil assessment suggests that more soil testing would be required before determining the soil's suitability for green infrastructure.

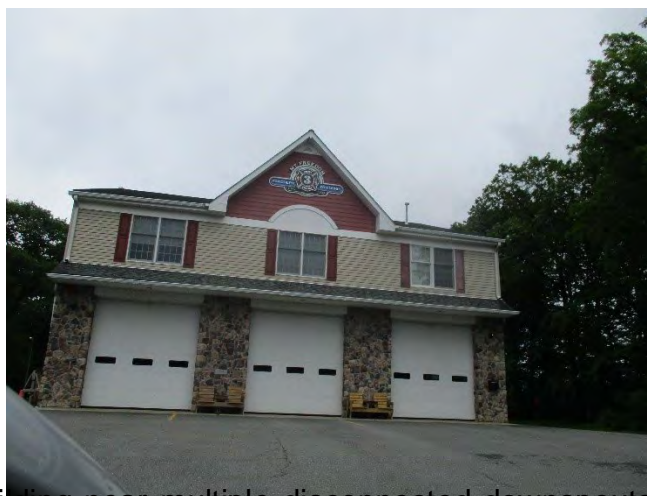
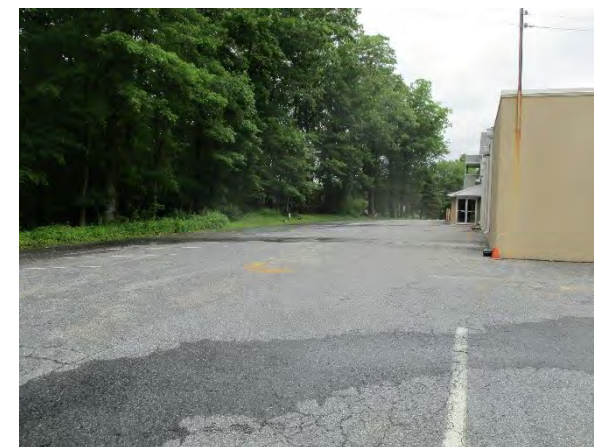
**Block and Lot:** Block 119 | Lot 114.01

Parking spaces along the south end of the building near multiple disconnected downspouts can be converted to pervious pavement to capture and infiltrate stormwater runoff from the parking lot and rooftop areas. A cistern can be installed on the north side of the building near a disconnected downspout to capture rainwater that can be used for watering gardens, washing vehicles, or for other non-potable uses. A preliminary soil assessment suggests that the soils have suitable drainage characteristics for green infrastructure.

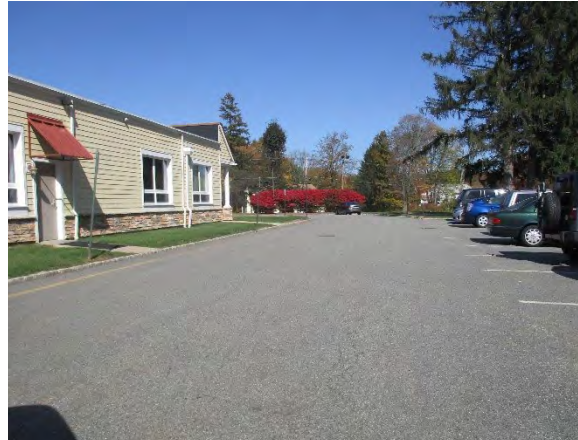
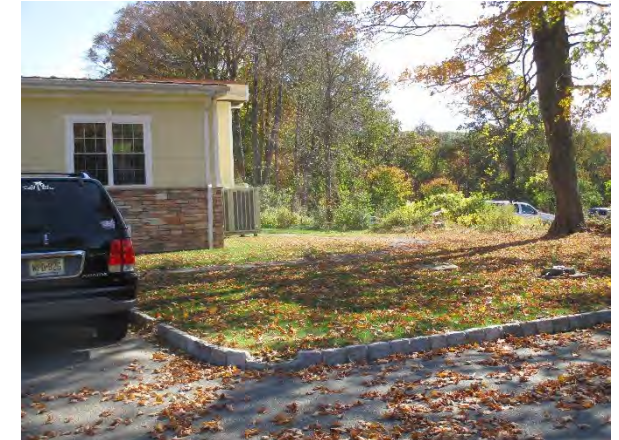
**Block and Lot:** Block 93 | Lot 3

Five downspout planter boxes can be installed on the north end of the library to filter the rooftop drainage area and beautify the area. Pervious pavement can be installed in the parking areas to capture and infiltrate stormwater runoff from the parking lot. Bioretention systems can be installed to manage areas from the rooftop by redirecting downspouts and from the parking lot by creating curb cuts. A preliminary soil assessment suggests that the soils have suitable drainage characteristics for green infrastructure.

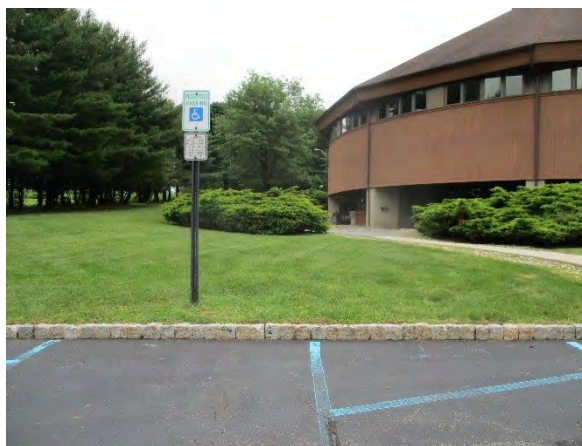
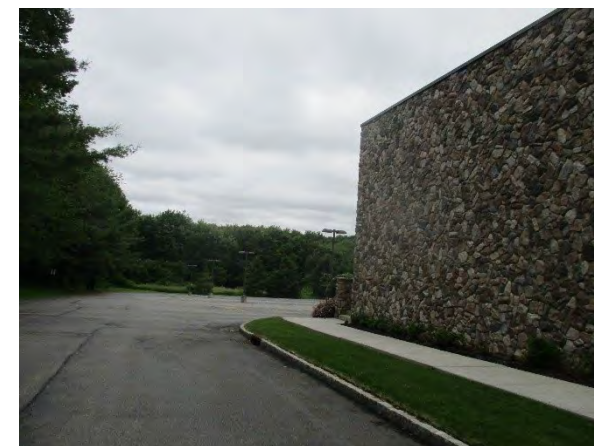
**Block and Lot:** Block 82 | Lot 40

A rain garden can be installed on the north side of the building near the connected downspouts. The connected downspouts can be disconnected and led into the rain garden to capture, treat, and infiltrate stormwater runoff from the roof. The parking spaces in the parking lot can be retrofitted into pervious pavement to capture a large volume of stormwater running off from the parking lot during storm events. A preliminary soil assessment suggests that the soils have suitable drainage characteristics for green infrastructure.

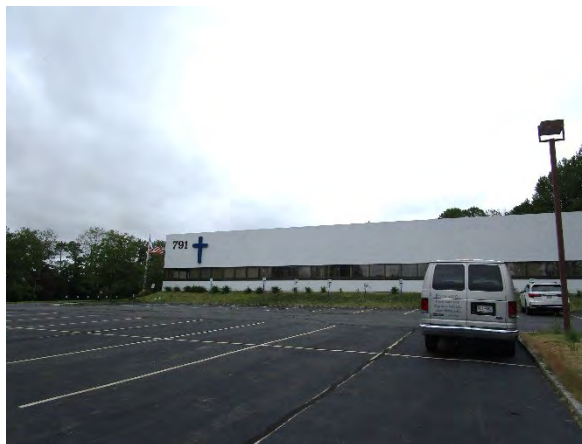
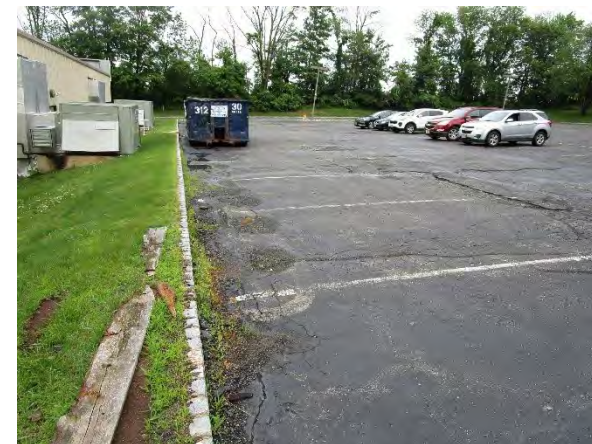
**Block and Lot:** Block 44 | Lot 13.01

Pervious pavement can be installed in both parking lots to capture and infiltrate stormwater runoff from the parking lot. Bioretention systems can be installed in the turfgrass areas by using curb cuts to direct water from the pavement into them. A preliminary soil assessment suggests that more soil testing would be required before determining the soil's suitability for green infrastructure.

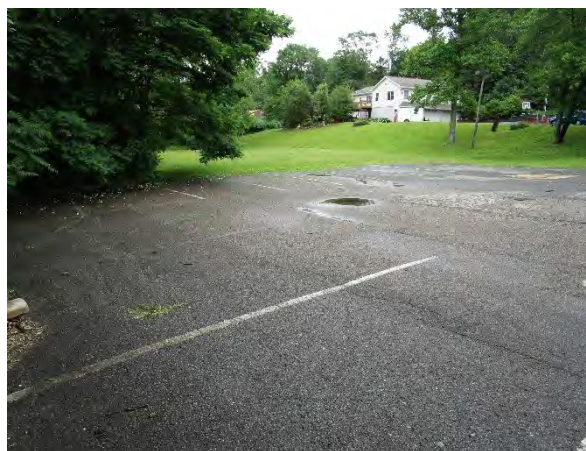
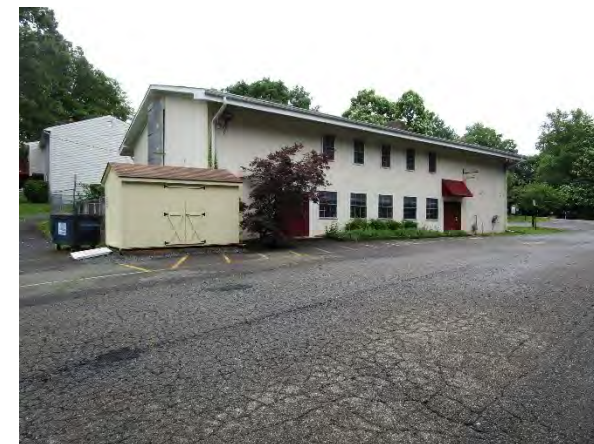
**Block and Lot:** Block 180 | Lot 1

Parking spaces in the parking lot to the northeast of the building can be converted to pervious pavement to capture and infiltrate stormwater runoff from the parking lot. A preliminary soil assessment suggests that more soil testing would be required before determining the soil's suitability for green infrastructure.

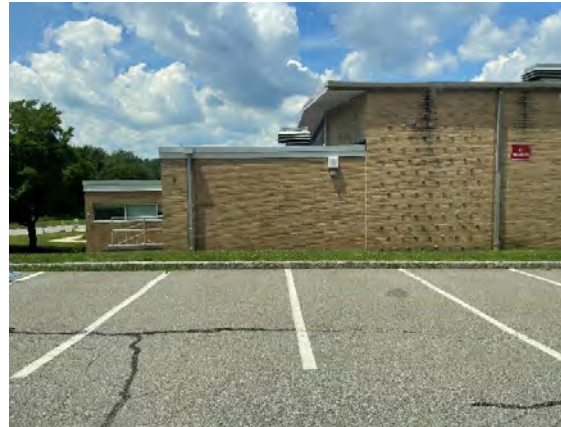
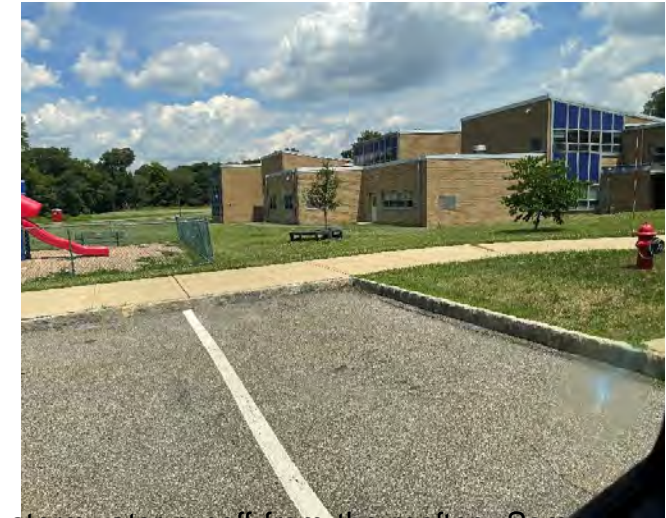
**Address:** 206 Quaker Church Road  
Randolph, NJ 07869

Multiple rain gardens can be installed to the west of the school to capture, treat, and infiltrate stormwater runoff from the rooftop. Some downspouts will need to be redirected beneath the asphalt pathway. Rain gardens can also be installed to the north of the northern parking lot and the western play area. Trench drains will need to be installed on the western side of the asphalt to intercept and redirect the runoff to the rain gardens. Existing parking spaces to the east of the building can be converted into pervious pavement to capture and infiltrate the stormwater runoff from the asphalt. Adjacent downspouts can be disconnected to the pervious pavement to manage stormwater runoff from the rooftop. The concrete entryway to the south of the building can be replaced with permeable pavers. A preliminary soil assessment suggests that more soil testing would be required before determining the soil's suitability for green infrastructure.

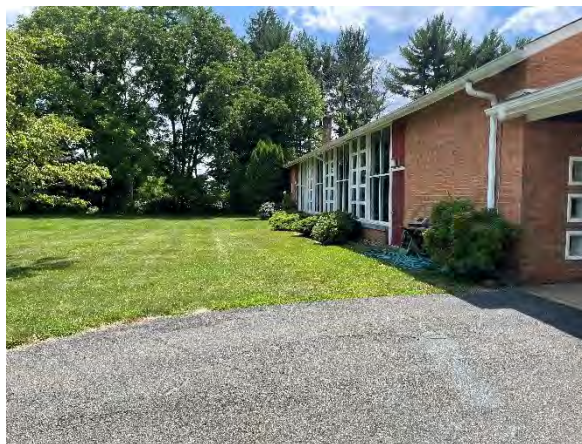
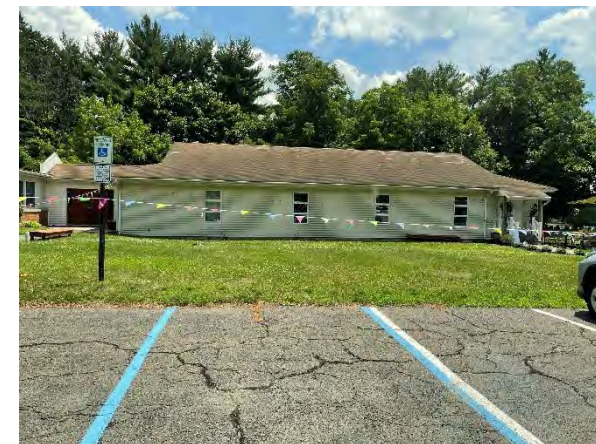
**Address:** 319 Quaker Church Road  
Randolph, NJ 07869

Rain gardens can be installed to the north and west of the church buildings to capture, treat, and infiltrate the stormwater runoff from the rooftop. Some downspouts will need to be disconnected. A preliminary soil assessment suggests that the soils have suitable drainage characteristics for green infrastructure.

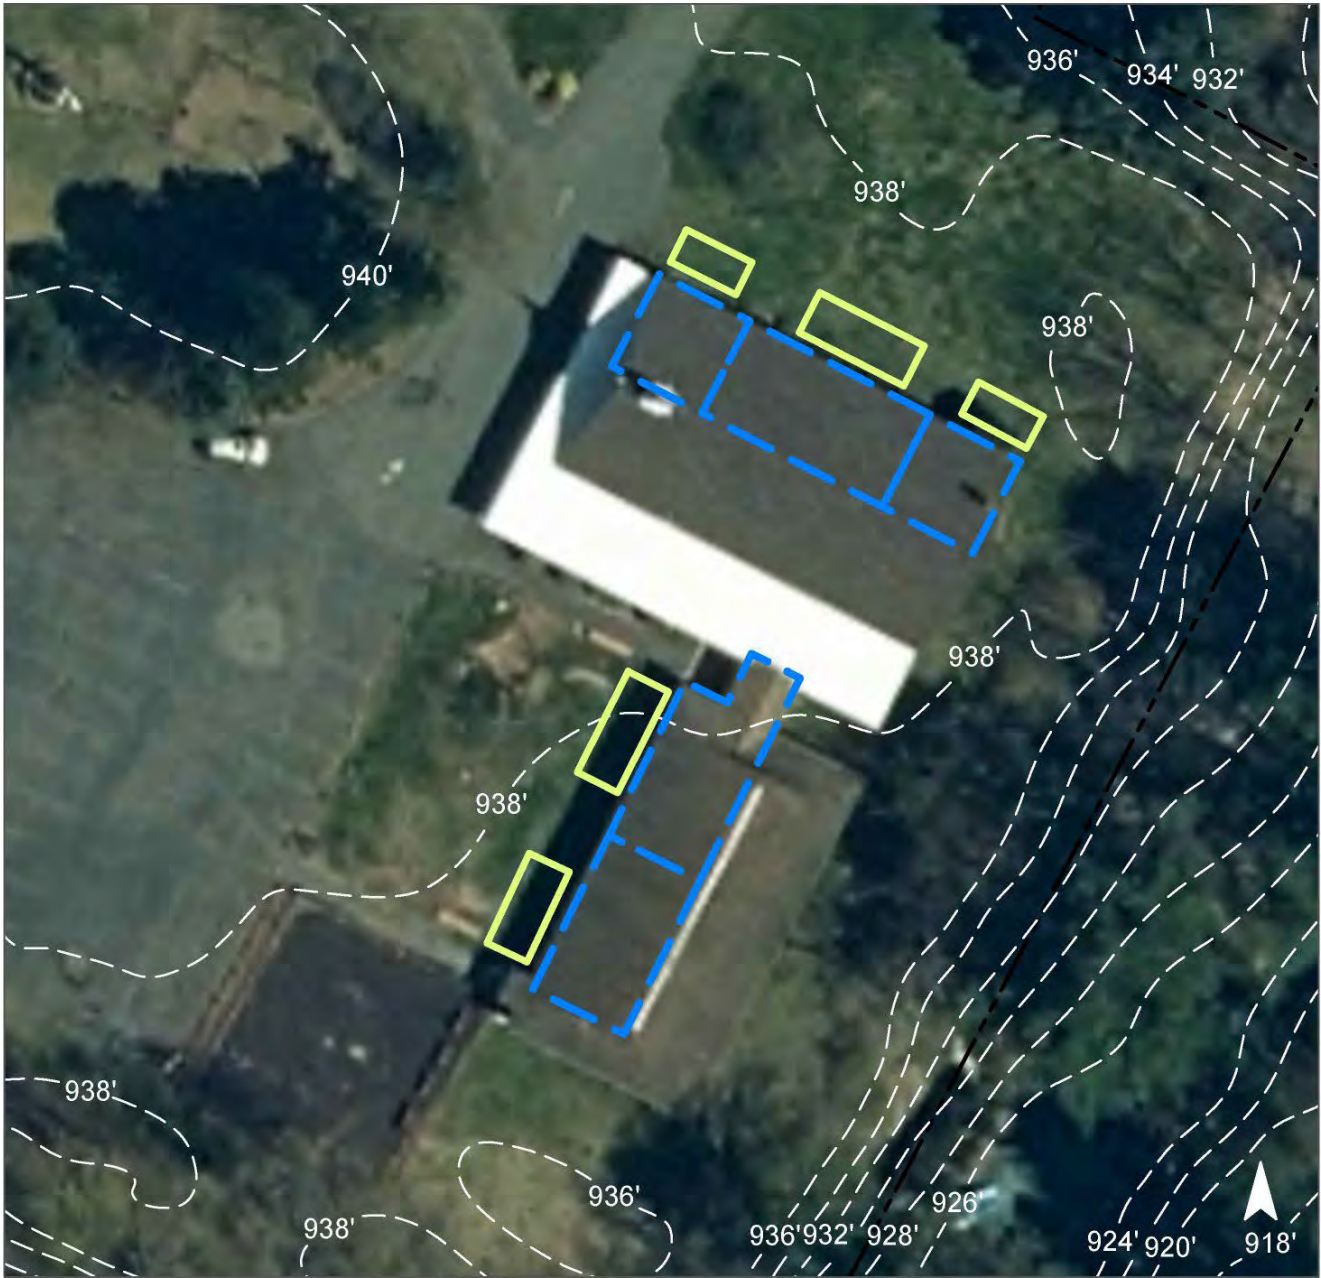
## Good Shepherd Lutheran Church

Pervious pavement can be installed on a strip of parking spaces north of the building near connected downspouts. Parking spaces can be replaced with pervious pavement to capture and infiltrate stormwater. The downspouts can be disconnected and redirected into the pervious pavement to capture additional stormwater. A preliminary soil assessment suggests that the soils have suitable drainage characteristics for green infrastructure.

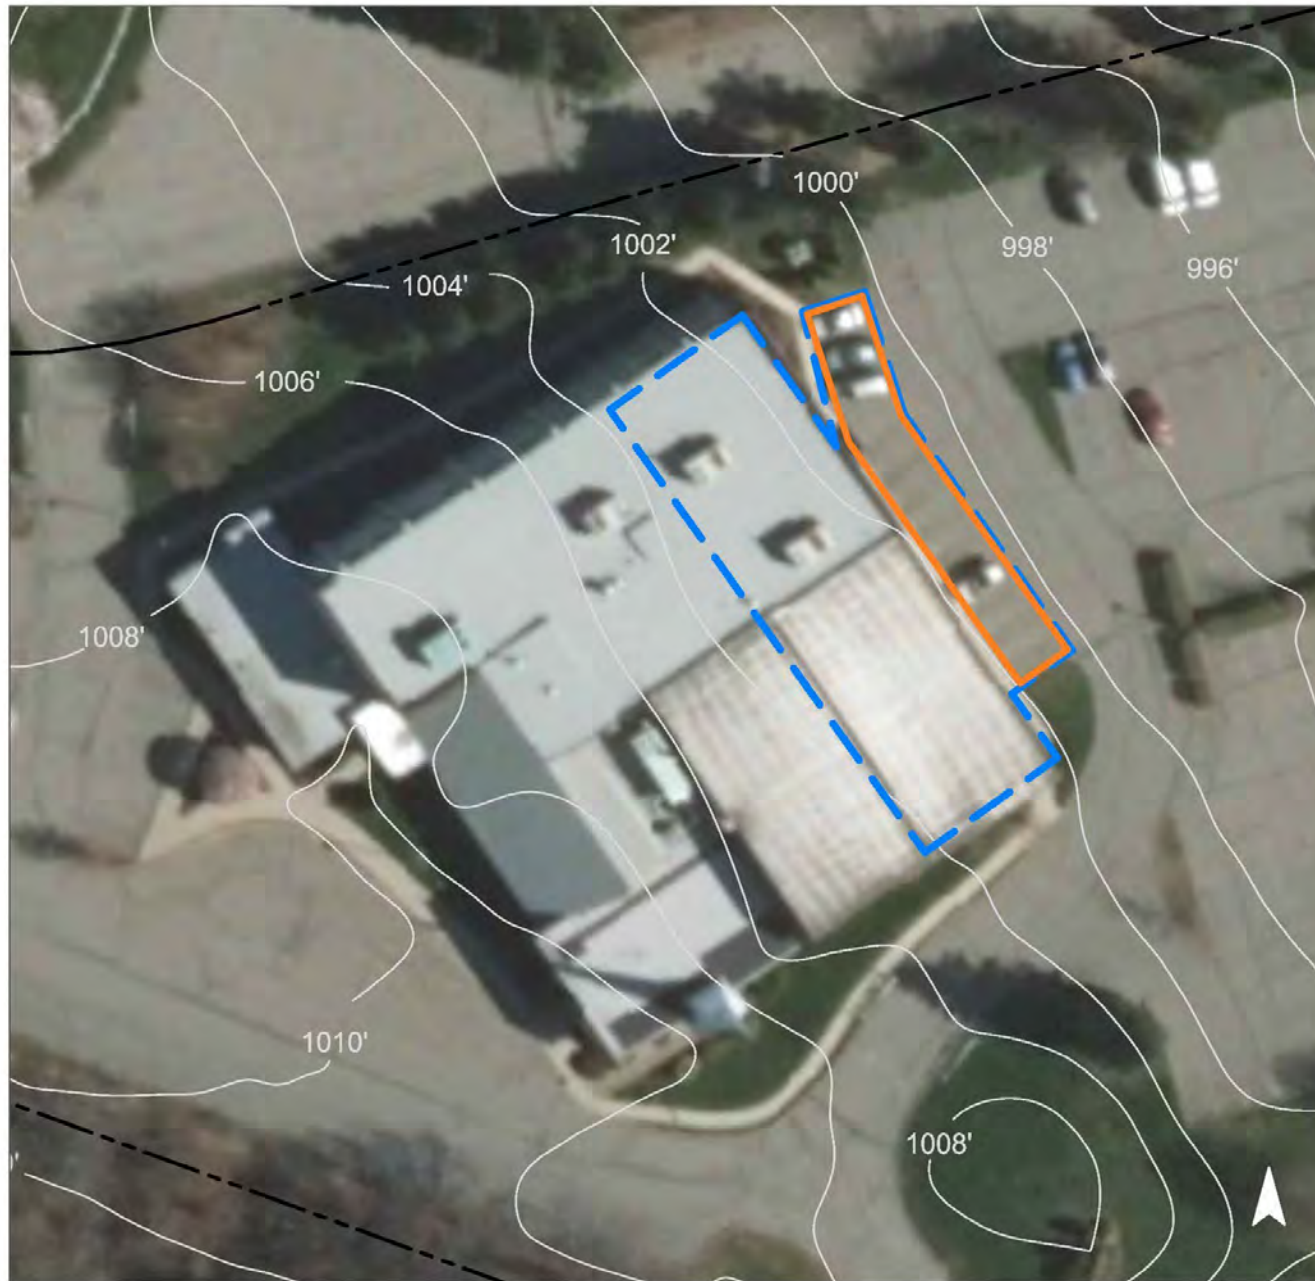
## Grace Church Bethlehem Campus

Parking spaces in the parking lot to the southwest of the building can be converted to pervious pavement to capture and infiltrate stormwater runoff from the parking lot. A rain garden can be installed in the turfgrass area west of the building to capture, treat, and infiltrate stormwater runoff from the roof. A preliminary soil assessment suggests that the soils have suitable drainage characteristics for green infrastructure.

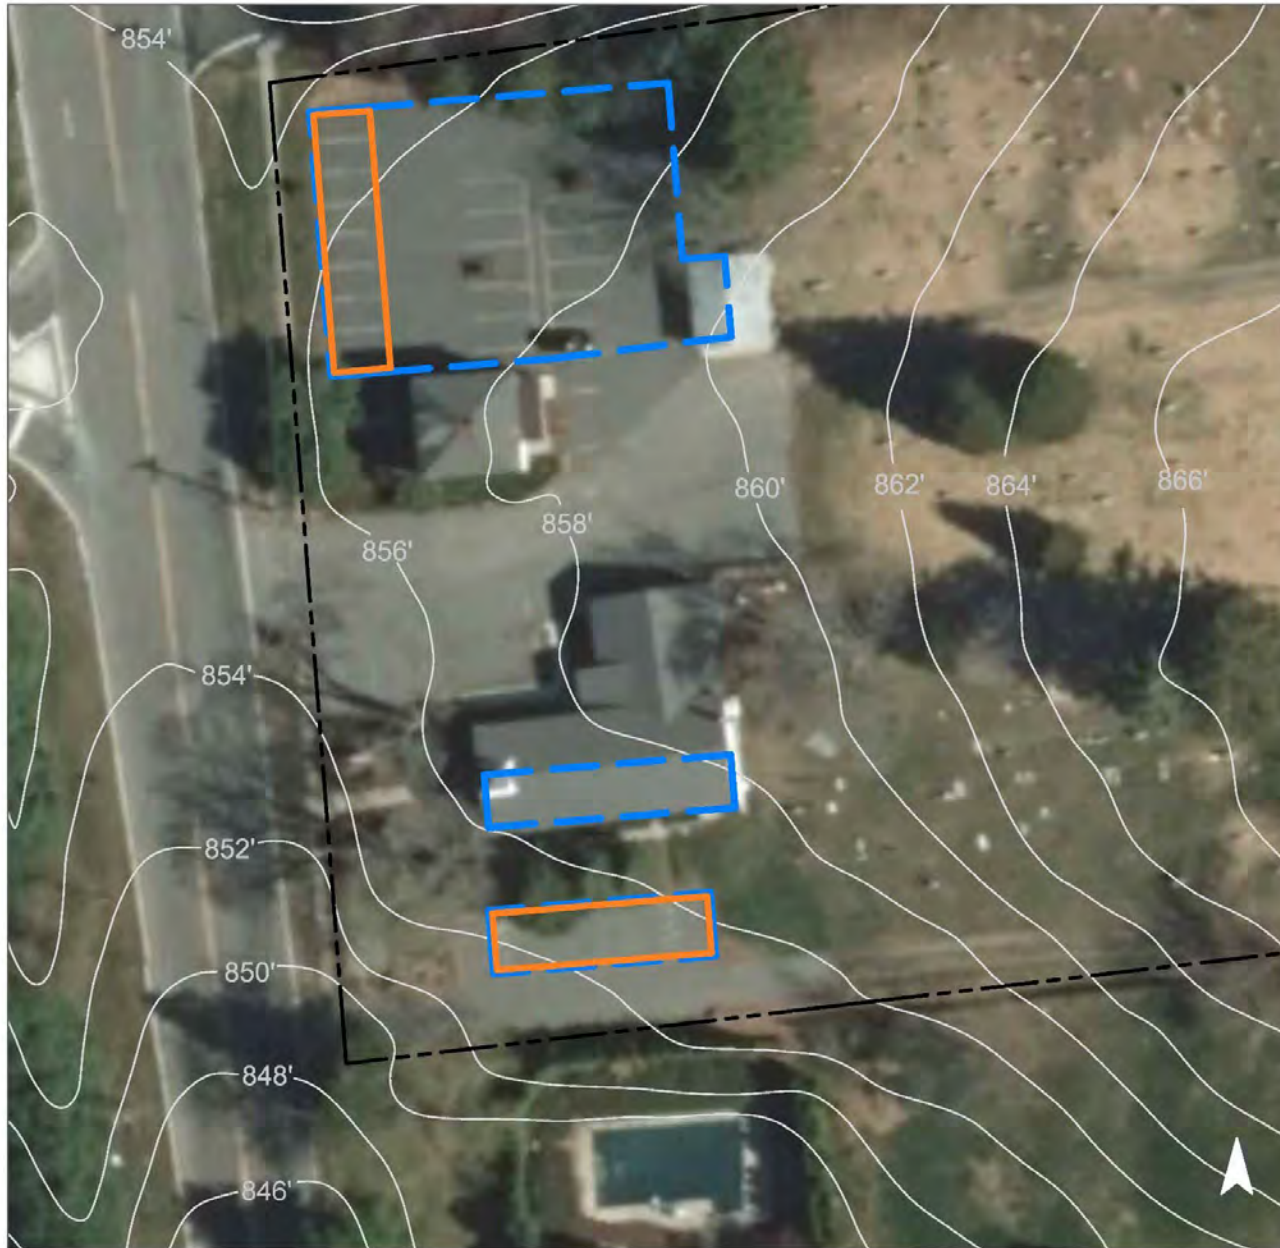
## Millbrook United Methodist Church

Rain gardens can be installed to the northwest and southwest of the building to capture, treat, and infiltrate stormwater runoff from the rooftop. This will require downspout disconnections. Existing parking spaces to the north and east of the building can be converted into pervious pavement to capture and infiltrate the stormwater runoff from the asphalt. Downspouts on the north of the building can be disconnected to the pervious pavement to manage stormwater runoff from the rooftop. A cistern can be installed to the north of the building to divert and detain the stormwater runoff from the rooftop for later non-potable reuse such as washing vehicles. A preliminary soil assessment suggests that the soils have suitable drainage characteristics for green infrastructure.

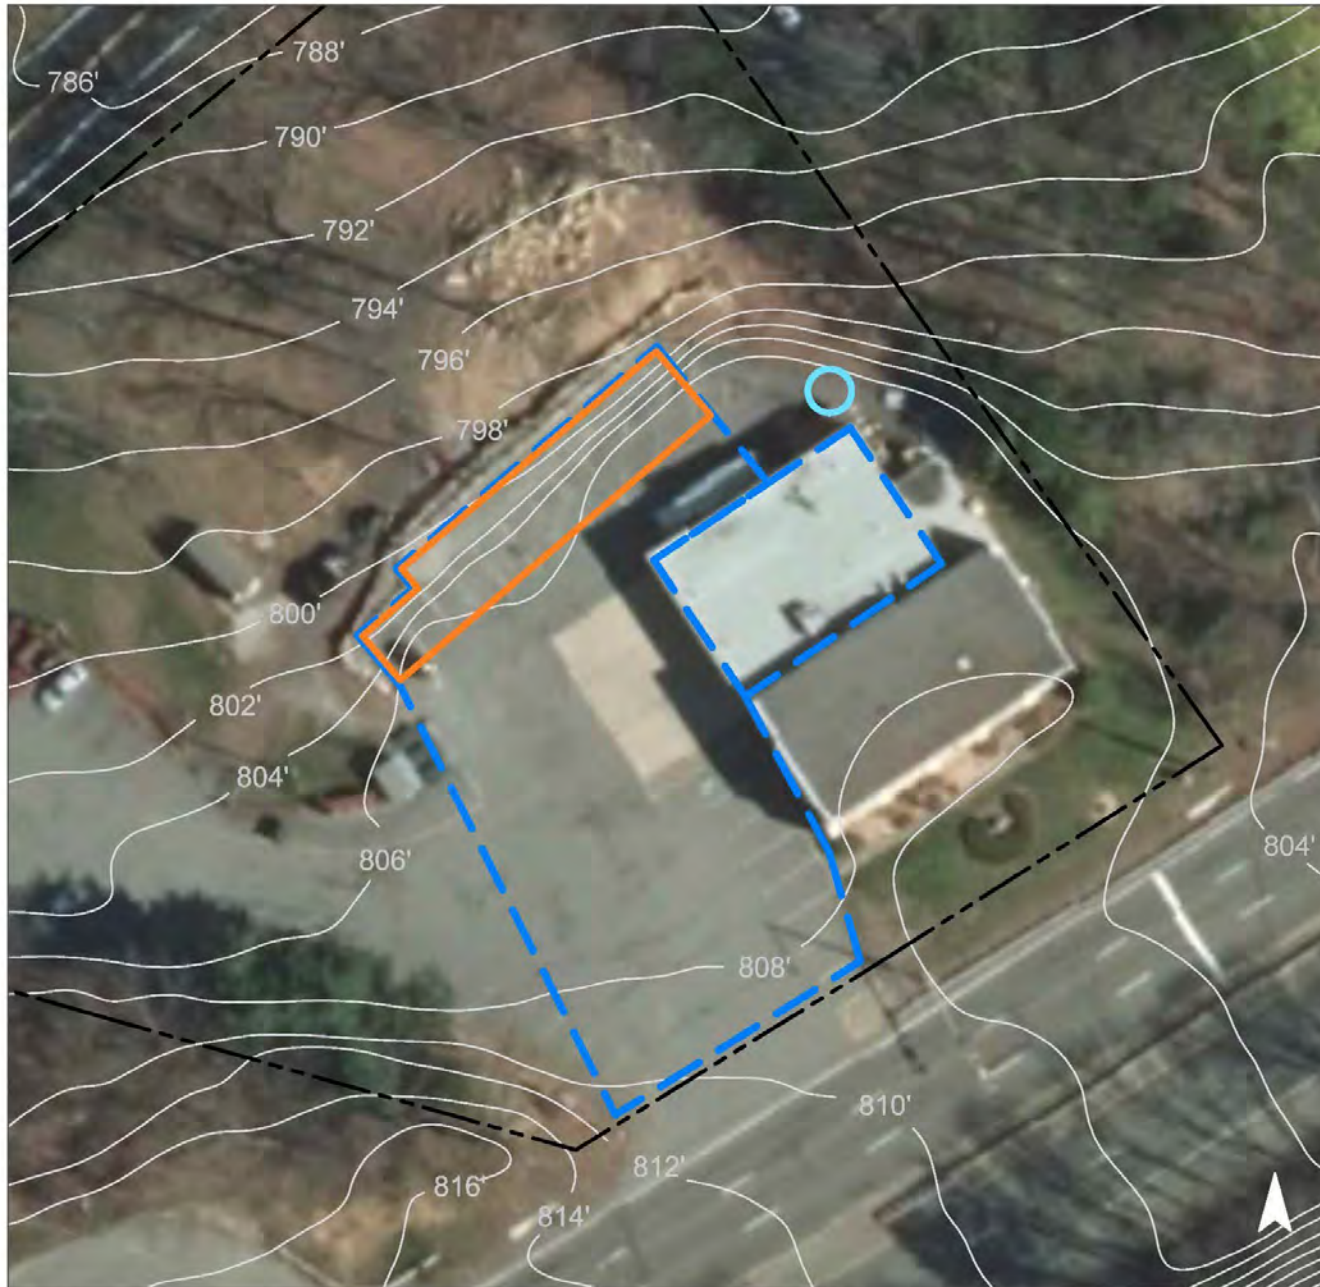
## Randolph Township Fire Department Company #2

Pervious pavement can be installed in the center parking spaces to capture and infiltrate stormwater runoff from the parking lot. A stormwater planter can be installed by depaving a portion of the wide sidewalk. A curb cut can be used to intercept stormwater runoff from the parking lot. A preliminary soil assessment suggests that the soils have suitable drainage characteristics for green infrastructure.
