## Bedminster Township

### Introduction

The purpose of this report is to provide a comprehensive understanding of key, defining features within the subwatersheds throughout Bedminster Township. This involves gathering, organizing, and presenting information about existing conditions and infrastructure within each subwatershed. It aims to serve as a tool for informed decision-making, planning, and implementation of sustainable watershed management strategies aimed to protect and enhance the health of the watershed, its associated ecosystems, and the surrounding communities.

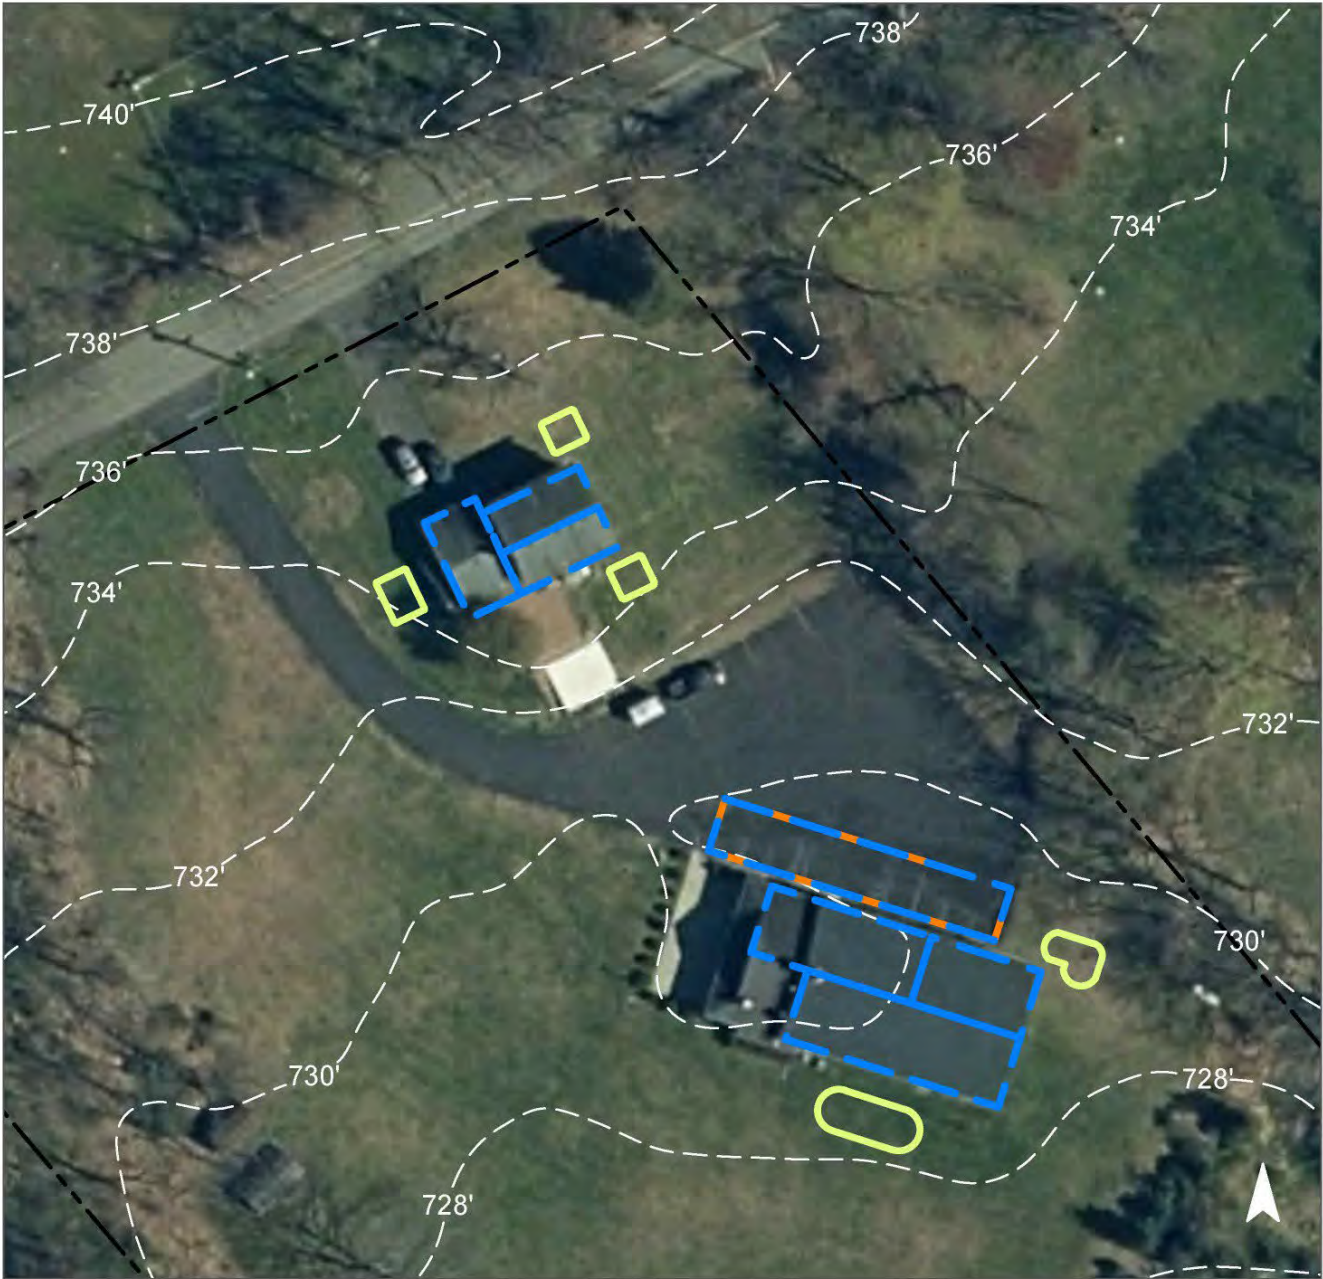
**Holy Wisdom Byzantine Catholic Church**

Parking spaces can be replaced with pervious pavement to capture and infiltrate stormwater. Downspout planter boxes can be installed on multiple locations north of the building. A rain garden can be installed in the parking island to capture, treat, and infiltrate additional stormwater runoff. Downspout planter boxes can be installed near the entrances to capture rooftop runoff and provide visual interest. A preliminary soil assessment suggests that more soil testing would be required before determining the soil's suitability for green infrastructure.

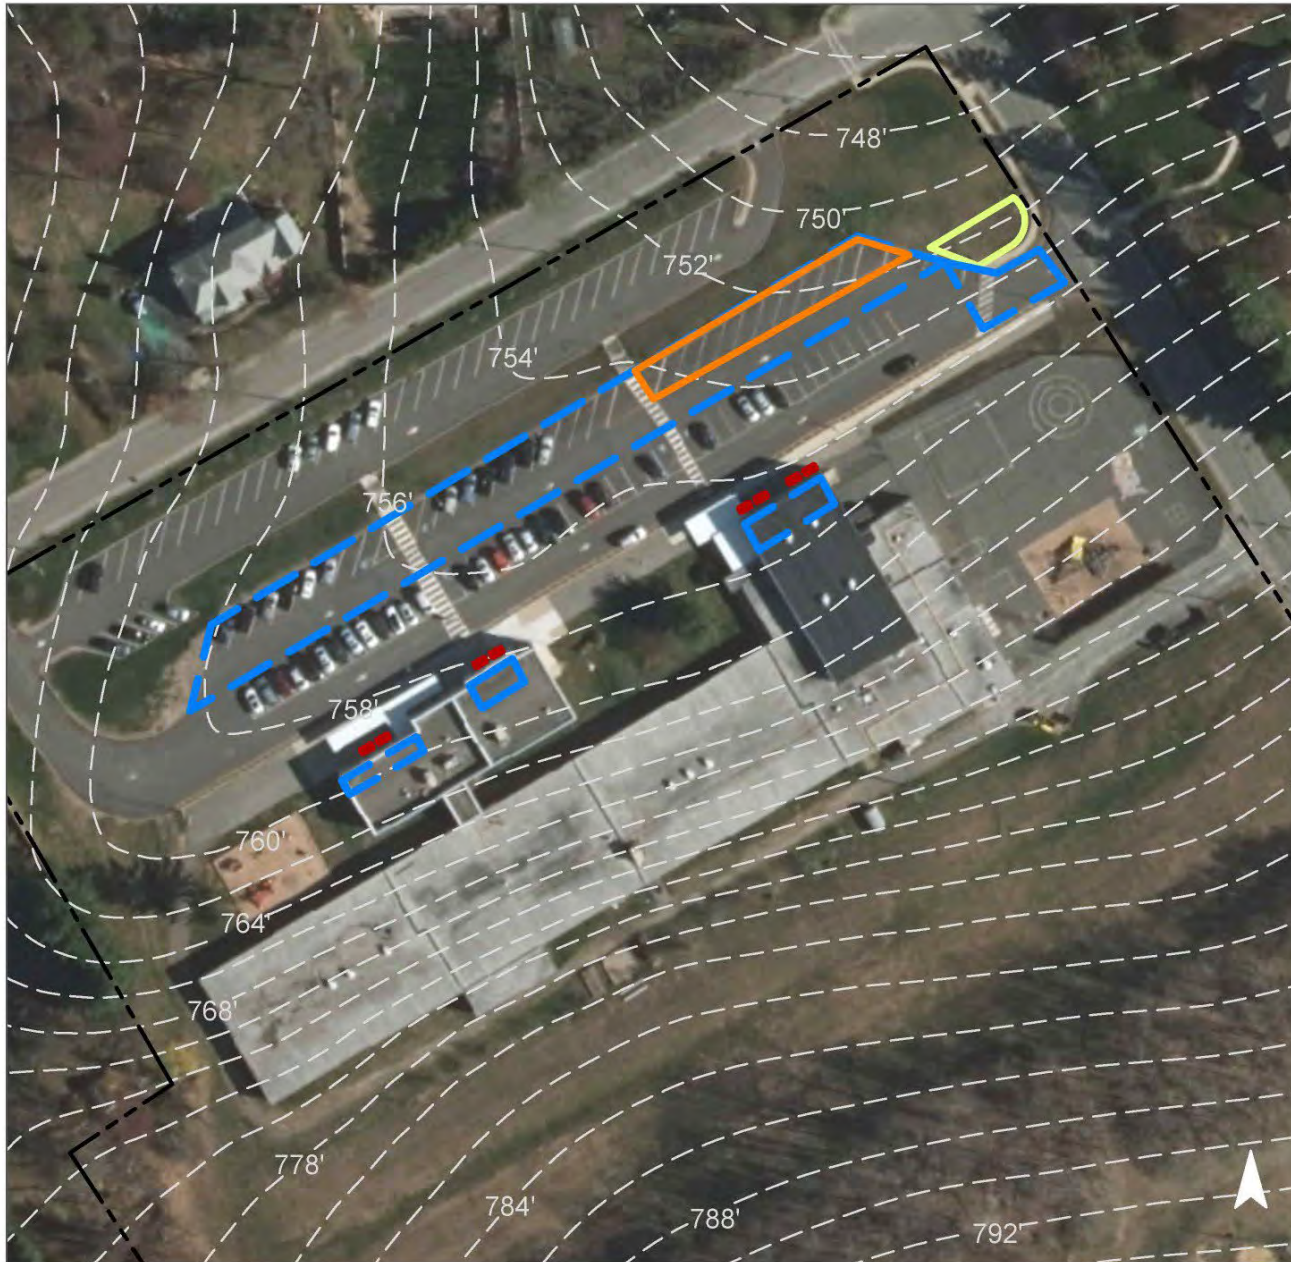
## Jefferson Elementary School

Parking spaces can be replaced with pervious pavement on the southernmost parking strip in the lot to capture and infiltrate stormwater. A rain garden can be installed near the tennis court to capture stormwater. A preliminary soil assessment suggests that more soil testing would be required before determining the soil's suitability for green infrastructure.

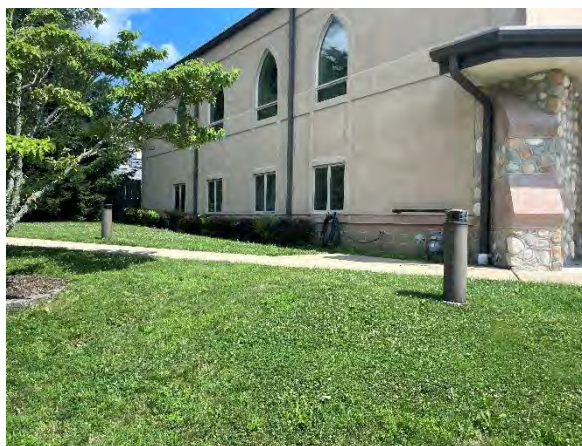
Four rain gardens that require downspout disconnection and redirection can be installed in the grass areas around the property building to capture, treat, and infiltrate stormwater runoff from the roofs. One rain garden can be installed in the grass area on the east side of the site to capture, treat, and infiltrate stormwater runoff from the parking lot. A preliminary soil assessment suggests that the soils have suitable drainage characteristics for green infrastructure.

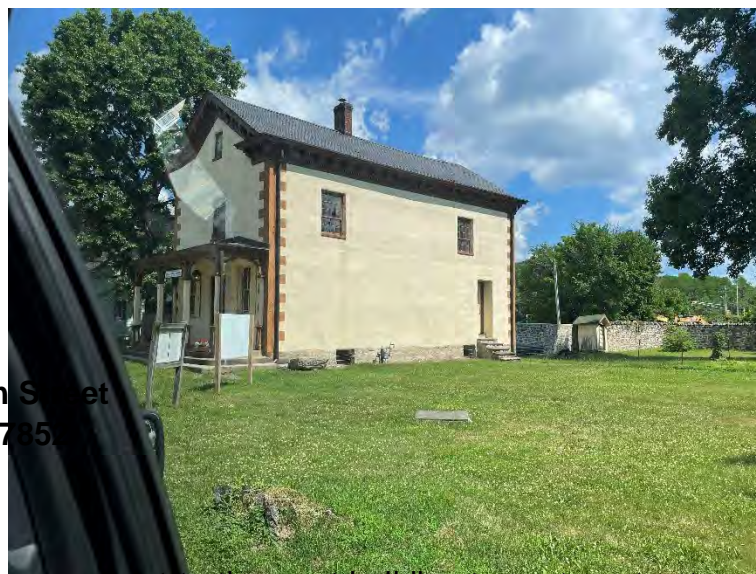
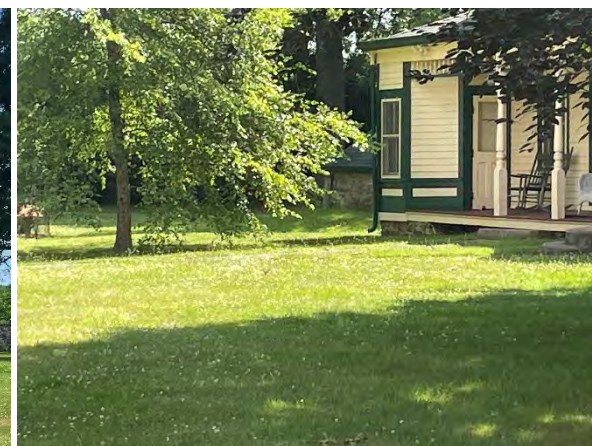
A rain garden can be installed in the grass area next to the west building to capture, treat, and infiltrate stormwater runoff from the roof. Three rain gardens, one of which requires downspout disconnection, can be installed next to the east building to capture, treat, and infiltrate stormwater runoff from the roof. A preliminary soil assessment suggests that more soil testing would be required before determining the soil's suitability for green infrastructure.

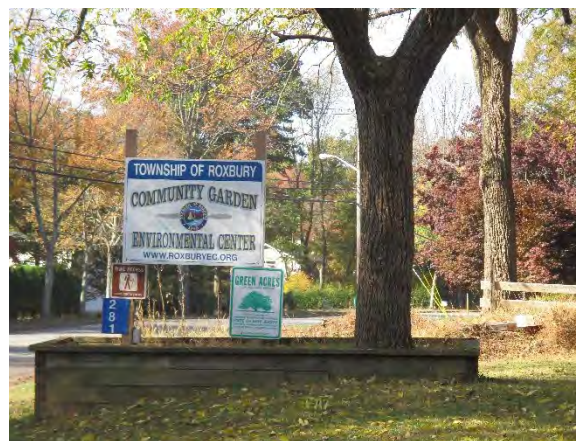
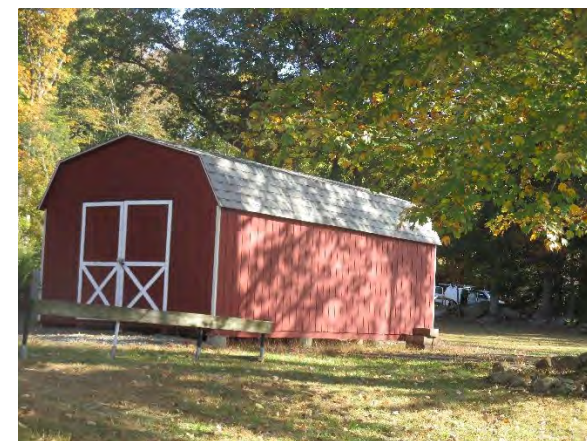
A cistern can be installed to capture stormwater from the roof of the shed in front of the garden, and the water can be reused for watering plants or other non-potable purposes. A preliminary soil assessment suggests that more soil testing would be required before determining the soil's suitability for green infrastructure.

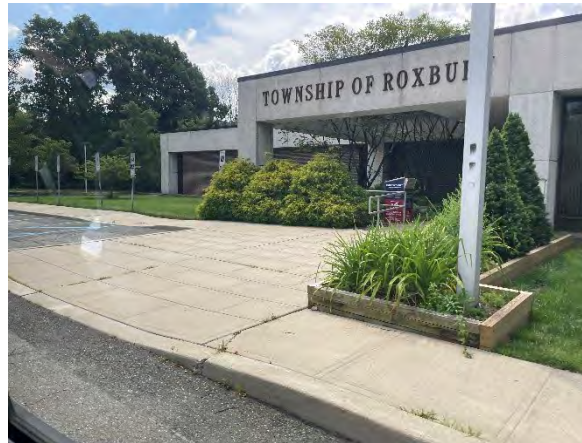
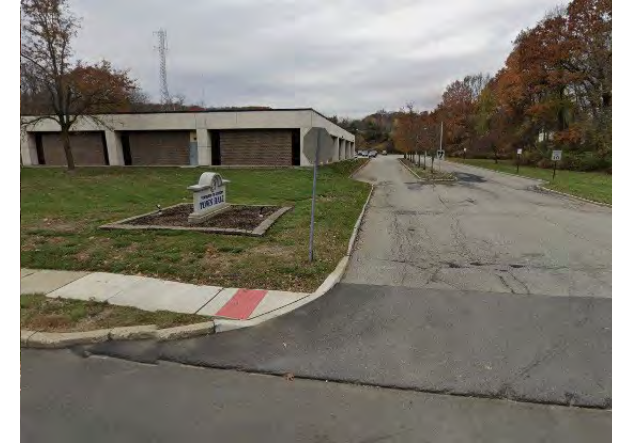
Three rain gardens can be installed in the grass areas on the east and west sides at the front of the building to capture, treat, and infiltrate stormwater runoff from the pavement. The gardens will require curb cuts and trench drains. Parking spaces on the west side of the building and behind the building can be converted to porous pavement to capture and infiltrate stormwater runoff from the parking lot. A preliminary soil assessment suggests that more soil testing would be required before determining the soil's suitability for green infrastructure.

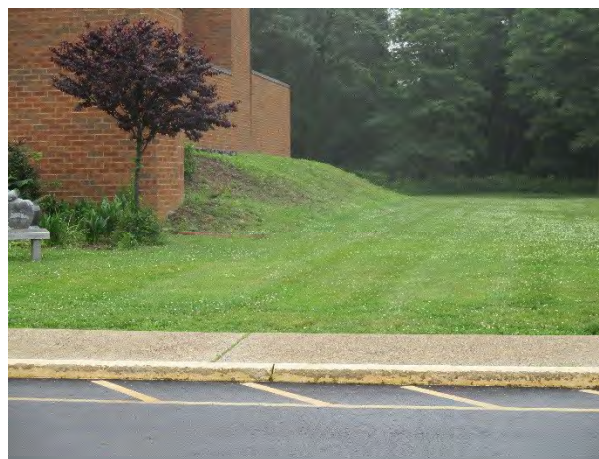
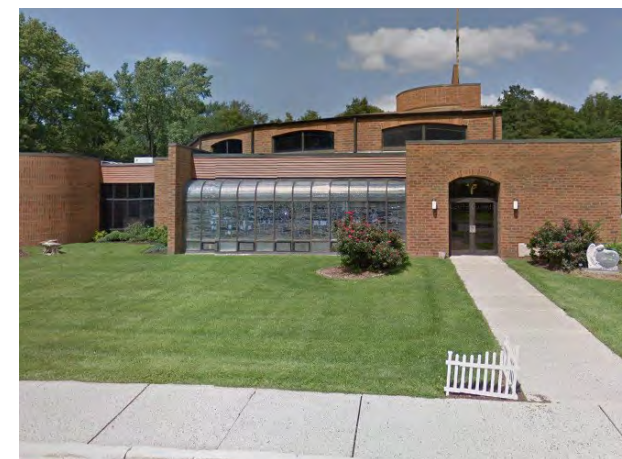
A rain garden can be installed on the east side of the building to capture, treat, and infiltrate rooftop runoff. A preliminary soil assessment suggests that more soil testing would be required before determining the soil's suitability for green infrastructure.

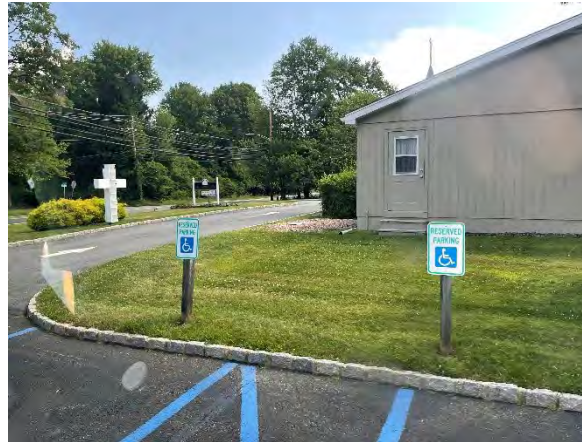
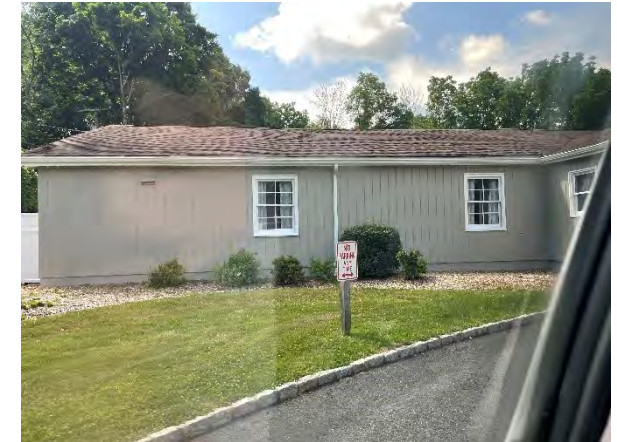
Parking spaces in the lot can be converted to porous pavement using trench drains to redirect, capture and infiltrate stormwater runoff from the pavement. A rain garden with a curb cut can be installed in the grass area near the entrance of the parking lot to capture, treat, and infiltrate stormwater runoff from the pavement. Two rain gardens can be installed near the building entrance to capture, treat, and infiltrate stormwater runoff from the roof via already disconnected downspouts that will require redirection. A preliminary soil assessment suggests that more soil testing would be required before determining the soil's suitability for green infrastructure.

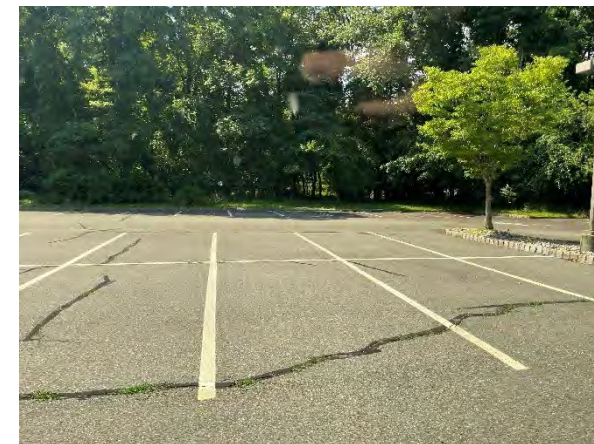
Parking spaces in the lot to the north and south of the building can be converted to porous pavement to capture and infiltrate stormwater runoff from the roof and asphalt; this requires downspout disconnection and trench drains for redirection. A rain garden requiring downspout disconnection can be installed in the grass area in the rear of the building to capture, treat, and infiltrate stormwater runoff from the roof. A preliminary soil assessment suggests that more soil testing would be required before determining the soil's suitability for green infrastructure.

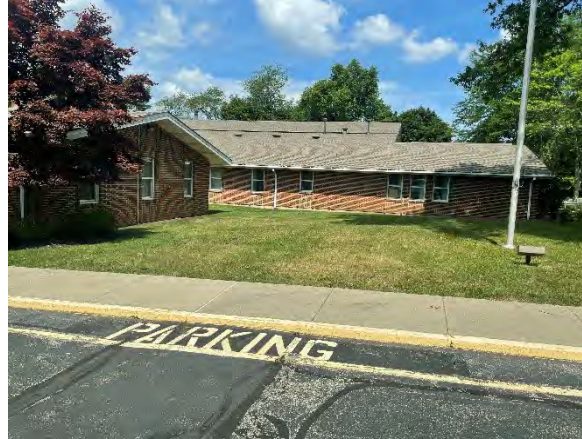
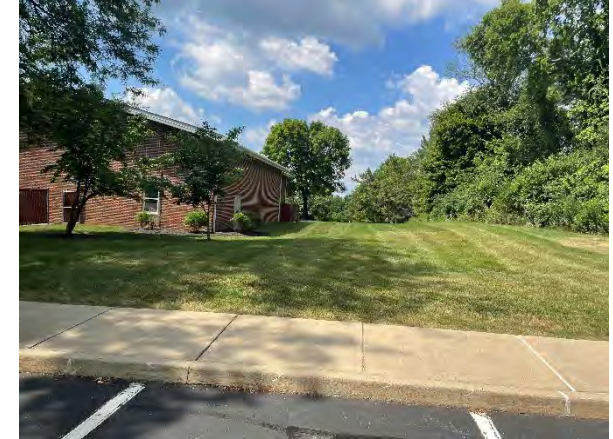
Several rain gardens that require downspout disconnection and redirection can be installed in the grass areas around the building to capture, treat, and infiltrate stormwater runoff from the roof. One rain garden that requires a curb cut and trench drain can be installed in the grass area southwest of the building to capture, treat, and infiltrate stormwater runoff from the pavement. A preliminary soil assessment suggests that the soils have suitable drainage characteristics for green infrastructure.

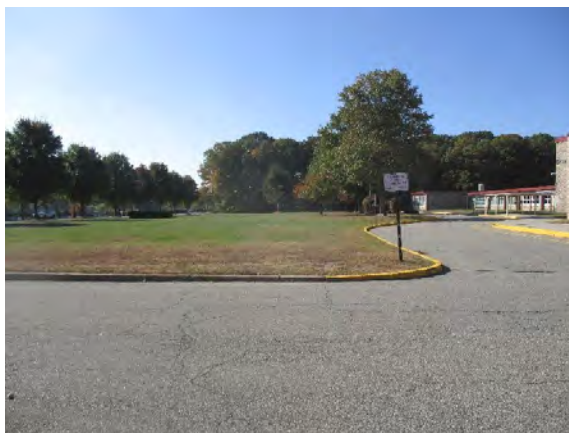
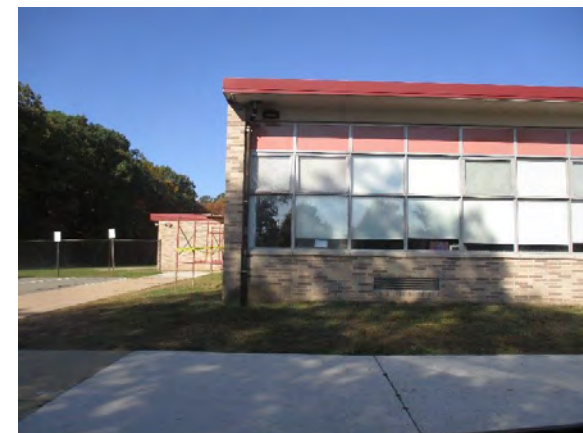
Three rain gardens can be installed to capture, treat, and infiltrate runoff from rooftops and paved areas. Parking spaces can be replaced with pervious pavement to capture and infiltrate stormwater runoff from the parking lot areas. A cistern can be installed to capture roof runoff from a maintenance shed. A preliminary soil assessment suggests that more soil testing would be required before determining the soil's suitability for green infrastructure.

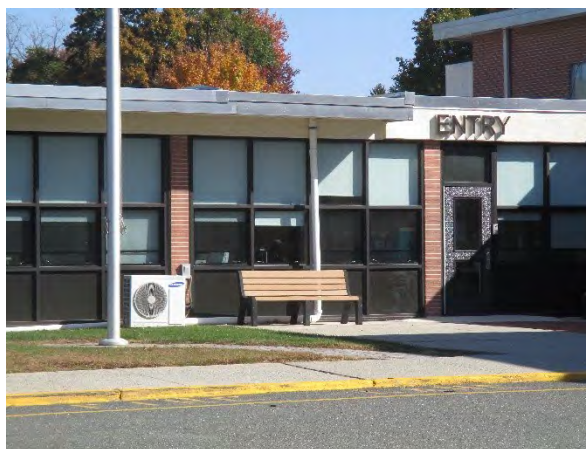
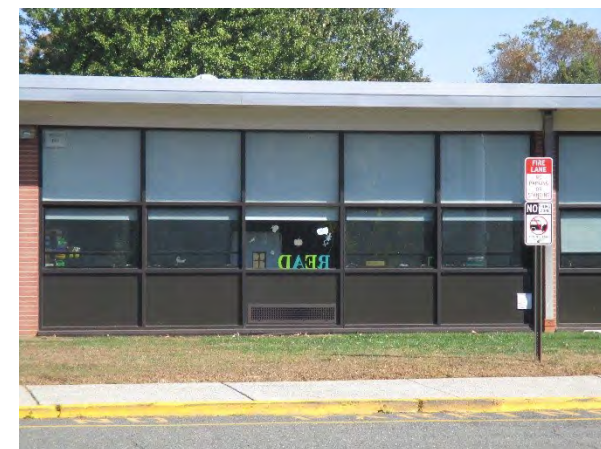
Rain gardens can be installed at the entrances of both buildings near downspouts to capture, treat, and infiltrate rooftop runoff. Another rain garden can be installed in the turfgrass area near a catch basin to capture water from the parking lot. A section of parking spaces can be converted to porous pavement to capture and infiltrate runoff from the parking lot. A preliminary soil assessment suggests that more soil testing would be required before determining the soil's suitability for green infrastructure.

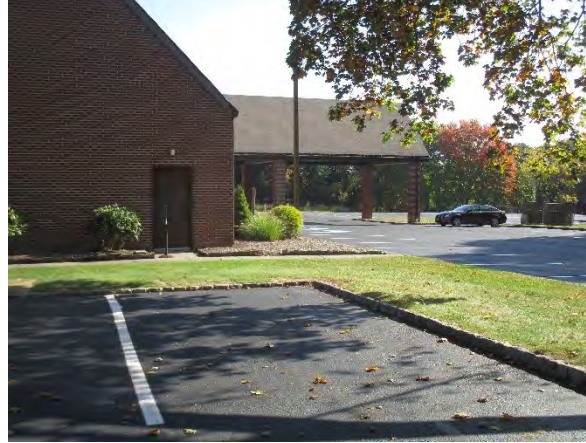
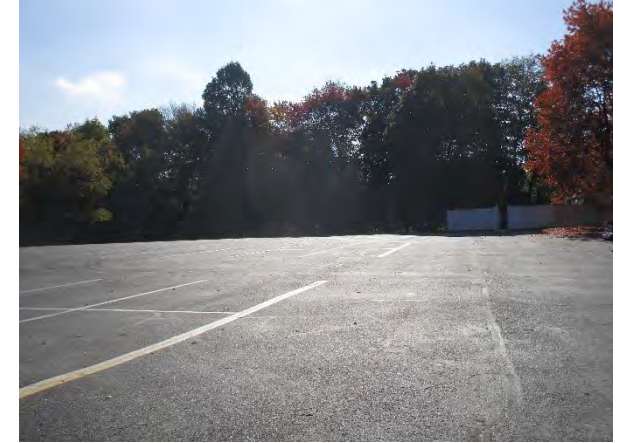
Rain gardens can be installed north and west of the building near downspouts to capture, treat, and infiltrate rooftop runoff. Another rain garden can be installed near the parking lot to capture runoff from the road. Parking spaces can be replaced with pervious pavement to capture and infiltrate stormwater runoff from the parking lot. A preliminary soil assessment suggests that more soil testing would be required before determining the soil's suitability for green infrastructure.

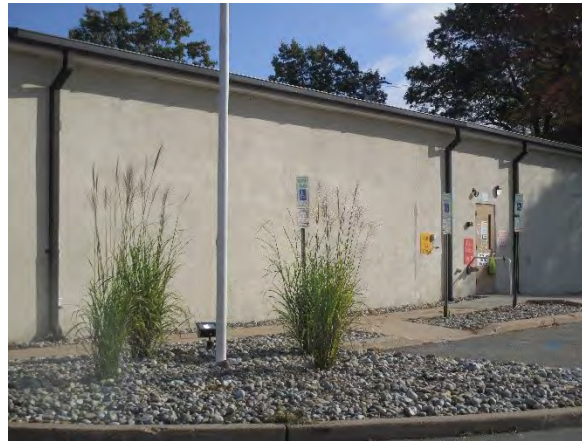
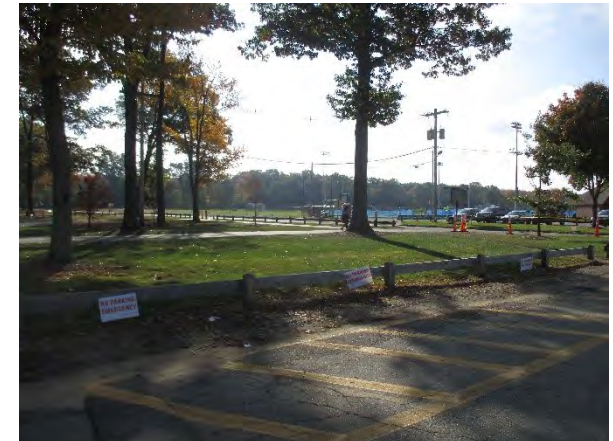
There are four downspouts along the north side of the building where downspout planter boxes can be installed. A rain garden can be installed at end of the parking lot that will capture stormwater from the parking lot. Another rain garden can be installed on the north side of the building near downspouts. Pervious pavement can be installed to capture and infiltrate runoff from the southern parking lot. A preliminary soil assessment suggests that more soil testing would be required before determining the soil's suitability for green infrastructure.

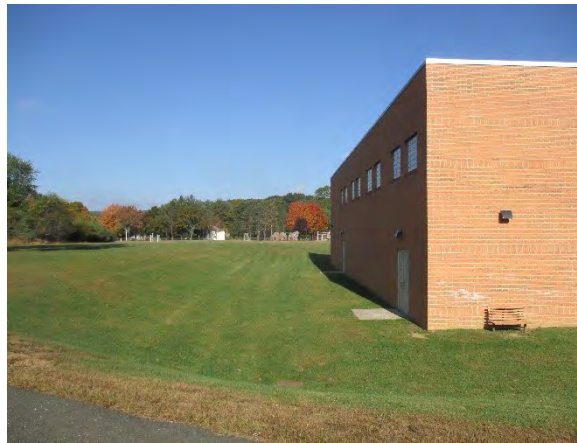
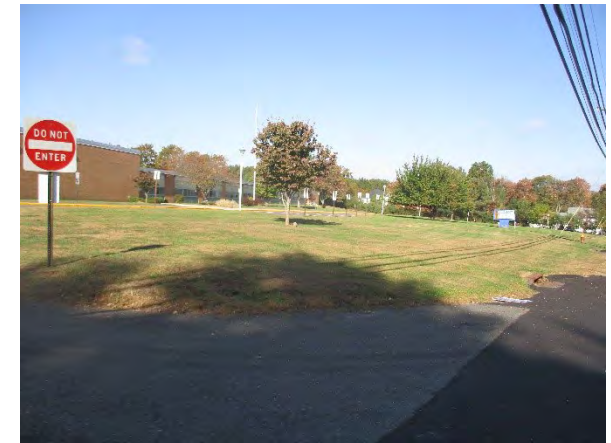
Two rains gardens can be installed in the turfgrass in front of the building to capture, treat, and infiltrate roadway runoff. Another rain garden can be installed south of the building to capture runoff from the basketball court. Pervious pavement can be installed in the parking lot to capture and infiltrate stormwater runoff from the parking lot. A preliminary soil assessment suggests that more soil testing would be required before determining the soil's suitability for green infrastructure.

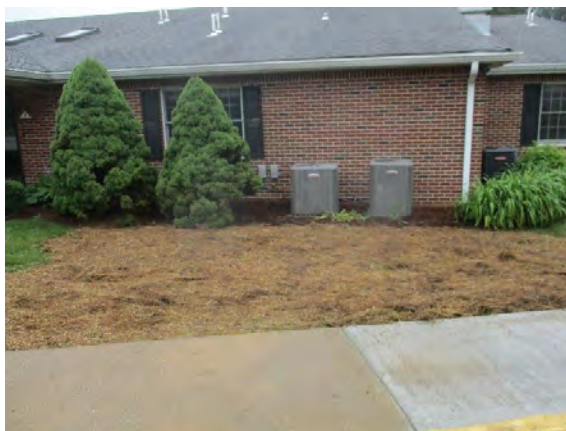
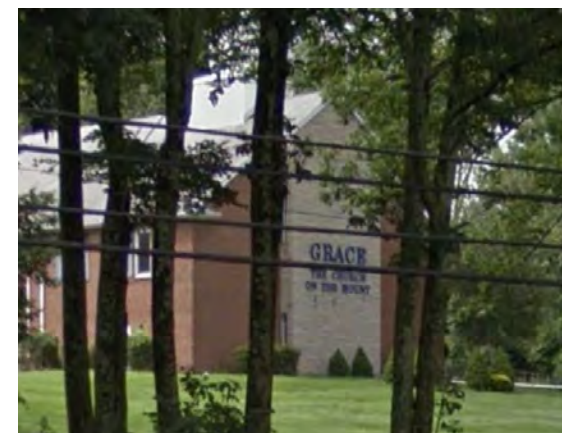
A rain garden can be installed near a connected downspout and a catch basin to capture, treat, and infiltrate rooftop runoff. Downspout planter boxes can be constructed along the building to allow roof runoff to be reused. A section of parking spaces can be converted to porous pavement to capture and infiltrate runoff from the parking lot. A preliminary soil assessment suggests that more soil testing would be required before determining the soil's suitability for green infrastructure.

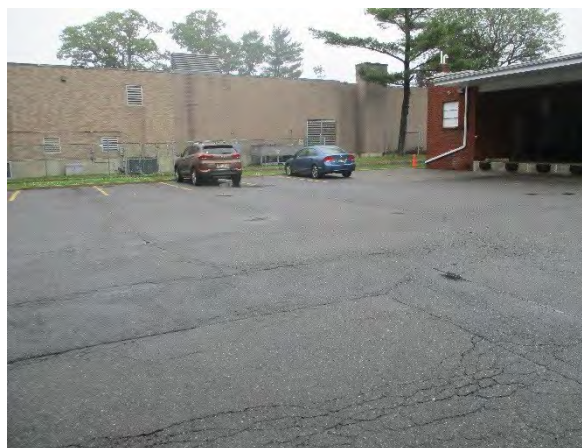
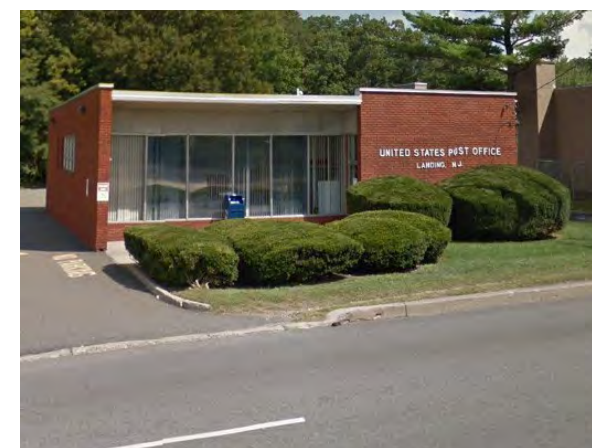
Pervious pavement can be installed near a downspout to capture and infiltrate stormwater runoff from the rooftop and parking lot. A preliminary soil assessment suggests that more soil testing would be required before determining the soil's suitability for green infrastructure.

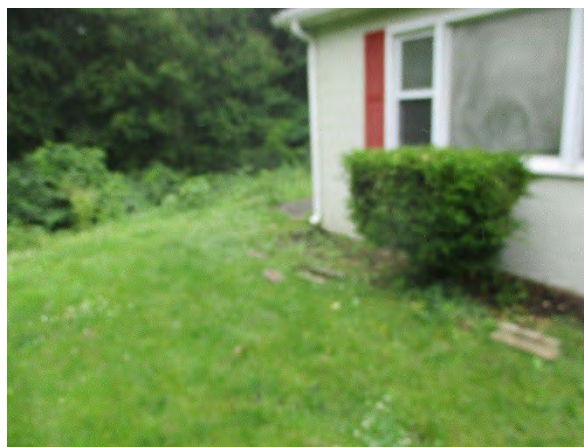
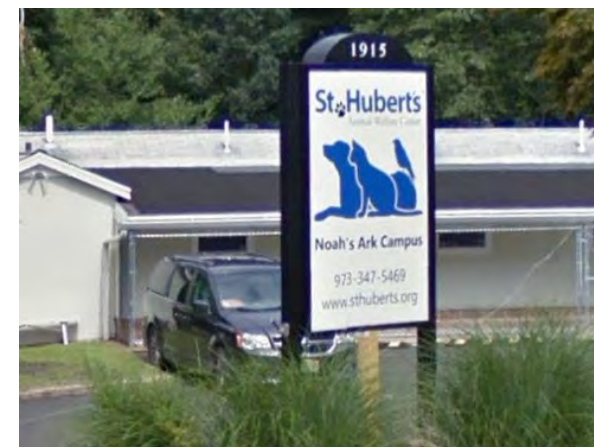
A rain garden can be installed south of the building near a disconnected downspout to capture, treat, and infiltrate rooftop runoff. A preliminary soil assessment suggests that more soil testing would be required before determining the soil's suitability for green infrastructure.

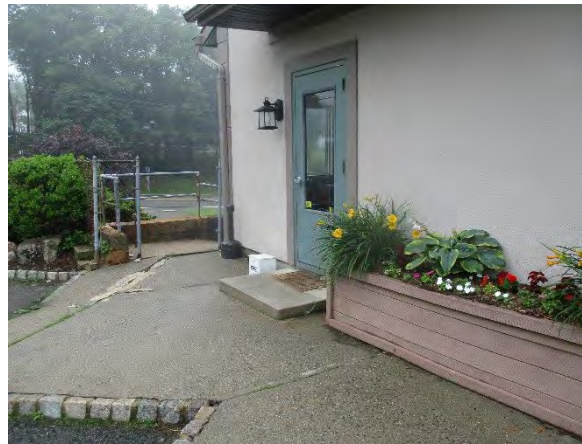
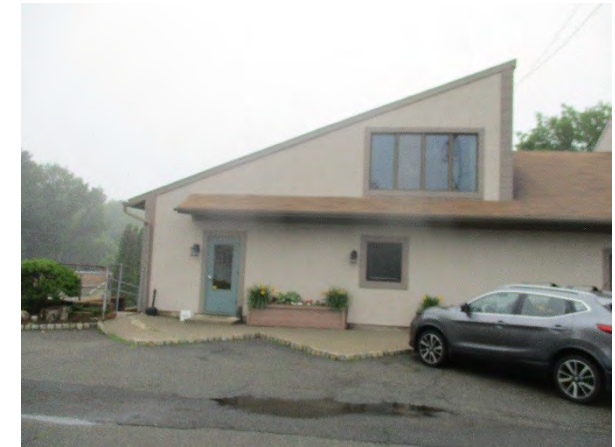
Connected downspouts can be rerouted into the existing planter boxes to be converted into downspout planter boxes. Downspout planter boxes can be constructed along the building to allow roof runoff to be reused. Porous pavement can be installed in the main parking spaces to capture and infiltrate stormwater runoff from the parking lot. A preliminary soil assessment suggests that more soil testing would be required before determining the soil's suitability for green infrastructure.

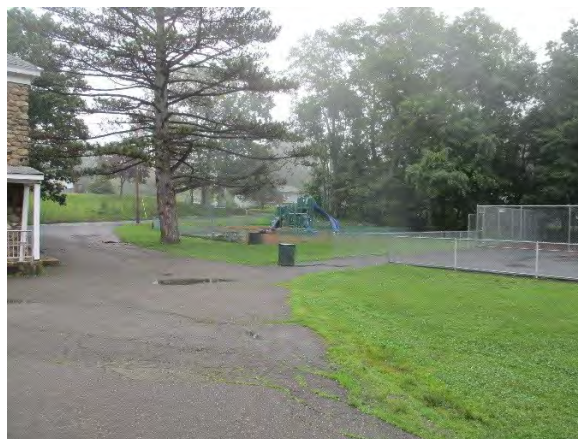
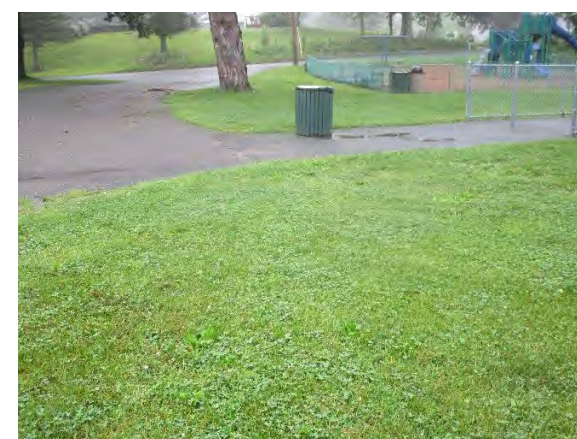
Two rain gardens can be installed on either side of the parking lot to capture, treat, and infiltrate stormwater runoff from the parking lot. A preliminary soil assessment suggests that more soil testing would be required before determining the soil's suitability for green infrastructure.

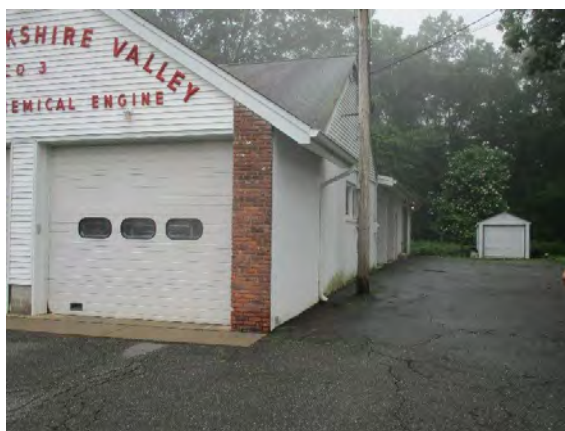
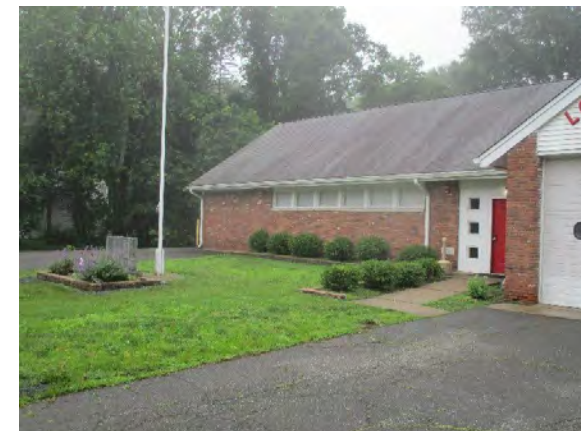
A rain garden can be installed near the entrance of the building to capture, treat, and infiltrate rooftop runoff. A cistern can be installed at the back of the building to capture roof runoff, which can be used for watering gardens, washing vehicles, or for other non-potable uses. Downspout planter boxes can be installed in front of the building to filter rooftop runoff and provide visual interest. A preliminary soil assessment suggests that more soil testing would be required before determining the soil's suitability for green infrastructure.

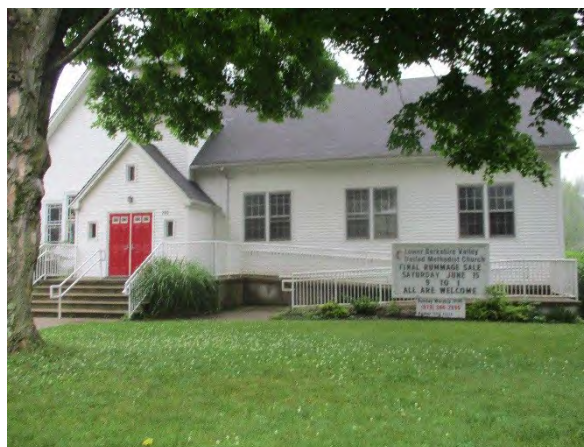
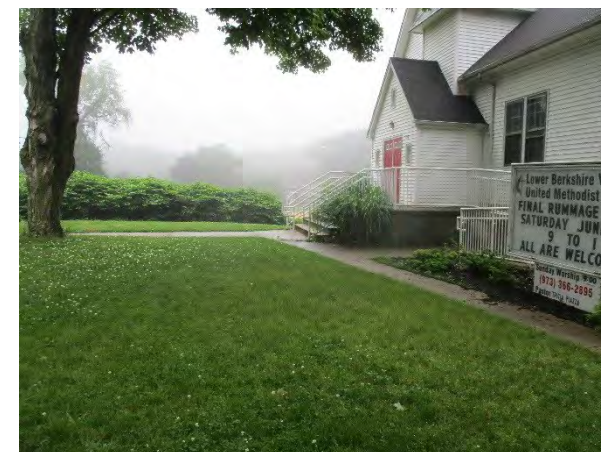
A connected downspout can be disconnected and led into a rain garden on the north side of the building near the entrance to capture, treat, and infiltrate rooftop runoff. A preliminary soil assessment suggests that more soil testing would be required before determining the soil's suitability for green infrastructure.

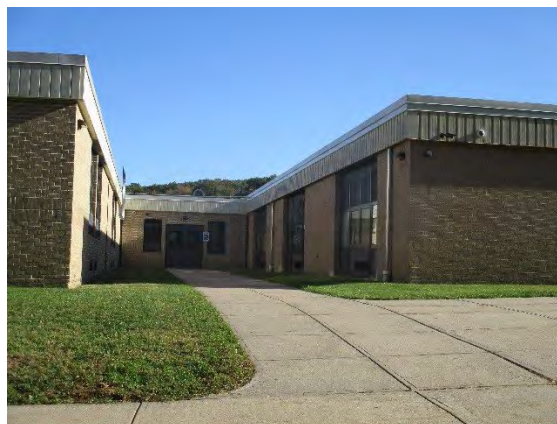
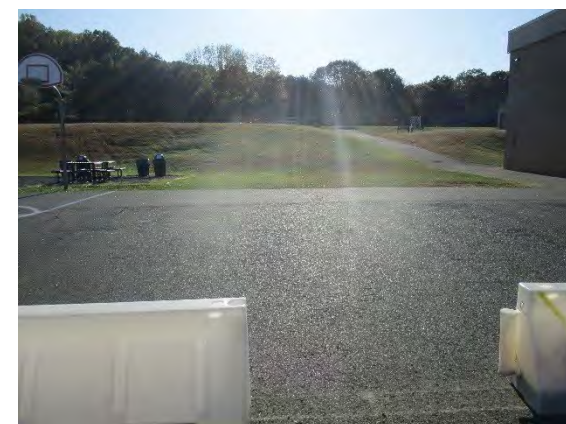
Two rain gardens can be installed adjacent to the entrance of the building and in the turfgrass south of the building to capture, treat, and infiltrate rooftop runoff. A section of parking spaces can be converted to pervious pavement to capture and infiltrate stormwater. A preliminary soil assessment suggests that more soil testing would be required before determining the soil's suitability for green infrastructure.

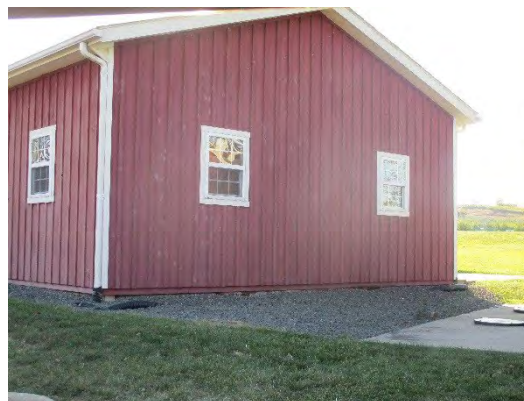
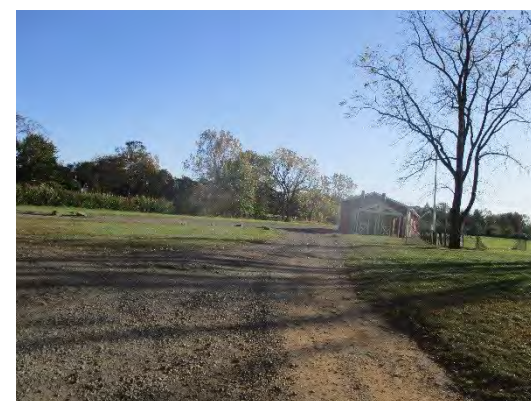
A cistern can be installed on the southern side of the building near a downspout to capture stormwater from the roof. The water can then be used for watering gardens, washing vehicles, or for other non-potable uses. Four downspout planter boxes can be constructed along the building to allow roof runoff to be reused. A preliminary soil assessment suggests that more soil testing would be required before determining the soil's suitability for green infrastructure.

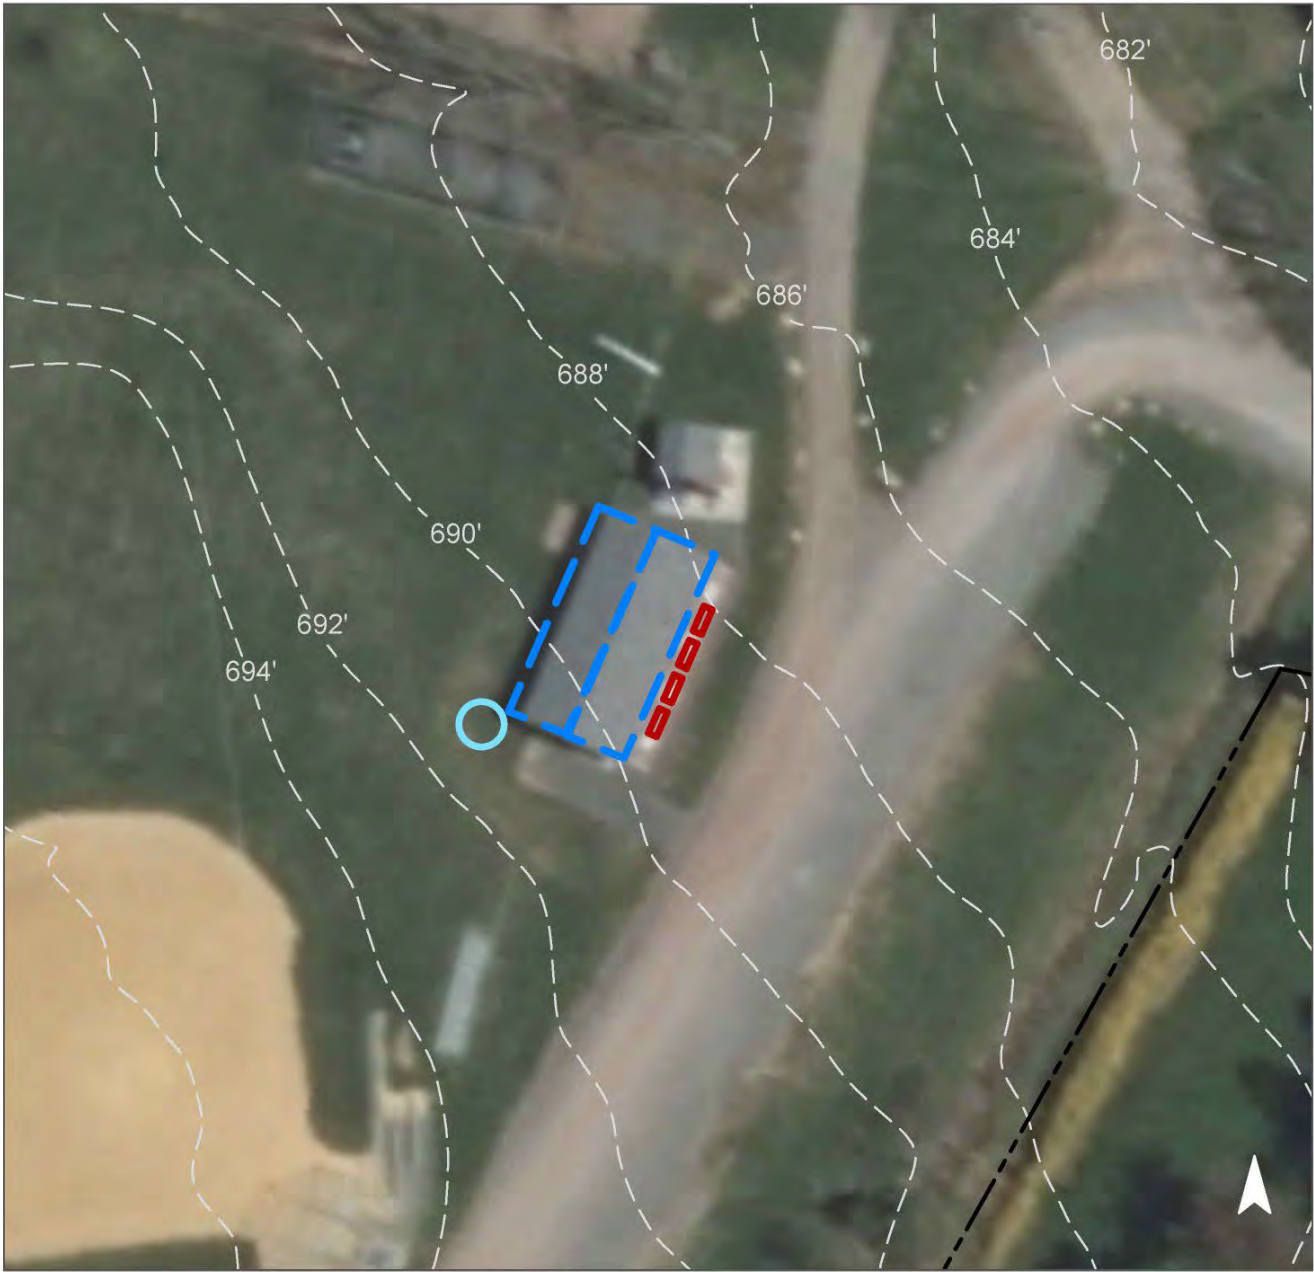
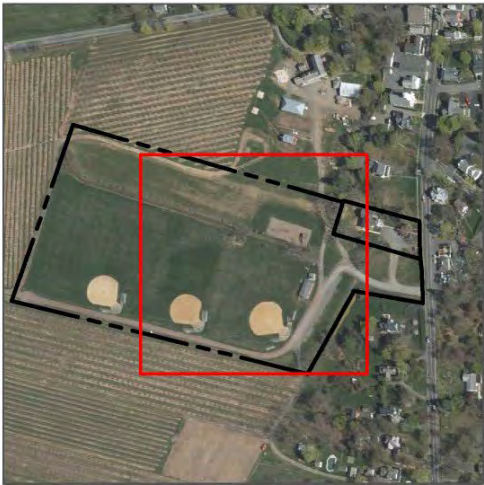
## Oldwick Park

- planter box
- rainwater harvesting
- drainage area
- property line
- 2015 Aerial: NJOIT, OGIS

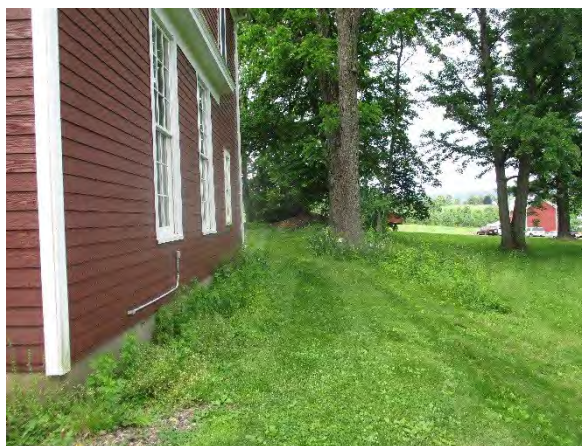
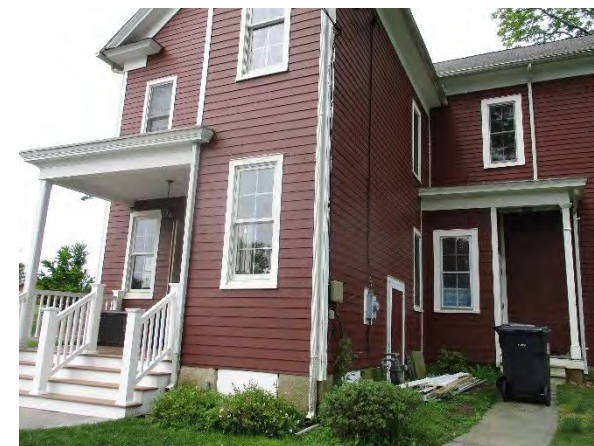
Two rain gardens can be used to capture, treat, and infiltrate rooftop runoff. A downspout planter box can be constructed along the building to allow roof runoff to be captured and reused. A preliminary soil assessment suggests that the soils have suitable drainage characteristics for green infrastructure.

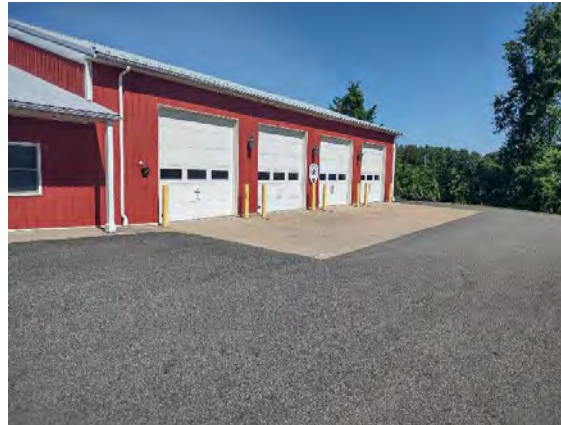
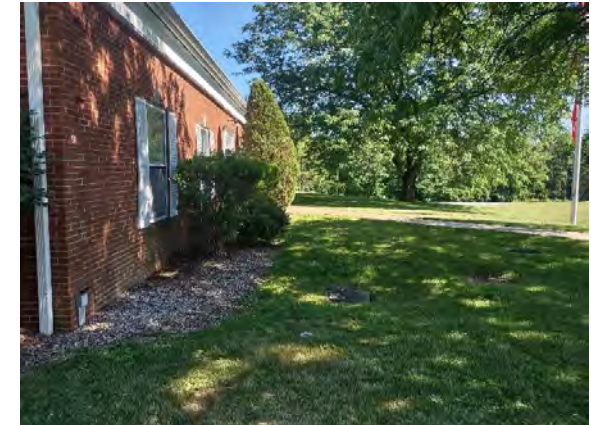
Rain gardens can be installed in multiple locations around the property to capture, treat, and infiltrate stormwater runoff from the rooftops. Most of these will require downspout disconnection and redirection. A rain garden can be installed to the northwest of the property to capture, treat, and infiltrate runoff from the asphalt. A trench drain will be needed. Cisterns can be installed near multiple buildings to divert and detain runoff from the rooftops via downspouts for non-potable future use, such as washing vehicles or watering the landscaping vegetation. The police vehicle parking lot and sections of existing parking spots can be converted into pervious pavement to capture and infiltrate stormwater runoff from the asphalt and the rooftops. This will require downspout disconnections. A preliminary soil assessment suggests that more soil testing would be required before determining the soil's suitability for green infrastructure.

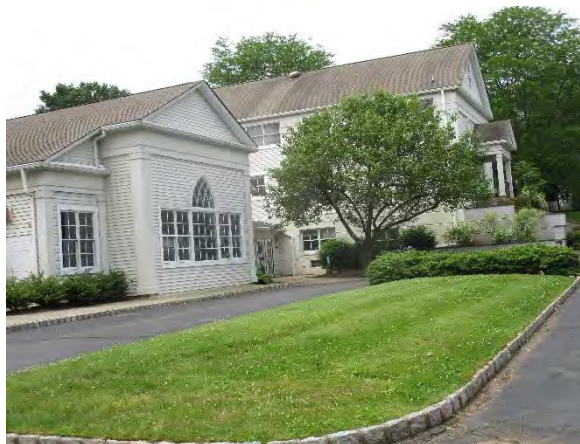
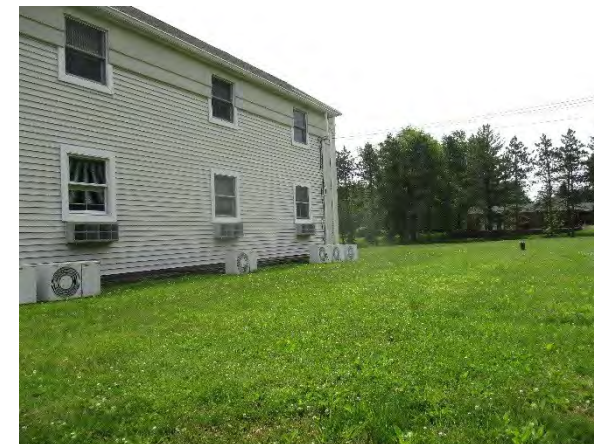
Two rain gardens can be installed in the turfgrass areas adjacent to the building to capture, treat, and infiltrate stormwater runoff from the roof. Another rain garden can be installed in a parking lot island to capture, treat, and infiltrate stormwater runoff from the parking lot. A preliminary soil assessment suggests that more soil testing would be required before determining the soil's suitability for green infrastructure.

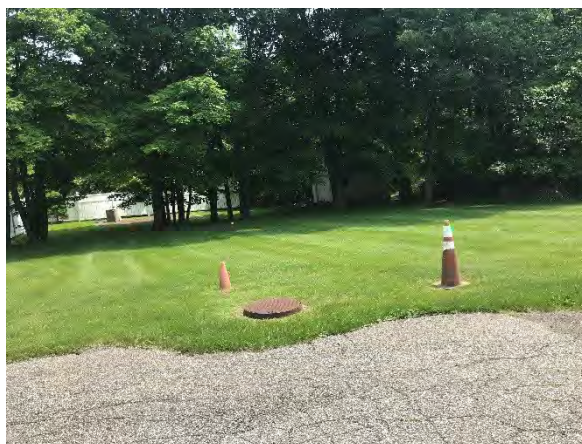
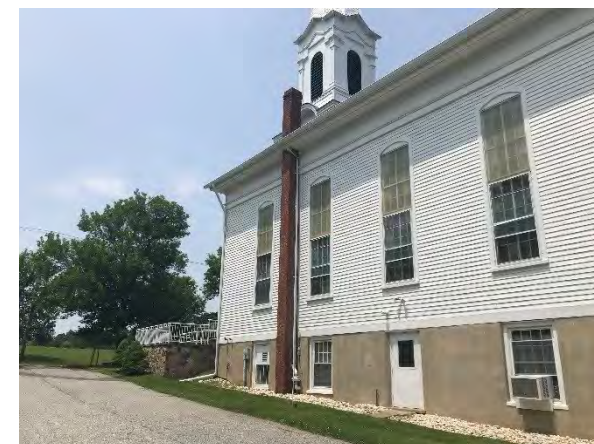
Rain gardens can be installed on the north side of the building and on the turfgrass area east of the parking lot to capture, treat, and infiltrate stormwater runoff from the roof. A preliminary soil assessment suggests that more soil testing would be required before determining the soil's suitability for green infrastructure.

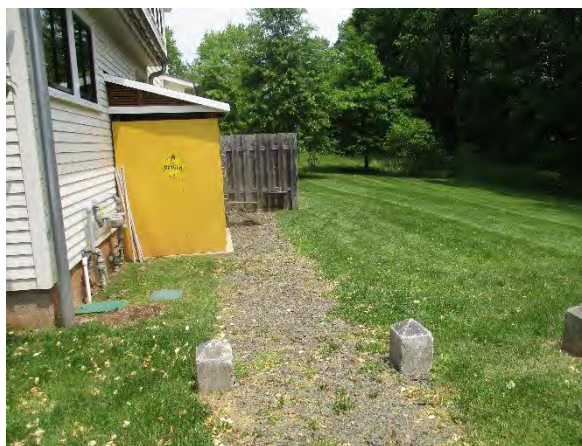
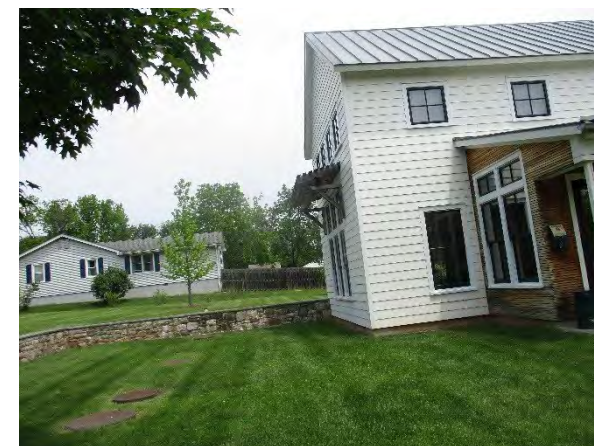
A rain garden can be installed in the turfgrass area to capture, treat, and infiltrate stormwater runoff from the roof. Downspout planter boxes can be constructed along the building to allow roof runoff to be captured and reused. A preliminary soil assessment suggests that more soil testing would be required before determining the soil's suitability for green infrastructure.
