## Bedminster Township

### Introduction

The purpose of this report is to provide a comprehensive understanding of key, defining features within the subwatersheds throughout Bedminster Township. This involves gathering, organizing, and presenting information about existing conditions and infrastructure within each subwatershed. It aims to serve as a tool for informed decision-making, planning, and implementation of sustainable watershed management strategies aimed to protect and enhance the health of the watershed, its associated ecosystems, and the surrounding communities.

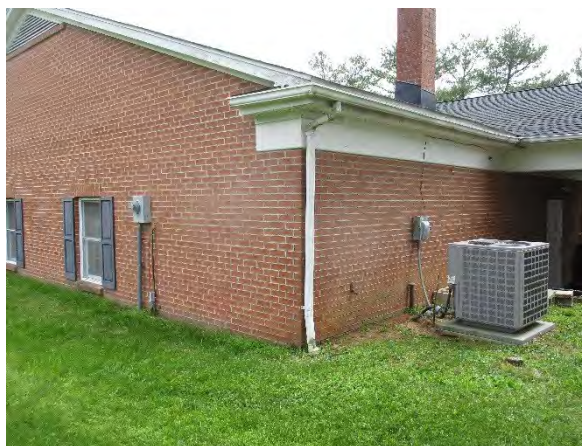
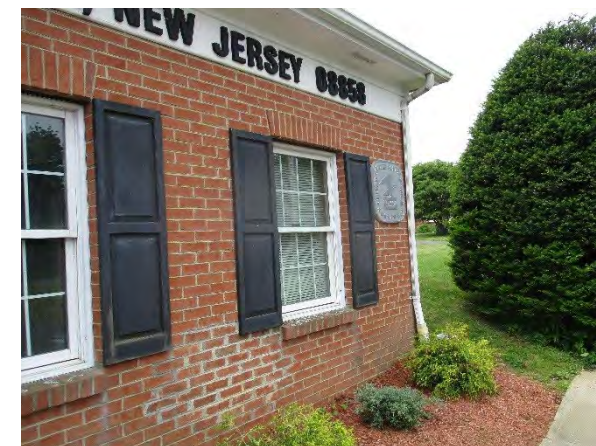
A rain garden can be installed on the west side of the building to capture, treat, and infiltrate stormwater runoff from the roof. A preliminary soil assessment suggests that more soil testing would be required before determining the soil's suitability for green infrastructure.

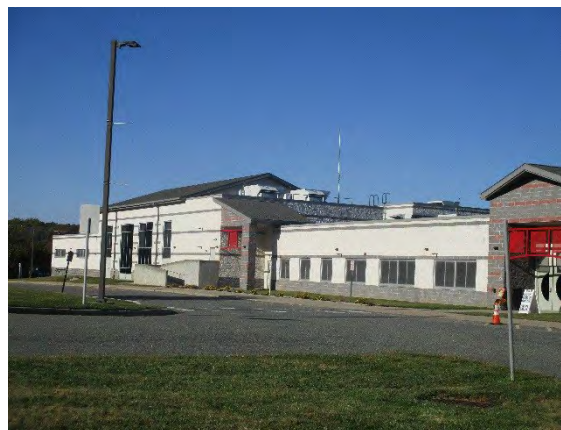
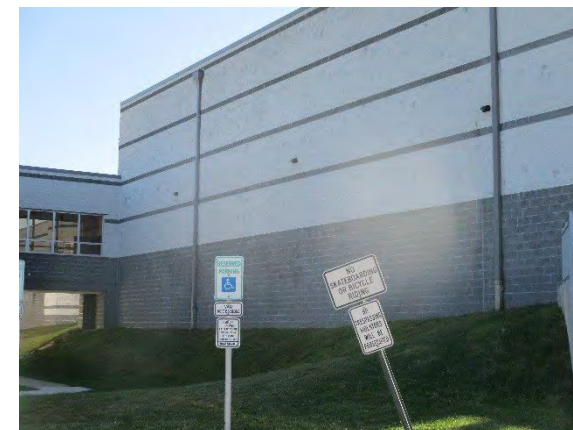
A rain garden can be installed in the turfgrass area on the west side of the building and on the turfgrass area in the parking lot to capture, treat, and infiltrate stormwater runoff from the roof. Parking spaces north of the building can be replaced with pervious pavement to capture and infiltrate stormwater runoff from the parking lot. A preliminary soil assessment suggests that more soil testing would be required before determining the soil's suitability for green infrastructure.

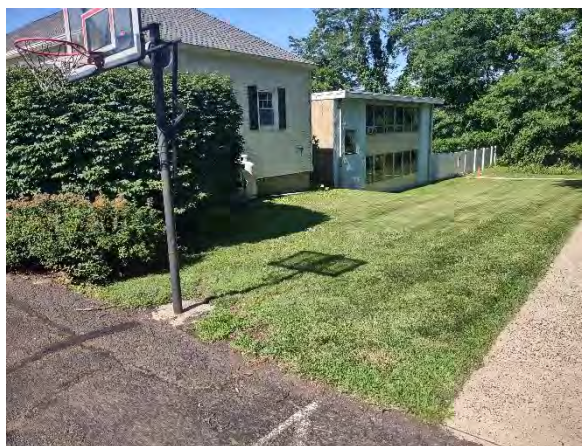
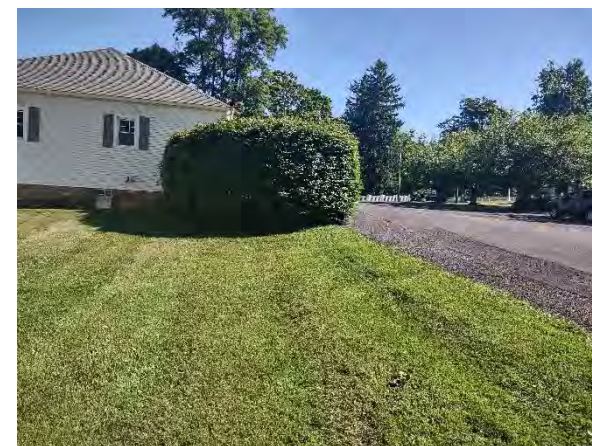
Rain gardens can be installed in multiple grass areas around the building to capture, treat, and infiltrate stormwater runoff from the rooftop. Downspout disconnection and redirection will be required. The existing parking spaces in the west of the lot can be converted to pervious pavement to capture and infiltrate runoff from the asphalt. A preliminary soil assessment suggests that the soils have suitable drainage characteristics for green infrastructure.

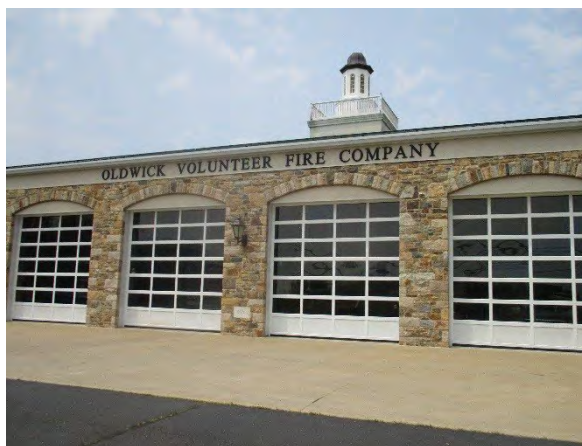
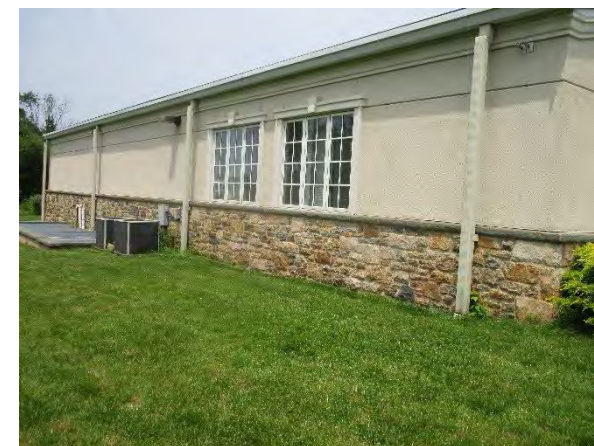
A rain garden can be installed on the south side of the building to capture, treat, and infiltrate stormwater runoff from the roof. Two cisterns can be installed on the north side of the building to capture stormwater from the roof. The water can then be used for watering gardens, washing vehicles, or for other non-potable uses. A preliminary soil assessment suggests that more soil testing would be required before determining the soil's suitability for green infrastructure.

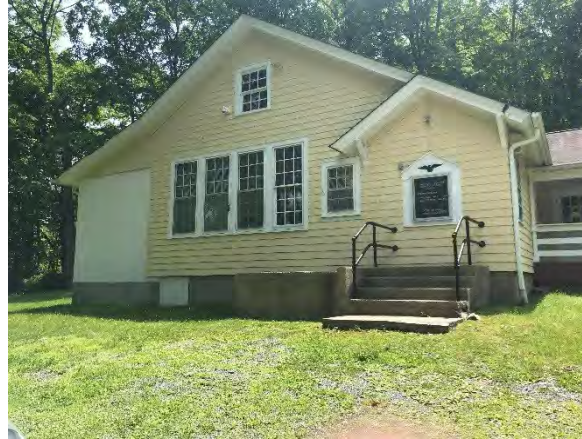
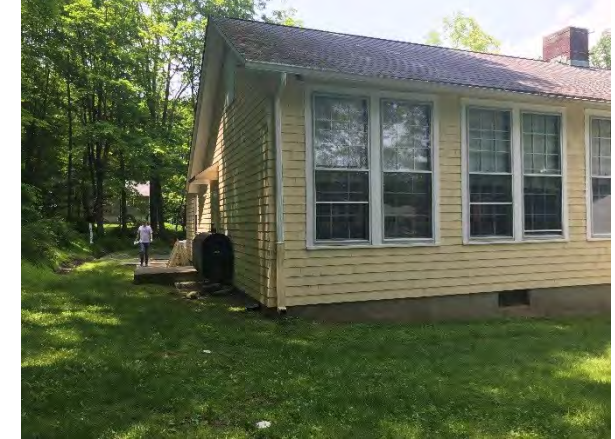
A rain garden can be installed in the turfgrass area on the east side of the building to capture, treat, and infiltrate stormwater runoff from the roof. Downspout planter boxes can be installed to allow roof runoff to be captured and reused. A preliminary soil assessment suggests that the soils have suitable drainage characteristics for green infrastructure.

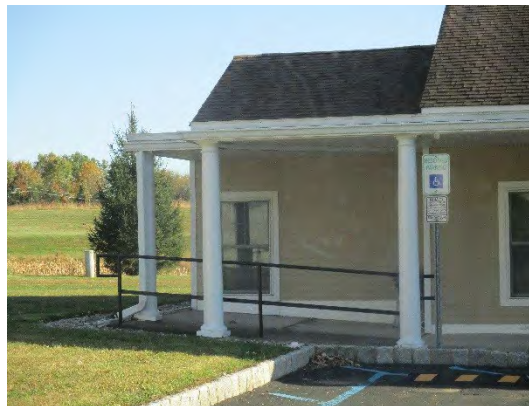
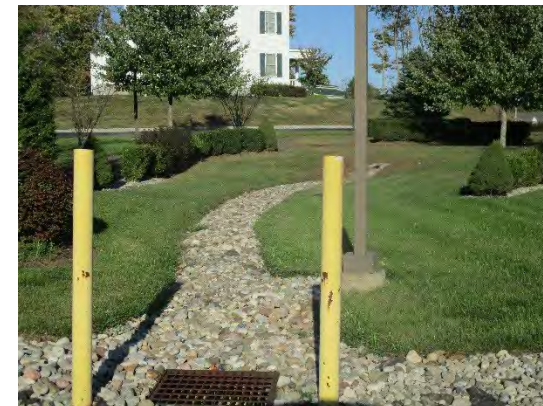
**Block and Lot:** Block 44, Lot 22

Multiple rain gardens can be installed in the turfgrass area adjacent to the buildings and in the center parking lot island to capture, treat, and infiltrate stormwater runoff from the roof. A preliminary soil assessment suggests that more soil testing would be required before determining the soil's suitability for green infrastructure.

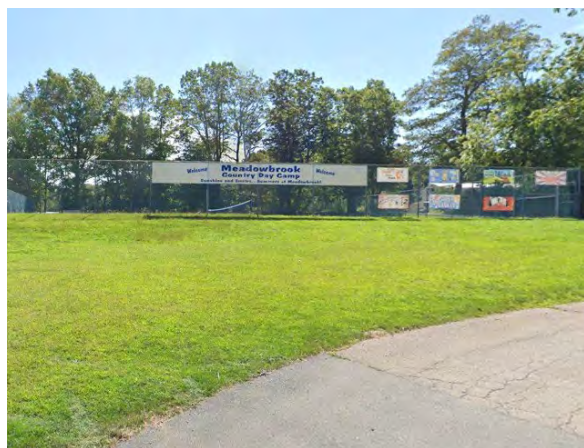
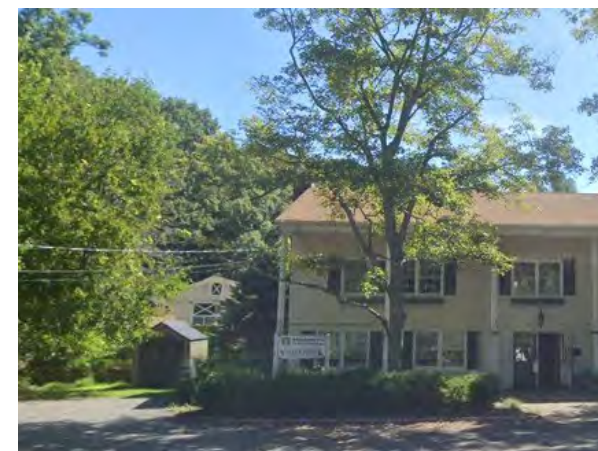
**Block and Lot:** Block 37, Lot 25

Rain gardens can be installed adjacent to buildings and impervious surfaces like the tennis courts to capture stormwater runoff. A preliminary soil assessment suggests that more soil testing would be required before determining the soil's suitability for green infrastructure.

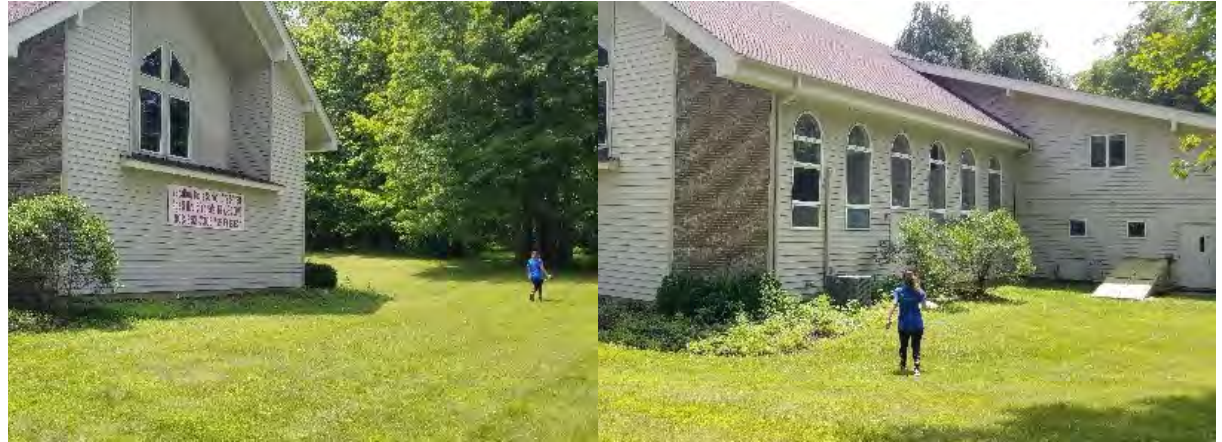
**Block and Lot:** Block 31 Lot 26

A rain garden and downspout planter boxes can be installed adjacent to the main building to capture, treat, and infiltrate stormwater runoff from the roof. Pervious pavement is proposed to treat runoff in the southeast parking lot. Planter boxes can also be installed to treat the rooftop drainage area. A preliminary soil assessment suggests that more soil testing would be required before determining the soil's suitability for green infrastructure.

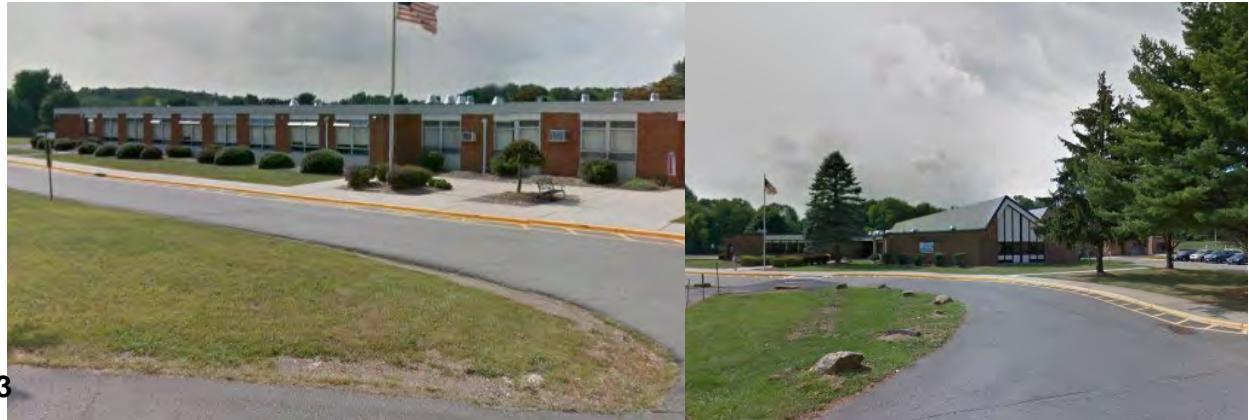
**Address:** 90 Flocktown Road  
Long Valley, NJ 07853

Rain gardens may be installed off the north, east, and west corners and the southeast facade of Flocktown Road Elementary (southern building in the depicted aerial). Rain gardens may also be installed off the north and south facades of Kossmann Elementary School (northern building in the provided aerial). These would capture, treat, and infiltrate stormwater runoff from the rooftops utilizing existing downspouts, most of which would require disconnection. The rain garden off the south facade of Kossmann Elementary School requires a downspout redirection as well. Portions of pavement in the parking lots along the east side of both buildings, and the basketball court in the west can be converted to pervious pavement. These sections of pervious pavement can capture and infiltrate stormwater runoff before reaching nearby catch basins or flooding the adjacent grassy areas. A preliminary soil assessment suggests that the soils have suitable drainage characteristics for green infrastructure.

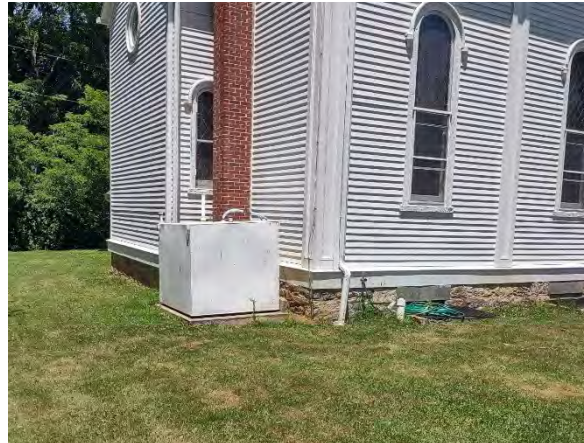
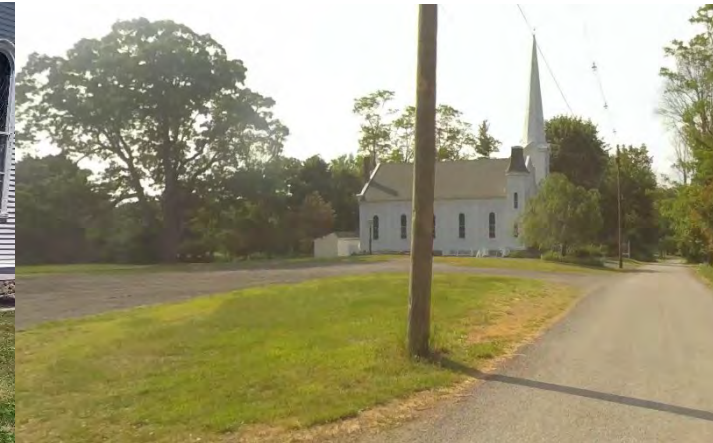
**Address:** 3 Heath Lane  
Long Valley, NJ 07853

Rain gardens may be installed off the east face, northwest and southwest corners of the church, utilizing downspouts which require disconnection, as well as the north corner and east edge of the parking lot. These would capture, treat, and infiltrate stormwater runoff from the rooftops and pavement. All four exits from the parking lot to the road would require a trench drain to redirect and convey stormwater runoff to the surrounding rain gardens. A preliminary soil assessment suggests that the soils have suitable drainage characteristics for green infrastructure.

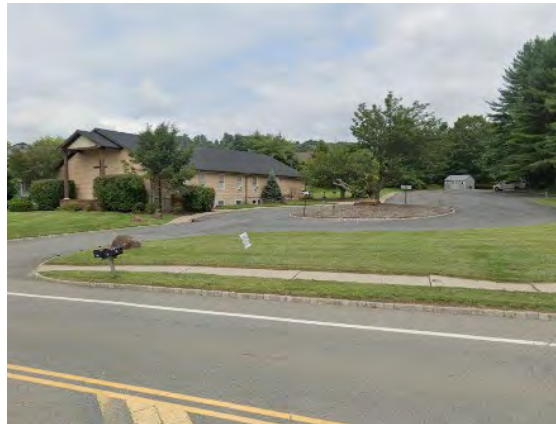
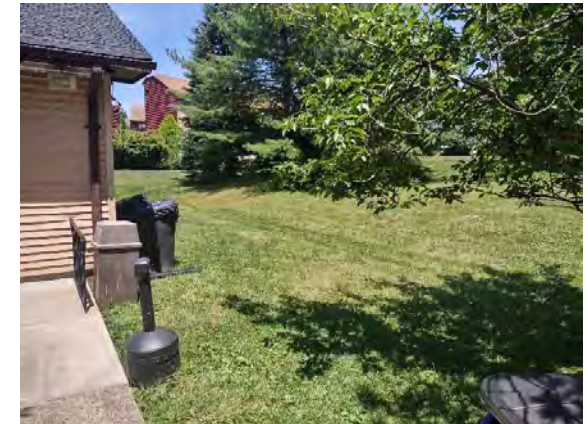
**Address:** 450 Schooleys Mountain Road  
Hackettstown, NJ 07840

Rain gardens can be installed off the northeast, southeast, and southwest corners, the north and south facades of the building to capture, treat, and infiltrate stormwater runoff from the roof. Existing downspouts convey water to the rain gardens; the downspouts on the southwest corner and south facade require disconnection. In the parking lot, a rain garden can also be installed off the west side of the roundabout to capture, treat, and infiltrate runoff. A row of parking stalls on the north edge of the parking lot can be converted to pervious pavement to capture and infiltrate stormwater before it reaches the adjacent catch. Despite what the contour data suggests, the grading of the pavement pitches to the northwest to two catch basins. Additionally, a curb cut on the west side of the roundabout and a trench drain before the exit to the street would be required to allow stormwater runoff to flow into the rain garden. A preliminary soil assessment suggests that more soil testing would be required before determining the soil's suitability for green infrastructure.

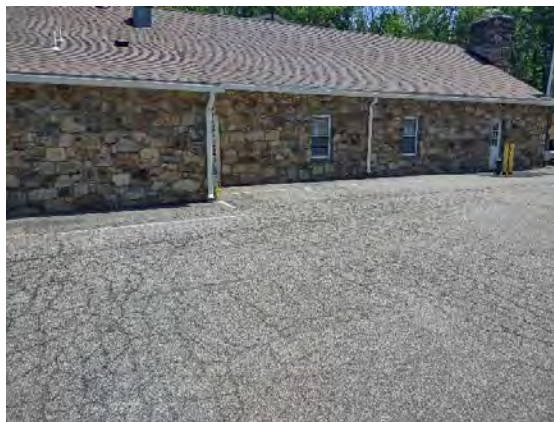
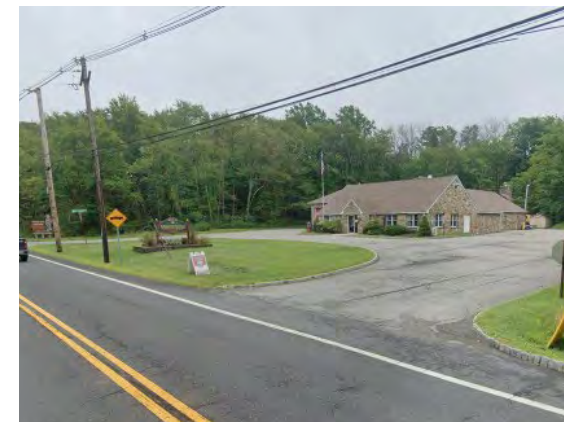
**Block and Lot:** Block 31, Lot 27

Runoff from different sections of the parking lot can be treated by a rain garden and also a section of porous parking spaces. A cistern can be installed adjacent to the building to capture runoff from the roof. The water can then be reused for washing vehicles or watering the lawn. Additionally, downspout planters can be installed to treat the northeast rooftop drainage area. Preliminary soil assessment suggests that more soil testing would be required before determining the soil's suitability for green infrastructure.

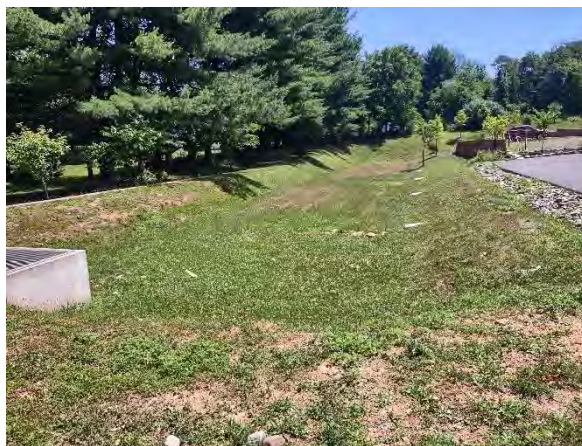
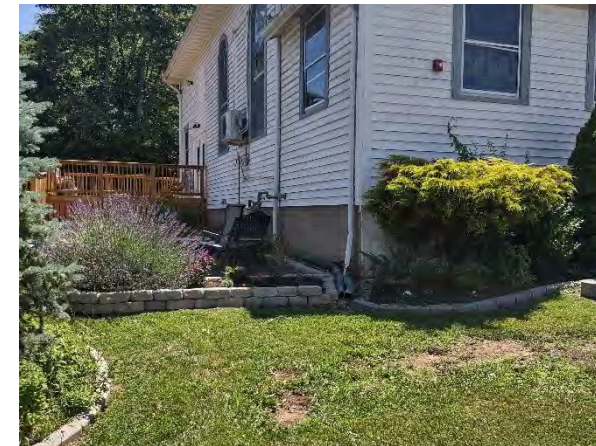
**Address:** 132 Califon Road  
Long Valley, NJ 07853

Rain gardens can be installed on the northwest corners of the parking lot to capture stormwater runoff from the pavement and rooftop of the church (which has no downspouts). and treat and infiltrate the stormwater. This requires curb cuts off the northwest corner of the building, and the north edge of the small row of parking stalls close to the road. An existing retention basin north of the parking lot can be transformed into a rain garden to capture, treat, and infiltrate runoff from the parking lot and church. Rain gardens can also be placed by disconnected downspouts off the northwest and southwest corners of the small building in the southwest corner of the property to capture, treat, and infiltrate stormwater runoff. A preliminary soil assessment suggests that the soils have suitable drainage characteristics for green infrastructure.

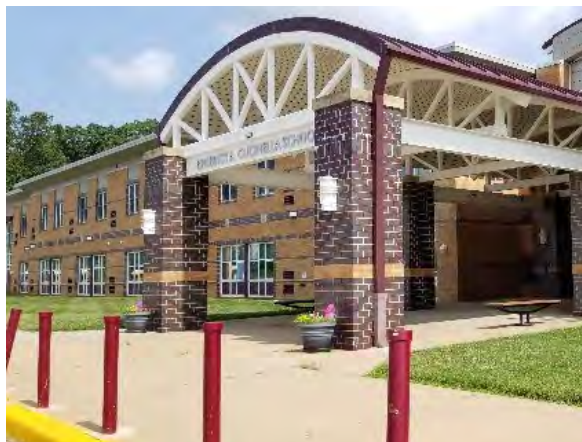
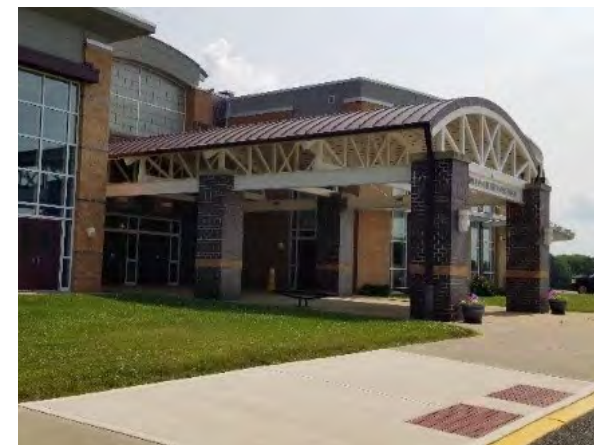
**Block and Lot:** Block 12, Lot 37

Downspout planter boxes are suggested at the entrance of the school to promote green infrastructure awareness. A section of parking spaces can be converted to pervious pavement to capture and infiltrate runoff from the parking lot. Tree filter boxes can be installed in islands in the parking lot to capture runoff from other spaces in the parking lot. A preliminary soil assessment suggests that more soil testing would be required before determining the soil's suitability for green infrastructure.

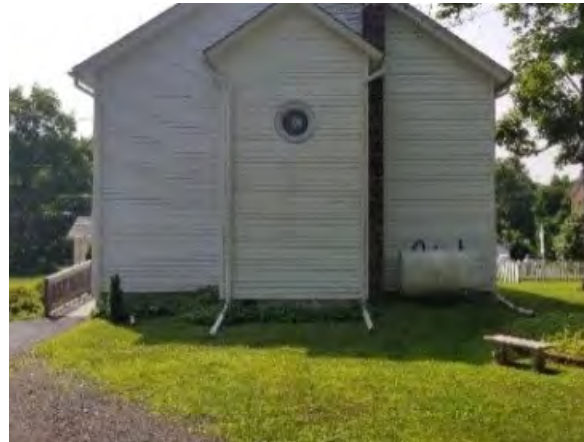
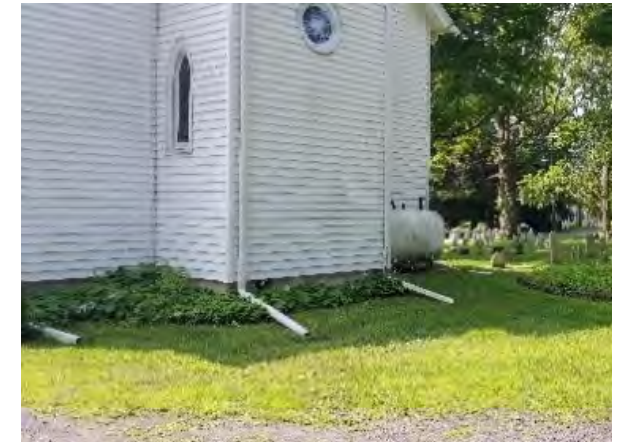
**Block and Lot:** Block 10, Lot 11

Downspout planter boxes can be installed to capture and retain runoff from the rooftop. Pervious pavement is proposed along the south edge of the parking lot to treat the entire parking lot's drainage area. A preliminary soil assessment suggests that more soil testing would be required before determining the soil's suitability for green infrastructure.

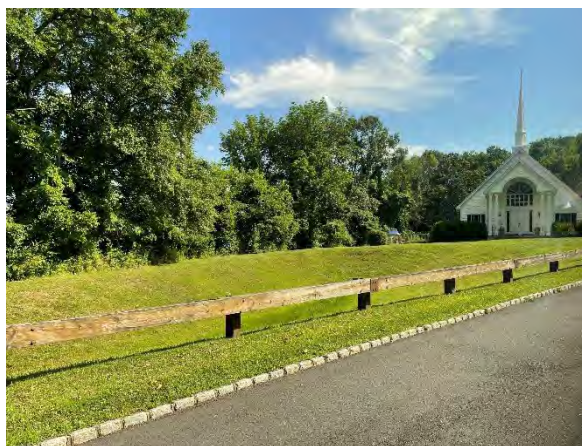
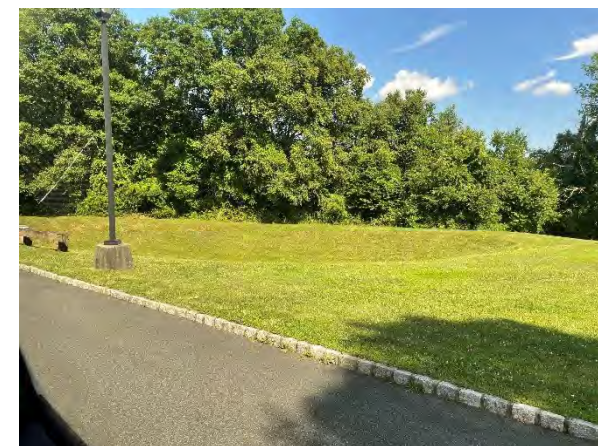
**Address:** 40 Coleman Road  
Long Valley, NJ 07853

In the southwest corner of the property, there is an existing retention basin to which water is conveyed from the rooftop and pavement via connected downspouts and catch basins. This can be converted into a rain garden to capture, treat, and infiltrate stormwater runoff. A trench drain can be installed half-way up the driveway coming from the southwest to increase runoff capture and convey it to the rain garden. Two rain gardens can also be installed off the northwest facade of the house in the southeast section of the property. A preliminary soil assessment suggests that more soil testing would be required before determining the soil's suitability for green infrastructure.

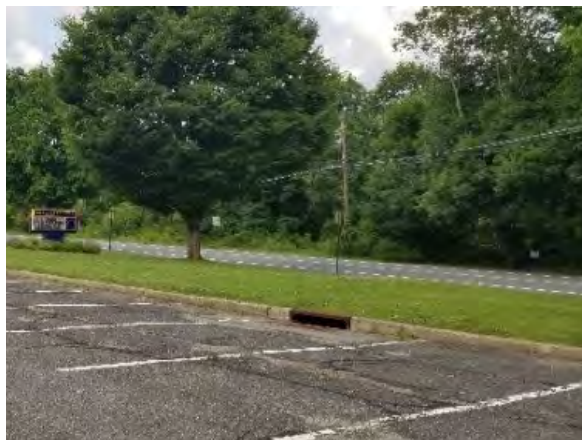
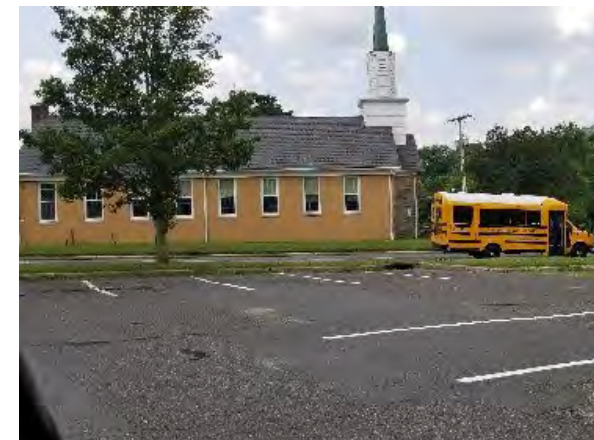
**Block and Lot:** Block 34 Lot 49

Pervious pavement is proposed in a section of parking spaces to capture and infiltrate runoff from the parking lot. A bioretention system is proposed in the north turfgrass area to capture runoff from the roof of the school. A preliminary soil assessment suggests that more soil testing would be required before determining the soil's suitability for green infrastructure.

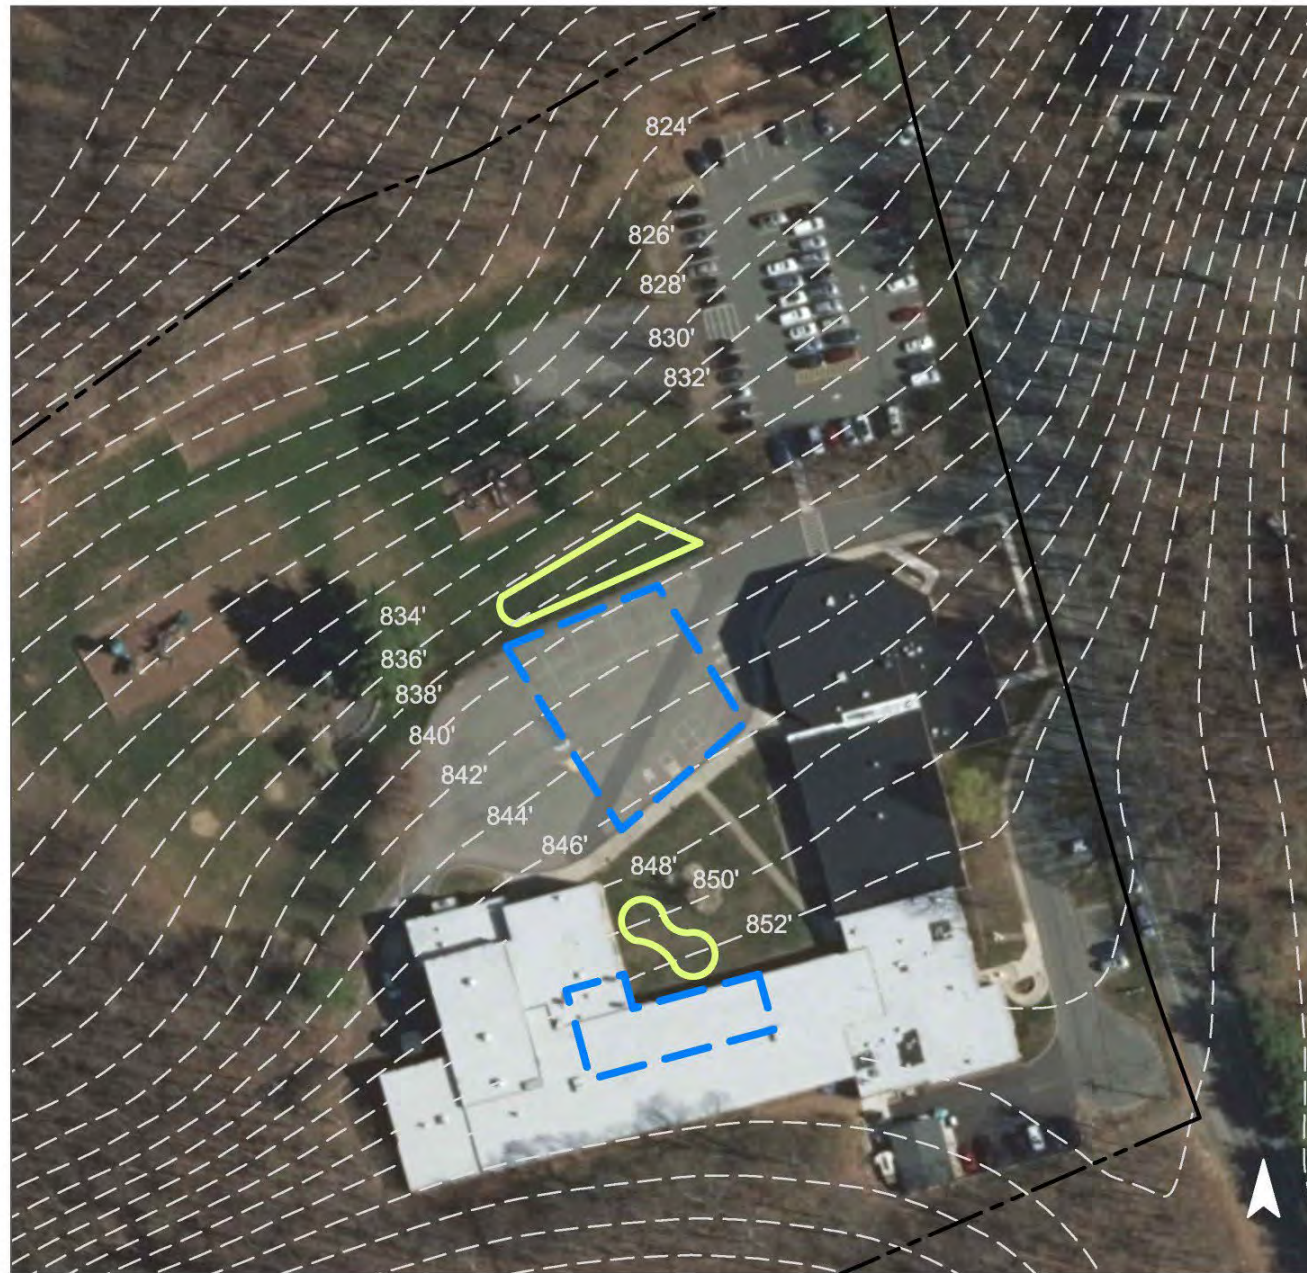
## OLD FARMERS ROAD ELEMENTARY SCHOOL

Two rain gardens can be installed to capture, treat, and infiltrate stormwater runoff from the building's roof as well as the adjacent parking lot. A preliminary soil assessment suggests that the soils have suitable drainage characteristics for green infrastructure.

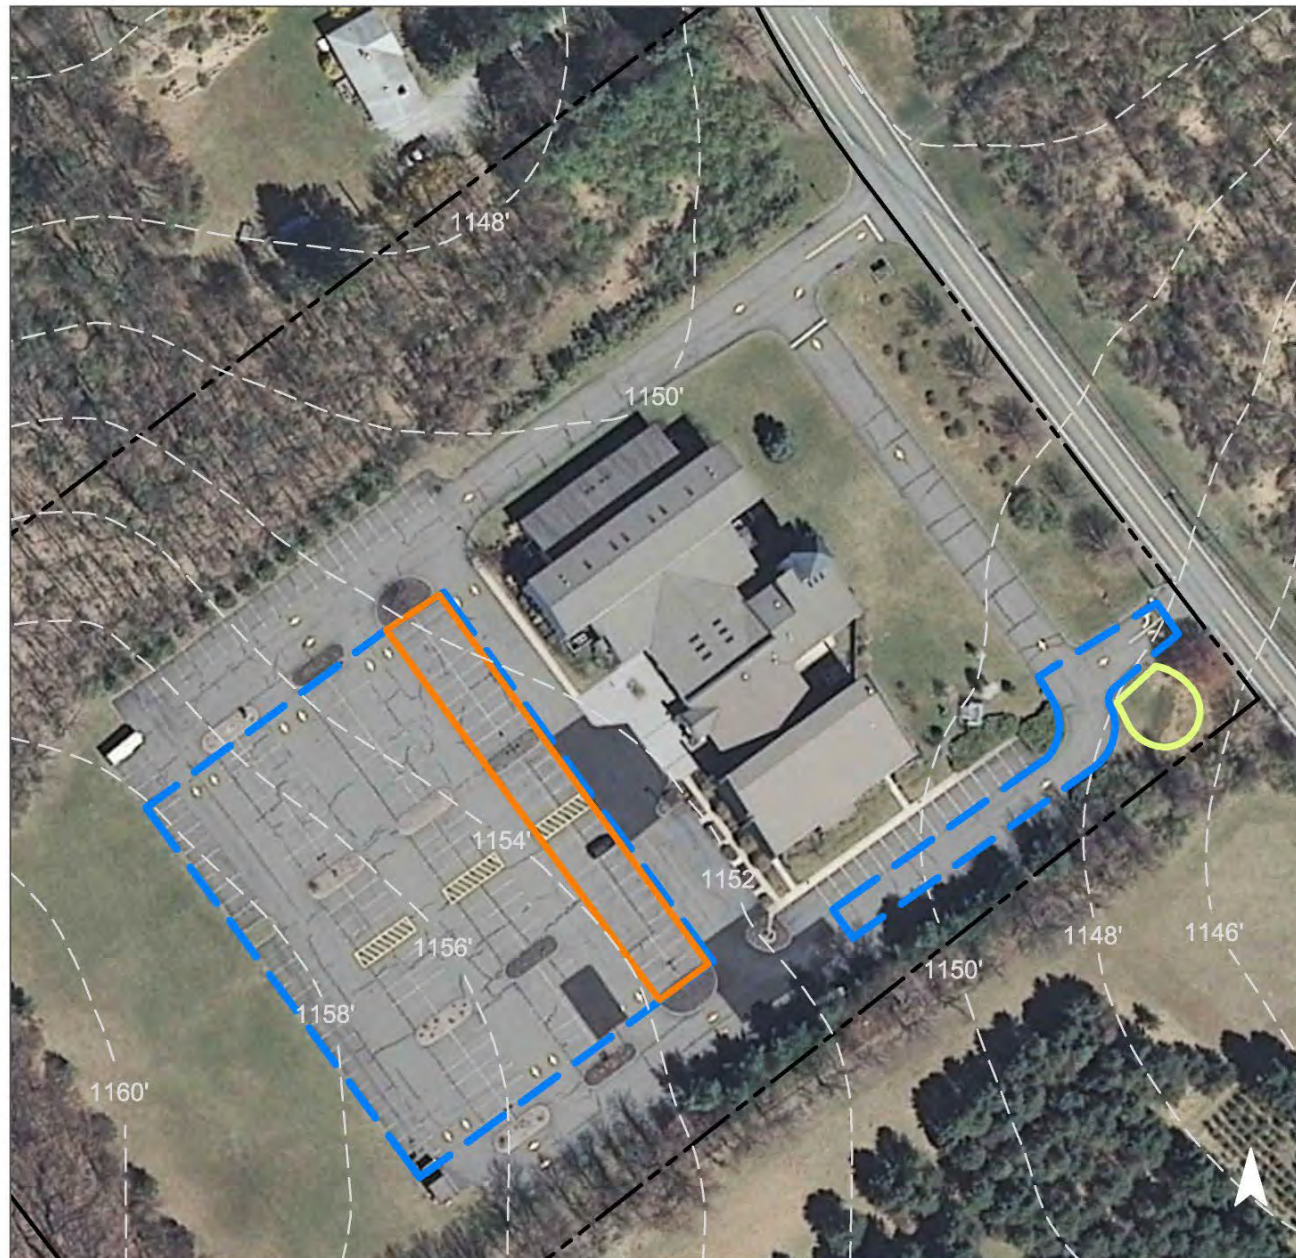
## St. Mark the Evangelist Roman Catholic Church

A bioretention system can be installed in the southeast corner of the property to mitigate flooding. Additionally, pervious pavement is suggested adjacent to the southwest edge of the building to capture and infiltrate stormwater runoff from the parking lot. A preliminary soil assessment suggests that more soil testing would be required before determining the soil's suitability for green infrastructure.

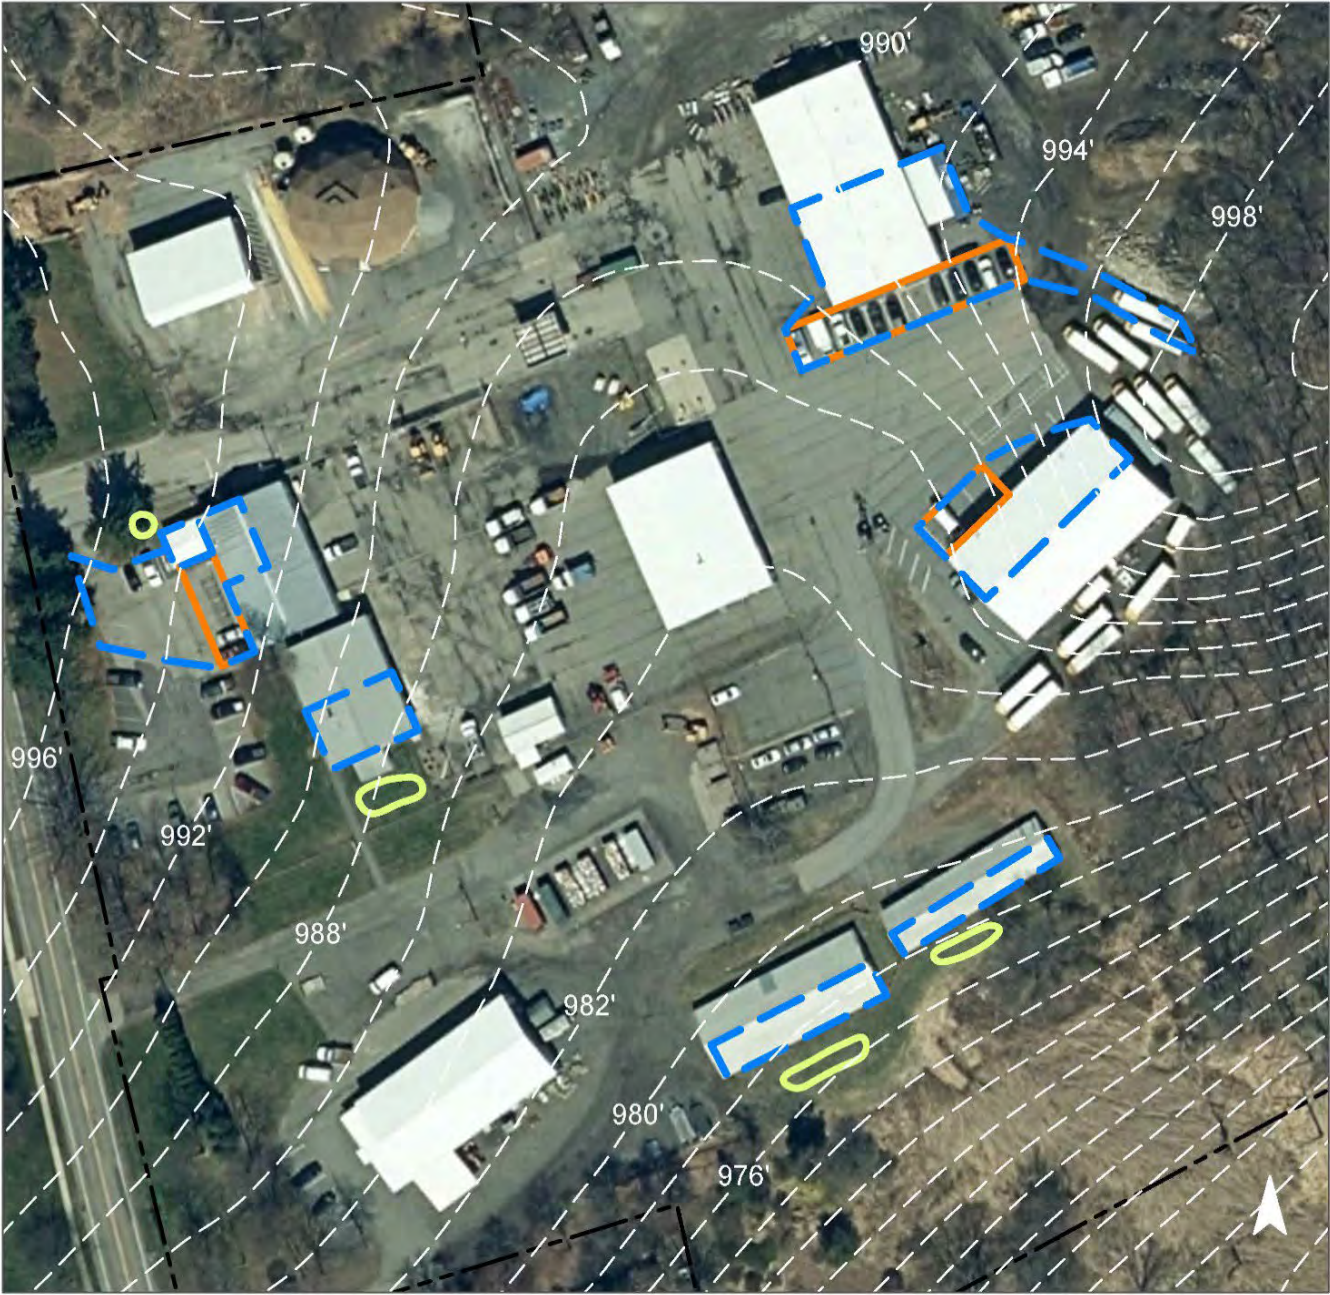
F-697

Rain gardens can be installed off the northwest corner and southern edge of the two buildings in the west edge of the property, and off the southern facades of the two buildings in the southeast edge of the property to capture, treat, and infiltrate stormwater from the rooftops via downspouts requiring disconnection. Rows of parking stalls off the west face of the western buildings, south face of the building in the northeast, and northwest corner of the building in the east can be converted to pervious pavement to capture and infiltrate stormwater runoff. The northeast and east buildings require one downspout each to be disconnected. A preliminary soil assessment suggests that the soils have suitable drainage characteristics for green infrastructure.

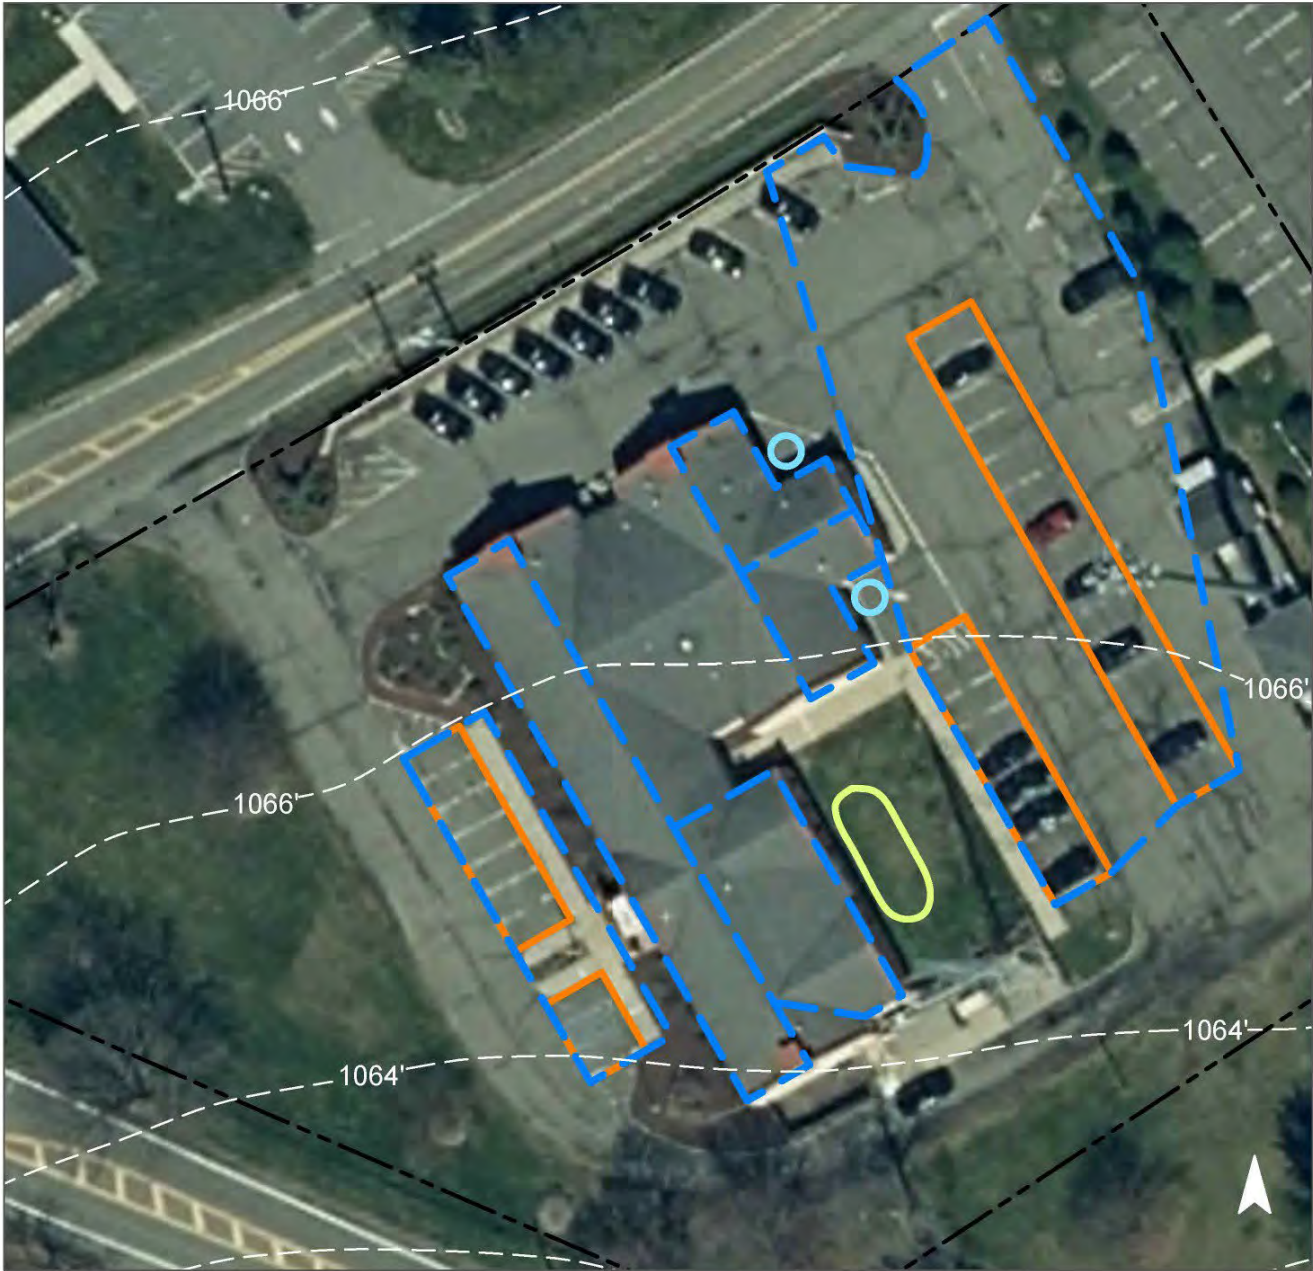
**Washington Twp. Police Dept.**

A rain garden off the southeast facade of the building to capture, treat, and infiltrate stormwater runoff from the rooftop. The rows of parking stalls off the southwest and northeast facades of the building can be converted into pervious pavement to capture and infiltrate stormwater from the rooftop. Two cisterns could be installed off the northeast corner and eastern nook of the building to divert and detain stormwater runoff for later non-potable reuse such as washing police vehicles. All stormwater conveyed from the rooftop is via downspouts which would require disconnection. A preliminary soil assessment suggests that the soils have suitable drainage characteristics for green infrastructure.

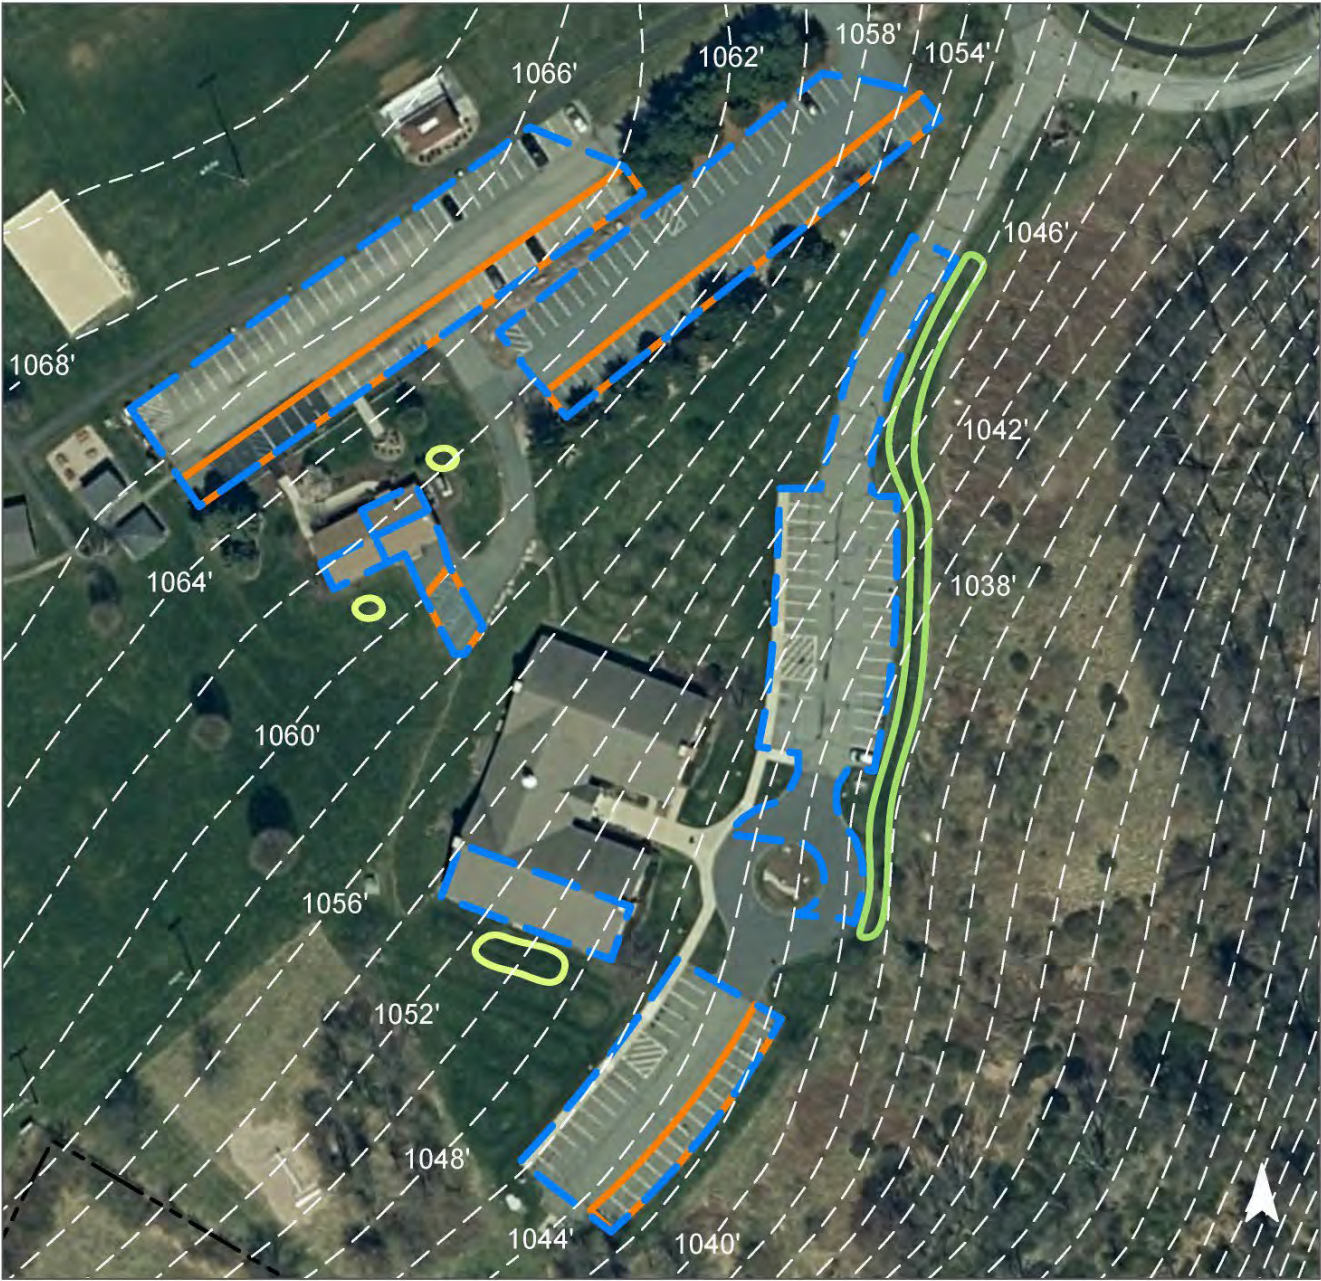
**Washington Twp. Public Library & Senior Citizen Center**

Rain gardens can be installed off the northeast and southwest corners of the senior center, and the south face of the library to capture, treat, and infiltrate stormwater from the roof via disconnected downspouts. Rows of parking stalls in the two parking lots to the north, the small parking lot off the south facade of the senior center, and the southern tip of the library's parking lot can be converted to pervious pavement to capture and infiltrate stormwater from the roof and pavement. A bioswale can also be installed along the northern half of the library's parking lot to convey water to the catch basins along the way while treating it. A preliminary soil assessment suggests that the soils have suitable drainage characteristics for green infrastructure.

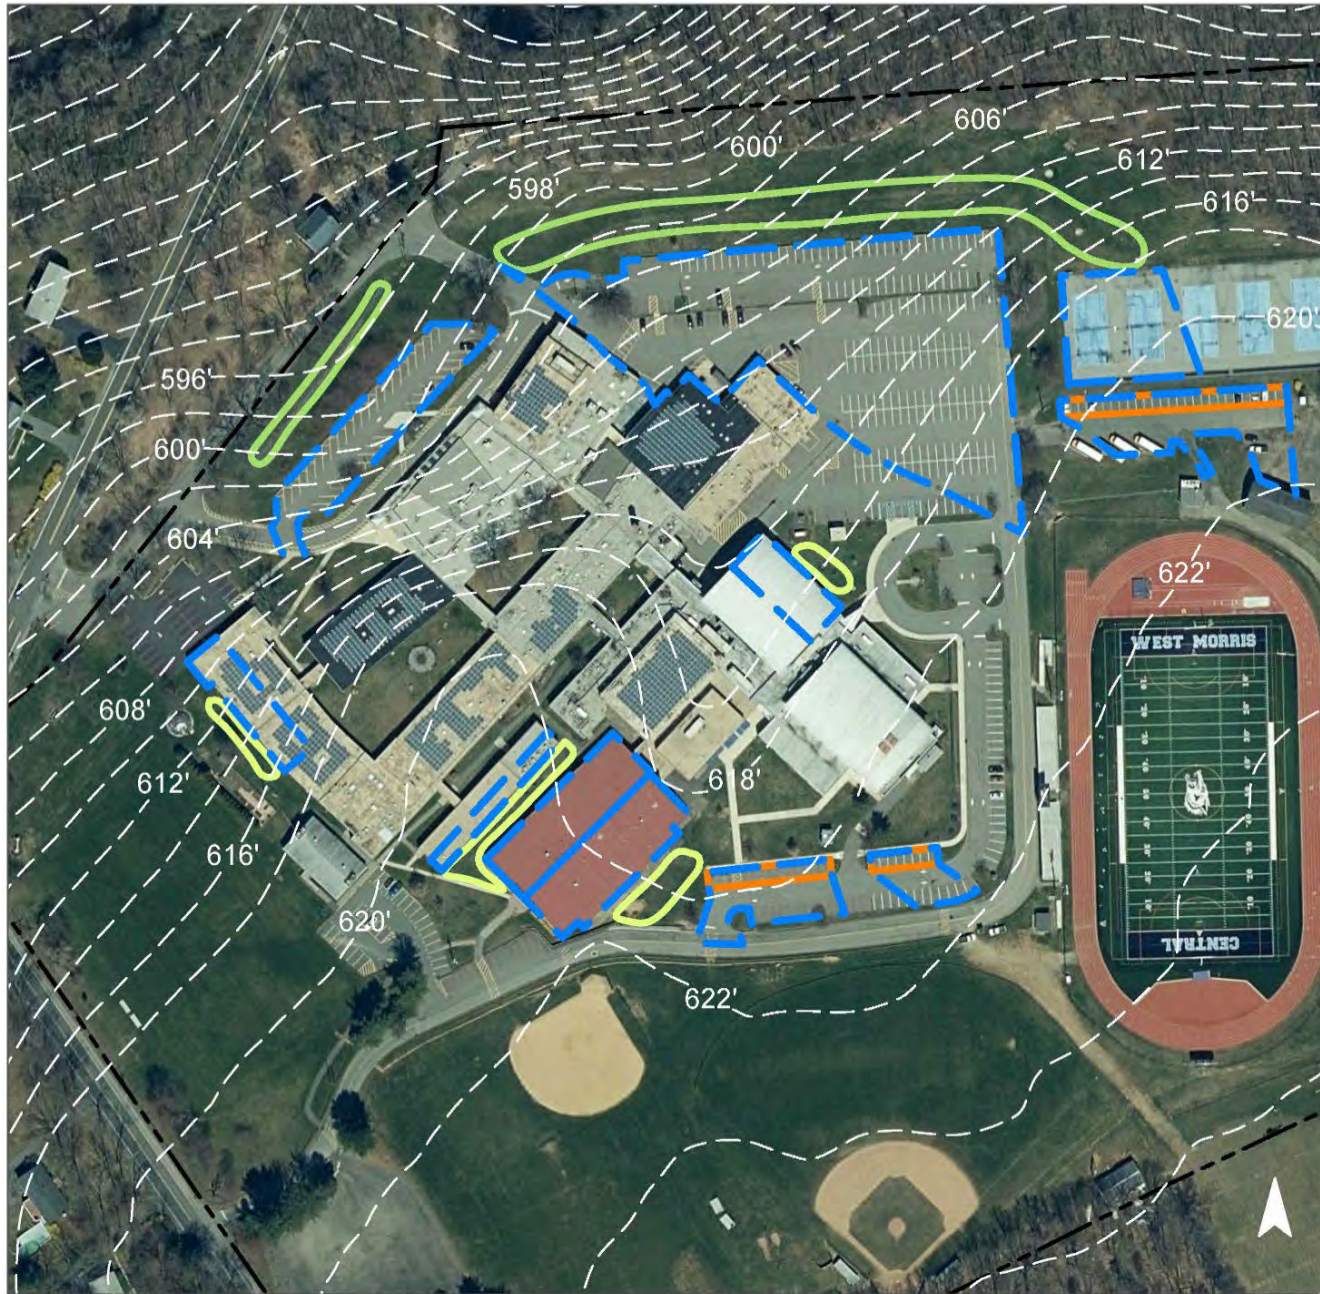
## West Morris Central High School

Rain gardens may be installed off portions of the west, south, and east facades of the school building to capture, treat and infiltrate stormwater runoff. Runoff would be conveyed to these rain gardens via downspouts requiring disconnection. Two existing swales can be converted to bioswales on the north and northwest sections of the property to treat stormwater runoff from adjacent parking lots, while conveying it to catch basins. Rows of parking stalls in the southeastern and northeastern parking lots can be converted to pervious pavement to capture and infiltrate stormwater runoff from the pavement. A preliminary soil assessment suggests that more soil testing would be required before determining the soil's suitability for green infrastructure.
