## Bedminster Township

### Introduction

The purpose of this report is to provide a comprehensive understanding of key, defining features within the subwatersheds throughout Bedminster Township. This involves gathering, organizing, and presenting information about existing conditions and infrastructure within each subwatershed. It aims to serve as a tool for informed decision-making, planning, and implementation of sustainable watershed management strategies aimed to protect and enhance the health of the watershed, its associated ecosystems, and the surrounding communities.

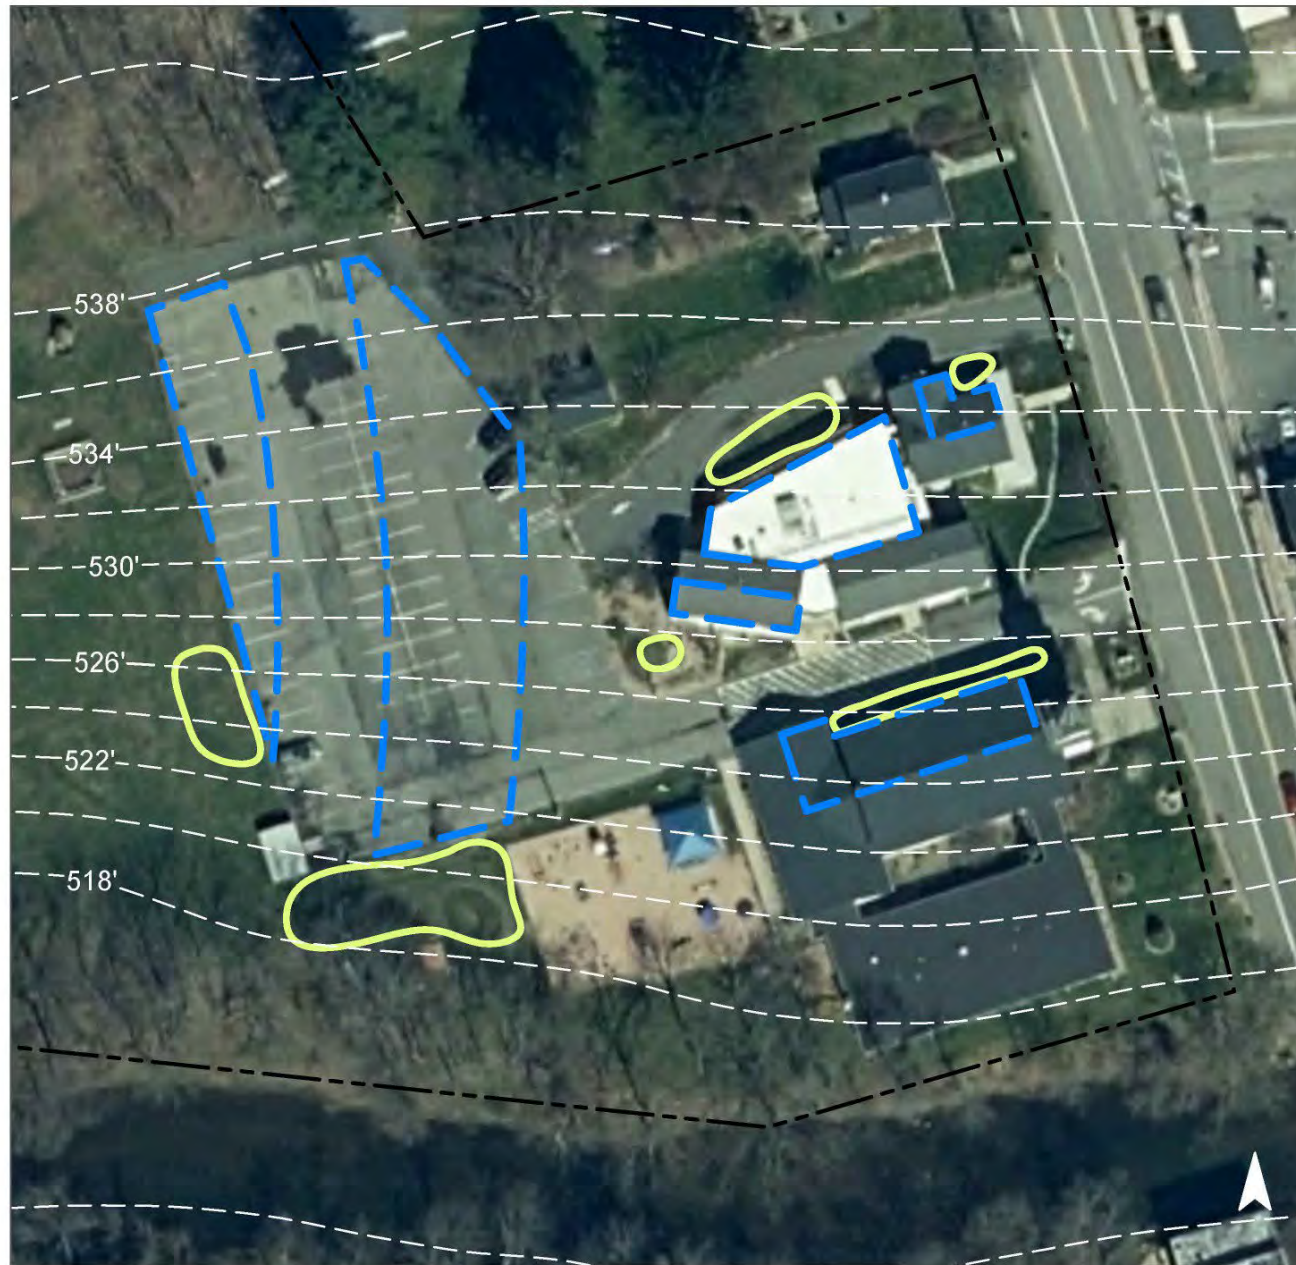
## Zion Lutheran Church and Parish Center

Rain gardens can be installed on the north and southwest faces of the church, the north face of the parish center building, and along the southwest corner of the parking lot to capture, treat, and infiltrate stormwater from the rooftops via disconnected downspouts and from the parking lot. A preliminary soil assessment suggests that more soil testing would be required before determining the soil's suitability for green infrastructure.
