Bedminster Township

Introduction

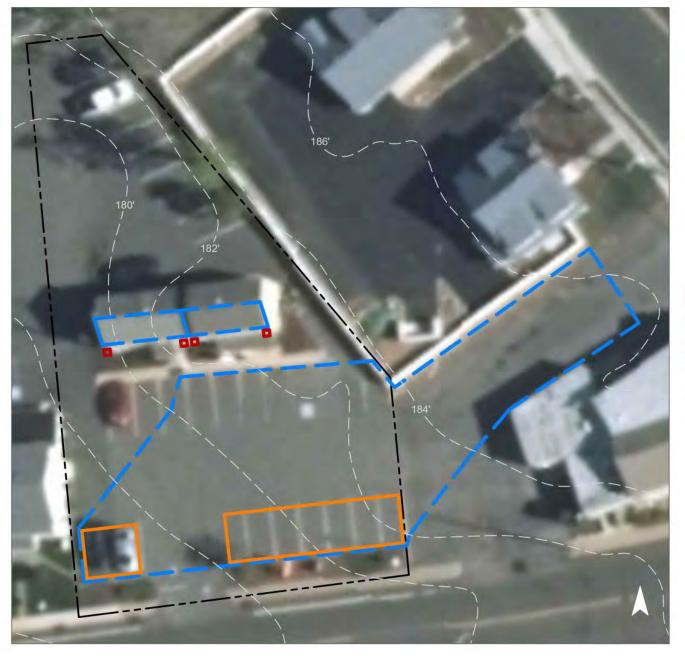
Annie's Deli

Recommended Green Infrastructure Practices	Recharge Potential (Mgal/yr)	TSS Removal Potential (lbs/yr)	Maximum Volume Reduction Potential (gal/storm)	Peak Discharge Reduction Potential (cu. ft./second)	Estimated Size (sq. ft.)	Estimated Cost
Pervious pavement	0.226	38	16,570	0.73	1,440	\$36,000
Planter boxes	n/a	2	n/a	n/a	4 (boxes)	\$4,000

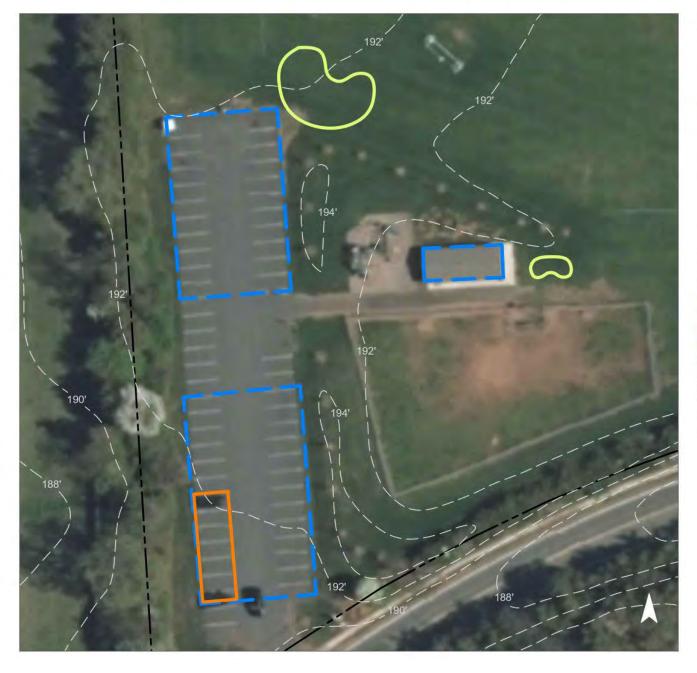
Burnt Mills Park

Bioretention systems can be installed to capture, treat, and infiltrate parking lot and rooftop runoff. Potential locations are in the northeast corner of the parking lot and the easternmost side of the structure shown in the above right image. Pervious pavement can be installed in the southwest corner of the parking lot to manage pavement runoff. A preliminary soil assessment suggests that more soil testing would be required before determining the soil's suitability for green infrastructure.

Recommended Green Infrastructure Practices	Recharge Potential (Mgal/yr)	TSS Removal Potential (lbs/yr)	Maximum Volume Reduction Potential (gal/storm)	Peak Discharge Reduction Potential (cu. ft./second)	Estimated Size (sq. ft.)	Estimated Cost
Bioretention systems	0.183	31	13,405	0.59	1,805	\$9,025
Pervious pavement	0.193	32	14,175	0.62	1,300	\$32,500

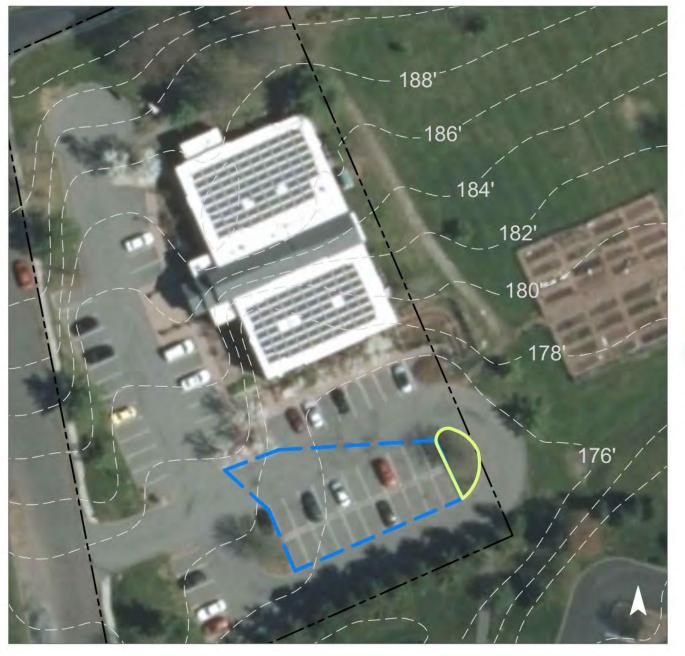
Clarence Dillon Public Library

Recommended Green Infrastructure Practices	Recharge Potential (Mgal/yr)	TSS Removal Potential (lbs/yr)	Maximum Volume Reduction Potential (gal/storm)	Peak Discharge Reduction Potential (cu. ft./second)	Estimated Size (sq. ft.)	Estimated Cost
Bioretention system	0.143	24	10,520	0.46	560	\$2,810

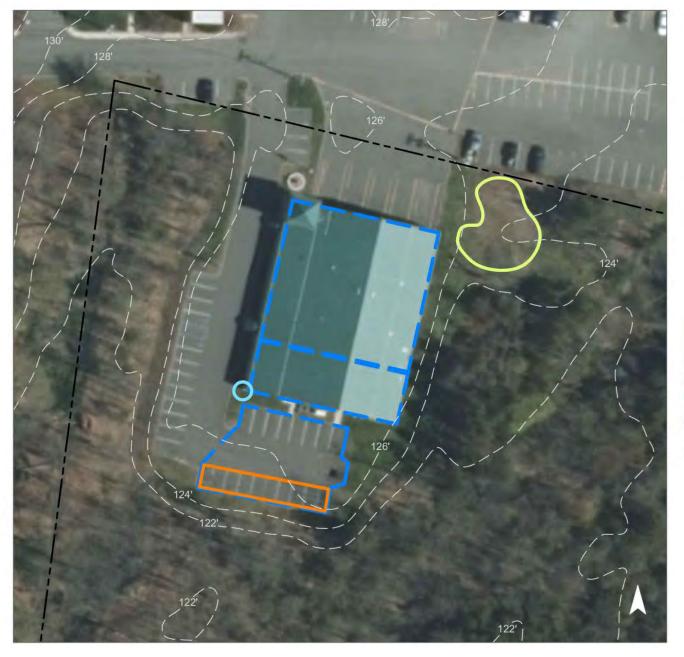
Far Hills-Bedminster Fire Department

A cistern can be installed in the southwest corner of the building to allow roof runoff to be reused. A bioretention system can be installed at the northeast corner of the building to capture, treat, and infiltrate rooftop runoff. Pervious pavement can be installed in the parking spaces behind and south of the building to filter and infiltrate pavement runoff. A preliminary soil assessment suggests that more soil testing would be required before determining the soil's suitability for green infrastructure.

Recommended Green Infrastructure Practices	Recharge Potential (Mgal/yr)	TSS Removal Potential (lbs/yr)	Maximum Volume Reduction Potential (gal/storm)	Peak Discharge Reduction Potential (cu. ft./second)	Estimated Size (sq. ft.)	Estimated Cost
Bioretention system	0.250	42	18,300	0.81	2,300	\$11,500
Pervious pavement	0.127	21	15,580	0.69	1,500	\$37,500
Rainwater harvesting	0.091	15	3,000	0.29	3,000 (gal)	\$6,000

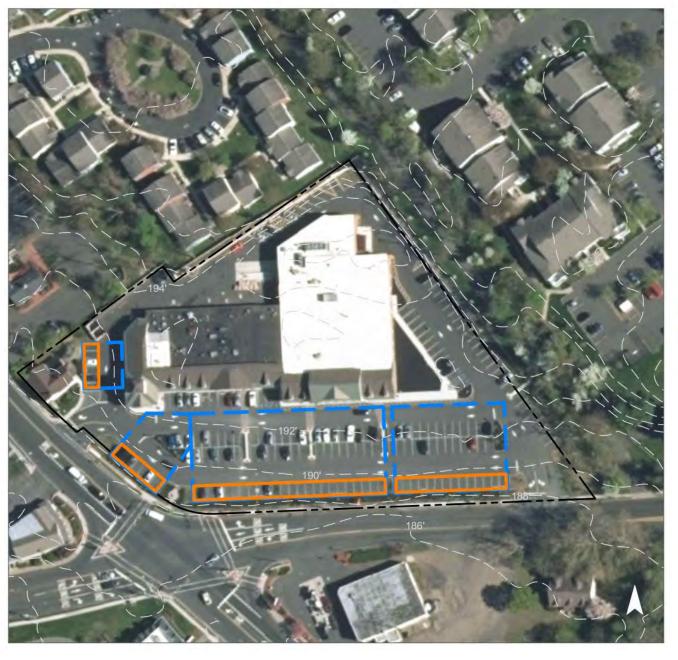
Fresh Market

Recommended Green Infrastructure Practices	Recharge Potential (Mgal/yr)	TSS Removal Potential (lbs/yr)	Maximum Volume Reduction Potential (gal/storm)	Peak Discharge Reduction Potential (cu. ft./second)	Estimated Size (sq. ft.)	Estimated Cost
Pervious pavement	1.039	174	76,235	3.36	8,170	\$204,250

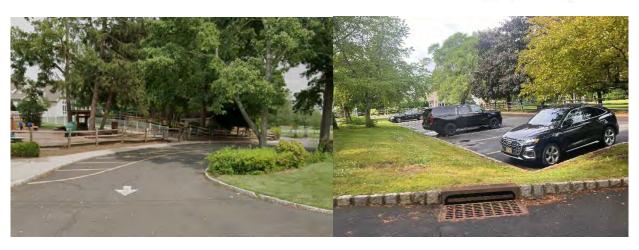
Rain gardens can be installed in multiple grass areas around the property to capture, treat, and infiltrate the stormwater runoff from rooftops, driveways, and parking lots. This may require curb cuts and redirection of downspouts underneath sidewalks. The proposed rain garden on the south of the property can be constructed around an existing catch basin. Existing parking spaces in the northern and eastern lots can be converted into pervious pavement to capture and infiltrate the stormwater runoff from the asphalt. A stormwater planter can be installed in the no-parking zone on the southwest driveway to capture, treat, and infiltrate the stormwater runoff from the roadway. A preliminary soil assessment suggests that more soil testing would be required before determining the soil's suitability for green infrastructure.

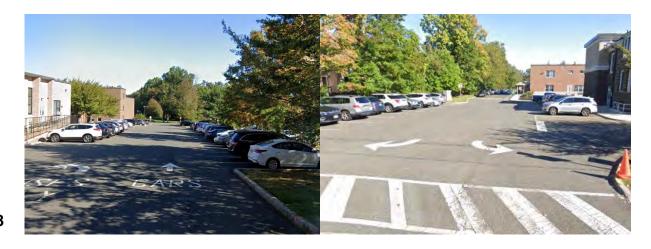
Rain gardens can be installed in multiple grass areas around the property to capture, treat, and infiltrate the stormwater runoff from the driveway, parking lot, and basketball court. This will require curb cuts and trench drains. Existing parking spaces in the extern and western parking lots can be converted into pervious pavement to capture and infiltrate the stormwater runoff from the asphalt. A prelminary soil assessment suggests that more soil testing would be required before determining the soil's suitability for green infrastructure.

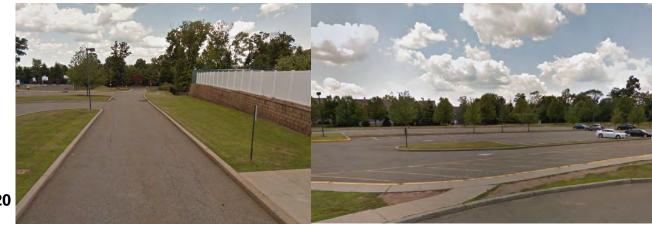
Rain gardens can be installed in multiple grass areas around the property to capture, treat, and infiltrate the stormwater runoff from the driveways and building rooftop. This will require curb cuts, trench drains, and redirection of downspouts underneath the sidewalk. Existing parking spaces in the western parking lot can be converted into pervious pavement to capture and infiltrate the stormwater runoff from the asphalt. A preliminary soil assessment suggests that more soil testing would be required before determining the soil's suitability for green infrastructure.

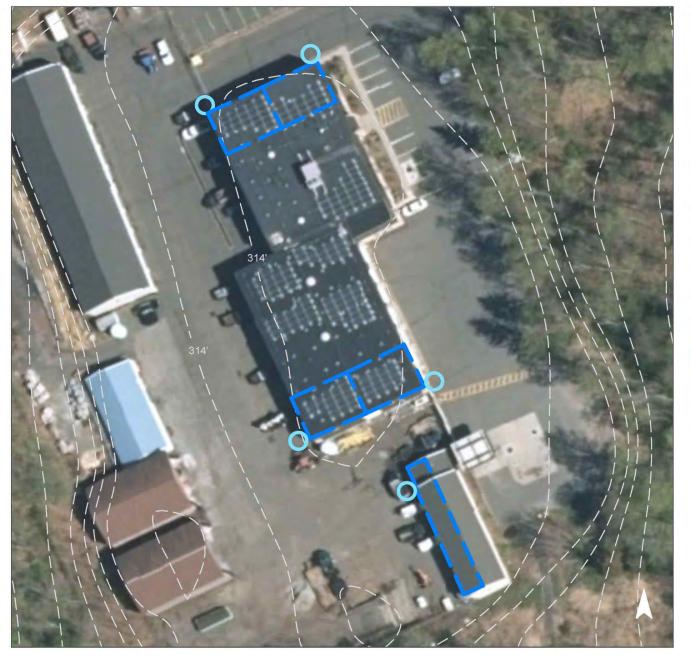
Bernards Township Fire Department

Impervio	ous Cover		sting Loads f		Runoff Volume from Impervious Cover (Mgal)		
0/0	sq. ft.	TP	TN	TSS	For the 1.25" Water Quality Storm	For an Annual Rainfall of 44"	
39	180,157	8.7	91.0	827.2	0.140 4.94

Recommended Green Infrastructure Practices	Recharge Potential (Mgal/yr)	TSS Removal Potential (lbs/yr)	Maximum Volume Reduction Potential (gal/storm)	Peak Discharge Reduction Potential (cu. ft./second)	Estimated Size (sq. ft.)	Estimated Cost
Rainwater harvesting	0.169	28	5,000	0.19	5,000 (gal)	\$10,000

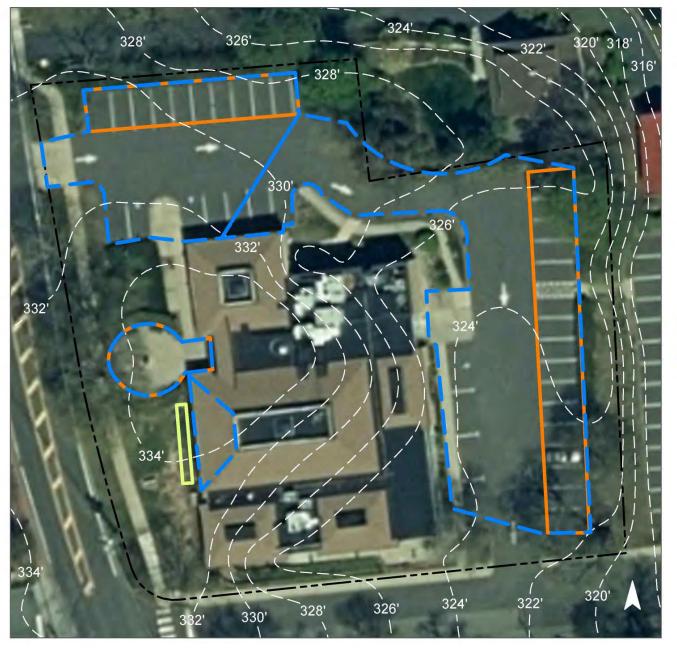
Bernards Township Library

A rain garden can be installed in front of the building to capture, treat, and infiltrate the stormwater runoff from the rooftop. This will require a downspout disconnection. Existing parking spaces in the northern and eastern parking lots can be converted into pervious pavement to capture and infiltrate the stormwater runoff from the asphalt. The concrete walkway near the library entrance can be replaced with porous pavers to infiltrate runoff from the walkway. A preliminary soil assessment suggests that more soil testing would be required before determining the soil's suitability for green infrastructure.

Impervio	ous Cover		sting Loads f		Riinatt valiime tram impervialis (aver (vigal)			
%	sq. ft.	TP	TN	TSS	For the 1.25" Water Quality Storm	For an Annual Rainfall of 49"		
80	40,288	1.9	20.3	185.0	0.031	1.23

Recommended Green Infrastructure Practices	Drainage Area (sq. ft.)	Recharge Potential (Mgal/yr)	TSS Removal Potential (lbs/yr)	Maximum Volume Reduction Potential (gal/storm)	Peak Discharge Reduction Potential (cu. ft./second)	Estimated Size (sq. ft.)	Estimated Cost
Bioretention system	610	0.018	2	1,180	0.04	150	\$1,500
Pervious pavement	19,330	0.561	84	37,440	1.41	5,965	\$149,125

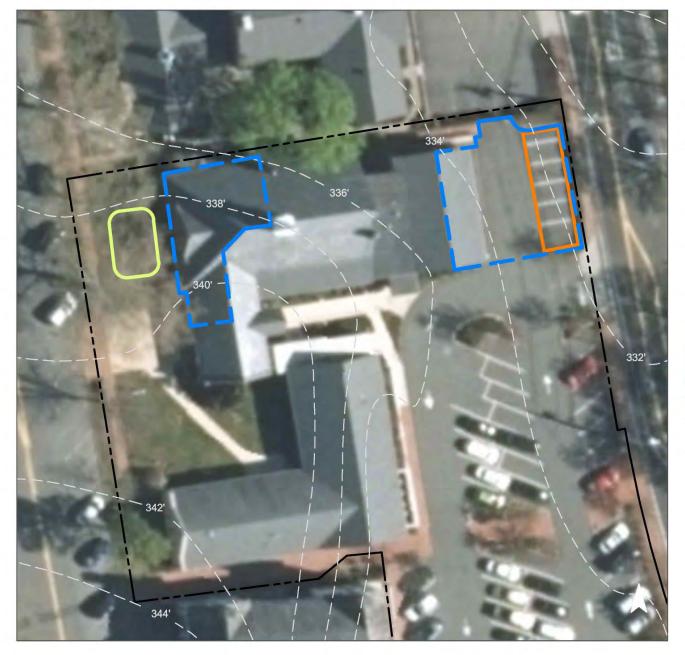
Bishop Janes United Methodist Church

A rain garden can be planted in the patch of turf grass in front of the west entrance to the building. A section of parking spaces can be converted to porous pavement to capture and infiltrate stormwater runoff from the parking lot. A preliminary soil assessment suggests that more soil testing would be required before determining the soil's suitability for green infrastructure.

Impervio	ous Cover		sting Loads f		Runoff Volume from Impervious Cover (Mgal)		
0/0	sq. ft.	TP	TN	TSS	For the 1.25" Water Quality Storm	For an Annual Rainfall of 44''	
81	32,042	1.5	16.2	147.1	0.025	0.88

Recommended Green Infrastructure Practices	Recharge Potential (Mgal/yr)	TSS Removal Potential (lbs/yr)	Maximum Volume Reduction Potential (gal/storm)	Peak Discharge Reduction Potential (cu. ft./second)	Estimated Size (sq. ft.)	Estimated Cost
Bioretention system	0.057	10	4,200	0.16	550	\$2,750
Pervious pavement	0.085	14	6,250	0.23	830	\$20,750

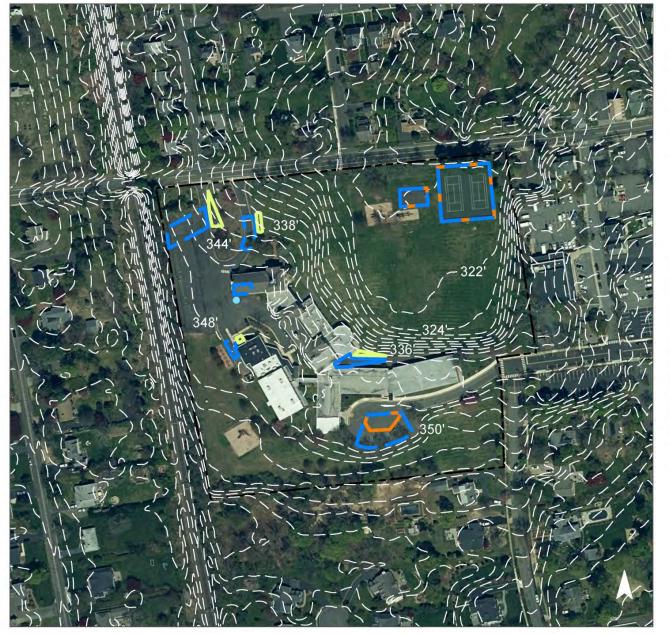
Oak Street Elementary School

Rain gardens can be installed in multiple grass areas around the property to capture, treat, and infiltrate the stormwater runoff from the asphalt driveways and walkways. The tennis court, basketball court, and existing parking spaces in the southern parking lot can be converted into pervious pavement to capture and infiltrate the stormwater runoff from the asphalt and courts. A cistern can be installed to the west of the building to divert and detain the stormwater runoff from the rooftop for later non-potable reuse such as washing a vehicle or watering a garden. A preliminary soil assessment suggests that more soil testing would be required before determining the sol's suitability for green infrastructure.

Impervi	ous Cover		sting Loads f vious Cover		Runoff Volume from Impervious Cover (Mgal)			
%	sq. ft.	TP	TN	TSS	For the 1.25" Water Quality Storm	For an Annual Rainfall of 49''		
35	184,476	8.9	93.2	847.0	0.144	5.63

Recommended Green Infrastructure Practices	Drainage Area (sq. ft.)	Recharge Potential (Mgal/yr)	TSS Removal Potential (lbs/yr)	Maximum Volume Reduction Potential (gal/storm)	Peak Discharge Reduction Potential (cu. ft./second)	Estimated Size (sq. ft.)	Estimated Cost
Bioretention system	8,095	0.235	36	15,680	0.59	2,035	\$20,350
Pervious pavement	24,385	0.708	106	47,230	1.77	19,385	\$484,625
Rainwater harvesting	885	0.026	4	700	N/A	700 (gal)	\$2,100

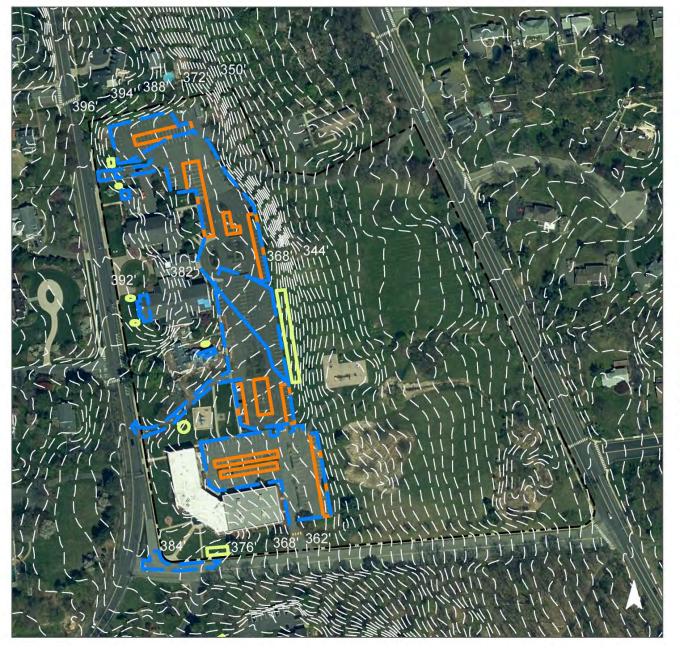
St. James Roman Catholic Church & School

Rain gardens can be installed in multiple grass areas around the property to capture, treat, and infiltrate the stormwater runoff from the road, driveway, parking lot, and building rooftops. This will require curb cuts, trench drains, and downspout redirection bereath sidewalks. Existing parking spaces in much of the parking lot can be converted into pervious pavement to capture and infiltrate the stormwater runoff from the asphalt. A preliminary soil assessment suggests that more soil testing would be required before determining the soil's suitability for green infrastructure.

Impervi	Impervious Cover		sting Loads f vious Cover		Runoff Volume from Impervious Cover (Mgal)	
%	sq. ft.	TP	TN	TSS	For the 1.25" Water Quality Storm	For an Annual Rainfall of 49''
35	280,406	13.5	141.6	1,287.4	0.218	8.56

Recommended Green Infrastructure Practices	Drainage Area (sq. ft.)	Recharge Potential (Mgal/yr)	TSS Removal Potential (lbs/yr)	Maximum Volume Reduction Potential (gal/storm)	Peak Discharge Reduction Potential (cu. ft./second)	Estimated Size (sq. ft.)	Estimated Cost
Bioretention system	22,635	0.657	99	43,840	1.65	5,655	\$56,550
Pervious pavement	121,055	3.513	528	234,450	8.81	23,185	\$579,625

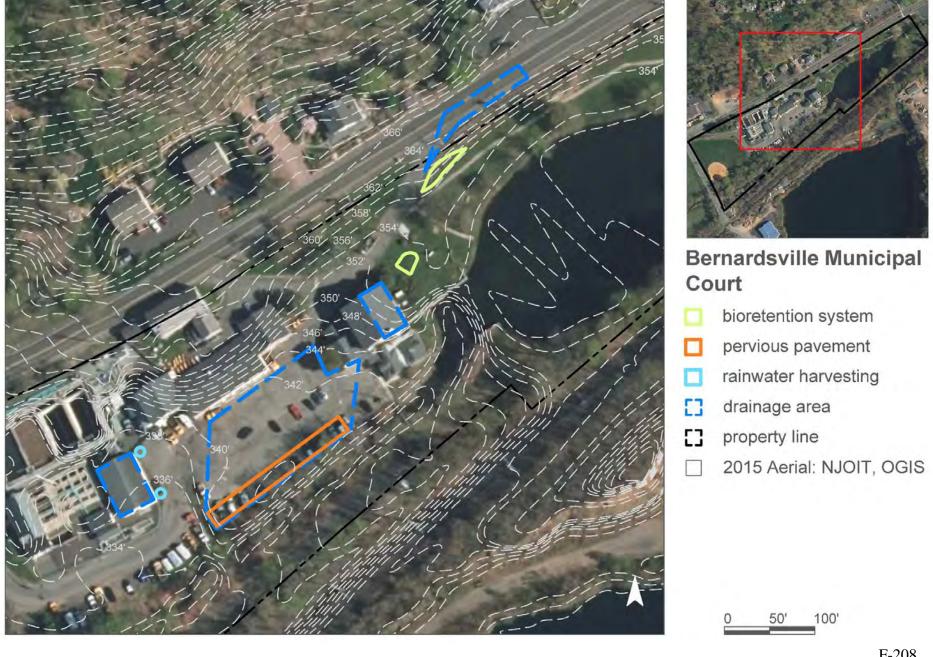
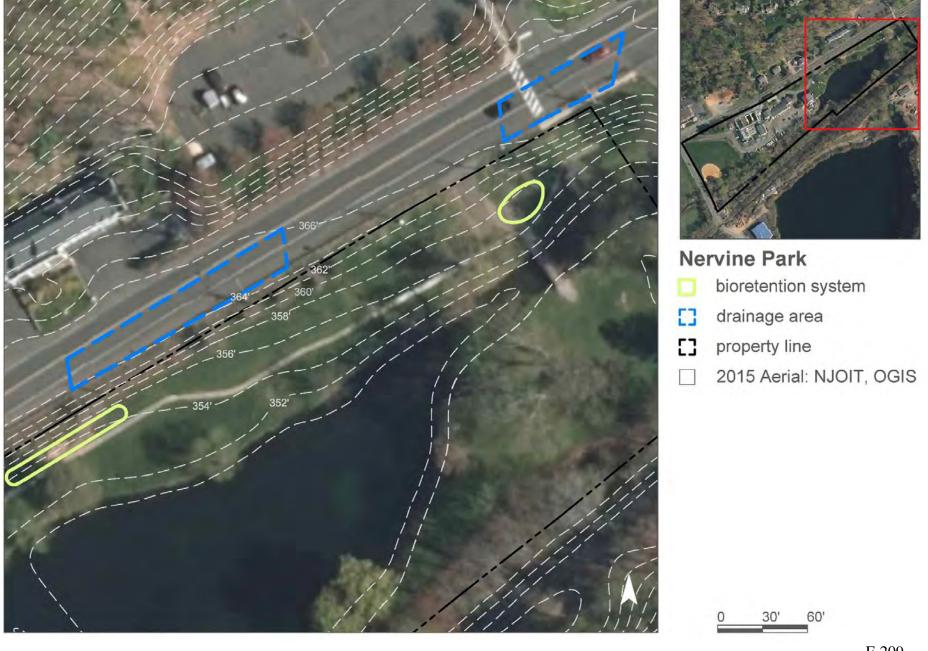
BERNARDSVILLE MUNICIPAL POOL

Pervious pavement can be installed in the parking lot to capture, treat, and infiltrate parking lot runoff. Two cisterns can be attached to the building to capture and filter stormwater runoff from the rooftop. Rain gardens can be installed adjacent to the roadways to capture, treat, and infiltrate runoff from the road. A preliminary soil assessment suggests that more soil testing would be required before determining the soil's suitability for green infrastructure.

Impervio	ous Cover		sting Loads f		Runoff Volume from Impervious Cover (Mgal)		
0/0	sq. ft.	TP	TN	TSS	For the 1.25" Water Quality Storm	For an Annual Rainfall of 44''	
34	156,500	7.5	79.0	718.5	0.122	4.29

Recommended Green Infrastructure Practices	Recharge Potential (Mgal/yr)	TSS Removal Potential (lbs/yr)	Maximum Volume Reduction Potential (gal/storm)	Peak Discharge Reduction Potential (cu. ft./second)	Estimated Size (sq. ft.)	Estimated Cost
Bioretention systems	0.241	40	17,710	0.67	2,315	\$11,575
Pervious pavement	0.473	79	34,690	1.30	3,240	\$81,000
Rainwater harvesting	0.061	10	1,830	0.07	1,830 (gal)	\$3,660

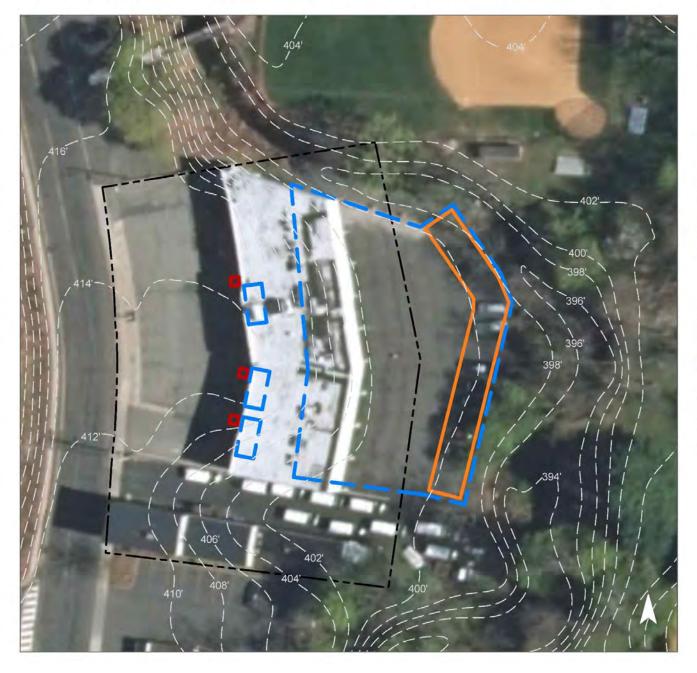
Bernardsville School of Music

Pervious pavement can be installed in the back parking lot to capture, treat, and infiltrate parking lot runoff. Downspout planter boxes can be installed at the bases of the downspouts connected to the support beams at the southeast corner of the building to capture and filter stormwater. A preliminary soil assessment suggests that more soil testing would be required before determining the soil's suitability for green infrastructure.

Impervi	ous Cover		sting Loads f vious Cover		Runoff Volume from Impervious Cover (Mgal)		
0/0	sq. ft.	TP	TN	TSS	For the 1.25" Water Quality Storm	For an Annual Rainfall of 44"	
81	29,441	1.4	14.9	135.2	0.023 0.81

Recommended Green Infrastructure Practices	Recharge Potential (Mgal/yr)	TSS Removal Potential (lbs/yr)	Maximum Volume Reduction Potential (gal/storm)	Peak Discharge Reduction Potential (cu. ft./second)	Estimated Size (sq. ft.)	Estimated Cost
Pervious pavement	0.423	71	31,050	1.17	2,900	\$72,500
Planter boxes	n/a	2	n/a	n/a	3 (boxes)	\$3,000

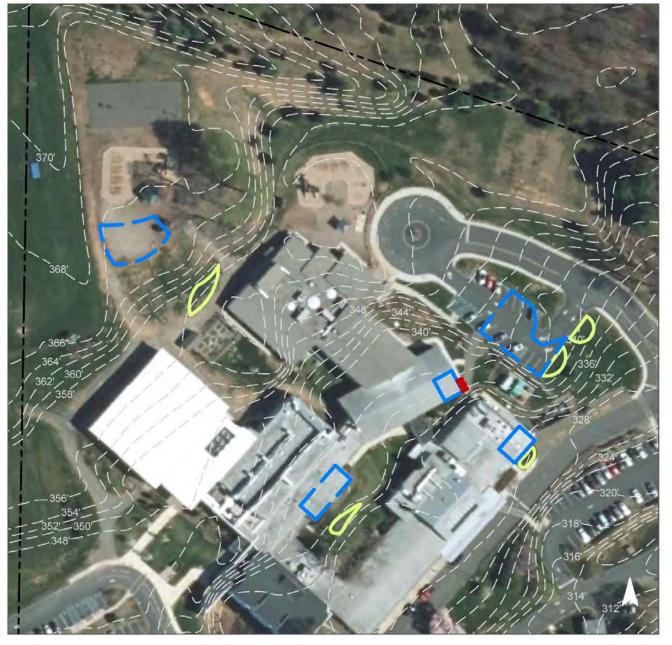
Far Hills Country Day School

Impervious Cover		Existing Loads from Impervious Cover (lbs/yr)			Runoff Volume from Impervious Cover (Mgal)		
%	sq. ft.	TP	TN	TSS	For the 1.25" Water Quality Storm	For an Annual Rainfall of 44''	
44	350,940	16.9	177.2	1,611.3	0.273	9.63

Recommended Green Infrastructure Practices	Recharge Potential (Mgal/yr)	TSS Removal Potential (lbs/yr)	Maximum Volume Reduction Potential (gal/storm)	Peak Discharge Reduction Potential (cu. ft./second)	Estimated Size (sq. ft.)	Estimated Cost
Bioretention systems	0.229	38	16,820	0.63	2,200	\$11,000
Planter boxes	n/a	2	n/a	n/a	3 (boxes)	\$3,000

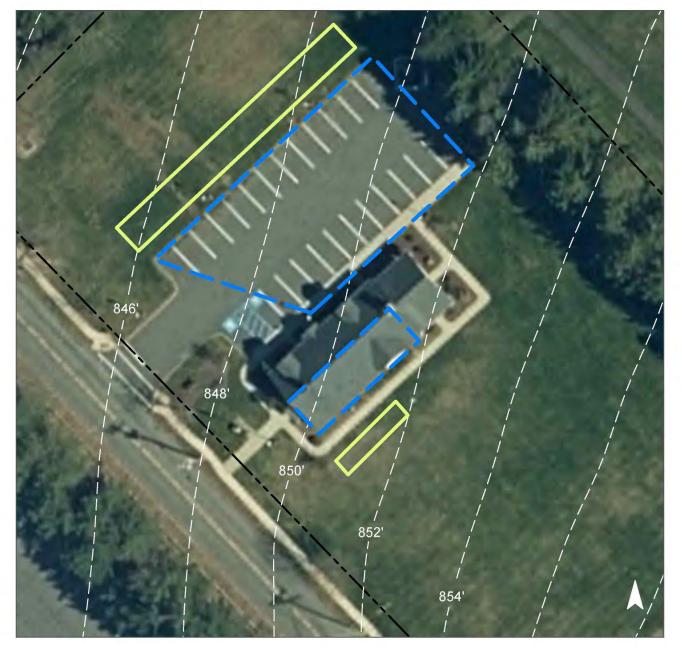
Boro of Chester Recreation Office

Impervio	ous Cover		sting Loads f vious Cover		Runoff Volume from Impervious Cover (Mgal)		
%	sq. ft.	TP	TN	TSS	For the 1.25" Water Quality Storm	For an Annual Rainfall of 50''	
19	16,463	0.8	8.3	75.6	0.013	0.51

Recommended Green Infrastructure Practices	Drainage Area (sq. ft.)	Recharge Potential (Mgal/yr)	TSS Removal Potential (lbs/yr)	Maximum Volume Reduction Potential (gal/storm)	Peak Discharge Reduction Potential (cu. ft./second)	Estimated Size (sq. ft.)	Estimated Cost
Bioretention system	8,915	0.264	38	18,600	0.70	2,230	\$22,300

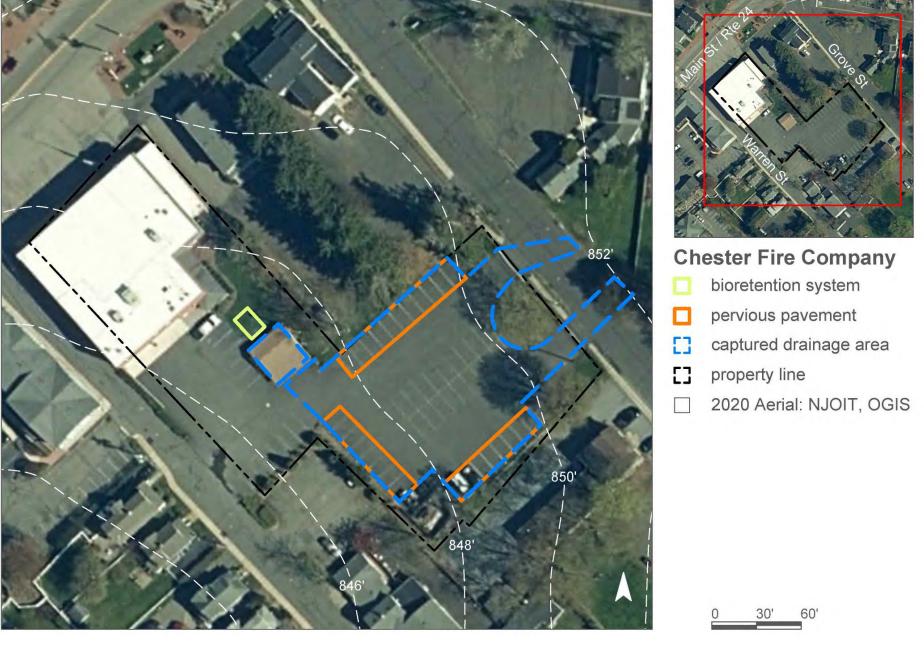
CHESTER TENNIS CLUB

A rain garden can be installed to the west of the shed to capture, treat, and infiltrate the stormwater runoff from the rooftop. This will require a downspout disconnection. The gutters on the eastern section of the shed can also be reworked and directed towards the raingarden to increase the treated drainage area. Existing parking spaces in the eastern parking lot can be converted into pervious pavement to capture and infiltrate the stormwater runoff from the asphalt. A preliminary soil assessment suggests that more soil testing would be required before determining the soil's suitability for green infrastructure.

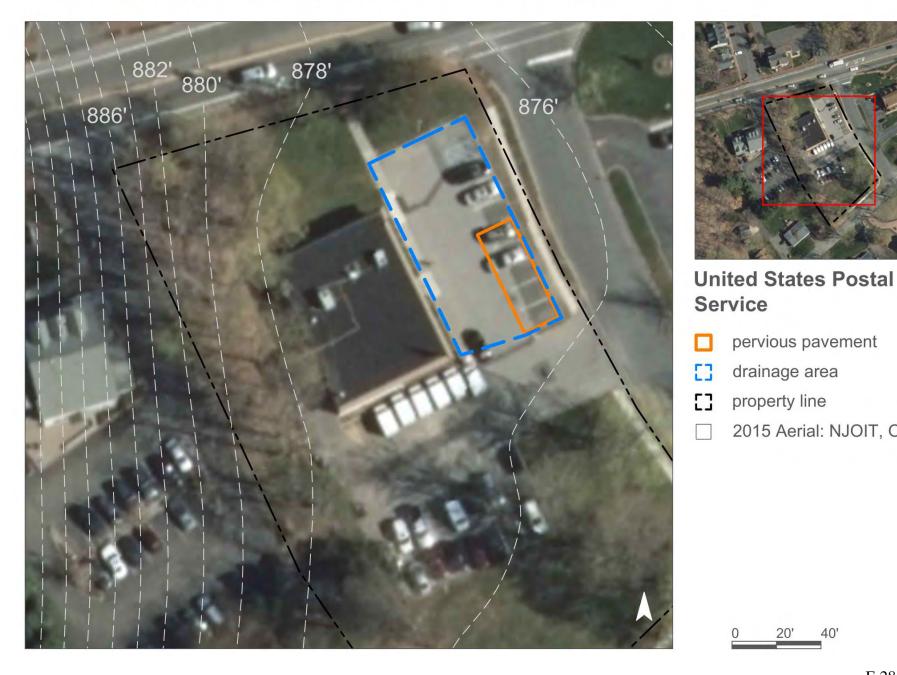
Parking spaces in the parking lot to the east of the building can be converted to porous pavement to capture and infiltrate stormwater runoff from the parking lot and the downspout. A septic system in the turfgrass area north of the building limits rain garden opportunities. A preliminary soil assessment suggests that the soils have suitable drainage characteristics for green infrastructure.

pervious pavement

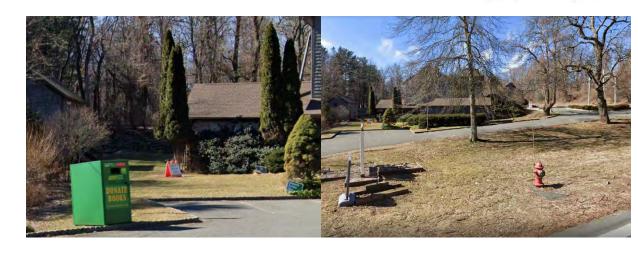
Block and Lot: Block 17, Lot 38

A rain garden can be installed near the south of the building using the disconnected downspouts to capture, treat, and infiltrate the stormwater runoff from the rooftop. Another rain garden can be installed around an existing catch basin near the driveway entrance to capture, treat, and infiltrate the stormwater runoff from the asphalt. A trench drain will be needed to intercept and redirect the driveway runoff. Existing parking spaces to the northwest of the building can be converted into pervious pavement to capture and infiltrate the stormwater runoff from the asphalt. The concrete walkway near the building entrance can be replaced with permeable pavers. A preliminary soil assessment suggests that the soils have suitable drainage characteristics for green infrastructure.

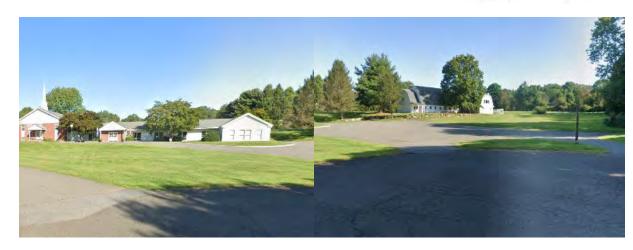
Block and Lot: Block 33.01, Lot 10

Rain gardens can be installed in multiple grass areas around the property to capture, treat, and infiltrate the stormwater runoff from the rooftop and driveways. This may require downspout disconnections, trench drains, and curb cuts. Existing parking spaces to the east of the building can be converted into pervious pavement to capture and infiltrate the stormwater runoff from the asphalt. This may require a trench drain. A preliminary soil assessment suggests that the soils have suitable drainage characteristics for green infrastructure.

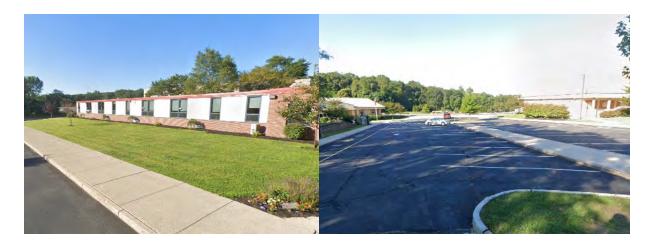
Block and Lot: Block 25.01, Lot 38.01

Rain gardens can be installed in multiple grass areas around the property to capture, treat, and infiltrate the stormwater runoff from the rooftops, parking lots, and driveways. This may require downspout disconnections, redirection of downspouts beneath sidewalks trench drains, and curb cuts. Existing parking spaces in multiple lots can be converted into pervious pavement to capture and infiltrate the stormwater runoff from the asphalt. This may require trench drains in some locations. The basketball courts near each school building can also be converted into pervious pavement. The concrete walkway near the entrance of Bragg School can be replaced with permeable pavers. A preliminary soil assessment suggests that the soils have suitable drainage characteristics for green infrastructure.

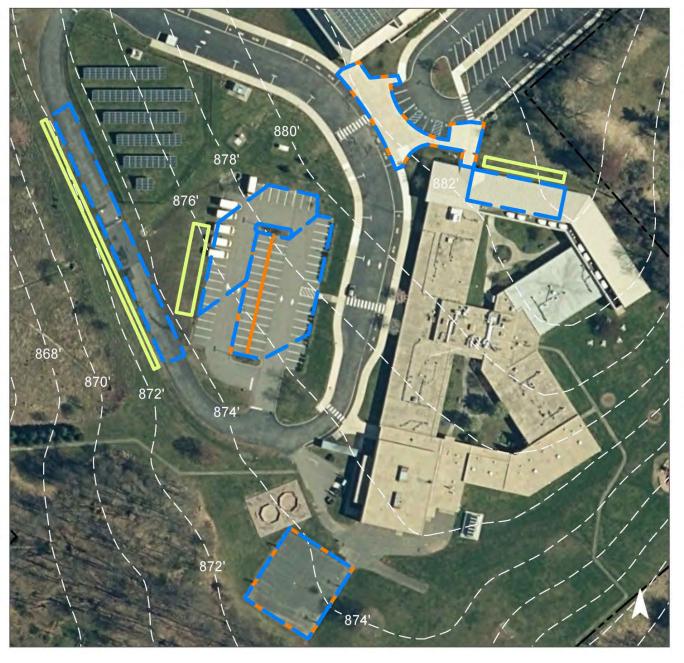
Bragg School

- bioretention system
- pervious pavement
- captured drainage area
- property line
- 2020 Aerial: NJOIT, OGIS

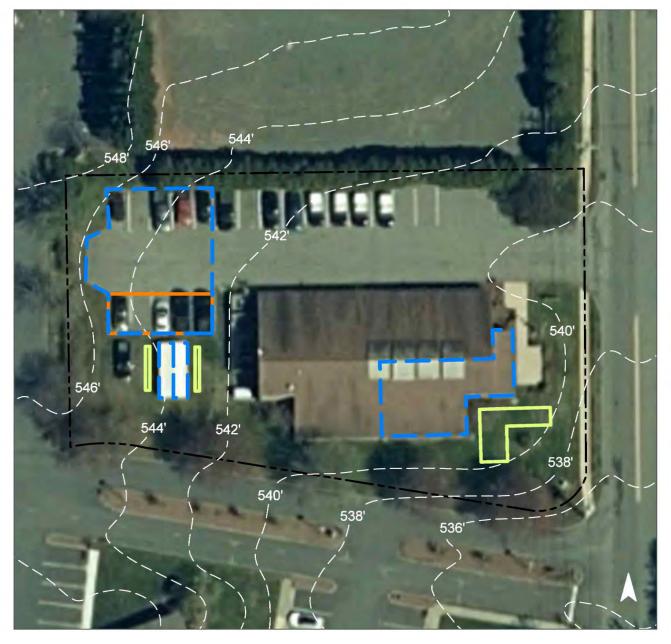
Mendham Borough Police Department

A rain garden can be installed to the east of the building using the disconnected downspouts to capture, treat, and infiltrate the stormwater runoff from the rooftop. Two rain gardens can be installed to the east and west of the shed to capture, treat, and infiltrate stormwater runoff from the rooftop. Existing parking spaces on the western side of the lot can be converted into pervious pavement to capture and infiltrate the stormwater runoff from the asphalt. This may require trench drains. A preliminary soil assessment suggests that more soil testing would be required before determining the soil's suitability for green infrastructure.

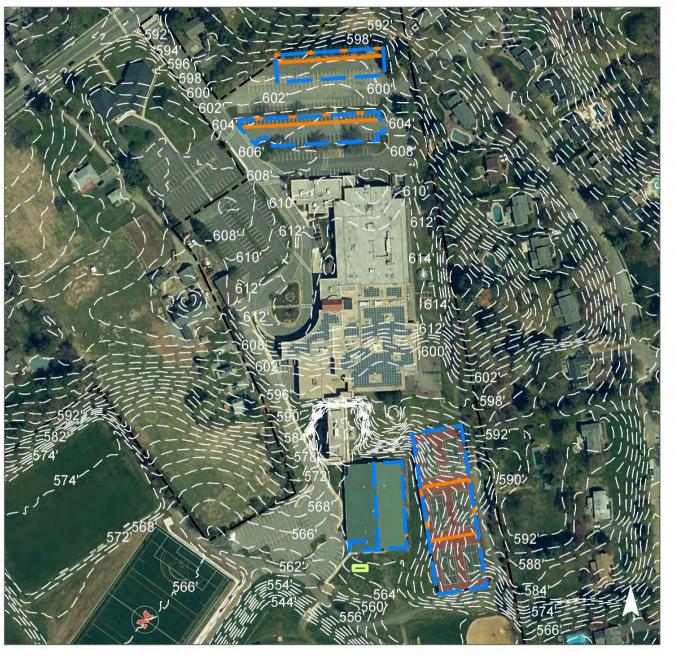
West Morris Mendham High School

A rain garden can be installed to the south corner of the building near the tennis courts to capture, treat, and infiltrate the stormwater runoff from the rooftop. This will require downspout disconnection and redirection. The center tennis courts can be converted into pervious pavement to capture and infiltrate the stormwater runoff from all the courts. The downspouts on the adjacent building can be disconnected and redirected to the courts as well, to manage rooftop runoff with the pervious pavement. Existing parking spaces in the northern lot can be converted into pervious pavement to capture and infiltrate stormwater runoff from the asphalt. Trench drains may be required. A preliminary soil assessment suggests that the soils have suitable drainage characteristics for green infrastructure.

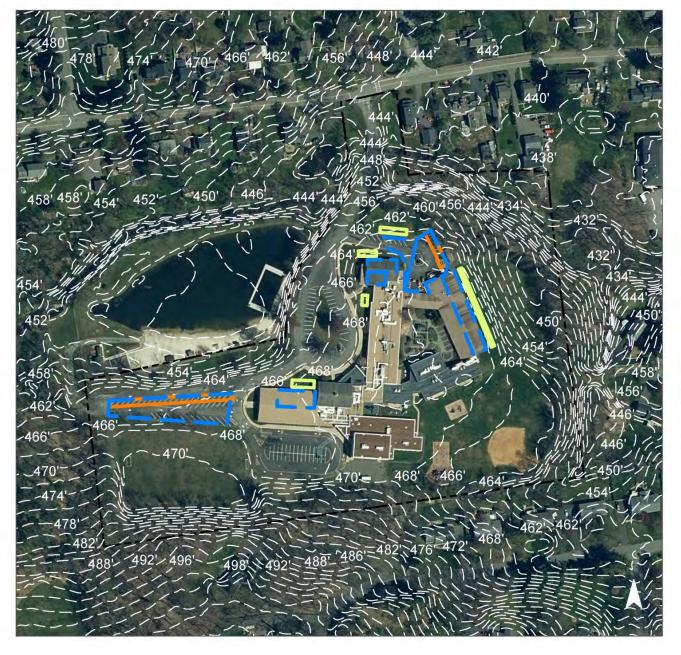
Mendham Township Elementary School

Multiple rain gardens can be installed in the grass areas around the property to capture, treat, and infiltrate stormwater runoff from the rooftops. This may require downspout disconnections, downspout redirections, curb cuts, and a trench drain. The existing parking spaces to west and to the northeast of the building can be converted into pervious pavement to capture and infiltrate the stormwater runoff from the asphalt. A preliminary soil assessment suggests that more soil testing would be required before determining the soil's suitability for green infrastructure.

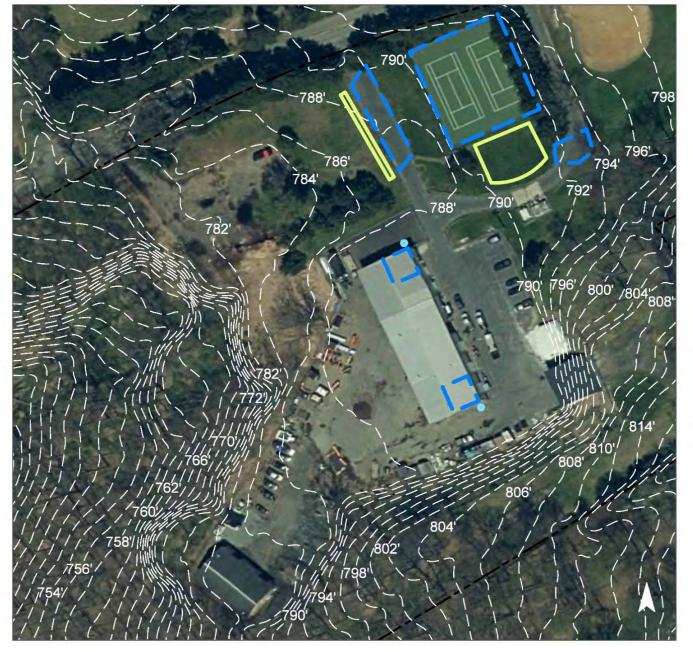
Mt. Pleasant Recreation Area

Recommended Green Infrastructure Practices	Drainage Area (sq. ft.)	Recharge Potential (Mgal/yr)	TSS Removal Potential (lbs/yr)	Maximum Volume Reduction Potential (gal/storm)	Peak Discharge Reduction Potential (cu. ft./second)	Estimated Size (sq. ft.)	Estimated Cost
Bioretention system	16,775	0.497	74	34,990	1.31	4,195	\$41,950
Rainwater harvesting	1,800	0.053	8	1,400	0.05	1,400 (gal)	\$4,200

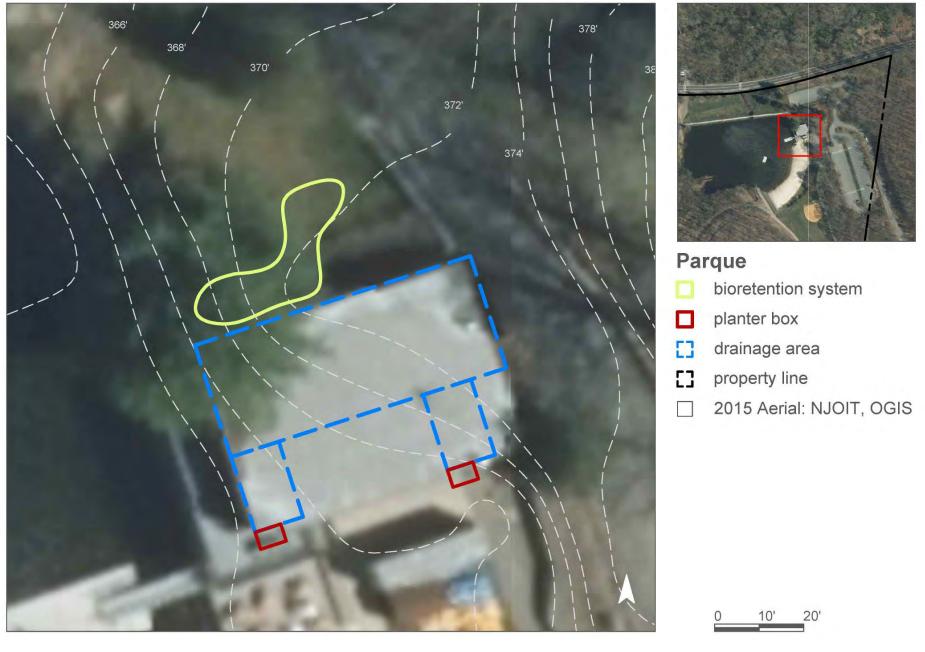
Bioretention systems can be installed in the back of the building to capture, treat, and infiltrate rooftop runoff. Downspout planter boxes can be constructed at the entrance of the building to allow roof runoff to be reused and to spread awareness about green infrastructure programs. A preliminary soil assessment suggests that the soils have suitable drainage characteristics for green infrastructure.

Recommended Green Infrastructure Practices	Recharge Potential (Mgal/yr)	TSS Removal Potential (lbs/yr)	Maximum Volume Reduction Potential (gal/storm)	Peak Discharge Reduction Potential (cu. ft./second)	Estimated Size (sq. ft.)	Estimated Cost
Bioretention system	0.045	7	3,280	0.12	430	\$2,150
Planter boxes	n/a	1	n/a	n/a	2 (boxes)	\$2,000

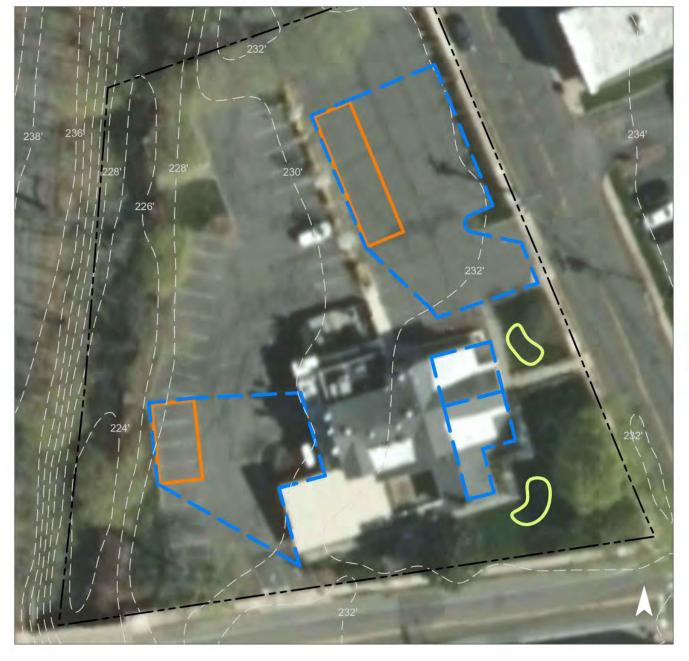
Gladstone Tavern

Rain gardens can be installed at the southeast corner of the building to help capture, treat, and infiltrate stormwater runoff from the roof of the building. Pervious pavement can be installed in the parking spaces to the west and to the north of the tavern to infiltrate parking lot runoff. A preliminary soil assessment suggests that more soil testing would be required before determining the soil's suitability for green infrastructure.

Recommended Green Infrastructure Practices	Recharge Potential (Mgal/yr)	TSS Removal Potential (lbs/yr)	Maximum Volume Reduction Potential (gal/storm)	Peak Discharge Reduction Potential (cu. ft./second)	Estimated Size (sq. ft.)	Estimated Cost
Bioretention systems	0.038	6	2,780	0.10	500	\$2,500
Pervious pavement	0.246	41	18,060	0.68	1,855	\$46,375

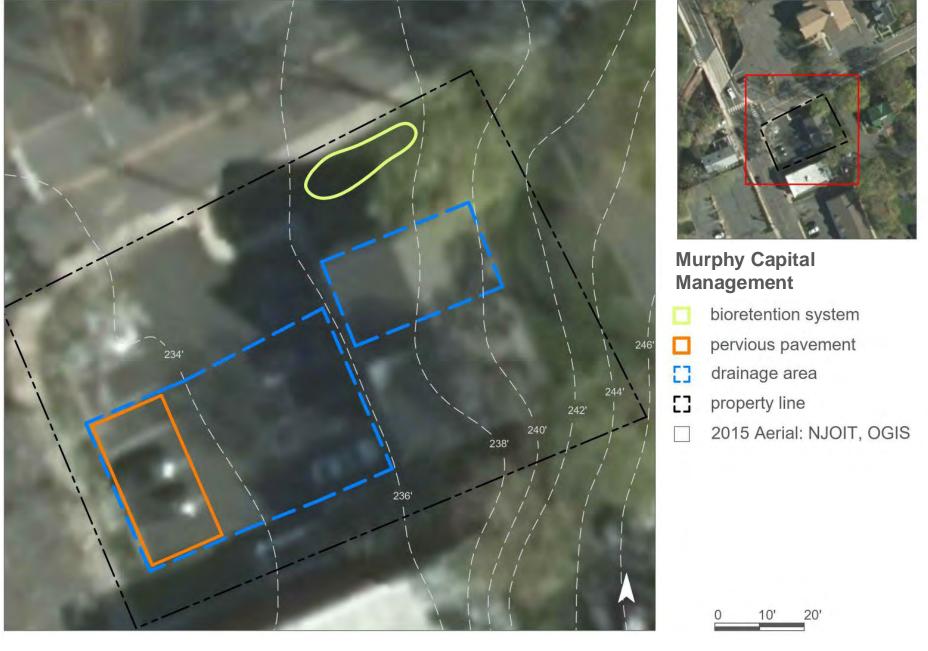
PEAPACK-GLADSTONE FIRST AID SQUAD

A rain garden can be installed adjacent to the sidewalk and north of the building to capture, treat, and infiltrate stormwater runoff from the roof of the building. Pervious pavement can be installed in the southeastern corner of the parking lot to infiltrate pavement runoff. A preliminary soil assessment suggests that more soil testing would be required before determining the soil's suitability for green infrastructure.

Recommended Green Infrastructure Practices	Recharge Potential (Mgal/yr)	TSS Removal Potential (lbs/yr)	Maximum Volume Reduction Potential (gal/storm)	Peak Discharge Reduction Potential (cu. ft./second)	Estimated Size (sq. ft.)	Estimated Cost
Bioretention system	0.019	3	1,380	0.05	180	\$900
Pervious pavement	0.057	9	4,160	0.16	650	\$16,250

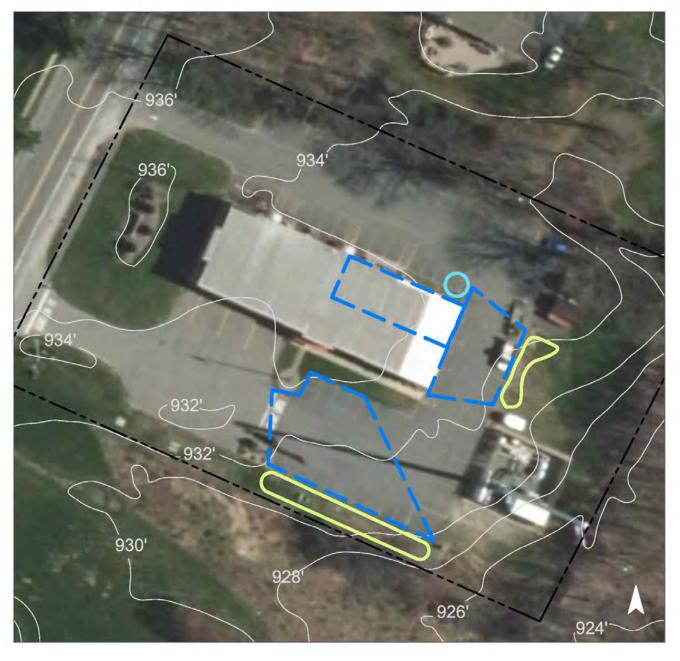
Randolph Township Fire Department Company #4

Recommended Green Infrastructure Practices	Recharge Potential (Mgal/yr)	TSS Removal Potential (lbs/yr)	Maximum Volume Reduction Potential (gal/storm)	Peak Discharge Reduction Potential (cu. ft./second)	Estimated Size (sq. ft.)	Estimated Cost
Bioretention systems	0.231	39	18,060	0.68	2,220	\$55,500
Rainwater harvesting	0.066	11	2,000	0.07	2,000 (gal)	\$4,000

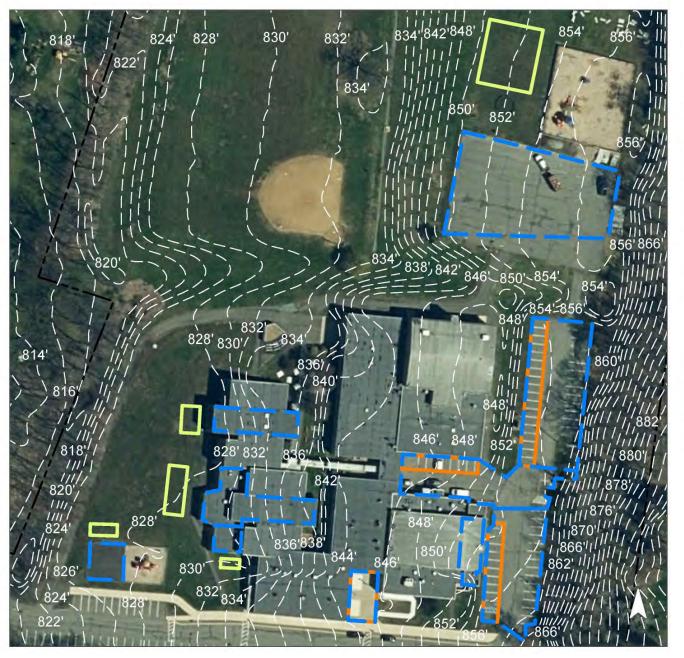
Fernbrook Elementary School

Recommended Green Infrastructure Practices	Drainage Area (sq. ft.)	Recharge Potential (Mgal/yr)	TSS Removal Potential (lbs/yr)	Maximum Volume Reduction Potential (gal/storm)	Peak Discharge Reduction Potential (cu. ft./second)	Estimated Size (sq. ft.)	Estimated Cost
Bioretention system	26,235	0.777	114	54,720	2.06	6,565	\$65,650
Pervious pavement	29,455	0.872	129	61,440	2.31	7,615	\$190,375

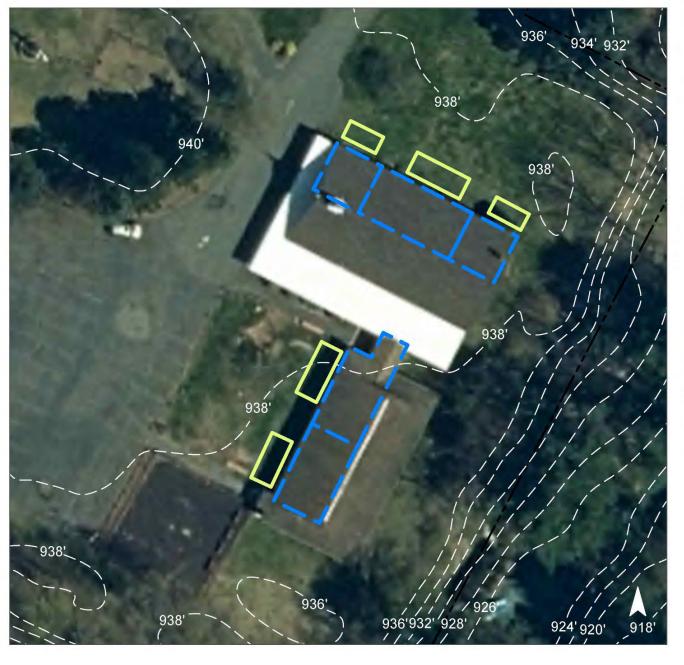
Good Shepherd Lutheran Church

Recommended Green Infrastructure Practices	Drainage Area (sq. ft.)	Recharge Potential (Mgal/yr)	TSS Removal Potential (lbs/yr)	Maximum Volume Reduction Potential (gal/storm)	Peak Discharge Reduction Potential (cu. ft./second)	Estimated Size (sq. ft.)	Estimated Cost
Bioretention system	3,930	0.116	17	8,200	0.31	985	\$9,850

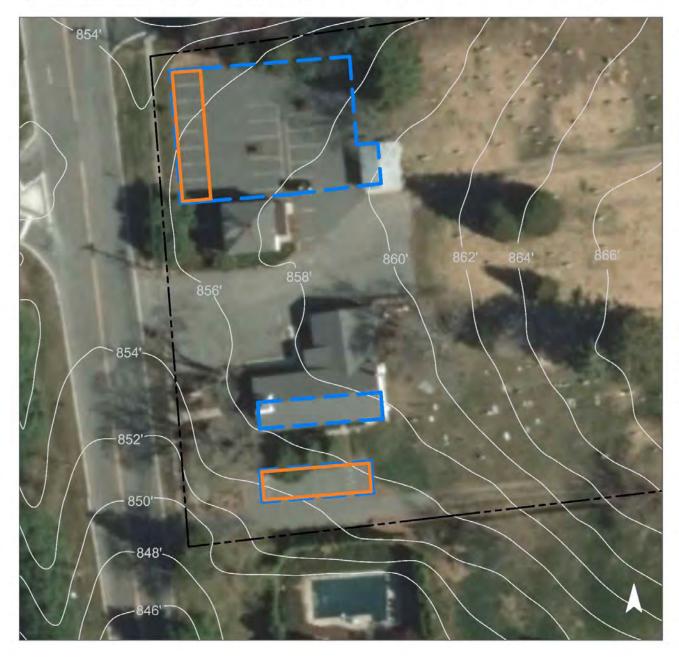
Millbrook United Methodist Church

Recommended Green Infrastructure Practices	Recharge Potential (Mgal/yr)	TSS Removal Potential (lbs/yr)	Maximum Volume Reduction Potential (gal/storm)	Peak Discharge Reduction Potential (cu. ft./second)	Estimated Size (sq. ft.)	Estimated Cost
Pervious pavement	0.254	43	19,840	0.75	2,485	\$62,125

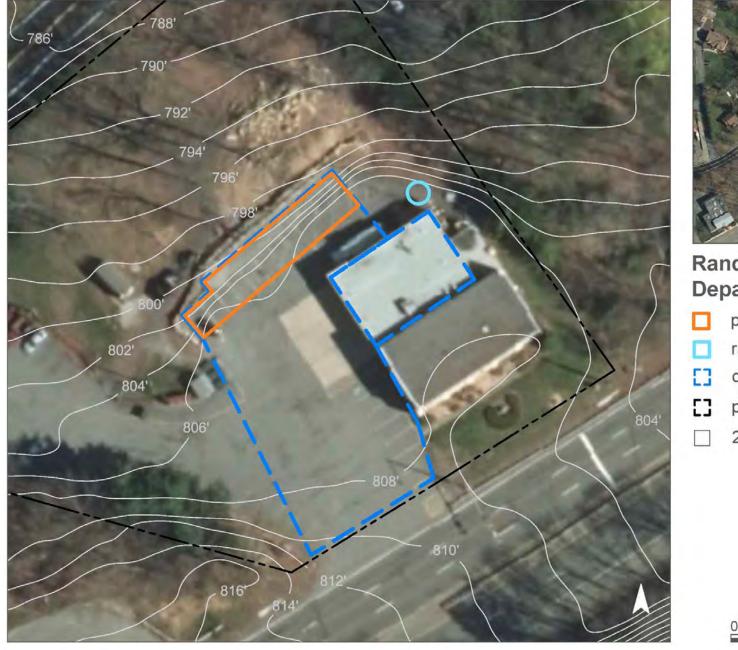
Randolph Township Fire Department Company #2

Recommended Green Infrastructure Practices	Recharge Potential (Mgal/yr)	TSS Removal Potential (lbs/yr)	Maximum Volume Reduction Potential (gal/storm)	Peak Discharge Reduction Potential (cu. ft./second)	Estimated Size (sq. ft.)	Estimated Cost
Pervious pavement	0.384	64	30,000	1.13	2,710	\$67,750
Rainwater harvesting	0.061	10	2,300	0.09	2,300 (gal)	\$4,000
