Appendix C
Concept Plans for Potential Green Infrastructure Projects

SOUTH BRANCH RARITAN RIVER WATERSHED: GREEN INFRASTRUCTURE SITES

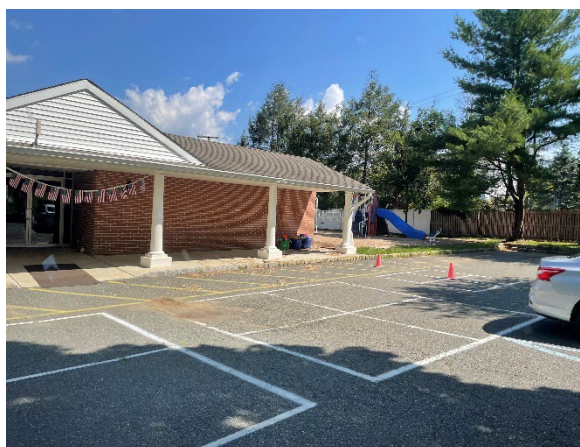
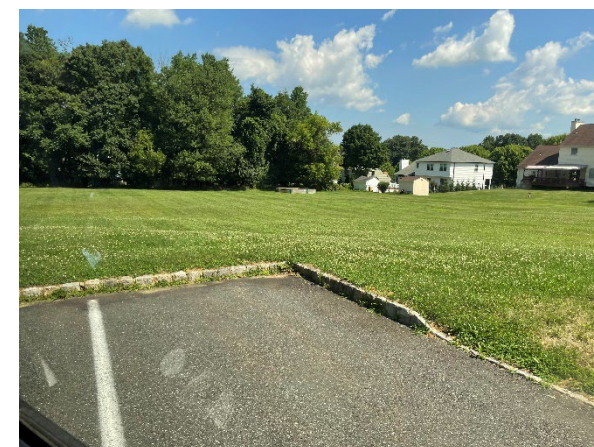
The pavement in the front of the building can be converted to porous pavement to capture and infiltrate stormwater runoff from the roof via already disconnected downspouts; the western downspout may require redirection towards the porous pavement. A rain garden with a curb cut can be installed in the grass area near the northwest corner of the building and a rain garden with a trench drain can be installed south of the building to capture, treat, and infiltrate stormwater runoff from the pavement. A preliminary soil assessment suggests that more soil testing would be required before determining the soil's suitability for green infrastructure.

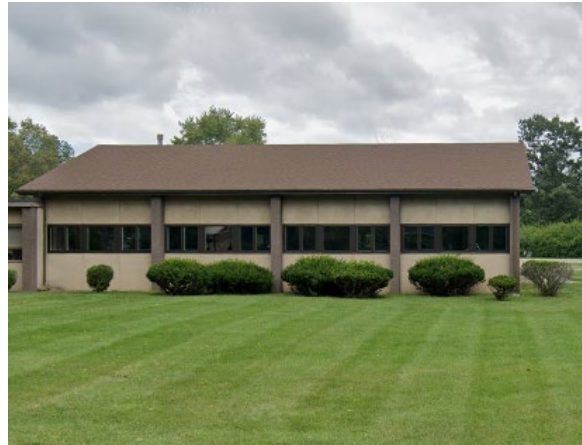
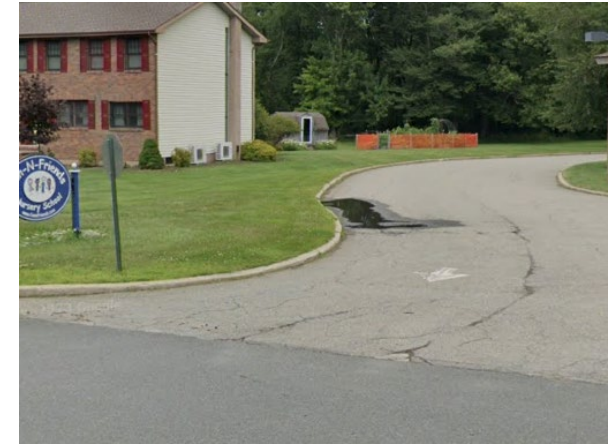
Rain gardens can be installed in multiple grass areas around the property to capture, treat, and infiltrate stormwater runoff from the rooftops and the driveway. Downspout redirections and disconnections will be required for some of these raingardens. A gutter system will need to be installed on the western section of the building for the northwestern rain garden. A trench train and curb cut will be needed for the southwestern rain garden. Existing parking spaces to the south and west of the lot can be converted into pervious pavement to capture and infiltrate stormwater runoff from the asphalt. A preliminary soil assessment suggests that more soil testing would be required before determining the soil's suitability for green infrastructure.

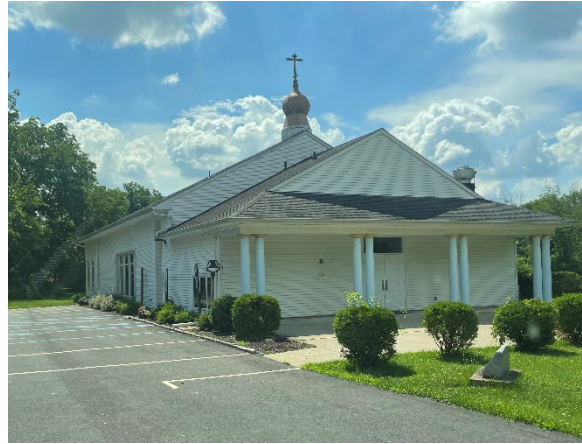
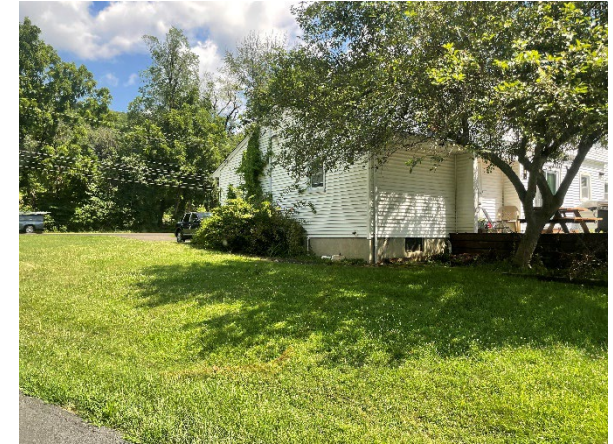
Parking spaces in the lot next to the southeast building can be converted to porous pavement to capture and infiltrate stormwater runoff from the asphalt and rooftop via already disconnected downspouts. Rain gardens can be installed in multiple grass areas around the property to capture, treat, and infiltrate stormwater runoff from the roofs and pavement. Trench drains and downspout disconnection and redirection will be required for some of these gardens. A preliminary soil assessment suggests that the soils have suitable drainage characteristics for green infrastructure.

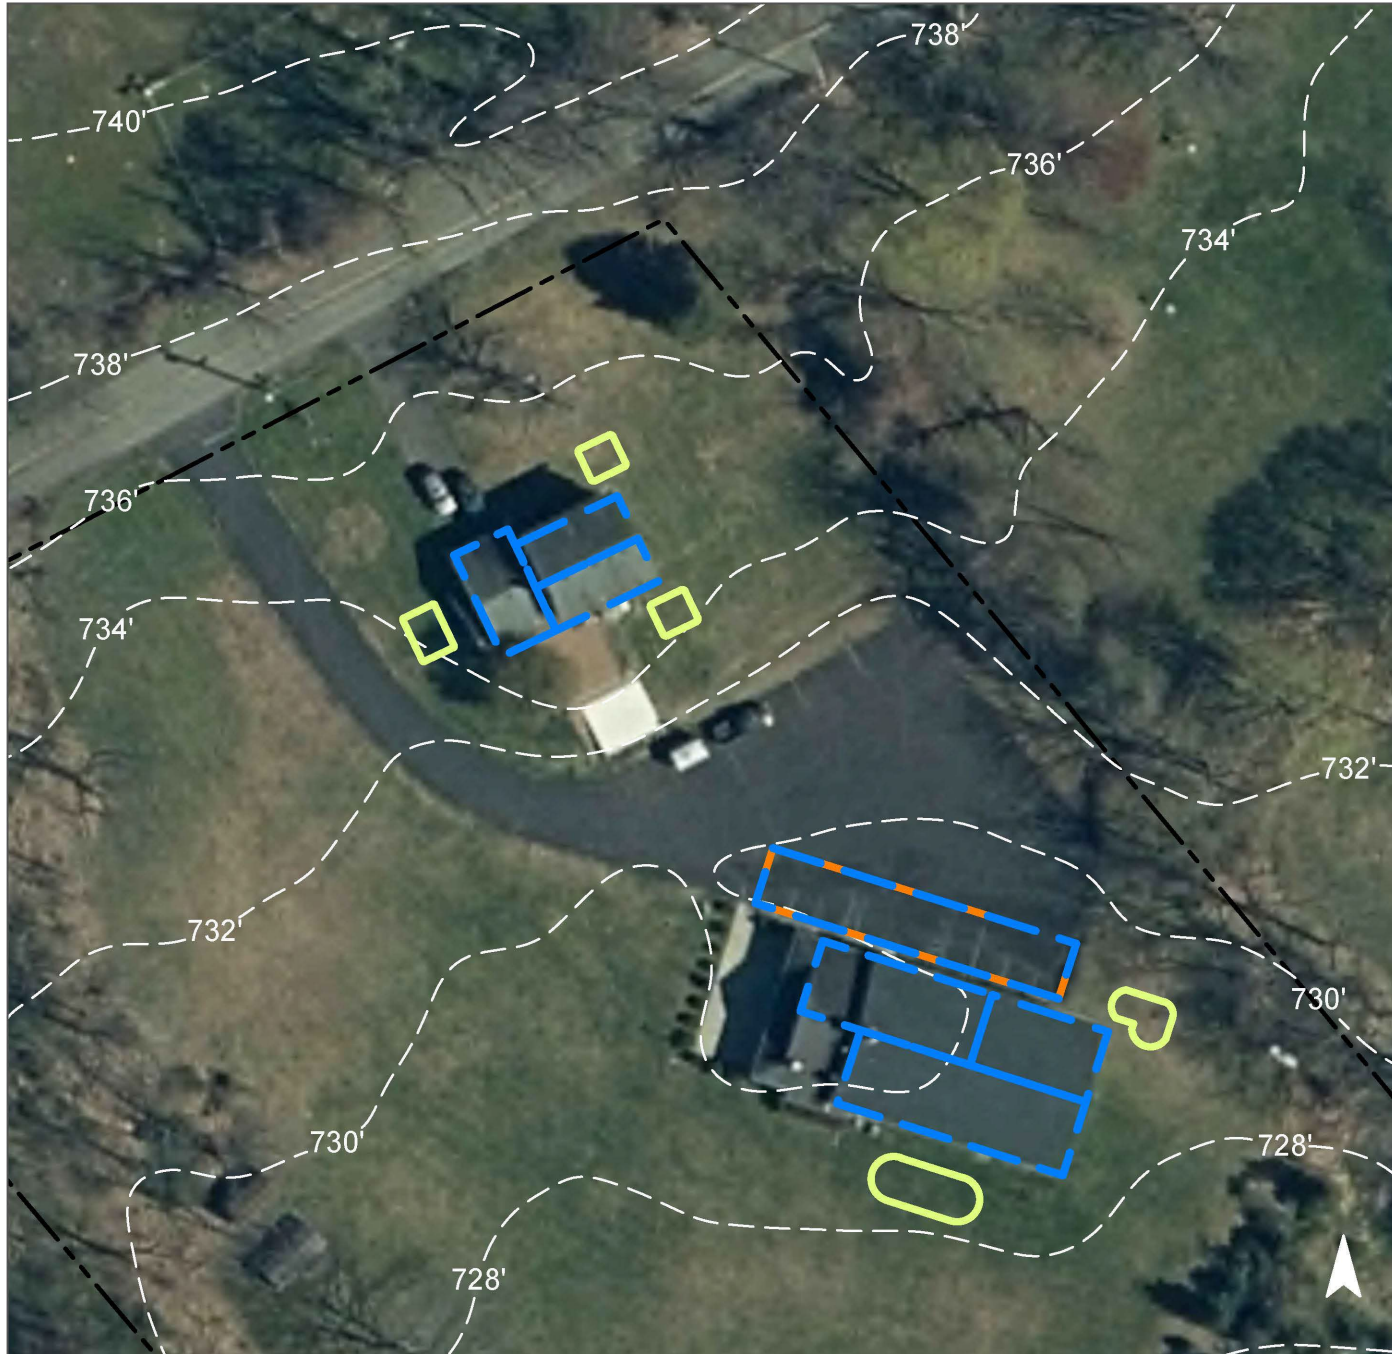
Holy Wisdom Byzantine Catholic Church

-   bioretention system
-   pervious pavement
-   captured drainage area
-   property line
-   2020 Aerial: NJOIT, OGIS

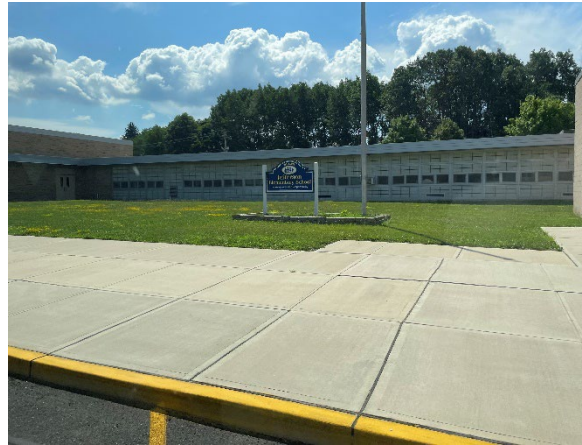
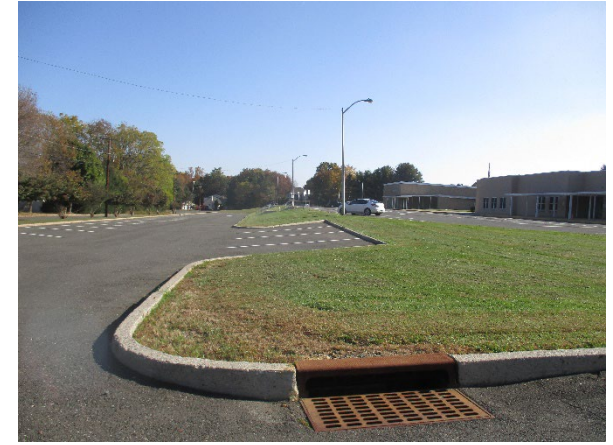
Parking spaces can be replaced with pervious pavement to capture and infiltrate stormwater. Downspout planter boxes can be installed on multiple locations north of the building. A rain garden can be installed in the parking island to capture, treat, and infiltrate additional stormwater runoff. Downspout planter boxes can be installed near the entrances to capture rooftop runoff and provide visual interest. A preliminary soil assessment suggests that more soil testing would be required before determining the soil's suitability for green infrastructure.

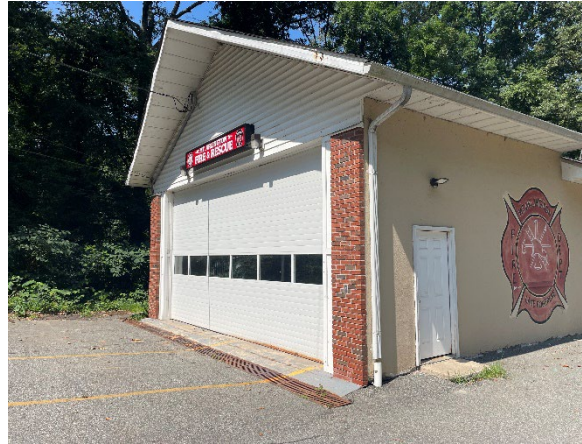
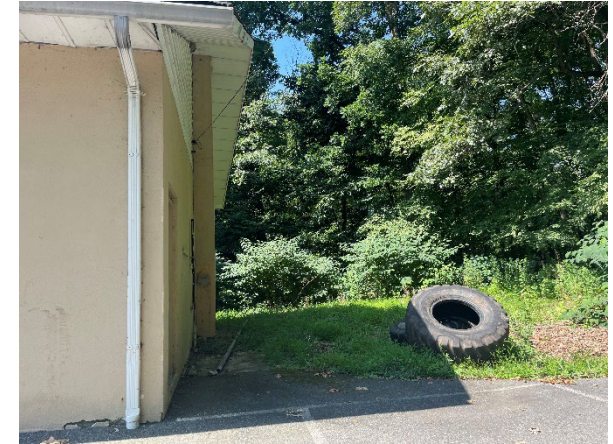
Cisterns can be installed to the northeast and southeast of the building to divert and detain the stormwater runoff from the rooftop for later non-potable reuse such as washing vehicles.

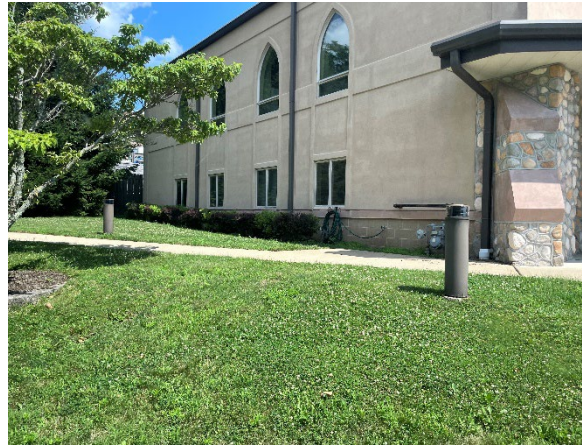
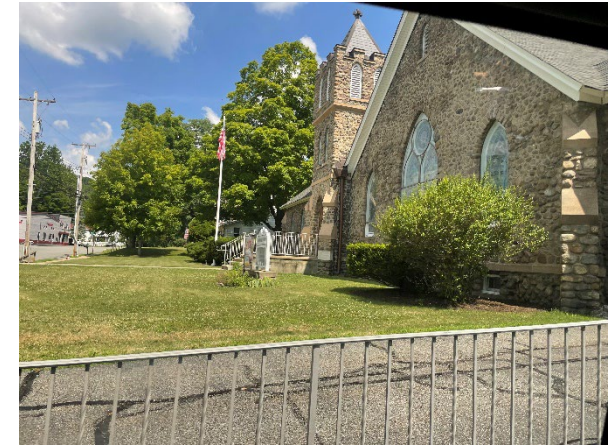
Four rain gardens that require downspout disconnection and redirection can be installed in the grass areas around the property building to capture, treat, and infiltrate stormwater runoff from the roofs. One rain garden can be installed in the grass area on the east side of the site to capture, treat, and infiltrate stormwater runoff from the parking lot. A preliminary soil assessment suggests that the soils have suitable drainage characteristics for green infrastructure.

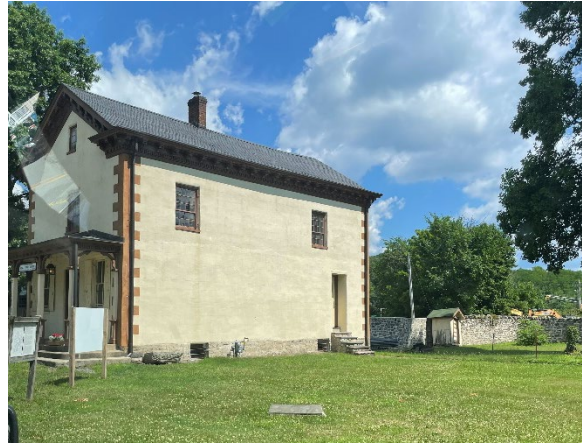
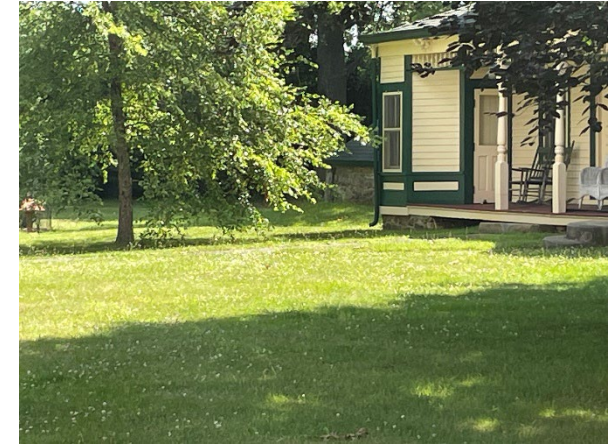
A rain garden can be installed in the grass area next to the west building to capture, treat, and infiltrate stormwater runoff from the roof. Three rain gardens, one of which requires downspout disconnection, can be installed next to the east building to capture, treat, and infiltrate stormwater runoff from the roof. A preliminary soil assessment suggests that more soil testing would be required before determining the soil's suitability for green infrastructure.

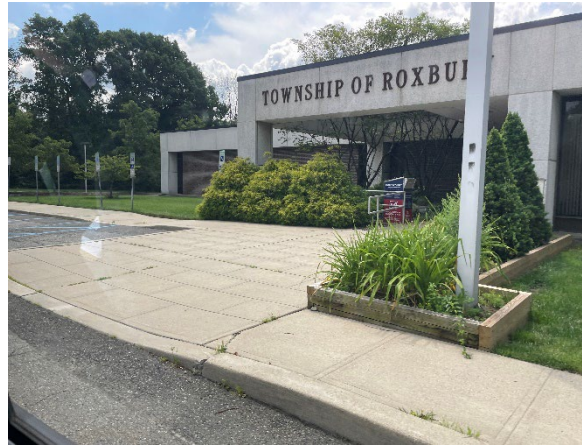
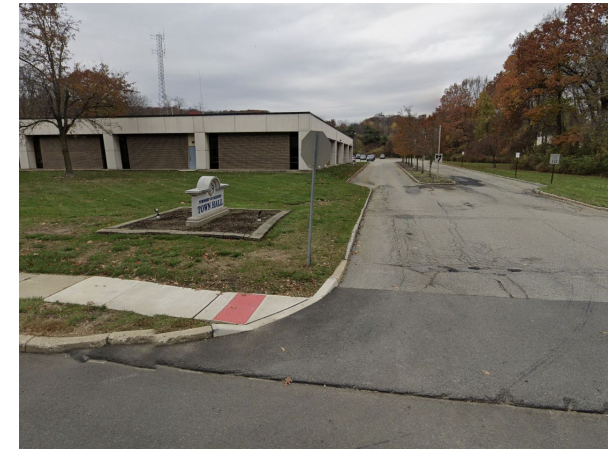
Three rain gardens can be installed in the grass areas on the east and west sides at the front of the building to capture, treat, and infiltrate stormwater runoff from the pavement. The gardens will require curb cuts and trench drains. Parking spaces on the west side of the building and behind the building can be converted to porous pavement to capture and infiltrate stormwater runoff from the parking lot. A preliminary soil assessment suggests that more soil testing would be required before determining the soil's suitability for green infrastructure.

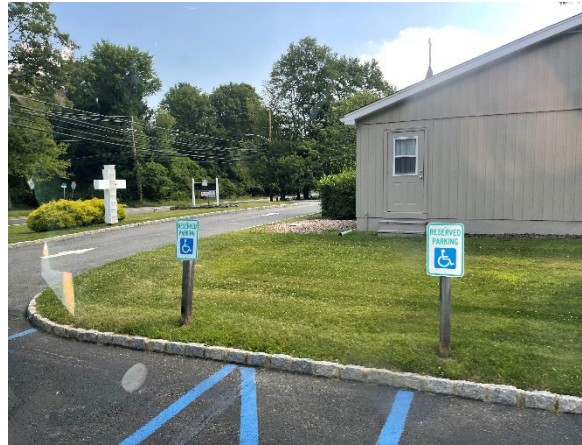
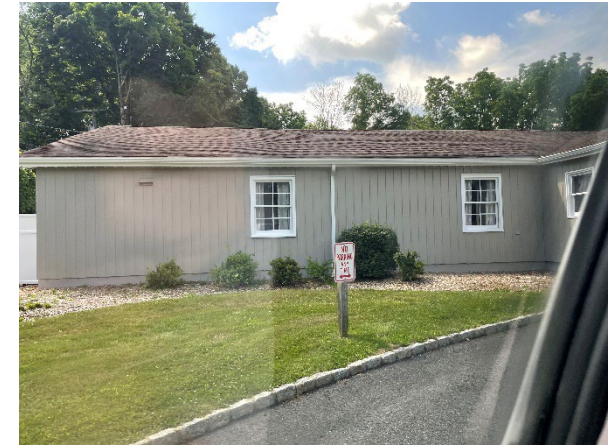
Parking spaces in the lot can be converted to porous pavement using trench drains to redirect, capture and infiltrate stormwater runoff from the pavement. A rain garden with a curb cut can be installed in the grass area near the entrance of the parking lot to capture, treat, and infiltrate stormwater runoff from the pavement. Two rain gardens can be installed near the building entrance to capture, treat, and infiltrate stormwater runoff from the roof via already disconnected downspouts that will require redirection. A preliminary soil assessment suggests that more soil testing would be required before determining the soil's suitability for green infrastructure.

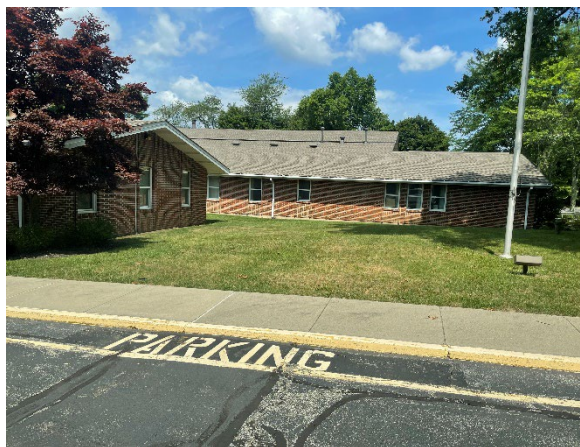
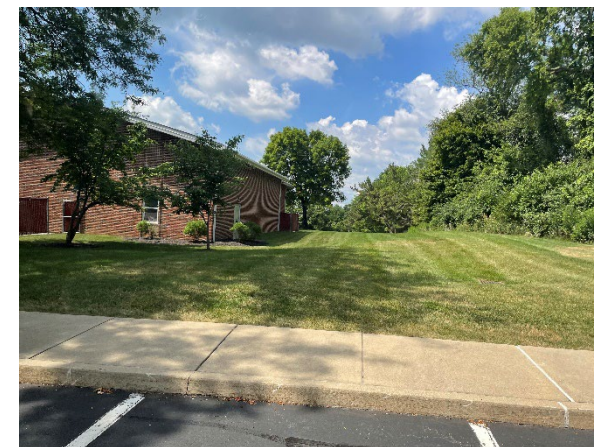
Several rain gardens that require downspout disconnection and redirection can be installed in the grass areas around the building to capture, treat, and infiltrate stormwater runoff from the roof. One rain garden that requires a curb cut and trench drain can be installed in the grass area southwest of the building to capture, treat, and infiltrate stormwater runoff from the pavement. A preliminary soil assessment suggests that the soils have suitable drainage characteristics for green infrastructure.

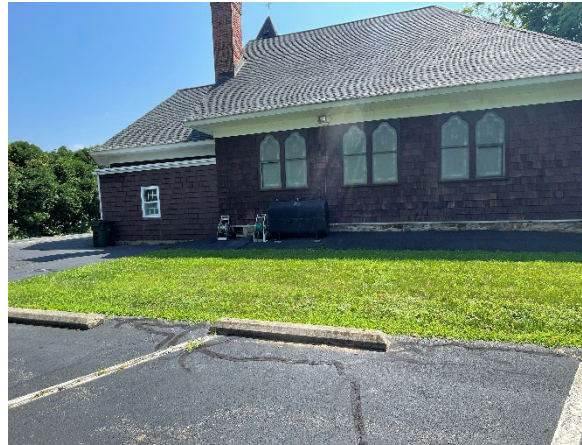
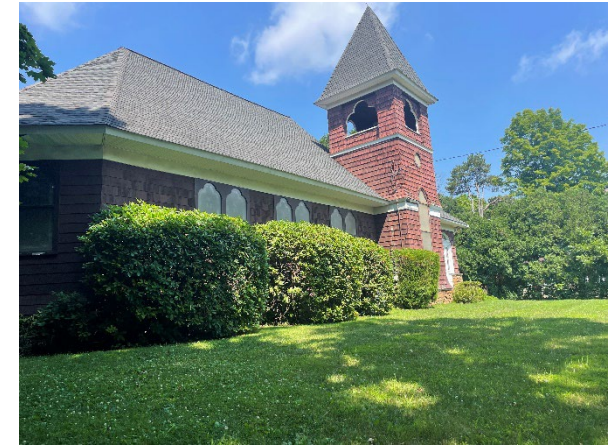
Rain gardens can be installed to the east and west of the building to capture, treat, and infiltrate stormwater runoff from the rooftop. This will require the installation of a gutter system on the building. Existing parking spaces to the west and north of the building can be converted into pervious pavement to capture and infiltrate stormwater runoff from the asphalt. A preliminary soil assessment suggests that more soil testing would be required before determining the soil's suitability for green infrastructure.

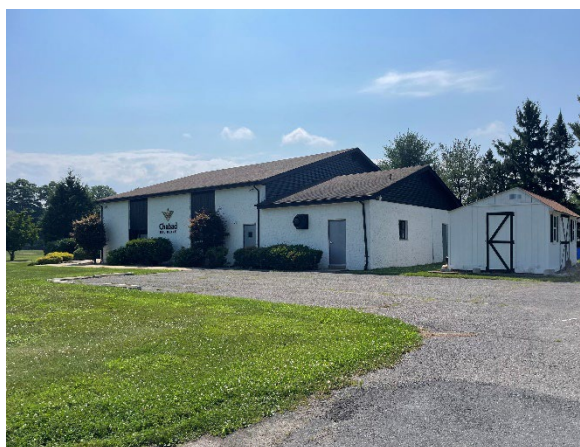
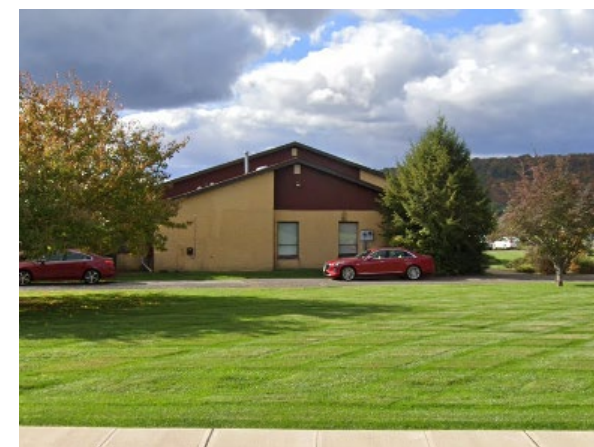
Rain gardens can be installed to the north and east of the building to capture, treat, and infiltrate stormwater runoff from the rooftop and the driveway. This will require downspout redirections beneath the sidewalk and the driveway, as well as trench drains. A cistern can be installed to the northwest of the building to divert and detain the stormwater runoff from the rooftop for later non-potable reuse such as watering the landscaping vegetation. A preliminary soil assessment suggests that more soil testing would be required before determining the soil's suitability for green infrastructure.

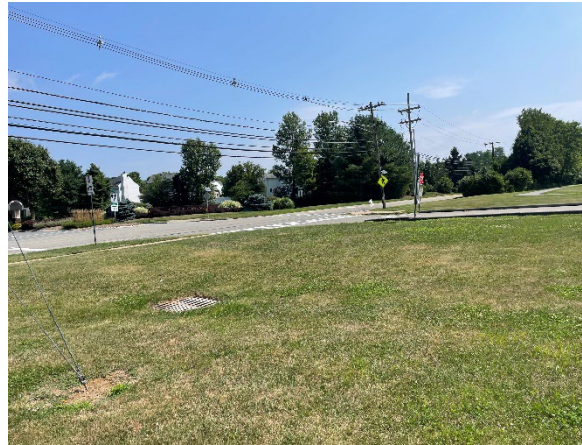
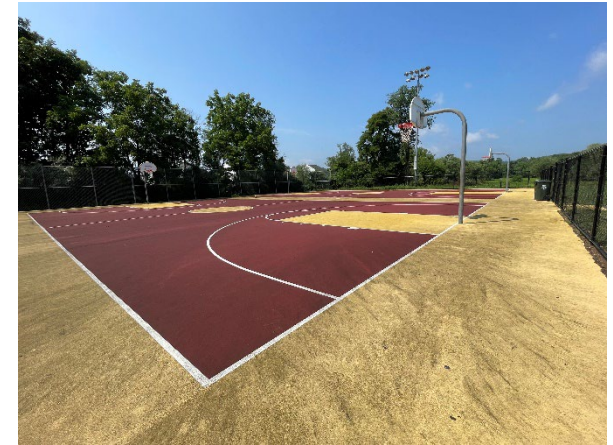
A rain garden can be installed to the southeast corner of the pavilion to capture, treat, and infiltrate stormwater runoff from the rooftop. A gutter system will need to be installed. Another rain garden can be installed to the west of the driveway entrance to capture, treat, and infiltrate stormwater runoff from the asphalt. A trench drain will be required. The rain garden can be installed near the existing catch basin, which can be used as an overflow. Existing parking spaces to the west of the lot can be converted into pervious pavement to capture and infiltrate stormwater runoff from the asphalt. The basketball courts can be converted to pervious pavement to capture and infiltrate stormwater runoff from the courts. A preliminary soil assessment suggests that more soil testing would be required before determining the soil's suitability for green infrastructure.

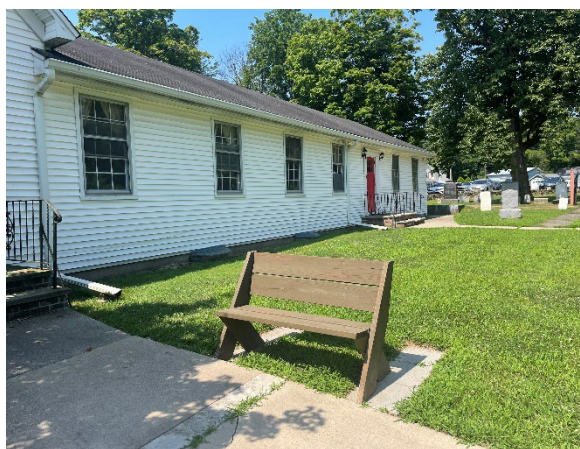
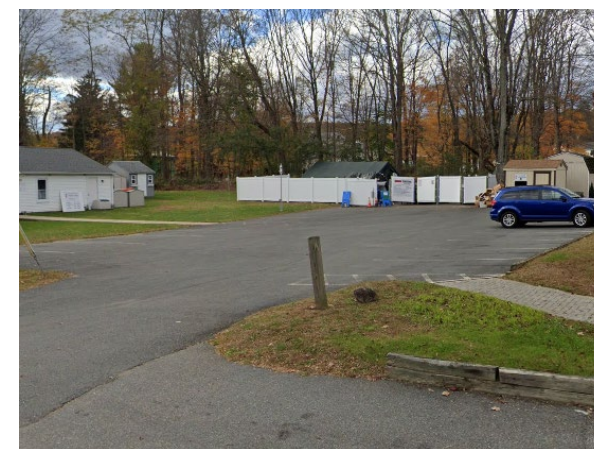
Rain gardens can be installed in multiple grass areas around the buildings using the existing disconnected downspouts to capture, treat, and infiltrate stormwater runoff from the rooftops. Some of the disconnected downspouts will need to be extended to the rain gardens. The existing parking spaces to the north of the thrift shop building can be converted into pervious pavement to capture and infiltrate stormwater runoff from the asphalt. A preliminary soil assessment suggests that more soil testing would be required before determining the soil's suitability for green infrastructure.

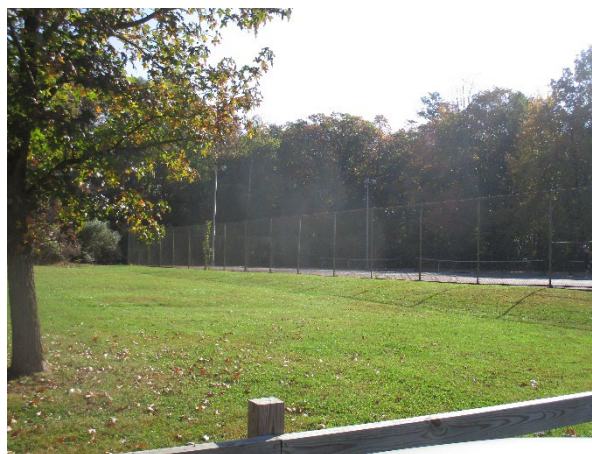
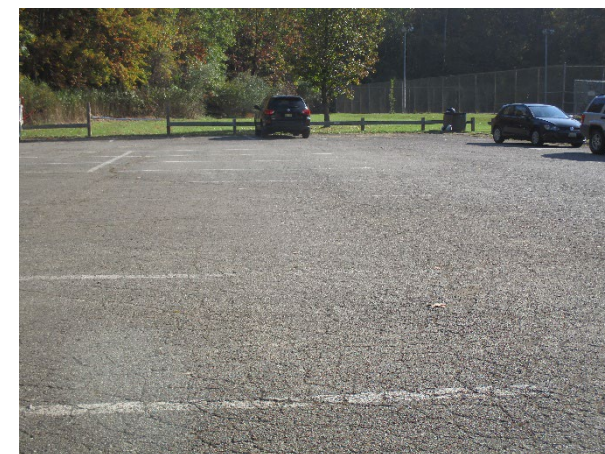
Parking spaces can be replaced with pervious pavement on the southernmost parking strip in the lot to capture and infiltrate stormwater. A rain garden can be installed near the tennis court to capture stormwater. A preliminary soil assessment suggests that more soil testing would be required before determining the soil's suitability for green infrastructure.

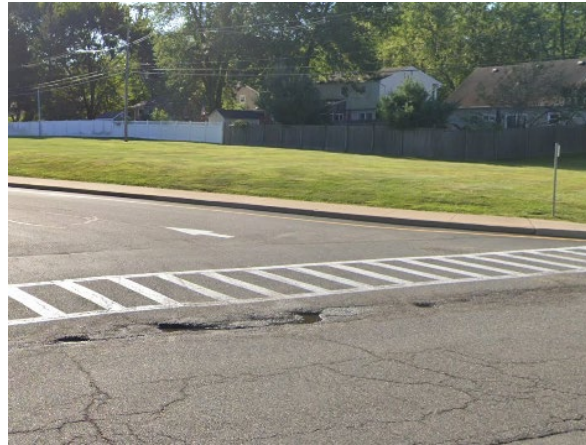
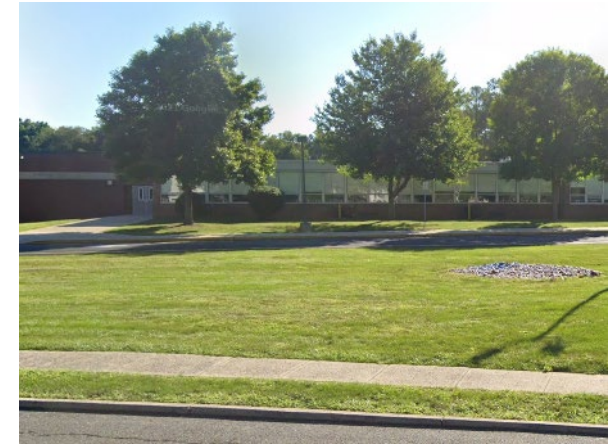
Rain gardens can be installed in multiple grass areas around the property to capture, treat, and infiltrate stormwater runoff from the driveways and the southern parking lot. Curb cuts and a trench drain will be required for some of these rain gardens. Existing parking spaces to the north of the northern lot can be converted into pervious pavement to capture and infiltrate stormwater runoff from the asphalt. A preliminary soil assessment suggests that more soil testing would be required before determining the soil's suitability for green infrastructure.

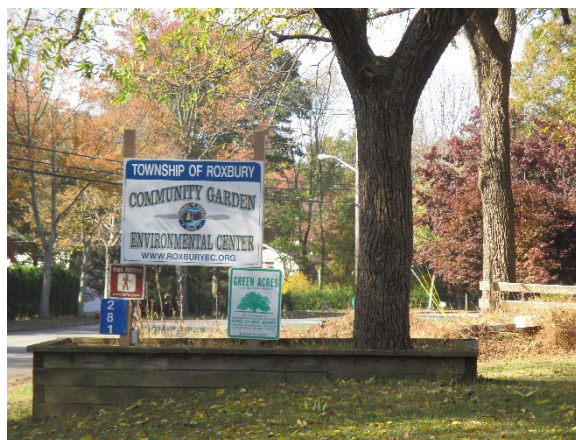
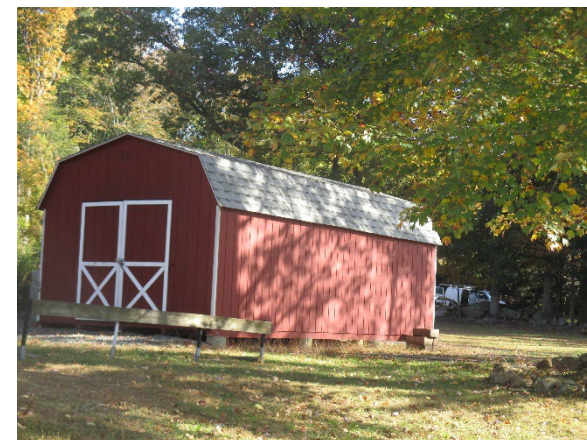
A cistern can be installed to capture stormwater from the roof of the shed in front of the garden, and the water can be reused for watering plants or other non-potable purposes. A preliminary soil assessment suggests that more soil testing would be required before determining the soil's suitability for green infrastructure.

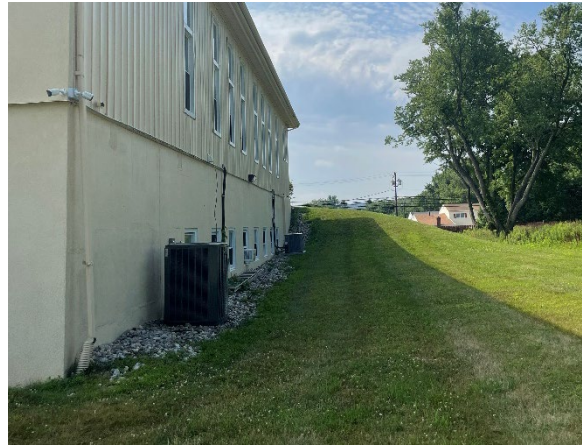
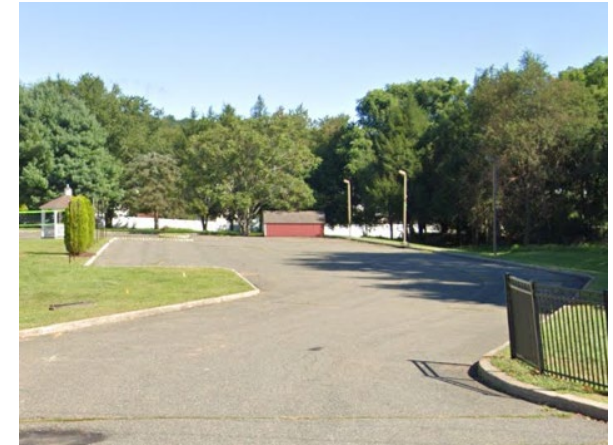
Rain gardens can be installed to the east and west of the building to capture, treat, and infiltrate stormwater runoff from the rooftop. Downspout redirections beneath the sidewalk will be required for the eastern rain garden. Downspout redirection and disconnection will be required for the western rain garden. Existing parking spaces to the north and east of the building can be converted into pervious pavement to capture and infiltrate stormwater runoff from the asphalt. A preliminary soil assessment suggests that more soil testing would be required before determining the soil's suitability for green infrastructure.

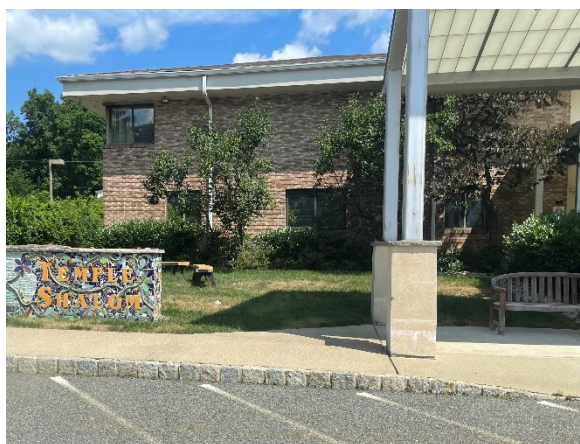
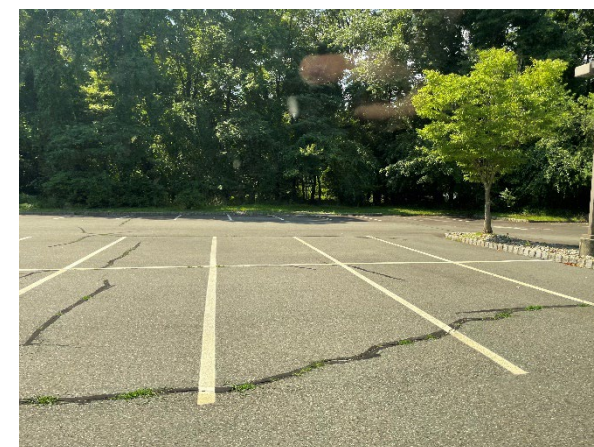
Parking spaces in the lot to the north and south of the building can be converted to porous pavement to capture and infiltrate stormwater runoff from the roof and asphalt; this requires downspout disconnection and trench drains for redirection. A rain garden requiring downspout disconnection can be installed in the grass area in the rear of the building to capture, treat, and infiltrate stormwater runoff from the roof. A preliminary soil assessment suggests that more soil testing would be required before determining the soil's suitability for green infrastructure.

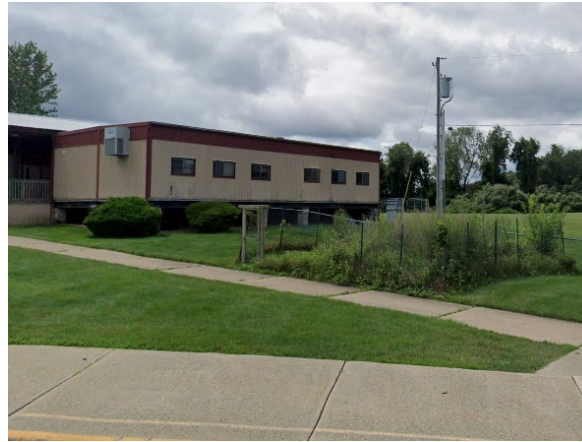
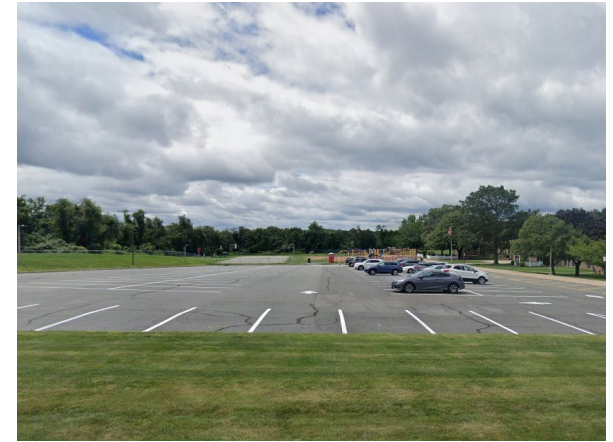
Rain gardens can be installed in multiple grass areas around the property to capture, treat, and infiltrate stormwater runoff from the driveway. Curb cuts will be required, and a trench drain may also be needed for the rain garden to the north of the school. Existing parking spaces in the lot can be converted into pervious pavement to capture and infiltrate stormwater runoff from the asphalt. Trench drains will be required. The basketball courts can be converted into pervious pavement to capture and infiltrate stormwater runoff from the courts. A cistern can be installed to the northwest of the northern shed to divert and detain the stormwater runoff from the rooftop for later non-potable reuse such as watering the nearby garden. The downspouts can be reworked so that all shed runoff is managed by the cistern. A preliminary soil assessment suggests that the soils have suitable drainage characteristics for green infrastructure.

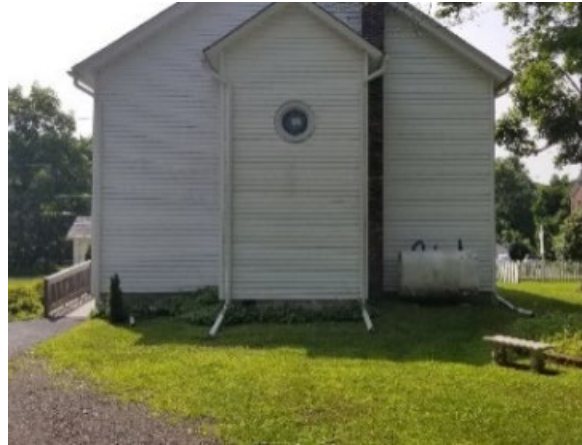
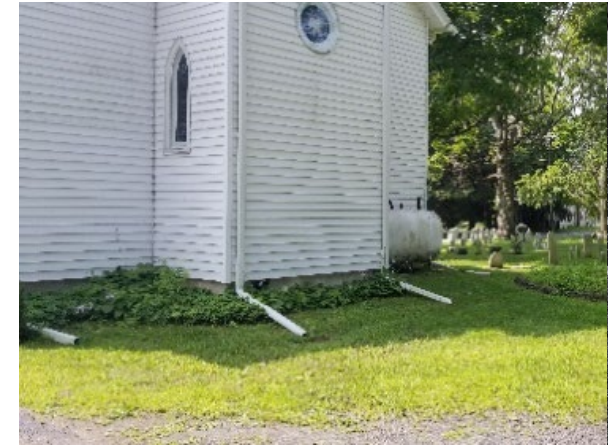
Downspout planter boxes can be installed to capture and retain runoff from the rooftop. Pervious pavement is proposed along the south edge of the parking lot to treat the entire parking lot's drainage area. A preliminary soil assessment suggests that more soil testing would be required before determining the soil's suitability for green infrastructure.

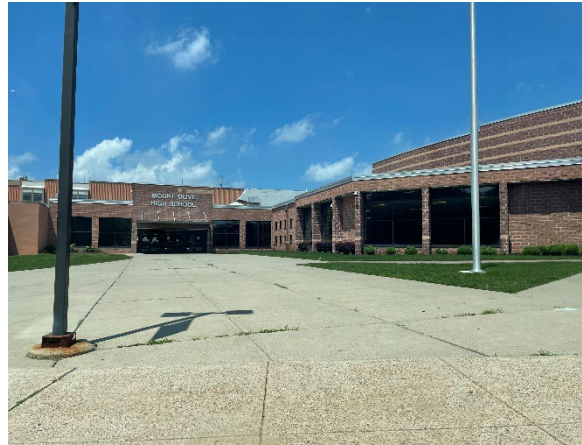
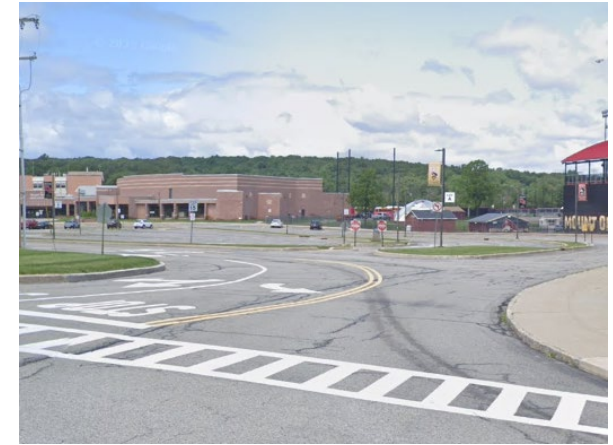
A rain garden can be installed to the south of the eastern sheds to capture, treat, and infiltrate stormwater runoff from the rooftops. This may require gutter installation or reworking of existing downspouts. Existing parking spaces in the eastern, western, and northern lots can be converted into pervious pavement to capture and infiltrate stormwater runoff from the asphalt. The concrete entryway to the south of the school can be replaced with permeable pavers. A preliminary soil assessment suggests that the soils have suitable drainage characteristics for green infrastructure.

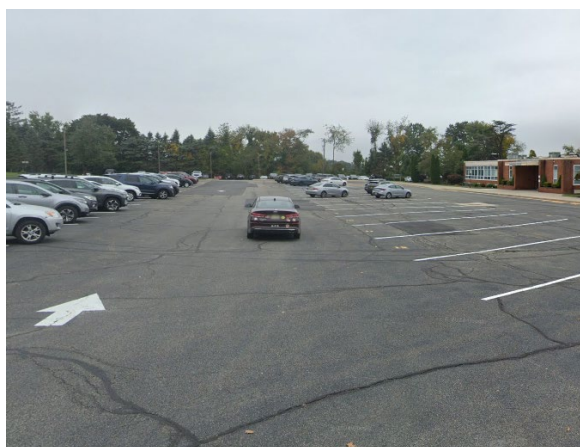
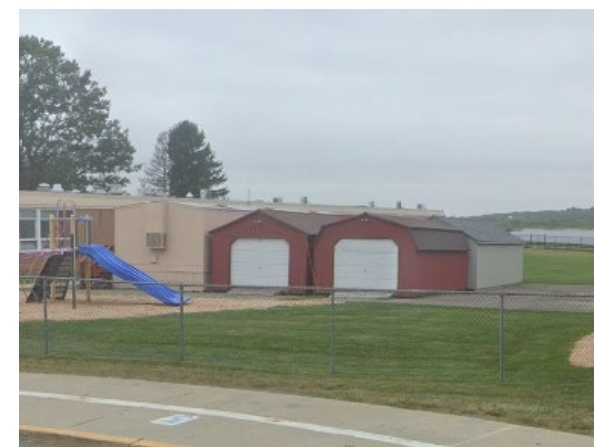
A rain garden can be installed to the north of the eastern sheds to capture, treat, and infiltrate stormwater runoff from the rooftops. This will require gutter system installations. Existing parking spaces to the south and west of the building can be converted into pervious pavement to capture and infiltrate stormwater runoff from the asphalt. The basketball court can be converted into pervious pavement to capture and infiltrate stormwater runoff from the court. A preliminary soil assessment suggests that the soils have suitable drainage characteristics for green infrastructure.

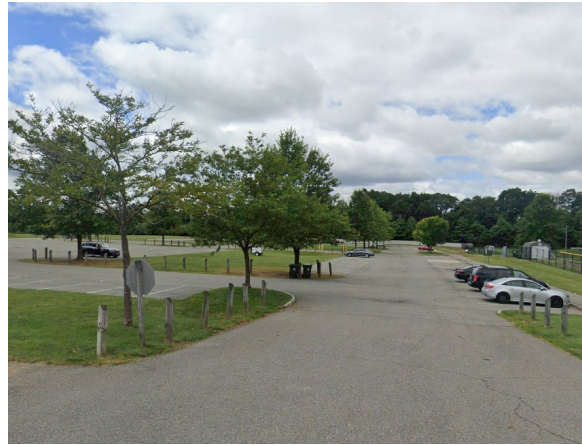
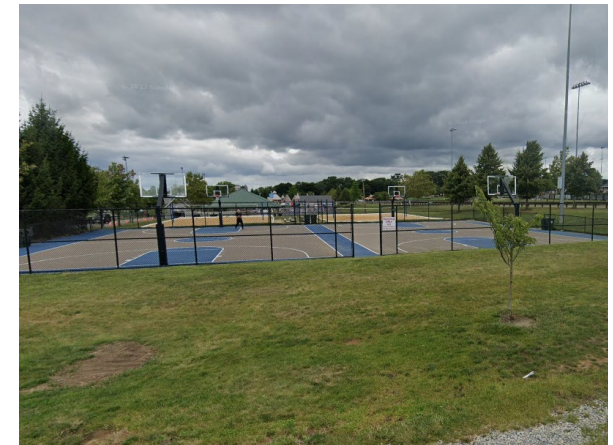
A rain garden can be installed to the northwest corner of the southwestern shed to capture, treat, and infiltrate stormwater runoff from the rooftop. This will require gutter system installation. Another rain garden can be installed to the north of the southwestern parking lot to capture, treat, and infiltrate stormwater runoff from the asphalt. Existing parking spaces to the north, east, and southwest can be converted into pervious pavement to capture and infiltrate stormwater runoff from the asphalt. The tennis and basketball courts can be converted into pervious pavement to capture and infiltrate stormwater runoff from the courts. A preliminary soil assessment suggests that more soil testing would be required before determining the soil's suitability for green infrastructure.

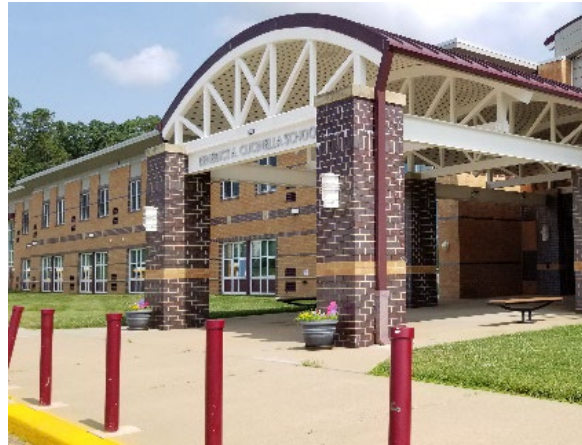
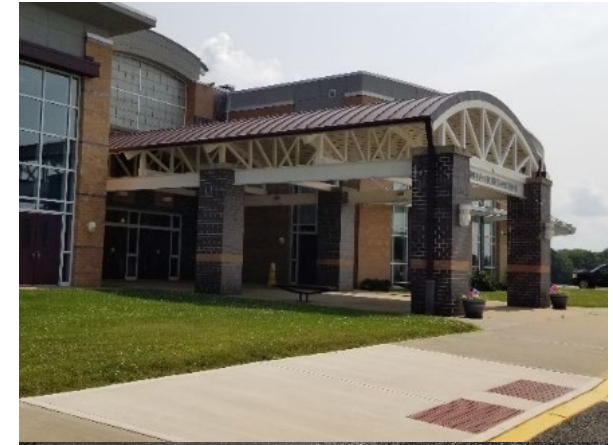
Downspout planter boxes are suggested at the entrance of the school to promote green infrastructure awareness. A section of parking spaces can be converted to pervious pavement to capture and infiltrate runoff from the parking lot. Tree filter boxes can be installed in islands in the parking lot to capture runoff from other spaces in the parking lot. A preliminary soil assessment suggests that more soil testing would be required before determining the soil's suitability for green infrastructure.

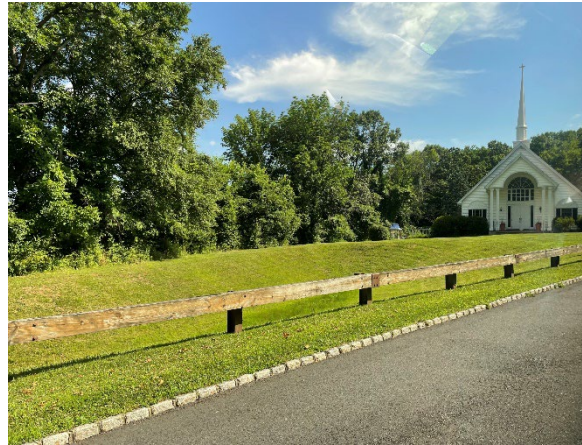
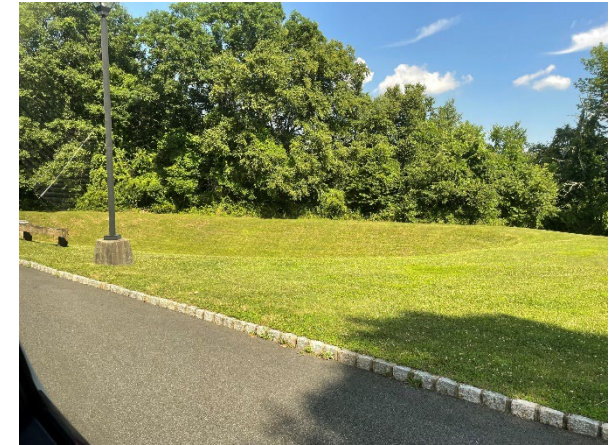
In the southwest corner of the property, there is an existing retention basin to which water is conveyed from the rooftop and pavement via connected downspouts and catch basins. This can be converted into a rain garden to capture, treat, and infiltrate stormwater runoff. A trench drain can be installed half-way up the driveway coming from the southwest to increase runoff capture and convey it to the rain garden. Two rain gardens can also be installed off the northwest facade of the house in the southeast section of the property. A preliminary soil assessment suggests that more soil testing would be required before determining the soil's suitability for green infrastructure.

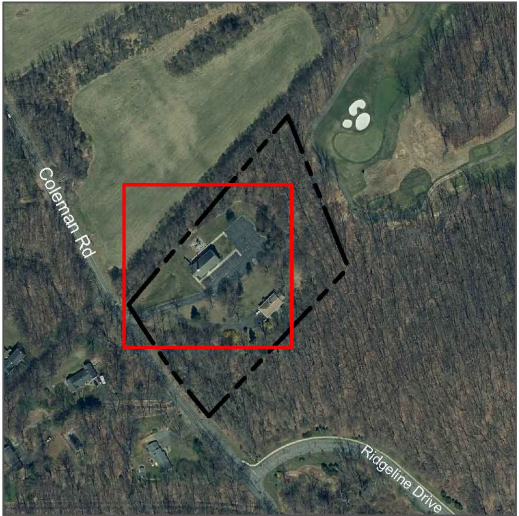
Immanuel Lutheran Church

-   bioretention system
-   captured drainage area
-   property line
-

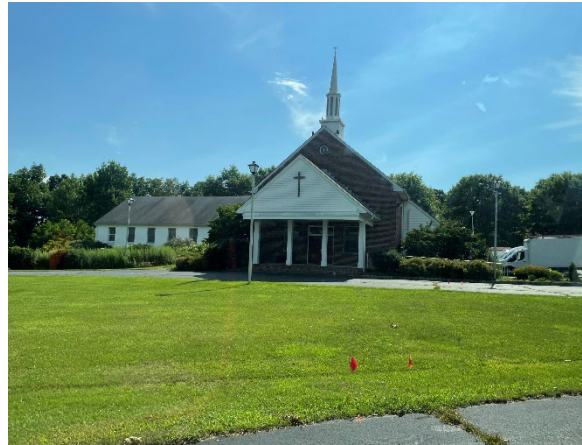
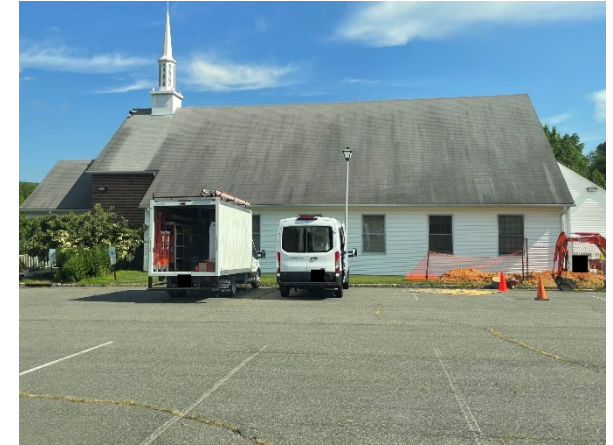
Rain gardens can be installed off the north and west ends of the parking lot, and the west face of the church to capture, treat, and infiltrate stormwater runoff. In the west end of the parking lot, a trench drain could be installed on the western side of the roundabout to increase stormwater runoff capture. The existing parking spaces off the south and east faces of the building can be converted into pervious pavement to capture and infiltrate stormwater. The pervious pavement off the south face of the building would collect runoff from the parking lot and via downspouts which require disconnection, and the pervious pavement off the east face would collect runoff from the parking lot. A preliminary soil assessment suggests that more soil testing would be required before determining the soil's suitability for green infrastructure.

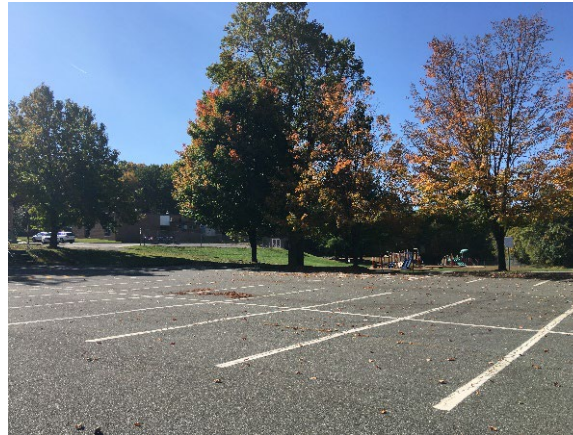
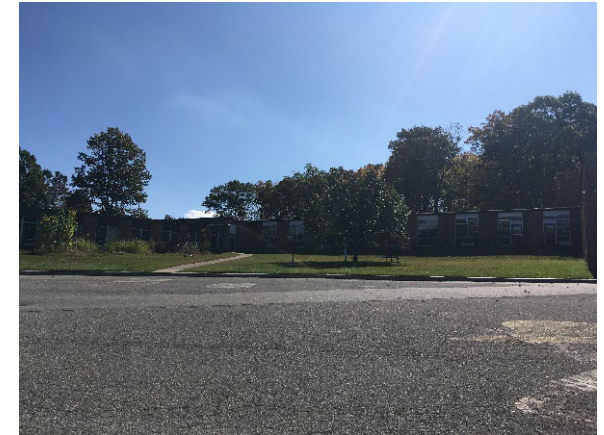
Two rain gardens can be installed to capture, treat, and infiltrate stormwater runoff from the building's roof as well as the adjacent parking lot. A preliminary soil assessment suggests that the soils have suitable drainage characteristics for green infrastructure.

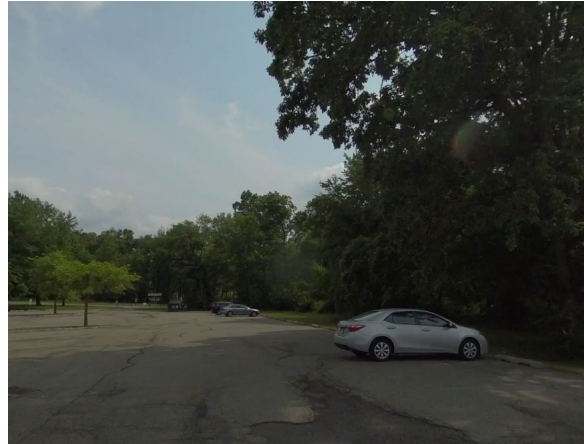
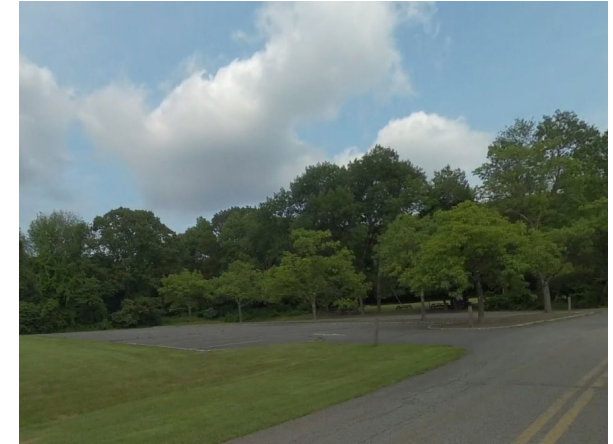
Rain gardens can be installed to capture, treat, and infiltrate stormwater runoff coming from the rooftops of buildings in the northwest corner of the property, in the west corners of the central parking lot, and the smaller parking lot further southeast. A bioswale can be installed off the northern edge of the central eastern parking lot to treat stormwater runoff while conveying it toward a catch basin in the western corner of this lot. In the furthest southeast parking lots, rows of parking stalls can be converted to pervious pavement to capture and infiltrate stormwater runoff from the pavement. A preliminary soil assessment suggests that more soil testing would be required before determining the soil's suitability for green infrastructure.
