Appendix C
Concept Plans for Potential Green Infrastructure Projects

SOUTH BRANCH RARITAN RIVER WATERSHED: GREEN INFRASTRUCTURE SITES

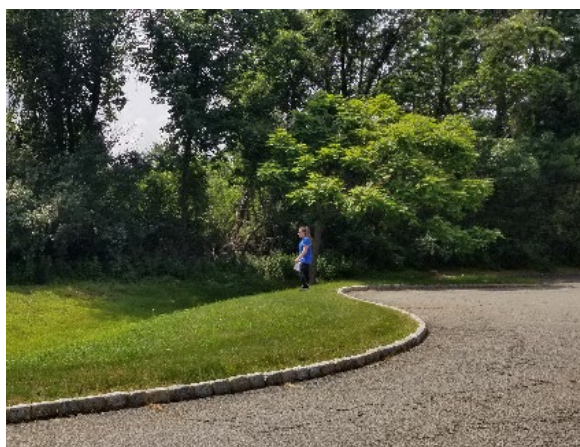
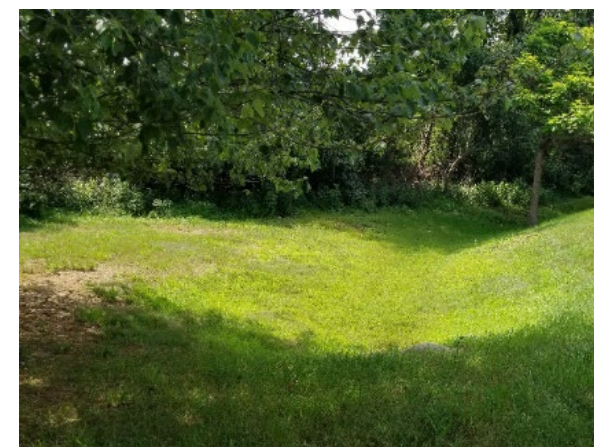
A bioretention system can be installed in the southeast corner of the property to mitigate flooding. Additionally, pervious pavement is suggested adjacent to the southwest edge of the building to capture and infiltrate stormwater runoff from the parking lot. A preliminary soil assessment suggests that more soil testing would be required before determining the soil's suitability for green infrastructure.

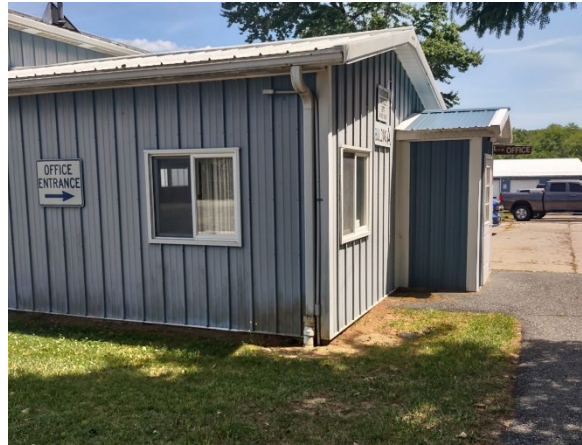
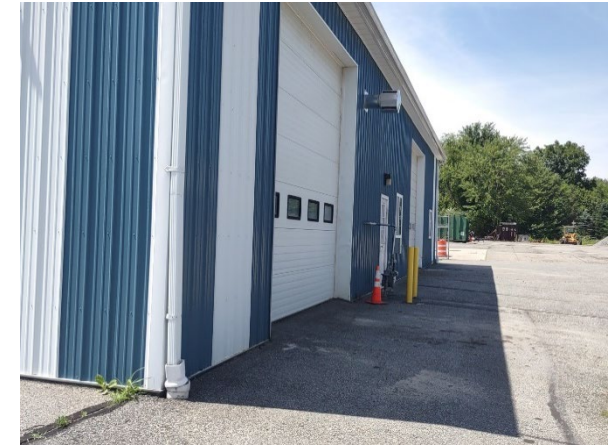
Rain gardens can be installed off the northwest corner and southern edge of the two buildings in the west edge of the property, and off the southern facades of the two buildings in the southeast edge of the property to capture, treat, and infiltrate stormwater from the rooftops via downspouts requiring disconnection. Rows of parking stalls off the west face of the western buildings, south face of the building in the northeast, and northwest corner of the building in the east can be converted to pervious pavement to capture and infiltrate stormwater runoff. The northeast and east buildings require one downspout each to be disconnected. A preliminary soil assessment suggests that the soils have suitable drainage characteristics for green infrastructure.

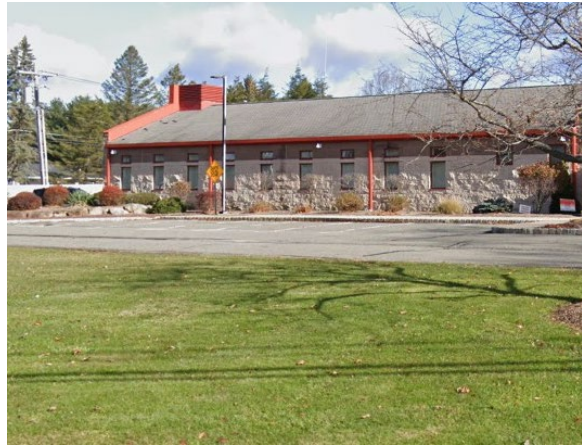
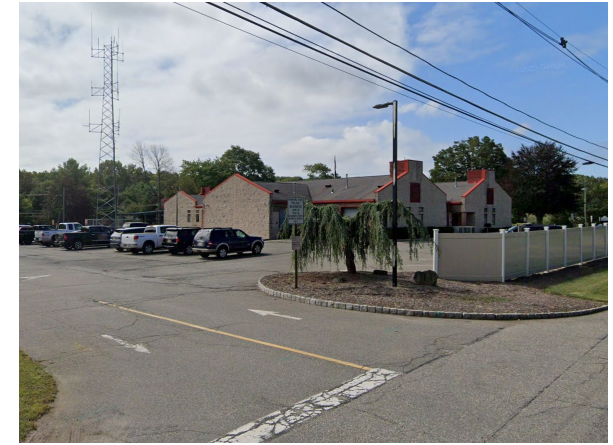
A rain garden off the southeast facade of the building to capture, treat, and infiltrate stormwater runoff from the rooftop. The rows of parking stalls off the southwest and northeast facades of the building can be converted into pervious pavement to capture and infiltrate stormwater from the rooftop. Two cisterns could be installed off the northeast corner and eastern nook of the building to divert and detain stormwater runoff for later non-potable reuse such as washing police vehicles. All stormwater conveyed from the rooftop is via downspouts which would require disconnection. A preliminary soil assessment suggests that the soils have suitable drainage characteristics for green infrastructure.

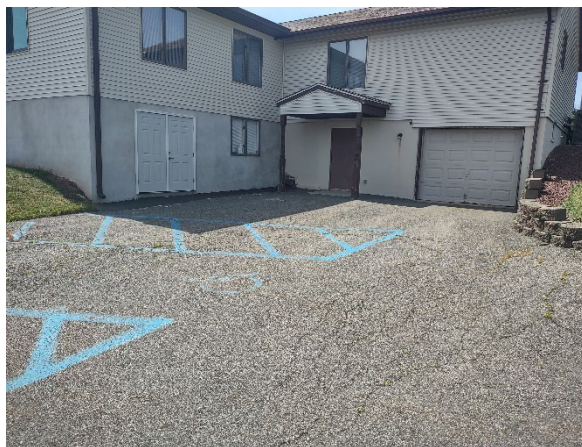
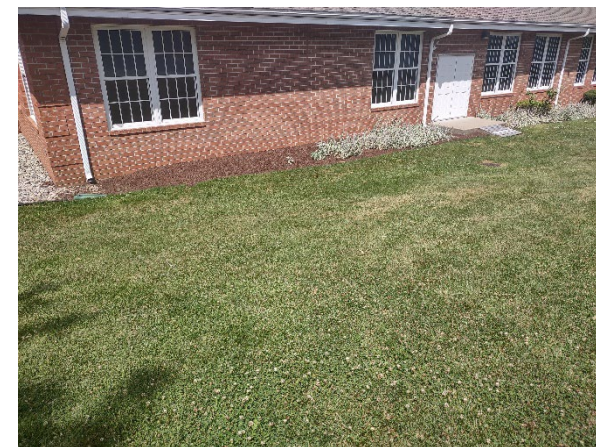
Rain gardens can be installed off the northeast and southwest corners of the senior center, and the south face of the library to capture, treat, and infiltrate stormwater from the roof via disconnected downspouts. Rows of parking stalls in the two parking lots to the north, the small parking lot off the south facade of the senior center, and the southern tip of the library's parking lot can be converted to pervious pavement to capture and infiltrate stormwater from the roof and pavement. A bioswale can also be installed along the northern half of the library's parking lot to convey water to the catch basins along the way while treating it. A preliminary soil assessment suggests that the soils have suitable drainage characteristics for green infrastructure.

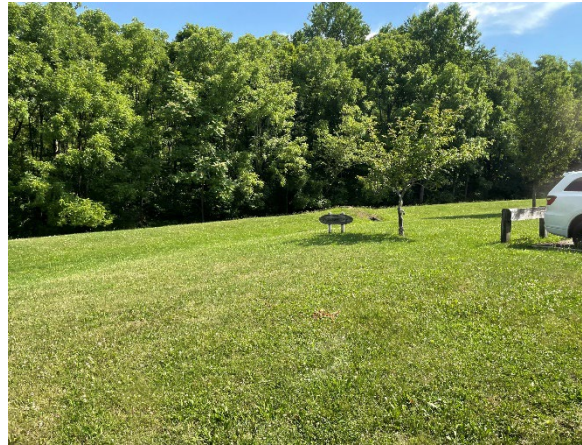
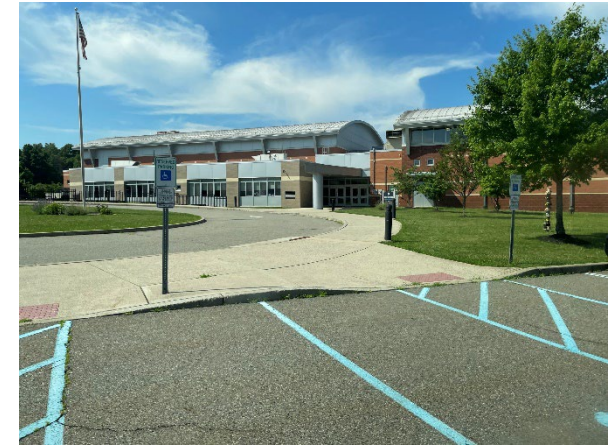
Rain gardens may be installed off portions of the west, south, and east facades of the school building to capture, treat and infiltrate stormwater runoff. Runoff would be conveyed to these rain gardens via downspouts requiring disconnection. Two existing swales can be converted to bioswales on the north and northwest sections of the property to treat stormwater runoff from adjacent parking lots, while conveying it to catch basins. Rows of parking stalls in the southeastern and northeastern parking lots can be converted to pervious pavement to capture and infiltrate stormwater runoff from the pavement. A preliminary soil assessment suggests that more soil testing would be required before determining the soil's suitability for green infrastructure.

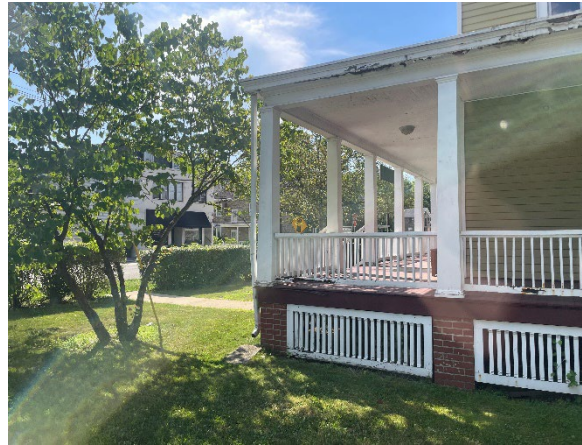
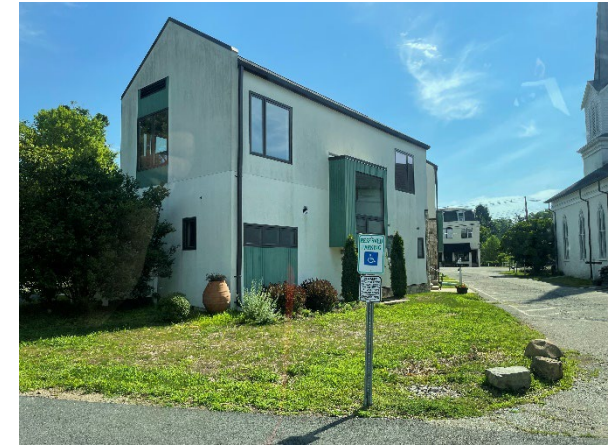
Rain gardens can be installed on the north and southwest faces of the church, the north face of the parish center building, and along the southwest corner of the parking lot to capture, treat, and infiltrate stormwater from the rooftops via disconnected downspouts and from the parking lot. A preliminary soil assessment suggests that more soil testing would be required before determining the soil's suitability for green infrastructure.

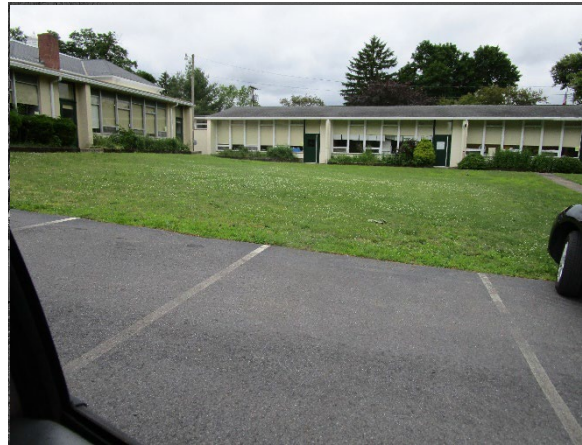
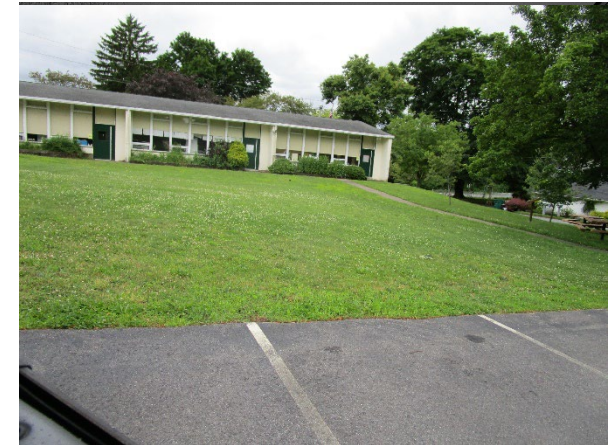
A rain garden centralized in the courtyard could be installed to collect rooftop stormwater. A preliminary soil assessment suggests that the soils have suitable drainage characteristics for green infrastructure.

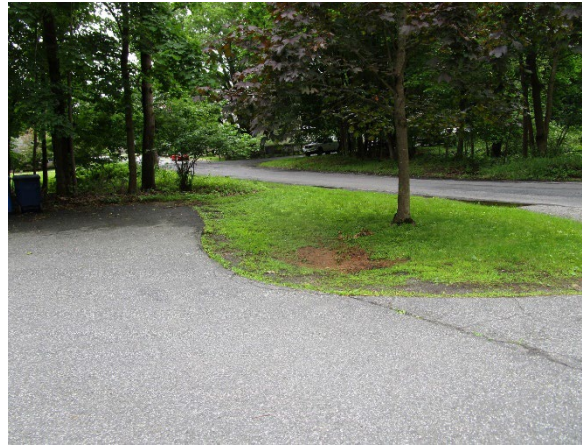
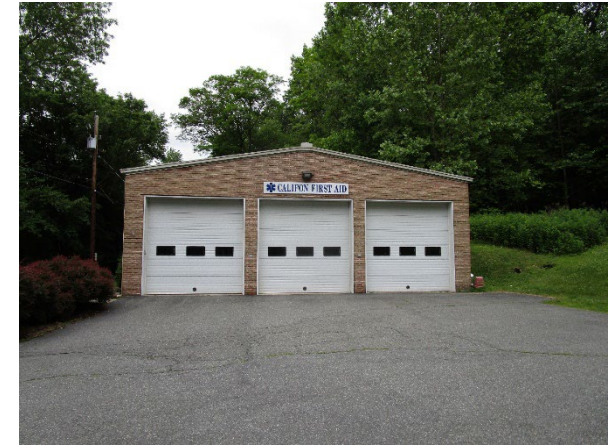
A rain garden can be installed next to the entrance of the parking lot to capture stormwater from the sloped lot. A cistern can be installed to harvest rainwater from the rooftop. Collected rainwater can be used for washing first aid squad vehicles or be used to water landscaping. A preliminary soil assessment suggests that more soil testing would be required before determining the soil's suitability for green infrastructure.

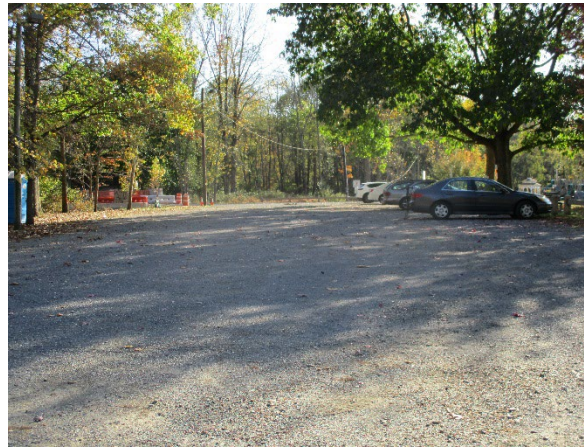
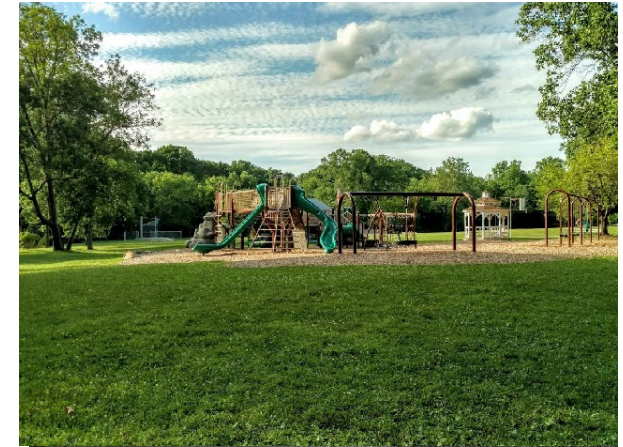
Porous pavement can be installed in the rear parking spaces to aid in infiltration of stormwater. A preliminary soil assessment suggests that more soil testing would be required before determining the soil's suitability for green infrastructure.

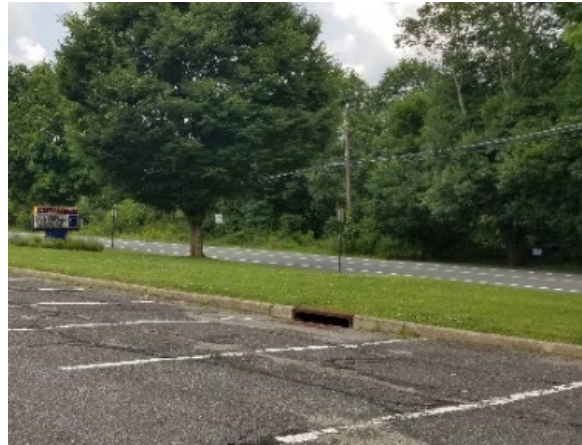
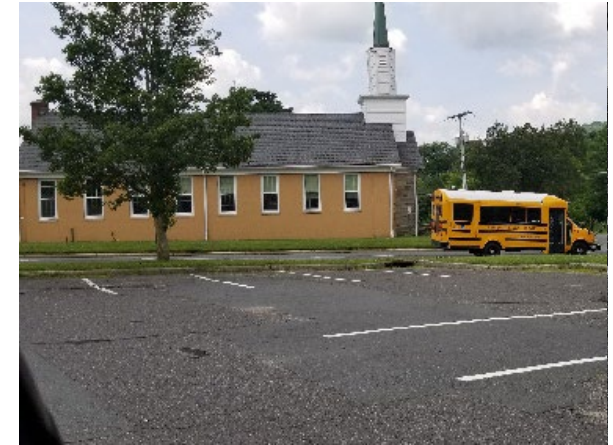
Pervious pavement is proposed in a section of parking spaces to capture and infiltrate runoff from the parking lot. A bioretention system is proposed in the north turfgrass area to capture runoff from the roof of the school. A preliminary soil assessment suggests that more soil testing would be required before determining the soil's suitability for green infrastructure.

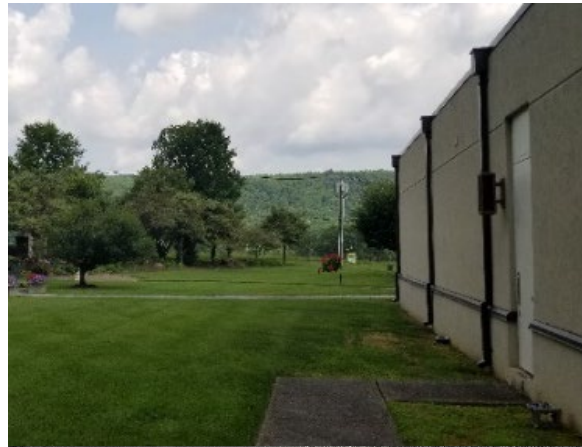
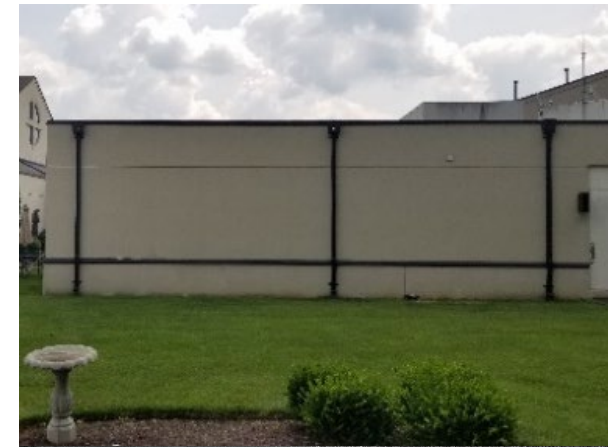
A bioretention system can be installed to infiltrate the water from three disconnected downspouts on the west side of the building. In addition, pervious pavement is proposed along the southeast corner of the parking lot to the parking lot's drainage area. A preliminary soil assessment suggests that the soils have suitable drainage characteristics for green infrastructure.

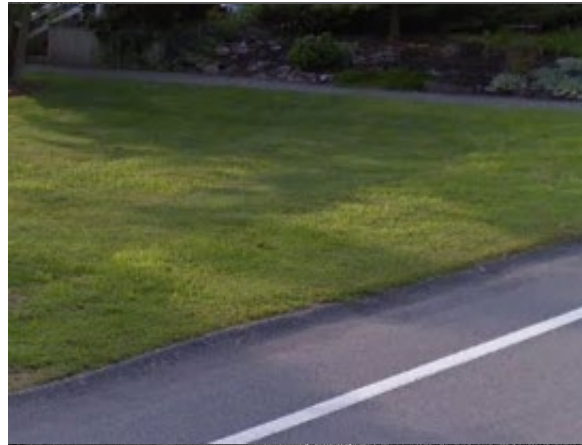
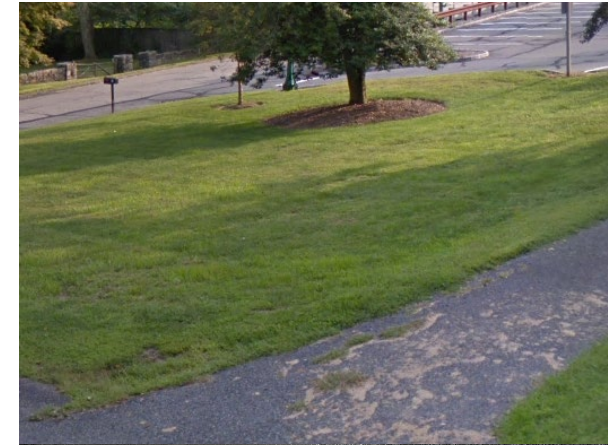
A rain garden can be installed adjacent to the building to infiltrate water from two connected downspouts. Additionally, pervious pavement can capture and infiltrate the stormwater runoff from the entire parking lot and a portion of the roof. Downspout planter boxes can be installed at downspouts to capture runoff from the roof as well. A preliminary soil assessment suggests that more soil testing would be required before determining the soil's suitability for green infrastructure.

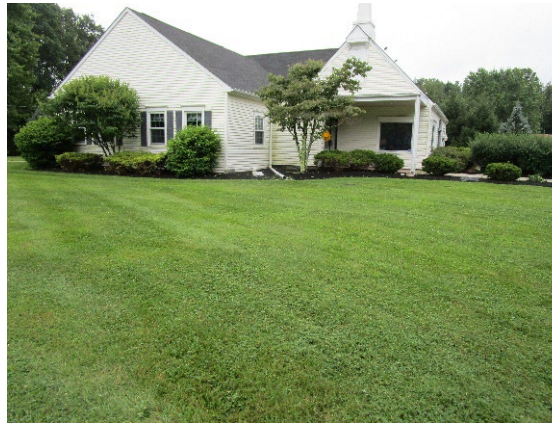
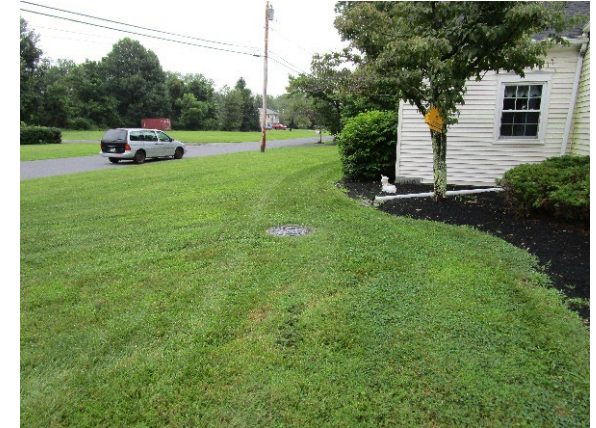
Two bioretention systems are proposed to infiltrate the water from the sloped lawn and a disconnected downspout. A preliminary soil assessment suggests that more soil testing would be required before determining the soil's suitability for green infrastructure.

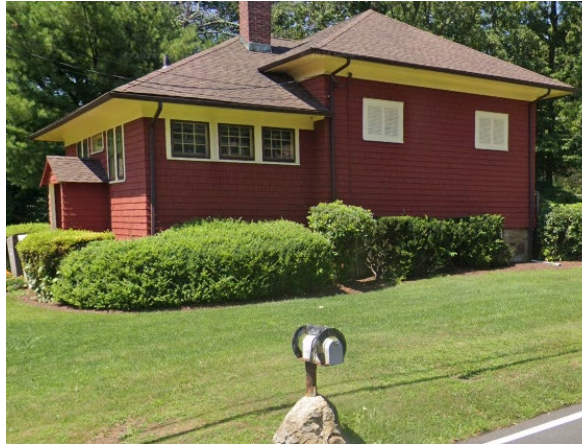
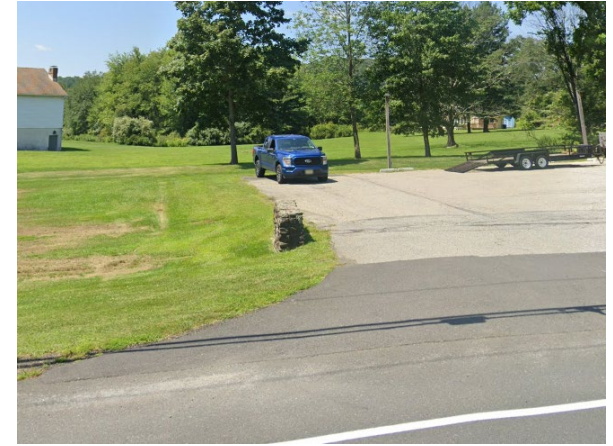
Rain gardens can be installed to the northeast and to the west of the building using the existing disconnected downspouts to capture, treat, and infiltrate the stormwater runoff from the rooftop. Downspout redirection may be needed. An additional rain garden can be constructed to the south of the parking lot to capture, treat, and infiltrate the stormwater runoff from the asphalt. A preliminary soil assessment suggests that the soils have suitable drainage characteristics for green infrastructure.

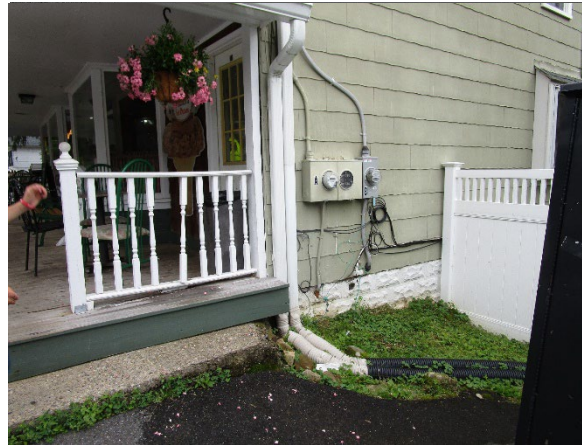
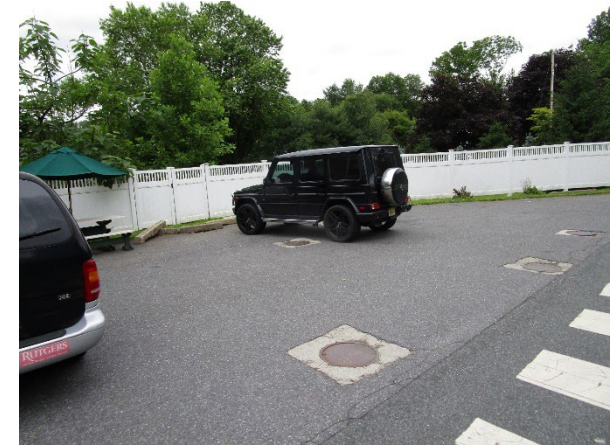
Porous pavement can be installed in the rear parking spaces to aid in infiltration of stormwater. A downspout planter box can be constructed along the building to allow roof runoff to be reused. A preliminary soil assessment suggests that the soils have suitable drainage characteristics for green infrastructure.

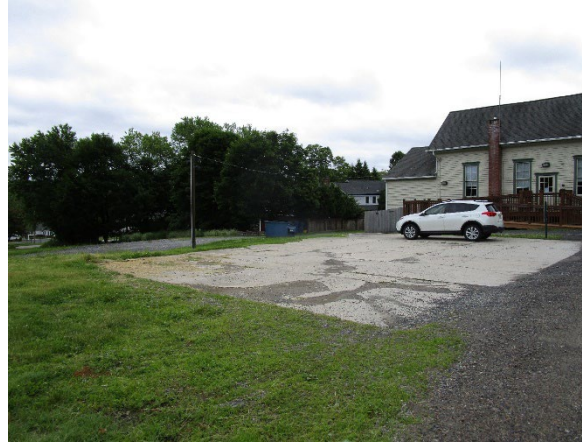
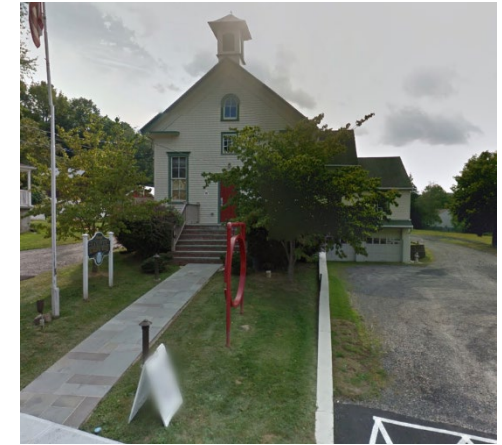
A rain garden can be installed to infiltrate stormwater draining from the parking lot. Downspout planter boxes can be constructed along the building to allow roof runoff to be reused. A preliminary soil assessment suggests that the soils have suitable drainage characteristics for green infrastructure.

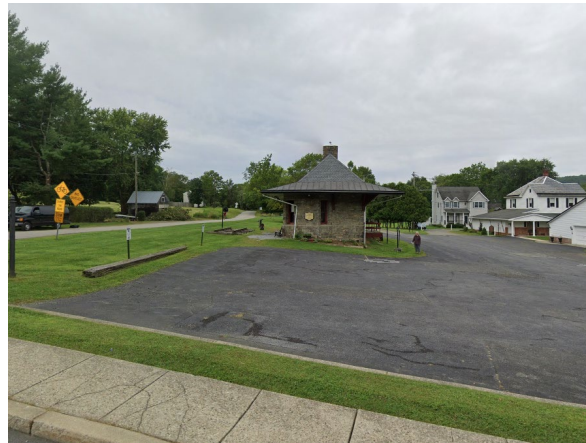
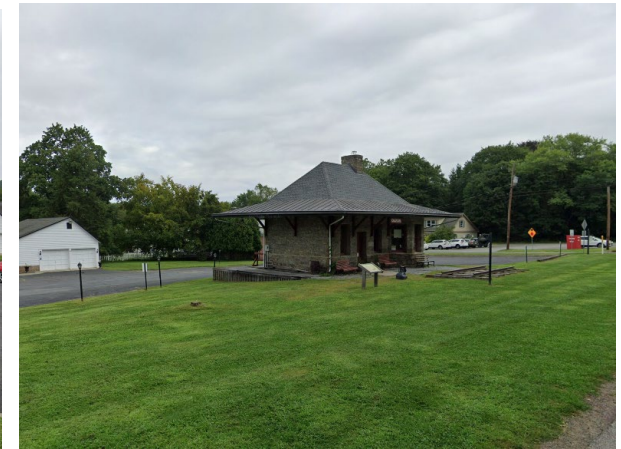
Rain gardens can be installed north of the building and in the turfgrass area east of the building to infiltrate stormwater draining from the parking lot. A preliminary soil assessment suggests that more soil testing would be required before determining the soil's suitability for green infrastructure.

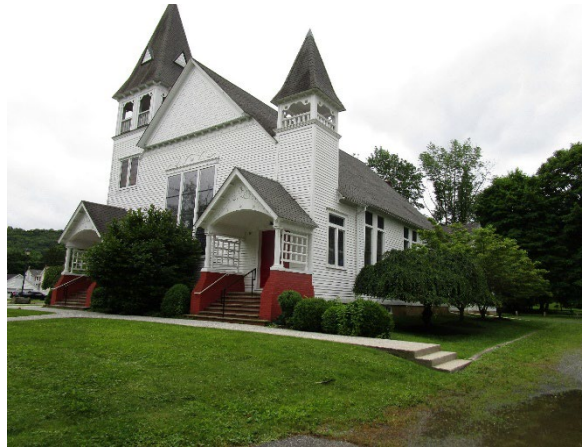
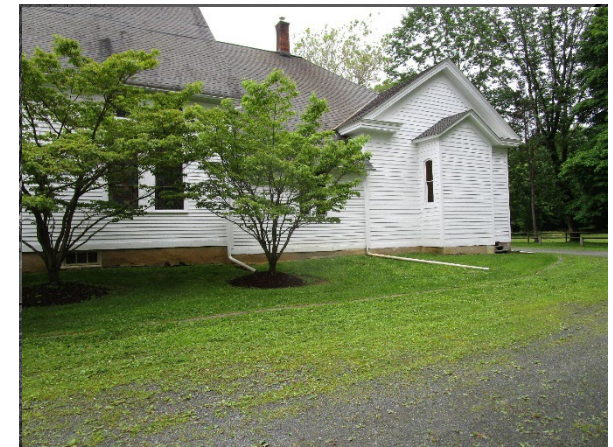
Two rain gardens can be installed to capture, treat, and infiltrate stormwater runoff from the roof. Downspout planter boxes can be constructed along the building to allow roof runoff to be reused. A preliminary soil assessment suggests that more soil testing would be required before determining the soil's suitability for green infrastructure.

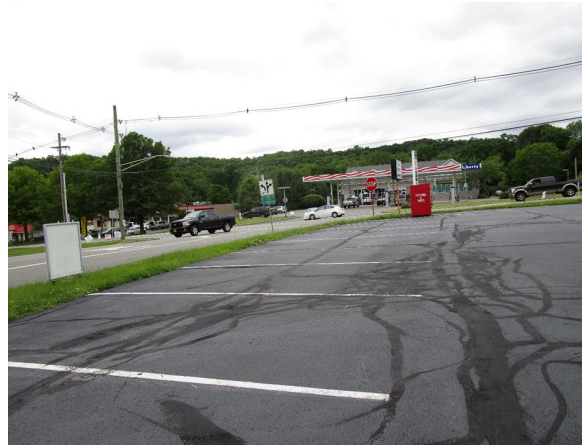
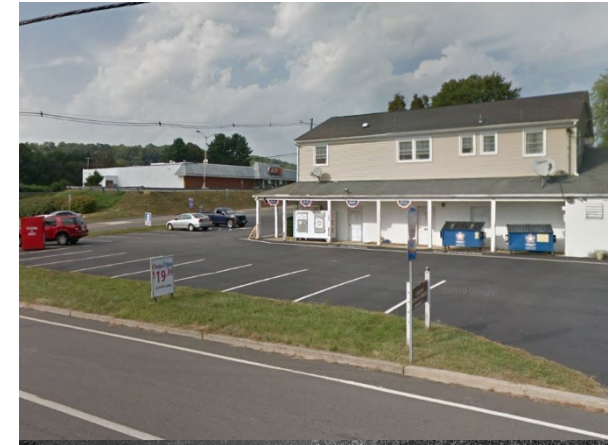
Areas of the parking lot can be retrofitted with porous pavement to capture stormwater runoff from the parking lot. A preliminary soil assessment suggests that the soils have suitable drainage characteristics for green infrastructure.

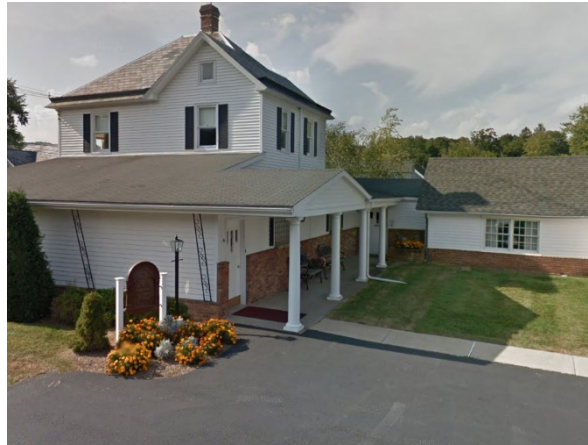
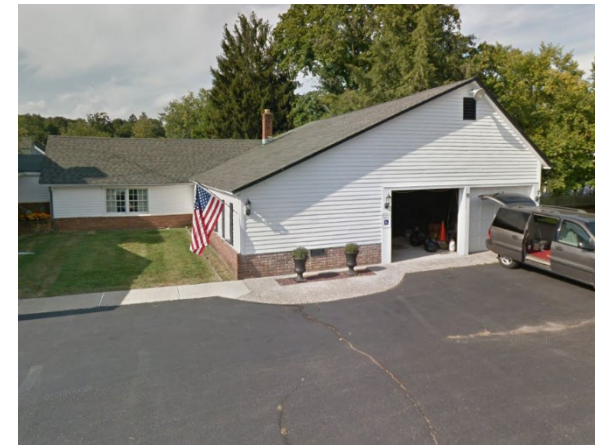
A central rain garden can be installed to capture stormwater runoff from the inward sloping rooftops. A downspout planter box can be constructed along the building to allow roof runoff to be reused. A preliminary soil assessment suggests that more soil testing would be required before determining the soil's suitability for green infrastructure.

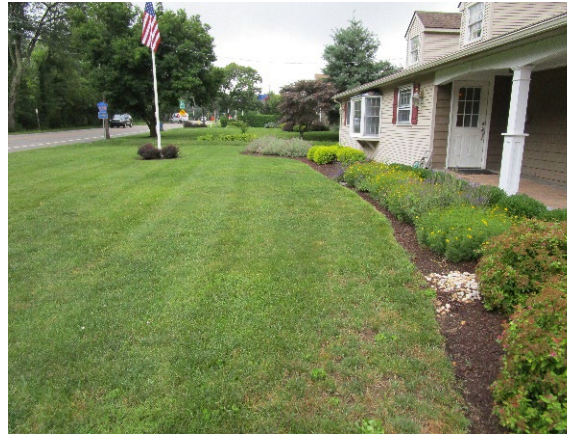
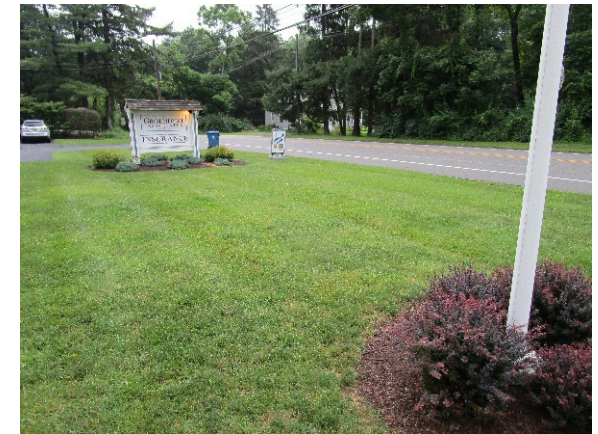
Two bioretention systems are proposed in the front of the building to infiltrate the water from the roof as well as the downspouts. A preliminary soil assessment suggests that the soils have suitable drainage characteristics for green infrastructure.

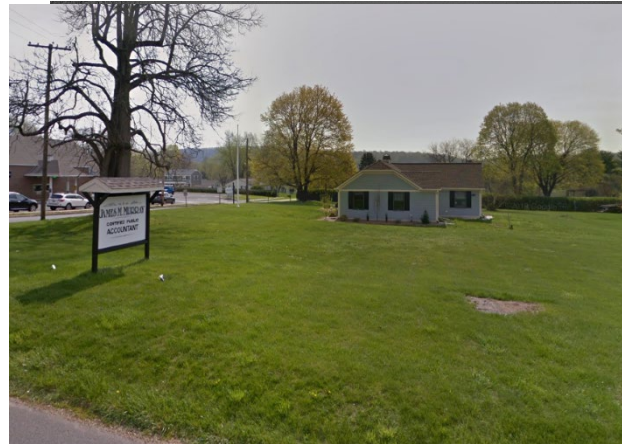
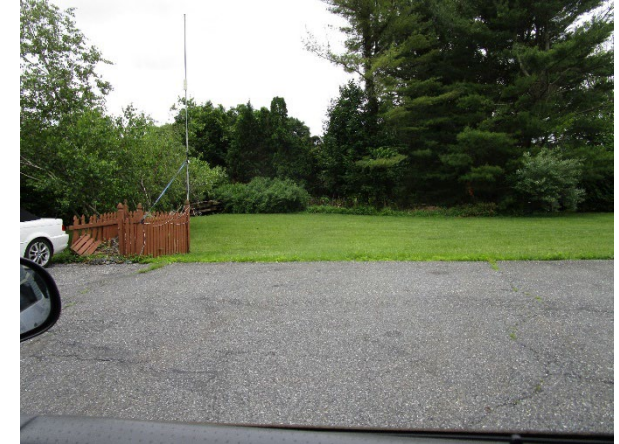
A rain garden can be installed at the end of the parking lot to capture, treat, and infiltrate stormwater runoff from the parking lot . Downspout planter boxes can be constructed along the building to allow roof runoff to be reused. A preliminary soil assessment suggests that the soils have suitable drainage characteristics for green infrastructure.

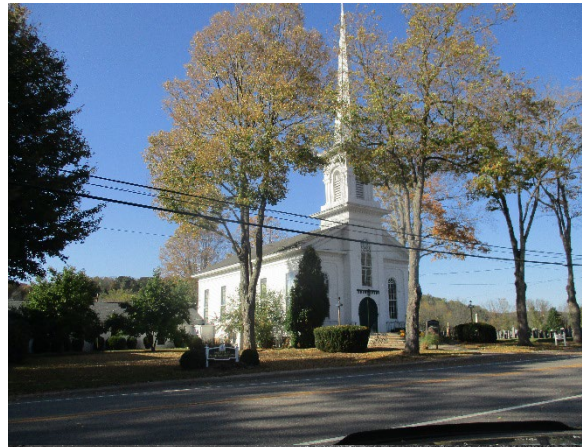
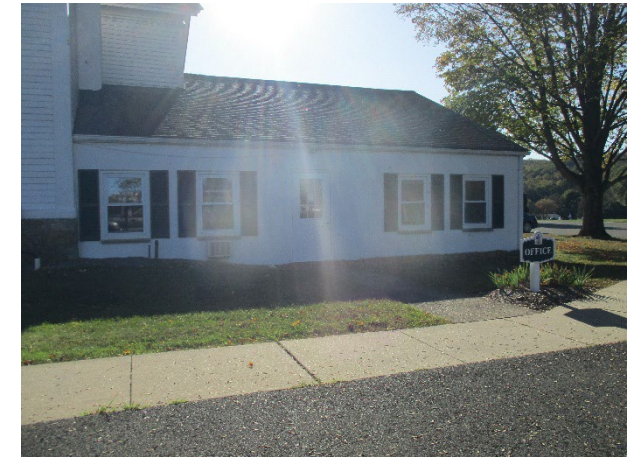
A rain garden can be installed to capture, treat, and infiltrate stormwater runoff from the roof. Downspout planter boxes can be constructed along the building to allow roof runoff to be reused. A preliminary soil assessment suggests that the soils have suitable drainage characteristics for green infrastructure.

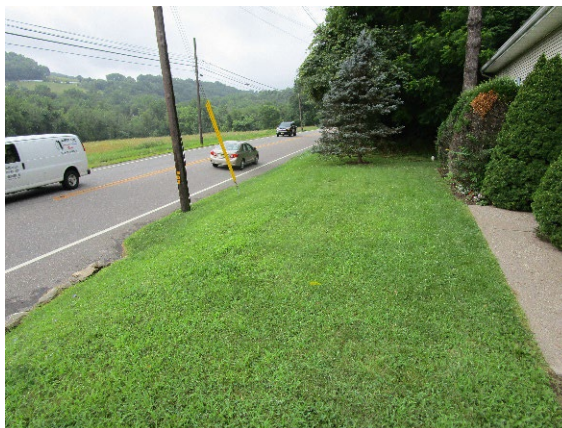
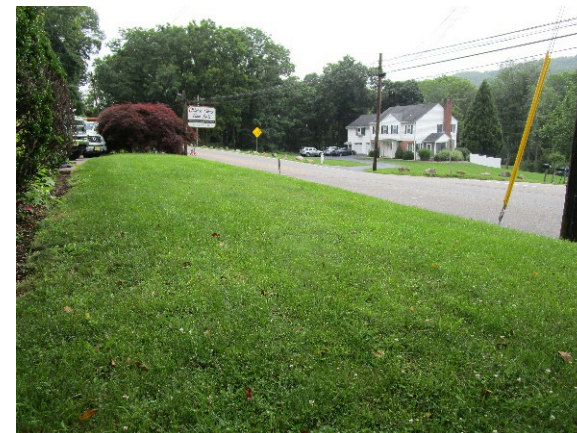
Two rainwater harvesting cisterns are proposed on opposite corners of the building to capture stormwater runoff from the roof. The water can be used for washing vehicles, watering plants, or other non-potable purposes. A preliminary soil assessment suggests that the soils have suitable drainage characteristics for green infrastructure.

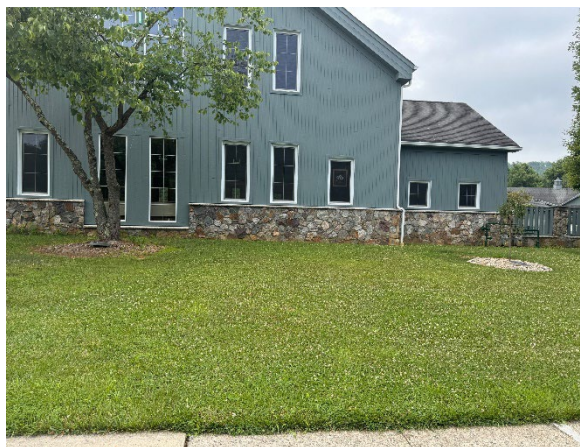
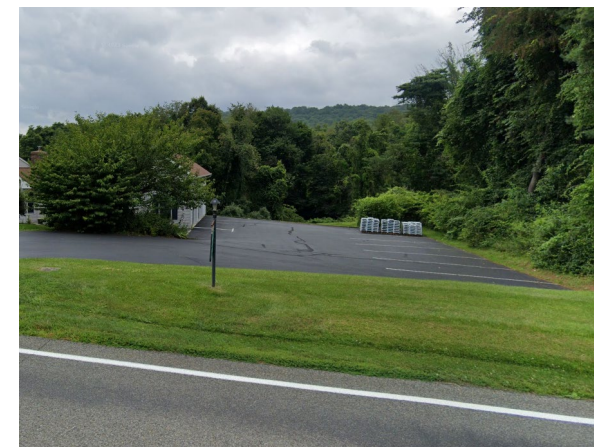
Rain gardens can be installed in multiple grass areas around the property to capture, treat, and infiltrate the stormwater runoff from various rooftops. This may require downspout redirections and disconnections, as well as trench drains. Existing parking spaces in the northern, southern, and western parking lots can be converted into pervious pavement to capture and infiltrate the stormwater runoff from the asphalt, roadway, and sidewalks. This may require trench drains. A preliminary soil assessment suggests that the soils have suitable drainage characteristics for green infrastructure.

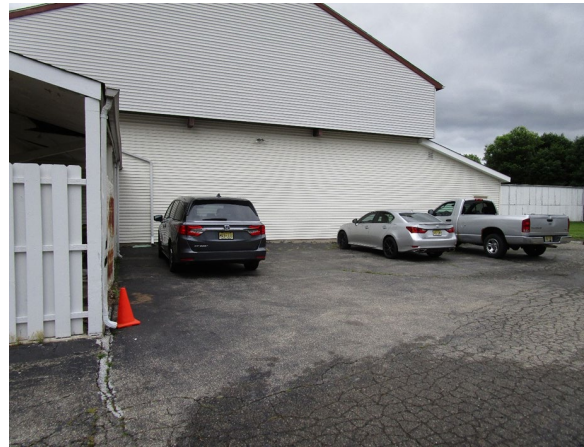
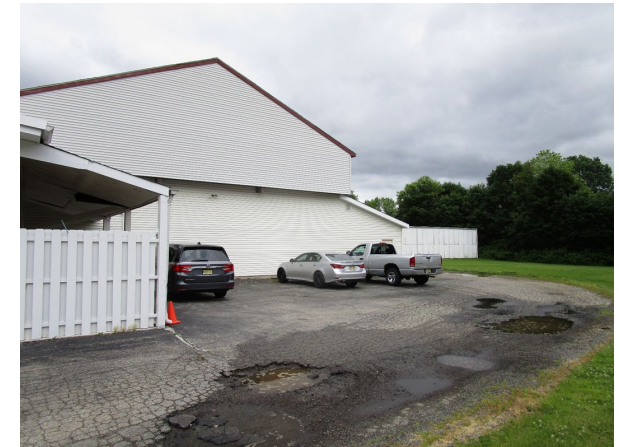
Porous pavement can be installed along the parking spots in the back lot of the building. The downspouts currently empty onto asphalt which is impervious and does not aid in infiltration. A preliminary soil assessment suggests that the soils have suitable drainage characteristics for green infrastructure.

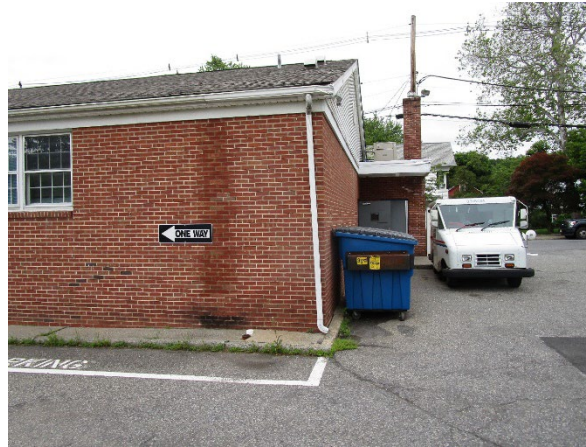
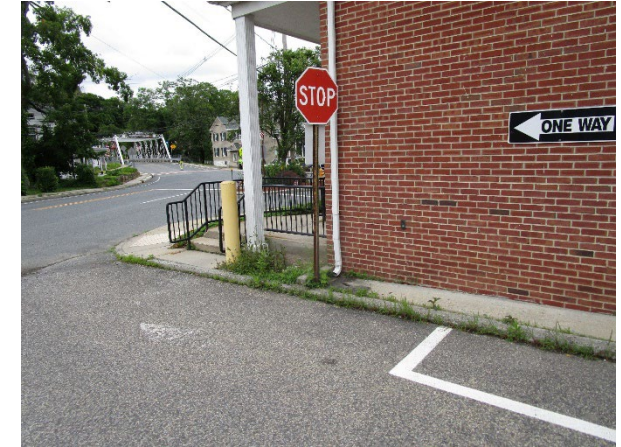
Porous pavement can be installed to collect stormwater from both the disconnected downspouts as well as from the parking lot surface. A preliminary soil assessment suggests that more soil testing would be required before determining the soil's suitability for green infrastructure.

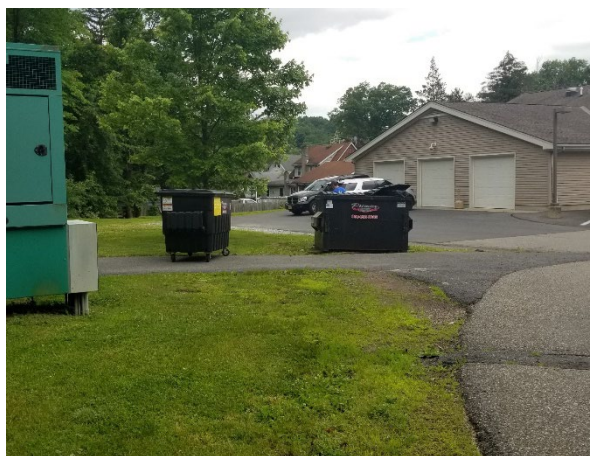
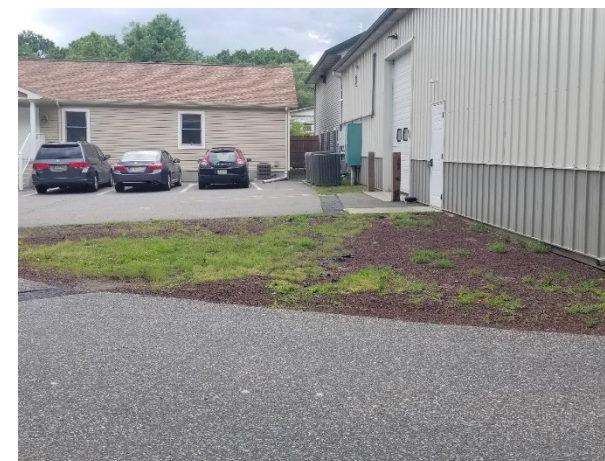
Parking spaces in the parking lot to the north and east of the building can be converted to porous pavement to capture and infiltrate stormwater runoff from the parking lot and downspouts. Porous pavements can support parked vehicles while allowing stormwater to infiltrate and have an underlying stone layer to store and slowly release captured stormwater into the ground. Rain gardens can be installed in the turfgrass areas adjacent to the parking lot areas to capture additional stormwater runoff from the parking lot. A preliminary soil assessment suggests that more soil testing would be required before determining the soil's suitability for green infrastructure.

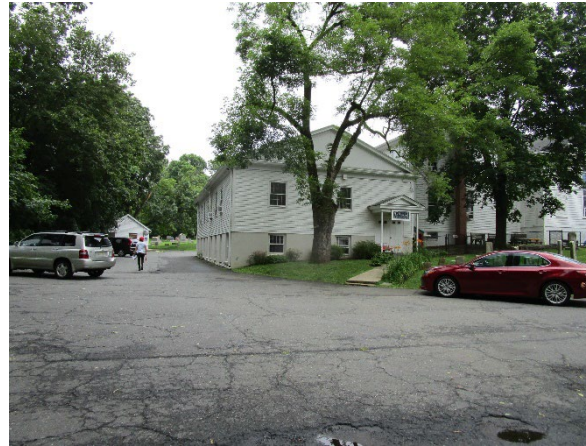
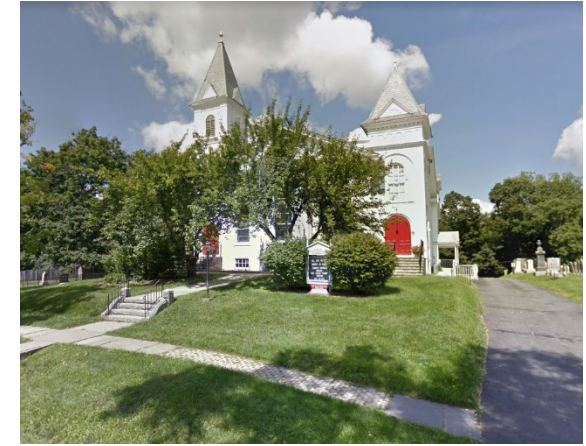
Porous pavement can be installed in the northwestern corner of the parking lot to capture stormwater from the parking lot as well as the nearby building's disconnected downspouts. A downspout planter box can be installed next to the south entrance of the building to capture and treat the rooftop runoff. A preliminary soil assessment suggests that the soils have suitable drainage characteristics for green infrastructure.

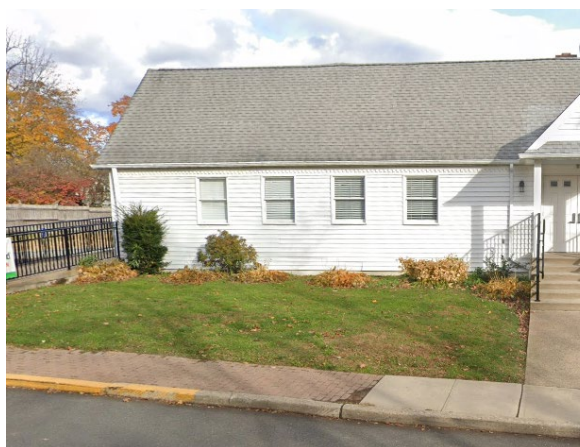
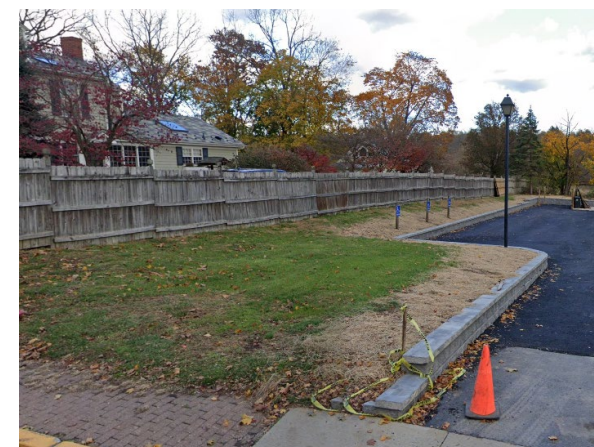
Rain gardens can be installed in multiple grass areas around the property to capture, treat, and infiltrate the stormwater runoff from the asphalt and rooftops. This will require downspout disconnections, trench drains, and curb cuts. Existing parking spaces in the east and south of the lot can be converted into pervious pavement to capture and infiltrate the stormwater runoff from the asphalt. The pervious pavement will also manage some rooftop runoff, as the connected downspouts on the east of the church building direct runoff to the parking lot. Trench drains will be needed to intercept and redirect some of the parking lot runoff to the pervious pavement. A preliminary soil assessment suggests that the soils have suitable drainage characteristics for green infrastructure.

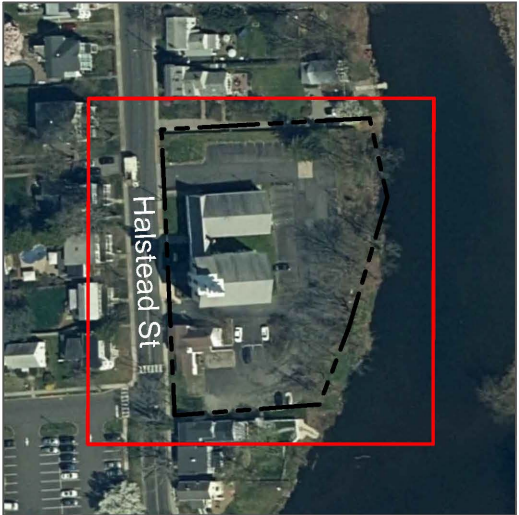
Clinton United Methodist Church

- bioretention system
- pervious pavement
- captured drainage area
- property line
- 2020 Aerial: NJOIT, OGIS

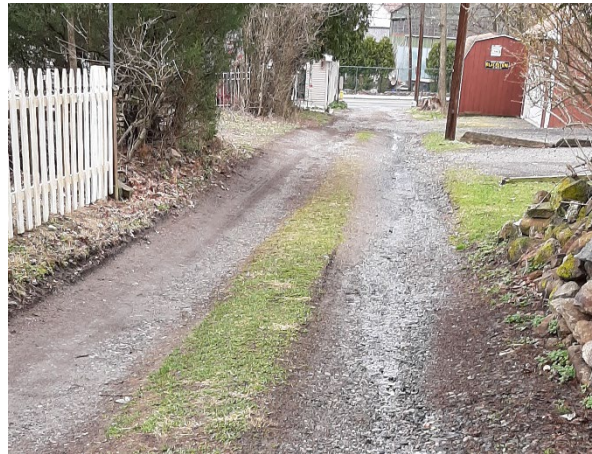
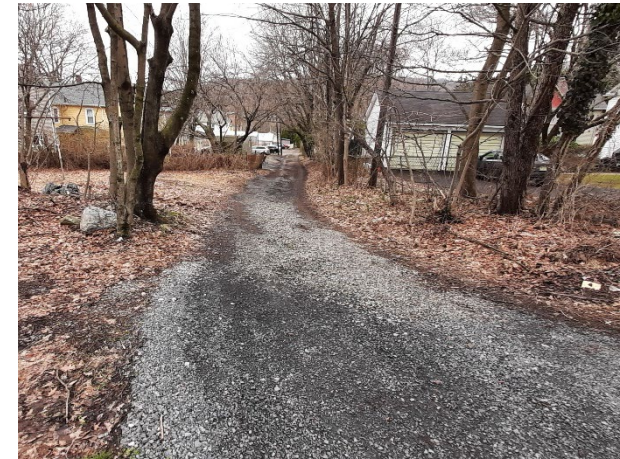
The alleyway between Washington Avenue and Elm Street can be converted to a pervious pavement road. It will capture and infiltrate the nearby stormwater runoff from Washington Avenue, Elm Street, and the adjacent properties.

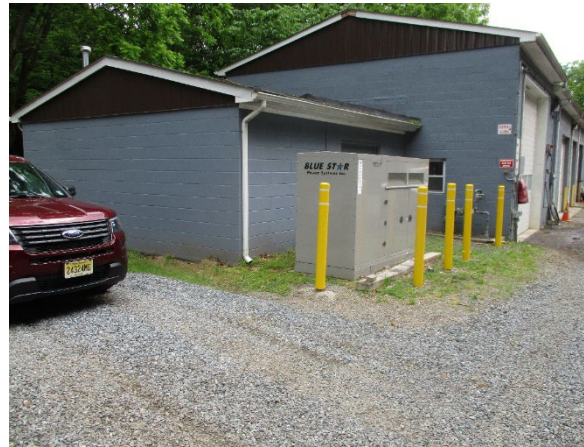
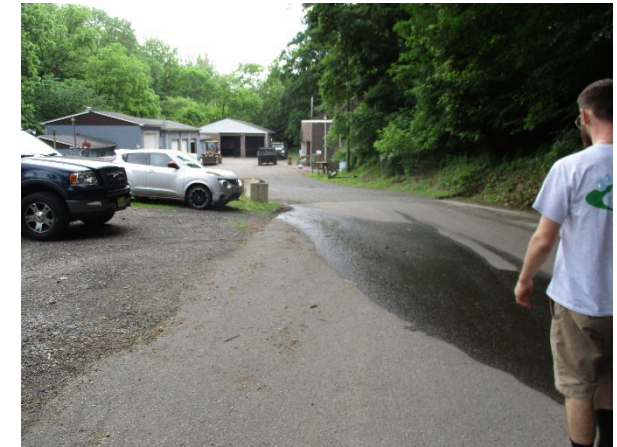
Downspouts on the garages at the High Bridge Department of Works can be connected to cisterns to harvest rainwater from the rooftops. Collected rainwater from the cisterns can then be used for washing public works vehicles as part of a green car wash or be used to water landscaping. A preliminary soil assessment suggests that more soil testing would be required before determining the soil's suitability for green infrastructure.

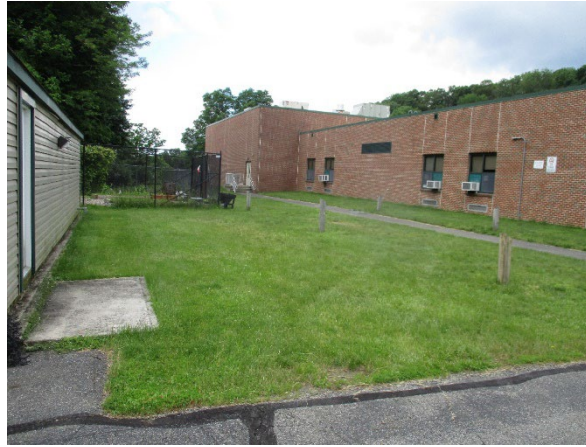
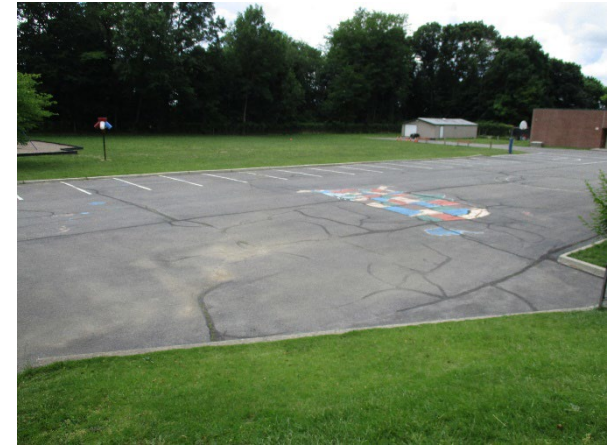
A rain garden can be installed in the turfgrass area near the garden shed and another near the rear parking lot to capture, treat, and infiltrate stormwater runoff from the roof and parking lot. Parking spaces can be converted to porous pavement to intercept water before reaching nearby catch basins. A small cistern could be installed on the shed to collect water for use in watering the garden. A preliminary soil assessment suggests that the soils have suitable drainage characteristics for green infrastructure.

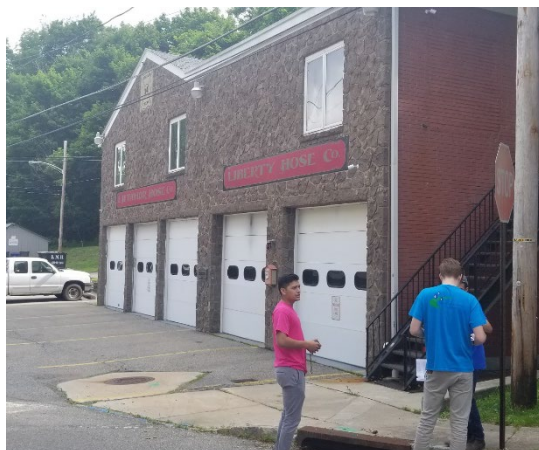
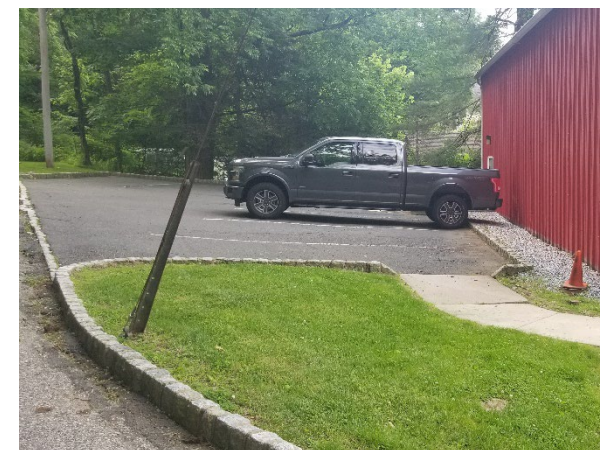
The connected downspouts of the High Bridge Fire Department, near the south end, can be rerouted into a cistern. The cistern can capture and store rainwater from the rooftop that can then be used for washing fire department vehicles or watering landscaping. The parking spaces adjacent to the side building can be repaved with porous asphalt. A preliminary soil assessment suggests that the soils have suitable drainage characteristics for green infrastructure.
