Appendix C
Concept Plans for Potential Green Infrastructure Projects

SOUTH BRANCH RARITAN RIVER WATERSHED: GREEN INFRASTRUCTURE SITES

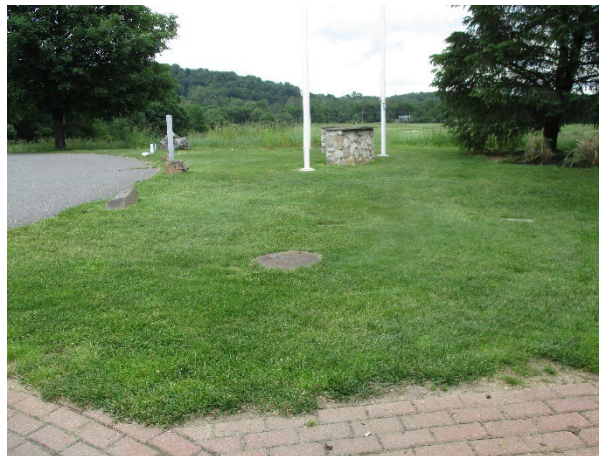
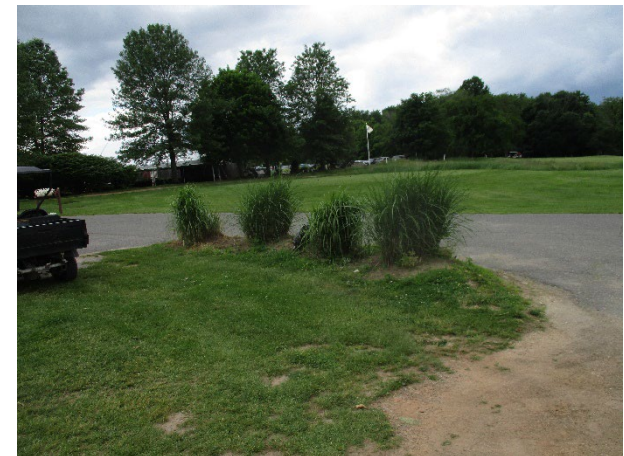
Near the entrance of the main building, a rain garden can be installed to collect water from the rooftop. Areas of the parking lot can be retrofitted with porous pavement to capture stormwater runoff from the parking lot. A preliminary soil assessment suggests that the soils have suitable drainage characteristics for green infrastructure.

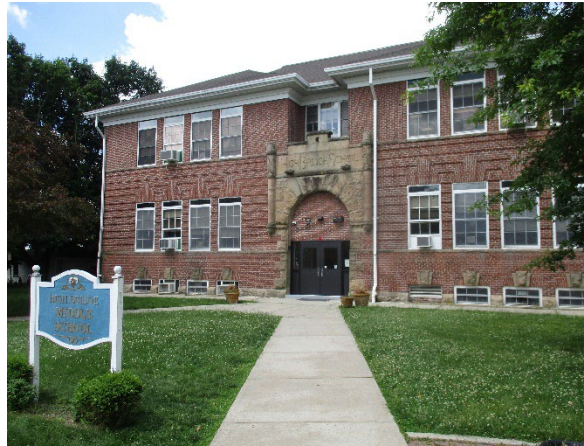
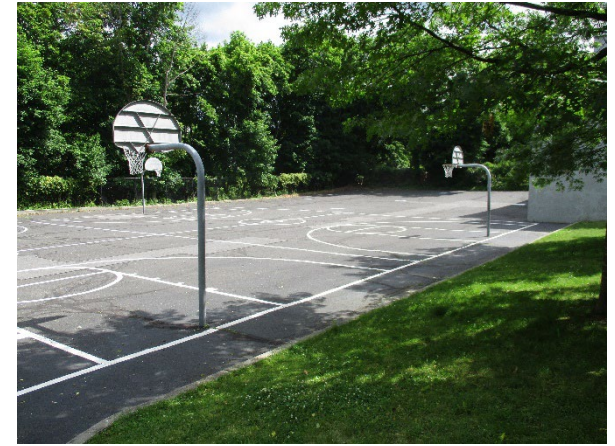
Rain gardens can be installed on the front lawn of the school to capture, filter, and infiltrate rainwater from the rooftop by redirecting downspouts into them. The blacktop playground area could be partially or fully repaved with pervious pavement to capture additional stormwater. A preliminary soil assessment suggests that the soils have suitable drainage characteristics for green infrastructure.

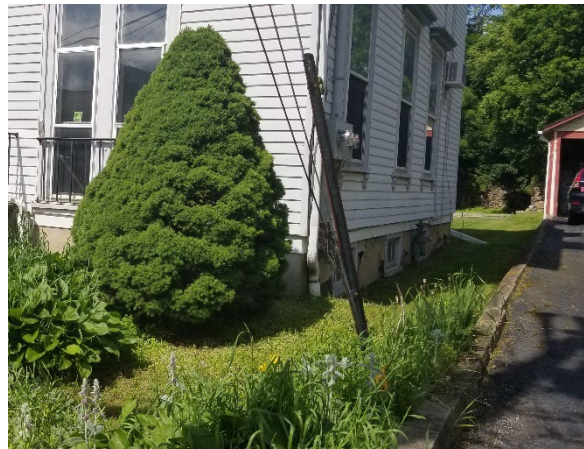
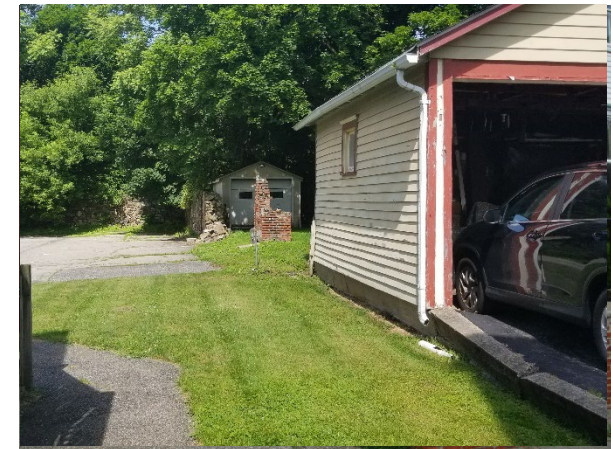
A rain barrel could be installed at one of the downspouts to collect rainwater to be used for watering the plants at the front of the building. A rain garden could be installed adjacent to the neighboring shed if the homeowner gives permission to redirect their gutter into it. The parking space could be repaved with porous asphalt to capture a majority of the parking lot's runoff. A preliminary soil assessment suggests that the soils have suitable drainage characteristics for green infrastructure.

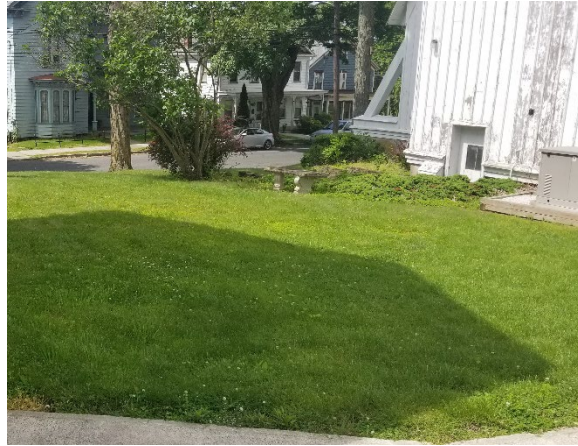
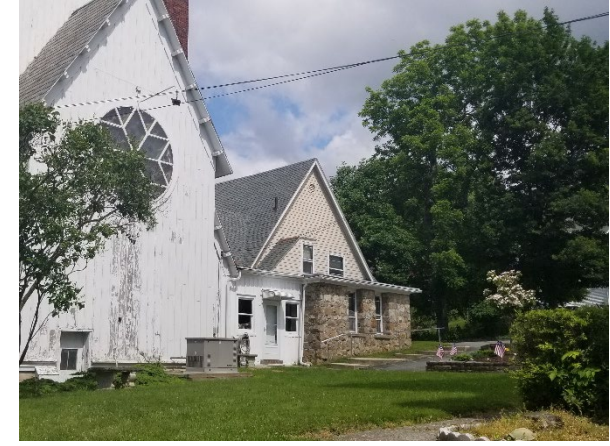
A rain garden to the east the church can be installed to capture, filter, and infiltrate roof runoff. The garden will also provide aesthetic value to the property, attract natural pollinators, and create an education experience. A preliminary soil assessment suggests that the soils have suitable drainage characteristics for green infrastructure.

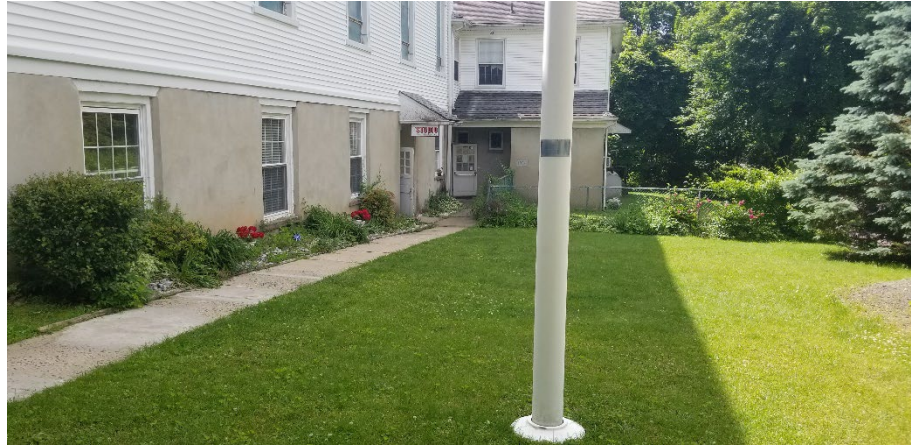
A rain garden can be installed to the west of the church to capture, treat, and infiltrate stormwater from the rooftop. The garden will provide aesthetic value to the property, attract natural pollinators, and create an education experience. A preliminary soil assessment suggests that the soils have suitable drainage characteristics for green infrastructure.

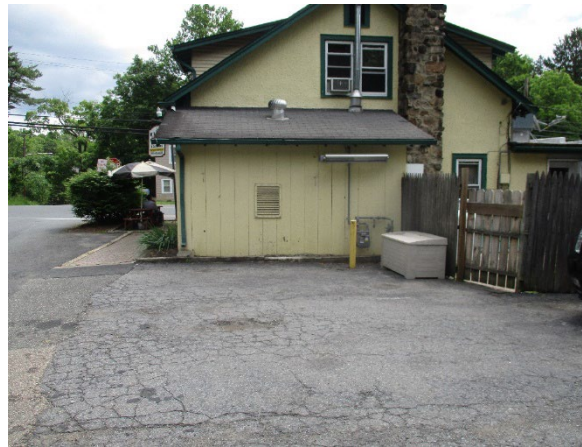
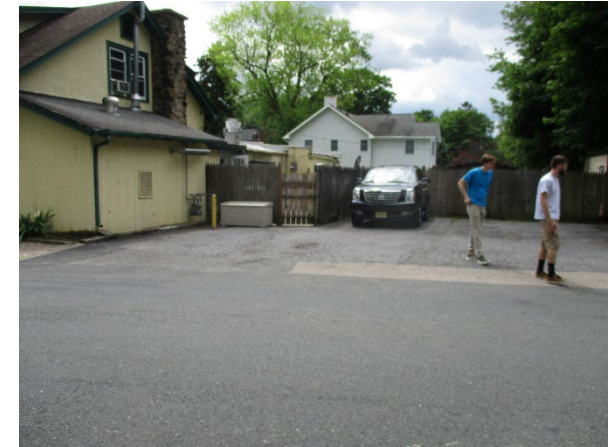
Downspout planter boxes can be installed at the downspouts of the building. Downspout planter boxes are constructed at the base of downspouts with plants that will utilize rooftop runoff. A preliminary soil assessment suggests that the soils have suitable drainage characteristics for green infrastructure.

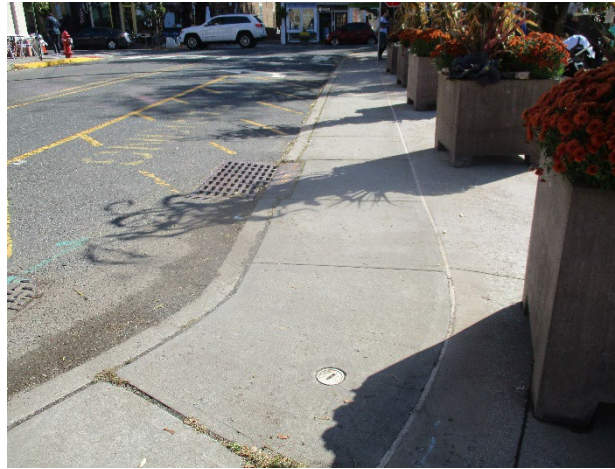
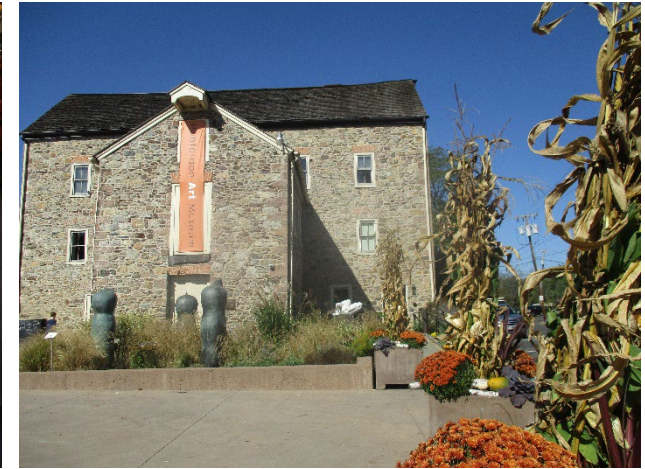
A stormwater planter can be installed in the sidewalk to intercept stormwater runoff from the roadway or sidewalk to allow the stormwater to infiltrate into the ground. Downspout planter boxes can be constructed along the building to allow roof runoff to be reused. A preliminary soil assessment suggests that more soil testing would be required before determining the soil's suitability for green infrastructure.

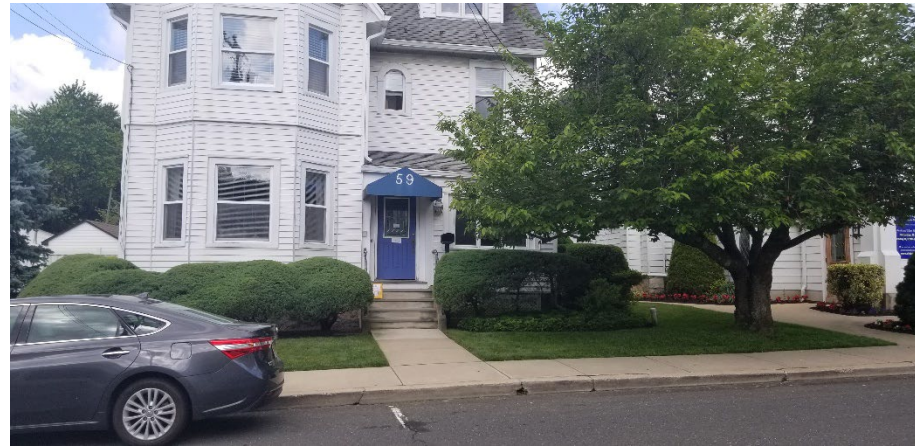
The downspouts along the north side of the building can be rerouted into downspout planter boxes to filter roof runoff. A small rain garden can be installed at the front of the building by redirecting downspouts into it. A preliminary soil assessment suggests that the soils have suitable drainage characteristics for green infrastructure.

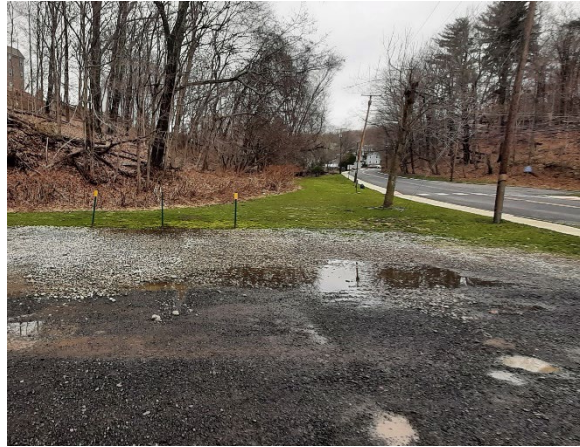
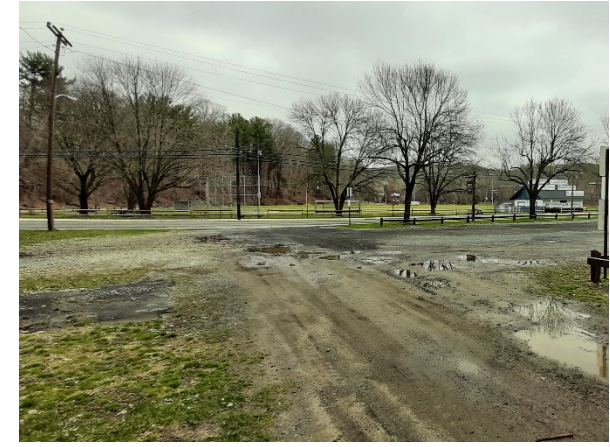
The southern corner of the parking lot can be converted to pervious pavement to allow for capture and infiltration of the stormwater runoff from the parking lot area. A bioretention system can be installed north of the parking lot to capture, treat, and infiltrate the stormwater runoff from the nearby grass and uphill area.

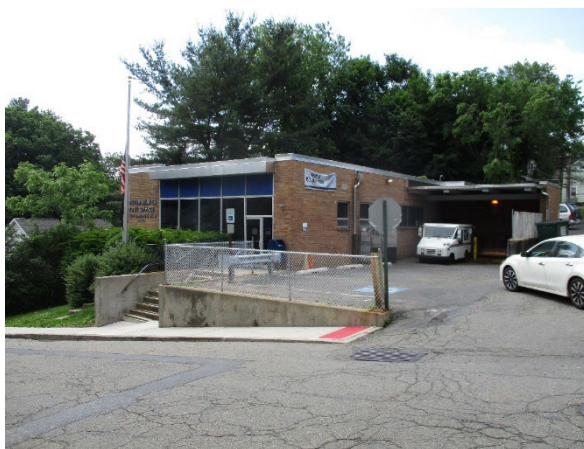
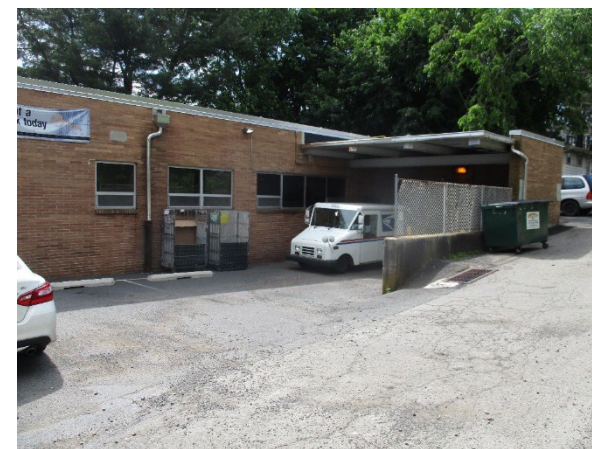
The parking spaces to the north and south of the building can be converted into porous pavement. Porous pavement will allow water directed from the rooftop to pass through where it is stored and allowed to infiltrate into the ground. A preliminary soil assessment suggests that the soils have suitable drainage characteristics for green infrastructure.

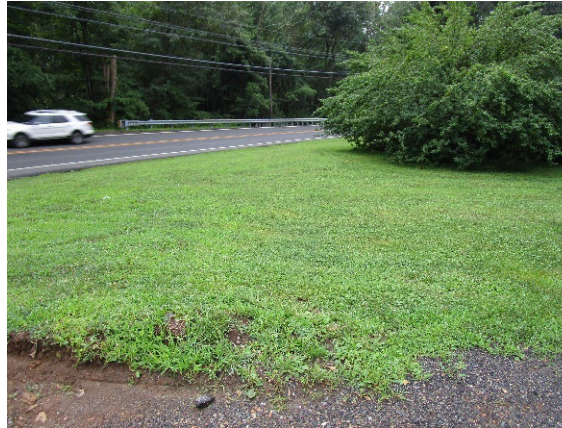
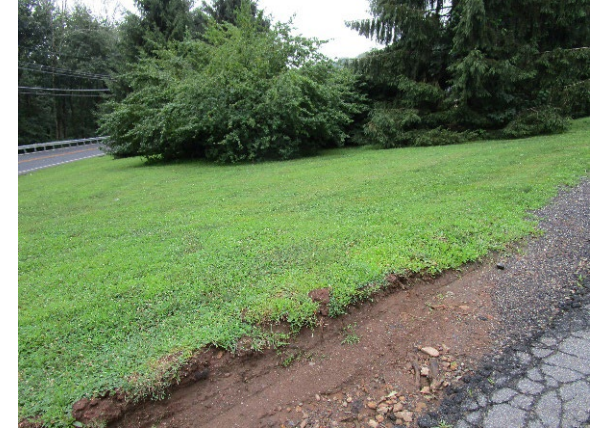
A bioretention system is proposed at the entrance of the property to reduce erosion and infiltrate the stormwater runoff from the parking area. A preliminary soil assessment suggests that the soils have suitable drainage characteristics for green infrastructure.
