Bedminster Township

Introduction

The purpose of this report is to provide a comprehensive understanding of key, defining features within the subwatersheds throughout Bedminster Township. This involves gathering, organizing, and presenting information about existing conditions and infrastructure within each subwatershed. It aims to serve as a tool for informed decision-making, planning, and implementation of sustainable watershed management strategies aimed to protect and enhance the health of the watershed, its associated ecosystems, and the surrounding communities.

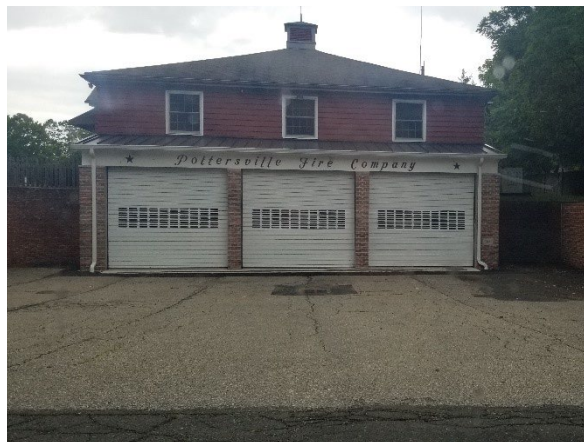
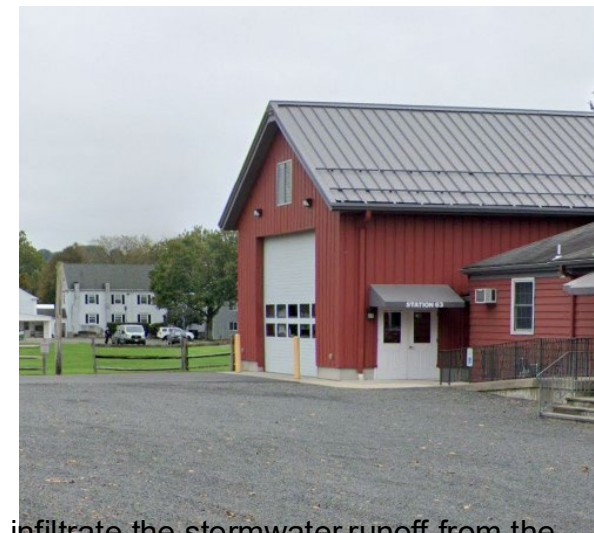
Block and Lot: Block 2, Lot 3

A rain garden can be installed in the grass area to the east of the building to capture, treat, and infiltrate the stormwater runoff from the rooftop. This would require downspout disconnections. Cisterns can be installed to the northeast and southwest of the building to divert and detain the stormwater runoff from the rooftop for later non-potable reuse such as washing vehicles. A preliminary soil assessment suggests that the soils have suitable drainage characteristics for green infrastructure. An underdrain would be required.

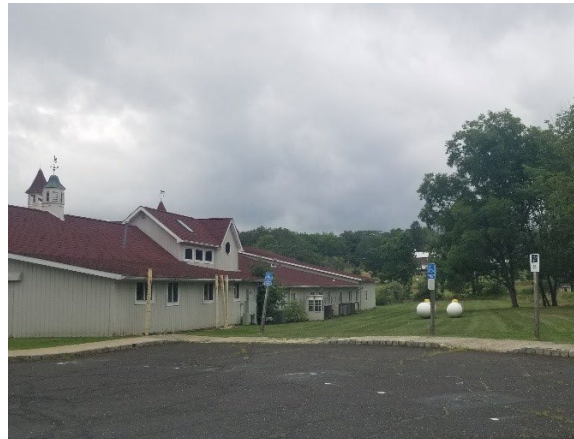
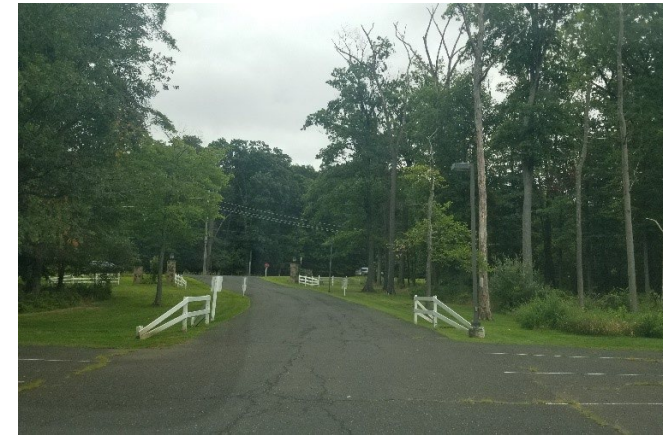
Block and Lot: Block 5, Lot 1.04

Multiple rain gardens can be installed in grass areas around the property to capture, treat, and infiltrate the stormwater runoff from the rooftops and driveway. This may require downspout disconnections, curb cuts, and trench drains. The existing eastern parking spaces can be converted into pervious pavement to capture and infiltrate the stormwater runoff from the driveway. A cistern can be installed to the south of the church building to divert and detain the stormwater runoff from the rooftop for later non-potable reuse such as watering a garden or washing a vehicle. A preliminary soil assessment suggests that more soil testing would be required before determining the soil's suitability for green infrastructure.

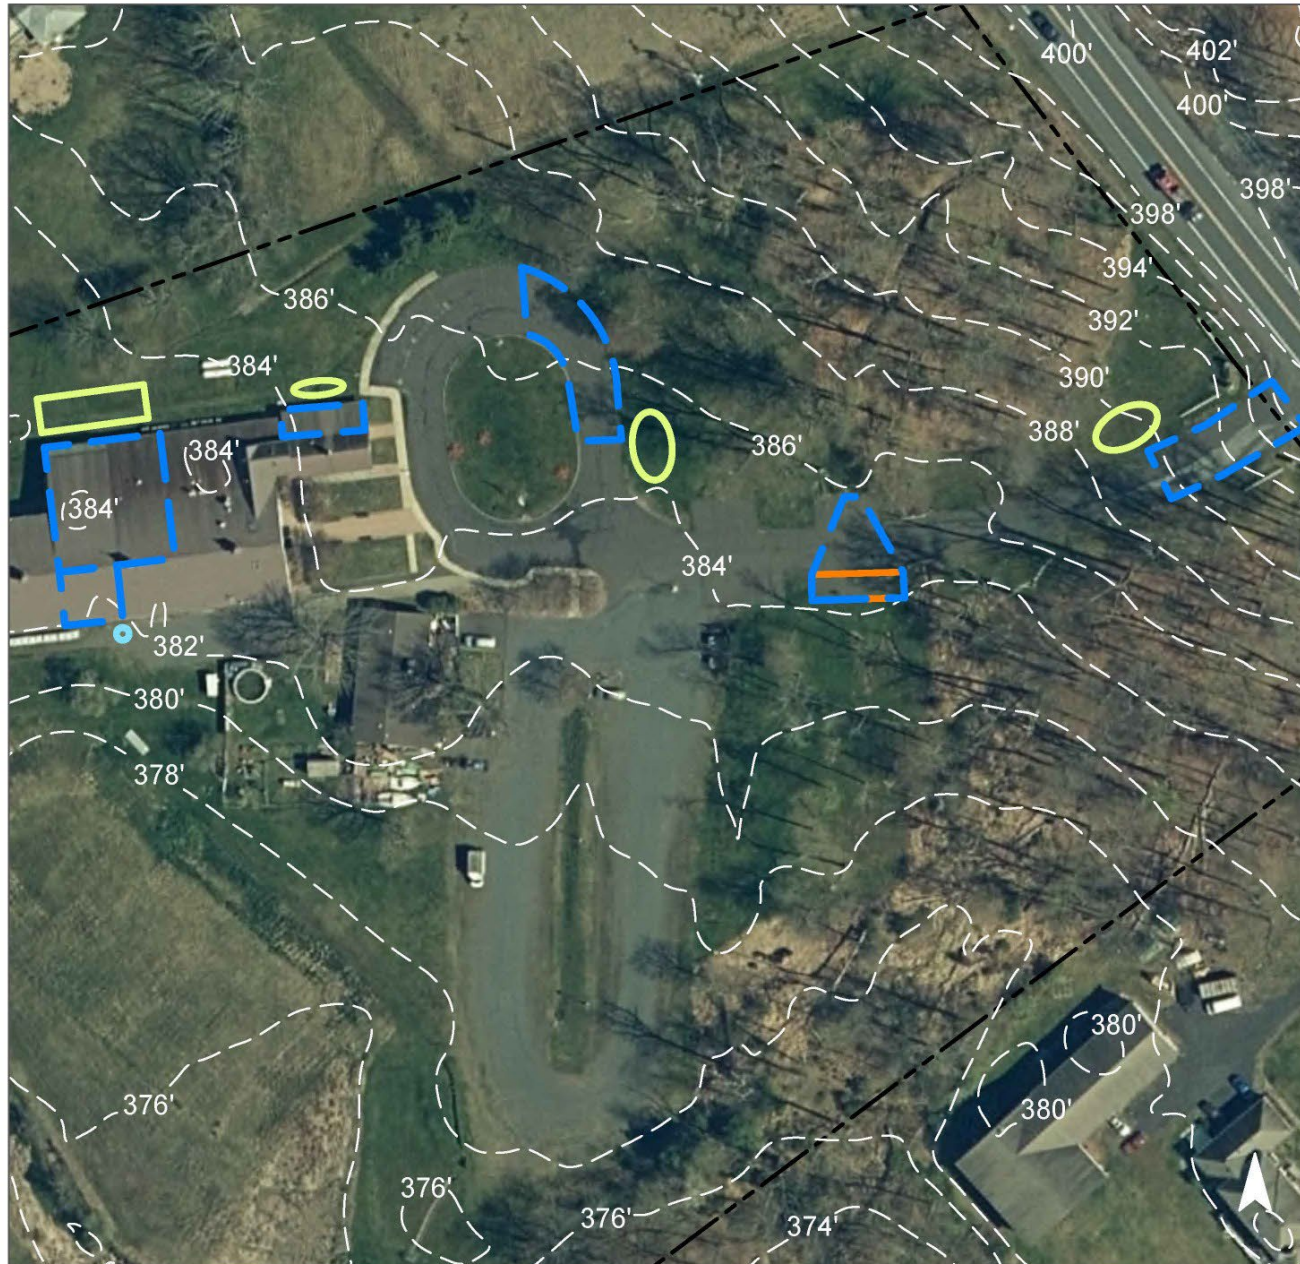
Resurgent Church

Recommended Green Infrastructure Practices	Drainage Area (sq. ft.)	Recharge Potential (Mgal/yr)	TSS Removal Potential (lbs/yr)	Maximum Volume Reduction Potential (gal/storm)	Peak Discharge Reduction Potential (cu. ft./second)	Estimated Size (sq. ft.)	Estimated Cost
Bioretention system	10,365	0.301	46	20,080	0.75	2,595	\$25,950
Pervious pavement	2,030	0.059	10	3,930	0.15	740	\$18,500
Rainwater harvesting	975	0.028	4	800	N/A	800 (gal)	\$2,400

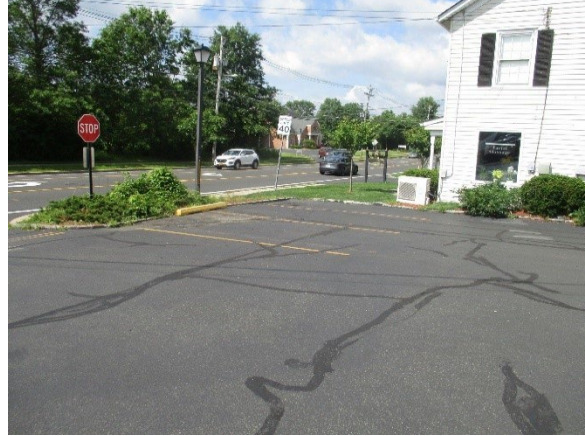
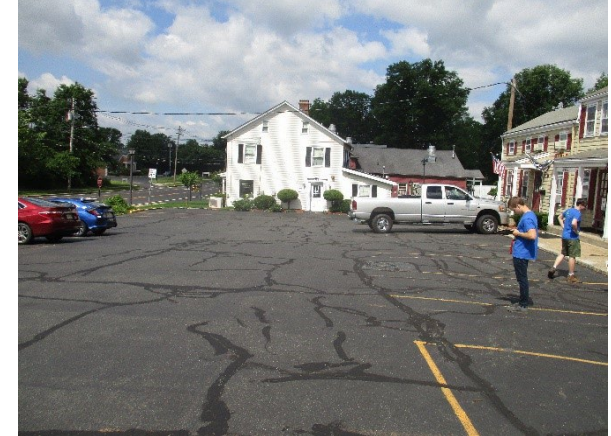
Block and Lot: Block 57, Lot 19

Parking spaces located in the south section of the parking lot can be replaced with pervious pavement to capture and infiltrate stormwater. Downspouts at Annie's Deli can be disconnected and directed into downspout planter boxes to capture and filter rooftop runoff. A preliminary soil assessment suggests that more soil testing would be required before determining the soil's suitability for green infrastructure.

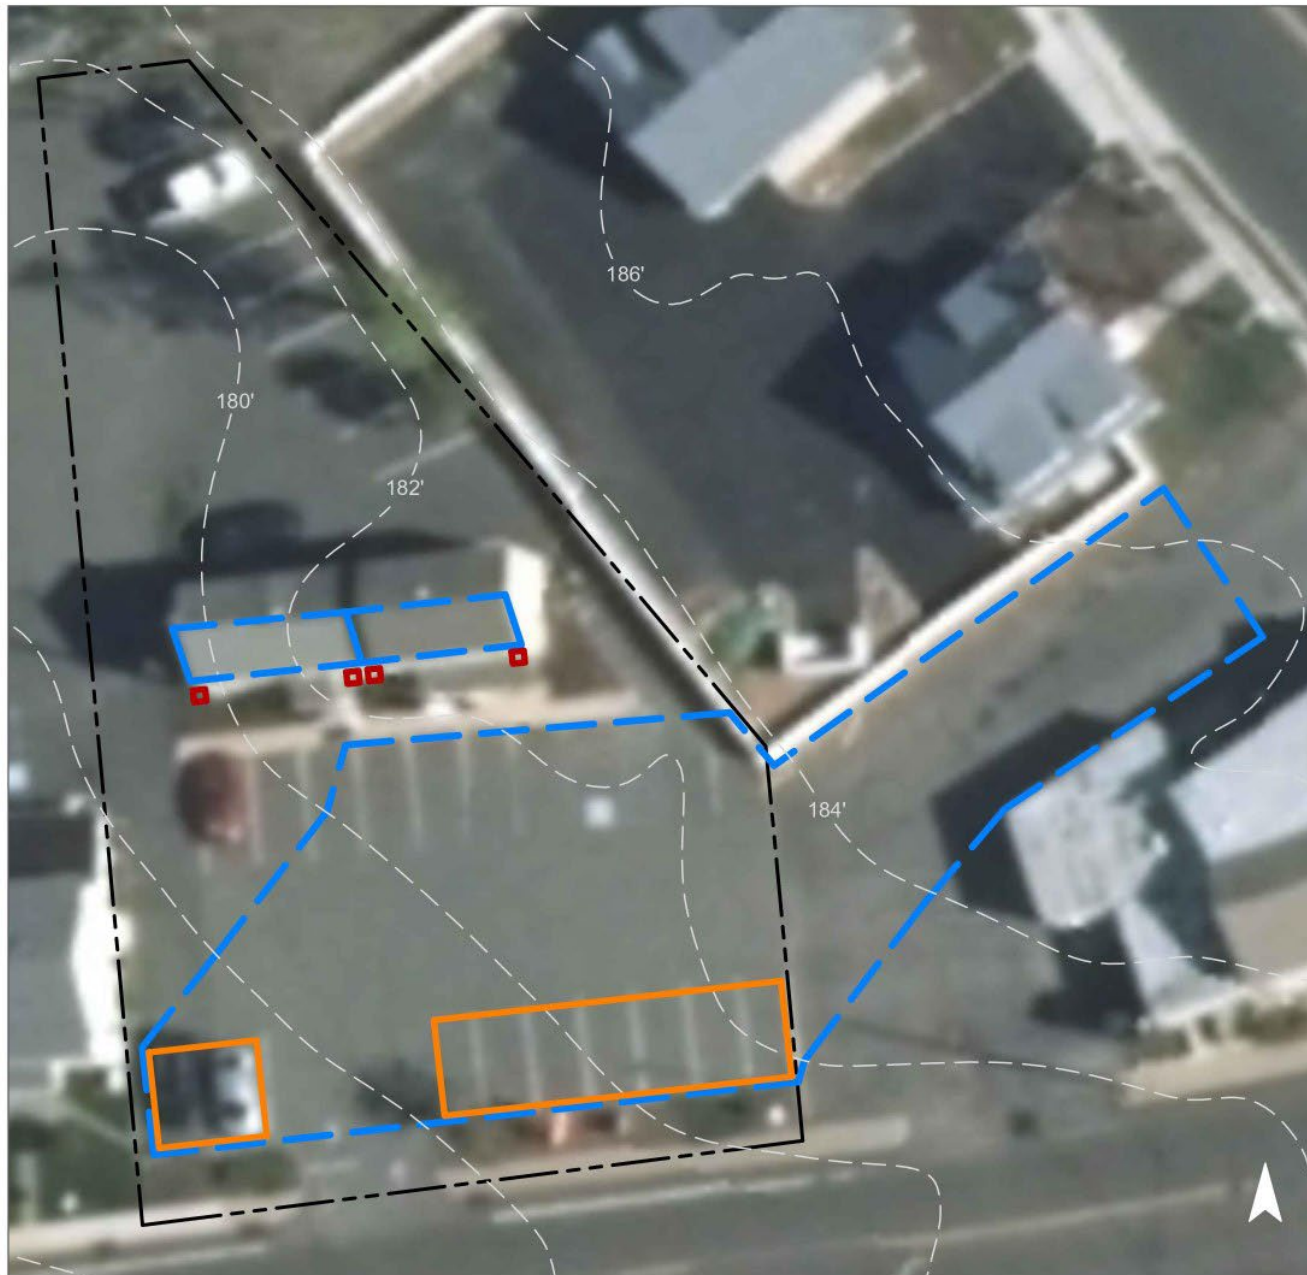
Annie's Deli

Recommended Green Infrastructure Practices	Recharge Potential (Mgal/yr)	TSS Removal Potential (lbs/yr)	Maximum Volume Reduction Potential (gal/storm)	Peak Discharge Reduction Potential (cu. ft./second)	Estimated Size (sq. ft.)	Estimated Cost
Pervious pavement	0.226	38	16,570	0.73	1,440	\$36,000
Planter boxes	n/a	2	n/a	n/a	4 (boxes)	\$4,000

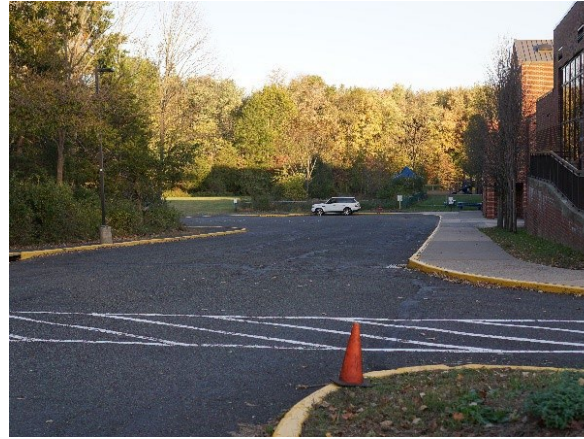
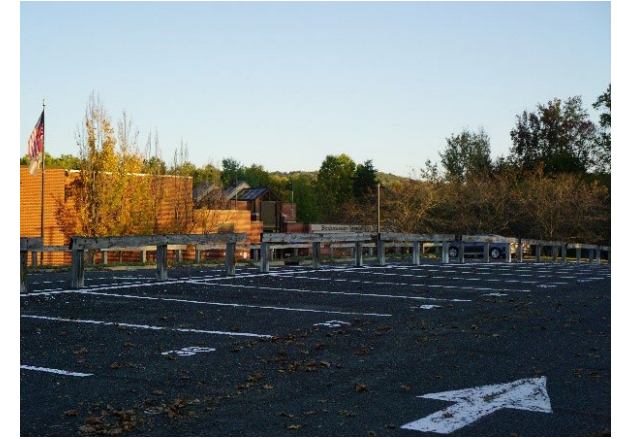
Block and Lot: Block 36, Lot 1

Pervious pavement can be installed in the front parking lot of the building to capture storm water runoff from the parking lot. A preliminary soil assessment suggests that the soil is suitable for green infrastructure implementations.

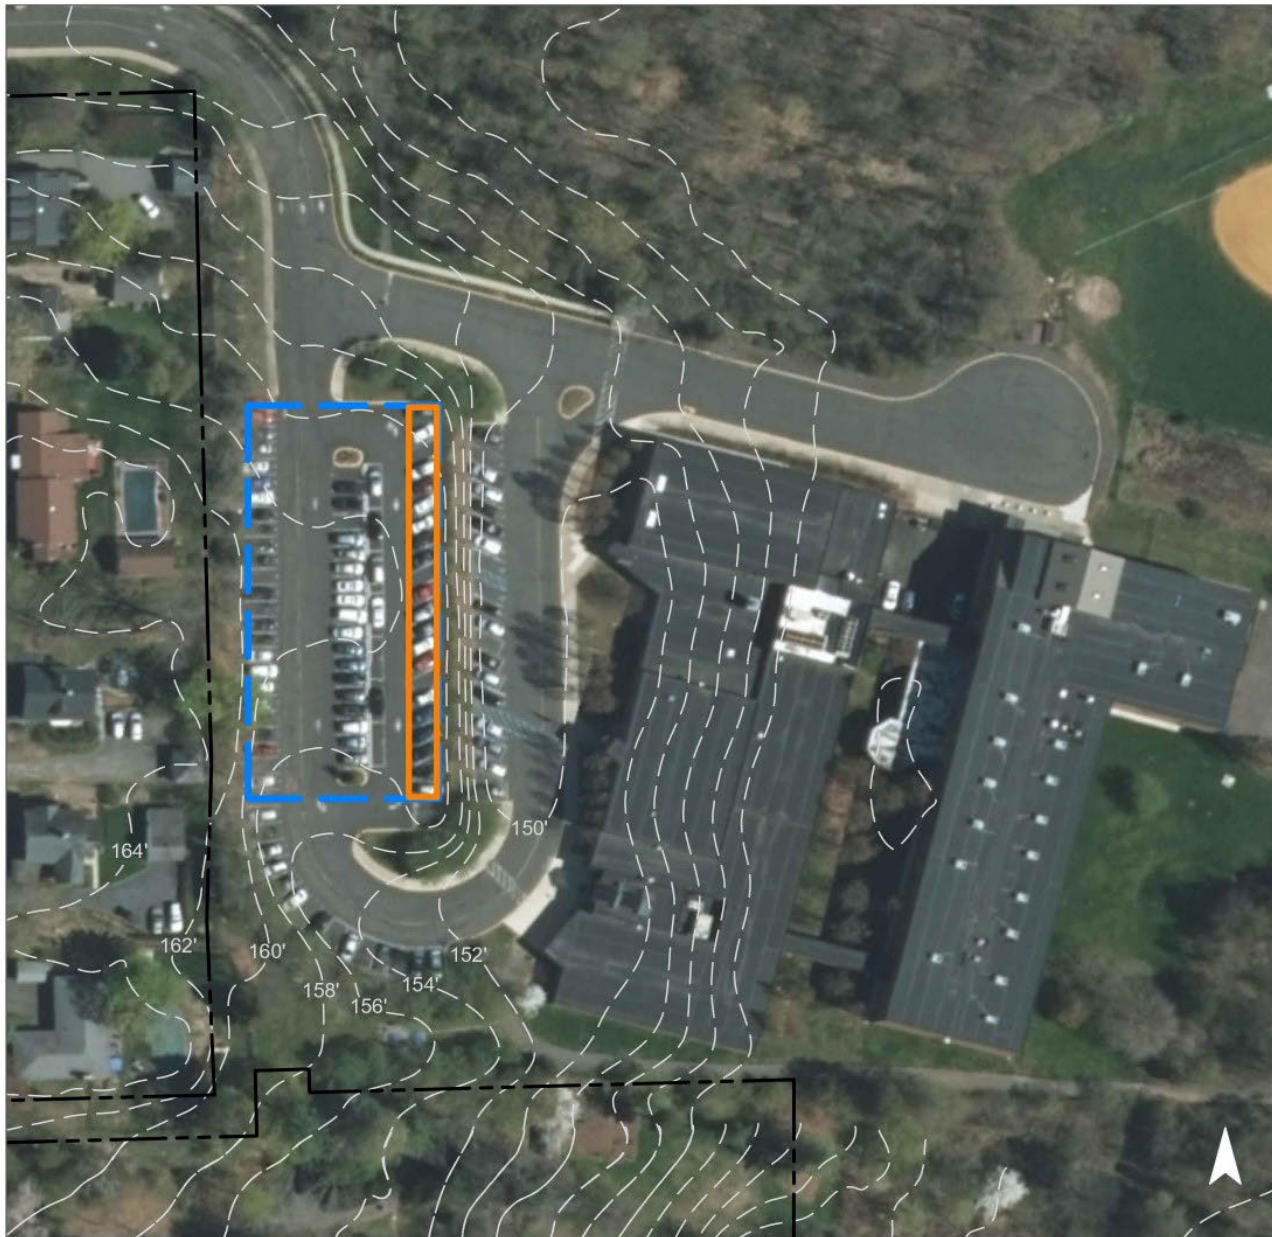
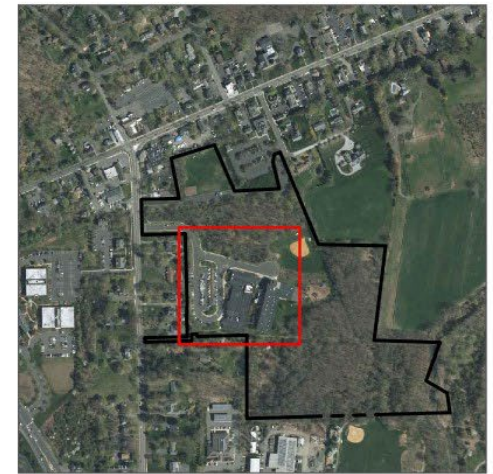
Bedminster Public School

Recommended Green Infrastructure Practices	Recharge Potential (Mgal/yr)	TSS Removal Potential (lbs/yr)	Maximum Volume Reduction Potential (gal/storm)	Peak Discharge Reduction Potential (cu. ft./second)	Estimated Size (sq. ft.)	Estimated Cost
Pervious pavement	0.636	107	46,690	2.06	4,300	\$107,500

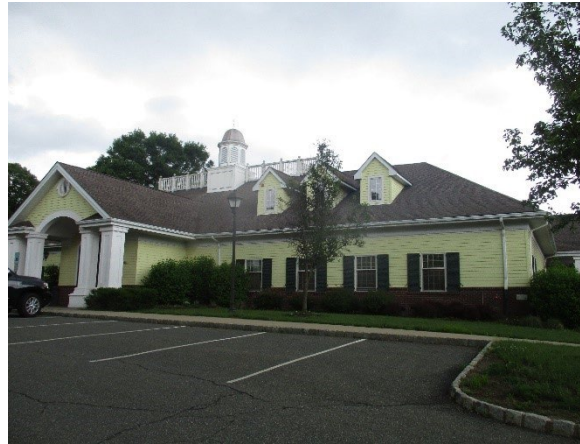
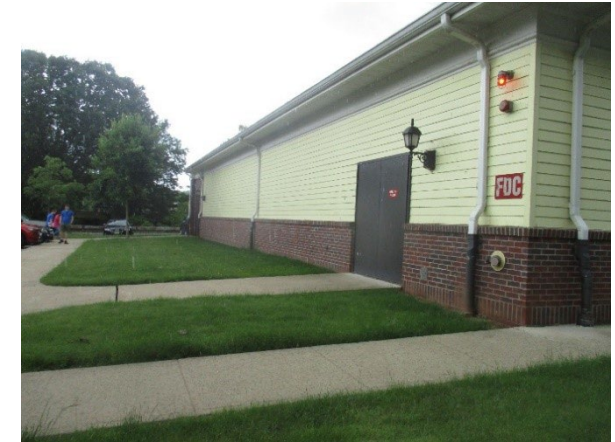
Block and Lot: Block 36, Lots 10,11,12,14

Bioretention systems can be installed to capture, treat, and infiltrate rooftop runoff on the north and south of the building. Pervious pavement can be installed in the southeast corner of the parking lot to capture and infiltrate stormwater. A preliminary soil assessment suggests that the soils have suitable drainage characteristics for green infrastructure.

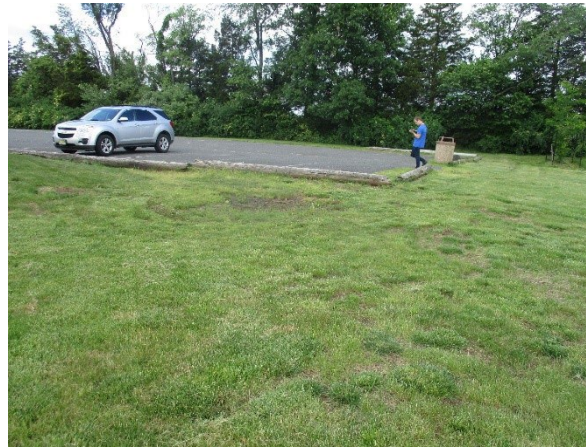
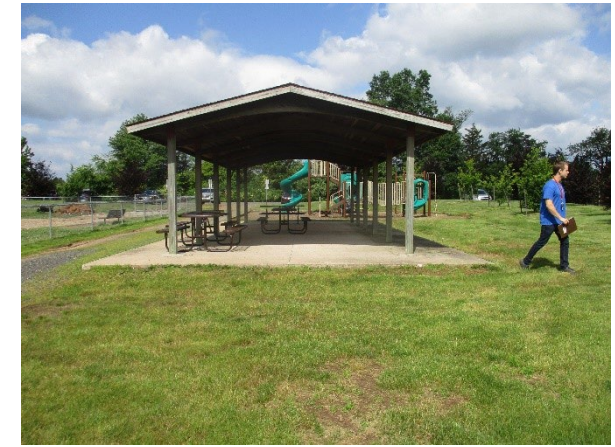
Block and Lot: Block 54, Lot 5

Bioretention systems can be installed to capture, treat, and infiltrate parking lot and rooftop runoff. Potential locations are in the northeast corner of the parking lot and the easternmost side of the structure shown in the above right image. Pervious pavement can be installed in the southwest corner of the parking lot to manage pavement runoff. A preliminary soil assessment suggests that more soil testing would be required before determining the soil's suitability for green infrastructure.

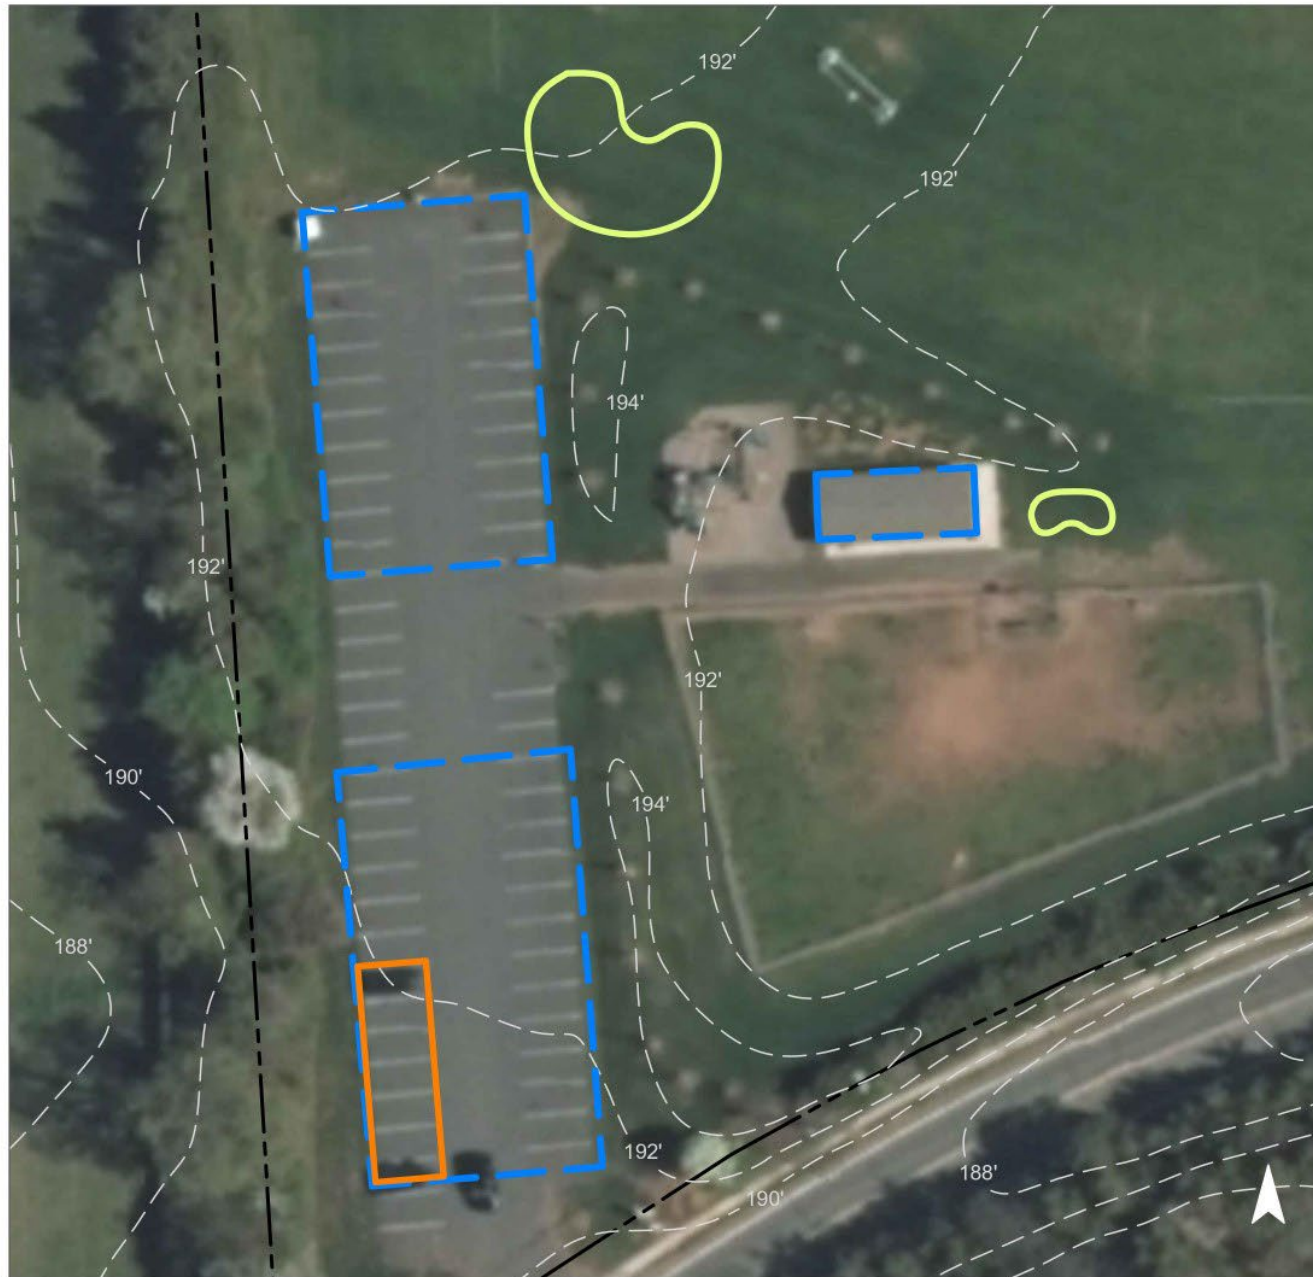
Burnt Mills Park

Recommended Green Infrastructure Practices	Recharge Potential (Mgal/yr)	TSS Removal Potential (lbs/yr)	Maximum Volume Reduction Potential (gal/storm)	Peak Discharge Reduction Potential (cu. ft./second)	Estimated Size (sq. ft.)	Estimated Cost
Bioretention systems	0.183	31	13,405	0.59	1,805	\$9,025
Pervious pavement	0.193	32	14,175	0.62	1,300	\$32,500

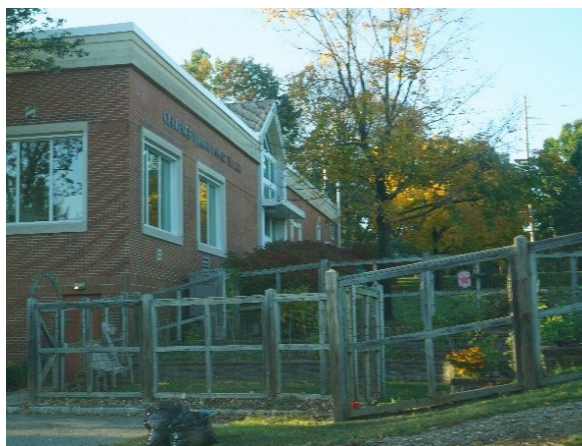
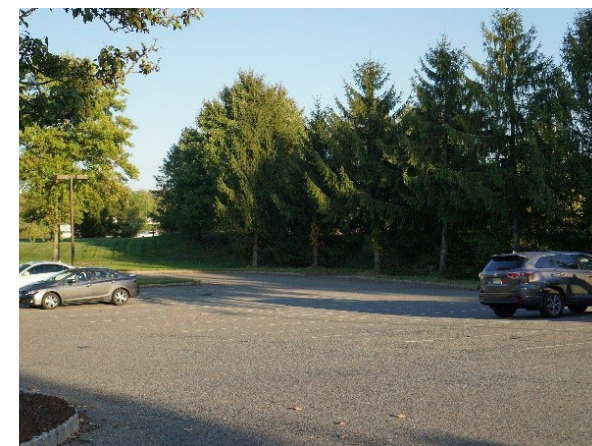
Block and Lot: Block 41, Lot 16.01

A rain garden can be installed on the eastern island in the parking lot to capture stormwater runoff from the impervious surface. A preliminary soil assessment suggests that more soil testing would be required before determining the soil's suitability for green infrastructure.

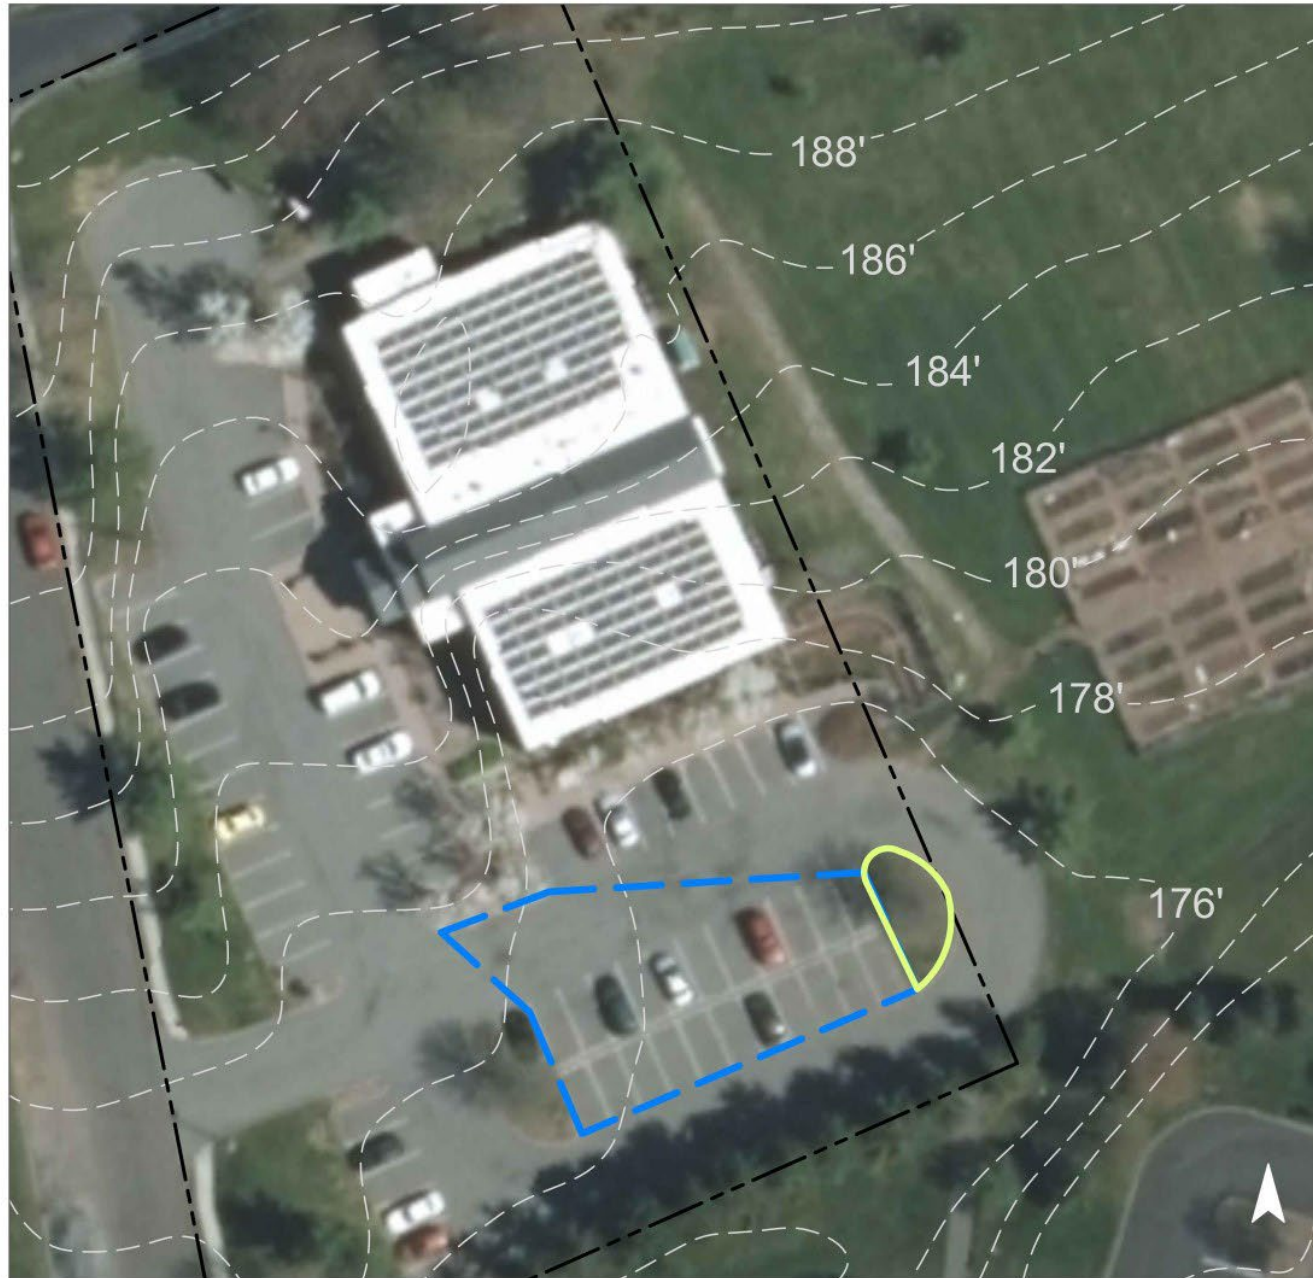
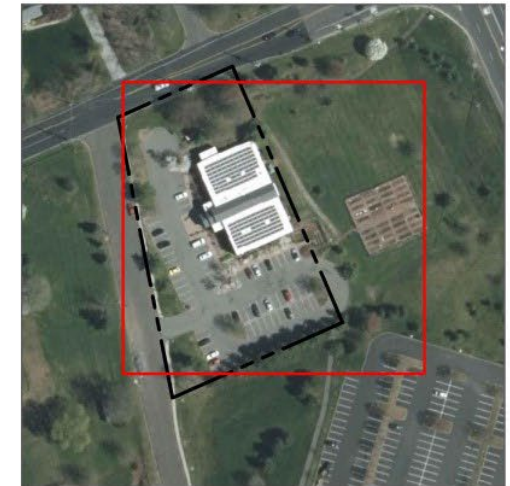
Clarence Dillon Public Library

Recommended Green Infrastructure Practices	Recharge Potential (Mgal/yr)	TSS Removal Potential (lbs/yr)	Maximum Volume Reduction Potential (gal/storm)	Peak Discharge Reduction Potential (cu. ft./second)	Estimated Size (sq. ft.)	Estimated Cost
Bioretention system	0.143	24	10,520	0.46	560	\$2,810

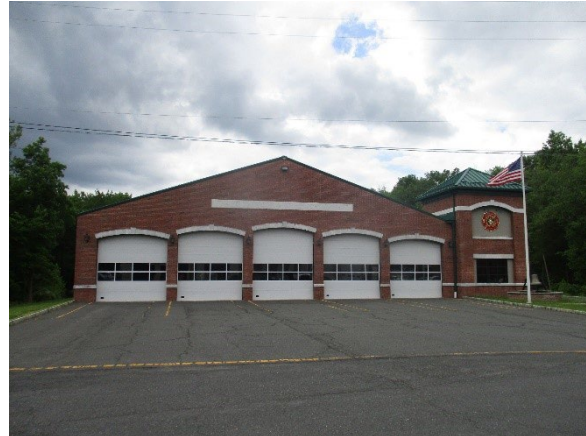
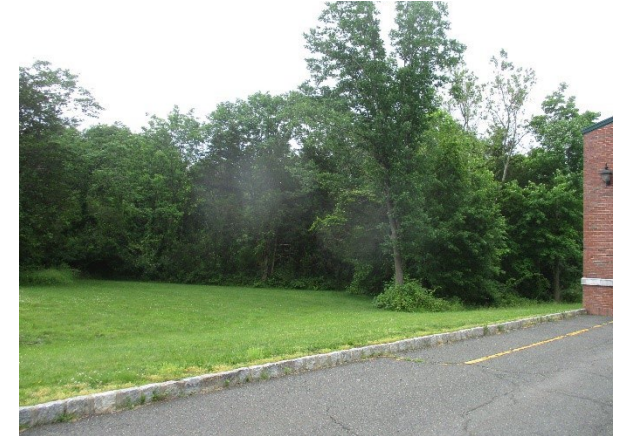
Block and Lot: Block 36, Lot 19

A cistern can be installed in the southwest corner of the building to allow roof runoff to be reused. A bioretention system can be installed at the northeast corner of the building to capture, treat, and infiltrate rooftop runoff. Pervious pavement can be installed in the parking spaces behind and south of the building to filter and infiltrate pavement runoff. A preliminary soil assessment suggests that more soil testing would be required before determining the soil's suitability for green infrastructure.

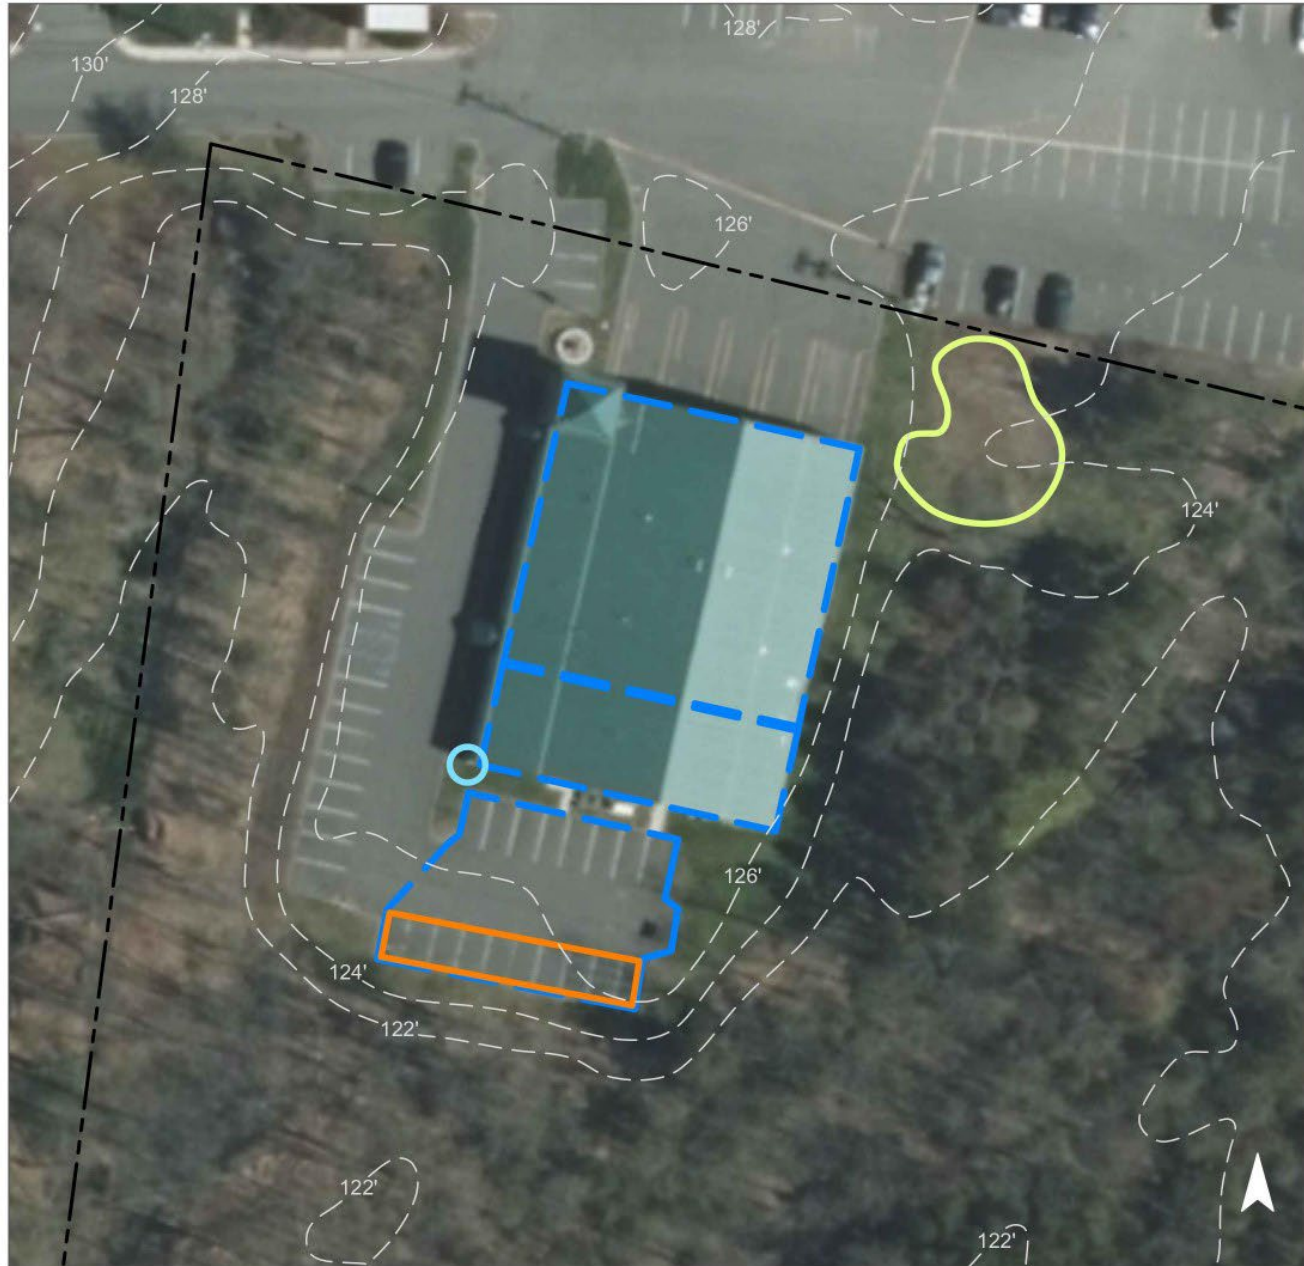
Far Hills-Bedminster Fire Department

Recommended Green Infrastructure Practices	Recharge Potential (Mgal/yr)	TSS Removal Potential (lbs/yr)	Maximum Volume Reduction Potential (gal/storm)	Peak Discharge Reduction Potential (cu. ft./second)	Estimated Size (sq. ft.)	Estimated Cost
Bioretention system	0.250	42	18,300	0.81	2,300	\$11,500
Pervious pavement	0.127	21	15,580	0.69	1,500	\$37,500
Rainwater harvesting	0.091	15	3,000	0.29	3,000 (gal)	\$6,000

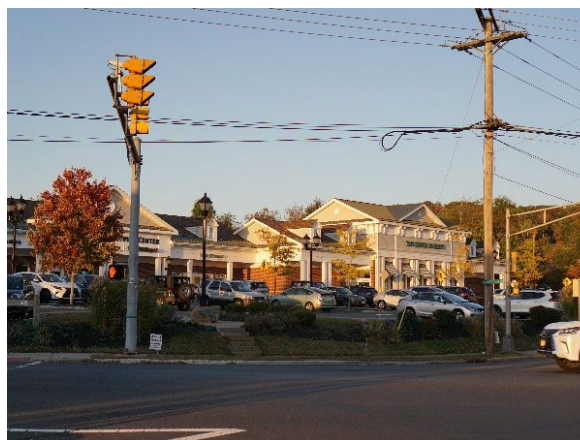
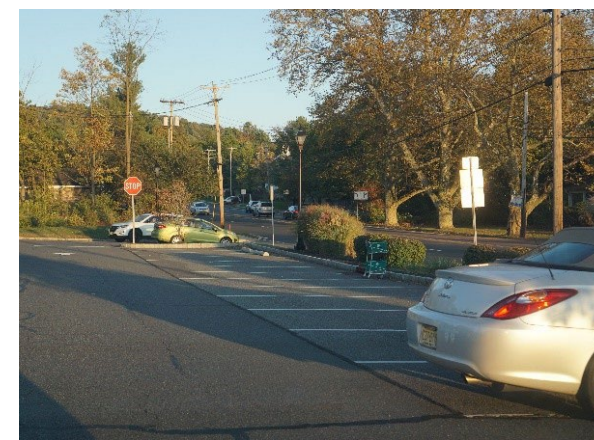
Block and Lot: Block 58, Lot 13, 14

Pervious pavement can be installed within the parking lot to capture stormwater runoff from the impervious surfaces that surround the area. A preliminary soil assessment suggests that more soil testing would be required before determining the soil's suitability for green infrastructure.

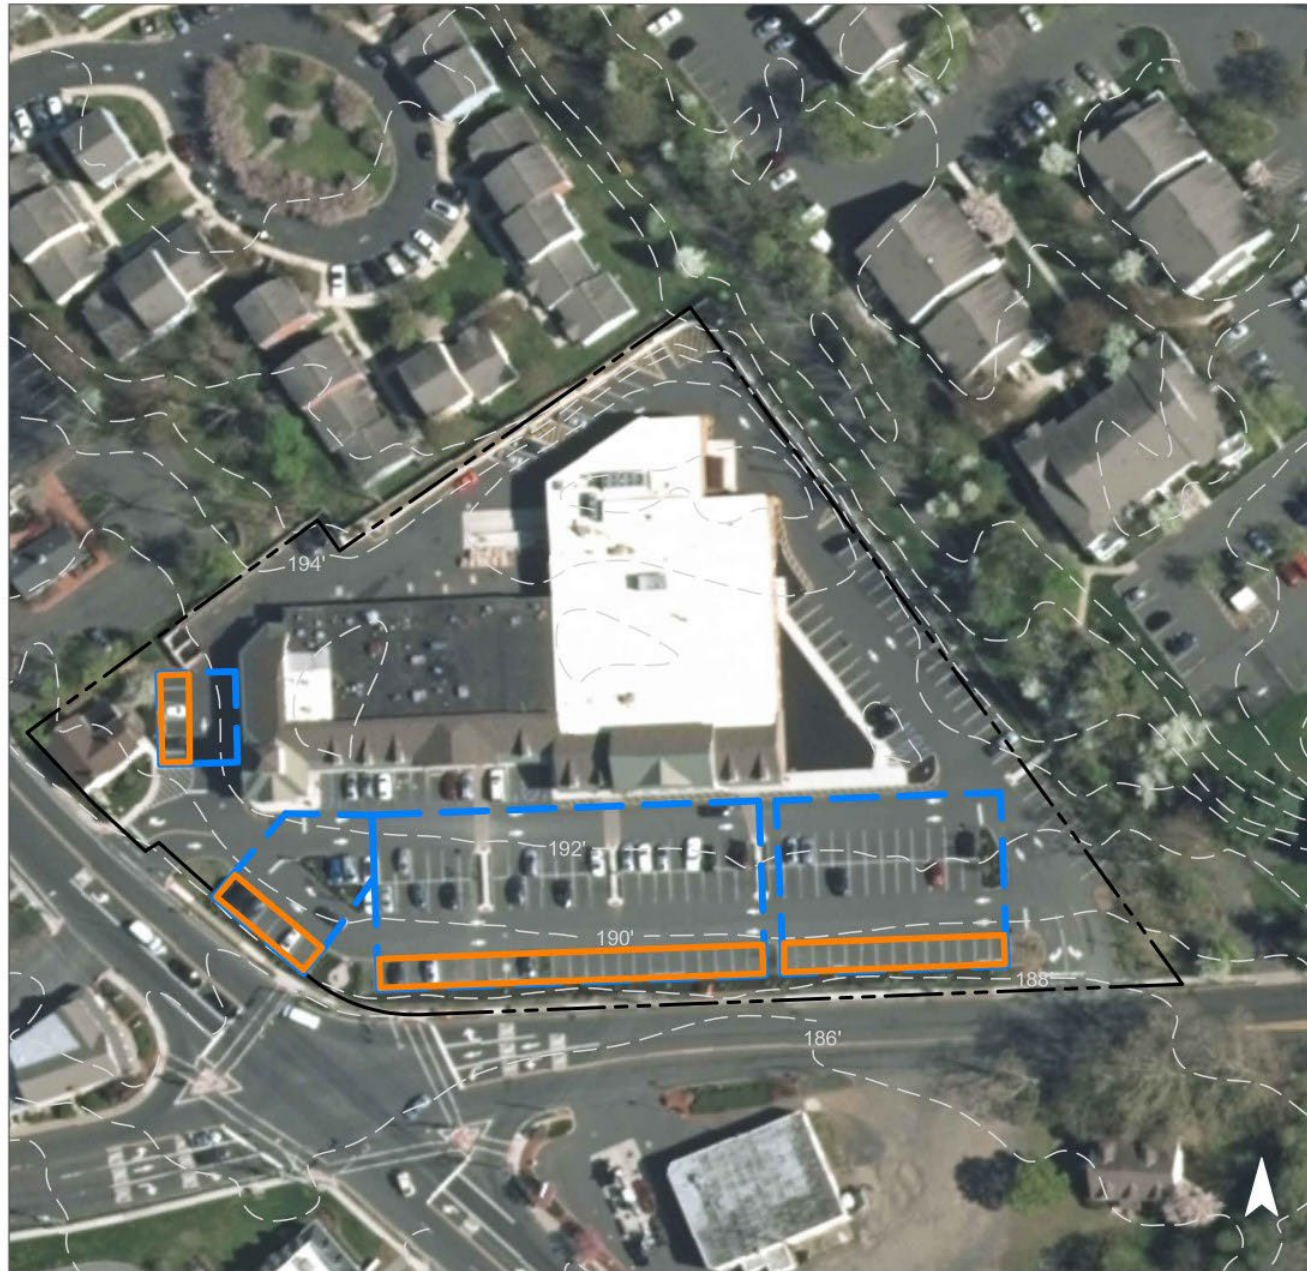
Fresh Market

Recommended Green Infrastructure Practices	Recharge Potential (Mgal/yr)	TSS Removal Potential (lbs/yr)	Maximum Volume Reduction Potential (gal/storm)	Peak Discharge Reduction Potential (cu. ft./second)	Estimated Size (sq. ft.)	Estimated Cost
Pervious pavement	1.039	174	76,235	3.36	8,170	\$204,250

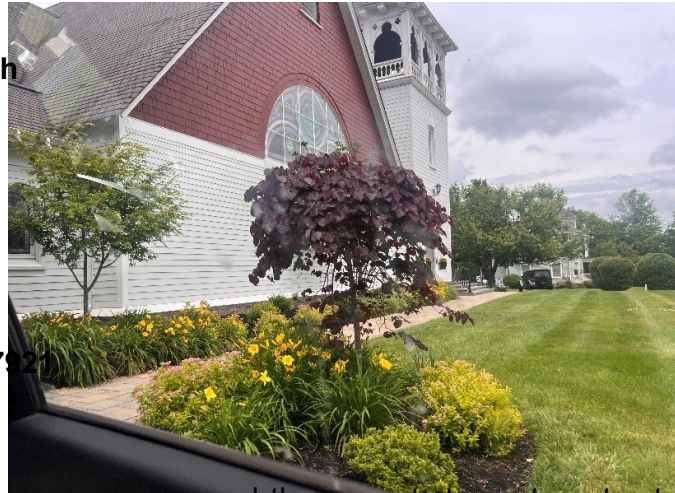
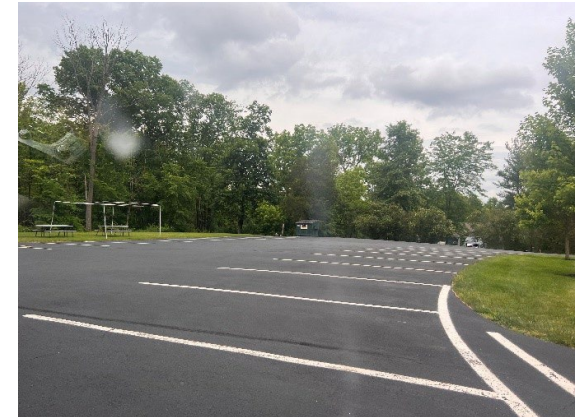
Block and Lot: Block 32, Lot 5

Multiple rain gardens can be installed in grass areas around the property to capture, treat, and infiltrate the stormwater runoff from the rooftops and driveway. This will require downspout disconnections. The existing northern, eastern, and western parking spaces can be converted into pervious pavement to capture and infiltrate the stormwater runoff from the driveway and parking lot. A cistern can be installed to the north of the church building to divert and detain the stormwater runoff from the rooftop for later non-potable reuse such as watering a garden. A preliminary soil assessment suggests that more soil testing would be required before determining the soil's suitability for green infrastructure.

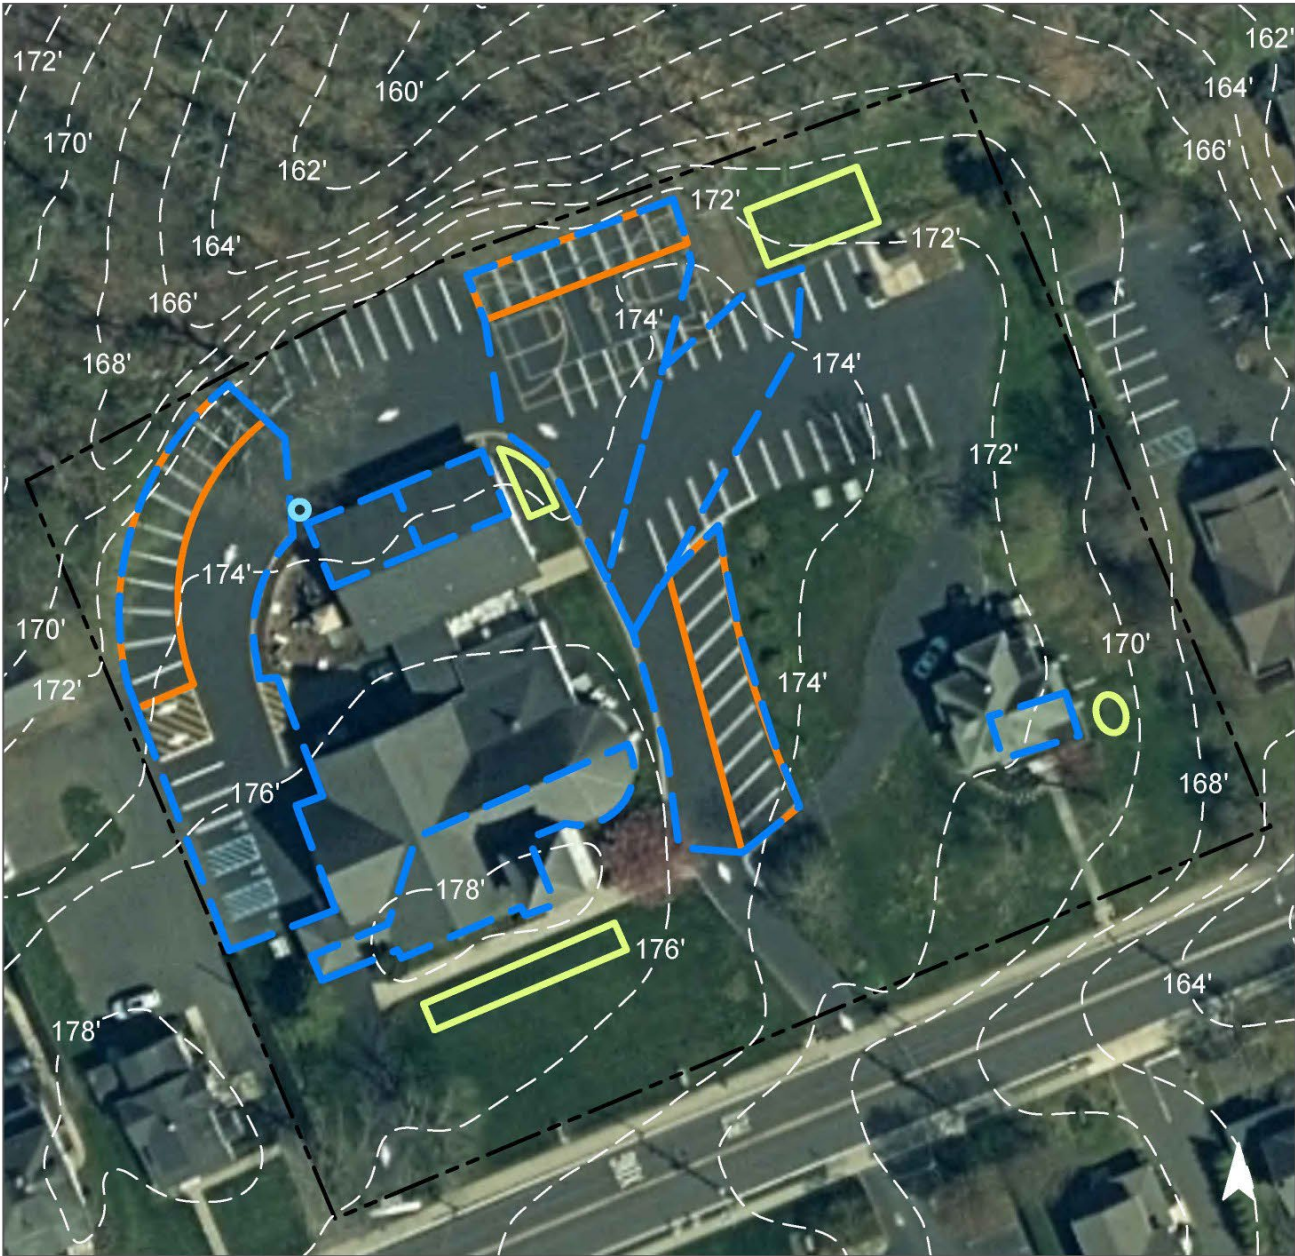
Grace Chapel

Recommended Green Infrastructure Practices	Drainage Area (sq. ft.)	Recharge Potential (Mgal/yr)	TSS Removal Potential (lbs/yr)	Maximum Volume Reduction Potential (gal/storm)	Peak Discharge Reduction Potential (cu. ft./second)	Estimated Size (sq. ft.)	Estimated Cost
Bioretention system	7,085	0.206	30	13,720	0.52	1,770	\$17,700
Pervious pavement	16,675	0.484	72	32,290	1.21	5,140	\$128,500
Rainwater harvesting	735	0.021	4	600	N/A	600 (gal)	\$1,800

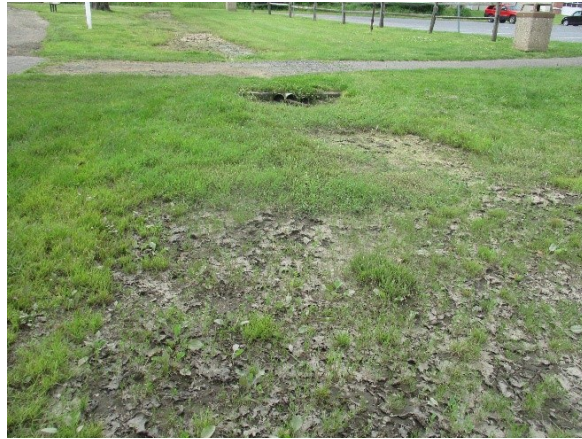
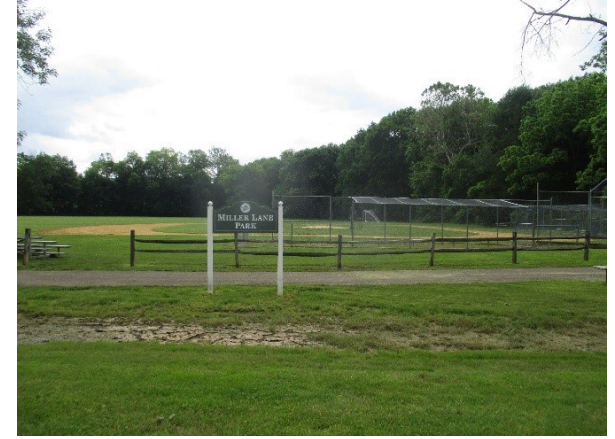
Block and Lot: Block 36, Lot 14

Connected bioretention systems can be installed on the eastern edge of the parking lot to capture, treat, and infiltrate runoff. The systems can be linked by pipes (already installed) shown in the above image. Pervious pavement can be installed in the parking spaces on the southern edge of the parking lot to filter and infiltrate pavement runoff. A preliminary soil assessment suggests that more soil testing would be required before determining the soil's suitability for green infrastructure.

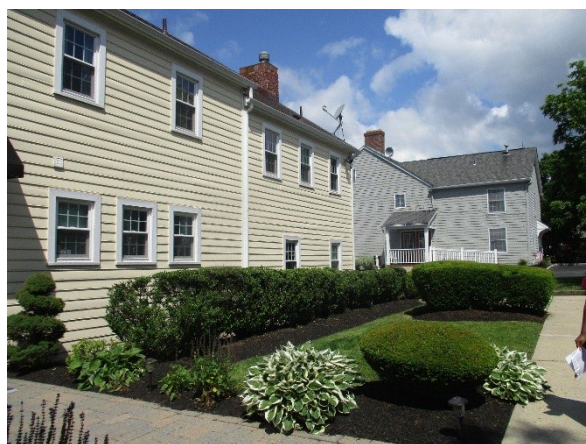
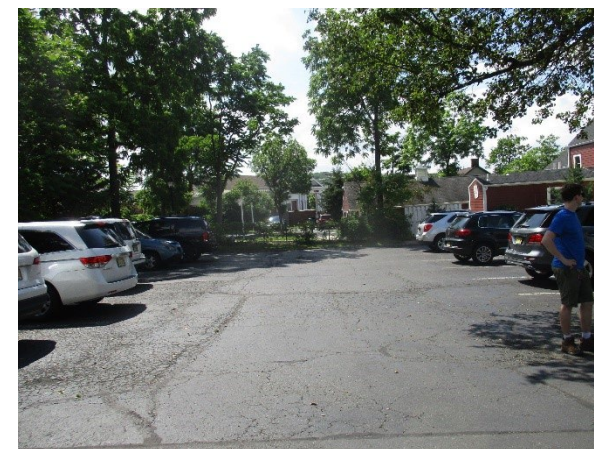
Block and Lot: Block 58, Lots 9 and 10

A bioretention system can be installed northeast of the building, adjacent to the parking lot, to capture, treat, and infiltrate rooftop runoff. The potential site location is shown in the above left image. Pervious pavement can be installed on the southwest side of the parking lot, adjacent to the sidewalk, to capture, filter, and infiltrate pavement runoff. A preliminary soil assessment suggests that more soil testing would be required before determining the soil's suitability for green infrastructure.
