Bedminster Township

Introduction

The purpose of this report is to provide a comprehensive understanding of key, defining features within the subwatersheds throughout Bedminster Township. This involves gathering, organizing, and presenting information about existing conditions and infrastructure within each subwatershed. It aims to serve as a tool for informed decision-making, planning, and implementation of sustainable watershed management strategies aimed to protect and enhance the health of the watershed, its associated ecosystems, and the surrounding communities.

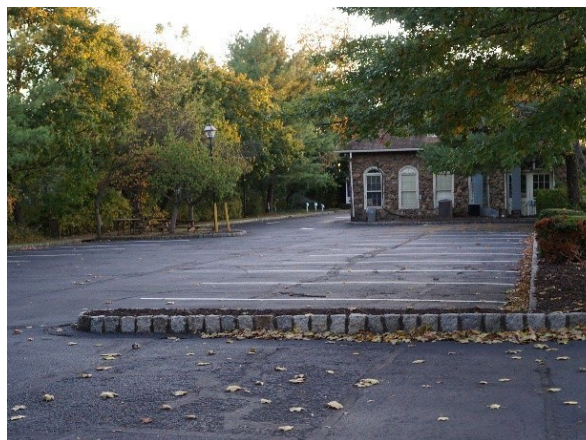
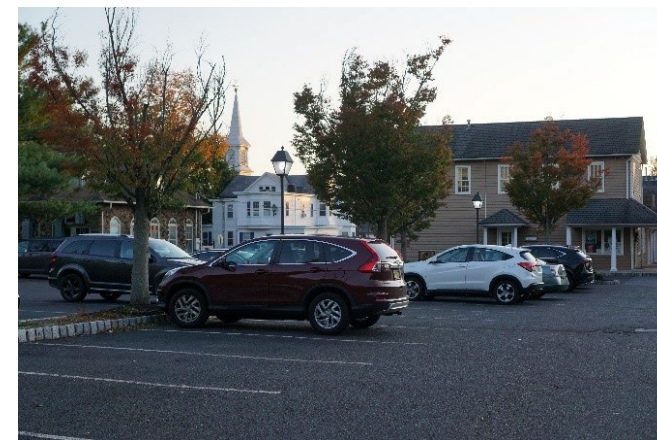
Block and Lot: Block 58, Lot 2

A rain garden can be installed north of the building to capture, treat, and infiltrate stormwater runoff from the rooftop of the building. Additionally, pervious pavement can be installed in the northeast parking lot to capture stormwater from the parking lot. A preliminary soil assessment suggests that more soil testing would be required before determining the soil's suitability for green infrastructure.

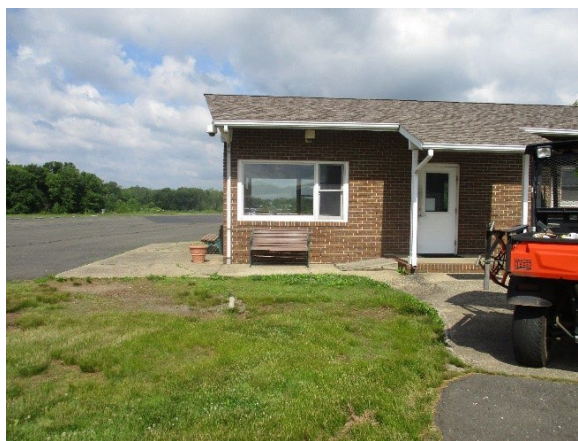
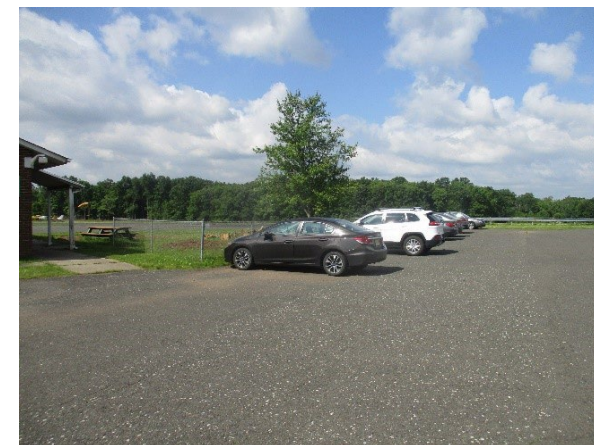
Block and Lot: Block 61, Lot 6

A bioretention system can be installed in the turfgrass located at the southeast corner of the building (shown in the above left image) to capture, treat, and infiltrate rooftop and pavement runoff. Parking spaces can be replaced with pervious pavement to filter and infiltrate stormwater runoff from the parking lot located north of the building shown. A preliminary soil assessment suggests that the soils have suitable drainage characteristics for green infrastructure.

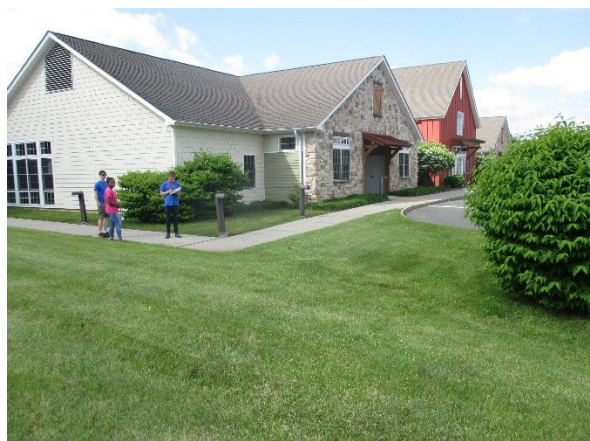
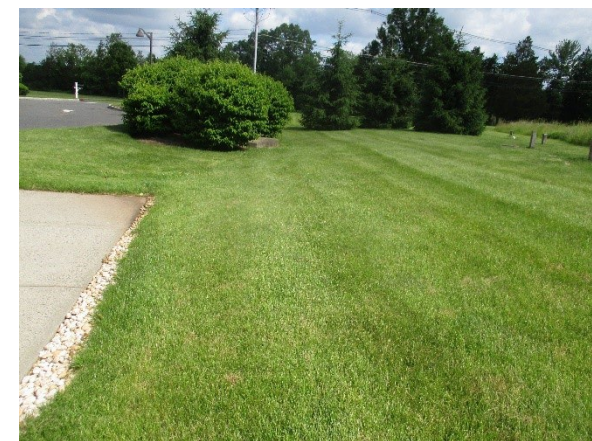
Block and Lot: Block 62.01, Lot 1

Bioretention systems can be installed at the northeast corner of the school (just beyond the corner of the sidewalk seen) and in the center of the courtyard to capture, treat, and infiltrate rooftop runoff. Pervious pavement can be installed at the western edge of the parking lot to manage pavement runoff. A preliminary soil assessment suggests that more soil testing would be required before determining the soil's suitability for green infrastructure.

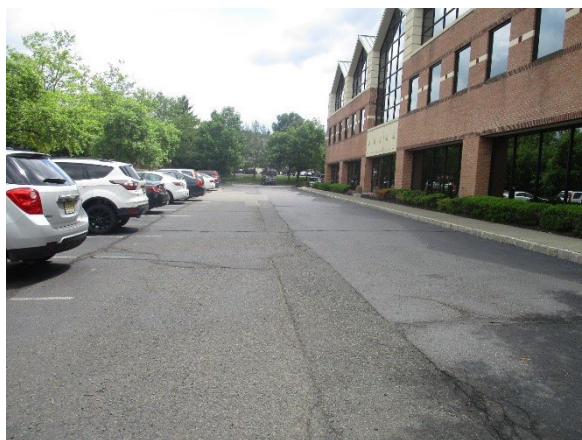
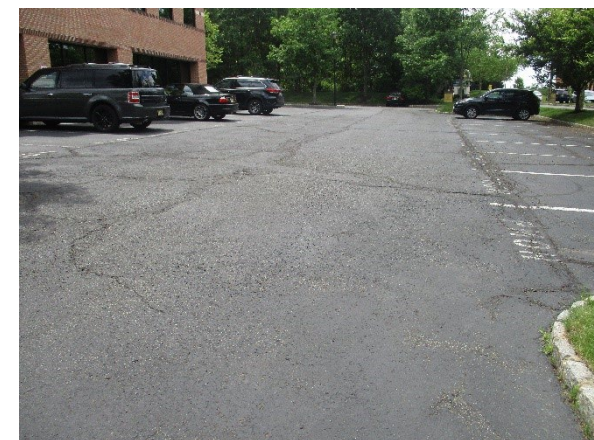
Block and Lot: Block 57, Lot 7

A bioretention system can be installed north of the road in front of the building to manage pavement runoff. Parking spaces north of the building can be replaced with pervious pavement to capture and infiltrate stormwater runoff from the parking lot. A preliminary soil assessment suggests that more soil testing would be required before determining the soil's suitability for green infrastructure.

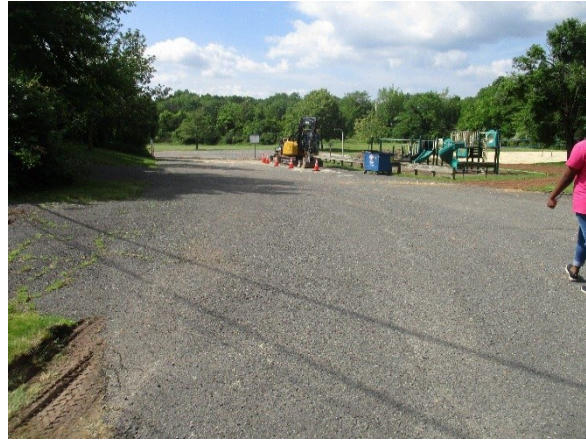
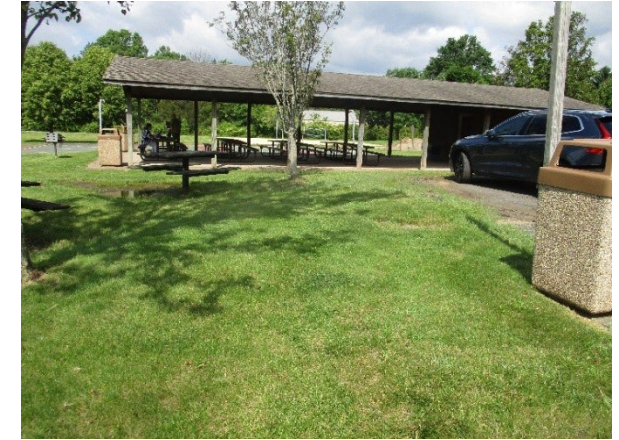
Block and Lot: Block 71, Lot 4

Bioretention systems can be installed southeast of the southernmost building and southeast of the tennis court to capture, treat, and infiltrate rooftop, tennis court, and parking lot runoff. Parking spaces located to the west of the northernmost building can be replaced with pervious pavement to capture and infiltrate stormwater. A preliminary soil assessment suggests that more soil testing would be required before determining the soil's suitability for green infrastructure.

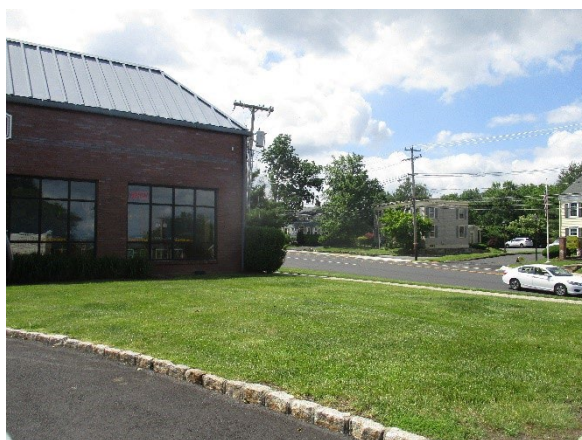
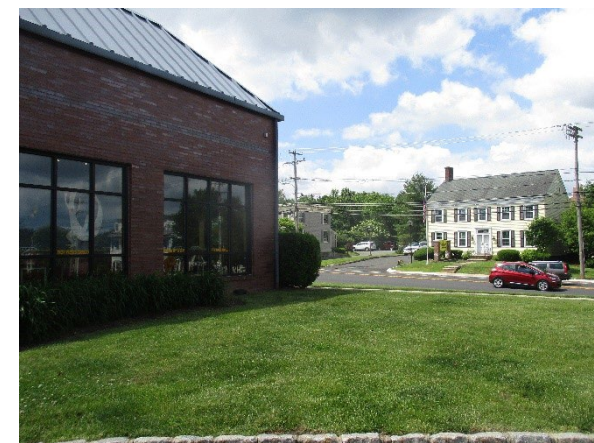
Block and Lot: Block 59.27, Lot 11.1

A bioretention system can be installed on the northwestern side of Pancheros Mexican Grill to capture, treat, and infiltrate rooftop runoff from Pancheros Mexican Grill located in the Hills Village Center. Pervious pavement can be installed in various locations on the northern side of the parking lot to filter and infiltrate pavement runoff. A preliminary soil assessment suggests that more soil testing would be required before determining the soil's suitability for green infrastructure.

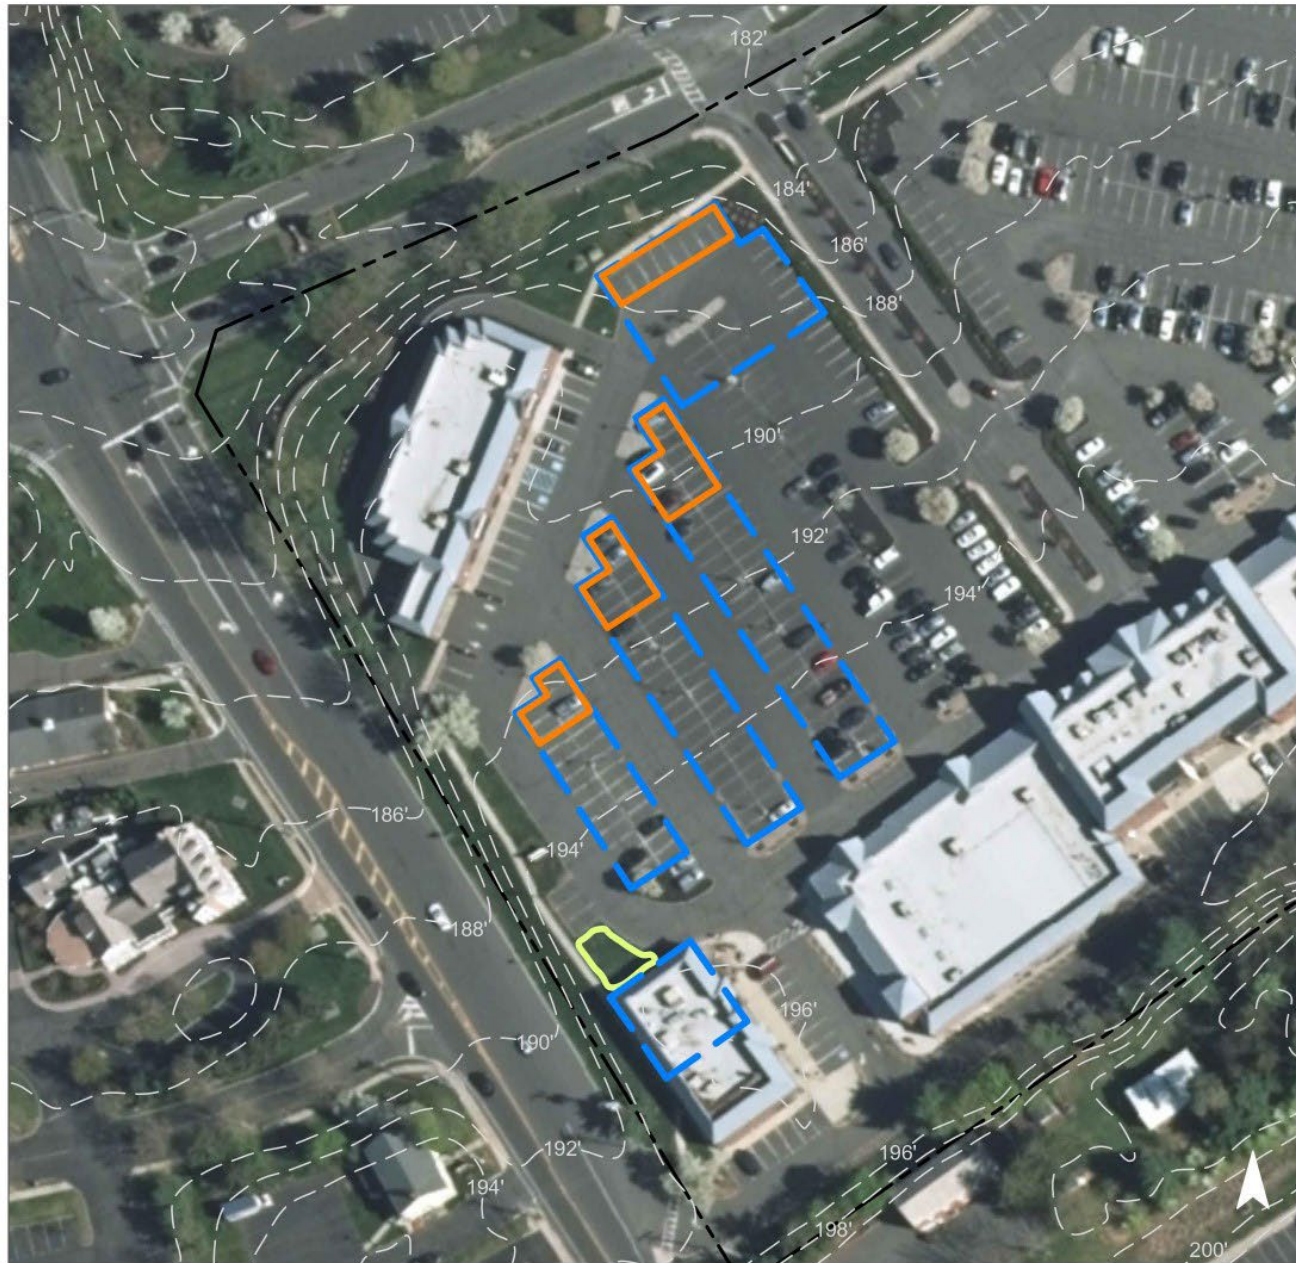
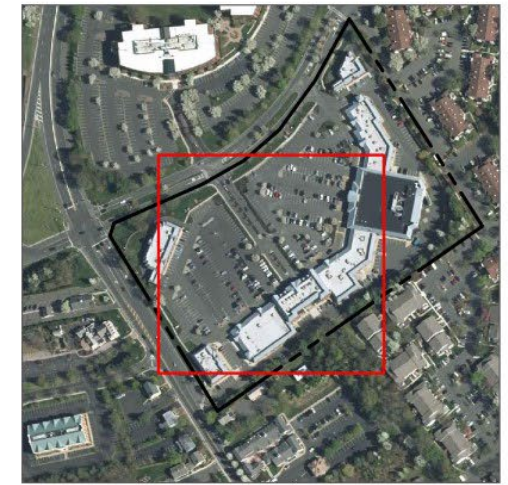
The Hills Village Center

- bioretention system
- pervious pavement
- drainage area
- property line
- 2015 Aerial: NJOIT, OGIS

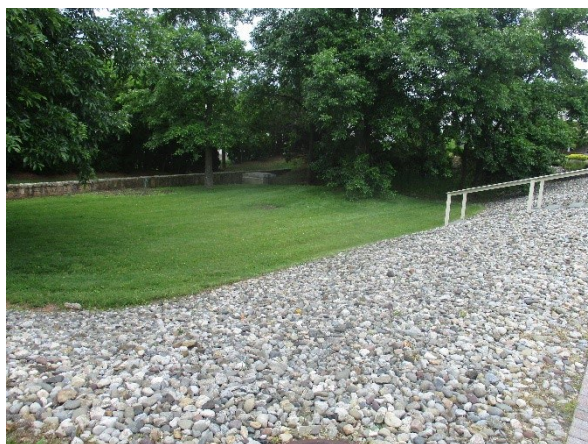
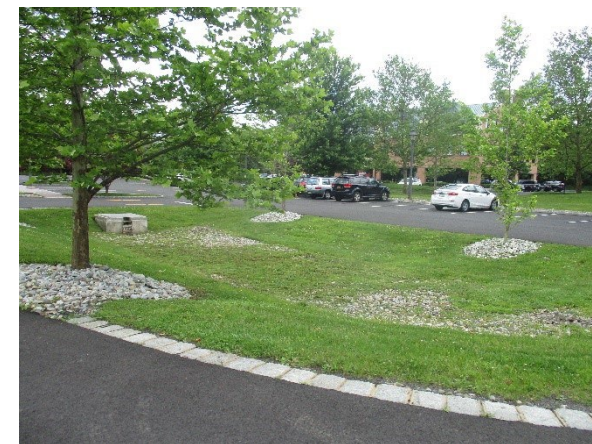
Block and Lot: Block 57, Lot 3

The detention basin in the center of the parking lot can be retrofitted to act as a bioretention system to capture, treat, and infiltrate parking lot runoff. An additional bioretention system can be installed north of the parking lot to capture, treat, and infiltrate additional parking lot runoff. Pervious pavement can be installed in the parking spaces in the northeastern side of the parking lot to infiltrate pavement runoff. A preliminary soil assessment suggests that more soil testing would be required before determining the soil's suitability for green infrastructure.
