Branchburg Township

Introduction

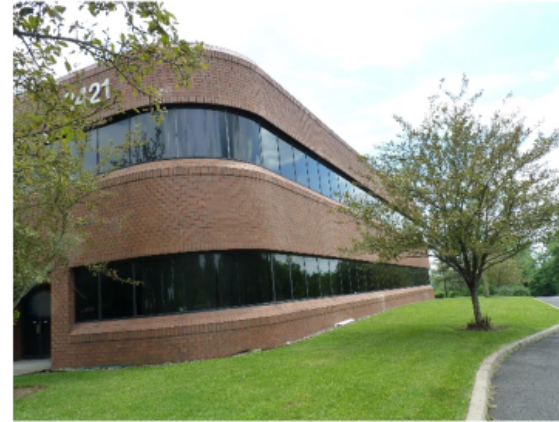
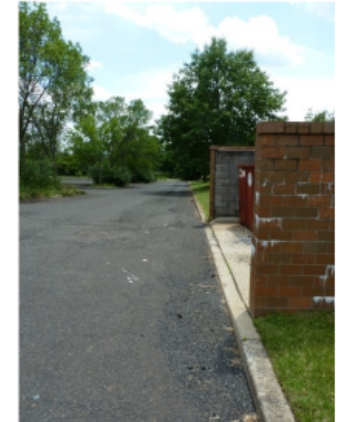
Address: 3421 US 22
Branchburg, NJ 08876

Parking spots on the south side of the building can be replaced with porous asphalt to capture and infiltrate stormwater runoff from the parking lot. A preliminary soil assessment suggests that the soils have suitable drainage characteristics for green infrastructure.

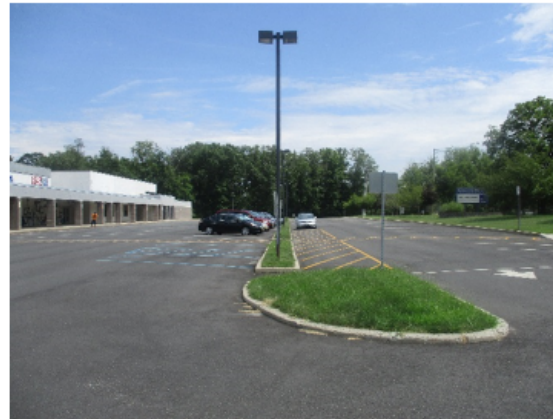
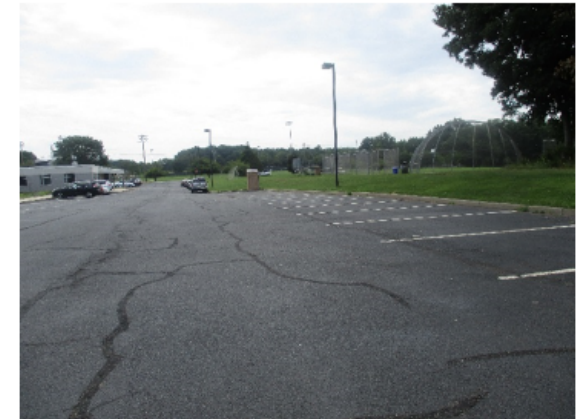
Address: 220 Baird Road
Branchburg, NJ 08876

Parking spots on the south and west sides of the building can be replaced with porous asphalt to capture and infiltrate stormwater runoff from the parking lot. A preliminary soil assessment suggests that more soil testing would be required before determining the soil's suitability for green infrastructure.

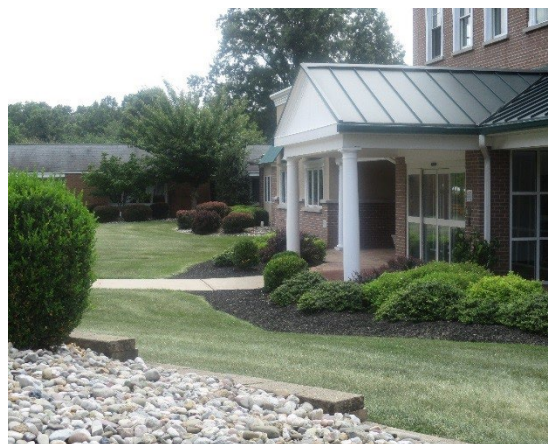
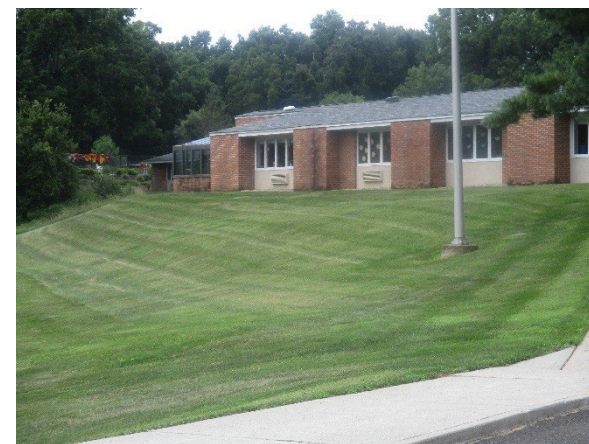
Address: 94 Readington Road
Branchburg, NJ 08876

Parking spaces can be replaced with pervious pavement to infiltrate parking lot runoff. A rain garden can be installed to capture, treat, and infiltrate driveway runoff. A preliminary soil assessment suggests that the soils have suitable drainage characteristics for green infrastructure.

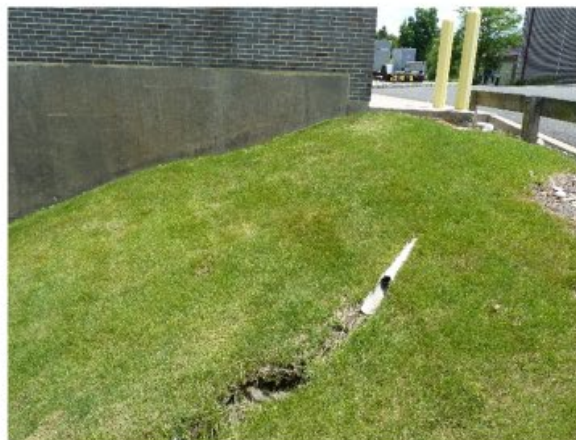
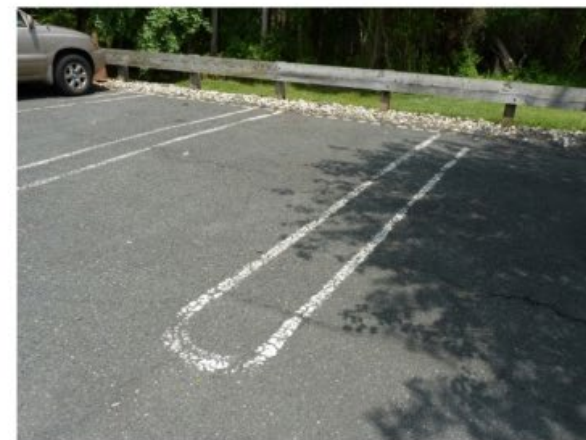
Address: 141 Industrial Parkway
Branchburg, NJ 08876

Parking spots on the east and west sides of the building can be replaced with porous asphalt to capture and infiltrate parking lot runoff. A preliminary soil assessment suggests that the soils have suitable drainage characteristics for green infrastructure.

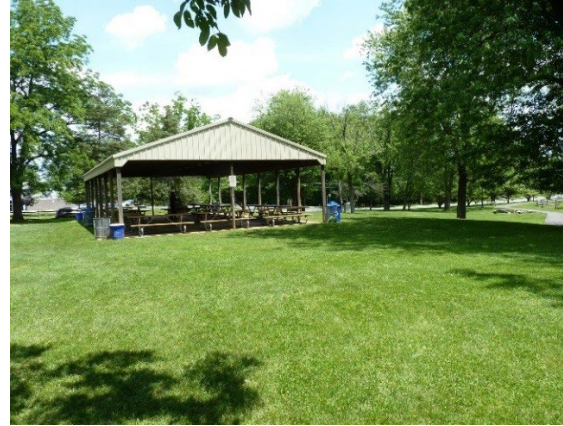
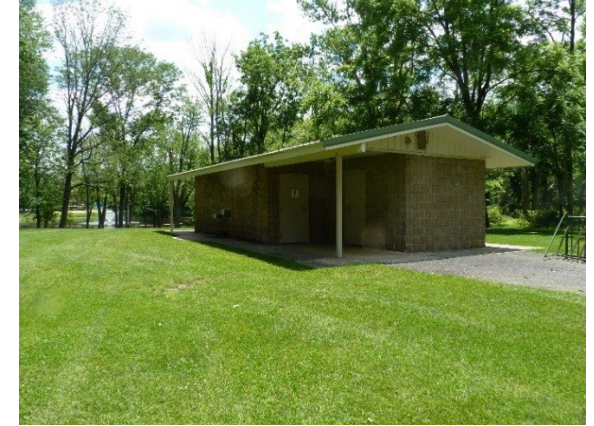
Address: 200 Baird Road
Branchburg, NJ 08876

Rain gardens can be built to capture, treat, and infiltrate roof runoff. A preliminary soil assessment suggests that more soil testing would be required before determining the soil's suitability for green infrastructure.

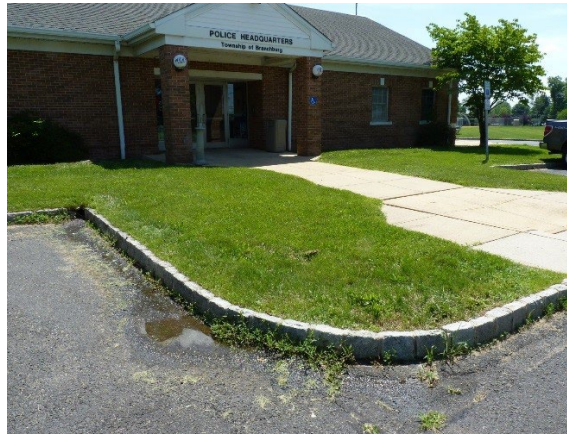
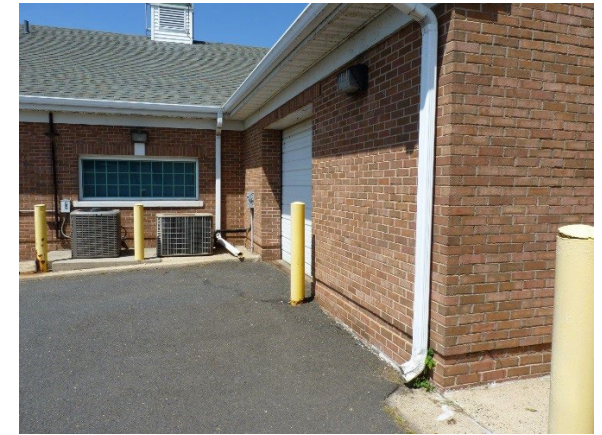
Address: 1077 US 202
Branchburg, NJ 08876

Parking spaces can be replaced with pervious pavement to infiltrate runoff. A rain garden can be installed to capture, treat, and infiltrate roof runoff. A preliminary soil assessment suggests that the soils have suitable drainage characteristics for green infrastructure.

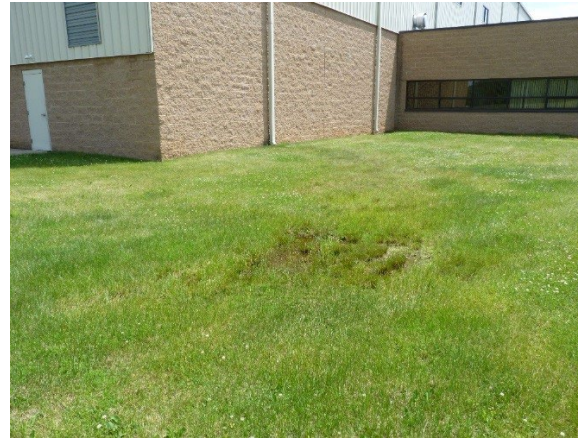
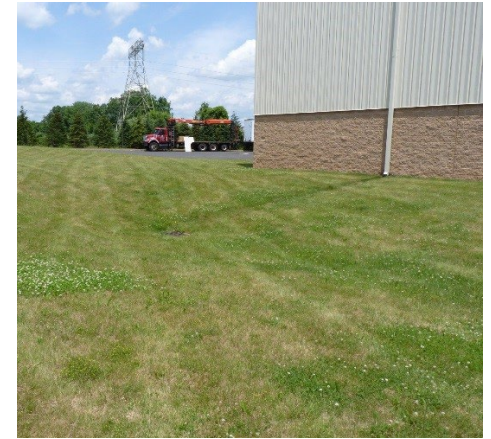
Address: 260 Evans Way
Branchburg, NJ 08876

Bioretention systems can be installed to capture, treat, and infiltrate rooftop runoff. Parking spaces can be replaced with pervious pavement to infiltrate parking lot runoff. A preliminary soil assessment suggests that the soils have suitable drainage characteristics for green infrastructure.

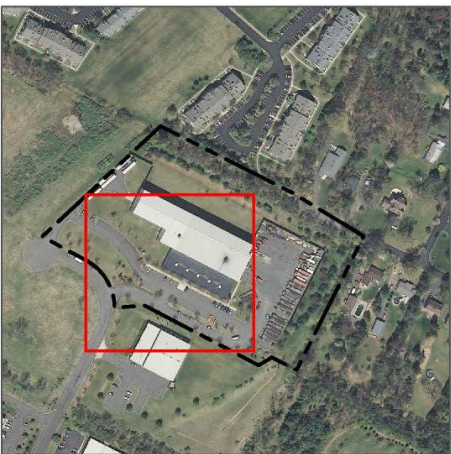
Mid-Atlantic CNC Inc.

- disconnected downspouts
- pervious pavements
- bioretention / rain gardens
- drainage areas
- property line
- 2012 Aerial: NJOIT, OGIS

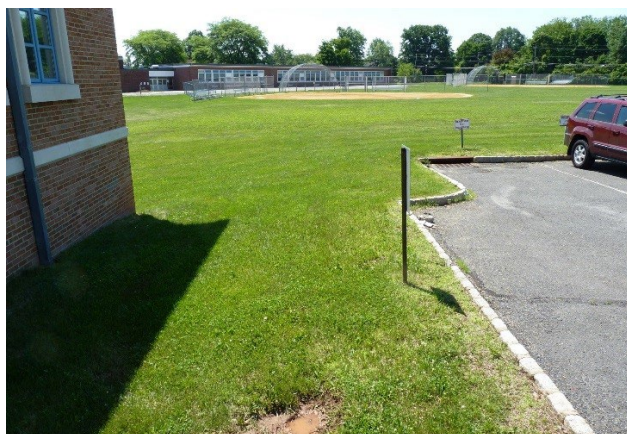
Address: 1077 US 202
Branchburg, NJ 08876

Parking spaces can be replaced with pervious pavement to infiltrate runoff. Bioretention systems can be installed to capture, treat, and infiltrate additional stormwater. A preliminary soil assessment suggests that more soil testing would be required before determining the soil's suitability for green infrastructure.

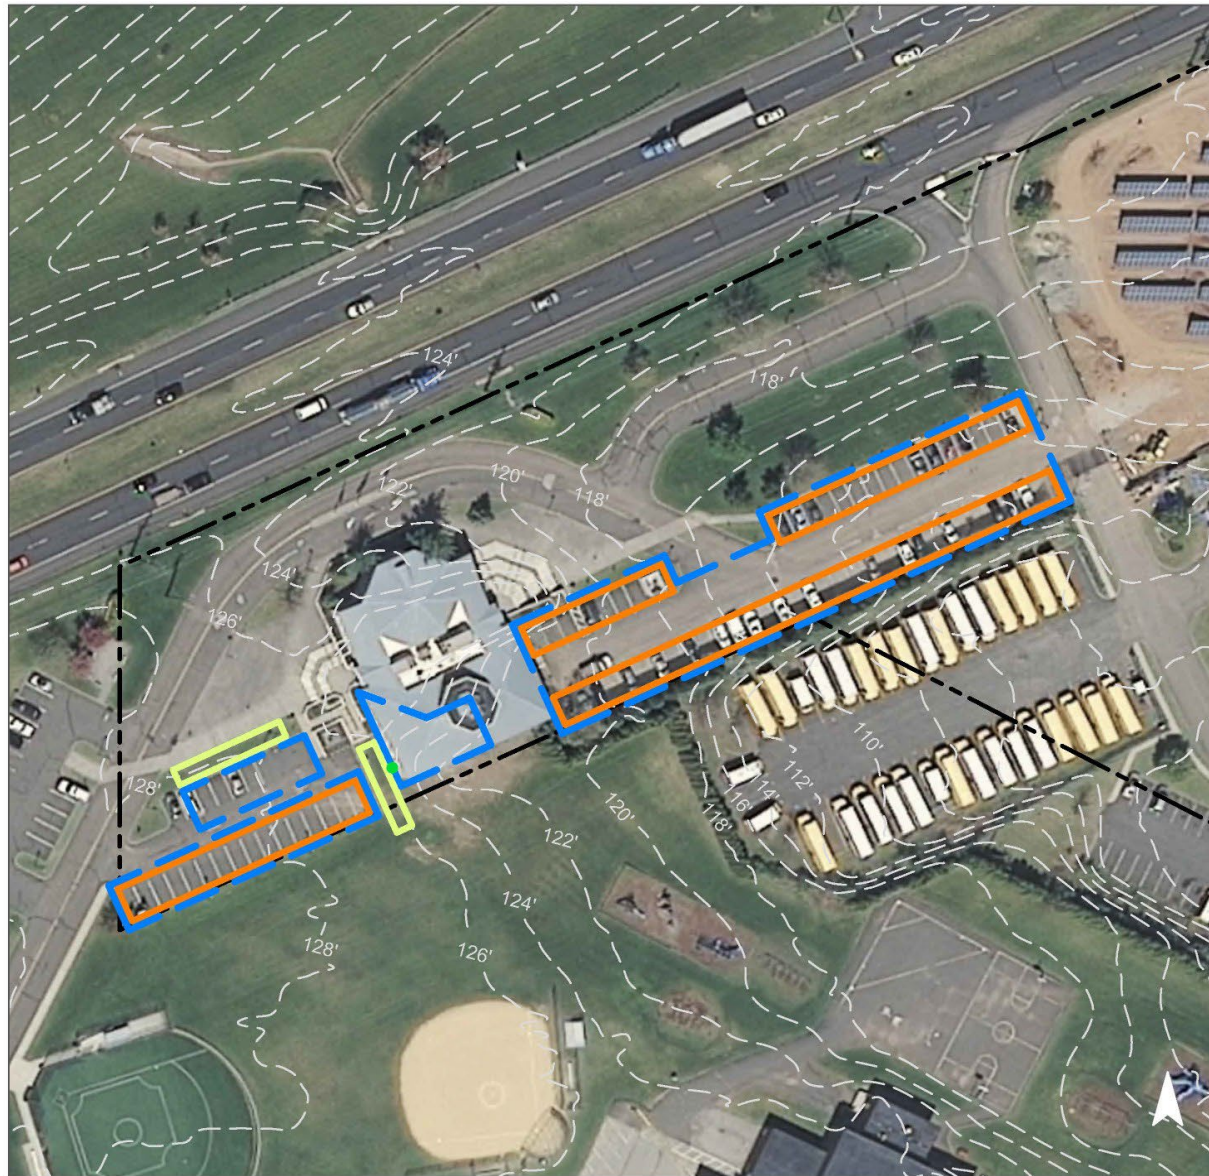
Branchburg Municipal Building

- disconnected downspouts
- pervious pavements
- bioretention / rain gardens
- drainage areas
- property line
- 2012 Aerial: NJOIT, OGIS

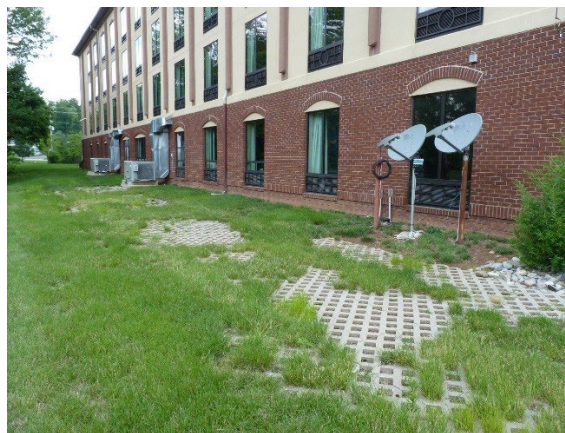
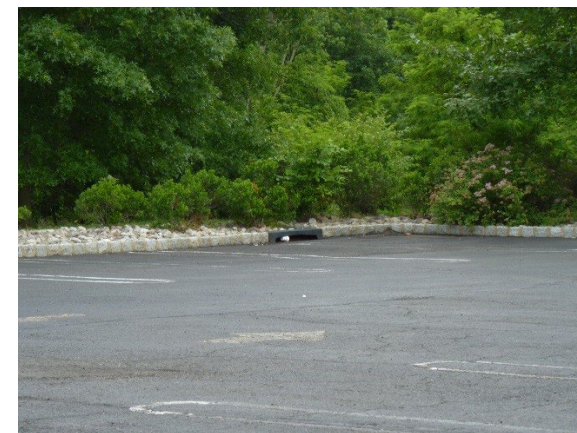
Address: 347 US 202
Branchburg, NJ 08876

Existing pervious pavers surround the south and west sides of the buildings. Downspouts can be disconnected and directed into the pavers to capture and infiltrate roof runoff. Parking spaces can be replaced with porous asphalt to capture parking lot runoff. A preliminary soil assessment suggests that the soils have suitable drainage characteristics for green infrastructure.

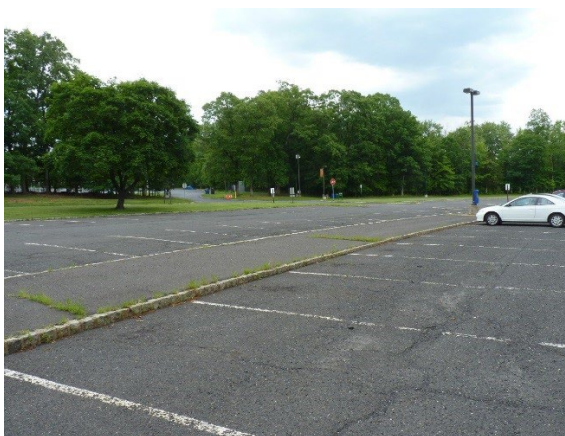
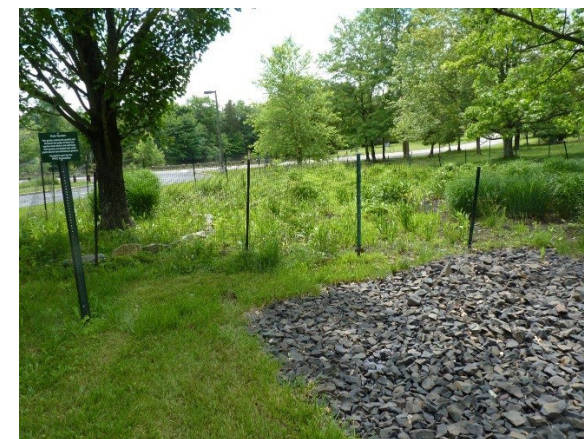
Address: 118 Lamington Road
Branchburg, NJ 08876

Two rain gardens can be installed in the parking lot to capture, treat, and infiltrate runoff from the parking lot. A preliminary soil assessment suggests that the soils have suitable drainage characteristics for green infrastructure.

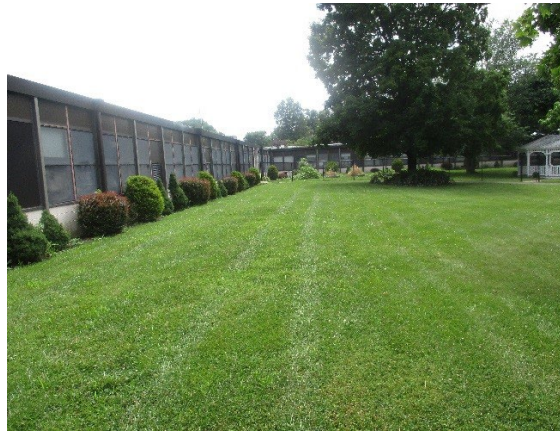
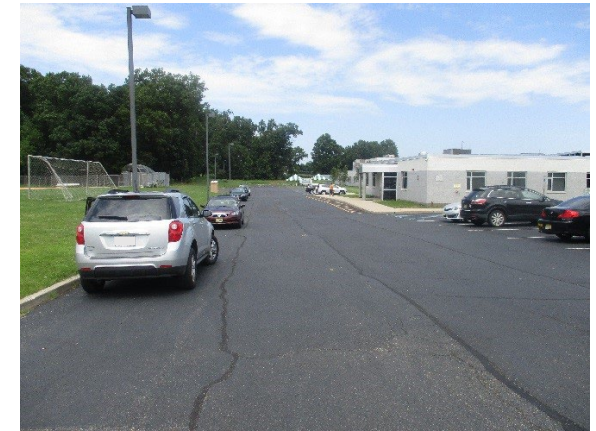
Address: 136 Cedar Grove Road
Branchburg, NJ 08876

Parking spaces on the east and west sides of the school can be replaced with porous asphalt to capture and infiltrate stormwater runoff from the parking lot. Bioretention systems can be installed to capture, treat, and infiltrate rooftop runoff. A preliminary soil assessment suggests that the soils have suitable drainage characteristics for green infrastructure.

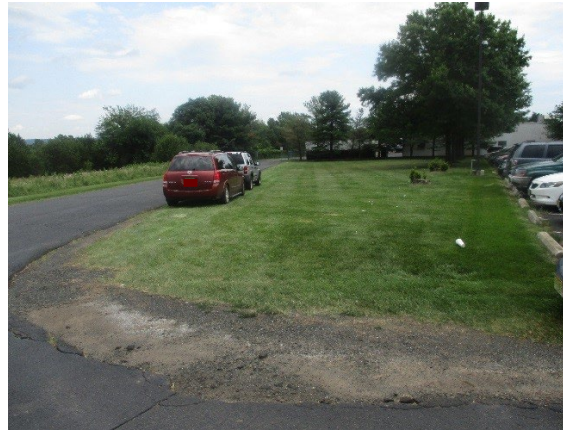
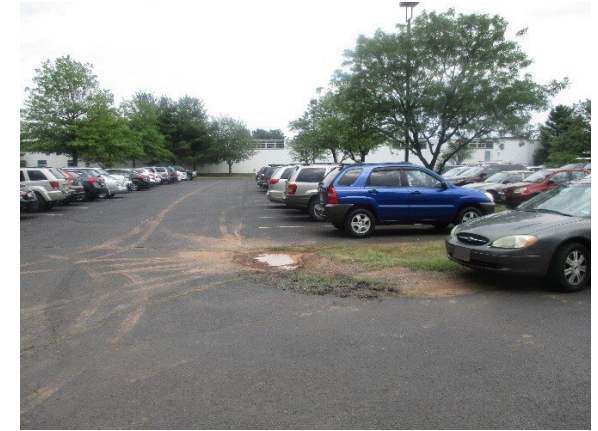
Address: 3140 US 22
Branchburg, NJ 08876

Parking spaces can be replaced with pervious pavement to infiltrate runoff. In the northwest corner of the site a rain garden can be installed to capture, treat, and infiltrate stormwater generated by the parking lot. A preliminary soil assessment suggests that the soils have suitable drainage characteristics for green infrastructure.

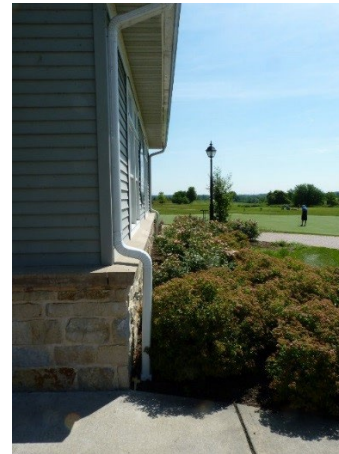
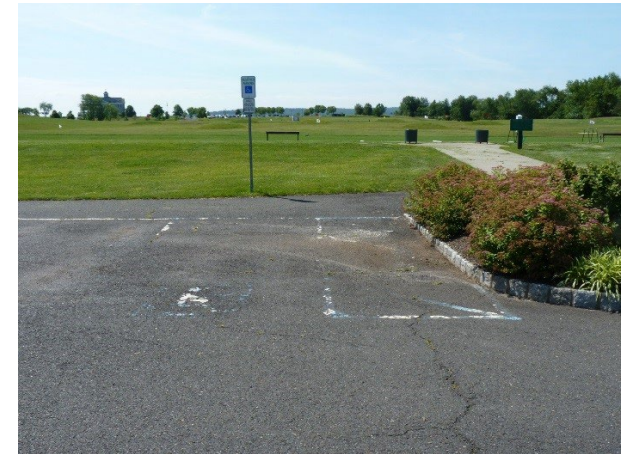
Address: 2301 South Branch Road
Branchburg, NJ 08876

Parking spaces can be replaced with porous asphalt to capture and infiltrate runoff. Bioretention systems can also be installed to capture, treat, and infiltrate roof runoff. A preliminary soil assessment suggests that the soils have suitable drainage characteristics for green infrastructure.

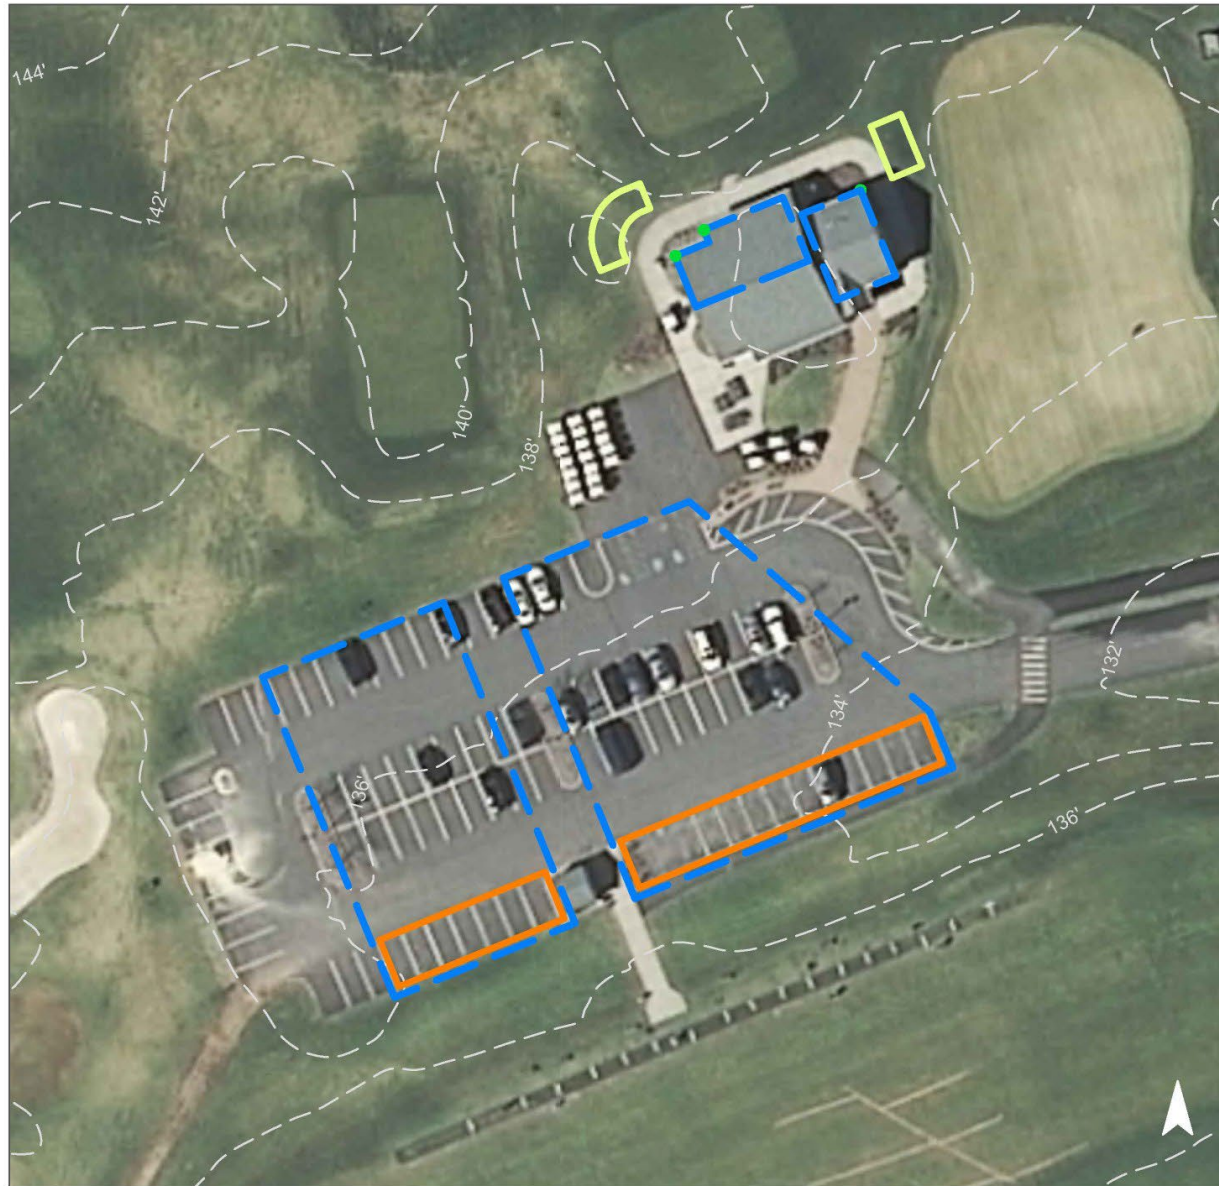
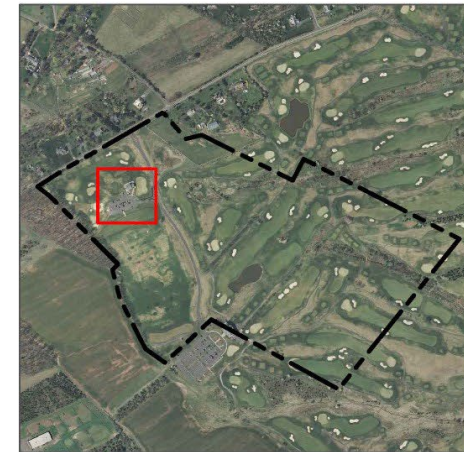
Neshanic Valley Golf Course

-   disconnected downspouts
-   pervious pavements
-

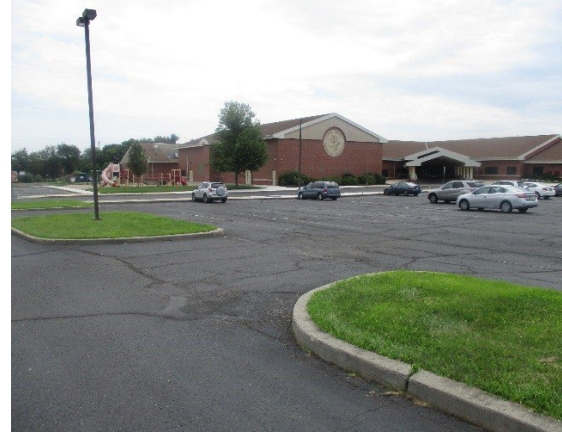
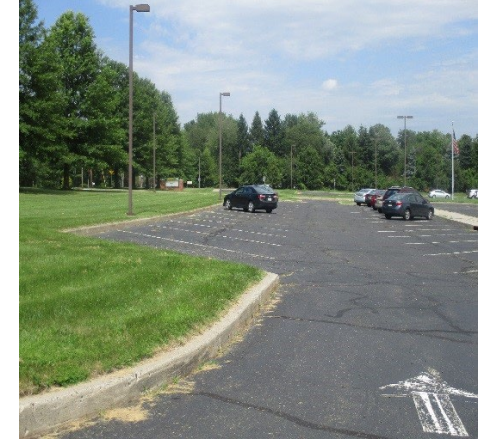
Address: 470 Whiton Road
Neshanic Station, NJ 08853

Bioretention systems can be built to capture, treat, and infiltrate parking lot runoff. Parking spaces can be replaced with pervious pavement. A preliminary soil assessment suggests that the soils have suitable drainage characteristics for green infrastructure.
