Chester Borough

Introduction

Analysis by Municipality

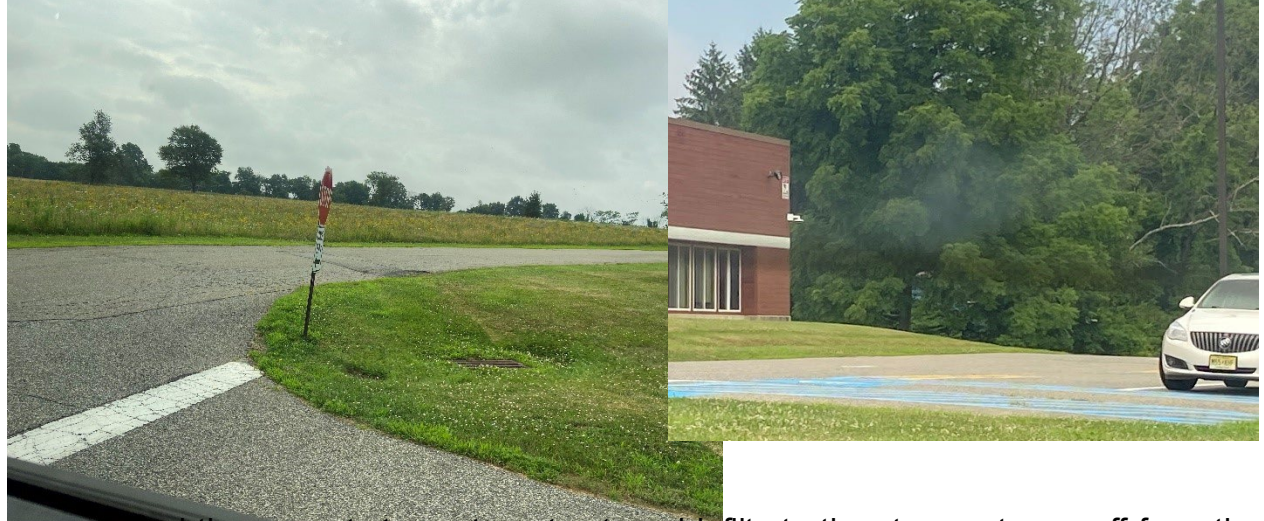
Rain gardens can be installed in multiple grass areas around the property to capture, treat, and infiltrate the stormwater runoff from the driveway and parking lot. Trench drains will be required for some of these gardens. Existing parking spaces in the northern and southern parking lots can be converted into pervious pavement to capture and infiltrate the stormwater runoff from the asphalt. A preliminary soil assessment suggests that the soils have suitable drainage characteristics for green infrastructure.

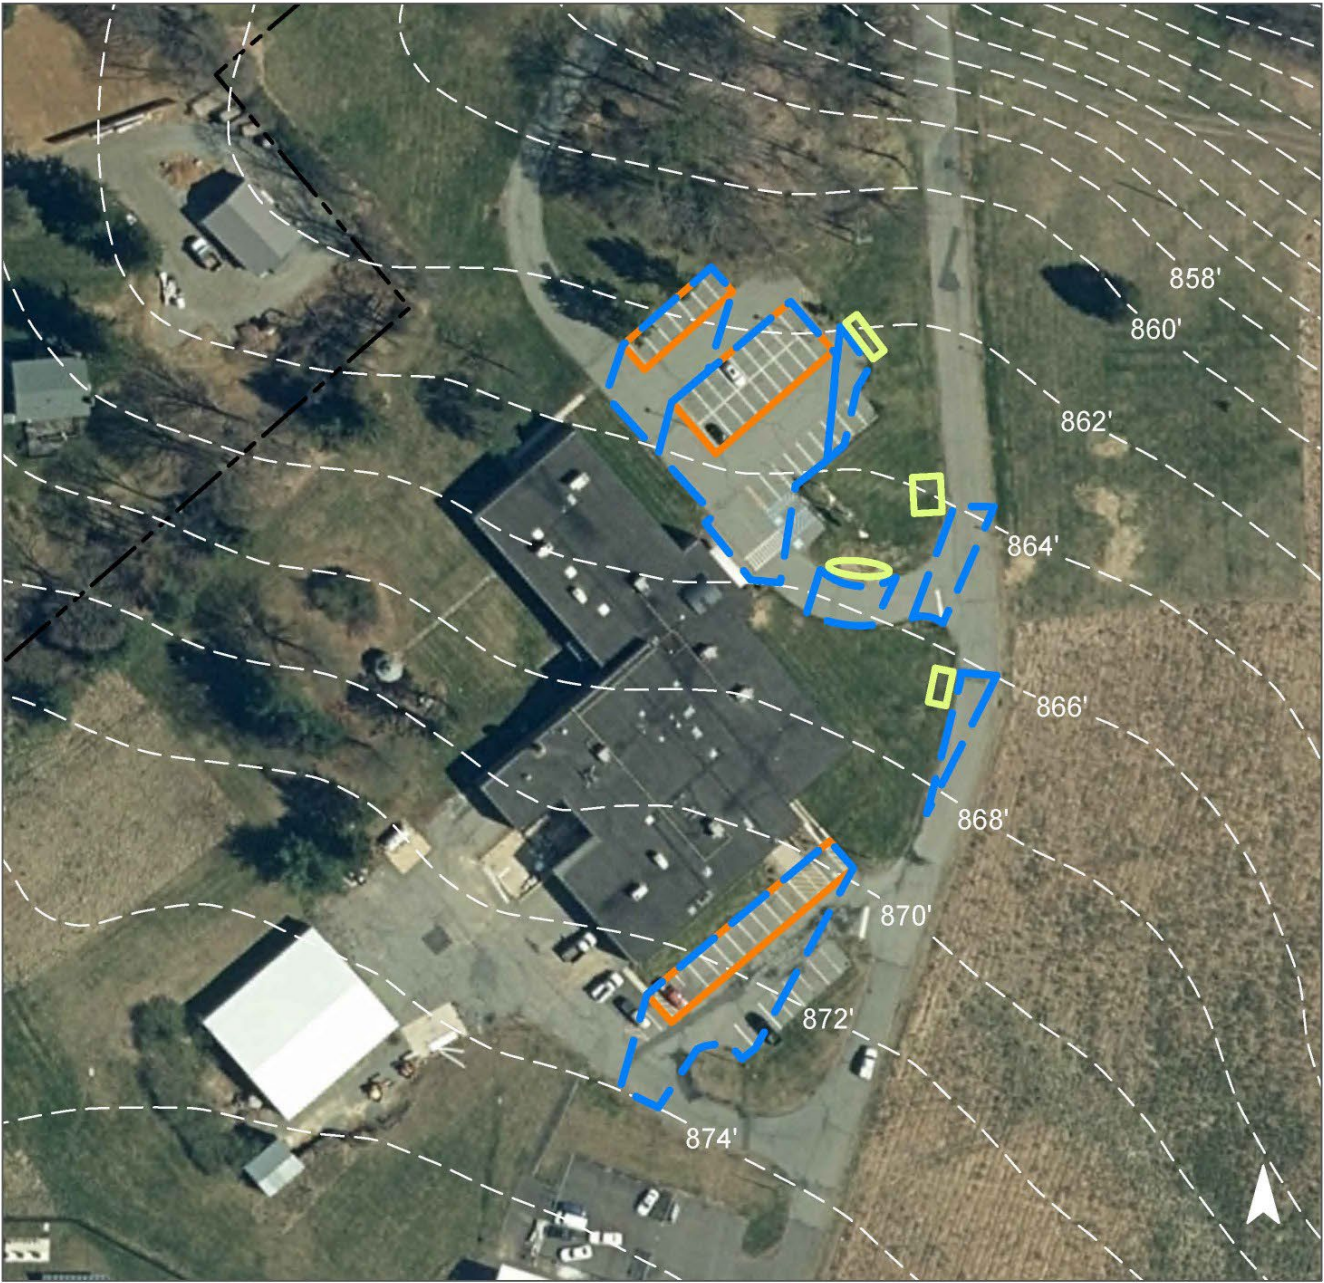
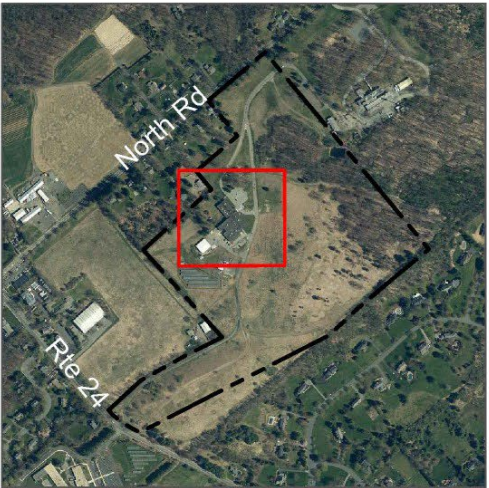
Chester Borough Office

- bioretention system
- pervious pavement
- captured drainage area
- property line
- 2020 Aerial: NJOIT, OGIS

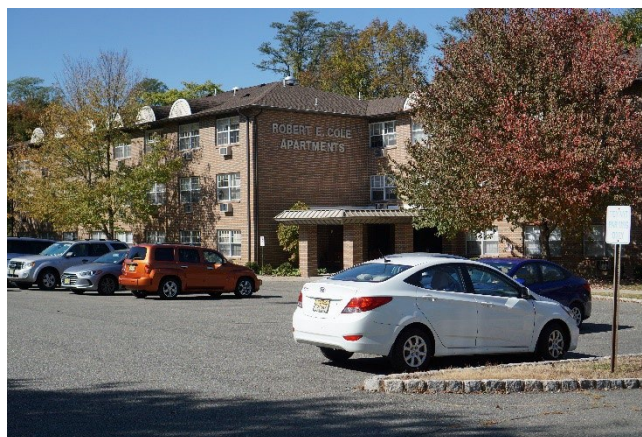
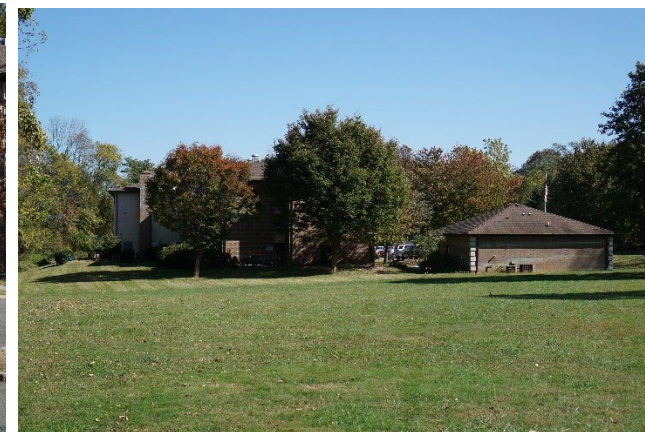
Two rain gardens can be installed west of the two buildings to accumulate and infiltrate stormwater runoff from the buildings. Additionally, porous pavement can be used to capture stormwater from the parking lot in front of the main building. A preliminary soil assessment suggests that more soil testing would be required before determining the soil's suitability for green infrastructure.

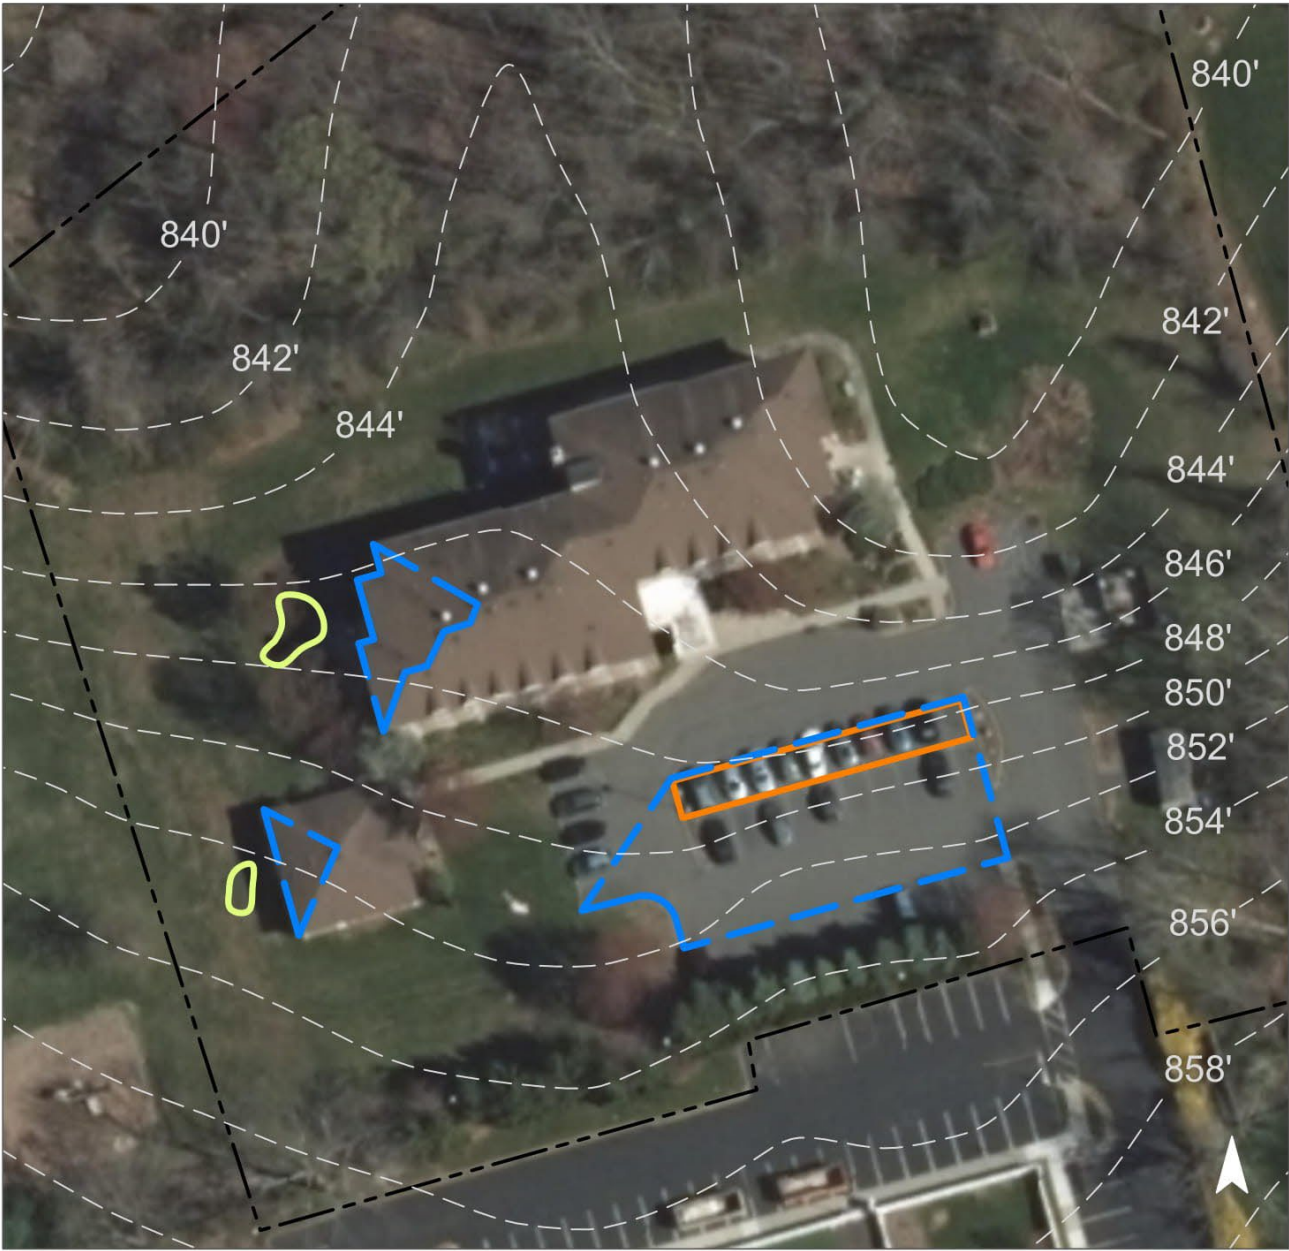
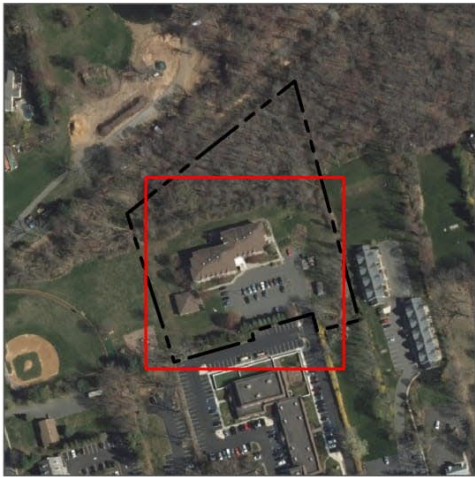
Chester Senior Housing

bioretention system
-

pervious pavement
-

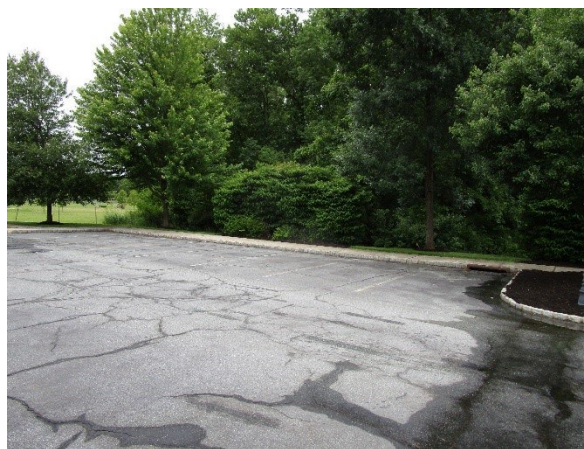
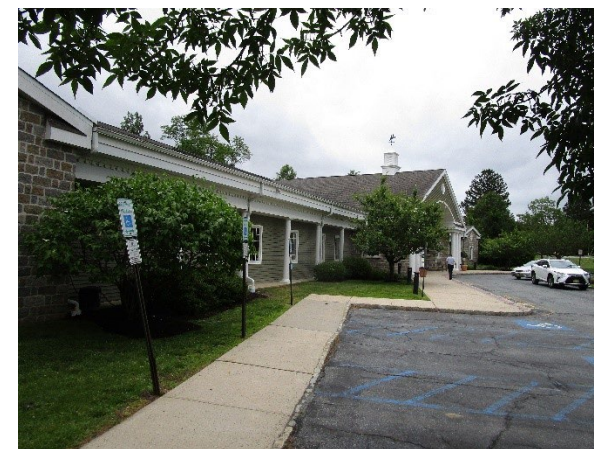
Parking spaces in the parking lot to the west of the building can be converted to porous pavement to capture and infiltrate stormwater runoff from the parking lot, before it enters the nearby storm drain. A rain garden can be installed south of the building to capture, filter, and infiltrate stormwater runoff from the roof if the front downspouts are disconnected. A preliminary soil assessment suggests that more soil testing would be required before determining the soil's suitability for green infrastructure.

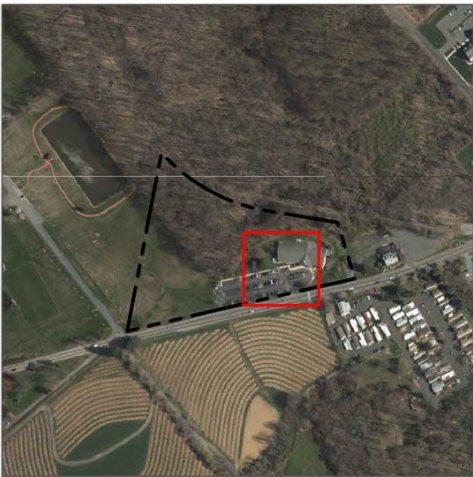
Chester Library

- bioretention system
- pervious pavement
- drainage area
- property line
- 2015 Aerial: NJOIT, OGIS

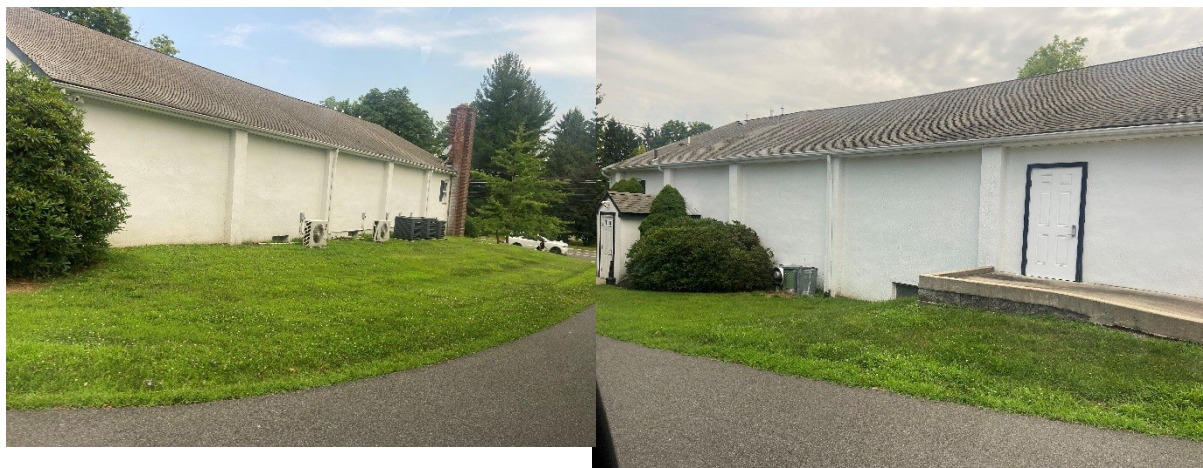
Rain gardens can be installed in multiple grass areas around the property to capture, treat, and infiltrate the stormwater runoff from the driveway and rooftop. This will require downspout disconnections, trench drains, and in some cases downspout redirection beneath the sidewalk. A cistern can be installed to the southwest of the building to divert and detain the stormwater runoff from the rooftop for later non-potable reuse such as watering a garden bed. A preliminary soil assessment suggests that the soils have suitable drainage characteristics for green infrastructure.

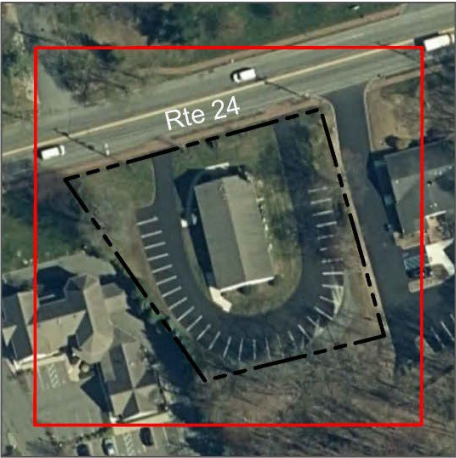
**Colonial Prospect Lodge
#24 Masonic Lodge**

- bioretention system
- rainwater harvesting
- captured drainage area
- property line
- 2020 Aerial: NJOIT, OGIS

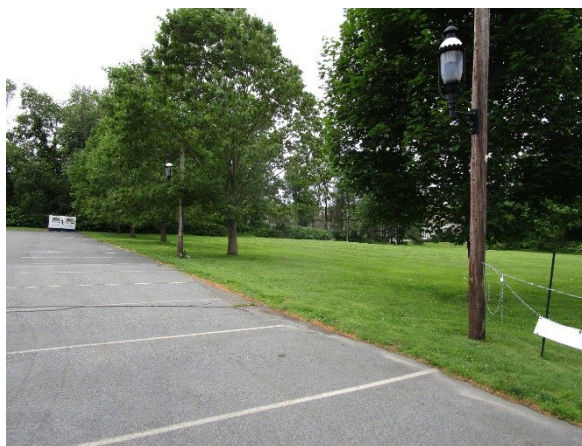
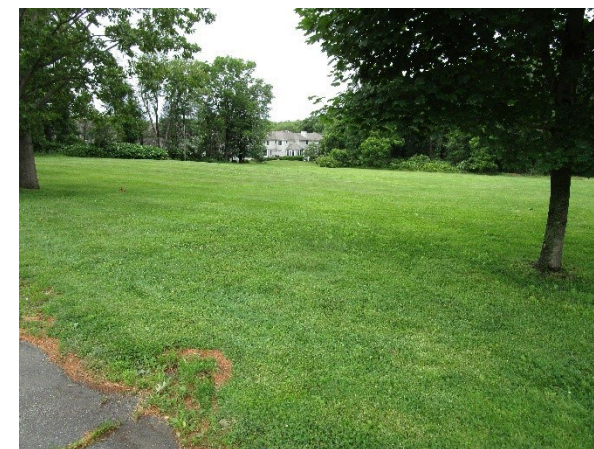
A rain garden can be installed west of the building behind the parking lot to capture, treat, and infiltrate stormwater runoff from the roof. A preliminary soil assessment suggests that the soils have suitable drainage characteristics for green infrastructure.

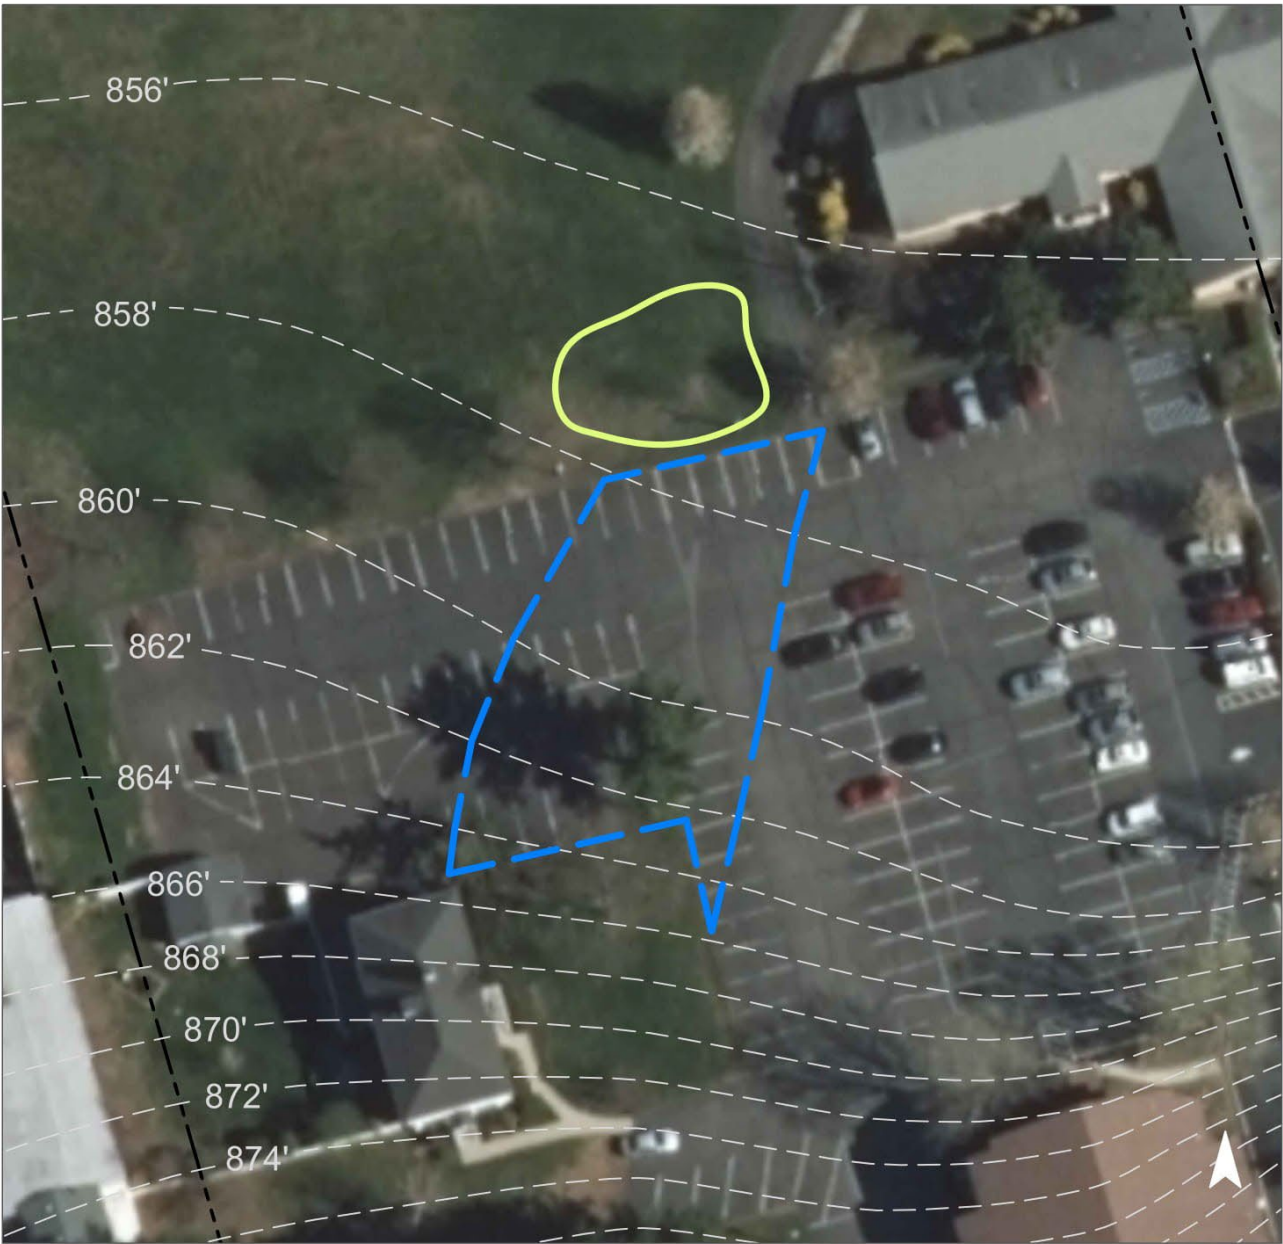
St. Lawrence Church

bioretention system
-

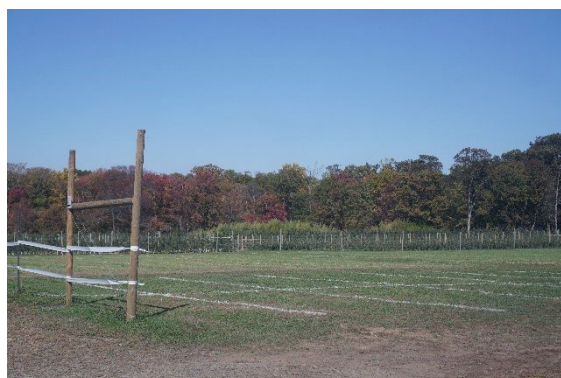
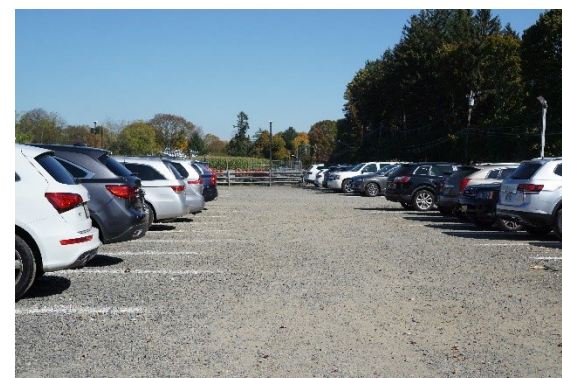
Pervious pavement can be installed in the parking lot to capture the stormwater runoff from the parking lot. A preliminary soil assessment suggests that the soils have suitable drainage characteristics for green infrastructure.

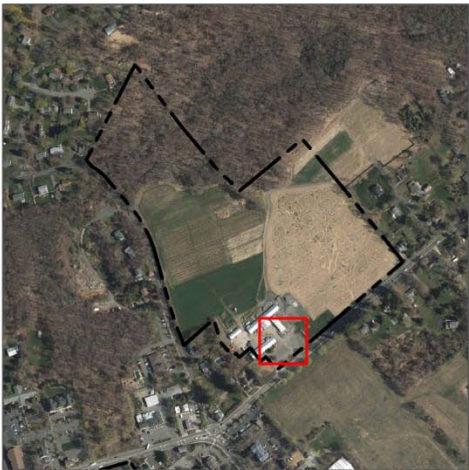
Stony Hill Farm Market

pervious pavement
-

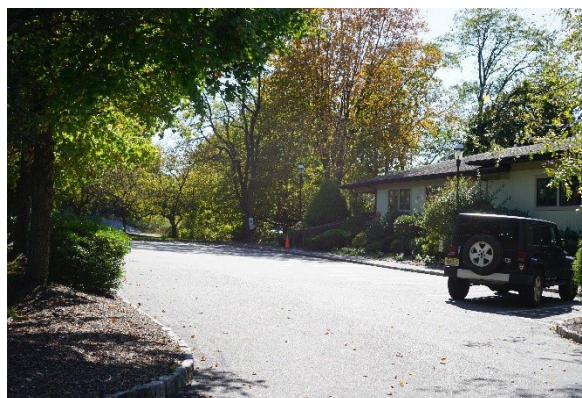
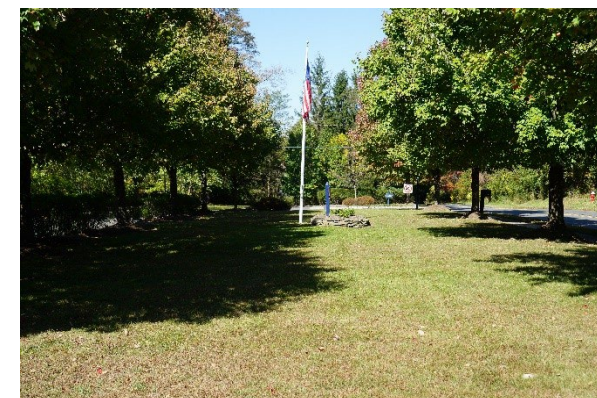
Parking spaces in the parking lot to the northeast of the building can be converted to porous pavement to capture and infiltrate stormwater runoff from the parking lot. A rain garden can be installed in the turfgrass area near the entrance of the building to capture, treat, and infiltrate stormwater runoff from the roof. A preliminary soil assessment suggests that the soils have suitable drainage characteristics for green infrastructure.

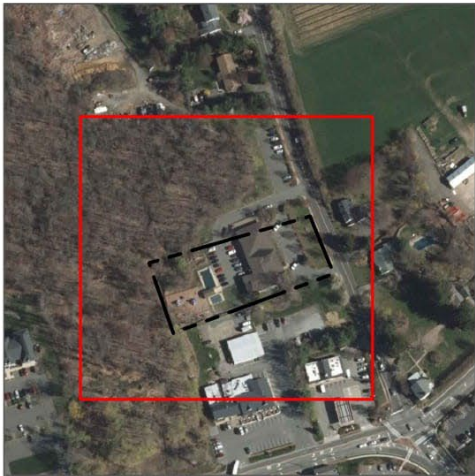
Suburban Hills School

- bioretention system
- pervious pavement
- drainage area
- property line
- 2015 Aerial: NJOIT, OGIS

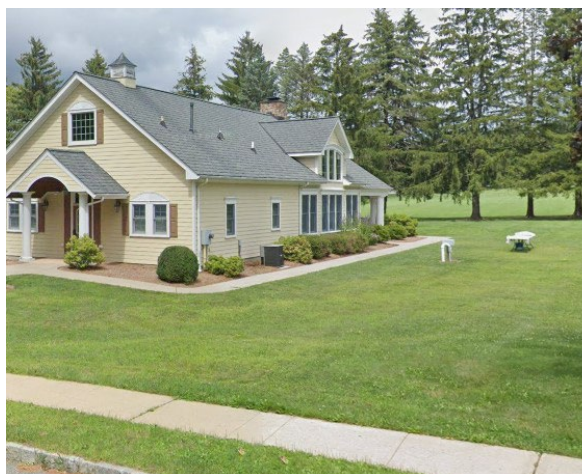
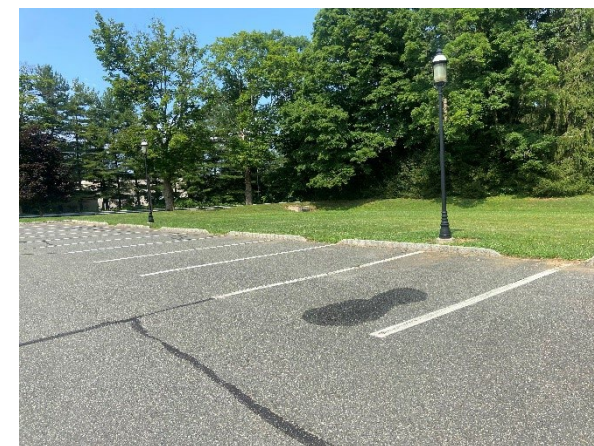
Rain gardens can be installed to the northwest of the parking lot and to the southeast of the building to capture, treat, and infiltrate the stormwater runoff from the parking lot and building rooftop. This will require curb cuts and downspout redirection beneath the sidewalk. A preliminary soil assessment suggests that the soils have suitable drainage characteristics for green infrastructure.

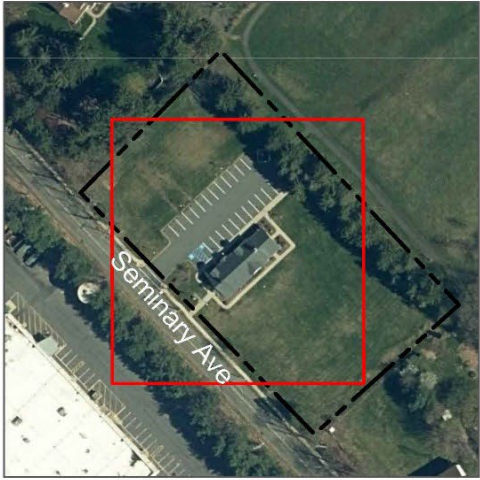
Boro of Chester Recreation Office

bioretention system
-

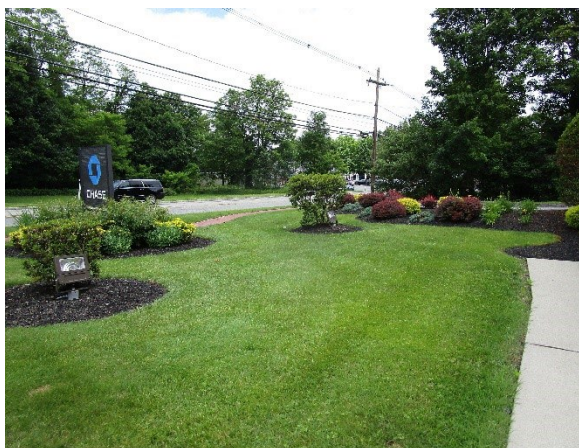
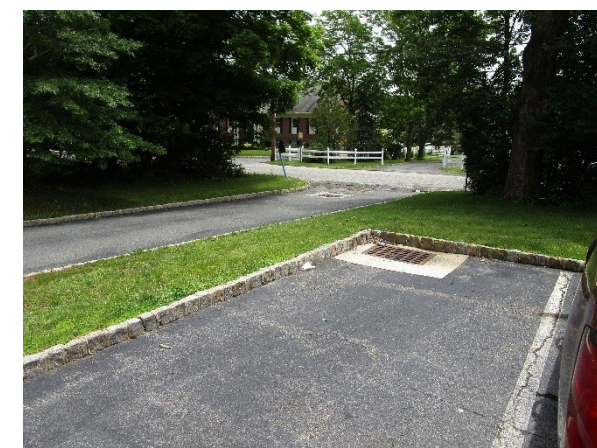
A rain garden can be installed north of the building to capture, treat, and infiltrate stormwater runoff from the roof and parking lot. Parking spaces near the catch basin in the rear parking lot can be converted to porous pavement to capture and infiltrate stormwater runoff from the parking lot. A preliminary soil assessment suggests that the soils have suitable drainage characteristics for green infrastructure.

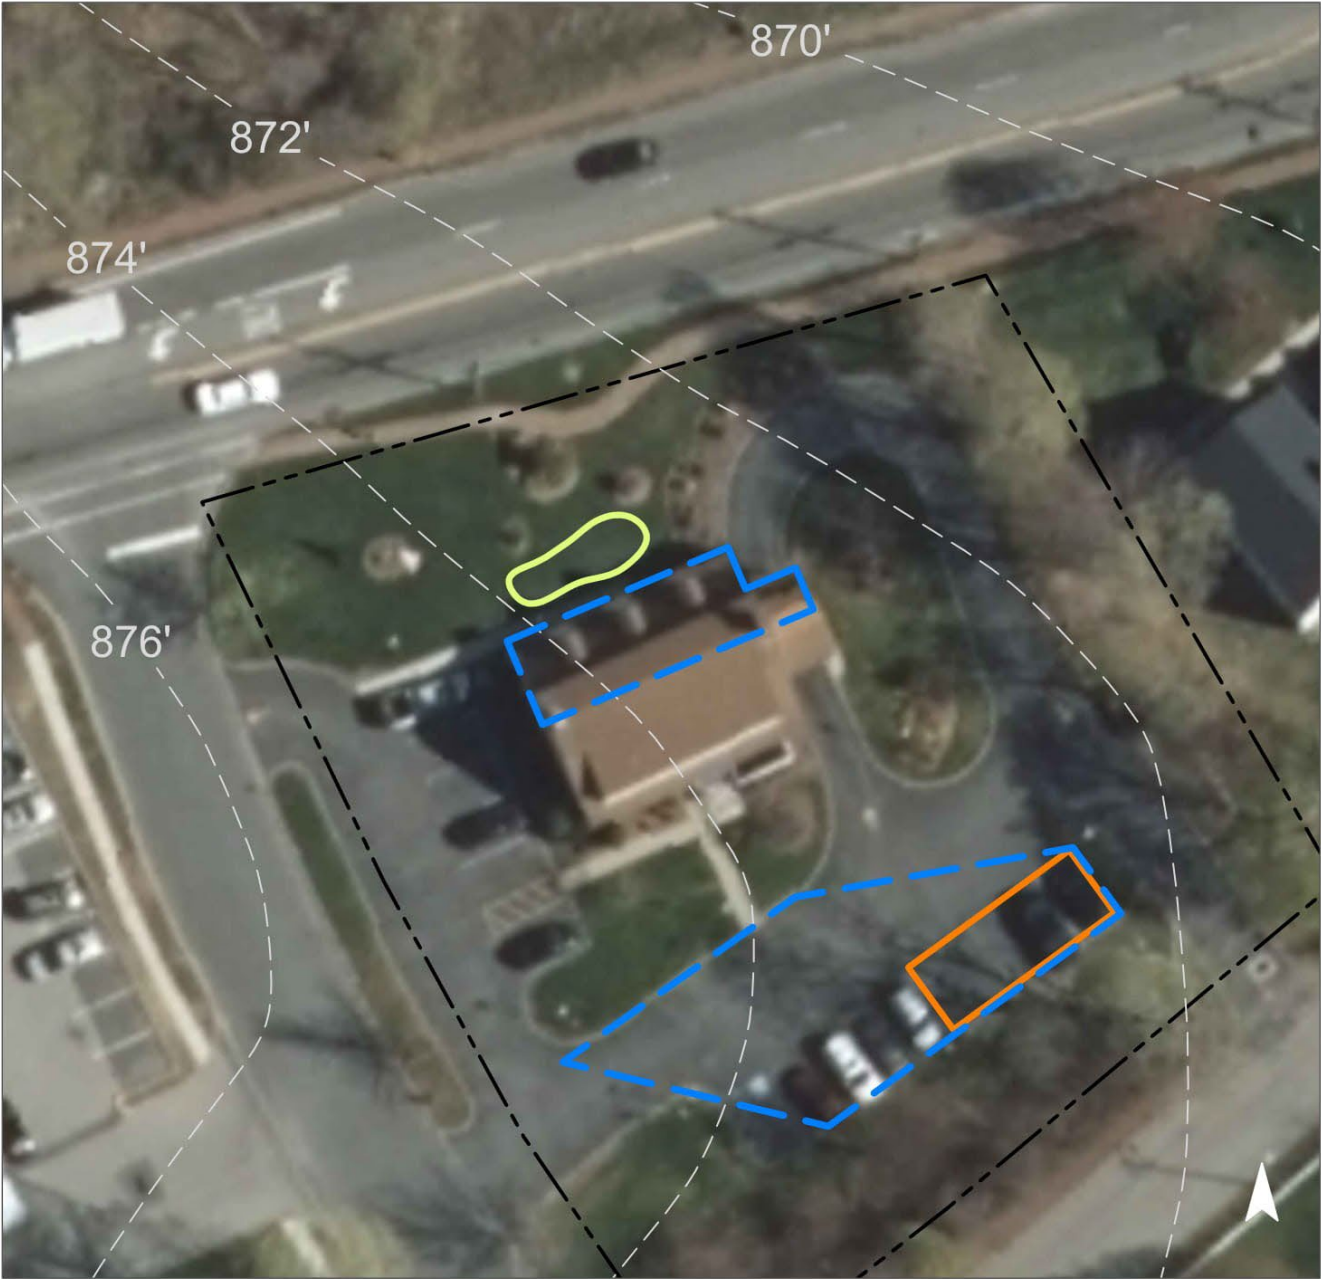
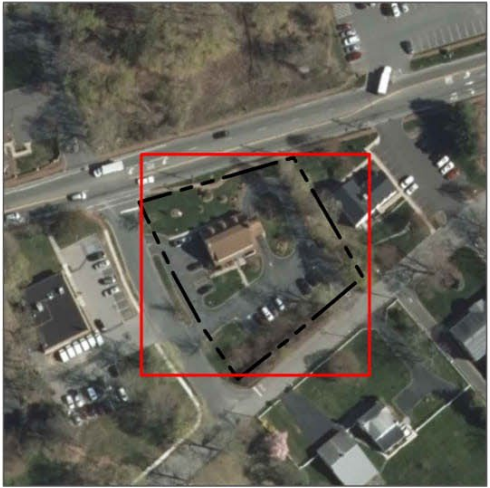
Chase Bank

- bioretention system
- pervious pavement
- drainage area
- property line
- 2015 Aerial: NJOIT, OGIS

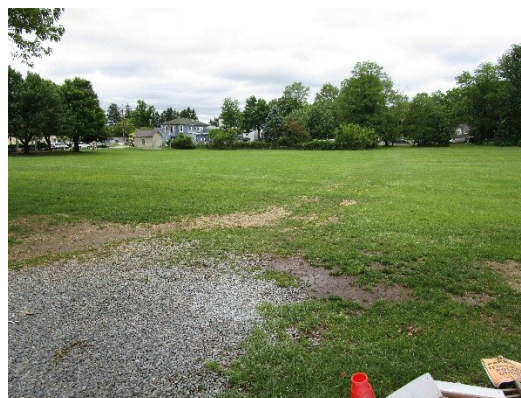
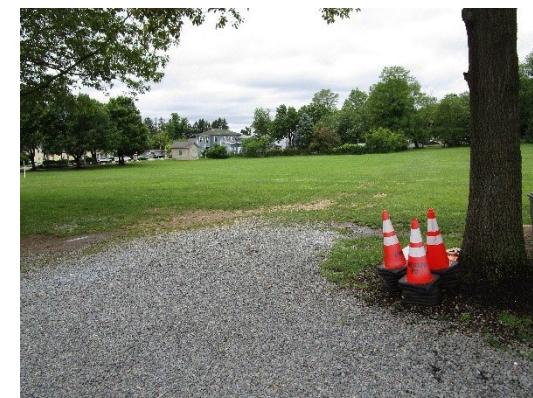
A rain garden can be installed to the west of the building nearby the baseball field. A preliminary soil assessment suggests that the soils have suitable drainage characteristics for green infrastructure.

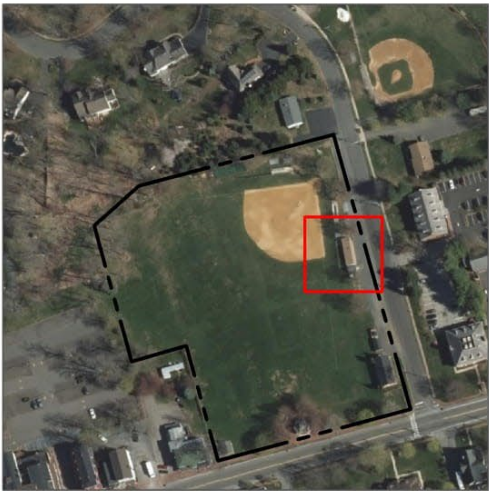
Chester Borough Park

- bioretention system
- drainage area
- property line
- 2015 Aerial: NJOIT, OGIS

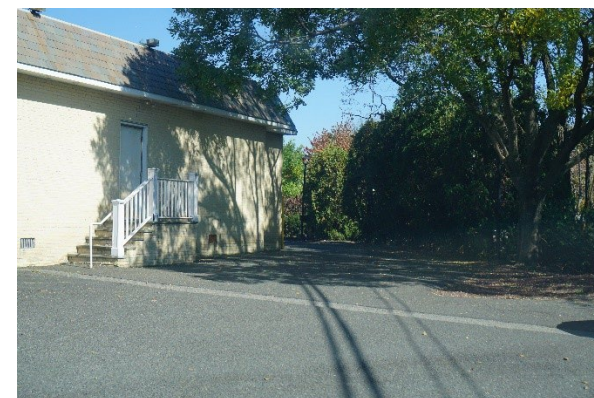
Porous pavement can be installed on the west side of the building to capture and infiltrate stormwater runoff from the building and surrounding area. A preliminary soil assessment suggests that more soil testing would be required before determining the soil's suitability for green infrastructure.

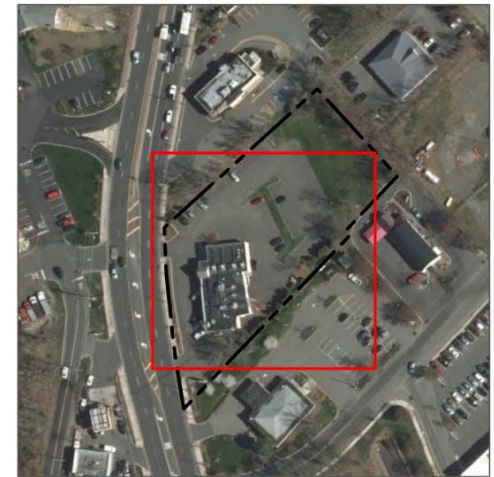
Chester Diner

pervious pavement
-

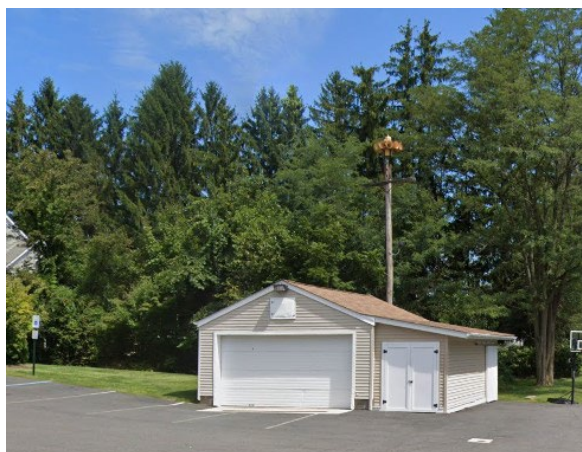
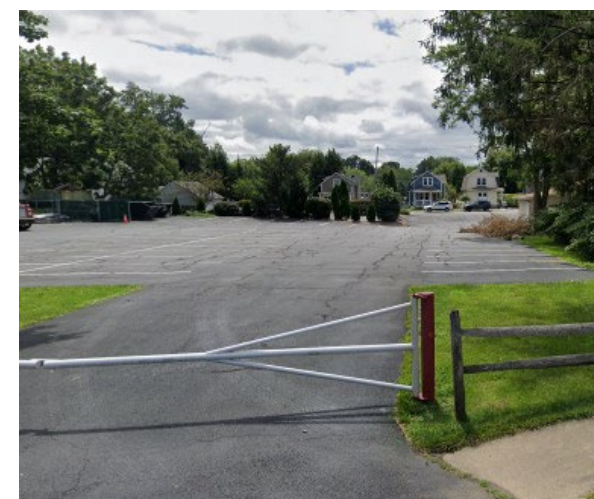
A rain garden can be installed to the west of the shed to capture, treat, and infiltrate the stormwater runoff from the rooftop. This will require a downspout disconnection. The gutters on the eastern section of the shed can also be reworked and directed towards the raingarden to increase the treated drainage area. Existing parking spaces in the eastern parking lot can be converted into pervious pavement to capture and infiltrate the stormwater runoff from the asphalt. A preliminary soil assessment suggests that more soil testing would be required before determining the soil's suitability for green infrastructure.

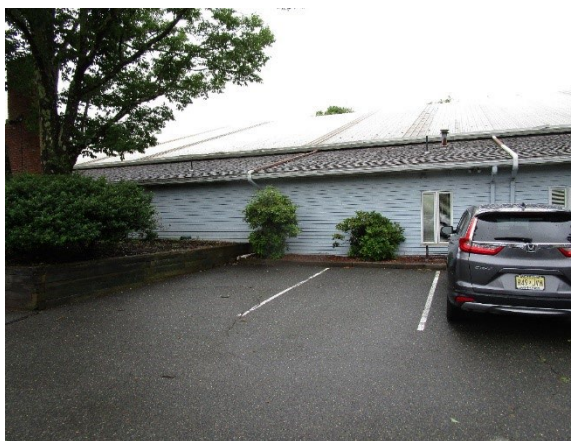
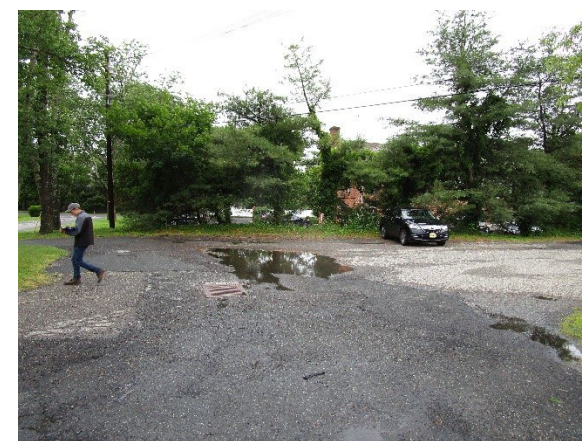
Parking spaces in the parking lot to the south of the building can be converted to porous pavement to capture and infiltrate stormwater runoff from the roof via the downspouts, which are disconnected. A preliminary soil assessment suggests that more soil testing would be required before determining the soil's suitability for green infrastructure.

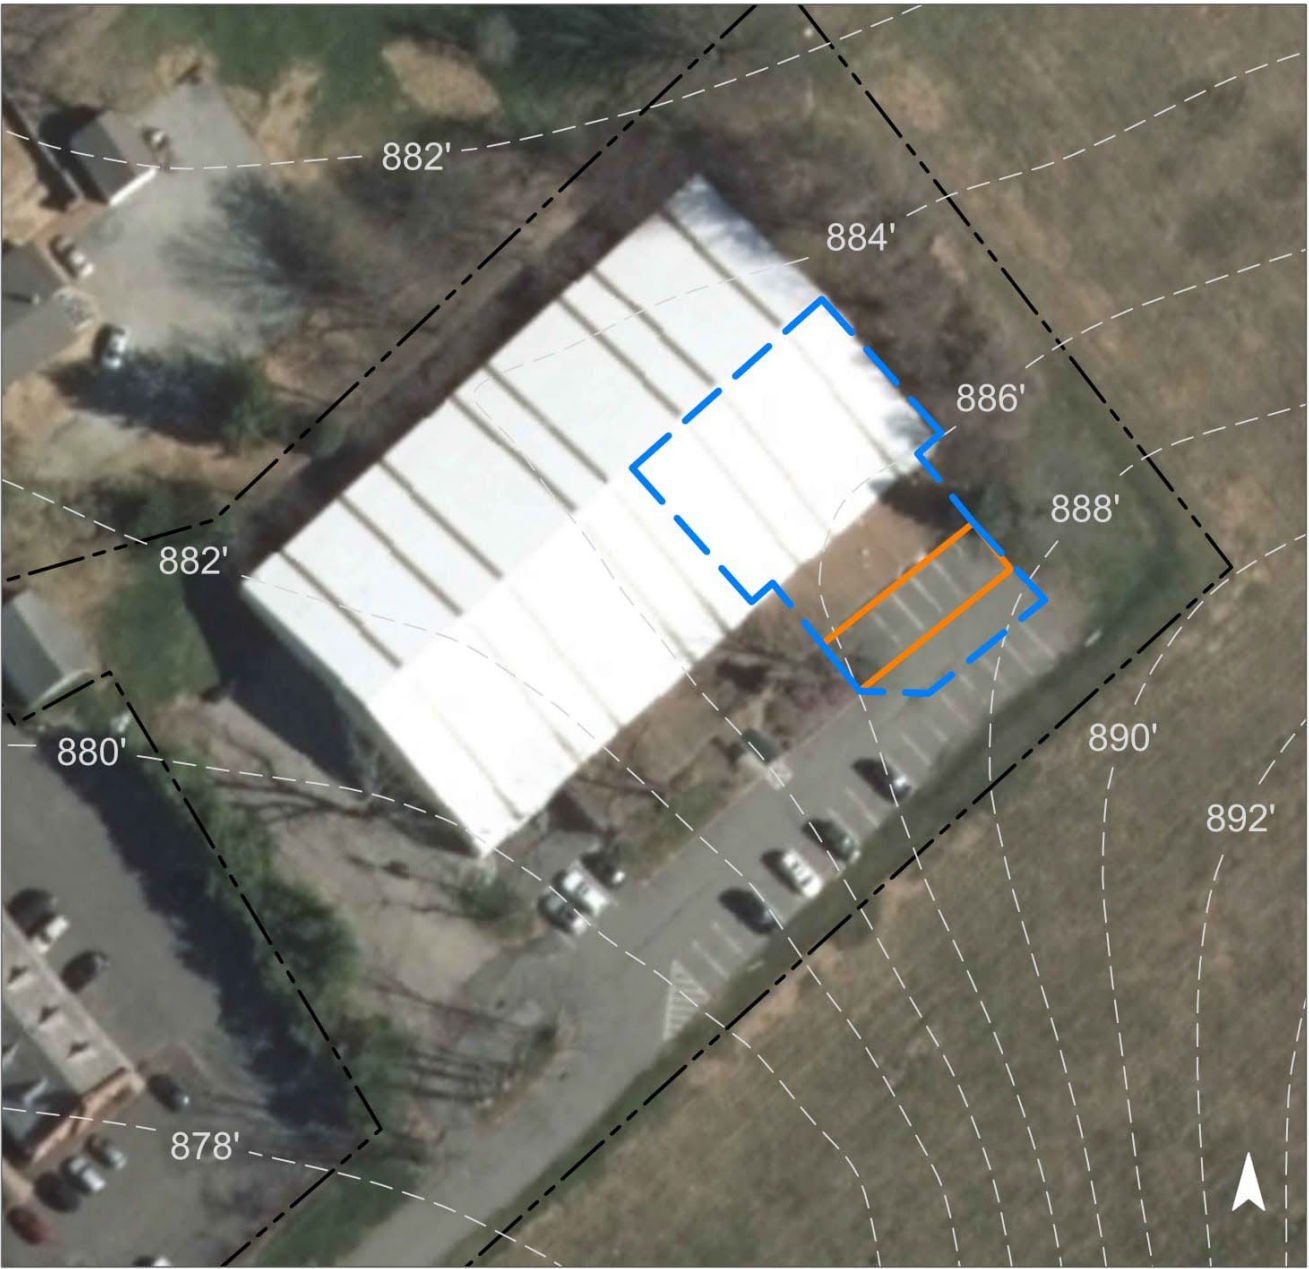
Chester Tennis Club

pervious pavement
-

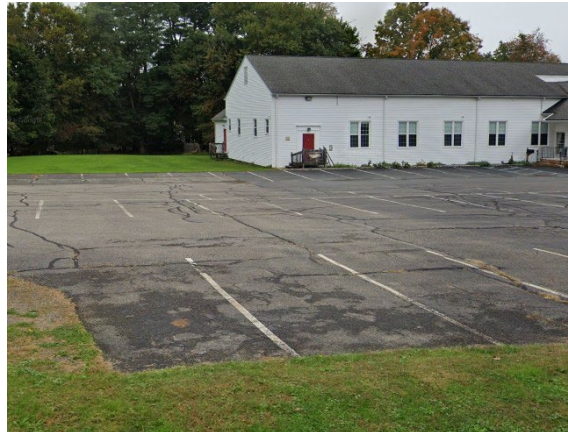
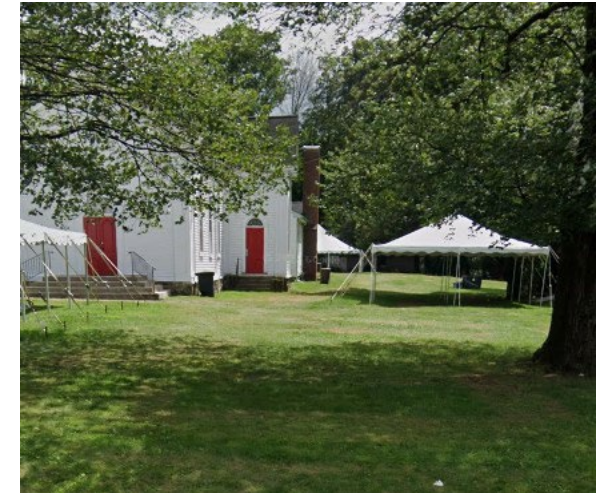
Rain gardens can be installed in multiple grass areas around the property to capture, treat, and infiltrate the stormwater runoff from the rooftops and parking lot. This will require downspout redirection and disconnections. Existing parking spaces in western section of the parking lot can be converted into pervious pavement to capture and infiltrate the stormwater runoff from the asphalt. A cistern can be installed to the southeast of the building to divert and detain the stormwater runoff from the rooftop for later non-potable reuse such as watering a garden bed. A preliminary soil assessment suggests that the soils have suitable drainage characteristics for green infrastructure.

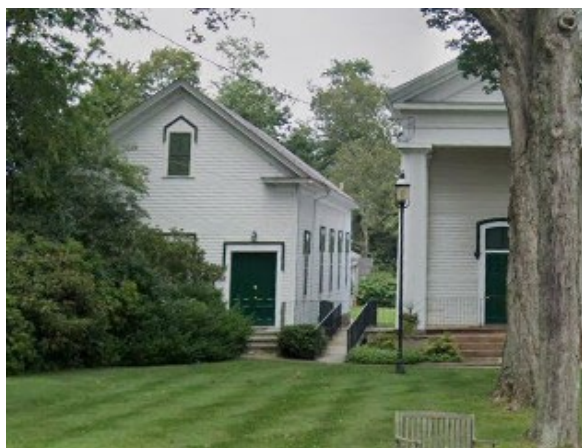
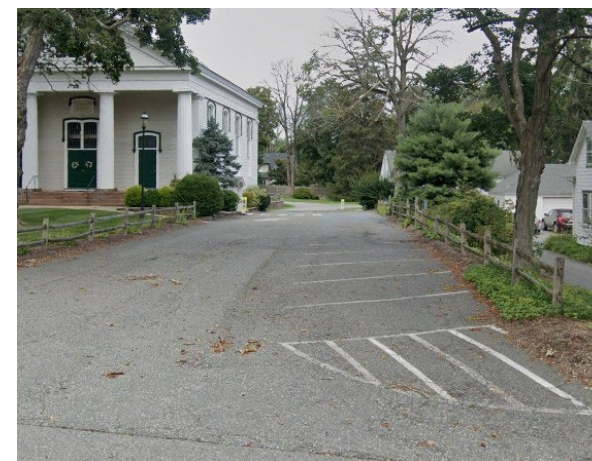
Address: 30 Hillside Road
Chester, NJ 07930

Rain gardens can be installed in multiple grass areas around the property to capture, treat, and infiltrate the stormwater runoff from the rooftops. This will require downspout disconnections, and in some cases downspout redirection underneath the sidewalk. Existing parking spaces in the eastern and western parking lots can be converted into pervious pavement to capture and infiltrate the stormwater runoff from the asphalt. A preliminary soil assessment suggests that more soil testing would be required before determining the soil's suitability for green infrastructure.

Recommended Green Infrastructure Practices	Drainage Area (sq. ft.)	Recharge Potential (Mgal/yr)	TSS Removal Potential (lbs/yr)	Maximum Volume Reduction Potential (gal/storm)	Peak Discharge Reduction Potential (cu. ft./second)	Estimated Size (sq. ft.)	Estimated Cost
Bioretention system	2,090	0.062	10	4,360	0.16	520	\$5,200
Pervious pavement	14,800	0.438	65	30,870	1.16	3,480	\$87,000

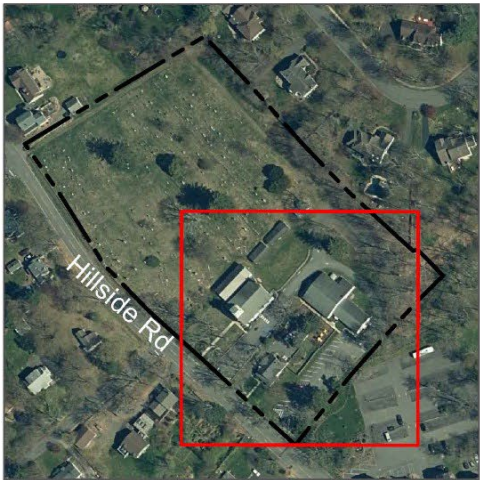
First Congregational Church

- bioretention system
- pervious pavement
- captured drainage area
- property line
- 2020 Aerial: NJOIT, OGIS

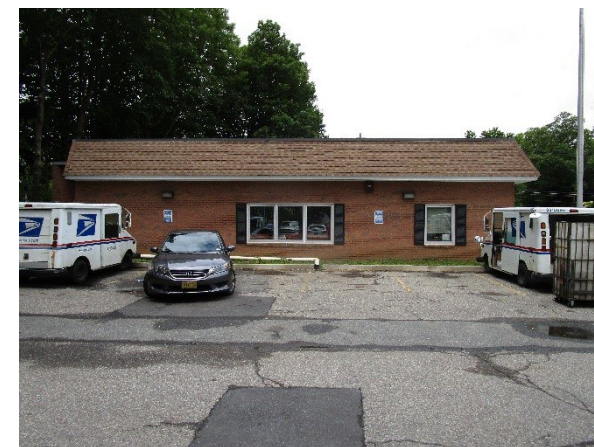
Address: 1 Sentry Lane
Chester, NJ 07930

Parking spaces in the parking lot to the east of the building can be converted to porous pavement to capture and infiltrate stormwater runoff from the parking lot and the downspout. A septic system in the turfgrass area north of the building limits rain garden opportunities. A preliminary soil assessment suggests that the soils have suitable drainage characteristics for green infrastructure.

Recommended Green Infrastructure Practices	Recharge Potential (Mgal/yr)	TSS Removal Potential (lbs/yr)	Maximum Volume Reduction Potential (gal/storm)	Peak Discharge Reduction Potential (cu. ft./second)	Estimated Size (sq. ft.)	Estimated Cost
Pervious pavement	0.123	21	8,750	0.33	900	\$22,500
