Clinton Township

Introduction

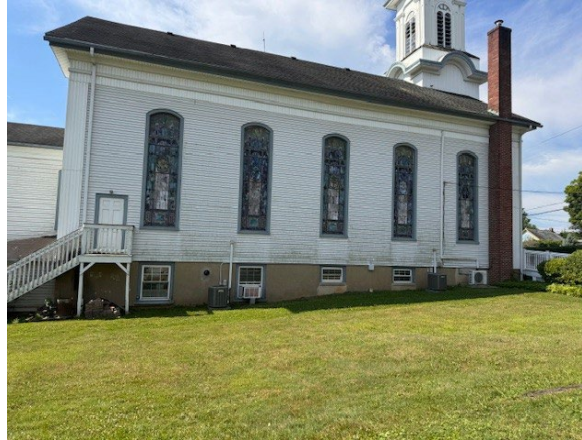
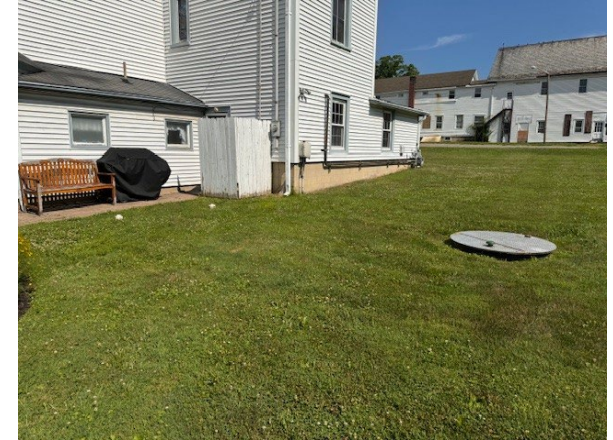
Three rain gardens requiring downspout disconnection and redirection can be installed in the grass areas around the building to capture, treat, and infiltrate stormwater runoff from the roof. A preliminary soil assessment suggests that the soils have suitable drainage characteristics for green infrastructure.

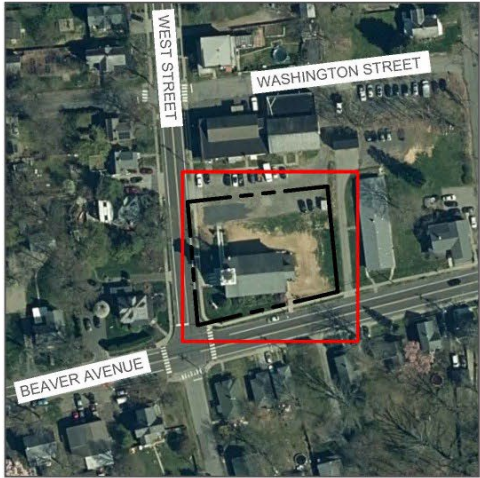
Annandale Reformed Church

bioretention system
-

captured drainage area
-

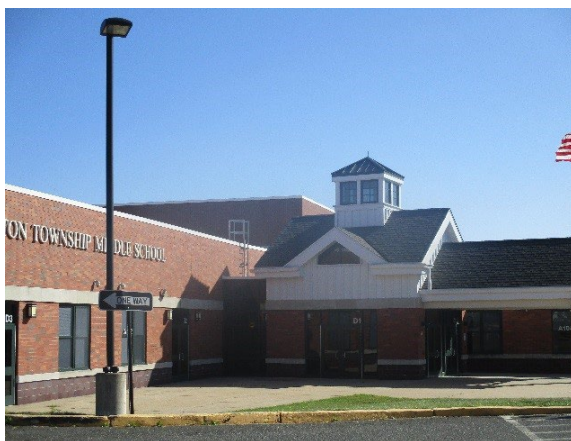
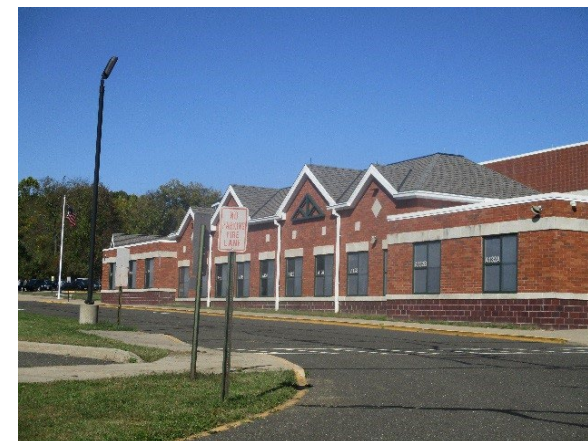
Two downspout planter boxes can be installed along the building, and bioretention systems can be installed in the turfgrass median in front of the building. A preliminary soil assessment suggests that more soil testing would be required before determining the soil's suitability for green infrastructure.

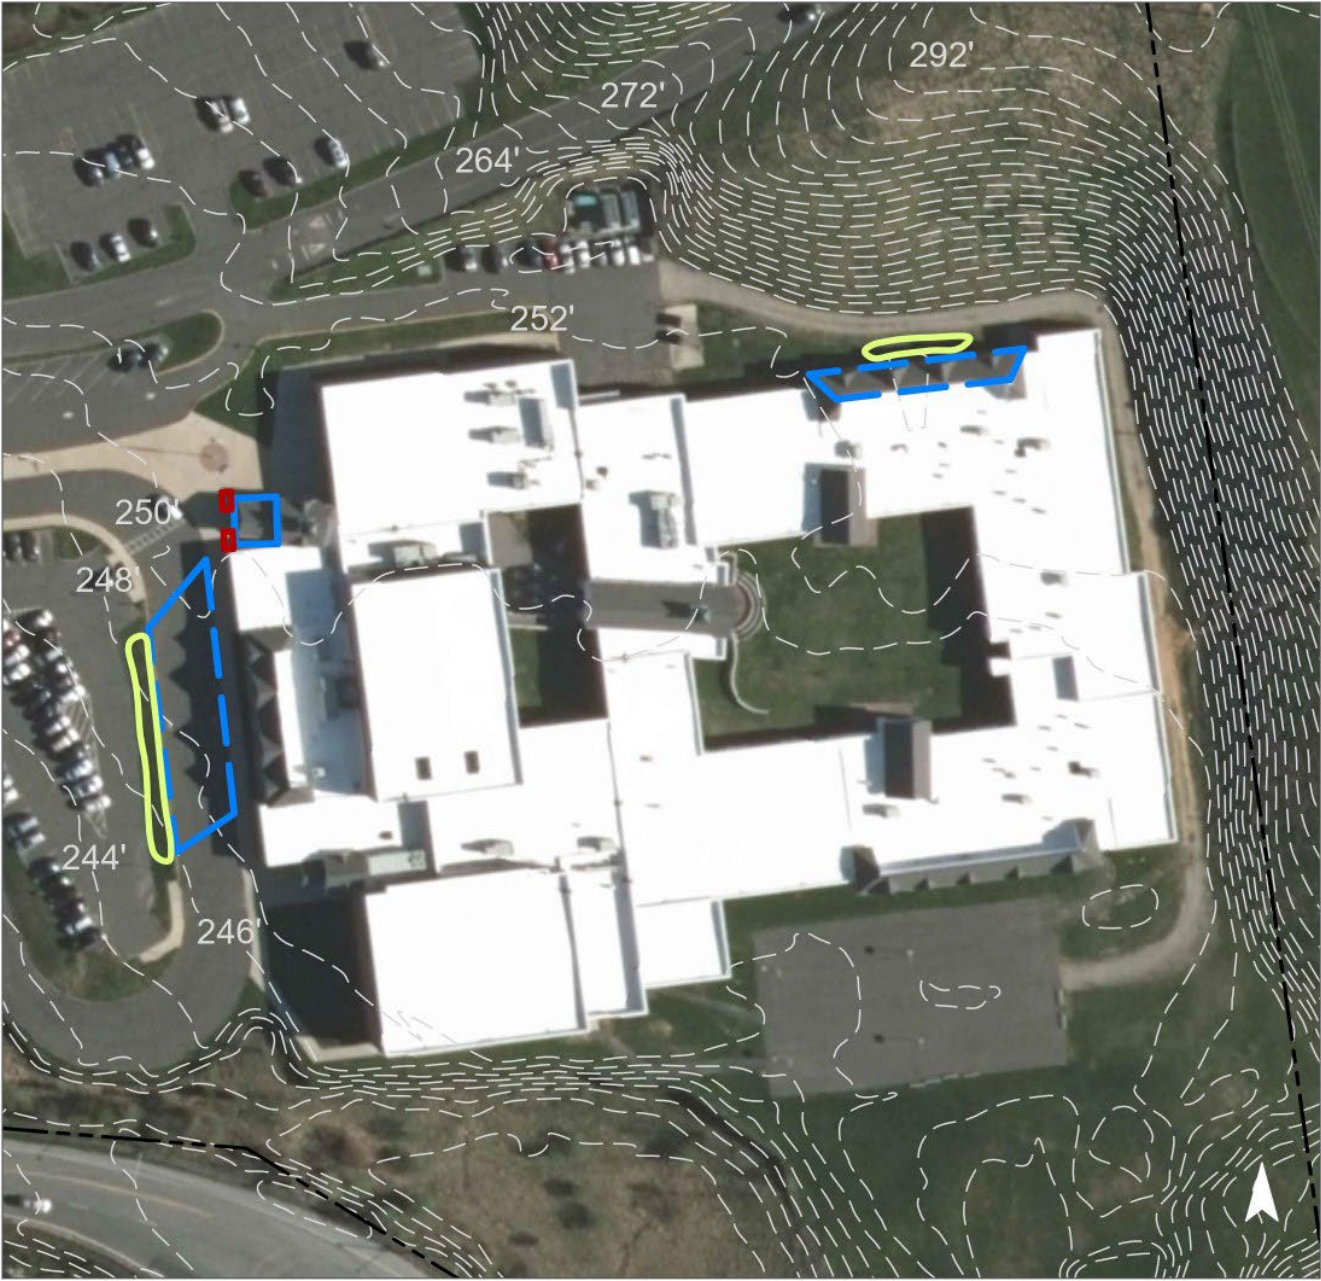
Clinton Township Middle School

- bioretention system
- planter box
- drainage area
- property line
- 2015 Aerial: NJOIT, OGIS

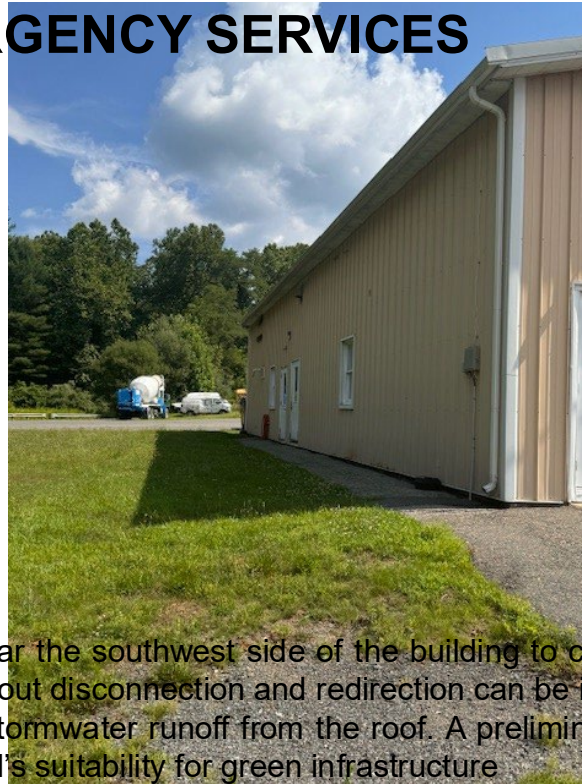
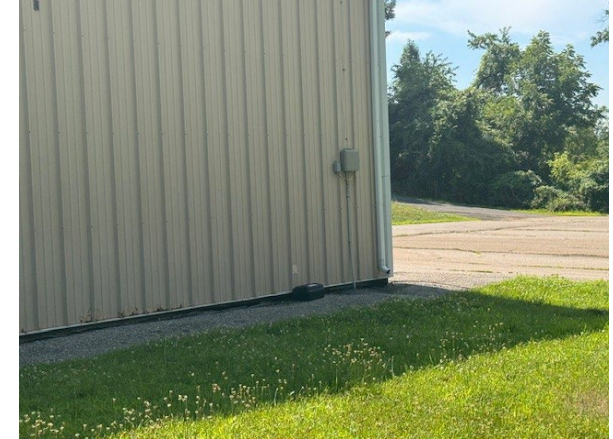
A rain garden can be installed in the grass area near the southwest side of the building to capture, treat, and infiltrate stormwater runoff from the roof. Another rain garden requiring downspout disconnection and redirection can be installed in the grass area near the northwest side of the building to capture, treat, and infiltrate stormwater runoff from the roof. A preliminary soil assessment suggests that more soil testing would be required before determining the soil's suitability for green infrastructure.

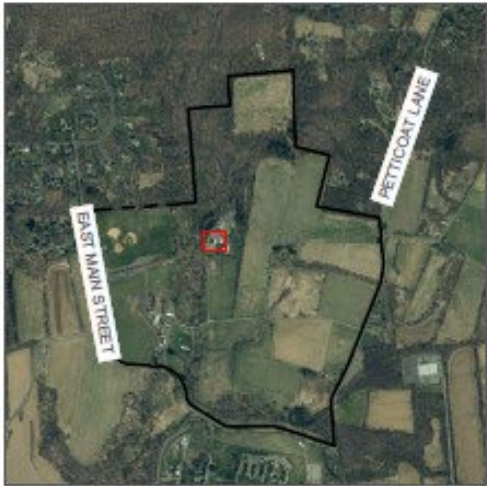
Hunterdon County Emergency Services

bioretention system
-

captured drainage area
-

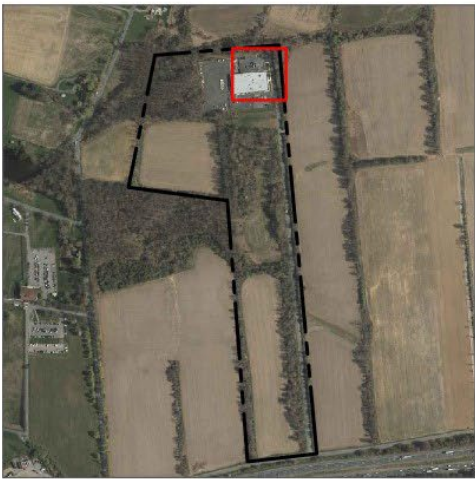
Hunterdon Preparatory School

bioretention system
-

pervious pavement
-

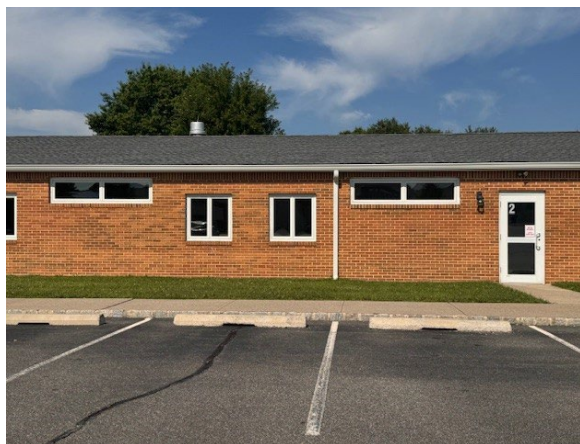
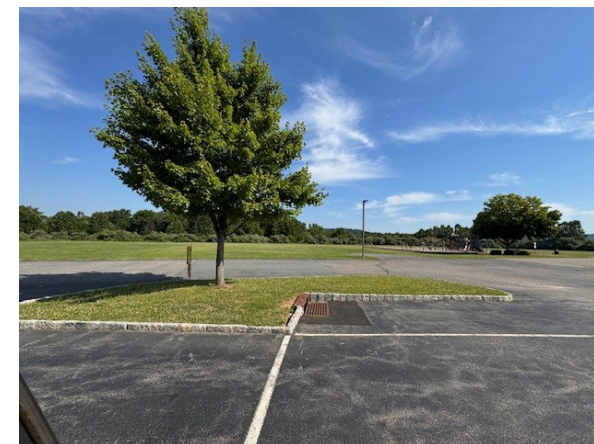
Parking spaces in the lot can be converted to porous pavement to capture and infiltrate stormwater runoff from the asphalt. Two rain gardens requiring downspout disconnection and redirection can be installed in the grass areas near the west and east buildings to capture, treat, and infiltrate stormwater runoff from the roof. Two rain gardens with curb cuts and trench drains can be installed in the grass areas south of the parking lot to capture, treat, and infiltrate stormwater runoff from the pavement. A preliminary soil assessment suggests that the soils have suitable drainage characteristics for green infrastructure.

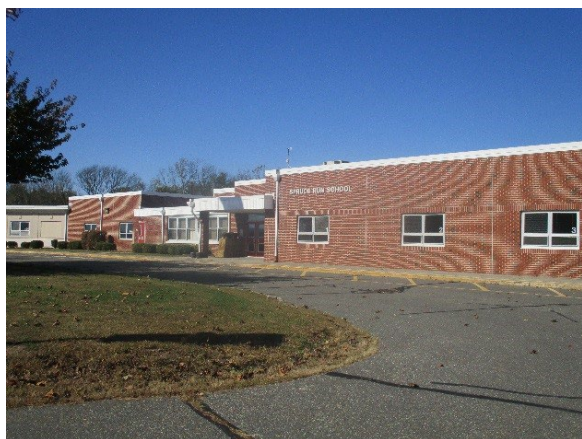
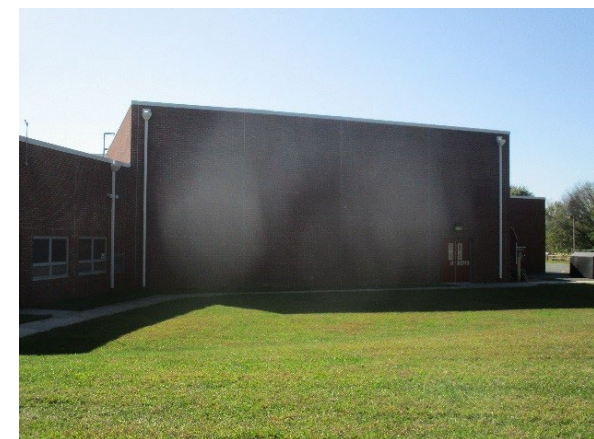
Bioretention systems can be installed in the north, west, and east corners of the building to capture, treat, and infiltrate rooftop runoff. Downspout planter boxes can be constructed along the south of the building to allow roof runoff to be reused. A preliminary soil assessment suggests that more soil testing would be required before determining the soil's suitability for green infrastructure.

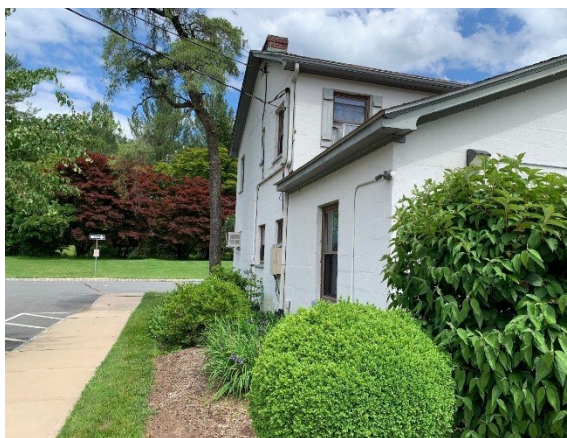
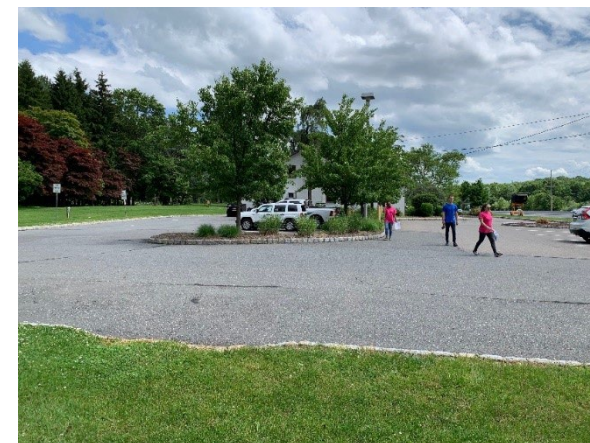
A bioretention system can be installed along the north edge of the parking lot to capture, treat, and infiltrate rooftop runoff from the tilted pitch of the pavement. Downspout planter boxes can be installed to treat the rooftop stormwater near the western entrance. A preliminary soil assessment suggests that more soil testing would be required before determining the soil's suitability for green infrastructure.

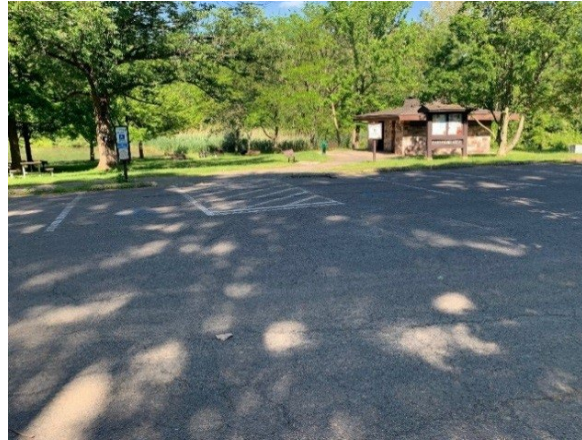
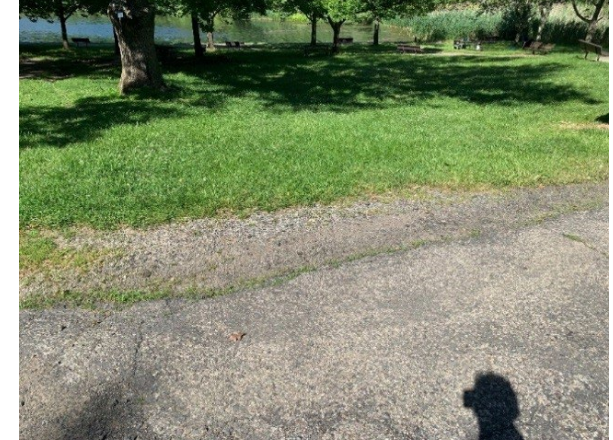
A bioretention system can be installed to capture the stormwater runoff from the building on its eastern side. Pervious pavement on the northeastern corner of the parking lot can capture and treat the stormwater runoff from the parking lot. A preliminary soil assessment suggests that the soils have suitable drainage characteristics for green infrastructure.

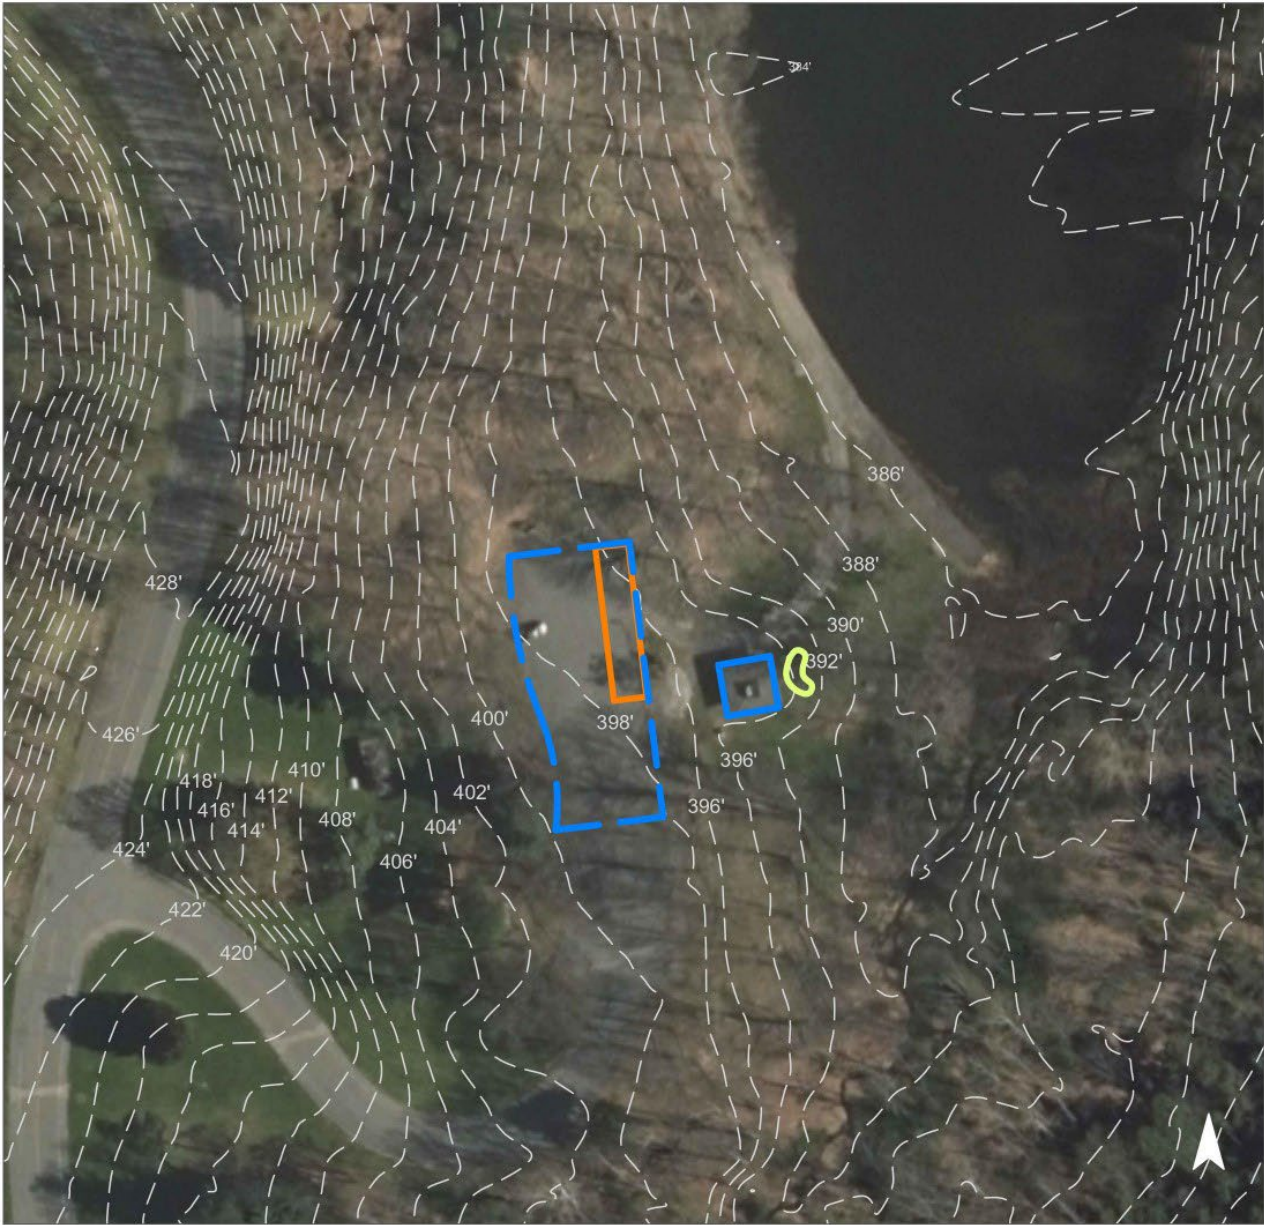
Round Valley Recreation Area

- bioretention system
- pervious pavement
- drainage area
- property line
- 2015 Aerial: NJOIT, OGIS

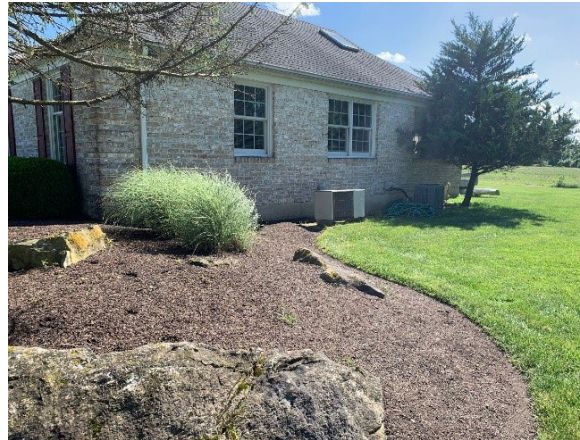
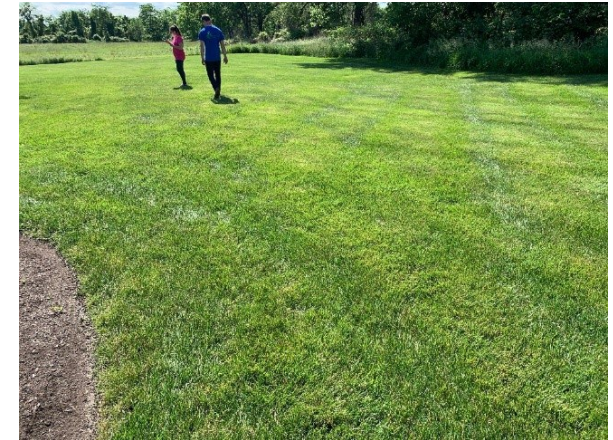
A bioretention system can be installed north of the building to capture, treat, and infiltrate stormwater runoff from the roof. Pervious pavement can be installed in the southern parking spots to capture and infiltrate stormwater runoff from the parking lot. Downspout planter boxes can be installed next to the eastern entrance to capture and treat the stormwater runoff from the roof. A preliminary soil assessment suggests that the soils have suitable drainage characteristics for green infrastructure.

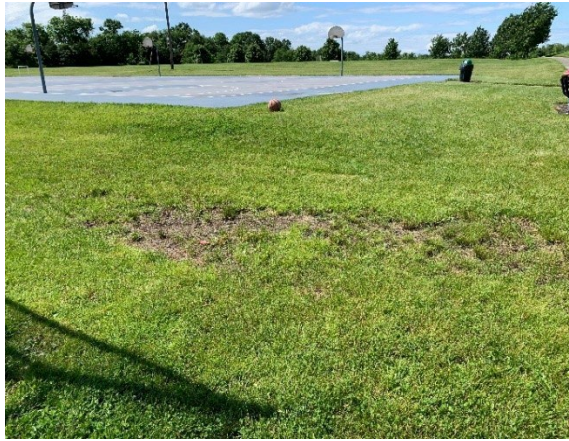
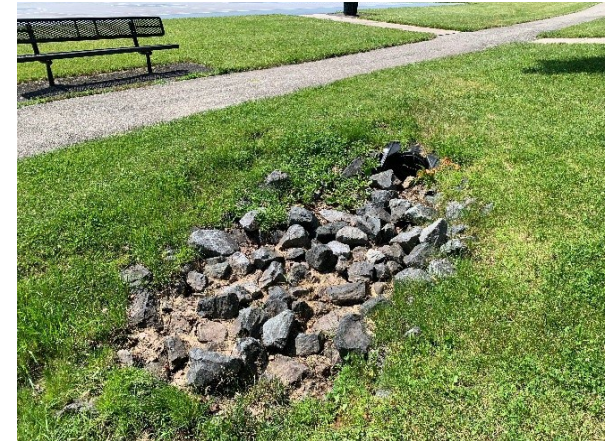
A bioretention system can be installed next to the southeast corner of the basketball court to help infiltrate the stormwater that tends to pool in that area. Pervious pavement can be installed on the western section of the parking lot to capture, treat, and infiltrate the stormwater runoff from it. A preliminary soil assessment suggests that more soil testing would be required before determining the soil's suitability for green infrastructure.

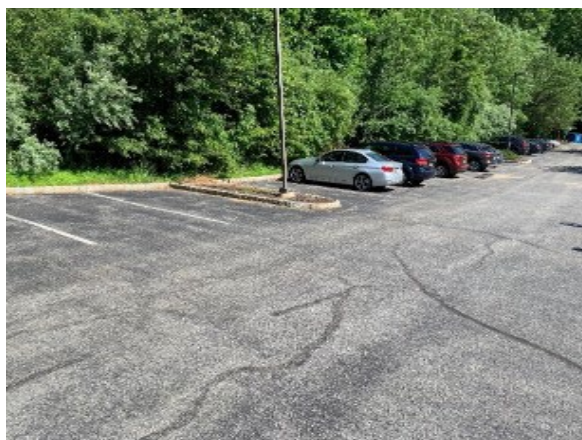
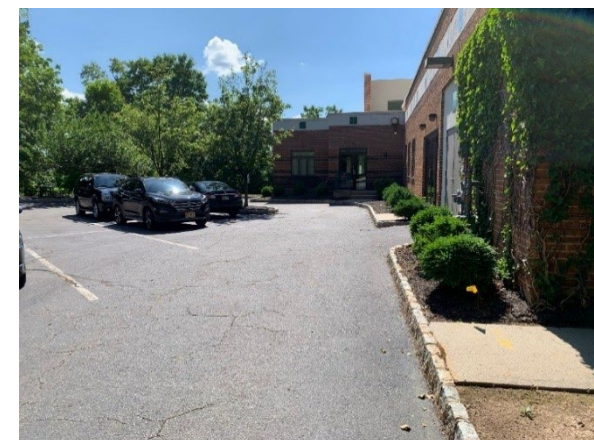
Pervious pavement can be installed in the eastern parking lot to capture, treat, and infiltrate the stormwater from the parking lot. A bioretention system can be installed on the northern side of the building to capture stormwater runoff from the north section of the parking lot. A preliminary soil assessment suggests that the soils have suitable drainage characteristics for green infrastructure.

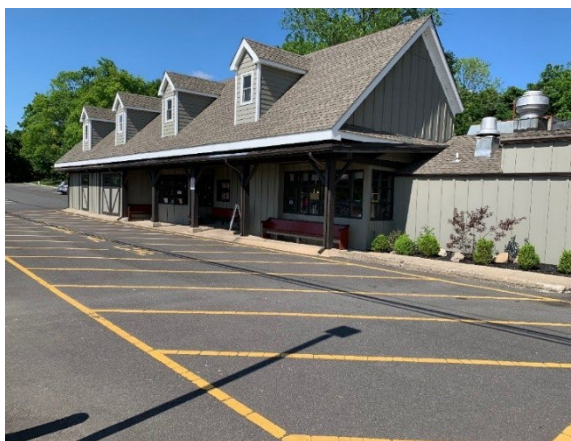
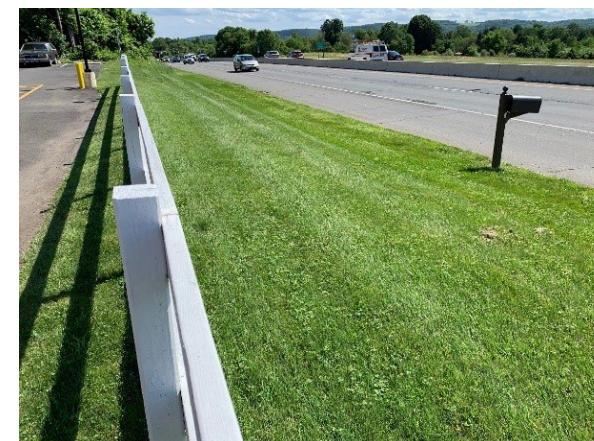
A bioretention system can be installed between the parking lot and roadway to capture the parking lot and rooftop runoff. Pervious pavement can be installed in the southeastern corner of the parking lot to capture, treat, and infiltrate stormwater runoff from the lot. A soil assessment suggests that the soils have suitable drainage characteristics for green infrastructure.

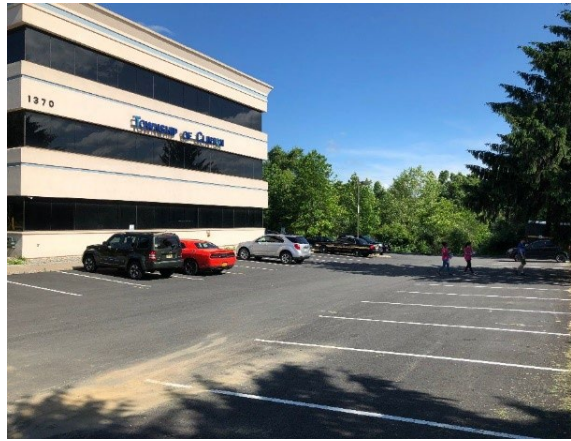
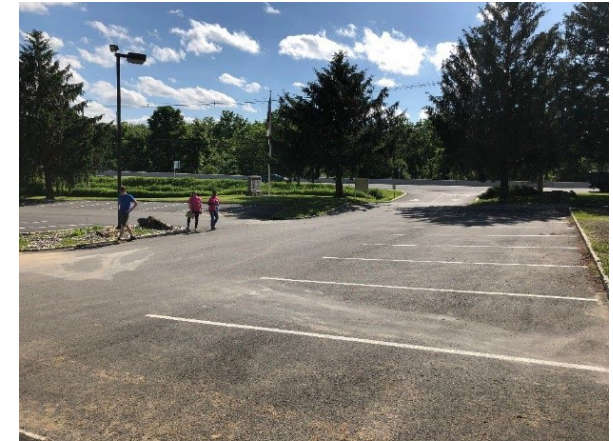
Pervious pavement can be installed in the southern parking lot to help remediate the pooling that occurs due to the pitch of the pavement. Bioretention systems can be installed west of the parking lot to allow for the capture of the parking lot runoff. A preliminary soil assessment suggests that the soils have suitable drainage characteristics for green infrastructure.

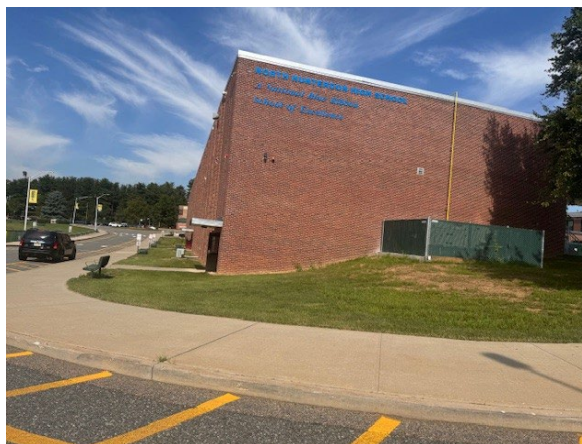
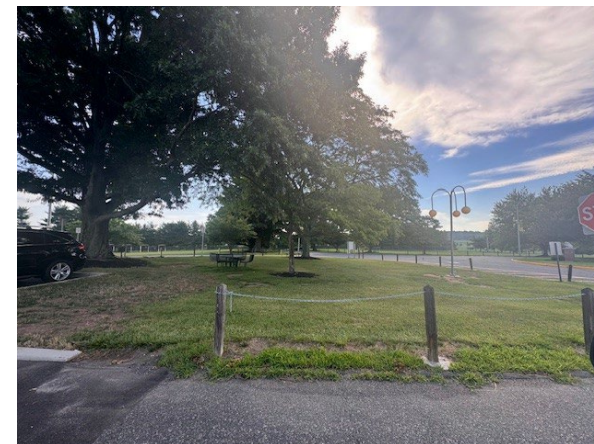
Parking spaces in the lots north and south of the building can be converted to porous pavement using trench drains to redirect, capture and infiltrate stormwater runoff from the pavement. Two rain gardens with trench drains and curb cuts can be installed in the grass areas to the east of the building to capture, treat, and infiltrate stormwater runoff from the pavement. A preliminary soil assessment suggests that more soil testing would be required before determining the soil's suitability for green infrastructure.

Recommended Green Infrastructure Practices	Drainage Area (sq. ft.)	Recharge Potential (Mgal/yr)	TSS Removal Potential (lbs/yr)	Maximum Volume Reduction Potential (gal/storm)	Peak Discharge Reduction Potential (cu. ft./second)	Estimated Size (sq. ft.)	Estimated Cost
Bioretention system	6,375	0.186	29	12,780	0.48	1,595	\$15,950
Pervious pavement	45,565	1.333	200	91,360	3.43	8,740	\$218,500

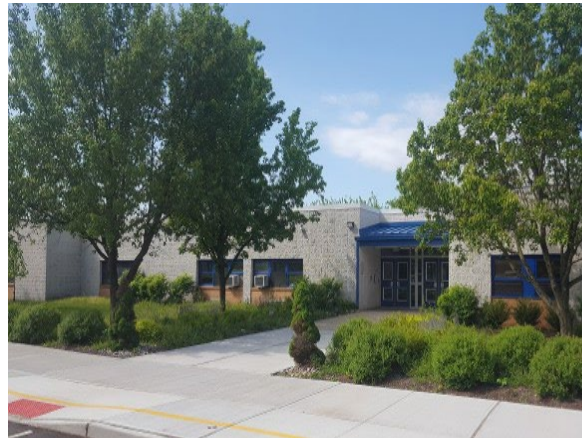
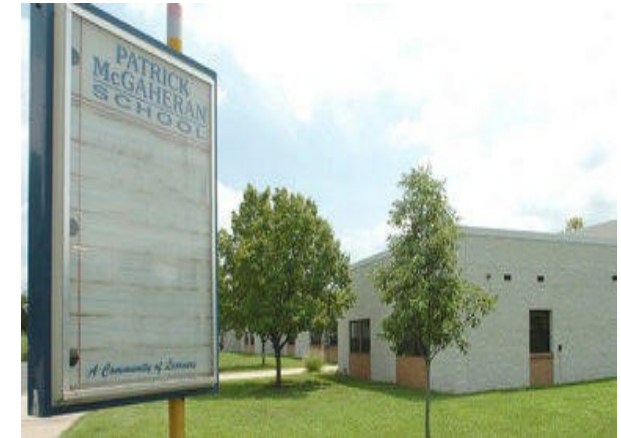
A bioretention system can be installed north of the building to capture, treat, and infiltrate rooftop runoff. Pervious pavement can be installed in the middle parking strip of the parking lot to capture and infiltrate stormwater. Two rainwater harvesting systems can be installed on the eastern building, and the water can then be used for watering gardens, washing vehicles, or for other non-potable uses. A preliminary soil assessment suggests that more soil testing would be required before determining the soil's suitability for green infrastructure.

Recommended Green Infrastructure Practices	Recharge Potential (Mgal/yr)	TSS Removal Potential (lbs/yr)	Maximum Volume Reduction Potential (gal/storm)	Peak Discharge Reduction Potential (cu. ft./second)	Estimated Size (sq. ft.)	Estimated Cost
Bioretention system	0.078	13	5,939	0.26	755	\$3,775
Pervious pavement	0.283	47	21,468	0.94	1,945	\$48,625
Rainwater harvesting	0.043	7	3,254	0.14	1,500 (gal)	\$3,000

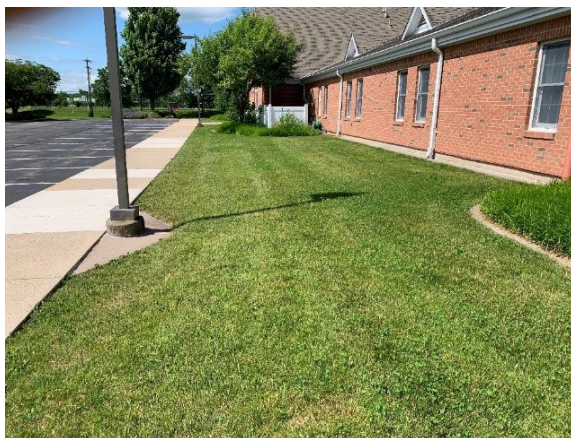
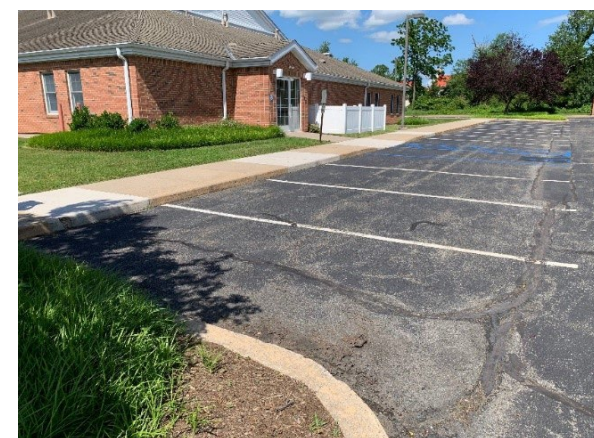
A bioretention system can be installed on the west side of the building to help infiltrate the stormwater from four downspouts. Pervious pavement can be installed in the south parking lot to capture the stormwater runoff from the lot. A preliminary soil assessment suggests that more soil testing would be required before determining the soil's suitability for green infrastructure.

Recommended Green Infrastructure Practices	Recharge Potential (Mgal/yr)	TSS Removal Potential (lbs/yr)	Maximum Volume Reduction Potential (gal/storm)	Peak Discharge Reduction Potential (cu. ft./second)	Estimated Size (sq. ft.)	Estimated Cost
Bioretention system	0.112	19	8,505	0.37	1,080	\$5,400
Pervious pavement	0.205	34	15,528	0.68	1,495	\$37,375

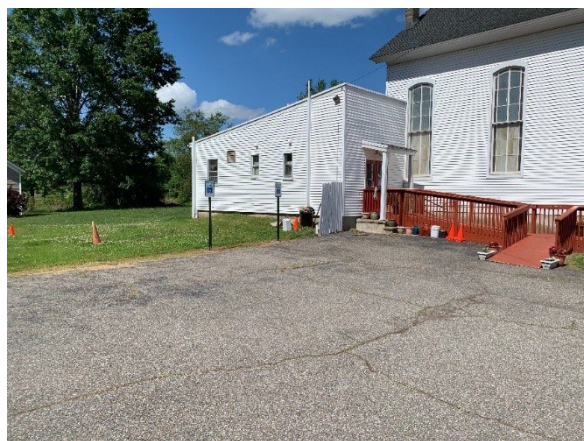
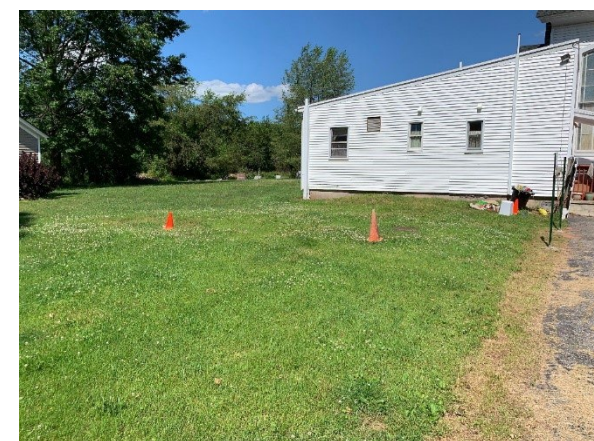
A bioretention system can be placed north of the church to help infiltrate the stormwater from the rooftop. Pervious pavement on the northwestern corner of the parking lot can capture, treat, and infiltrate the runoff from the parking lot. A preliminary soil assessment suggests that the soils have suitable drainage characteristics for green infrastructure.

Recommended Green Infrastructure Practices	Recharge Potential (Mgal/yr)	TSS Removal Potential (lbs/yr)	Maximum Volume Reduction Potential (gal/storm)	Peak Discharge Reduction Potential (cu. ft./second)	Estimated Size (sq. ft.)	Estimated Cost
Bioretention system	0.039	7	2,962	0.13	375	\$1,875
Pervious pavement	0.178	30	13,524	0.59	1,200	\$30,000

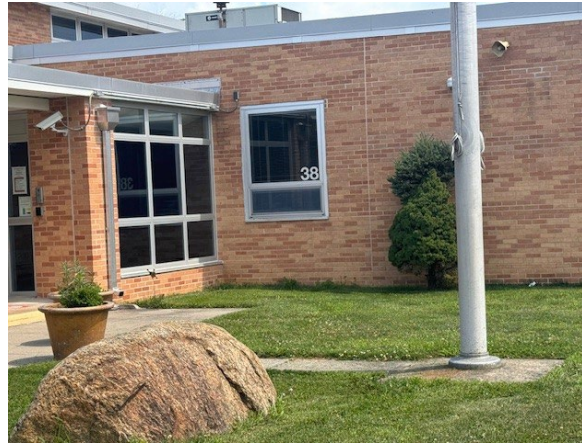
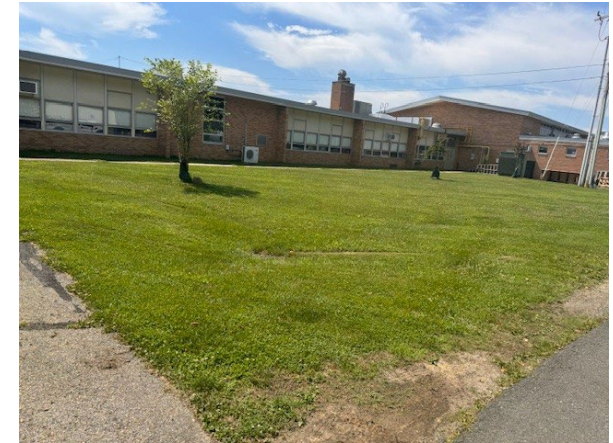
Several rain gardens can be installed in the grass areas around the building or by the parking lot to capture, treat, and infiltrate stormwater runoff from the roof or pavement. Downspout disconnection and redirection, trench drains, and curb cuts will be required for some of these gardens. Parking spaces in the lot in front of one of the gardens can be converted to porous pavement to capture and infiltrate stormwater runoff from the asphalt. A preliminary soil assessment suggests that more soil testing would be required before determining the soil's suitability for green infrastructure.

Recommended Green Infrastructure Practices	Drainage Area (sq. ft.)	Recharge Potential (Mgal/yr)	TSS Removal Potential (lbs/yr)	Maximum Volume Reduction Potential (gal/storm)	Peak Discharge Reduction Potential (cu. ft./second)	Estimated Size (sq. ft.)	Estimated Cost
Bioretention system	13,885	0.406	61	27,840	1.05	3,470	\$34,700
Pervious pavement	4,590	0.134	21	9,200	0.35	875	\$21,875
