Lebanon Township

Introduction

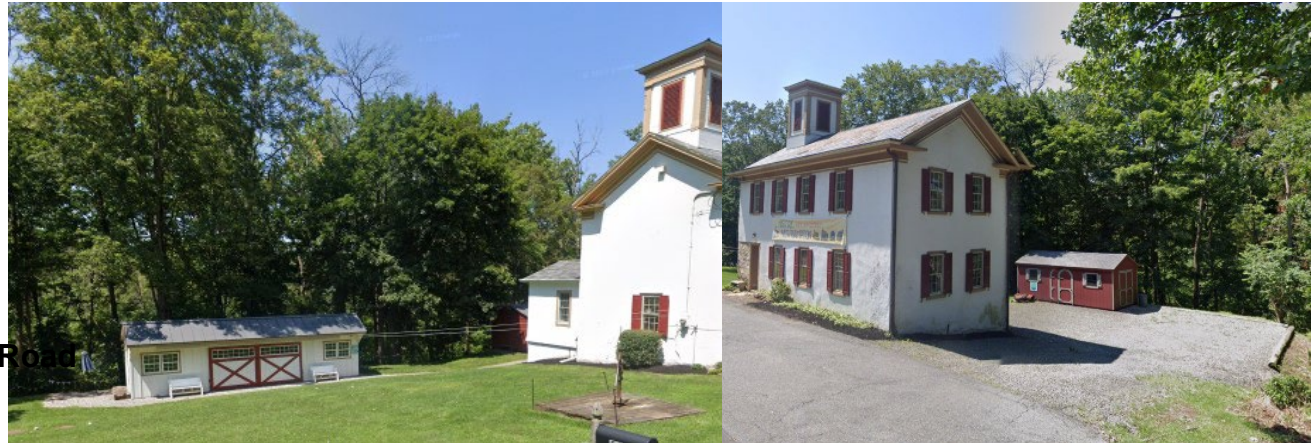
A rain garden can be installed to the southwest of the building using the existing disconnected downspouts to capture, treat, and infiltrate the stormwater runoff from the rooftop. An additional rain garden can be constructed to the south of the western shed to capture, treat, and infiltrate the stormwater runoff from the rooftop. The existing gravel parking lot can be converted into pervious pavement to capture and infiltrate the stormwater runoff from the lot, driveway, road, and northern shed. A gutter system can be installed on both sheds to maximize the drainage area being managed. A preliminary soil assessment suggests that the soils have suitable drainage characteristics for green infrastructure.

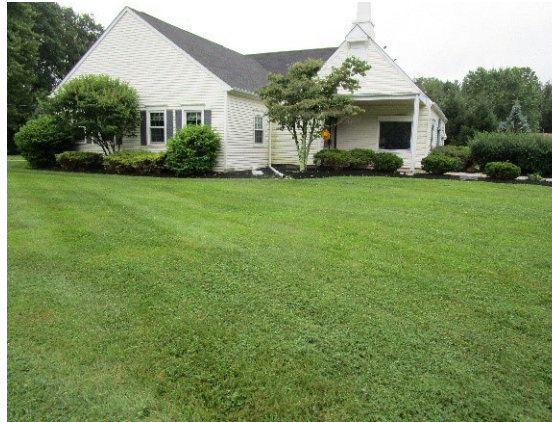
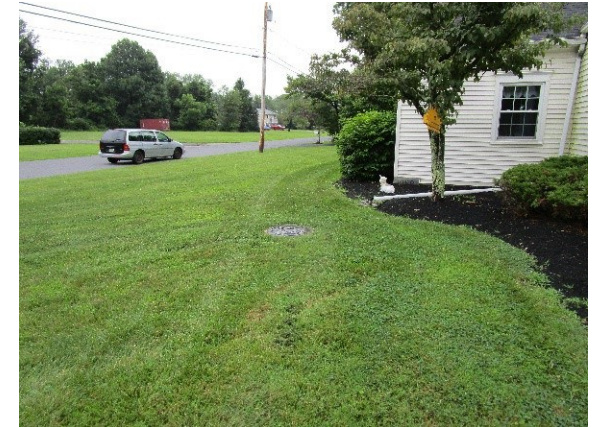
BODY OF CHRIST MINISTRIES

Two bioretention systems are proposed to infiltrate the water from the sloped lawn and a disconnected downspout. A preliminary soil assessment suggests that more soil testing would be required before determining the soil's suitability for green infrastructure.

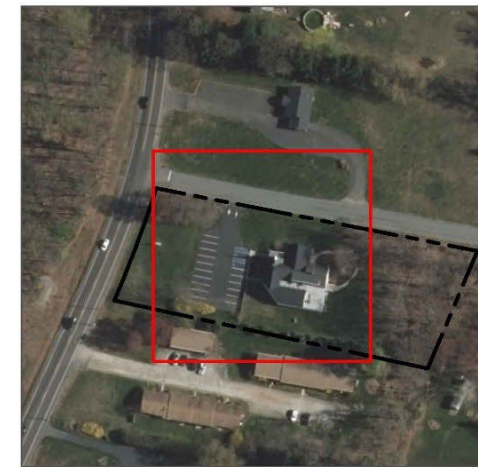
Body of Christ Ministries

bioretention system
-

drainage area
-

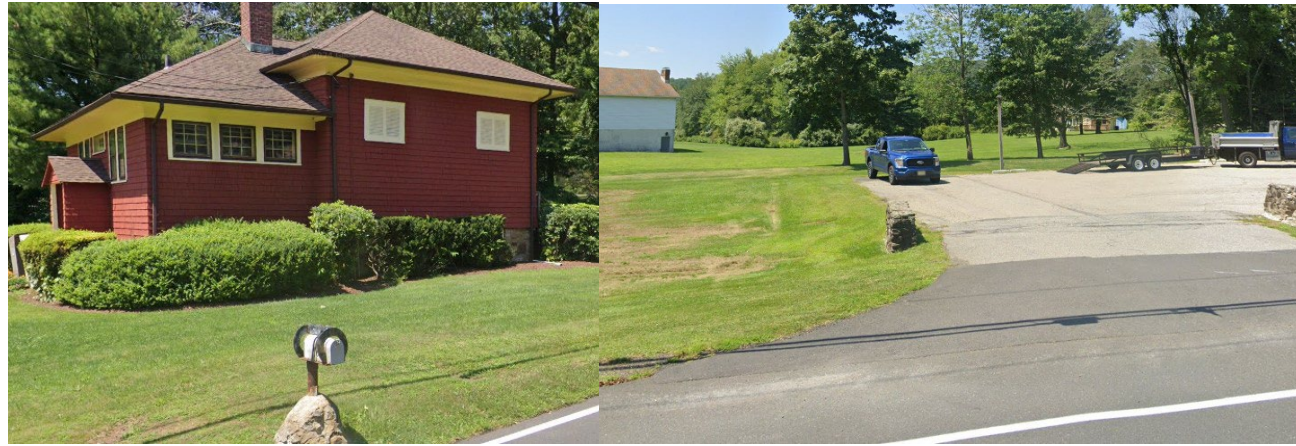
BUNNVALE LIBRARY

Rain gardens can be installed to the northeast and to the west of the building using the existing disconnected downspouts to capture, treat, and infiltrate the stormwater runoff from the rooftop. Downspout redirection may be needed. An additional rain garden can be constructed to the south of the parking lot to capture, treat, and infiltrate the stormwater runoff from the asphalt. A preliminary soil assessment suggests that the soils have suitable drainage characteristics for green infrastructure.

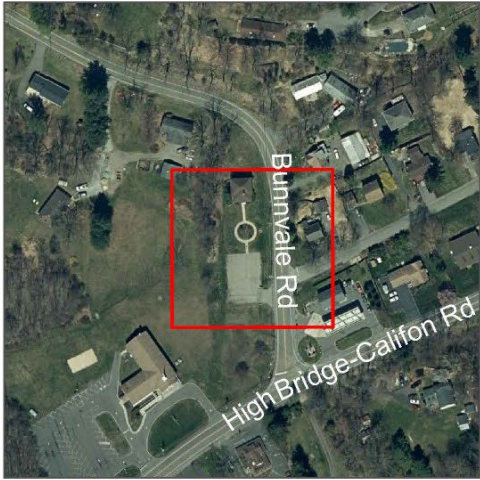
Bunnvale Library

bioretention system
-

captured drainage area
-

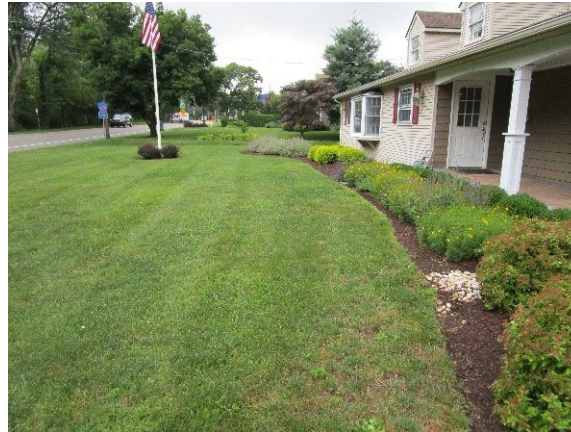
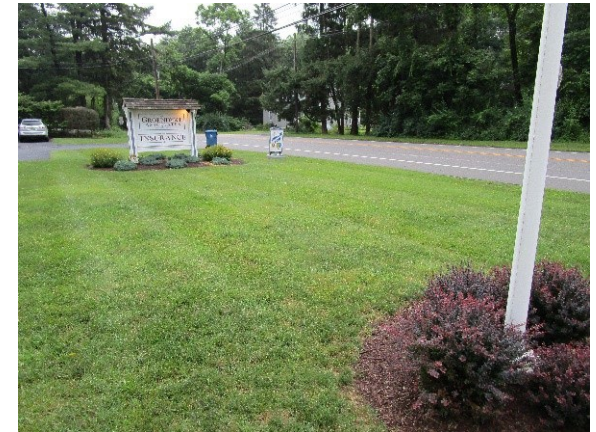
GROENDYKE ASSOCIATES

Two bioretention systems are proposed in the front of the building to infiltrate the water from the roof as well as the downspouts. A preliminary soil assessment suggests that the soils have suitable drainage characteristics for green infrastructure.

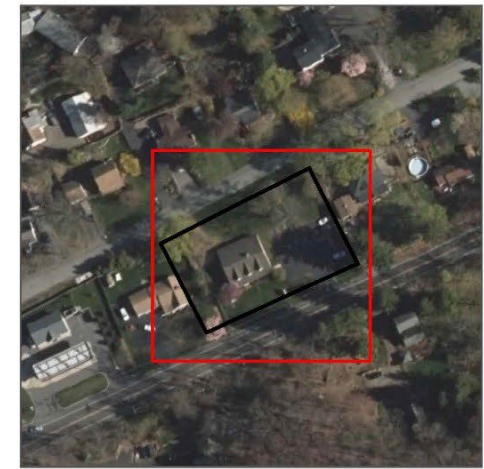
Groendyke Associates

bioretention system
-

drainage area
-

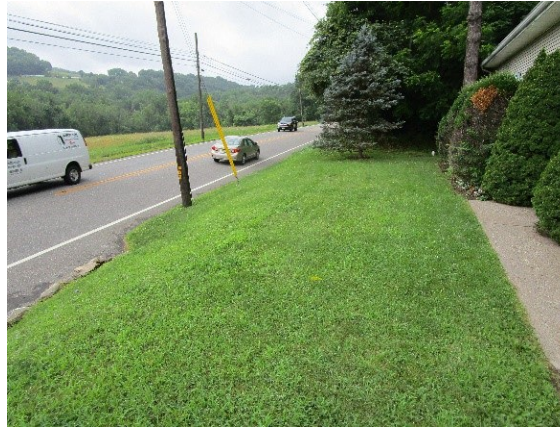
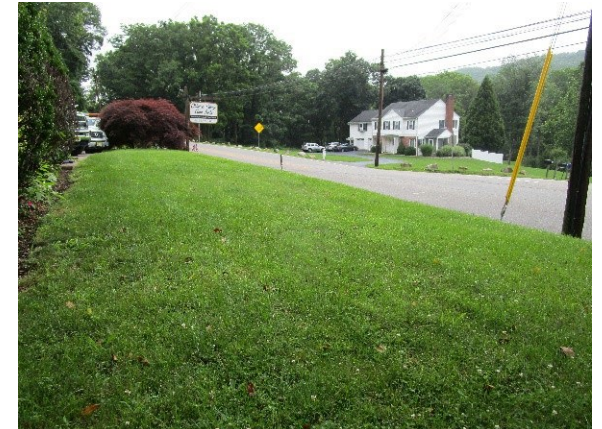
OLDWICK VILLAGE AUTO BODY

Two rainwater harvesting cisterns are proposed on opposite corners of the building to capture stormwater runoff from the roof. The water can be used for washing vehicles, watering plants, or other non-potable purposes. A preliminary soil assessment suggests that the soils have suitable drainage characteristics for green infrastructure.

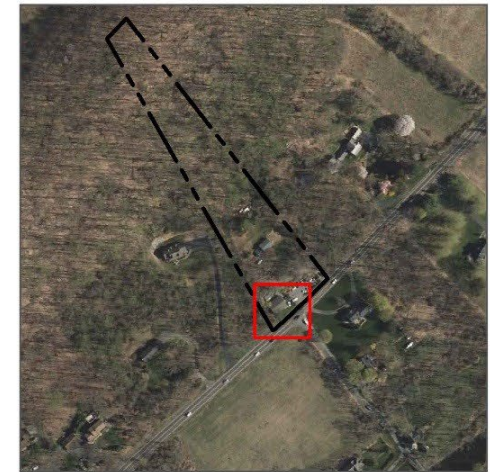
Oldwick Village Auto Body

rainwater harvesting
-

drainage area
-

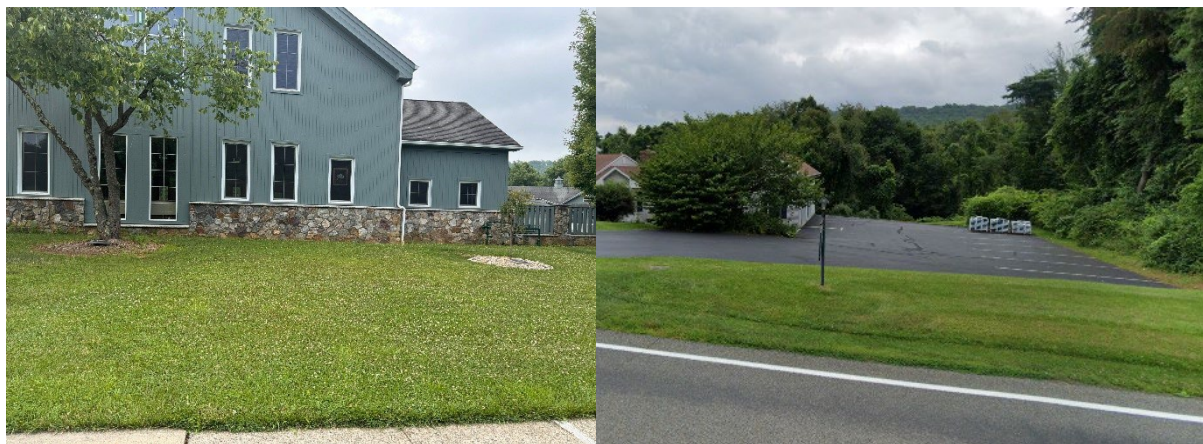
ST. JOHN NEUMANN ROMAN CATHOLIC CHURCH

Rain gardens can be installed in multiple grass areas around the property to capture, treat, and infiltrate the stormwater runoff from various rooftops. This may require downspout redirections and disconnections, as well as trench drains. Existing parking spaces in the northern, southern, and western parking lots can be converted into pervious pavement to capture and infiltrate the stormwater runoff from the asphalt, roadway, and sidewalks. This may require trench drains. A preliminary soil assessment suggests that the soils have suitable drainage characteristics for green infrastructure.

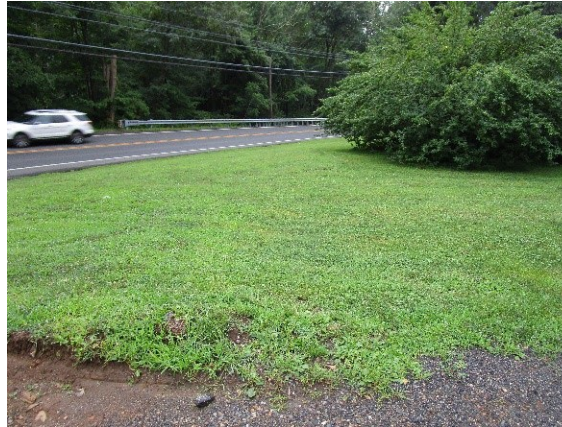
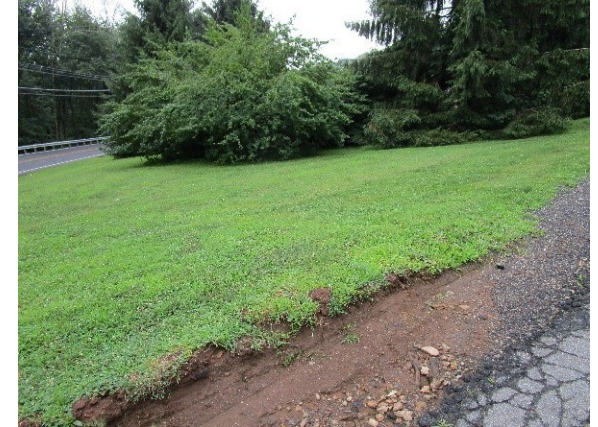
VOORHEES RESIDENTIAL COMMUNITY HOME

A bioretention system is proposed at the entrance of the property to reduce erosion and infiltrate the stormwater runoff from the parking area. A preliminary soil assessment suggests that the soils have suitable drainage characteristics for green infrastructure.

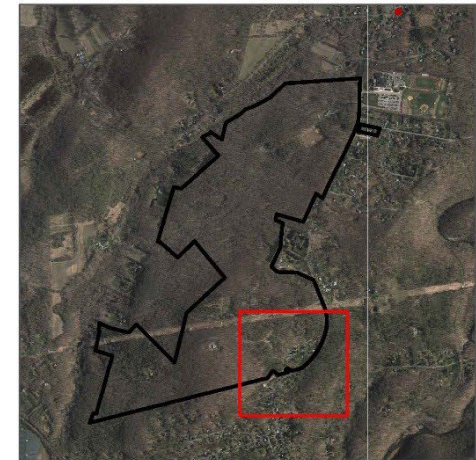
Voorhees Residential Community Home

bioretention system
-

drainage area
-

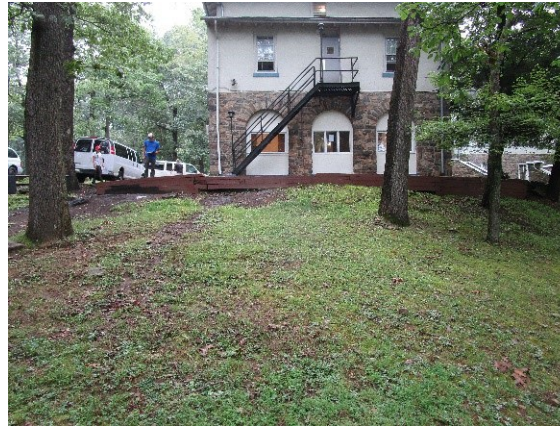
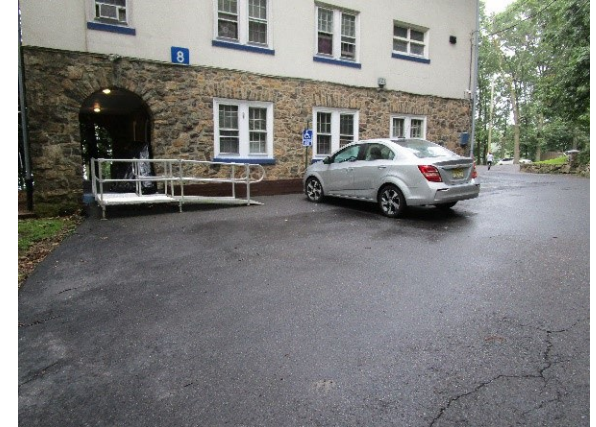
FREEDOM HOUSE

A bioretention system is proposed on the south side of the building to infiltrate the water from the downspouts of the building and to prevent erosion and flooding at the bottom of the hill. A rainwater harvesting cistern is proposed at the north side of the building to capture stormwater runoff from the roof. This water can be reused for non-potable purposes. A preliminary soil assessment suggests that the soils have suitable drainage characteristics for green infrastructure.

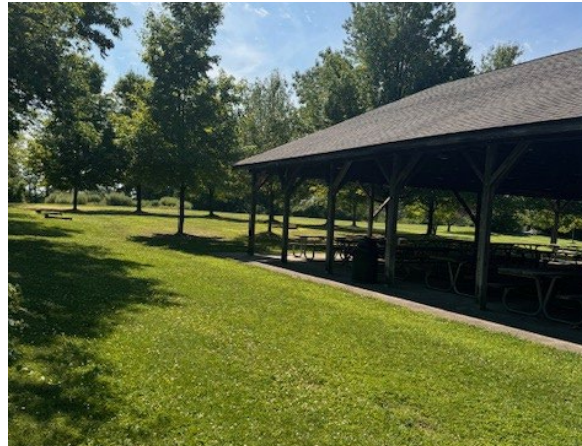
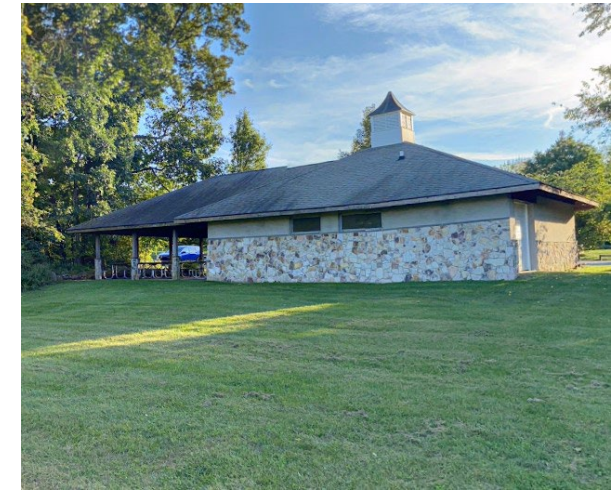
LEBANON TOWNSHIP MEMORIAL PARK

Rain gardens can be installed in multiple grass areas around the property to capture, treat, and infiltrate the stormwater runoff from rooftops. Existing parking spaces in the middle and southern lots can be converted into pervious pavement to capture and infiltrate the stormwater runoff from the asphalt. The tennis courts can be converted into pervious pavement to capture and infiltrate the stormwater runoff from the courts and from the northern parking lot. Trench drains may be needed to intercept and redirect stormwater to the pervious pavement. A preliminary soil assessment suggests that more soil testing would be required before determining the soil's suitability for green infrastructure.

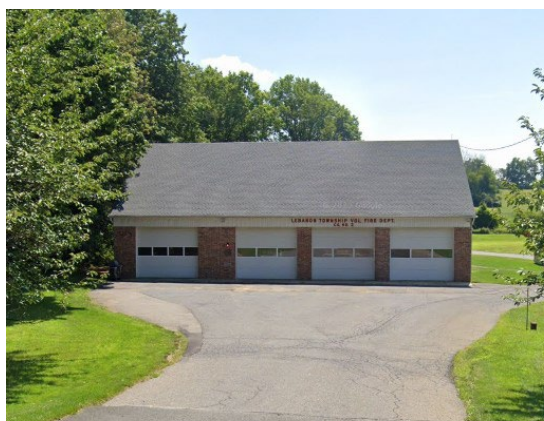
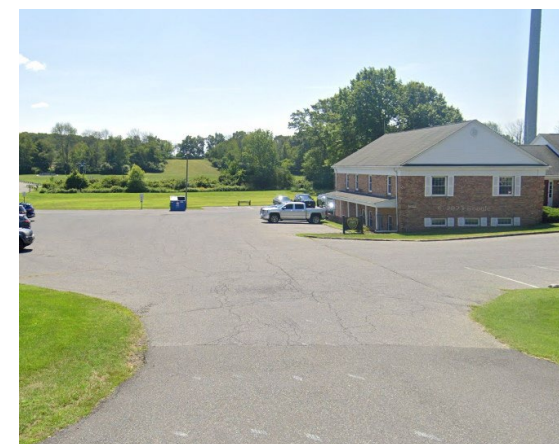
LEBANON TOWNSHIP MUNICIPAL BUILDING & FIRE DEPARTMENT

Rain gardens can be installed in multiple grass areas around the property to capture, treat, and infiltrate the stormwater runoff from the rooftops, driveways, parking lots, and roadway. This may require downspout redirections and trench drains. Existing parking spaces to the south and west in the eastern parking area can be converted into pervious pavement to capture and infiltrate the stormwater runoff from the asphalt. Downspouts on the adjacent building can also be disconnected to direct rooftop runoff to the pervious pavement. A cistern can be installed to the west of the fire department building to divert and detain the stormwater runoff from the rooftop for later non-potable reuse such as washing vehicles. A preliminary soil assessment suggests that the soils have suitable drainage characteristics for green infrastructure.

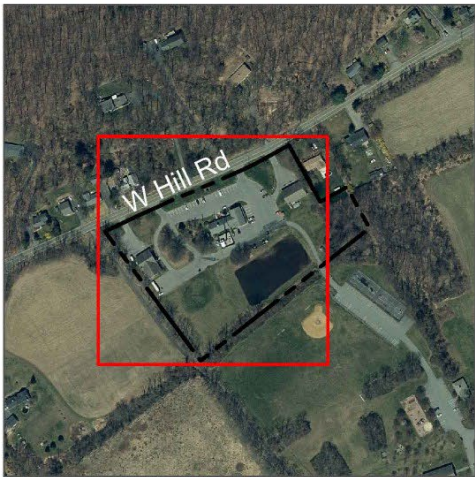
**Lebanon Township
Municipal Building &
Fire Department**

bioretention system
-

pervious pavement
-

rainwater harvesting
-

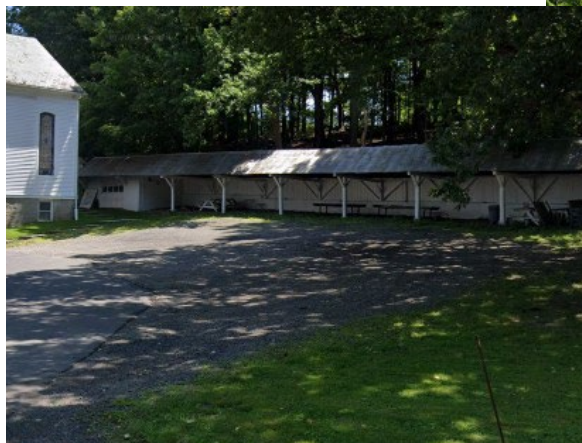
SPRUCE RUN LUTHERAN CHURCH

Rain gardens can be installed in multiple grass areas to capture, treat, and infiltrate the stormwater runoff from the driveway and parking lot. This may require trench drains and curb cuts. The existing asphalt playground can be converted into pervious pavement to capture and infiltrate the stormwater runoff from the play area. The western gravel parking lot can be converted into pervious pavement to capture and infiltrate the stormwater runoff from the lot and the shed rooftop. Building downspouts can be disconnected and redirected to both pervious pavement areas to increase the drainage area being managed. A preliminary soil assessment suggests that the soils have suitable drainage characteristics for green infrastructure.

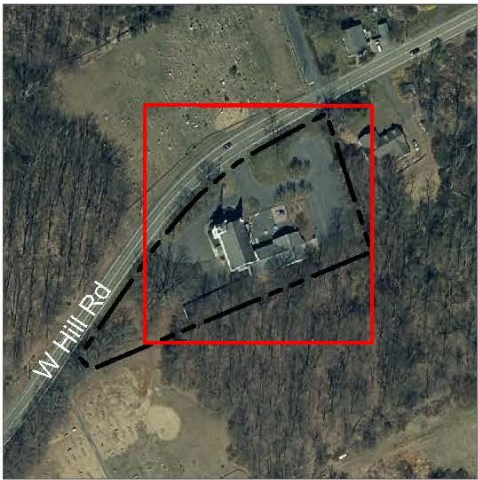
Spruce Run Lutheran Church

bioretention system
-

pervious pavement
-

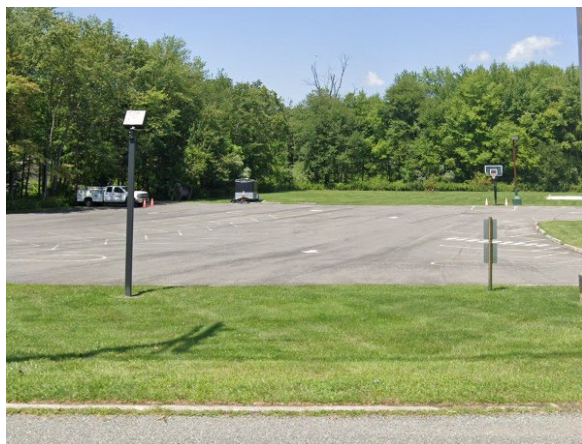
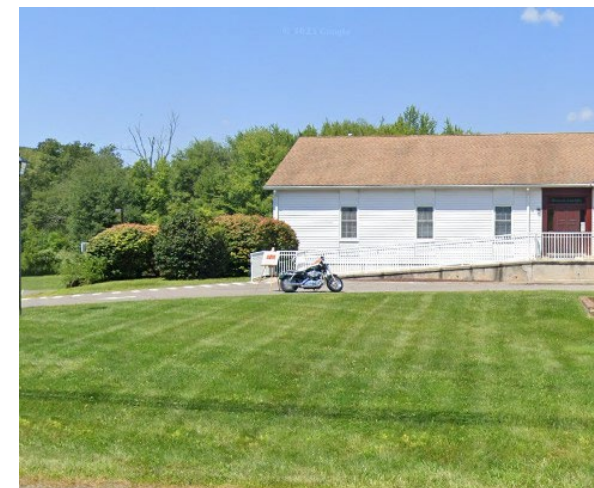
BUNNVALE ASSEMBLY OF GOD

Rain gardens can be installed in multiple grass areas around the property to capture, treat, and infiltrate the stormwater runoff from the rooftop, driveway, and parking lot. This may require downspout disconnections, redirections, and trench drains. A preliminary soil assessment suggests that the soils have suitable drainage characteristics for green infrastructure.

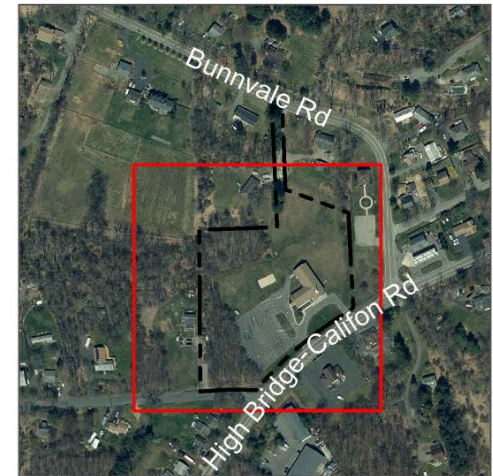
Bunnvale Assembly of God

bioretention system
-

captured drainage area
-

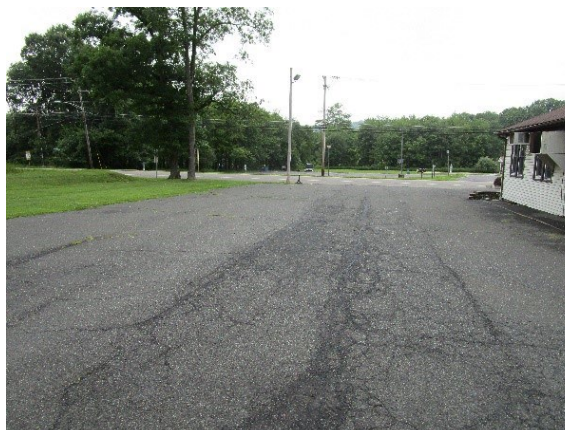
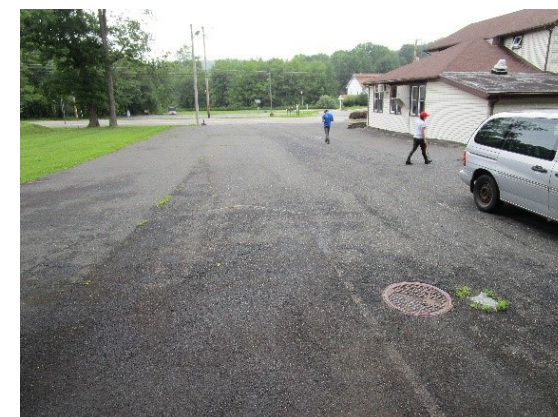
A bioretention system is proposed in the turfgrass to capture, treat, and infiltrate the west side of the parking lot and rooftop. Parking spaces on the east side of the parking lot can be converted to porous pavement to capture and infiltrate stormwater from the parking lot and rooftop. Planter boxes can be added to both entrances to capture runoff from the downspouts. A preliminary soil assessment suggests that the soils have suitable drainage characteristics for green infrastructure.

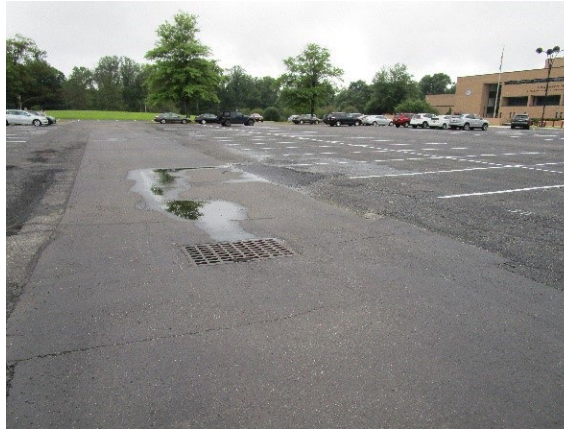
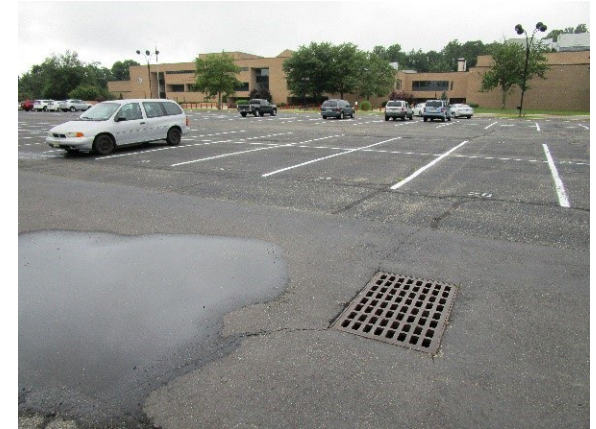
Two mowed detention basins at the east entrance can be retrofitted with rain gardens to capture, treat, and infiltrate stormwater runoff from the driveway and enhance pollinator habitat. Two sections of parking spaces can be converted to porous pavement to capture and infiltrate runoff from the parking lot. A preliminary soil assessment suggests that more soil testing would be required before determining the soil's suitability for green infrastructure.

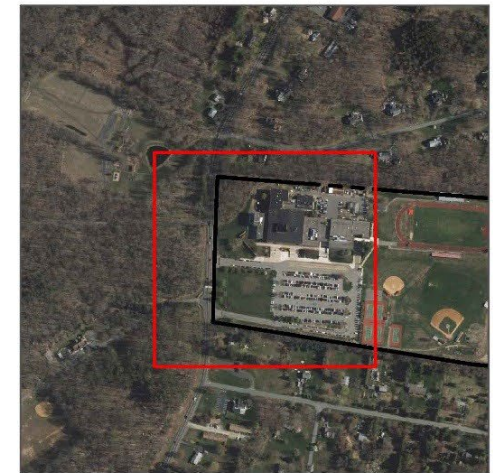
Voorhees High School

- bioretention system
- pervious pavement
- drainage area
- property line
- 2015 Aerial: NJOIT, OGIS
