## Mendham Borough

### Introduction

### **Analysis by Municipality**

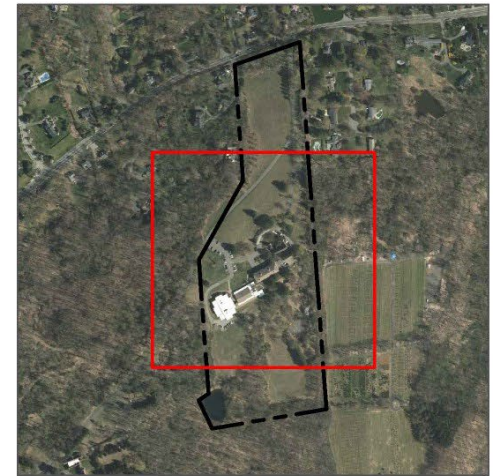
A rain garden can be installed to capture, treat, and filter runoff from the rooftop of the easternmost building on the property. Pervious pavement can be installed in the parking spaces to infiltrate the water from the driveway, and downspout planter boxes can be installed along the front of the school. A preliminary soil assessment suggests that the soils have suitable drainage characteristics for green infrastructure.

bioretention system
-

pervious pavement
-

planter box
-

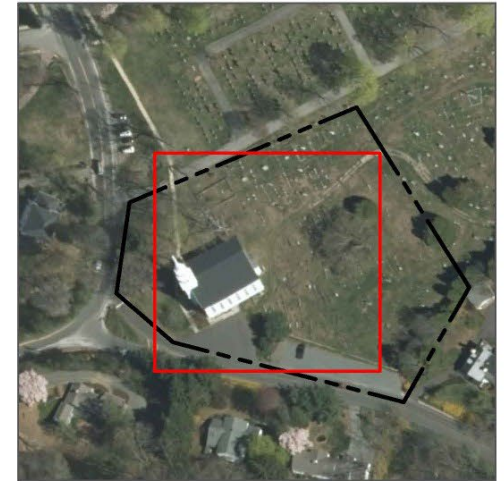
**Hilltop Presbyterian Church**

A small section of pervious pavement in parking spaces near the entrance can capture rooftop runoff and help prevent pooling in the adjacent street. Additionally, a rain garden can be installed in front of the building to capture, treat, and infiltrate runoff from the roof. A preliminary soil assessment suggests that the soils have suitable drainage characteristics for green infrastructure.

bioretention system
-

pervious pavement
-

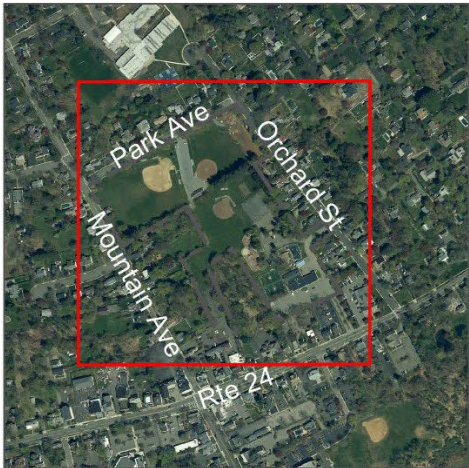
## Mendham Borough Park

Rain gardens can be installed in multiple grass areas around the property to capture, treat, and infiltrate the stormwater runoff from rooftops, a driveway, and a parking lot. Downspout redirection and redirection beneath a sidewalk may be required. The rain garden to the east of the carriage house can be constructed around the nearby catch basin. Parking spaces to the south of fire department can be converted into pervious pavement to capture and infiltrate the stormwater runoff from the asphalt lot. The basketball court can also be converted into pervious pavement to capture and infiltrate stormwater runoff from the court. A cistern can be installed to the south of the shed near the fire department to divert and detain the stormwater runoff from the rooftop for later non-potable reuse such as washing vehicles. A gutter system would need to be installed on the structure. A preliminary soil assessment suggests that more soil testing would be required before determining the soil's suitability for green infrastructure.

bioretention system
-

pervious pavement
-

rainwater harvesting
-

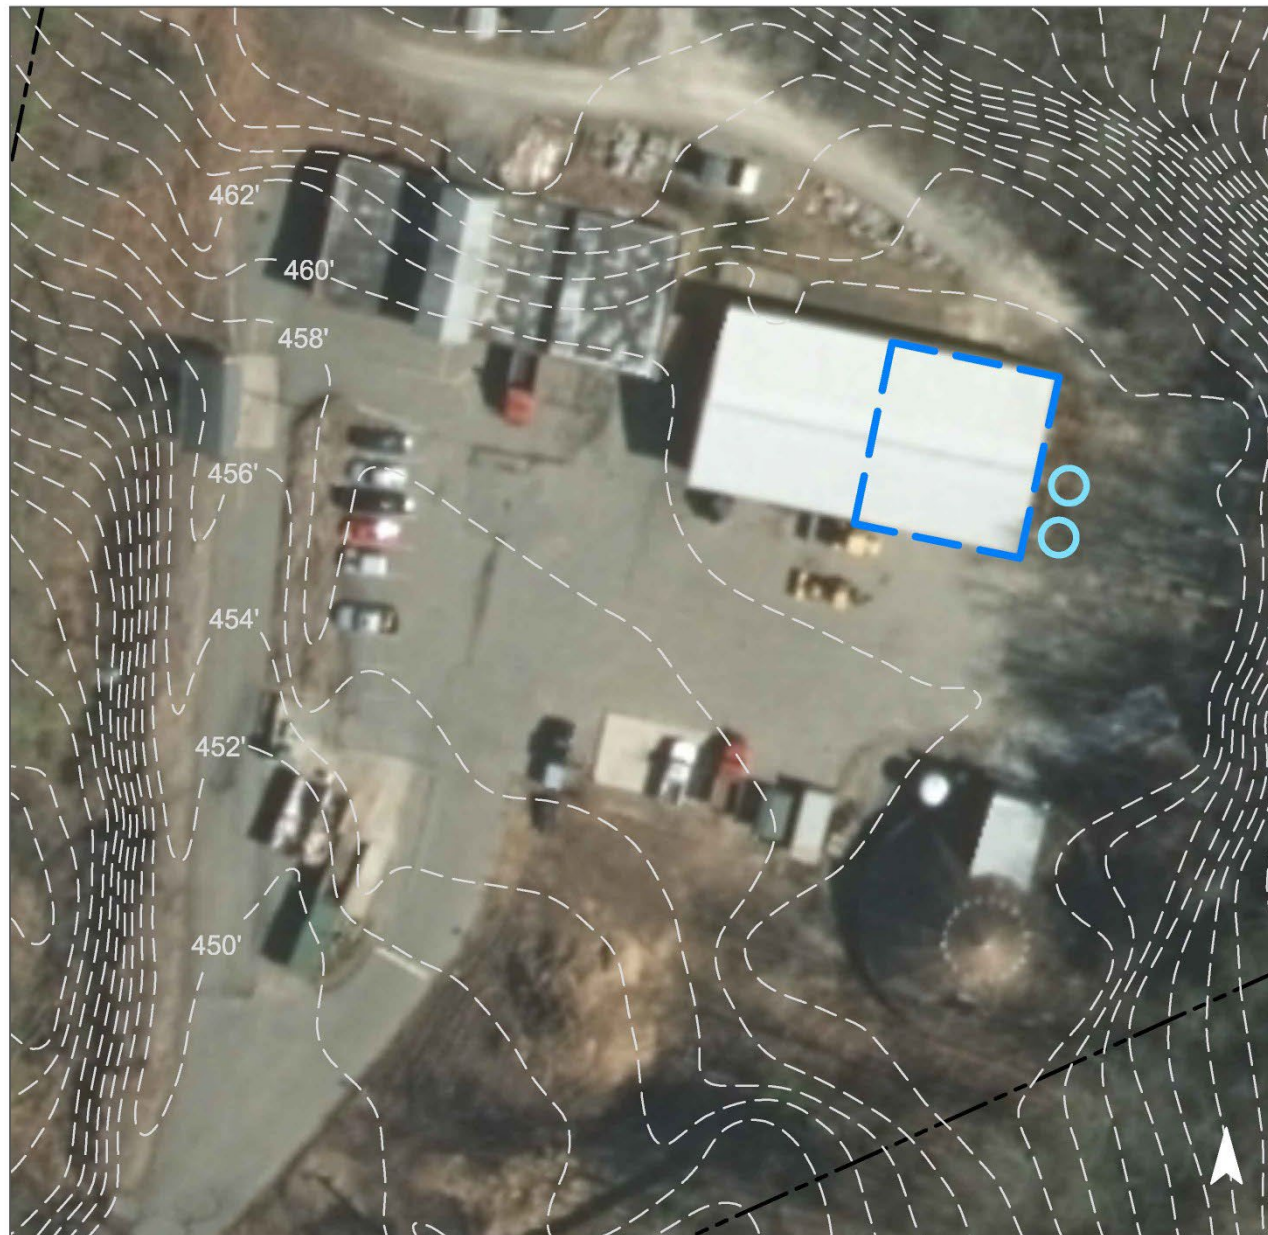
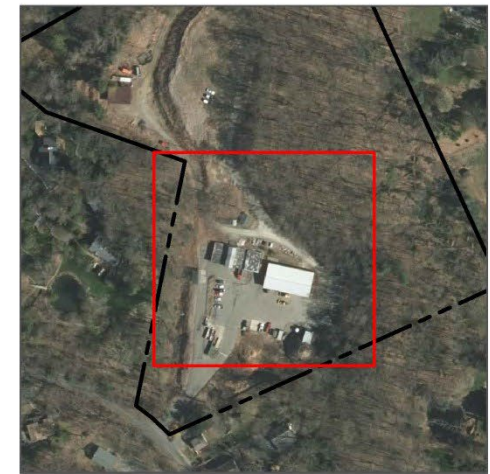
## Mendham Borough Public Works Garage

Two cisterns can be installed adjacent to the building to treat the building's drainage area. A preliminary soil assessment suggests that more soil testing would be required before determining the soil's suitability for green infrastructure.

rainwater harvesting
-

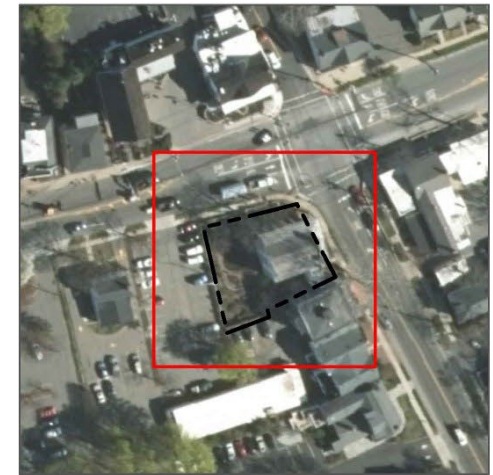
## Mendham Recreation Department

A section of the rooftop runoff can be treated with a small rain garden, and two additional sections of the roof can be treated with two downspout planter boxes. A preliminary soil assessment suggests that the soils have suitable drainage characteristics for green infrastructure.

bioretention system
-

planter box
-

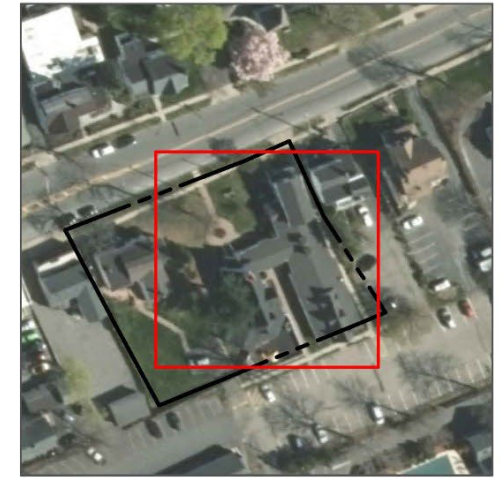
**St. Mark's Episcopal Church**

A rain garden can be installed near the rear entrance of the building to capture, treat, and infiltrate the water from five nearby connected downspouts. Two downspout planter boxes can be installed to capture rooftop runoff from different sections of the building. A preliminary soil assessment suggests that the soils have suitable drainage characteristics for green infrastructure.

bioretention system
-

planter box
-

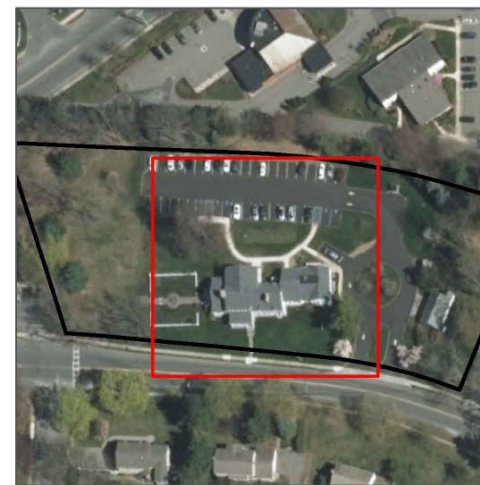
**Atlantic Cardiology  
Group, LLP**

Rain gardens can be installed throughout the property to capture, treat, and infiltrate stormwater runoff from both the rooftop and the parking lot areas. A preliminary soil assessment suggests that more soil testing would be required before determining the soil's suitability for green infrastructure.

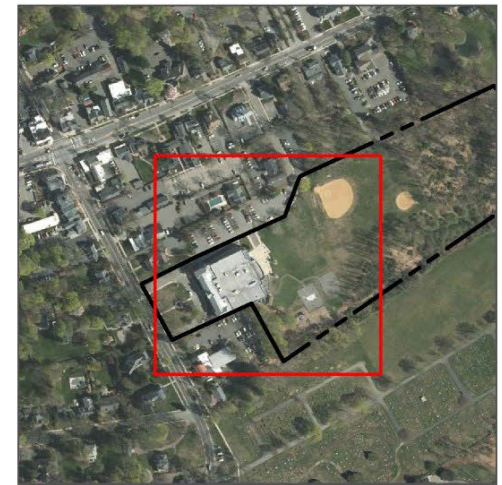
**Hilltop Elementary School**

Two rain gardens can be installed in the front and back of the building in the turfgrass areas to help infiltrate the water from the nearby downspouts. A preliminary soil assessment suggests that the soils have suitable drainage characteristics for green infrastructure.

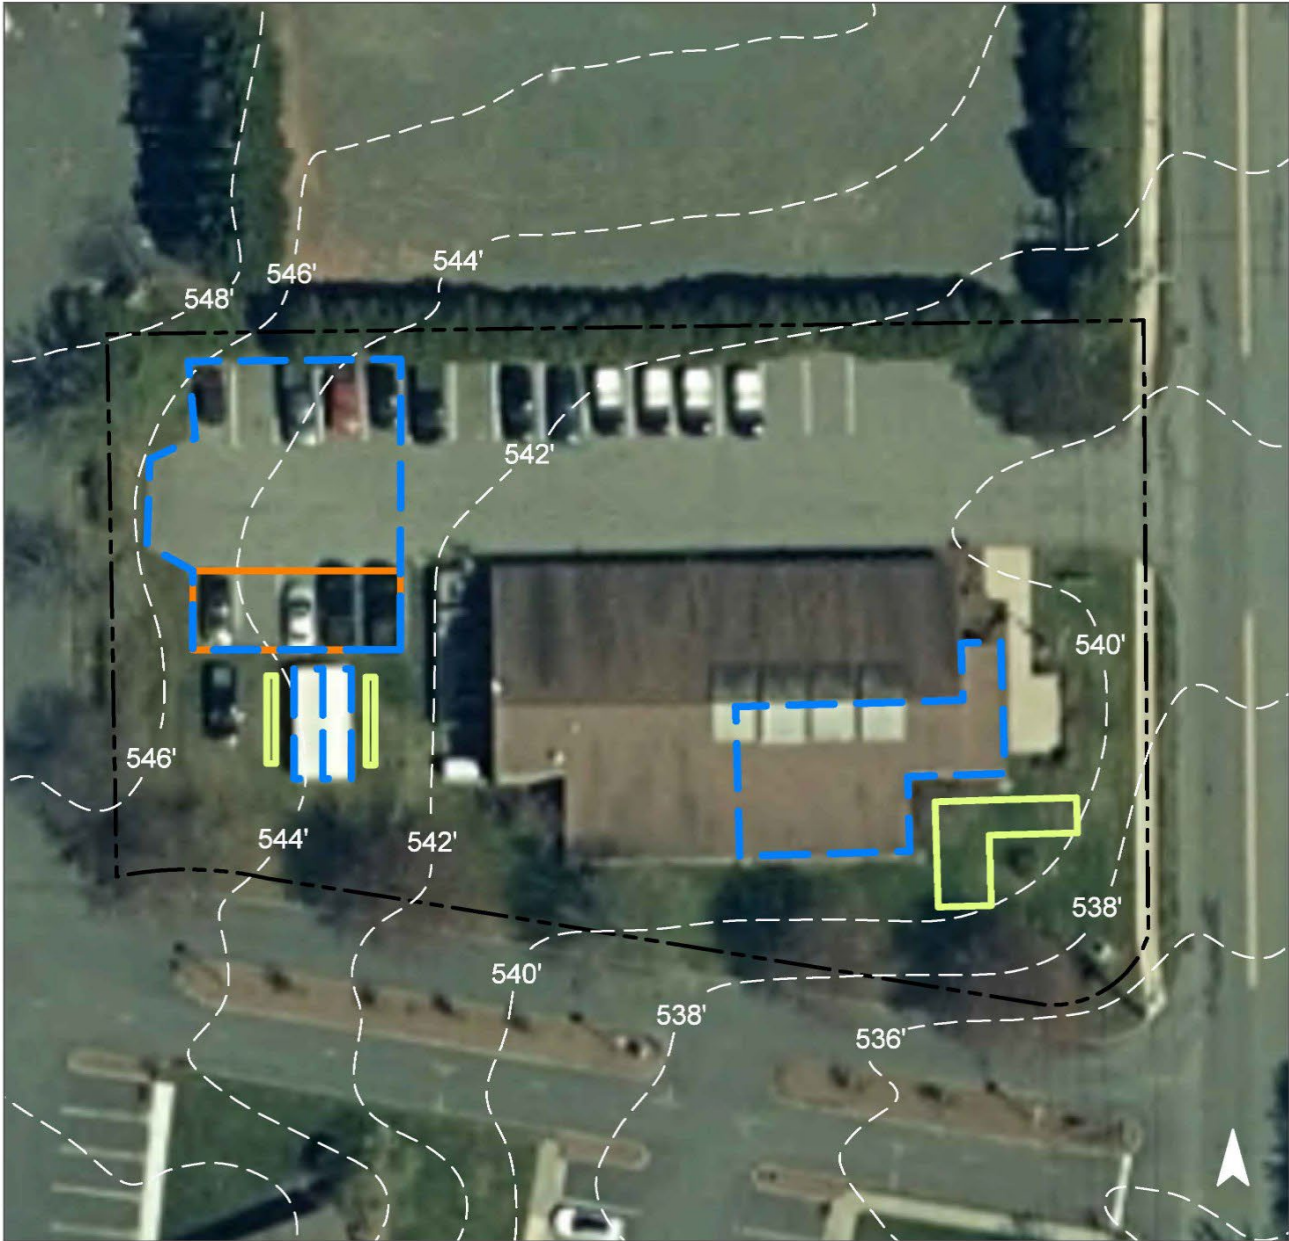
## Mendham Borough Police Department

A rain garden can be installed to the east of the building using the disconnected downspouts to capture, treat, and infiltrate the stormwater runoff from the rooftop. Two rain gardens can be installed to the east and west of the shed to capture, treat, and infiltrate stormwater runoff from the rooftop. Existing parking spaces on the western side of the lot can be converted into pervious pavement to capture and infiltrate the stormwater runoff from the asphalt. This may require trench drains. A preliminary soil assessment suggests that more soil testing would be required before determining the soil's suitability for green infrastructure.

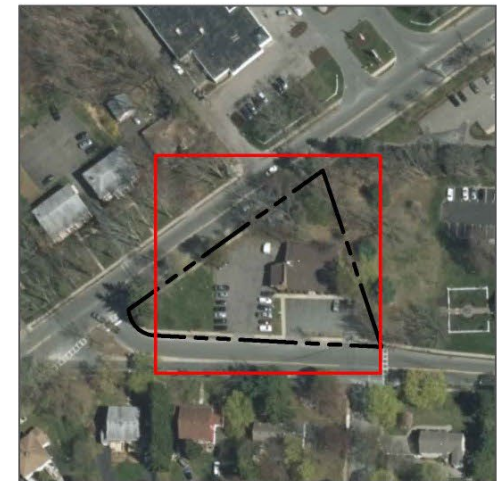
## Mendham Post Office

- Pervious pavement can be installed in parking spaces to treat runoff from the parking lot. A preliminary soil assessment suggests that more soil testing would be required before determining the soil's suitability for green infrastructure.

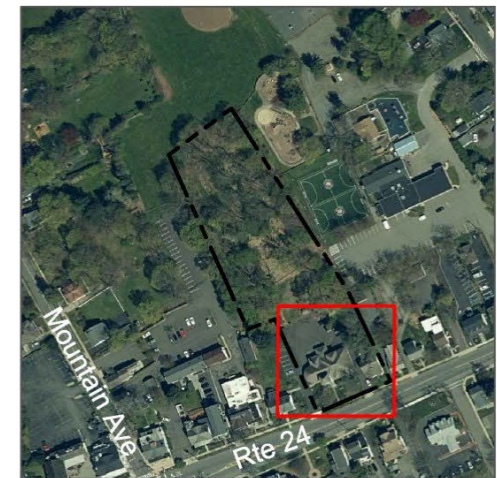
## Mendham United Methodist Church

A rain garden can be installed to the south of the building using to capture, treat, and infiltrate the stormwater runoff from the rooftop. This will require downspout disconnection and redirection. Existing parking spaces in the northern area of the lot can be converted into pervious pavement to capture and infiltrate the stormwater runoff from the asphalt. A preliminary soil assessment suggests that more soil testing would be required before determining the soil's suitability for green infrastructure.

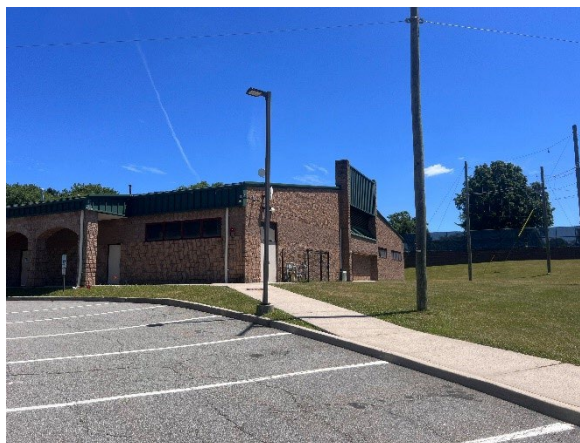
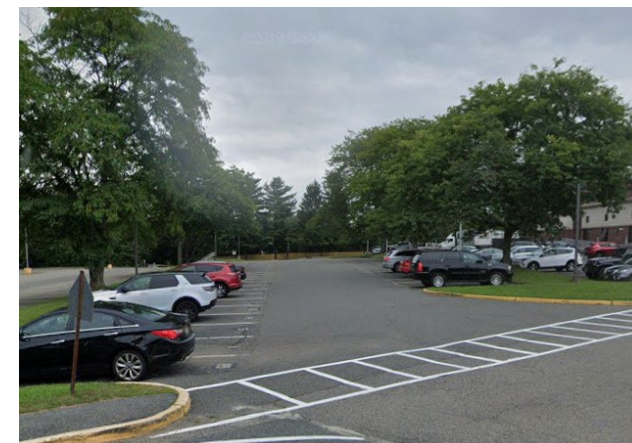
A rain garden can be installed to the south corner of the building near the tennis courts to capture, treat, and infiltrate the stormwater runoff from the rooftop. This will require downspout disconnection and redirection. The center tennis courts can be converted into pervious pavement to capture and infiltrate the stormwater runoff from all the courts. The downspouts on the adjacent building can be disconnected and redirected to the courts as well, to manage rooftop runoff with the pervious pavement. Existing parking spaces in the northern lot can be converted into pervious pavement to capture and infiltrate stormwater runoff from the asphalt. Trench drains may be required. A preliminary soil assessment suggests that the soils have suitable drainage characteristics for green infrastructure.

Recommended Green Infrastructure Practices	Drainage Area (sq. ft.)	Recharge Potential (Mgal/yr)	TSS Removal Potential (lbs/yr)	Maximum Volume Reduction Potential (gal/storm)	Peak Discharge Reduction Potential (cu. ft./second)	Estimated Size (sq. ft.)	Estimated Cost
Bioretention system	1,260	0.037	6	2,630	0.10	315	\$3,150
Pervious pavement	83,990	2.487	367	175,190	6.58	22,550	\$563,750
