## Mendham Township

### Introduction

The purpose of this report is to provide a comprehensive understanding of key, defining features within the subwatersheds throughout Mendham Township. This involves gathering, organizing, and presenting information about existing conditions and infrastructure within each subwatershed. It aims to serve as a tool for informed decision-making, planning, and implementation of sustainable watershed management strategies aimed to protect and enhance the health of the watershed, its associated ecosystems, and the surrounding communities.

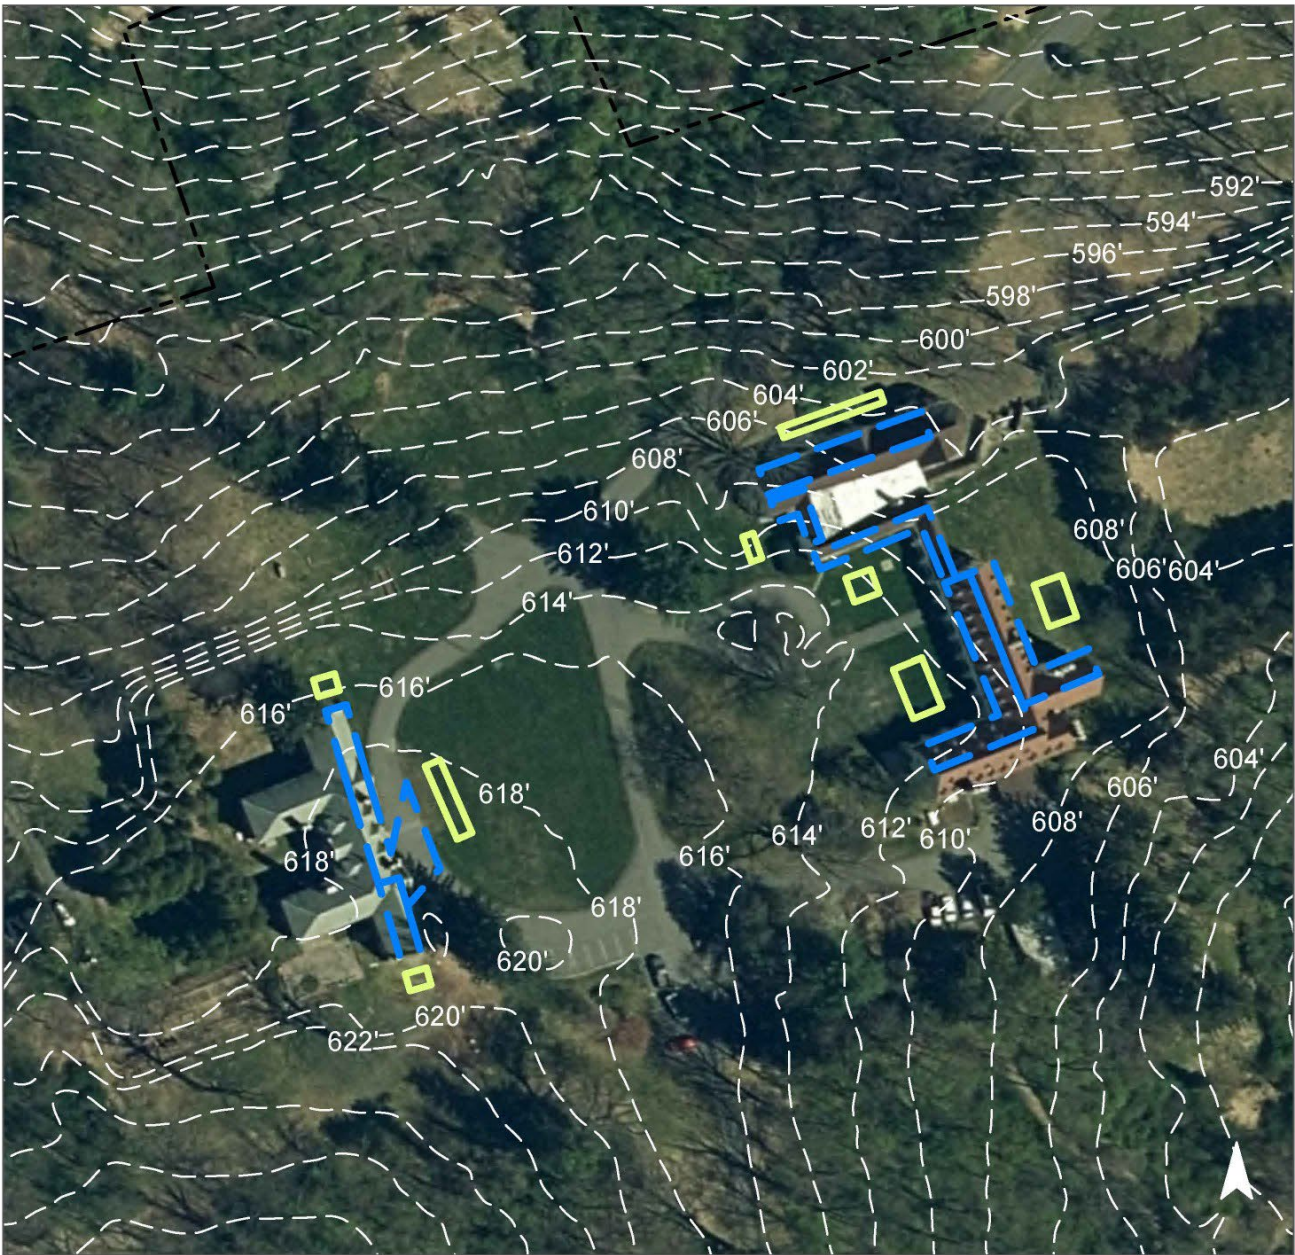
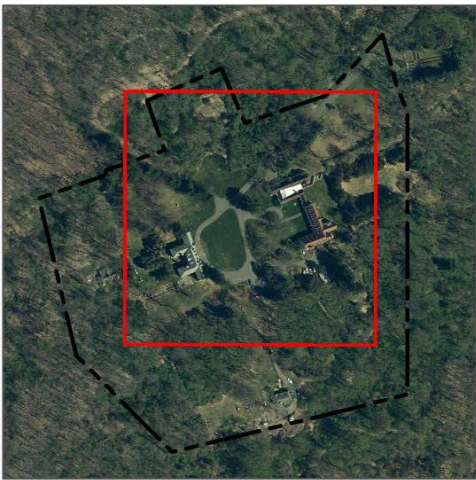
**Community of St. John Baptist**

Rain gardens can be installed in multiple grass areas around the property to capture, treat, and infiltrate stormwater runoff from the building rooftops and pavement. For some of the gardens, this may require downspout redirections and downspout disconnections. A preliminary soil assessment suggests that the soils have suitable drainage characteristics for green infrastructure. A preliminary soil assessment suggests that the soils have suitable drainage characteristics for green infrastructure.

- bioretention system
- captured drainage area
- property line
- 2020 Aerial: NJOIT, OGIS

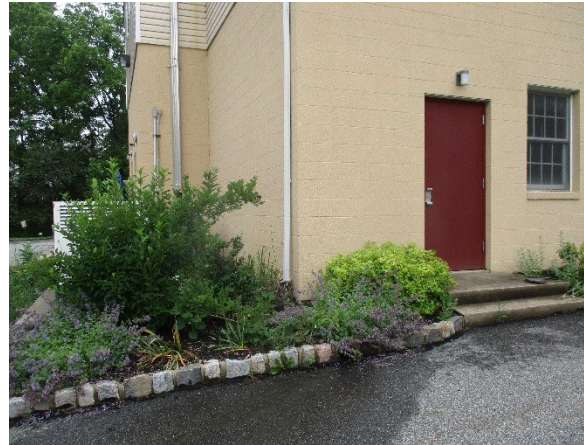
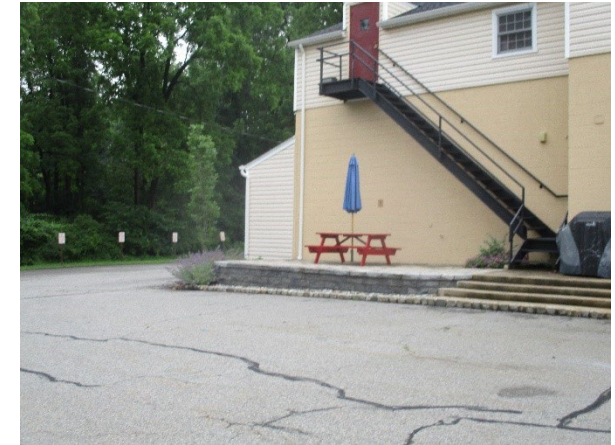
A cistern can be installed along the building to allow stormwater runoff from the roof to be reused for activities such as washing fire engines. To capture runoff from the parking lot, a section of parking spaces can be converted to porous pavement. Downspout planter boxes can be placed on the front of the building to help capture stormwater runoff. A preliminary soil assessment suggests that more soil testing would be required before determining the soil's suitability for green infrastructure.

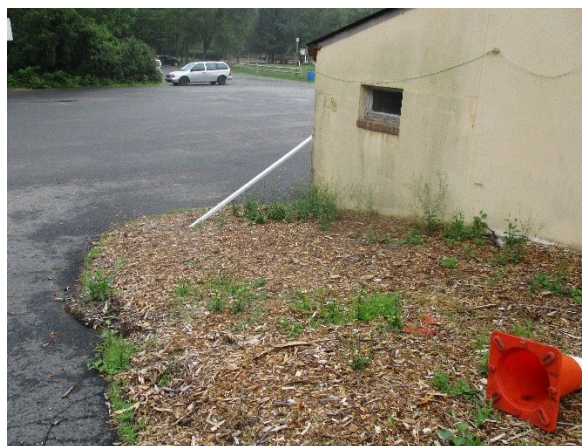
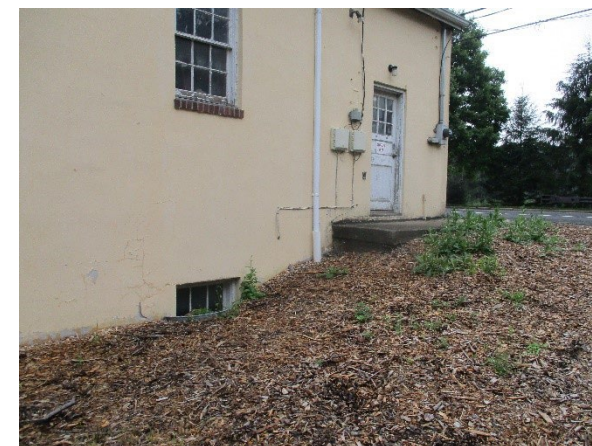
A rain garden can be installed on the east side of the building to capture, treat, and infiltrate rooftop runoff. Along the western side of the building a downspout planter box can be installed to help capture stormwater runoff. A preliminary soil assessment suggests that more soil testing would be required before determining the soil's suitability for green infrastructure.

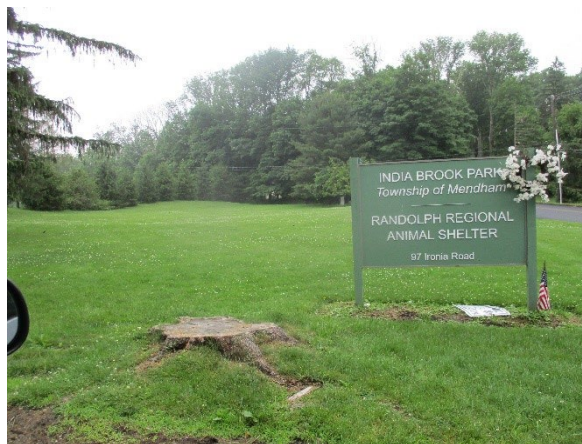
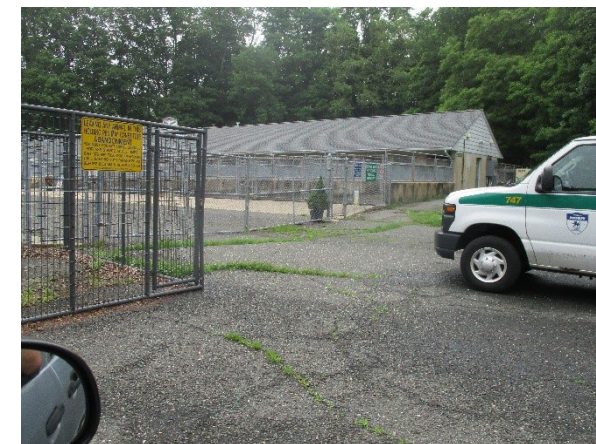
A rain garden can be installed adjacent to the main building to capture, treat, and infiltrate rooftop runoff. The gated pavement area can be replaced with pervious pavement to capture and infiltrate stormwater from the nearby buildings and the lot. A preliminary soil assessment suggests that the soils have suitable drainage characteristics for green infrastructure.

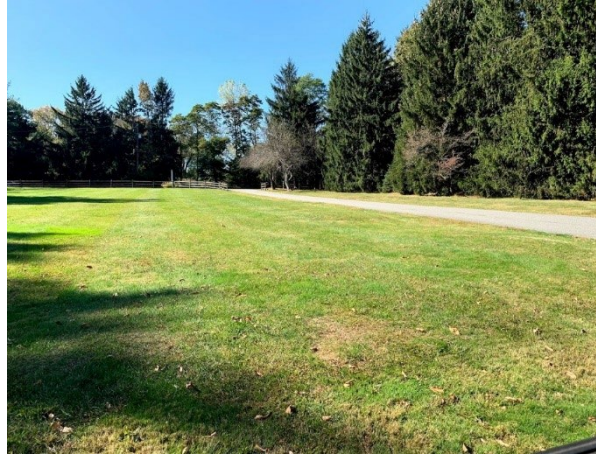
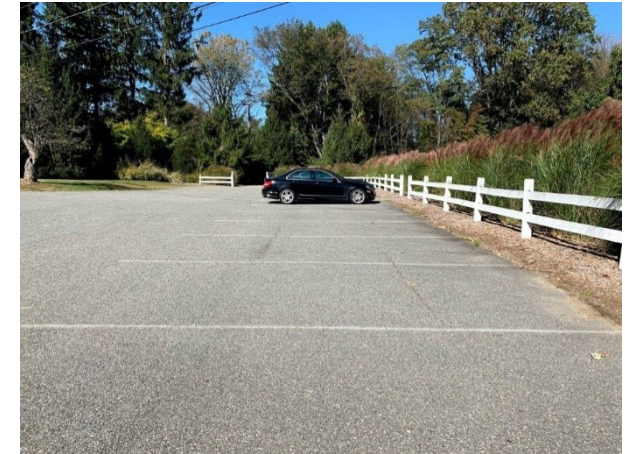
Pervious pavement can be installed in the west parking lot of the tennis courts to treat the runoff from the driveway and parking lot. A preliminary soil assessment suggests that more soil testing would be required before determining the soil's suitability for green infrastructure.

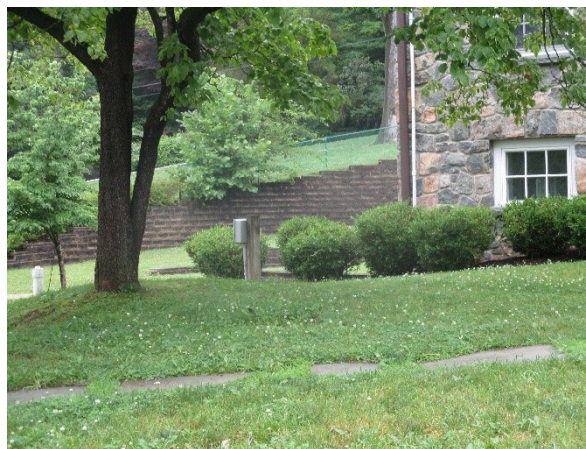
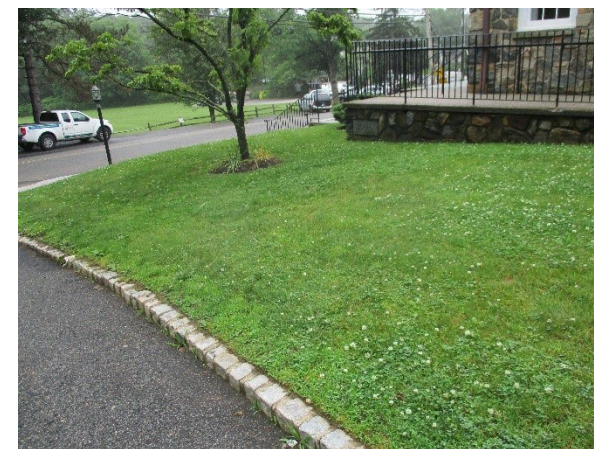
Bioretention systems can be installed on the southeast and southwest side of the building to capture, treat, and infiltrate rooftop runoff. To help with stormwater capture, downspout planter boxes can be placed along the southwestern part of the building. A preliminary soil assessment suggests that the soils have suitable drainage characteristics for green infrastructure.

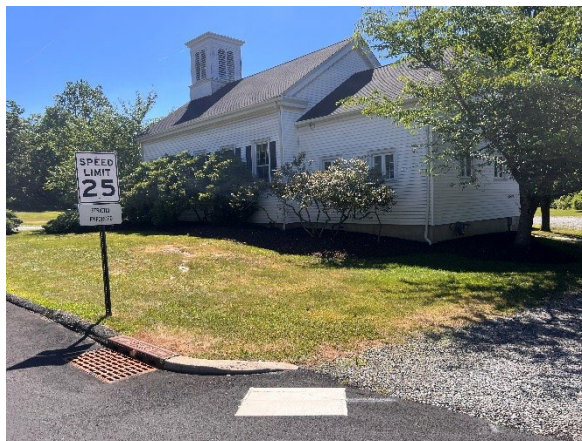
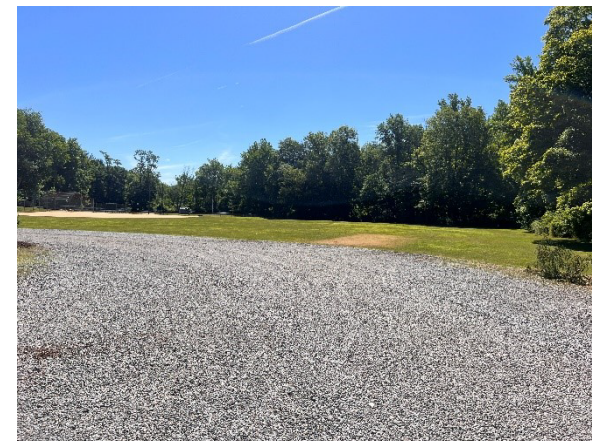
A rain garden can be installed to the north of the building to capture, treat, and infiltrate stormwater runoff from the rooftop. This will require downspout disconnection and redirection. Another rain garden can be installed to the south of the parking lot to capture, treat, and infiltrate stormwater runoff from the driveway and the lot. A cistern can be installed to the west of the building to divert and detain stormwater runoff from the rooftop for later non-potable reuse such as watering the plants around the building. A preliminary soil assessment suggests that more soil testing would be required before determining the soil's suitability for green infrastructure.

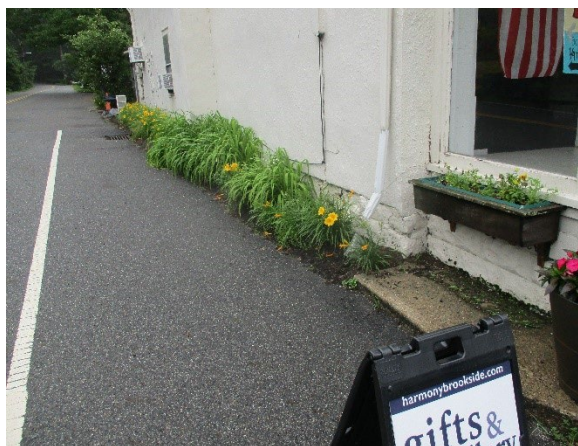
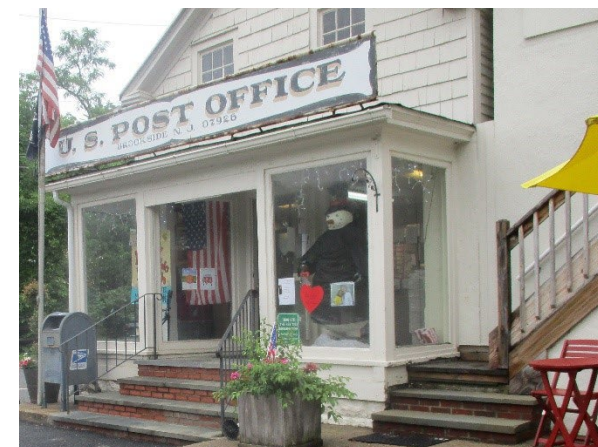
Downspout planter boxes can be installed along the southwest corner of the building to allow roof runoff to be reused and to spread awareness about green infrastructure programs. Along the eastern side of the building a bioretention system can be installed to help capture, treat, and infiltrate stormwater runoff. A preliminary soil assessment suggests that more soil testing would be required before determining the soil's suitability for green infrastructure.

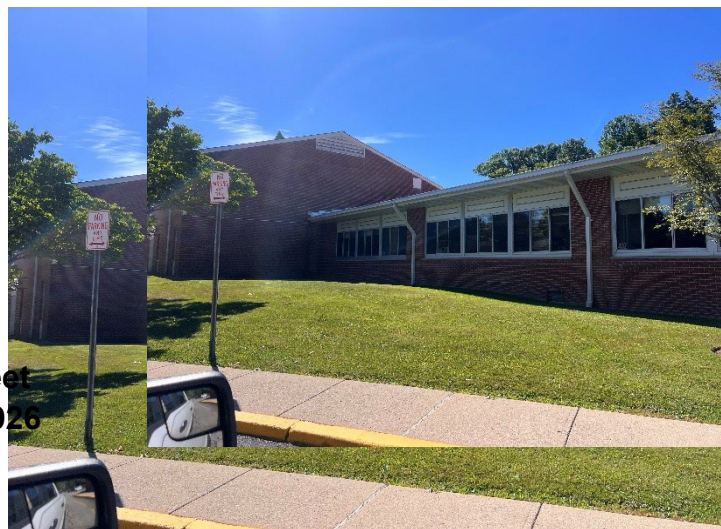
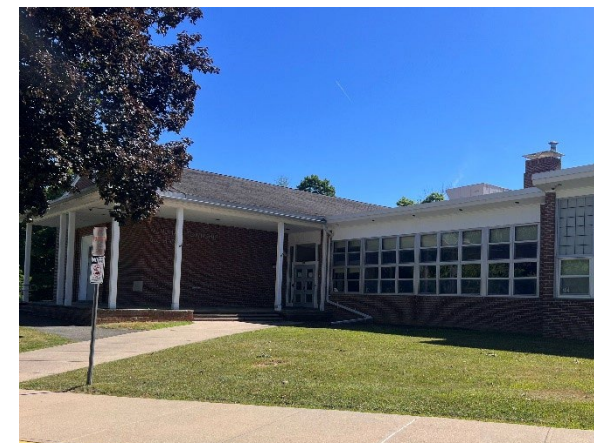
Multiple rain gardens can be installed in the grass areas around the property to capture, treat, and infiltrate stormwater runoff from the rooftops. This may require downspout disconnections, downspout redirections, curb cuts, and a trench drain. The existing parking spaces to west and to the northeast of the building can be converted into pervious pavement to capture and infiltrate the stormwater runoff from the asphalt. A preliminary soil assessment suggests that more soil testing would be required before determining the soil's suitability for green infrastructure.

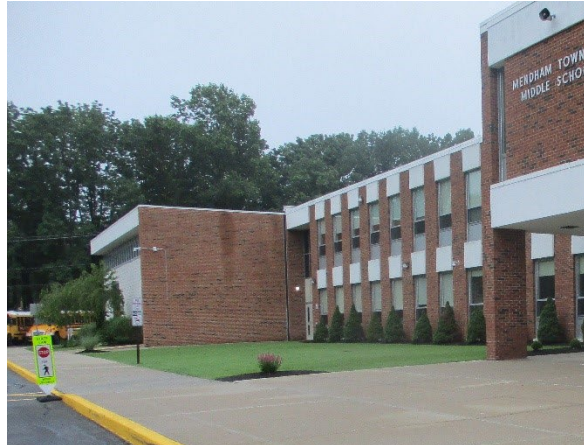
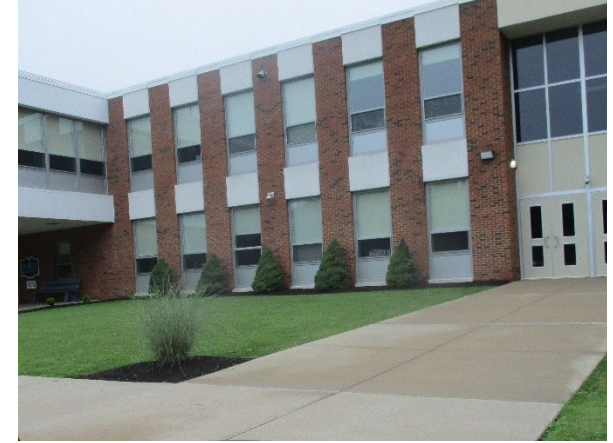
Bioretention systems can be installed on the east side of the building to capture, treat, and infiltrate rooftop runoff. To help with stormwater runoff from the parking lot, the low northeastern section of parking spaces can be converted to pervious pavement to help capture and infiltrate the runoff. A preliminary soil assessment suggests that more soil testing would be required before determining the soil's suitability for green infrastructure.

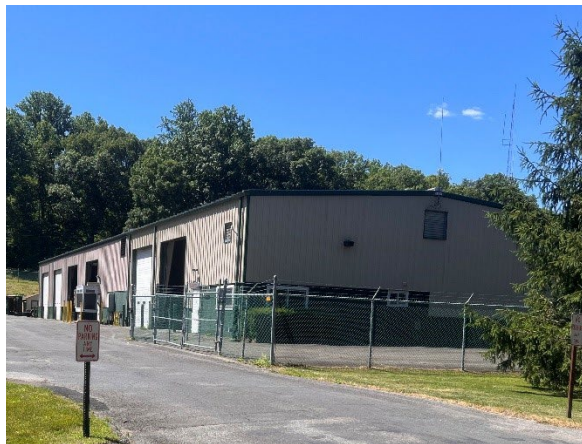
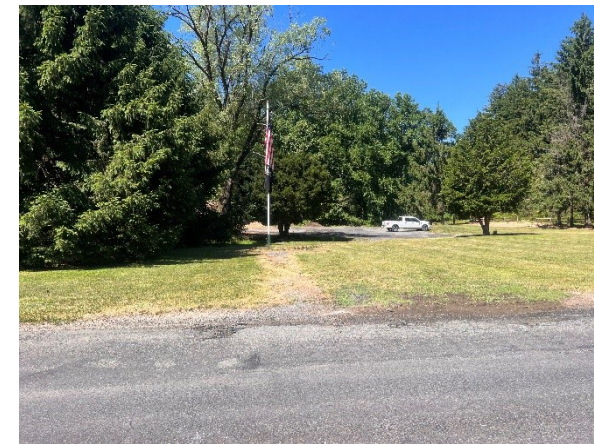
A rain garden can be installed to the west of the entry to capture, treat, and infiltrate stormwater runoff from the asphalt. Another rain garden can be installed to the south of the tennis courts to capture, treat, and infiltrate stormwater runoff from the court and asphalt driveway. This may require trench drains. Cisterns can be installed to the north and south of the building to divert and detain the stormwater runoff from the rooftop for later non-potable reuse such as washing vehicles. A preliminary soil assessment suggests that the soils have suitable drainage characteristics for green infrastructure.

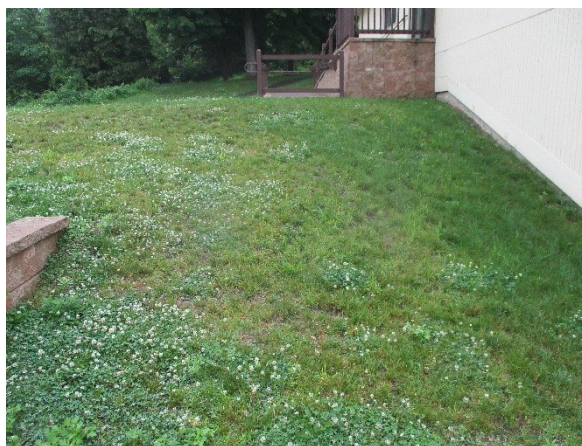
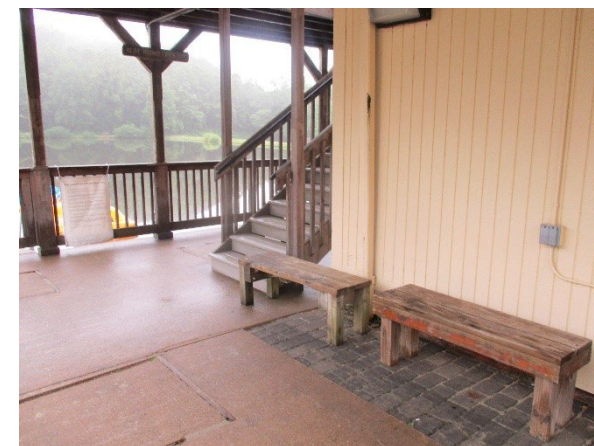
Bioretention systems can be installed in the back of the building to capture, treat, and infiltrate rooftop runoff. Downspout planter boxes can be constructed at the entrance of the building to allow roof runoff to be reused and to spread awareness about green infrastructure programs. A preliminary soil assessment suggests that the soils have suitable drainage characteristics for green infrastructure.
