Peapack-Gladstone Borough

Introduction

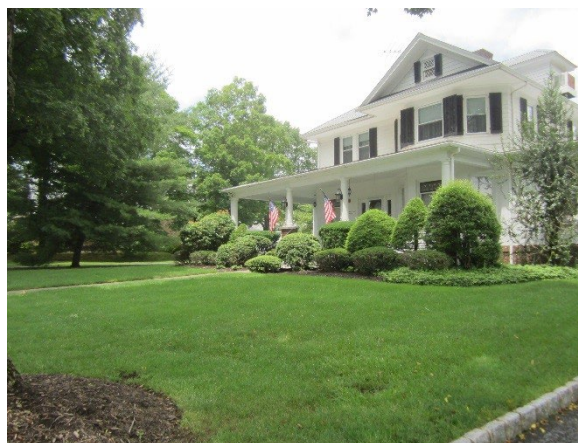
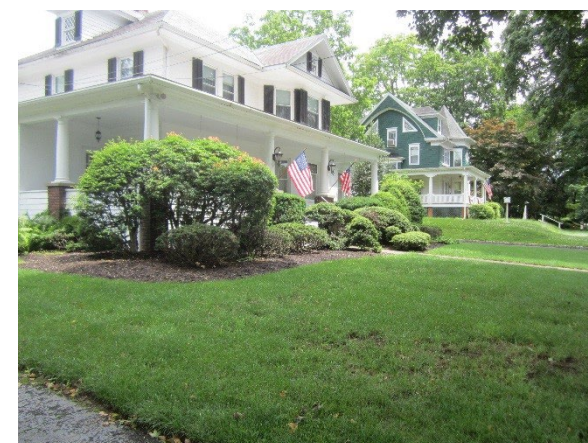
Rain gardens can be installed in front of the building, on either side of the walkway to help capture, treat, and infiltrate rooftop runoff. Pervious pavement can be installed on the northwest side of the home to infiltrate and filter parking lot runoff. A preliminary soil assessment suggests that more soil testing would be required before determining the soil's suitability for green infrastructure.

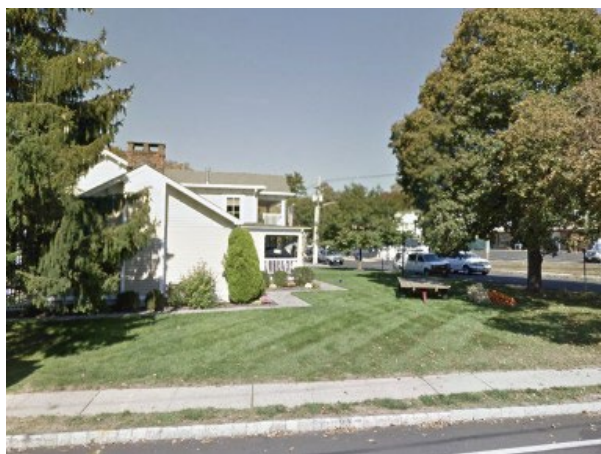
RAP ID: 2

Rain gardens can be installed at the southeast corner of the building to help capture, treat, and infiltrate stormwater runoff from the roof of the building. Pervious pavement can be installed in the parking spaces to the west and to the north of the tavern to infiltrate parking lot runoff. A preliminary soil assessment suggests that more soil testing would be required before determining the soil's suitability for green infrastructure.

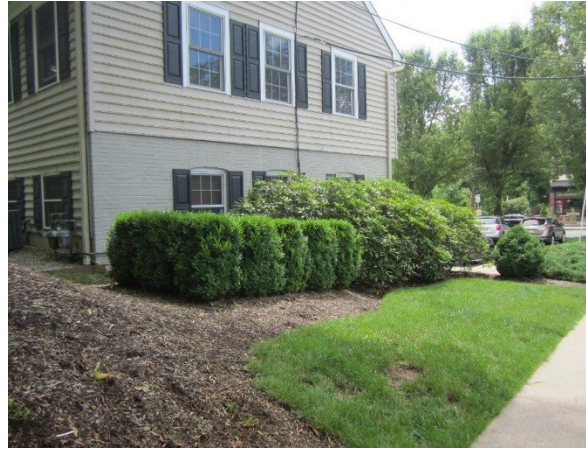
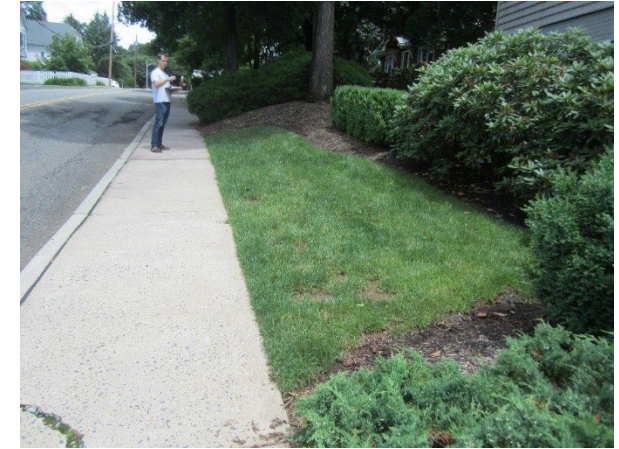
RAP ID: 3

A rain garden can be installed adjacent to the sidewalk and north of the building to capture, treat, and infiltrate stormwater runoff from the roof of the building. Pervious pavement can be installed in the southeastern corner of the parking lot to infiltrate pavement runoff. A preliminary soil assessment suggests that more soil testing would be required before determining the soil's suitability for green infrastructure.

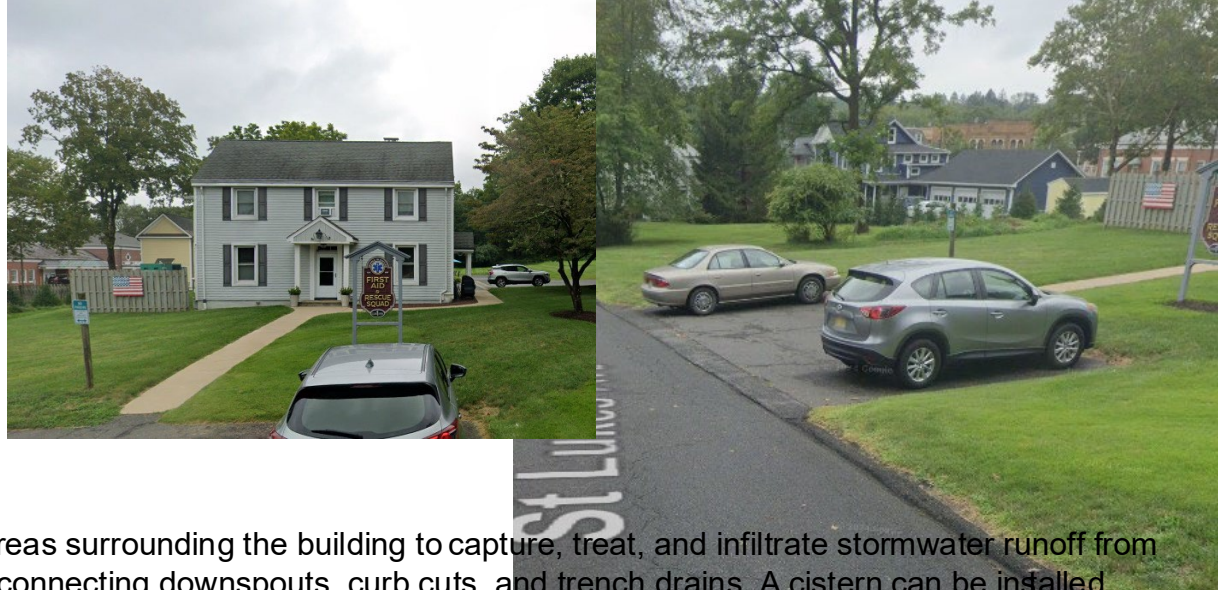
RAP ID: 4

Multiple rain gardens can be installed in the grass areas surrounding the building to capture, treat, and infiltrate stormwater runoff from the rooftop and from the driveway. This requires disconnecting downspouts, curb cuts, and trench drains. A cistern can be installed behind the building to divert and detain the stormwater runoff from the rooftop for later non-potable reuse such as watering a garden bed or washing vehicles. A preliminary soil assessment suggests that more soil testing would be required before determining the soil's suitability for green infrastructure.

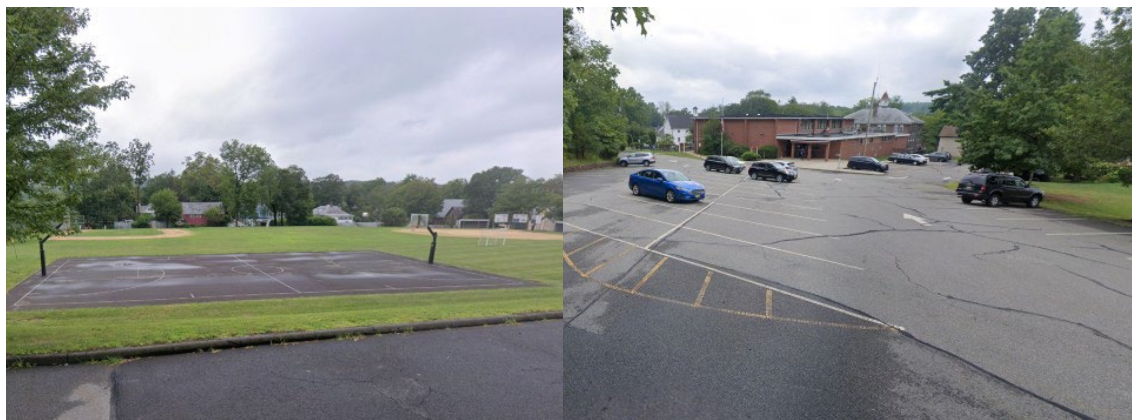
RAP ID: 5

Rain gardens can be installed near the southern end of the building and next to the basketball court to capture, treat, and infiltrate the stormwater runoff from the rooftop and court. This will require disconnecting downspouts, redirecting downspouts under sidewalks, curb cuts, and a trench drain. Existing parking spaces in the parking lot can be converted into pervious pavement to capture and infiltrate the stormwater runoff from the asphalt. A trench drain may be needed. A cistern can be installed to the west of the building to divert and detain the stormwater runoff from the rooftop for later non-potable reuse such as watering a garden bed or washing vehicles. A preliminary soil assessment suggests that more soil testing would be required before determining the soil's suitability for green infrastructure.

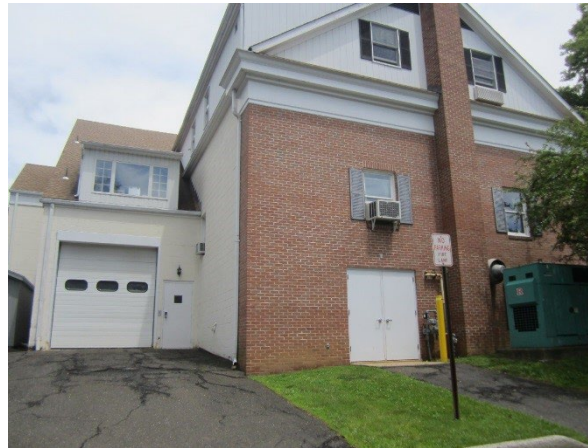
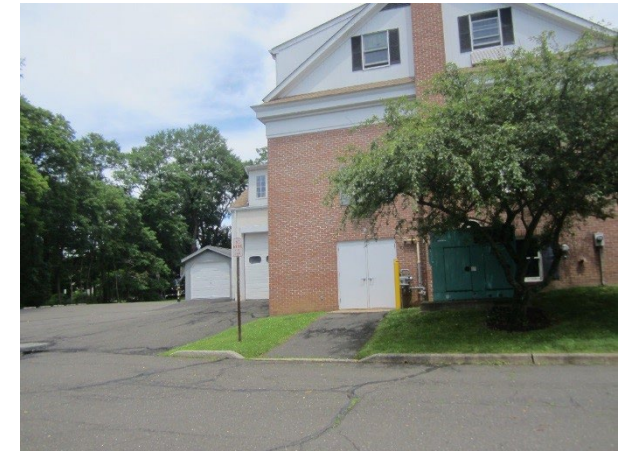
RAP ID: 6

Cisterns can be installed at the southwest, west, and northeast corners of the building to capture and allow non-potable reuse of stormwater. Pervious pavement can be installed in the parking spaces southwest of the building to infiltrate parking lot runoff. A preliminary soil assessment suggests that more soil testing would be required before determining the soil's suitability for green infrastructure.

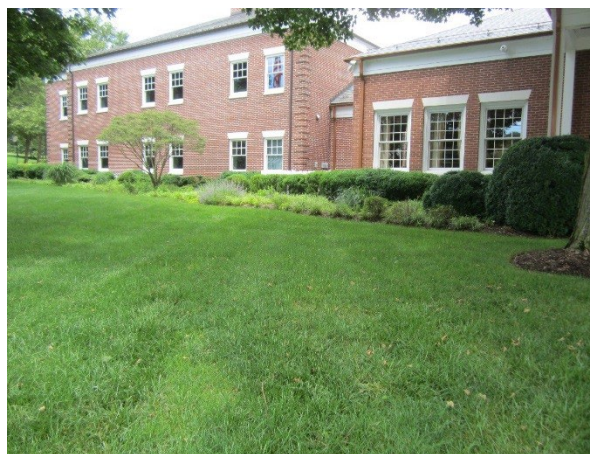
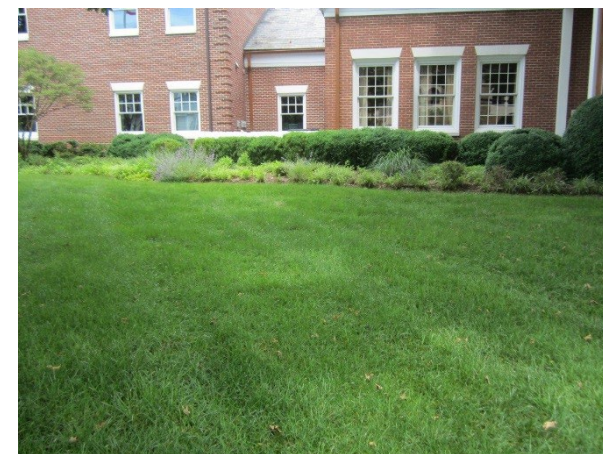
RAP ID: 7

Rain gardens can be installed at the northwest corner and in front of the bank to capture, treat, and infiltrate rooftop runoff. Pervious pavement can be installed in the parking spaces behind the building to infiltrate and filter parking lot runoff. A preliminary soil assessment suggests that more soil testing would be required before determining the soil's suitability for green infrastructure.

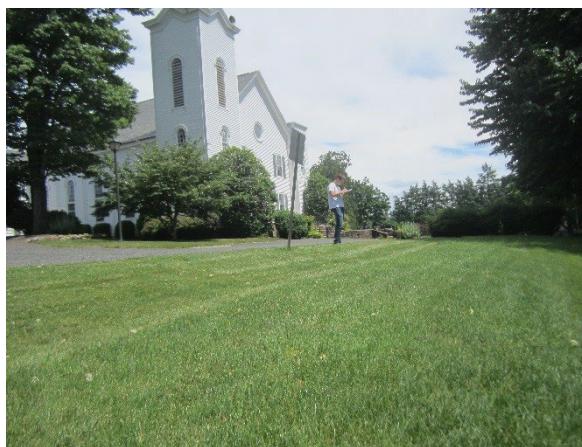
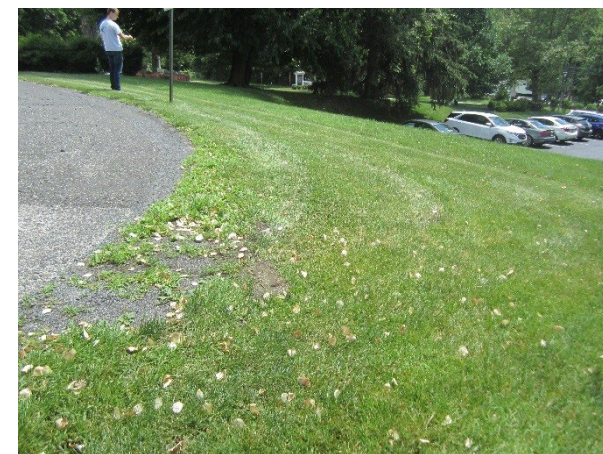
RAP ID: 8

A rain garden can be installed at the edge of the parking lot to the southwest of the church to capture, treat, and infiltrate parking lot runoff. Pervious pavement can be installed in the parking spaces south of the church to infiltrate parking lot runoff. A preliminary soil assessment suggests that more soil testing would be required before determining the soil's suitability for green infrastructure.

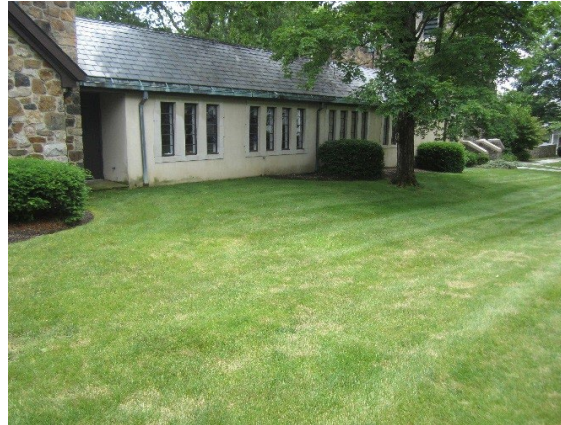
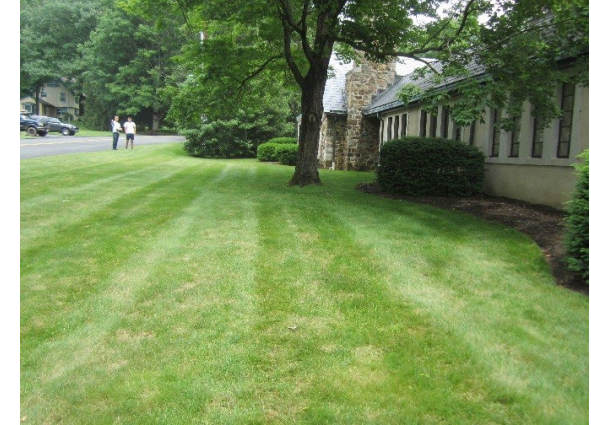
RAP ID: 9

A rain garden can be installed north of the church to capture, treat, and infiltrate rooftop runoff. Downspout planter boxes can be installed by the main entrance to capture and filter stormwater. Pervious pavement can be installed in the parking spaces to the northeast of the church to filter and infiltrate stormwater. A preliminary soil assessment suggests that more soil testing would be required before determining the soil's suitability for green infrastructure.

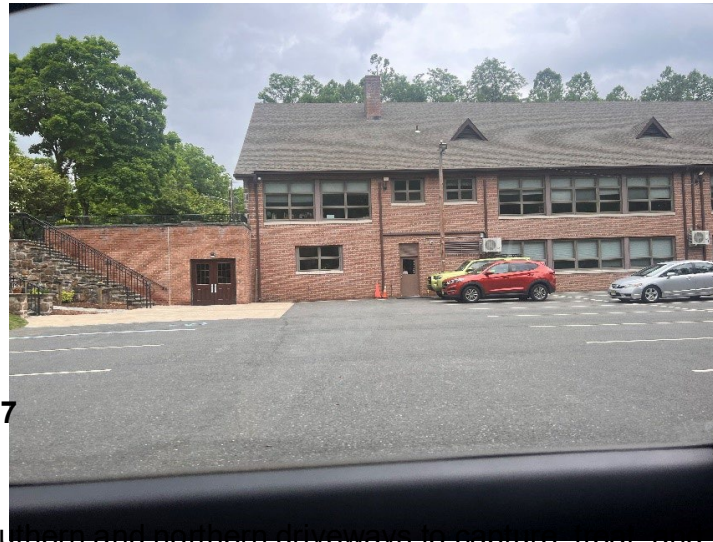
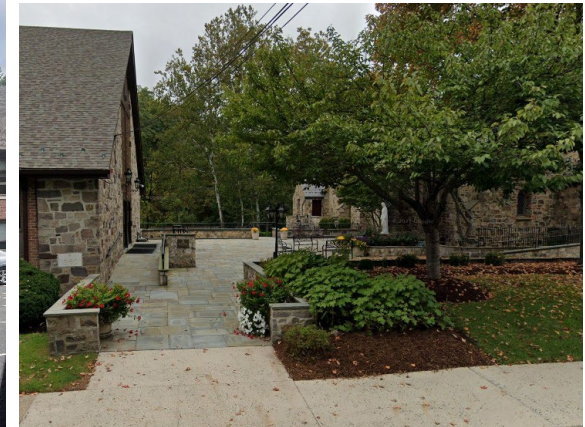
RAP ID: 10

Rain gardens can be installed near the southern and northern driveways to capture, treat, and infiltrate the stormwater runoff from the asphalt. A trench drain and curb cuts may be required. The existing parking spaces in the center of the parking lot can be converted into pervious pavement to capture and infiltrate the stormwater runoff from the asphalt. The stone in the courtyard can be replaced with porous pavers to infiltrate stormwater runoff from the courtyard. A cistern can be installed to the south of the building to divert and detain the stormwater runoff from the rooftop for later non-potable reuse such as watering a garden bed or washing a vehicle. A preliminary soil assessment suggests that more soil testing would be required before determining the soil's suitability for green infrastructure.

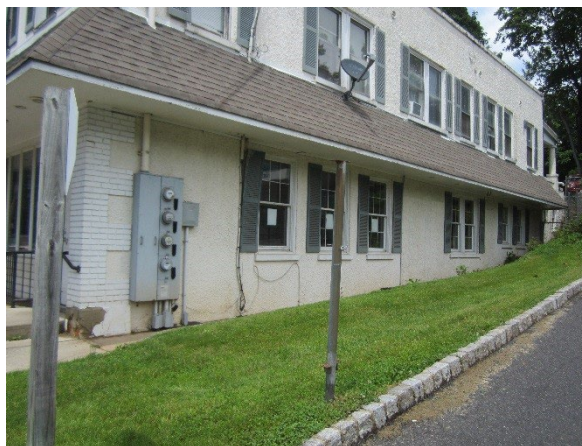
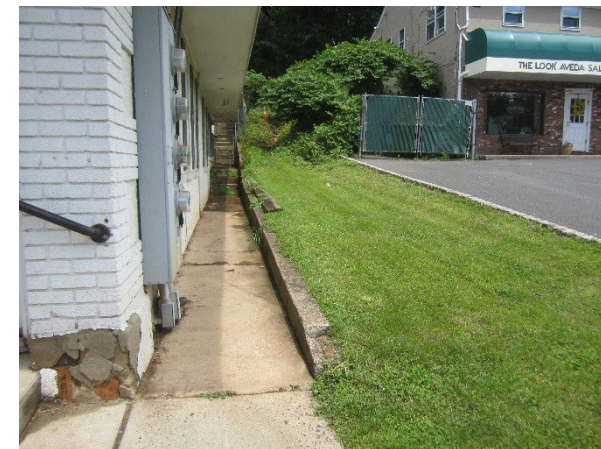
RAP ID: 11

A rain garden can be installed between the post office and the parking lot to capture, treat, and infiltrate rooftop runoff since no gutters are installed. A preliminary soil assessment suggests that more soil testing would be required before determining the soil's suitability for green infrastructure.

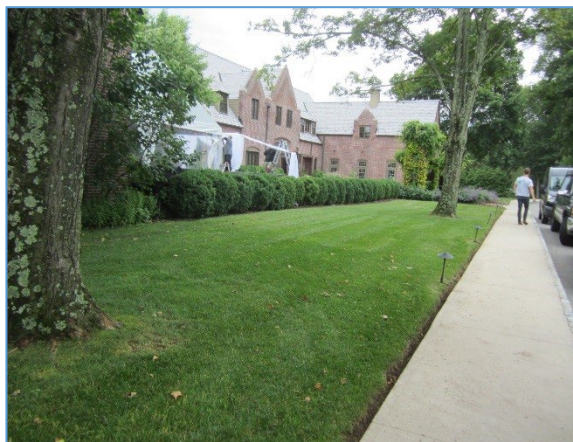
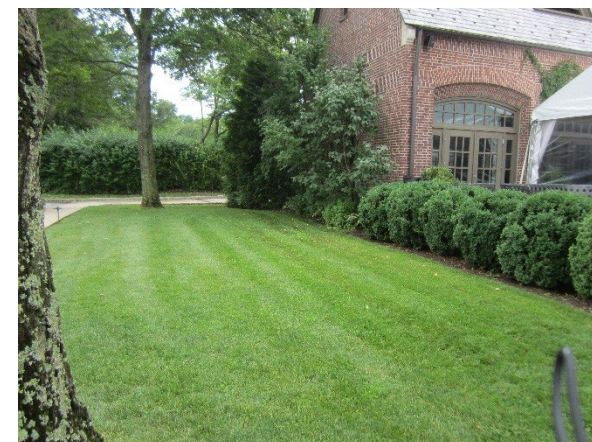
RAP ID: 12

Rain gardens can be installed between the existing landscaped area and the sidewalk to capture, treat, and infiltrate stormwater runoff from the roof of the building. Downspout planter boxes can be installed on the eastern side of the building to capture and filter stormwater. A preliminary soil assessment suggests that the soils have suitable drainage characteristics for green infrastructure.

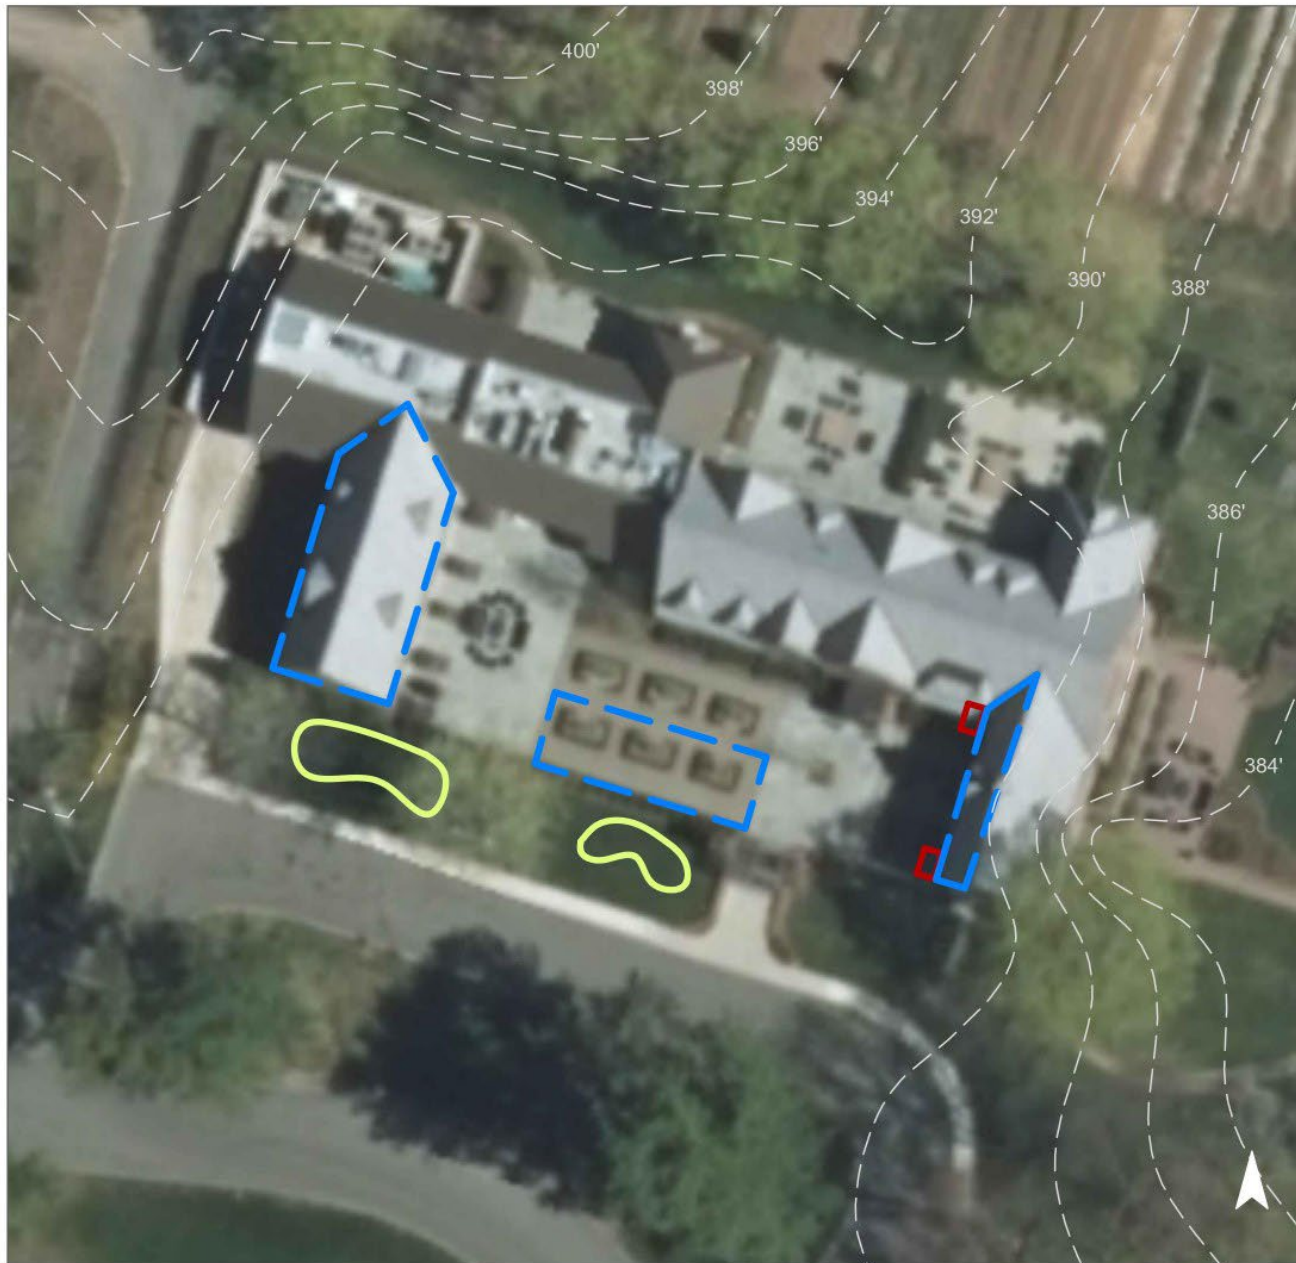
The Cooking School at Natirar

Recommended Green Infrastructure Practices	Recharge Potential (Mgal/yr)	TSS Removal Potential (lbs/yr)	Maximum Volume Reduction Potential (gal/storm)	Peak Discharge Reduction Potential (cu. ft./second)	Estimated Size (sq. ft.)	Estimated Cost
Bioretention system	0.062	10	4,550	0.17	595	\$2,975
Planter boxes	n/a	1	n/a	n/a	2 (boxes)	\$2,000

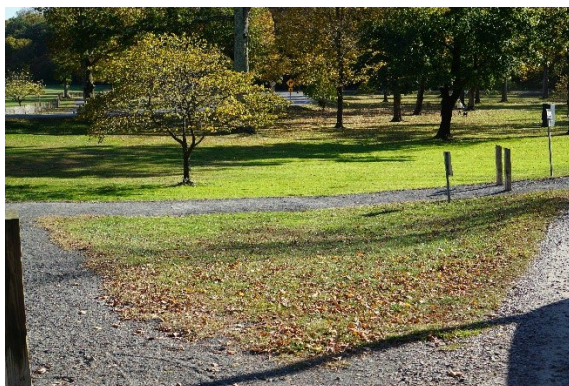
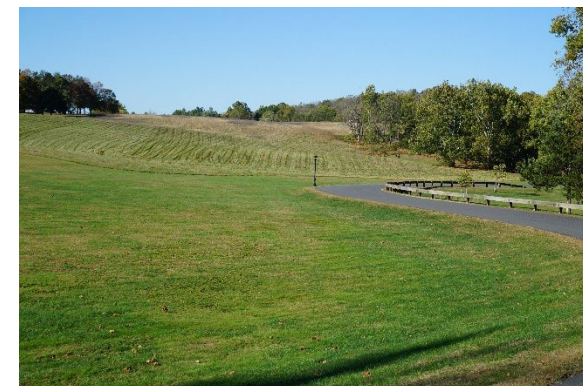
RAP ID: 13

Several rain gardens can be installed in multiple locations around the parking lots and driveways to capture stormwater runoff from those areas. A preliminary soil assessment suggests that the soils have suitable drainage characteristics for green infrastructure.

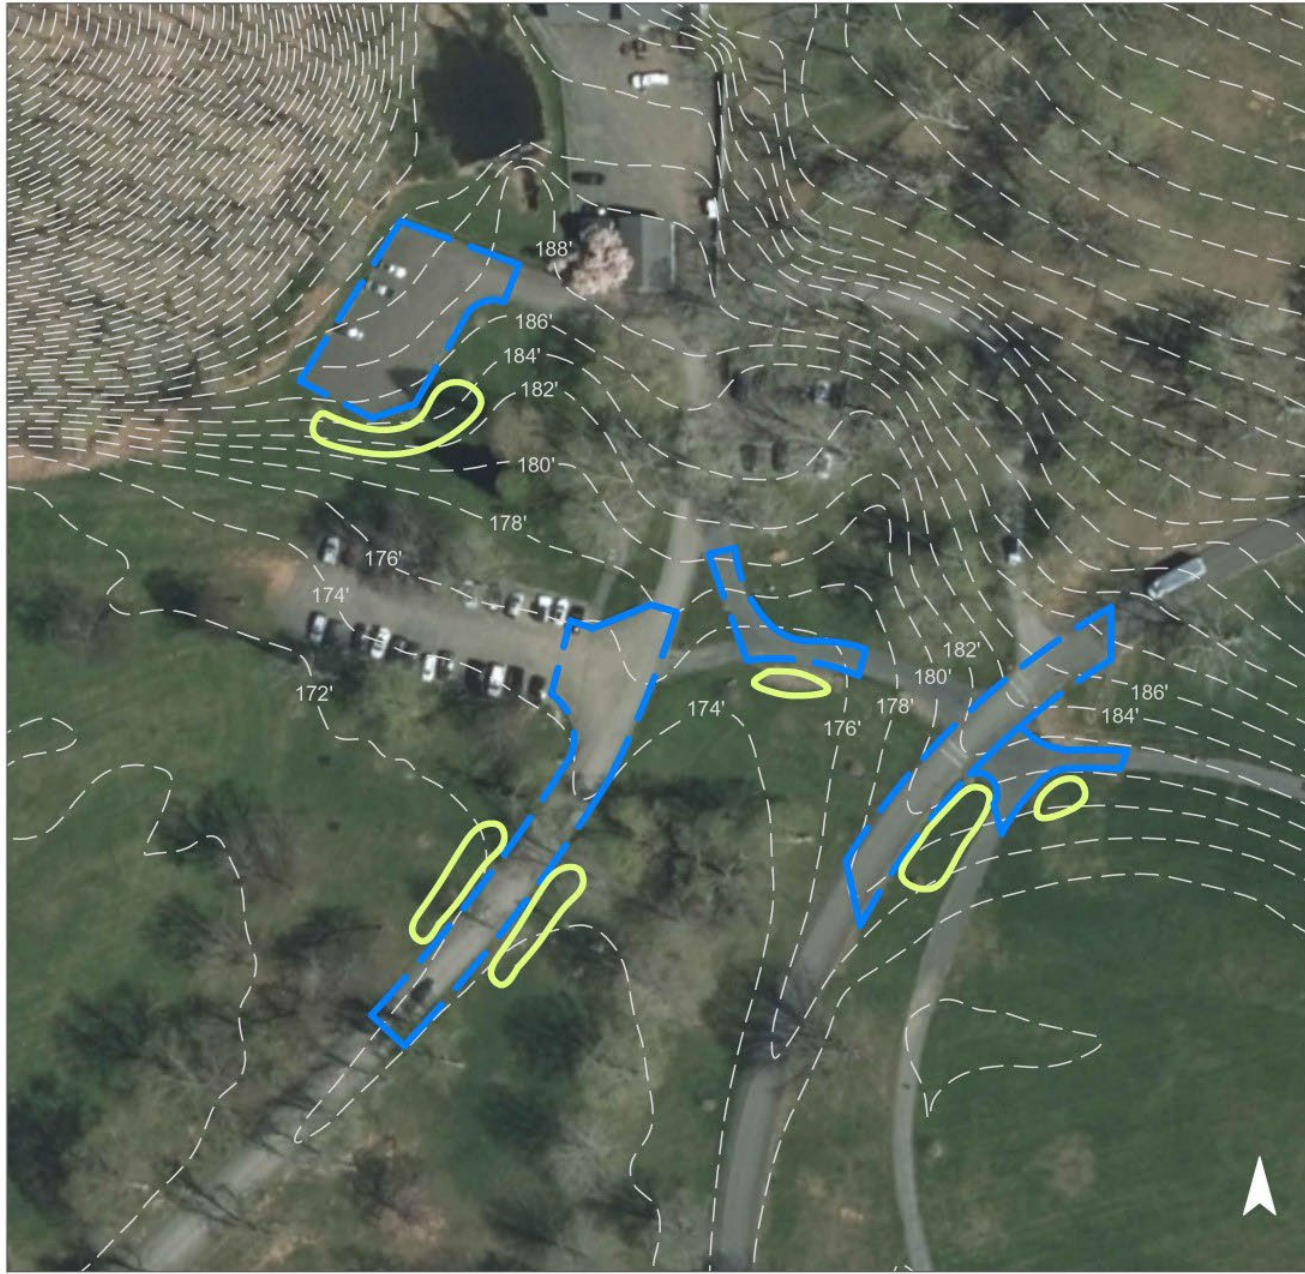
Natirar Park

Recommended Green Infrastructure Practices	Recharge Potential (Mgal/yr)	TSS Removal Potential (lbs/yr)	Maximum Volume Reduction Potential (gal/storm)	Peak Discharge Reduction Potential (cu. ft./second)	Estimated Size (sq. ft.)	Estimated Cost
Bioretention systems	0.612	106	44,920	1.69	5,880	\$29,400

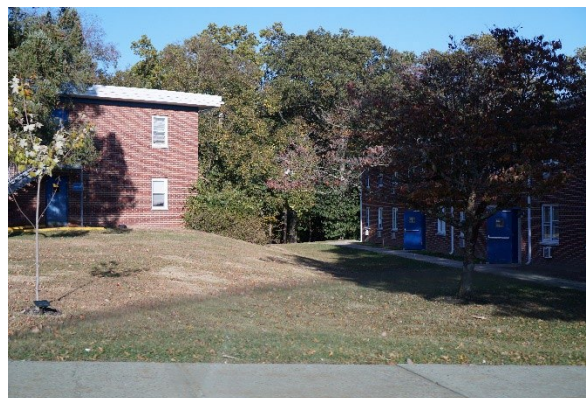
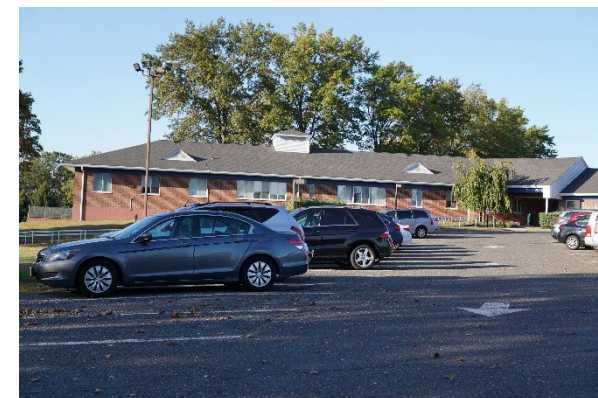
Rain gardens can be installed along the outer perimeter of the property, adjacent to the driveways and parking spaces, to capture, treat, and infiltrate stormwater runoff. A preliminary soil assessment suggests that the soils have suitable drainage characteristics for green infrastructure.
