## Randolph Township

### Introduction

The purpose of this report is to provide a comprehensive understanding of key, defining features within the subwatersheds throughout Randolph Township. This involves gathering, organizing, and presenting information about existing conditions and infrastructure within each subwatershed. It aims to serve as a tool for informed decision-making, planning, and implementation of sustainable watershed management strategies aimed to protect and enhance the health of the watershed, its associated ecosystems, and the surrounding communities.

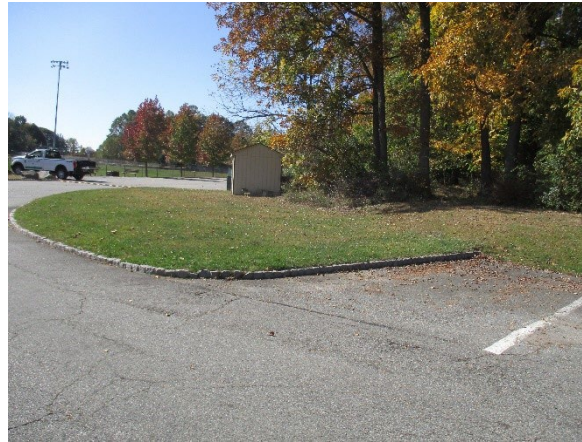
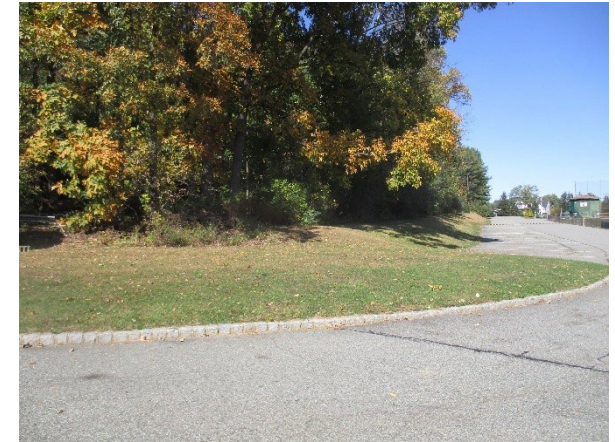
A bioretention system can be installed in the parking lot bump out to treat the parking lot drainage area. Pervious pavement can be installed in the east and west strips of the parking lot to manage additional runoff from the parking lot. A preliminary soil assessment suggests that the soils have suitable drainage characteristics for green infrastructure.

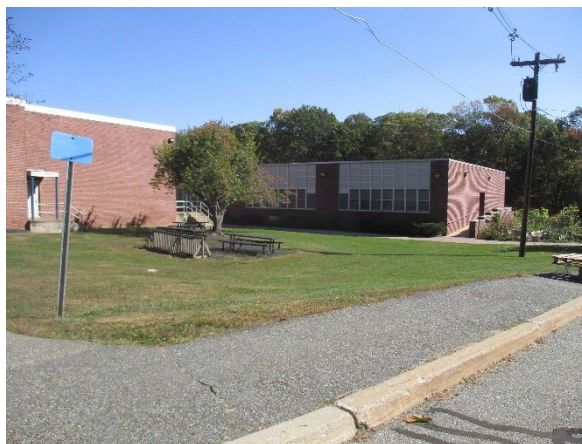
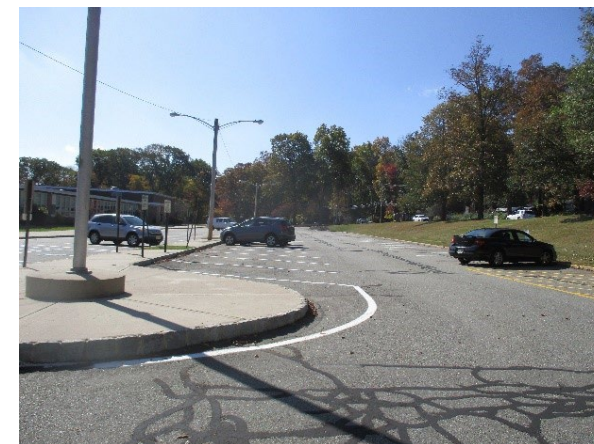
A bioretention system can be created at the south end the building to capture, treat, and infiltrate the building's stormwater runoff. Pervious pavement can be installed in a strip of parking spaces to treat runoff from the parking lot. A preliminary soil assessment suggests that more soil testing would be required before determining the soil's suitability for green infrastructure.

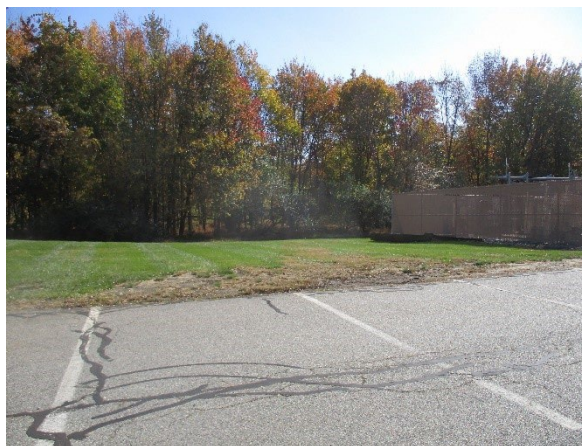
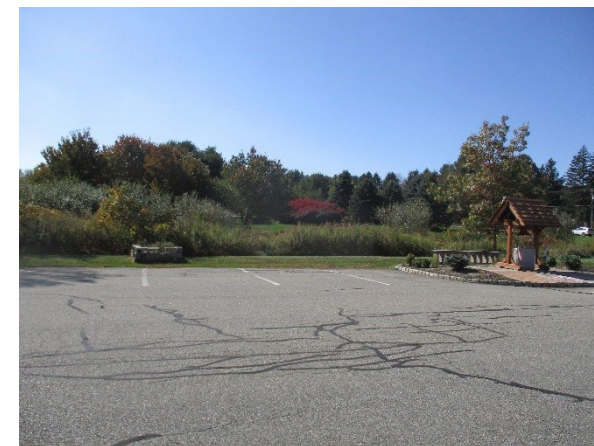
A bioretention system can be installed in the east and south turfgrass areas to capture, treat, and infiltrate the runoff from the parking area. Additionally, a cistern can be installed on the northeast corner of the building to capture the rooftop drainage area that can be reused to wash the fire trucks and water the existing landscaping. A preliminary soil assessment suggests that the soils have suitable drainage characteristics for green infrastructure.

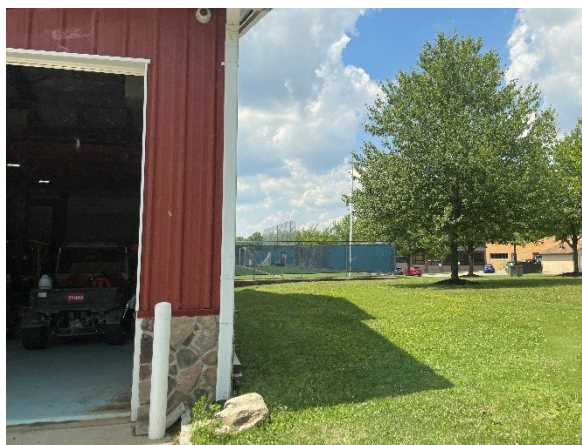
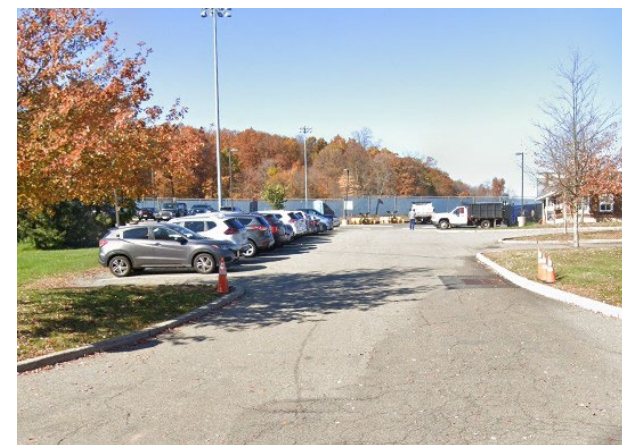
A rain garden can be installed to the northeast of the garage to capture, treat, and infiltrate the stormwater runoff from the rooftop. This will require disconnecting downspouts. The existing parking spaces to the west of the entry driveway and in the western lot can be converted into pervious pavement to capture and infiltrate the stormwater runoff from the asphalt. A preliminary soil assessment suggests that the soils have suitable drainage characteristics for green infrastructure.

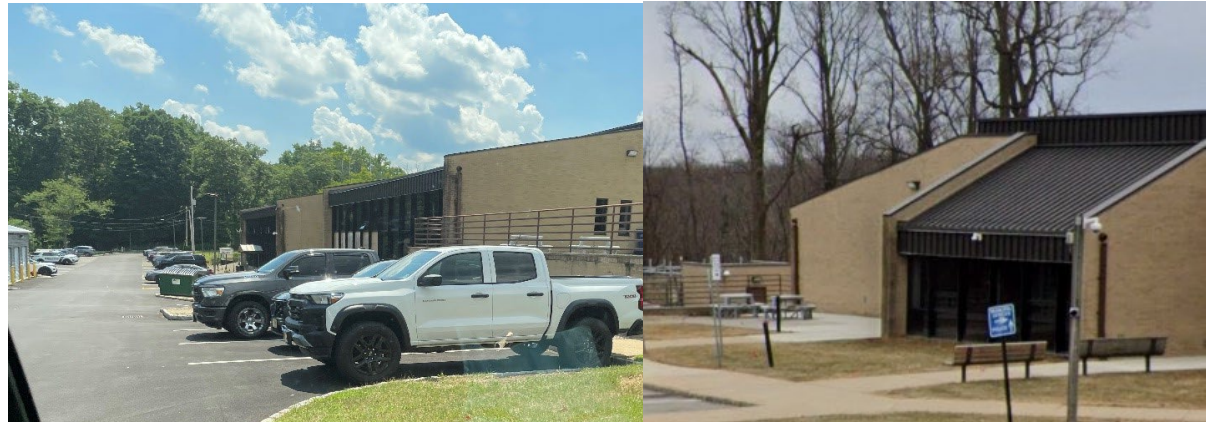
A rain garden can be installed to the northeast corner of the building to capture, treat, and infiltrate the stormwater runoff from the rooftop. This will require downspout disconnection and redirection. The concrete entry walkway to the southwest of the building can be replaced with permeable pavers. Existing parking spaces in the southeastern and southwestern lots can be converted into pervious pavement to capture and infiltrate stormwater runoff from the asphalt. The pervious pavement to the southeast will require a trench drain to intercept and redirect runoff. The downspouts on the southwest of the adjacent shed can be disconnected to the porous pavement to manage runoff from the rooftop. A cistern can be installed to the north of the shed to divert and detain the stormwater runoff from the rooftop for later non-potable reuse such as washing township vehicles. A preliminary soil assessment suggests that the soils have suitable drainage characteristics for green infrastructure.

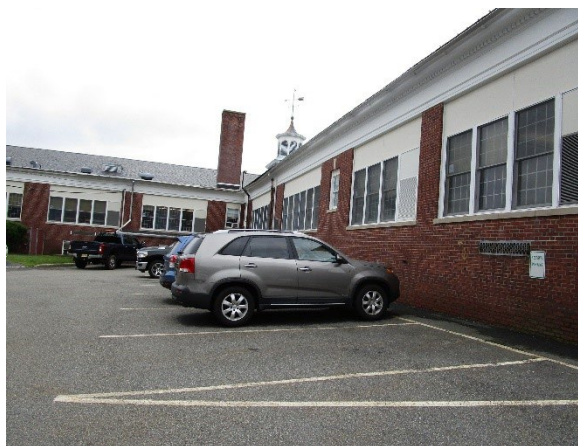
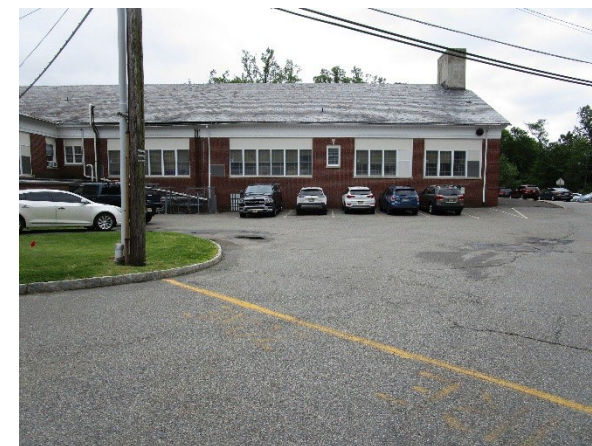
Pervious pavement can be installed in parking spaces throughout the site to capture and infiltrate stormwater runoff from the parking lot and adjacent rooftops. A rain garden can be installed in the area to the south of the building to capture additional stormwater from the rooftop by redirecting downspouts into it. A preliminary soil assessment suggests that the soils have suitable drainage characteristics for green infrastructure.

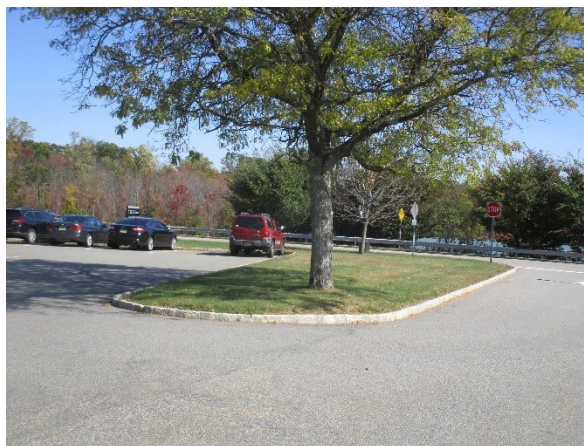
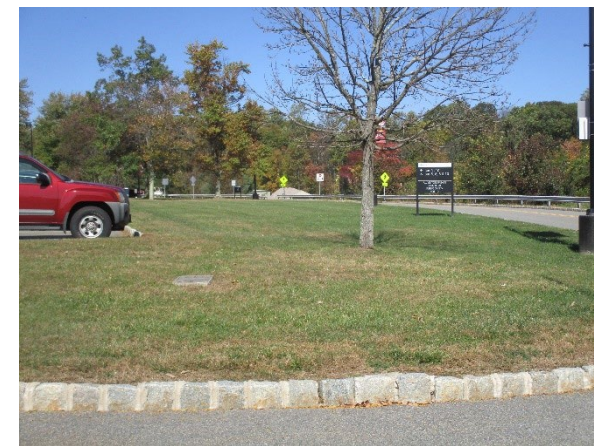
A bioretention system can be installed at the east end of the parking lot adjacent to Henderson Hall to treat the parking lot's drainage area. Pervious pavement can be installed in parking spaces throughout the campus to manage the large amount of stormwater runoff generated by the parking lot areas. A preliminary soil assessment suggests that more soil testing would be required before determining the soil's suitability for green infrastructure.

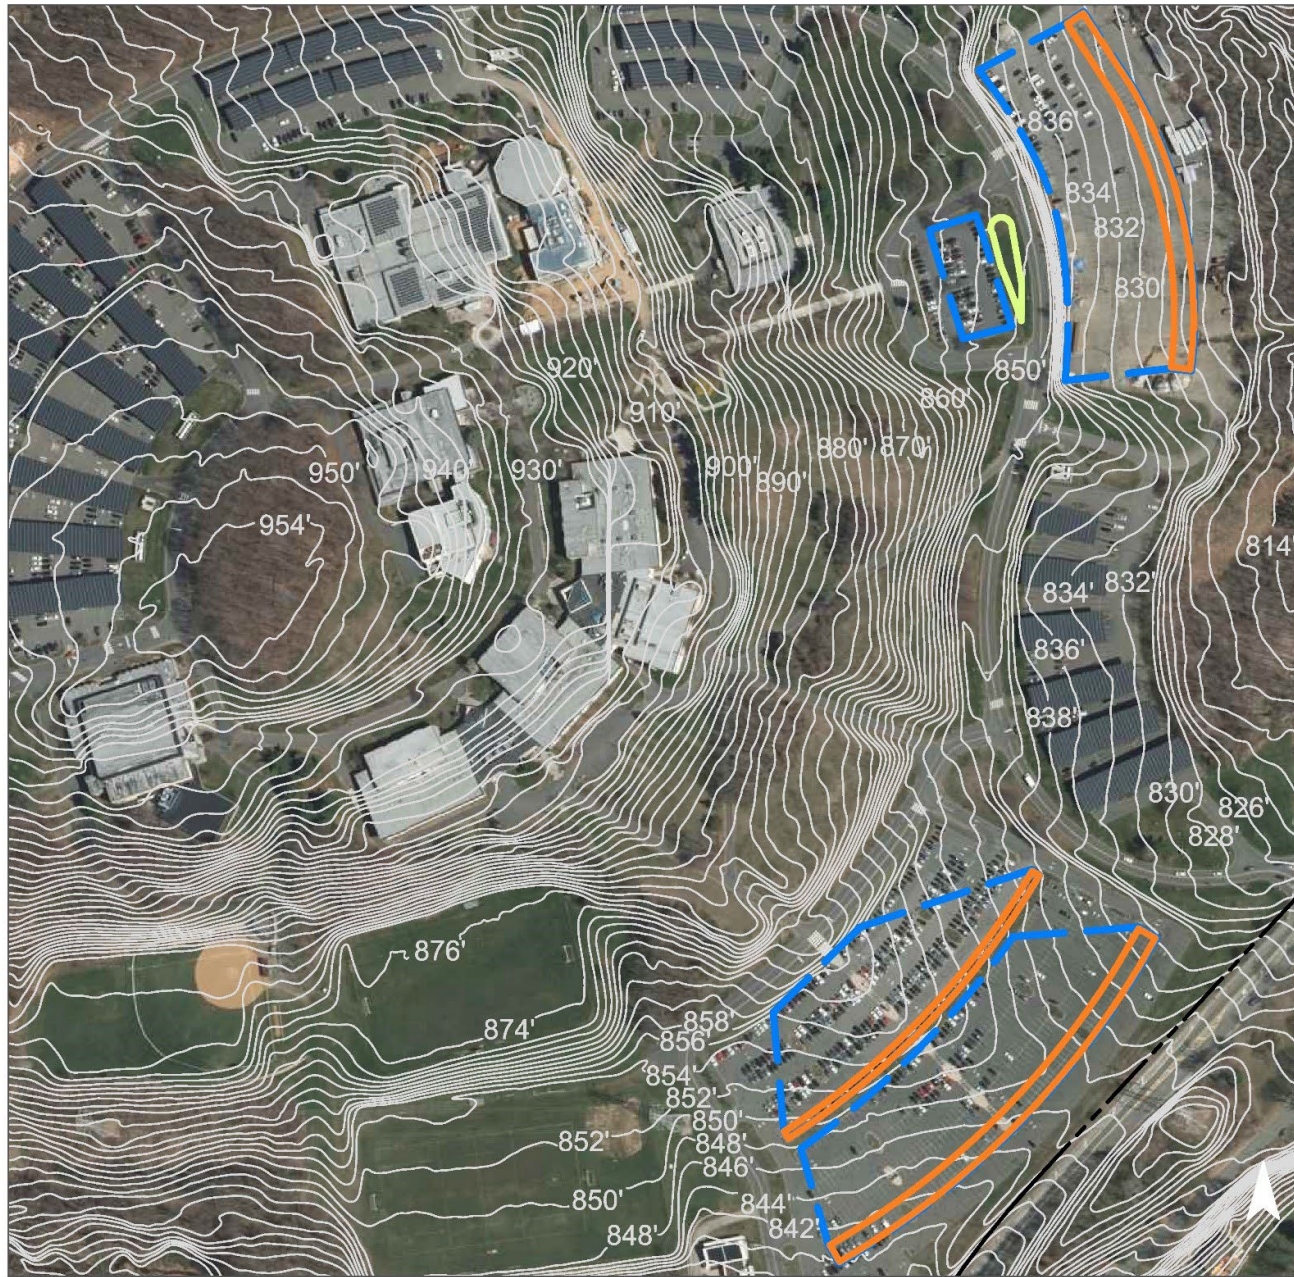
## County College of Morris

- bioretention system
- pervious pavement
- drainage area
- property line
- 2015 Aerial: NJOIT, OGIS

Existing parking spaces to the north and southwest of the building can be converted into pervious pavement to capture and infiltrate the stormwater runoff from the asphalt. The pervious pavement to the north of the building will also manage rooftop runoff. A trench drain will be needed to intercept and redirect the water to the southwestern pervious pavement. A preliminary soil assessment suggests that the soils have suitable drainage characteristics for green infrastructure.

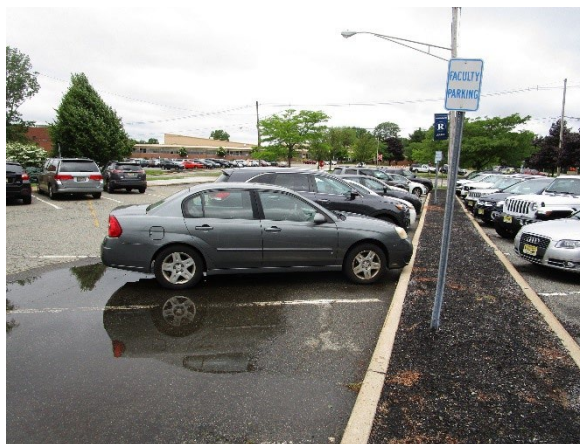
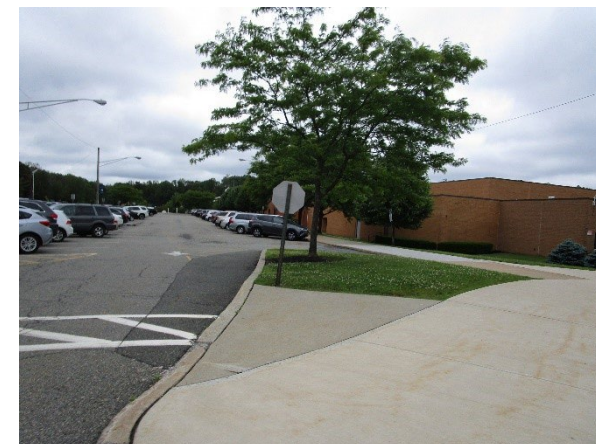
Parking spaces in the parking lot to the southeast of the building can be converted to pervious pavement to capture and infiltrate stormwater runoff from the parking lot. Additional parking spaces throughout the site could be retrofitted as well. A small bioretention system can be installed adjacent to the shed to manage the rooftop runoff. A preliminary soil assessment suggests that the soils have suitable drainage characteristics for green infrastructure.

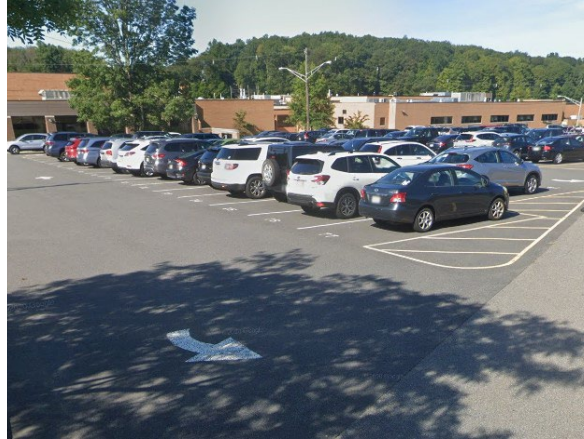
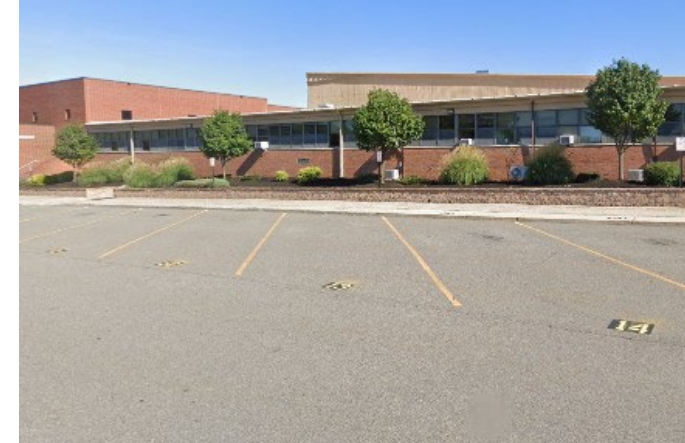
The existing parking spaces to the south of the school can be converted into pervious pavement to capture and infiltrate the stormwater runoff from the asphalt. Trench drains will be required. The downspouts on the southern side of the building can also be disconnected to the pervious pavement to manage rooftop runoff. A preliminary soil assessment suggests that more soil testing would be required before determining the soil's suitability for green infrastructure.

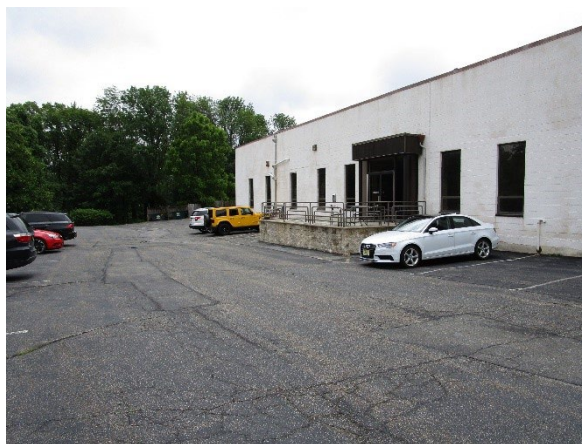
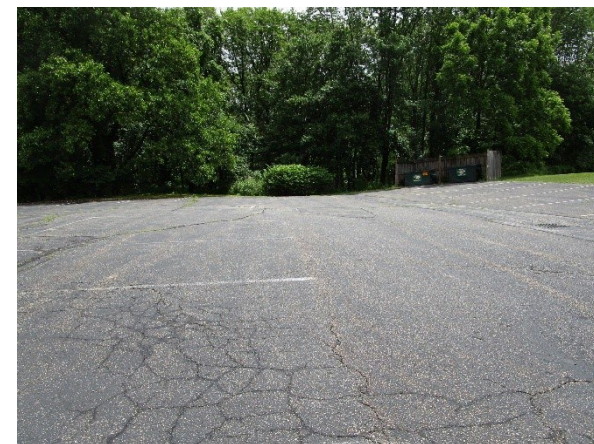
Pervious pavement can be installed in the northeast portion of the parking lot to capture and infiltrate stormwater runoff from the parking area. A preliminary soil assessment suggests that the soils have suitable drainage characteristics for green infrastructure.

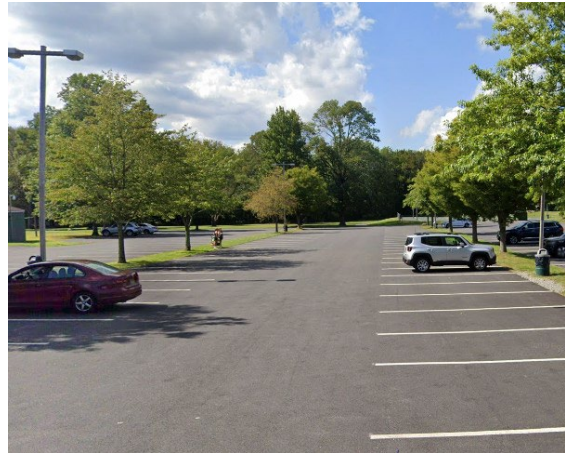
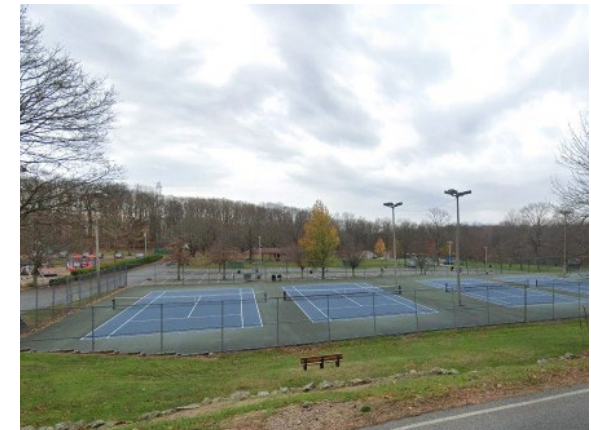
Rain gardens can be installed in multiple grass areas around the property to capture, treat, and infiltrate stormwater runoff from the rooftops of the park buildings. This may require downspout redirections and disconnections. A gutter system will need to be installed on the pavilion for the northern rain garden. Existing parking spaces in the northern lot can be converted into pervious pavement to capture and infiltrate the stormwater runoff from the asphalt. The tennis and basketball courts can be converted into pervious pavement to capture and infiltrate the stormwater runoff from the courts. A cistern can be installed to the northeast of the southern park building to divert and detain the stormwater runoff from the rooftop for later non-potable reuse such as washing vehicles. A preliminary soil assessment suggests that the soils have suitable drainage characteristics for green infrastructure.

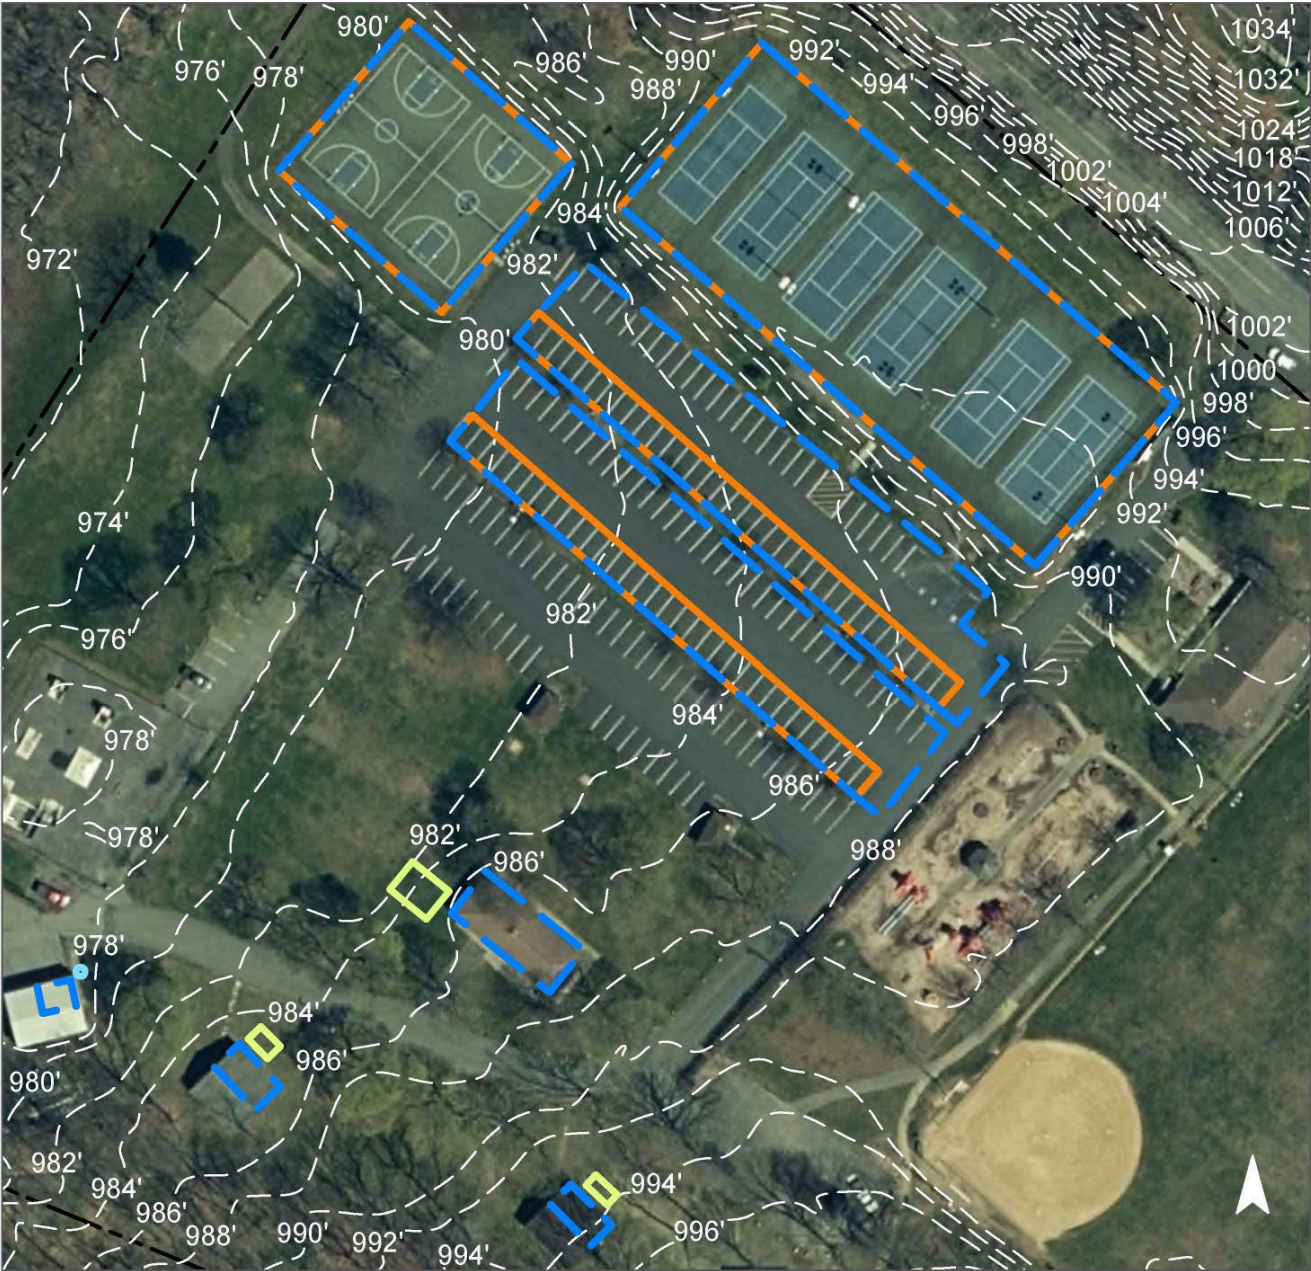
## Brundage Park

- bioretention system
- pervious pavement
- rainwater harvesting
- captured drainage area
- property line
- 2020 Aerial: NJOIT, OGIS

Bioretention systems can be installed near the park buildings to manage their rooftop areas. The existing swales in the center of the parking lot can be retrofitted with bioswales to enhance infiltration and slow down the stormwater runoff from the parking lot area. Pervious pavement can be installed in the northwest corner of the parking lot to capture additional stormwater runoff. A preliminary soil assessment suggests that more soil testing would be required before determining the soil's suitability for green infrastructure.

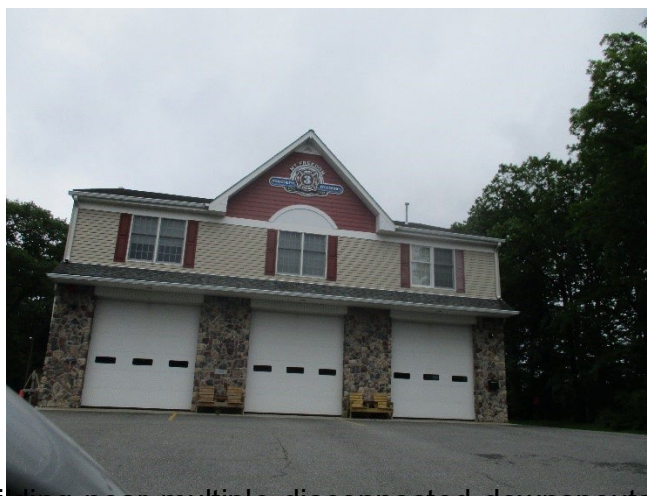
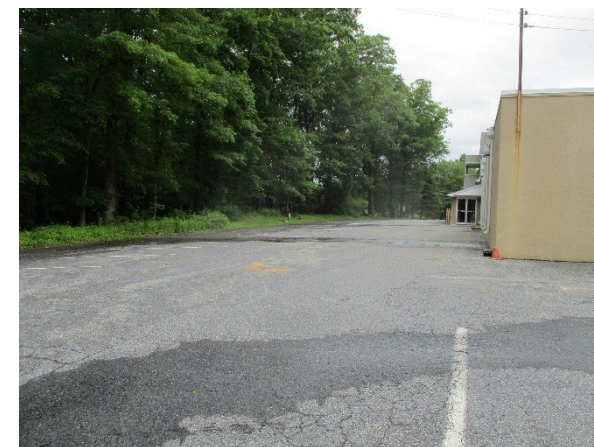
Parking spaces along the south end of the building near multiple disconnected downspouts can be converted to pervious pavement to capture and infiltrate stormwater runoff from the parking lot and rooftop areas. A cistern can be installed on the north side of the building near a disconnected downspout to capture rainwater that can be used for watering gardens, washing vehicles, or for other non-potable uses. A preliminary soil assessment suggests that the soils have suitable drainage characteristics for green infrastructure.

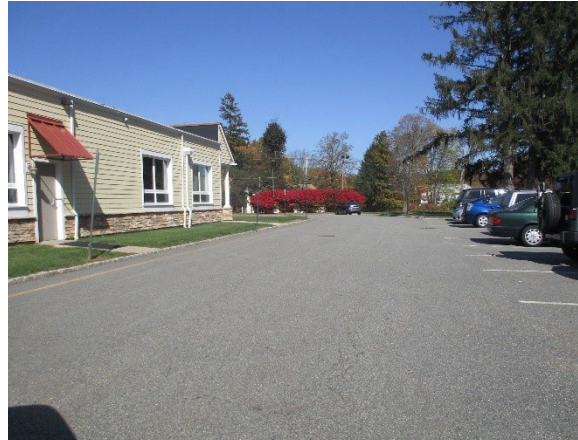
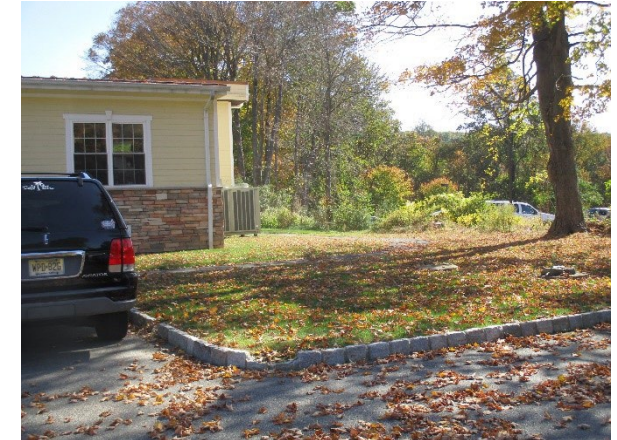
Five downspout planter boxes can be installed on the north end of the library to filter the rooftop drainage area and beautify the area. Pervious pavement can be installed in the parking areas to capture and infiltrate stormwater runoff from the parking lot. Bioretention systems can be installed to manage areas from the rooftop by redirecting downspouts and from the parking lot by creating curb cuts. A preliminary soil assessment suggests that the soils have suitable drainage characteristics for green infrastructure.

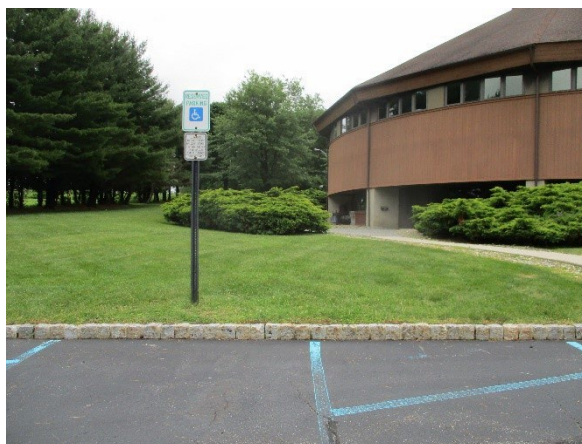
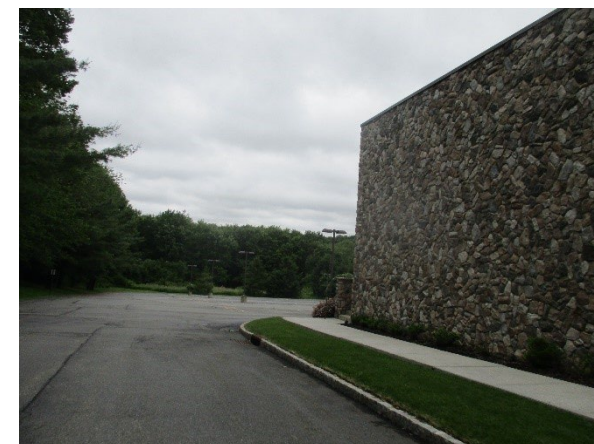
A rain garden can be installed on the north side of the building near the connected downspouts. The connected downspouts can be disconnected and led into the rain garden to capture, treat, and infiltrate stormwater runoff from the roof. The parking spaces in the parking lot can be retrofitted into pervious pavement to capture a large volume of stormwater running off from the parking lot during storm events. A preliminary soil assessment suggests that the soils have suitable drainage characteristics for green infrastructure.

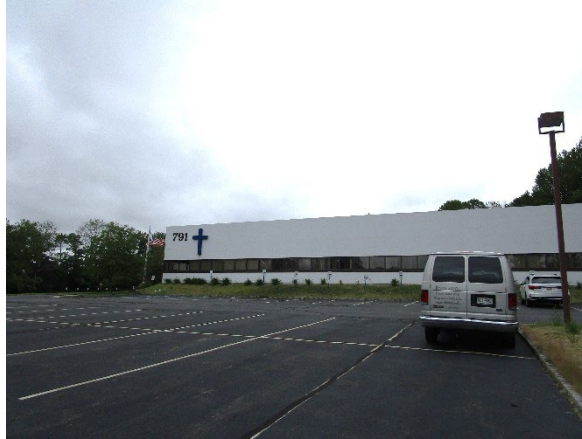
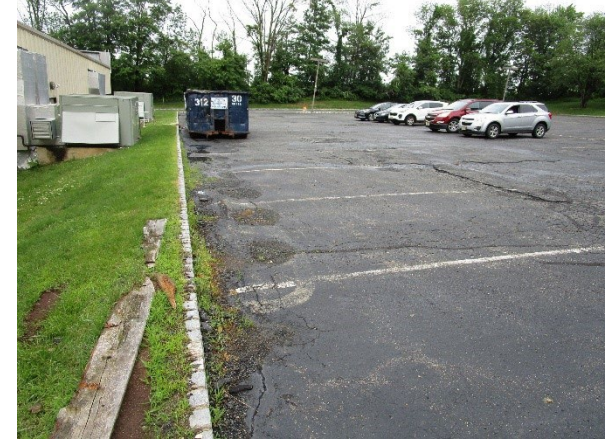
Pervious pavement can be installed in both parking lots to capture and infiltrate stormwater runoff from the parking lot. Bioretention systems can be installed in the turfgrass areas by using curb cuts to direct water from the pavement into them. A preliminary soil assessment suggests that more soil testing would be required before determining the soil's suitability for green infrastructure.

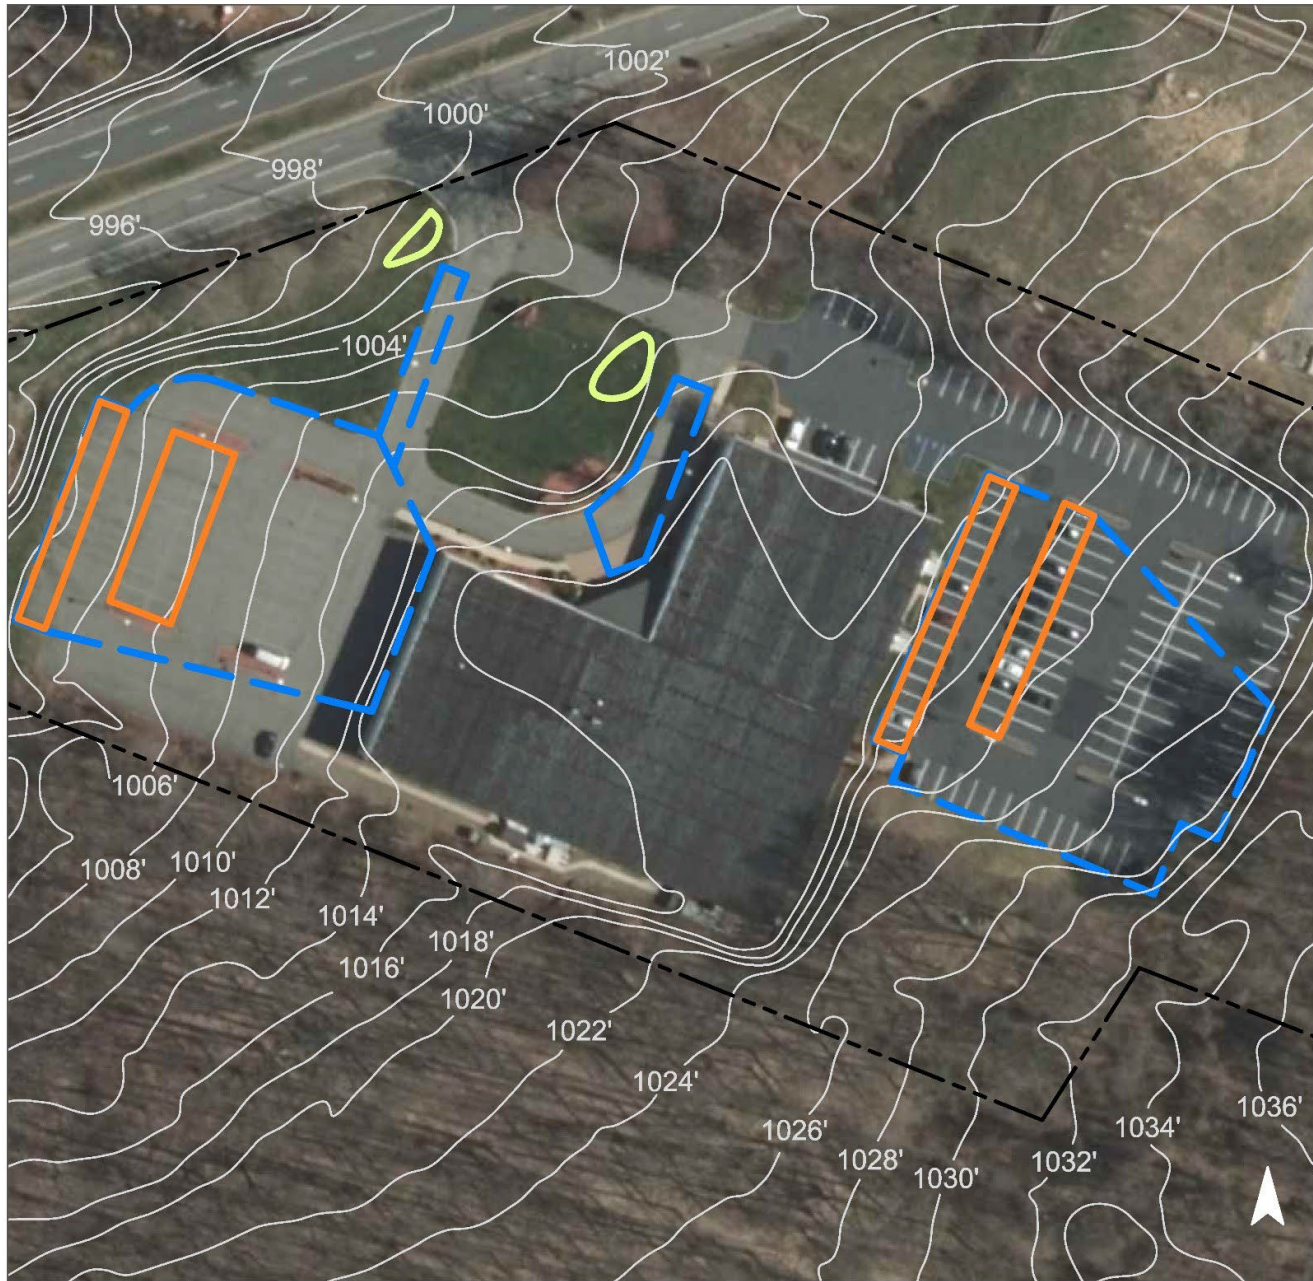
## Bible Church International

- bioretention system
- pervious pavement
- drainage area
- property line
- 2015 Aerial: NJOIT, OGIS

Parking spaces in the parking lot to the northeast of the building can be converted to pervious pavement to capture and infiltrate stormwater runoff from the parking lot. A preliminary soil assessment suggests that more soil testing would be required before determining the soil's suitability for green infrastructure.

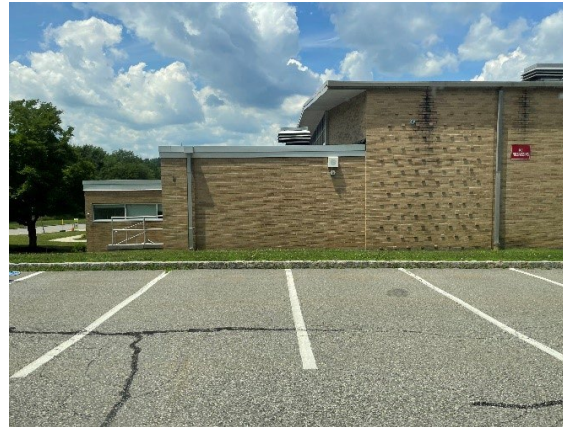
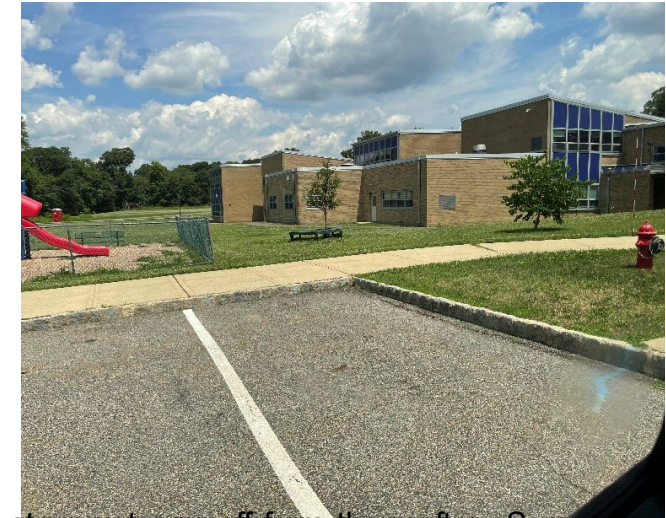
Multiple rain gardens can be installed to the west of the school to capture, treat, and infiltrate stormwater runoff from the rooftop. Some downspouts will need to be redirected beneath the asphalt pathway. Rain gardens can also be installed to the north of the northern parking lot and the western play area. Trench drains will need to be installed on the western side of the asphalt to intercept and redirect the runoff to the rain gardens. Existing parking spaces to the east of the building can be converted into pervious pavement to capture and infiltrate the stormwater runoff from the asphalt. Adjacent downspouts can be disconnected to the pervious pavement to manage stormwater runoff from the rooftop. The concrete entryway to the south of the building can be replaced with permeable pavers. A preliminary soil assessment suggests that more soil testing would be required before determining the soil's suitability for green infrastructure.

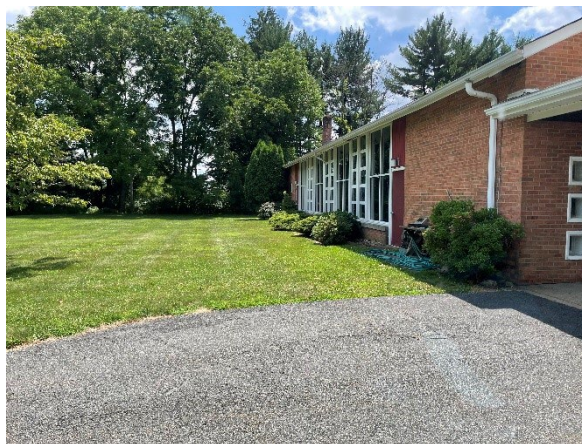
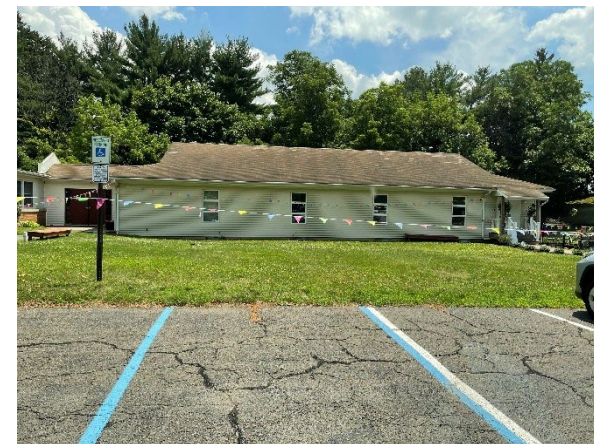
Rain gardens can be installed to the north and west of the church buildings to capture, treat, and infiltrate the stormwater runoff from the rooftop. Some downspouts will need to be disconnected. A preliminary soil assessment suggests that the soils have suitable drainage characteristics for green infrastructure.

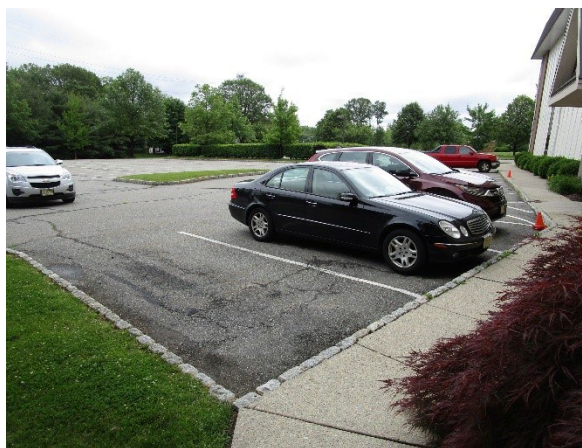
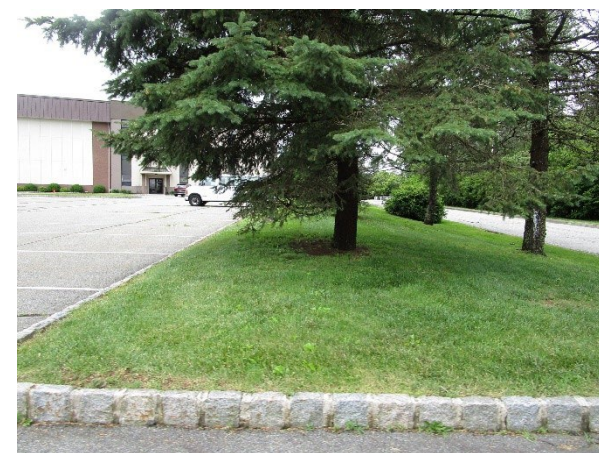
Pervious pavement can be installed on a strip of parking spaces north of the building near connected downspouts. Parking spaces can be replaced with pervious pavement to capture and infiltrate stormwater. The downspouts can be disconnected and redirected into the pervious pavement to capture additional stormwater. A preliminary soil assessment suggests that the soils have suitable drainage characteristics for green infrastructure.

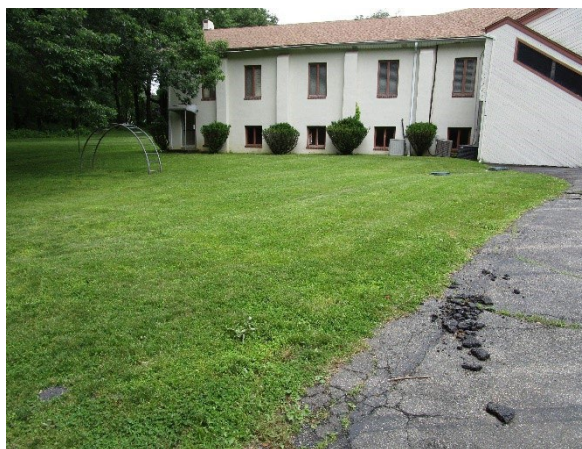
Parking spaces in the parking lot to the southwest of the building can be converted to pervious pavement to capture and infiltrate stormwater runoff from the parking lot. A rain garden can be installed in the turfgrass area west of the building to capture, treat, and infiltrate stormwater runoff from the roof. A preliminary soil assessment suggests that the soils have suitable drainage characteristics for green infrastructure.

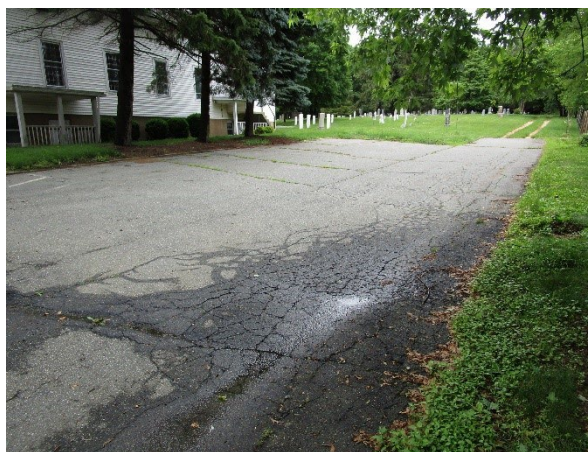
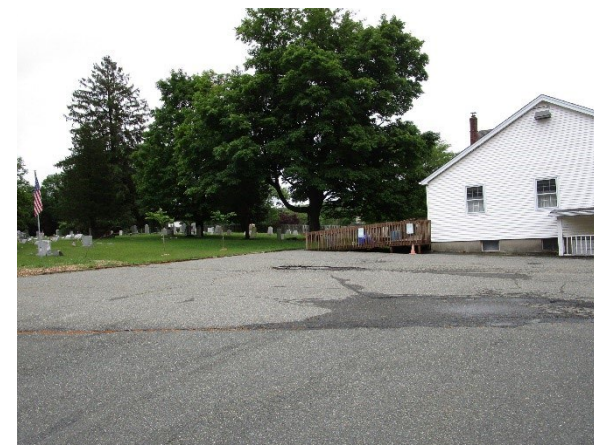
Pervious pavement can be installed south of the building near two disconnected downspouts to capture and infiltrate stormwater runoff from the parking lot and building. Parking spaces in the north parking lot can also be retrofitted with pervious pavement. A preliminary soil assessment suggests that the soils have suitable drainage characteristics for green infrastructure.

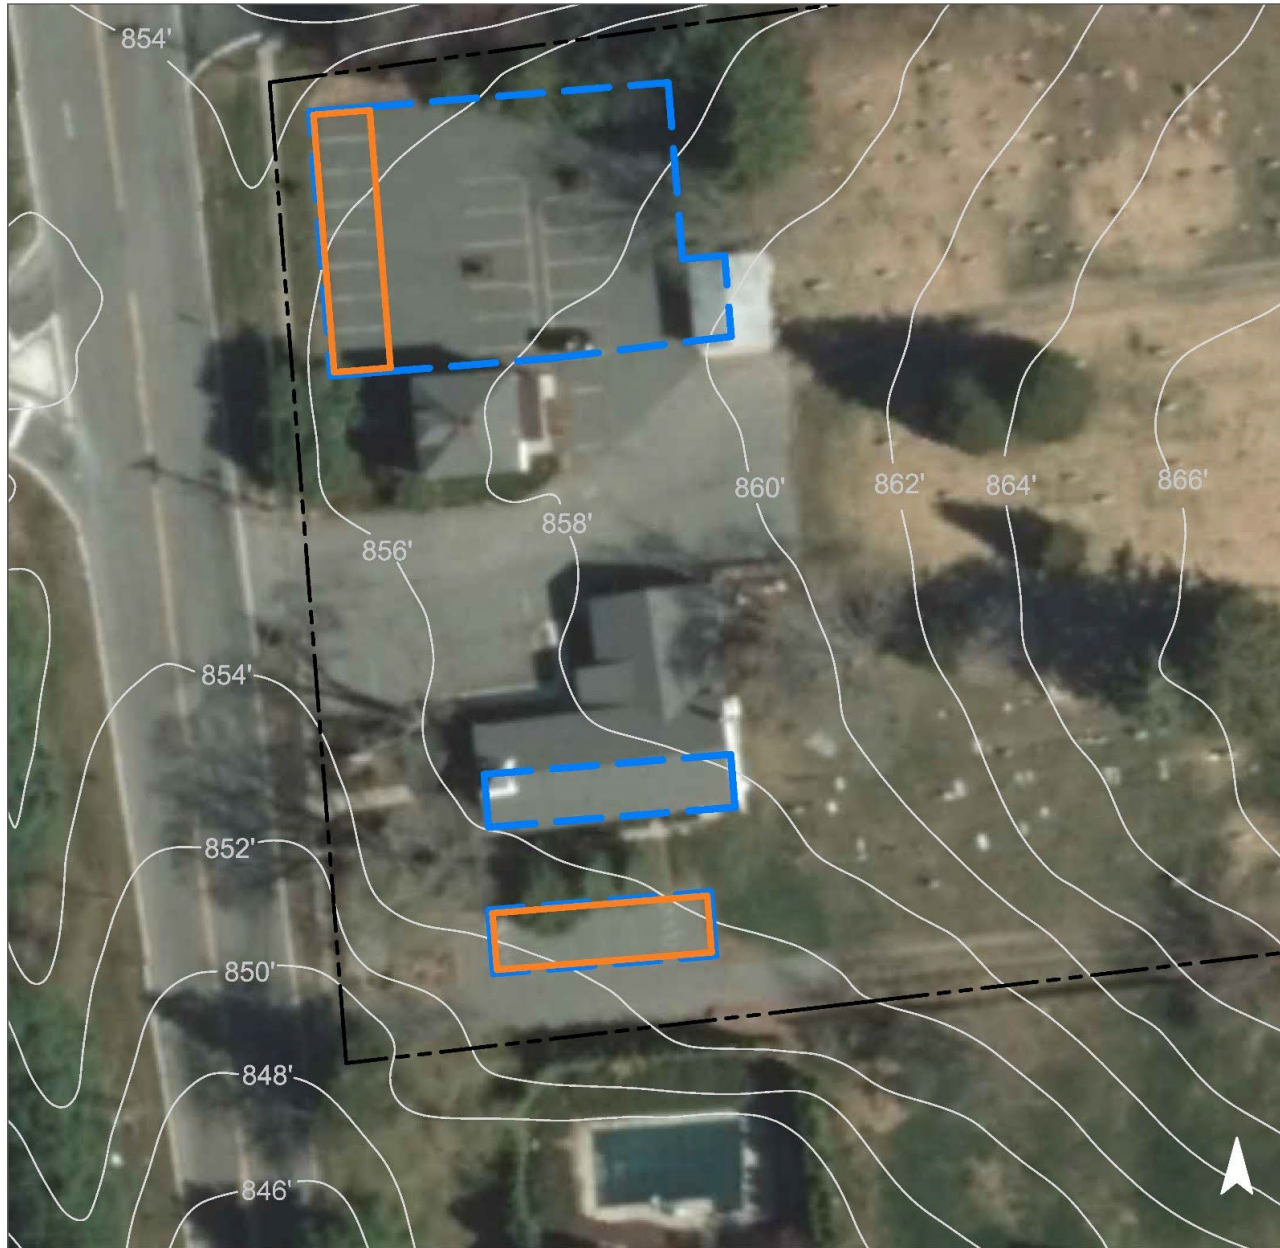
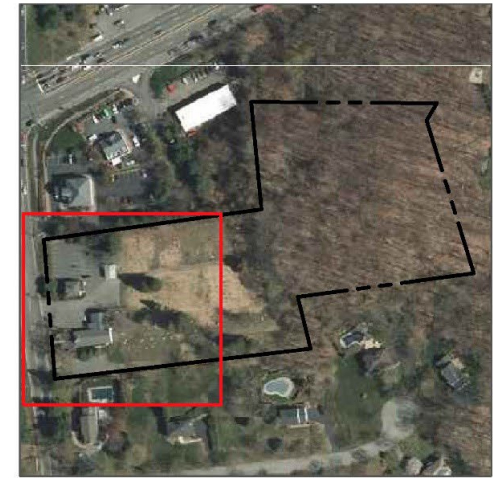
**Millbrook United Methodist Church**

Rain gardens can be installed to the northwest and southwest of the building to capture, treat, and infiltrate stormwater runoff from the rooftop. This will require downspout disconnections. Existing parking spaces to the north and east of the building can be converted into pervious pavement to capture and infiltrate the stormwater runoff from the asphalt. Downspouts on the north of the building can be disconnected to the pervious pavement to manage stormwater runoff from the rooftop. A cistern can be installed to the north of the building to divert and detain the stormwater runoff from the rooftop for later non-potable reuse such as washing vehicles. A preliminary soil assessment suggests that the soils have suitable drainage characteristics for green infrastructure.

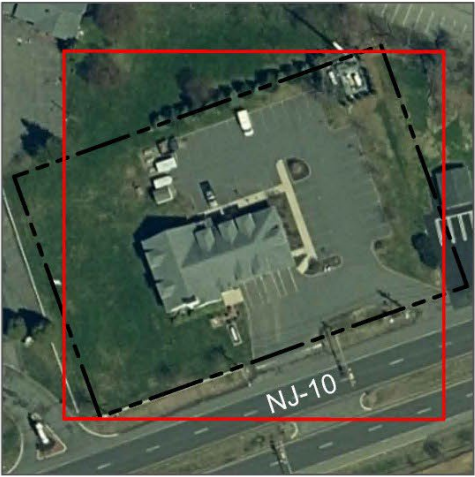
## Randolph Rescue Squad

Pervious pavement can be installed in the parking spaces north of the building to capture and infiltrate stormwater runoff from the parking lot. A cistern can be installed north of the building near a downspout. The water from the cistern can then be used for watering gardens, washing vehicles, or for other non-potable uses. A preliminary soil assessment suggests that the soils have suitable drainage characteristics for green infrastructure.
