## Randolph Township

### Introduction

The purpose of this report is to provide a comprehensive understanding of key, defining features within the subwatersheds throughout Randolph Township. This involves gathering, organizing, and presenting information about existing conditions and infrastructure within each subwatershed. It aims to serve as a tool for informed decision-making, planning, and implementation of sustainable watershed management strategies aimed to protect and enhance the health of the watershed, its associated ecosystems, and the surrounding communities.

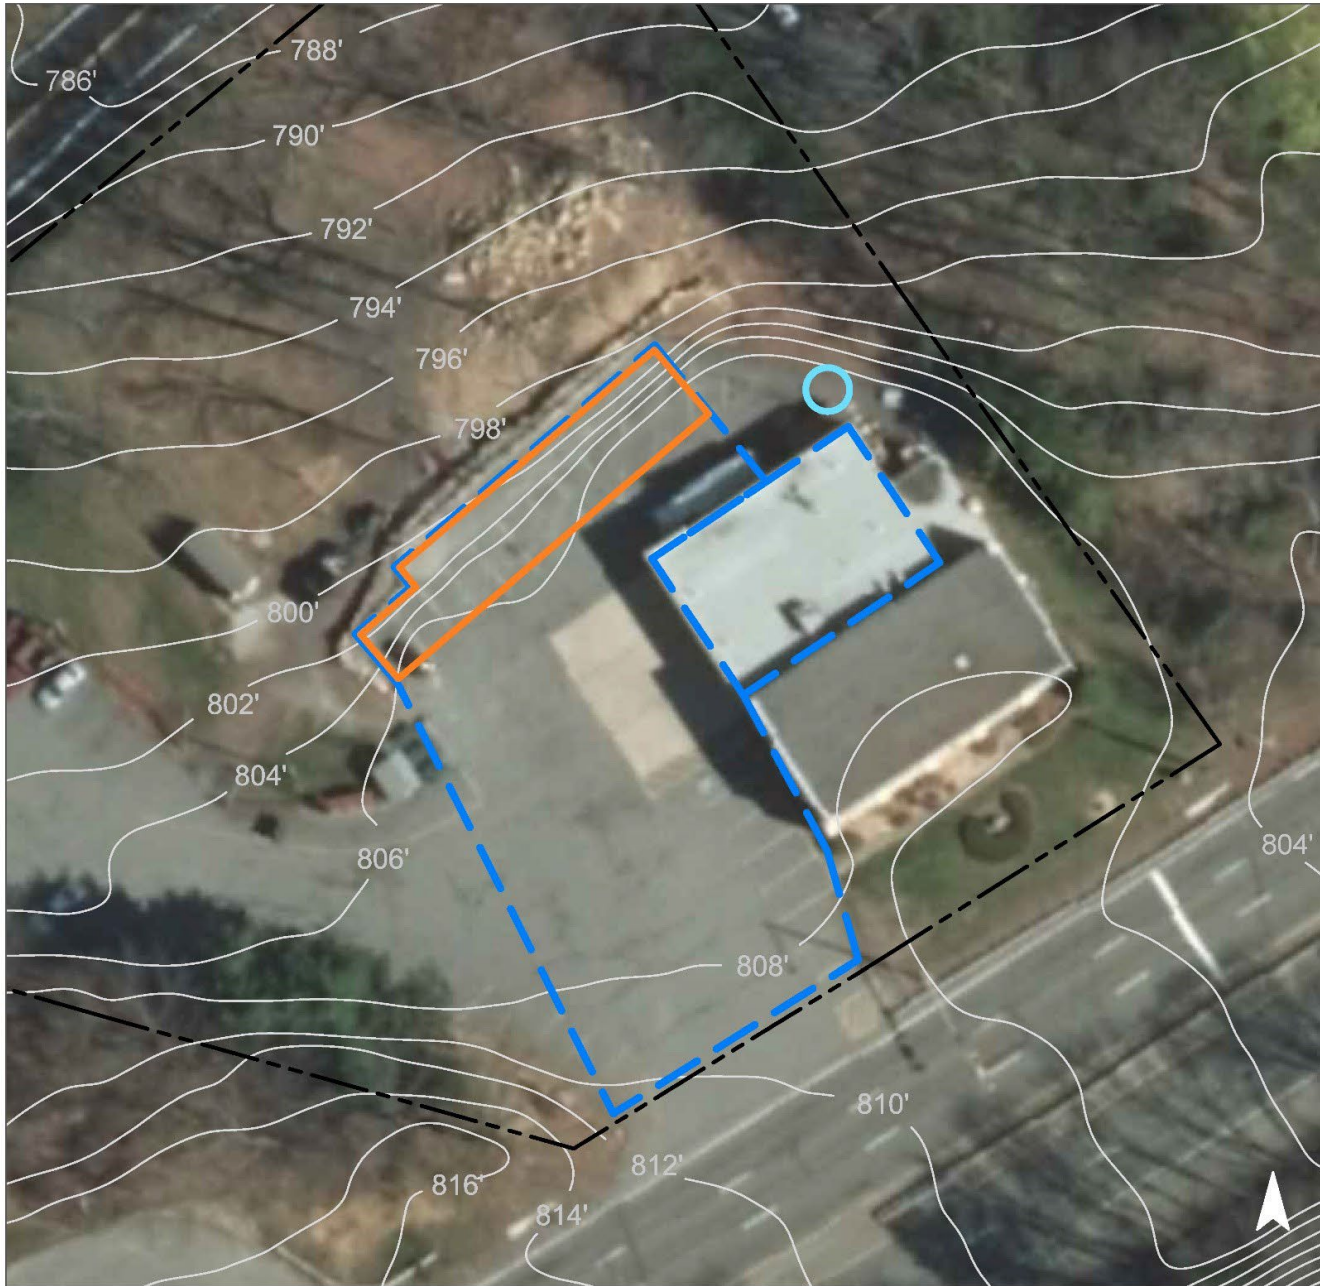
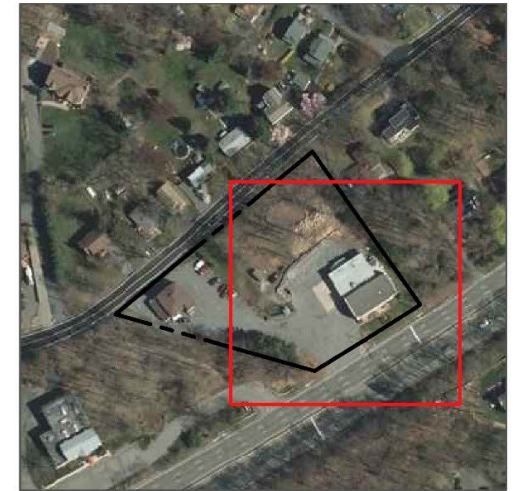
## Randolph Township Fire Department Company #2

Pervious pavement can be installed in the center parking spaces to capture and infiltrate stormwater runoff from the parking lot. A stormwater planter can be installed by depaving a portion of the wide sidewalk. A curb cut can be used to intercept stormwater runoff from the parking lot. A preliminary soil assessment suggests that the soils have suitable drainage characteristics for green infrastructure.

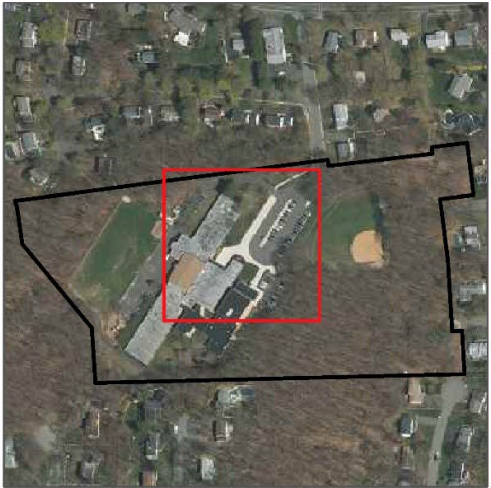
## Shongum Elementary School

Pervious pavement can be installed in parking spaces along the south side of the building to capture and infiltrate stormwater from the adjacent paved areas and rooftop. A rain garden can be installed to the east of the building near a disconnected downspout to capture, treat, and infiltrate stormwater runoff. A cistern can be installed on the north side of the building to capture stormwater and reuse it for watering gardens, washing vehicles, or for other non-potable uses. A preliminary soil assessment suggests that the soils have suitable drainage characteristics for green infrastructure.
