Roxbury Township

Introduction

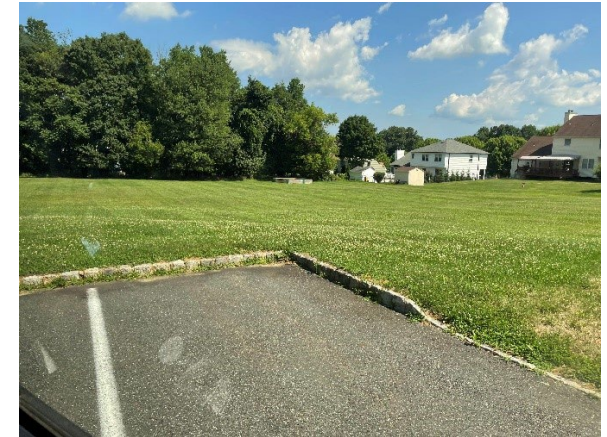
Block and Lot: Block 4601, Lot 13

The pavement in the front of the building can be converted to porous pavement to capture and infiltrate stormwater runoff from the roof via already disconnected downspouts; the western downspout may require redirection towards the porous pavement. A rain garden with a curb cut can be installed in the grass area near the northwest corner of the building and a rain garden with a trench drain can be installed south of the building to capture, treat, and infiltrate stormwater runoff from the pavement. A preliminary soil assessment suggests that more soil testing would be required before determining the soil's suitability for green infrastructure.

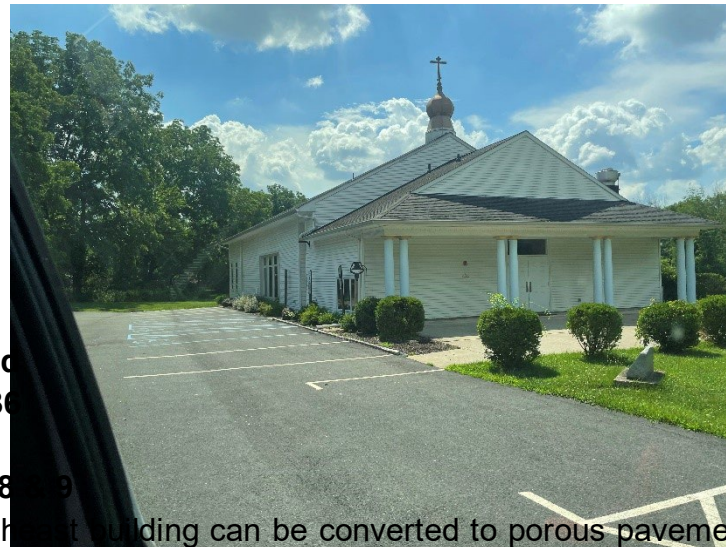
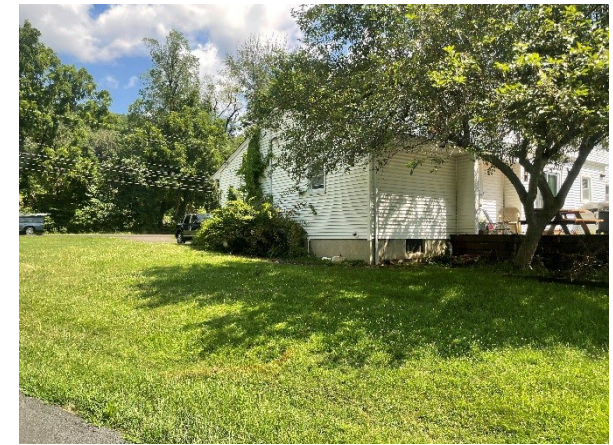
Block and Lot: Block 5701, Lots 8 & 9

Parking spaces in the lot next to the south east building can be converted to porous pavement to capture and infiltrate stormwater runoff from the asphalt and rooftop via already disconnected downspouts. Rain gardens can be installed in multiple grass areas around the property to capture, treat, and infiltrate stormwater runoff from the roofs and pavement. Trench drains and downspout disconnection and redirection will be required for some of these gardens. A preliminary soil assessment suggests that the soils have suitable drainage characteristics for green infrastructure.

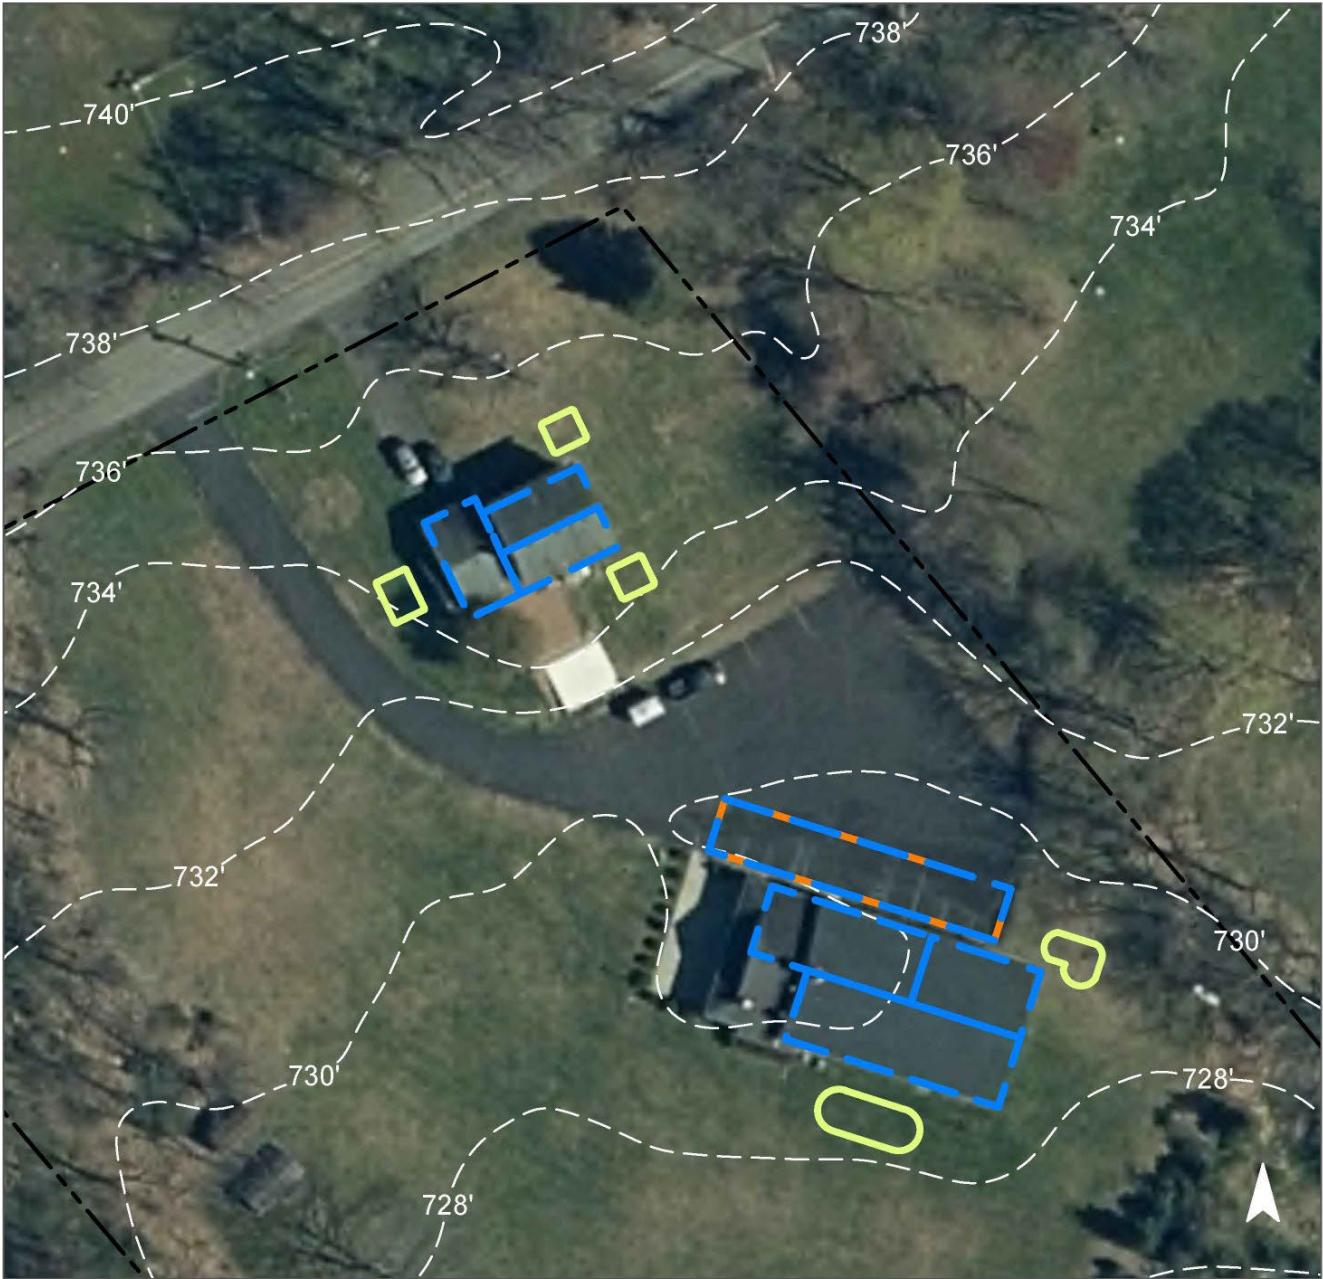
Holy Wisdom Byzantine Catholic Church

- bioretention system
- pervious pavement
- captured drainage area
- property line
- 2020 Aerial: NJOIT, OGIS

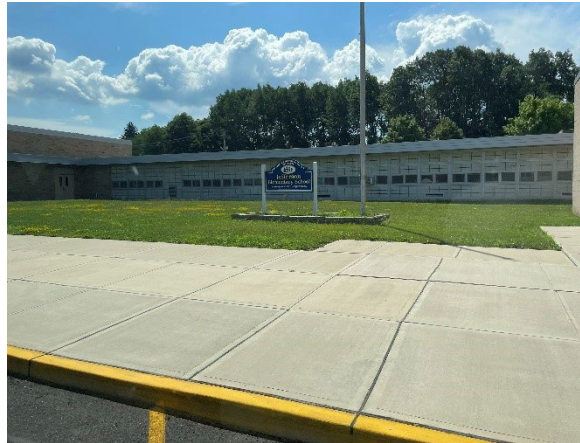
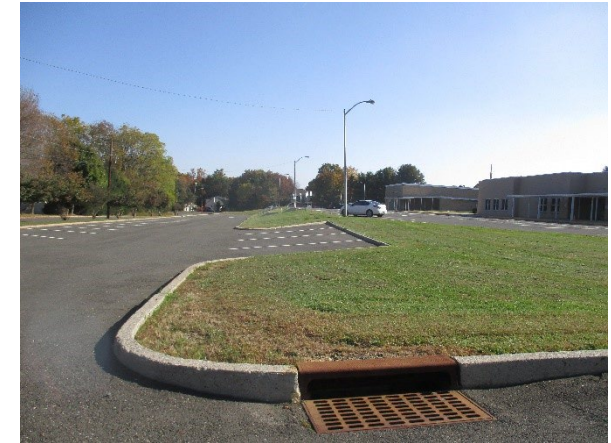
Block and Lot: Block 4501, Lot 10

Parking spaces can be replaced with pervious pavement to capture and infiltrate stormwater. Downspout planter boxes can be installed on multiple locations north of the building. A rain garden can be installed in the parking island to capture, treat, and infiltrate additional stormwater runoff. Downspout planter boxes can be installed near the entrances to capture rooftop runoff and provide visual interest. A preliminary soil assessment suggests that more soil testing would be required before determining the soil's suitability for green infrastructure.

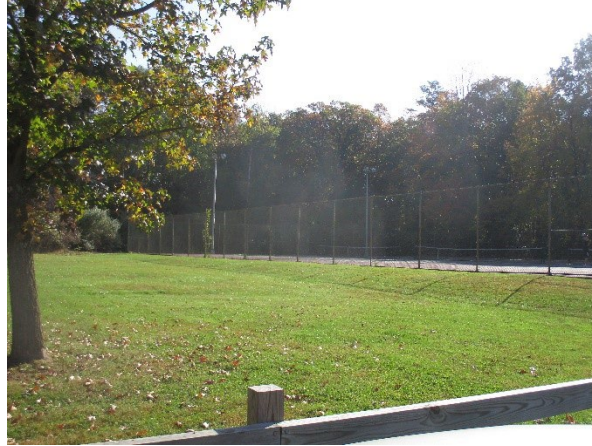
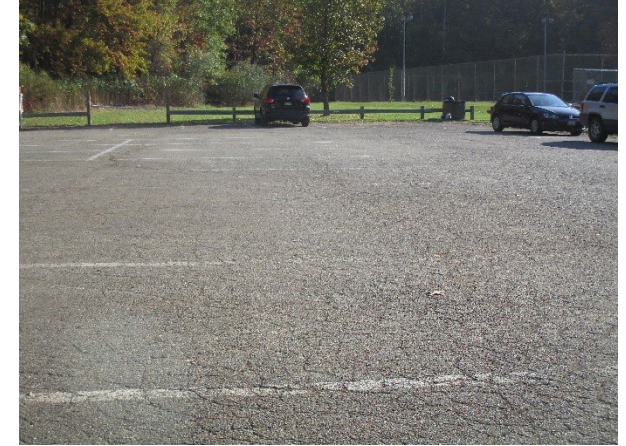
Block and Lot: Block 901, Lot 19

Parking spaces can be replaced with pervious pavement on the southernmost parking strip in the lot to capture and infiltrate stormwater. A rain garden can be installed near the tennis court to capture stormwater. A preliminary soil assessment suggests that more soil testing would be required before determining the soil's suitability for green infrastructure.

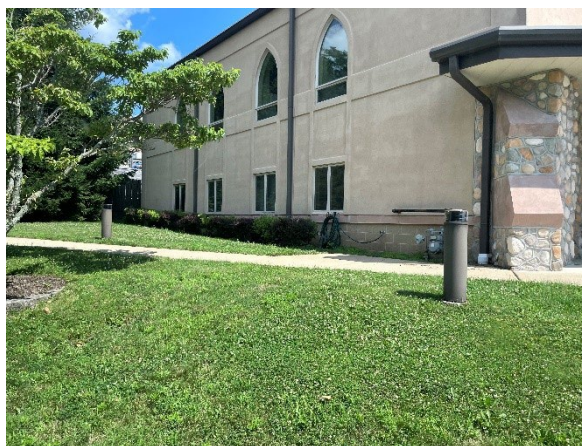
Block and Lot: Block 6406, Lot 5.01

Four rain gardens that require downspout disconnection and redirection can be installed in the grass areas around the property building to capture, treat, and infiltrate stormwater runoff from the roofs. One rain garden can be installed in the grass area on the east side of the site to capture, treat, and infiltrate stormwater runoff from the parking lot. A preliminary soil assessment suggests that the soils have suitable drainage characteristics for green infrastructure.

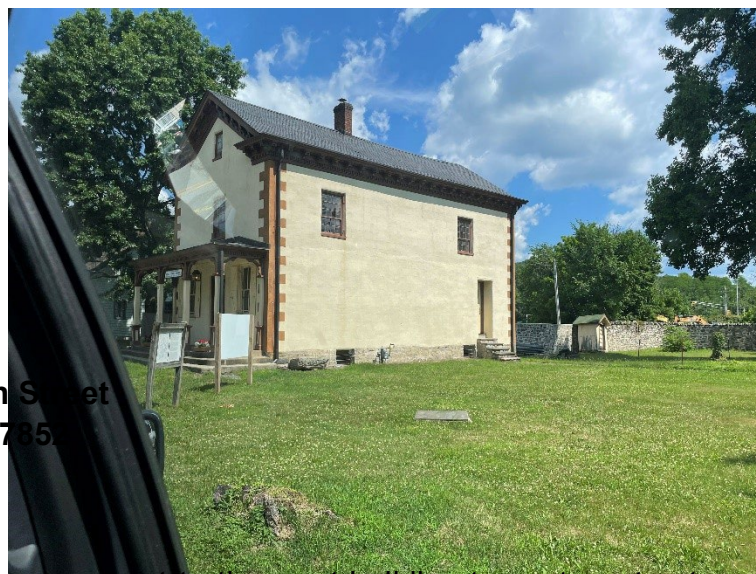
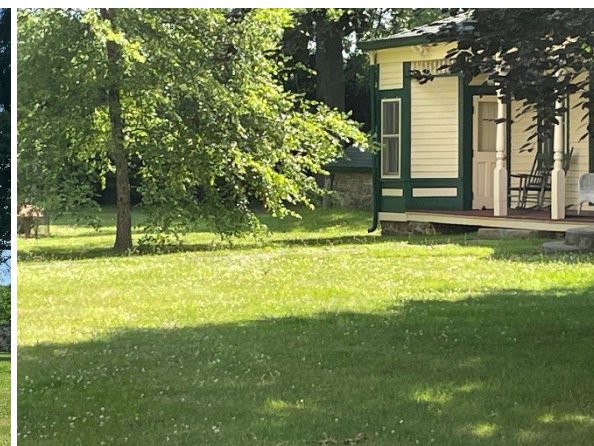
Block and Lot: Block 6408, Lot 2

A rain garden can be installed in the grass area next to the west building to capture, treat, and infiltrate stormwater runoff from the roof. Three rain gardens, one of which requires downspout disconnection, can be installed next to the east building to capture, treat, and infiltrate stormwater runoff from the roof. A preliminary soil assessment suggests that more soil testing would be required before determining the soil's suitability for green infrastructure.

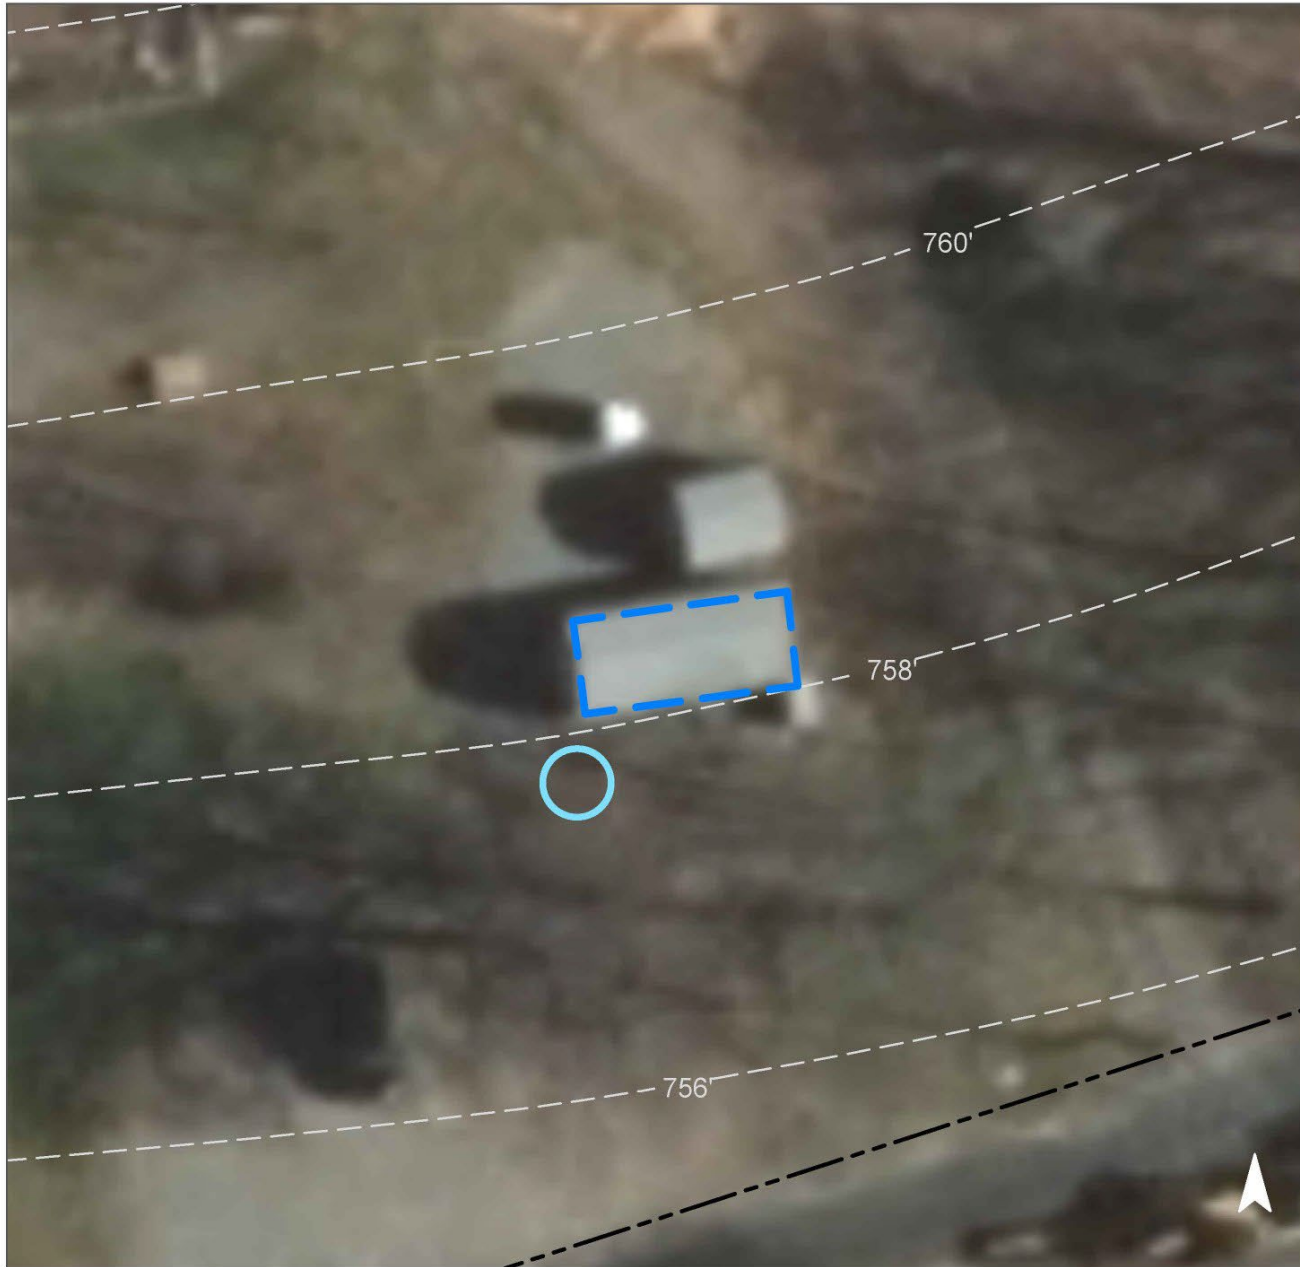
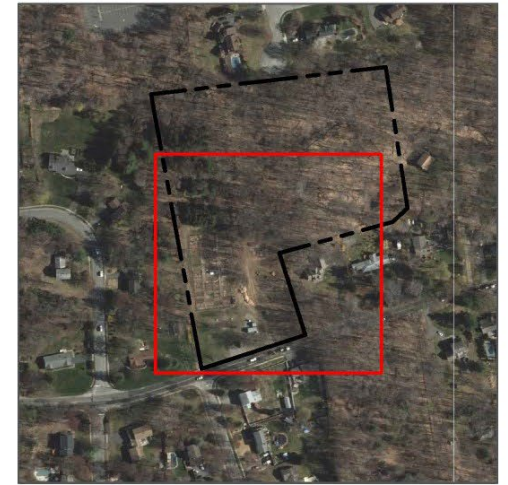
Roxbury Community Garden

A cistern can be installed to capture stormwater from the roof of the shed in front of the garden, and the water can be reused for watering plants or other non-potable purposes. A preliminary soil assessment suggests that more soil testing would be required before determining the soil's suitability for green infrastructure.

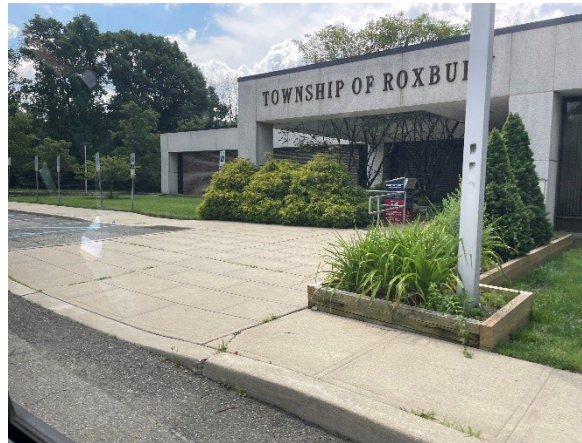
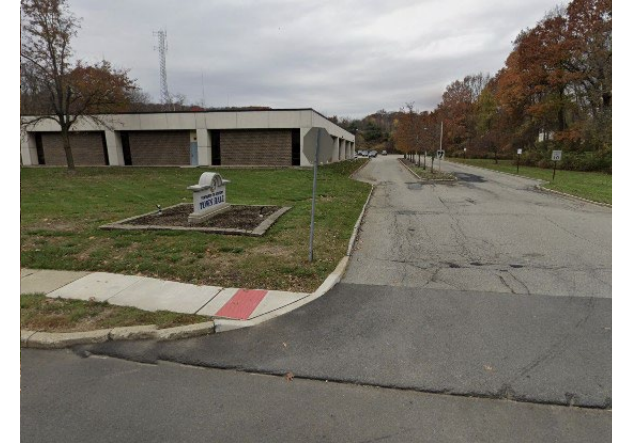
Block and Lot: Block 9603, Lot 5

Three rain gardens can be installed in the grass areas on the east and west sides at the front of the building to capture, treat, and infiltrate stormwater runoff from the pavement. The gardens will require curb cuts and trench drains. Parking spaces on the west side of the building and behind the building can be converted to porous pavement to capture and infiltrate stormwater runoff from the parking lot. A preliminary soil assessment suggests that more soil testing would be required before determining the soil's suitability for green infrastructure.

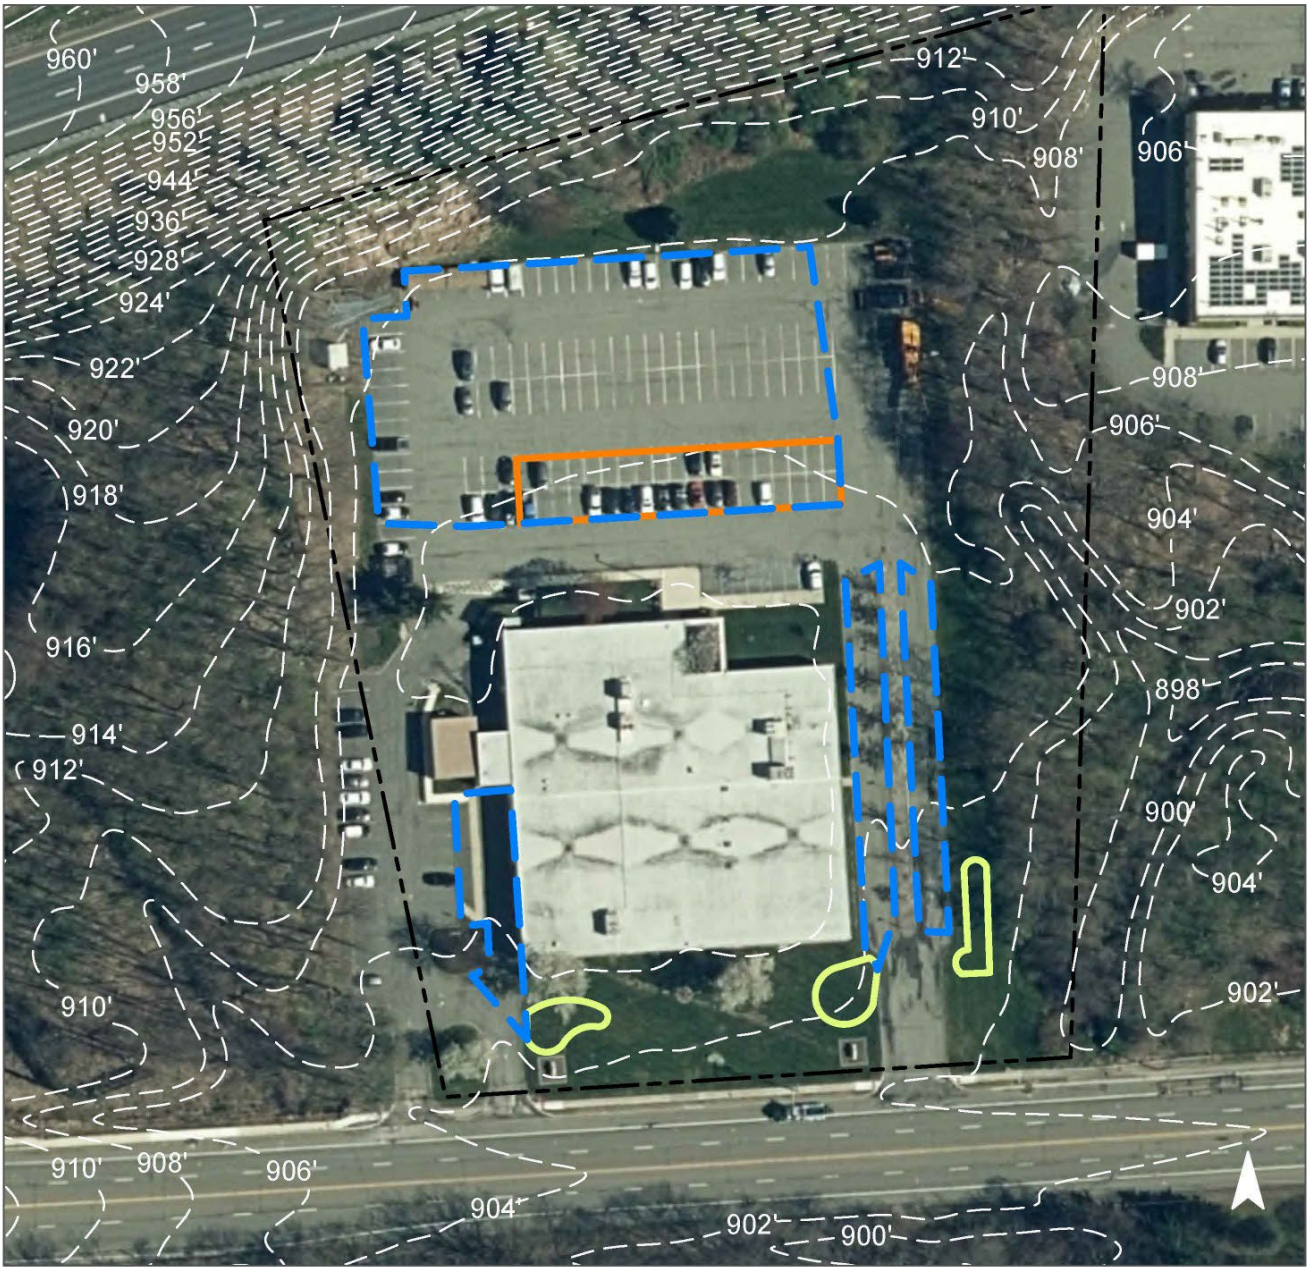
Roxbury Township Court Clerk and Police Department

- bioretention system
- pervious pavement
- captured drainage area
- property line
- 2020 Aerial: NJOIT, OGIS

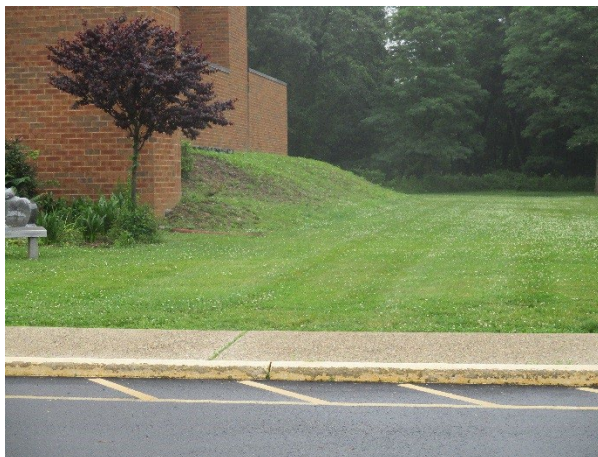
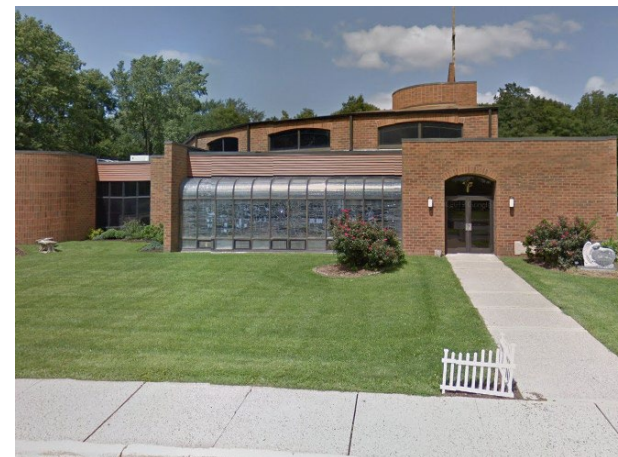
Block and Lot: Block 5103, Lot 1

A rain garden can be installed on the east side of the building to capture, treat, and infiltrate rooftop runoff. A preliminary soil assessment suggests that more soil testing would be required before determining the soil's suitability for green infrastructure.

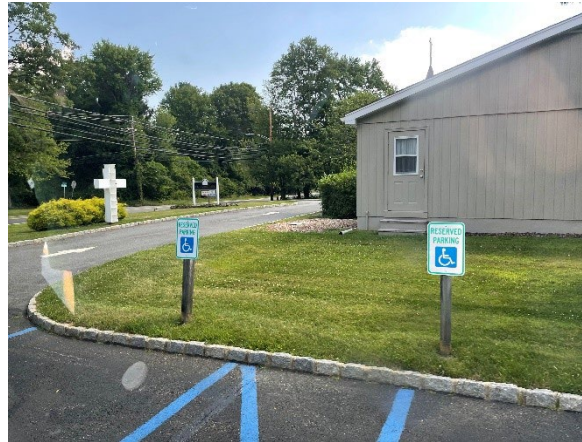
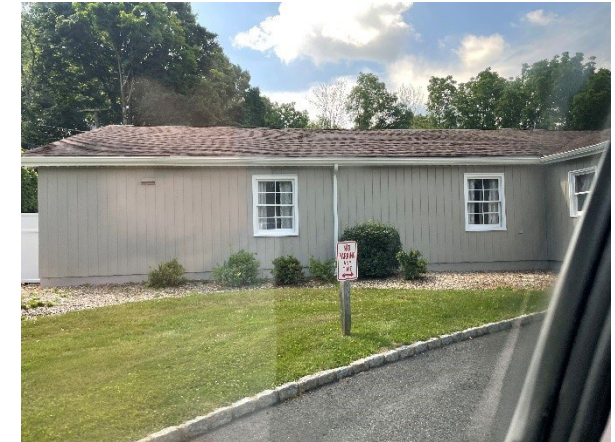
Block and Lot: Block 2904, Lot 2

Parking spaces in the lot can be converted to porous pavement using trench drains to redirect, capture and infiltrate stormwater runoff from the pavement. A rain garden with a curb cut can be installed in the grass area near the entrance of the parking lot to capture, treat, and infiltrate stormwater runoff from the pavement. Two rain gardens can be installed near the building entrance to capture, treat, and infiltrate stormwater runoff from the roof via already disconnected downspouts that will require redirection. A preliminary soil assessment suggests that more soil testing would be required before determining the soil's suitability for green infrastructure.

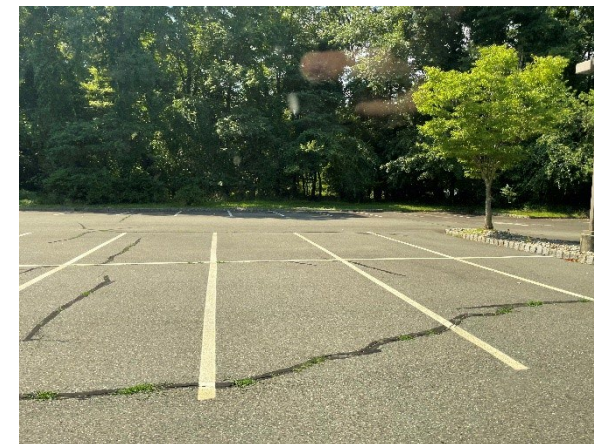
Block and Lot: Block 2802, Lot 20

Parking spaces in the lot to the north and south of the building can be converted to porous pavement to capture and infiltrate stormwater runoff from the roof and asphalt; this requires downspout disconnection and trench drains for redirection. A rain garden requiring downspout disconnection can be installed in the grass area in the rear of the building to capture, treat, and infiltrate stormwater runoff from the roof. A preliminary soil assessment suggests that more soil testing would be required before determining the soil's suitability for green infrastructure.

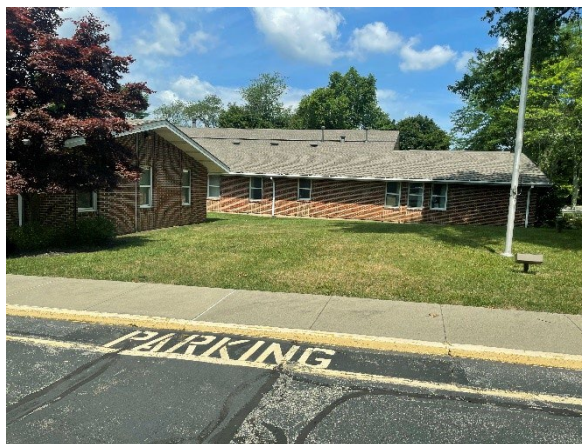
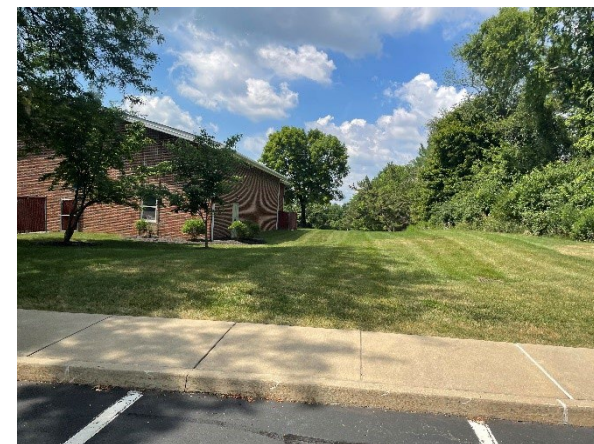
Block and Lot: Block 8201, Lot 9

Several rain gardens that require downspout disconnection and redirection can be installed in the grass areas around the building to capture, treat, and infiltrate stormwater runoff from the roof. One rain garden that requires a curb cut and trench drain can be installed in the grass area southwest of the building to capture, treat, and infiltrate stormwater runoff from the pavement. A preliminary soil assessment suggests that the soils have suitable drainage characteristics for green infrastructure.

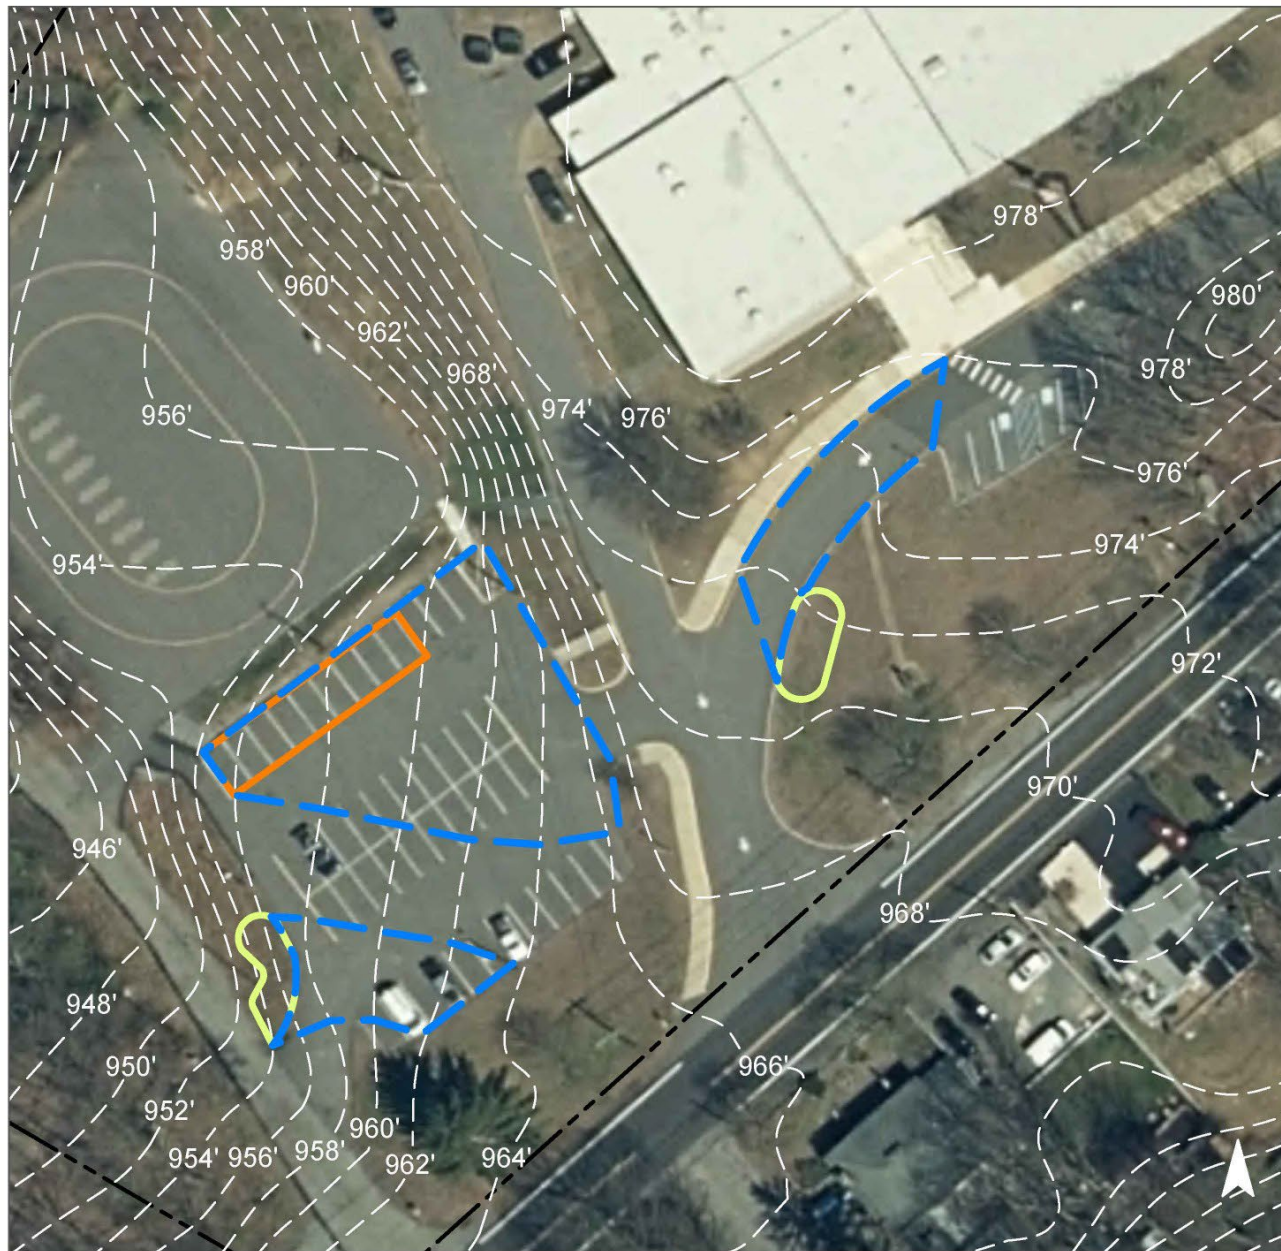
Nixon Elementary School

- bioretention system
- pervious pavement
- captured drainage area
- property line
- 2020 Aerial: NJOIT, OGIS

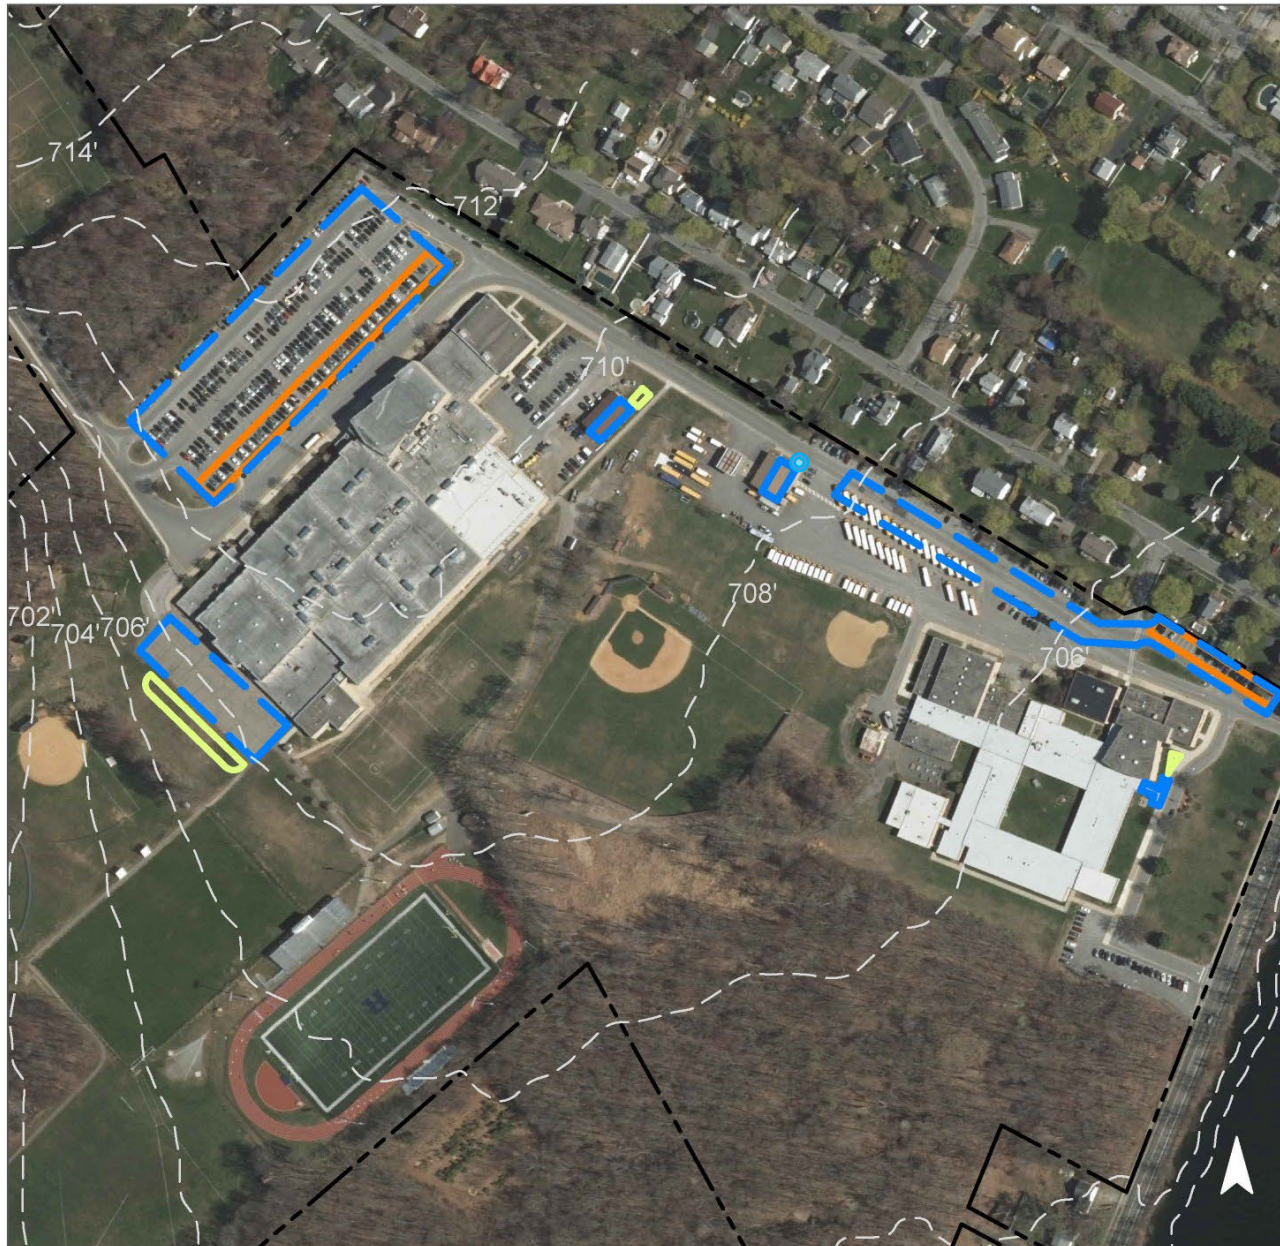
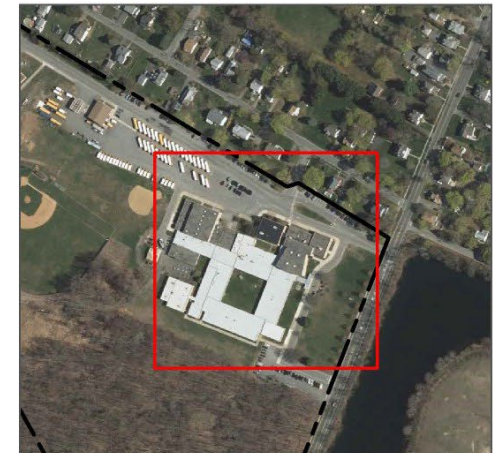
Eisenhower Middle School & Roxbury High School

Three rain gardens can be installed to capture, treat, and infiltrate runoff from rooftops and paved areas. Parking spaces can be replaced with pervious pavement to capture and infiltrate stormwater runoff from the parking lot areas. A cistern can be installed to capture roof runoff from a maintenance shed. A preliminary soil assessment suggests that more soil testing would be required before determining the soil's suitability for green infrastructure.

- bioretention system
- pervious pavement
- rainwater harvesting
- drainage area
- property line
- 2015 Aerial: NJOIT, OGIS

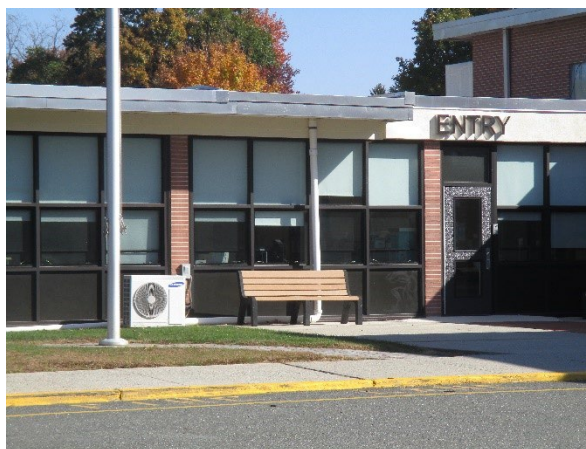
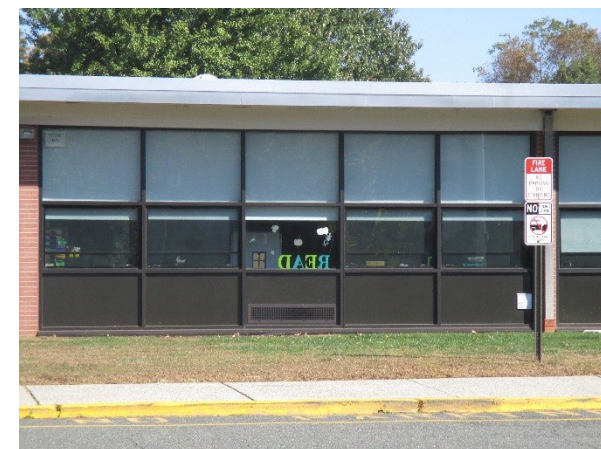
Block and Lot: Block 3901, Lot 2

Rain gardens can be installed at the entrances of both buildings near downspouts to capture, treat, and infiltrate rooftop runoff. Another rain garden can be installed in the turfgrass area near a catch basin to capture water from the parking lot. A section of parking spaces can be converted to porous pavement to capture and infiltrate runoff from the parking lot. A preliminary soil assessment suggests that more soil testing would be required before determining the soil's suitability for green infrastructure.

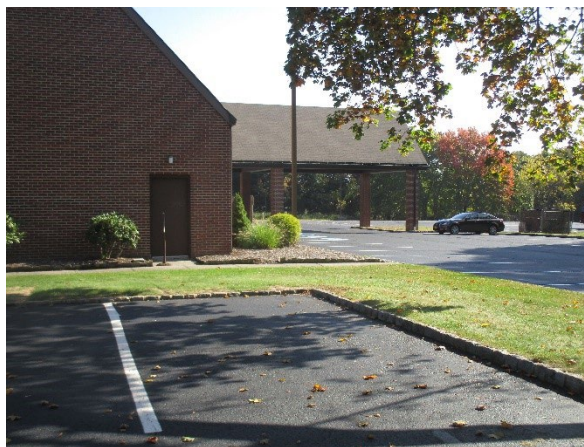
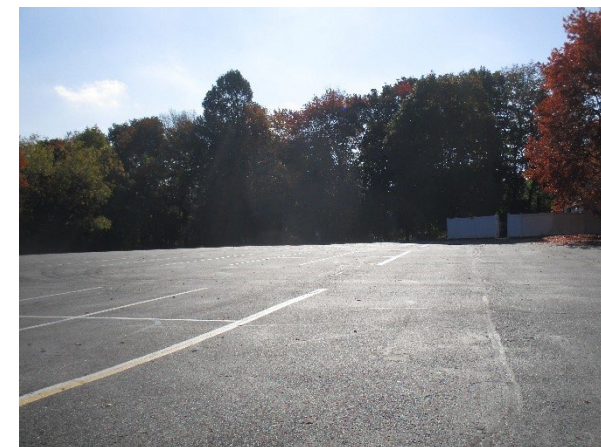
Block and Lot: Block 3103, Lot 1

Rain gardens can be installed north and west of the building near downspouts to capture, treat, and infiltrate rooftop runoff. Another rain garden can be installed near the parking lot to capture runoff from the road. Parking spaces can be replaced with pervious pavement to capture and infiltrate stormwater runoff from the parking lot. A preliminary soil assessment suggests that more soil testing would be required before determining the soil's suitability for green infrastructure.

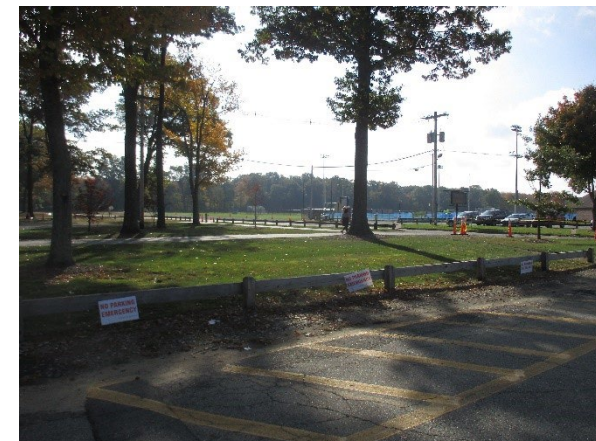
Block and Lot: Block 1802, Lot 7-8

There are four downspouts along the north side of the building where downspout planter boxes can be installed. A rain garden can be installed at end of the parking lot that will capture stormwater from the parking lot. Another rain garden can be installed on the north side of the building near downspouts. Pervious pavement can be installed to capture and infiltrate runoff from the southern parking lot. A preliminary soil assessment suggests that more soil testing would be required before determining the soil's suitability for green infrastructure.

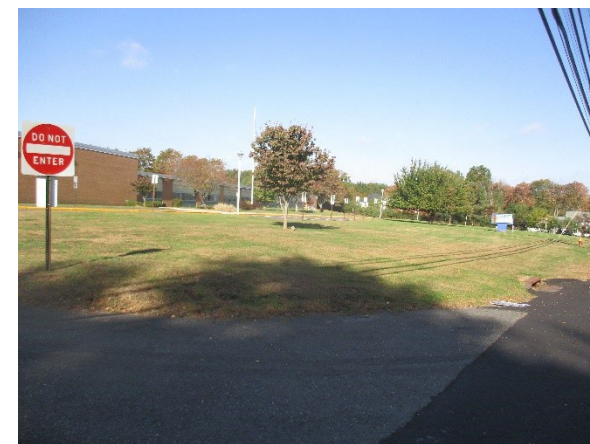
Block and Lot: Block 1201, Lot 19

Two rains gardens can be installed in the turfgrass in front of the building to capture, treat, and infiltrate roadway runoff. Another rain garden can be installed south of the building to capture runoff from the basketball court. Pervious pavement can be installed in the parking lot to capture and infiltrate stormwater runoff from the parking lot. A preliminary soil assessment suggests that more soil testing would be required before determining the soil's suitability for green infrastructure.

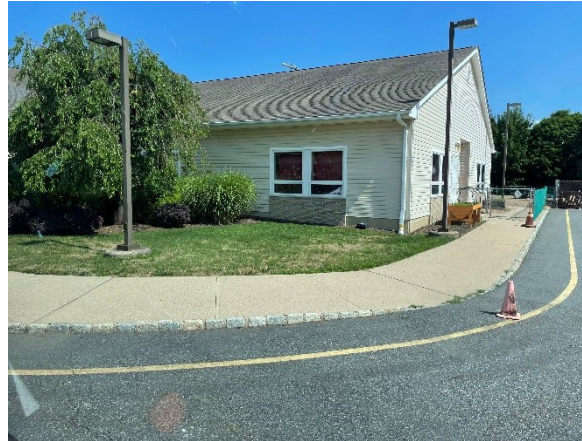
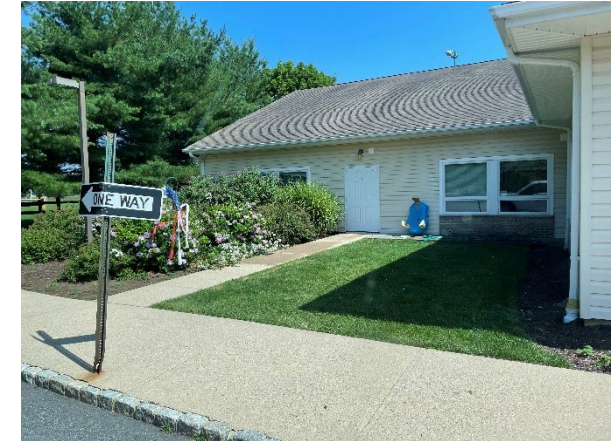
Block and Lot: Block 1802, Lot 8

Parking spaces in the lot to the south of the building can be converted to porous pavement to capture and infiltrate stormwater runoff from the asphalt using trench drains for redirection. Two rain gardens requiring downspout disconnection can be installed in the grass areas near the entrance of the building to capture, treat, and infiltrate stormwater runoff from the roof. A rain garden with a curb cut can be installed in the grass area east of the building to capture, treat, and infiltrate stormwater runoff from the parking lot. A preliminary soil assessment suggests that the soils have suitable drainage characteristics for green infrastructure.

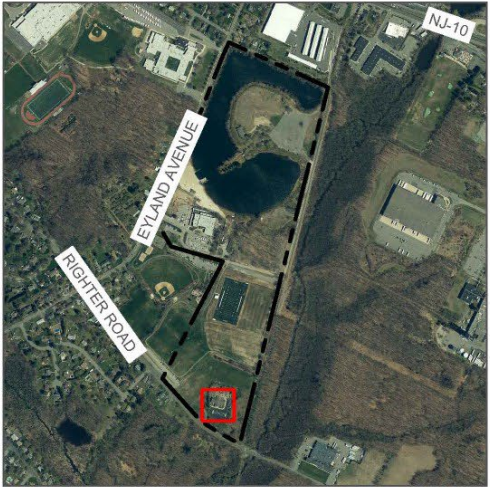
Roxbury Day Care Center

- bioretention system
- pervious pavement
- captured drainage area
- property line
- 2020 Aerial: NJOIT, OGIS

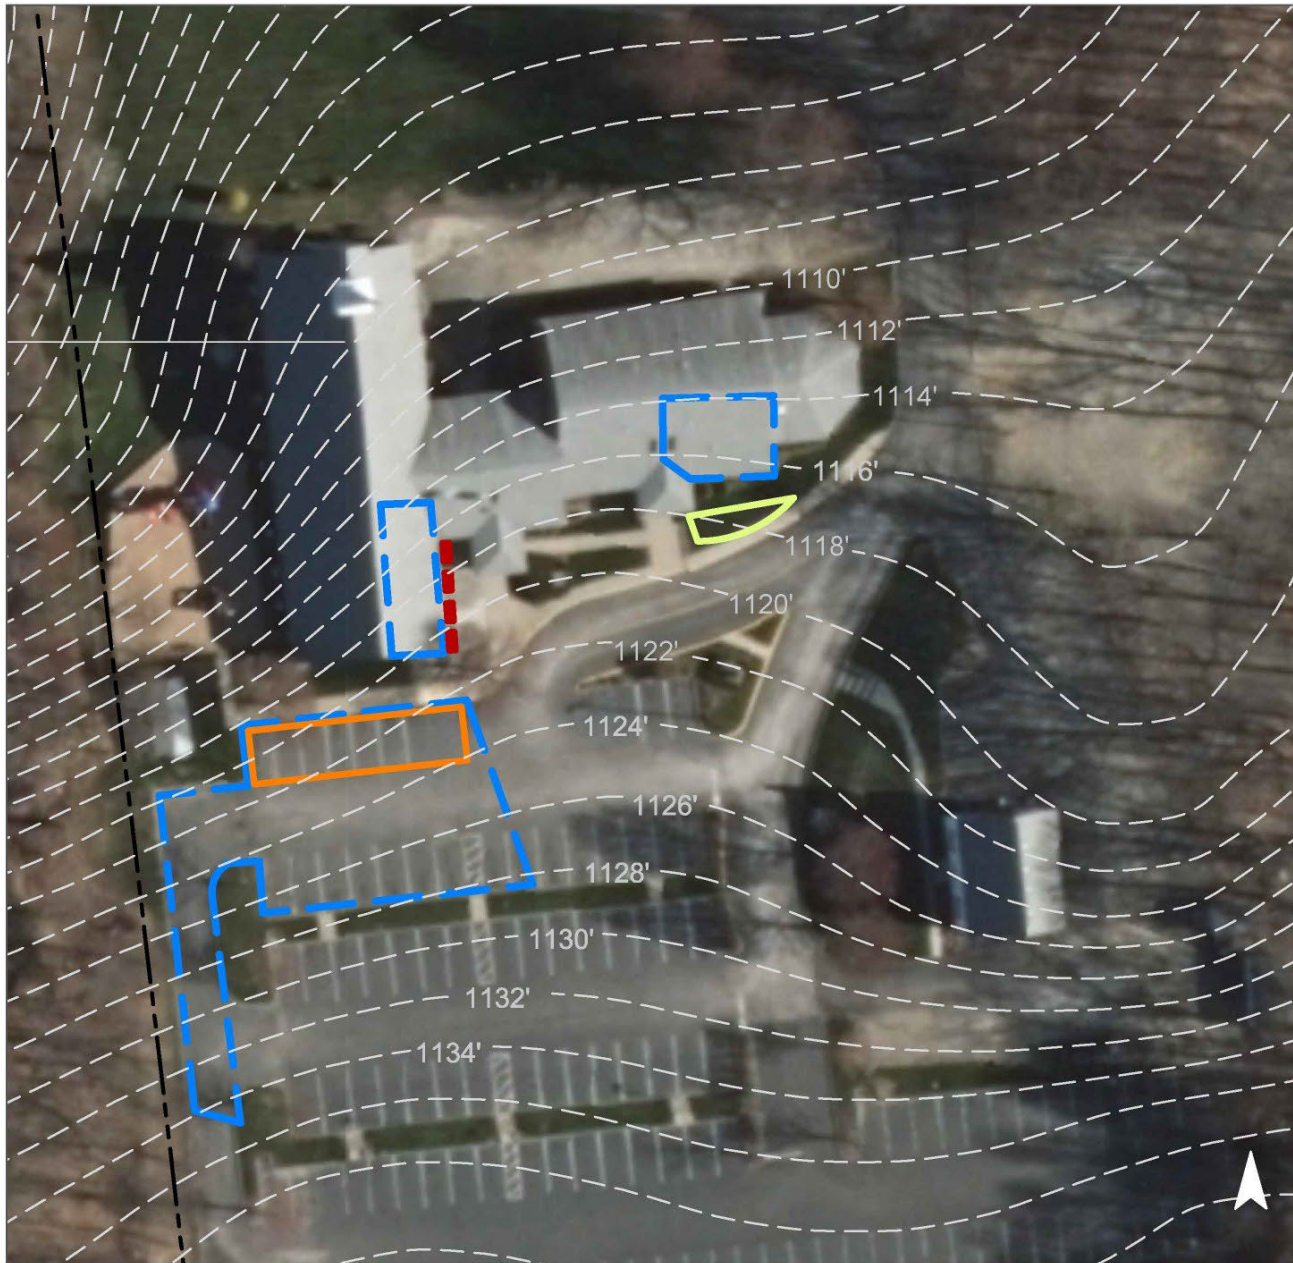
Grace Church on the Mount

A rain garden can be installed near a connected downspout and a catch basin to capture, treat, and infiltrate rooftop runoff. Downspout planter boxes can be constructed along the building to allow roof runoff to be reused. A section of parking spaces can be converted to porous pavement to capture and infiltrate runoff from the parking lot. A preliminary soil assessment suggests that more soil testing would be required before determining the soil's suitability for green infrastructure.
