Roxbury Township

Introduction

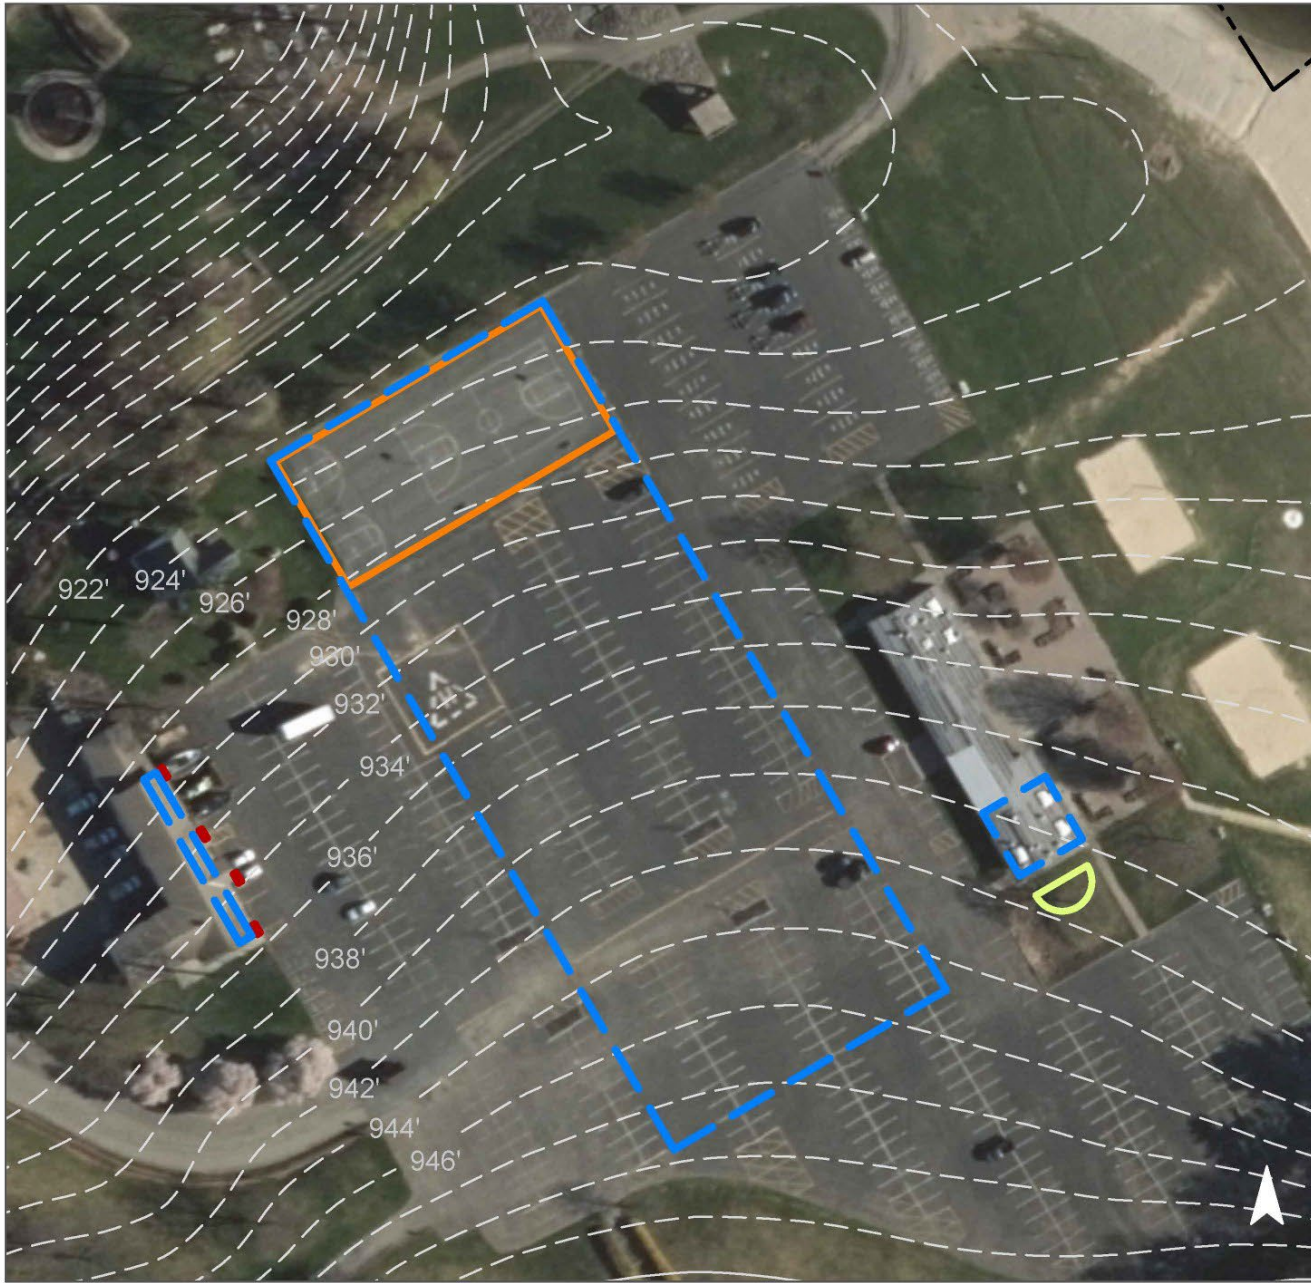
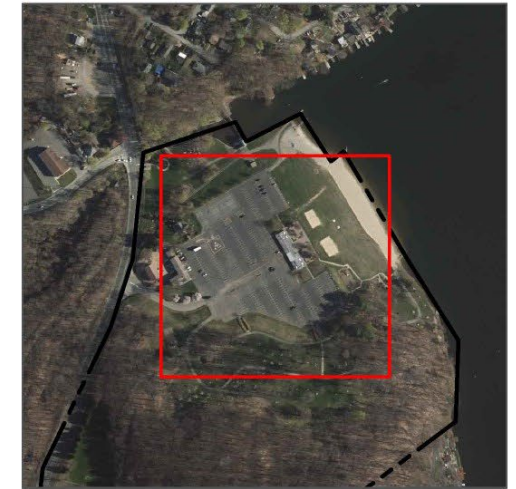
**Lake Hopatcong
Historical Museum and
State Park**

The basketball court area in the parking lot can be converted to porous pavement to capture and infiltrate runoff from the parking lot. A rain garden can be installed near the bathrooms to capture, treat, and infiltrate runoff from the rooftop. Downspout planter boxes can be installed near the main building at the ends of downspouts to filter rooftop runoff. A preliminary soil assessment suggests that more soil testing would be required before determining the soil's suitability for green infrastructure.

- bioretention system
- planter box
- pervious pavement
- drainage area
- property line
- 2015 Aerial: NJOIT, OGIS

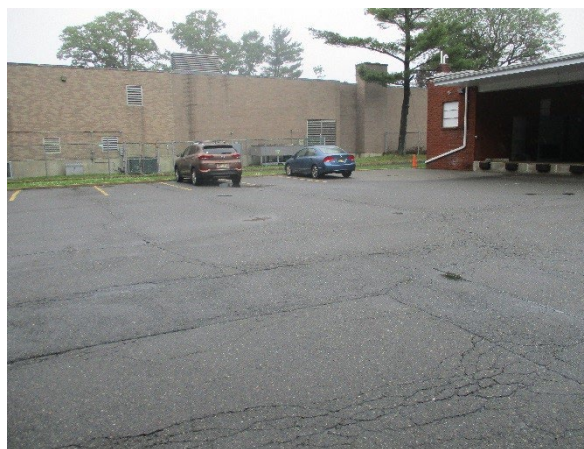
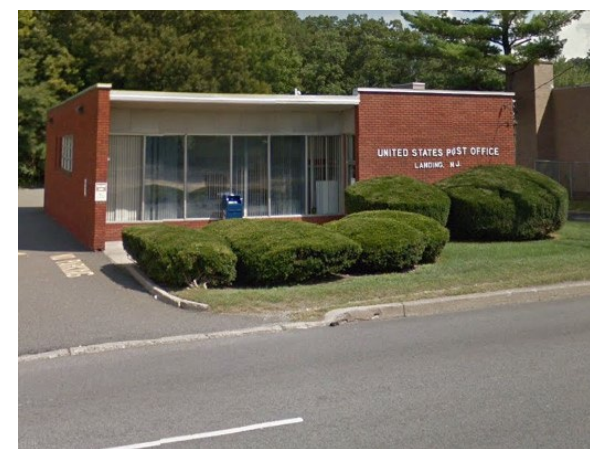
Block and Lot: Block 11001, Lot 6

Pervious pavement can be installed near a downspout to capture and infiltrate stormwater runoff from the rooftop and parking lot. A preliminary soil assessment suggests that more soil testing would be required before determining the soil's suitability for green infrastructure.

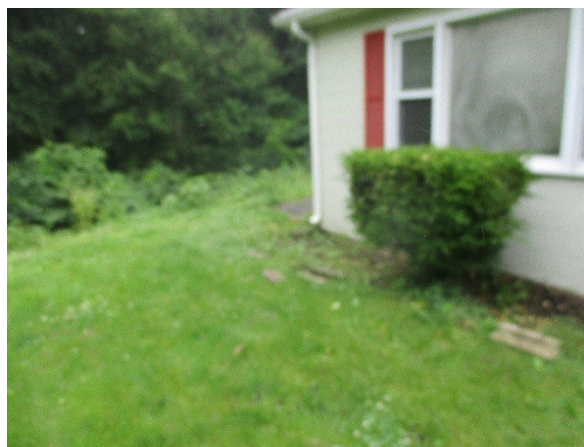
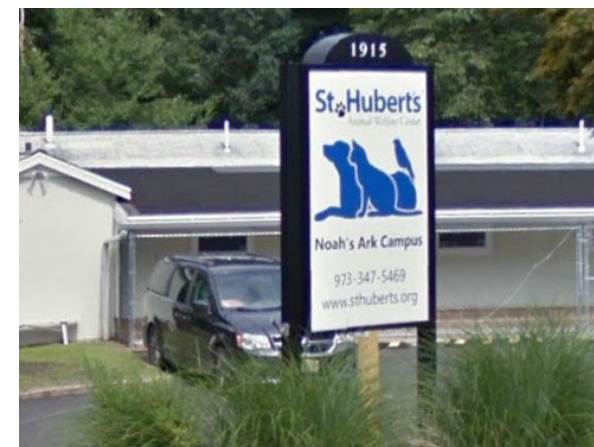
Block and Lot: Block 9402, Lot 11

A rain garden can be installed south of the building near a disconnected downspout to capture, treat, and infiltrate rooftop runoff. A preliminary soil assessment suggests that more soil testing would be required before determining the soil's suitability for green infrastructure.

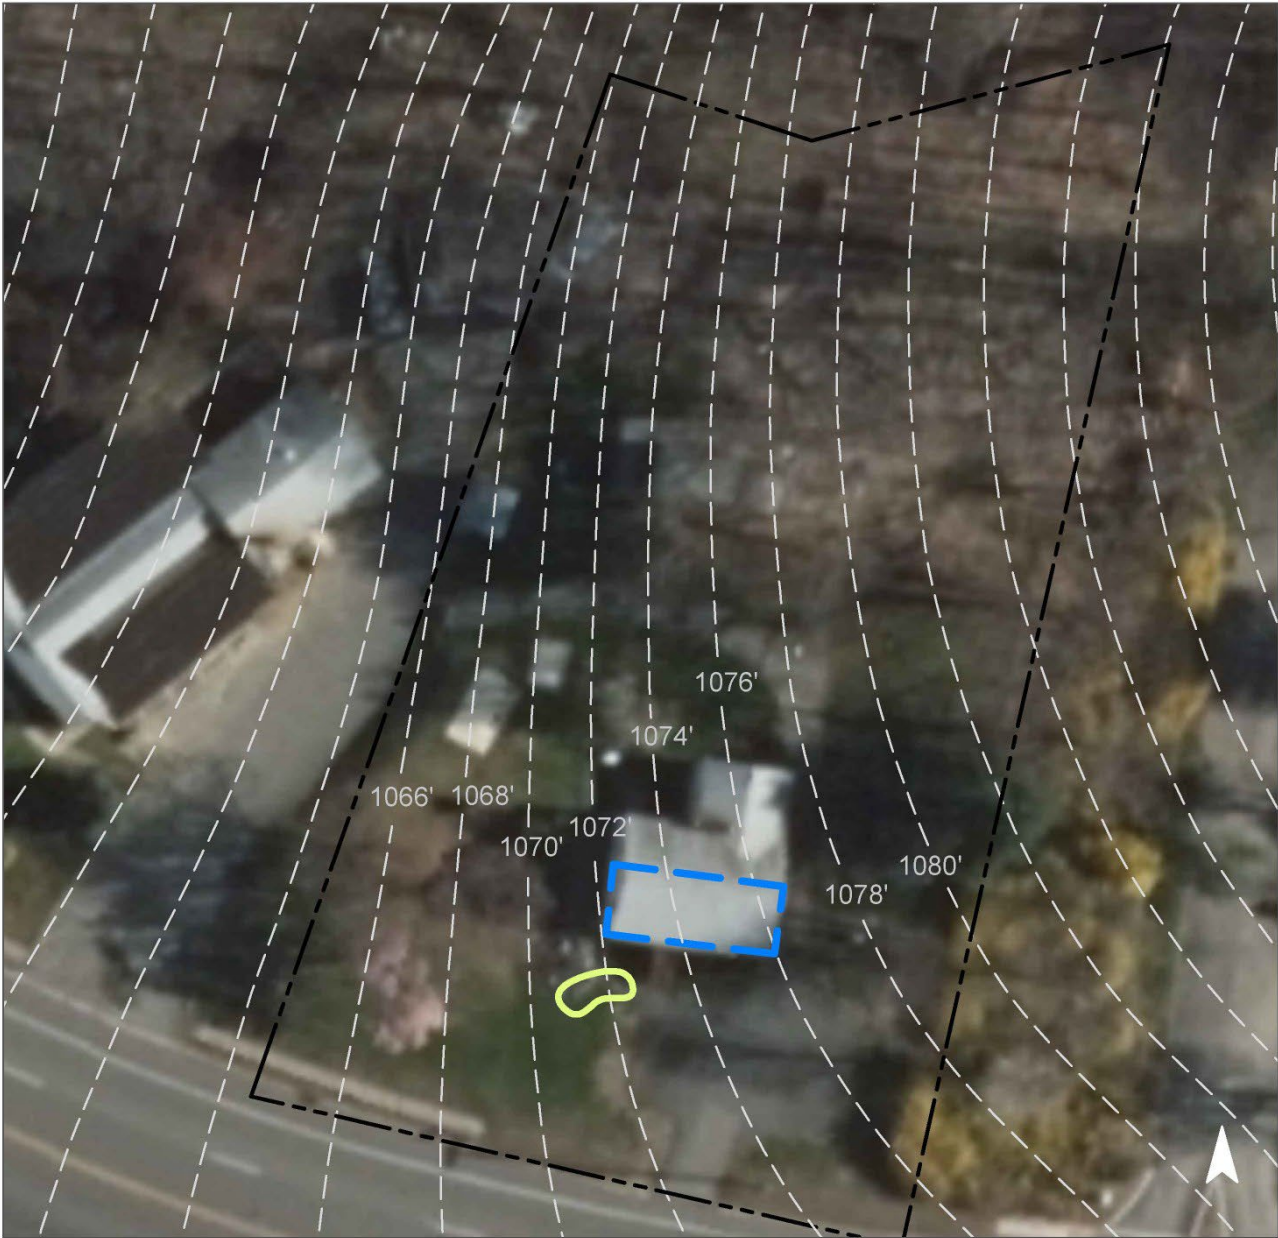
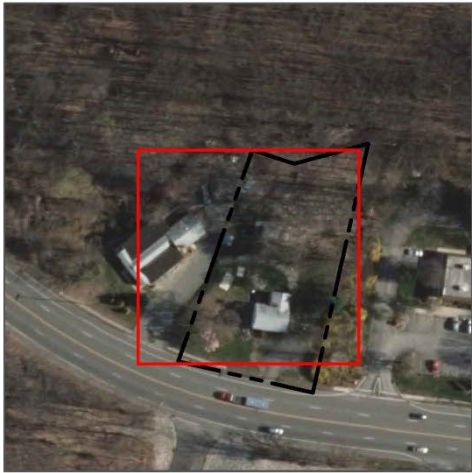
Saint Hubert's Animal Welfare Center Noah's Ark

Connected downspouts can be rerouted into the existing planter boxes to be converted into downspout planter boxes. Downspout planter boxes can be constructed along the building to allow roof runoff to be reused. Porous pavement can be installed in the main parking spaces to capture and infiltrate stormwater runoff from the parking lot. A preliminary soil assessment suggests that more soil testing would be required before determining the soil's suitability for green infrastructure.

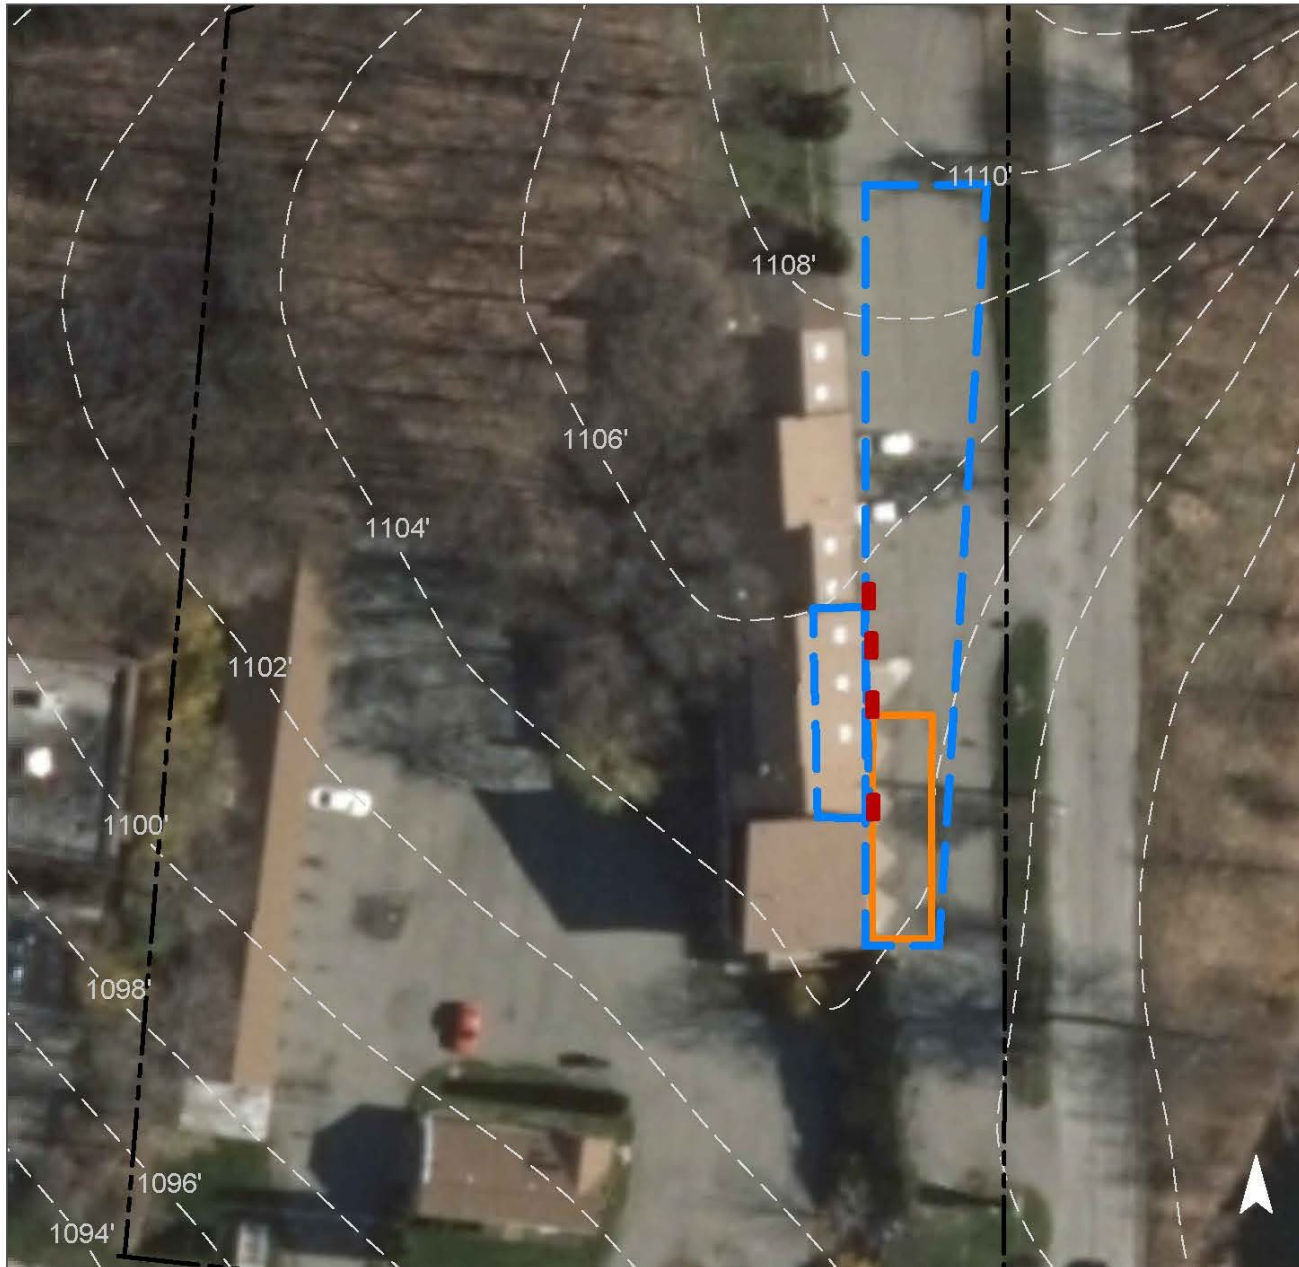
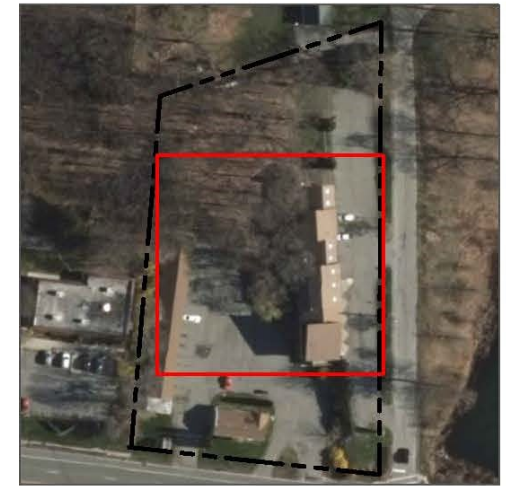
The Animal Hospital of Roxbury

-   pervious pavement
-   planter box
-   drainage area
-   property line
-   2015 Aerial: NJOIT, OGIS

Two rain gardens can be installed on either side of the parking lot to capture, treat, and infiltrate stormwater runoff from the parking lot. A preliminary soil assessment suggests that more soil testing would be required before determining the soil's suitability for green infrastructure.

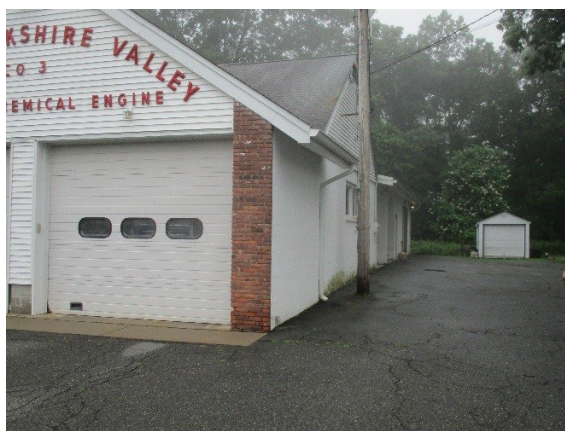
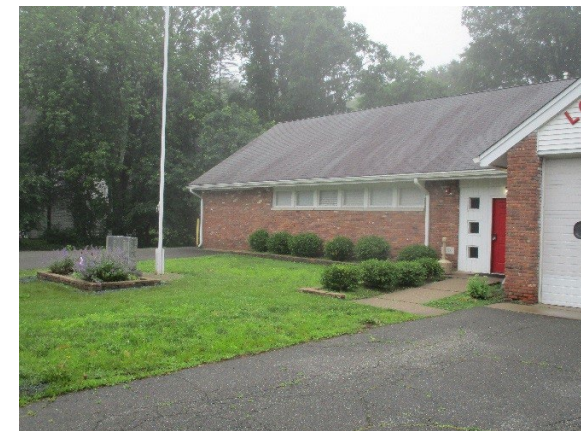
A rain garden can be installed near the entrance of the building to capture, treat, and infiltrate rooftop runoff. A cistern can be installed at the back of the building to capture roof runoff, which can be used for watering gardens, washing vehicles, or for other non-potable uses. Downspout planter boxes can be installed in front of the building to filter rooftop runoff and provide visual interest. A preliminary soil assessment suggests that more soil testing would be required before determining the soil's suitability for green infrastructure.

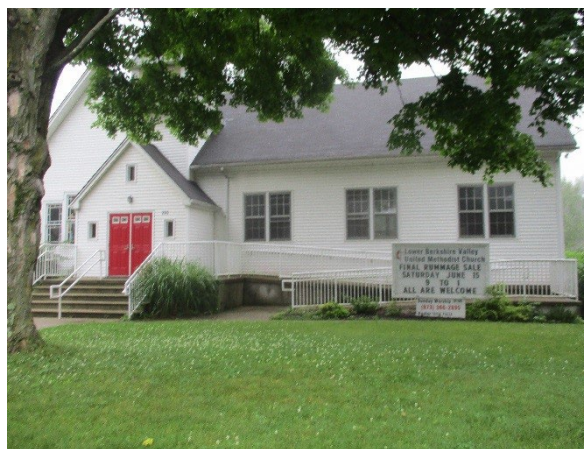
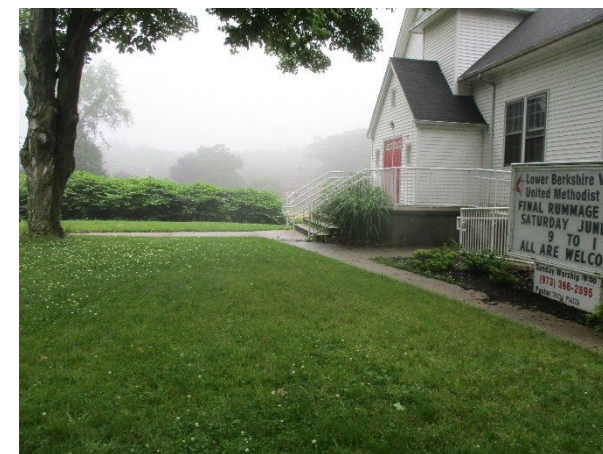
Block and Lot: Block 13002, Lot 1

A connected downspout can be disconnected and led into a rain garden on the north side of the building near the entrance to capture, treat, and infiltrate rooftop runoff. A preliminary soil assessment suggests that more soil testing would be required before determining the soil's suitability for green infrastructure.
