Impervious Cover Assessment for Manville Borough, Somerset County, New Jersey

Prepared for Manville Borough by the Rutgers Cooperative Extension Water Resources Program

February 6, 2015

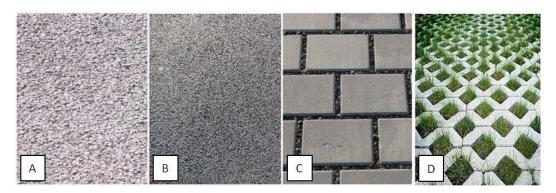
Permeable surfaces: (A) pervious concrete, (B) porous asphalt, (C) interlocking concrete pavers, (D) grid pavers (Rowe, 2012)

Pervious concrete and porous asphalt are the most common of the permeable surfaces. They are similar to regular concrete and asphalt but without the fine materials. This allows water to quickly pass through the material into an underlying layered system of stone that holds the water allowing it to infiltrate into the underlying uncompacted soil.

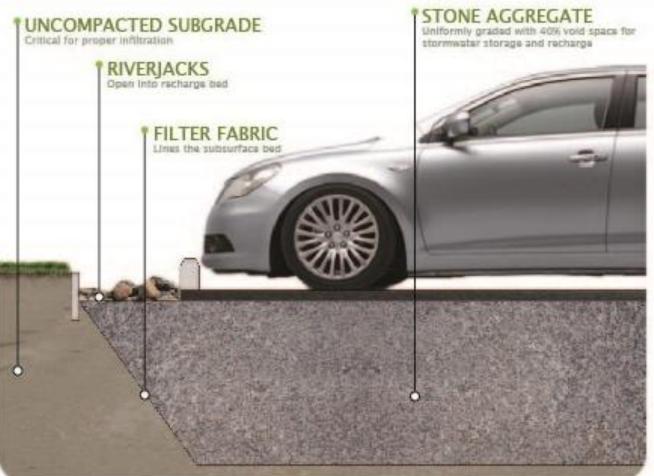
POROUS PAVEMENT

The paved over islands could be depaved and converted into bioswales to capture the stormwater runoff from the parking lot, with bioswale #1 in the middle of the parking lot and bioswale #2 along the southeast end. Additionally, the parking spaces along the southeast side can be replaced with porous pavement to capture, filter, and allow infiltration of stormwater runoff from both the parking lot and the small outlets.

The bioswale would reduce TN by 30%, TP by 60%, and TSS by 90% and would also provide ancillary benefits such as enhanced wildlife habitat and aesthetic appeal. Porous pavement allows stormwater to penetrate through to soil layers which will promote groundwater recharge as well as intercept and filter stormwater runoff. The porous pavement system is estimated to achieve a 95% pollutant load reduction for TN, TP, and TSS.

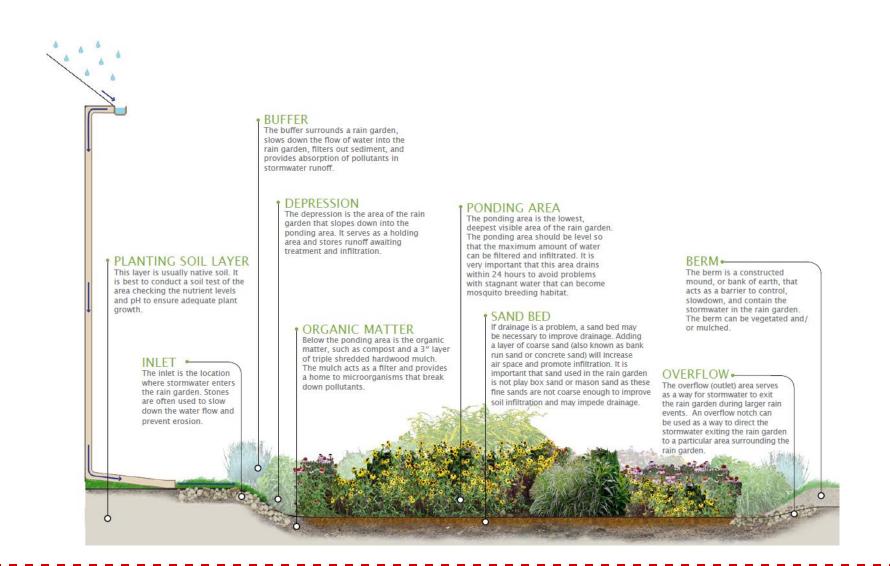
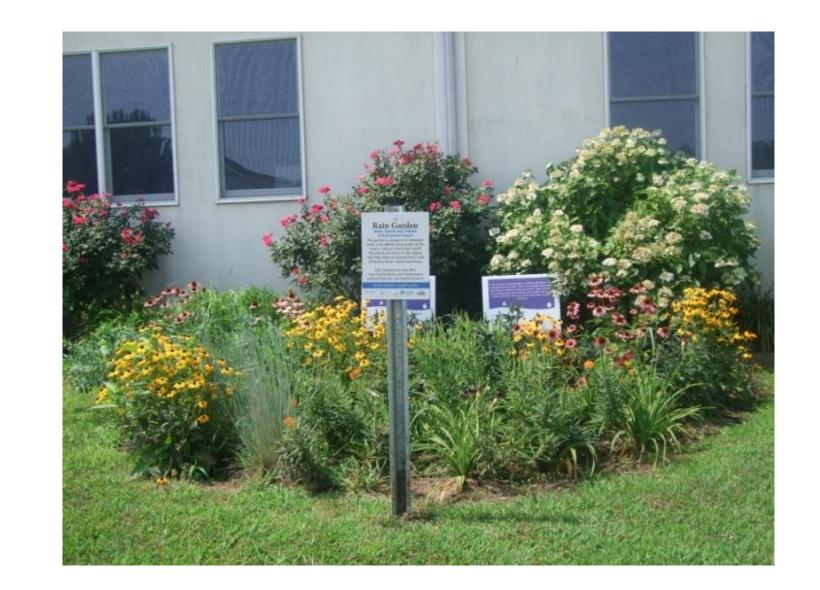
BIORETENTION SYSTEM

BIORETENTION SYSTEMS: Rain gardens can be used to reduce sediment and nutrient loading to the local waterway and increase groundwater recharge. This site has two locations along Roosevelt Avenue.

Along the Roosevelt Avenue side, there are five connected downspouts and one disconnected downspouts near the west corner. A bioretention system can be installed on each side of the walkway (western #1, eastern #2) which divides the turf grass area on this side of the building. Some or all of the connected downspouts can be disconnected and rerouted under the walkway to flow into the bioretention systems.

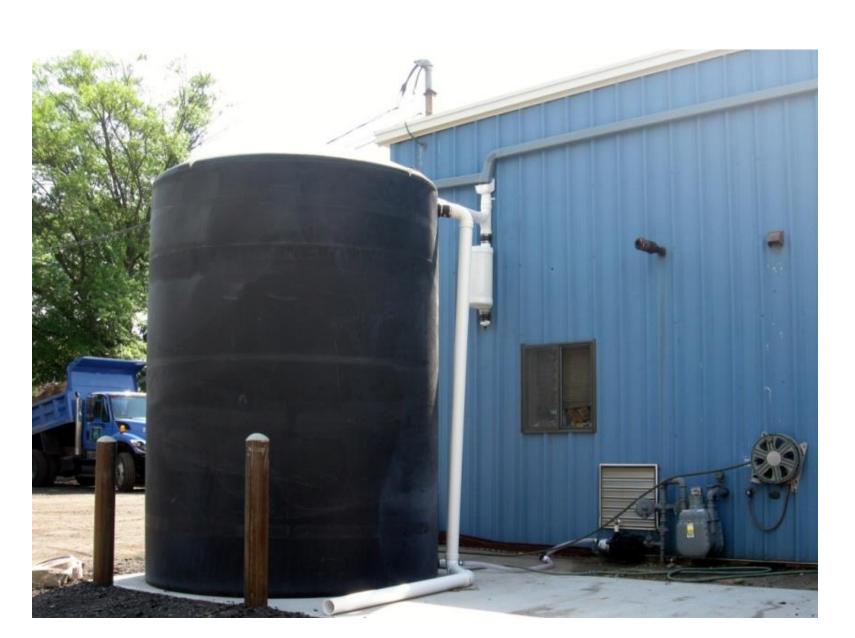
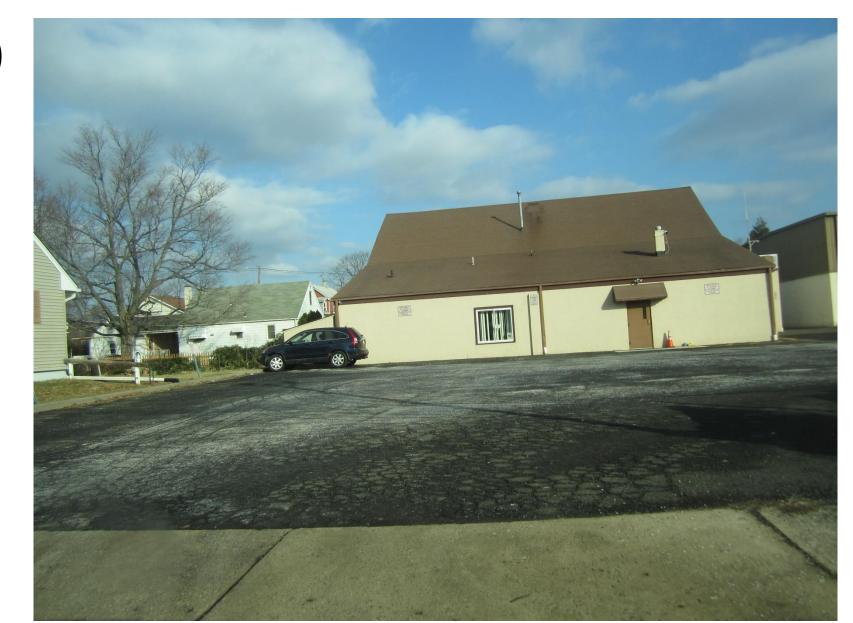
RAINWATER HARVESTING SYSTEM

RAINWATER HARVESTING SYSTEM: Rainwater can be harvested from the roof of the building and stored in a cistern. The water can then be used to wash the fire trucks.

A cistern can be installed to capture stormwater runoff from the roof by redirecting downspouts at the back face of the building into it.
