Impervious Cover Assessment for Millstone Township, Monmouth County, New Jersey

Prepared for Millstone Township by the Rutgers Cooperative Extension Water Resources Program

February 4, 2015

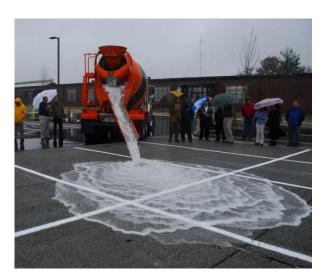
Figure 2: Rapid infiltration of water through porous pavement is demonstrated at the USEPA Edison New Jersey test site

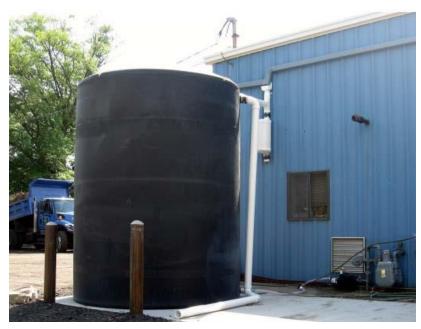
Figure 8b: A 5,000 gallon cistern used to disconnect the rooftop of the Department of Public Works in Clark Township to harvest rainwater for nonprofit car wash events

• Rainwater Harvesting: Rainwater harvesting includes the use of rain barrels and cisterns (Figures 8a and 8b). These can be placed below downspouts to collect rooftop runoff. The collected water has a variety of uses including watering plants and washing cars. This practice also helps cut down on the use of potable water for nondrinking purposes. It is important to divert the overflow from the rainwater harvesting system to a pervious area.

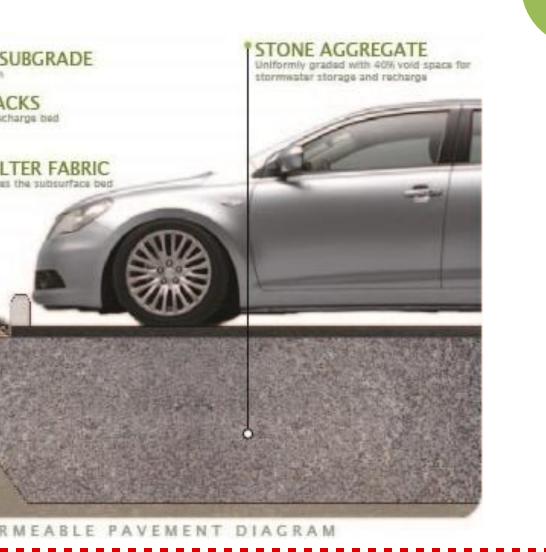
SITE PLAN:

Two bioretention systems could be installed on the lawn directly behind (or west of) the school. Each system would have three downspouts routed to it. The first system would be installed near the utility building behind the school; the second system would be installed in the interior area of the lawn. Two sections of the front parking lot could be repaved with porous pavement systems to better manage its stormwater.

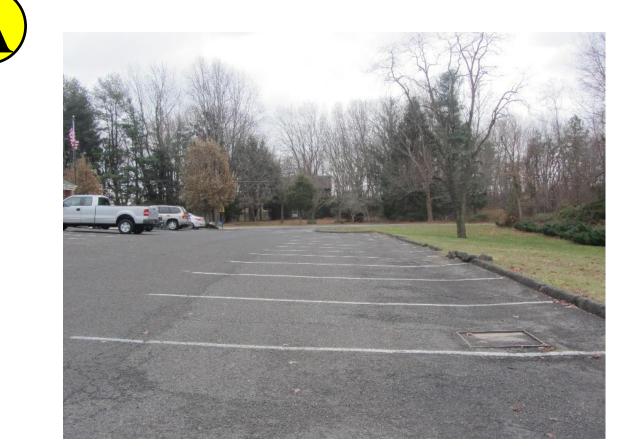
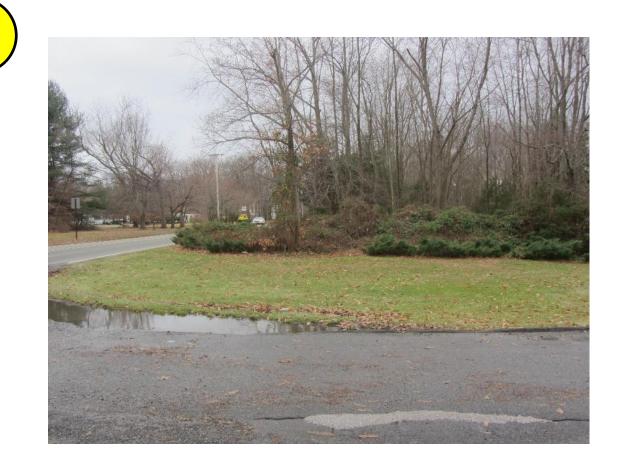
SITE PLAN:

- POROUS PAVEMENT: Porous pavement promotes groundwater recharge and filters treat, and infiltrate stormwater runoff.
- BIORETENTION SYSTEM: On this property a bioretention system or rain garden can be used to reduce sediment and nutrient loading to the local waterway and increase groundwater recharge. This garden could be installed along the main entrance.

A bioretention systems could be installed along the western side of the entrance to the post office to capture stormwater from the roadway and parking lot and enhance the visual appeal of this space. The southwest parking area could be repaved with porous asphalt with a stone reservoir underneath to store stormwater while it is slowly infiltrated.
