**Impervious Cover Reduction Action Plan  
for  
Marlboro Township, Monmouth County, New Jersey**

*Prepared for Marlboro Township by the  
Rutgers Cooperative Extension Water Resources Program*

October 6, 2015

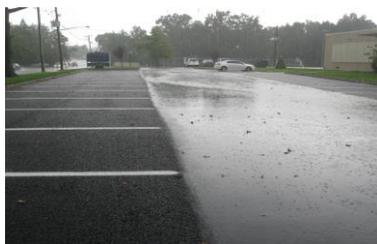
There are several types of permeable pavement systems including porous asphalt, pervious concrete, permeable pavers, and grass pavers. These surfaces are hard and support vehicle traffic but also allow water to infiltrate through the surface. They have an underlying stone layer to store stormwater runoff and allow it to slowly seep into the ground.

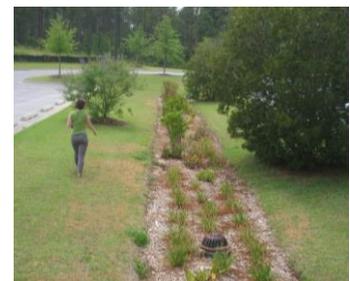
Bioswales are landscape features that convey stormwater from one location to another while removing pollutants and providing water an opportunity to infiltrate.

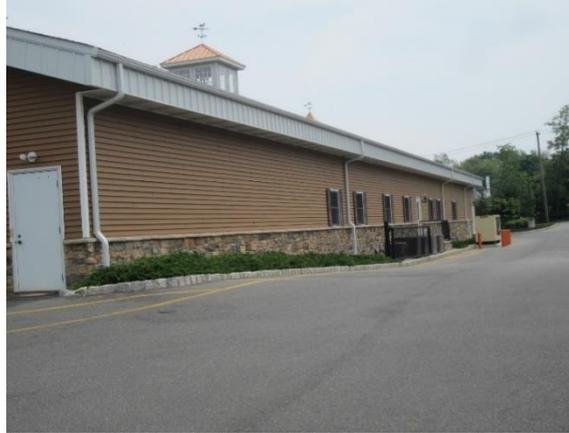
The building has directly connected downspouts. Most runoff is directed into a detention basin to the north. Pervious pavement can be utilized in the parking lot to capture and infiltrate this runoff. A rain garden can be constructed near the roadway to capture, treat, and infiltrate additional stormwater from the driveway. A preliminary soil assessment suggests that the soils have suitable drainage characteristics for green infrastructure.

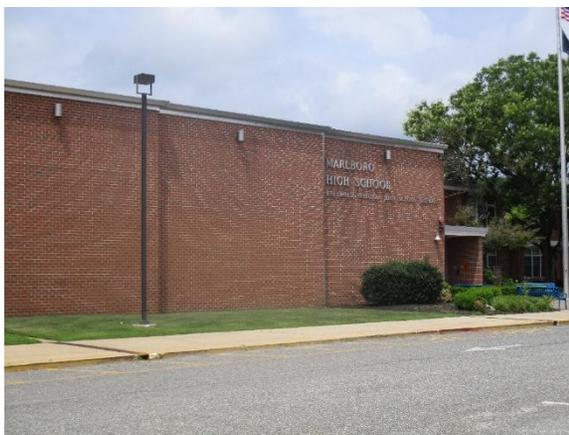
Most of the building has internal drainage, except at the front where downspouts drain onto the driveway. A rain garden can be constructed in front of the school to capture, treat, and infiltrate runoff. Pervious pavement can also be used to replace parking spaces to capture and infiltrate stormwater runoff. A preliminary soil assessment suggests that the soils have suitable drainage characteristics for green infrastructure.

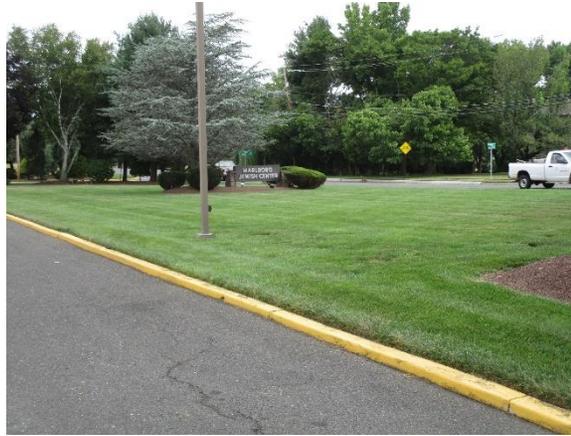
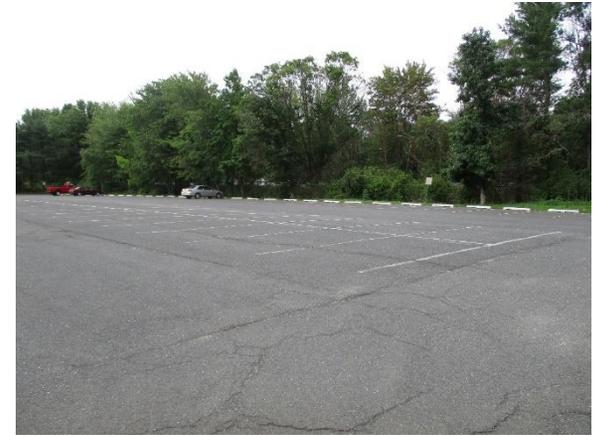
**Block and Lot:** Block 322, Lot 20

Most of the building has internal drainage. The front driveway drains into the roadway, and the parking lot drains into a swale near the highway. A rain garden can be installed in front of the building to treat stormwater from the driveway. Pervious pavement can replace parking spaces along the southwest edge of the parking lot to capture and infiltrate runoff. A preliminary soil assessment suggests that the soils have suitable drainage characteristics for green infrastructure.

Recommended Green Infrastructure Practices	Recharge Potential (Mgal/yr)	TSS Removal Potential (lbs/yr)	Maximum Volume Reduction Potential (gal/storm)	Peak Discharge Reduction Potential (cu. ft./second)	Estimated Size (sq. ft.)	Estimated Cost
Bioretention systems	0.115	19	8,677	0.33	1,465	\$7,325
Pervious pavements	0.967	162	73,274	2.75	6,000	\$150,000

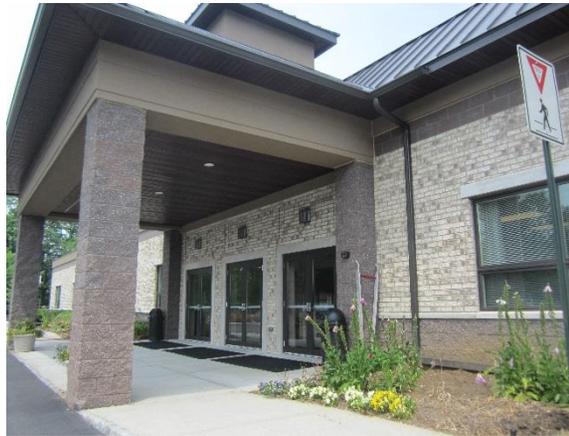
Runoff from the roof and parking lot appears to drain into an existing bioswale. A rain garden can be constructed in the turf grass area south of the Worship Center to capture, treat, and infiltrate some of this runoff. A preliminary soil assessment suggests that more soil testing would be required before determining the soil's suitability for green infrastructure.

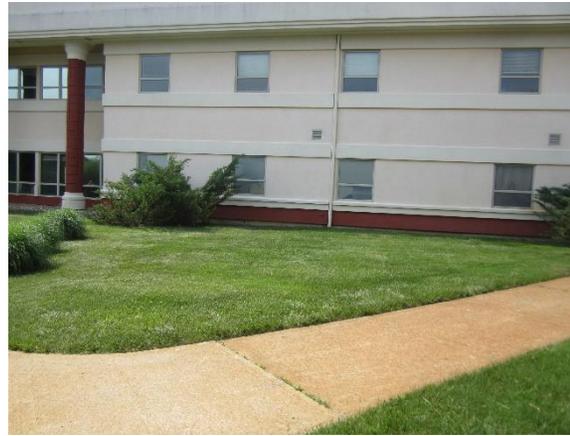
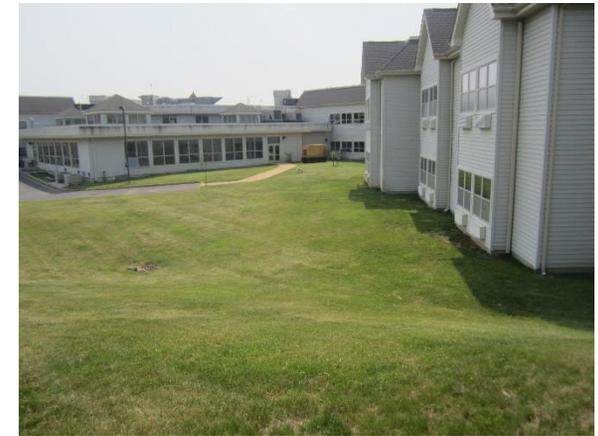
**Block and Lot:** Block 157, Lot 34.02

New Hope has a mix of connected and disconnected downspouts, as well as internal drainage. The paved areas drain into catch basin's and all runoff appears to flow into a detention basin at the site's south end. There are several areas where rain garden can be installed to capture, treat, and infiltrate roof runoff. Parking spaces can also be replaced with pervious pavement to capture and infiltrate stormwater. A preliminary soil assessment suggests that the soils have suitable drainage characteristics for green infrastructure.

Recommended Green Infrastructure Practices	Recharge Potential (Mgal/yr)	TSS Removal Potential (lbs/yr)	Maximum Volume Reduction Potential (gal/storm)	Peak Discharge Reduction Potential (cu. ft./second)	Estimated Size (sq. ft.)	Estimated Cost
Bioretention systems	0.208	35	15,790	0.59	2,000	\$10,000
Pervious pavements	0.256	43	19,411	0.73	2,100	\$52,500

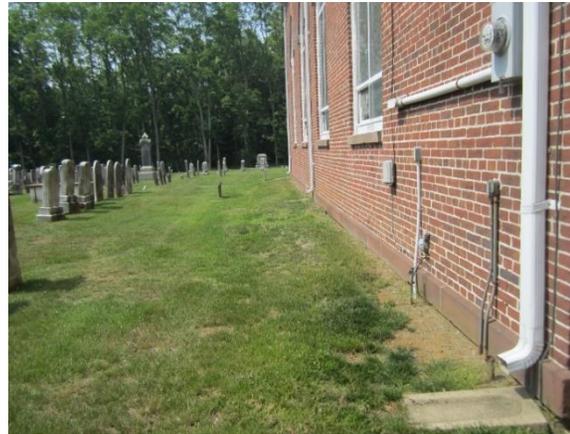
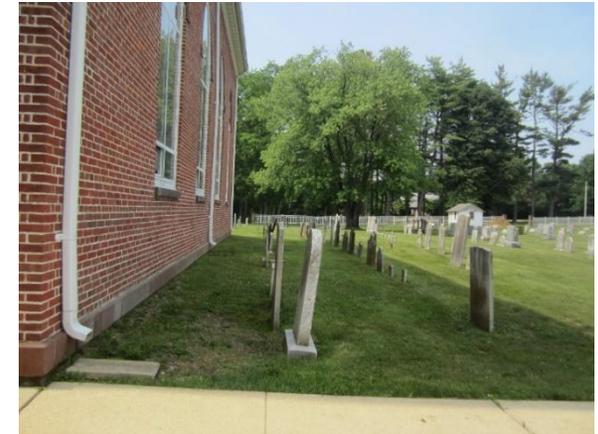
Roof runoff currently flows into six disconnected downspouts. Each downspout can be rerouted into planter boxes to reuse this runoff. A preliminary soil assessment suggests that the soils have suitable drainage characteristics for green infrastructure.

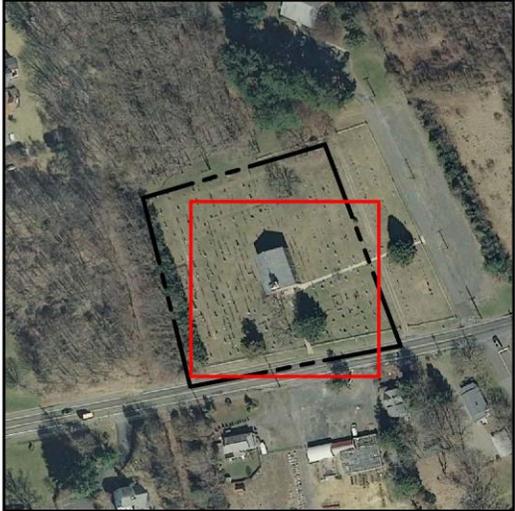
**Old Brick Reformed Church**

The building has internal drainage. Parking lot runoff currently flows into storm drains. Bioretention systems can be installed north and south of the facility to capture, treat and infiltrate runoff from the parking lot and driveway. Parking spaces can also be converted into pervious pavement to capture and infiltrate additional stormwater. A preliminary soil assessment suggests that the soils have suitable drainage characteristics for green infrastructure.

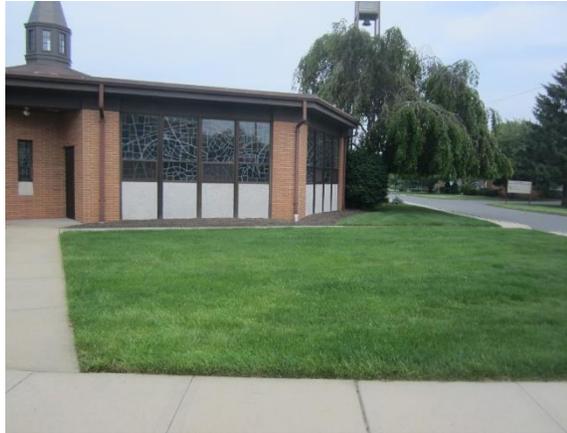
This church has several buildings with a mix of connected and disconnected downspouts. The parking lots drain to various catch basins. Runoff appears to flow into a detention basin on site. There are several locations where rain gardens can be installed to capture, treat, and infiltrate runoff from the rooftops as well as from the pavement. Parking spaces can be replaced with porous asphalt to capture additional runoff. A preliminary soil assessment suggests that the soils have suitable drainage characteristics for green infrastructure.

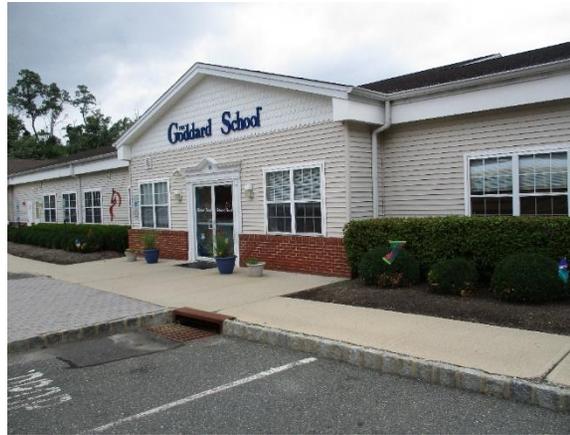
A bioretention system can be constructed in the front to capture, treat, and infiltrate driveway runoff. Another rain garden can be installed in the back to treat roof runoff by disconnecting two downspouts. Parking spaces can also be replaced with porous asphalt to capture and infiltrate parking lot runoff. A preliminary soil assessment suggests that the soils have suitable drainage characteristics for green infrastructure.

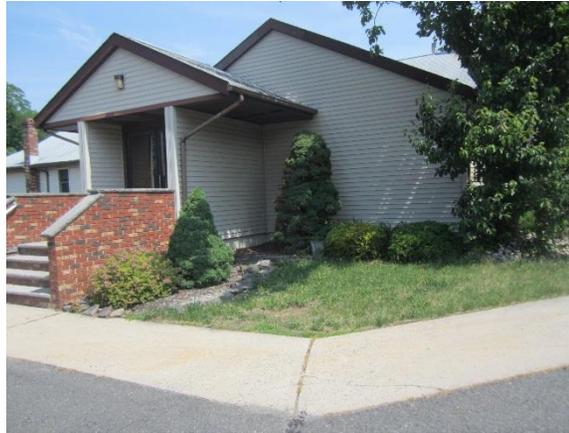
Stormwater from the roof flows into several connected downspouts. The parking lot runoff flows to the west end of the parking lot. Bioretention systems can be installed on the western side of the property to capture, treat, and infiltrate this runoff. A preliminary soil assessment suggests that the soils have suitable drainage characteristics for green infrastructure.

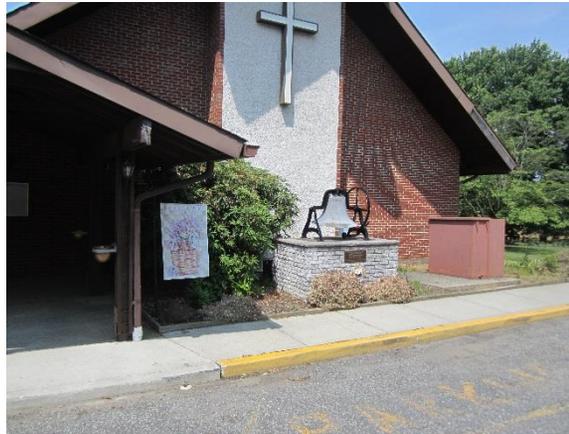
There are three locations where rain gardens can be installed to capture, treat, and infiltrate rooftop runoff by disconnecting and redirecting downspouts. A preliminary soil assessment suggests that the soils have suitable drainage characteristics for green infrastructure.

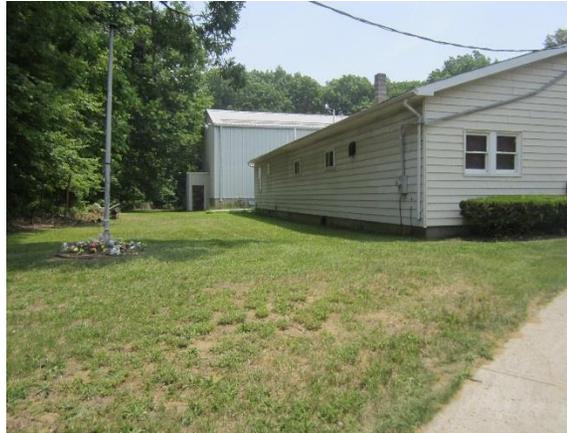
Rain gardens can be installed to capture, treat, and infiltrate runoff from the roof by redirecting downspouts. Parking spaces can be replaced with pervious pavement to capture and infiltrate stormwater. A preliminary soil assessment suggests that the soils have suitable drainage characteristics for green infrastructure.

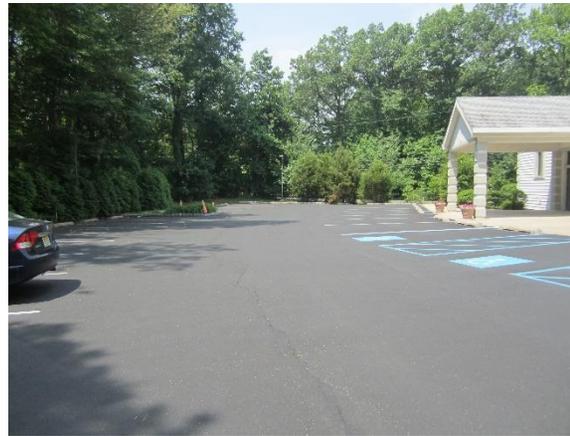
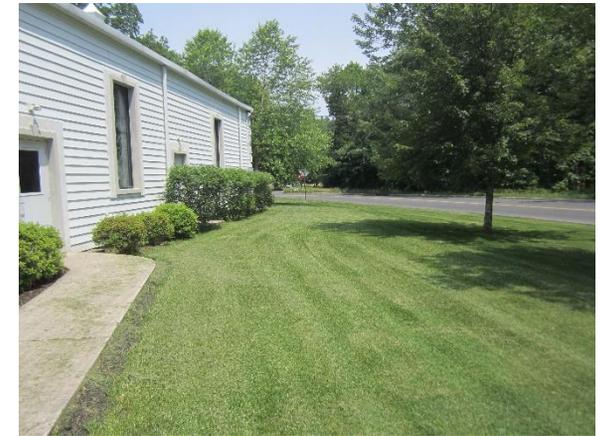
**Block and Lot:** Block 300.02, Lot 1

Stormwater from the roof flows into directly connected downspouts. Parking lot runoff drains into a forested area to the south. The downspouts on the east and west sides of the building can be disconnected into bioretention systems to allow roof runoff to be captured, treated, and infiltrated. Parking lot runoff can be captured and infiltrated by replacing parking spaces with pervious pavement. A preliminary soil assessment suggests that the soils have suitable drainage characteristics for green infrastructure.

Recommended Green Infrastructure Practices	Recharge Potential (Mgal/yr)	TSS Removal Potential (lbs/yr)	Maximum Volume Reduction Potential (gal/storm)	Peak Discharge Reduction Potential (cu. ft./second)	Estimated Size (sq. ft.)	Estimated Cost
Bioretention systems	0.141	24	10,696	0.40	1,350	\$6,750
Pervious pavements	0.204	34	15,476	0.58	1,700	\$42,500

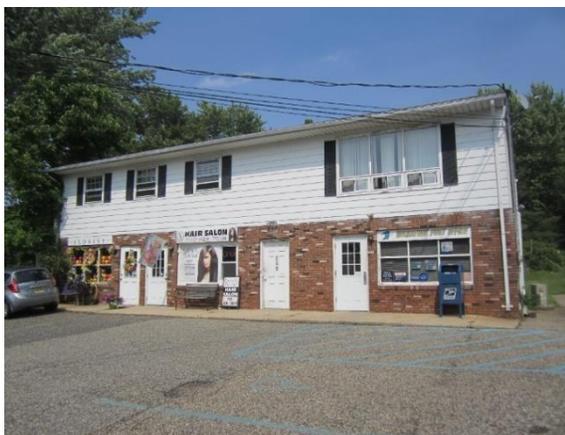
Roof runoff flows through disconnected downspouts into the parking lot, and to the rear of building. Parking spaces can be replaced with pervious pavement to capture parking lot and roof runoff. A rain garden can be installed in the rear of the building to capture, treat, and infiltrate roof runoff as well. A preliminary soil assessment suggests that more soil testing would be required before determining the soil's suitability for green infrastructure.

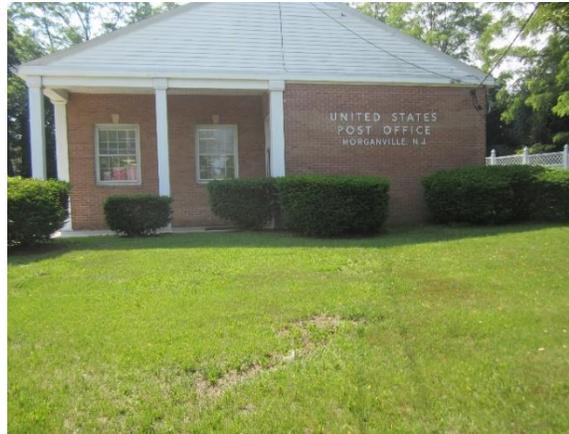
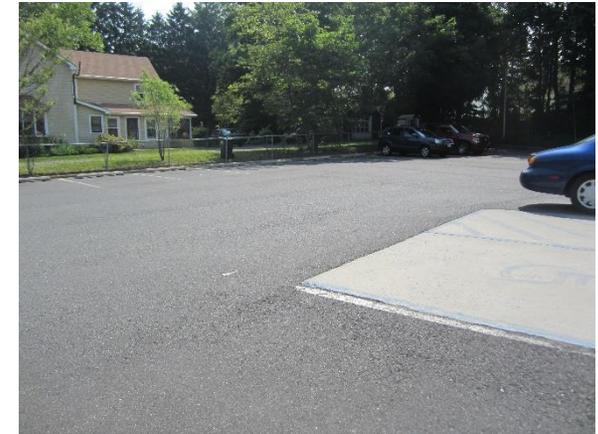
Stormwater flows from the roof into connected downspouts on the north face of the building, and disconnected downspouts on the south face. The parking lot drains into a storm drain in the north corner. Downspouts can be redirected into a bioretention system in front of the building to treat roof runoff. Parking lot runoff can be captured by replacing parking spaces with pervious pavement. A preliminary soil assessment suggests that the soils have suitable drainage characteristics for green infrastructure.

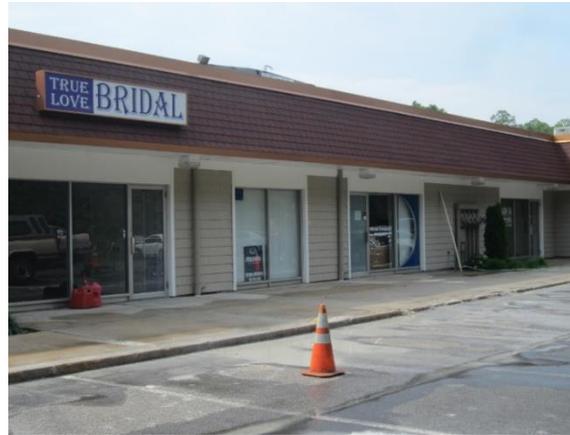
This commercial complex contains several connected downspouts and storm drains that release stormwater into an existing bioswale. A rain garden can be constructed near the road to capture, treat, and infiltrate runoff. Pervious pavement can replace traditional asphalt in parking areas, to capture and infiltrate additional stormwater. A preliminary soil assessment suggests that the soils have suitable drainage characteristics for green infrastructure.

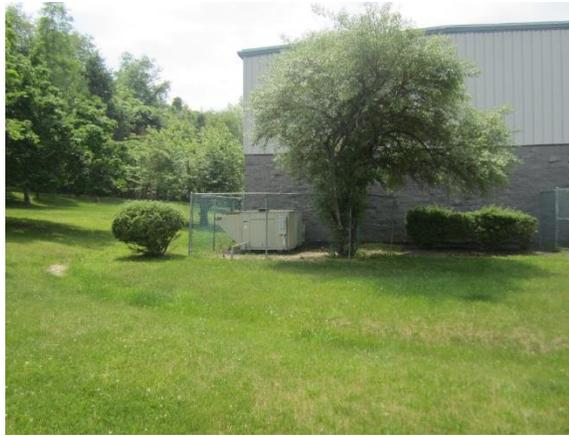
This site has both connected and disconnected downspouts; disconnected downspouts flow onto the grass. The parking lot also flows into the surrounding turf grass. Rain gardens can be installed to capture, treat, and infiltrate this runoff, as well as some roof runoff. A preliminary soil assessment suggests that the soils have suitable drainage characteristics for green infrastructure.

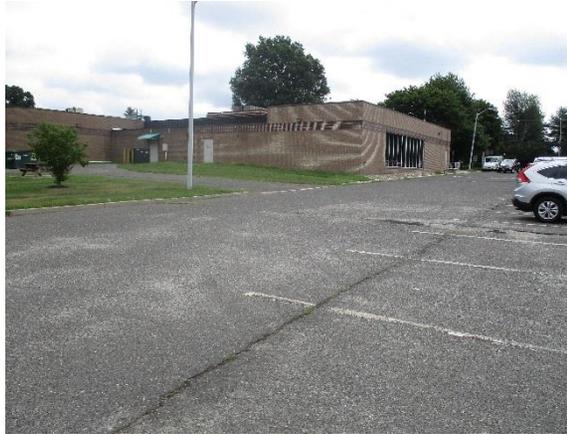
This library's parking lot drains into a turf grass field. Rain gardens can capture, treat, and infiltrate this runoff, as well as some of the buildings rooftop runoff. A preliminary soil assessment suggests that the soils have suitable drainage characteristics for green infrastructure.

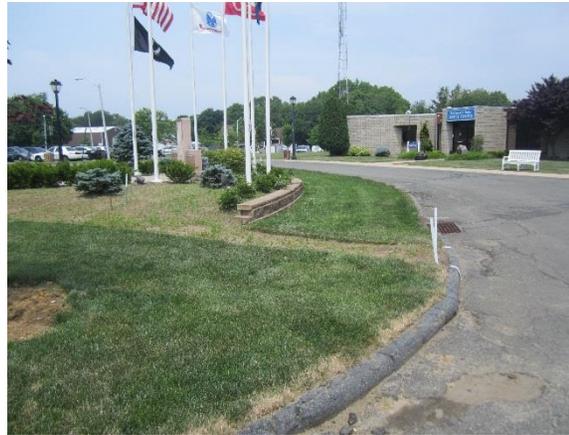
Several buildings have either connected downspouts or internal drainage. One building has disconnected downspouts that releases runoff onto the grass. Bioretention systems can be installed to capture, treat, and infiltrate both roof and parking lot runoff. A preliminary soil assessment suggests that the soils have suitable drainage characteristics for green infrastructure.

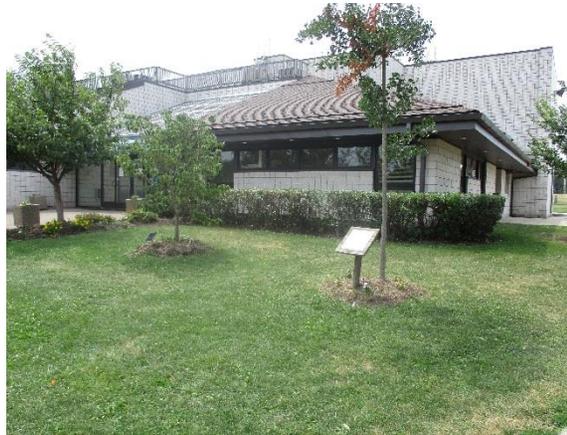
The recreation center's parking lot drains to the north. Parking spaces can be converted into pervious pavement to capture and infiltrate this runoff. The building already has disconnected downspouts that flow onto the grass and then into catch basins. Rain gardens can be installed to capture, treat and infiltrate this runoff. A preliminary soil assessment suggests that the soils have suitable drainage characteristics for green infrastructure.

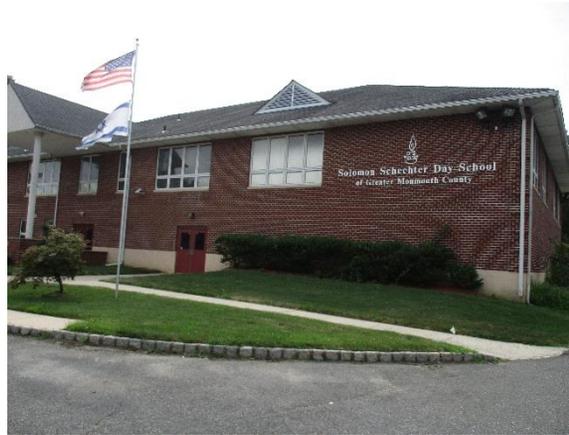
Rain gardens can be constructed at several locations to capture, treat, and infiltrate roof runoff. An additional rain garden can be installed to manage runoff from the driveway. A row of parking spaces can be replaced with pervious pavement to capture and infiltrate parking lot runoff. A preliminary soil assessment suggests that the soils have suitable drainage characteristics for green infrastructure.

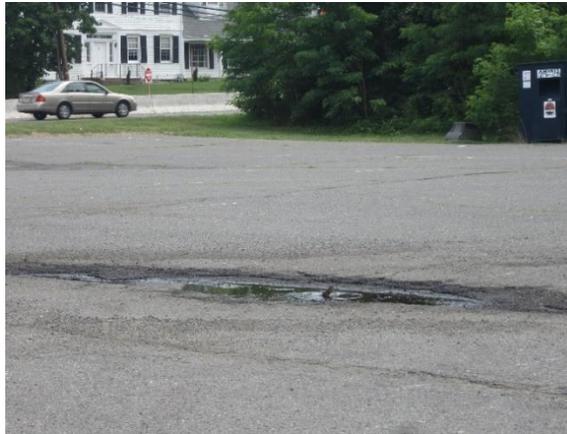
Stormwater from the roof flows through disconnected downspouts onto the pavement. Rain gardens can be constructed at two locations to capture, treat, and infiltrate parking lot runoff. Parking spaces can also be replaced with pervious pavement to capture and infiltrate additional stormwater. A preliminary soil assessment suggests that the soils have suitable drainage characteristics for green infrastructure.
