**Impervious Cover Reduction Action Plan
for
Metuchen Borough, Middlesex County, New Jersey**

*Prepared for Metuchen Borough by the
Rutgers Cooperative Extension Water Resources Program*

October 6, 2015

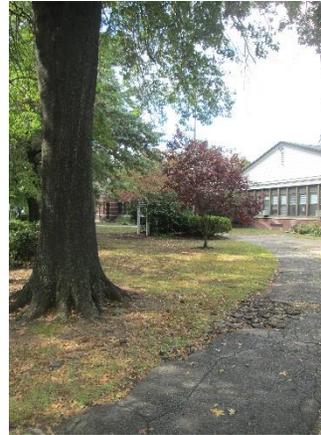
Address: 24 Durham Avenue
Metuchen, NJ 08840

On the east side of the school, two rain gardens can be installed to capture, treat, and infiltrate roof runoff by disconnecting and redirecting adjacent downspouts. A preliminary soil assessment suggests that the soils have suitable drainage characteristics for green infrastructure.

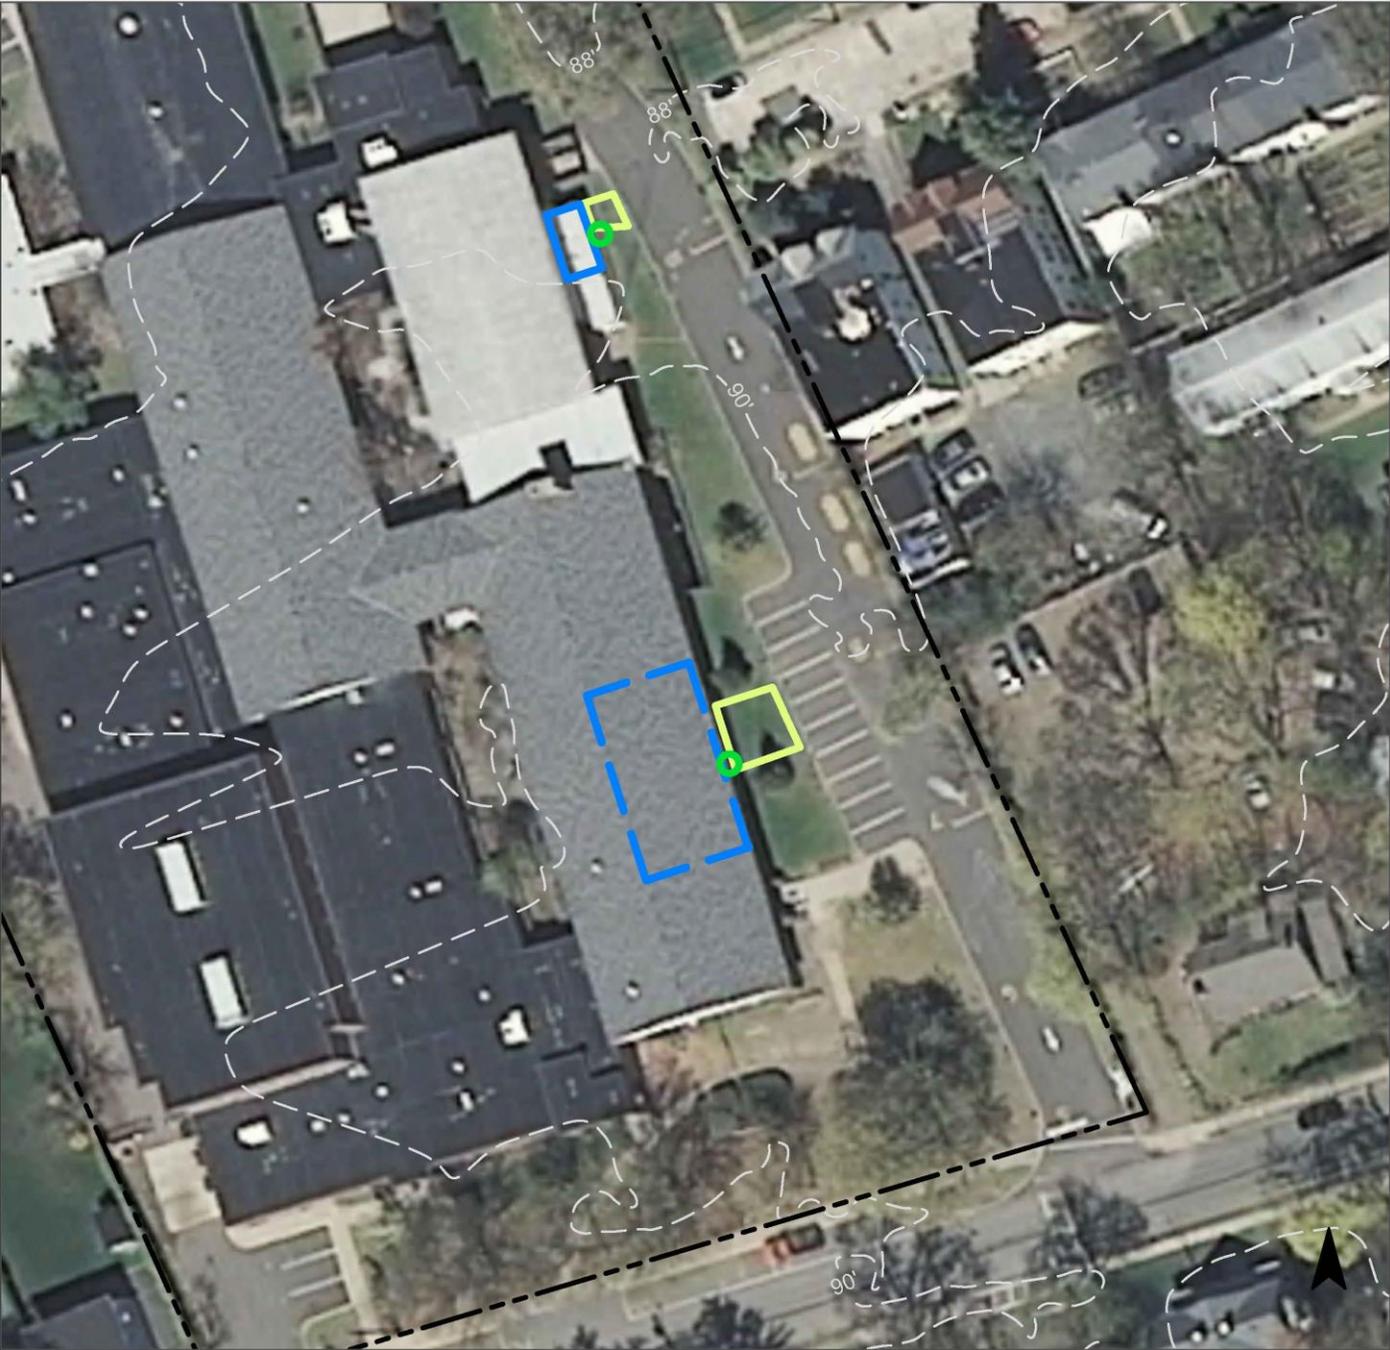
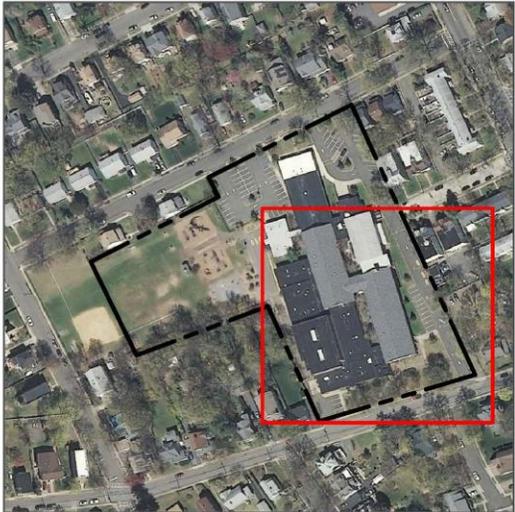
Campbell Elementary

Recommended Green Infrastructure Practices	Recharge Potential (Mgal/yr)	TSS Removal Potential (lbs/yr)	Maximum Volume Reduction Potential (gal/storm)	Peak Discharge Reduction Potential (cu. ft./second)	Estimated Size (sq. ft.)	Estimated Cost
Bioretention systems	0.060	8	4,376	0.16	513	\$2,565

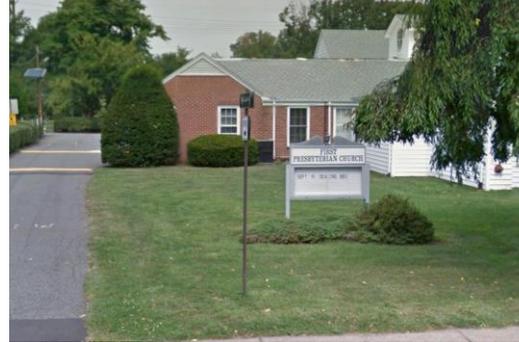
Address: 270 Woodbridge Avenue
Metuchen, NJ 08840

All of the church's downspouts are directly connected. A rain garden can capture, treat and infiltrate driveway runoff. Parking spaces can be replaced with porous asphalt to infiltrate parking lot runoff. A preliminary soil assessment suggests that the soils have suitable drainage characteristics for green infrastructure.

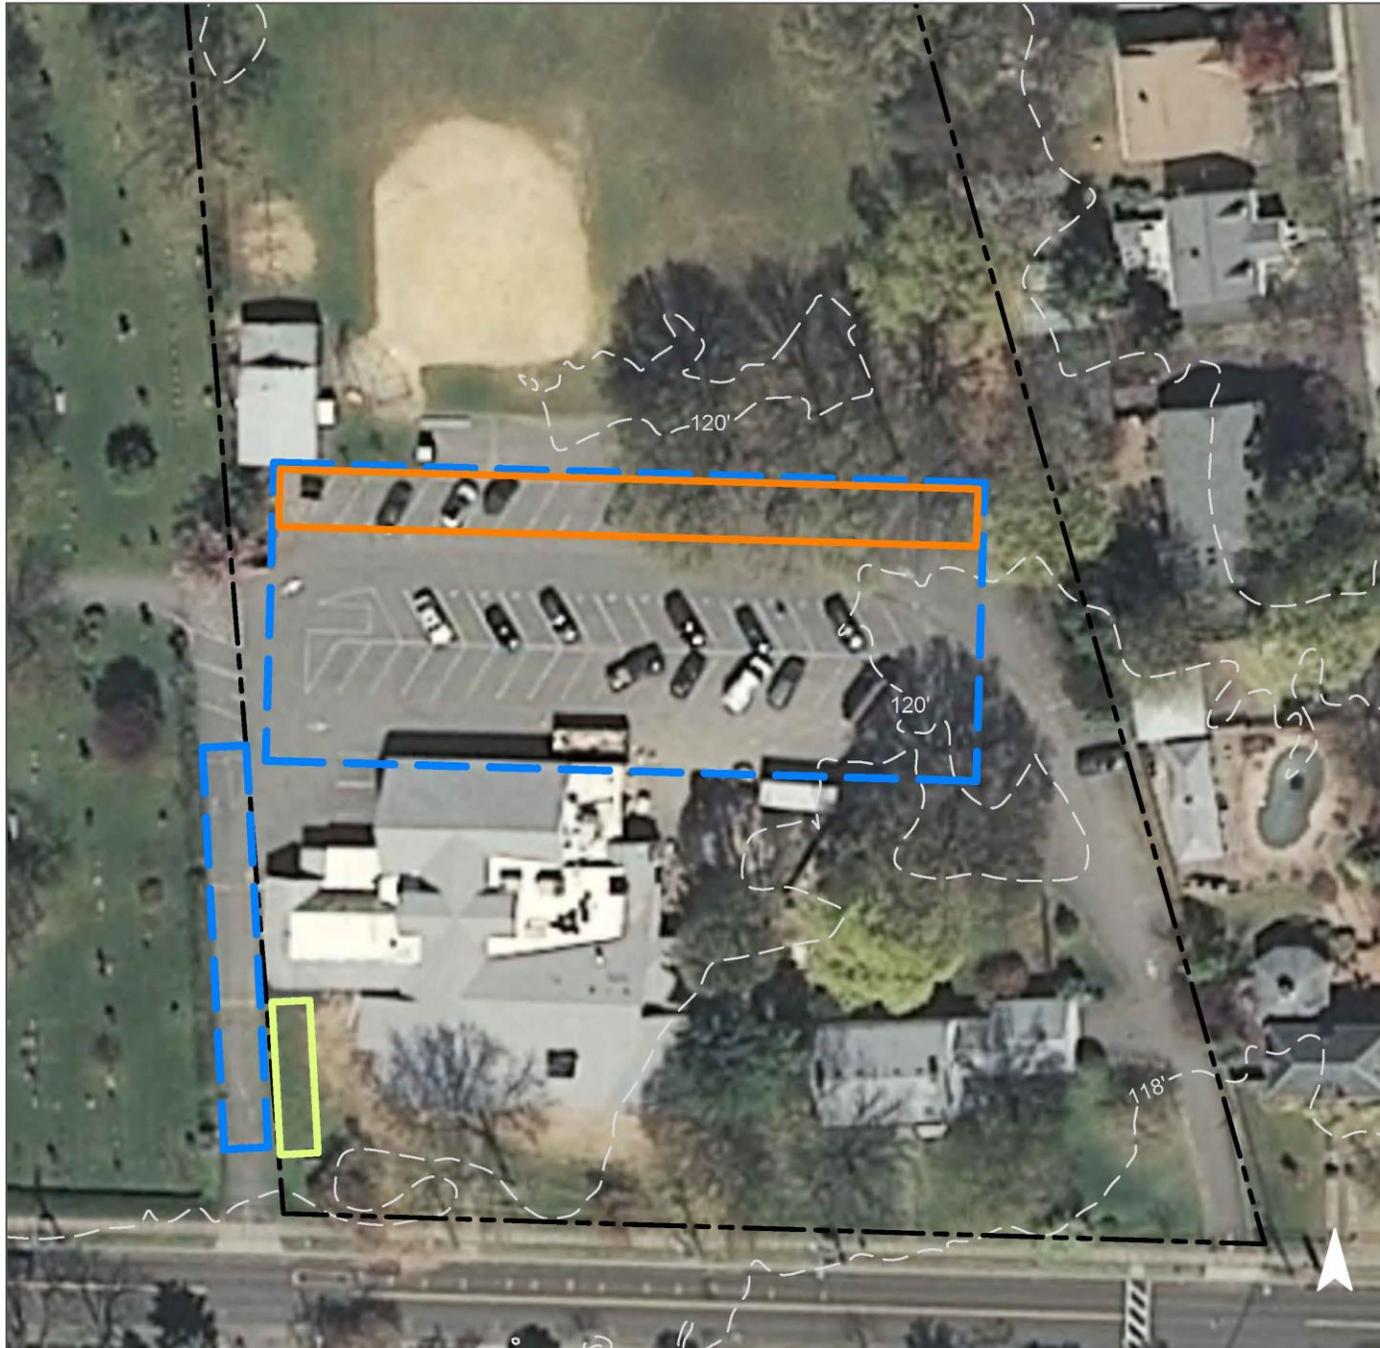
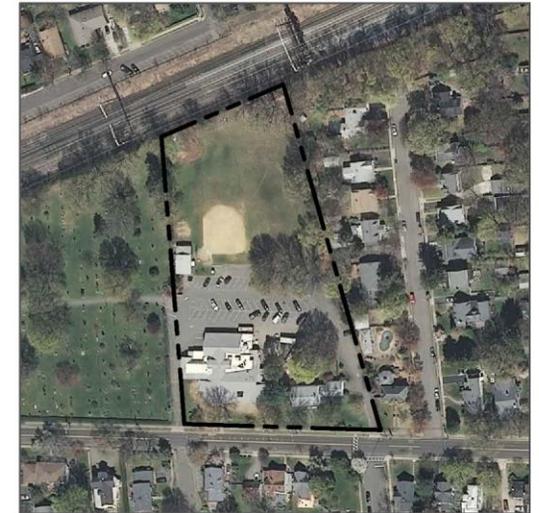
First Presbyterian Church

Recommended Green Infrastructure Practices	Recharge Potential (Mgal/yr)	TSS Removal Potential (lbs/yr)	Maximum Volume Reduction Potential (gal/storm)	Peak Discharge Reduction Potential (cu. ft./second)	Estimated Size (sq. ft.)	Estimated Cost
Bioretention systems	0.046	6	3,344	0.13	567	\$2,835
Pervious pavements	0.544	77	39,921	1.50	3,949	\$98,725

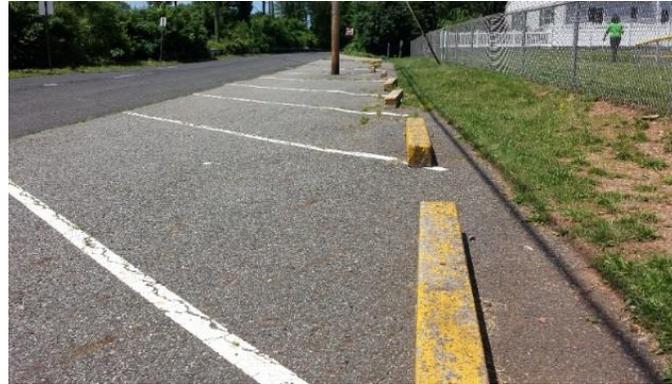
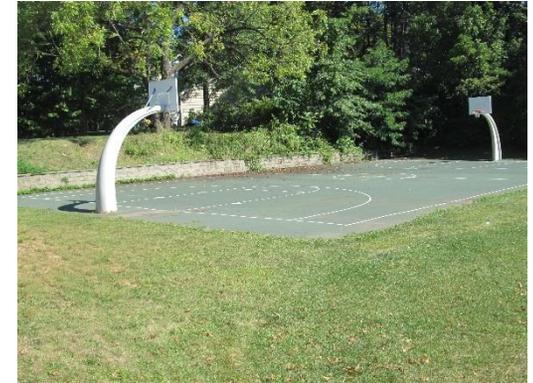
Hampton Park has a basketball court that can be repaved with pervious pavement to infiltrate stormwater. A bioswale and bioretention system can be installed adjacent to the parking area to capture, treat, and infiltrate runoff. A preliminary soil assessment suggests that more soil testing would be required before determining the soil's suitability for green infrastructure.

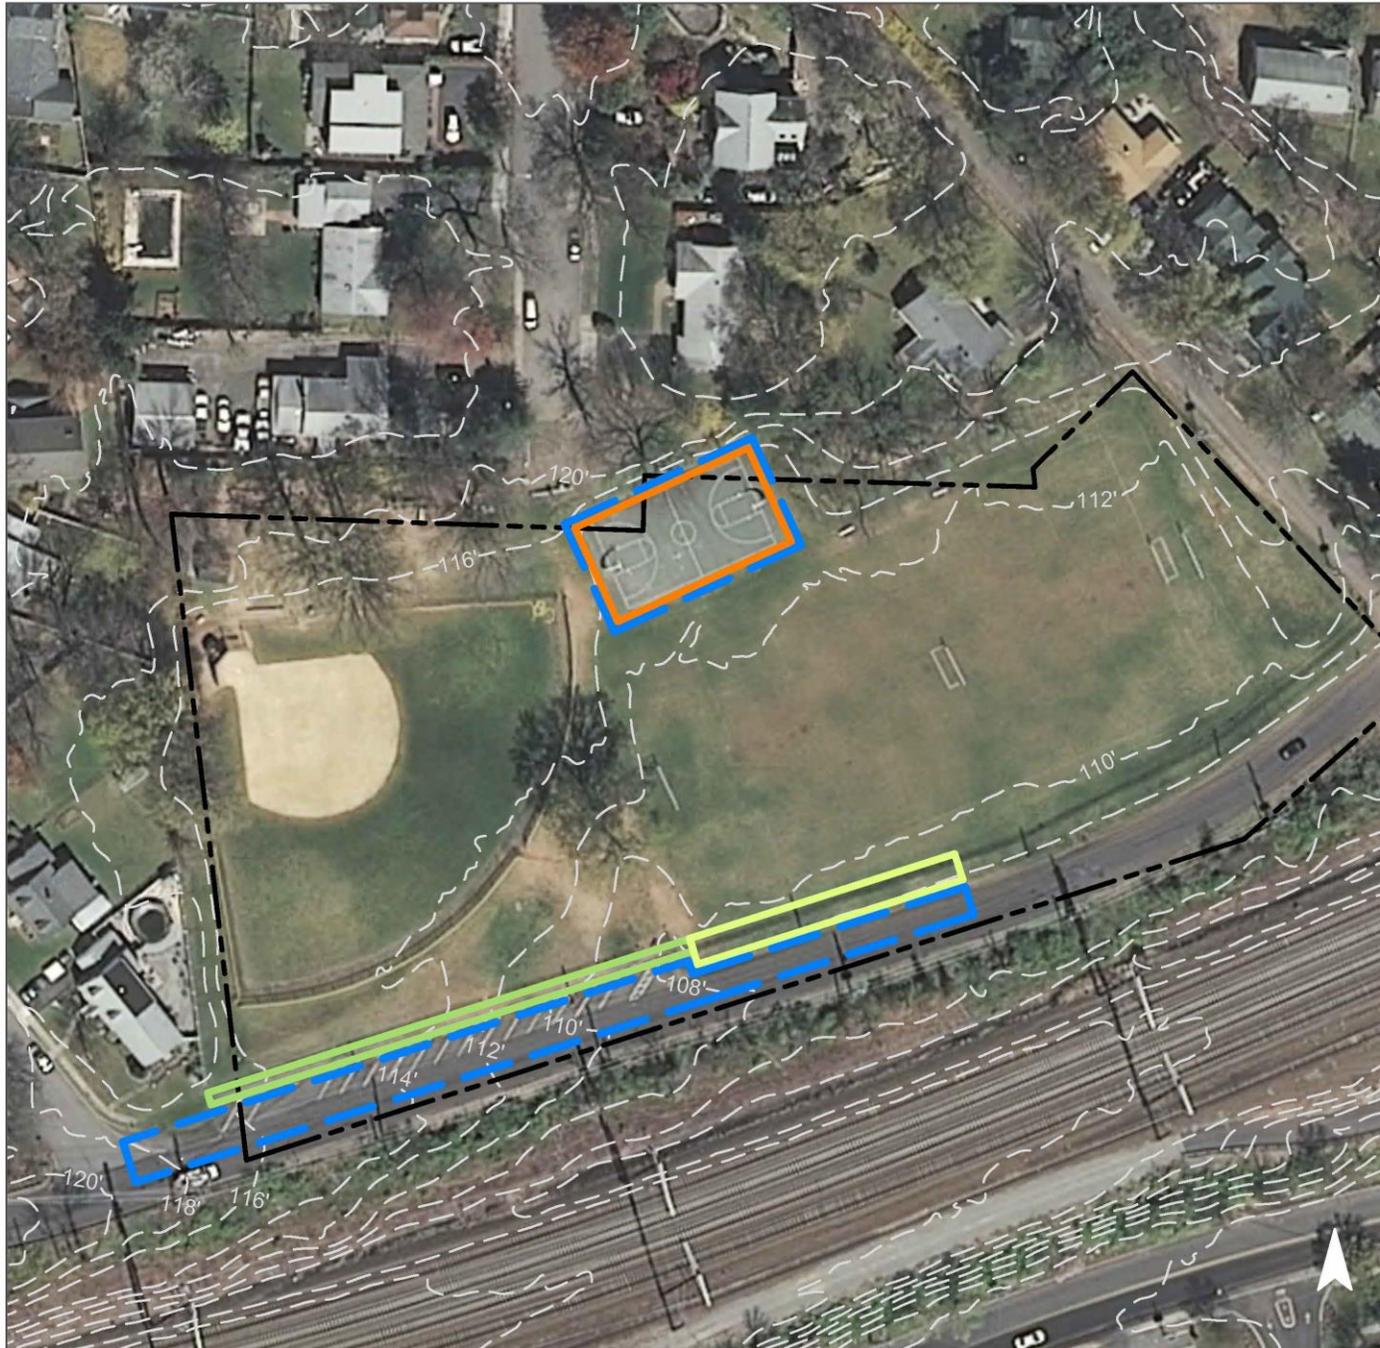
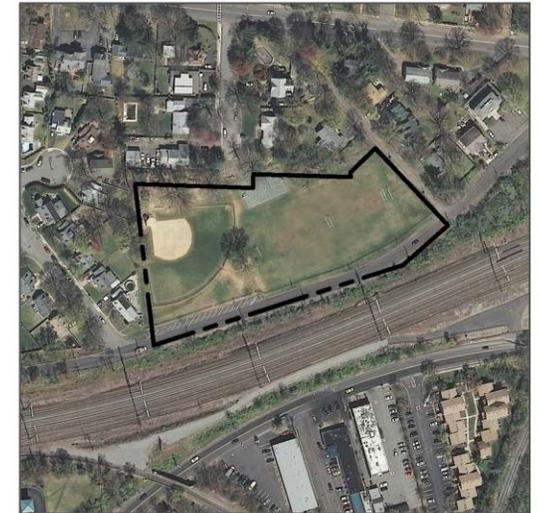
Hampton Park

Recommended Green Infrastructure Practices	Recharge Potential (Mgal/yr)	TSS Removal Potential (lbs/yr)	Maximum Volume Reduction Potential (gal/storm)	Peak Discharge Reduction Potential (cu. ft./second)	Estimated Size (sq. ft.)	Estimated Cost
Bioretention systems	0.130	18	9,530	0.36	2,072	\$10,360
Bioswales	0.109	15	7,974	0.30	1,734	\$8,670
Pervious pavements	0.174	25	12,783	0.48	6,650	\$166,250

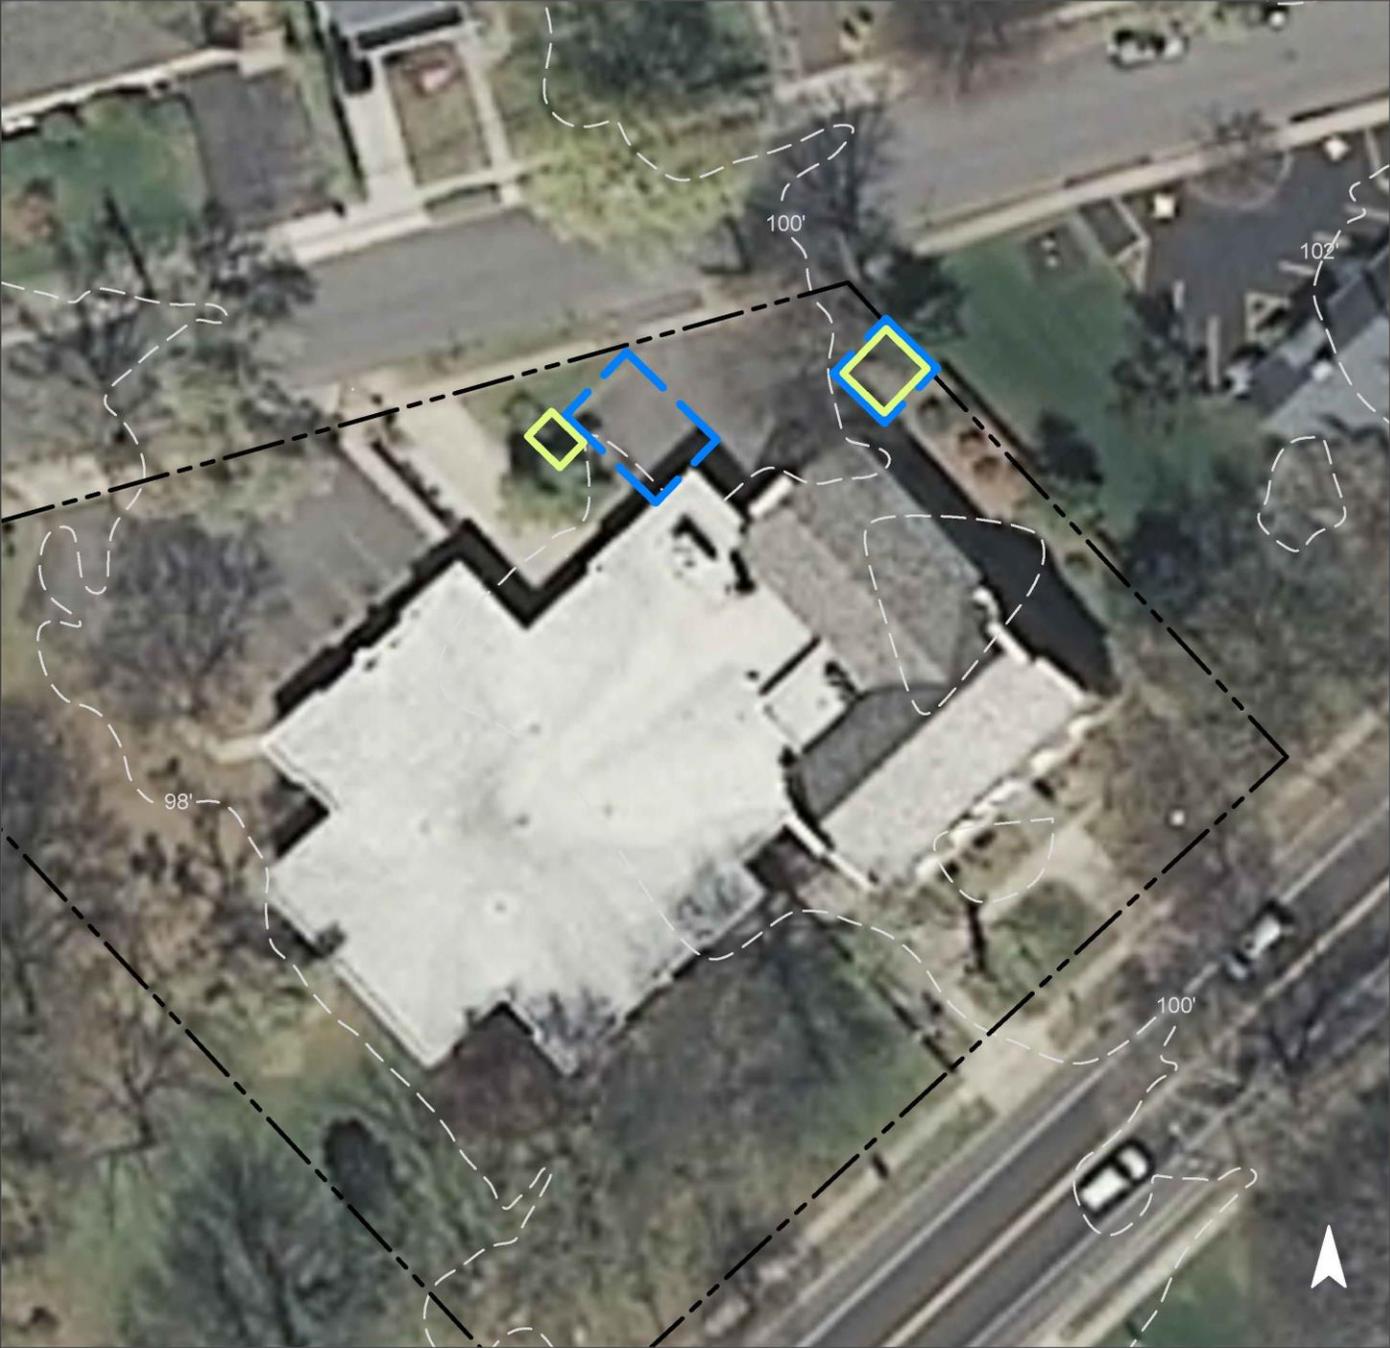
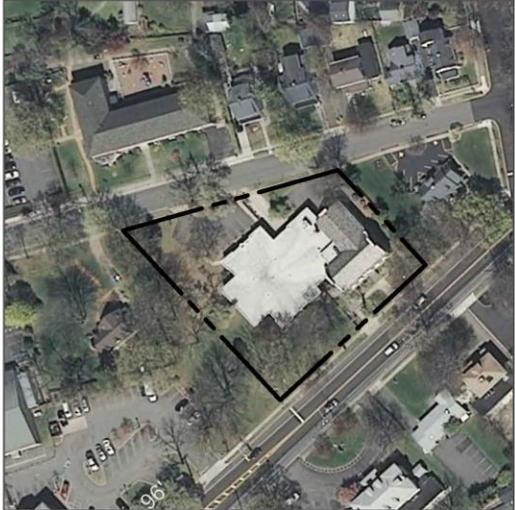
Municipal Borough Public Library

Recommended Green Infrastructure Practices	Recharge Potential (Mgal/yr)	TSS Removal Potential (lbs/yr)	Maximum Volume Reduction Potential (gal/storm)	Peak Discharge Reduction Potential (cu. ft./second)	Estimated Size (sq. ft.)	Estimated Cost
Bioretention systems	0.019	3	1,376	0.05	246	\$1,230

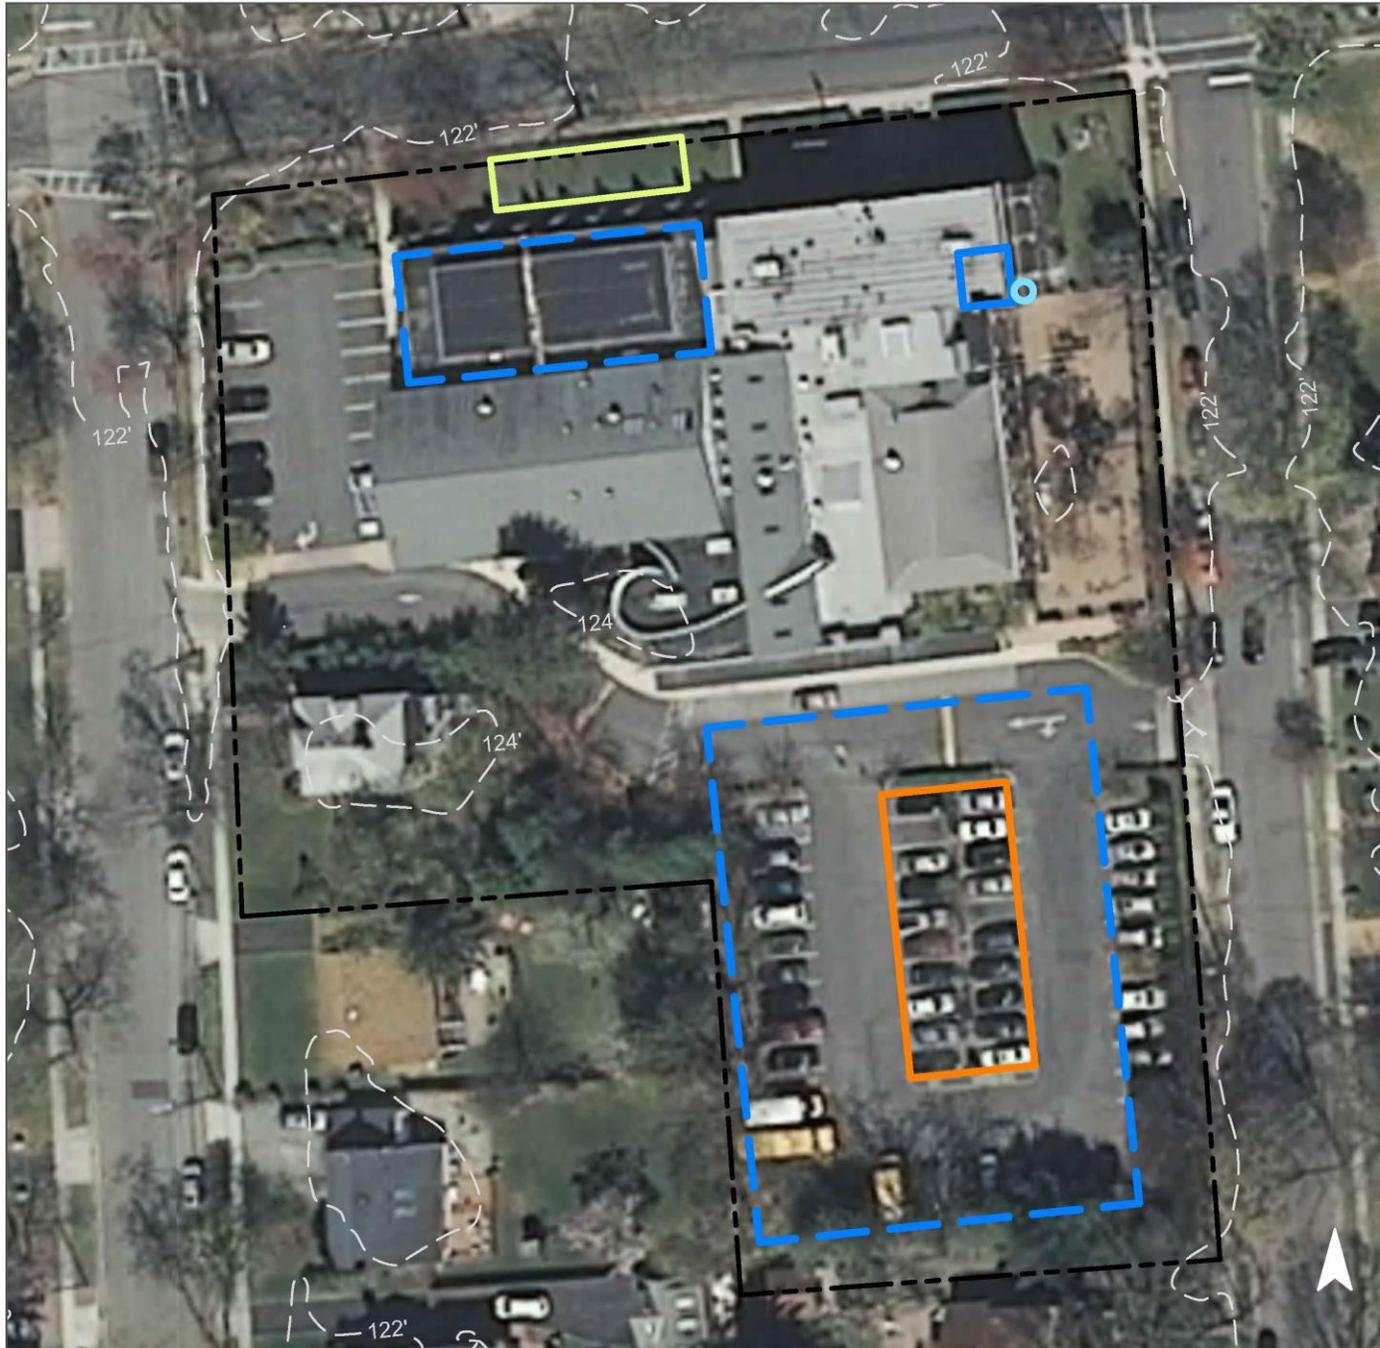
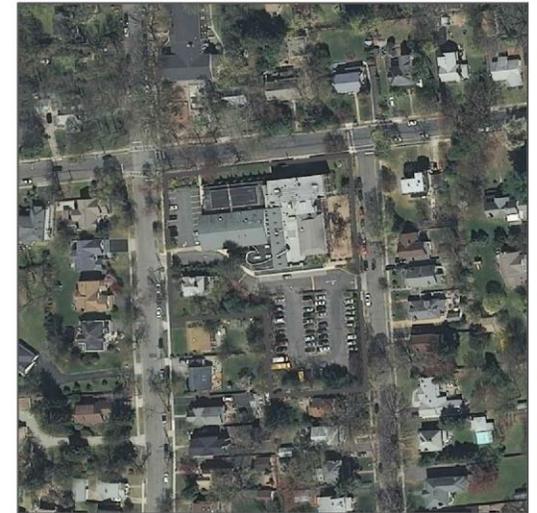
Metuchen YMCA

Recommended Green Infrastructure Practices	Recharge Potential (Mgal/yr)	TSS Removal Potential (lbs/yr)	Maximum Volume Reduction Potential (gal/storm)	Peak Discharge Reduction Potential (cu. ft./second)	Estimated Size (sq. ft.)	Estimated Cost
Bioretention systems	0.101	14	7,413	0.28	980	\$4,900
Pervious pavements	0.508	72	37,250	1.40	3,516	\$87,900
Rainwater harvesting systems	0.007	1	250	0.02	250 (gal)	\$499

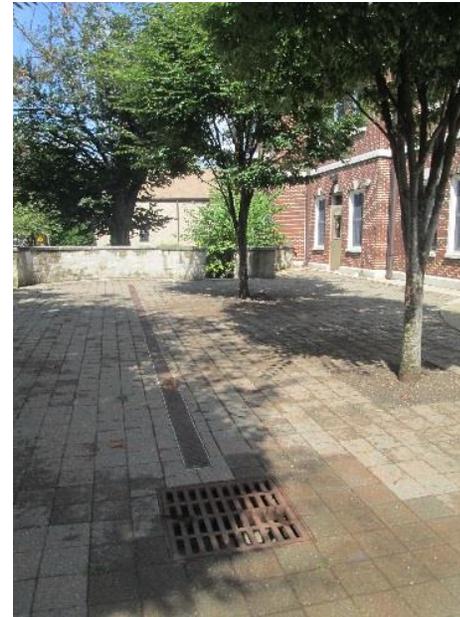
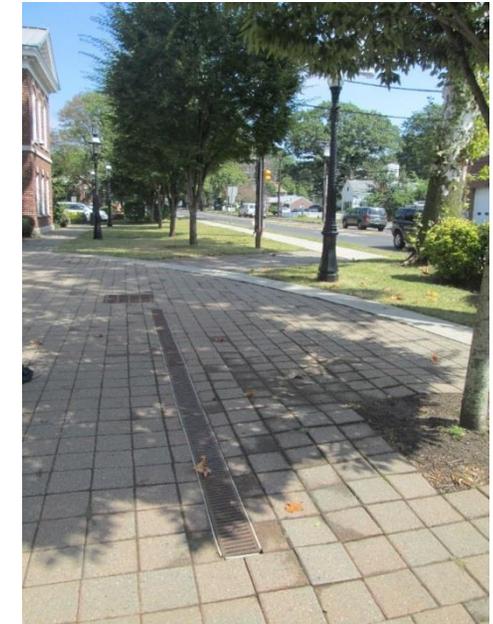
Subwatershed: Bound Brook
Site Area: 62,364 sq. ft.
Address: 500 Main Street
Metuchen, NJ 08840
Block and Lot: Block 102, Lot 25

The Municipal Court parking lot has an area where ponding occurs. In addition to installing a rain garden in the neighboring property of Saint Francis CYO, this ponding can be mediated by installing pervious pavement in parking spaces. A preliminary soil assessment suggests that the soils have suitable drainage characteristics for green infrastructure.

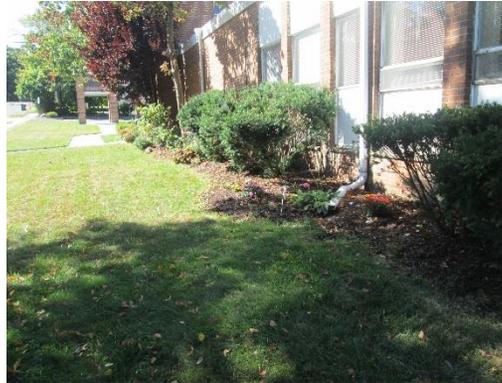
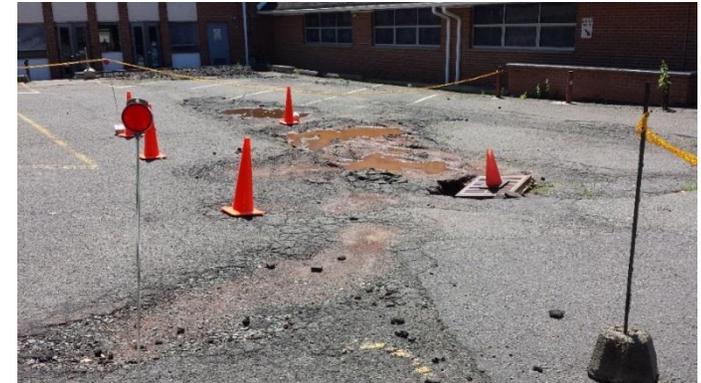
This church has severe damage to its northern parking lot near the building. This area can be replaced with pervious pavement to infiltrate parking lot runoff. Bioretention systems can also be installed to capture, treat, and infiltrate additional parking lot runoff as well as roof runoff. A preliminary soil assessment suggests that more soil testing would be required before determining the soil's suitability for green infrastructure.

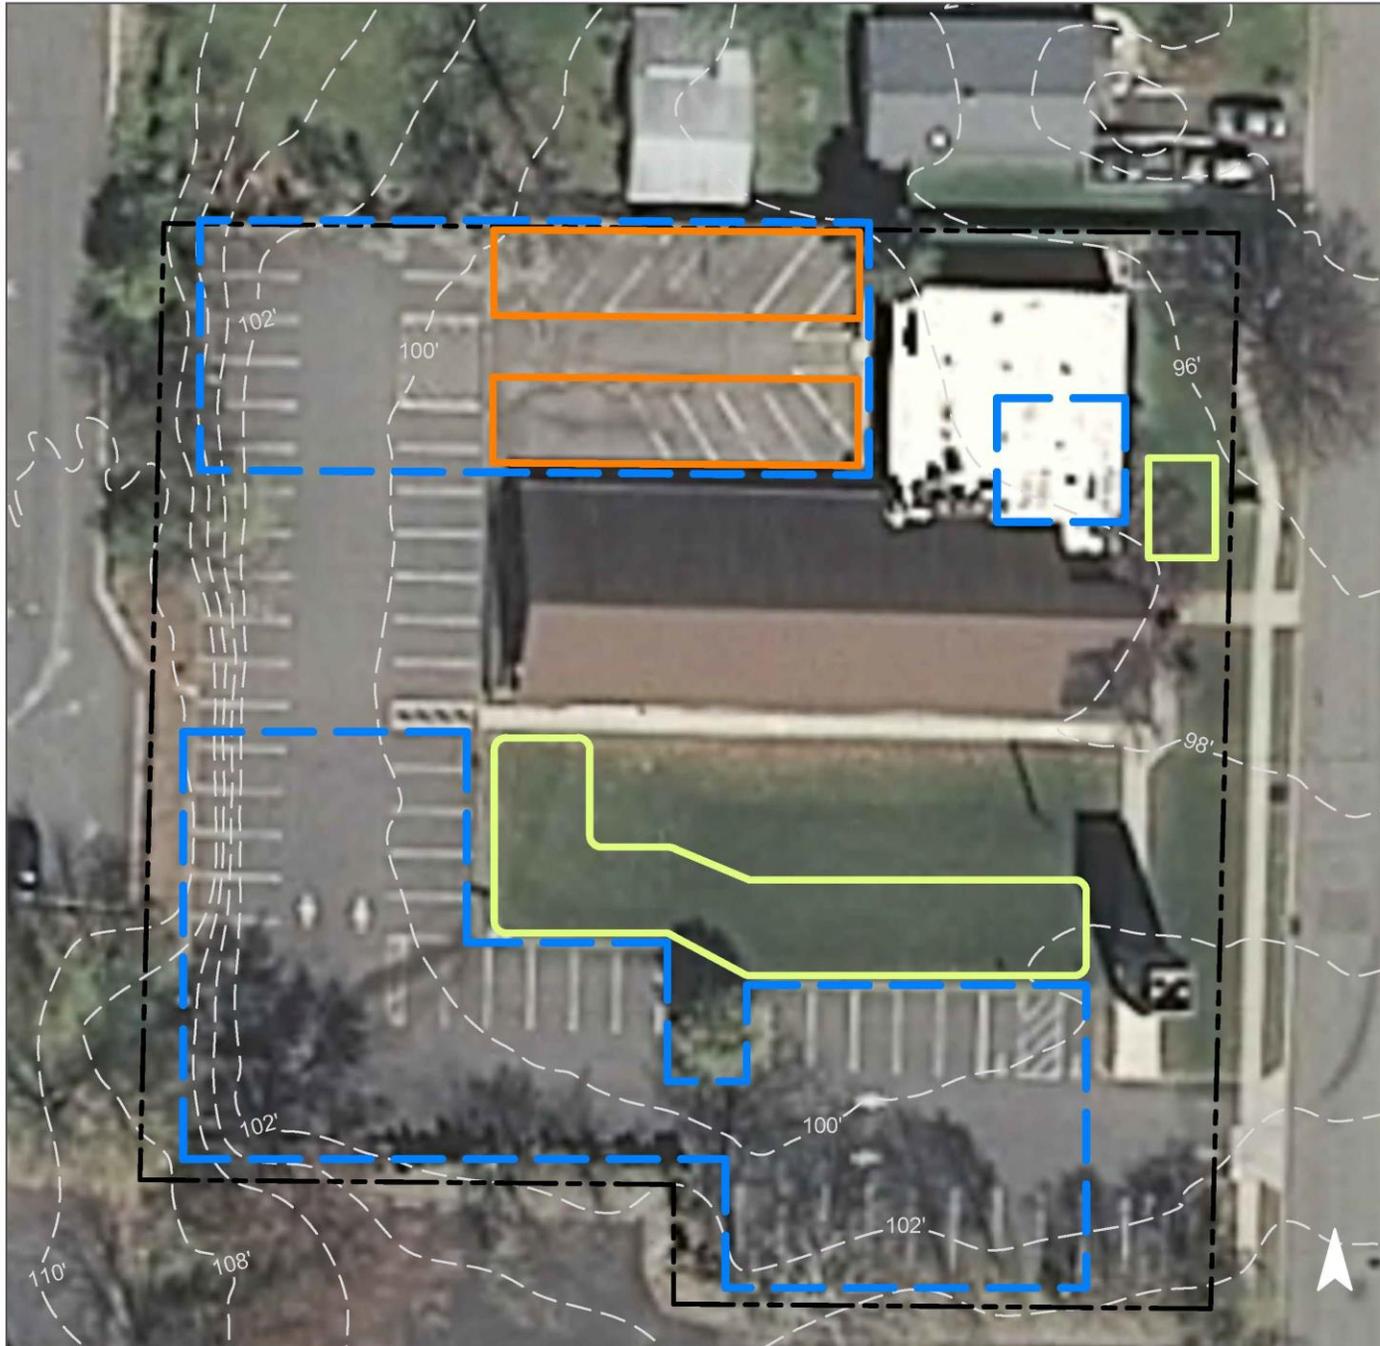
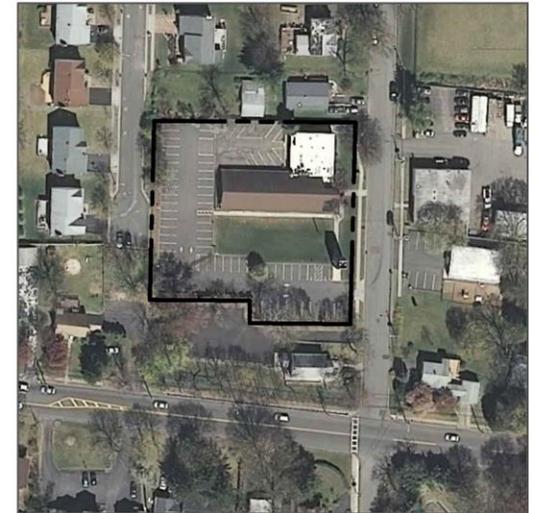
New Hope Baptist Church

Recommended Green Infrastructure Practices	Recharge Potential (Mgal/yr)	TSS Removal Potential (lbs/yr)	Maximum Volume Reduction Potential (gal/storm)	Peak Discharge Reduction Potential (cu. ft./second)	Estimated Size (sq. ft.)	Estimated Cost
Bioretention systems	0.334	47	24,490	0.92	3,138	\$15,690
Pervious pavements	0.192	27	14,107	0.53	2,756	\$68,900

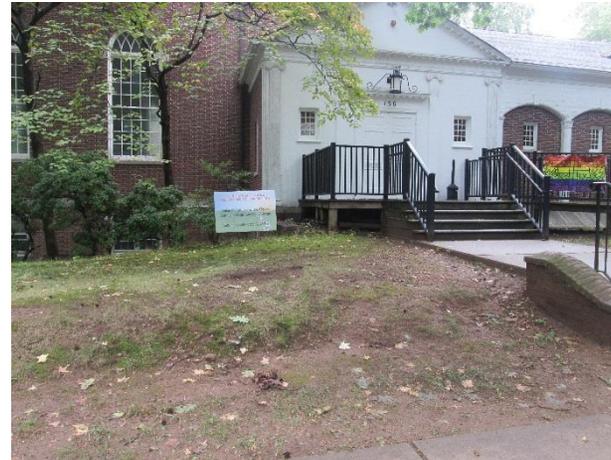
A rain garden can be constructed to capture, treat, and infiltrate runoff. A preliminary soil assessment suggests that more soil testing would be required before determining the soil's suitability for green infrastructure.

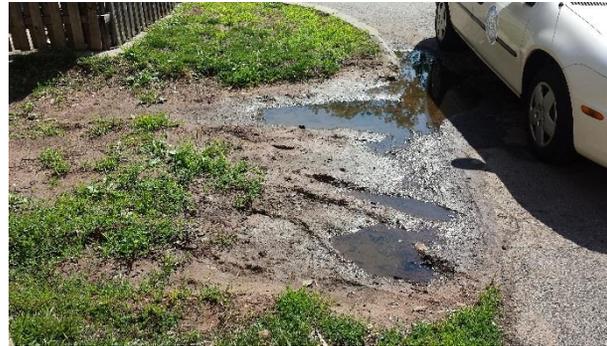
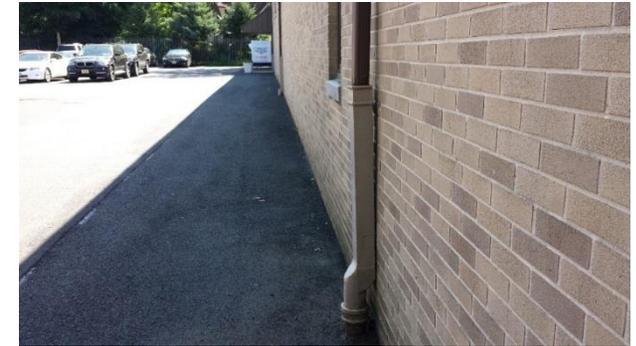
Parking spaces can be repaved with porous asphalt to infiltrate parking lot runoff. A bioretention system can also be installed in the turf grass area off of the southeast corner of the CYO building, where water currently pools. This rain garden could also infiltrate runoff from the adjacent Metuchen Municipal Court. A preliminary soil assessment suggests that the soils have suitable drainage characteristics for green infrastructure.

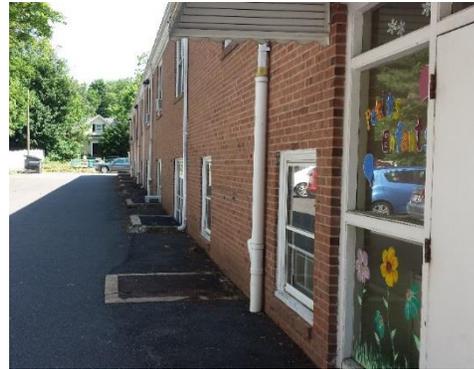
Subwatershed: Bound Brook
Site Area: 76,414 sq. ft.
Address: 17 Oak Avenue
Metuchen, NJ 08840
Block and Lot: Block 104, Lot 8

This site has several connected downspouts, as well as downspouts that are disconnected onto the parking lot. Parking lot and road runoff can be captured, treated and infiltrated with rain gardens. A preliminary soil assessment suggests that the soils have suitable drainage characteristics for green infrastructure.

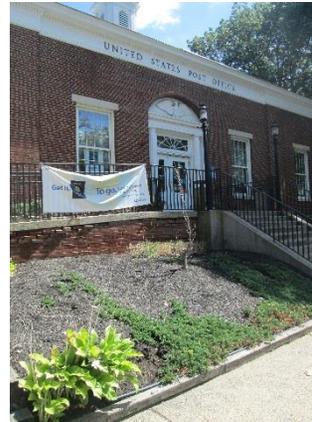
Subwatershed: Bound Brook
Site Area: 27,895 sq. ft.
Address: 360 Main Street
Metuchen, NJ 08840
Block and Lot: Block 182, Lot 33

The Post Office parking lot is in poor condition and ponding occurs after rain events. Parking spaces can be replaced with pervious pavement to reduce impervious cover and promote infiltration. The concrete flow channel near the employee driveway can also be replaced with a bioswale to remove pollutants and allow stormwater to infiltrate. A preliminary soil assessment suggests that the soils have suitable drainage characteristics for green infrastructure.

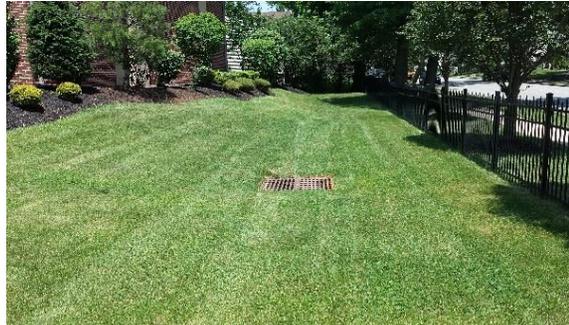
Address: 130 Whittman Avenue
Metuchen, NJ 08840

The church has several connected downspouts. On the east side of the church, downspouts can be disconnected into a rain garden, which can capture, treat, and infiltrate stormwater. Parking spaces can also be replaced with porous asphalt to infiltrate additional runoff. A preliminary soil assessment suggests that more soil testing would be required before determining the soil's suitability for green infrastructure.

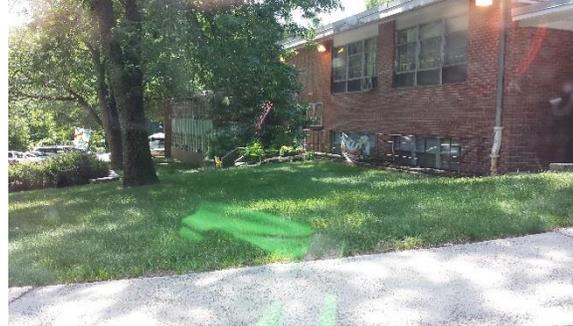
Address: 200 Hillside Avenue
Metuchen, NJ 08840

This site has several connected downspouts. A rain garden can capture, treat, and infiltrate roof runoff in the northeast lawn area. A preliminary soil assessment suggests that the soils have suitable drainage characteristics for green infrastructure.

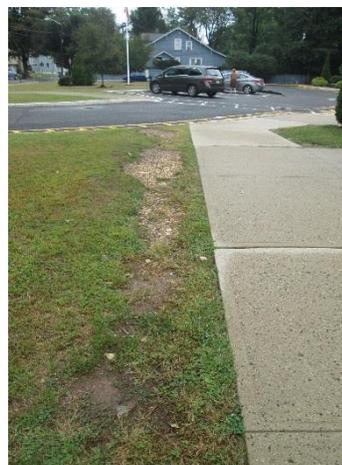
Address: 49 Brunswick Avenue
Metuchen, NJ 08840

Several areas have ponding water around the site. Bioretention systems can be installed in these areas to capture, treat and infiltrate runoff. A preliminary soil assessment suggests that the soils have suitable drainage characteristics for green infrastructure.

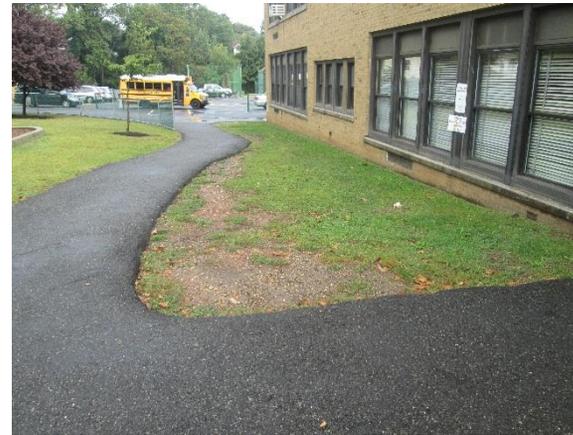
Drainage issues include water seeping into the basement and areas that pond after rain events. Parking spaces in the northwest section of the parking lot can be replaced with porous pavement to allow runoff to infiltrate. A rain garden can also be installed to capture, treat and infiltrate additional stormwater. A preliminary soil assessment suggests that more soil testing would be required before determining the soil's suitability for green infrastructure.

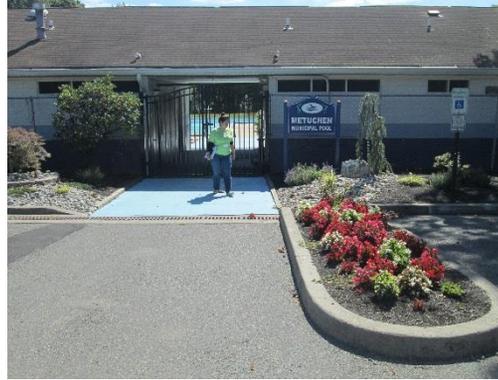
Address: 50 Lake Avenue
Metuchen, NJ 08840

The parking lot is in poor condition. Rows of parking spaces can be replaced using pervious pavement to promote infiltration. A preliminary soil assessment suggests that the soils have suitable drainage characteristics for green infrastructure.

Recommended Green Infrastructure Practices	Recharge Potential (Mgal/yr)	TSS Removal Potential (lbs/yr)	Maximum Volume Reduction Potential (gal/storm)	Peak Discharge Reduction Potential (cu. ft./second)	Estimated Size (sq. ft.)	Estimated Cost
Pervious pavements	1.411	199	103,523	3.89	13,463	\$336,575

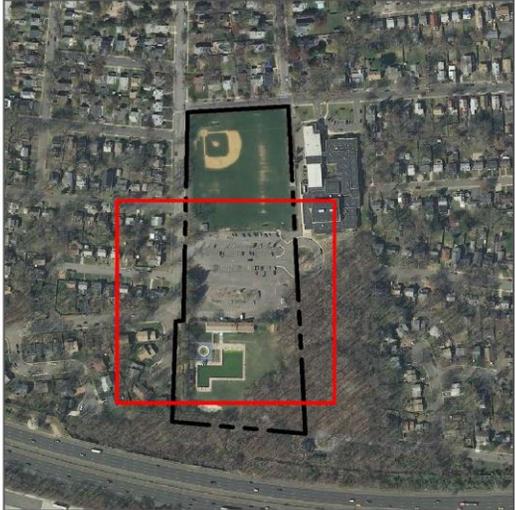
Municipal Pool

Parking spaces and play courts can be converted into pervious pavement to infiltrate runoff. A preliminary soil assessment suggests that the soils have suitable drainage characteristics for green infrastructure.

Recommended Green Infrastructure Practices	Recharge Potential (Mgal/yr)	TSS Removal Potential (lbs/yr)	Maximum Volume Reduction Potential (gal/storm)	Peak Discharge Reduction Potential (cu. ft./second)	Estimated Size (sq. ft.)	Estimated Cost
Pervious pavements	0.375	53	27,519	1.03	7,467	\$186,675

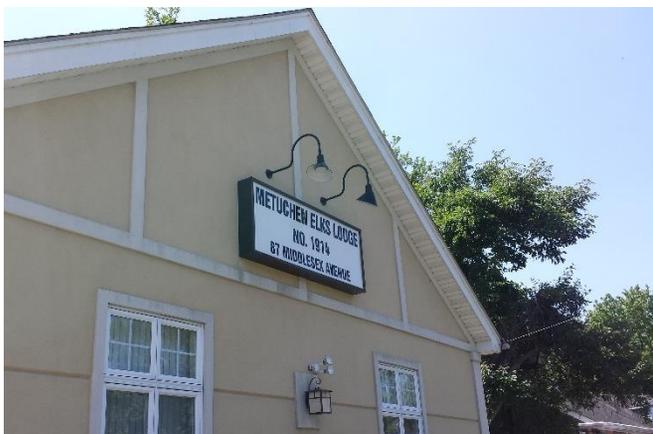
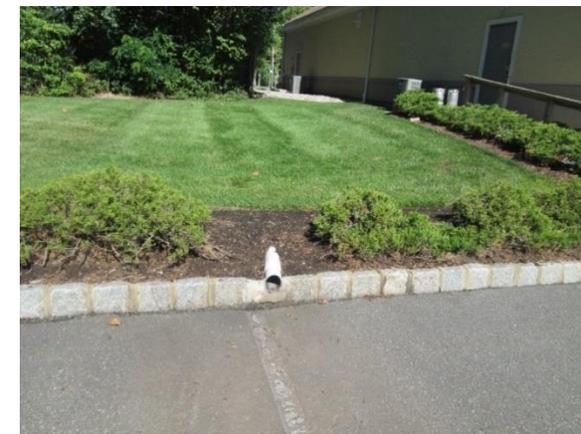
The Elks Lodge parking lot is in good condition. In the future, parking spaces can be converted into pervious pavement to infiltrate parking lot and roof runoff. A rain garden can also be installed to capture, treat, and infiltrate rooftop runoff by disconnecting and redirecting a downspout on the southwest side of the building. A preliminary soil assessment suggests that the soils have suitable drainage characteristics for green infrastructure.

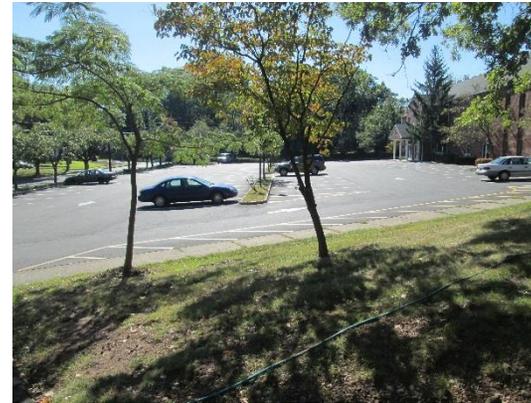
The church sits on a hill and runoff from the pathway and the downspouts is causing erosion and gulying. A bioretention system can be installed to help manage stormwater in this area. Rows of parking spaces can also be converted into pervious pavement to infiltrate parking lot runoff. A preliminary soil assessment suggests that the soils have suitable drainage characteristics for green infrastructure.

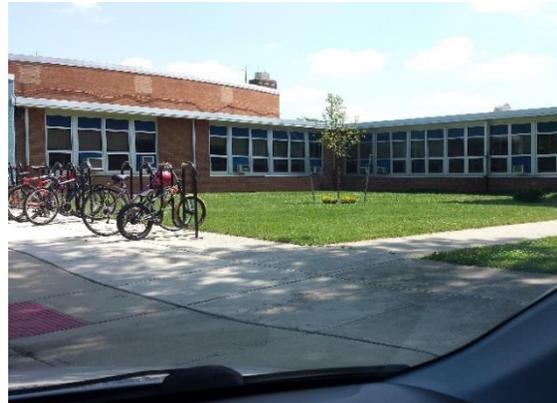
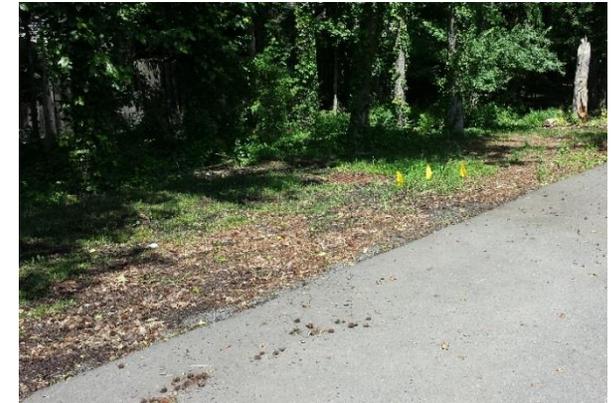
There are several downspouts that could be disconnected and redirected into a rain garden near the front of the school. This rain garden could capture, treat and infiltrate roof runoff. A preliminary soil assessment suggests that the soils have suitable drainage characteristics for green infrastructure.
