**Impervious Cover Reduction Action Plan
for
Milltown Borough, Middlesex County, New Jersey**

*Prepared for Milltown Borough by the
Rutgers Cooperative Extension Water Resources Program*

September 5, 2015

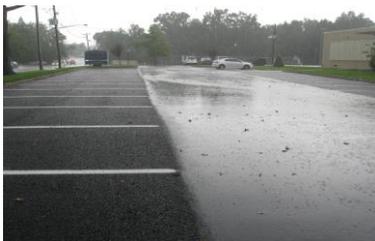
Pervious pavements

There are several types of permeable pavement systems including porous asphalt, pervious concrete, permeable pavers, and grass pavers. These surfaces are hard and support vehicle traffic but also allow water to infiltrate through the surface. They have an underlying stone layer to store stormwater runoff and allow it to slowly seep into the ground.

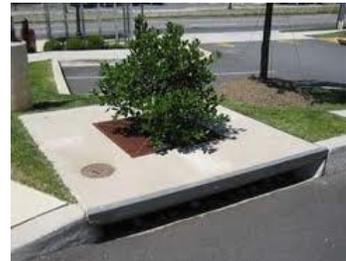
Tree filter boxes

These are pre-manufactured concrete boxes that contain a special soil mix and are planted with a tree or shrub. They filter stormwater runoff but provide little storage capacity. They are typically designed to quickly filter stormwater and then discharge it to the local sewer system.

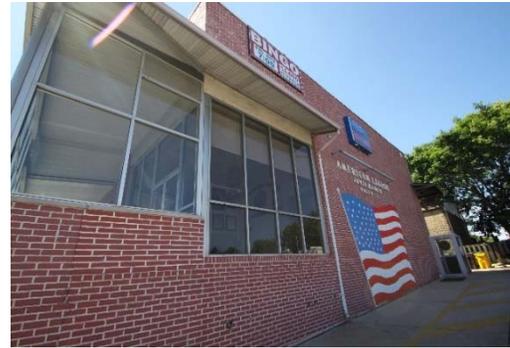
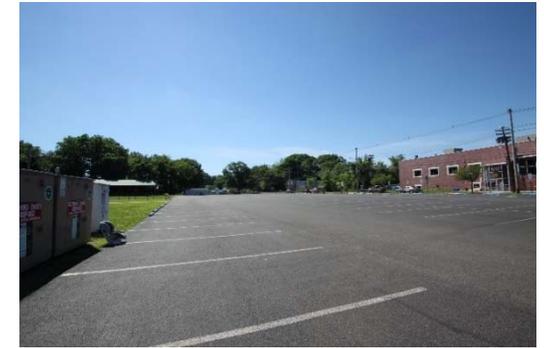
Block and Lot: Block 73, Lot 1.03

Downspouts on the southwest side of the building currently direct water onto an adjacent lot. A rain garden can be planted in the small grass area at the back of the building, and water from the downspouts can be directed into it. Rain gardens can also be planted next to the American Legion lot to capture runoff from parking spaces and from the roofs of nearby structures. A preliminary soil assessment suggests that soils have suitable drainage characteristics for green infrastructure.

Recommended Green Infrastructure Practices	Recharge Potential (Mgal/yr)	TSS Removal Potential (lbs/yr)	Maximum Volume Reduction Potential (gal/storm)	Peak Discharge Reduction Potential (cu. ft./second)	Estimated Size (sq. ft.)	Estimated Cost
Bioretention systems	0.177	30	13,008	0.49	1,798	\$8,990

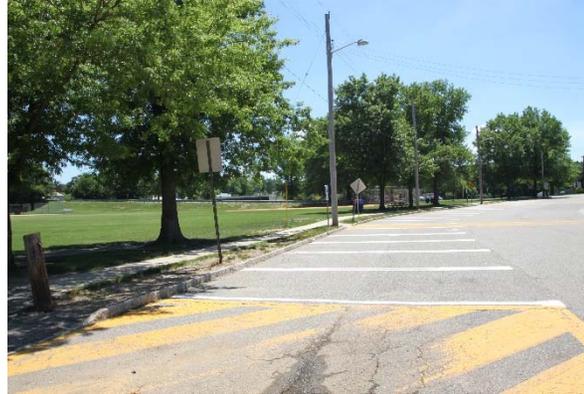
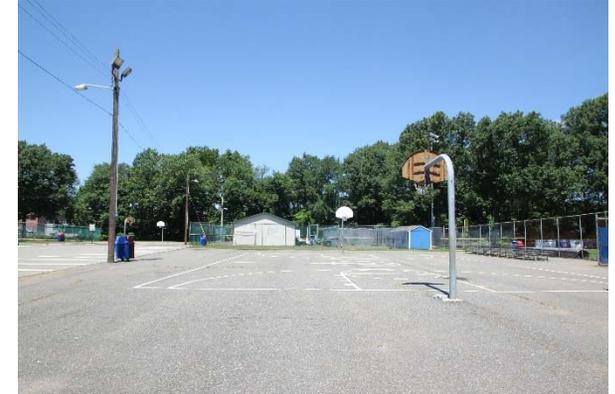
Currently, runoff from the parking lot and basketball courts is directed into catch basins throughout the site. The basketball courts can be replaced with porous asphalt to capture runoff. The areas adjacent to the eastern most basketball court can be de-paved into rain gardens to capture runoff too. A preliminary soil assessment suggests that more soil testing would be required before determining soil suitability for green infrastructure.

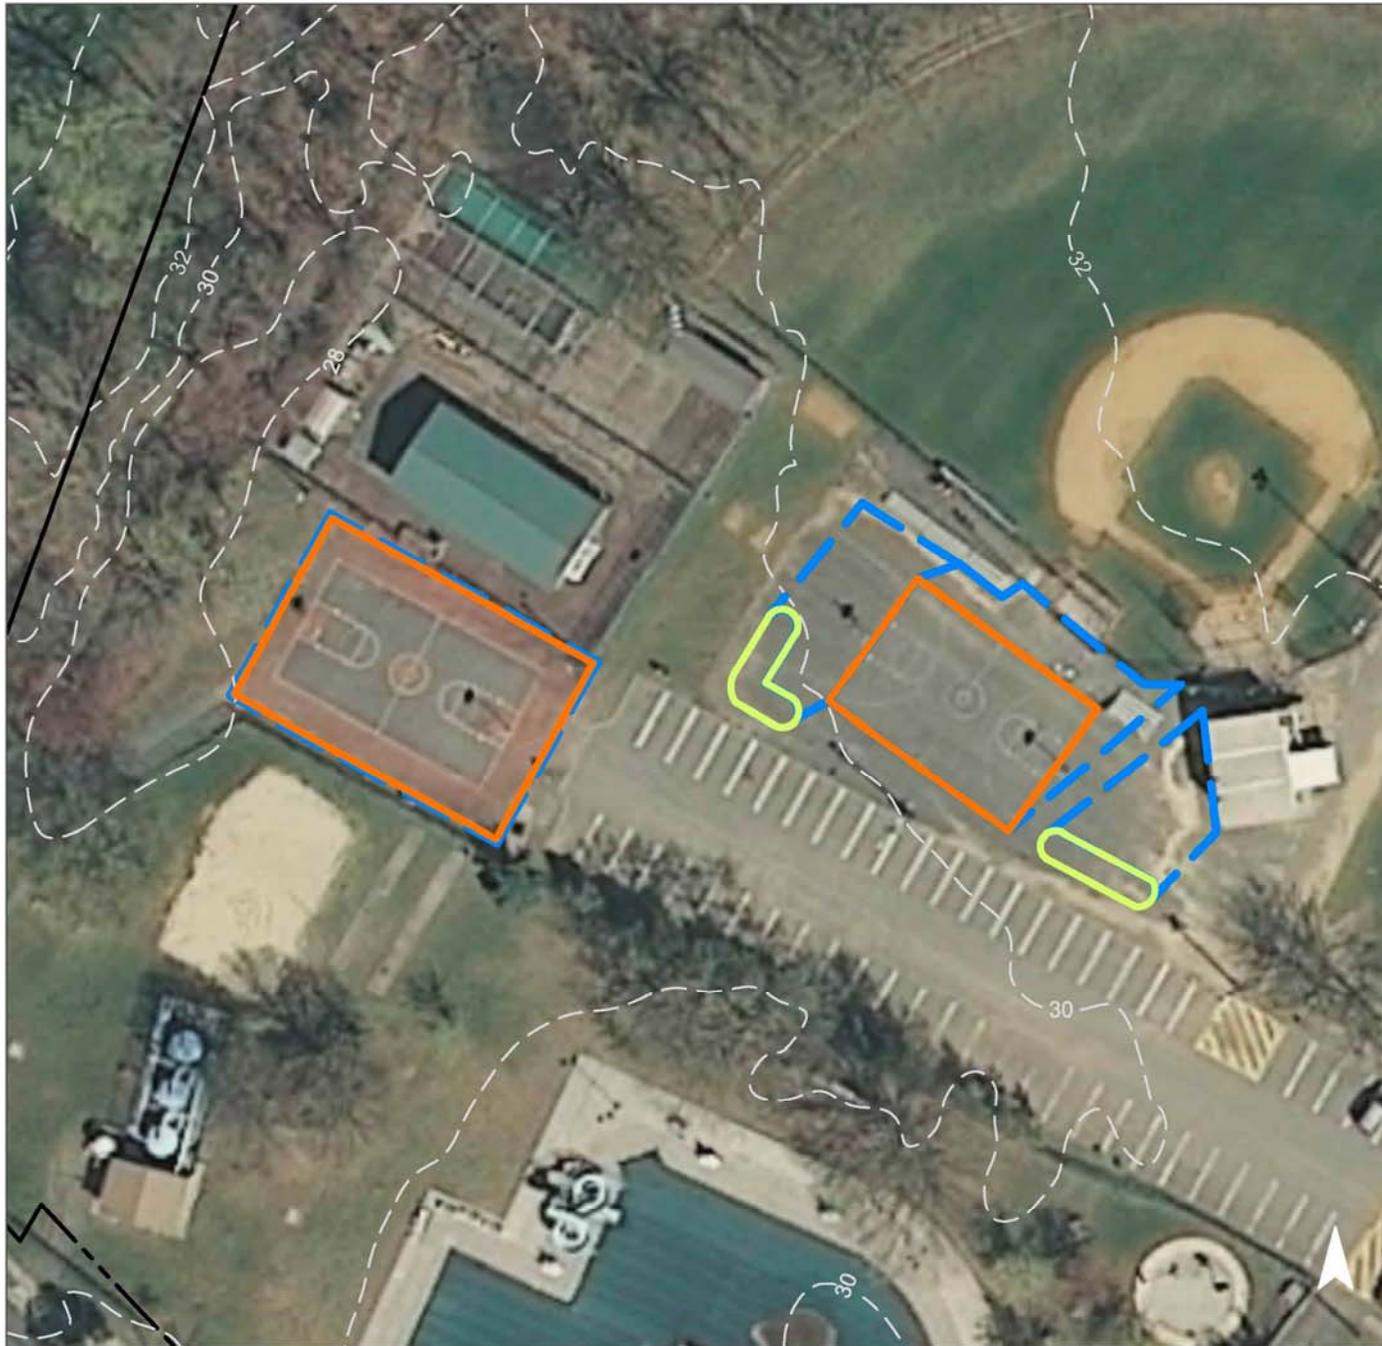
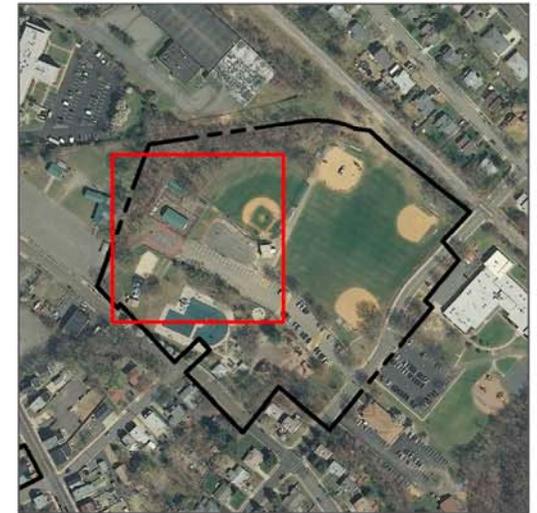
GREEN INFRASTRUCTURE RECOMMENDATIONS

Recommended Green Infrastructure Practices	Recharge Potential (Mgal/yr)	TSS Removal Potential (lbs/yr)	Maximum Volume Reduction Potential (gal/storm)	Peak Discharge Reduction Potential (cu. ft./second)	Estimated Size (sq. ft.)	Estimated Cost
Bioretention systems	0.082	14	6,021	0.23	797	\$3,987
Pervious pavements	0.280	47	20,525	0.77	9,258	\$231,462

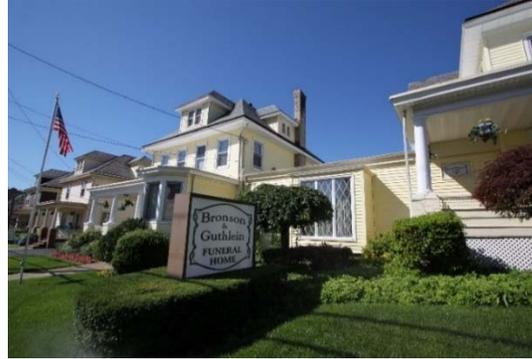
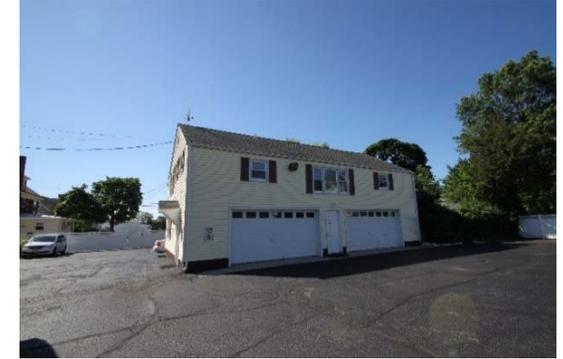
Several disconnected downspouts currently direct water onto the parking lot behind the buildings. Parking spots can be replaced with porous asphalt to infiltrate this runoff. Some downspouts can also be connected to a rainwater harvesting feature. There is an opportunity for de-paving asphalt into lawn between the buildings as well. A preliminary soil assessment suggests that soils have suitable drainage characteristics for green infrastructure.

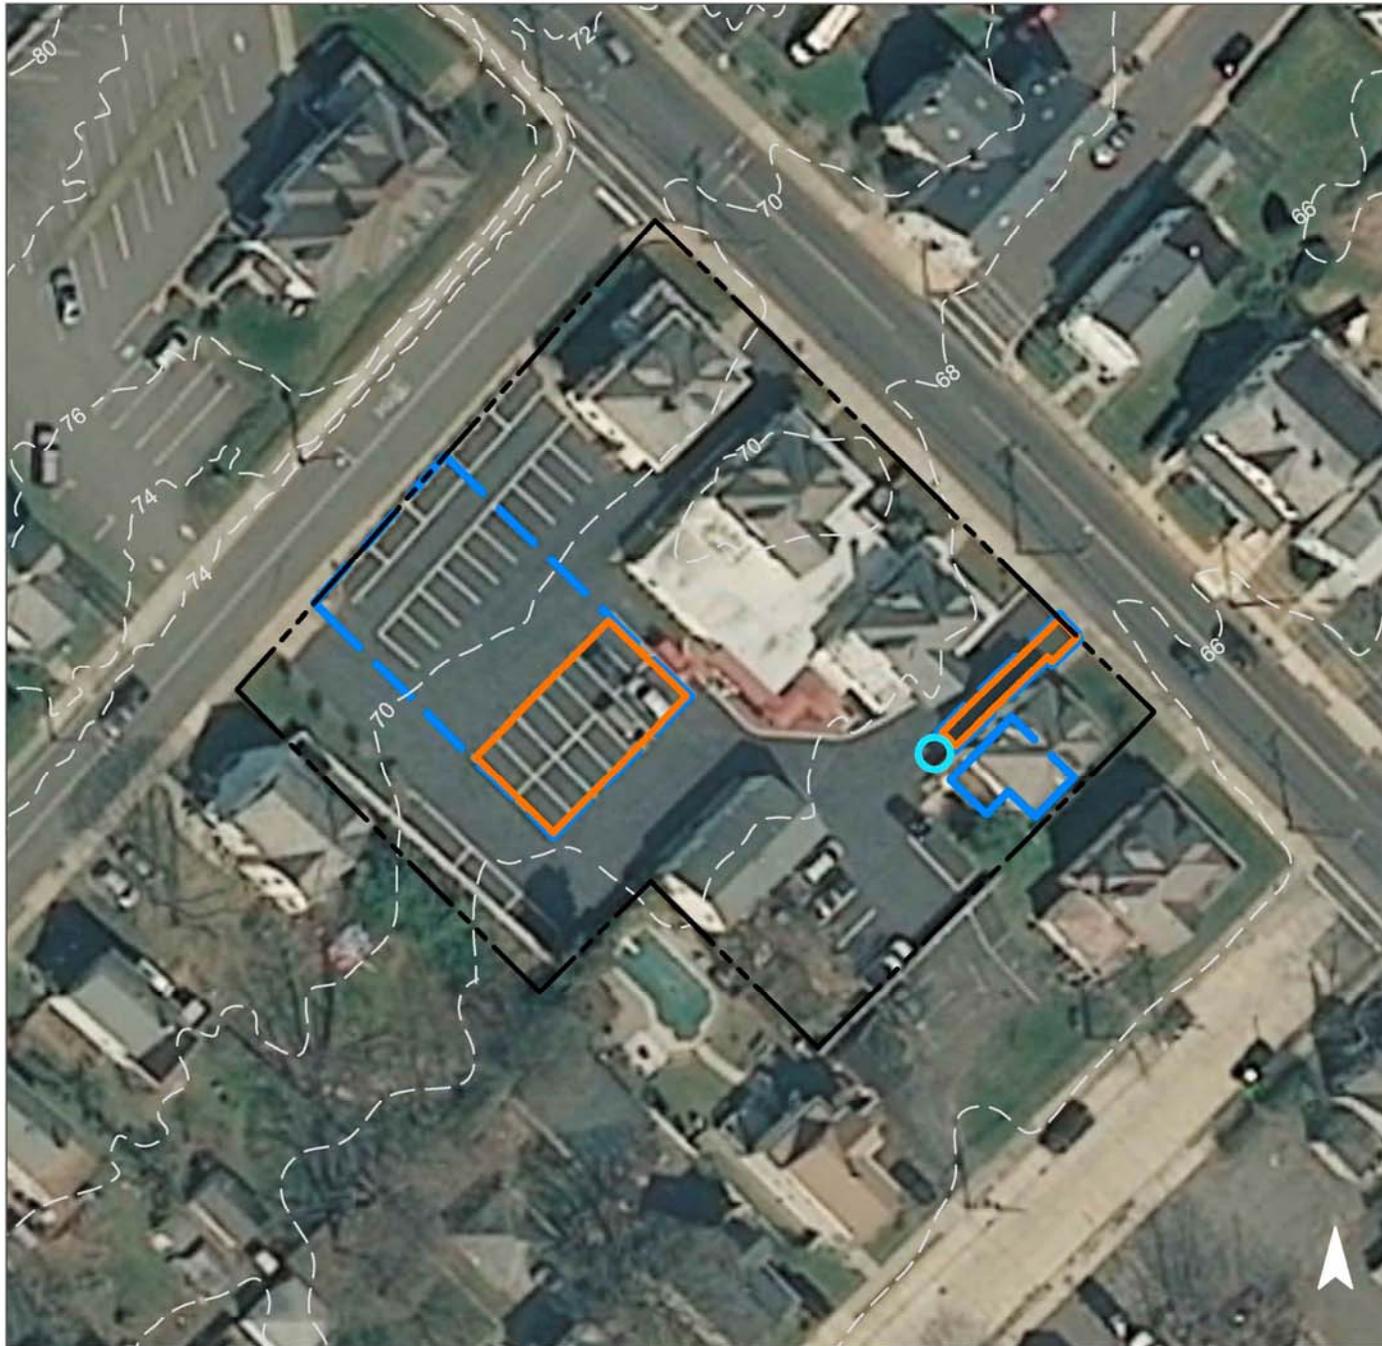
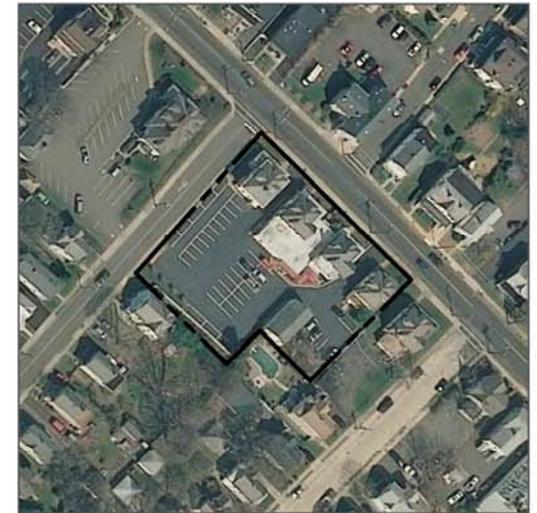
GREEN INFRASTRUCTURE RECOMMENDATIONS

Recommended Green Infrastructure Practices	Recharge Potential (Mgal/yr)	TSS Removal Potential (lbs/yr)	Maximum Volume Reduction Potential (gal/storm)	Peak Discharge Reduction Potential (cu. ft./second)	Estimated Size (sq. ft.)	Estimated Cost
Pervious pavements	0.171	29	12,574	0.47	2,232	\$55,811
Rainwater harvesting systems	0.017	3	500	0.05	500 (gal)	\$1,000

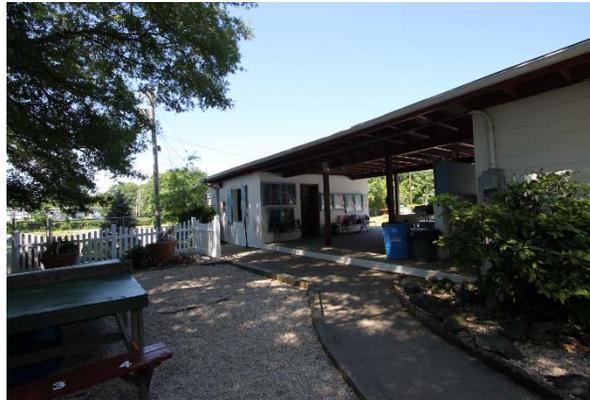
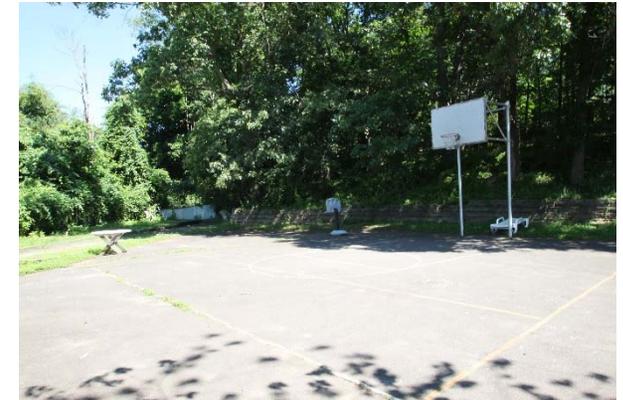
Several disconnected downspouts direct water onto existing porous pavement. A lot of runoff also flows onto the basketball court at the corner of the site, which could be replaced with porous pavement. A preliminary soil assessment suggests that more soil testing would be required before determining soil suitability for green infrastructure.

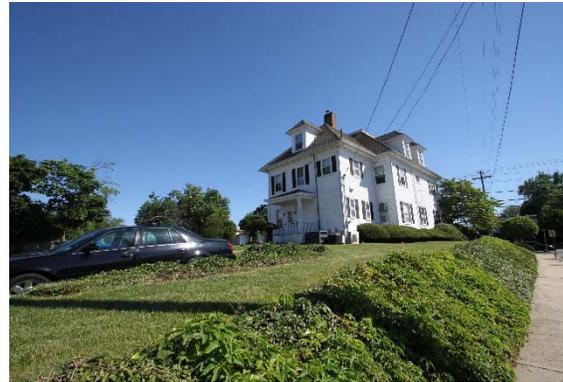
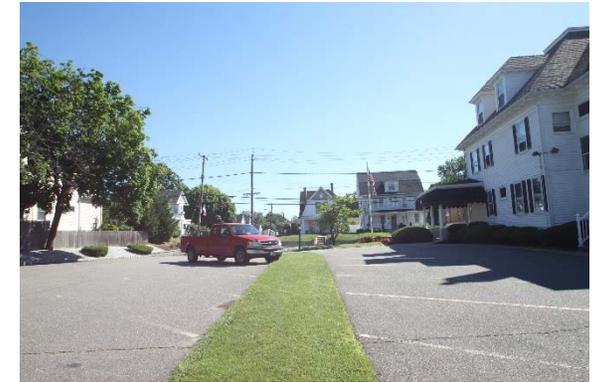
Water currently drains from the parking lot towards the building. The grass buffer in the parking lot can be converted to a rain garden to capture and treat runoff. The sidewalk can be replaced with porous pavement to infiltrate runoff as well. A preliminary soil assessment suggests that soils have suitable drainage characteristics for green infrastructure.

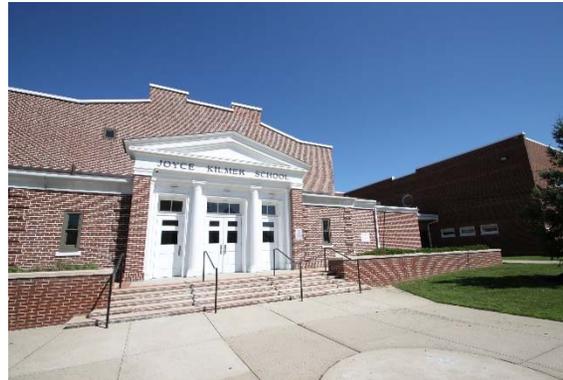
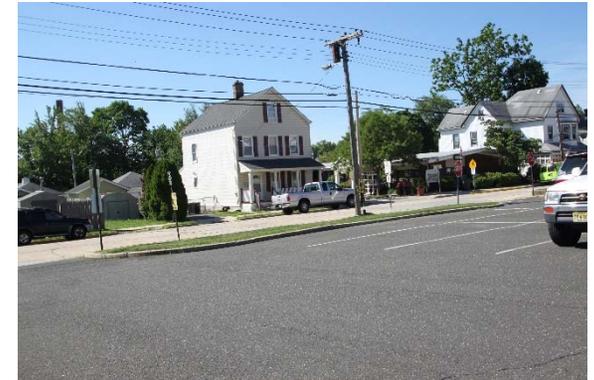
Runoff from the parking lot currently drains toward the street. The grass buffer in the parking lot can be replaced with a rain garden to capture, infiltrate, and treat this runoff. Additionally, areas behind the school can be de-paved into lawn and the basketball courts can be replaced with porous pavement. A preliminary soil assessment suggests that soils have suitable drainage characteristics for green infrastructure.

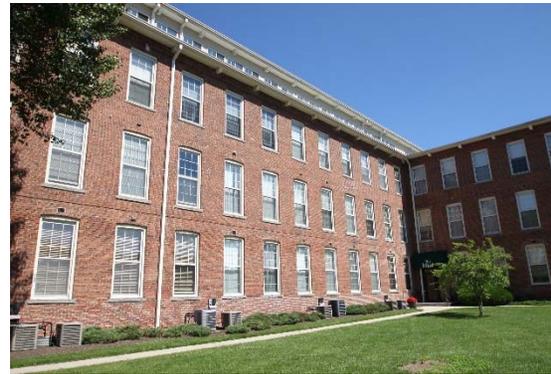
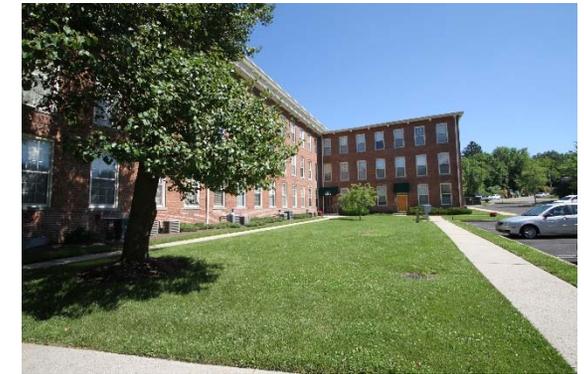
Runoff currently flows into catch basins within the parking lot or pools in lawn areas next to the building. Parking spaces can be replaced with porous pavement to infiltrate runoff from the parking lot. Rain gardens can also be planted between the building and parking lot, to capture, treat and infiltrate roof runoff. A preliminary soil assessment suggests that soils have suitable drainage characteristics for green infrastructure.

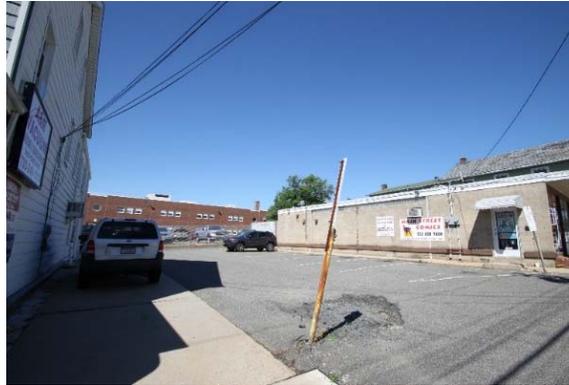
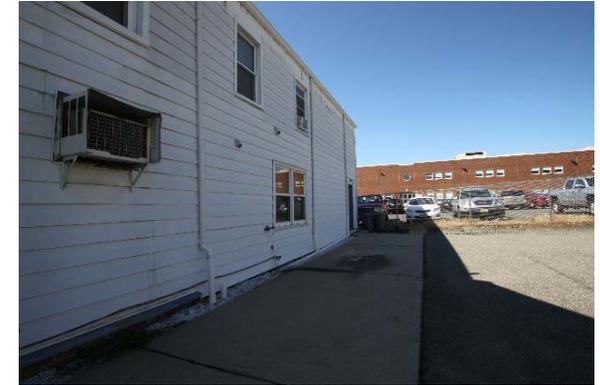
Runoff from the parking lot is currently directed towards an adjacent southeast building. Parking spots can be replaced with porous asphalt to capture and infiltrate this runoff. A preliminary soil assessment suggests that soils have suitable drainage characteristics for green infrastructure.

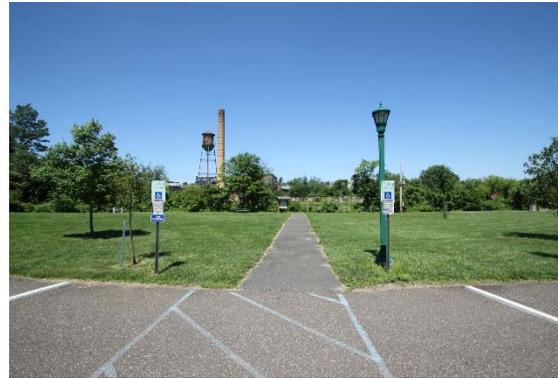
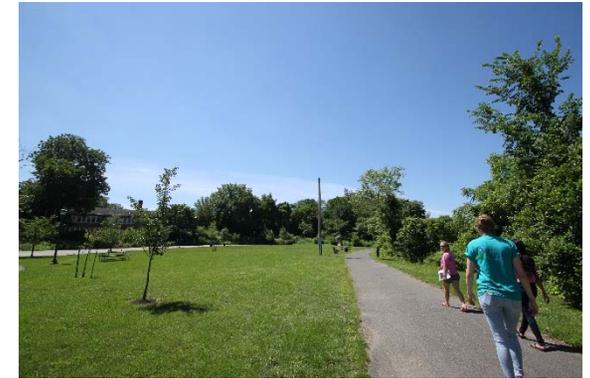
Runoff on the site currently drains toward a nearby lake. Rain gardens can be planted adjacent to the parking lot and path to capture, infiltrate and treat runoff before it reaches the lake. A preliminary soil assessment suggests that soils have suitable drainage characteristics for green infrastructure.

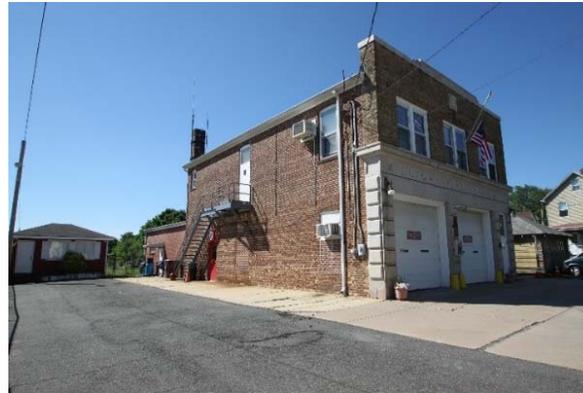
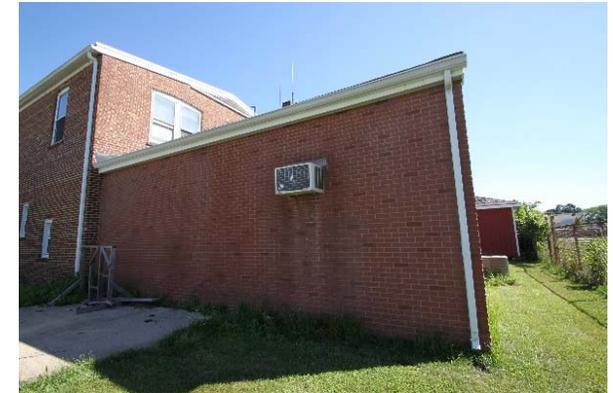
Subwatershed: Lawrence Brook
Site Area: 6,439 sq. ft.
Address: 40 Cottage Ave.
Milltown, NJ 08850
Block and Lot: Block 51, Lot 26

Downspouts currently direct water onto the lot beside the building. The downspouts can be connected to a rainwater harvesting feature. A preliminary soil assessment suggests that soils have suitable drainage characteristics for green infrastructure.

Recommended Green Infrastructure Practices	Recharge Potential (Mgal/yr)	TSS Removal Potential (lbs/yr)	Maximum Volume Reduction Potential (gal/storm)	Peak Discharge Reduction Potential (cu. ft./second)	Estimated Size (sq. ft.)	Estimated Cost
Rainwater harvesting systems	0.017	3	500	0.05	500 (gal)	\$1,000

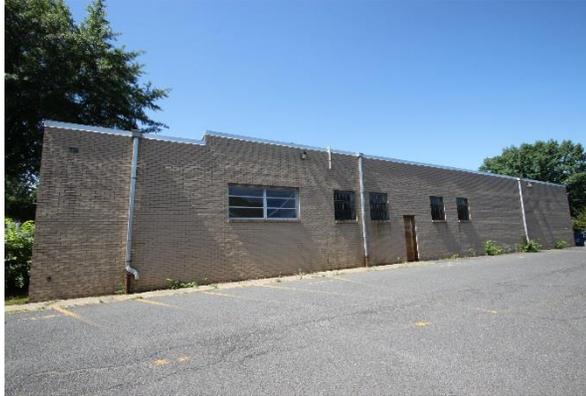
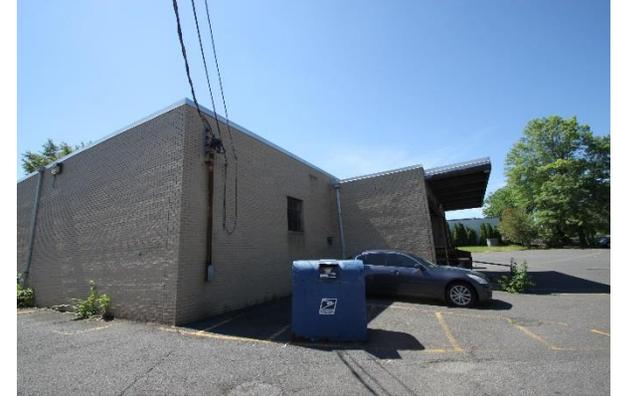
Water from the parking lot currently drains into catch basins behind the building. Parking spots can be replaced with porous asphalt to infiltrate this runoff. Downspouts can also be disconnected into a rainwater harvesting system as well. A preliminary soil assessment suggests that more soil testing would be required before determining soil suitability for green infrastructure.

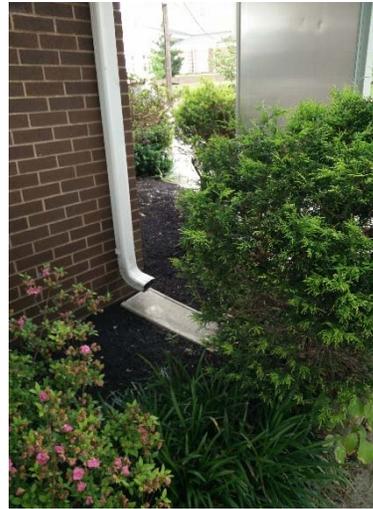
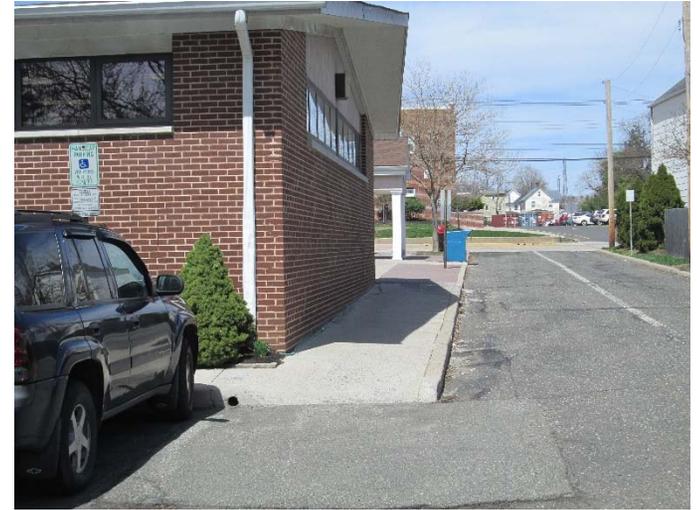
Block and Lot: Block 56, Lot 12

A cistern can harvest roof runoff to water an existing garden. A portion of the sidewalk can be converted into pervious pavement. A preliminary soil assessment suggests that soils have suitable drainage characteristics for green infrastructure.

Recommended Green Infrastructure Practices	Recharge Potential (Mgal/yr)	TSS Removal Potential (lbs/yr)	Maximum Volume Reduction Potential (gal/storm)	Peak Discharge Reduction Potential (cu. ft./second)	Estimated Size (sq. ft.)	Estimated Cost
Pervious pavements	0.032	5	2,311	0.09	366	\$9,150
Rainwater harvesting systems	0.054	9	1,948	0.15	1,948 (gal)	\$3,895

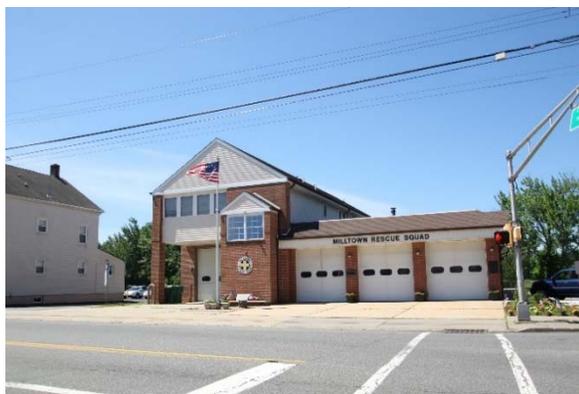
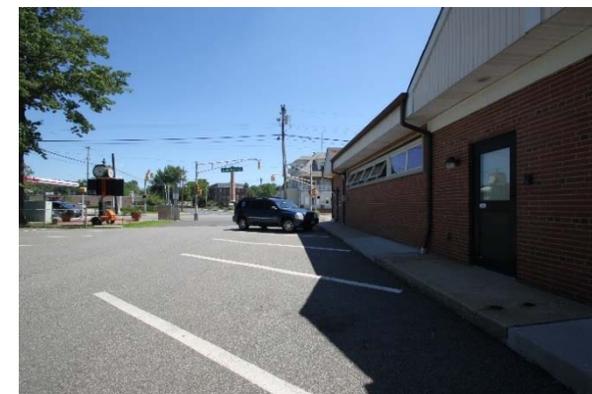
Runoff from the site currently flows onto a parking lot beside the building. Several downspouts can be connected to a cistern to harvest this water. Parking spots can also be replaced with porous asphalt to capture and infiltrate runoff as well. A preliminary soil assessment suggests that soils have suitable drainage characteristics for green infrastructure.

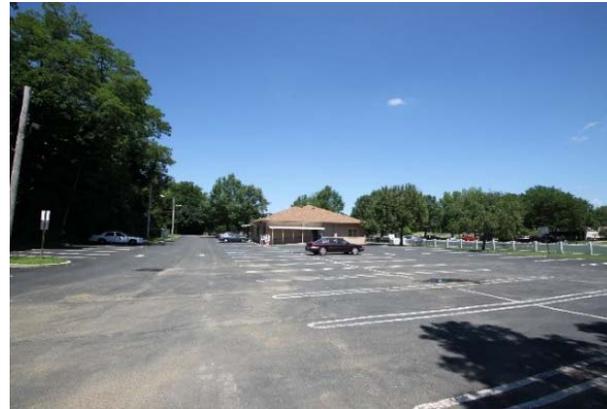
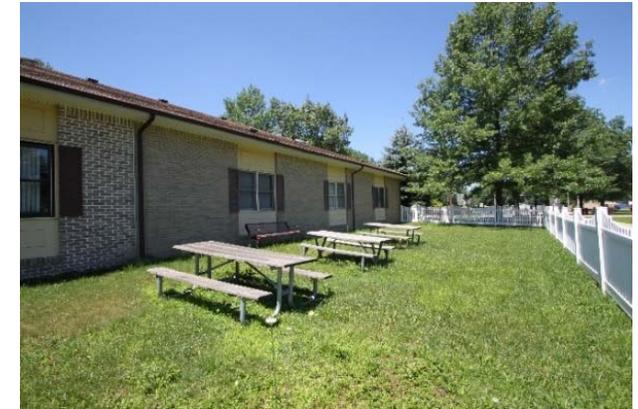
Runoff from the parking lot is currently directed towards several catch basins. Parking spots can be replaced with porous asphalt to infiltrate this runoff. A rain garden can also be placed along the east side of the building to capture roof runoff and minimize water flowing onto the parking lot. A preliminary soil assessment suggests that soils have suitable drainage characteristics for green infrastructure.

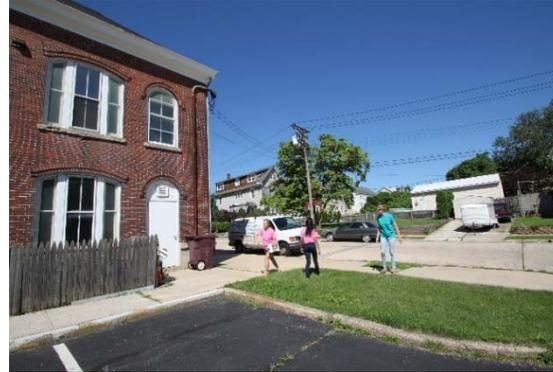
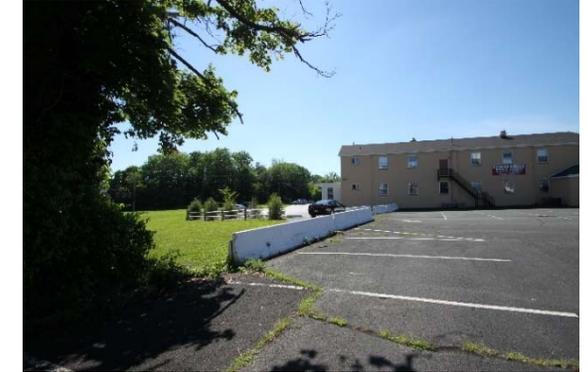
Currently, roof runoff is directed onto the parking lot behind the building. Parking spots can be replaced with porous asphalt to capture and infiltrate this runoff. A rain garden can also be planted to treat some of the roof runoff as well. Additionally, concrete barriers behind the building can be removed to allow rainwater to flow onto the grass, and parking spots south of the building can be replaced with porous asphalt to capture runoff too. A preliminary soil assessment suggests that soils have suitable drainage characteristics for green infrastructure.

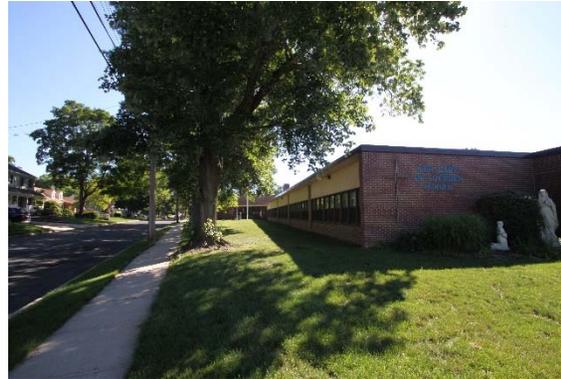
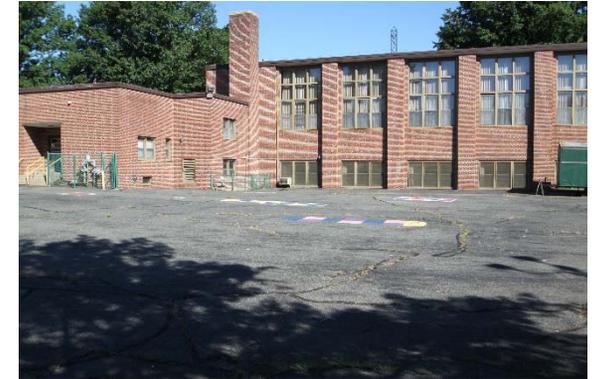
Water on the site currently pools in the parking lot behind the building complex. The lot behind the school can be partially de-paved into a lawn area to address the pooling. Pedestrian walkways can be replaced with porous pavement to capture runoff. A rain garden can also be planted at the back of the site to capture roof runoff and serve as an educational opportunity for students. A preliminary soil assessment suggests that soils have suitable drainage characteristics for green infrastructure.

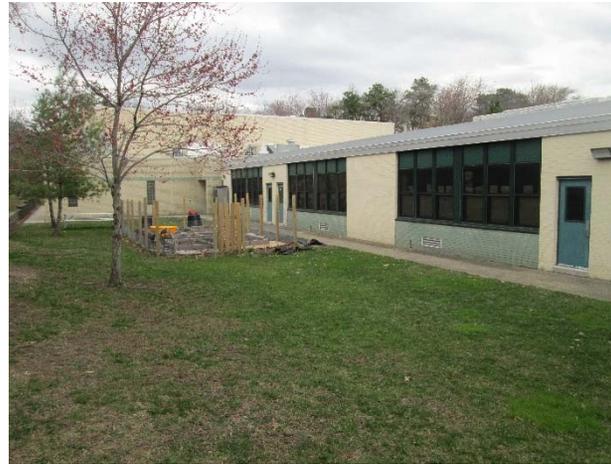
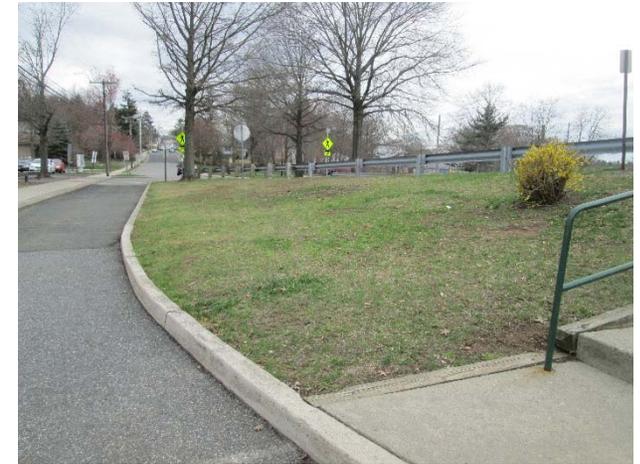
Subwatershed: Lawrence Brook
Site Area: 229,693 sq. ft.
Address: 80 Violet Terrace
Milltown, NJ 08850
Block and Lot: Block 73, Lot 10.03

A demonstration rain garden can be installed outside classrooms and adjacent to an existing garden. Road runoff can also be diverted into a terraced rain garden along the main driveway. A preliminary soil assessment suggests that more soil testing would be required before determining soil suitability for green infrastructure.

Recommended Green Infrastructure Practices	Recharge Potential (Mgal/yr)	TSS Removal Potential (lbs/yr)	Maximum Volume Reduction Potential (gal/storm)	Peak Discharge Reduction Potential (cu. ft./second)	Estimated Size (sq. ft.)	Estimated Cost
Bioretention systems	0.076	13	5,543	0.21	950	\$4,750

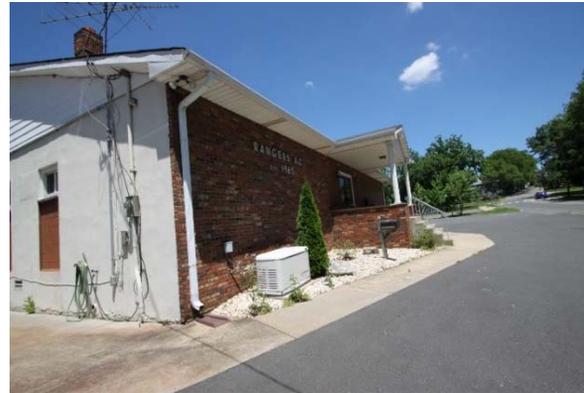
Subwatershed: Lawrence Brook
Site Area: 27,010 sq. ft.
Address: 111 Kuhlthau Ave.
Milltown, NJ 08850
Block and Lot: Block 89.04, Lot 7.01

Water from the entire site currently drains into a body of water behind the building. The grass area between the water and the parking lot can be converted into a rain garden to capture and treat this runoff. A preliminary soil assessment suggests that more soil testing would be required before determining soil suitability for green infrastructure.

Recommended Green Infrastructure Practices	Recharge Potential (Mgal/yr)	TSS Removal Potential (lbs/yr)	Maximum Volume Reduction Potential (gal/storm)	Peak Discharge Reduction Potential (cu. ft./second)	Estimated Size (sq. ft.)	Estimated Cost
Bioretention systems	0.129	22	9,470	0.36	1,225	\$6,124

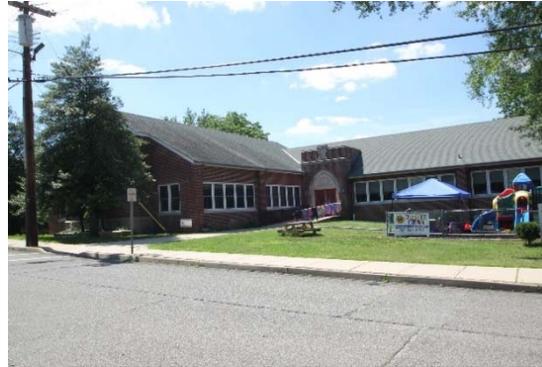
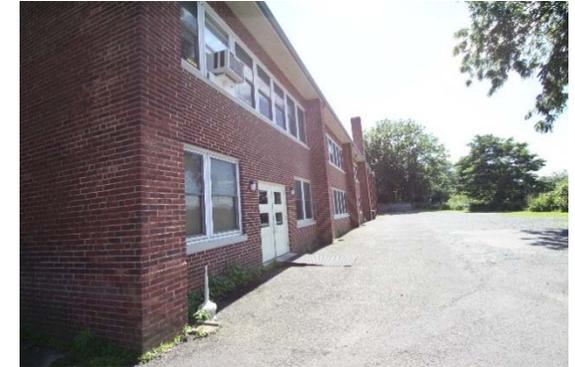
Runoff from the roof of the preschool currently drains onto pavement behind the building. The lawn area at the front can be converted into two rain gardens to capture and infiltrate this roof runoff. Downspouts may be redirected into rain barrels as well to harvest rainwater that could be used to water existing gardens behind the school. A preliminary soil assessment suggests that soils have suitable drainage characteristics for green infrastructure.
