**Impervious Cover Reduction Action Plan  
for  
Mountainside Borough, Union County, New Jersey**

*Prepared for Mountainside Borough by the  
Rutgers Cooperative Extension Water Resources Program*

November 16, 2015

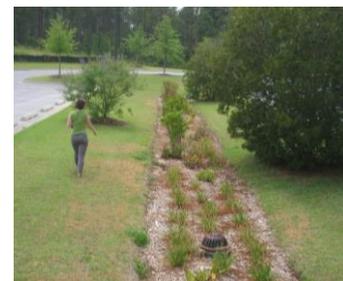
### ***Bioswale***

Bioswales are landscape features that convey stormwater from one location to another while removing pollutants and providing water an opportunity to infiltrate.

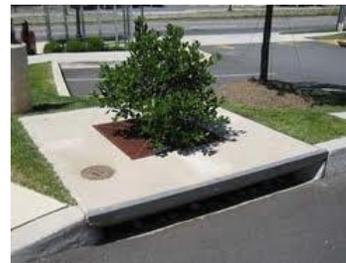
### ***Tree filter boxes***

These are pre-manufactured concrete boxes that contain a special soil mix and are planted with a tree or shrub. They filter stormwater runoff but provide little storage capacity. They are typically designed to quickly filter stormwater and then discharge it to the local sewer system.

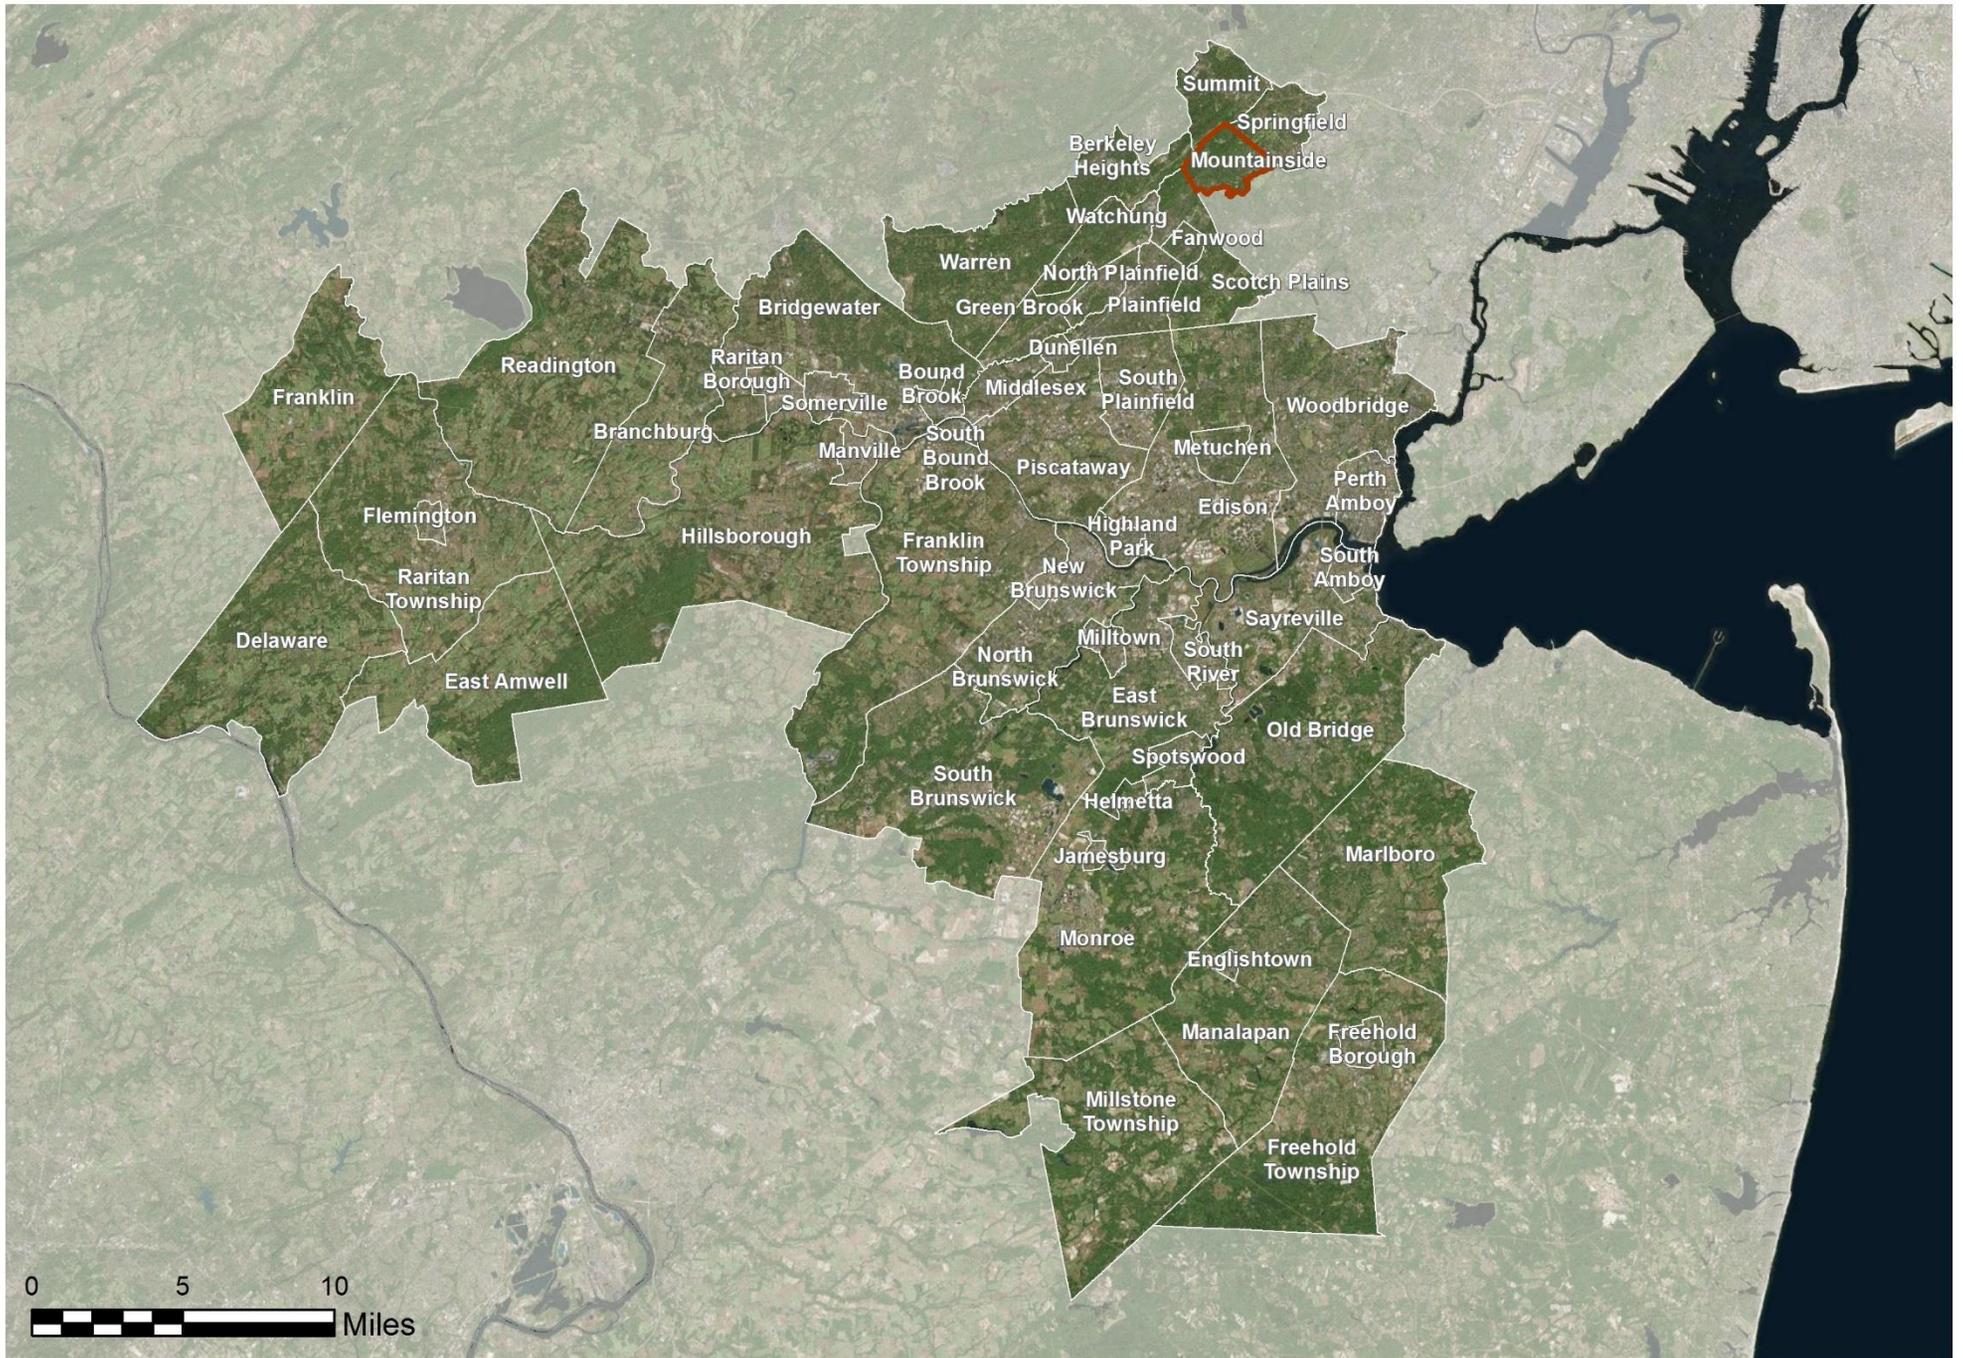
**a. Overview Map of the Project**

# MOUNTAINSIDE BOROUGH: CLIMATE RESILIENT GREEN INFRASTRUCTURE FOR THE RARITAN BASIN

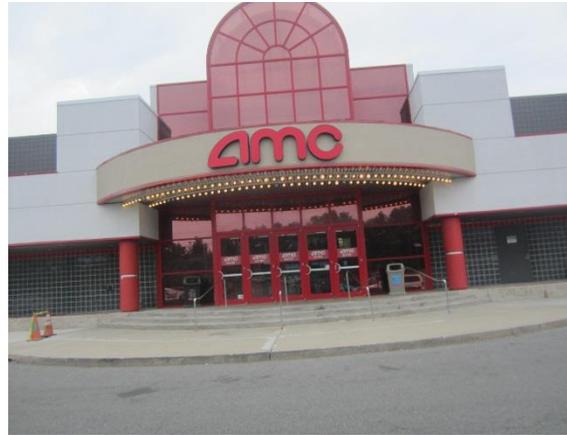
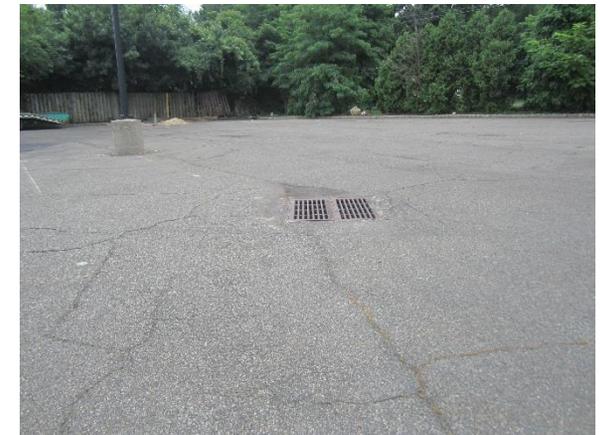
# AMC LOEWS MOUNTAINSIDE 10

The large parking lot contains many catch basins to which most of the stormwater drains. Pervious pavement can replace existing parking spaces to capture and infiltrate stormwater. A preliminary soil assessment suggests that more soil testing would be required before determining the soil's suitability for green infrastructure.

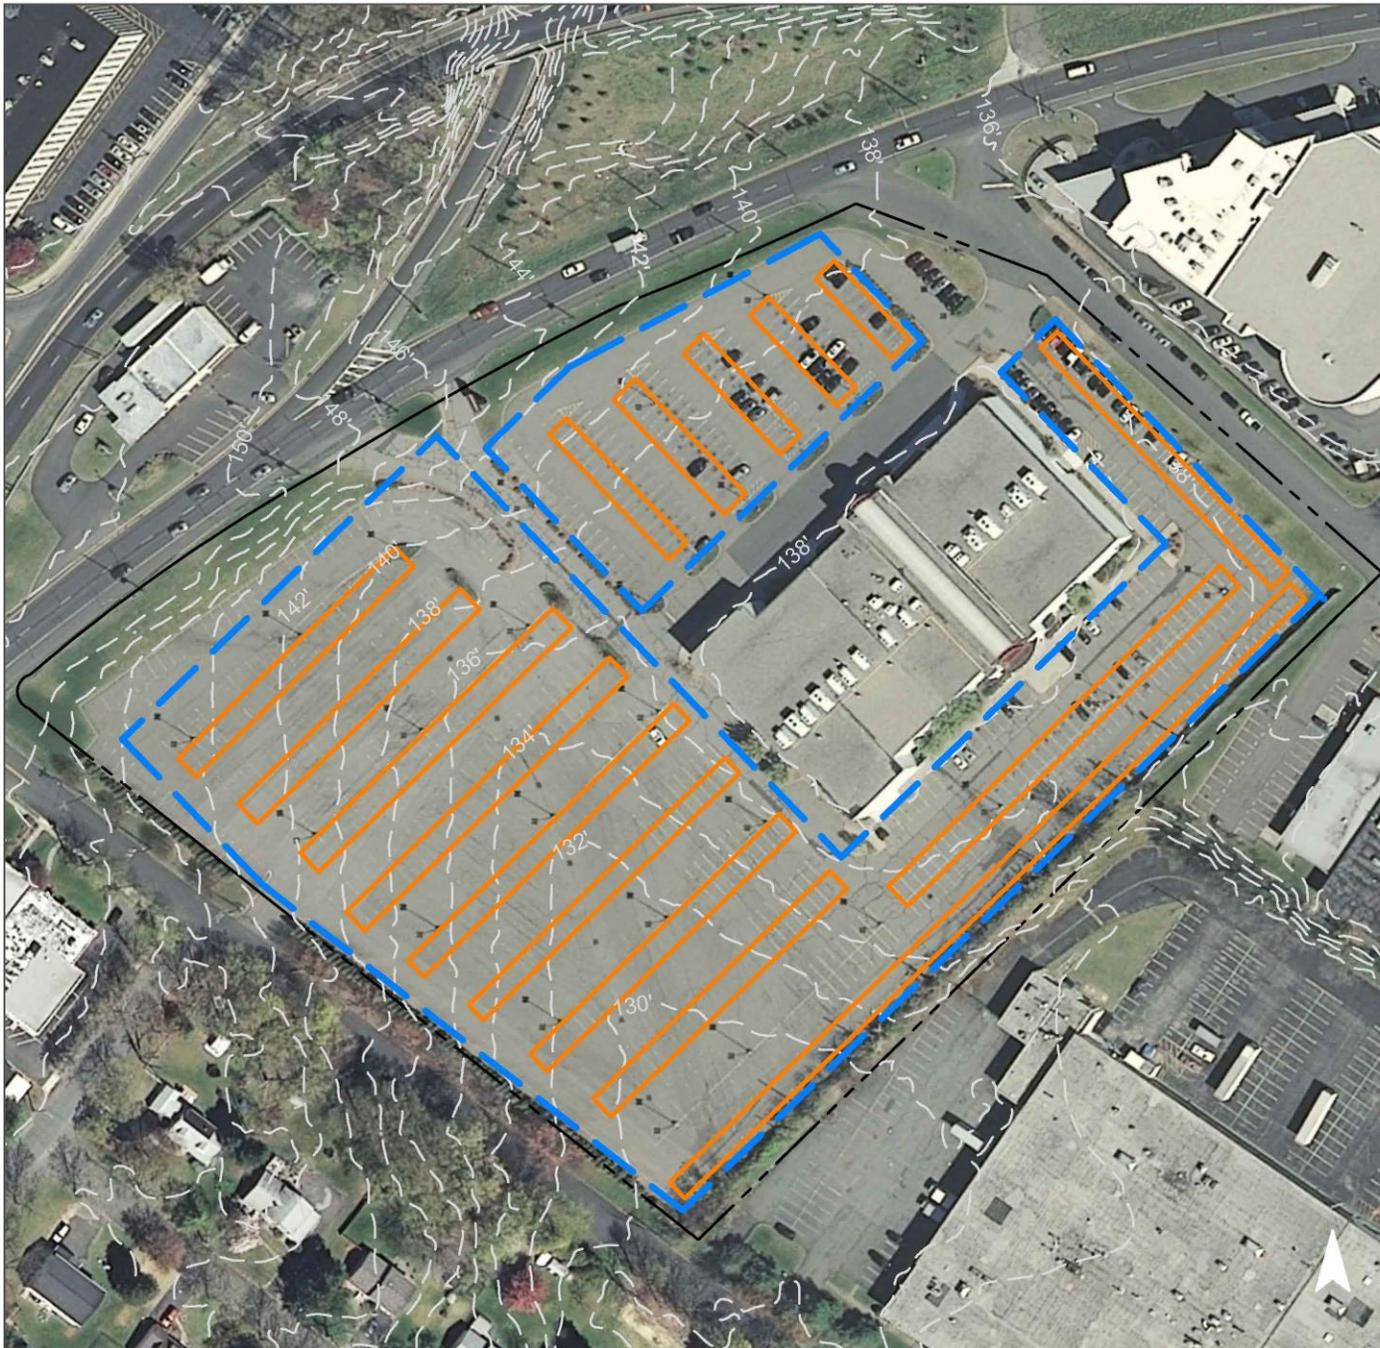
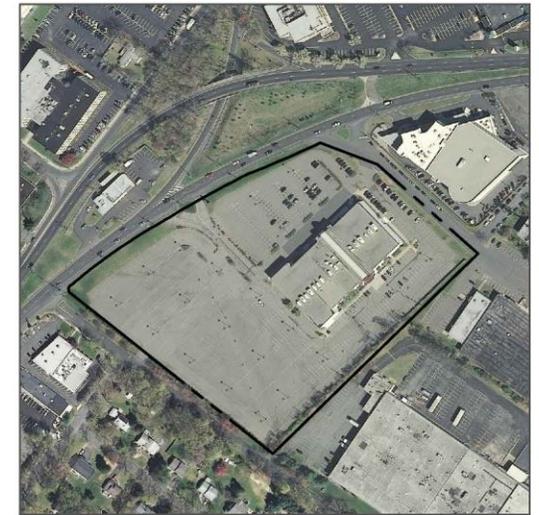
## AMC Loews Mountainside 10

Recommended Green Infrastructure Practices	Recharge Potential (Mgal/yr)	TSS Removal Potential (lbs/yr)	Maximum Volume Reduction Potential (gal/storm)	Peak Discharge Reduction Potential (cu. ft./second)	Estimated Size (sq. ft.)	Estimated Cost
Pervious pavements	7.524	1,260	570,013	21.40	77,941	\$1,948,525

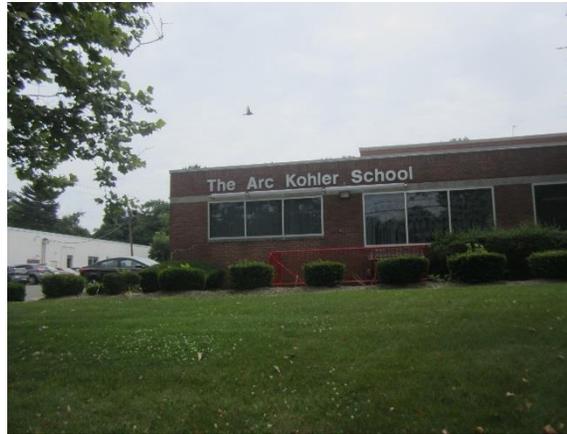
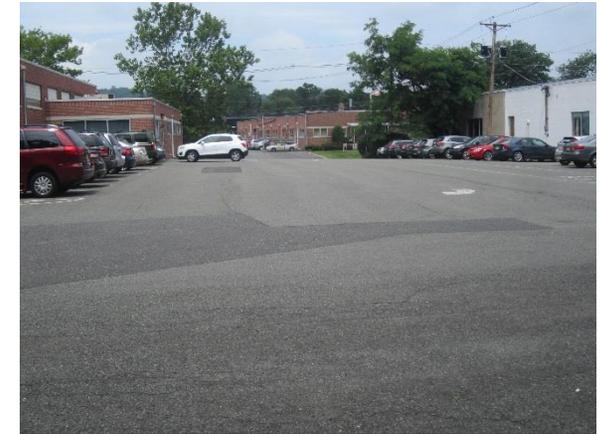
The school has disconnected downspouts flowing directly onto the parking lot on the eastern side of the school. Parking spaces can be replaced with pervious pavement to capture and infiltrate stormwater. A preliminary soil assessment suggests that more soil testing would be required before determining the soil's suitability for green infrastructure.

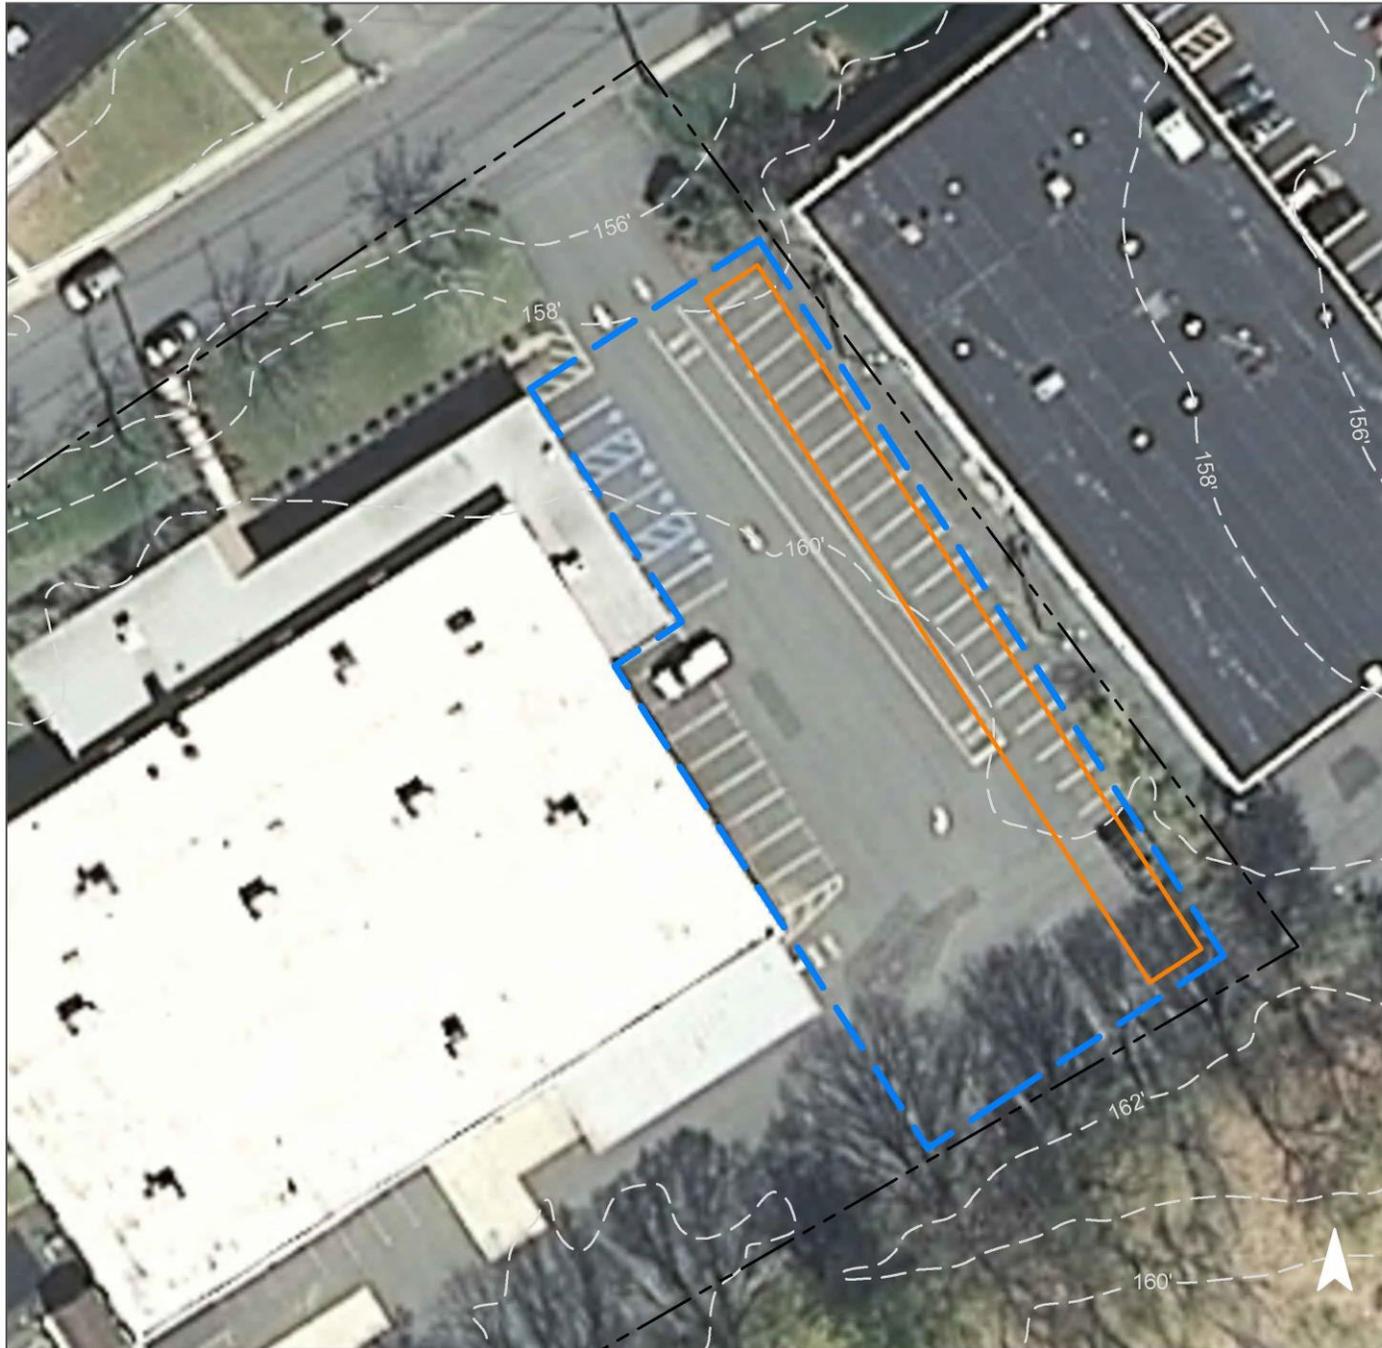
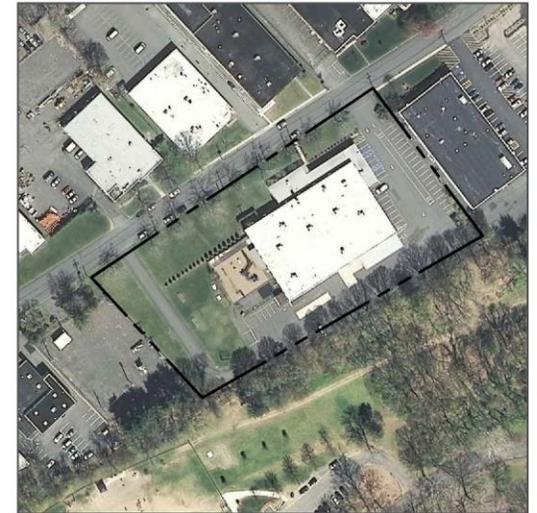
## Arc Kohler School

Recommended Green Infrastructure Practices	Recharge Potential (Mgal/yr)	TSS Removal Potential (lbs/yr)	Maximum Volume Reduction Potential (gal/storm)	Peak Discharge Reduction Potential (cu. ft./second)	Estimated Size (sq. ft.)	Estimated Cost
Pervious pavements	0.498	83	37,722	1.42	3,403	\$85,075

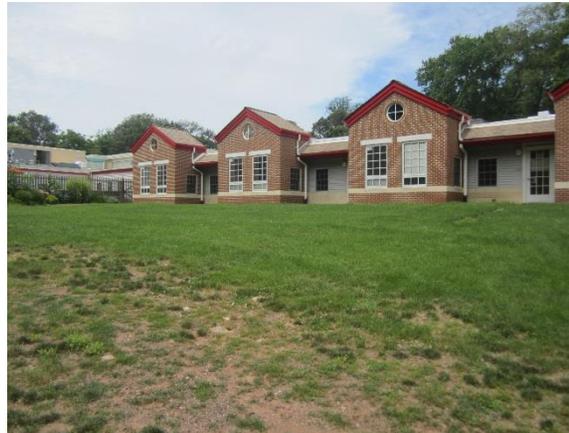
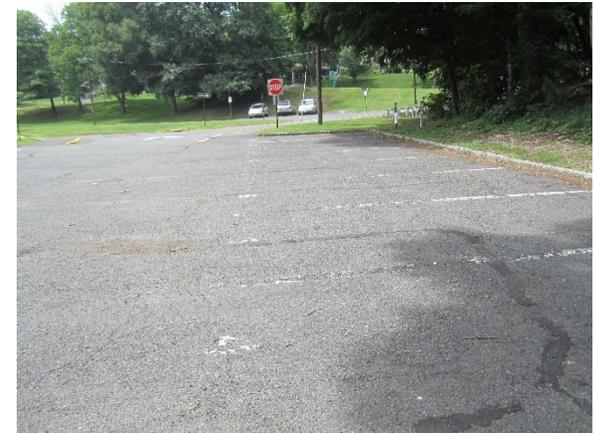
A bioretention system could be built off of the southern side of the school to capture, treat, and infiltrate roof runoff from the nearby downspouts. In both parking lots parking spaces can be replaced with pervious pavement to capture and infiltrate stormwater. A preliminary soil assessment suggests that the soils have suitable drainage characteristics for green infrastructure.

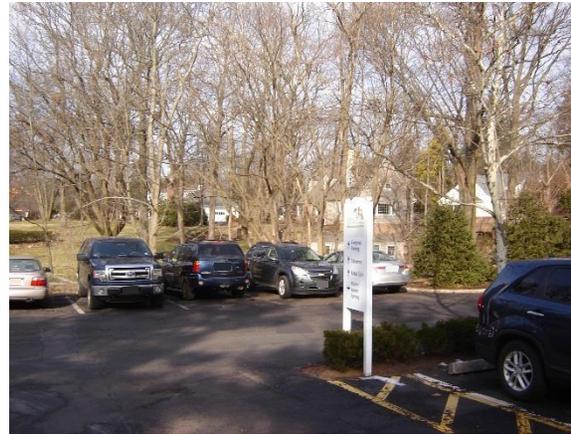
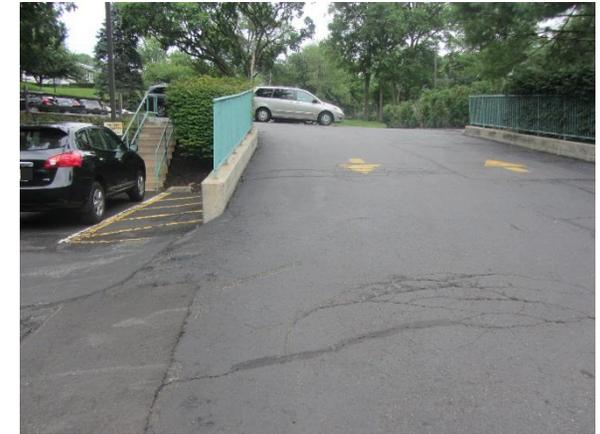
This site contains three parking areas in front of the hospital building. Many of the parking spots can be replaced with pervious pavement to collect and infiltrate runoff. A bioretention system can also be installed to capture, treat, and infiltrate rooftop runoff. A preliminary soil assessment suggests that the soils have suitable drainage characteristics for green infrastructure.

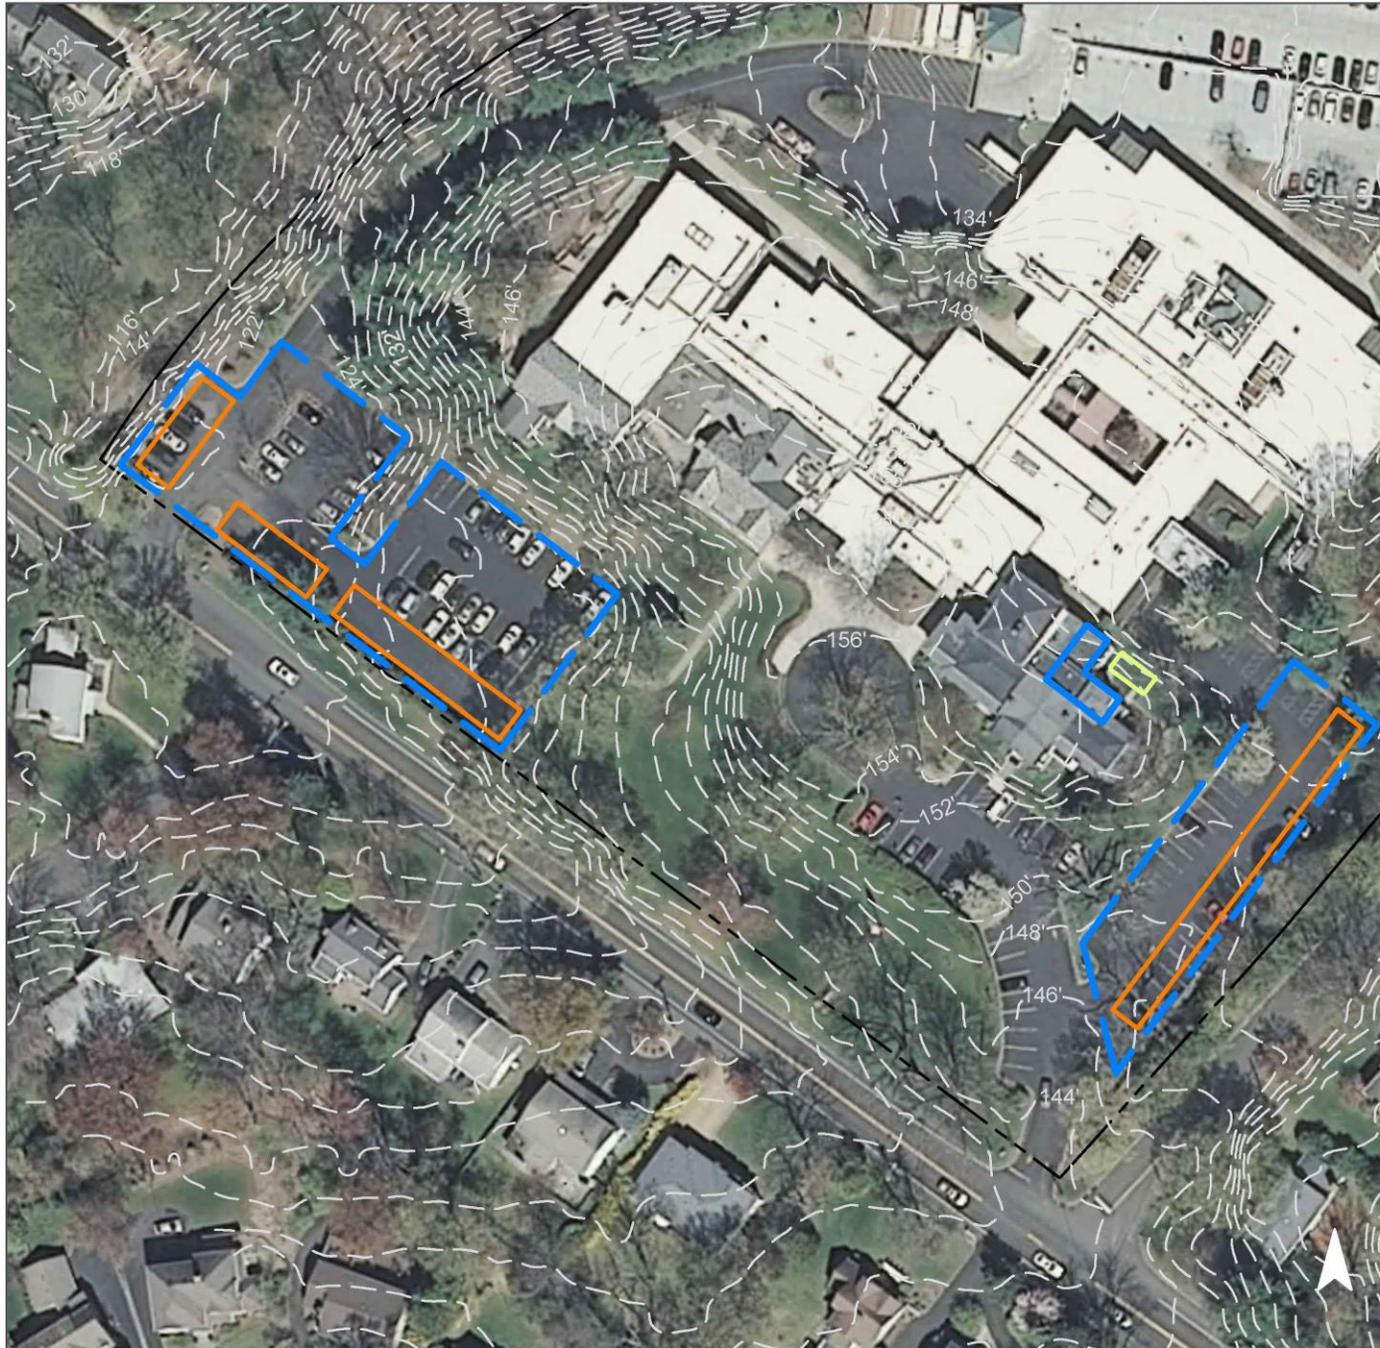
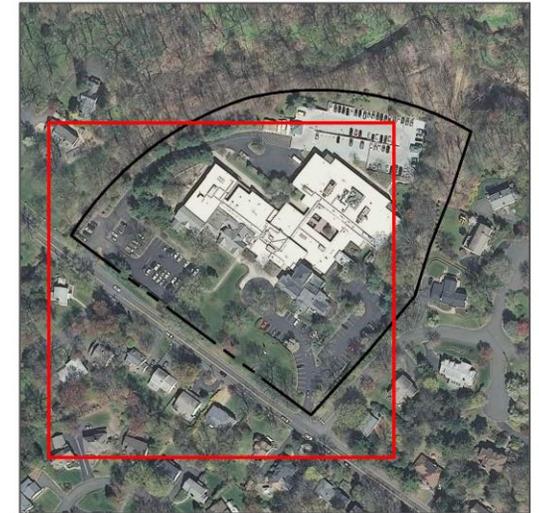
## Children's Specialized Hospital

Recommended Green Infrastructure Practices	Recharge Potential (Mgal/yr)	TSS Removal Potential (lbs/yr)	Maximum Volume Reduction Potential (gal/storm)	Peak Discharge Reduction Potential (cu. ft./second)	Estimated Size (sq. ft.)	Estimated Cost
Bioretention systems	0.022	4	1,638	0.06	236	\$1,180
Pervious pavements	0.887	149	67,238	2.52	7,407	\$185,175

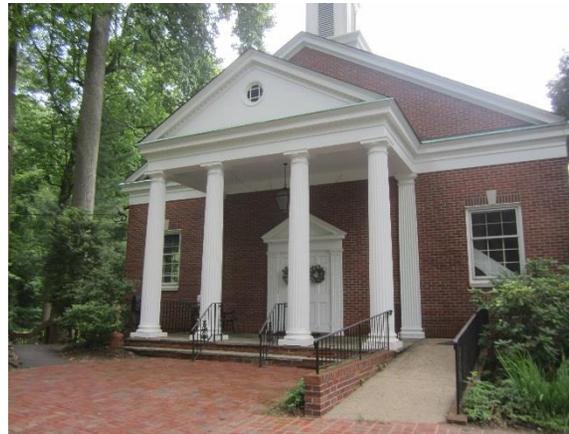
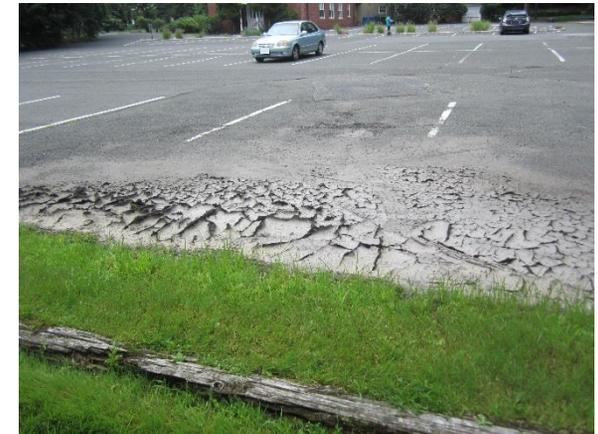
The church parking lot runoff primarily drains to turf grass on the east side of the site. Pervious pavement can be installed in parking spots to capture and infiltrate stormwater being generated by the parking lot. A preliminary soil assessment suggests that the soils have suitable drainage characteristics for green infrastructure.

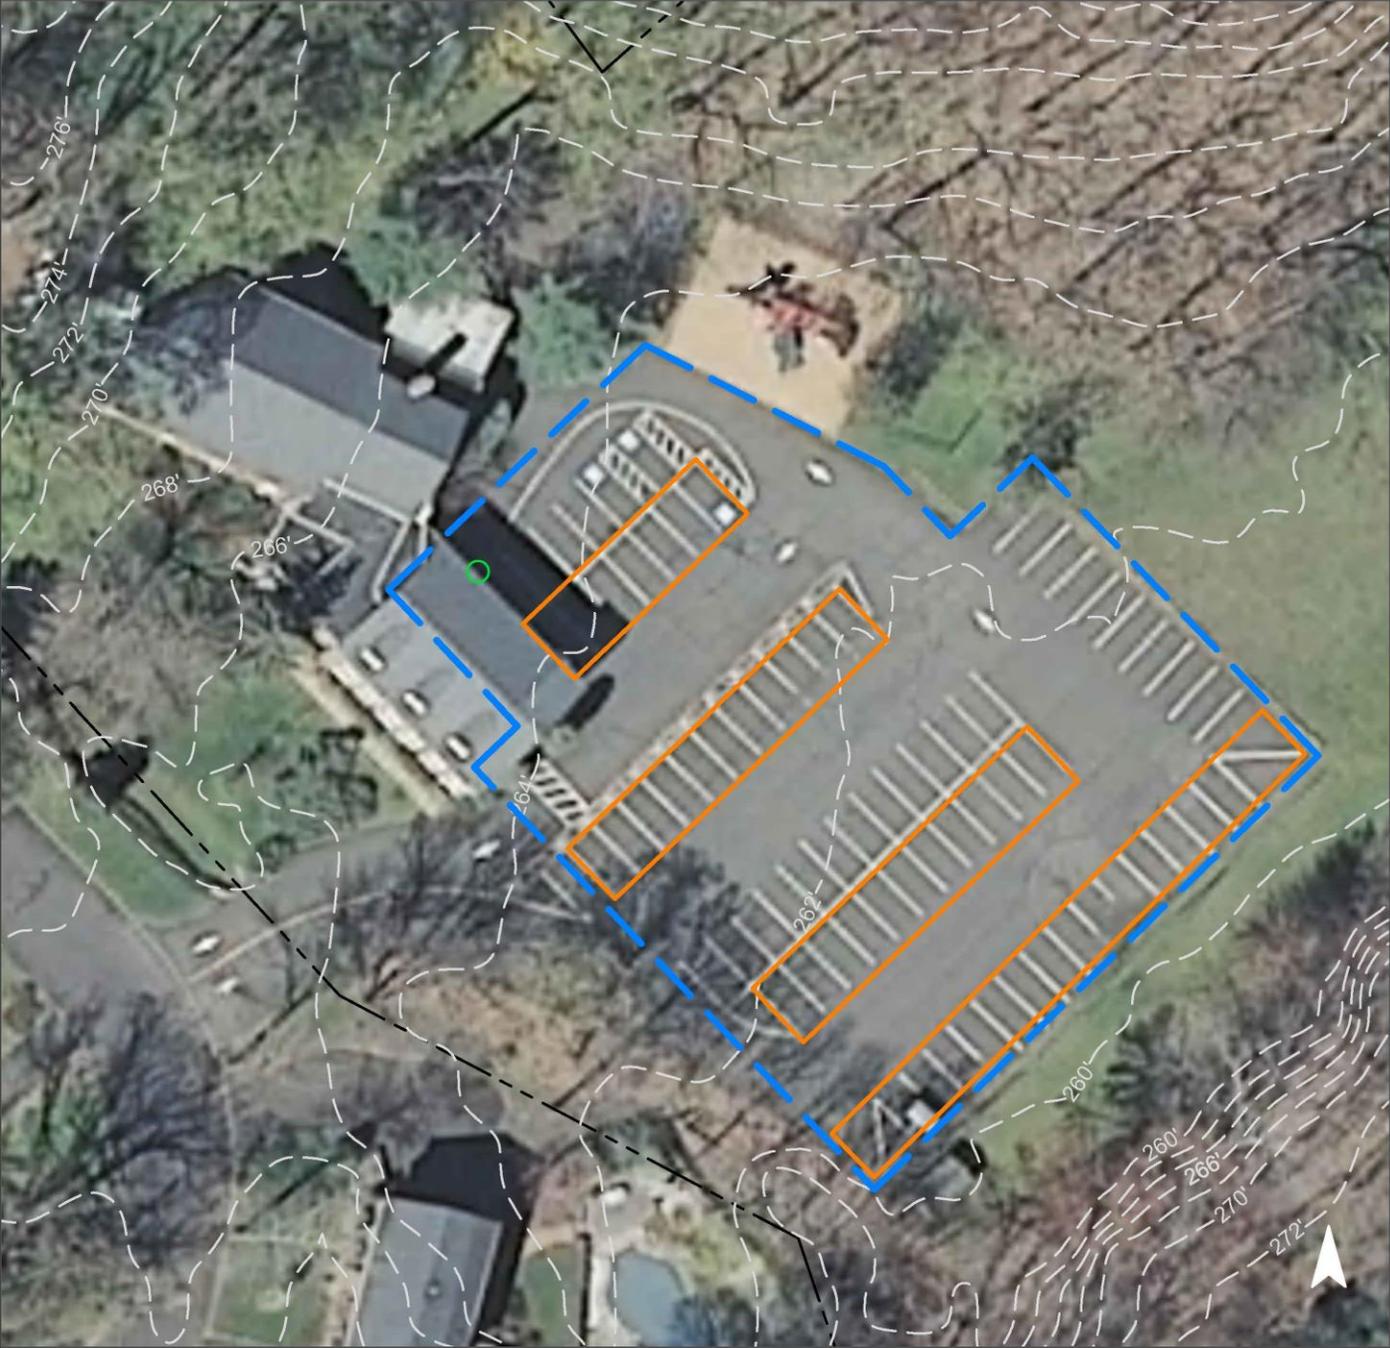
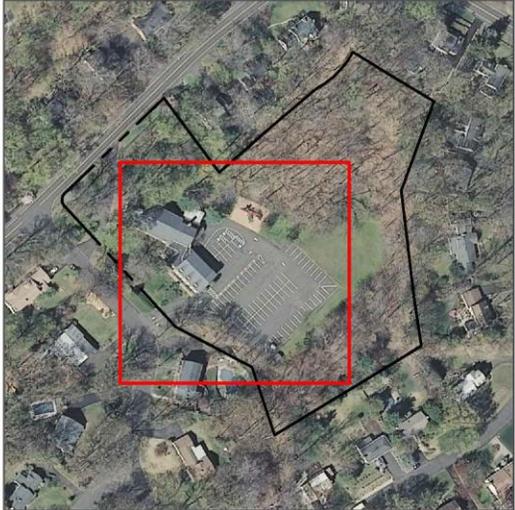
## Community Presbyterian Church

Recommended Green Infrastructure Practices	Recharge Potential (Mgal/yr)	TSS Removal Potential (lbs/yr)	Maximum Volume Reduction Potential (gal/storm)	Peak Discharge Reduction Potential (cu. ft./second)	Estimated Size (sq. ft.)	Estimated Cost
Pervious pavements	0.734	123	55,569	2.09	7,476	\$186,900

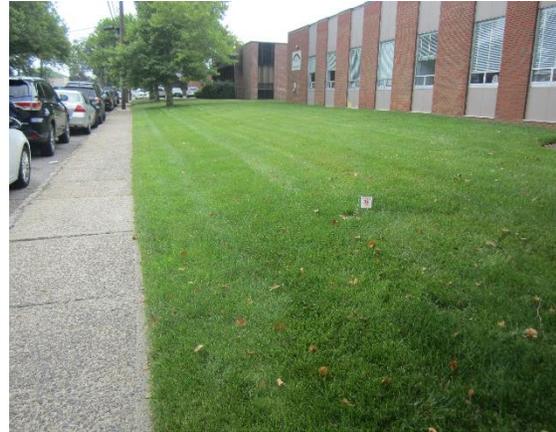
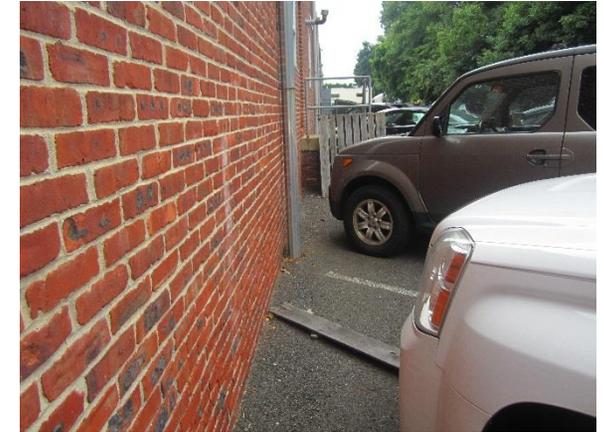
There are multiple connected downspouts along the southwest side of the building that can be disconnected and the parking spaces on the southwest side can be replaced with pervious pavement to capture and infiltrate stormwater. A preliminary soil assessment suggests that more soil testing would be required before determining the soil's suitability for green infrastructure.

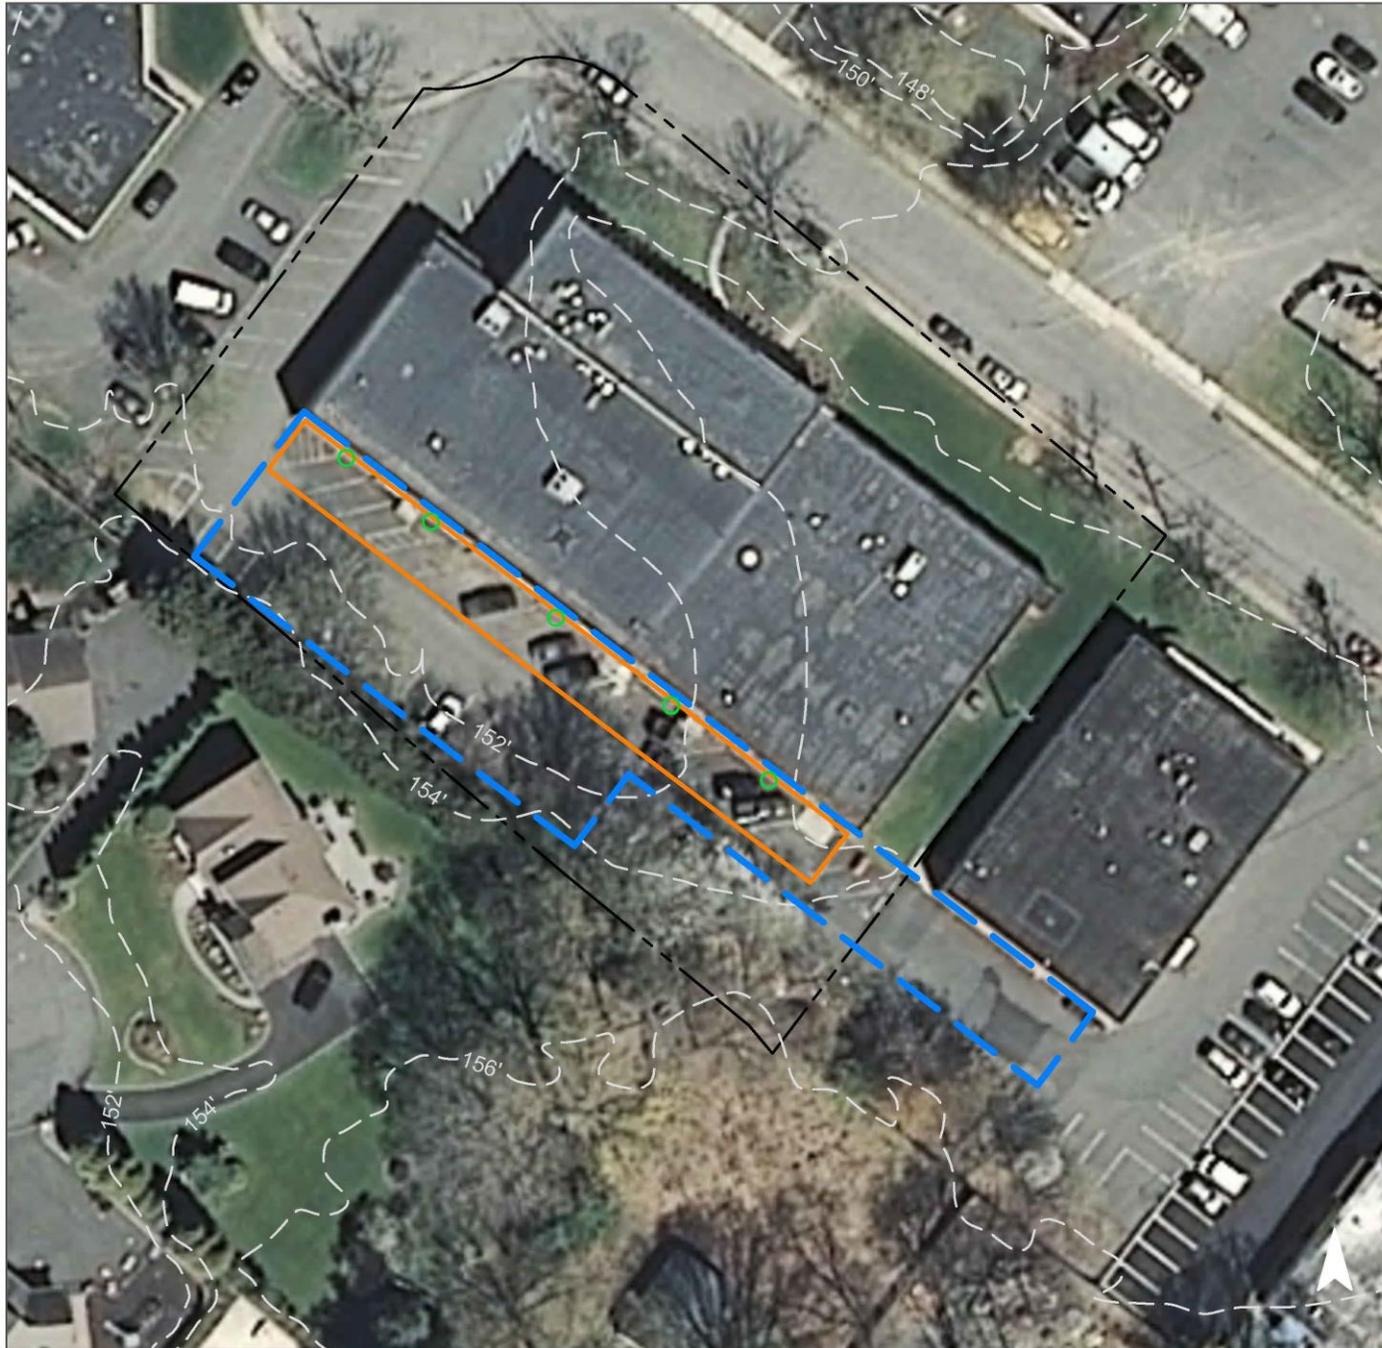
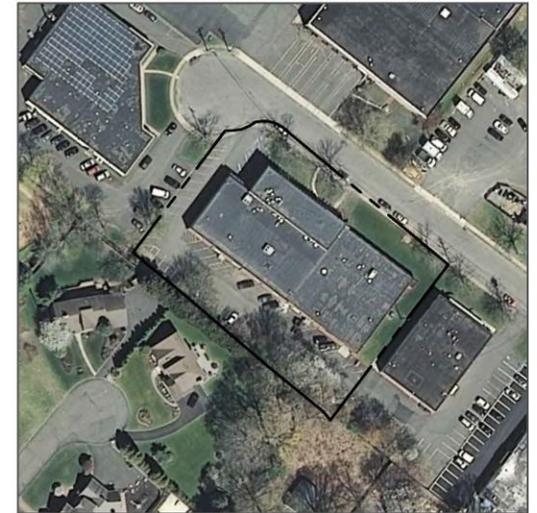
## Cornerstone Day School

Recommended Green Infrastructure Practices	Recharge Potential (Mgal/yr)	TSS Removal Potential (lbs/yr)	Maximum Volume Reduction Potential (gal/storm)	Peak Discharge Reduction Potential (cu. ft./second)	Estimated Size (sq. ft.)	Estimated Cost
Pervious pavements	0.344	58	26,053	0.98	4,137	\$103,425

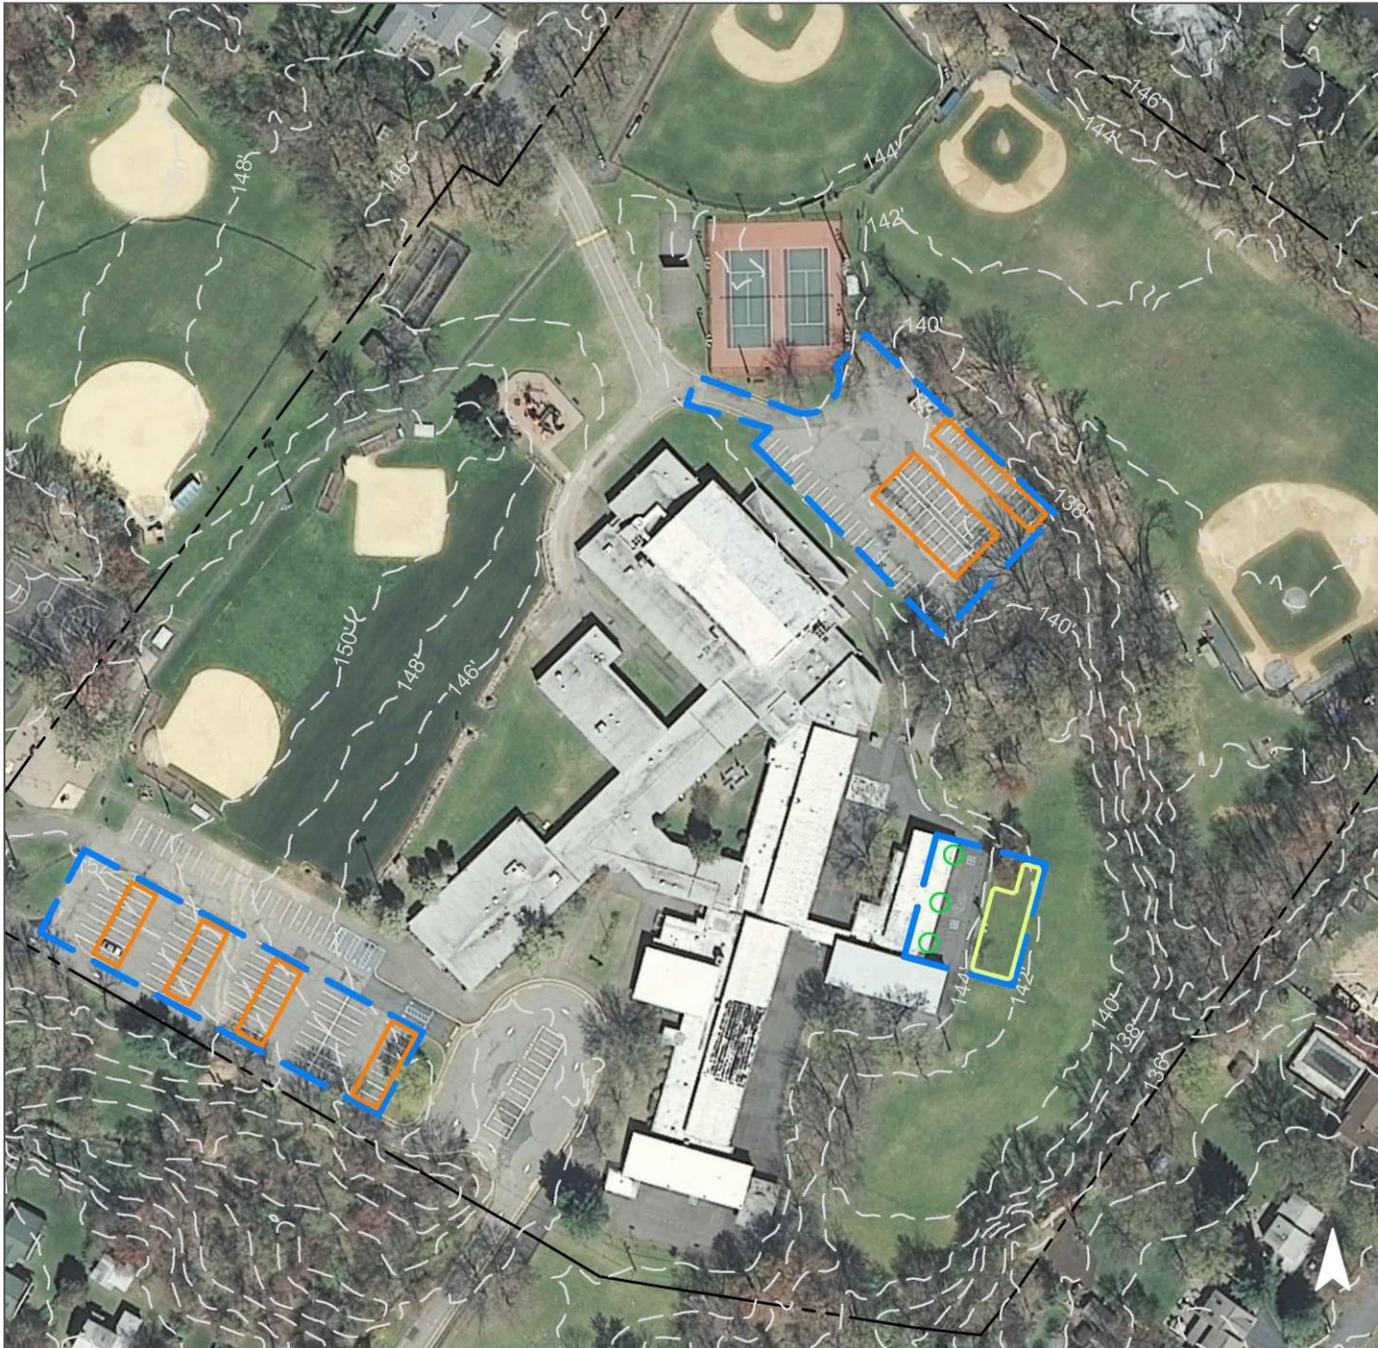
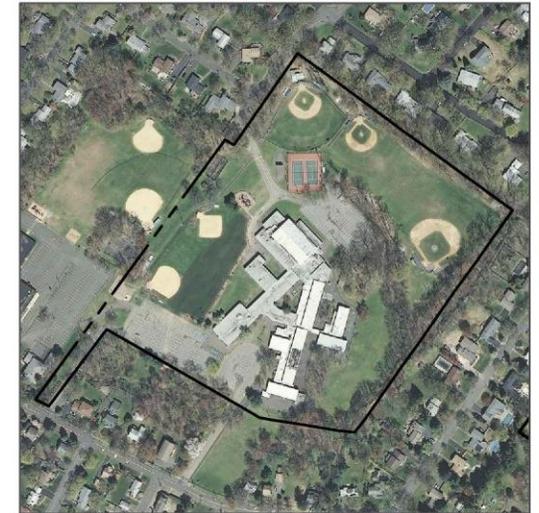
## Deerfield Middle School

Recommended Green Infrastructure Practices	Recharge Potential (Mgal/yr)	TSS Removal Potential (lbs/yr)	Maximum Volume Reduction Potential (gal/storm)	Peak Discharge Reduction Potential (cu. ft./second)	Estimated Size (sq. ft.)	Estimated Cost
Bioretention systems	0.228	38	17,271	0.65	2,400	\$12,000
Pervious pavements	0.579	97	43,900	1.65	11,962	\$299,050

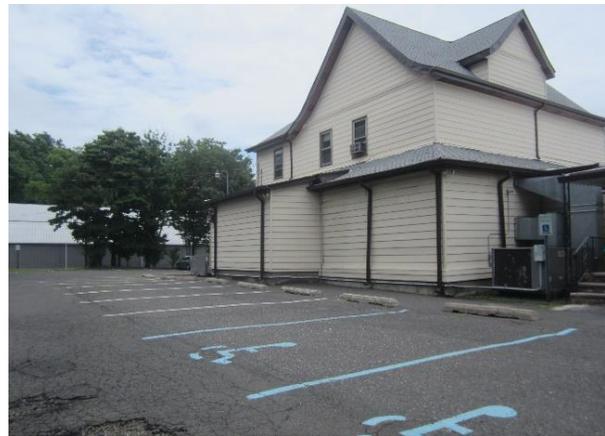
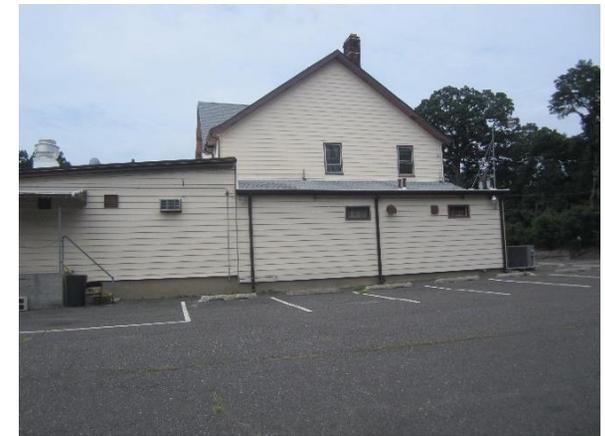
Parking spaces southeast of the building can be replaced with pervious pavement to capture and infiltrate stormwater generated by the parking lot. A preliminary soil assessment suggests that the soils have suitable drainage characteristics for green infrastructure.

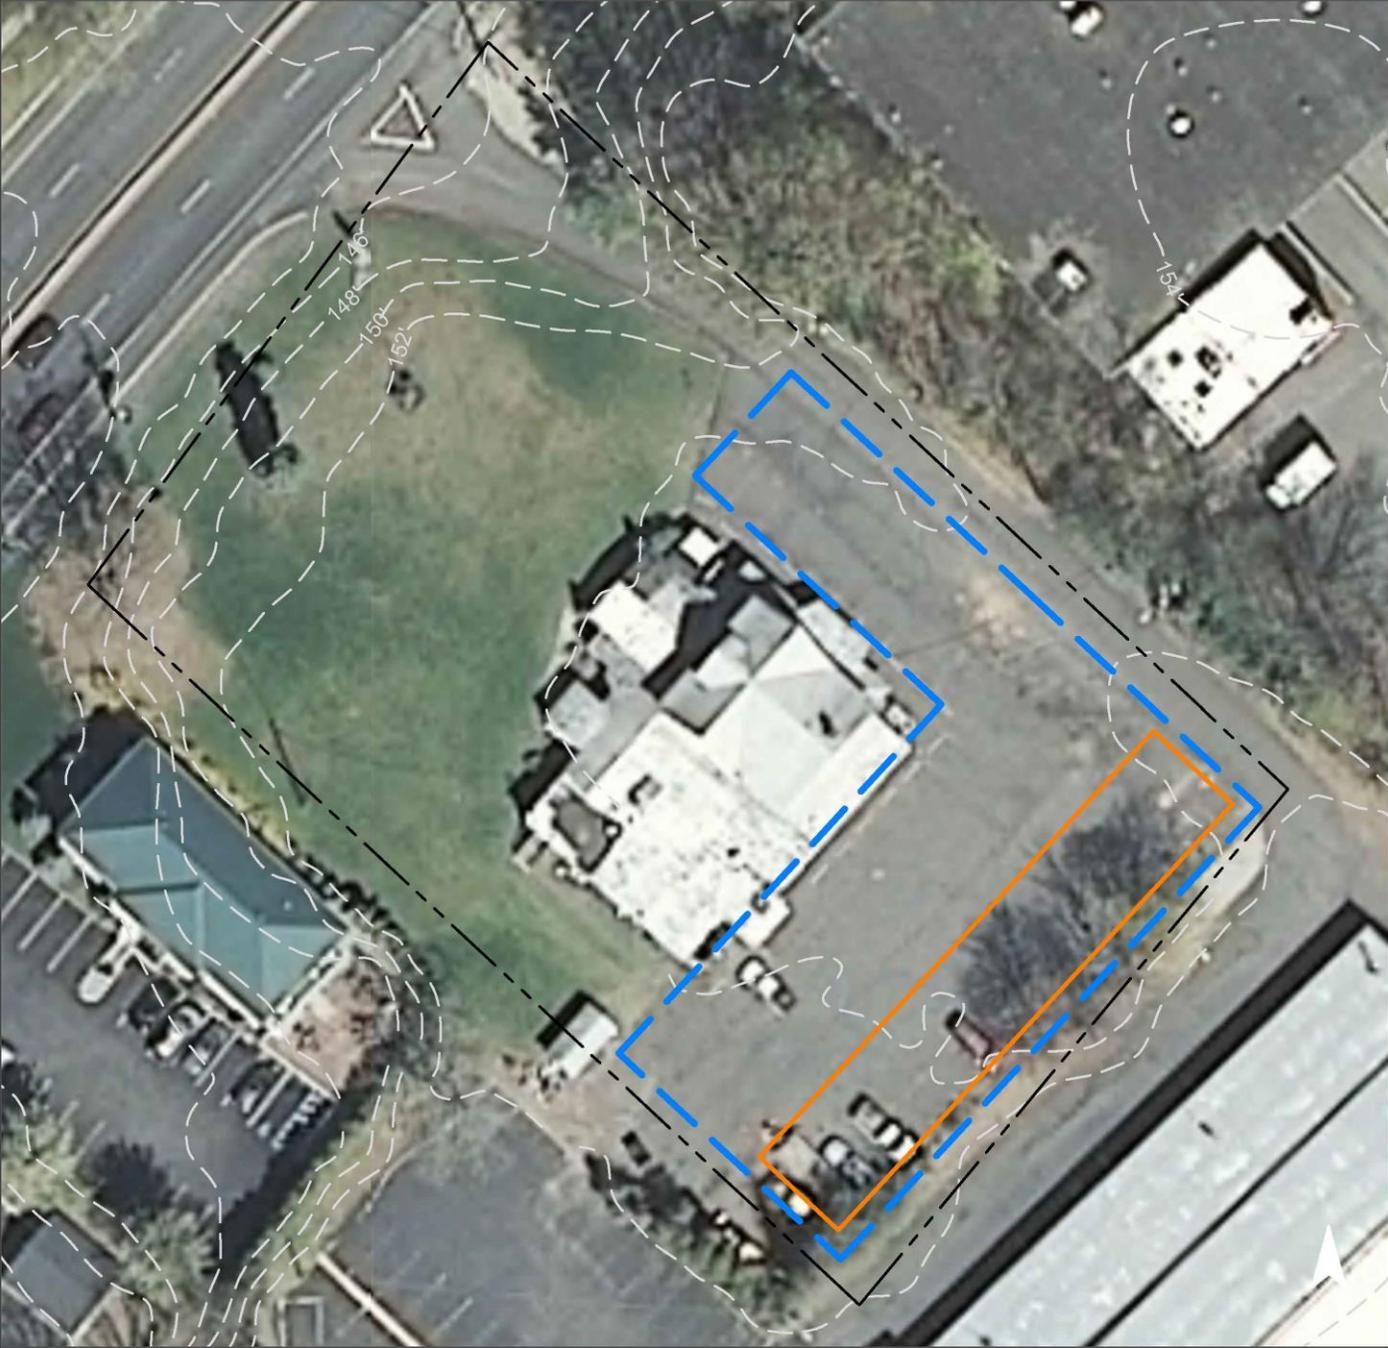
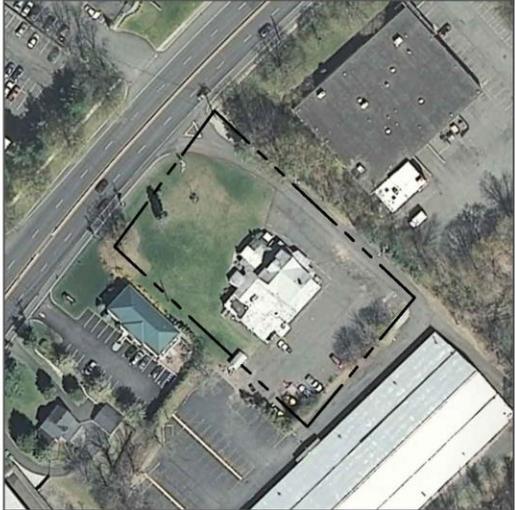
## Elks Lodge

Recommended Green Infrastructure Practices	Recharge Potential (Mgal/yr)	TSS Removal Potential (lbs/yr)	Maximum Volume Reduction Potential (gal/storm)	Peak Discharge Reduction Potential (cu. ft./second)	Estimated Size (sq. ft.)	Estimated Cost
Pervious pavements	0.417	70	31,603	1.19	4,272	\$106,850
