**Impervious Cover Reduction Action Plan  
for  
Mountainside Borough, Union County, New Jersey**

*Prepared for Mountainside Borough by the  
Rutgers Cooperative Extension Water Resources Program*

November 16, 2015

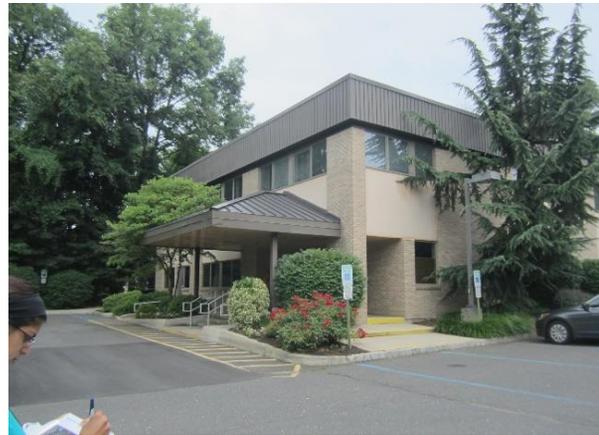
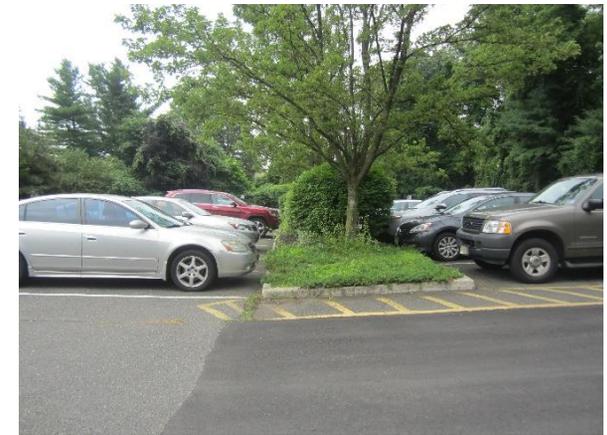
Parking spaces south of the building can be replaced with pervious pavement to capture and infiltrate stormwater. A preliminary soil assessment suggests that the soils have suitable drainage characteristics for green infrastructure.

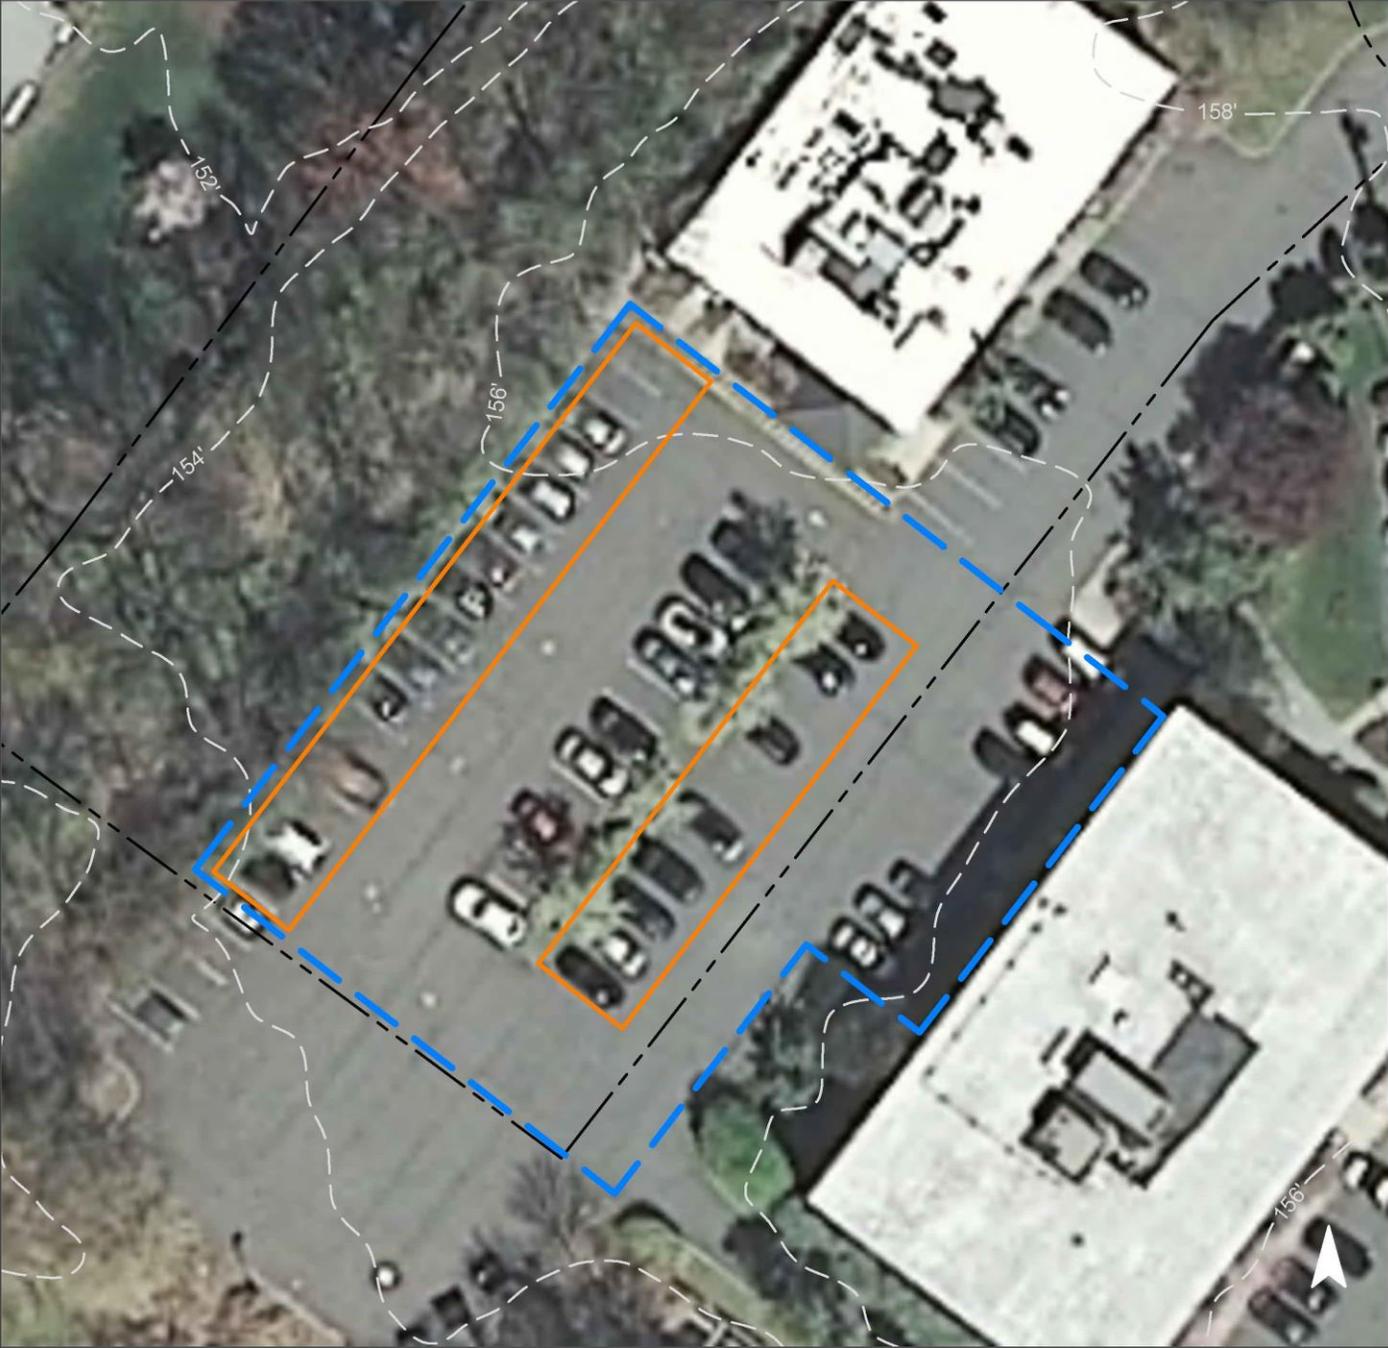
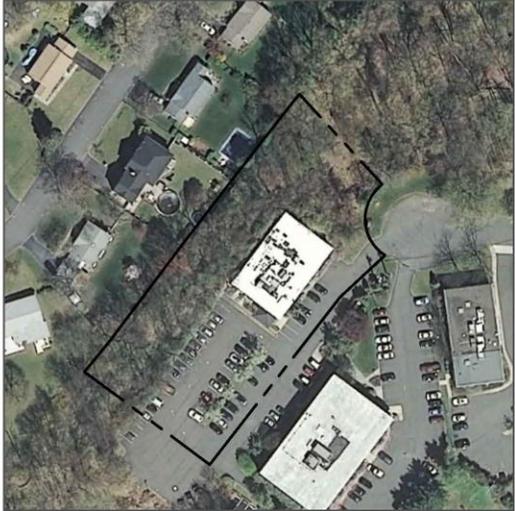
**Gastro-Surgi Center of New Jersey**

Recommended Green Infrastructure Practices	Recharge Potential (Mgal/yr)	TSS Removal Potential (lbs/yr)	Maximum Volume Reduction Potential (gal/storm)	Peak Discharge Reduction Potential (cu. ft./second)	Estimated Size (sq. ft.)	Estimated Cost
Pervious pavements	0.235	39	37,647	1.41	5,139	\$128,475

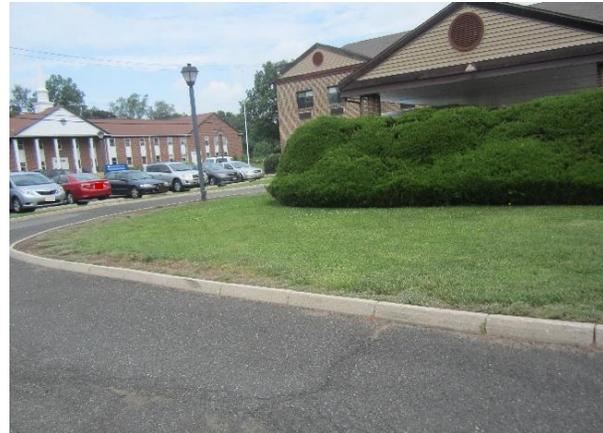
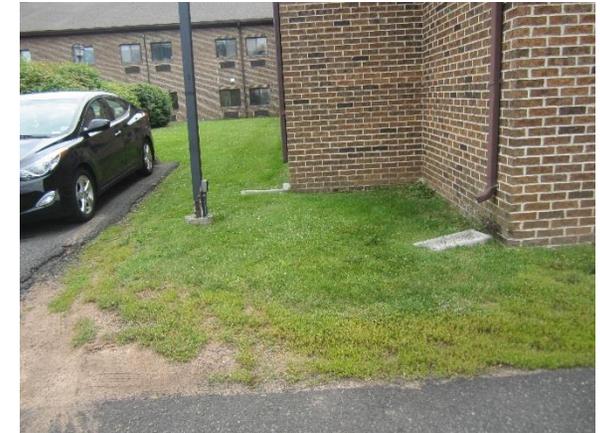
Parking spaces located southeast of the building can be replaced with pervious pavement to capture and infiltrate stormwater generated by the parking lot. A preliminary soil assessment suggests that the soils have suitable drainage characteristics for green infrastructure

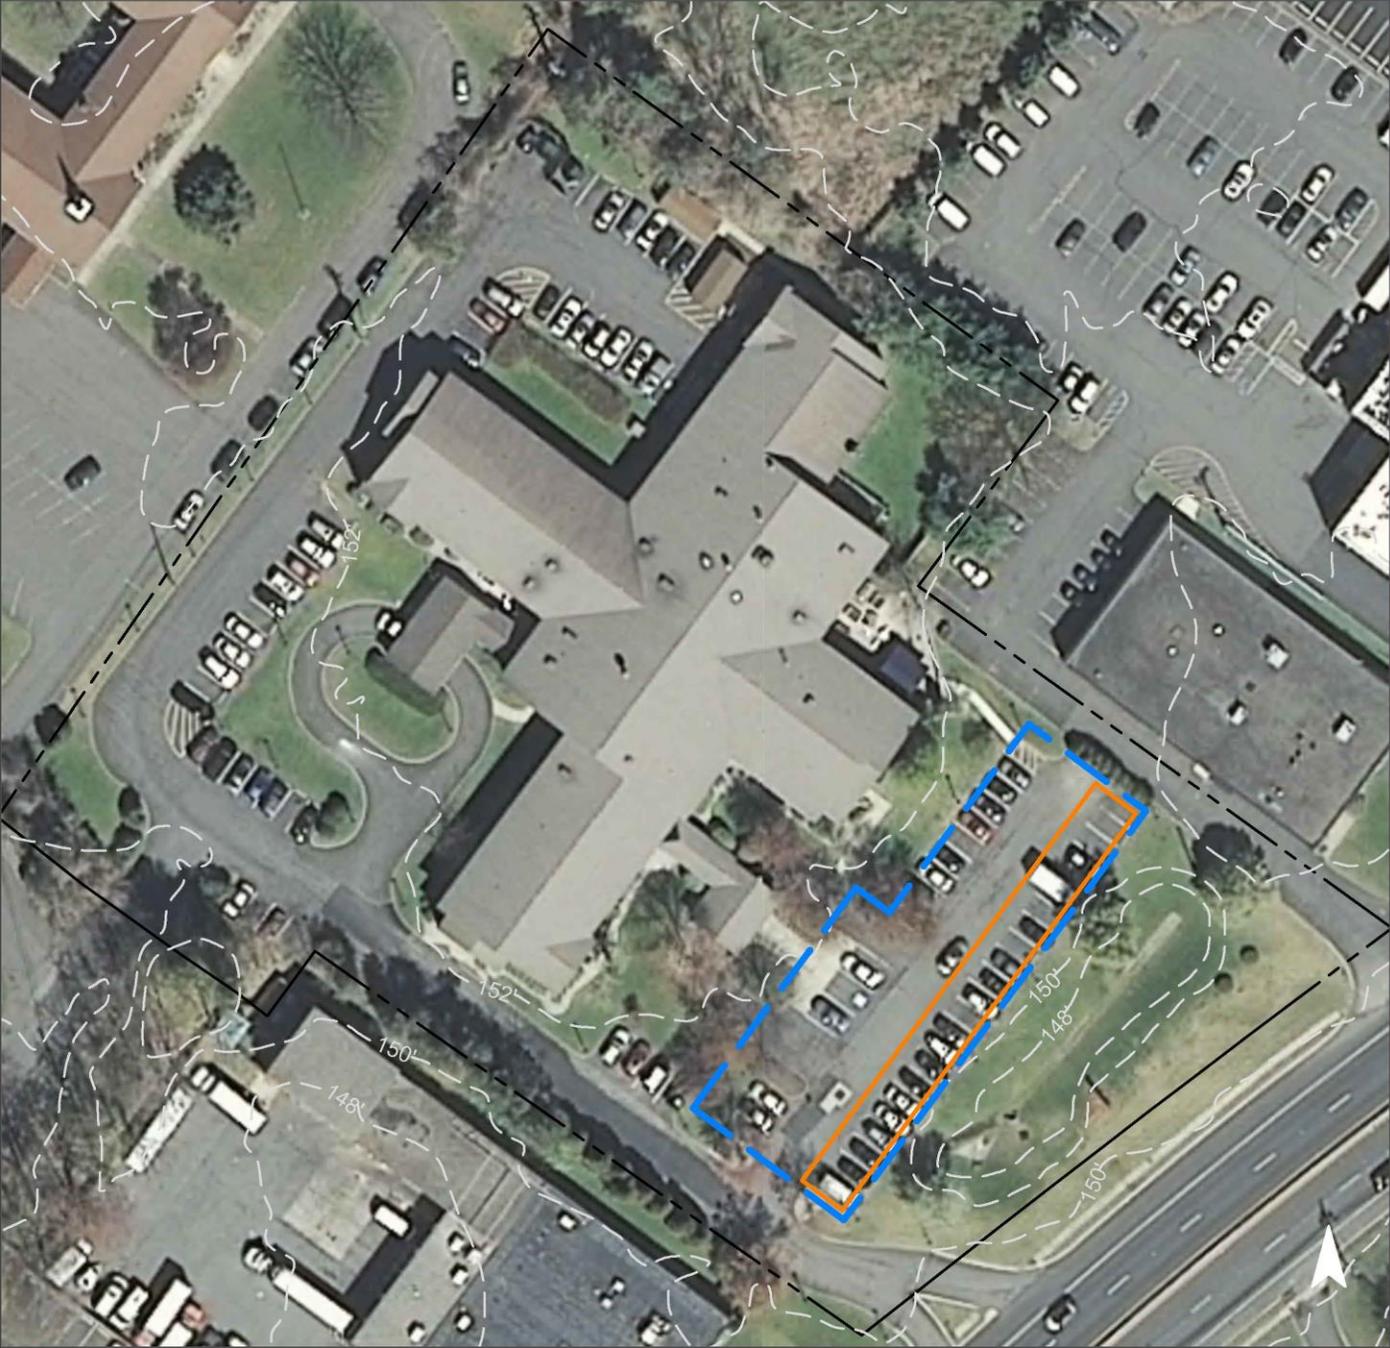
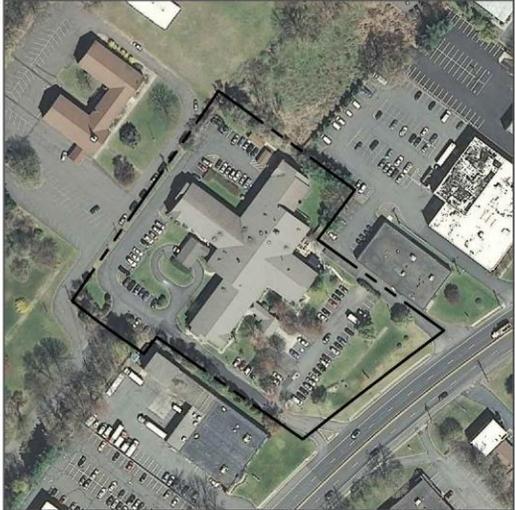
**ManorCare Health Services - Mountainside**

Recommended Green Infrastructure Practices	Recharge Potential (Mgal/yr)	TSS Removal Potential (lbs/yr)	Maximum Volume Reduction Potential (gal/storm)	Peak Discharge Reduction Potential (cu. ft./second)	Estimated Size (sq. ft.)	Estimated Cost
Pervious pavements	0.391	65	29,628	1.11	4,330	\$108,250

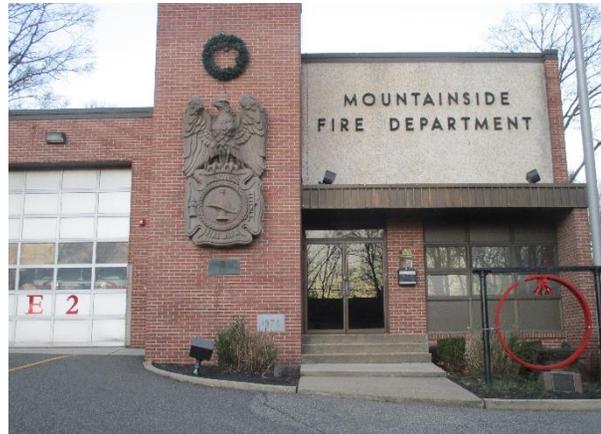
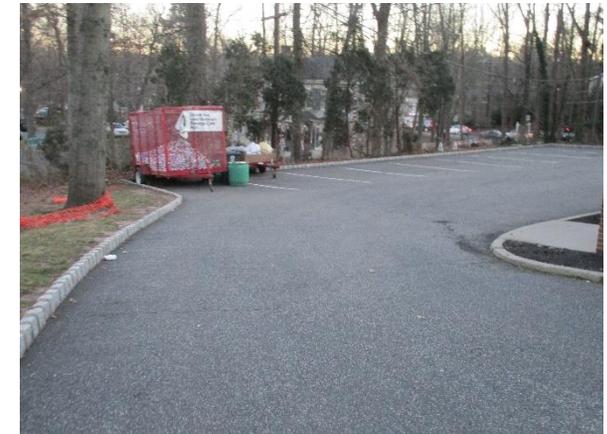
Rainwater can be harvested by installing a cistern at the firehouse. The water can be used for cleaning emergency vehicles or for conducting car wash fundraisers. Parking spots east of the building can be replaced with pervious pavement to capture and infiltrate stormwater. A preliminary soil assessment suggests that the soils have suitable drainage characteristics for green infrastructure.

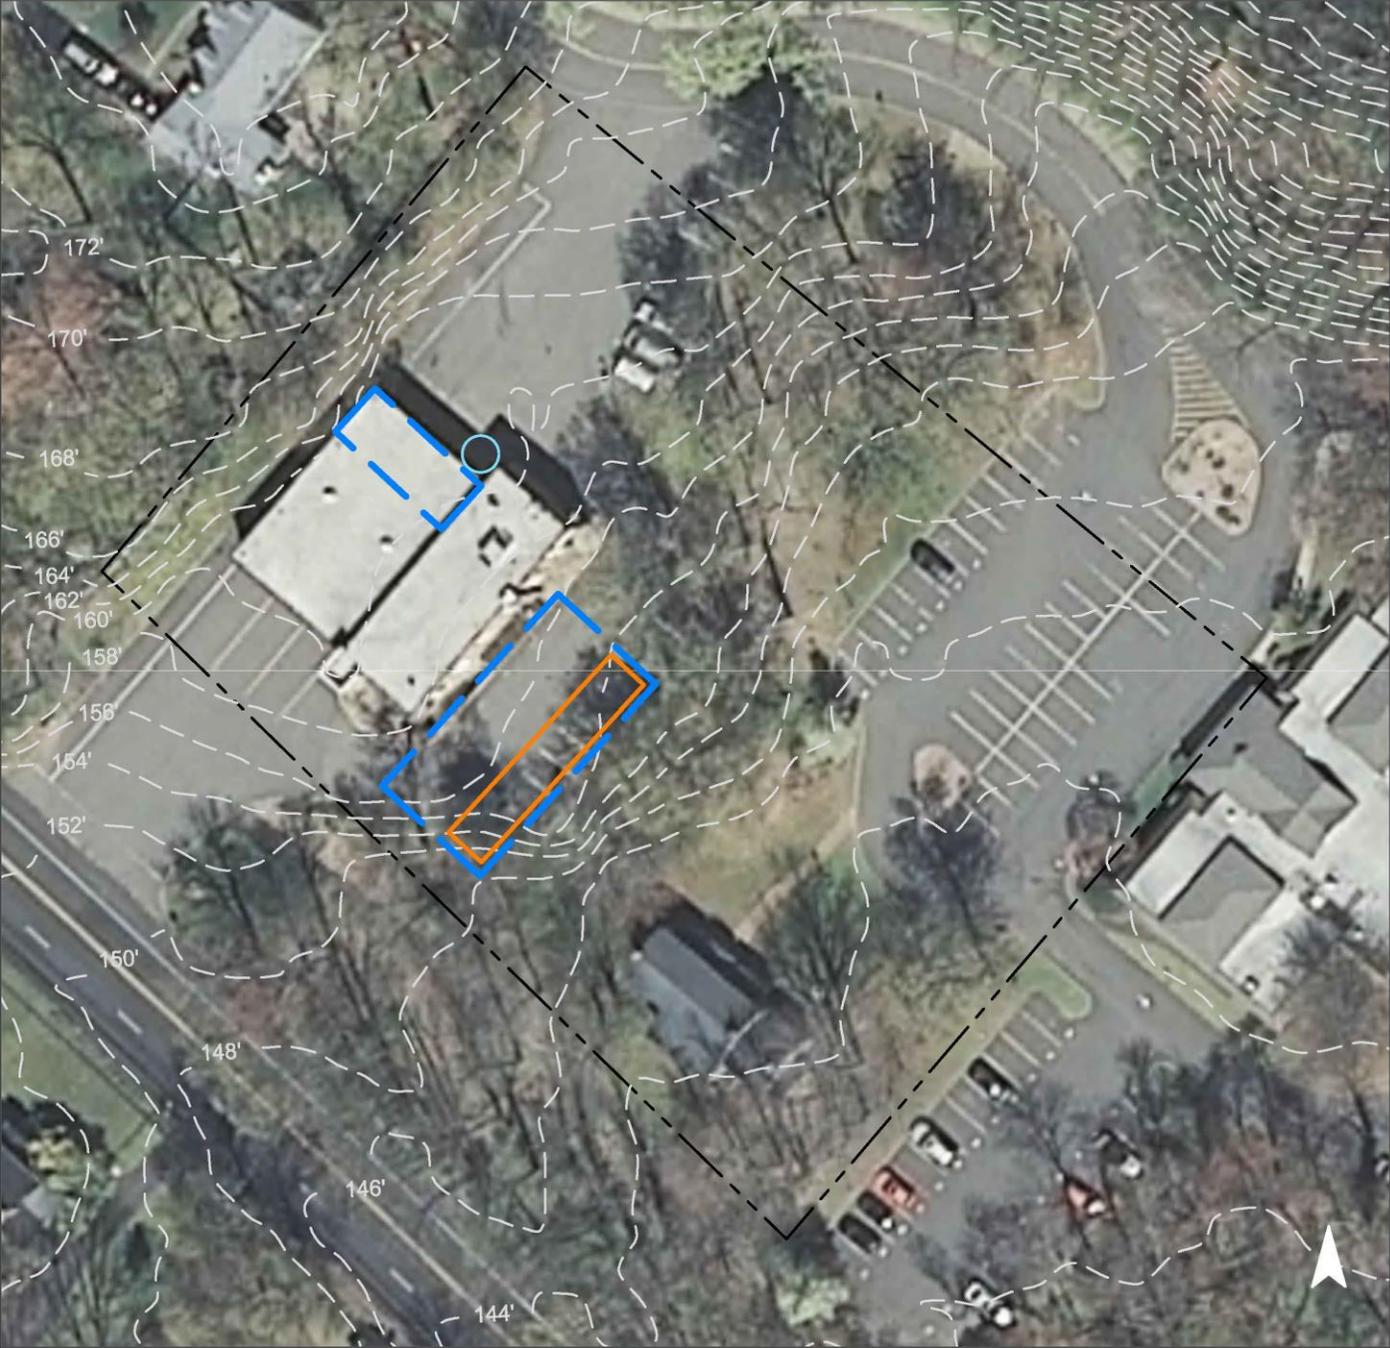
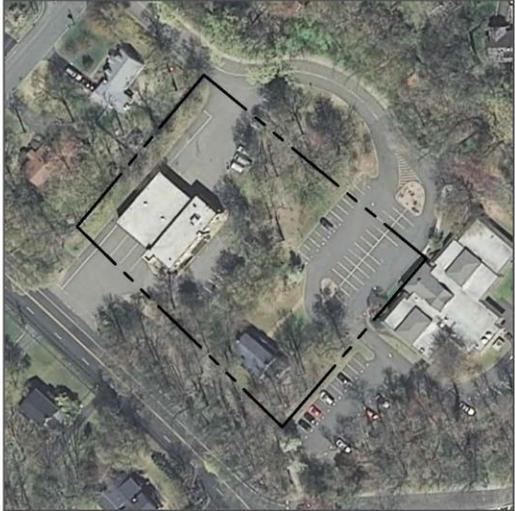
## Mountainside Fire Department

Recommended Green Infrastructure Practices	Recharge Potential (Mgal/yr)	TSS Removal Potential (lbs/yr)	Maximum Volume Reduction Potential (gal/storm)	Peak Discharge Reduction Potential (cu. ft./second)	Estimated Size (sq. ft.)	Estimated Cost
Pervious pavements	0.042	7	6,717	0.25	1,047	\$26,175
Rainwater harvesting systems	0.022	4	800	0.06	800 (gal)	\$1,600

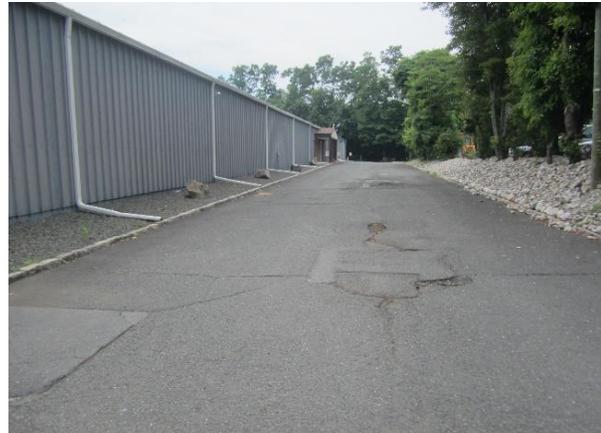
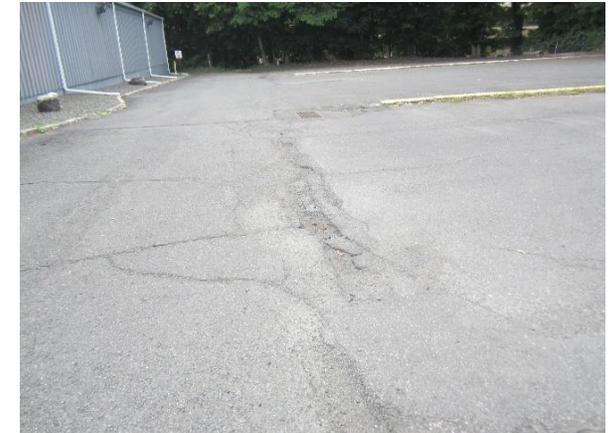
This site contains a building that has disconnected downspouts on both sides of it. The driveway is highly eroded and could benefit from pervious pavement. Porous asphalt can be used to replace the existing driveway and parking spaces north of the building to capture and infiltrate stormwater generated by the building and parking lot. A preliminary soil assessment suggests that the soils have suitable drainage characteristics for green infrastructure

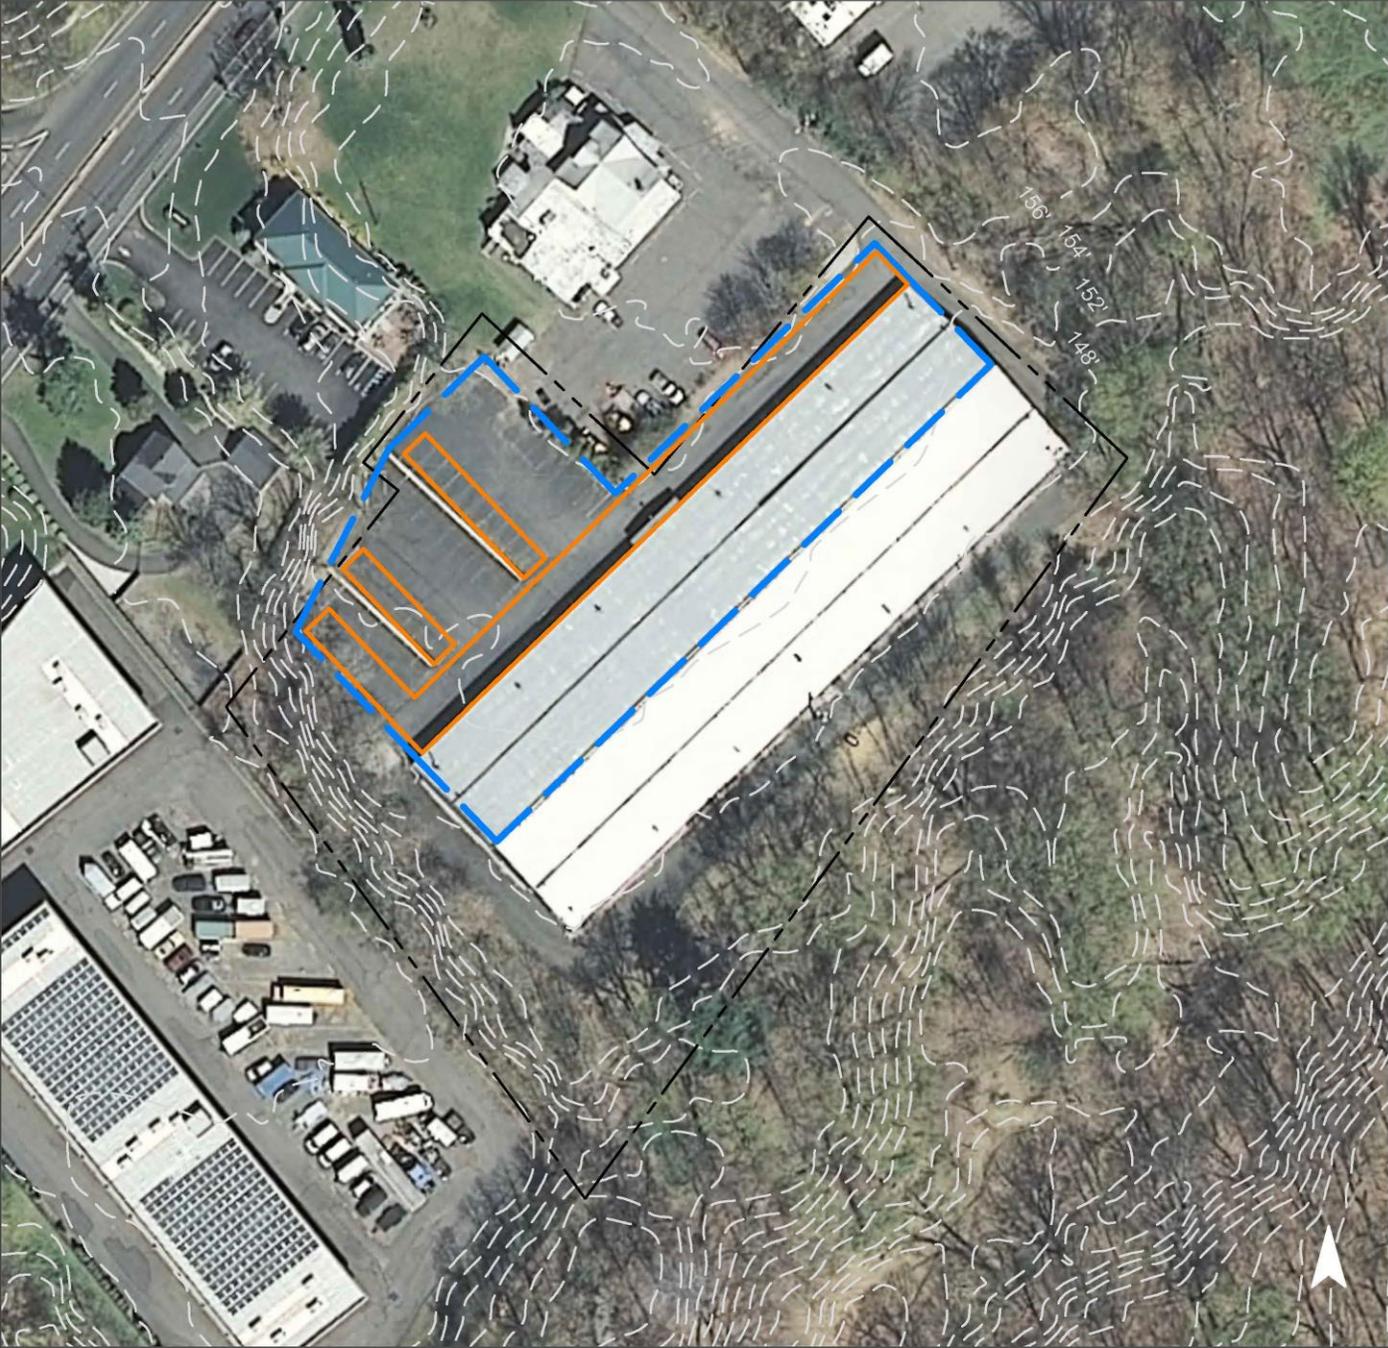
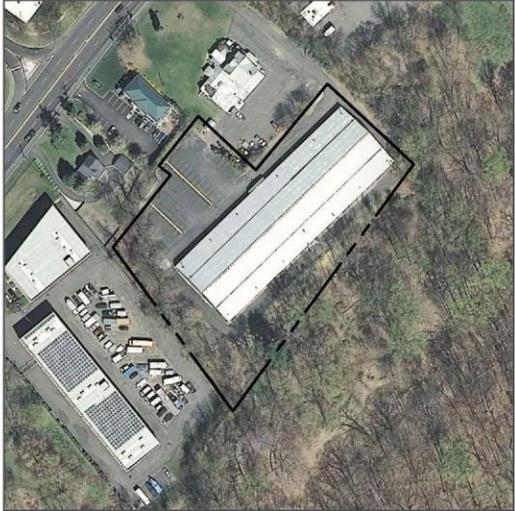
**Mountainside Indoor Tennis Center**

Recommended Green Infrastructure Practices	Recharge Potential (Mgal/yr)	TSS Removal Potential (lbs/yr)	Maximum Volume Reduction Potential (gal/storm)	Peak Discharge Reduction Potential (cu. ft./second)	Estimated Size (sq. ft.)	Estimated Cost
Pervious pavements	1.219	204	92,356	3.47	11,874	\$296,850

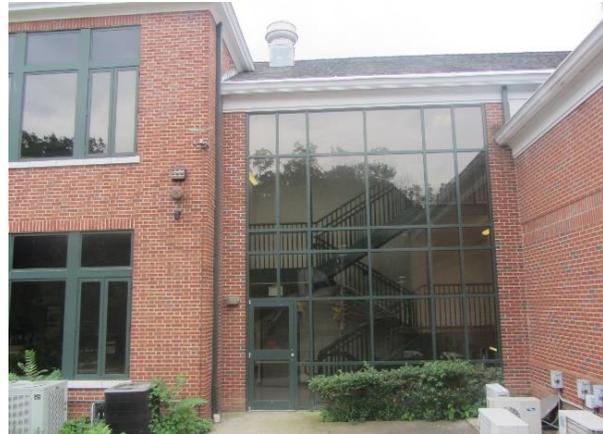
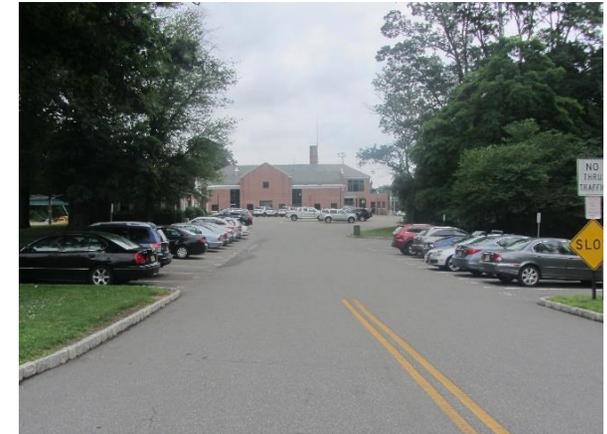
In the parking lot behind the building runoff flows from the building towards the woods. The parking spaces in this area can be replaced with pervious pavement to capture and infiltrate stormwater. A preliminary soil assessment suggests that the soils have suitable drainage characteristics for green infrastructure.

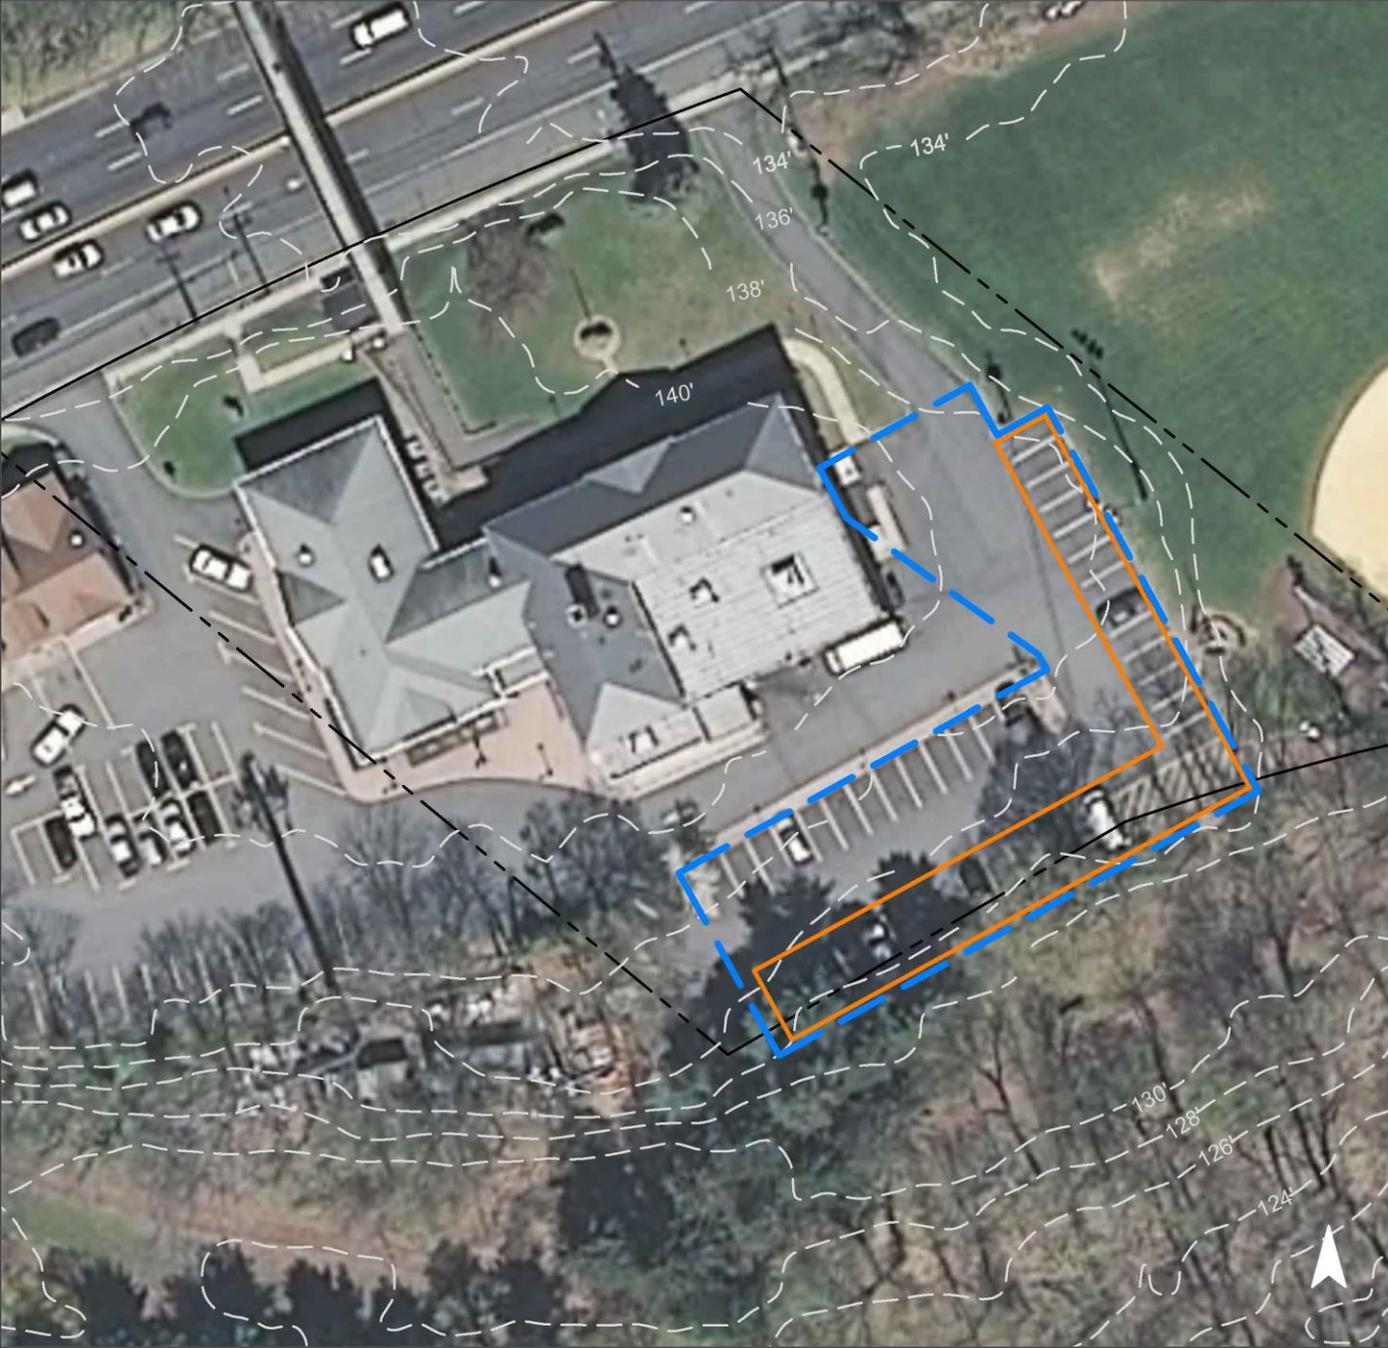
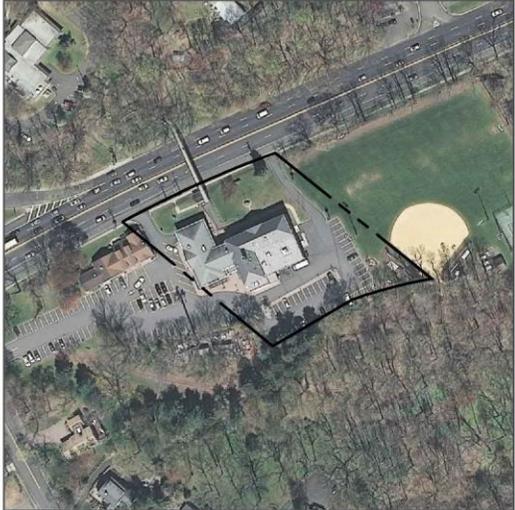
## Mountainside Municipal Building

Recommended Green Infrastructure Practices	Recharge Potential (Mgal/yr)	TSS Removal Potential (lbs/yr)	Maximum Volume Reduction Potential (gal/storm)	Peak Discharge Reduction Potential (cu. ft./second)	Estimated Size (sq. ft.)	Estimated Cost
Pervious pavements	0.421	70	31,872	1.20	5,971	\$149,275

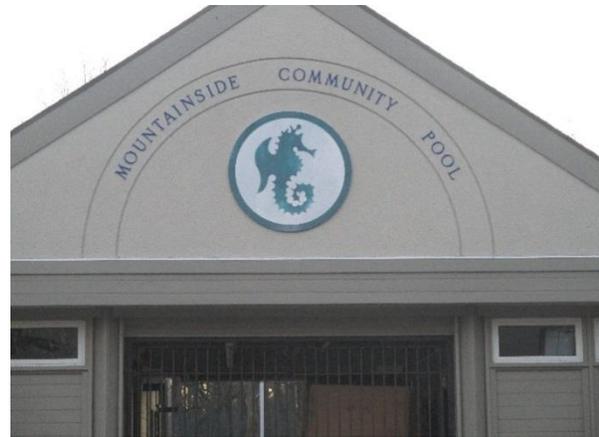
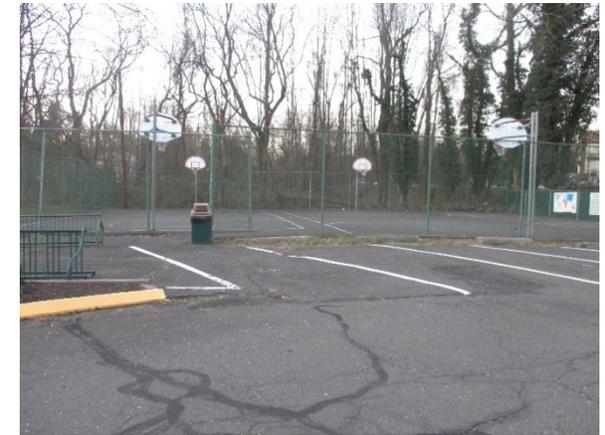
Two rows of parking spaces can be replaced with pervious pavement to capture and infiltrate stormwater. A preliminary soil assessment suggests that the soils have suitable drainage characteristics for green infrastructure.

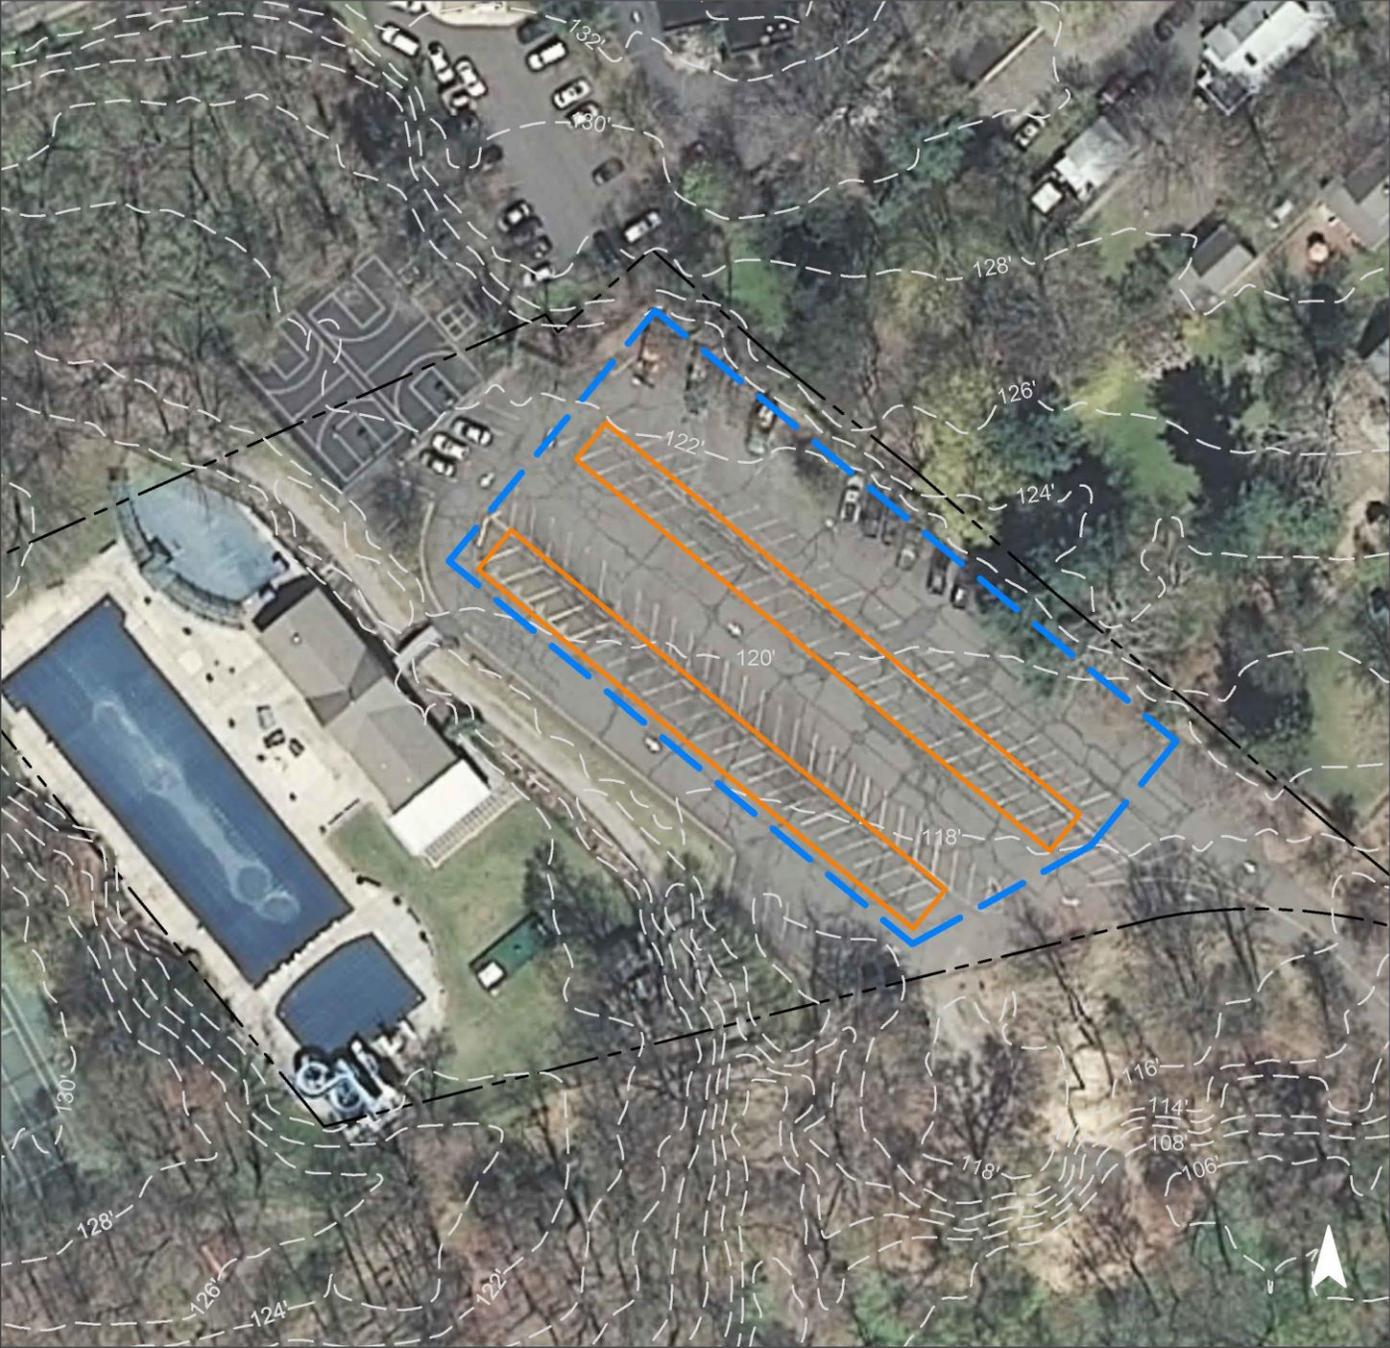
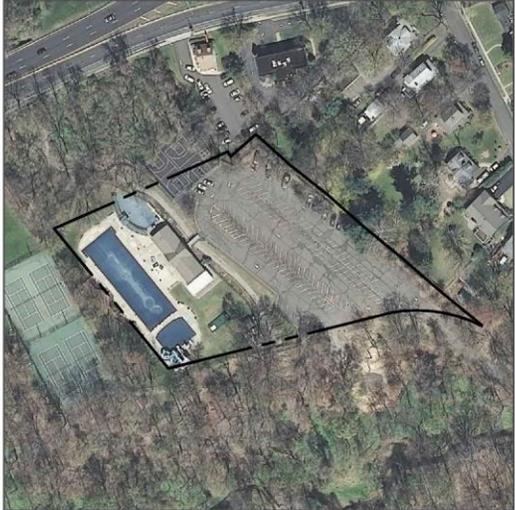
## Mountainside Swimming Pool

Recommended Green Infrastructure Practices	Recharge Potential (Mgal/yr)	TSS Removal Potential (lbs/yr)	Maximum Volume Reduction Potential (gal/storm)	Peak Discharge Reduction Potential (cu. ft./second)	Estimated Size (sq. ft.)	Estimated Cost
Pervious pavements	0.969	162	73,431	2.76	10,143	\$253,575

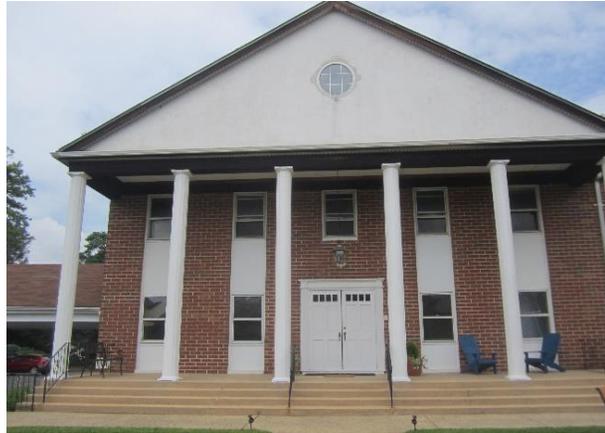
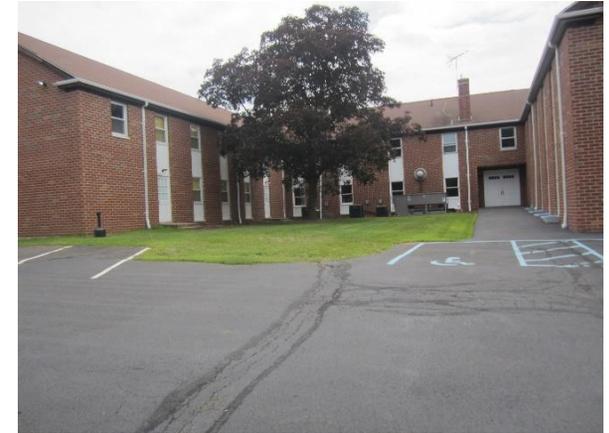
In the back of the church a bioretention system can be installed to capture, treat, and infiltrate rooftop runoff by disconnecting and redirecting multiple downspouts into it. A preliminary soil assessment suggests that the soils have suitable drainage characteristics for green infrastructure.

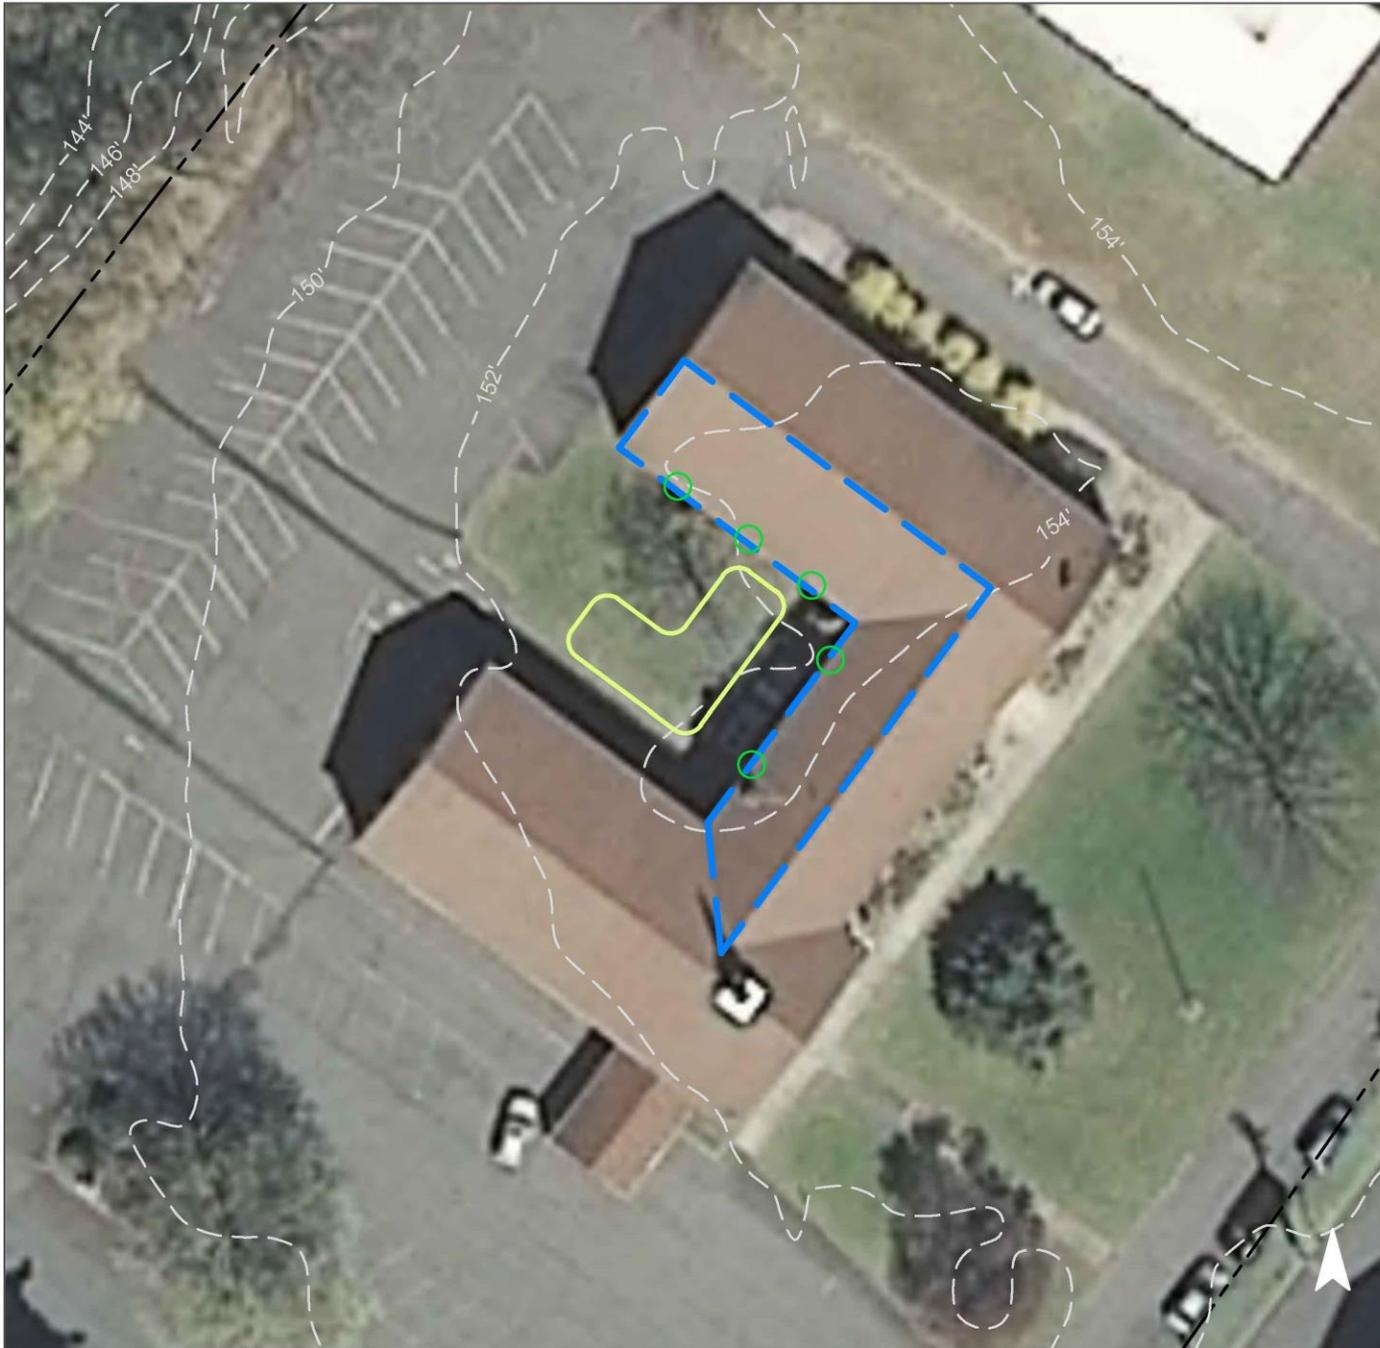
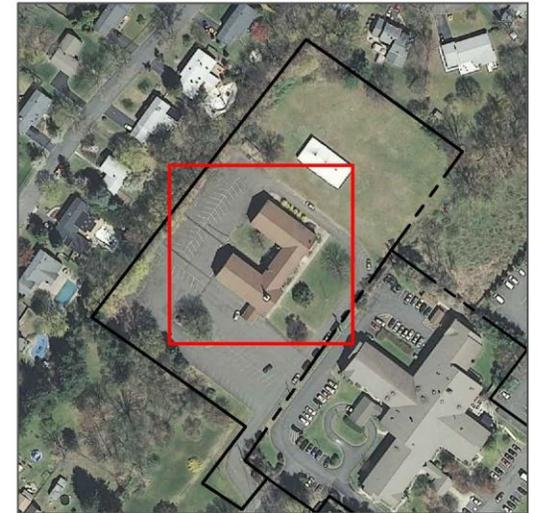
## Oasis Church

Recommended Green Infrastructure Practices	Recharge Potential (Mgal/yr)	TSS Removal Potential (lbs/yr)	Maximum Volume Reduction Potential (gal/storm)	Peak Discharge Reduction Potential (cu. ft./second)	Estimated Size (sq. ft.)	Estimated Cost
Bioretention systems	0.077	13	5,864	0.22	794	\$3,970

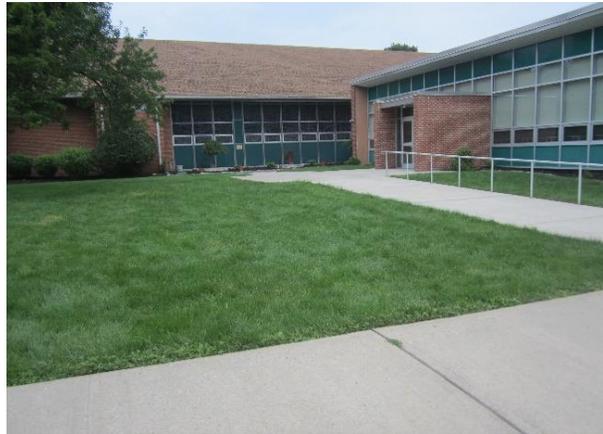
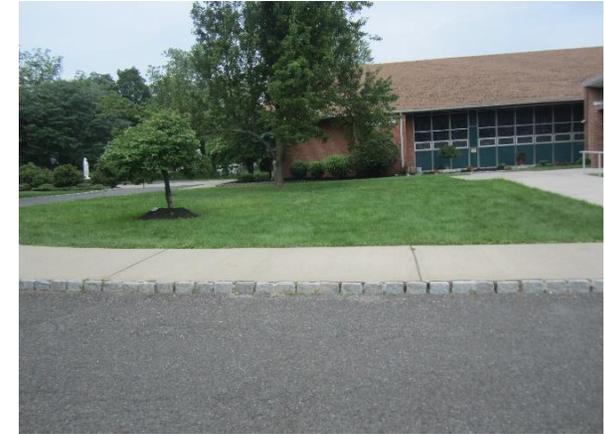
Parking spaces can be replaced with pervious pavement to capture and infiltrate stormwater generated by the parking lot. A preliminary soil assessment suggests that more soil testing would be required before determining the soil's suitability for green infrastructure.

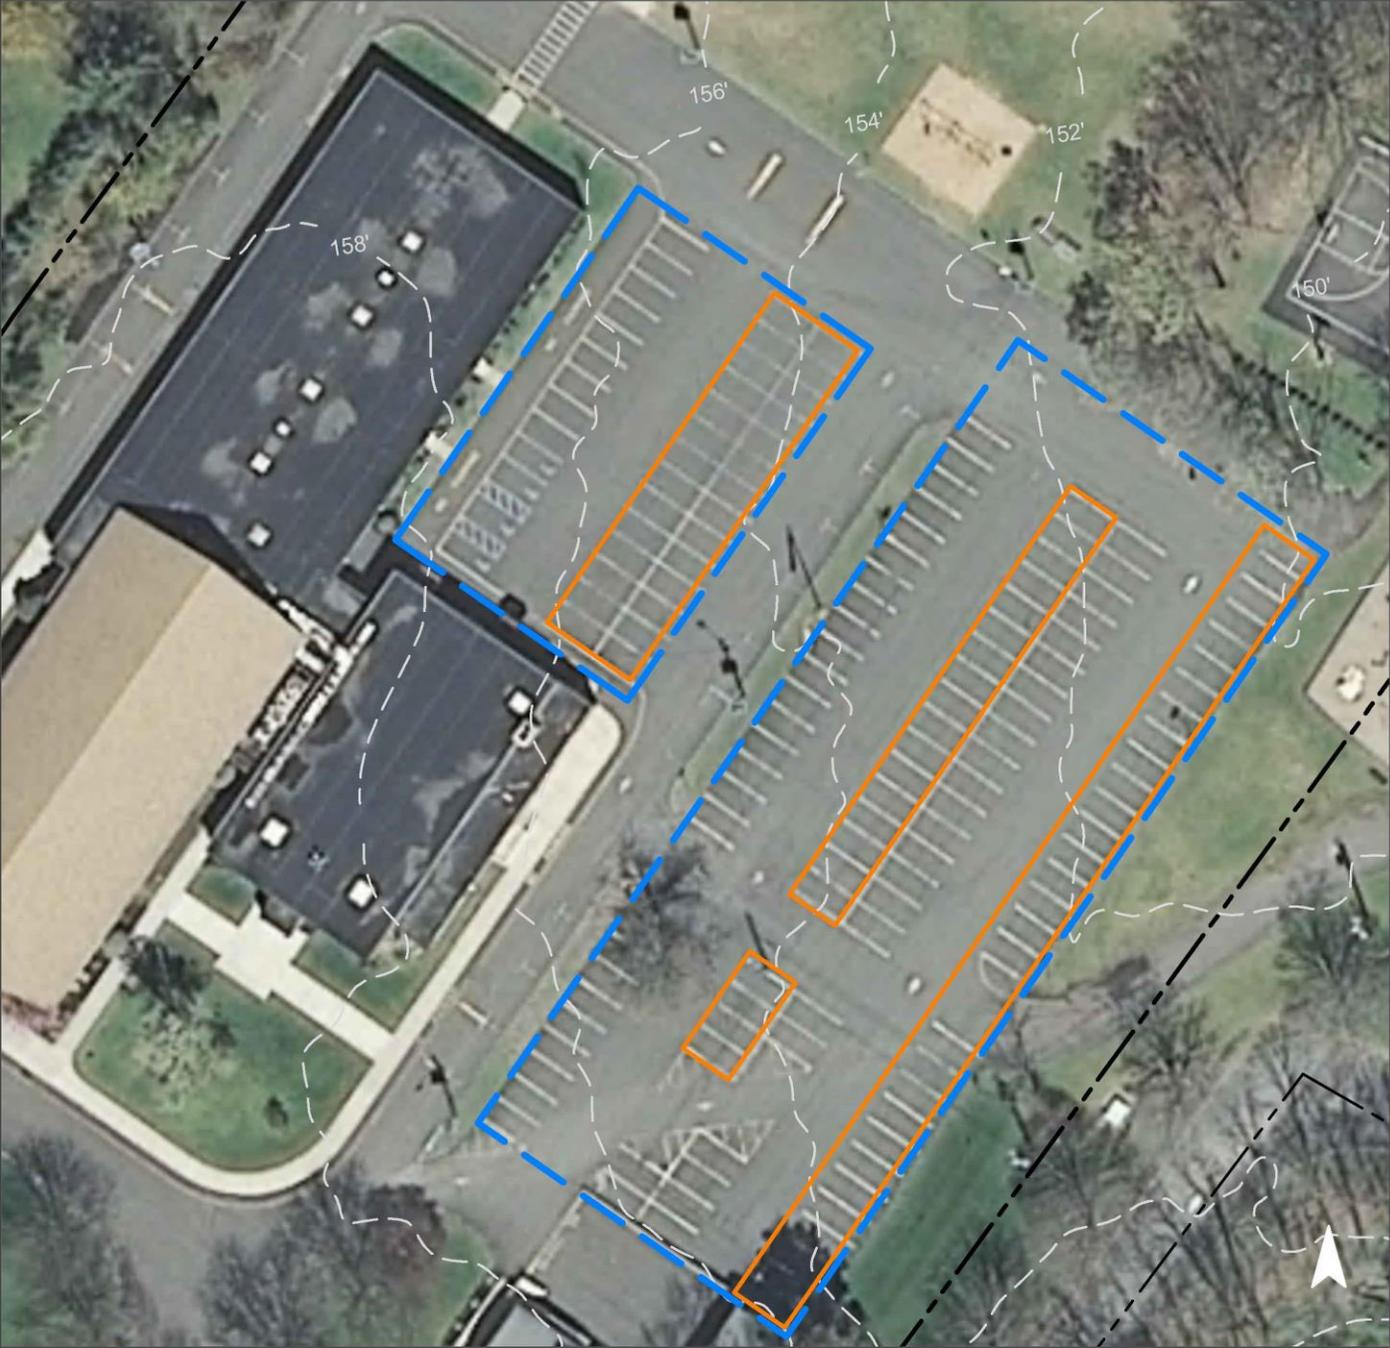
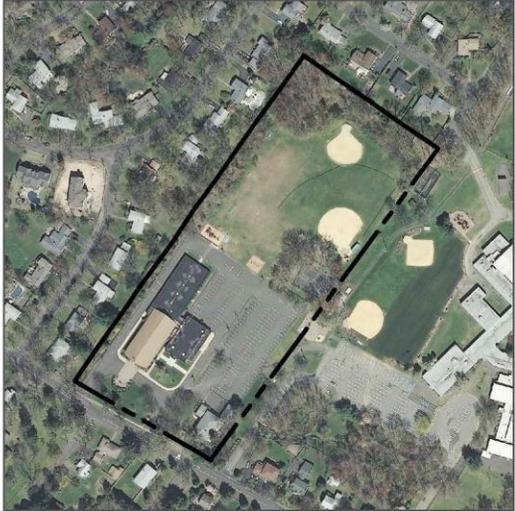
## Our Lady of Lourdes

Recommended Green Infrastructure Practices	Recharge Potential (Mgal/yr)	TSS Removal Potential (lbs/yr)	Maximum Volume Reduction Potential (gal/storm)	Peak Discharge Reduction Potential (cu. ft./second)	Estimated Size (sq. ft.)	Estimated Cost
Pervious pavements	0.581	97	92,909	3.49	12,958	\$323,950
