**Impervious Cover Reduction Action Plan  
for  
Mountainside Borough, Union County, New Jersey**

*Prepared for Mountainside Borough by the  
Rutgers Cooperative Extension Water Resources Program*

November 16, 2015

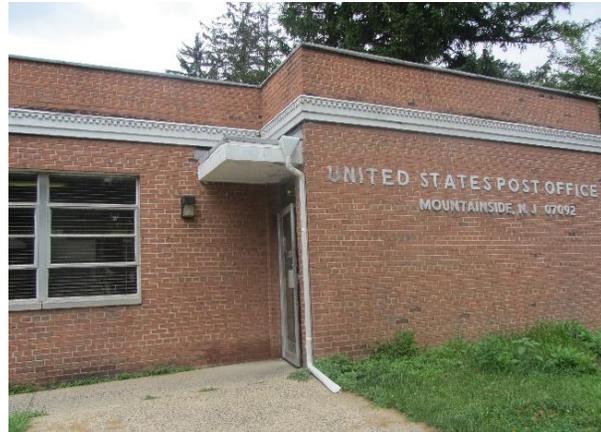
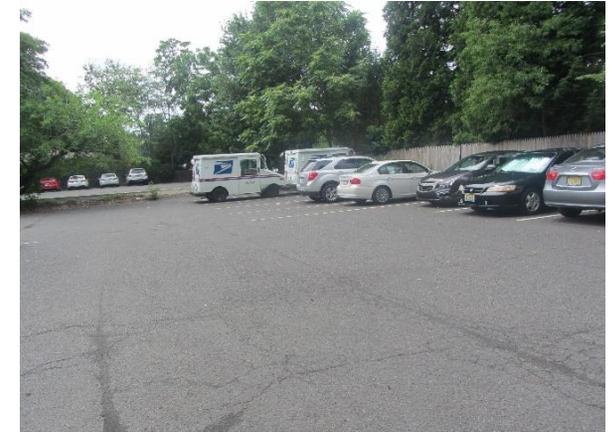
Parking spaces east of the building can be replaced with pervious pavement to capture and infiltrate stormwater. A preliminary soil assessment suggests that more soil testing would be required before determining the soil's suitability for green infrastructure.

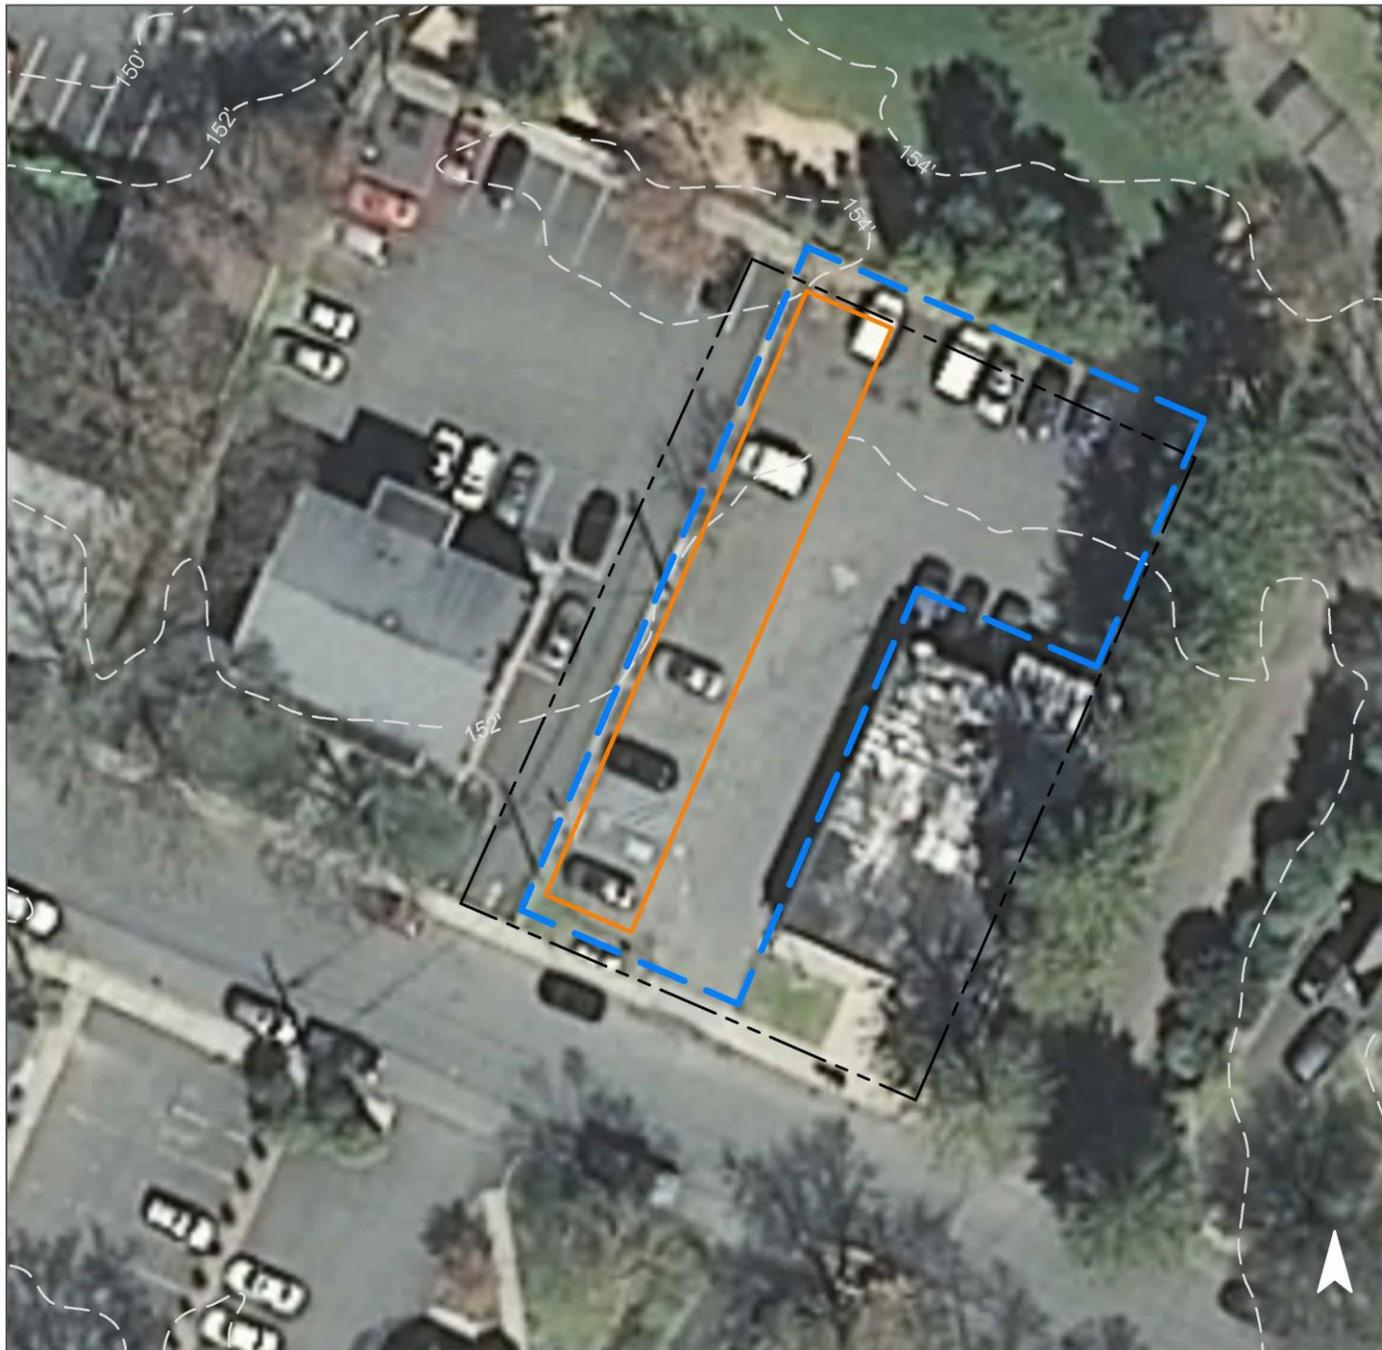
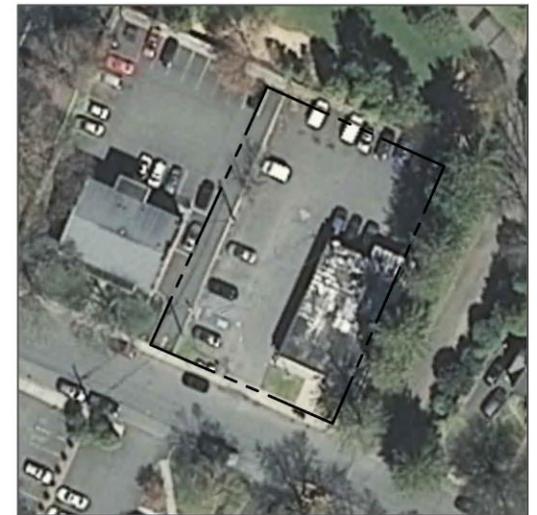
## US Post Office

Recommended Green Infrastructure Practices	Recharge Potential (Mgal/yr)	TSS Removal Potential (lbs/yr)	Maximum Volume Reduction Potential (gal/storm)	Peak Discharge Reduction Potential (cu. ft./second)	Estimated Size (sq. ft.)	Estimated Cost
Pervious pavements	0.121	20	19,328	0.73	2,681	\$67,025
