**Impervious Cover Reduction Action Plan
for
Watchung Borough, Somerset County, New Jersey**

*Prepared for Watchung Borough by the
Rutgers Cooperative Extension Water Resources Program*

September 30, 2015

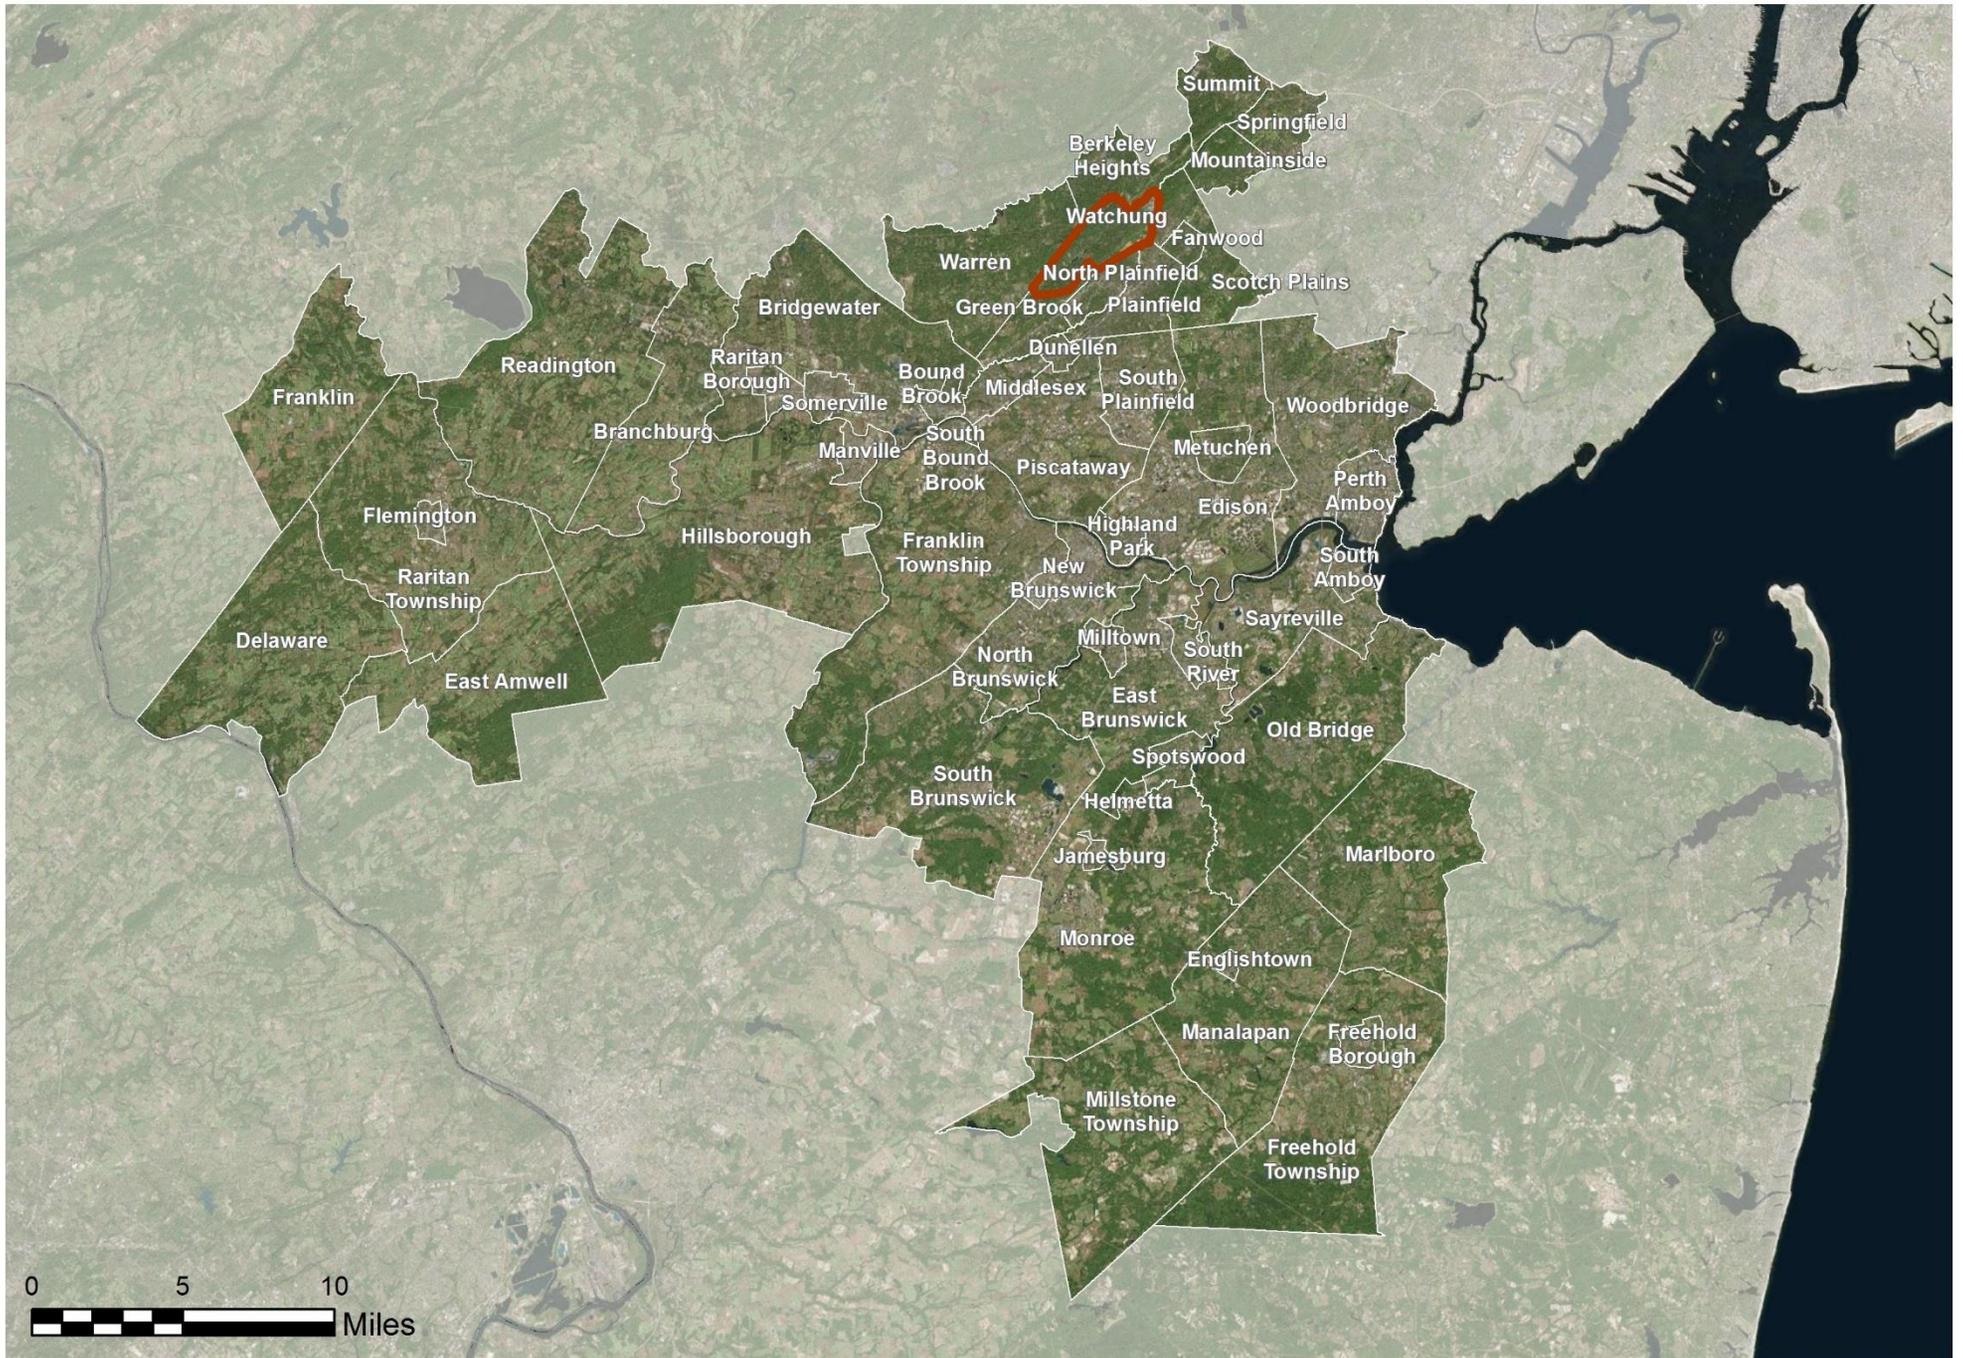
a. Overview Map of the Project

WATCHUNG: CLIMATE RESILIENT GREEN INFRASTRUCTURE FOR THE RARITAN BASIN

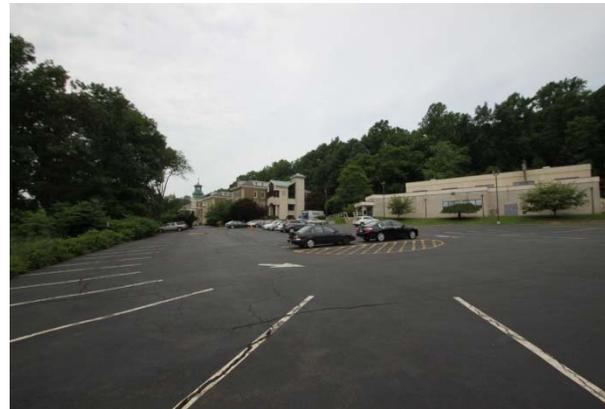
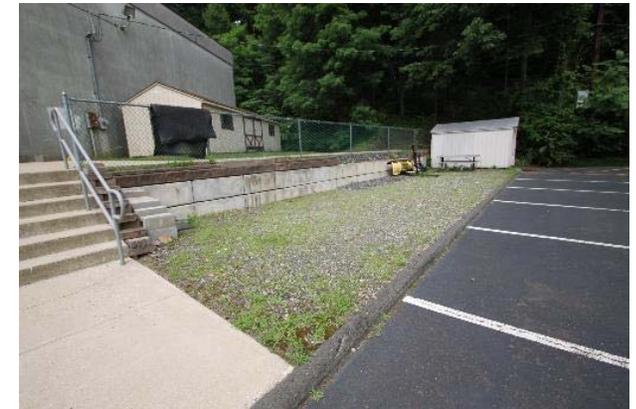
MOUNT SAINT MARY ACADEMY: GYMNASIUM

Rows of parking spaces and a picnic area next to the bus parking can be replaced with pervious pavement to infiltrate runoff. Rain gardens and bioswales can also capture, treat and infiltrate stormwater. A preliminary soil assessment suggests that more soil testing would be required before determining soil suitability for green infrastructure.

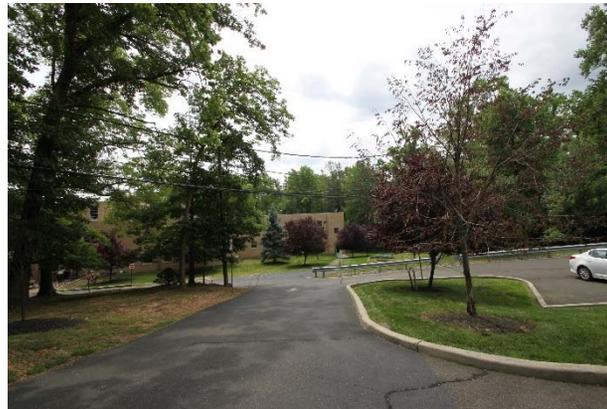
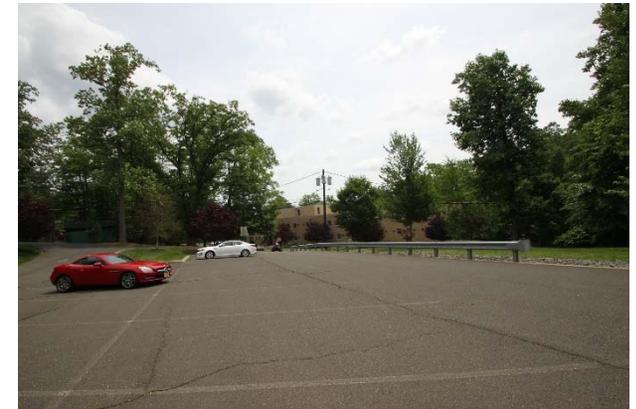
MOUNT SAINT MARY ACADEMY: PARKING LOT NEAR TRACK

Runoff from the parking lot currently drains toward the road. Parking spaces can be replaced with porous asphalt to capture and infiltrate stormwater. A rain garden can also capture, treat and infiltrate runoff on the site. A preliminary soil assessment suggests that more soil testing would be required before determining soil suitability for green infrastructure.

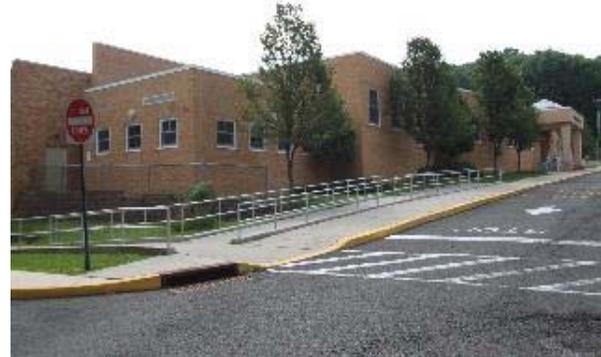
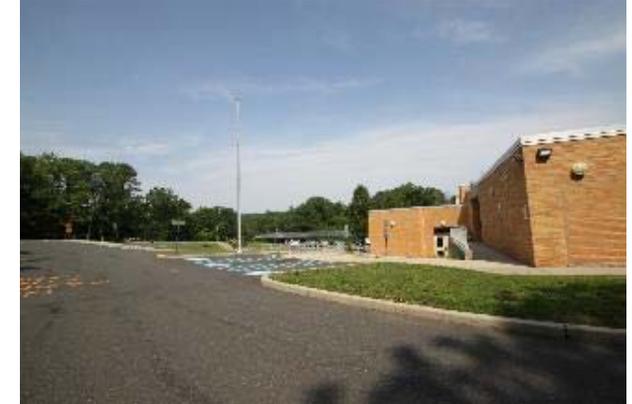
BAYBERRY SCHOOL

Stormwater is currently directed into a detention basin. The detention basin can be converted into a bioretention system to promote groundwater recharge and TSS removal. A smaller bioretention system can also be implemented in the northeast to capture, treat and infiltrate runoff. Additionally, parking spots can be replaced with porous asphalt to capture and infiltrate stormwater. A preliminary soil assessment suggests that more soil testing would be required before determining soil suitability for green infrastructure.

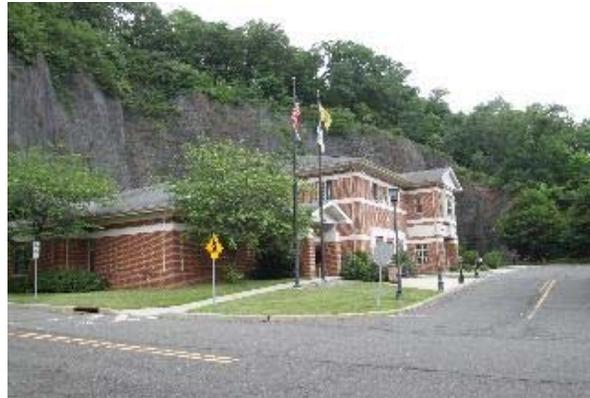
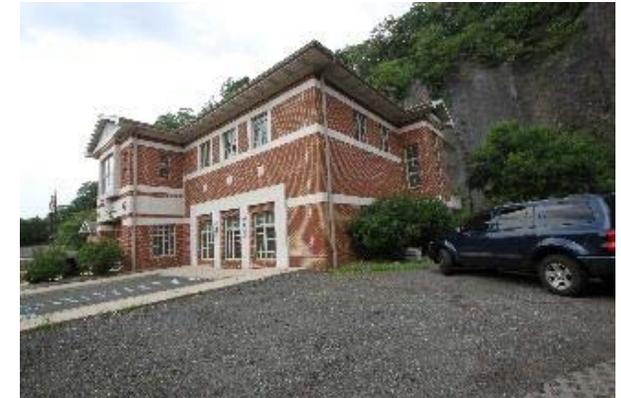
BOROUGH OF WATCHUNG POLICE DEPARTMENT

Parking spots can be replaced with porous asphalt to capture and infiltrate stormwater. Downspouts can be redirected into a cistern on the southeast side of the building to harvest rain water. A preliminary soil assessment suggests that more soil testing would be required before determining soil suitability for green infrastructure.

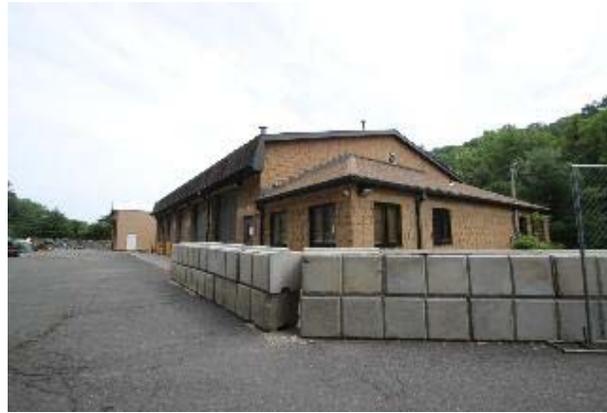
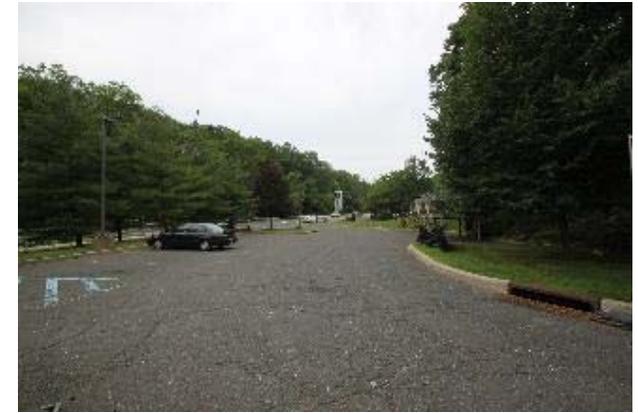
DONALD R. SCOTT PUBLIC WORKS CENTER

Parking spots west of the building can be replaced with porous asphalt to capture and infiltrate stormwater. A preliminary soil assessment suggests that more soil testing would be required before determining soil suitability for green infrastructure.

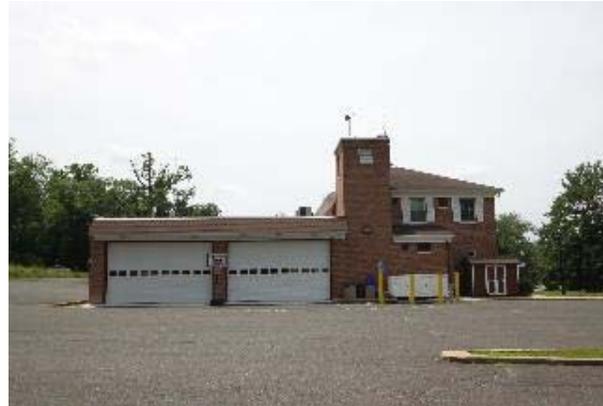
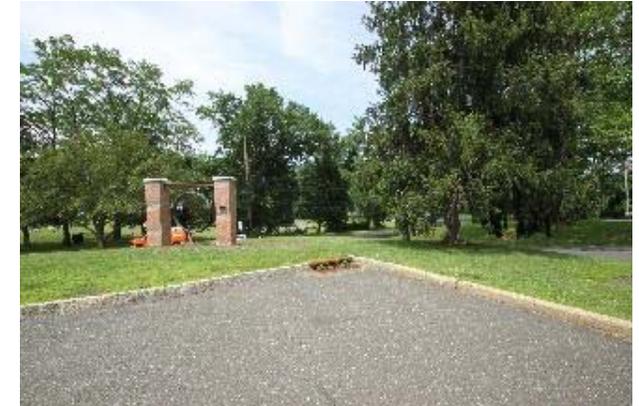
FIRE DEPARTMENT

Parking spots south of the building can be replaced with porous asphalt to capture and infiltrate stormwater. A wide drive way east of the building can be de-paved or converted into pervious pavement. Additionally, a rain garden can be installed beside the parking lot to capture, treat and infiltrate runoff. A preliminary soil assessment suggests that soils have suitable drainage characteristics for green infrastructure.

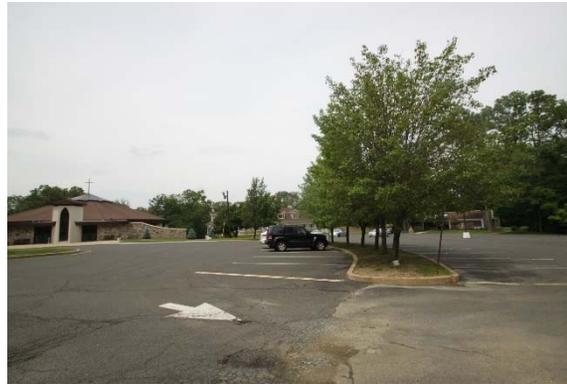
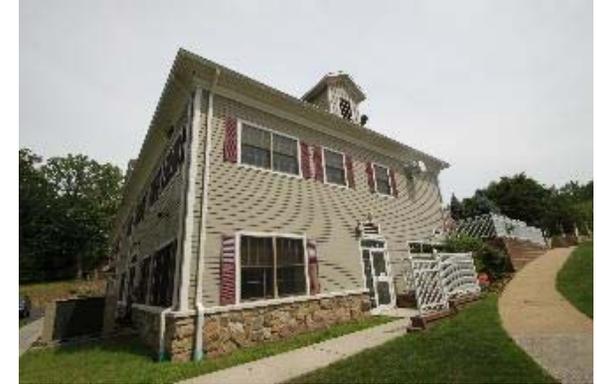
SAINT MARY'S STONY HILL YOUTH GROUP

Parking spots south of the building can be replaced with porous asphalt to capture and infiltrate stormwater. Several opportunities exist to disconnect downspouts into rain barrels, planting beds, or rain gardens. Rain gardens can also be installed to capture parking lot runoff. A preliminary soil assessment suggests that more soil testing would be required before determining soil suitability for green infrastructure.

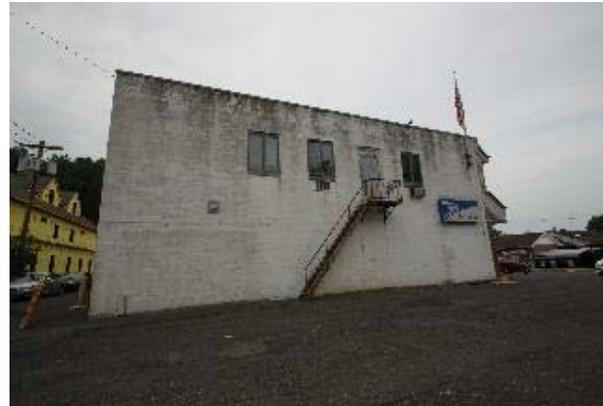
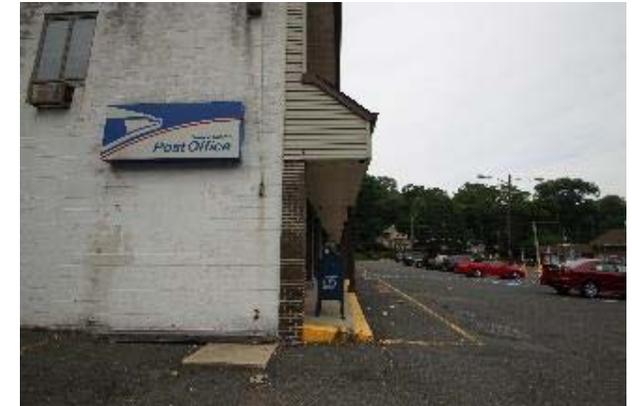
US POST OFFICE

Parking spots south of the building can be replaced with porous asphalt to capture and infiltrate stormwater. A preliminary soil assessment suggests that more soil testing would be required before determining soil suitability for green infrastructure.

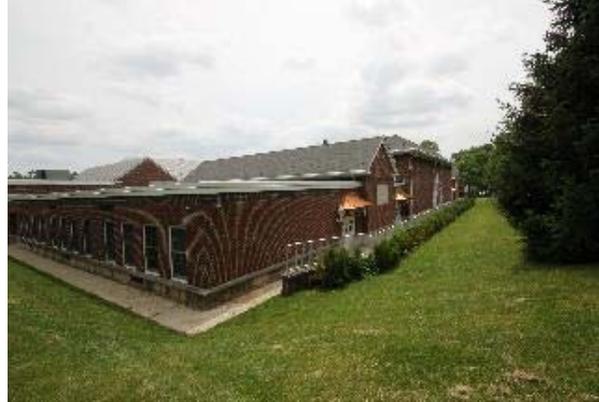
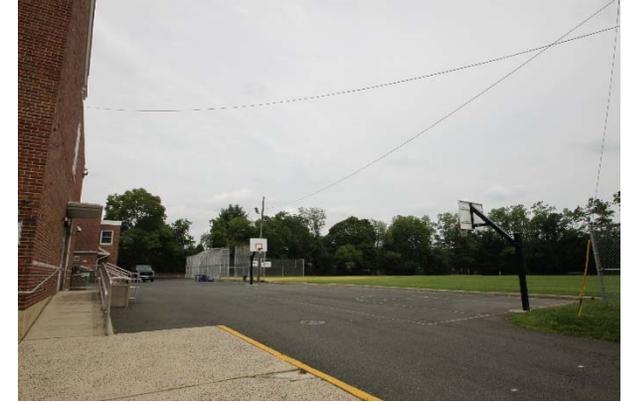
VALLEY VIEW SCHOOL

Parking spots and a basketball court can be replaced with pervious pavement to capture and infiltrate stormwater. Pedestrian walkways around the school can be replaced with pervious concrete to capture stormwater as well. A preliminary soil assessment suggests that more soil testing would be required before determining soil suitability for green infrastructure.

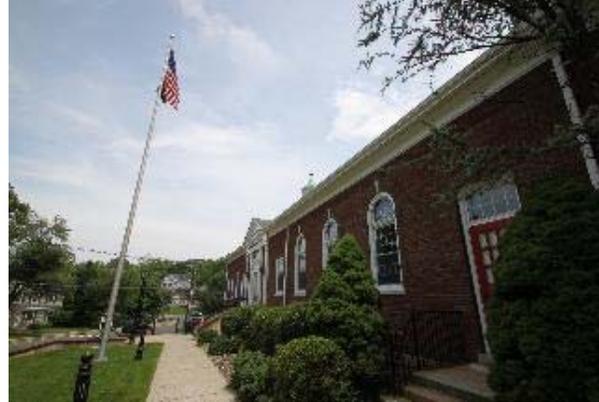
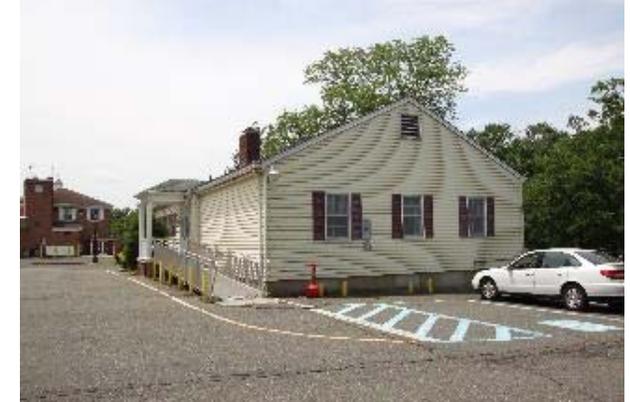
WATCHUNG BOROUGH ADMINISTRATION

Stormwater is currently directed to existing rain barrels and catch basins throughout the site. The paved picnic area beside the building can be replaced with permeable pavers to capture and infiltrate stormwater. Parking spaces can be replaced with porous asphalt to capture and infiltrate runoff as well. A preliminary soil assessment suggests that soils have suitable drainage characteristics for green infrastructure.

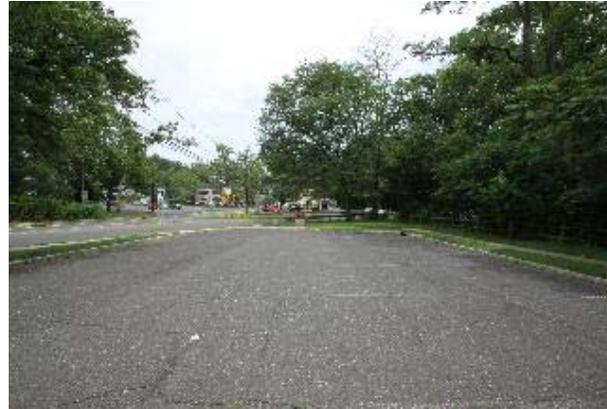
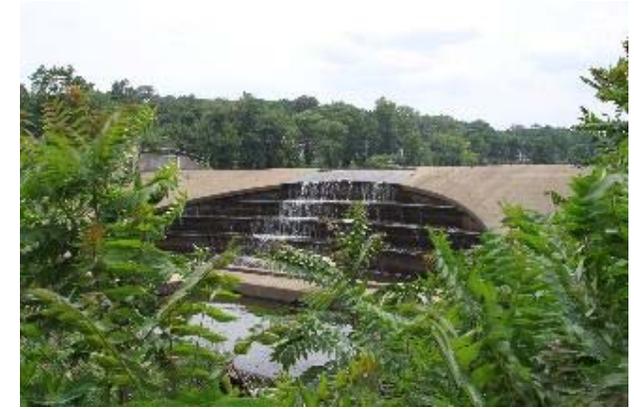
WATCHUNG LAKE DEV

Parking spots by the lake can be replaced with porous asphalt to capture and infiltrate stormwater. A preliminary soil assessment suggests that more soil testing would be required before determining soil suitability for green infrastructure.

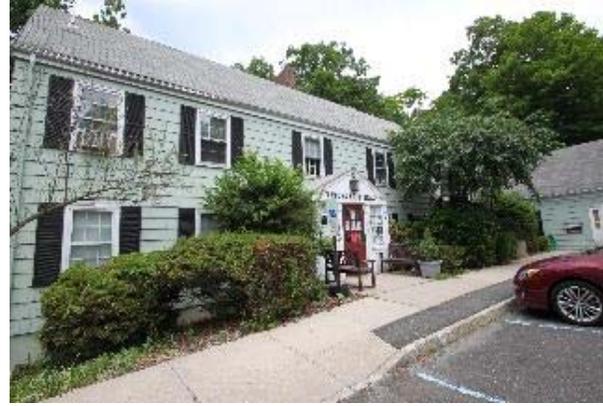
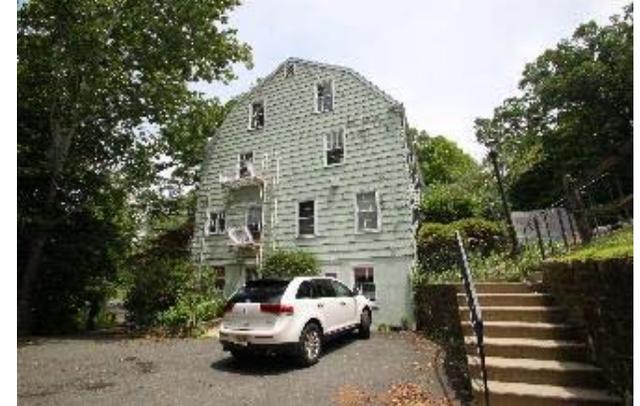
WATCHUNG PUBLIC LIBRARY

Stormwater is currently directed into existing rain barrels and catch basins. Parking spots and sidewalks south of the building can be replaced with pervious pavement to capture and infiltrate stormwater. The private parking area west of the building can also be replaced with permeable pavers to capture and infiltrate roof runoff. A preliminary soil assessment suggests that soils have suitable drainage characteristics for green infrastructure.

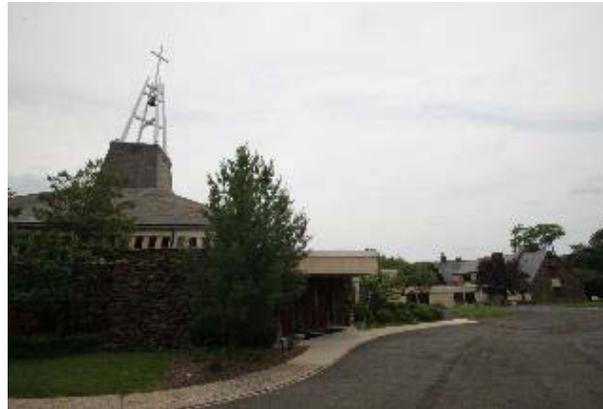
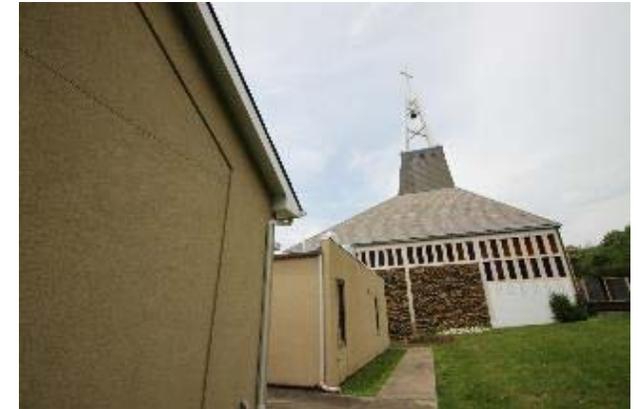
Parking spaces can be replaced with porous asphalt to capture and infiltrate stormwater. Sidewalks can be replaced with pervious pavement to capture stormwater as well. Rain gardens can capture, treat and infiltrate runoff from the roof. A preliminary soil assessment suggests that soils have suitable drainage characteristics for green infrastructure.
