**Impervious Cover Assessment
for
Buena Vista Township, Atlantic County, New Jersey**

*Prepared for Buena Vista Township by the
Rutgers Cooperative Extension Water Resources Program*

January 7, 2019

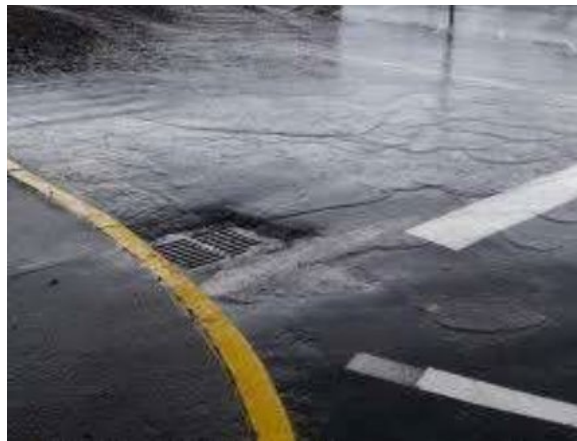
Figure 1: Stormwater draining from a parking lot

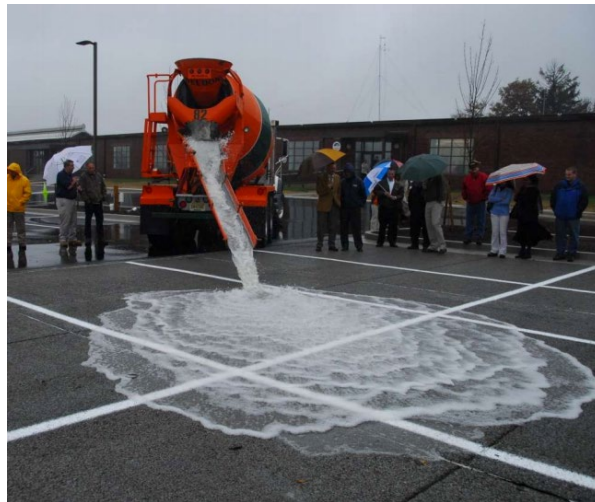
Figure 2: Rapid infiltration of water through porous pavement is demonstrated at the USEPA Edison New Jersey test site

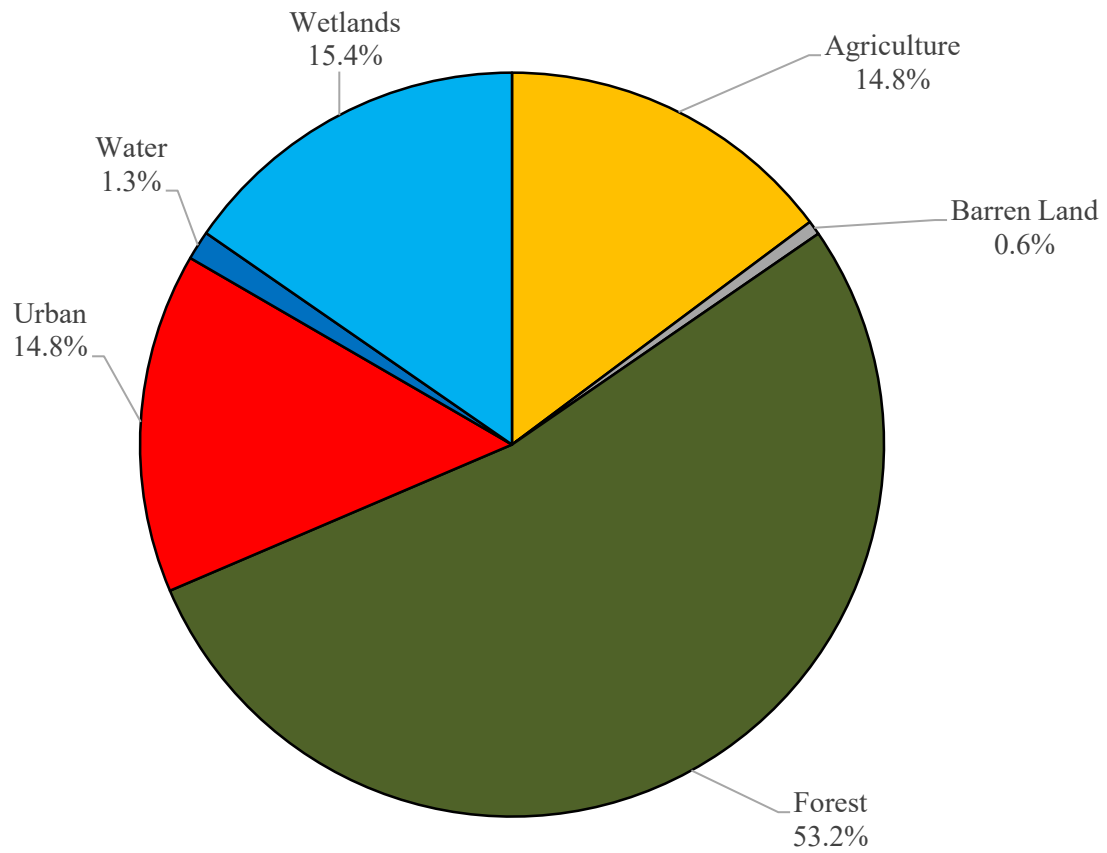
Figure 3: Pie chart illustrating the land use in Buena Vista Township

Buena Vista Township is located in Atlantic County, New Jersey and covers approximately 41.5 square miles south of Hammonton Township. Figures 3 and 4 illustrate that Buena Vista Township is dominated by forest land uses. A total of 14.8 of the municipality's land use is classified as urban. Of the urban land in Buena Vista Township, rural residential is the dominant land use (Figure 5).

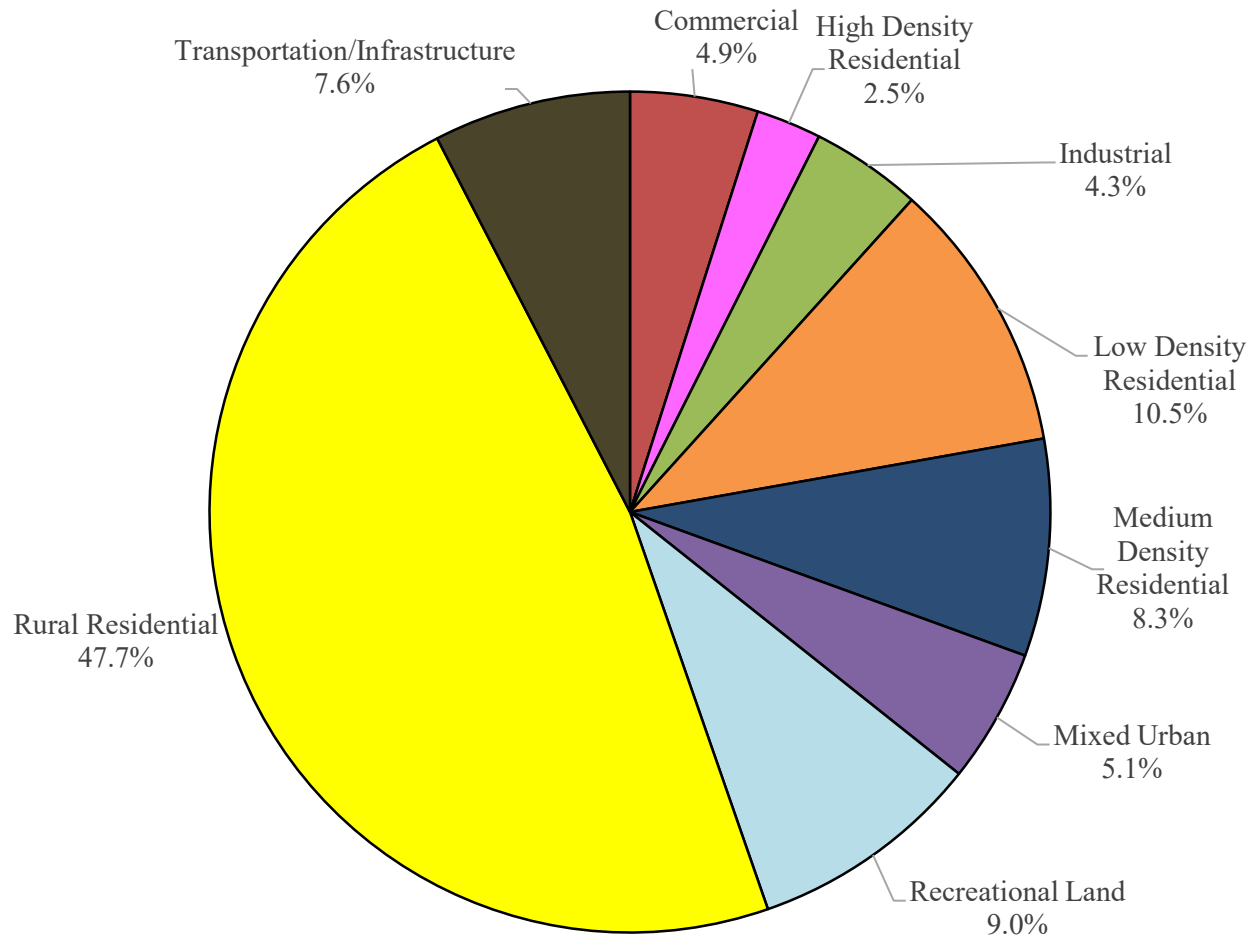
Figure 5: Pie chart illustrating the various types of urban land use in Buena Vista Township

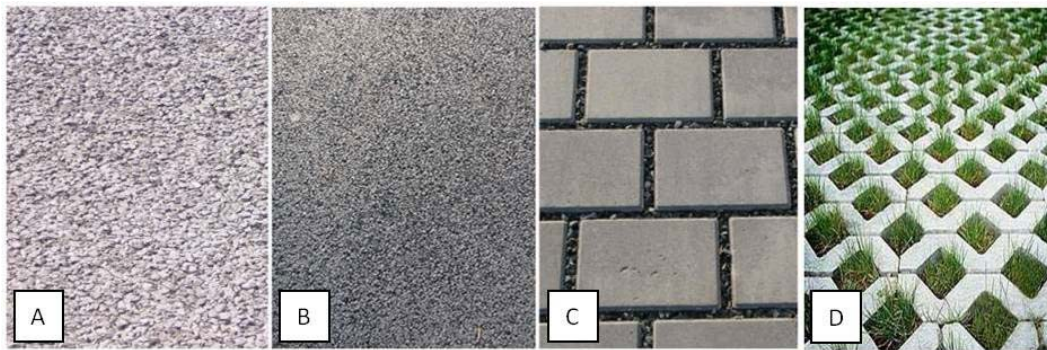
Permeable surfaces: (A) pervious concrete, (B) porous asphalt, (C) interlocking concrete pavers, (D) grid pavers (Rowe, 2012)

Pervious concrete and porous asphalt are the most common of the permeable surfaces. They are similar to regular concrete and asphalt but without the fine materials. This allows water to quickly pass through the material into an underlying layered system of stone that holds the water, allowing it to infiltrate into the underlying uncompacted soil.

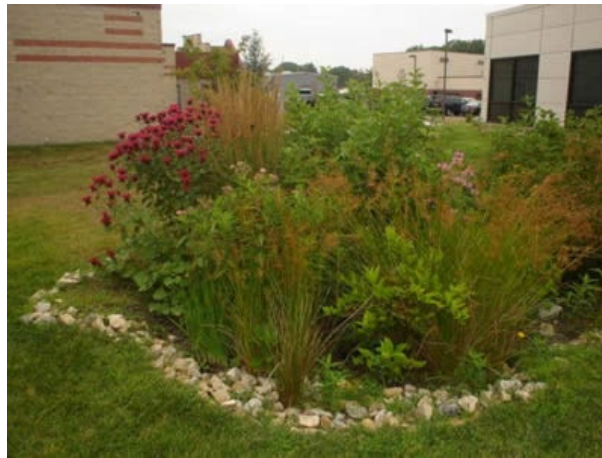
Figure 7: Rain garden outside the RCE of Gloucester County office which was designed to disconnect rooftop runoff from the local storm sewer system

- Rain Gardens: Stormwater can be diverted into shallow landscaped depressed areas (i.e., rain gardens) where the vegetation filters the water, and it is allowed to soak into the ground. Rain gardens, also known as bioretention systems, come in all shapes and sizes and can be designed to disconnect a variety of impervious surfaces (Figure 7).

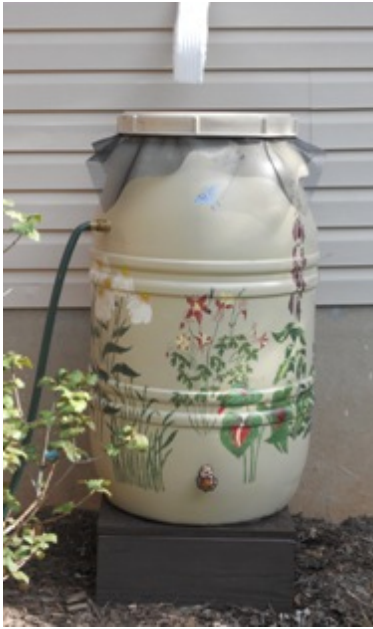
Figure 8a: Rain barrel used to disconnect a downspout with the overflow going to a flower bed

- Rainwater Harvesting: Rainwater harvesting includes the use of rain barrels and cisterns (Figures 8a and 8b). These can be placed below downspouts to collect rooftop runoff. The collected water has a variety of uses including watering plants and washing cars. This practice also helps cut down on the use of potable water for nondrinking purposes. It is important to divert the overflow from the rainwater harvesting system to a pervious area.

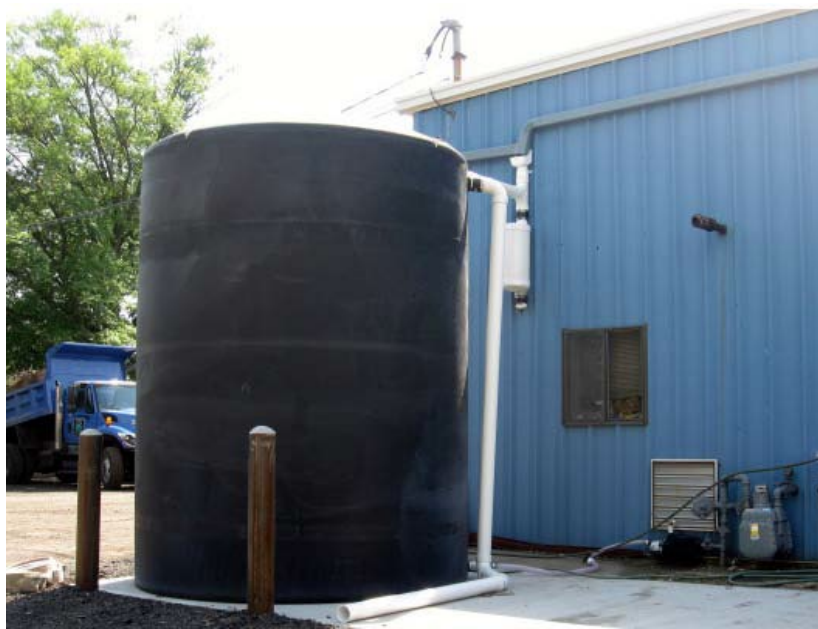
Figure 8b: A 5,000 gallon cistern used to disconnect the rooftop of the Department of Public Works in Clark Township to harvest rainwater for nonprofit car wash events

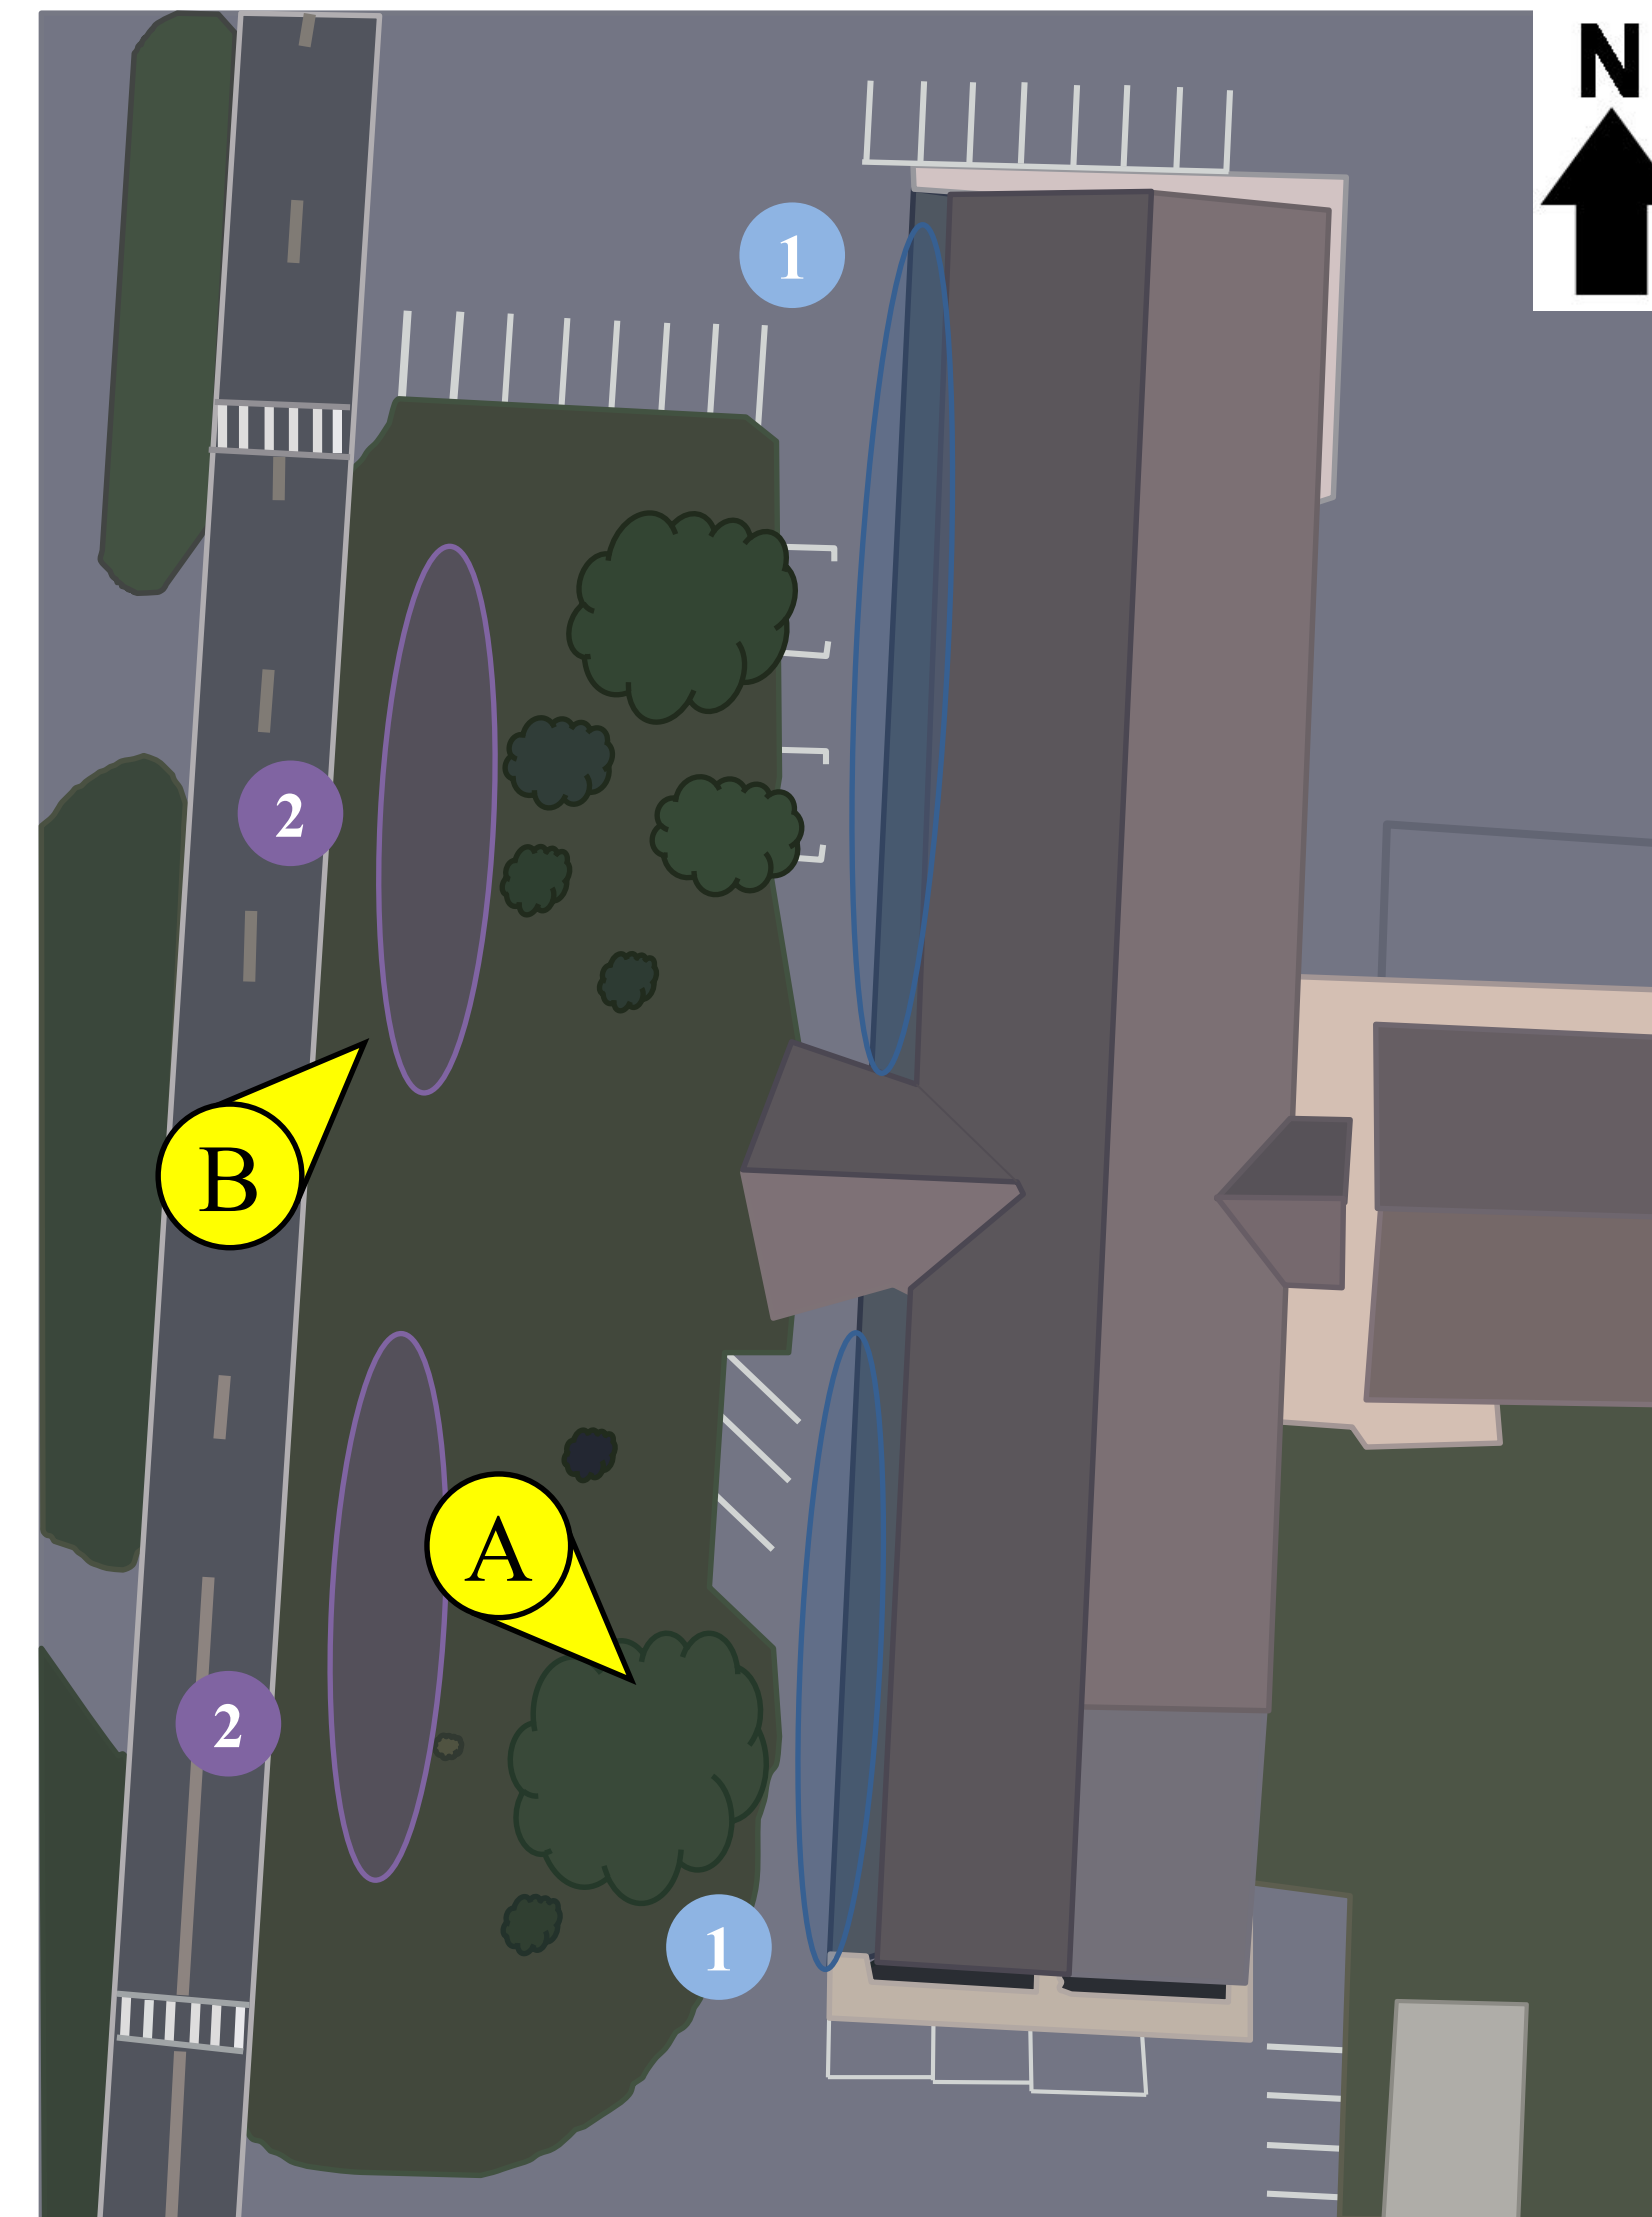
SITE PLAN:

- 1 PLANTER BOX:** Planter boxes can be installed along the west side of the building to collect water from the nearby downspouts. These are wooden boxes with plants installed at the base of a downspout that provide an opportunity to beneficially reuse rooftop runoff.
- 2 BIOSWALE:** Bioswales are landscape features that convey stormwater from one location to another while removing pollutants and providing water an opportunity to infiltrate.

<p>Proposed Solution(s): Two planter boxes can be placed at the base of each of the twelve disconnected downspouts on the west of the building to manage the stormwater runoff from the roof. In the turfgrass area east of the building adjacent to the street, two bioswales can be placed on the street side parallel to the street to manage stormwater coming in from the west over the impervious asphalt.</p>	
<p>Anticipated Benefits: The bioswales will capture, treat, and infiltrate stormwater reducing TN by 30%, TP by 60%, and TSS by 90%. Planter boxes will take in runoff from downspouts and achieve similar reductions in TN, TP, and TSS as the bioretention systems.</p>	
<p>Possible Funding Sources: mitigation funds from local developers NJDEP grant programs Buena Vista Township local social and community groups</p>	
<p>Partners/Stakeholders: Buena Vista Township St. Mary's Regional School local community groups students and parents Rutgers Cooperative Extension</p>

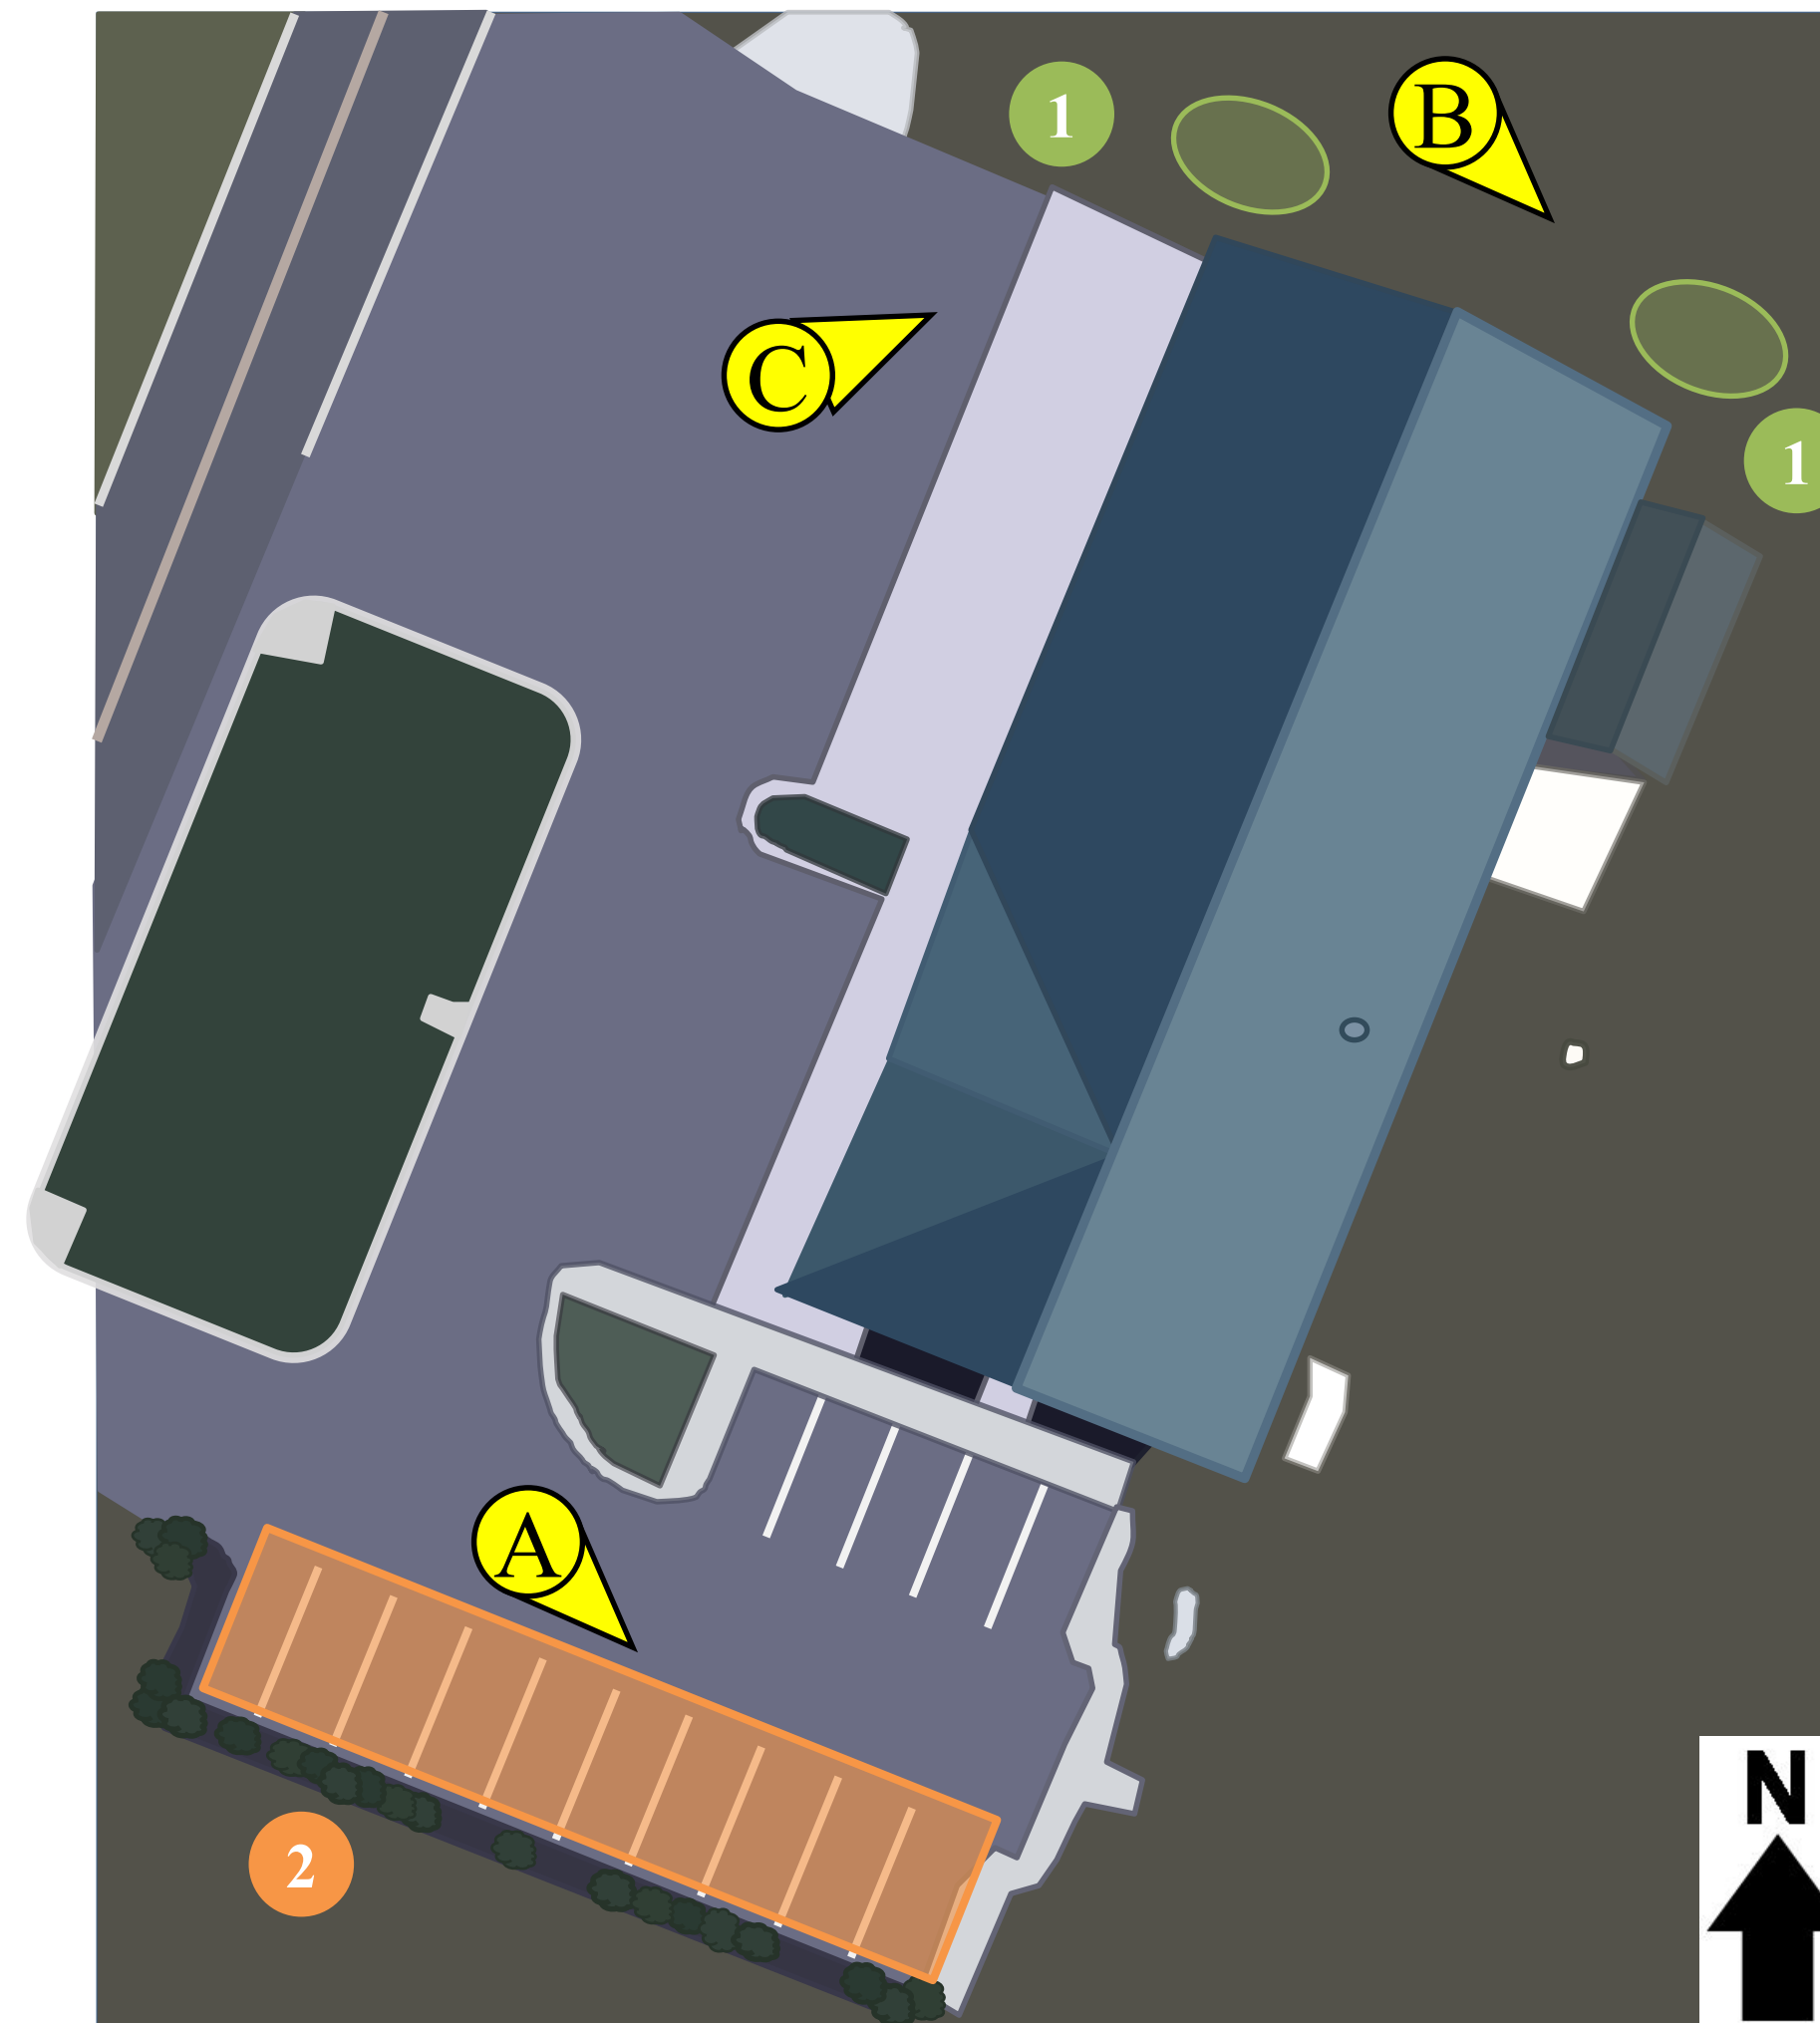
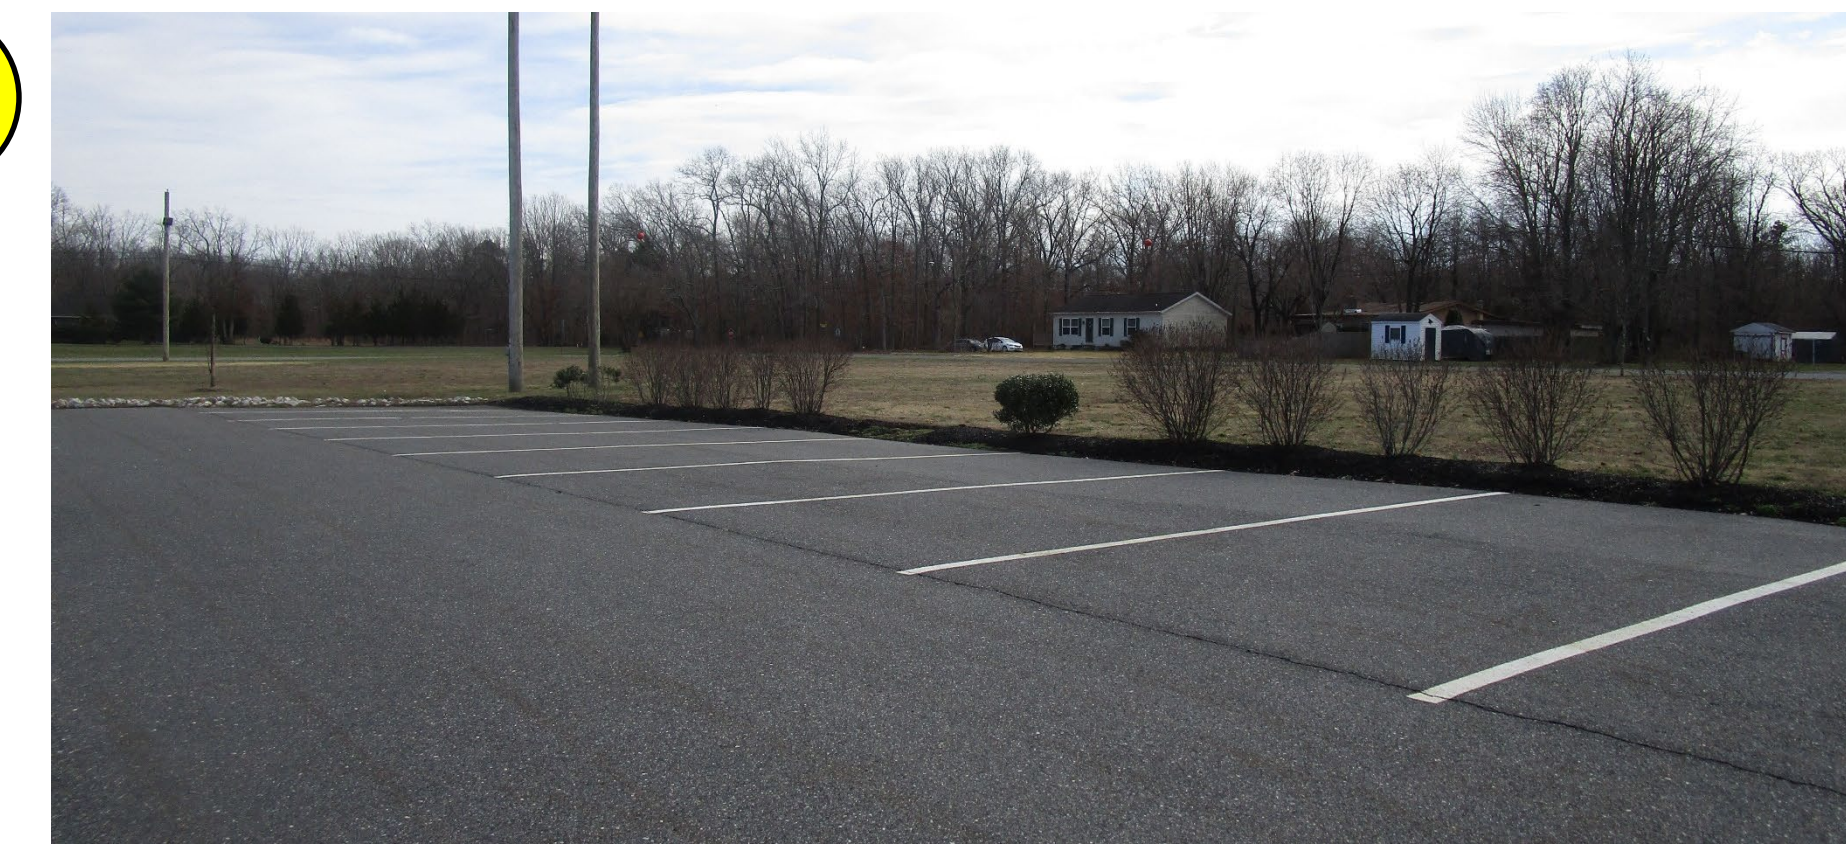
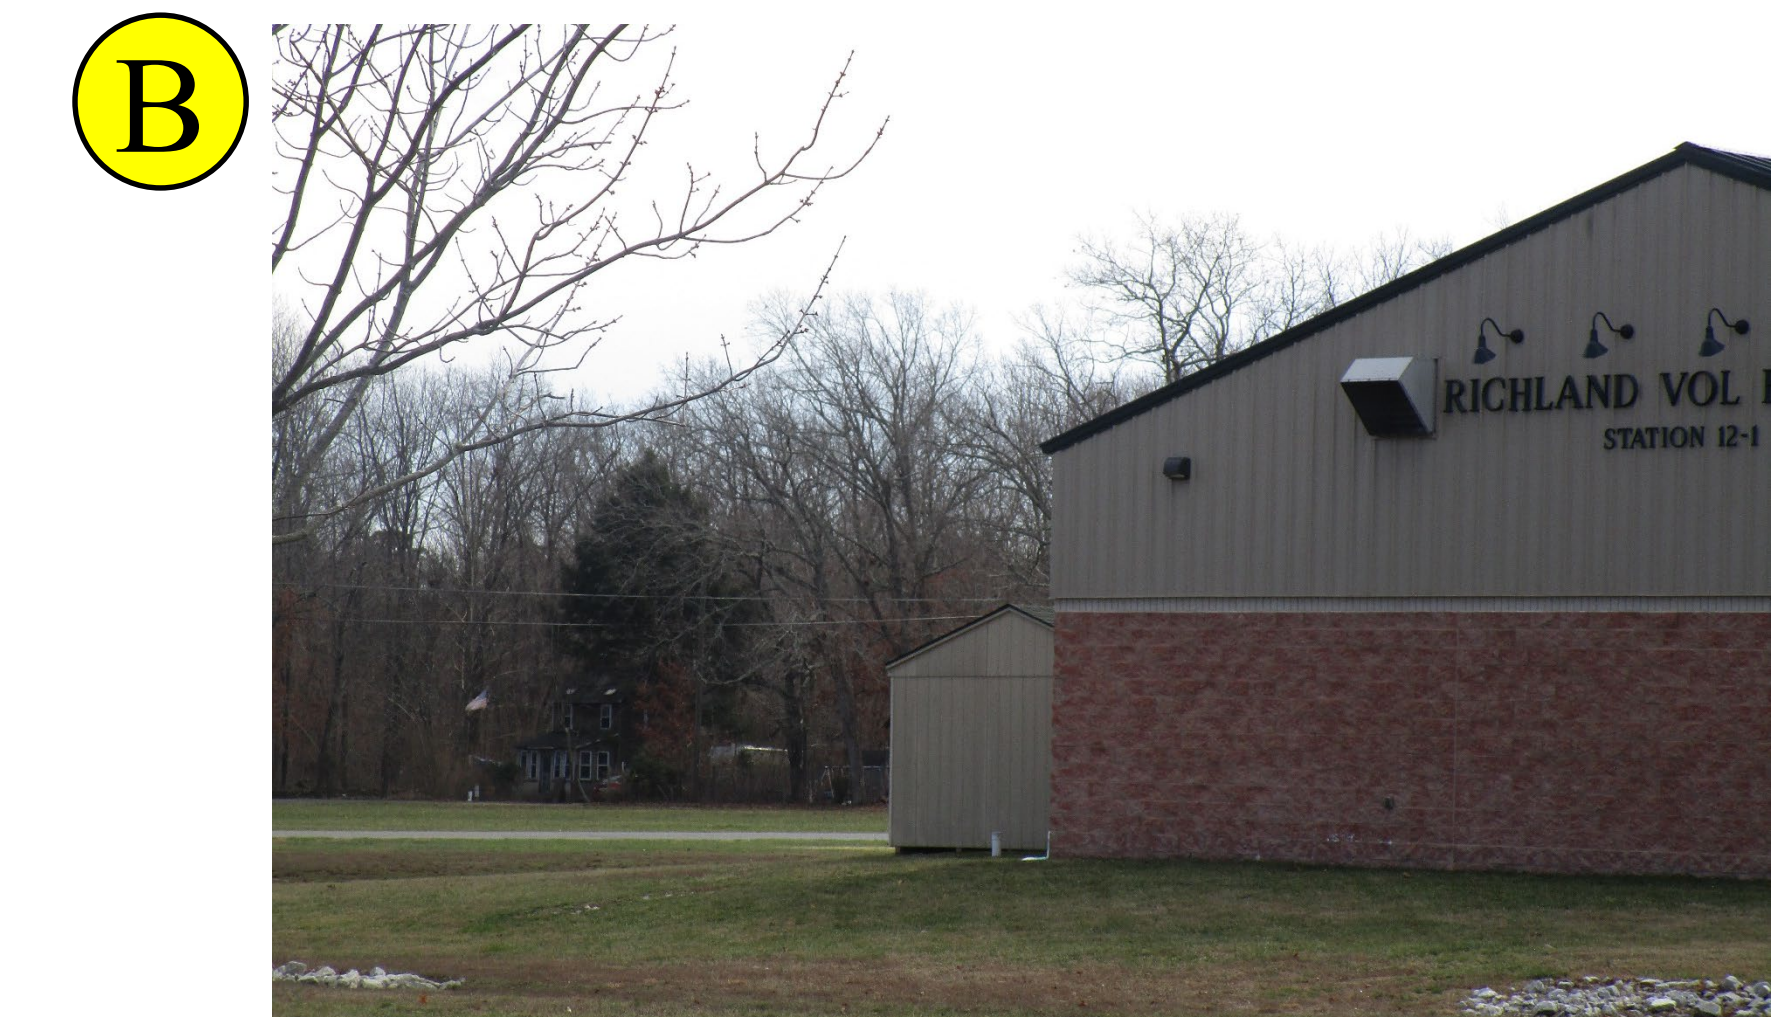
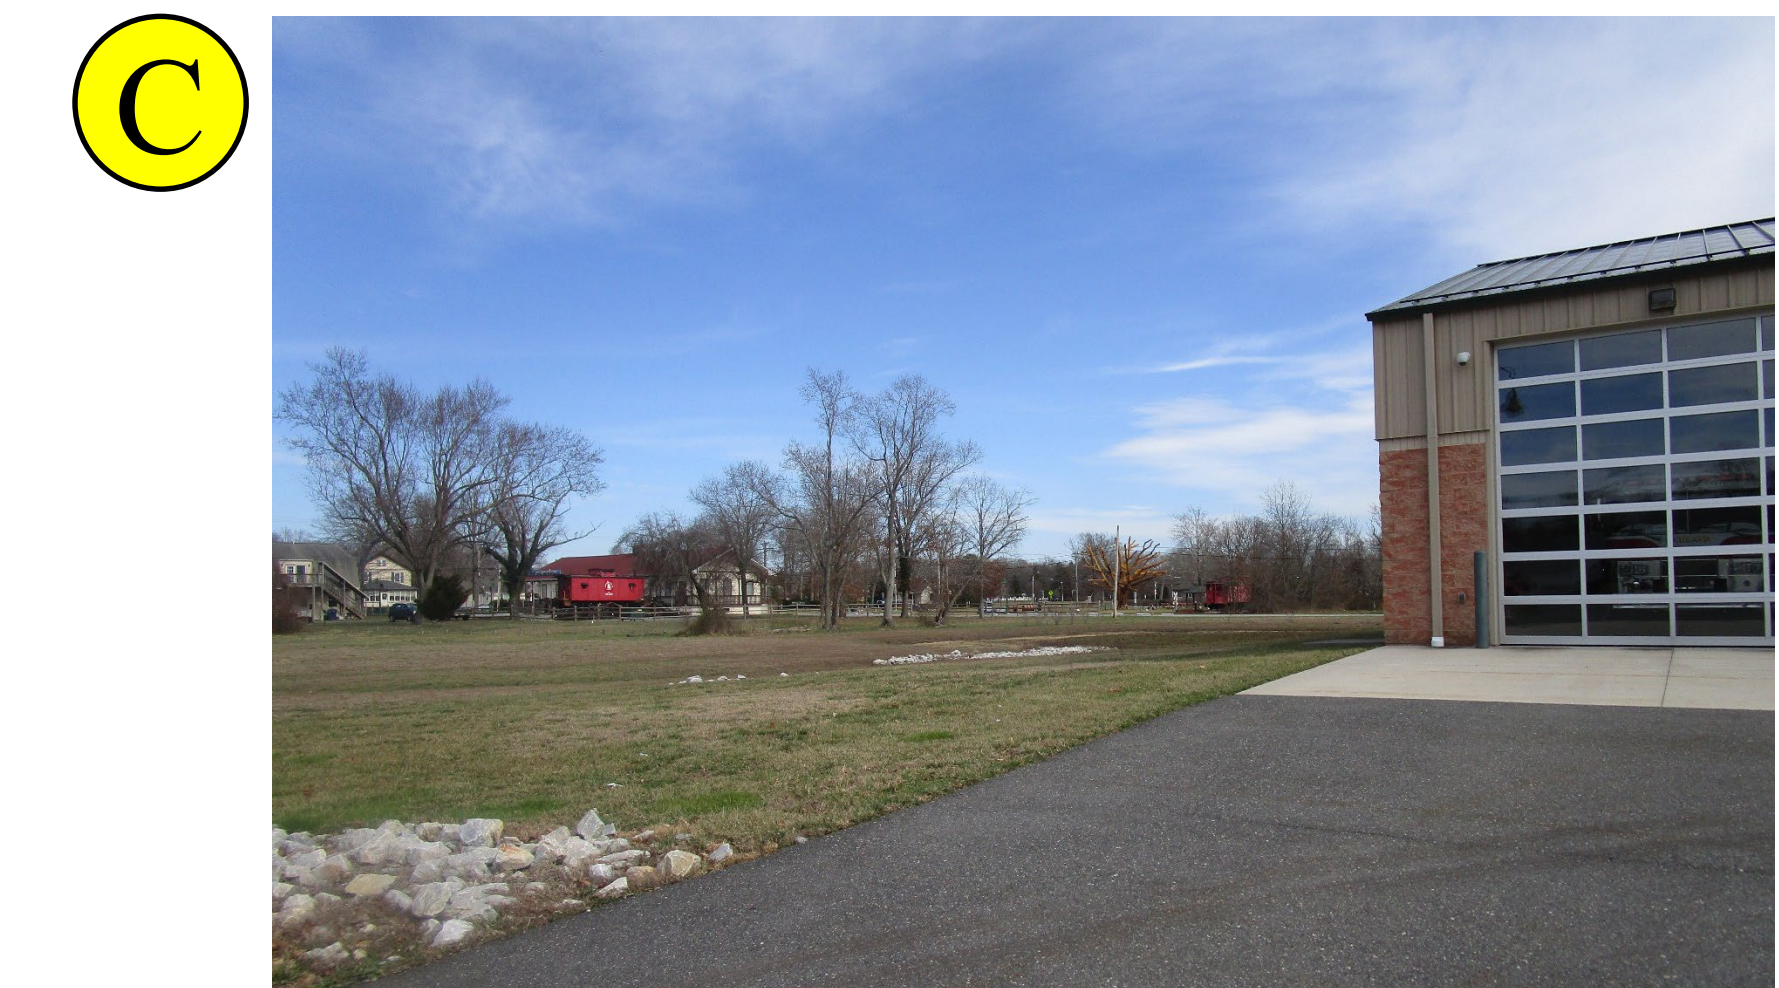
SITE PLAN:

- 1 **BIORETENTION SYSTEM:** Two rain gardens can be installed by the two north corners of the building to capture rooftop runoff. Rain gardens can be used to reduce sediment and nutrient loading to the local waterway and increase groundwater recharge.
- 2 **PERVIOUS PAVEMENT:** Pervious pavement can be used to replace the southernmost parking spaces to promote groundwater recharge and filter stormwater. These surfaces are hard and support vehicle traffic but also allow water to infiltrate through the surface.

<p>Proposed Solution(s): Two rain gardens can be installed on the northwest and northeast corners of the building to collect rooftop runoff from the downspouts. Pervious pavement can be used to replace the southernmost row of parking spaces to collect runoff from the impermeable driveway and parking lot, as well as rooftop runoff from the southwestern corner of the building.</p>	
<p>Anticipated Benefits: Since the bioretention systems would be designed to capture, treat, and infiltrate the entire 2-year design storm (3.3 inches of rain over 24 hours), these systems are estimated to reduce TN by 30%, TP by 60%, and TSS by 90%. A bioretention system would also provide ancillary benefits, such as enhanced wildlife and aesthetic appeal.</p> <p>Porous pavement allows stormwater to penetrate through to soil layers which will promote groundwater recharge as well as intercept and filter stormwater runoff. The porous pavement system will achieve the same level of pollutant load reduction for TN, TP, and TSS as the bioretention system.</p>
