ELMER BOROUGH: GREEN INFRASTRUCTURE SITES

SITES WITHIN THE MUDDY RUN SUBWATERSHED

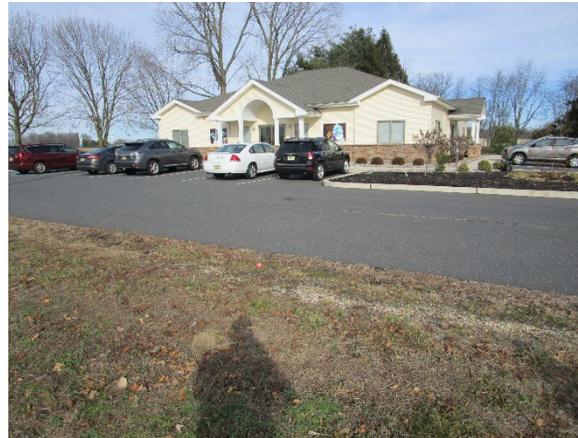
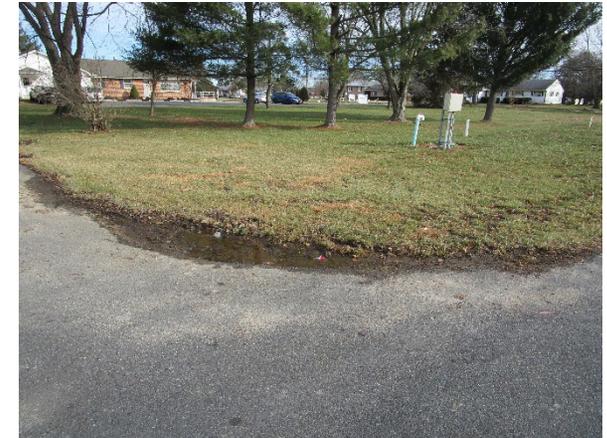
ELMER PEDIATRICS

Parking spaces in the parking lot can be converted to porous pavement to capture and infiltrate stormwater runoff from the parking lot and rooftop. A rain garden can be installed in the turfgrass area east of the parking lot to capture, treat, and infiltrate stormwater runoff from the parking lot. A preliminary soil assessment suggests that the soils have suitable drainage characteristics for green infrastructure.

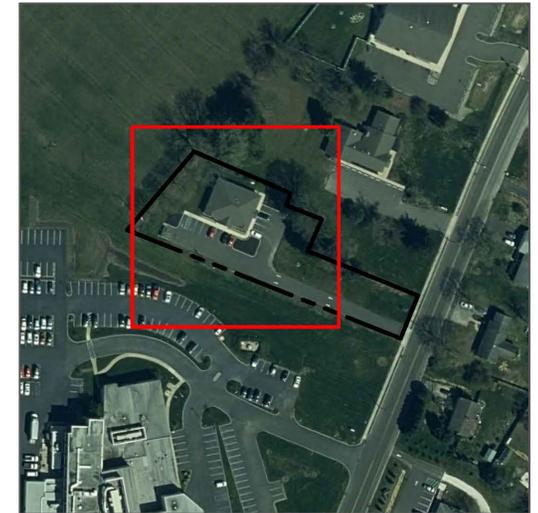
Elmer Pediatrics

bioretention system
-

pervious pavement
-

drainage area
-

Recommended Green Infrastructure Practices	Recharge Potential (Mgal/yr)	TSS Removal Potential (lbs/yr)	Maximum Volume Reduction Potential (gal/storm)	Peak Discharge Reduction Potential (cu. ft./second)	Estimated Size (sq. ft.)	Estimated Cost
Bioretention system	0.055	9	3,990	0.15	530	\$2,650
Pervious pavement	0.146	24	10,580	0.40	1,000	\$25,000

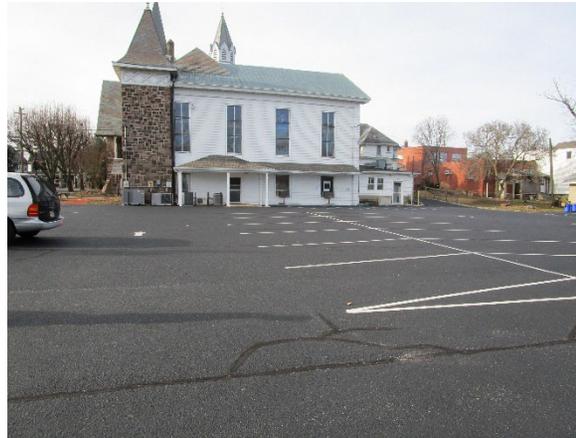
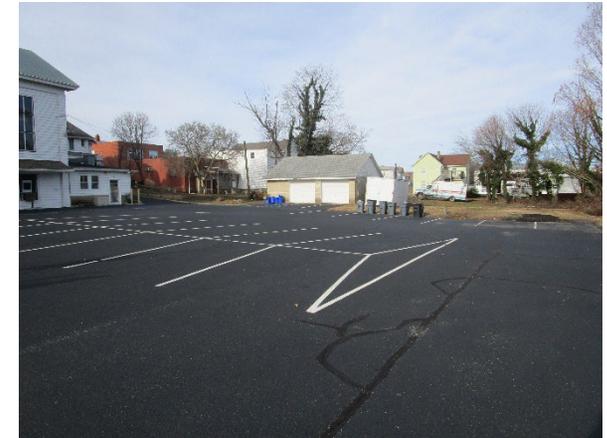
ELMER UNITED METHODIST CHURCH

A section of parking spaces can be converted to porous pavement to capture and infiltrate runoff from the parking lot. A preliminary soil assessment suggests that the soils have suitable drainage characteristics for green infrastructure.

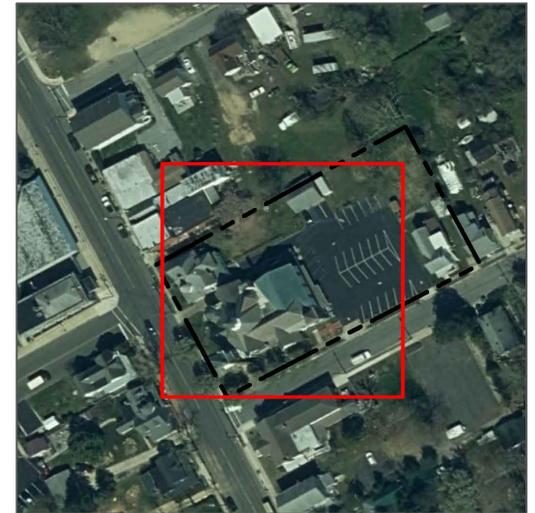
Elmer United Methodist Church

pervious pavement
-

drainage area
-

Recommended Green Infrastructure Practices	Recharge Potential (Mgal/yr)	TSS Removal Potential (lbs/yr)	Maximum Volume Reduction Potential (gal/storm)	Peak Discharge Reduction Potential (cu. ft./second)	Estimated Size (sq. ft.)	Estimated Cost
Pervious pavement	0.147	25	10,700	0.40	1,010	\$25,250

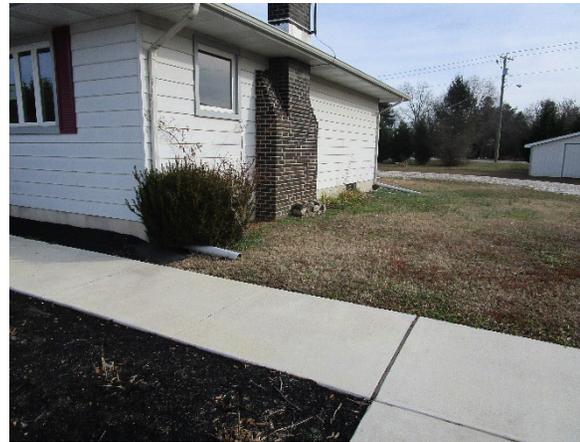
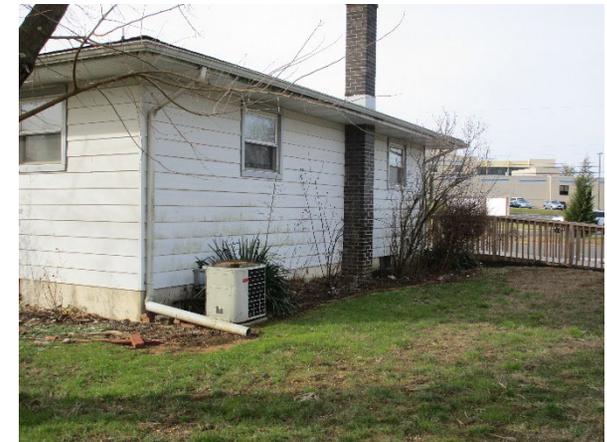
FOOT CARE CENTER

Two rain gardens can be installed to the north and south of the building to capture, treat, and infiltrate the stormwater runoff from the rooftop of the building. A preliminary soil assessment suggests that the soils have suitable drainage characteristics for green infrastructure.

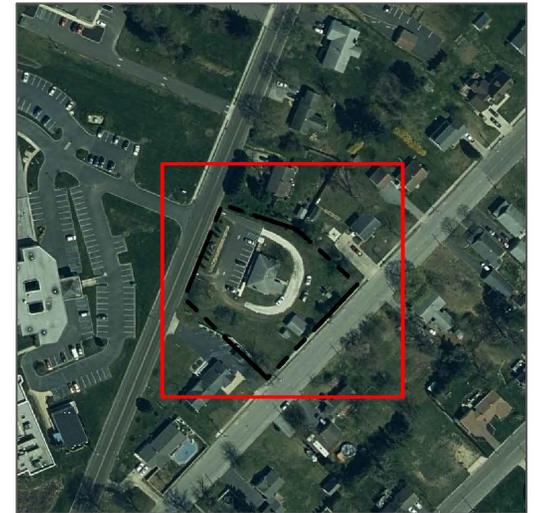
Foot Care Center

bioretention system
-

drainage area
-

Recommended Green Infrastructure Practices	Recharge Potential (Mgal/yr)	TSS Removal Potential (lbs/yr)	Maximum Volume Reduction Potential (gal/storm)	Peak Discharge Reduction Potential (cu. ft./second)	Estimated Size (sq. ft.)	Estimated Cost
Bioretention systems	0.063	11	4,570	0.17	605	\$3,025

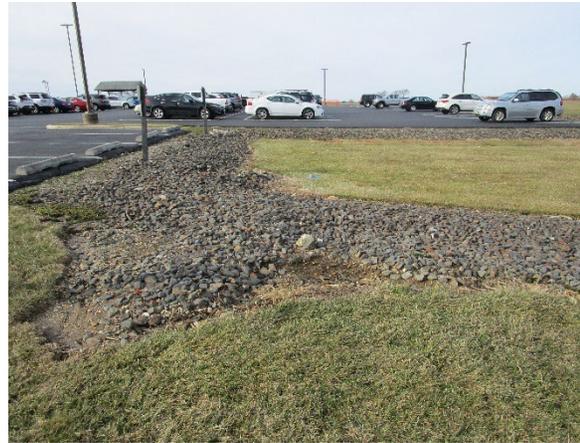
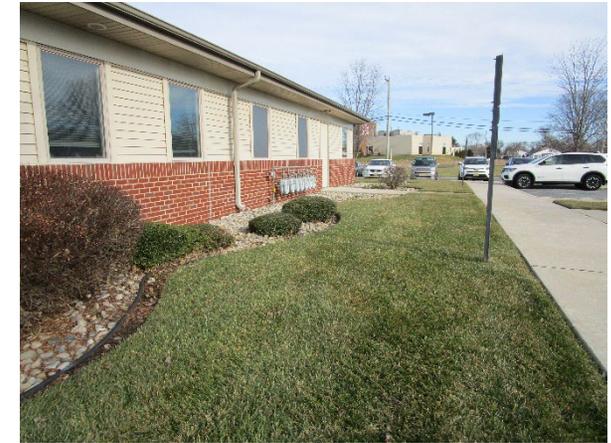
INSPIRA MEDICAL CENTER - ELMER

Rain gardens can be installed in the turfgrass area adjacent to the northernmost part of the parking lot and west of the southernmost building to capture, treat, and infiltrate stormwater runoff from the parking lot. Parking spaces in the northern and southern lot can be converted to porous pavement to capture and infiltrate stormwater runoff. A preliminary soil assessment suggests that more soil testing would be required before determining the soil's suitability for green infrastructure.

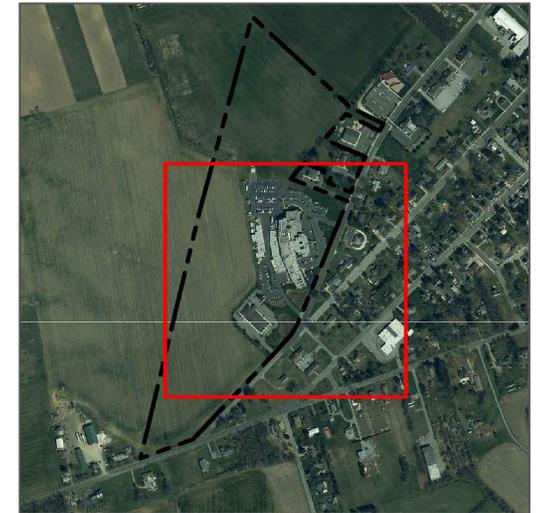
Inspira Medical Center - Elmer

bioretention system
-

pervious pavement
-

drainage area
-

Recommended Green Infrastructure Practices	Recharge Potential (Mgal/yr)	TSS Removal Potential (lbs/yr)	Maximum Volume Reduction Potential (gal/storm)	Peak Discharge Reduction Potential (cu. ft./second)	Estimated Size (sq. ft.)	Estimated Cost
Bioretention systems	0.335	56	24,310	0.91	3,210	\$16,050
Pervious pavement	0.422	71	30,680	1.15	3,000	\$75,000

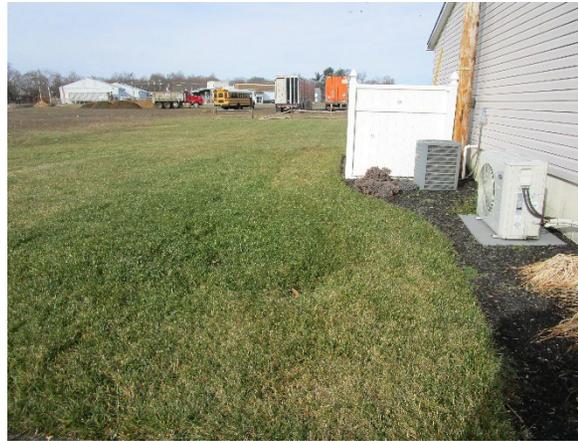
PHYSICAL THERAPY SERVICES

A rain garden can be installed west of the building to capture, treat, and infiltrate stormwater runoff from the roof, which drains via a nearby disconnected downspout. A preliminary soil assessment suggests that the soils have suitable drainage characteristics for green infrastructure.
