WOODSTOWN BOROUGH: GREEN INFRASTRUCTURE SITES

SITES WITHIN THE SALEM RIVER SUBWATERSHED

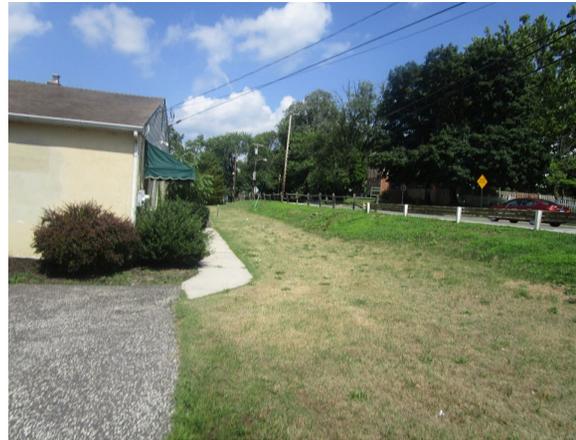
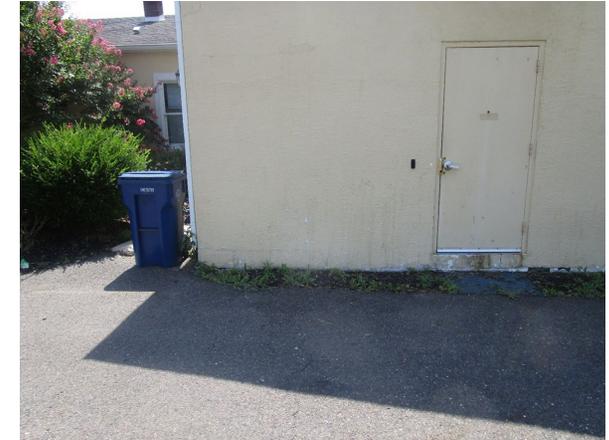
DELAWARE VALLEY MEDICAL CAREER INSTITUTE

A rain garden can be installed on the south side of the building near two downspouts that can be led into the rain garden to capture, treat, and infiltrate the stormwater runoff from the rooftop. A downspout planter box can be placed on the east side of building, and a disconnected downspout can be led into the planter box to capture and treat the stormwater from the rooftop. A preliminary soil assessment suggests that more soil testing would be required before determining the soil's suitability for green infrastructure.

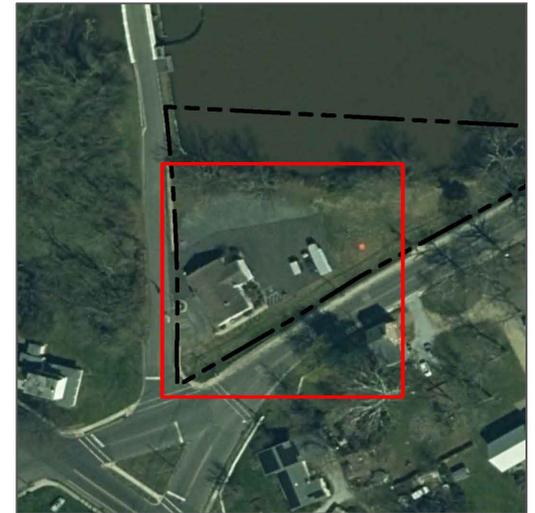
**Delaware Valley Medical
Career Institute**

bioretention system
-

planter box
-

drainage area
-

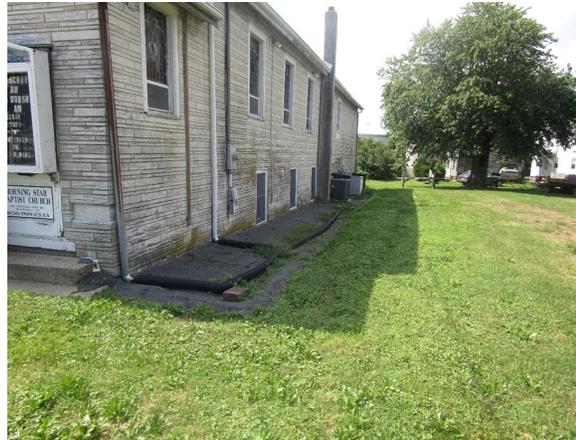
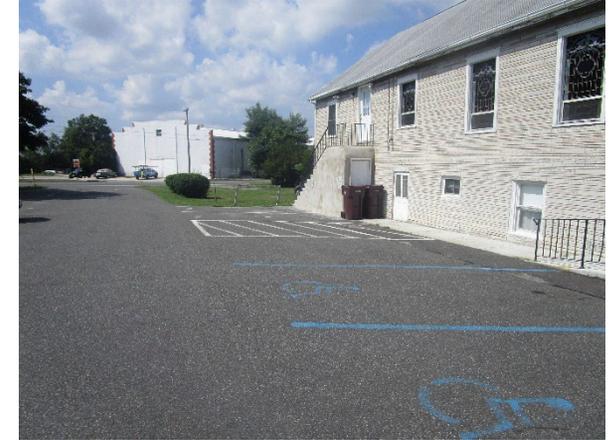
MORNING STAR BAPTIST CHURCH

A rain garden can be installed on the east side of the building to capture, treat, and infiltrate the stormwater from the rooftop. Parking spaces on the west side of the building can be replaced with pervious pavement. A preliminary soil assessment suggests that more soil testing would be required before determining the soil's suitability for green infrastructure.

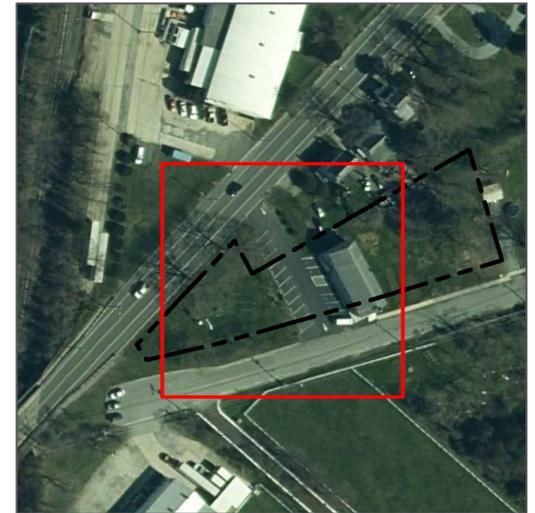
Morning Star Baptist Church

bioretention system
-

pervious pavement
-

drainage area
-

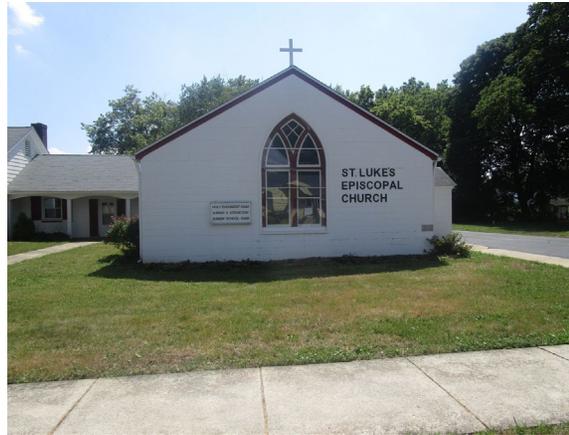
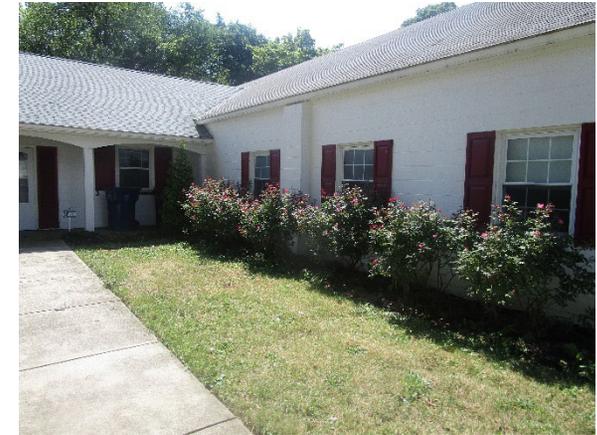
ST LUKE'S EPISCOPAL CHURCH

A rain garden can be installed at the northwest corner of the building to capture, treat, and infiltrate the stormwater runoff from the rooftop. Two downspouts on the north side of the building can be led to the rain garden. A preliminary soil assessment suggests that more soil testing would be required before determining the soil's suitability for green infrastructure.

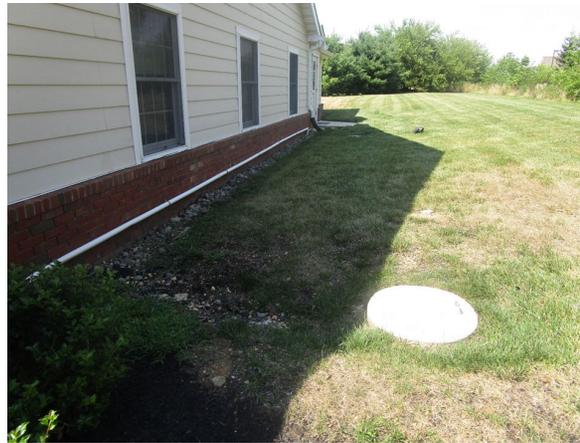
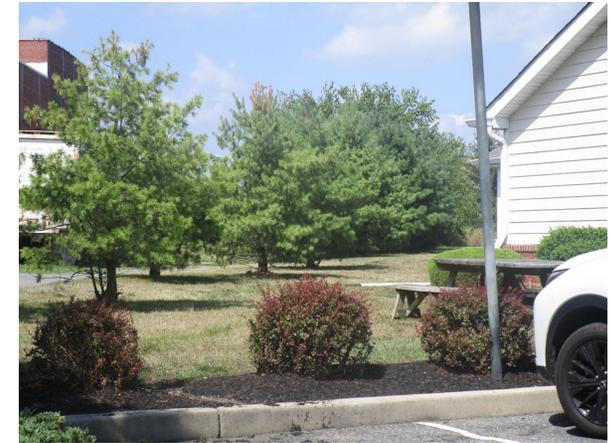
WOODSTOWN PHYSICAL THERAPY

A rain garden can be installed on the east side of the building where multiple downspouts are connected together to one outlet where the rain garden can be placed to capture, treat, and infiltrate the stormwater from the rooftop. Another rain garden can be installed on the west side of the building next to a downspout. A preliminary soil assessment suggests that more soil testing would be required before determining the soil's suitability for green infrastructure.

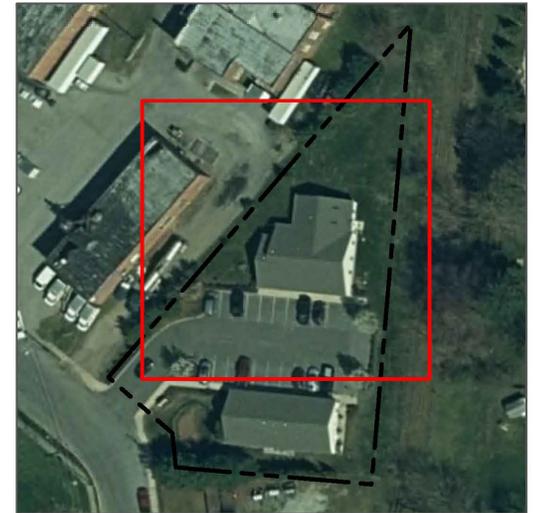
Woodstown Physical Therapy

bioretention system
-

drainage area
-

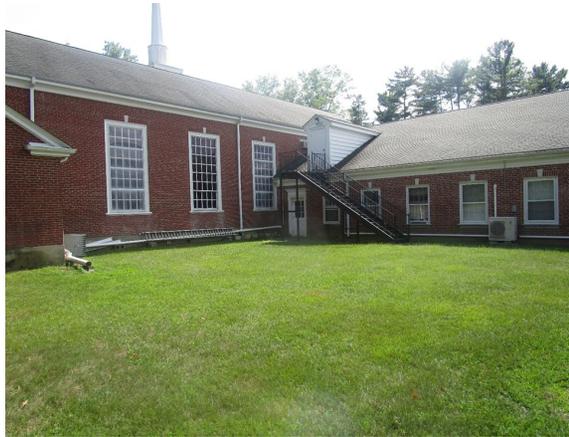
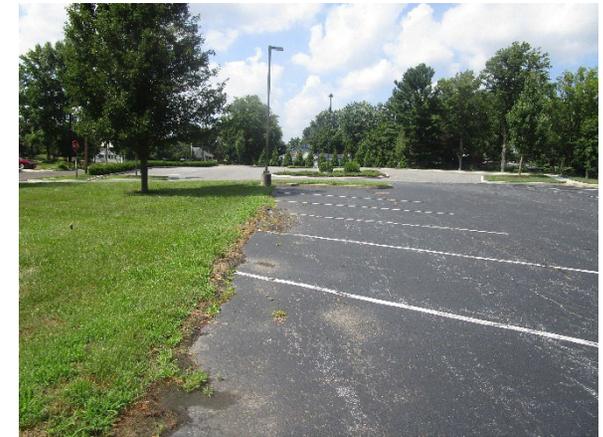
WOODSTOWN PRESBYTERIAN CHURCH

A rain garden can be installed on the east side of the building where multiple downspouts are connected to one outlet to capture, treat, and infiltrate the stormwater runoff from the rooftop. A strip of parking spaces at the northeast corner of the parking lot can be replaced with pervious pavement to capture, treat, and infiltrate the stormwater runoff from the parking lot. A preliminary soil assessment suggests that more soil testing would be required before determining the soil's suitability for green infrastructure.
