**Impervious Cover Reduction Action Plan
for
Branchville Borough, Sussex County, New Jersey**

*Prepared for Branchville Borough by the
Rutgers Cooperative Extension Water Resources Program*

August 10, 2016

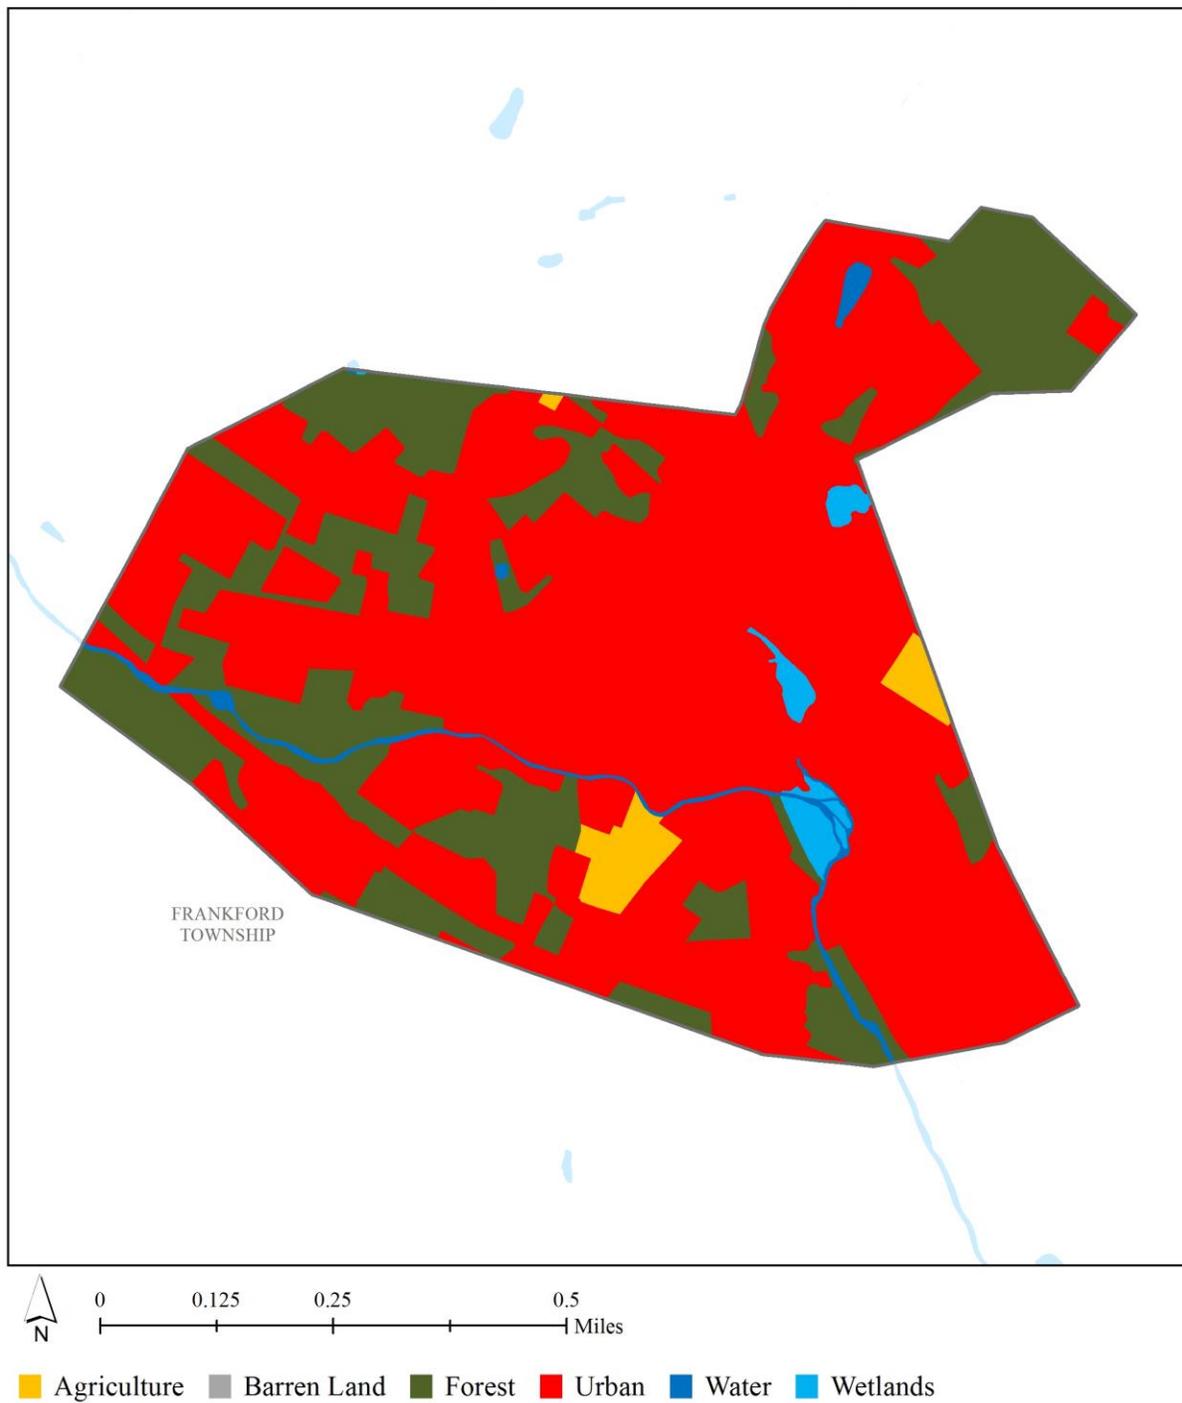
Figure 1: Map illustrating the land use in Branchville Borough

Located in Sussex County in northern New Jersey, Branchville Borough covers approximately 0.59 square miles. Figures 1 and 2 illustrate that Branchville Borough is dominated by urban land uses. A total of 70.6% of the municipality's land use is classified as urban. Of the urban land in Branchville Borough, medium density residential is the dominant land use (Figure 3).

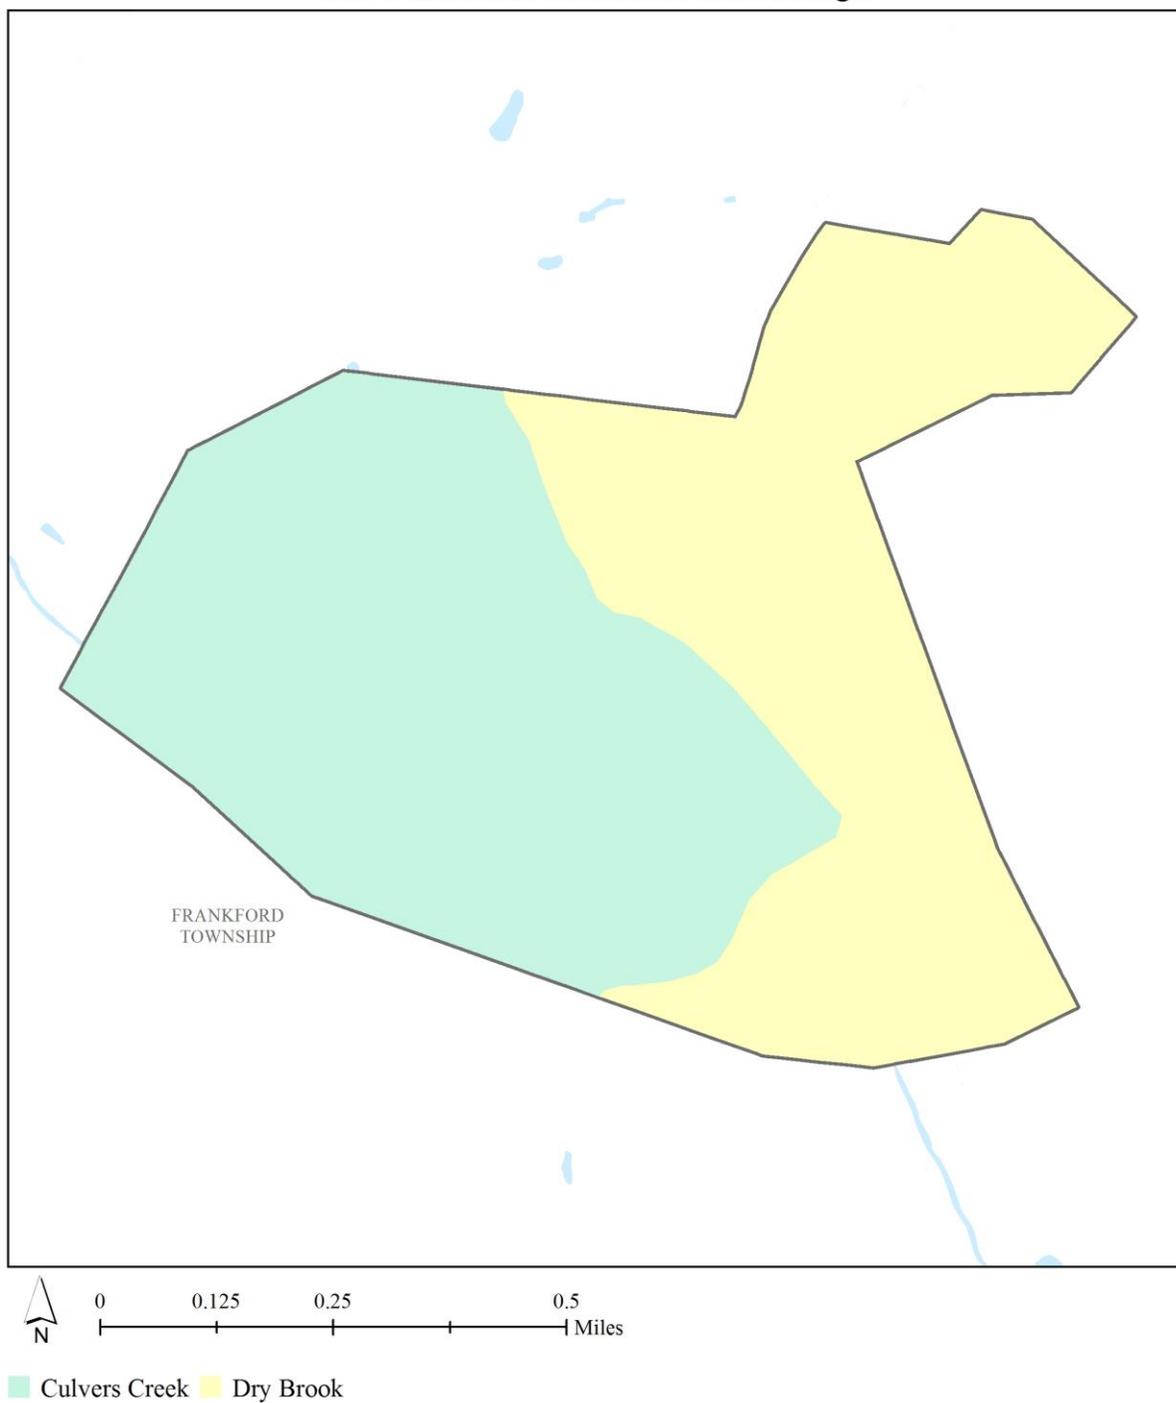
Figure 4: Map of the subwatersheds in Branchville Borough

Branchville Borough contains portions of two subwatersheds (Figure 4). For this impervious cover reduction action plan, projects have been identified in each of these watersheds. Initially, aerial imagery was used to identify potential project sites that contain extensive impervious cover. Field visits were then conducted at each of these potential project sites to determine if a viable option exists to reduce impervious cover or to disconnect impervious surfaces from draining directly to the local waterway or storm sewer system. During the site visit, appropriate green infrastructure practices for the site were determined. Sites that already had stormwater management practices in place were not considered.

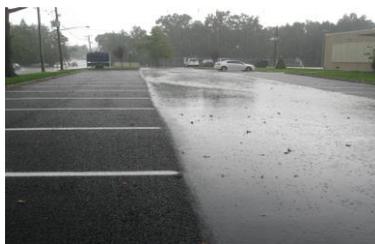
There are several types of permeable pavement systems including porous asphalt, pervious concrete, permeable pavers, and grass pavers. These surfaces are hard and support vehicle traffic but also allow water to infiltrate through the surface. They have an underlying stone layer to store stormwater runoff and allow it to slowly seep into the ground.

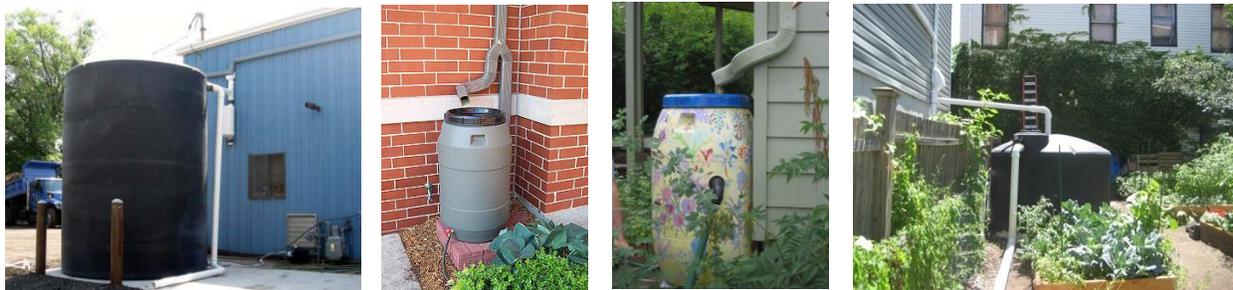
These systems capture rainwater, mainly from rooftops, in cisterns or rain barrels. The water can then be used for watering gardens, washing vehicles, or for other non-potable uses.

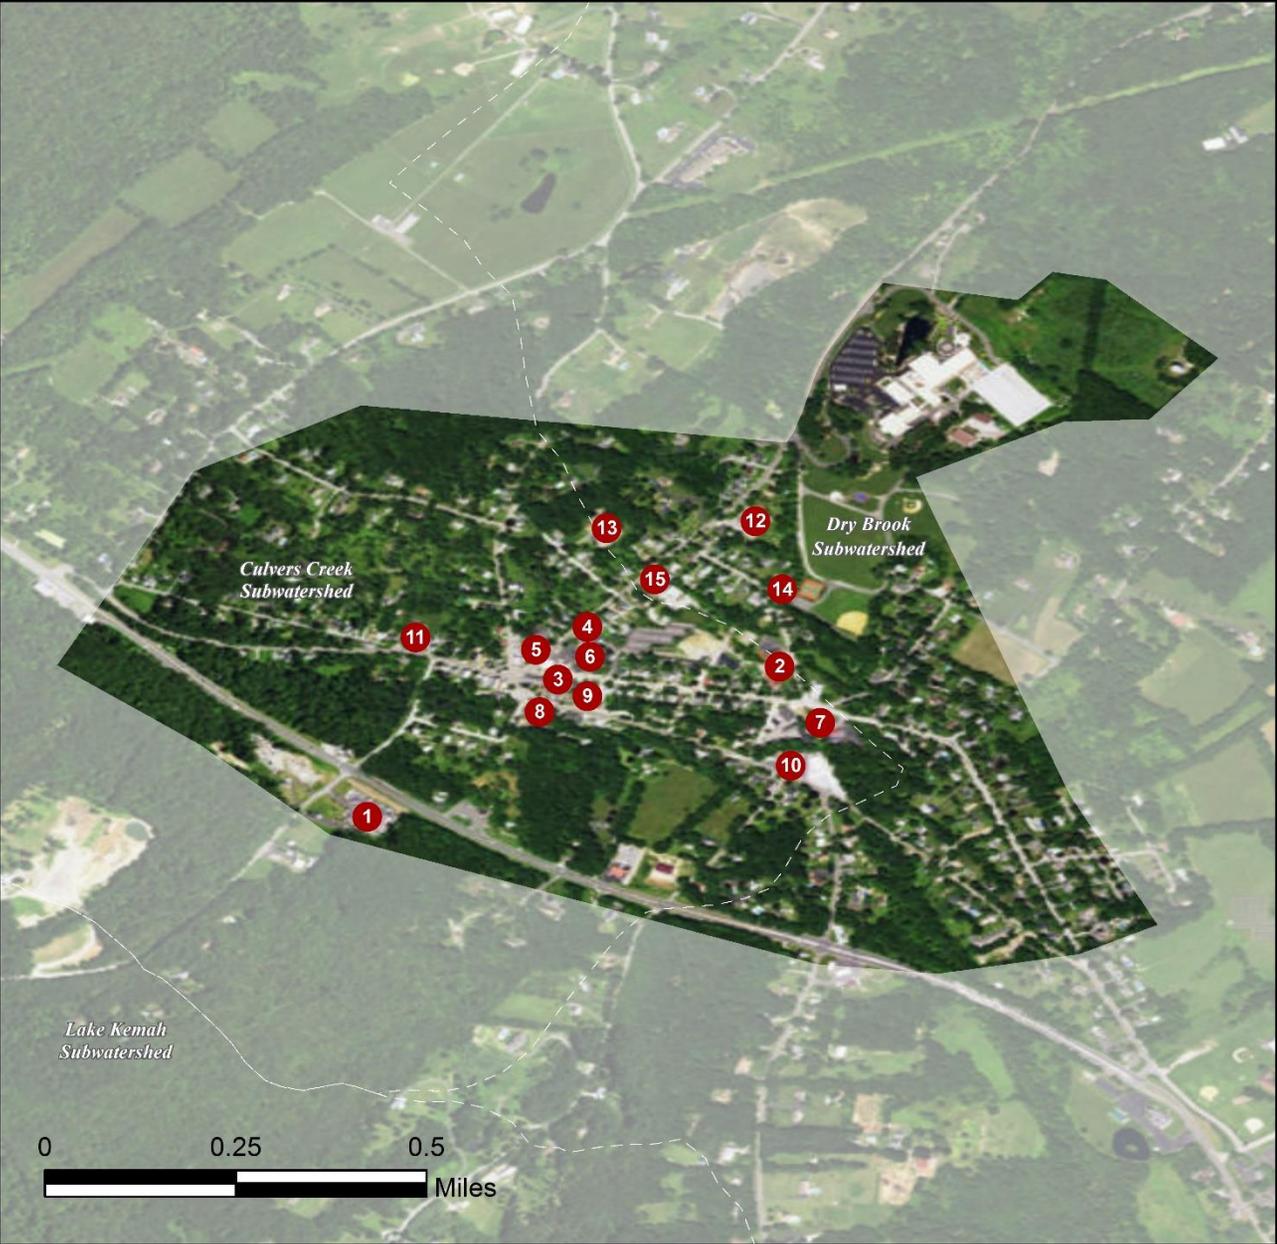
BRANCHVILLE BOROUGH: GREEN INFRASTRUCTURE SITES

SITES WITHIN THE CULVERS CREEK SUBWATERSHED:

- 1. 123 Auto Sales
- 2. Branchville Hose Company
- 3. Branchville Post Office
- 4. Castner Auction - Appraisal Services
- 5. First Presbyterian Church
- 6. Franklin Mutual Insurance
- 7. Montague Tool & Supply Company
- 8. Municipal Parking Lot
- 9. United Methodist Church
- 10. Wilco Air Conditioning Refrigeration & Heating
- 11. Wood Funeral Home

SITES WITHIN THE DRY BROOK SUBWATERSHED:

- 12. Branchville Borough Office
- 13. Branchville Borough Road Department
- 14. Branchville Country Vet Clinic
- 15. Lafayette Clay Works

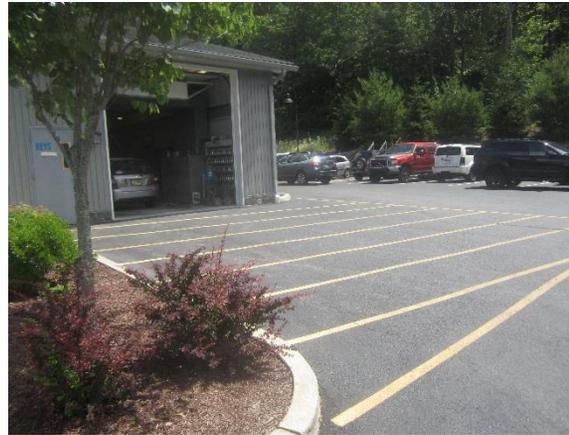
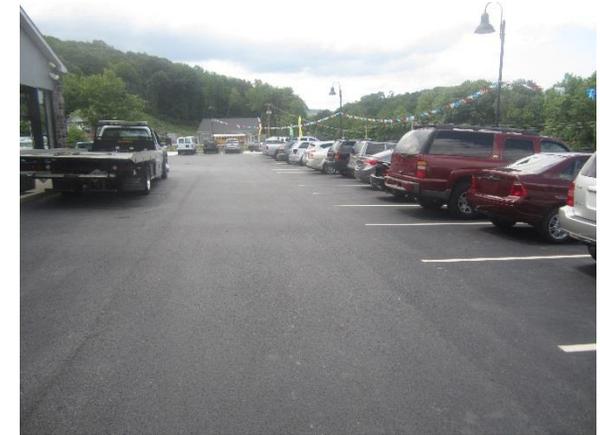
Address: 3 Kemah Lake Road
Branchville, NJ 07826

Stormwater is currently directed to the existing sewer system through connected downspouts. Parking spots can be replaced with porous asphalt to capture and infiltrate stormwater from the parking lot and roof. A cistern can be placed on the south corner of the building to capture roof runoff to be used for washing vehicles. A preliminary soil assessment suggests that more soil testing would be required before determining the soil’s suitability for green infrastructure.

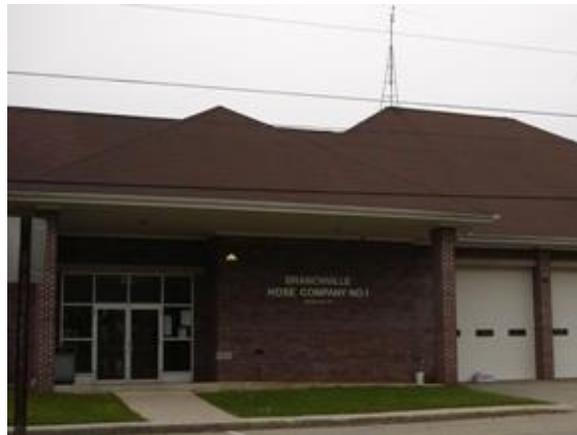
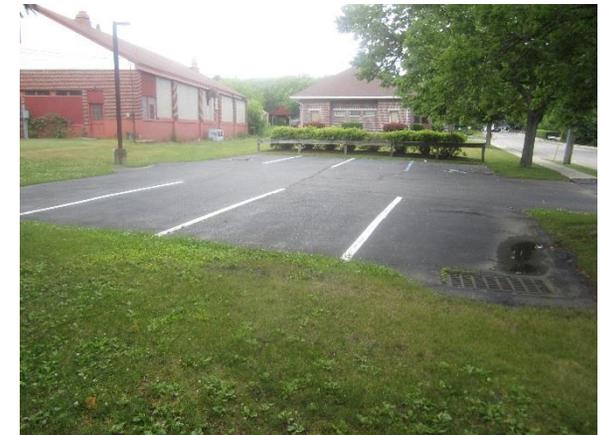
Address: 1 Railroad Avenue
Branchville, NJ 07826

Stormwater is currently directed to an existing catch basin and the local sewer system. Parking spots in both the south and the north parking lot can be replaced with porous asphalt to capture and infiltrate stormwater. A rain garden adjacent to the building can capture, treat, and infiltrate roof runoff. A preliminary soil assessment suggests that the soils have suitable drainage characteristics for green infrastructure.

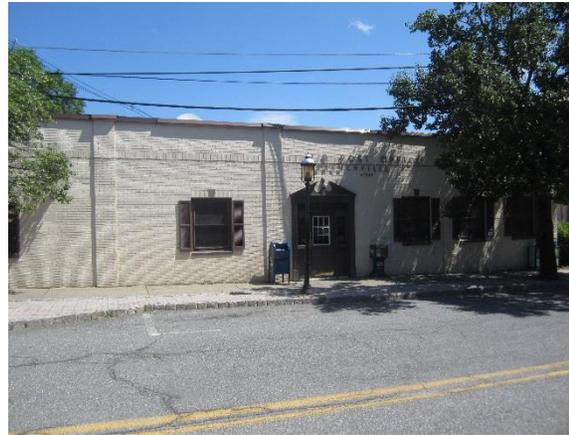
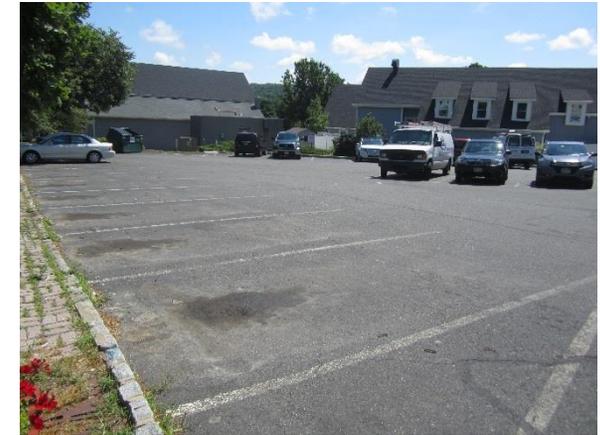
Address: 1 Broad Street
Branchville, NJ 07826

Stormwater is currently directed to an existing catch basin. Parking spots in the rear parking lot can be replaced with porous asphalt to capture and infiltrate stormwater. A preliminary soil assessment suggests that the soils have suitable drainage characteristics for green infrastructure.

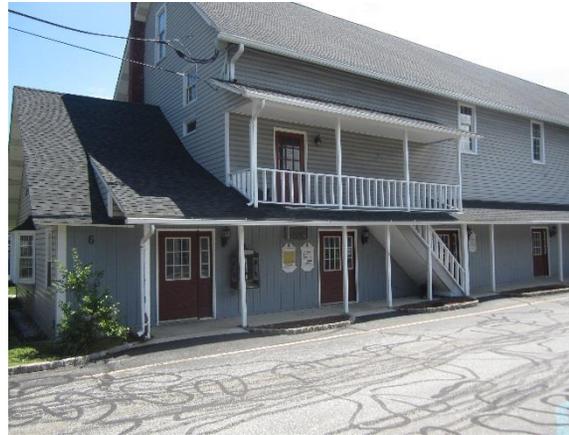
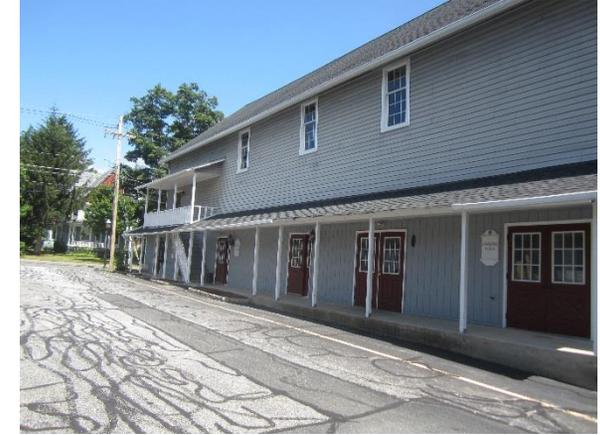
Address: 6 Wantage Avenue
Branchville, NJ 07826

Stormwater currently drains toward the rear of the building. Three downspout planter boxes adjacent to the building can capture, treat, and infiltrate roof runoff. A preliminary soil assessment suggests that the soils have suitable drainage characteristics for green infrastructure.

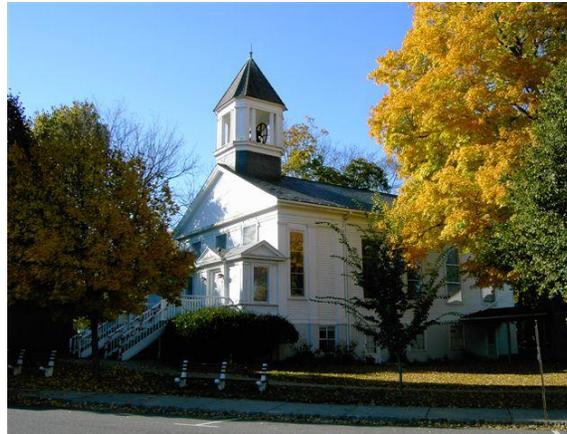
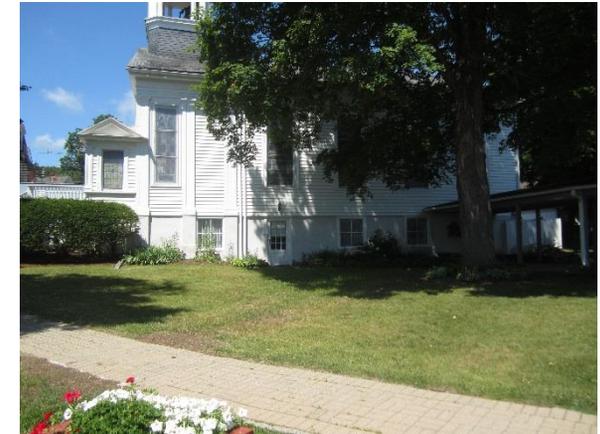
Address: 3 Wantage Avenue
Branchville, NJ 07826

Stormwater is currently directed across the church’s lawn causing erosion issues. A rain garden adjacent to the building on that lawn can capture, treat, and infiltrate roof runoff. A preliminary soil assessment suggests that the soils have suitable drainage characteristics for green infrastructure.

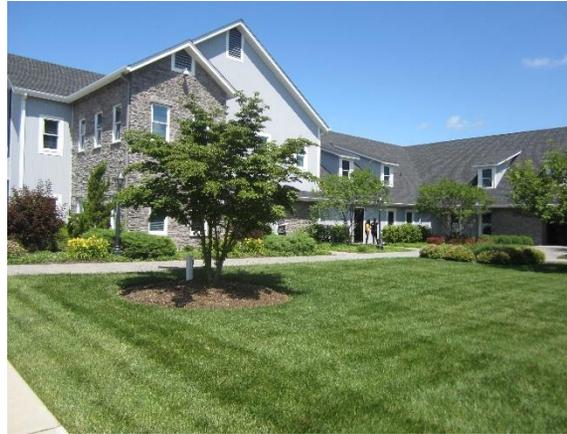
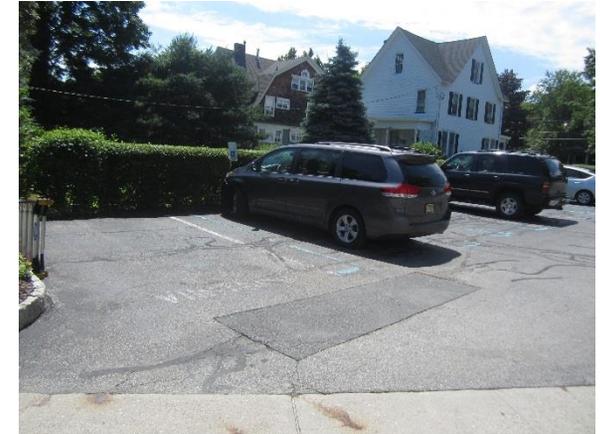
Address: 5 Broad Street
Branchville, NJ 07826

Stormwater is currently directed to the local sewer system through connected downspouts or existing catch basins. Parking spots on the east side of the building can be replaced with porous asphalt to capture and infiltrate stormwater. Rain gardens on the front lawn of the building can capture, treat, and infiltrate roof runoff. A preliminary soil assessment suggests that the soils have suitable drainage characteristics for green infrastructure.

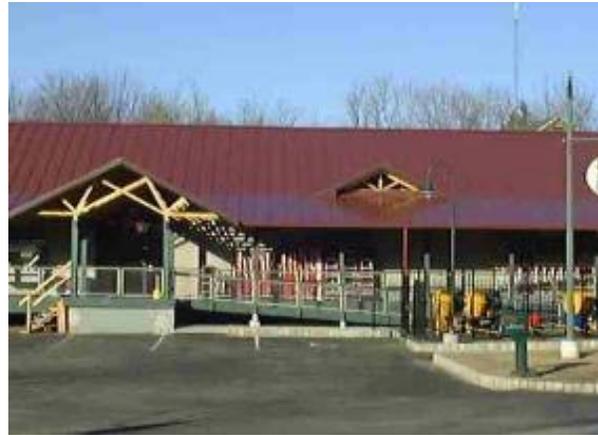
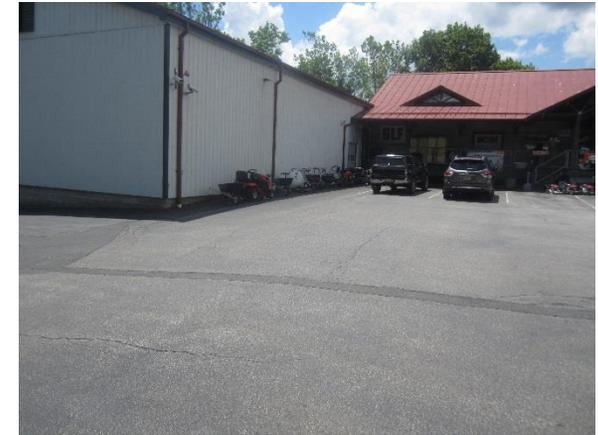
Address: 42 Broad Street
Branchville, NJ 07826

Stormwater is currently directed to the local sewer system by connected downspouts. A cistern can be installed on the south building to capture roof runoff. The water can then be used for washing vehicles or for other non-potable uses. A preliminary soil assessment suggests that the soils have suitable drainage characteristics for green infrastructure.

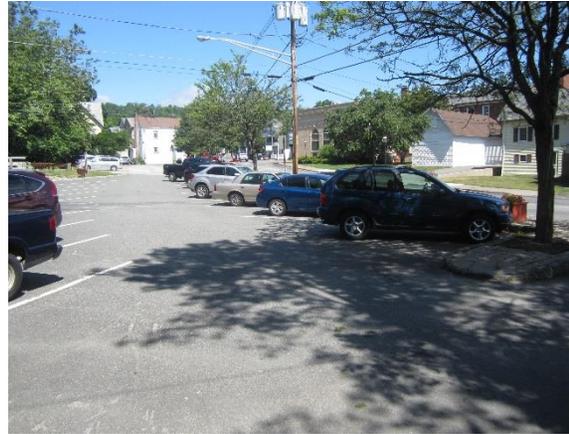
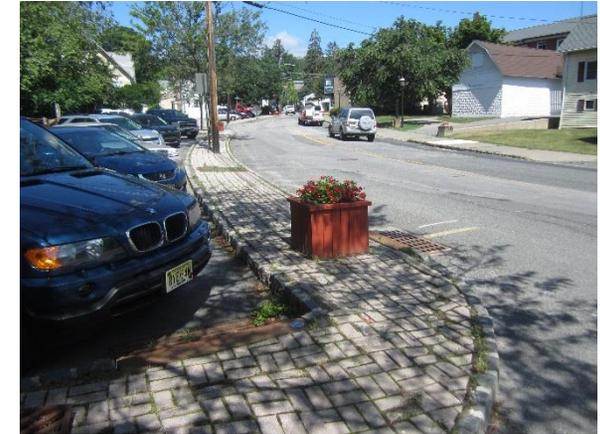
Subwatershed: Culvers Creek
Site Area: 10,657 sq. ft.
Address: 4 Mill Street
Branchville, NJ 07826
Block and Lot: Block 504, Lot 22

Stormwater is currently directed to an existing catch basin. Parking spots on the north side of the lot can be replaced with porous asphalt to capture and infiltrate stormwater. A preliminary soil assessment suggests that the soils have suitable drainage characteristics for green infrastructure.

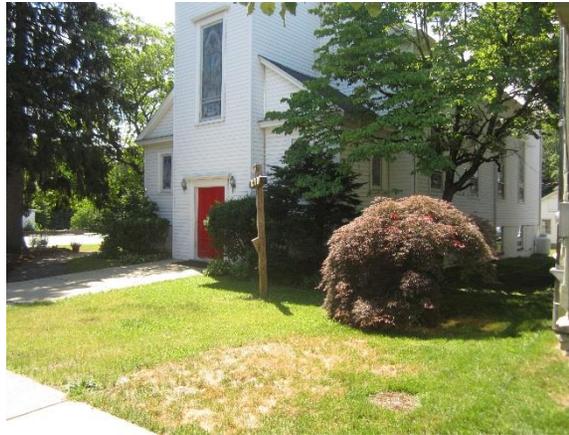
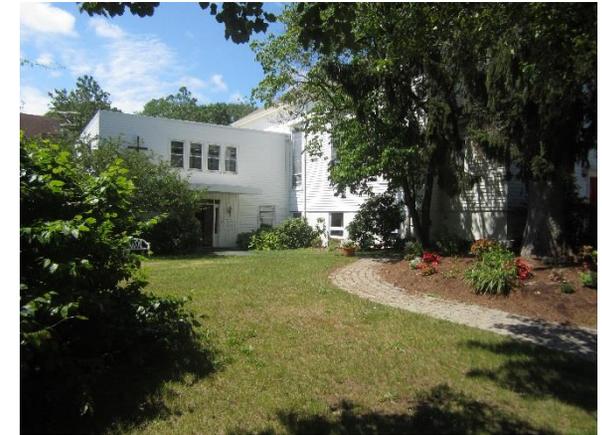
Address: 8 Broad Street
Branchville, NJ 07826

Stormwater is currently directed to the west side of the building where it is the cause of erosion issues. Rain gardens adjacent to the building can capture, treat, and infiltrate roof runoff. A preliminary soil assessment suggests that the soils have suitable drainage characteristics for green infrastructure.

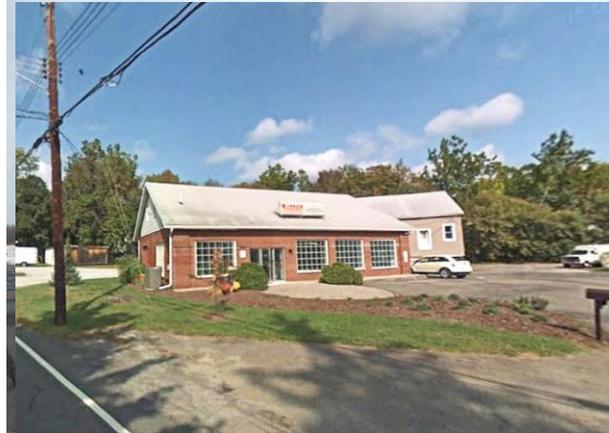
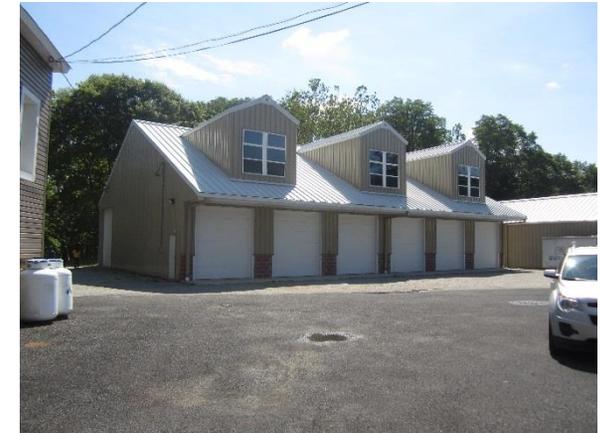
Subwatershed: Culvers Creek
Site Area: 68,671 sq. ft.
Address: 15 Mill Street
Branchville, NJ 07826
Block and Lot: Block 705, Lot 22

Stormwater is currently directed to the local sewer system by connected downspouts. Cisterns placed adjacent to the northwest building and the main building can capture roof runoff. The water can then be used for watering an existing garden on the property, washing vehicles, or other non-potable uses. A preliminary soil assessment suggests that the soils have suitable drainage characteristics for green infrastructure.

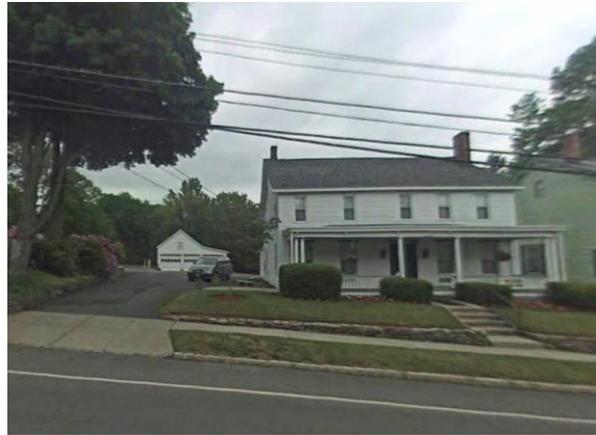
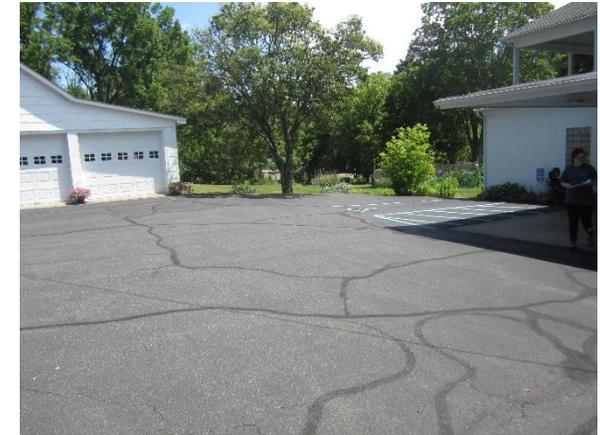
Address: 16 Main Street
Branchville, NJ 07826

Stormwater currently flows across the parking lot. Parking spots adjacent to the south building can be replaced with porous asphalt to capture and infiltrate stormwater. A preliminary soil assessment suggests that the soils have suitable drainage characteristics for green infrastructure.

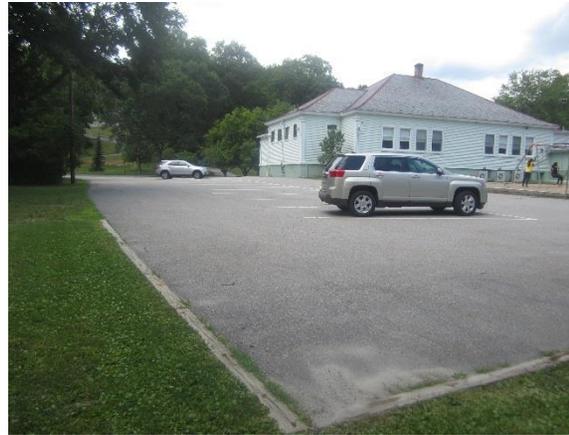
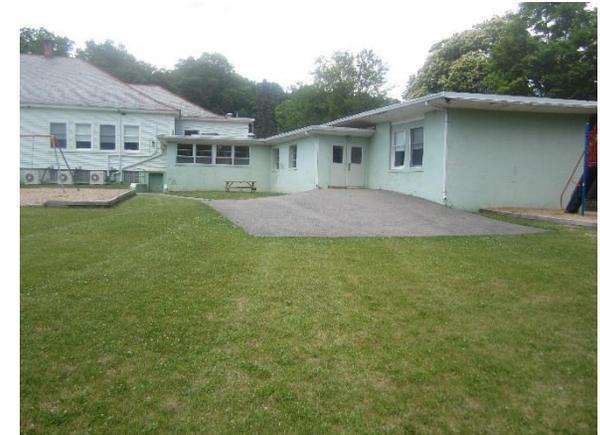
Subwatershed: Dry Brook
Site Area: 106,329 sq. ft.
Address: 34 Wantage Avenue
Branchville, NJ 07826
Block and Lot: Block 201, Lot 12

Stormwater is currently directed to an existing detention basin. Parking spots on the southwest side of the building can be replaced with porous asphalt to capture and infiltrate stormwater. A rain garden adjacent to the building can capture, treat, and infiltrate roof runoff. A preliminary soil assessment suggests that the soils have suitable drainage characteristics for green infrastructure.

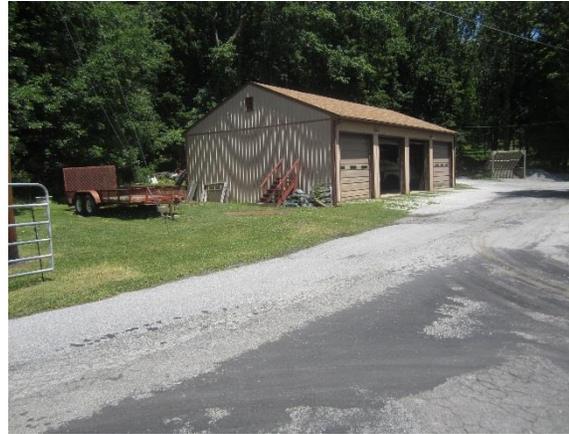
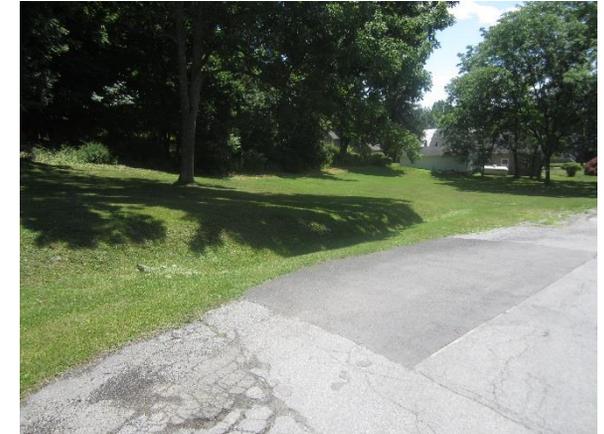
Subwatershed: Dry Brook
Site Area: 88,172 sq. ft.
Address: 6 New Street
Branchville, NJ 07826
Block and Lot: Block 204, Lot 8

Stormwater is currently draining from the impervious surfaces of the property. A rain garden placed near an existing trench adjacent to the building can capture, treat, and infiltrate roof and impervious surface runoff. A cistern can be added to the smaller building to collect runoff for washing trucks. A preliminary soil assessment suggests that the soils have suitable drainage characteristics for green infrastructure.

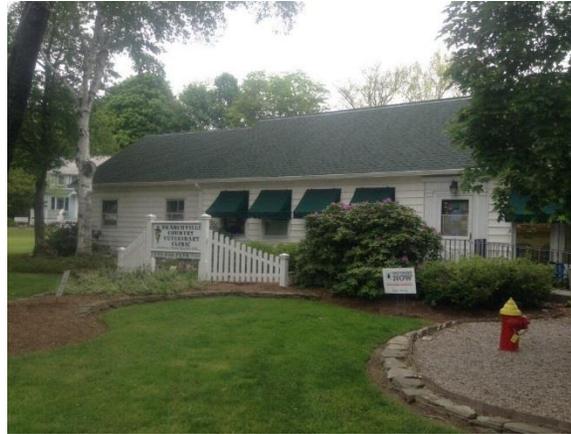
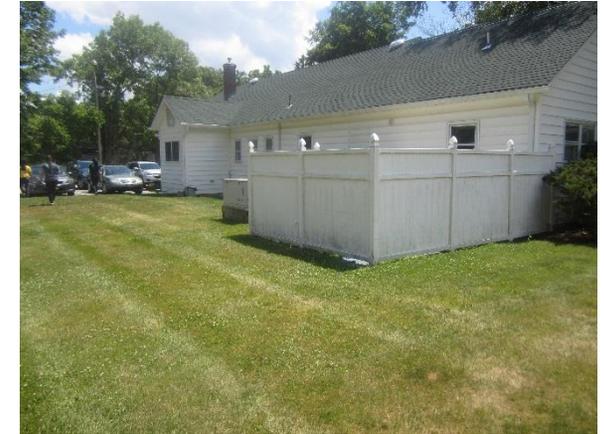
Address: 12 Maple Avenue
Branchville, NJ 07826

Stormwater is currently directed to drain from the parking lot towards Dry Brook. Parking spots adjacent to the building can be replaced with porous asphalt to capture and infiltrate stormwater. A rain garden in the yard placed away from the septic tank can capture, treat, and infiltrate roof runoff. A cistern placed at the north end of the property can capture roof runoff and be used to water the existing landscaping. A preliminary soil assessment suggests that the soils have suitable drainage characteristics for green infrastructure.

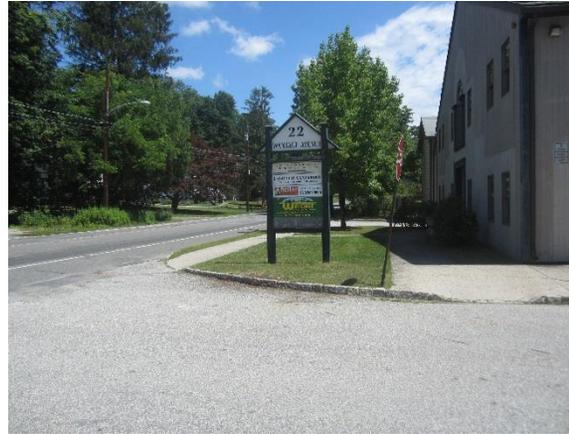
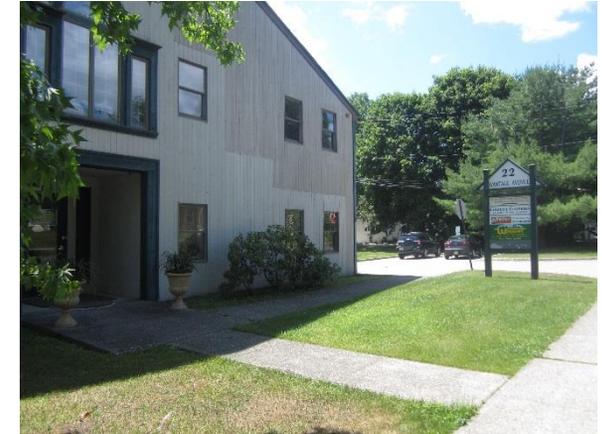
Subwatershed: Dry Brook
Site Area: 87,263 sq. ft.
Address: 22 Wantage Avenue
Branchville, NJ 07826
Block and Lot: Block 202, Lot 9

Stormwater is directed to the ground by disconnected downspouts. A rain garden adjacent to the building can capture, treat, and infiltrate roof runoff. A preliminary soil assessment suggests that the soils have suitable drainage characteristics for green infrastructure.
