**Impervious Cover Reduction Action Plan
for
Millville City, Cumberland County, New Jersey**

*Prepared for Millville City by the
Rutgers Cooperative Extension Water Resources Program*

August 10, 2016

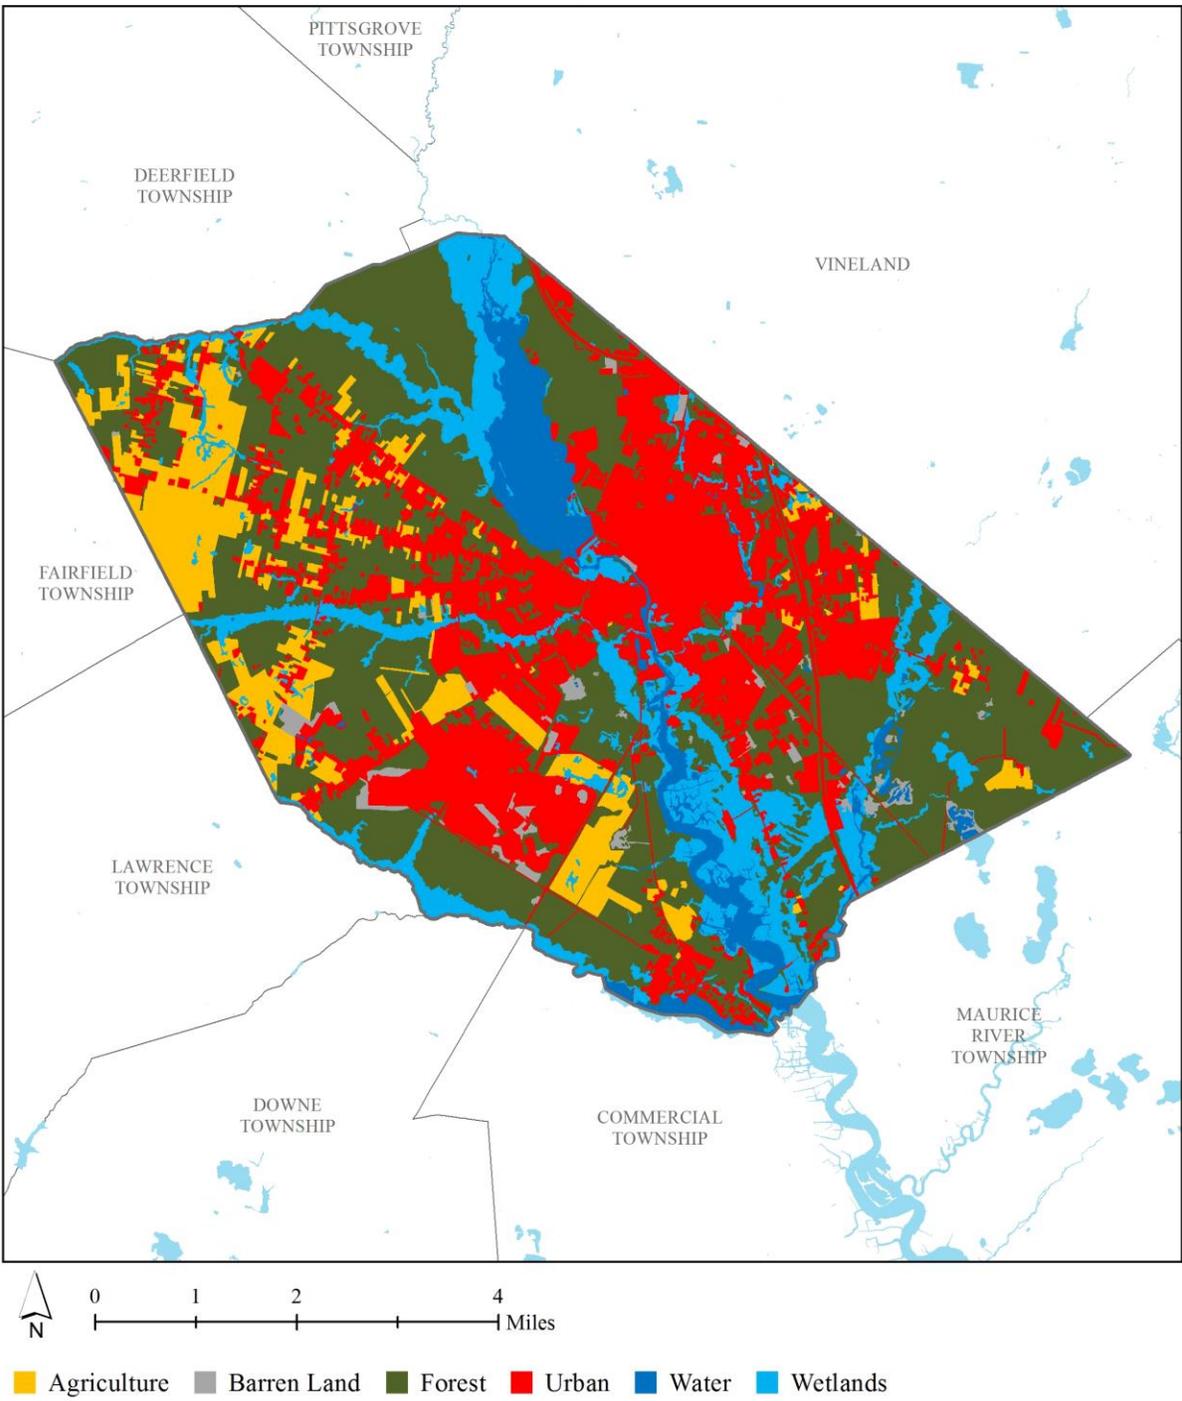
Figure 1: Map illustrating the land use in Millville City

Located in Cumberland County in southern New Jersey, Millville City covers approximately 44.5 square miles. Figures 1 and 2 illustrate that Millville City is dominated by forest land uses. A total of 27.9% of the municipality's land use is classified as urban. Of the urban land in Millville City, medium density residential is the dominant land use (Figure 3).

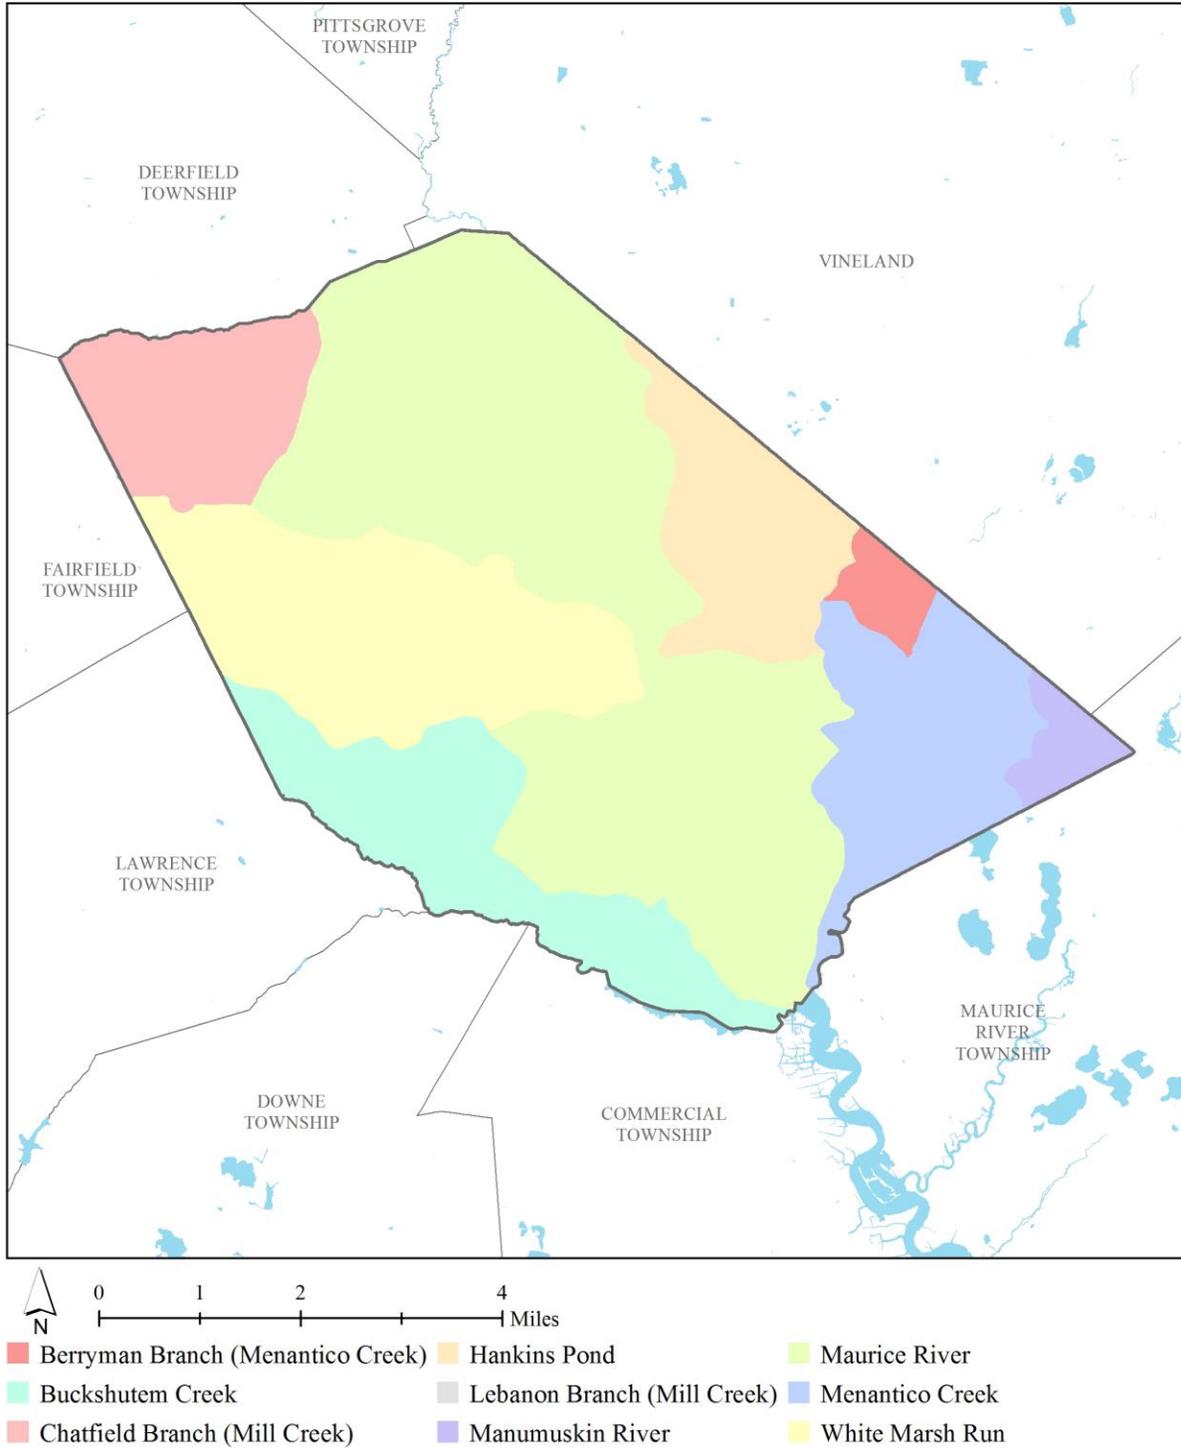
Figure 4: Map of the subwatersheds in Millville City

Millville City contains portions of nine subwatersheds (Figure 4). For this impervious cover reduction action plan, projects have been identified in each of these watersheds. Initially, aerial imagery was used to identify potential project sites that contain extensive impervious cover. Field visits were then conducted at each of these potential project sites to determine if a viable option exists to reduce impervious cover or to disconnect impervious surfaces from draining directly to the local waterway or storm sewer system. During the site visit, appropriate green infrastructure practices for the site were determined. Sites that already had stormwater management practices in place were not considered.

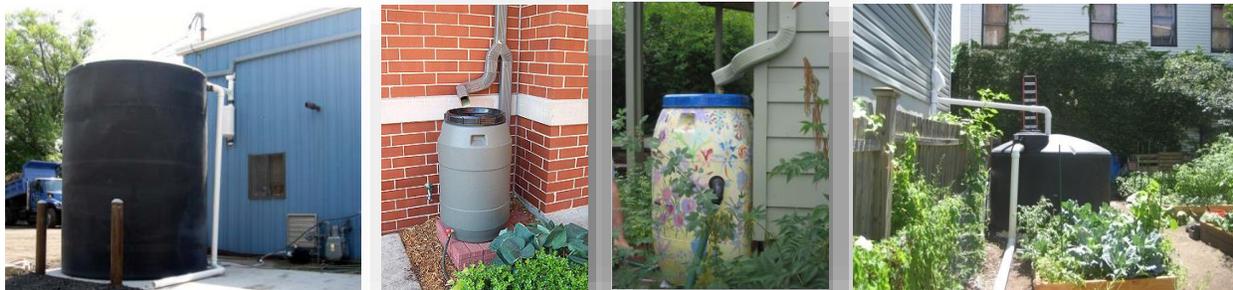
Rainwater harvesting systems (cistern or rain barrel)

These systems capture rainwater, mainly from rooftops, in cisterns or rain barrels. The water can then be used for watering gardens, washing vehicles, or for other non-potable uses.

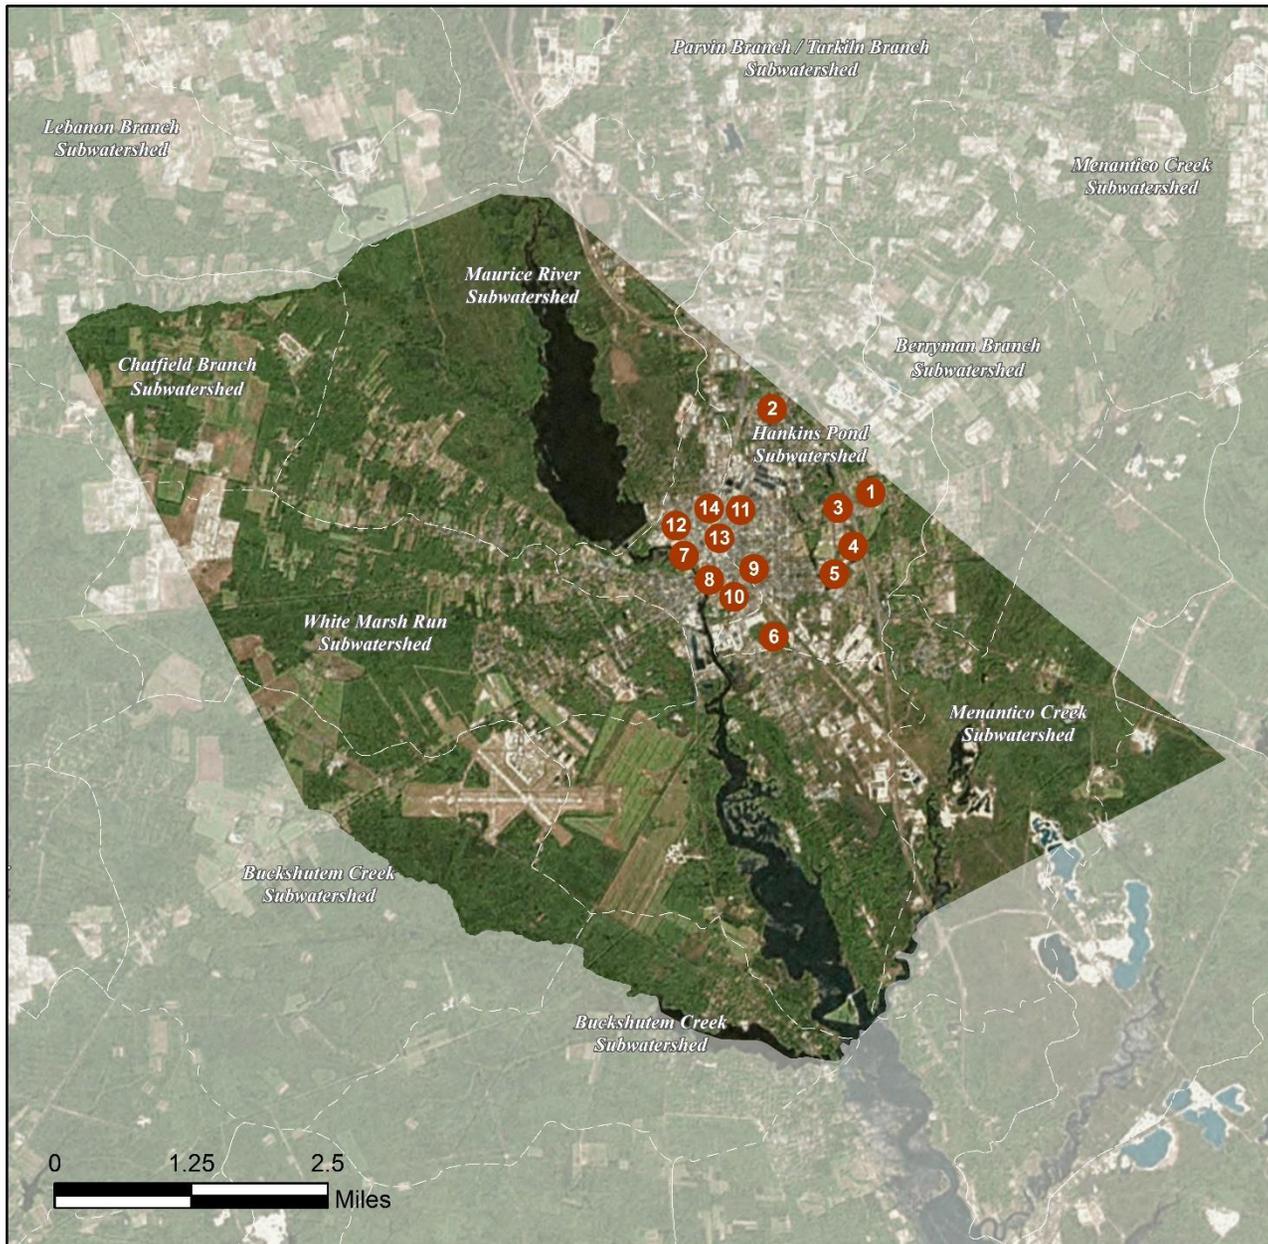
MILLVILLE: GREEN INFRASTRUCTURE SITES

1. Cumberland County Church
2. First Assembly of God
3. The Lighthouse Church of God
4. Millville Senior High School
5. Miracle Cogic Temple
6. R.M. Bacon Elementary School

7. American Legion Nabb - Leslie Post 82
8. Central Baptist Church
9. First Presbyterian Church
10. Millville City Hall and Police Department
11. Millville Fire Department
12. Millville Public Library
13. Millville Post Office
14. R.D. Wood Elementary School

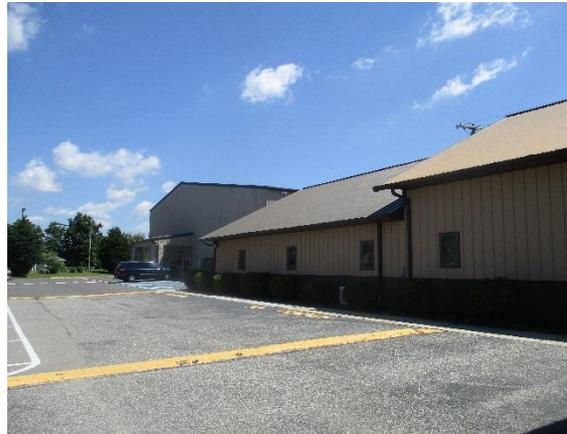
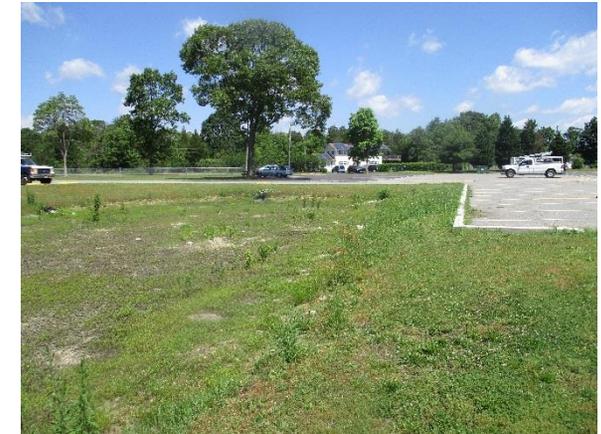
CUMBERLAND COUNTY CHURCH

Stormwater is currently directed to an existing detention basin. Rain gardens adjacent to the building can capture, treat, and infiltrate roof runoff. A water harvesting system such as a cistern can collect rainfall from rooftops as well and be put to other use. A preliminary soil assessment suggests that the soils have suitable drainage characteristics for green infrastructure.

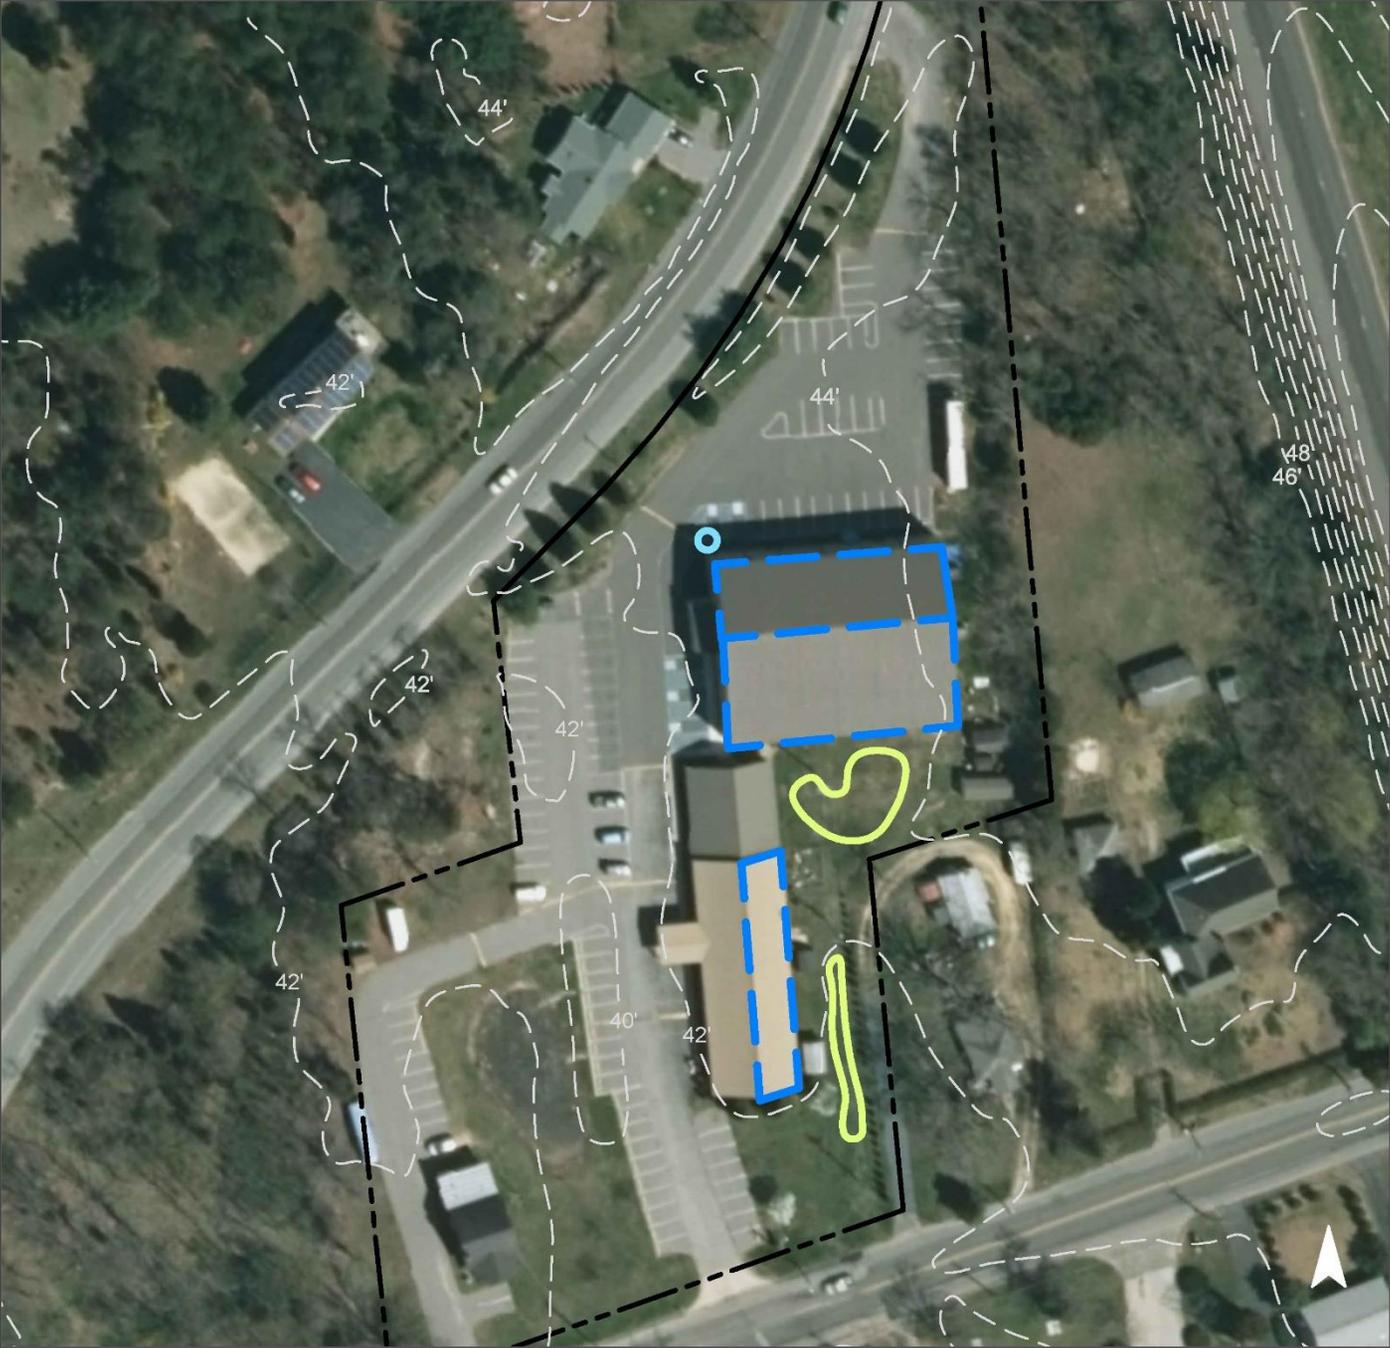
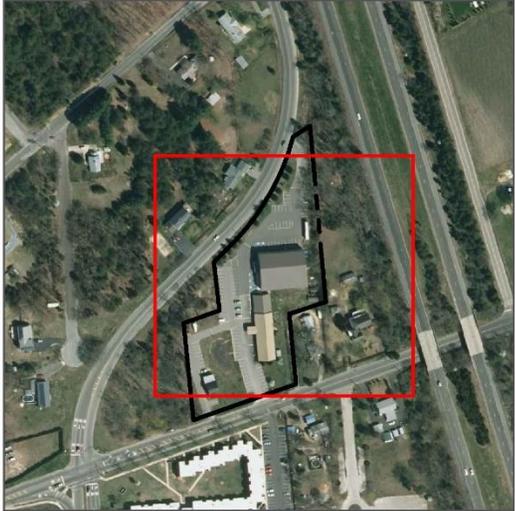
Cumberland County Church

Recommended Green Infrastructure Practices	Recharge Potential (Mgal/yr)	TSS Removal Potential (lbs/yr)	Maximum Volume Reduction Potential (gal/storm)	Peak Discharge Reduction Potential (cu. ft./second)	Estimated Size (sq. ft.)	Estimated Cost
Bioretention systems	0.247	41	18,722	0.70	2,370	\$11,850
Rainwater harvesting	0.119	20	9,043	0.34	3,570 (gal.)	\$7,140

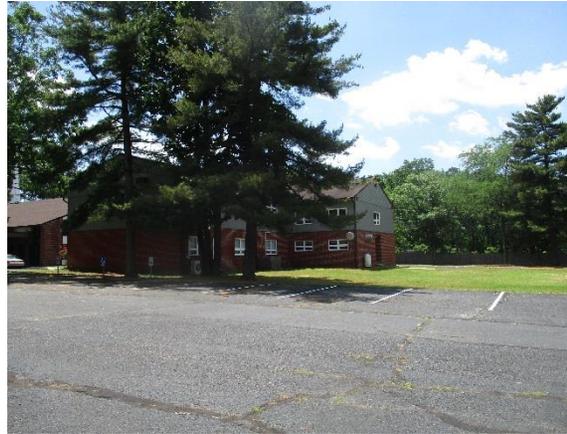
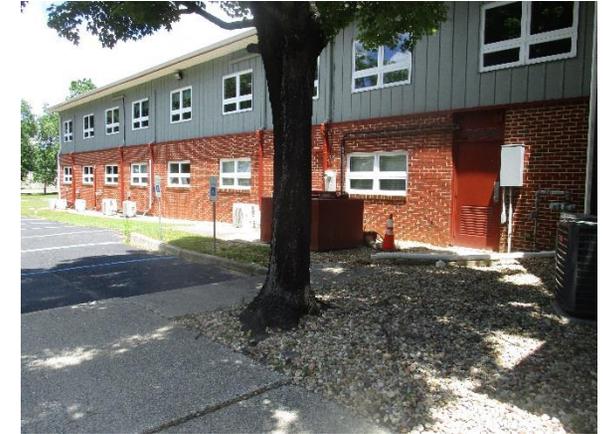
THE FIRST ASSEMBLY OF GOD

Parking spots in the north section of the parking lot can be replaced with porous asphalt to capture and infiltrate stormwater. A rain garden adjacent to the building can capture, treat, and infiltrate roof runoff. Planter boxes and rainwater harvesting systems can collect additional runoff and beneficially reuse it. A preliminary soil assessment suggests that the soils have suitable drainage characteristics for green infrastructure.

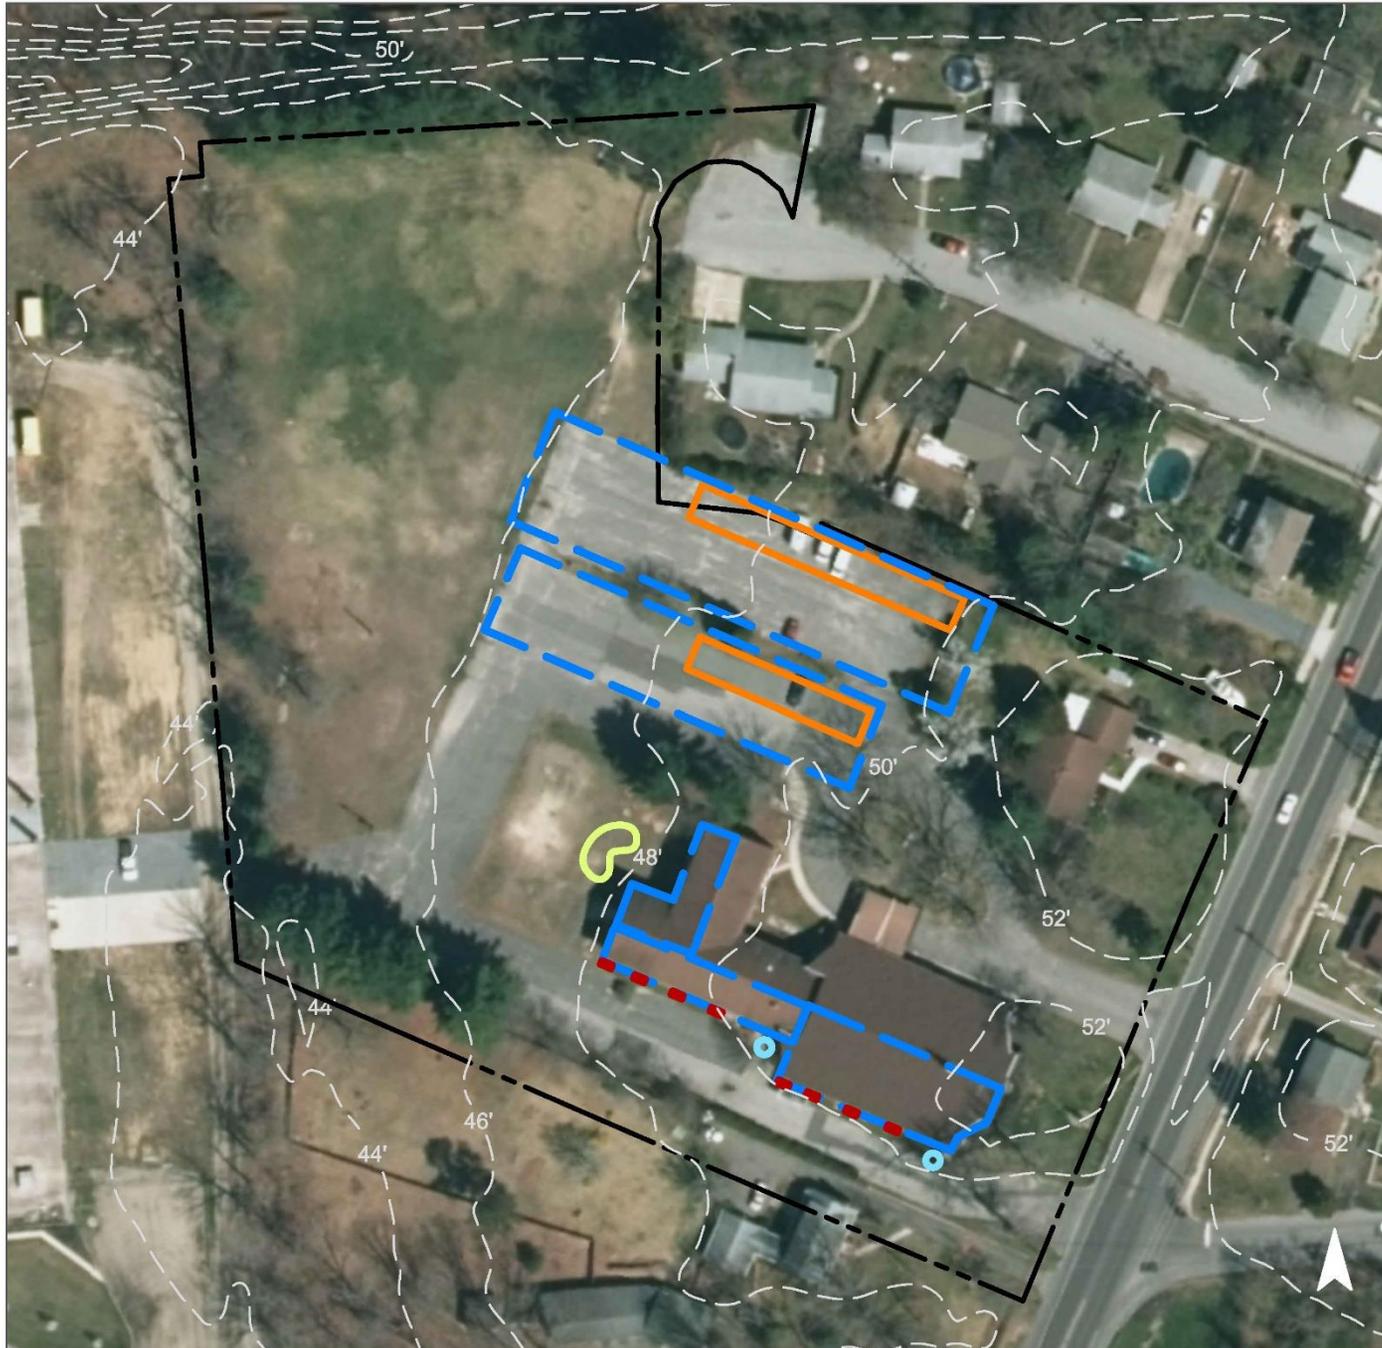
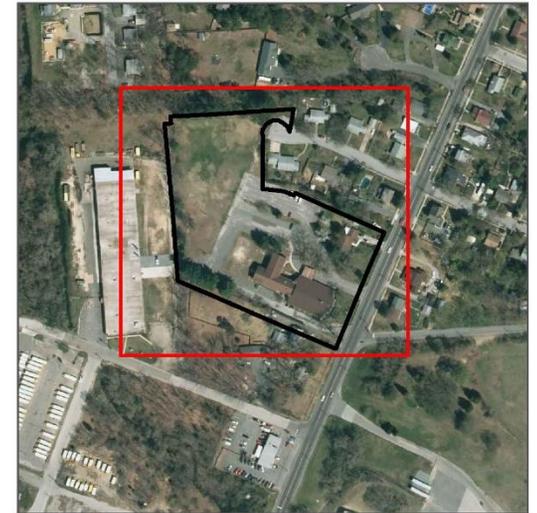
First Assembly of God

Recommended Green Infrastructure Practices	Recharge Potential (Mgal/yr)	TSS Removal Potential (lbs/yr)	Maximum Volume Reduction Potential (gal/storm)	Peak Discharge Reduction Potential (cu. ft./second)	Estimated Size (sq. ft.)	Estimated Cost
Bioretention system	0.046	8	3,523	0.13	445	\$2,225
Pervious pavement	0.649	109	49,181	1.85	4,450	\$111,250
Planter boxes	0.044	7	3,359	0.13	96	\$96,000
Rainwater harvesting	0.126	21	9,515	0.36	3,755 (gal.)	\$7,510

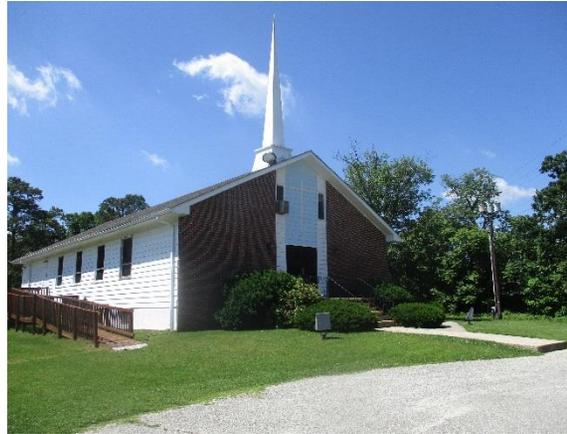
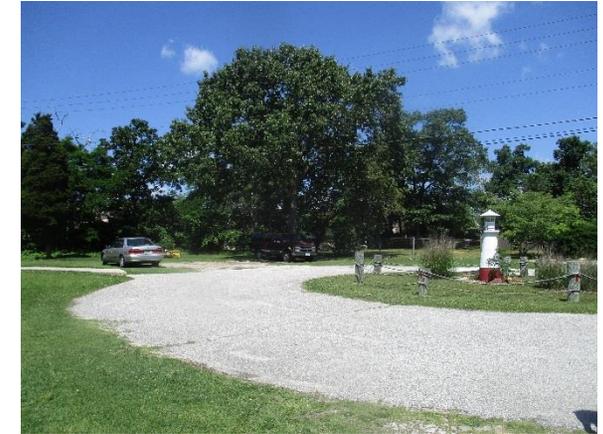
Parking spots to the north of the parking lot can be replaced with porous asphalt to capture and infiltrate stormwater. A rain garden in the middle of the parking circle north of the building can capture, treat, and infiltrate roof runoff. A preliminary soil assessment suggests that the soils have suitable drainage characteristics for green infrastructure.

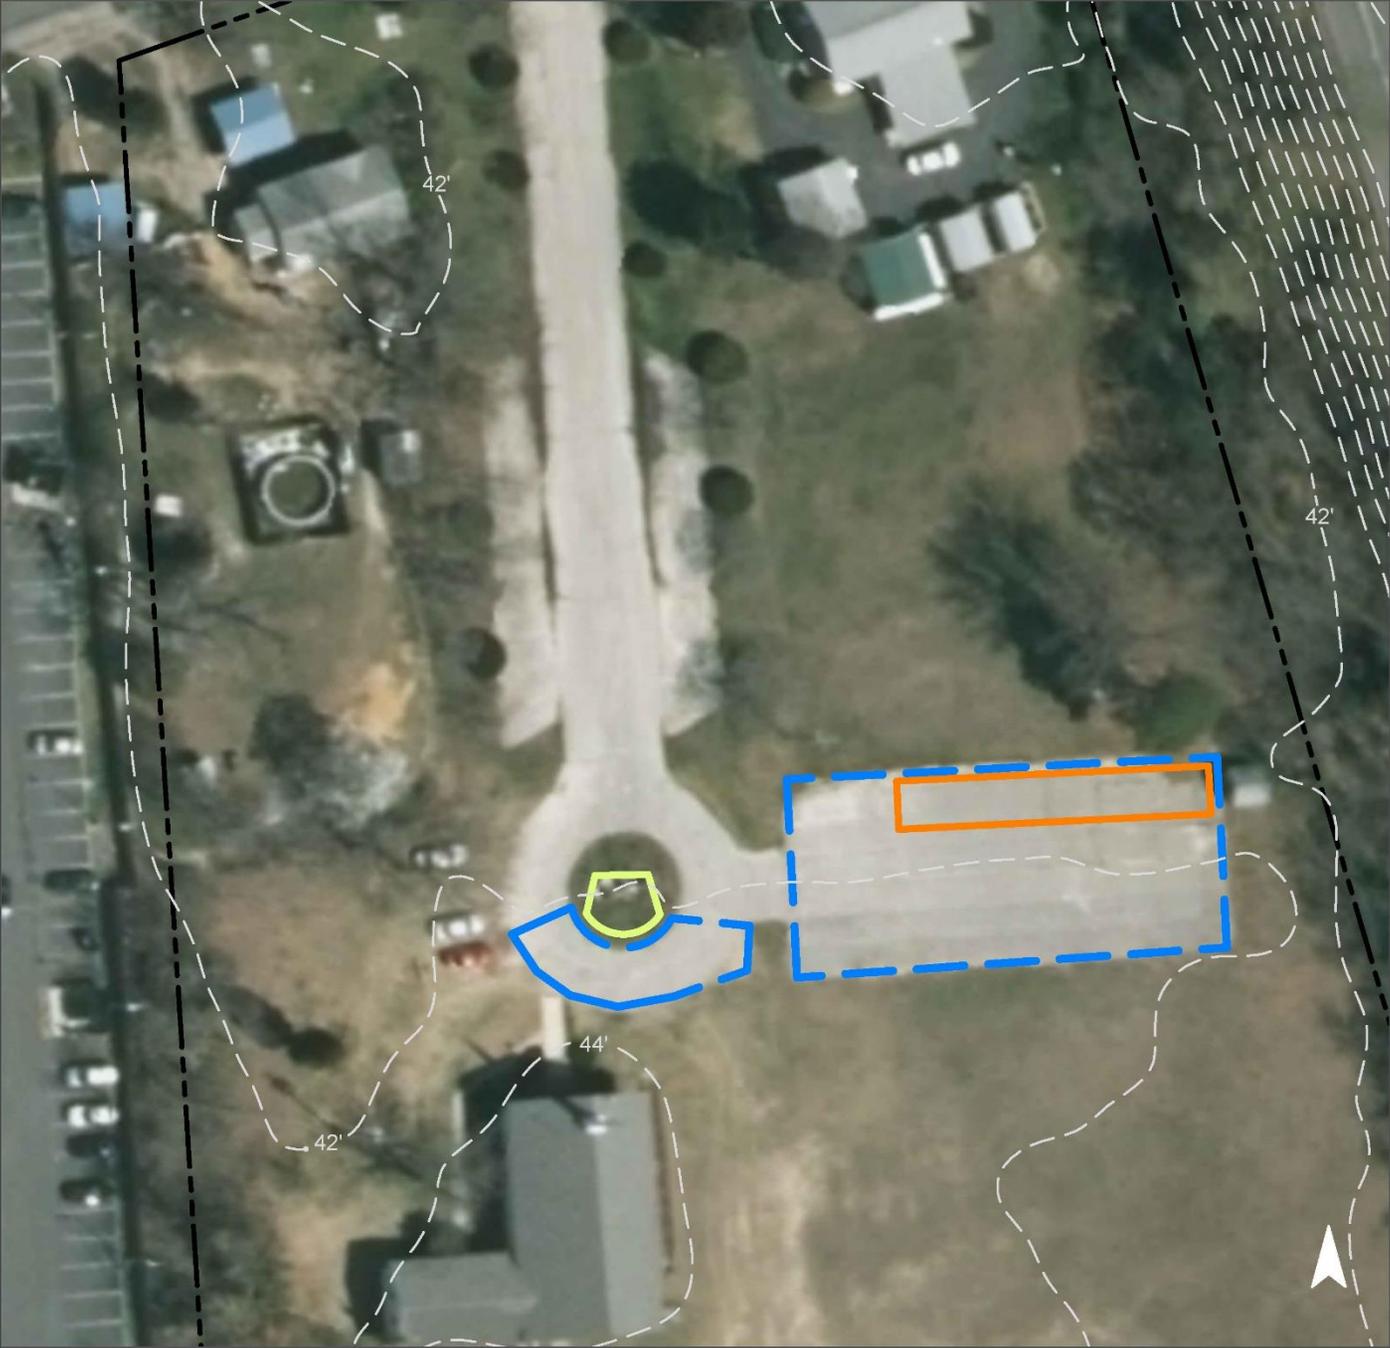
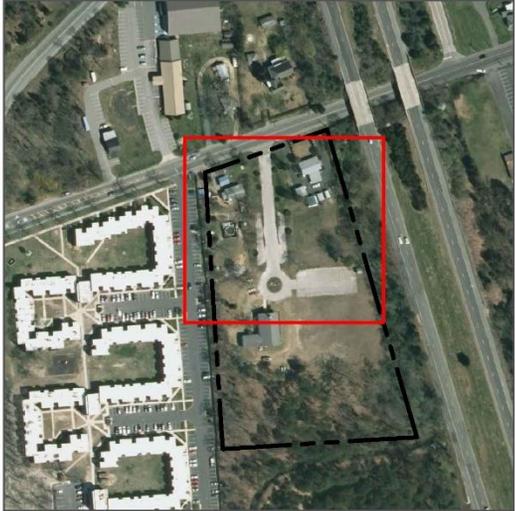
**The Lighthouse
Church of God**

Recommended Green Infrastructure Practices	Recharge Potential (Mgal/yr)	TSS Removal Potential (lbs/yr)	Maximum Volume Reduction Potential (gal/storm)	Peak Discharge Reduction Potential (cu. ft./second)	Estimated Size (sq. ft.)	Estimated Cost
Bioretention system	0.036	6	2,745	0.10	350	\$1,750
Pervious pavement	0.217	36	16,419	0.62	1,485	\$37,125

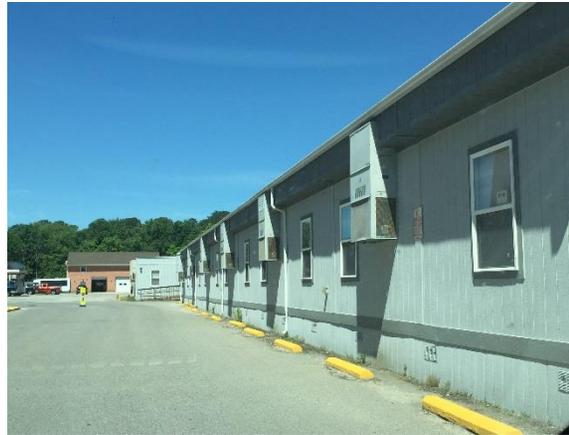
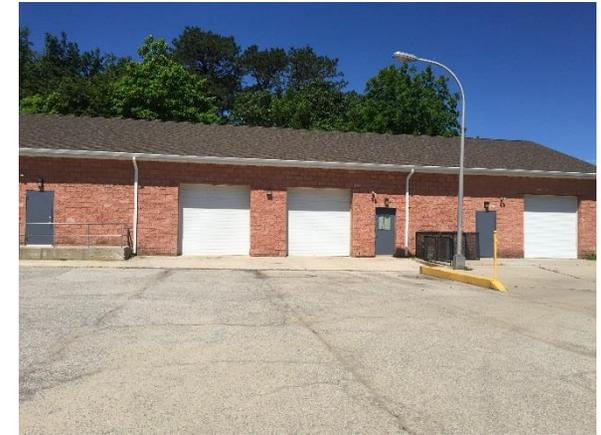
Parking spots can be replaced with porous asphalt to capture and infiltrate stormwater. Rain gardens at the entrance and near the sports fields can capture, treat, and infiltrate roof runoff. Planter boxes can collect rain water from the roofs and beneficially reuse it. A preliminary soil assessment suggests that the soils have suitable drainage characteristics for green infrastructure.

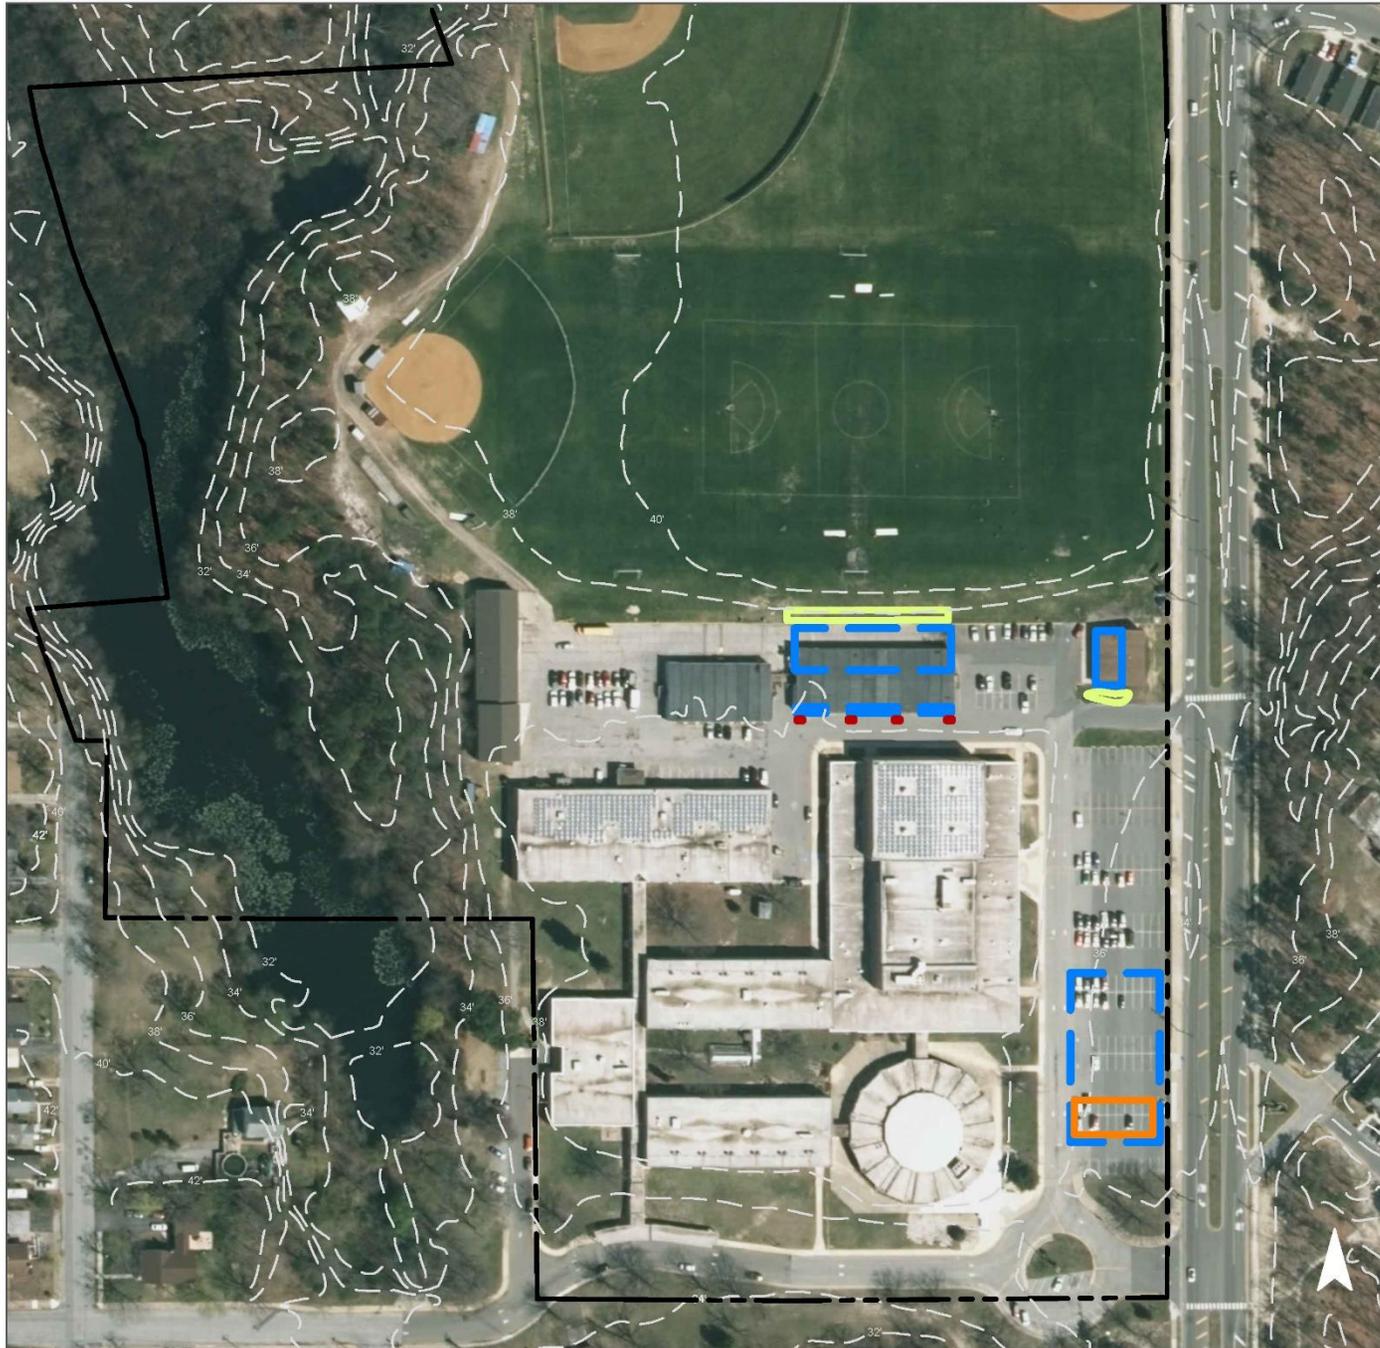
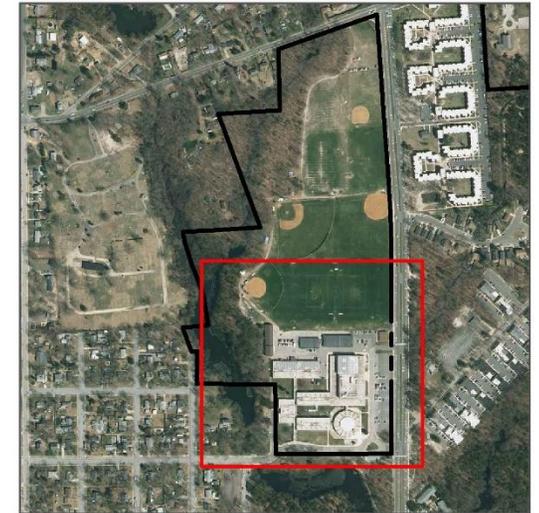
Millville Senior High School

Recommended Green Infrastructure Practices	Recharge Potential (Mgal/yr)	TSS Removal Potential (lbs/yr)	Maximum Volume Reduction Potential (gal/storm)	Peak Discharge Reduction Potential (cu. ft./second)	Estimated Size (sq. ft.)	Estimated Cost
Bioretention systems	0.227	38	17,182	0.64	2,175	\$10,875
Pervious pavement	0.433	72	32,777	1.23	2,965	\$74,125
Planter boxes	0.022	4	1,676	0.06	48	\$48,000

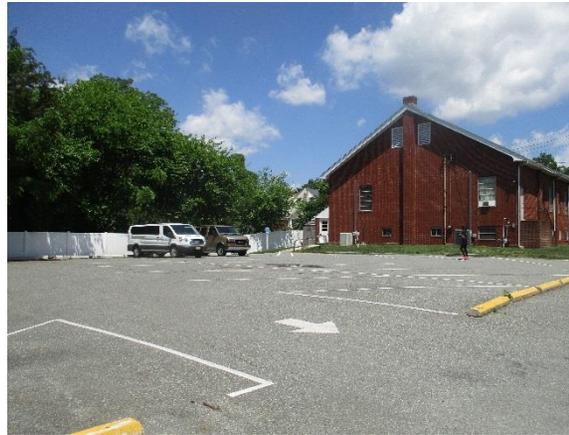
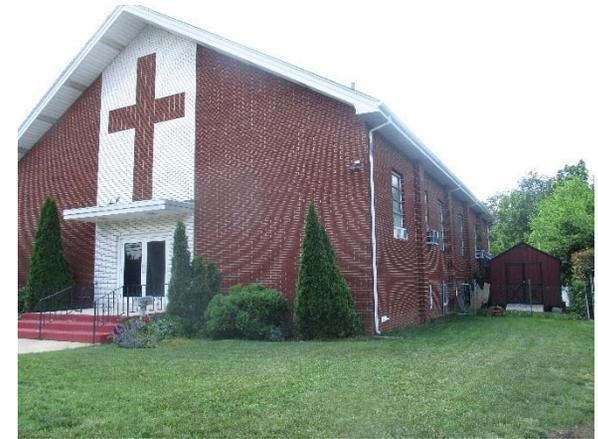
Parking spots in the western part of the building can be replaced with porous asphalt to capture and infiltrate stormwater. A rainwater harvesting system such as a cistern can collect rainwater from the roof. A preliminary soil assessment suggests that more soil testing would be required before determining the soil's suitability for green infrastructure.

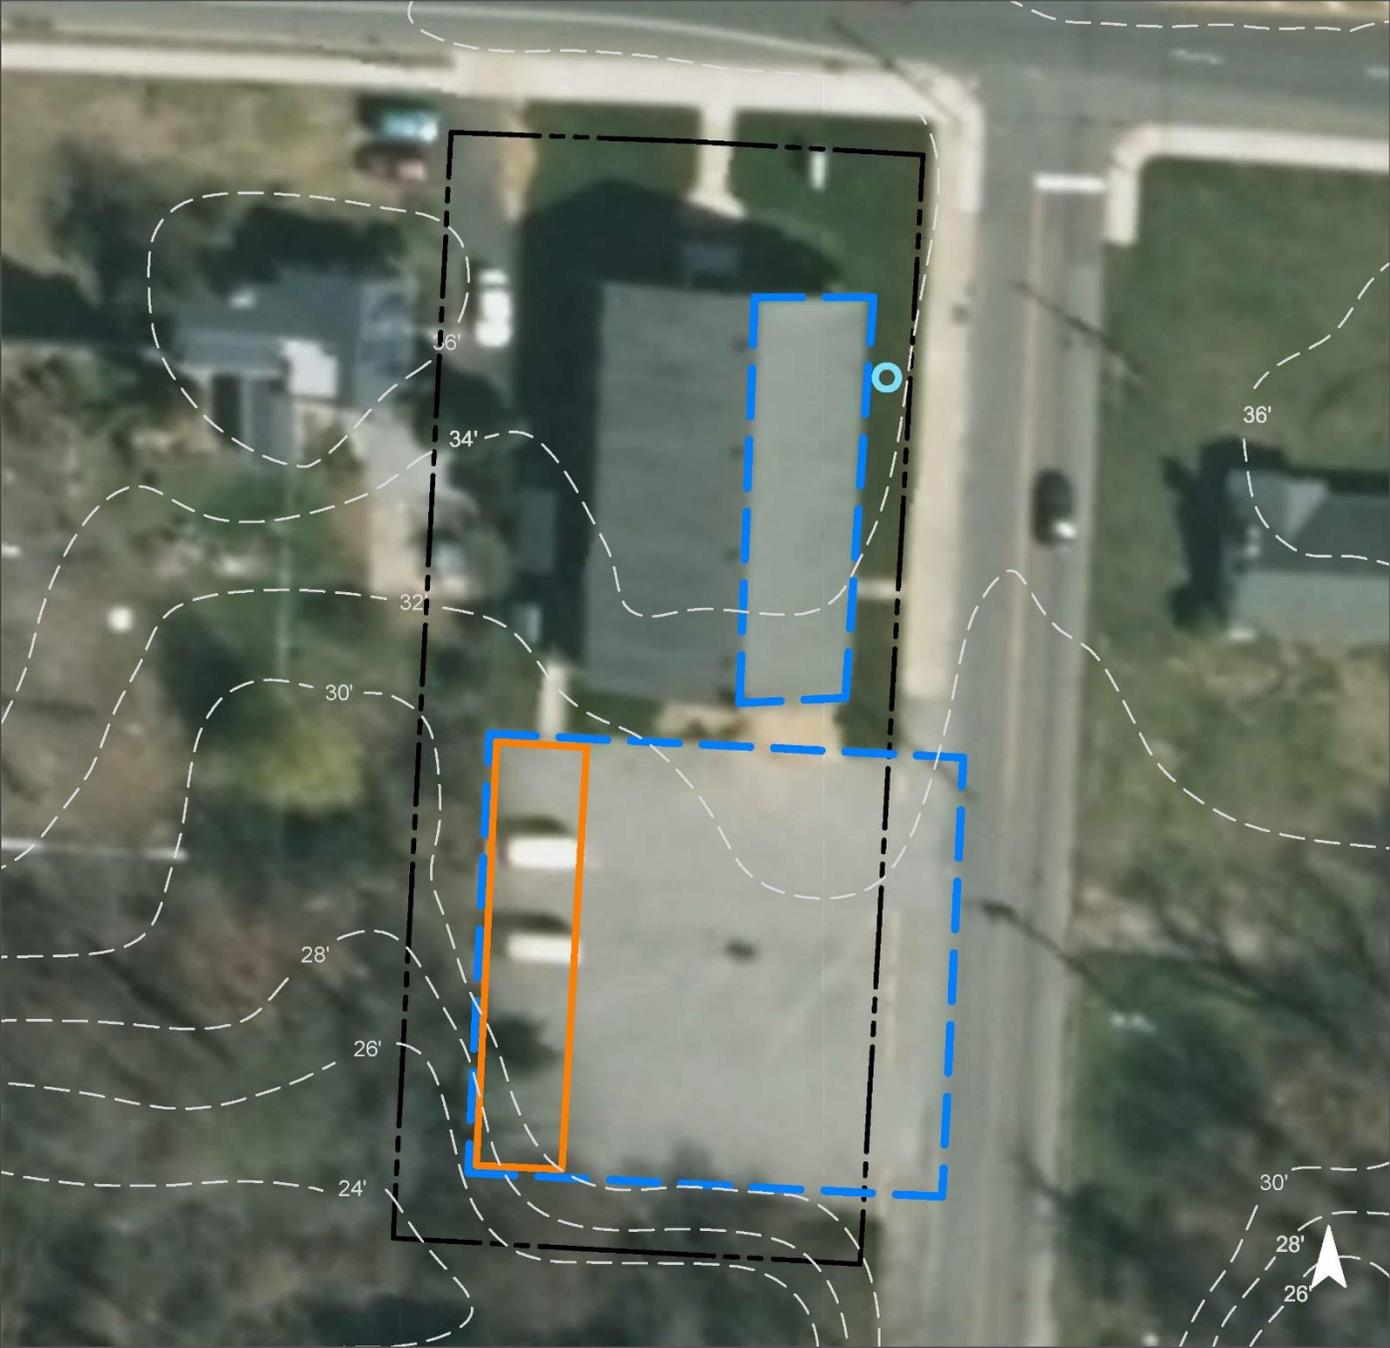
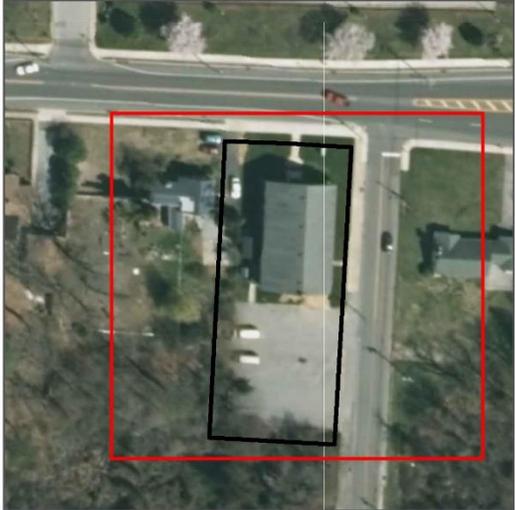
Miracle Cogie Temple

Recommended Green Infrastructure Practices	Recharge Potential (Mgal/yr)	TSS Removal Potential (lbs/yr)	Maximum Volume Reduction Potential (gal/storm)	Peak Discharge Reduction Potential (cu. ft./second)	Estimated Size (sq. ft.)	Estimated Cost
Pervious pavement	0.241	40	18,296	0.69	1,655	\$41,375
Rainwater harvesting	0.052	9	3,912	0.15	1,500 (gal)	\$3,000

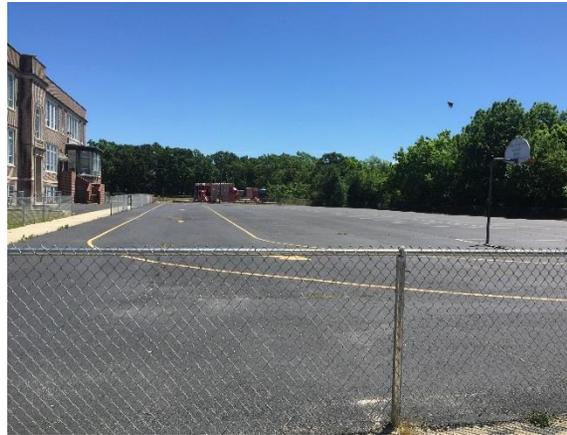
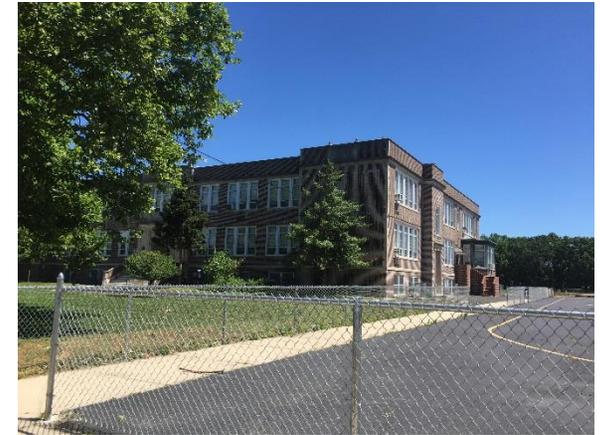
Parking spots in the north parking lot can be replaced with porous asphalt to capture and infiltrate stormwater. A preliminary soil assessment suggests that more soil testing would be required before determining the soil's suitability for green infrastructure.

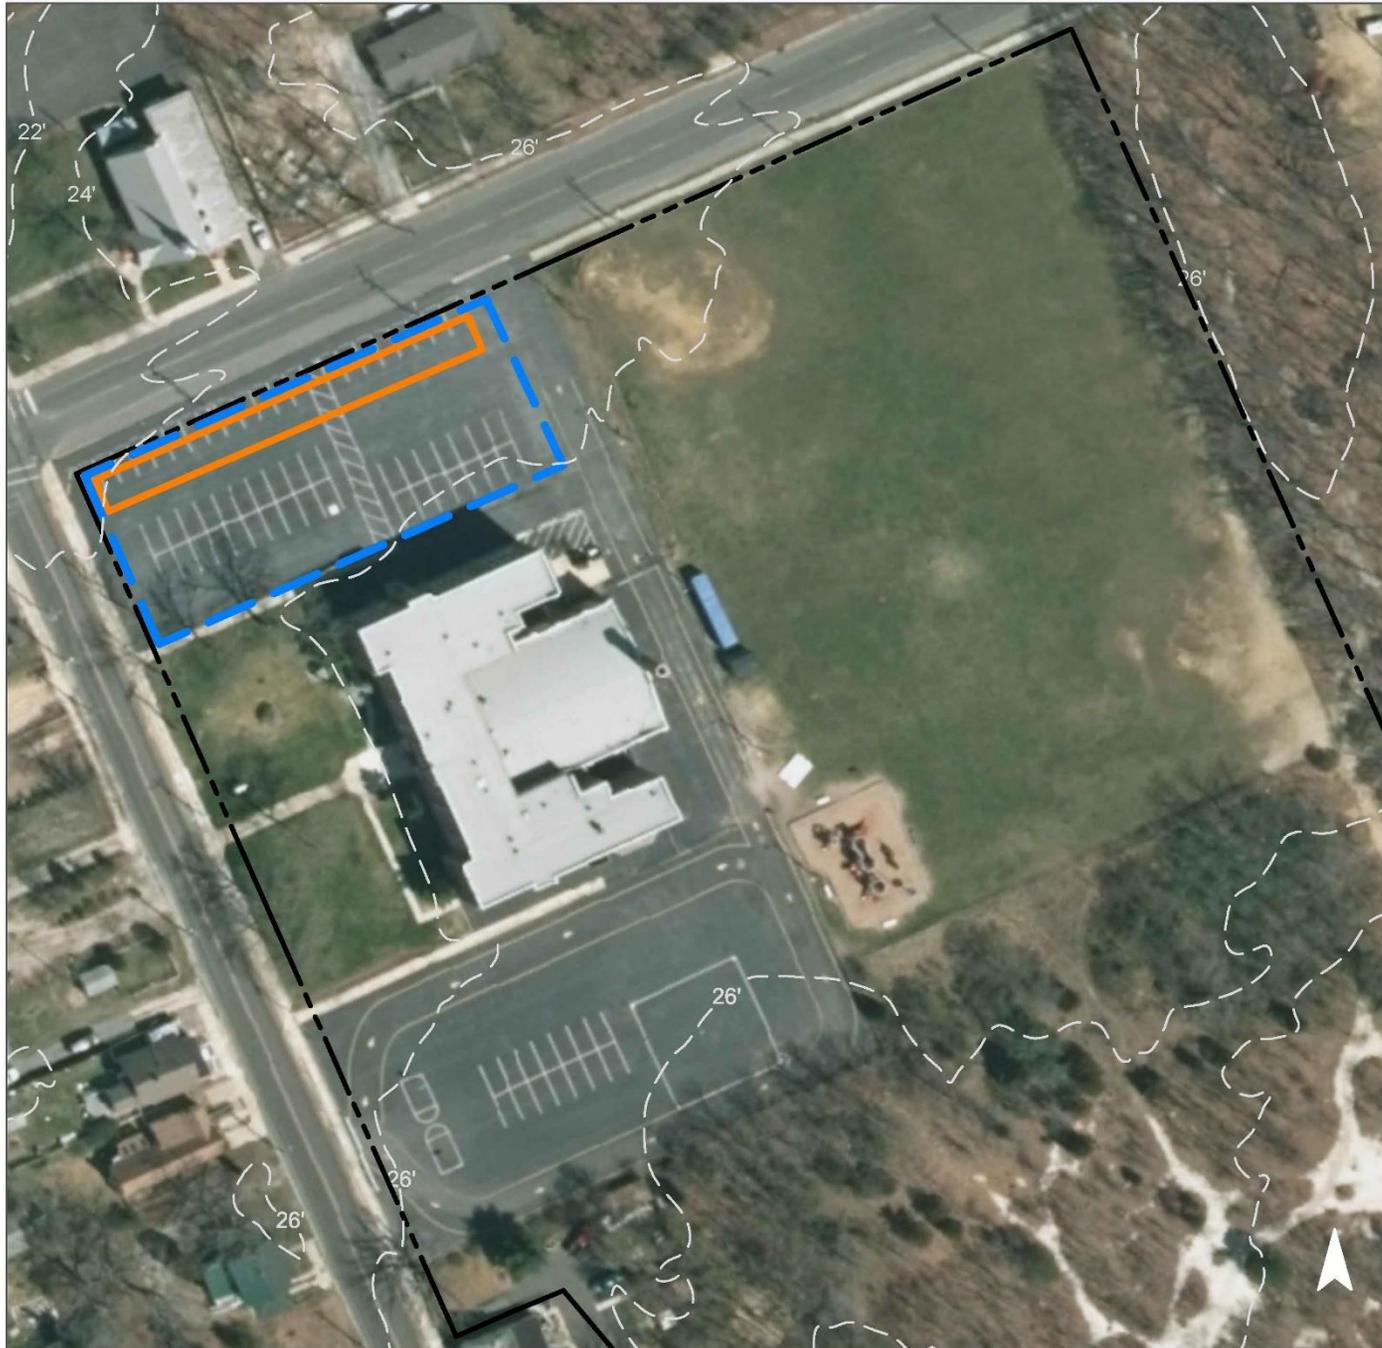
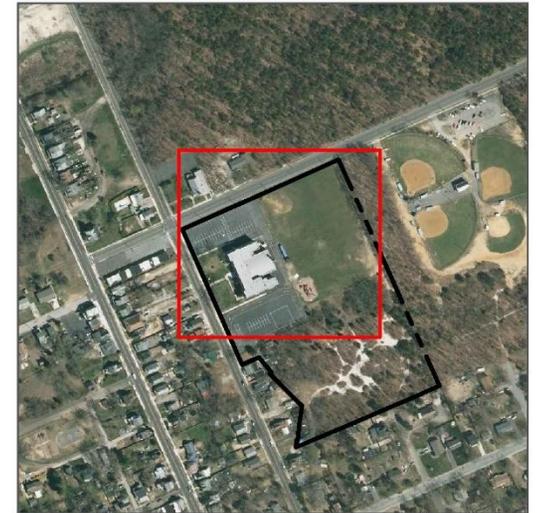
R.M. Bacon High School

Recommended Green Infrastructure Practices	Recharge Potential (Mgal/yr)	TSS Removal Potential (lbs/yr)	Maximum Volume Reduction Potential (gal/storm)	Peak Discharge Reduction Potential (cu. ft./second)	Estimated Size (sq. ft.)	Estimated Cost
Pervious pavement	0.578	97	43,773	1.64	3,960	\$99,000
