**Impervious Cover Reduction Action Plan
for
Millville City, Cumberland County, New Jersey**

*Prepared for Millville City by the
Rutgers Cooperative Extension Water Resources Program*

August 10, 2016

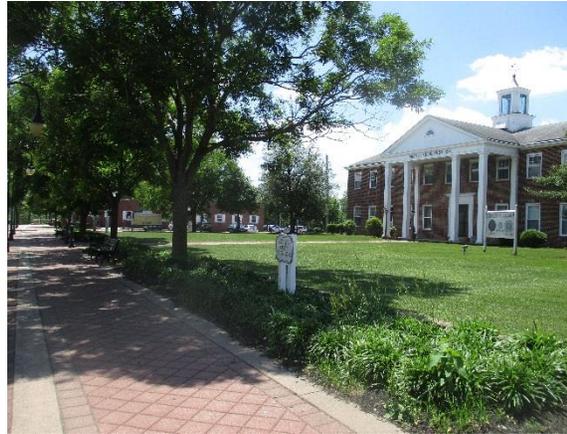
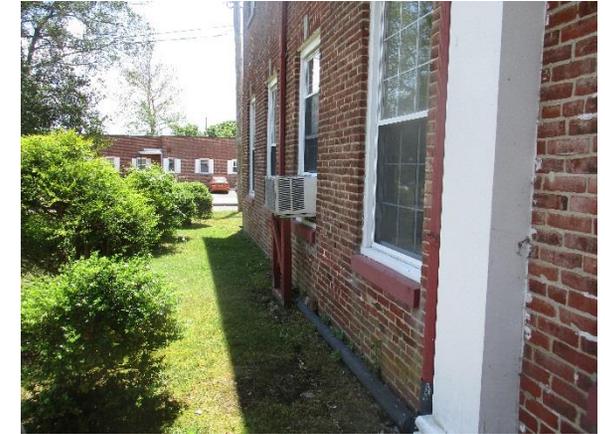
Parking spots west of the building can be replaced with porous asphalt to capture and infiltrate stormwater from the parking lot and roof. Rain gardens can be put in to the east of the building which will capture, treat, and infiltrate roof runoff. A preliminary soil assessment suggests that the soils have suitable drainage characteristics for green infrastructure.

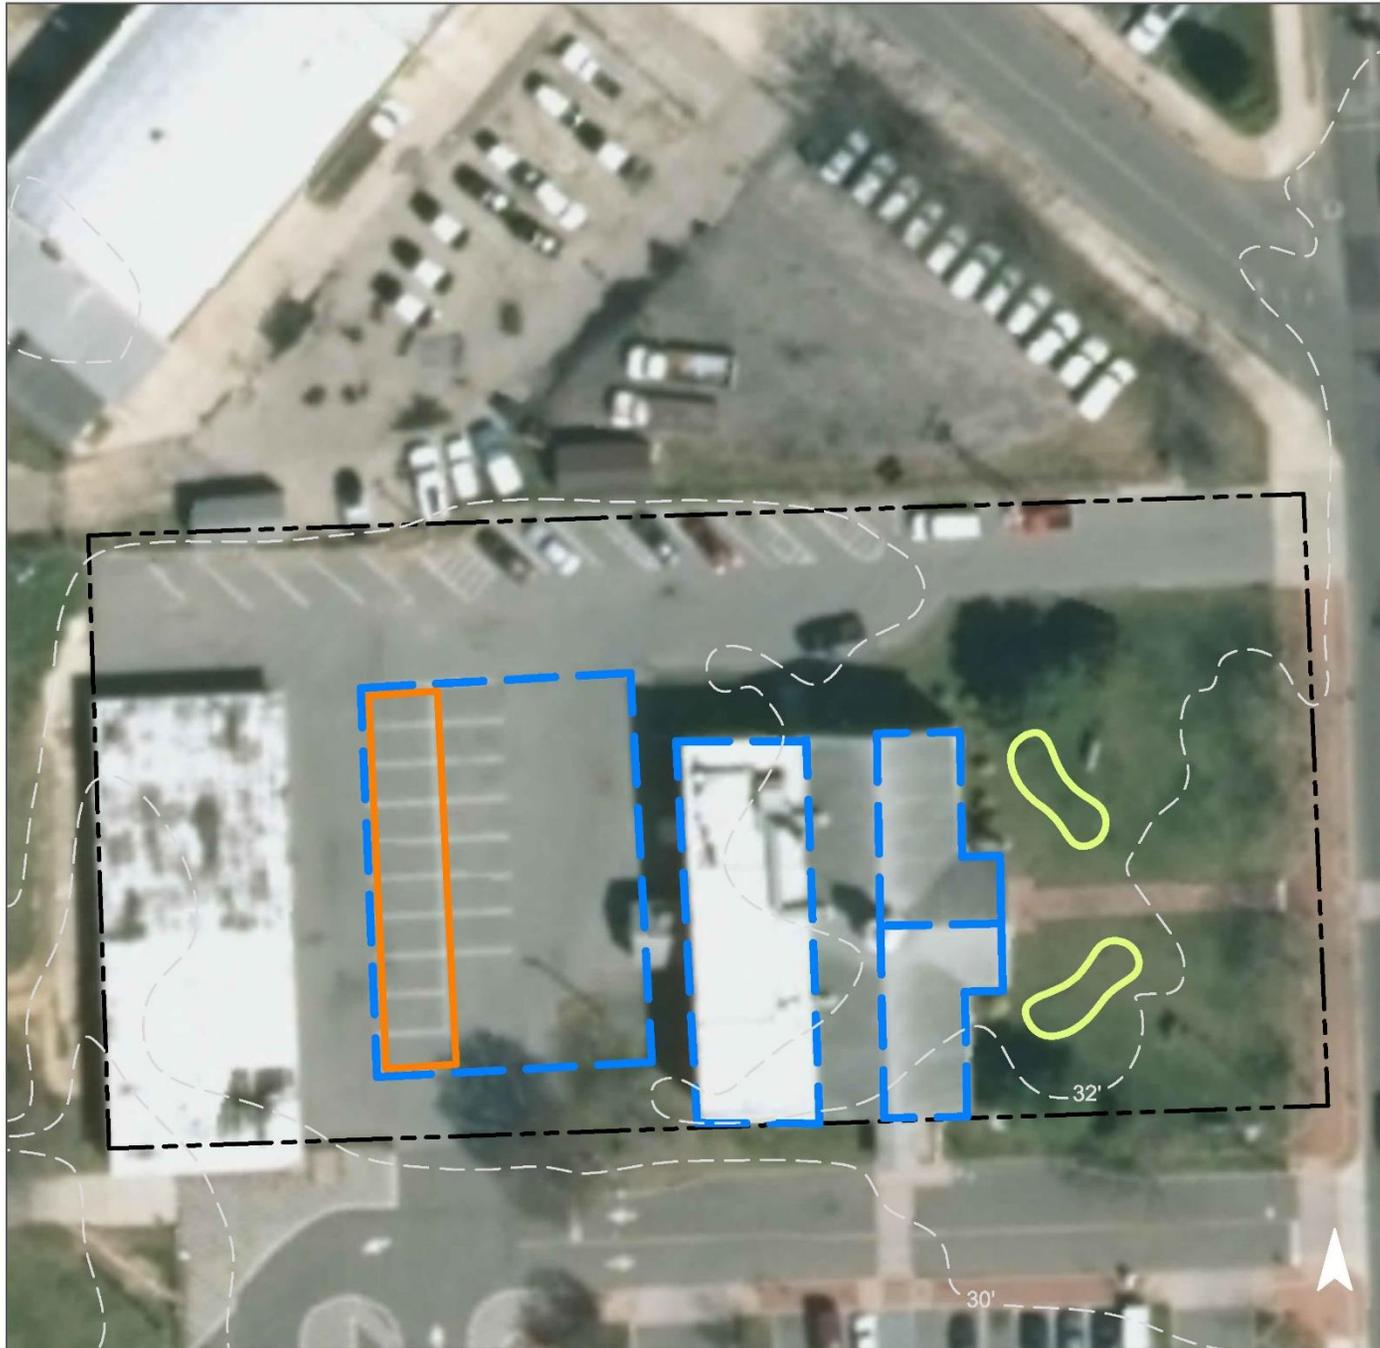
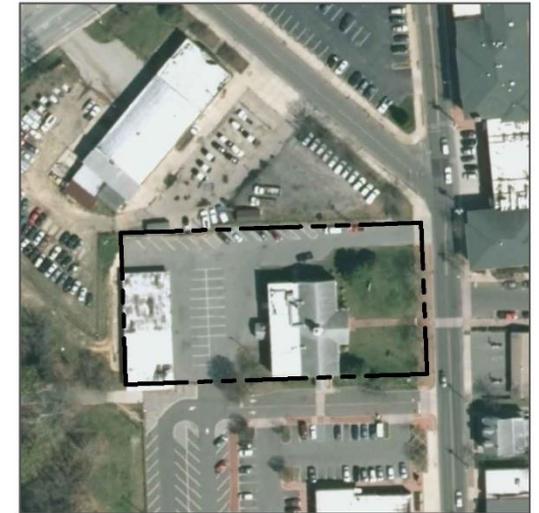
American Legion Nabb-Leslie Post 82

Recommended Green Infrastructure Practices	Recharge Potential (Mgal/yr)	TSS Removal Potential (lbs/yr)	Maximum Volume Reduction Potential (gal/storm)	Peak Discharge Reduction Potential (cu. ft./second)	Estimated Size (sq. ft.)	Estimated Cost
Bioretention systems	0.044	7	3,336	0.13	670	\$3,350
Pervious pavement	0.266	45	20,189	0.76	1,826	\$45,650

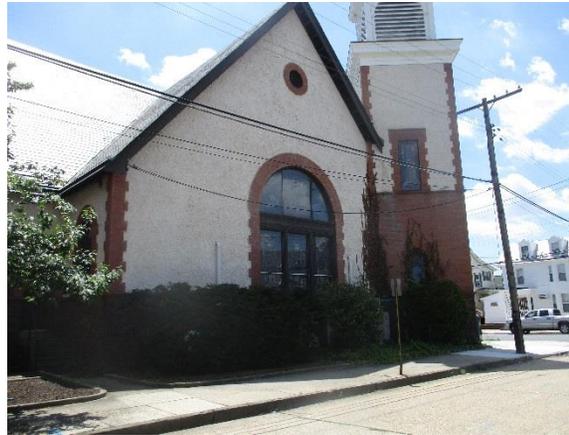
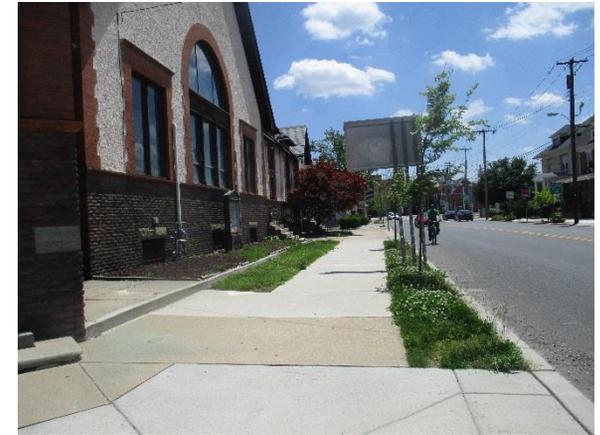
Pervious pavement such as pervious sidewalk can be implemented on the north side of the building which can capture, treat, and infiltrate roof runoff. A preliminary soil assessment suggests that the soils have suitable drainage characteristics for green infrastructure.

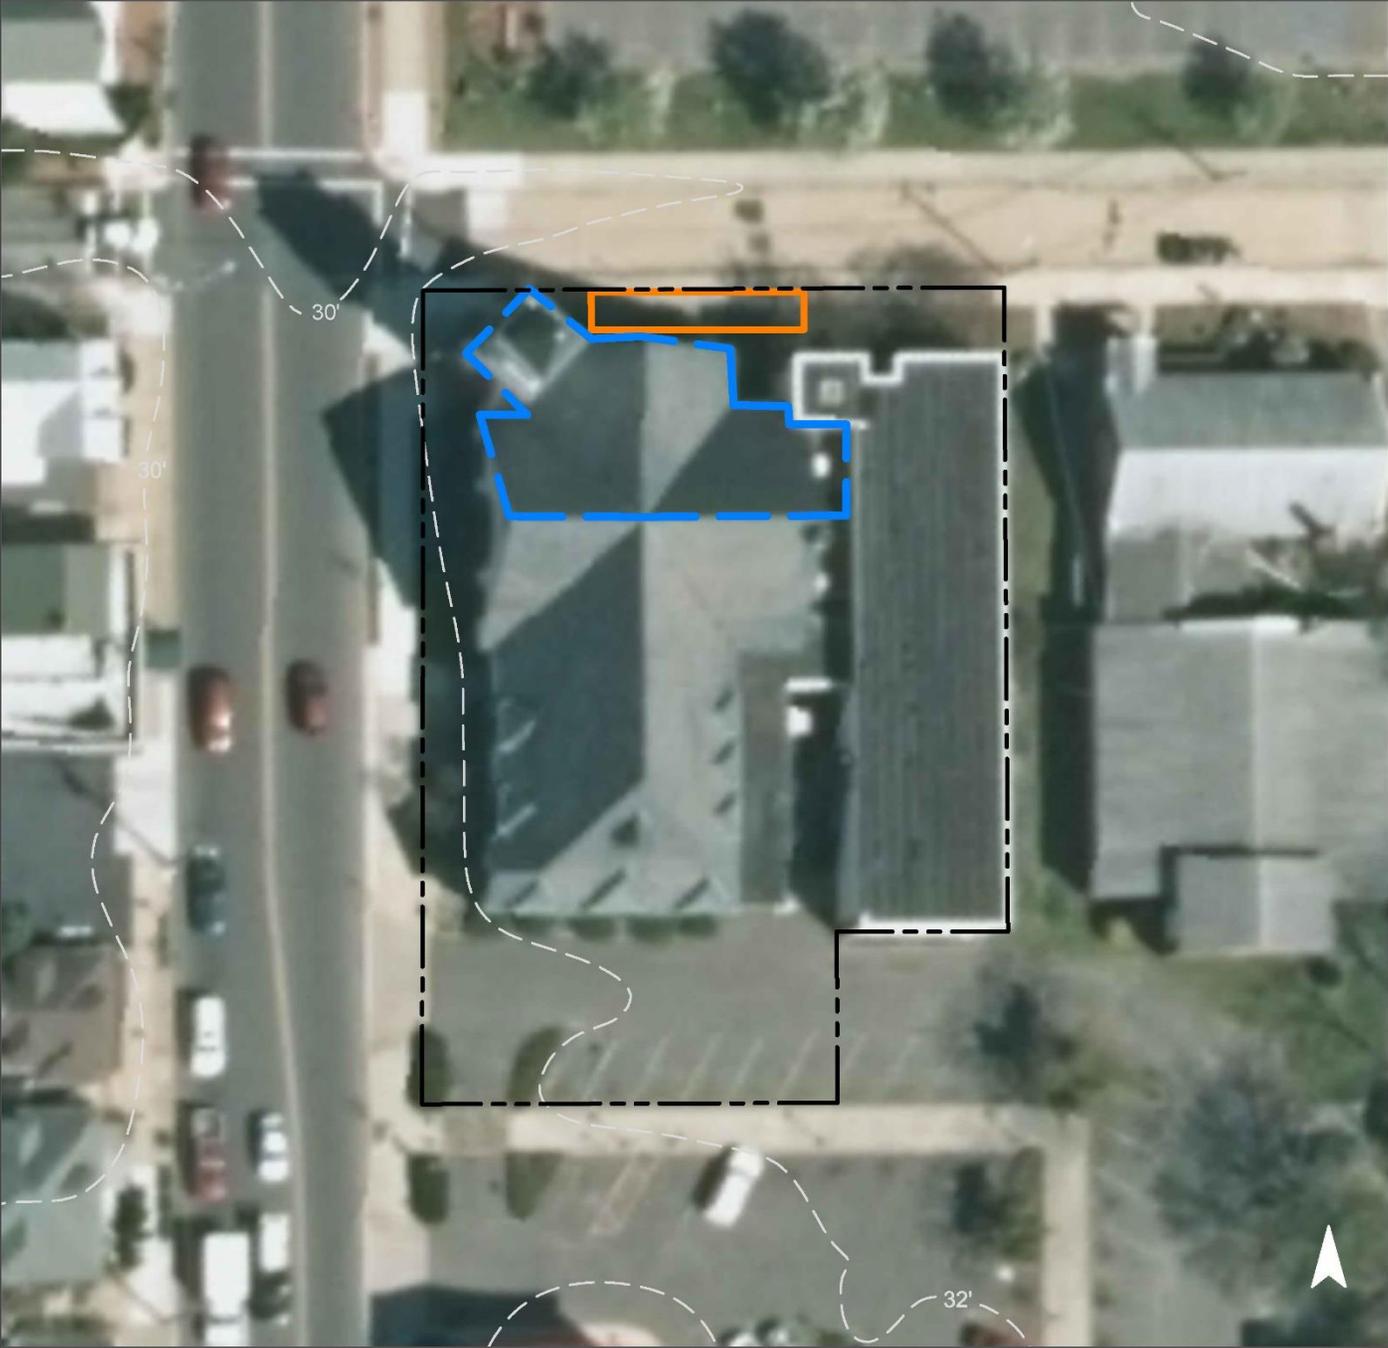
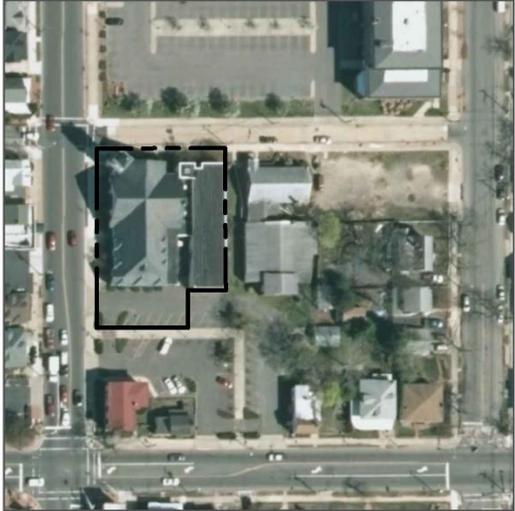
Central Baptist Church

Recommended Green Infrastructure Practices	Recharge Potential (Mgal/yr)	TSS Removal Potential (lbs/yr)	Maximum Volume Reduction Potential (gal/storm)	Peak Discharge Reduction Potential (cu. ft./second)	Estimated Size (sq. ft.)	Estimated Cost
Pervious pavement	0.064	11	4,877	0.18	440	\$11,000

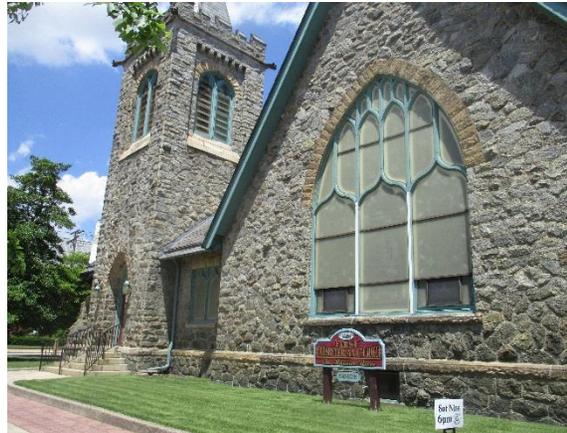
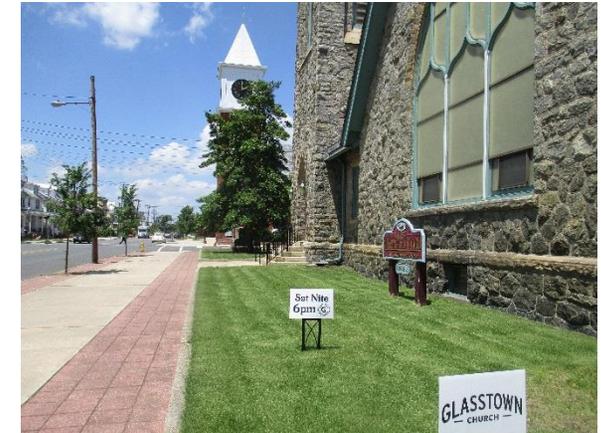
Parking spots east of the parking lot can be replaced with porous asphalt to capture and infiltrate stormwater. The sidewalk at the entrance of the church can be made porous to capture, treat, and infiltrate roof runoff. A preliminary soil assessment suggests that the soils have suitable drainage characteristics for green infrastructure.

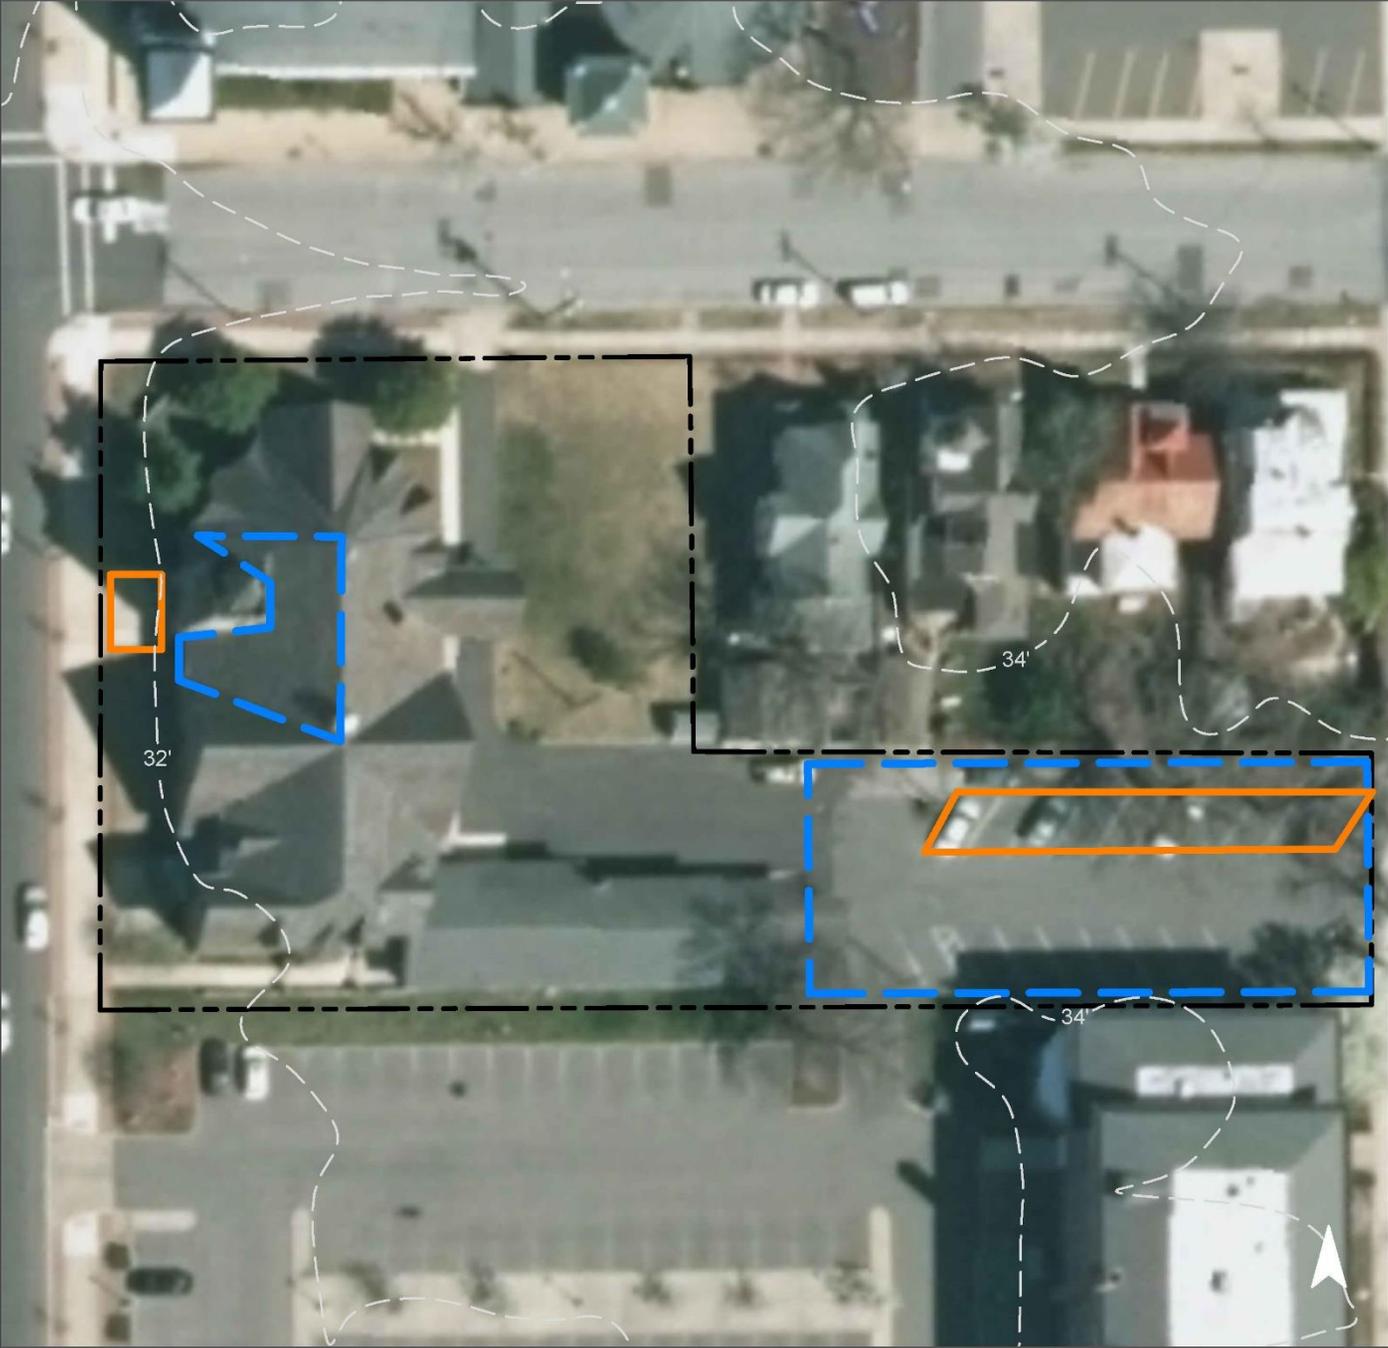
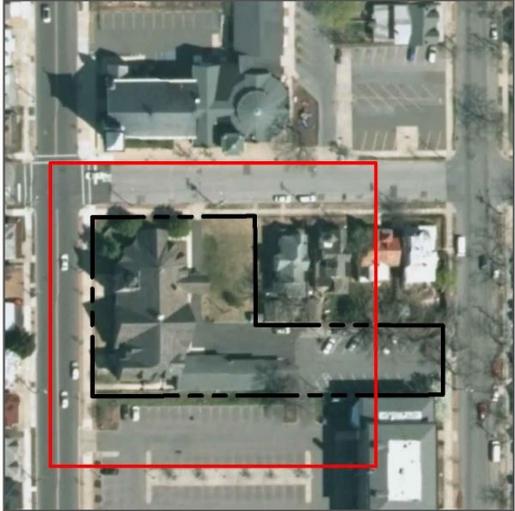
First Presbyterian Church

Recommended Green Infrastructure Practices	Recharge Potential (Mgal/yr)	TSS Removal Potential (lbs/yr)	Maximum Volume Reduction Potential (gal/storm)	Peak Discharge Reduction Potential (cu. ft./second)	Estimated Size (sq. ft.)	Estimated Cost
Pervious pavement	0.280	47	21,251	0.80	1,922	\$48,050

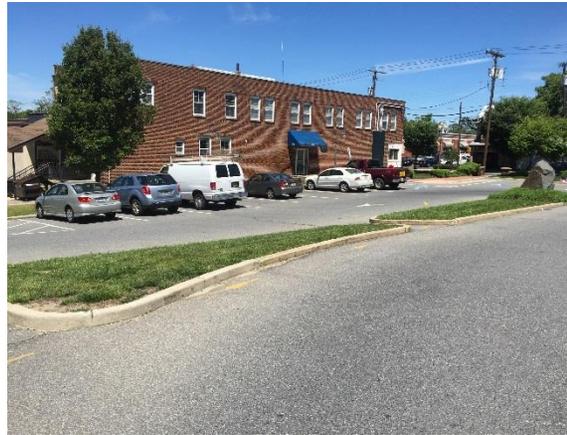
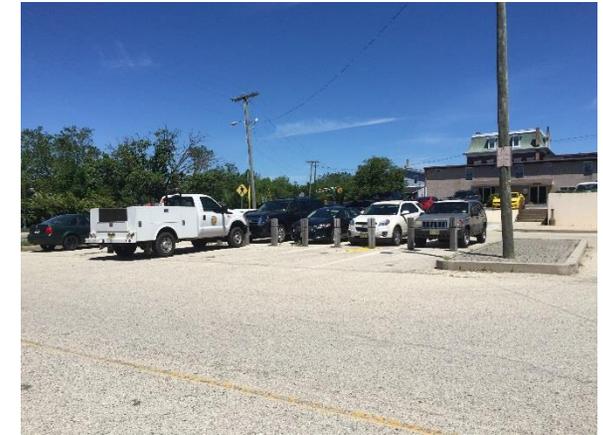
Stormwater is currently directed to an existing detention basin. Parking spots south of the building can be replaced with porous asphalt to capture and infiltrate stormwater. Rain gardens north of the building can capture, treat, and infiltrate road runoff. A preliminary soil assessment suggests that the soils have suitable drainage characteristics for green infrastructure.

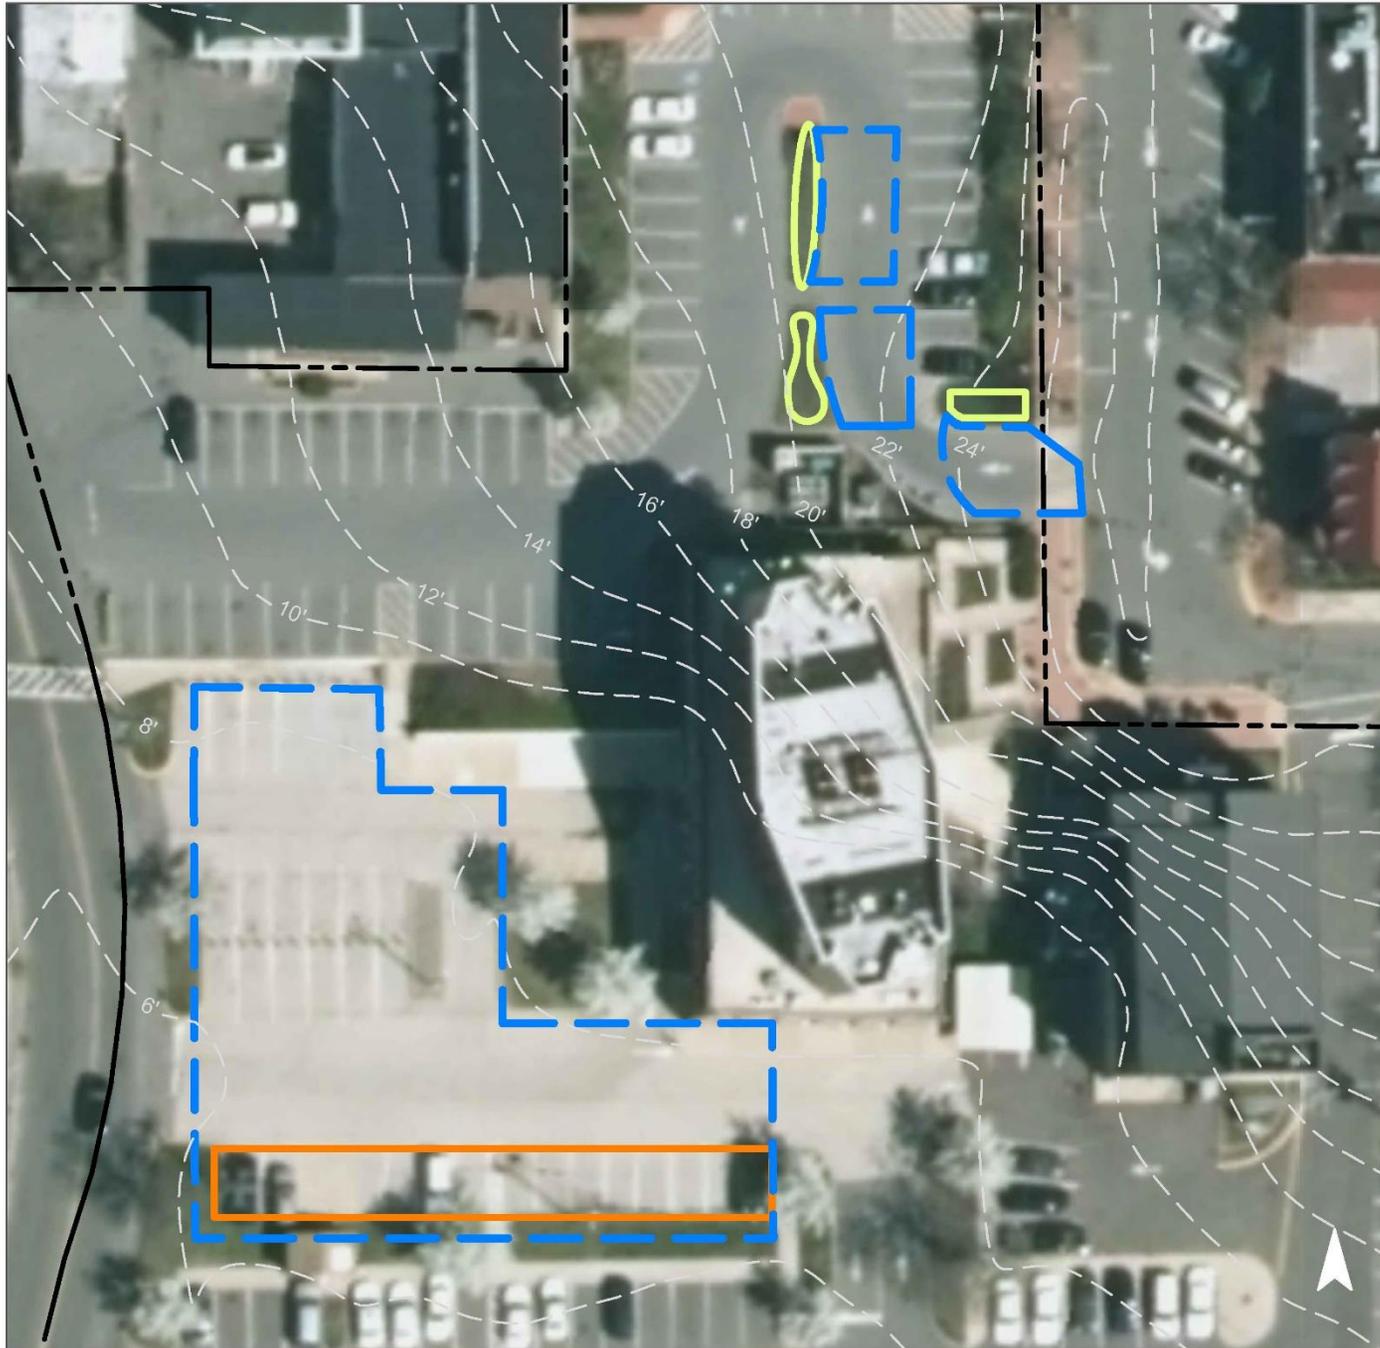
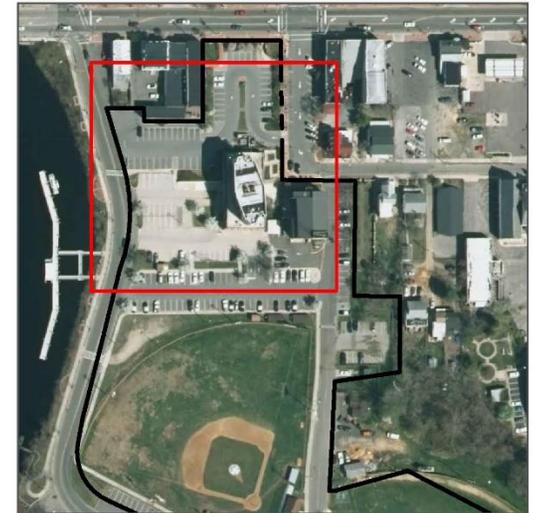
Millville City Hall and Police Department

Recommended Green Infrastructure Practices	Recharge Potential (Mgal/yr)	TSS Removal Potential (lbs/yr)	Maximum Volume Reduction Potential (gal/storm)	Peak Discharge Reduction Potential (cu. ft./second)	Estimated Size (sq. ft.)	Estimated Cost
Bioretention systems	0.056	9	15,947	0.16	530	\$2,650
Pervious pavement	0.384	64	29,075	1.09	2,630	\$65,750

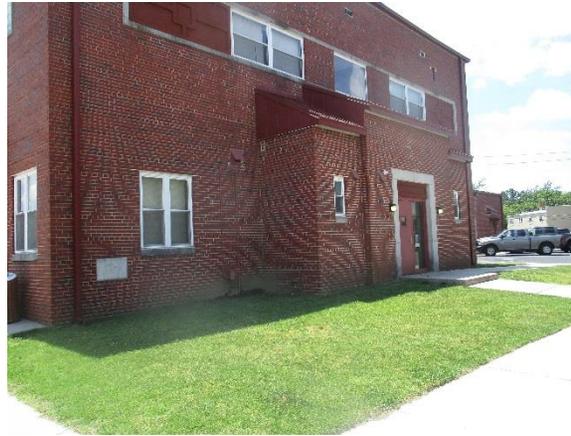
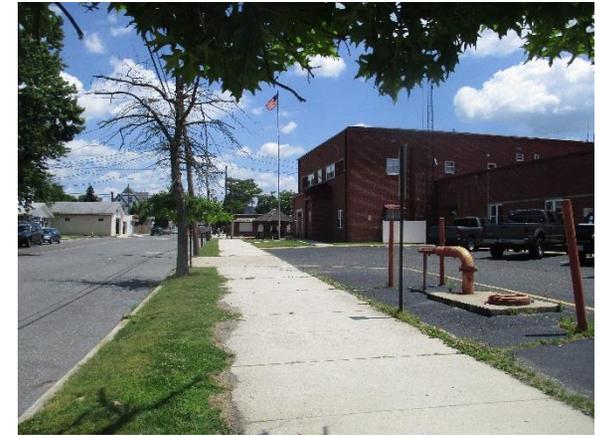
Parking spots west of the building can be replaced with porous asphalt to capture and infiltrate stormwater. A water harvesting system can be put in at the south end of the building to collect rainfall from the roof. A preliminary soil assessment suggests that the soils have suitable drainage characteristics for green infrastructure.

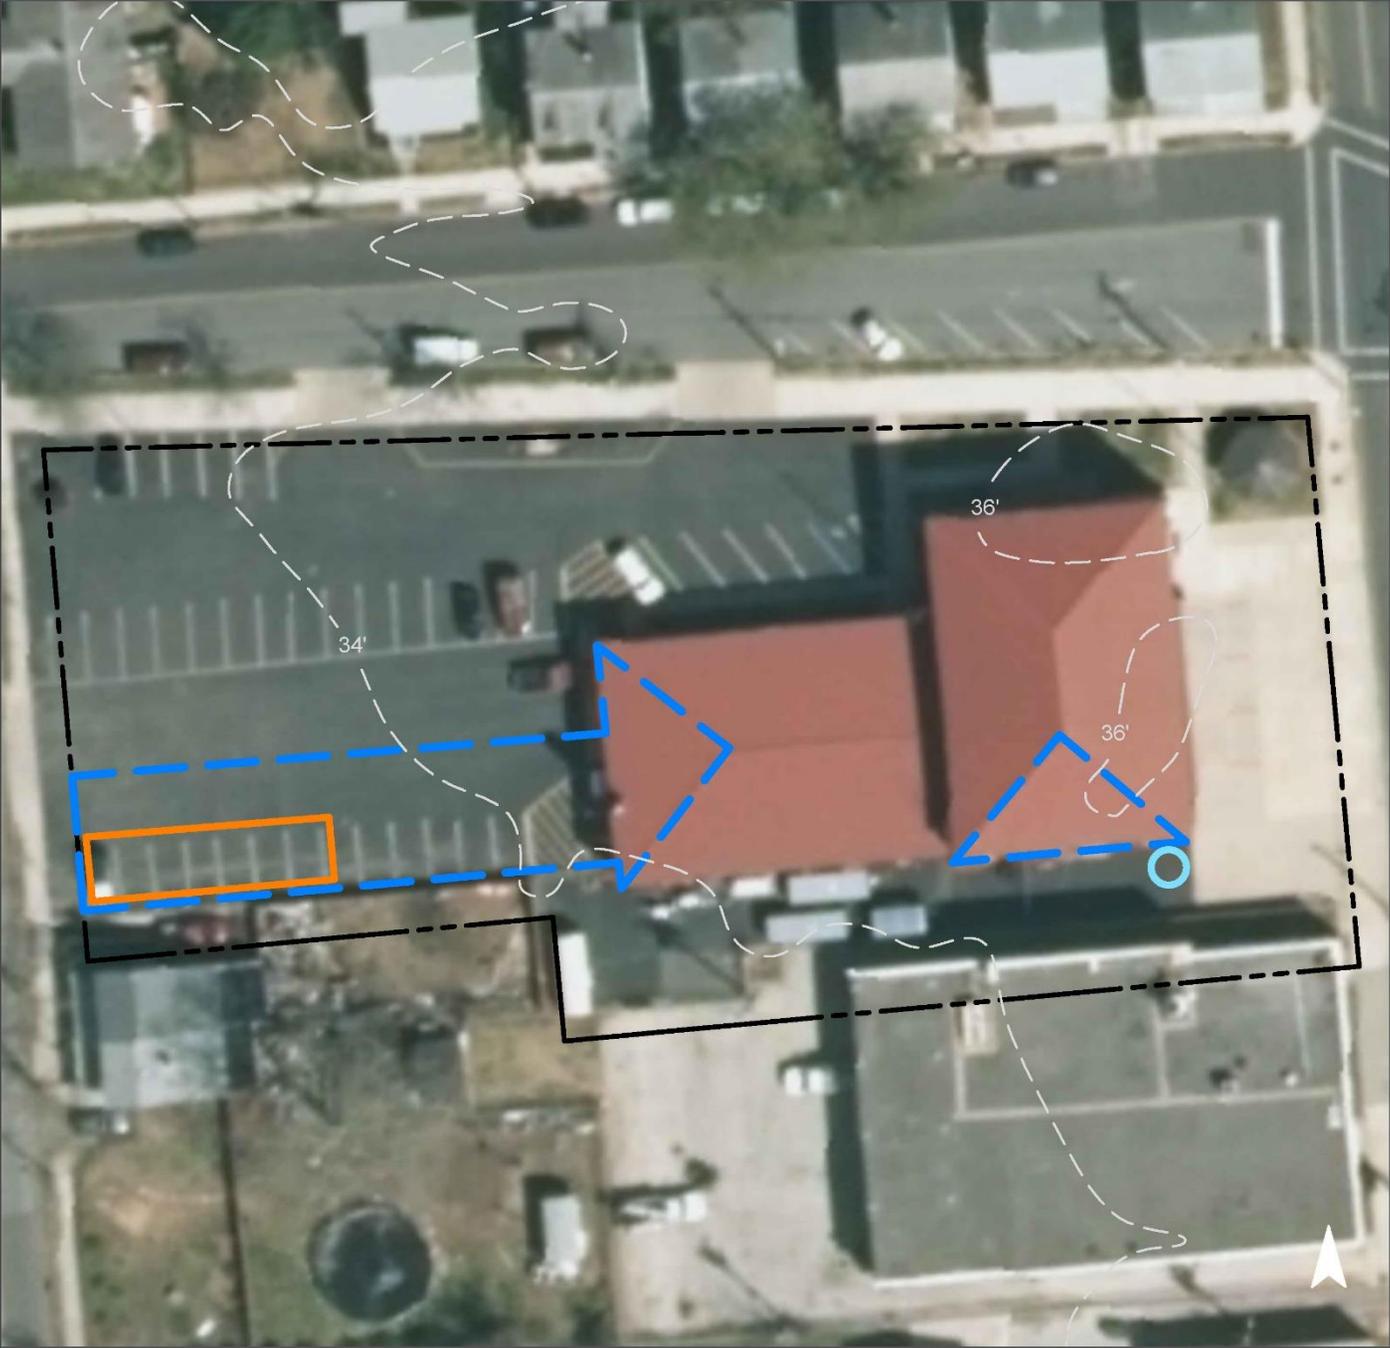
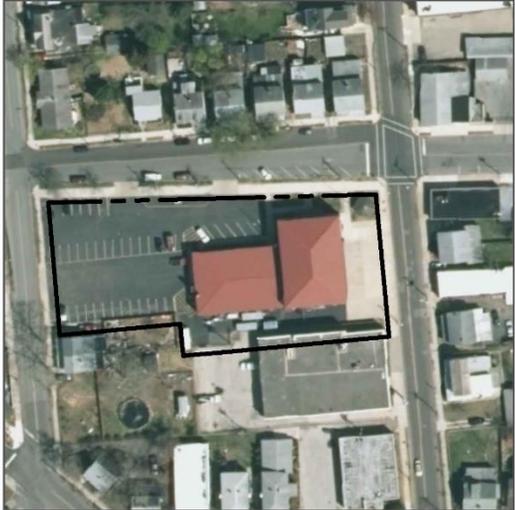
Millville Fire Department

Recommended Green Infrastructure Practices	Recharge Potential (Mgal/yr)	TSS Removal Potential (lbs/yr)	Maximum Volume Reduction Potential (gal/storm)	Peak Discharge Reduction Potential (cu. ft./second)	Estimated Size (sq. ft.)	Estimated Cost
Pervious pavement	0.153	26	11,601	0.44	1,050	\$26,250
Rainwater harvesting	0.024	4	1,855	0.07	732 (gal)	\$1,464

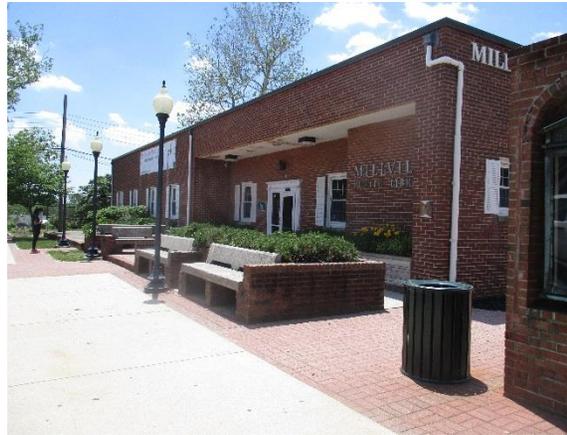
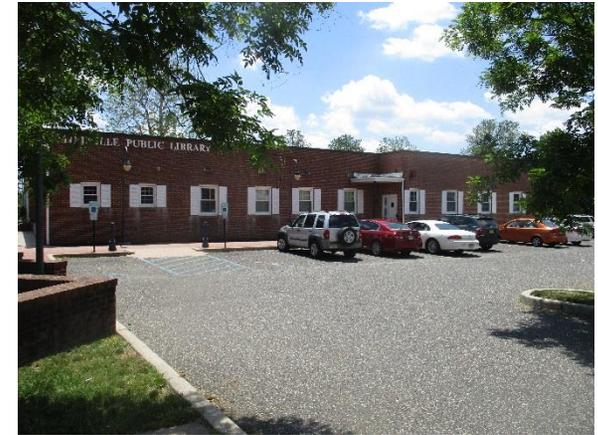
Parking spots north and west of the building can be replaced with porous asphalt to capture and infiltrate stormwater. A rain garden can be installed to capture, treat, and infiltrate runoff from the parking lot. A preliminary soil assessment suggests that the soils have suitable drainage characteristics for green infrastructure.

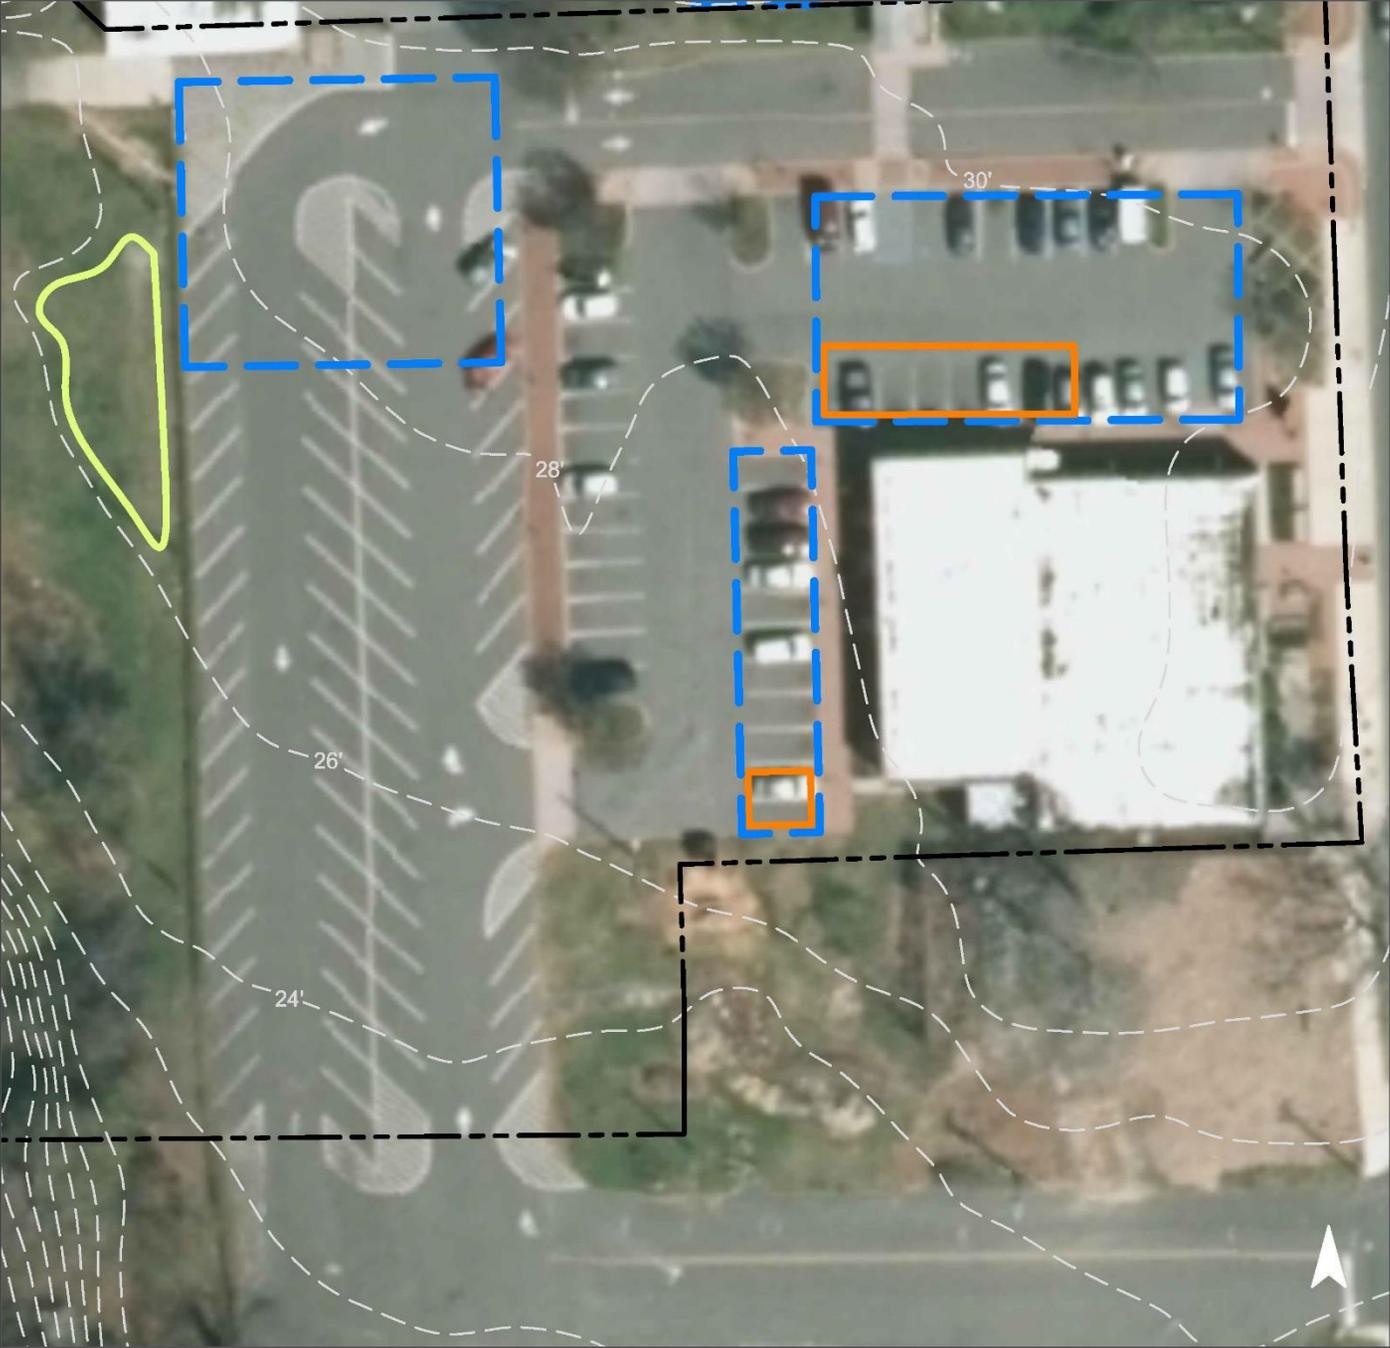
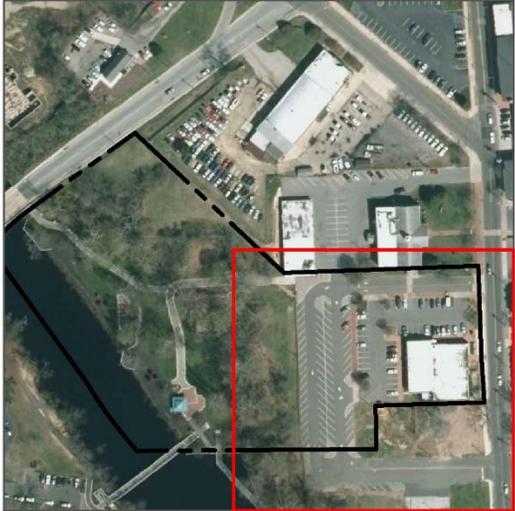
Millville Public Library

Recommended Green Infrastructure Practices	Recharge Potential (Mgal/yr)	TSS Removal Potential (lbs/yr)	Maximum Volume Reduction Potential (gal/storm)	Peak Discharge Reduction Potential (cu. ft./second)	Estimated Size (sq. ft.)	Estimated Cost
Bioretention system	0.163	27	12,320	0.46	1,560	\$7,800
Pervious pavement	0.219	37	16,598	0.62	1,500	\$37,500

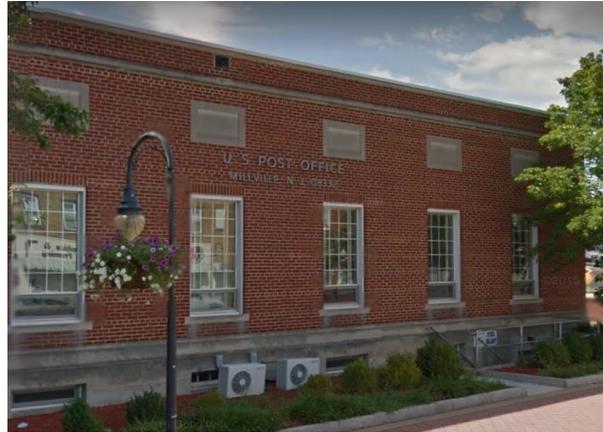
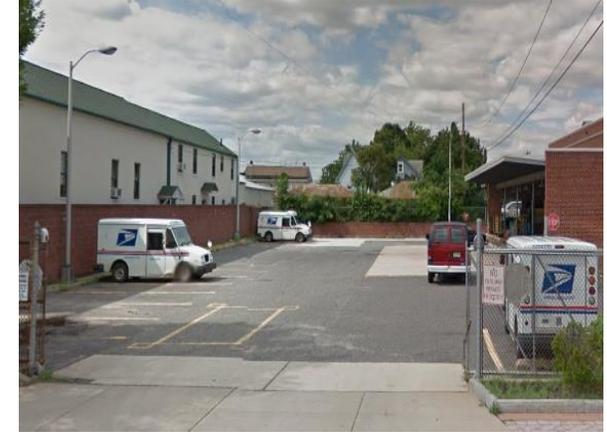
Parking spots can be replaced with porous asphalt to capture and infiltrate stormwater. A preliminary soil assessment suggests that the soils have suitable drainage characteristics for green infrastructure.

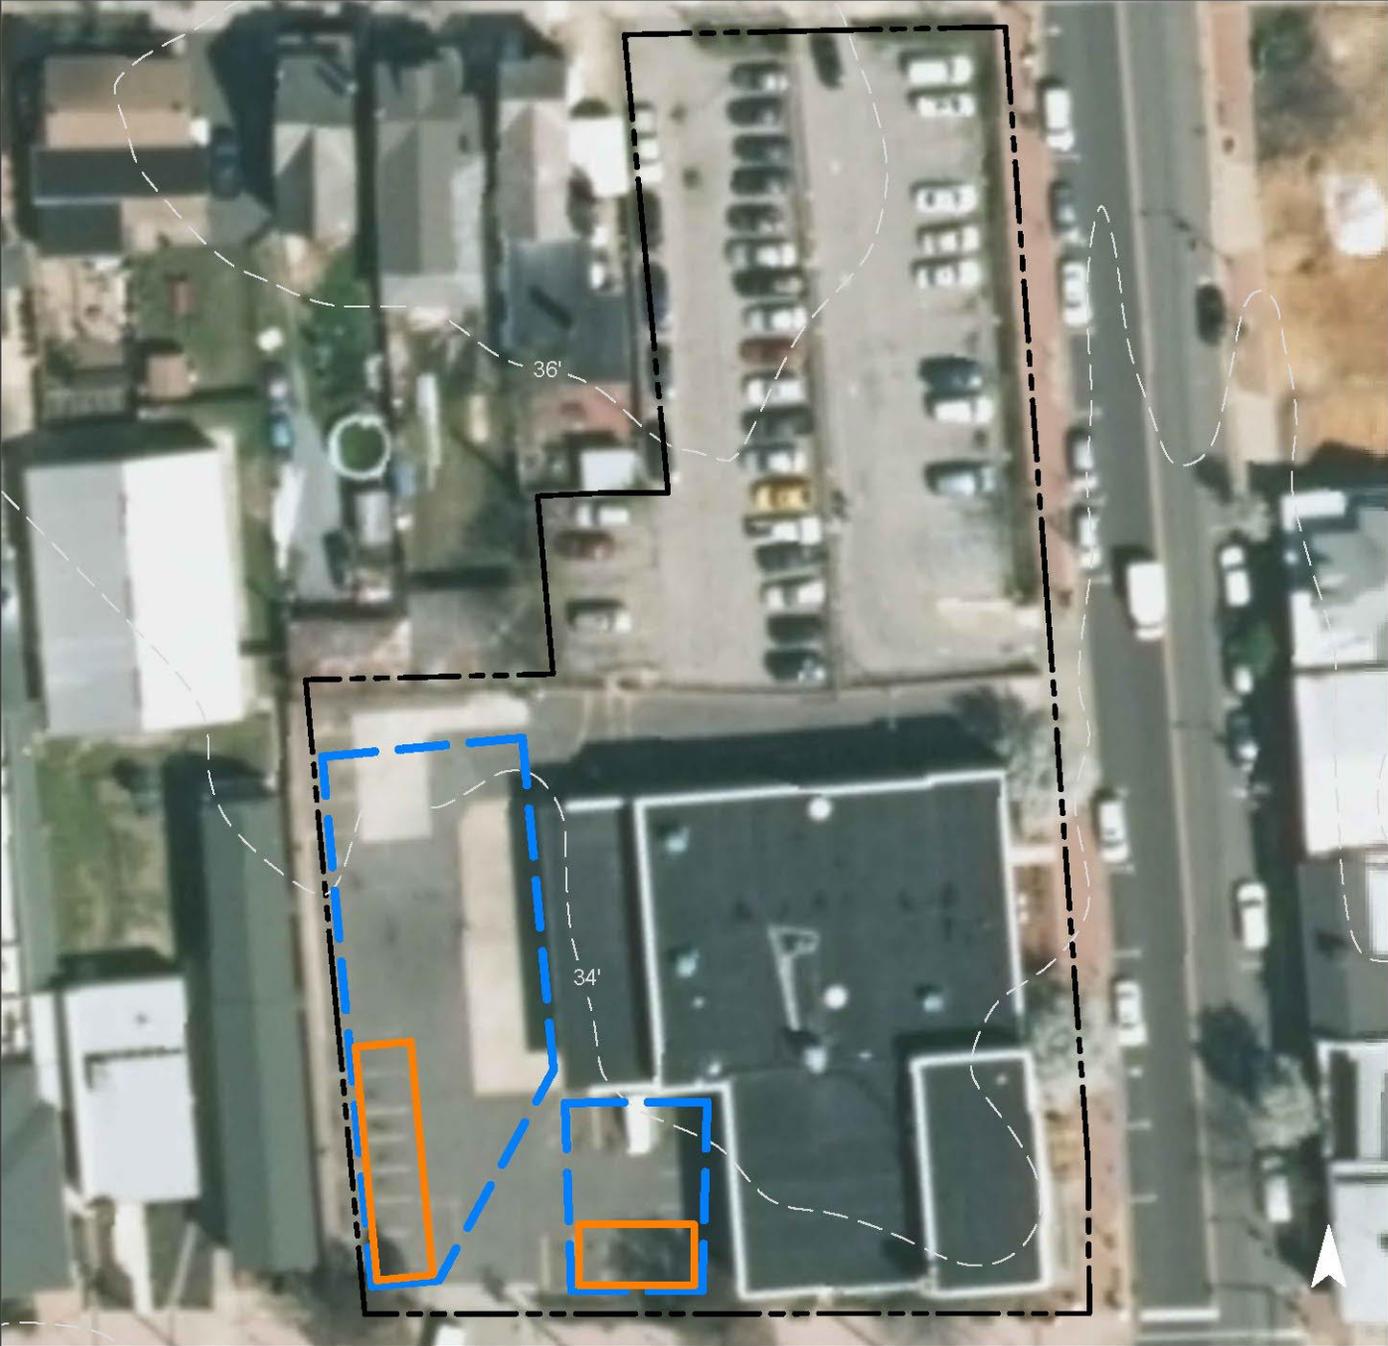
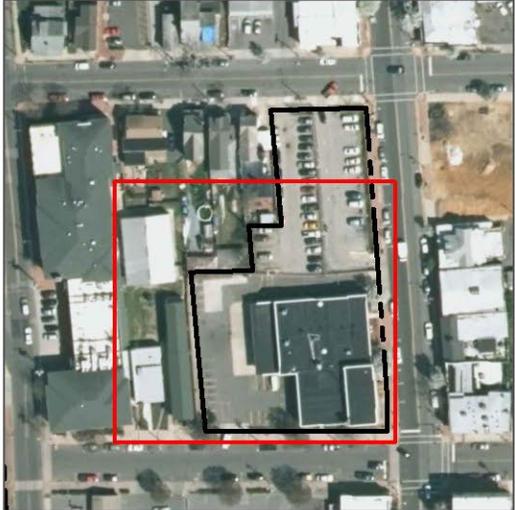
Millville Post Office

Recommended Green Infrastructure Practices	Recharge Potential (Mgal/yr)	TSS Removal Potential (lbs/yr)	Maximum Volume Reduction Potential (gal/storm)	Peak Discharge Reduction Potential (cu. ft./second)	Estimated Size (sq. ft.)	Estimated Cost
Pervious pavement	0.254	42	19,224	0.72	1,740	\$43,500

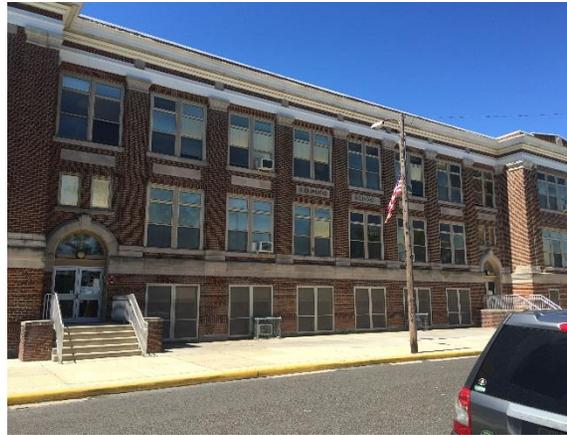
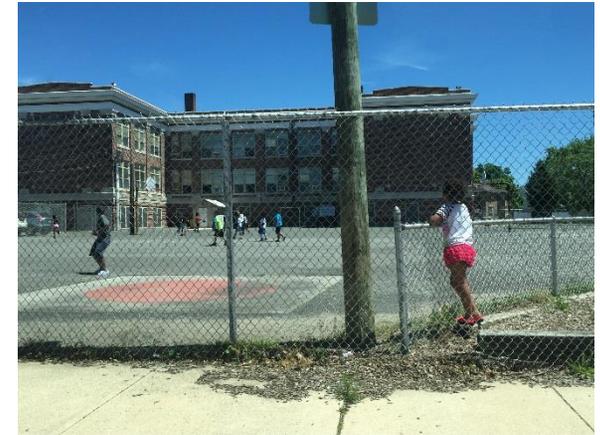
Parking spots southwest of the building can be replaced with porous asphalt to capture and infiltrate stormwater. A rain garden can be installed on the north side of the lawn to catch runoff from the parking lot and increase biodiversity. A preliminary soil assessment suggests that the soils have suitable drainage characteristics for green infrastructure.

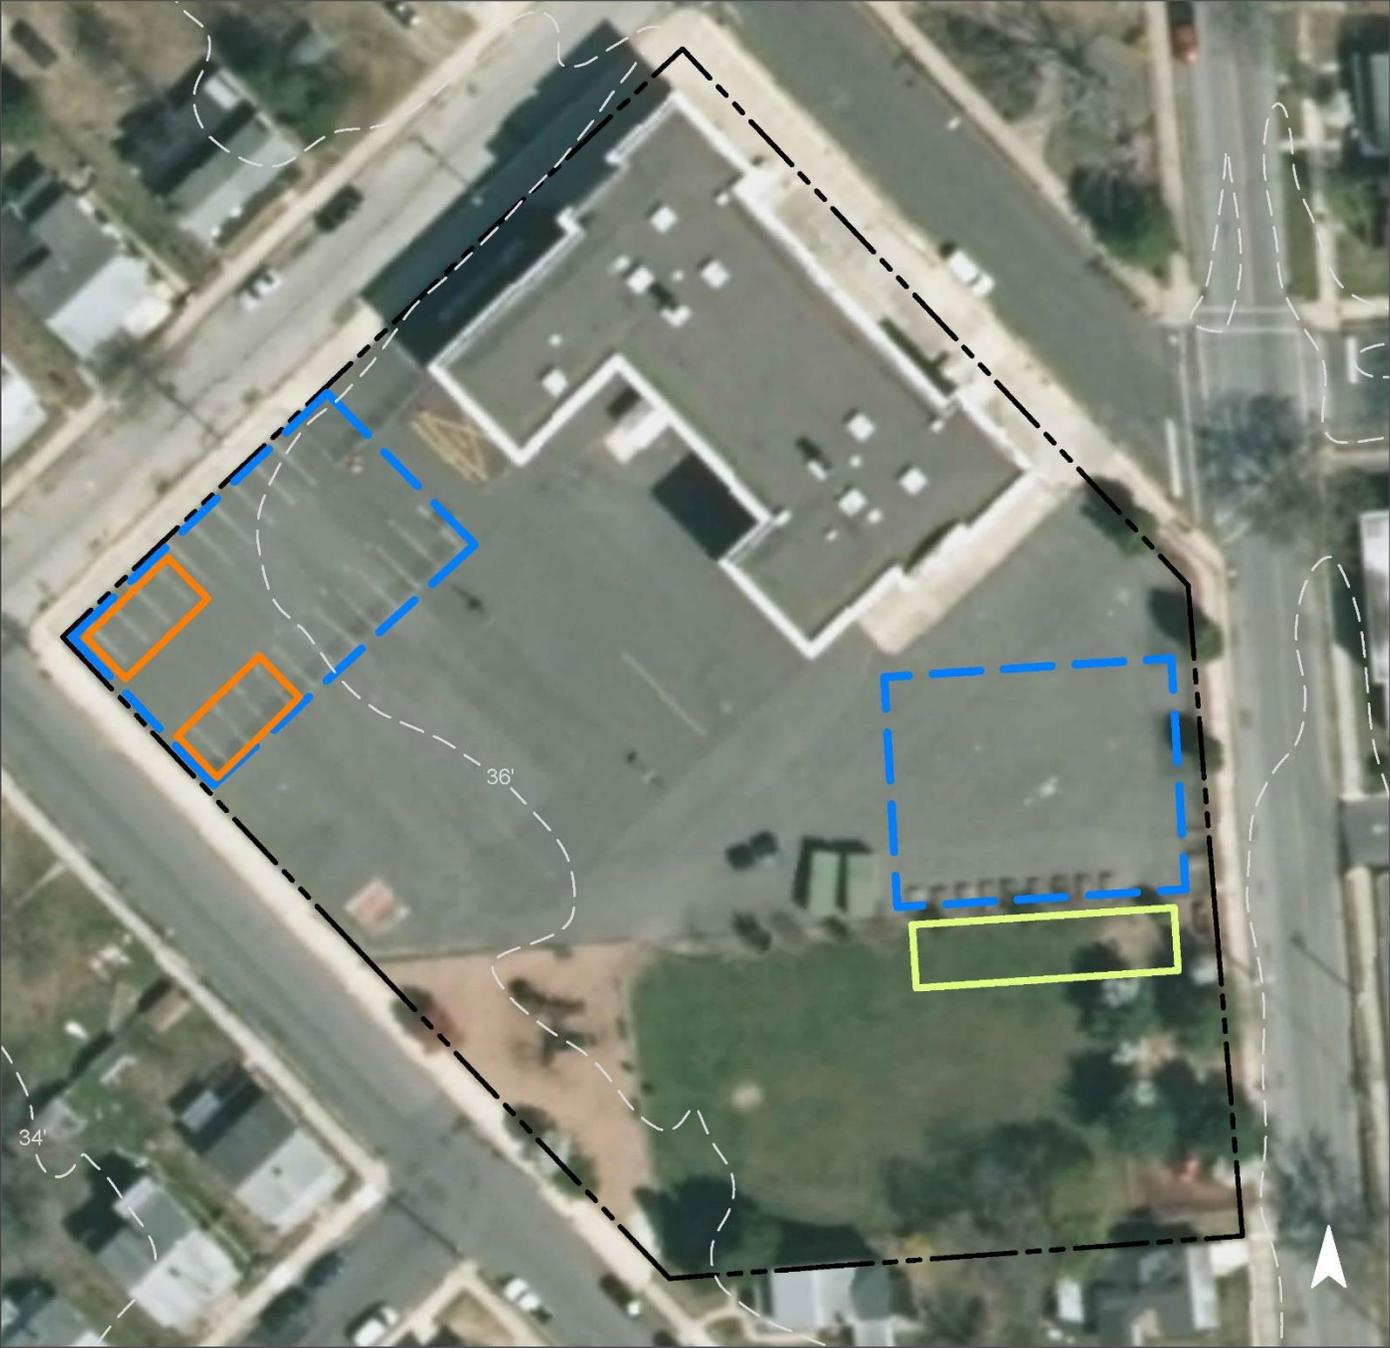
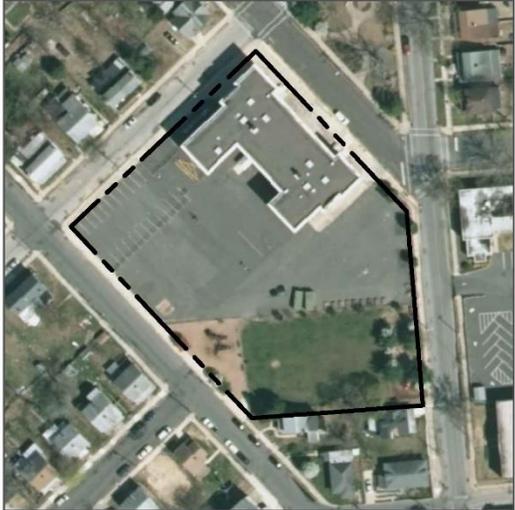
R.D. Wood Elementary School

Recommended Green Infrastructure Practices	Recharge Potential (Mgal/yr)	TSS Removal Potential (lbs/yr)	Maximum Volume Reduction Potential (gal/storm)	Peak Discharge Reduction Potential (cu. ft./second)	Estimated Size (sq. ft.)	Estimated Cost
Bioretention system	0.163	27	12,320	0.46	1,630	\$8,150
Pervious pavement	0.190	32	14,369	0.54	1,300	\$32,500
