**Impervious Cover Reduction Action Plan
for
Mount Arlington Borough, Morris County, New Jersey**

*Prepared for Mount Arlington Borough by the
Rutgers Cooperative Extension Water Resources Program*

August 10, 2016

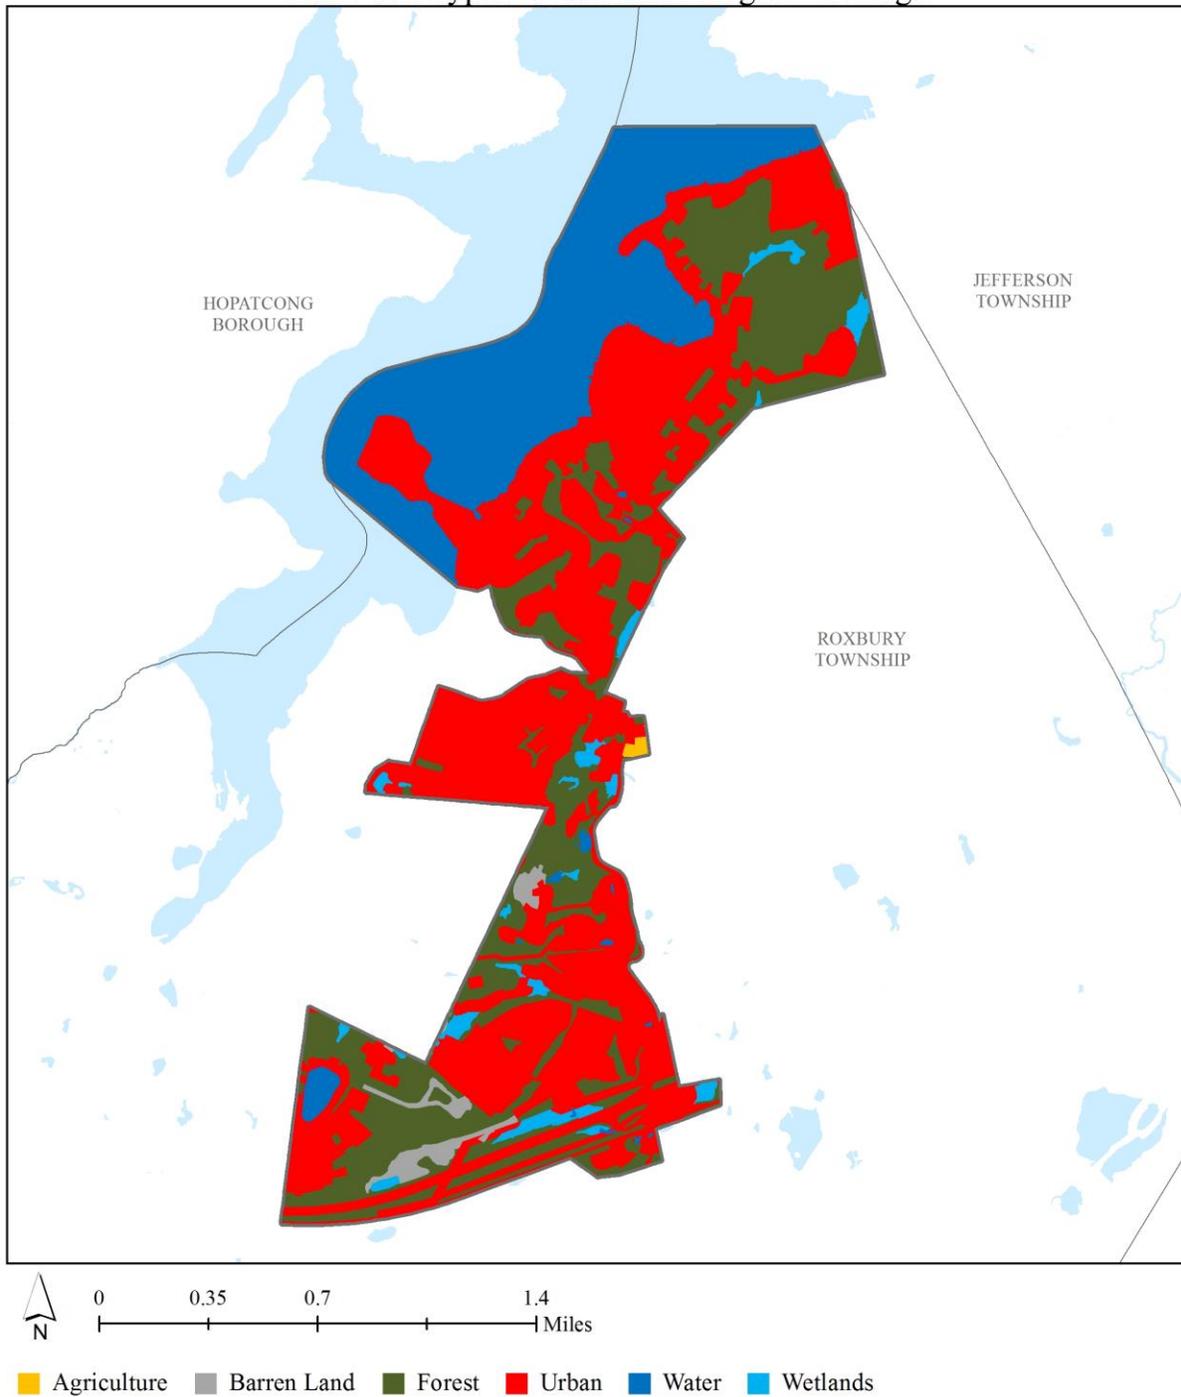
Figure 1: Map illustrating the land use in Mount Arlington Borough

Located in Morris County in northern New Jersey, Mount Arlington Borough covers approximately 2.80 square miles. Figures 1 and 2 illustrate that Mount Arlington Borough is dominated by urban land uses. A total of 47.3% of the municipality's land use is classified as urban. Of the urban land in Mount Arlington Borough, medium density residential is the dominant land use (Figure 3).

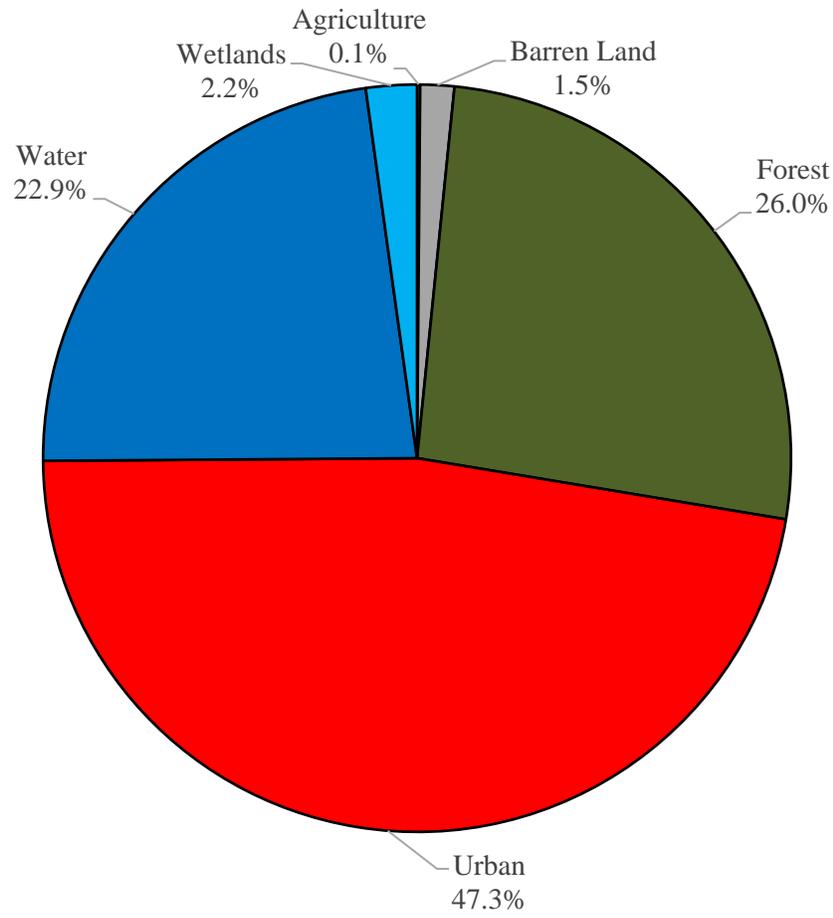
Figure 2: Pie chart illustrating the land use in Mount Arlington Borough

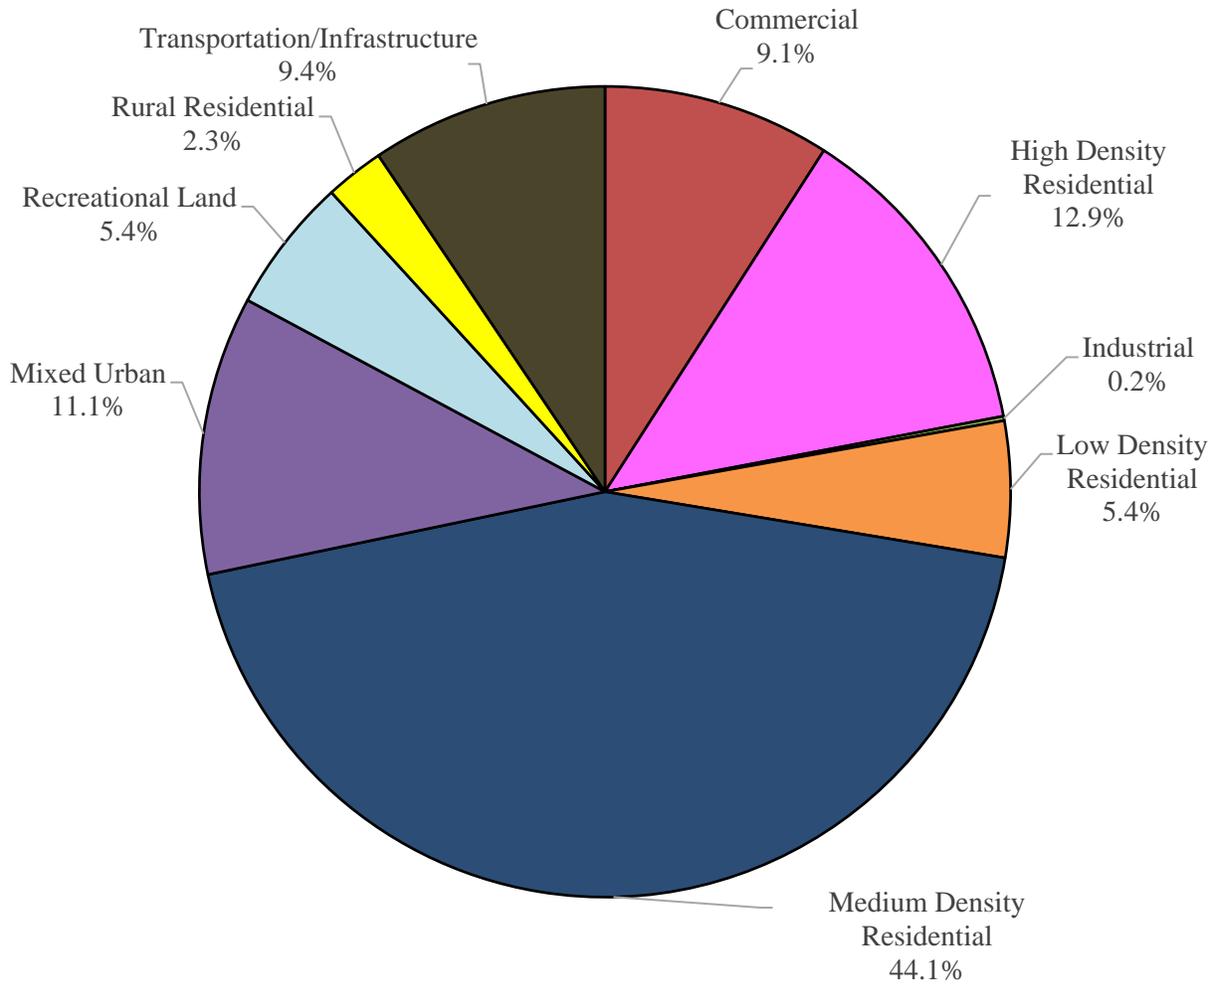
Figure 3: Pie chart illustrating the various types of urban land use in Mount Arlington Borough

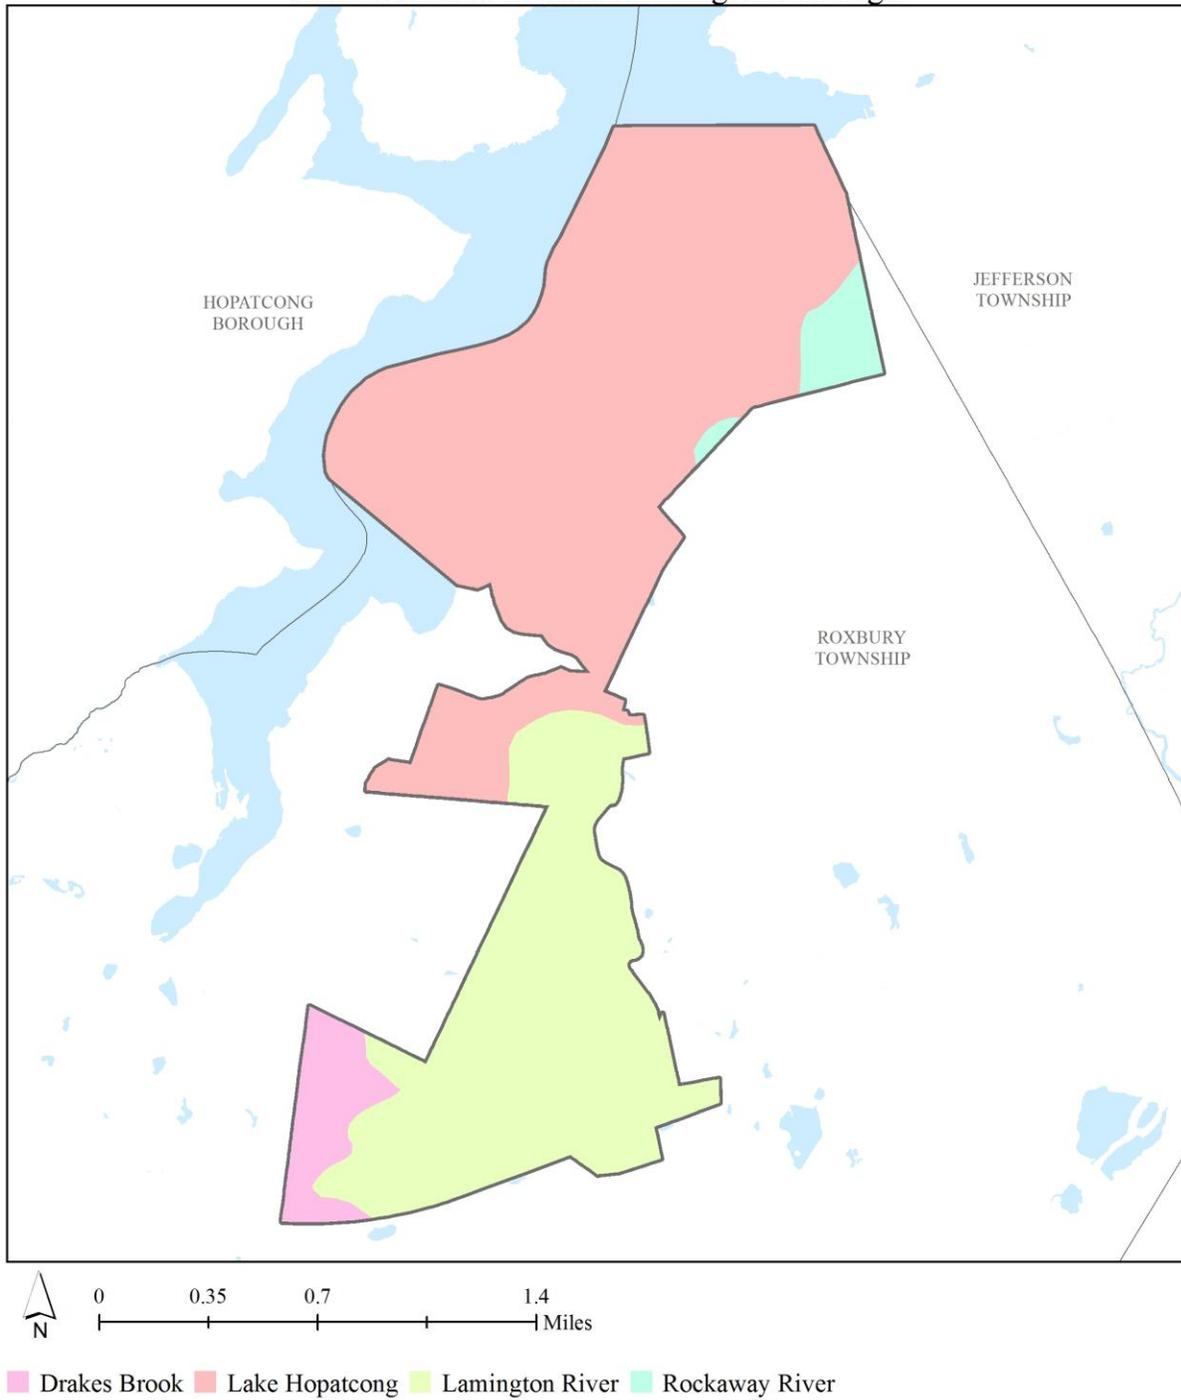
Figure 4: Map of the subwatersheds in Mount Arlington Borough

Mount Arlington Borough contains portions of four subwatersheds (Figure 4). For this impervious cover reduction action plan, projects have been identified in each of these watersheds. Initially, aerial imagery was used to identify potential project sites that contain extensive impervious cover. Field visits were then conducted at each of these potential project sites to determine if a viable option exists to reduce impervious cover or to disconnect impervious surfaces from draining directly to the local waterway or storm sewer system. During the site visit, appropriate green infrastructure practices for the site were determined. Sites that already had stormwater management practices in place were not considered.

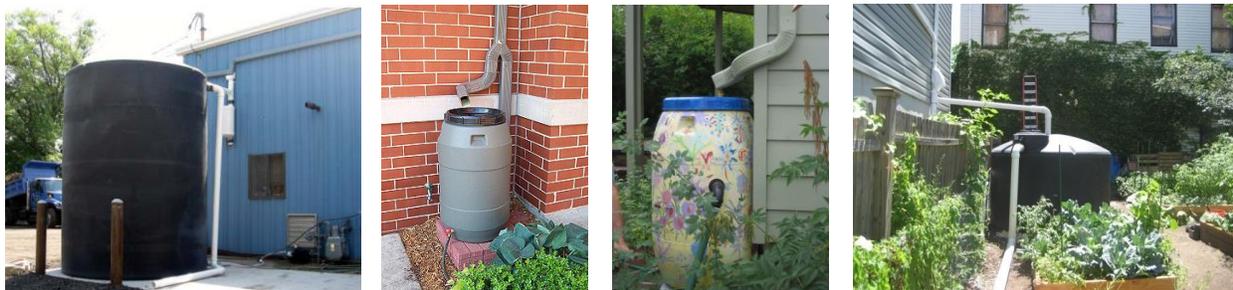
Rainwater harvesting systems (cistern or rain barrel)

These systems capture rainwater, mainly from rooftops, in cisterns or rain barrels. The water can then be used for watering gardens, washing vehicles, or for other non-potable uses.

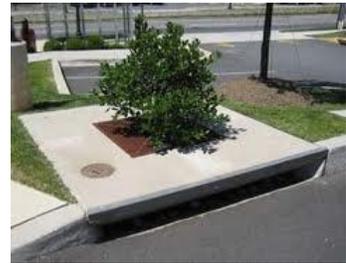
Tree filter boxes

These are pre-manufactured concrete boxes that contain a special soil mix and are planted with a tree or shrub. They filter stormwater runoff but provide little storage capacity. They are typically designed to quickly filter stormwater and then discharge it to the local sewer system.

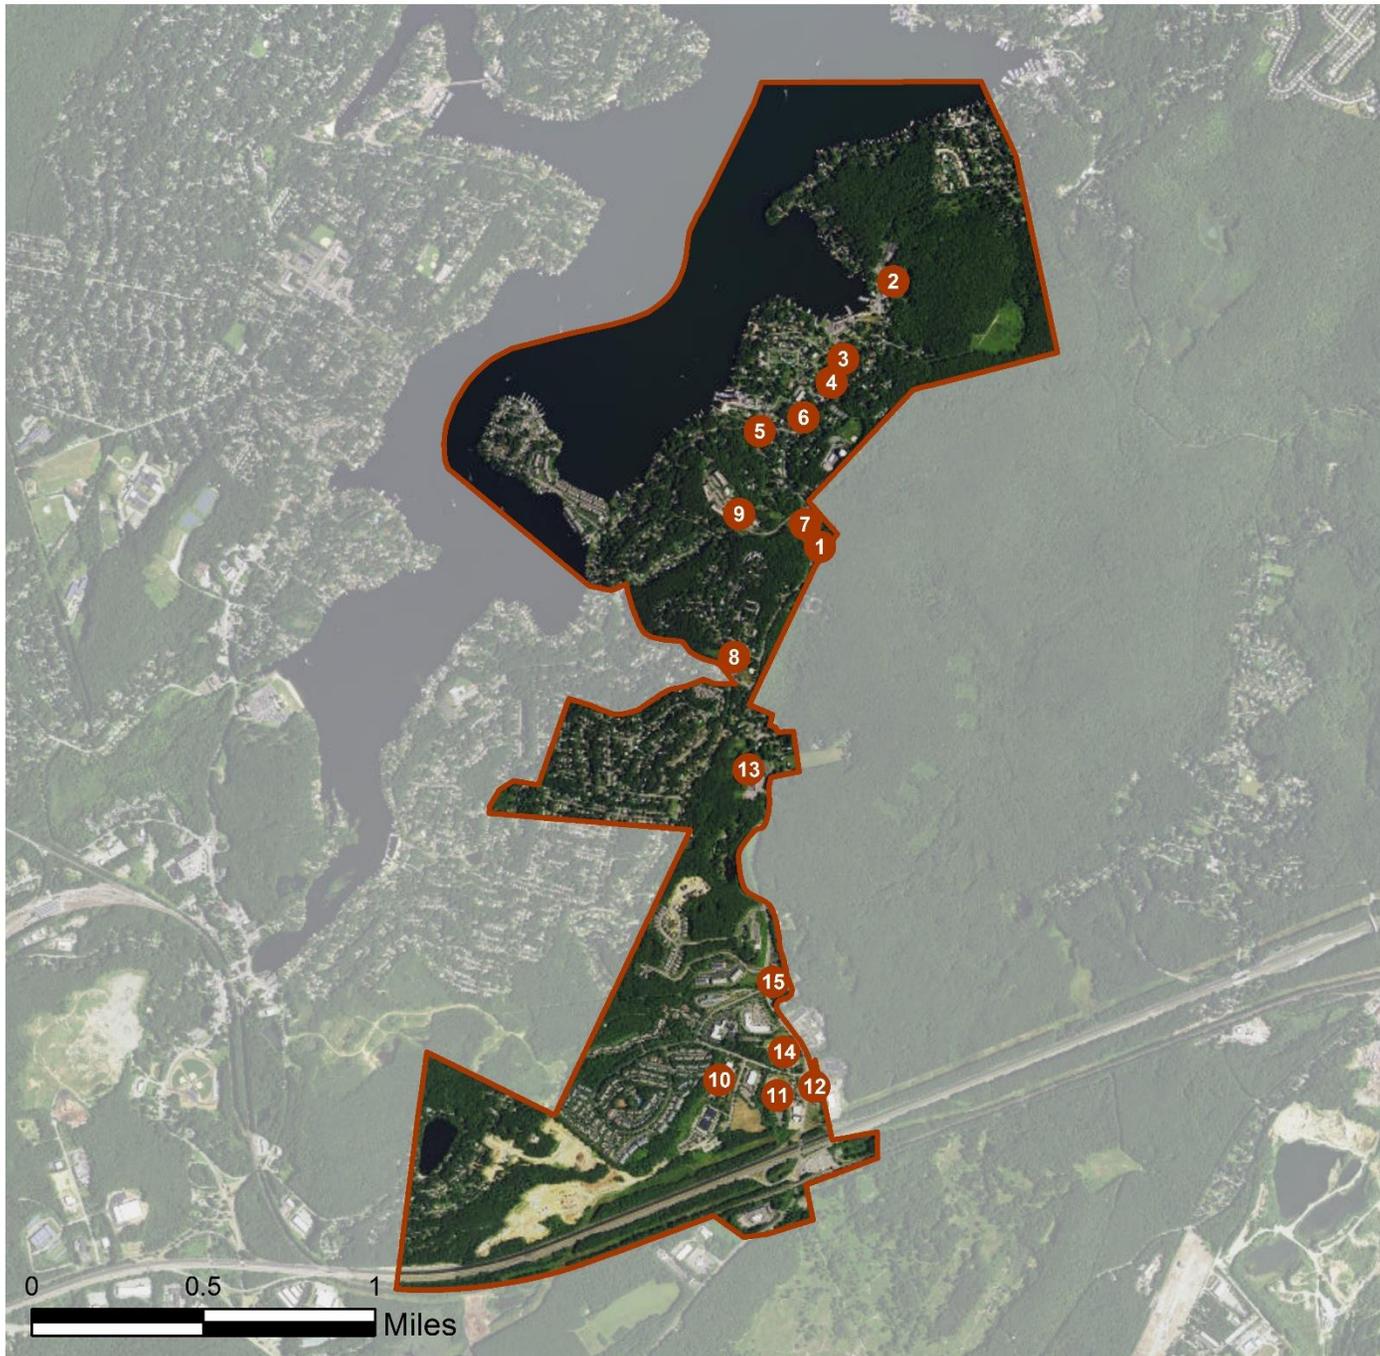
MOUNT ARLINGTON BOROUGH: GREEN INFRASTRUCTURE SITES

SITES WITHIN THE LAKE HOPATCONG SUBWATERSHED:

1. Bagel Mike's
2. Edith M. Decker Elementary School
3. Mount Arlington Borough Hall
4. Mount Arlington Fire Department
5. Mount Arlington Police Department
6. Mount Arlington Post Office
7. Mount Arlington Public Library
8. Mount Arlington Public School
9. Ridgeview Lane

SITES WITHIN THE LAMINGTON RIVER SUBWATERSHED:

10. Caring Partners-Morris Sussex
11. Courtyard Rockaway-Mount Arlington
12. Davy's Dogs
13. Elks Lodge
14. Guaranteed Rate of Mount Arlington
15. Professional Building

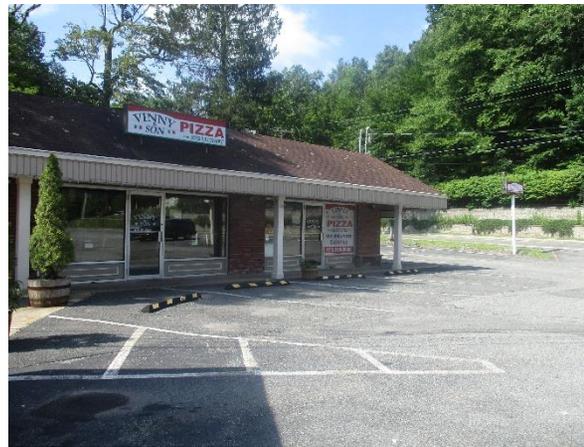
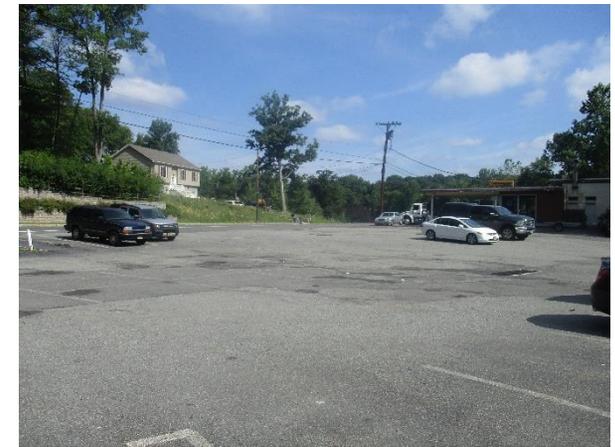
BAGEL MIKE'S

Stormwater from the rooftops of Vinny & Sons Pizza and Bagel Mike's building runs directly onto the parking lot. The parking spaces along the building can be replaced with pervious pavement to allow water to infiltrate through the surface. A preliminary soil assessment suggests that the soils have suitable drainage characteristics for green infrastructure.

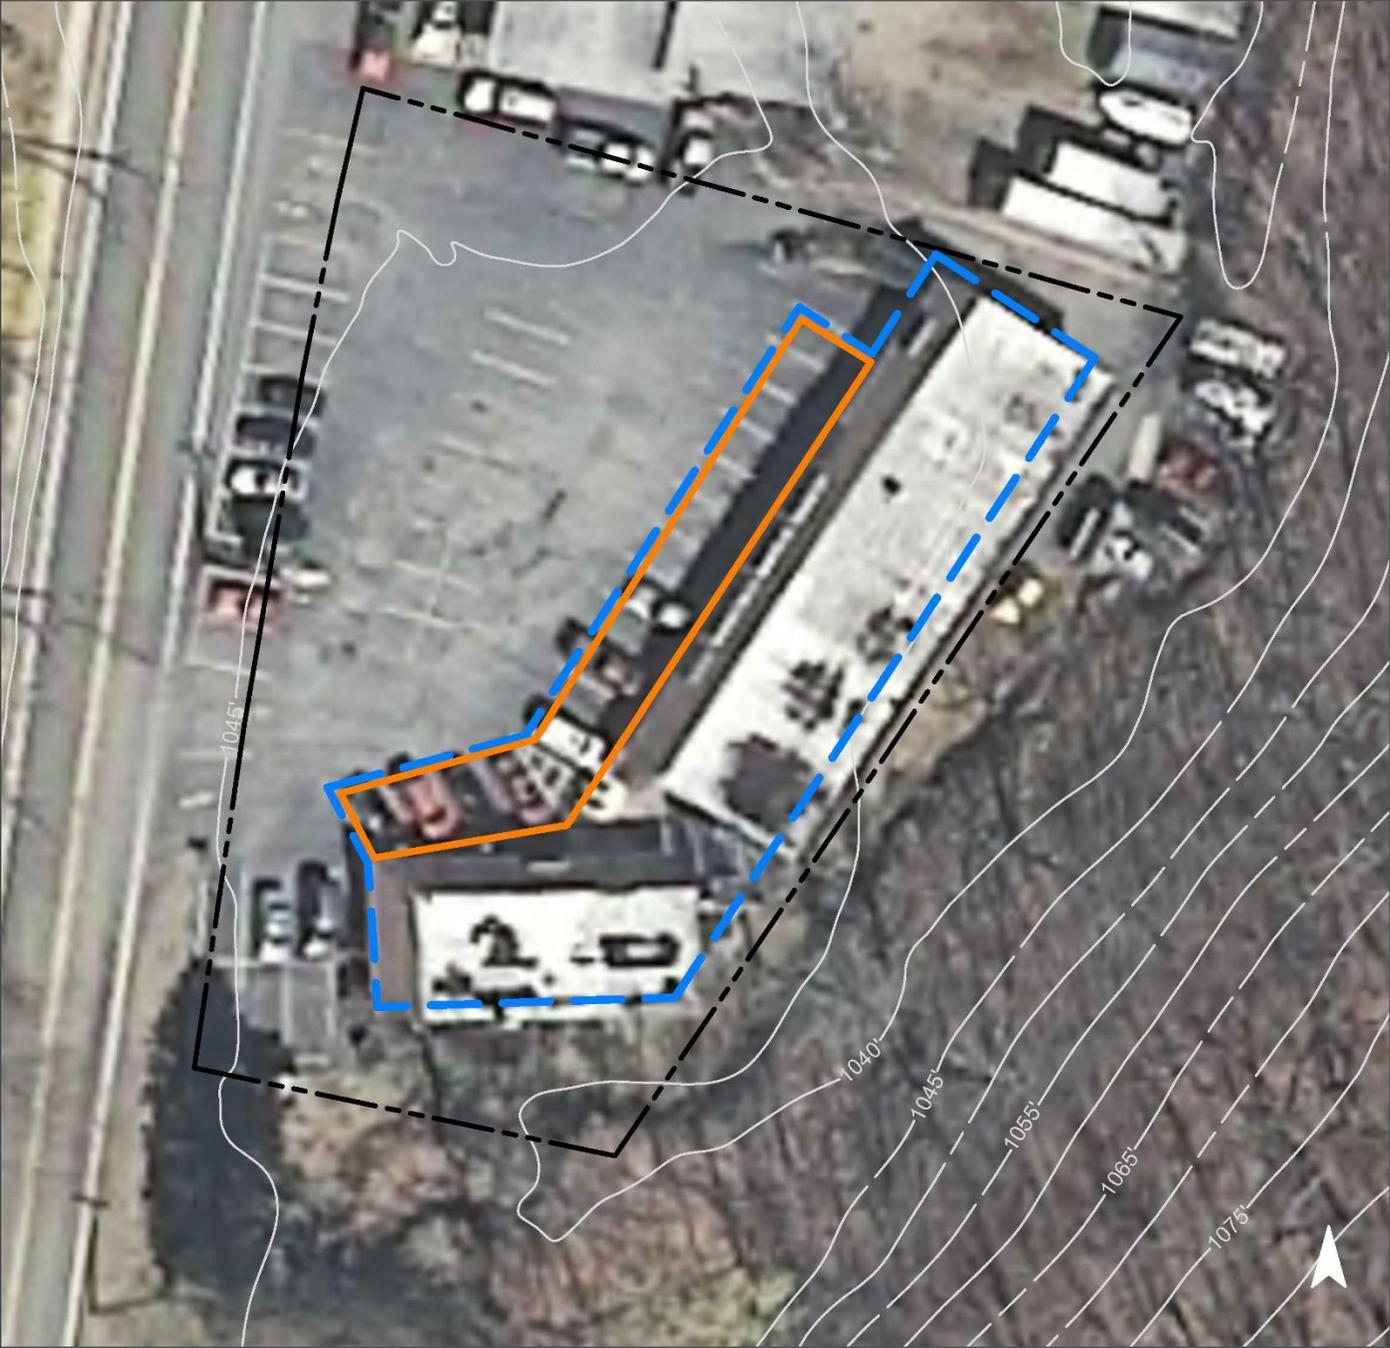
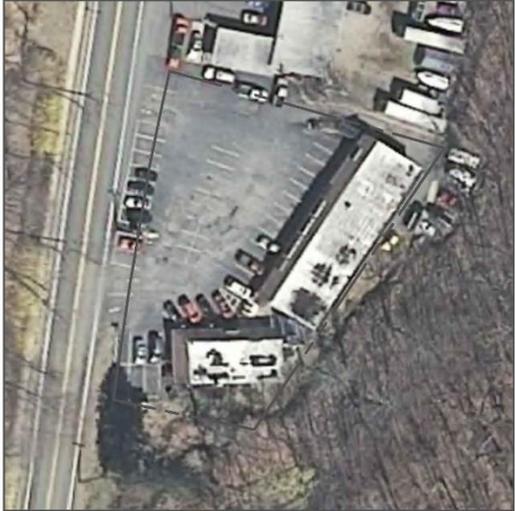
Bagel Mike's

GREEN INFRASTRUCTURE RECOMMENDATIONS

pervious pavement
-

drainage area
-

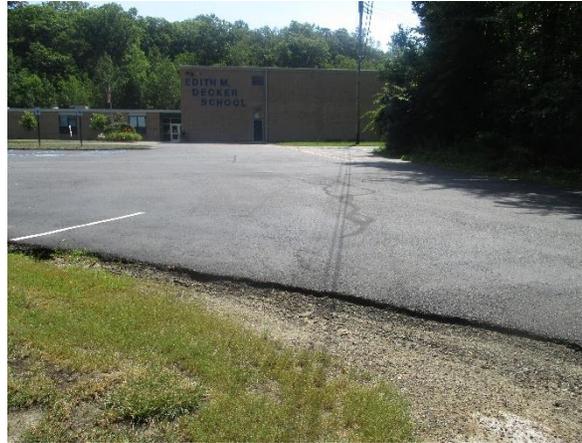
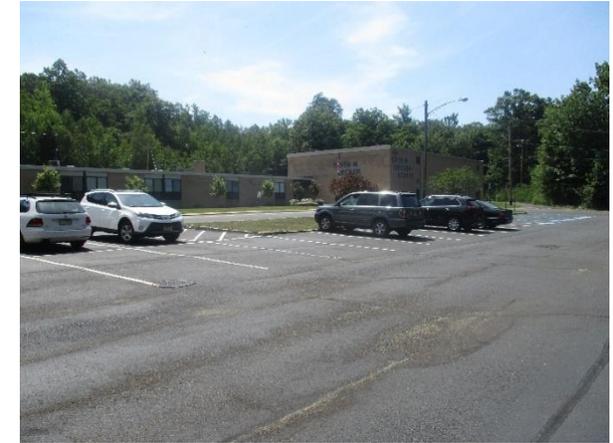
EDITH M. DECKER ELEMENTARY SCHOOL

A large amount of runoff is generated by the parking lot during storm events, causing erosion issues in the grass area along the parking lot. Two bioretention systems can be installed in the grass area to help mitigate the erosion problem. A third bioretention system can be built in the island located in the parking lot to manage more of the stormwater runoff. A preliminary soil assessment suggests that more soil testing would be required before determining the soil's suitability for green infrastructure.

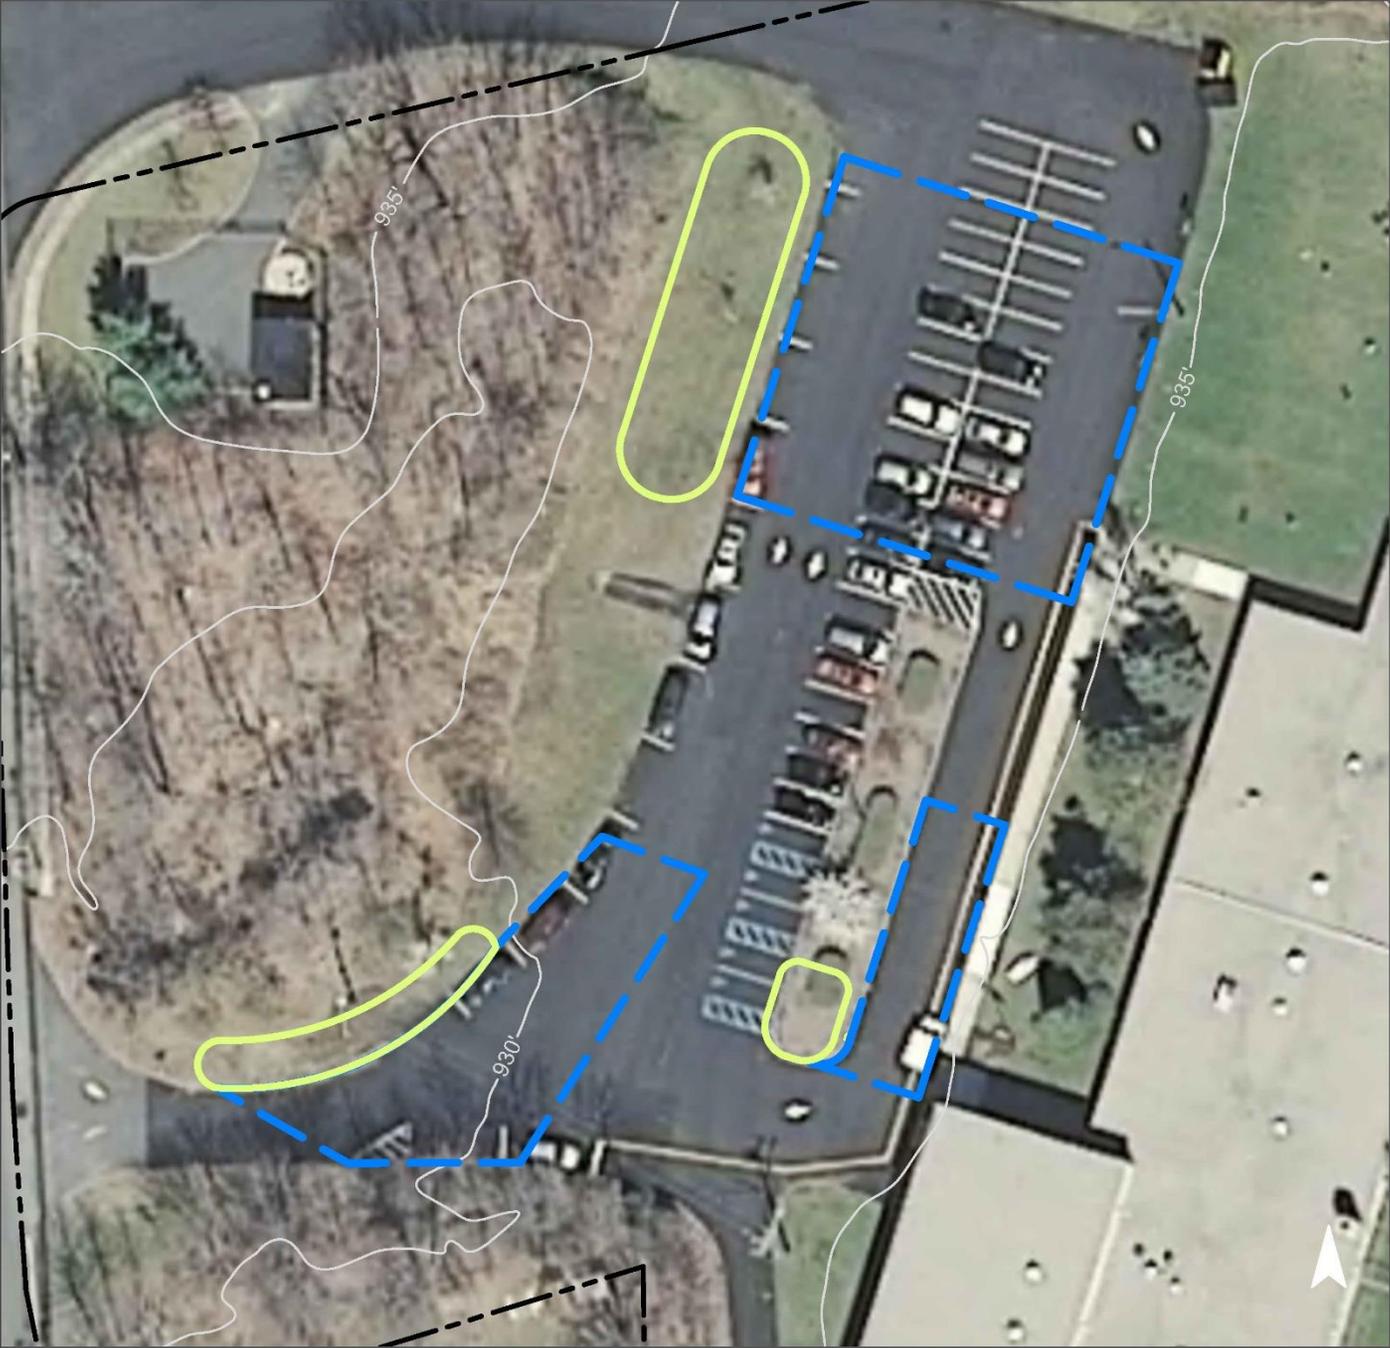
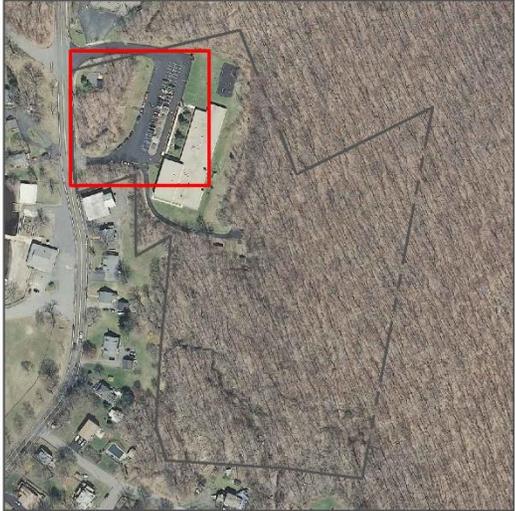
**Edith M. Decker
Elementary School**

GREEN INFRASTRUCTURE RECOMMENDATIONS

bioretention system
-

drainage area
-

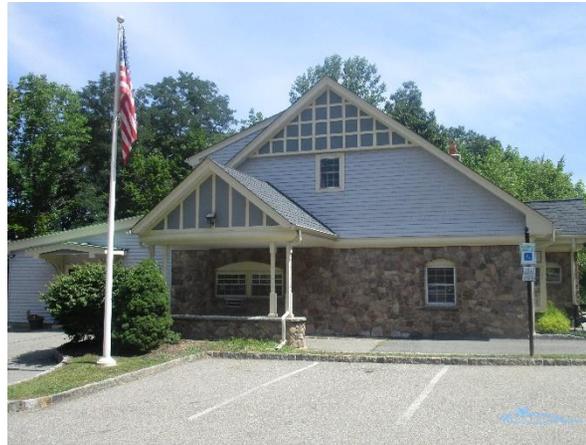
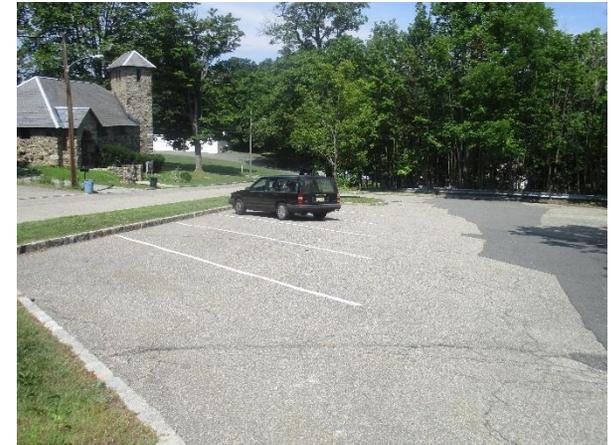
MOUNT ARLINGTON BOROUGH HALL

A bioretention system can be implemented in the grass area alongside Edgemere Avenue. The parking spaces next to this grass area can be replaced with pervious pavement. Bioretention systems and porous pavement can be installed to capture, treat, and infiltrate stormwater runoff. A preliminary soil assessment suggests that the soils have suitable drainage characteristics for green infrastructure.

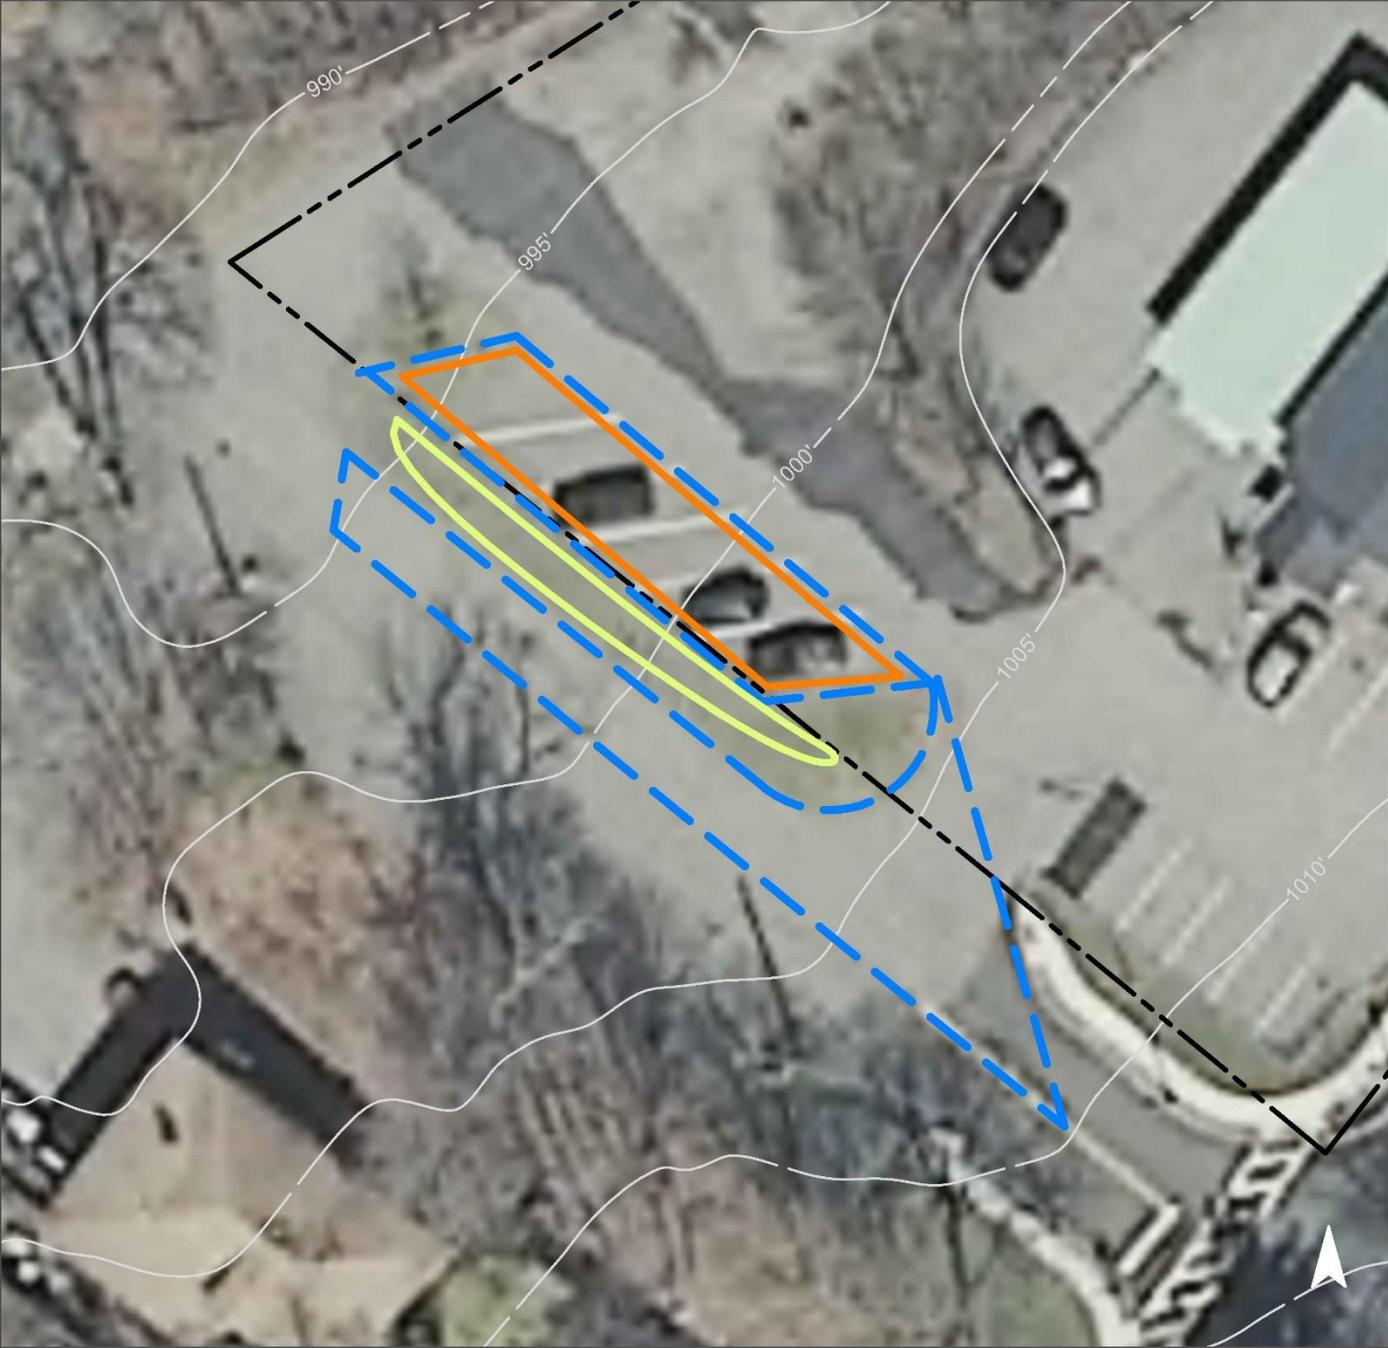
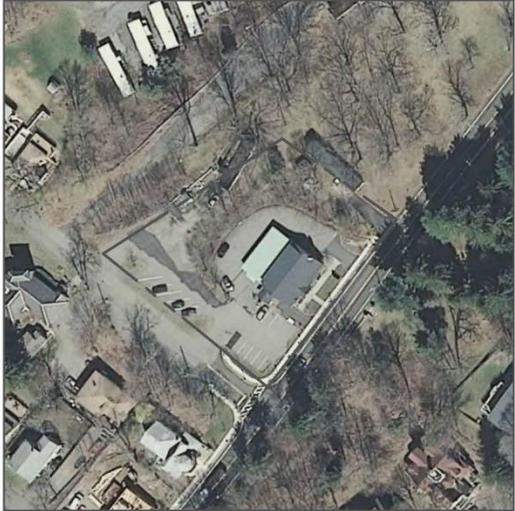
Mount Arlington Borough Hall

GREEN INFRASTRUCTURE RECOMMENDATIONS

bioretention system
-

pervious pavement
-

drainage area
-

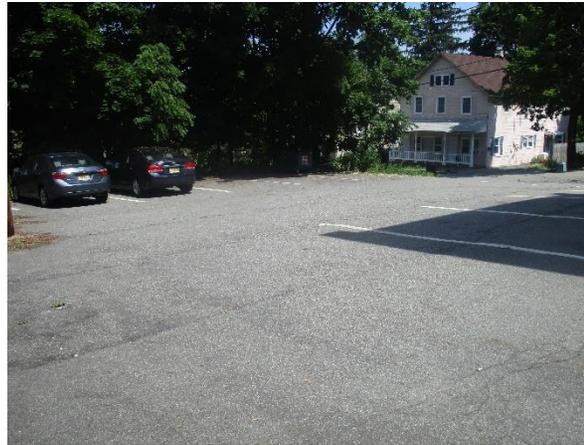
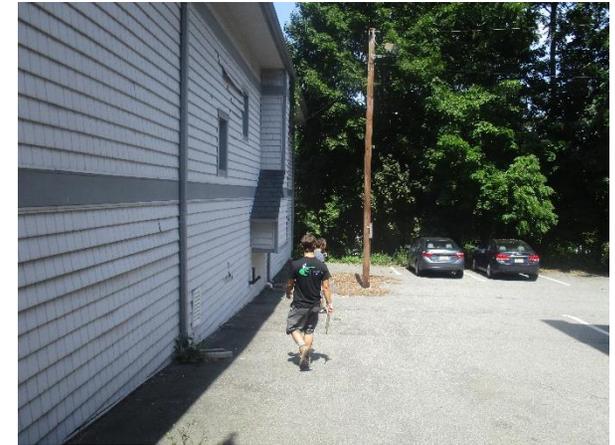
MOUNT ARLINGTON FIRE DEPARTMENT

A large amount of runoff is generated by the parking lot during storm events. The parking spaces farthest from the building can be replaced with pervious pavement to allow water to infiltrate through the surface. A preliminary soil assessment suggests that the soils have suitable drainage characteristics for green infrastructure.

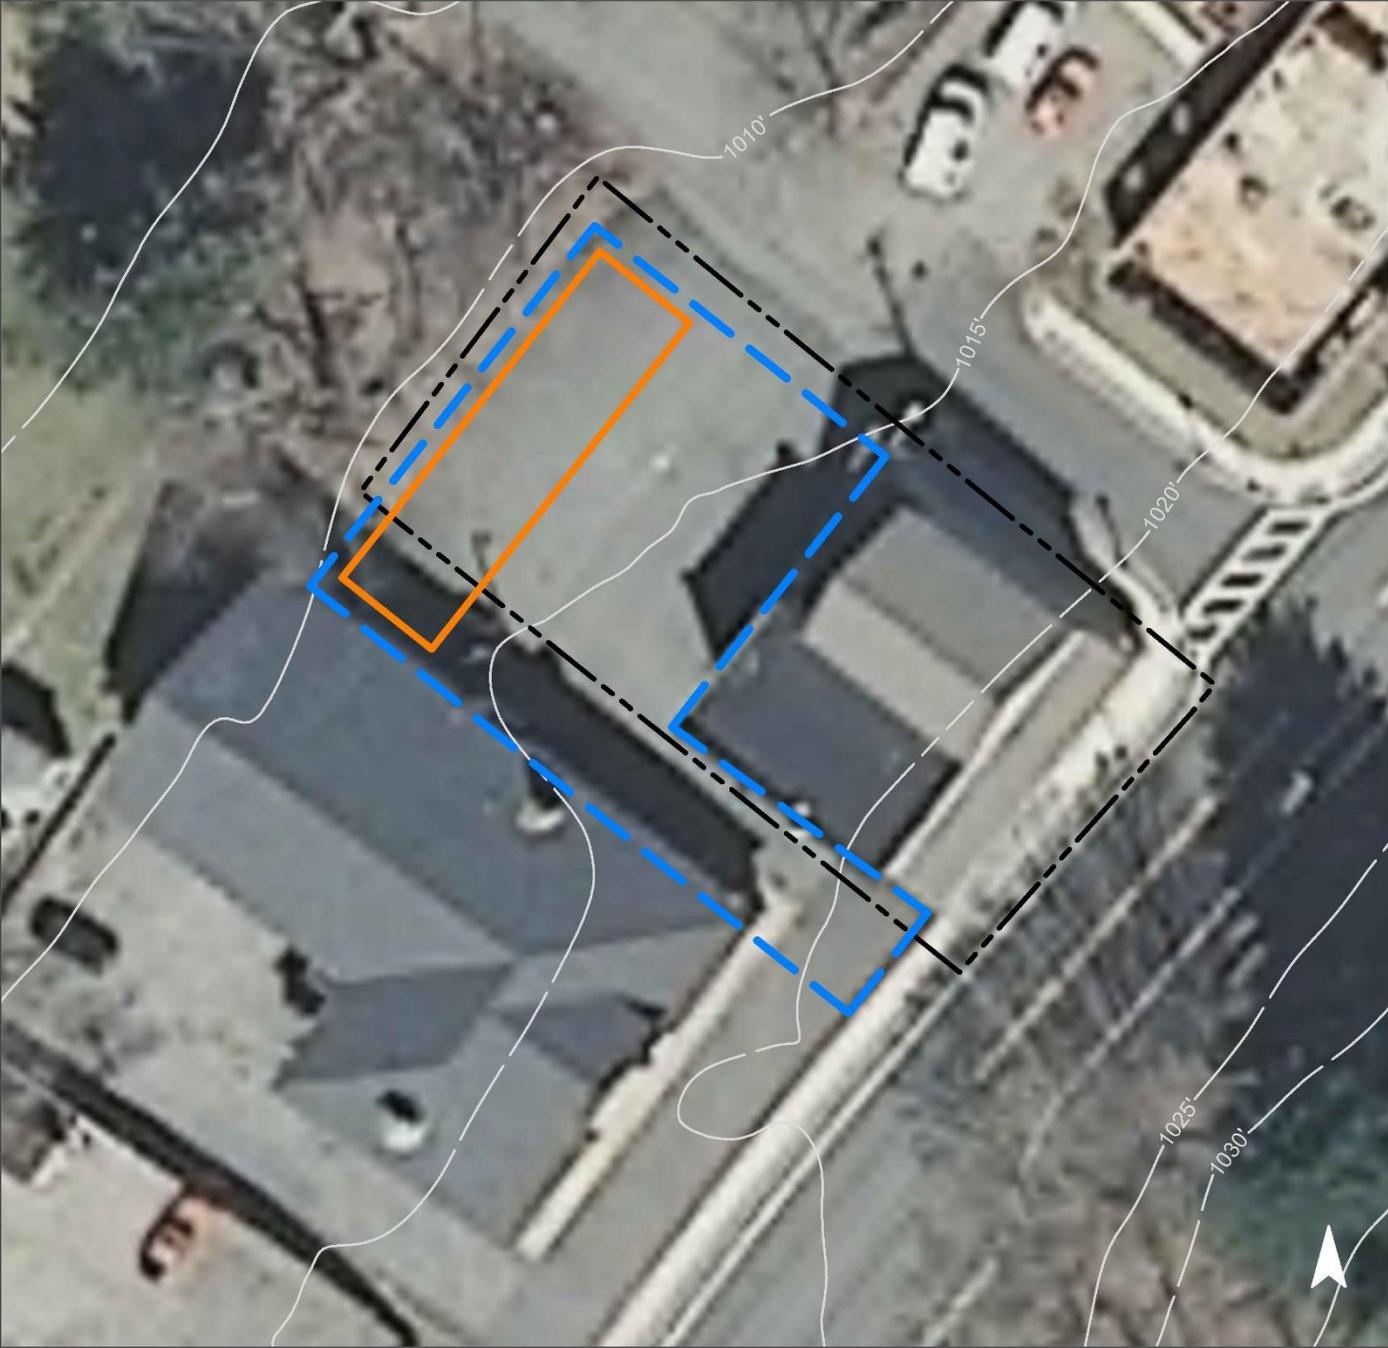
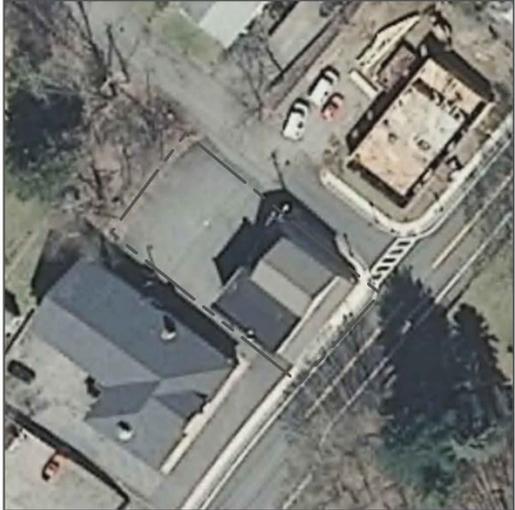
Mount Arlington Fire Department

GREEN INFRASTRUCTURE RECOMMENDATIONS

pervious pavement
-

drainage area
-

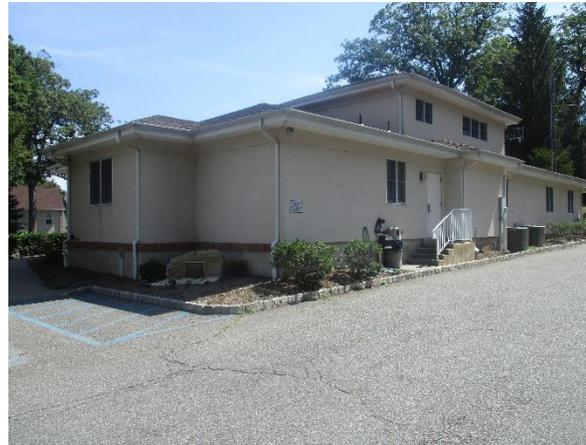
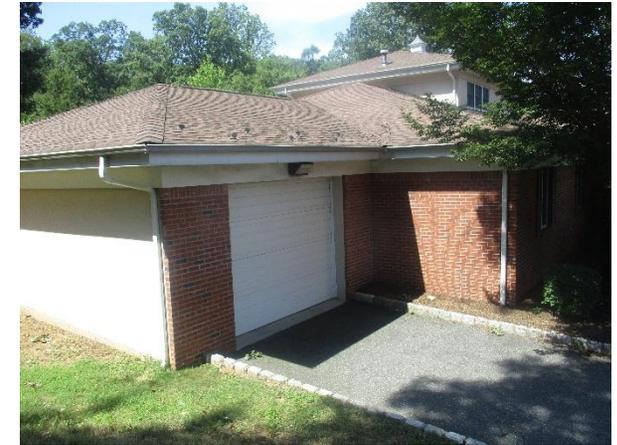
MOUNT ARLINGTON POLICE DEPARTMENT

Stormwater runoff from Altenbrand Avenue is directed into a catch basin without any possibility for infiltration. A bioretention system can be implemented in the grass area alongside Altenbrand Avenue. A curb cut will allow this system to manage runoff from the street. Parking spaces adjacent to the building can be replaced with porous asphalt to intercept and infiltrate rainwater from the roof. A cistern could capture water from the rooftop for reuse in watering the landscaping or washing vehicles. A preliminary soil assessment suggests that the soils have suitable drainage characteristics for green infrastructure.

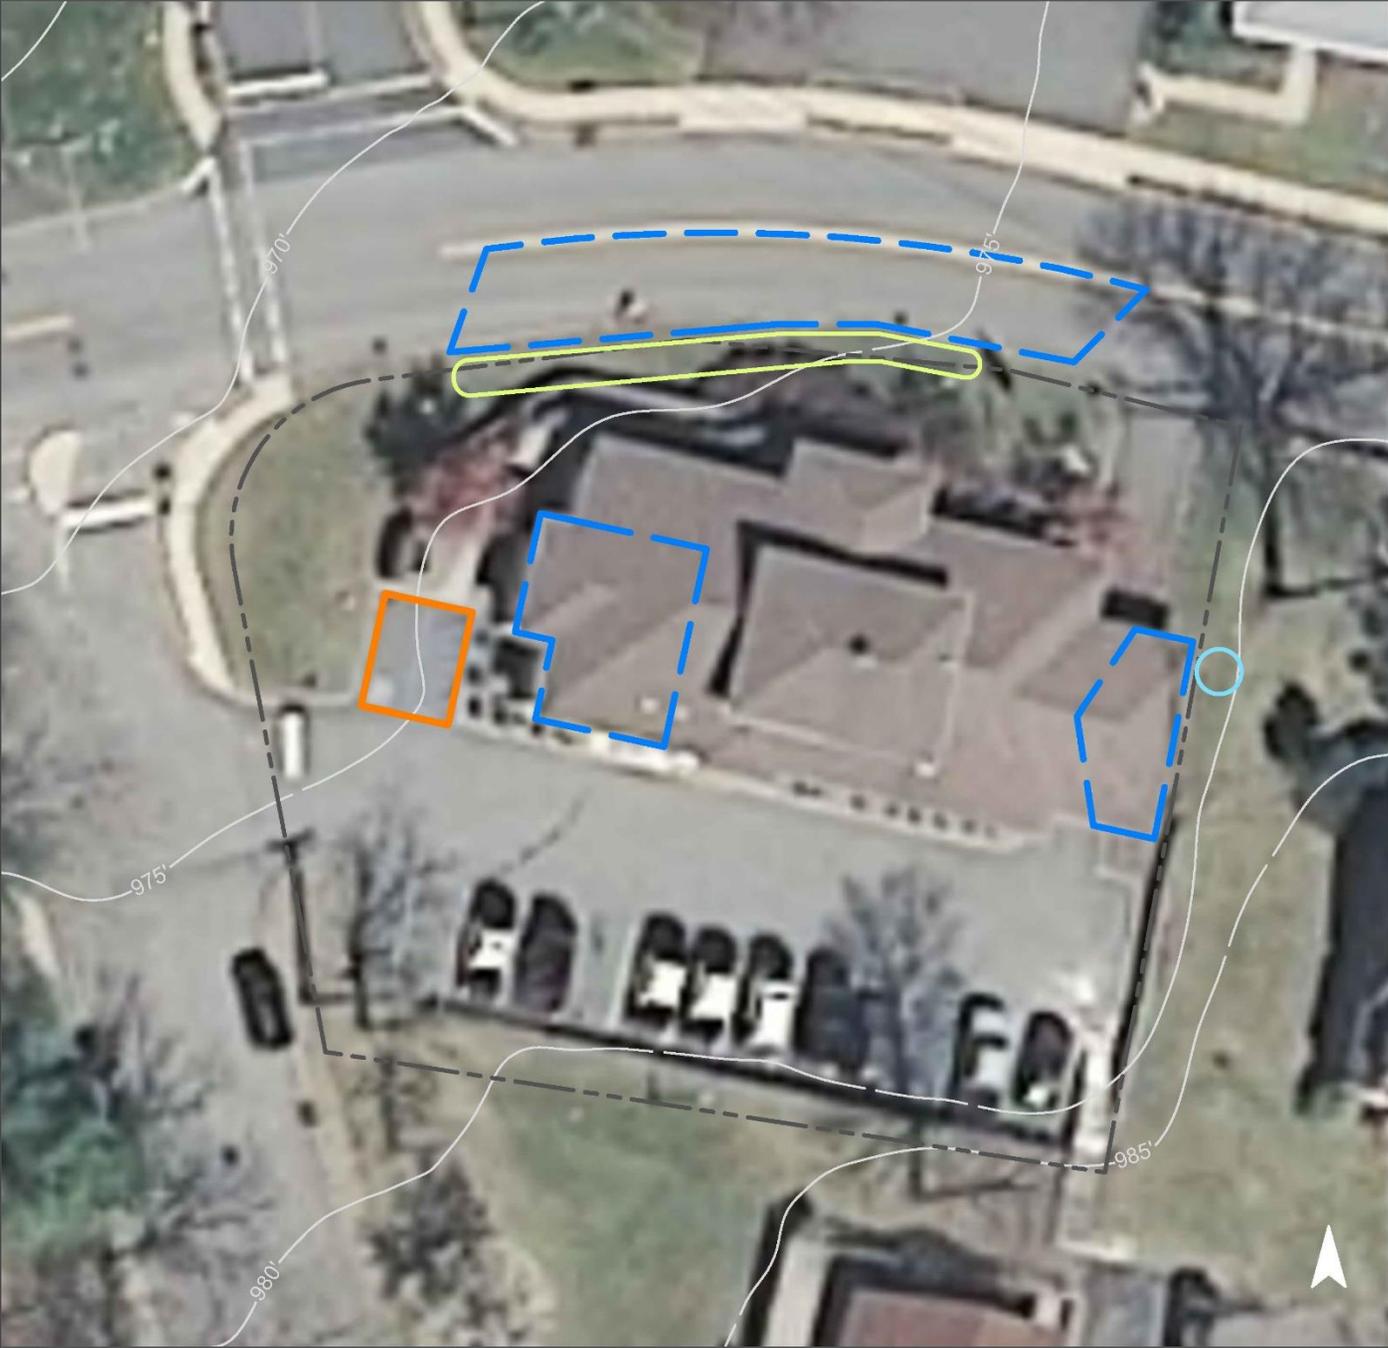
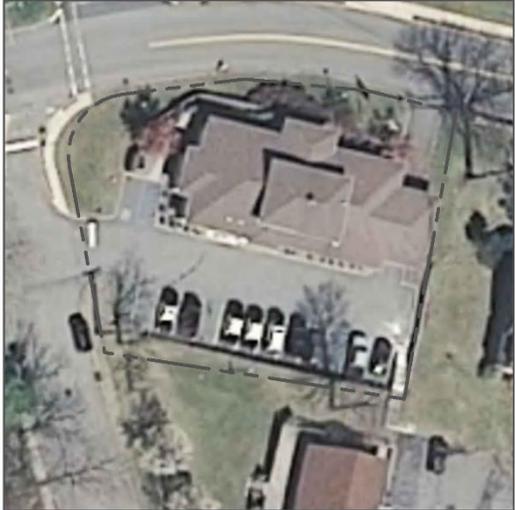
Mount Arlington Police Department

GREEN INFRASTRUCTURE RECOMMENDATIONS

bioretention system
-

pervious pavement
-

rainwater harvesting
-

drainage area
-

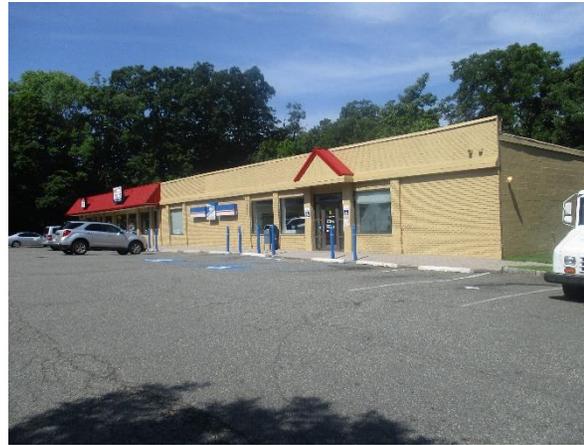
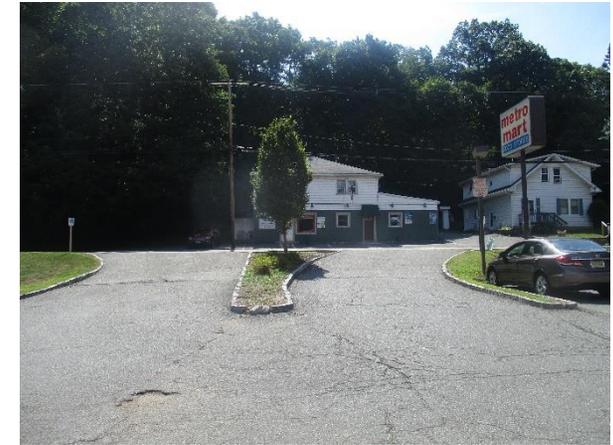
A large amount of runoff is generated by the parking lot during storm events. The parking spaces closest to the building can be replaced with pervious pavement to allow water to infiltrate through the surface. A preliminary soil assessment suggests that the soils have suitable drainage characteristics for green infrastructure.
