**Impervious Cover Reduction Action Plan
for
Mount Arlington Borough, Morris County, New Jersey**

*Prepared for Mount Arlington Borough by the
Rutgers Cooperative Extension Water Resources Program*

August 10, 2016

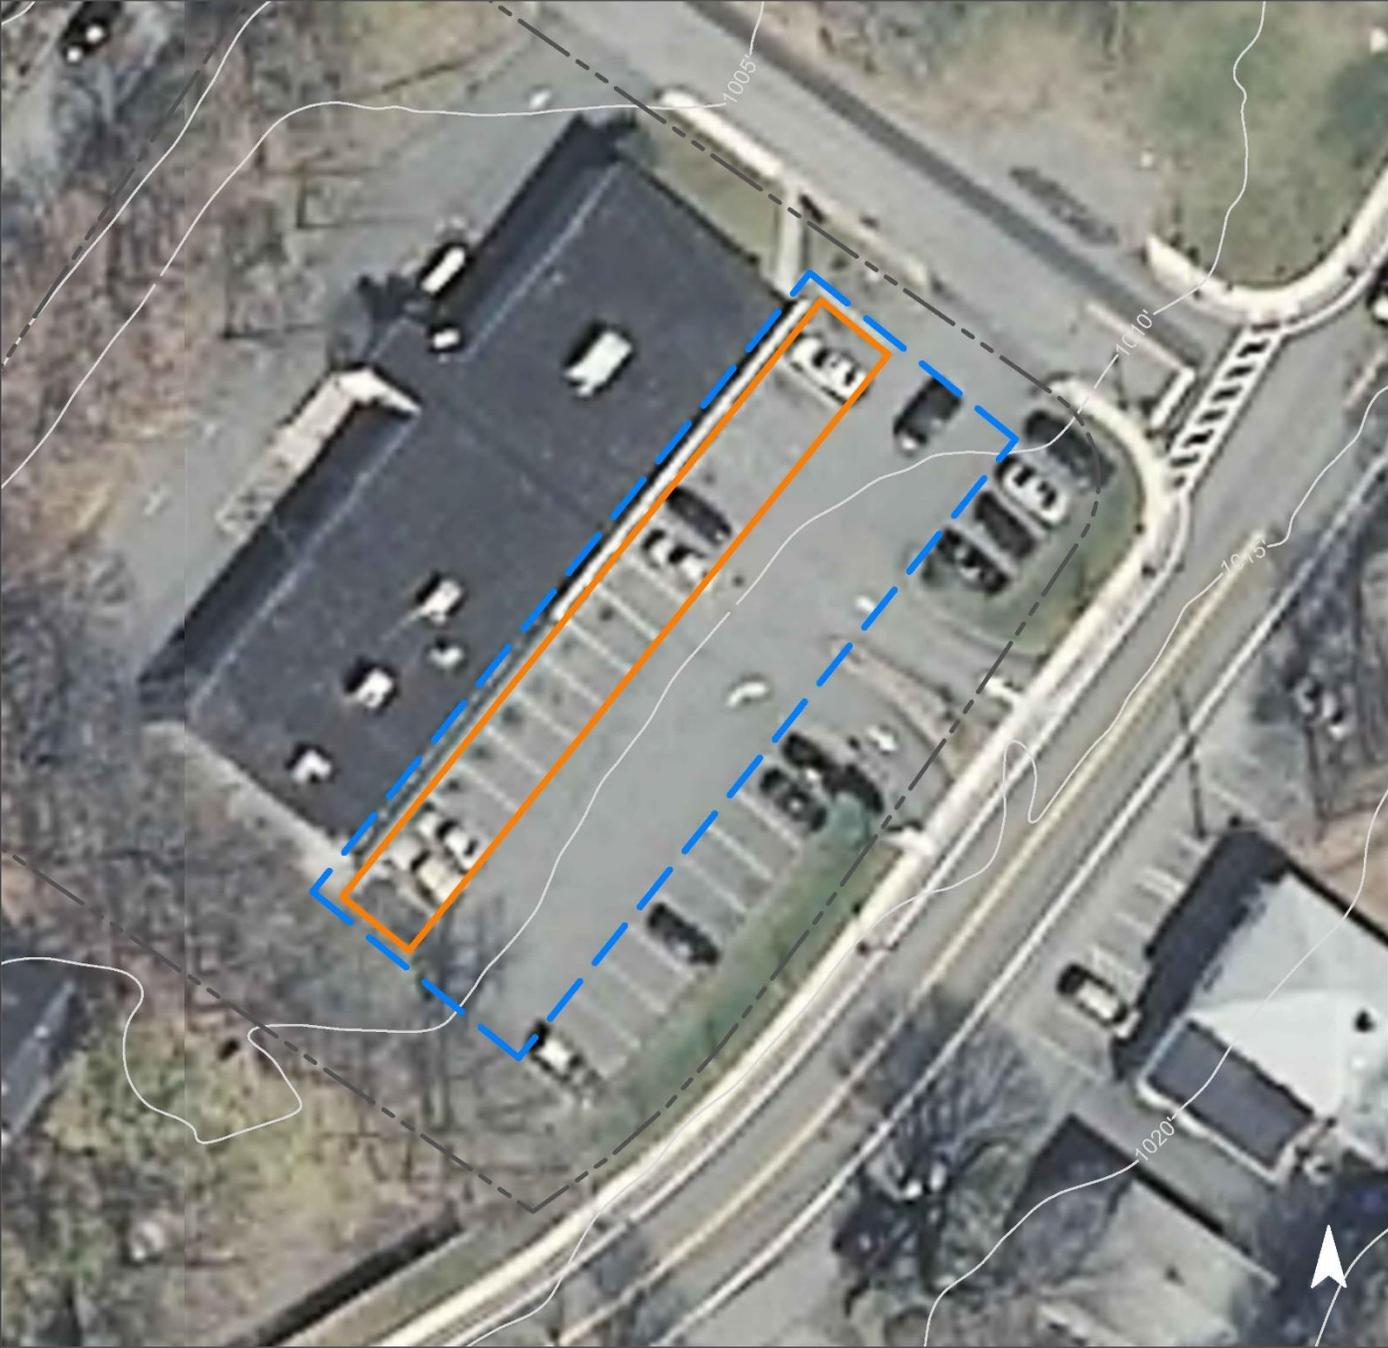
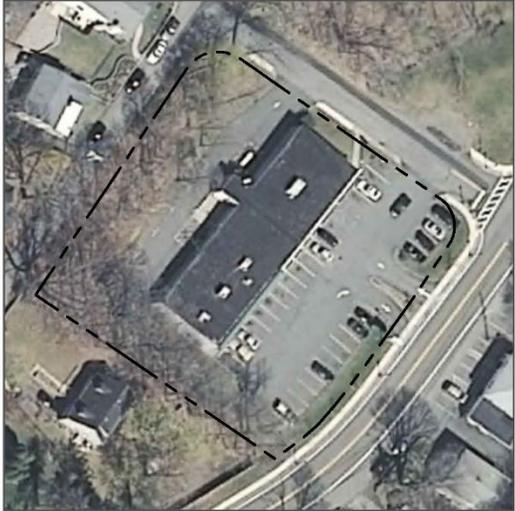
Mount Arlington Post Office

GREEN INFRASTRUCTURE RECOMMENDATIONS

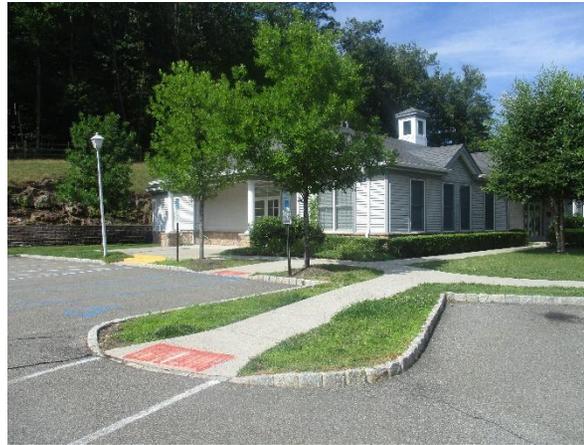
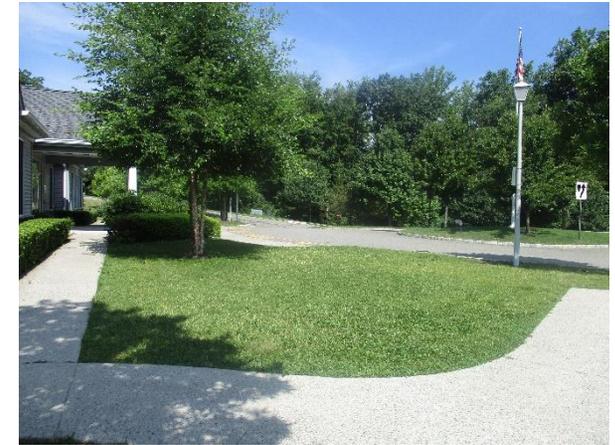
The parking spaces could be replaced with porous asphalt to manage runoff from the parking lot. A bioretention system can be implemented in the grass area near the northeast corner of the library, and a second bioretention system can be implemented in the southeast corner of the building. Bioretention systems and porous pavement can be installed to capture, treat, and infiltrate stormwater runoff. A preliminary soil assessment suggests that the soils have suitable drainage characteristics for green infrastructure.

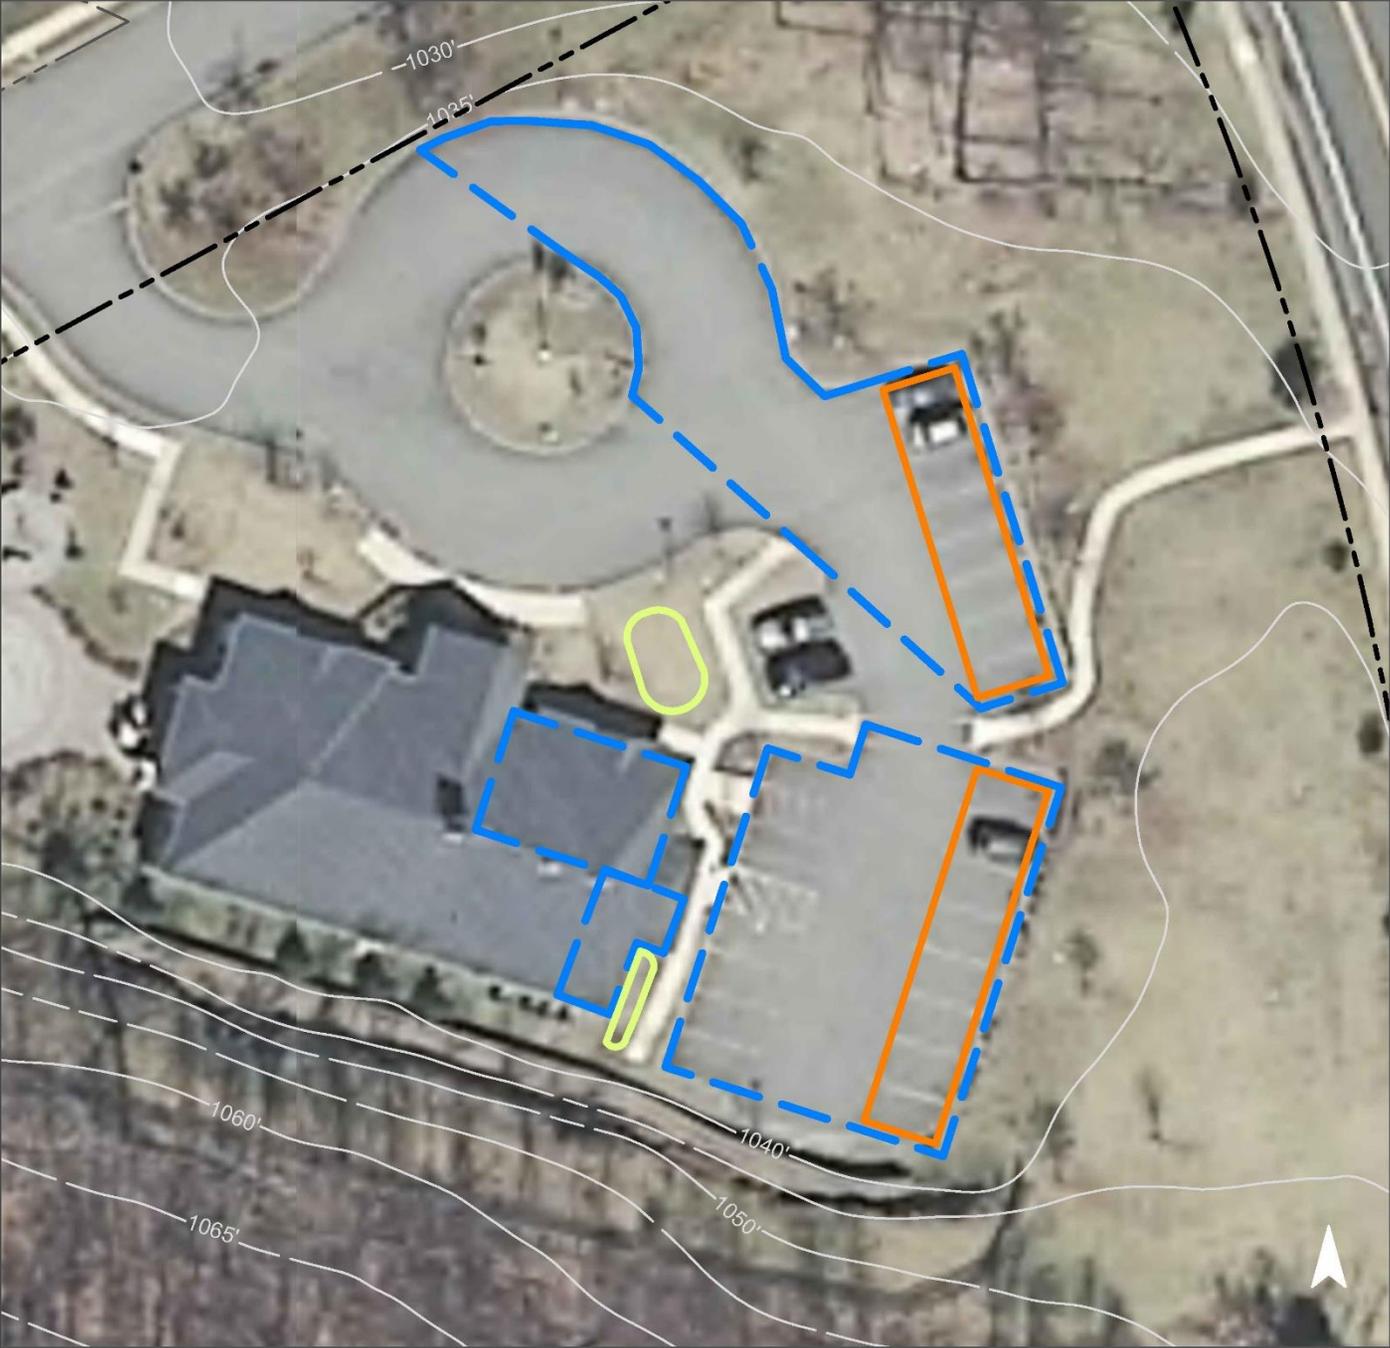
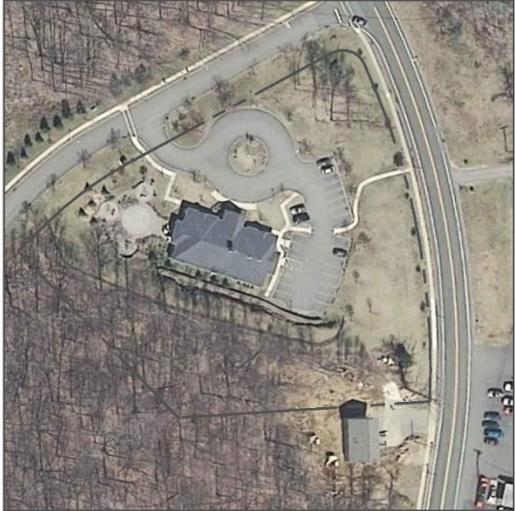
Mount Arlington Public Library

GREEN INFRASTRUCTURE RECOMMENDATIONS

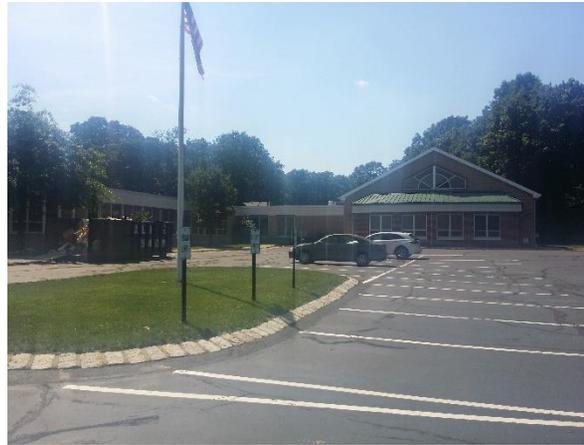
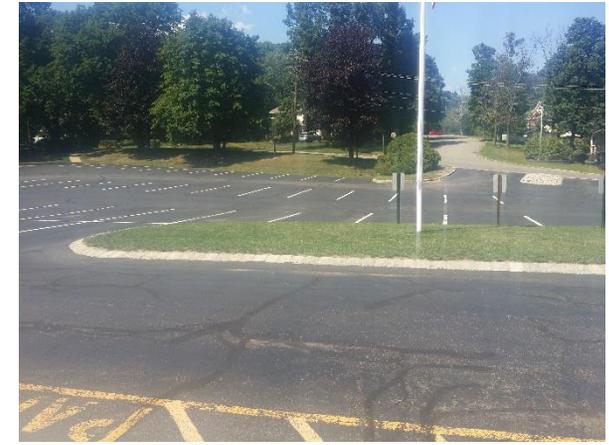
A large amount of runoff is generated by the parking lot during storm events. Multiple strips of parking spaces can be replaced with pervious pavement to capture and infiltrate stormwater. Additional runoff can be managed by implementing a rain garden in the island located in the front parking lot. A preliminary soil assessment suggests that the soils have suitable drainage characteristics for green infrastructure.

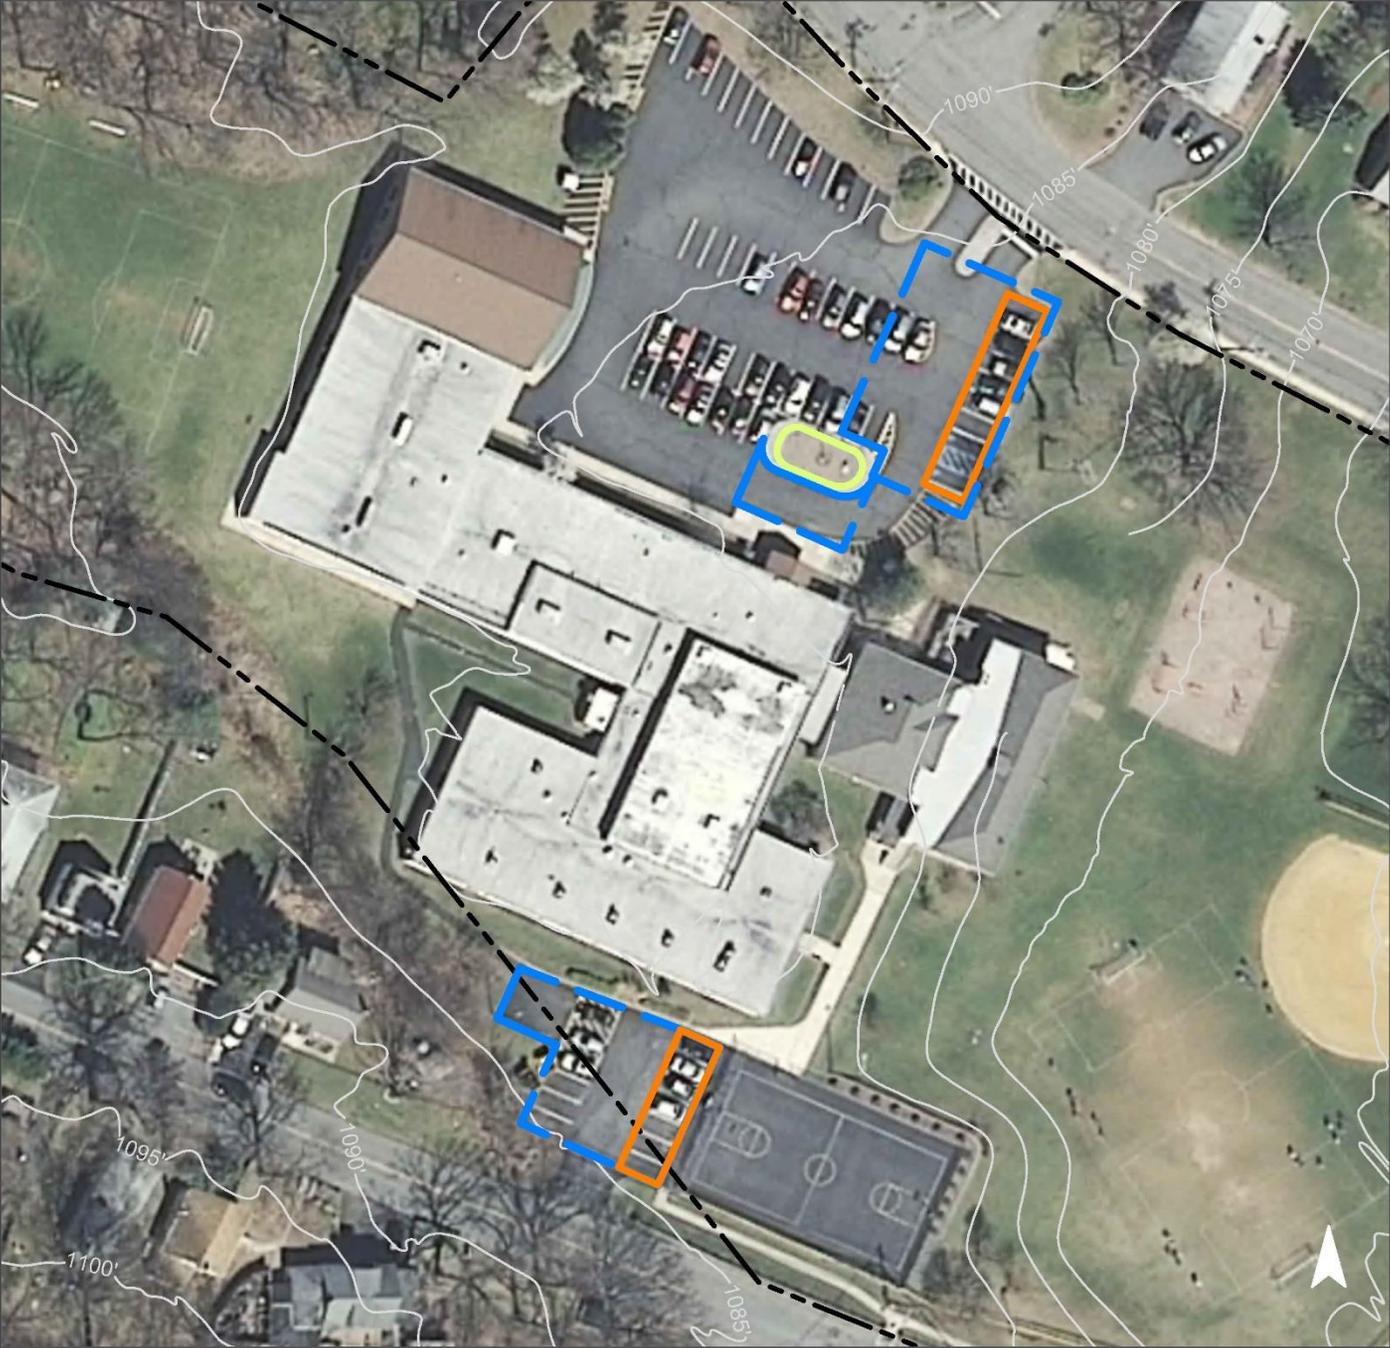
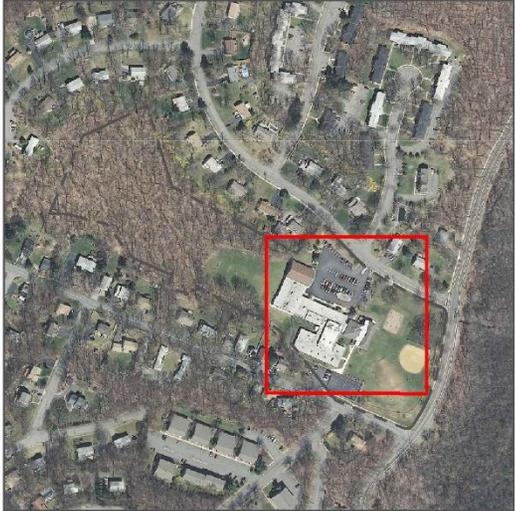
Mount Arlington Public School

GREEN INFRASTRUCTURE RECOMMENDATIONS

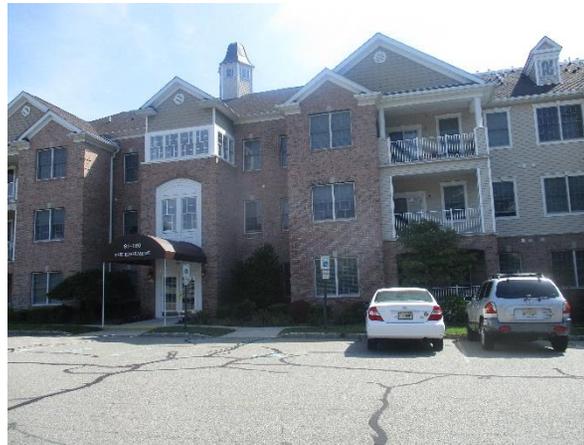
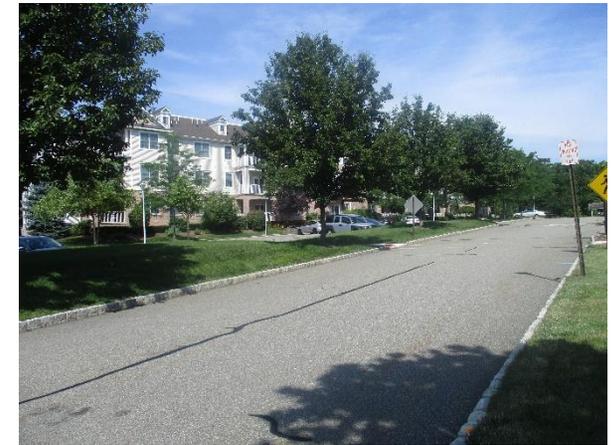
A large amount of runoff is generated by the parking lot and the buildings during storm events. Sections of parking spaces can be replaced with pervious pavement to capture, treat, and infiltrate runoff from roofs and the parking lot. Rain gardens can be implemented in the grass islands and alongside buildings. A preliminary soil assessment suggests that the soils have suitable drainage characteristics for green infrastructure.

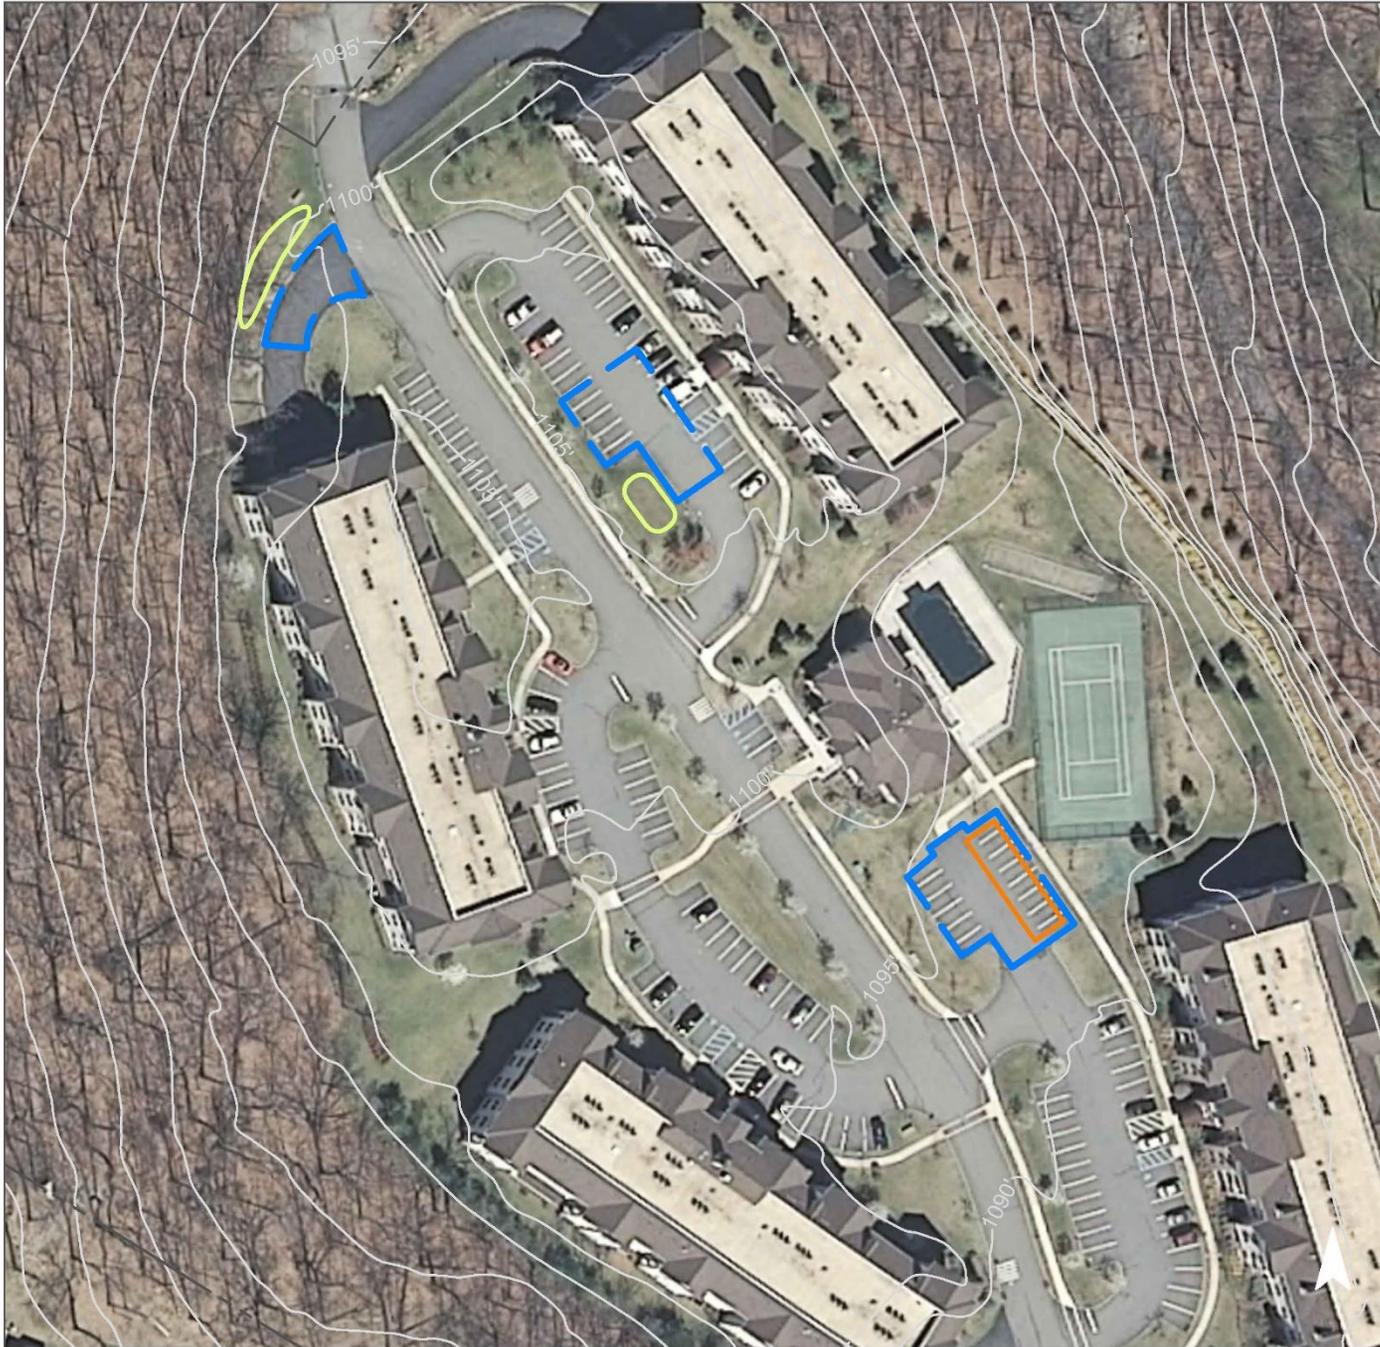
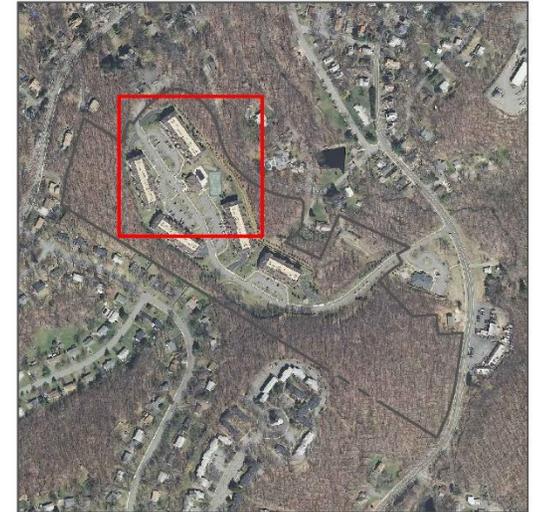
Ridgeview Lane

GREEN INFRASTRUCTURE RECOMMENDATIONS

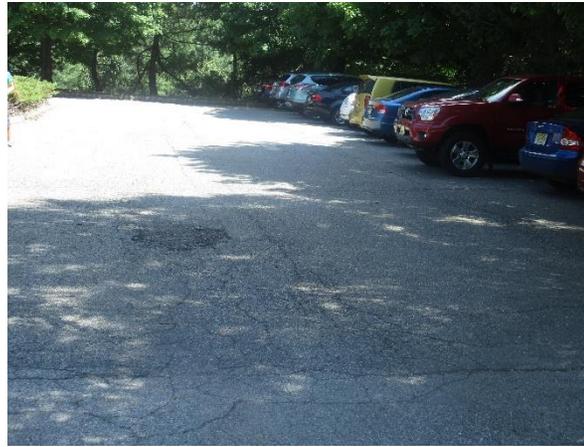
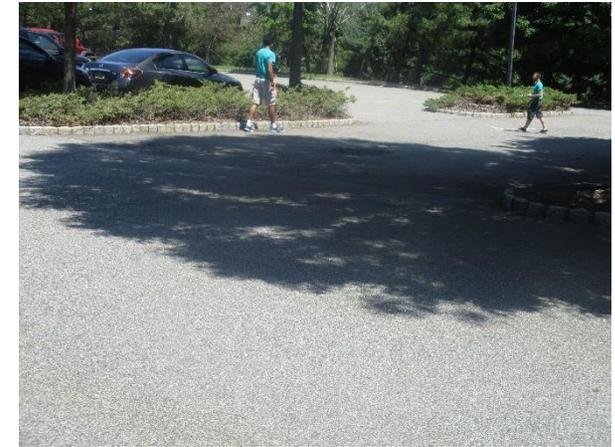
A large amount of runoff is generated by the parking lot during storm events. Two large sections of parking spaces can be replaced with pervious pavement to manage the majority of this runoff. A preliminary soil assessment suggests that more soil testing would be required before determining the soil's suitability for green infrastructure.

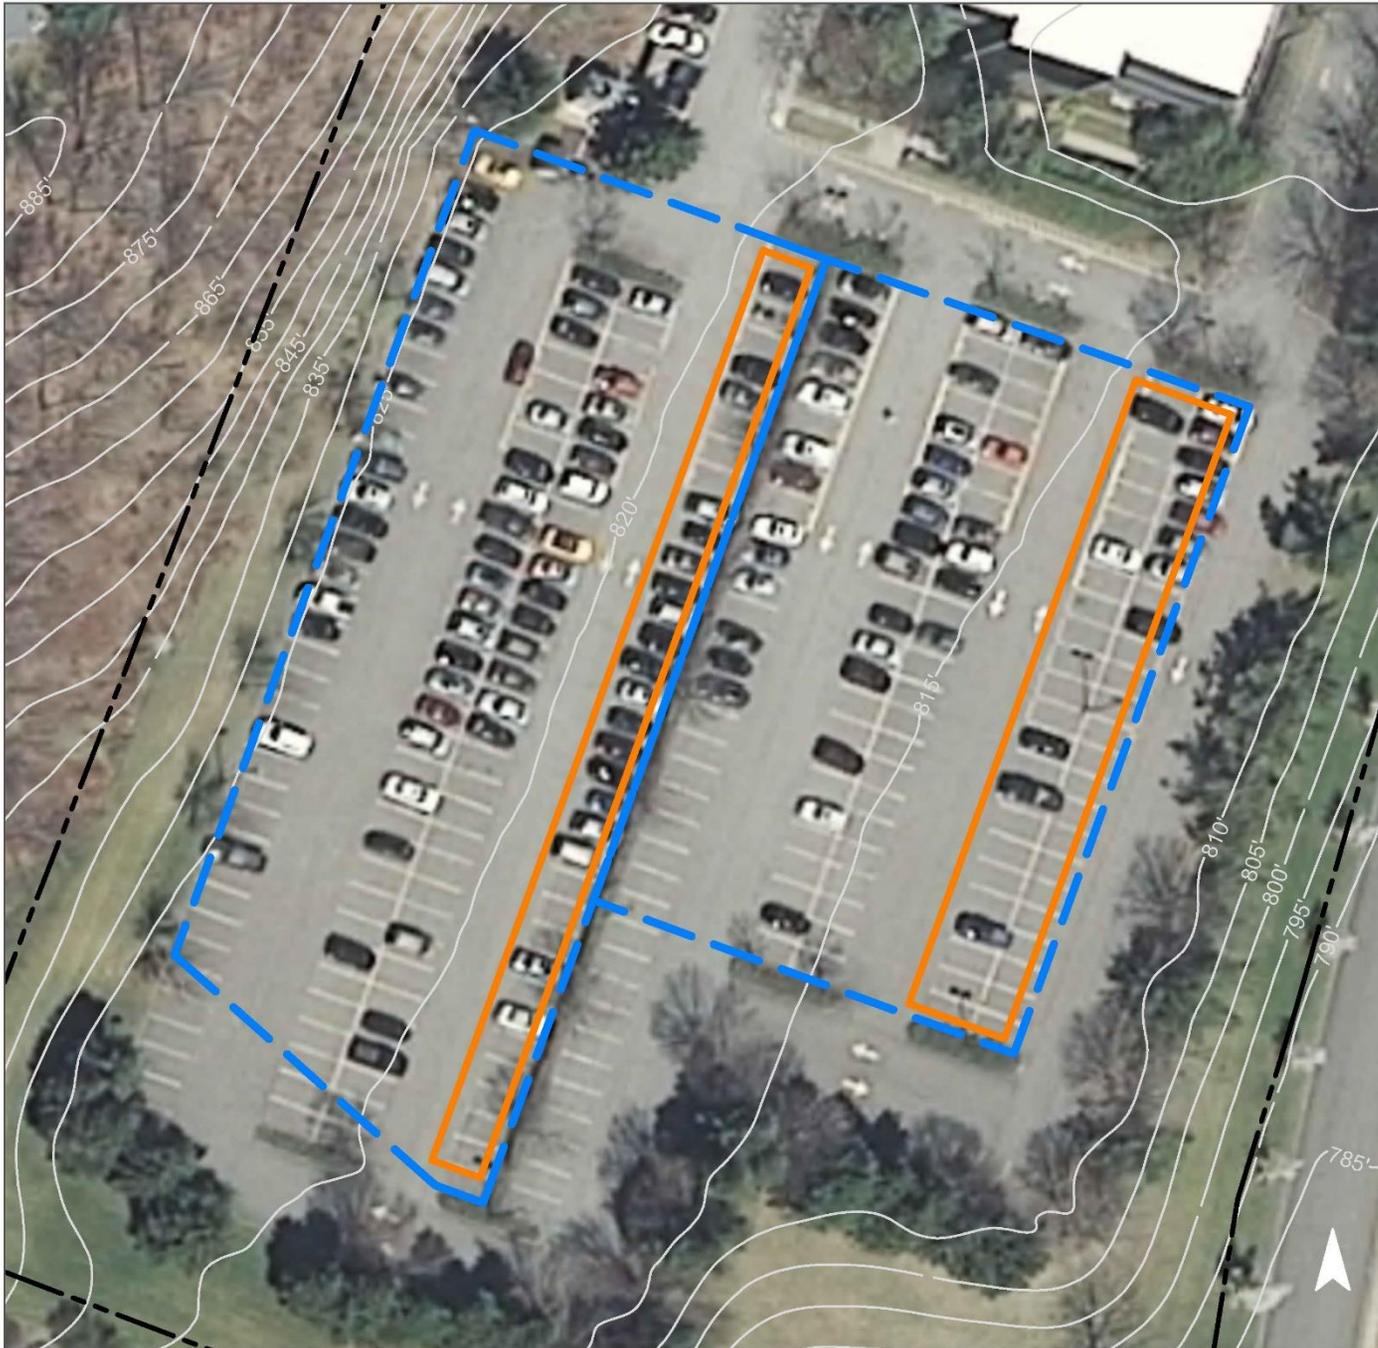
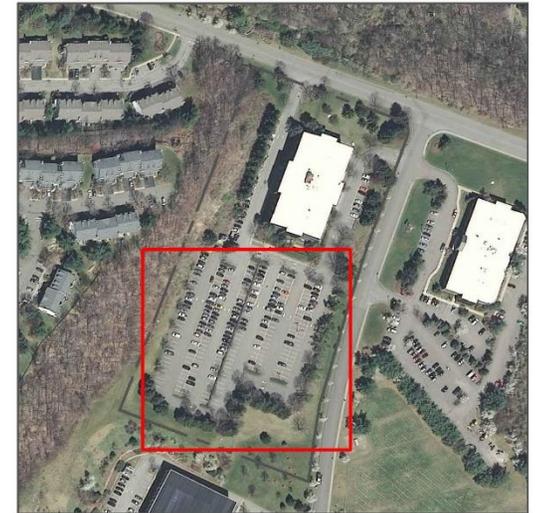
**Caring Partners - Morris
Sussex**

GREEN INFRASTRUCTURE RECOMMENDATIONS

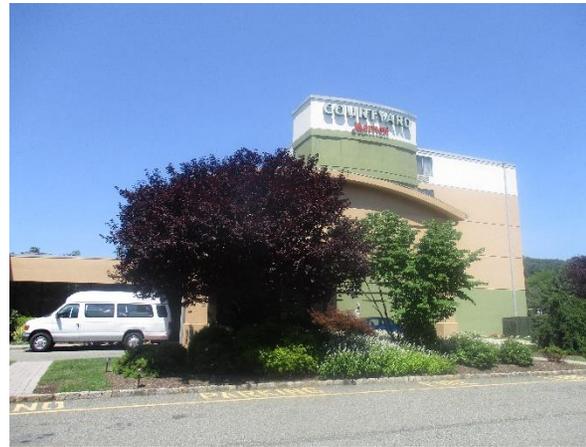
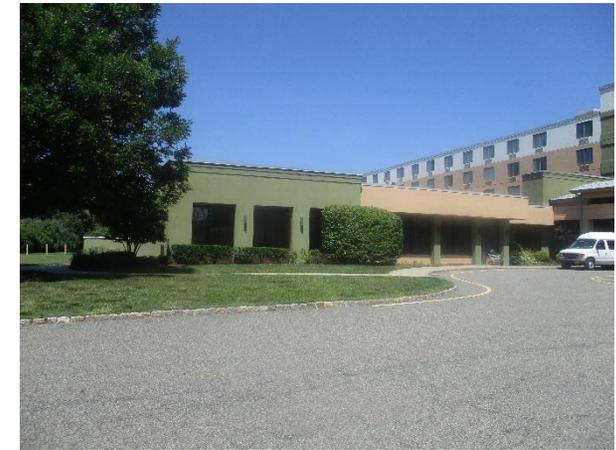
A large amount of runoff is generated by the parking lot during storm events. Most of the parking spaces can be replaced with pervious pavement to efficiently manage this stormwater runoff. Two rain gardens can be installed in the grass area along the west side of the building to capture, treat, and infiltrate stormwater runoff from the driveway. A preliminary soil assessment suggests that more soil testing would be required before determining the soil's suitability for green infrastructure.

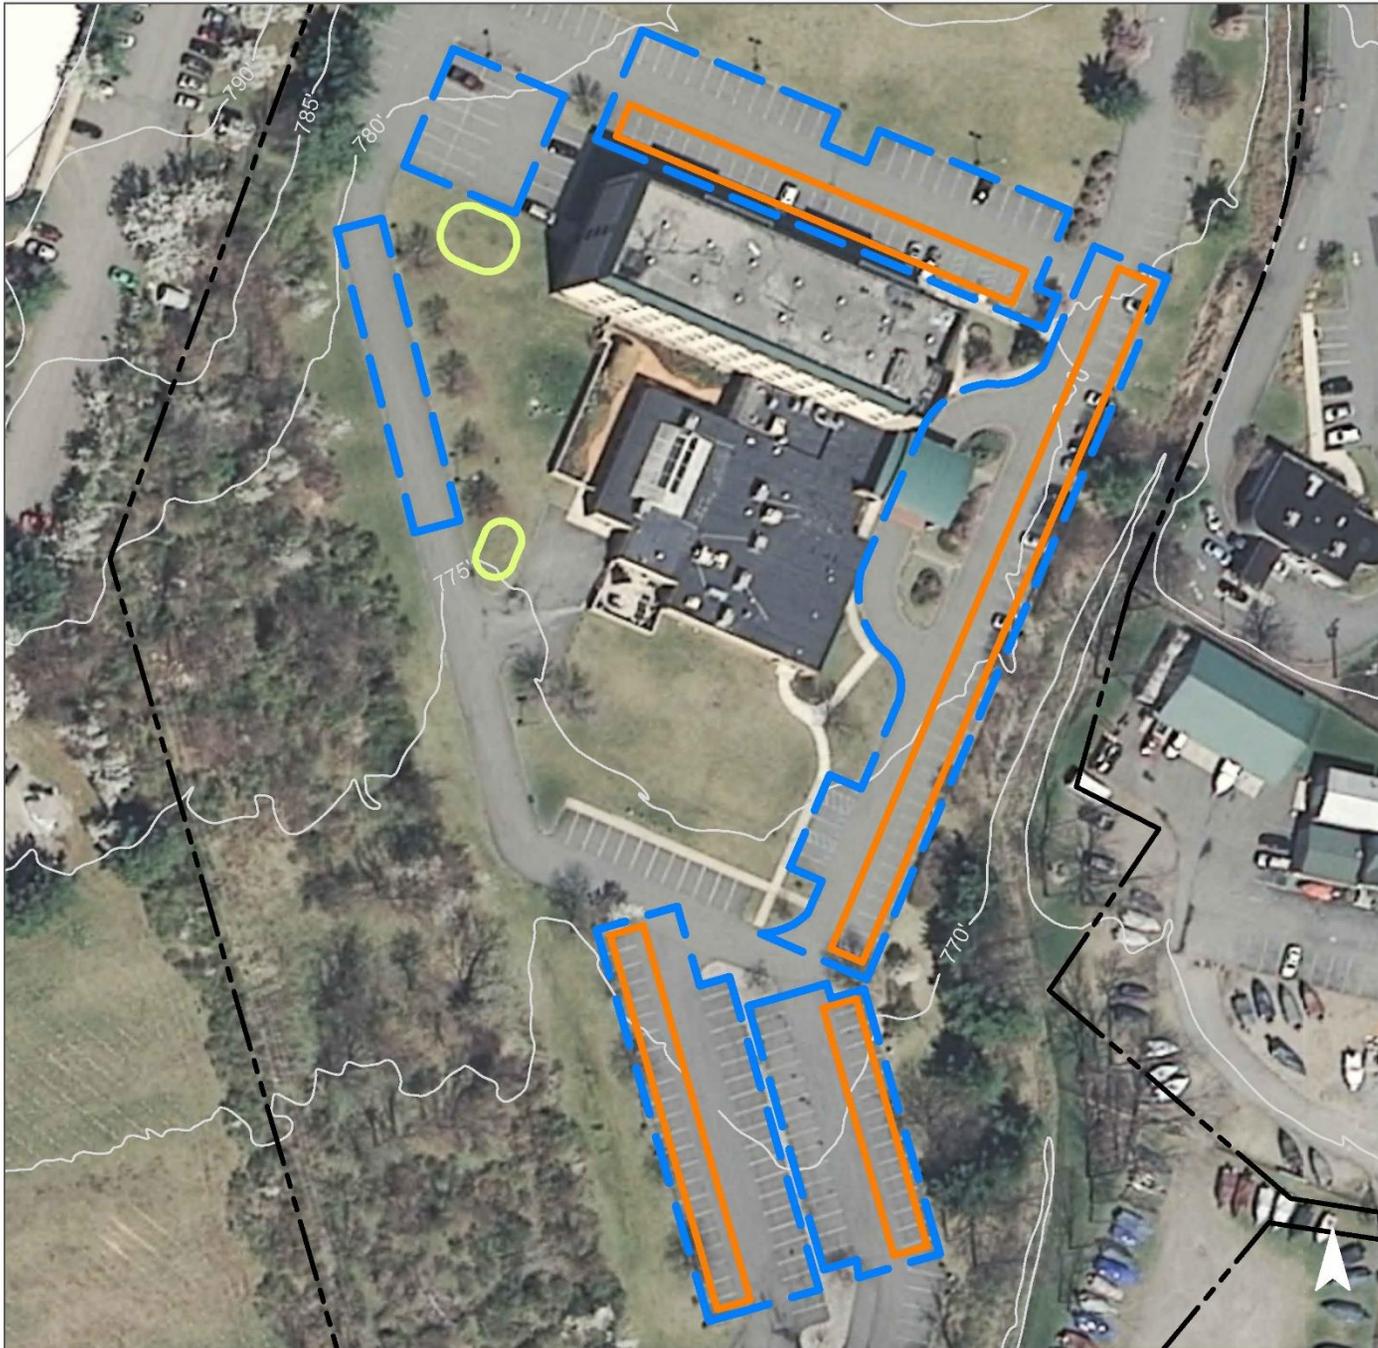
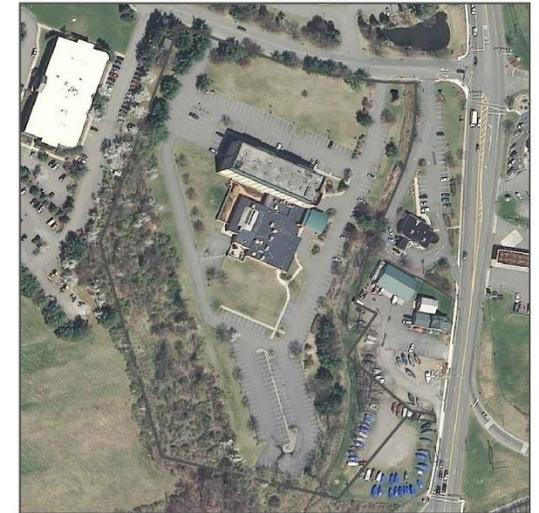
**Courtyard Rockaway -
Mount Arlington**

GREEN INFRASTRUCTURE RECOMMENDATIONS

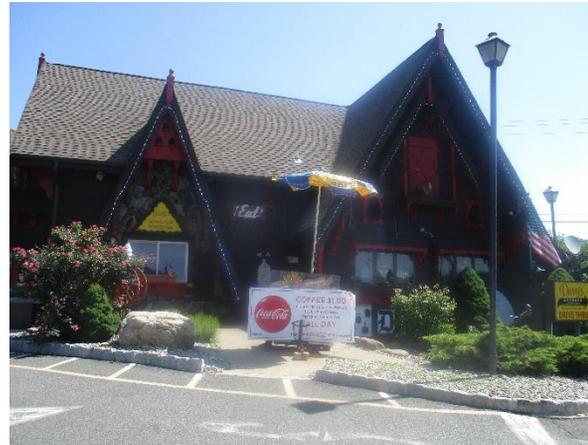
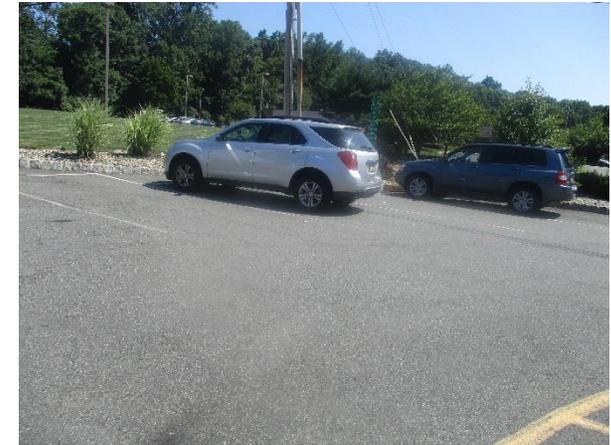
A large amount of runoff is generated by the parking lot during storm events. Parking spaces along the west and south sides of the building can be replaced with pervious pavement to manage this stormwater runoff. A preliminary soil assessment suggests that the soils have suitable drainage characteristics for green infrastructure.

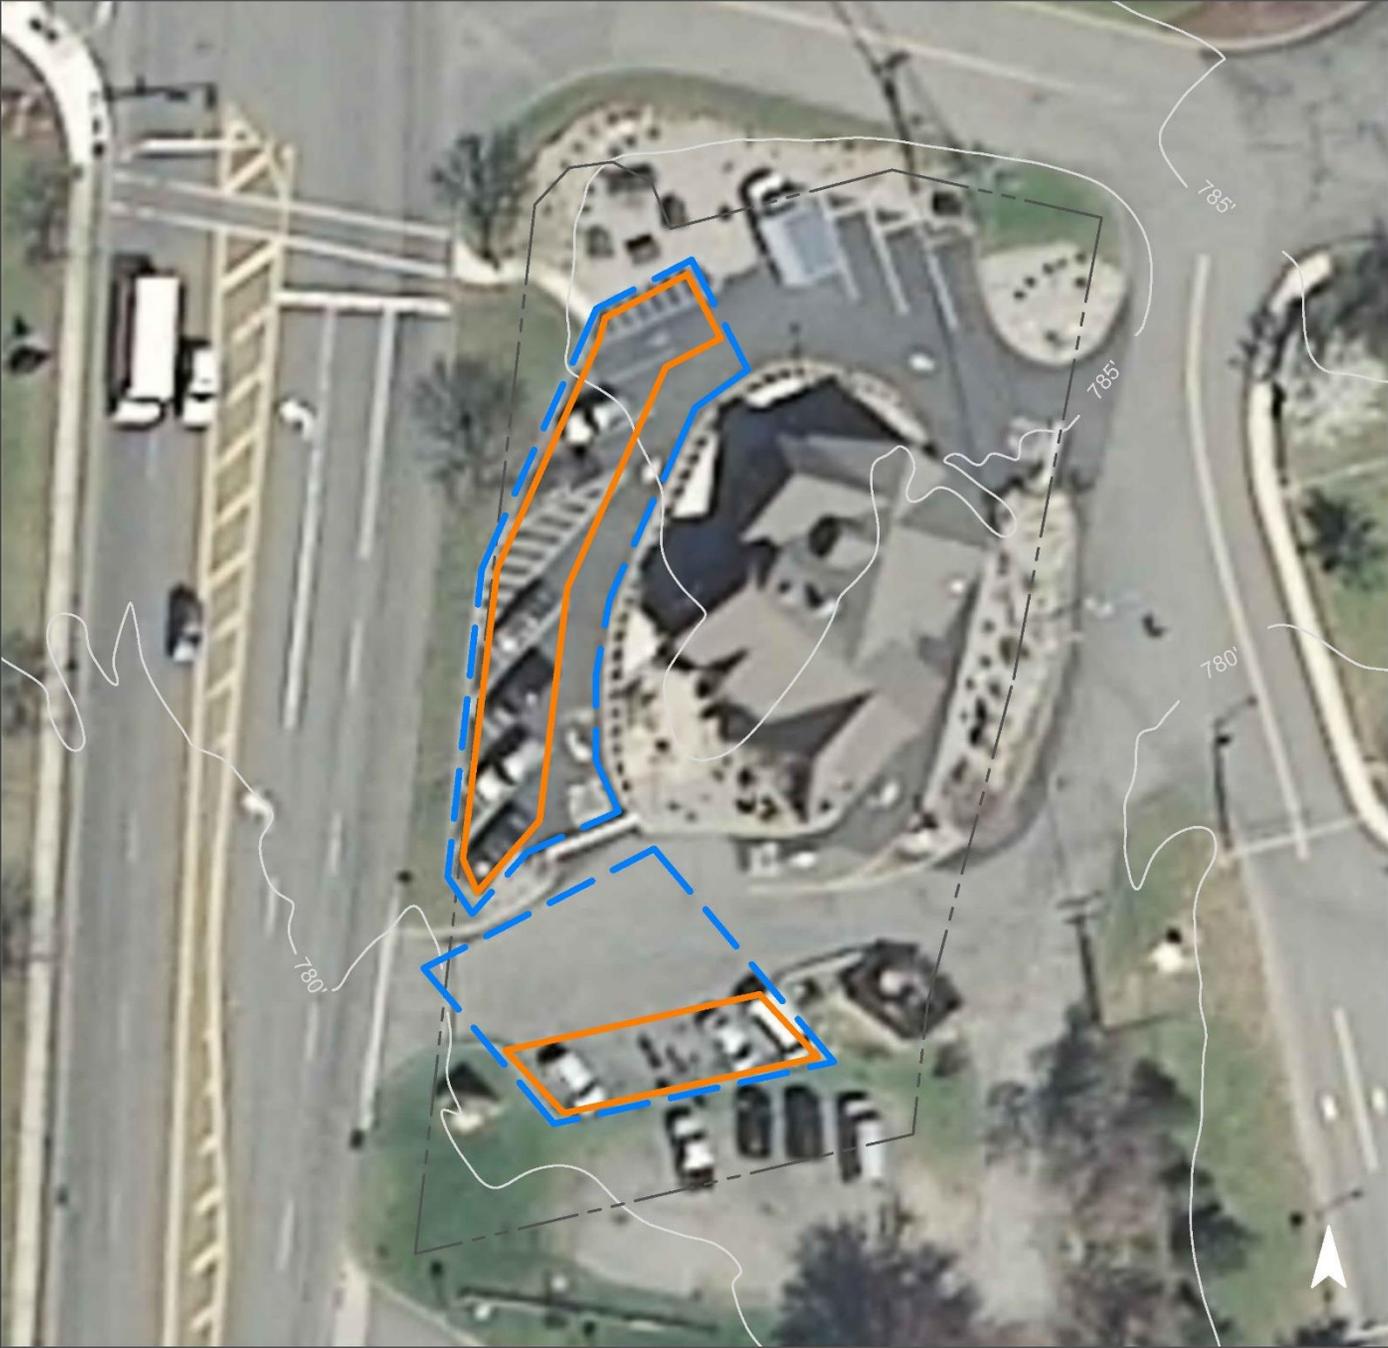
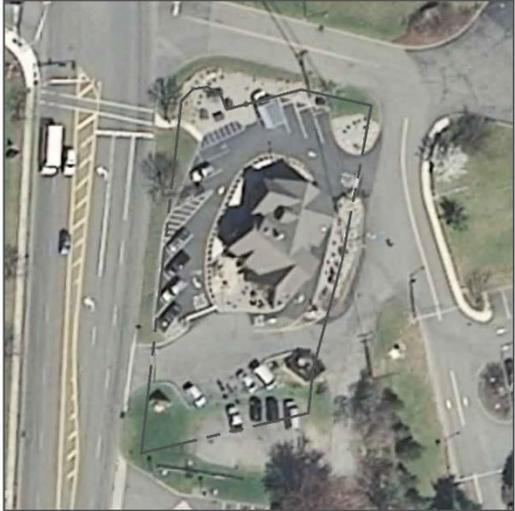
Davy's Dogs

GREEN INFRASTRUCTURE RECOMMENDATIONS

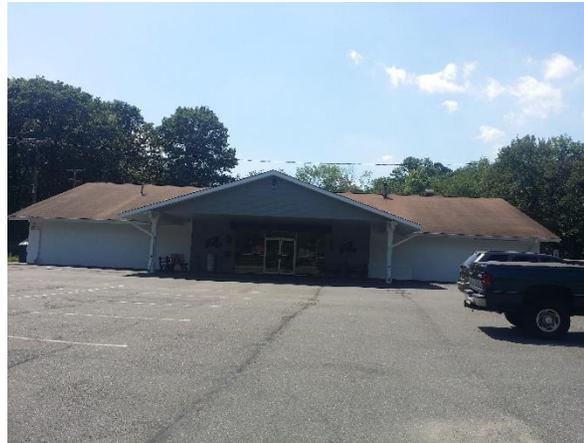
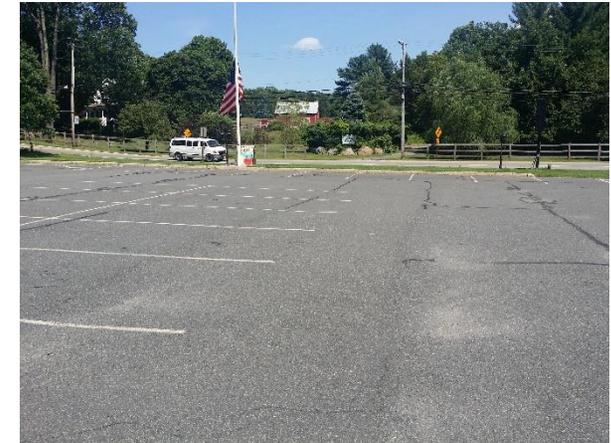
A large amount of runoff is generated from Howard Boulevard during storm events. A bioretention system can be implemented in the grass area along the road, and a curb cut will allow this system to capture, treat, and infiltrate stormwater runoff before it reaches the catch basin. A preliminary soil assessment suggests that the soils have suitable drainage characteristics for green infrastructure.

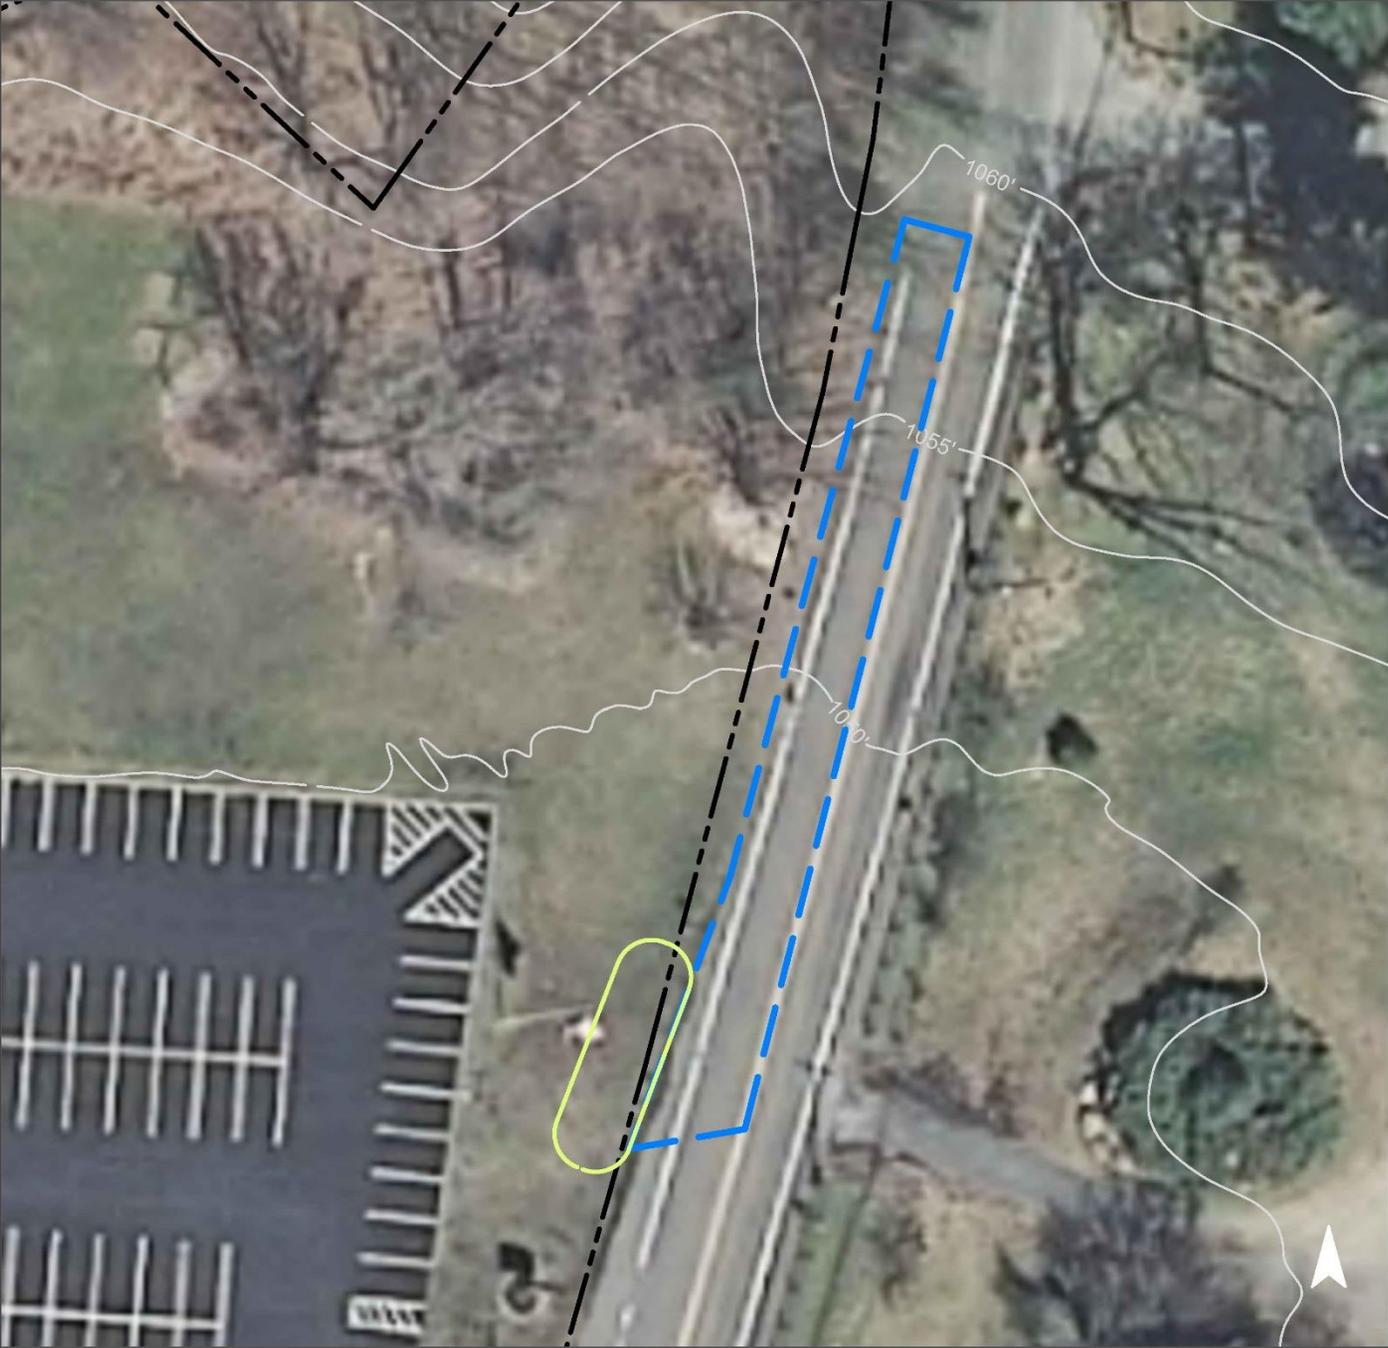
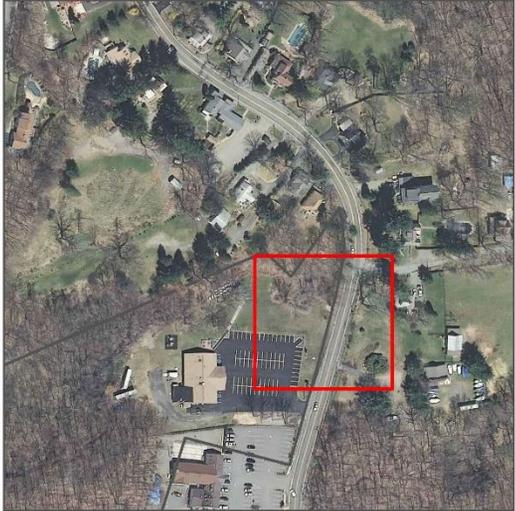
Elks Lodge

GREEN INFRASTRUCTURE RECOMMENDATIONS

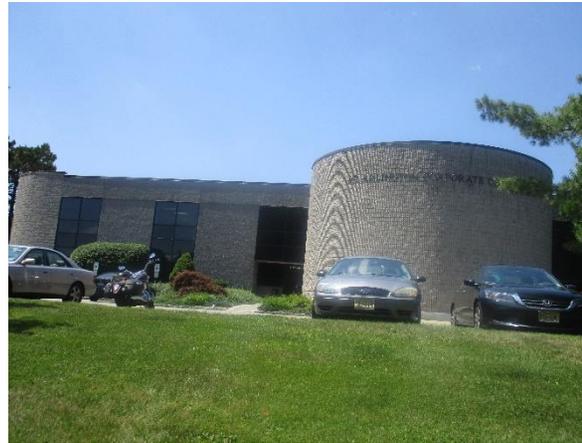
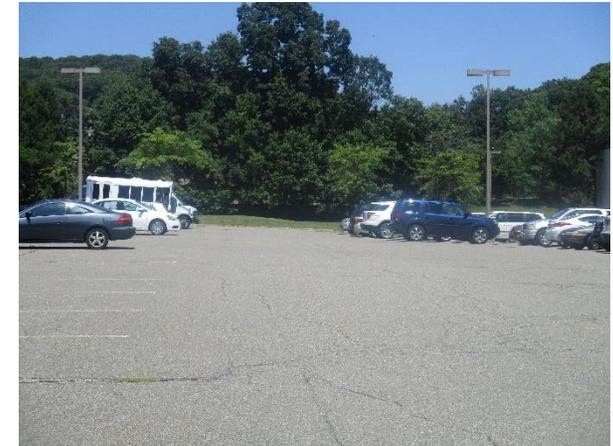
A large amount of runoff is generated by the parking lot during storm events. Most of the parking spaces can be replaced with pervious pavement to efficiently manage this stormwater runoff. A preliminary soil assessment suggests that more soil testing would be required before determining the soil's suitability for green infrastructure.
