**Impervious Cover Reduction Action Plan
for
Mount Arlington Borough, Morris County, New Jersey**

*Prepared for Mount Arlington Borough by the
Rutgers Cooperative Extension Water Resources Program*

August 10, 2016

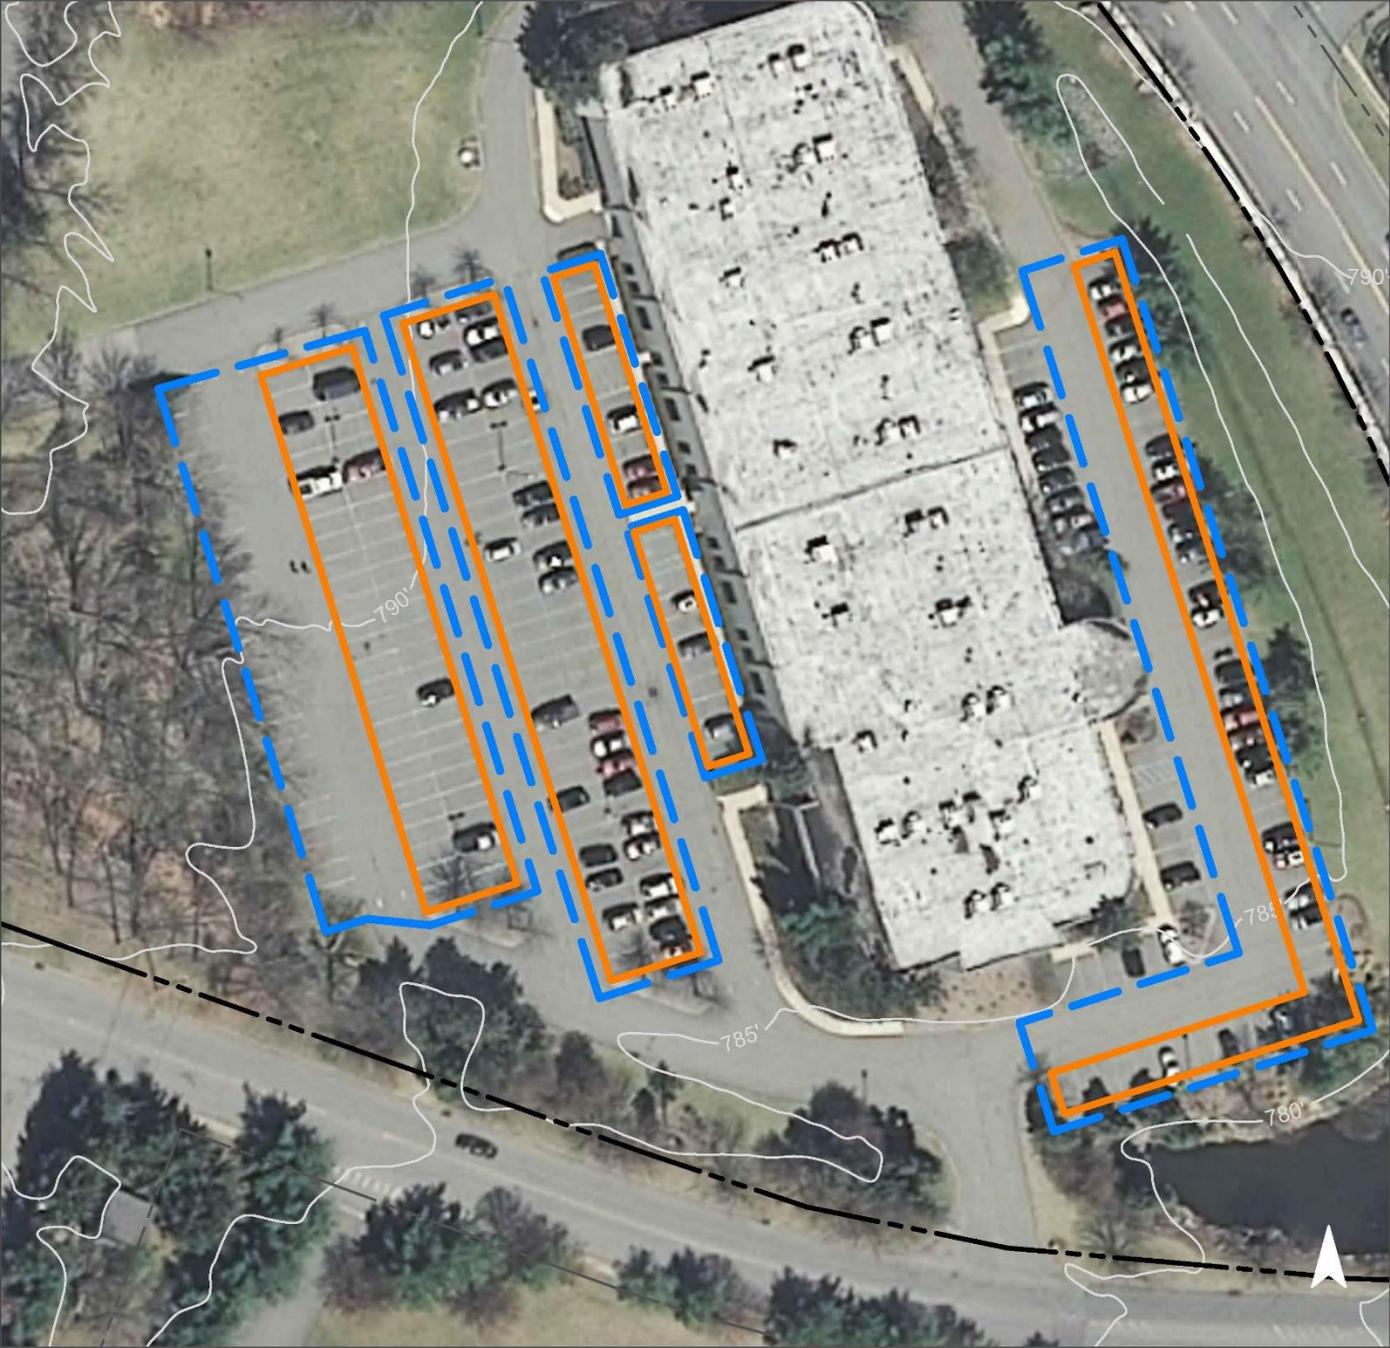
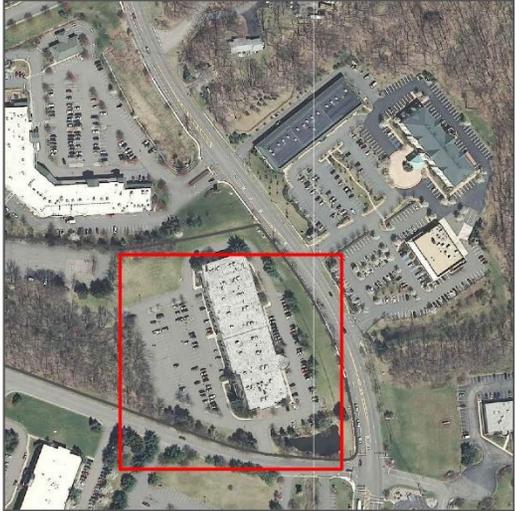
Guaranteed Rate of Mount Arlington

GREEN INFRASTRUCTURE RECOMMENDATIONS

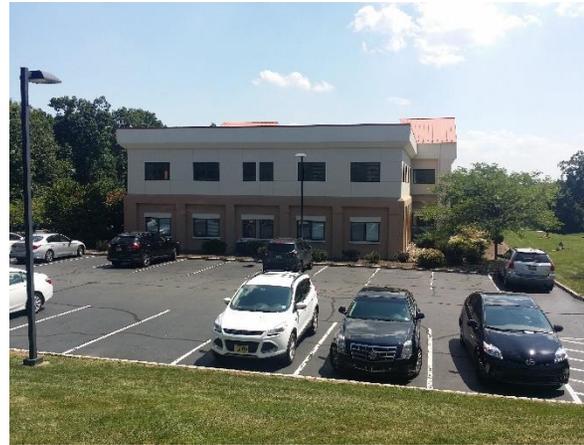
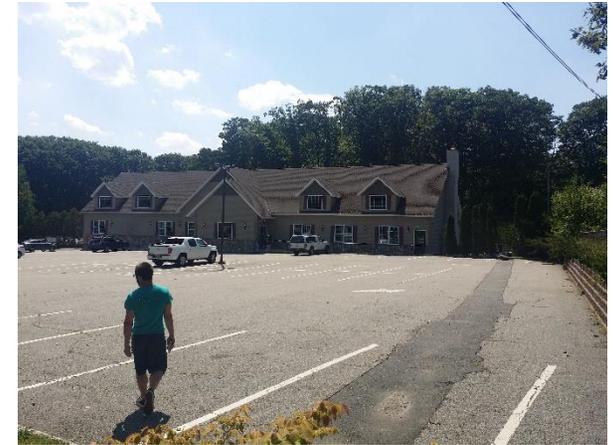
A bioretention system can be implemented in the grass area between the entrance of the parking lot and the building to capture, treat, and infiltrate stormwater runoff from the driveway. A preliminary soil assessment suggests that the soils have suitable drainage characteristics for green infrastructure.

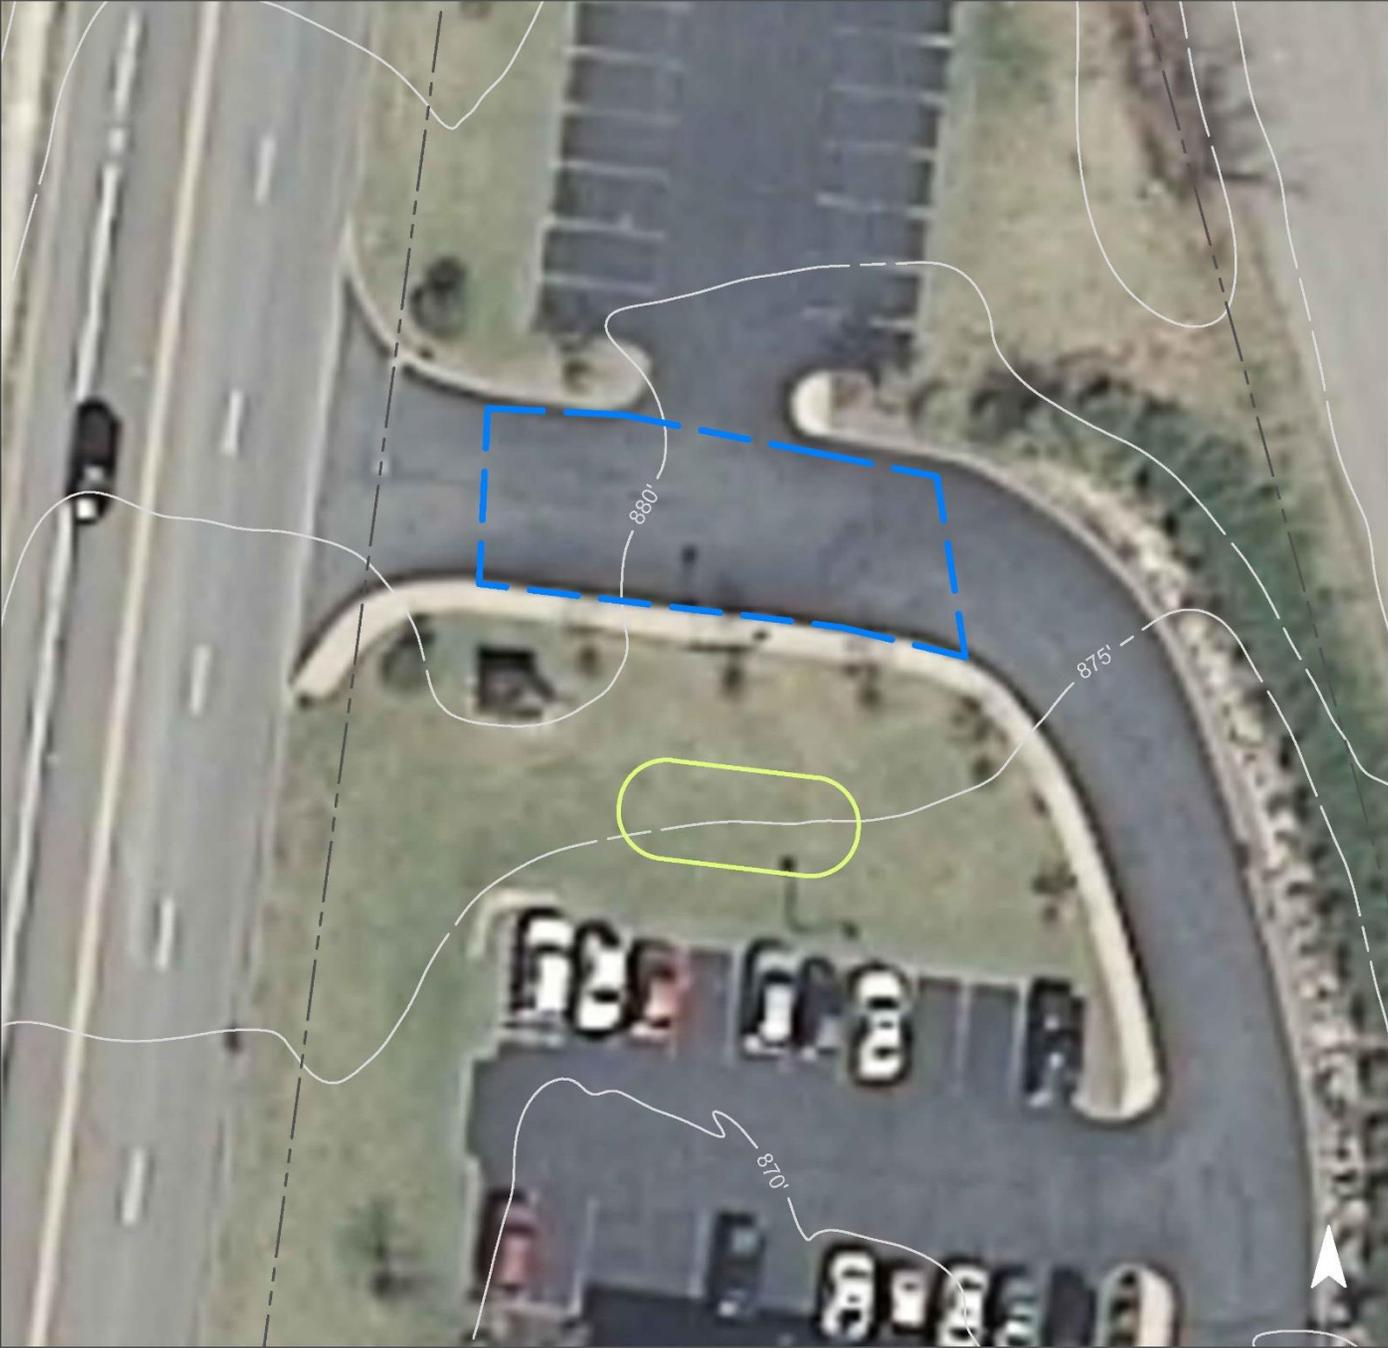
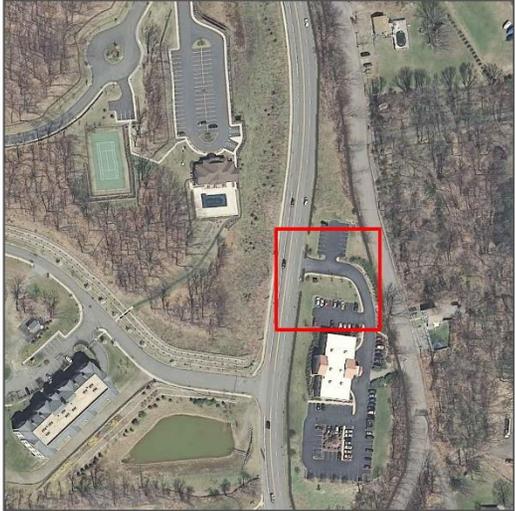
Professional Building

GREEN INFRASTRUCTURE RECOMMENDATIONS
