## Hamilton Township (Mercer County) Stormwater Outfall Assessment Summary 2023: North Pond Run (Region 2)

Developed by the Rutgers Cooperative Extension Water Resources Program  
Funded by Hamilton Township, Mercer County, New Jersey  
August 21, 2023

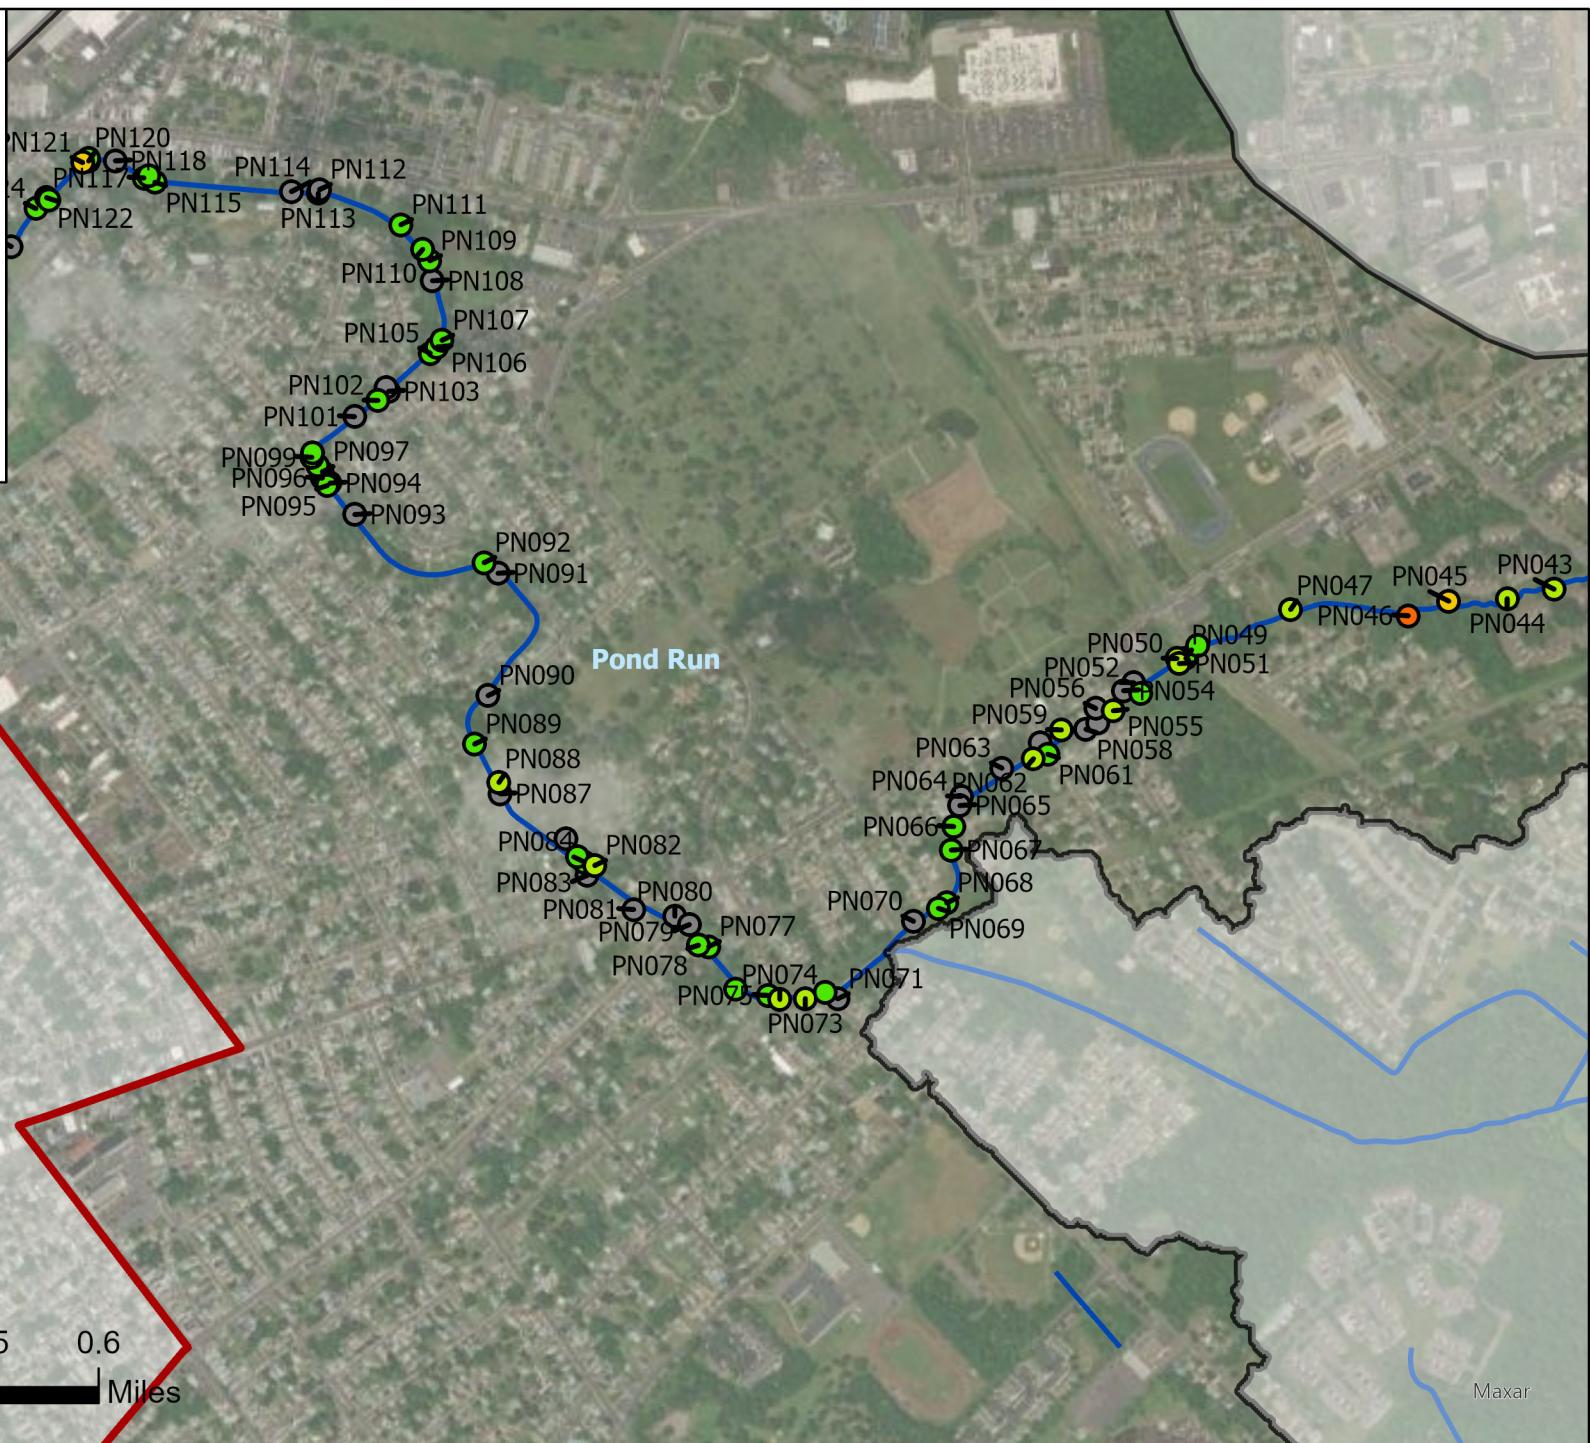
# Hamilton Outfall Region 2: Overall Priority West

- 1 - None
  - 2 - Low
  - 3 - Medium
  - 4 - High
  - 5 - Highest
  - Unassessed
- Hamilton Streams  
Hamilton Boundary

Detailed information about each outfall assessed can be found in the Tabular Data section of this document. There are a series of tables highlighting each priority criteria. Summary maps of this information can be found in the Summary Maps section. The data with images of the outfalls can also be viewed using the web map (<https://go.rutgers.edu/c1vpvcv2>). This is presented instead of the individual outfall assessment pages that were provided in previous reports to allow a more interactable version of these pages.

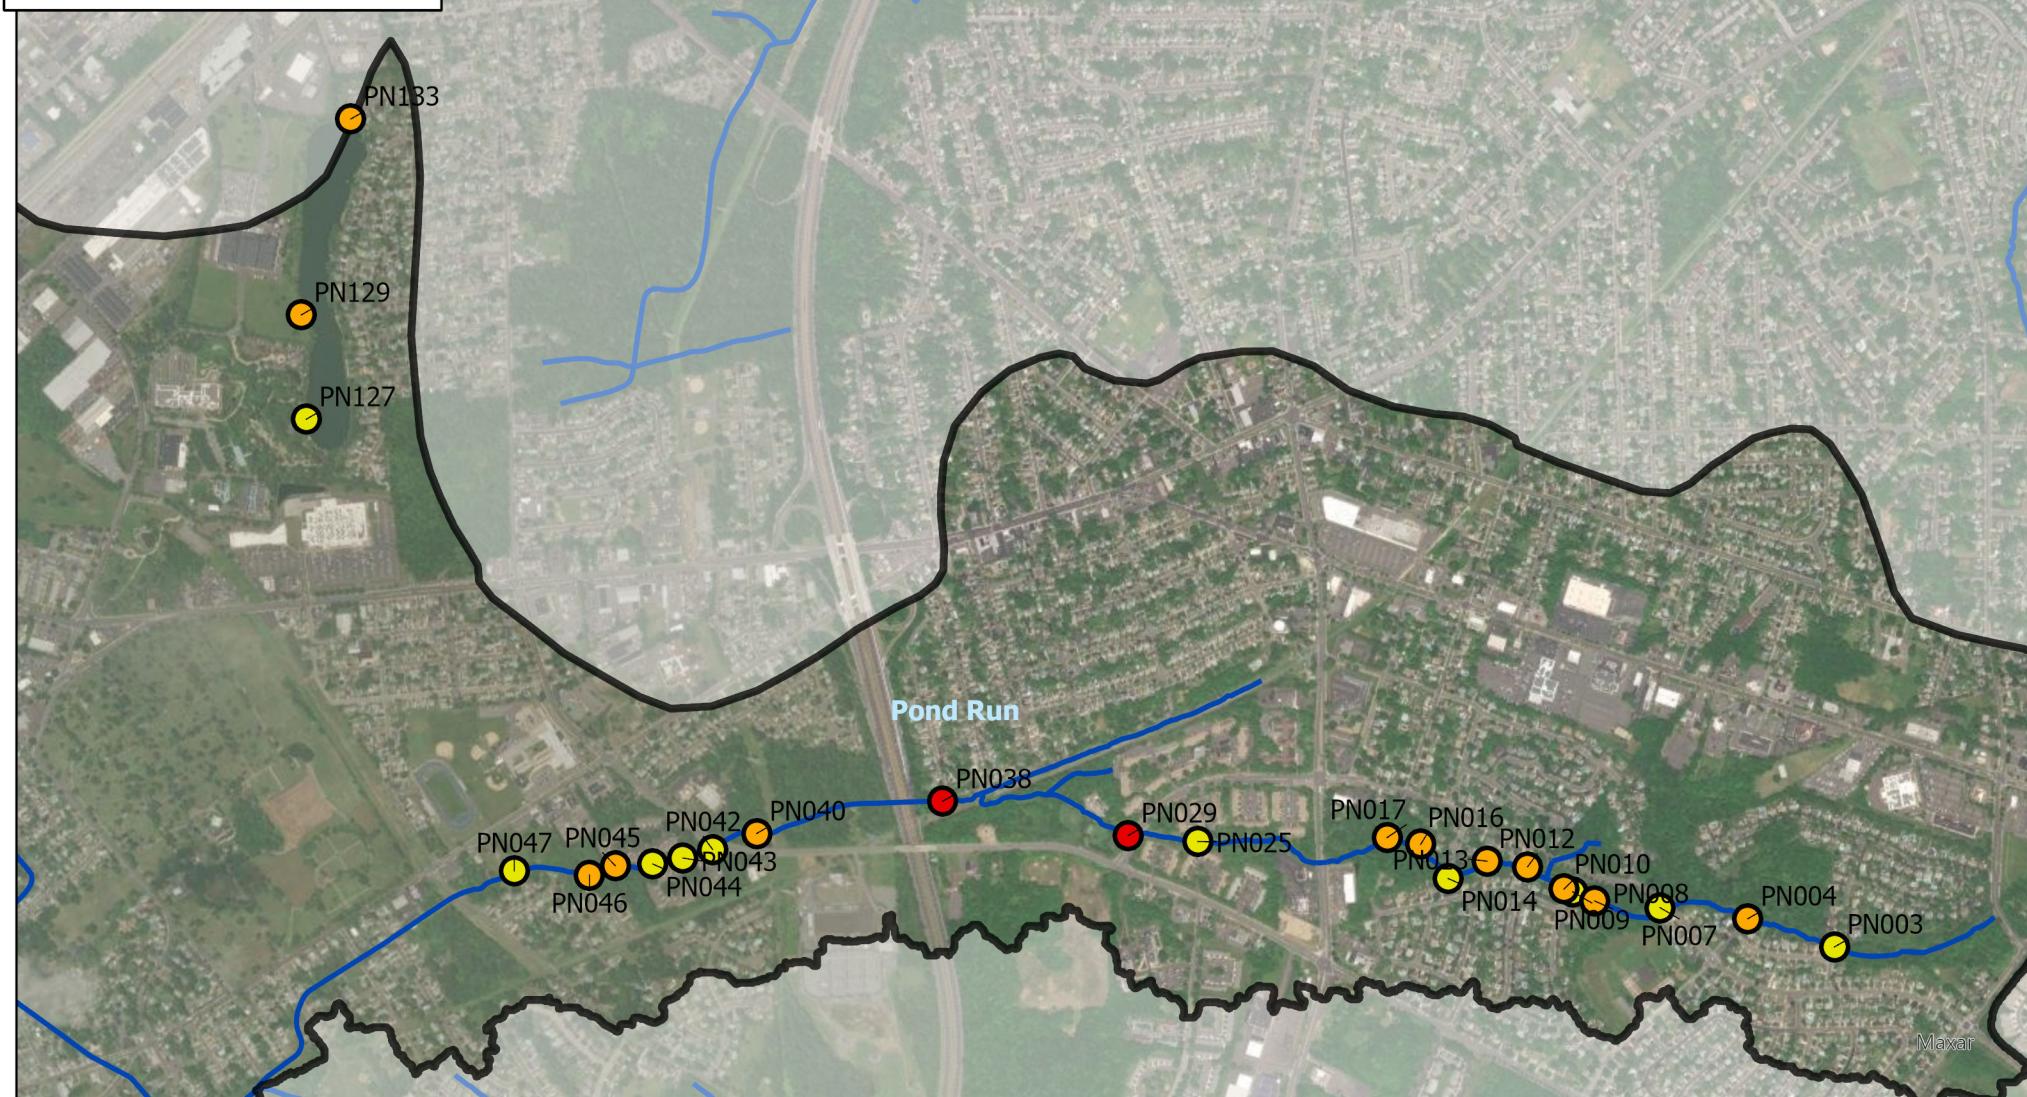
# Hamilton Outfall Region 2: Erosion

## Scour Severity

- Low (Yellow)
- Medium (Orange)
- High (Red)
- Hamilton Boundary (Black Line)
- Hamilton Streams (Blue Lines)
