# **MS4 Permit Requirements and Inspection/Maintenance of Stormwater Management Facilities**

**Presented to Hamilton Township**

Rutgers Cooperative Extension Water Resources Program  
Chris Obropta and Matt Leconey

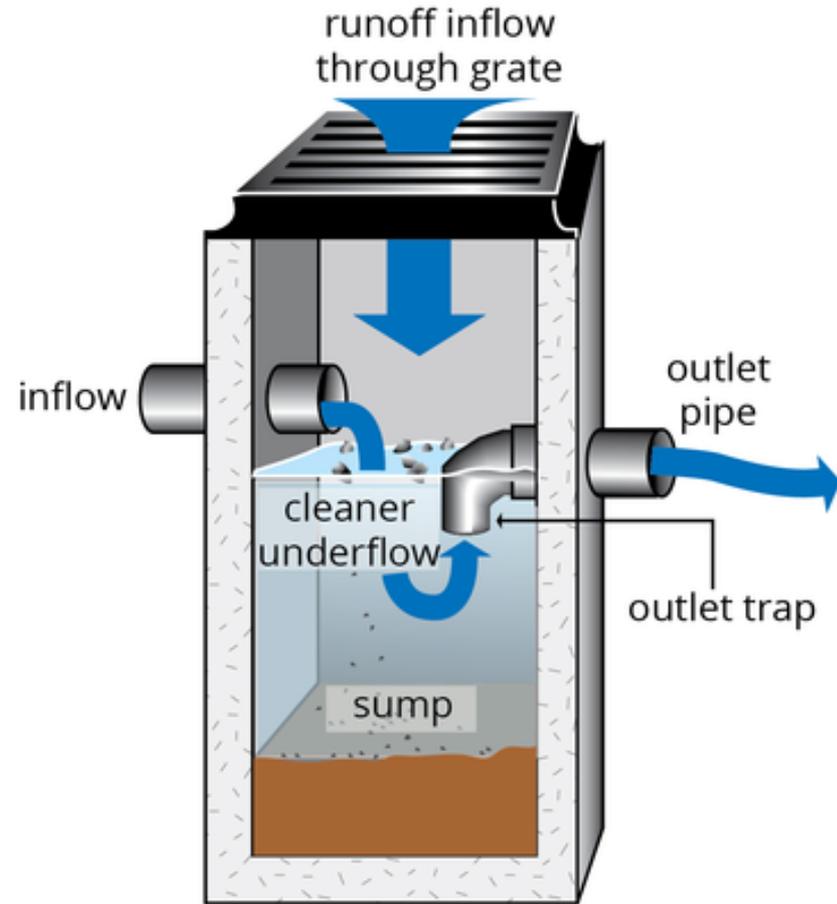
# Catch Basin Inspections

- “Storm drain inlet”
  - Grate surface
  - Inspected annually
  - Claim inspected during street sweeping, may need to inspect those not directly on the road separately
- “Catch basin”
  - The concrete vault below the street
  - Inspected once every five years

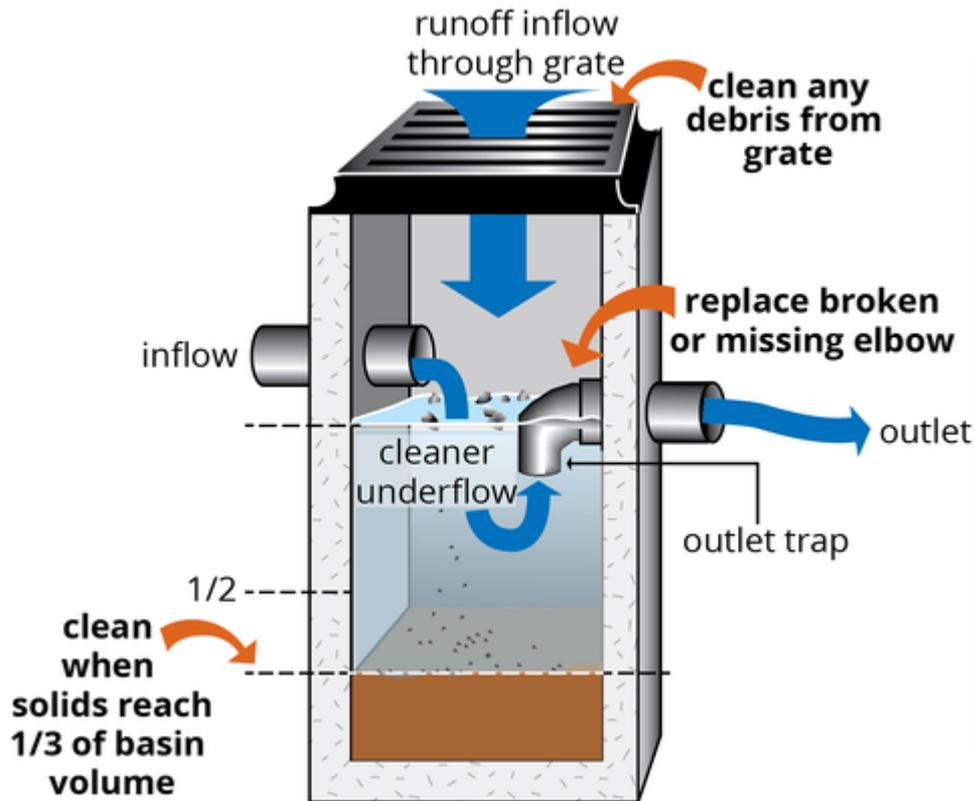
# Catch Basin Maintenance

- Clear vegetation or debris from basin surface
- Collect sediment from basin with vacuum truck
- Repair damaged structures

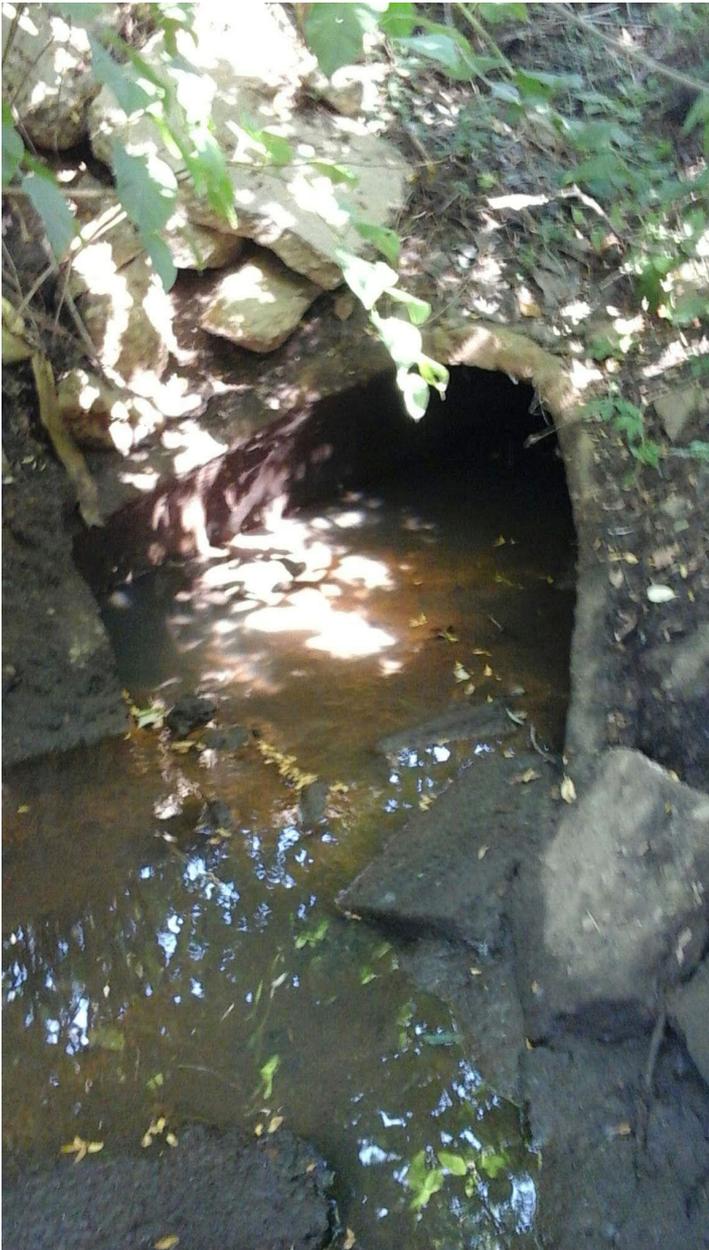
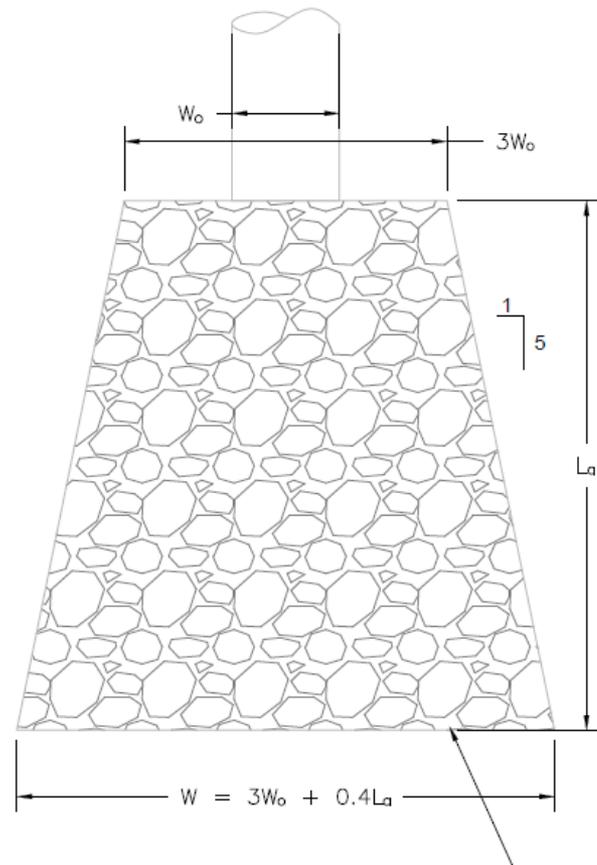
E606

## Rirap Apron

**TAILWATER  $\geq 0.5 D_o$**   
 $L_a = 1.8(q / D_o^{0.5}) + 7D_o$   
 $q = Q/W_o$

- Fix scouring problems per appropriate solutions
  - Riprap apron, scour hole, riprap channel, rock/gabion flume
  - Anything at High and Medium Erosion should be planned for repair prioritizing highest erosion first
  - Minor monitored in future inspection

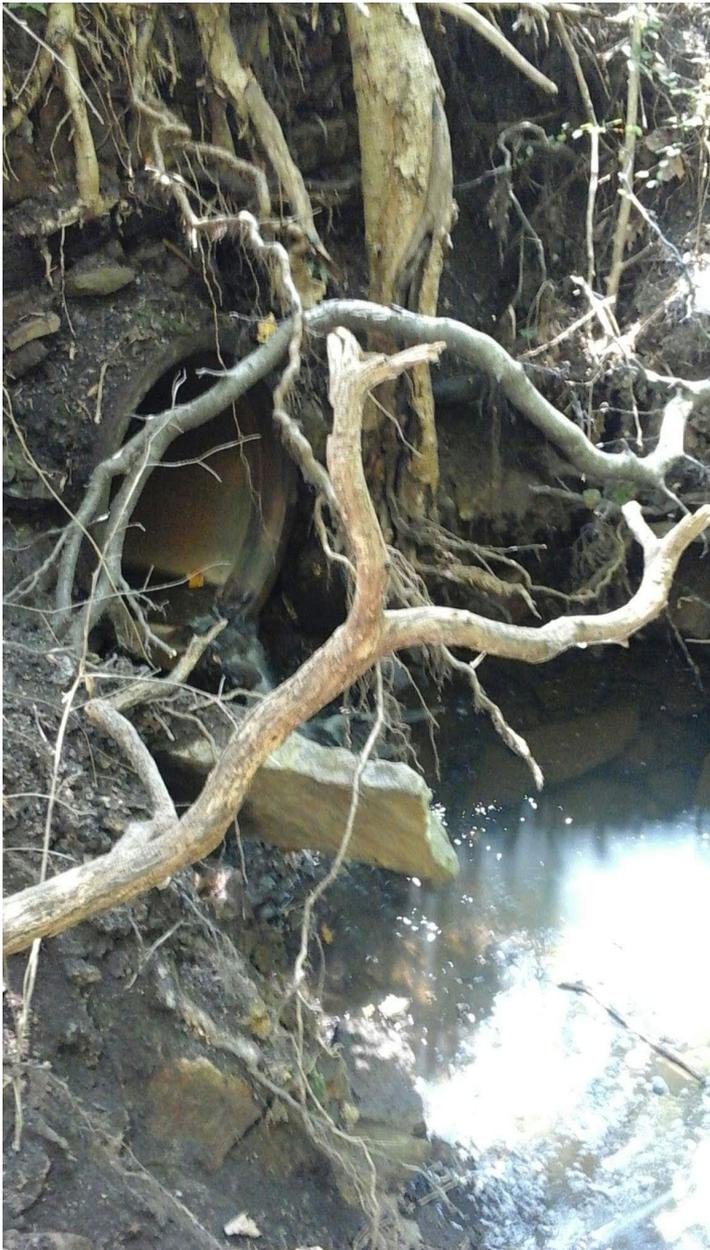
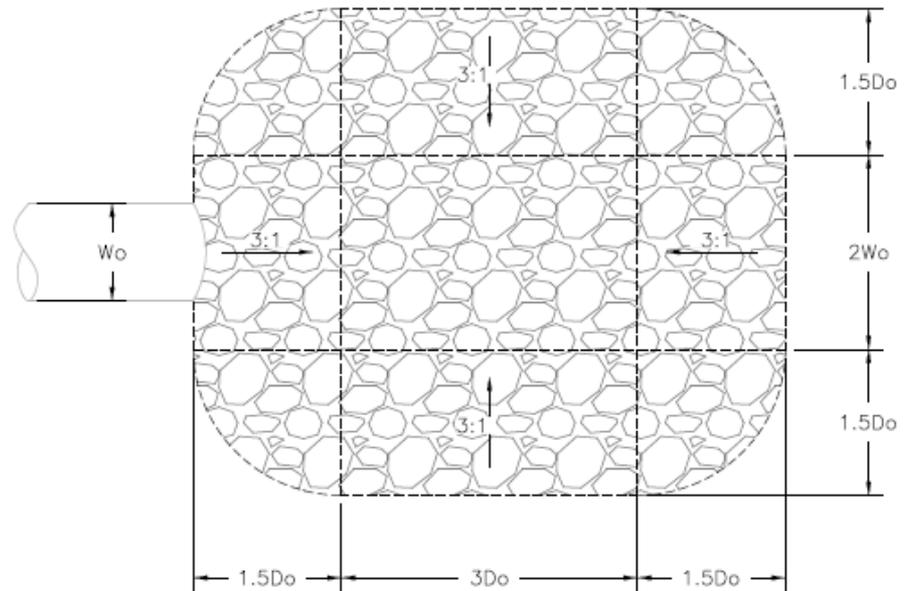
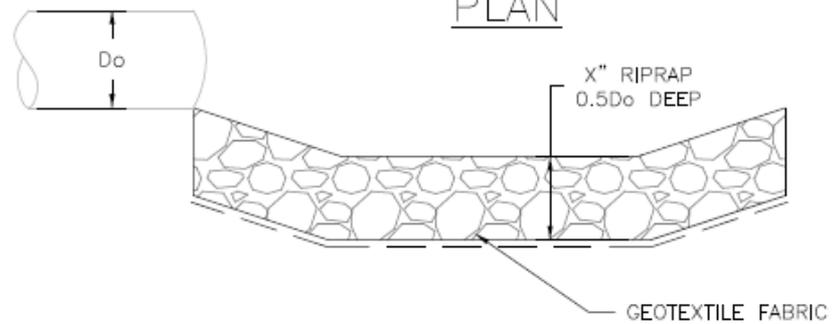
G506

## Scour Hole

PLAN

SECTION

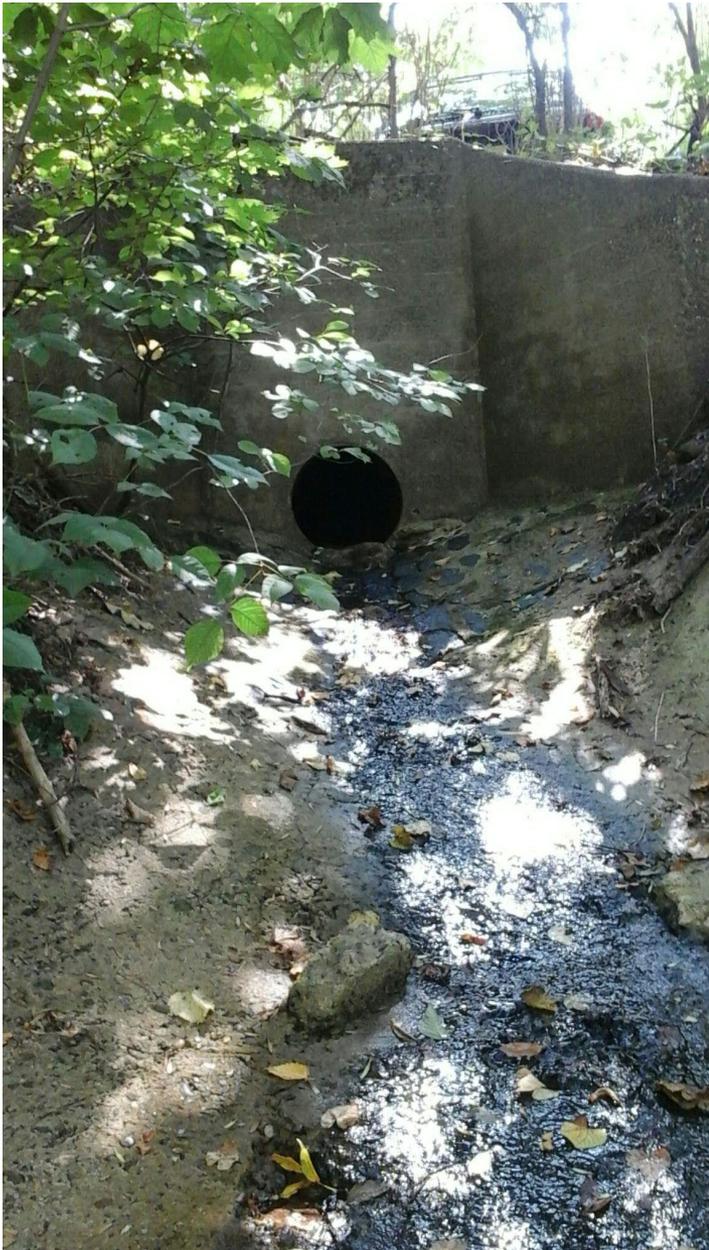
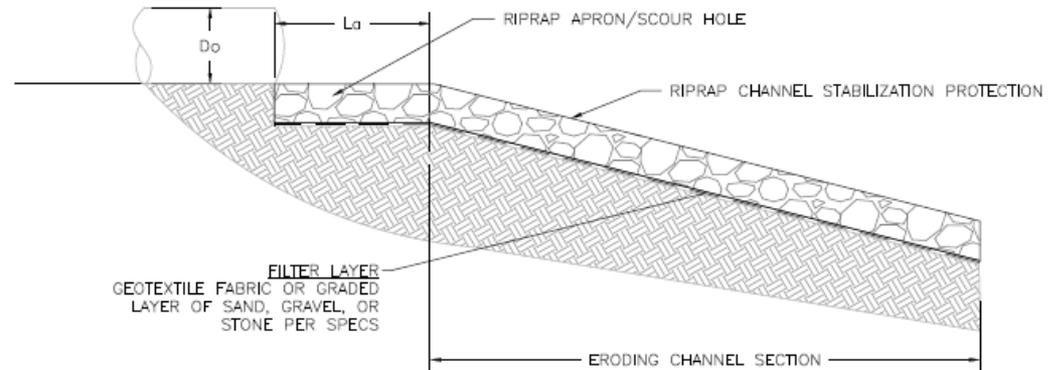
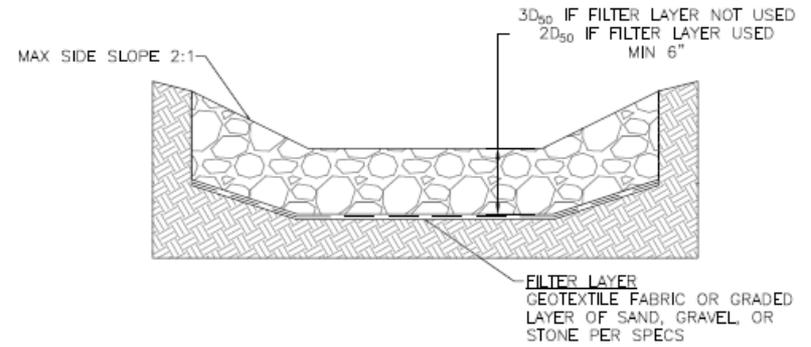
## Riprap Channel

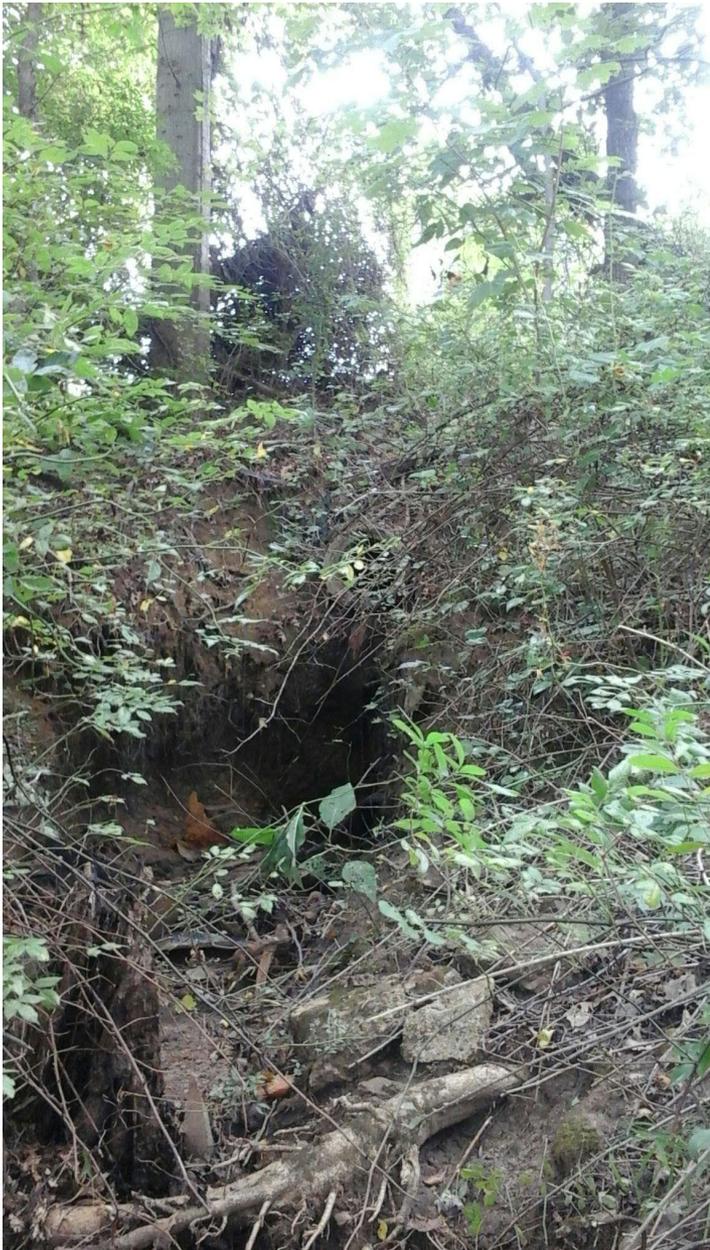
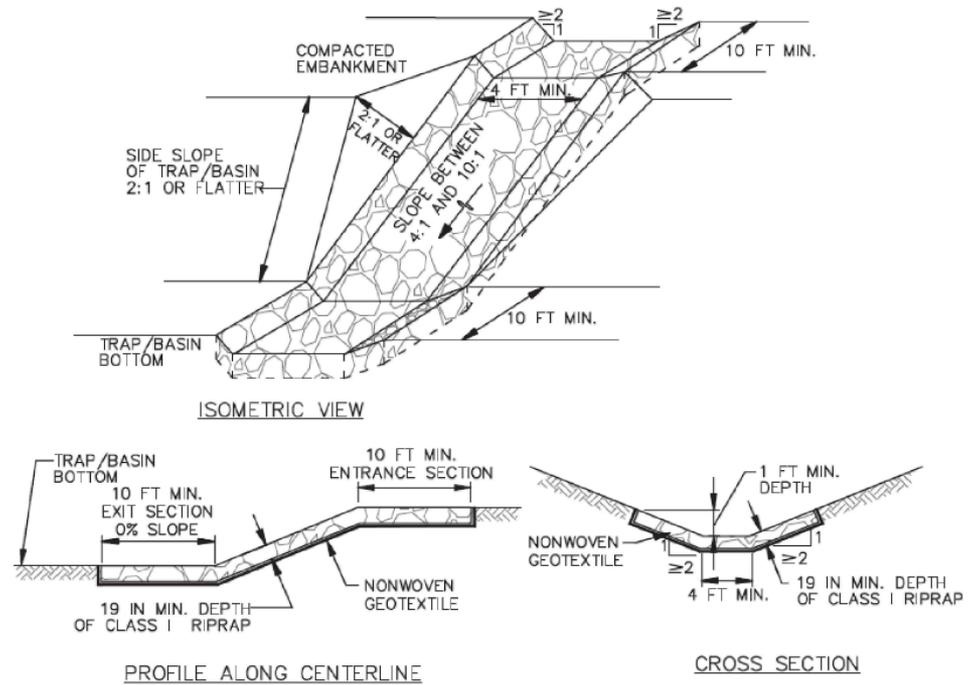
## Rock/Gabion Flume

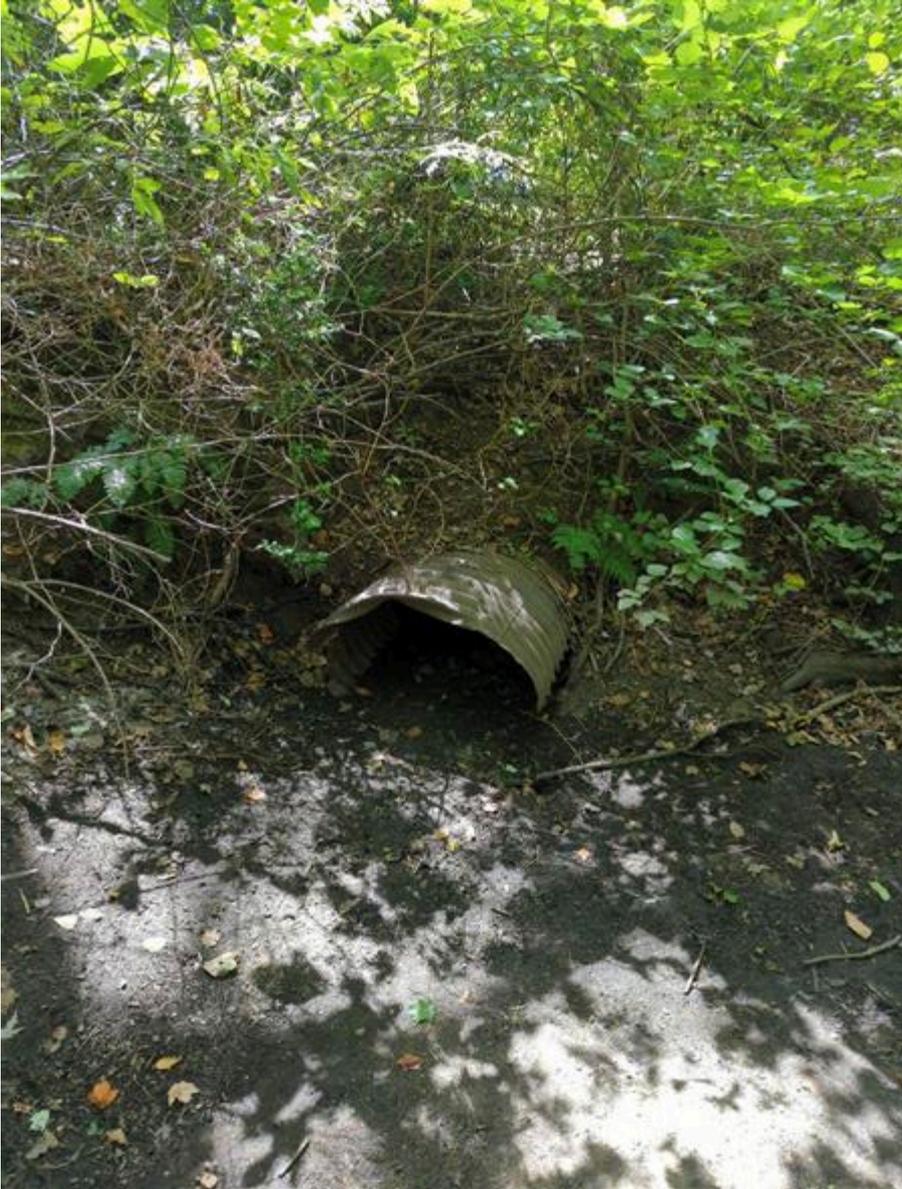
Remove  
Sediments

- Repair Outfall Structures
  - Remove sediments to restore conveyance, stabilize base structure, reconstruct outfall structure
  - Anything with major or moderate cracking should be planned for repair prioritizing highest erosion first, minor monitored in future inspection
- Designs to be developed for AC09 and MR33

MR77	E0201	Y	34	Metal			8/16/2022	Needs Maintenance		2 - Moderate Cracking or Corrosion	partially filled with sediment, pipe corroding	4 - High
MR80	D0206	Y	24	Metal			7/22/2022	Needs Maintenance	Needs Stabilization	2 - Moderate Cracking or Corrosion	Very hidden, some undermining, pipe to the left	3 - Medium
MR88	D0202	Y	34	Concrete			7/22/2022	Needs Maintenance	Good	2 - Moderate Cracking or Corrosion	Lots of sediment, 6 inches sediment	3 - Medium
MR94	E0214	Y	13	Concrete			7/22/2022	Needs Maintenance	Needs Stabilization	2 - Moderate Cracking or Corrosion	mostly covered with sediment	3 - Medium

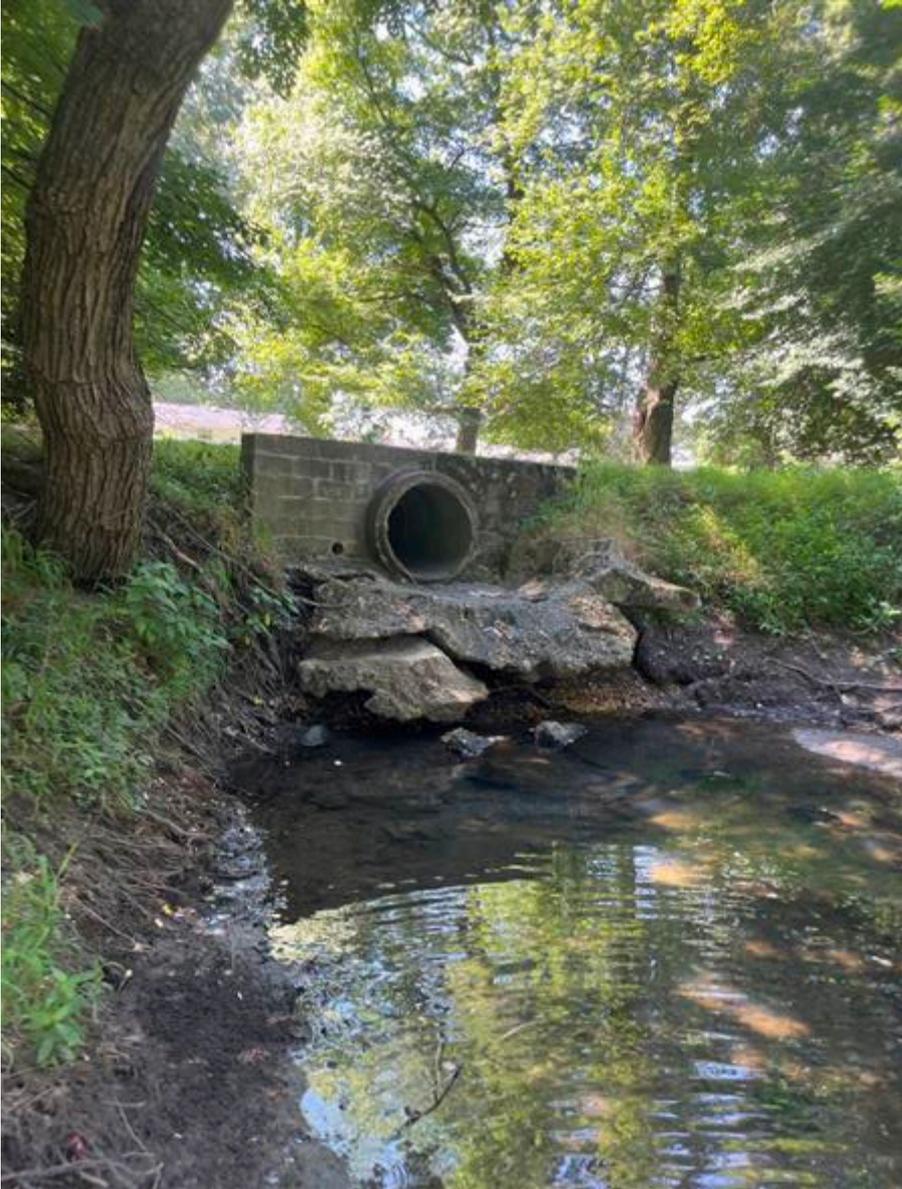
**MR51**

# Stabilize Structure

MR51	C0204	Y	36	Concrete			7/22/2022	Needs Repair	Fair	3 - Major Cracking or Corrosion		4 - High
MR62	C0213	Y	30	Concrete			7/22/2022	Needs Repair	Fair	3 - Major Cracking or Corrosion	Portion of pipe unseated, some erosion control in the form of sticks and stones placed at outfall preventing worse erosion	3 - Medium
MR69		Y	30	Concrete			8/16/2022	Needs Repair	Fair	3 - Major Cracking or Corrosion	Pipe is cracked and disconnected	4 - High
MR93		Y					8/4/2022	Needs Repair	Needs Stabilization	3 - Major Cracking or Corrosion		4 - High
MR01			40	Concrete			8/4/2022	Needs Maintenance	Fair	2 - Moderate Cracking or Corrosion		3 - Medium
MR17	B0313	Y	18	Metal			7/21/2022	Needs Repair	Needs Stabilization	2 - Moderate Cracking or Corrosion	Undermining; pipe is half buried with sediment; overall structure is collapsing	4 - High
MR26	B0322	Y	6	Concrete			7/21/2022	Needs Maintenance	Needs Stabilization	2 - Moderate Cracking or Corrosion	pipe subsided into stream	3 - Medium

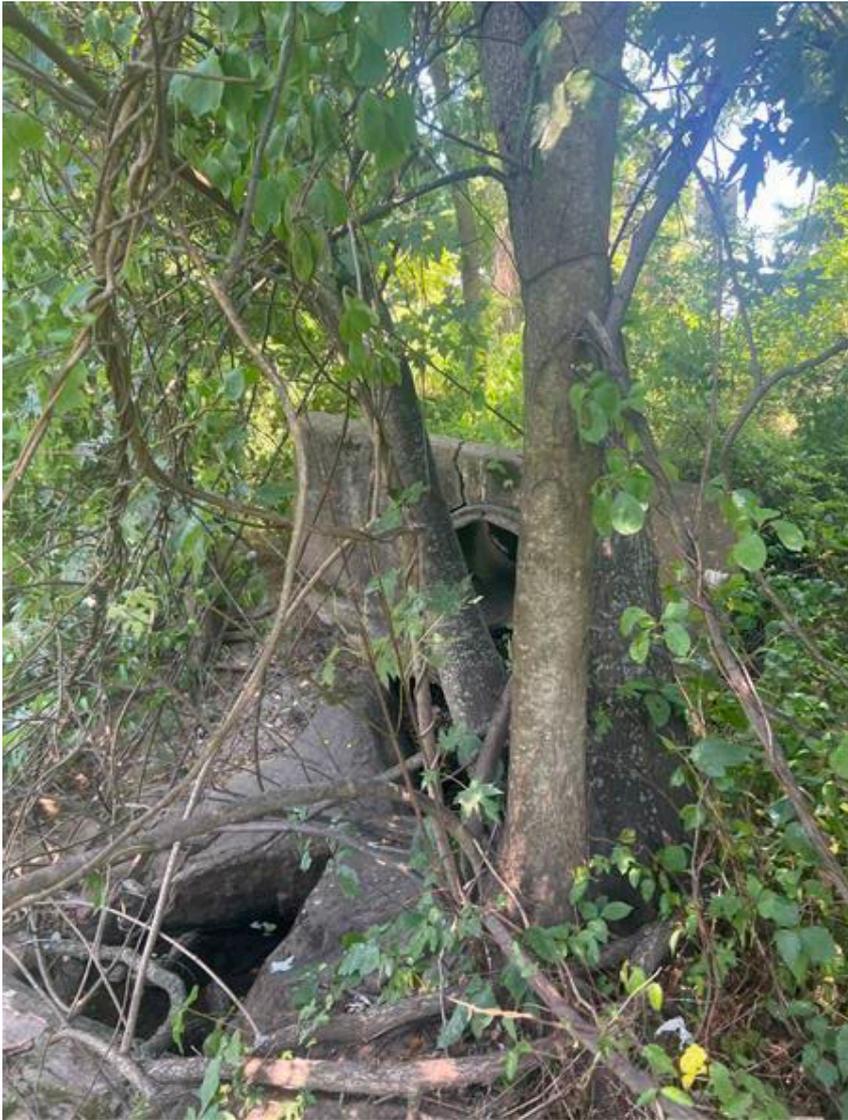
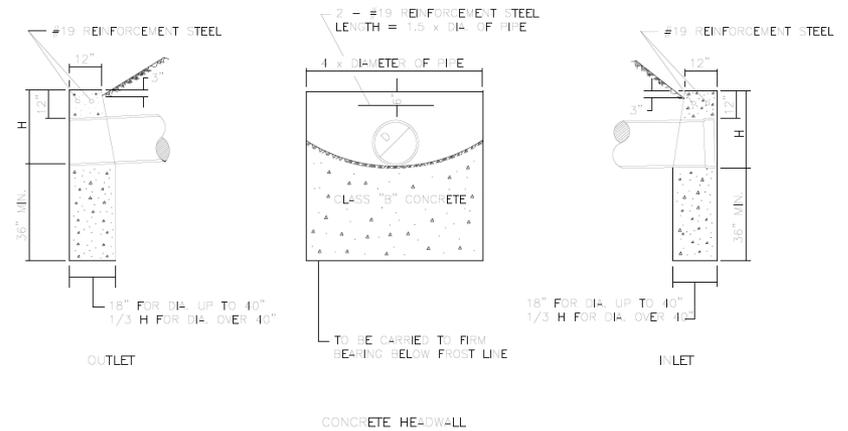
AC09

# Reconstruct Outfall or Headwall

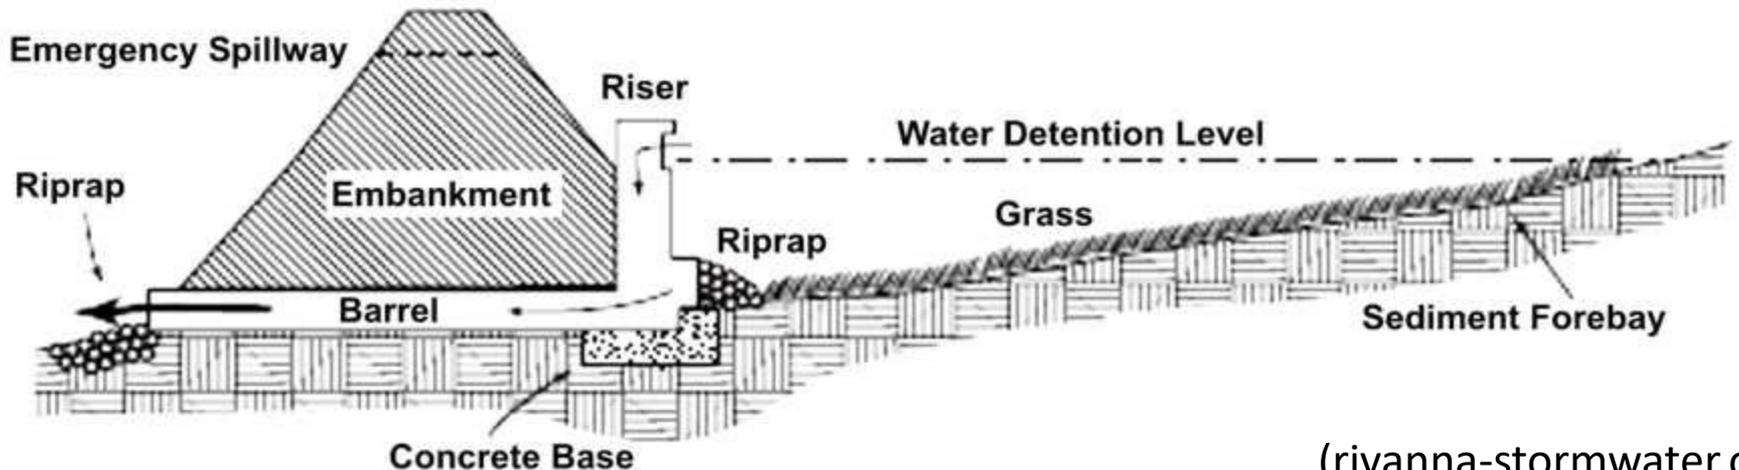
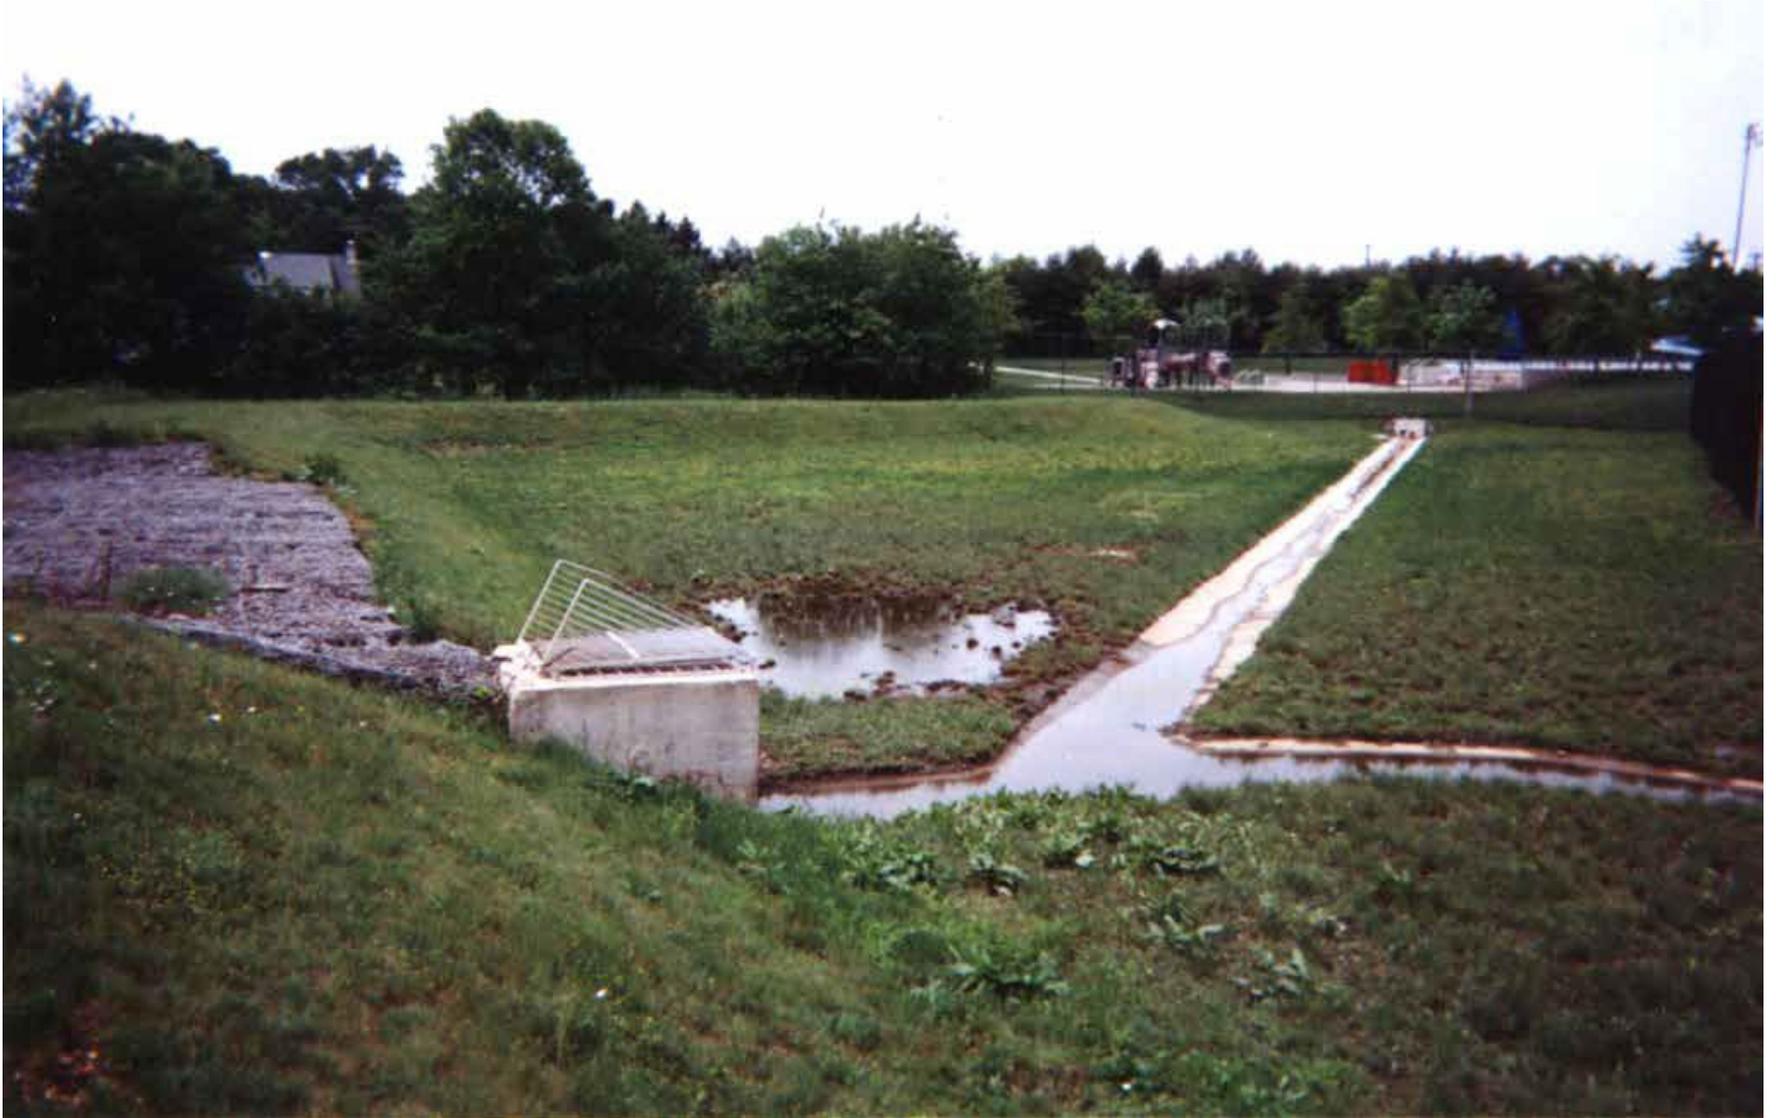
# Typical Detention Basin

Detention basins are designed to detain stormwater runoff during a storm and slowly release the stormwater after the storm.

- Prevents downstream flooding
- Removes pollutants only through settling
- Typically goes dry 48-hours after storm
- Usually contains turf grass that is regularly mowed
- Often contain concrete low-flow channel
- Follow old regulation standard

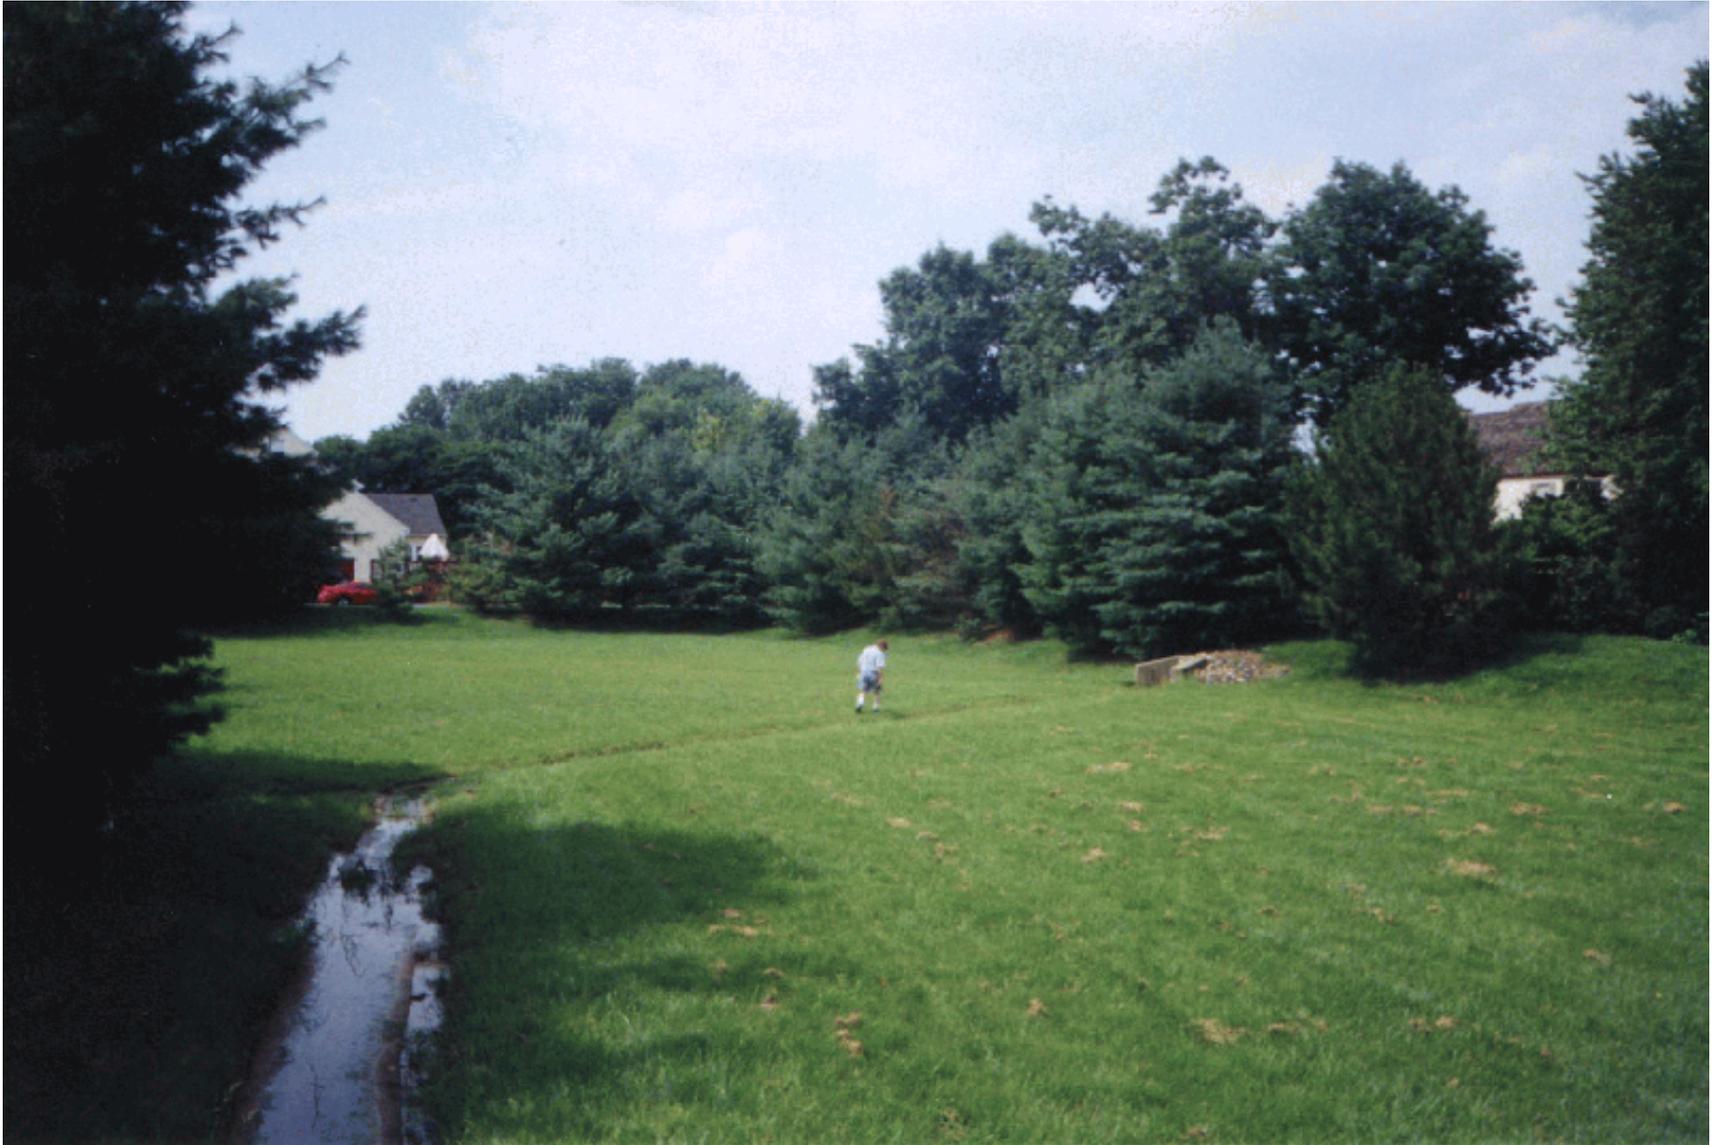
# Typical Detention Basin

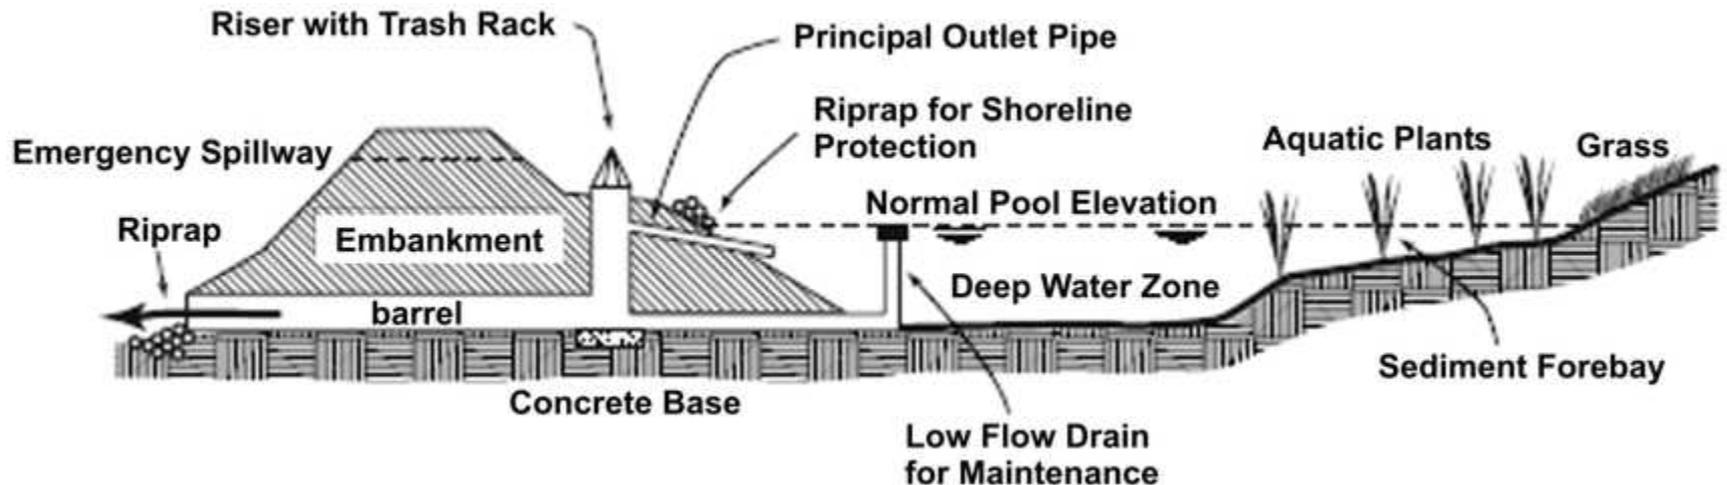
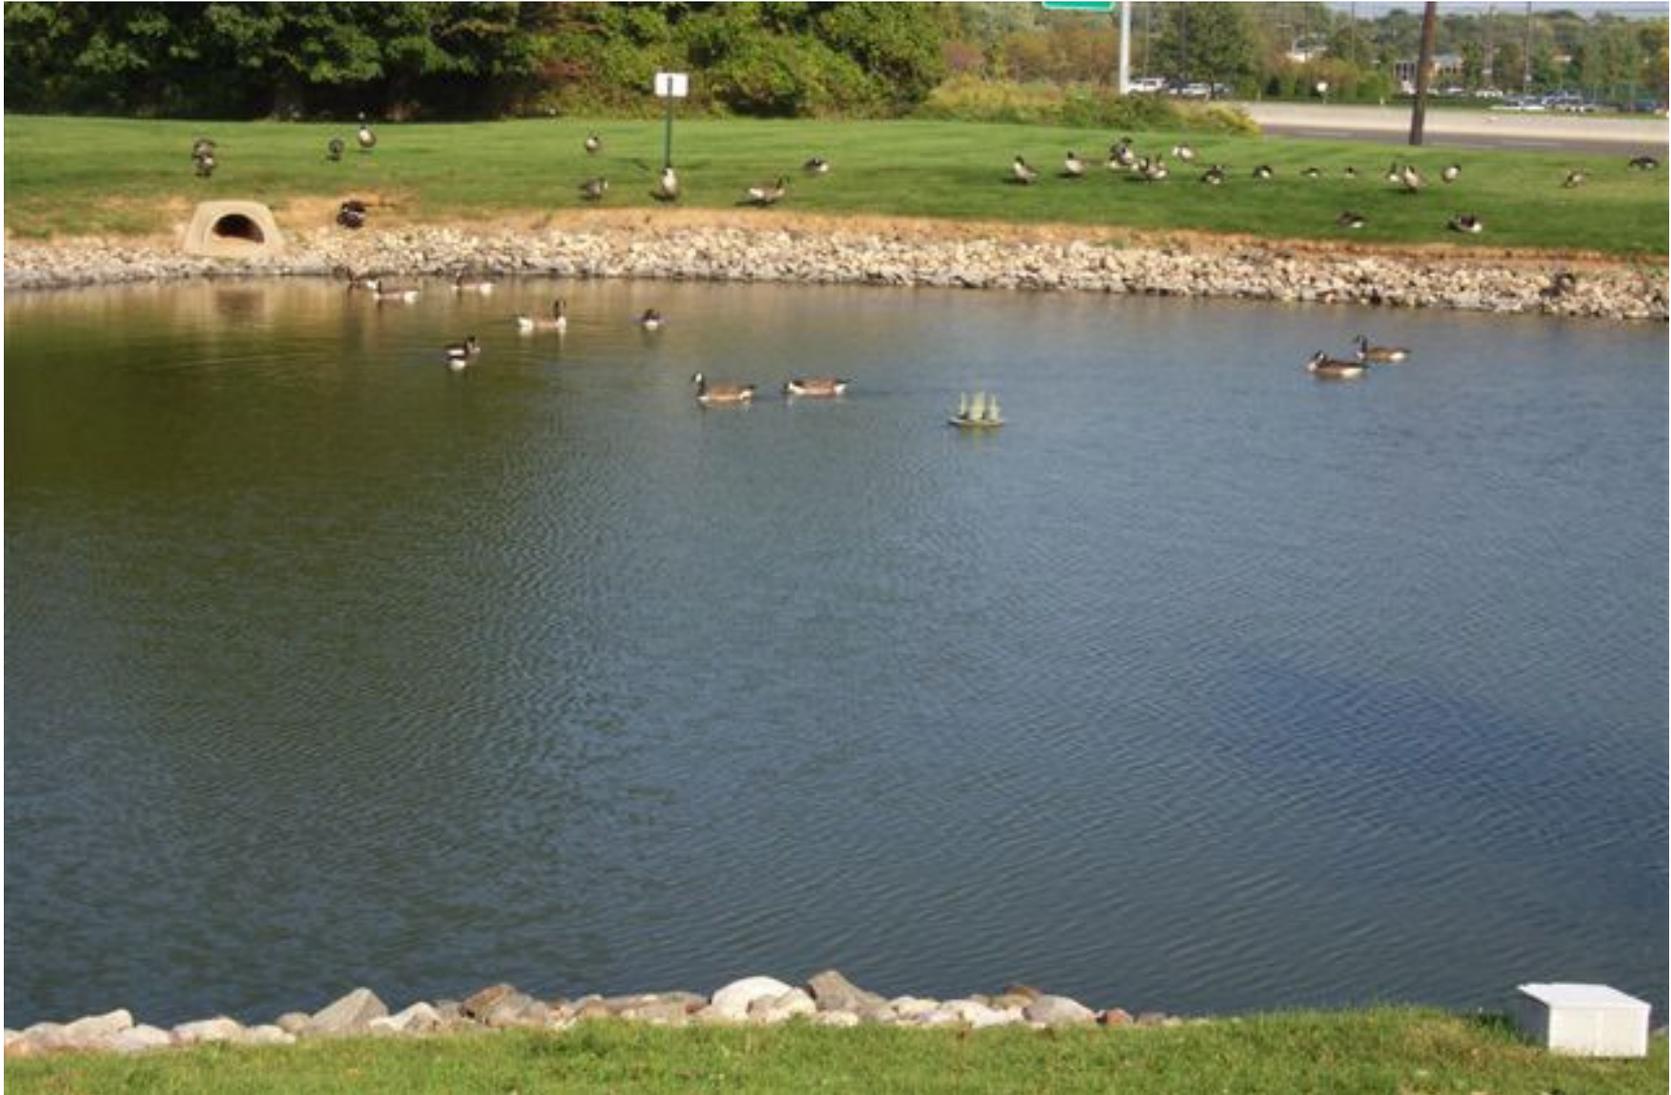
# Typical Detention Basin

Retention basins maintains permanent pools and stores stormwater runoff on tope of existing standing water.

- Prevents downstream flooding
- Removes pollutants mainly through settling and algal uptake
- Always has a minimum of three feet of standing water
- Often attract lots of geese
- Can require dredging

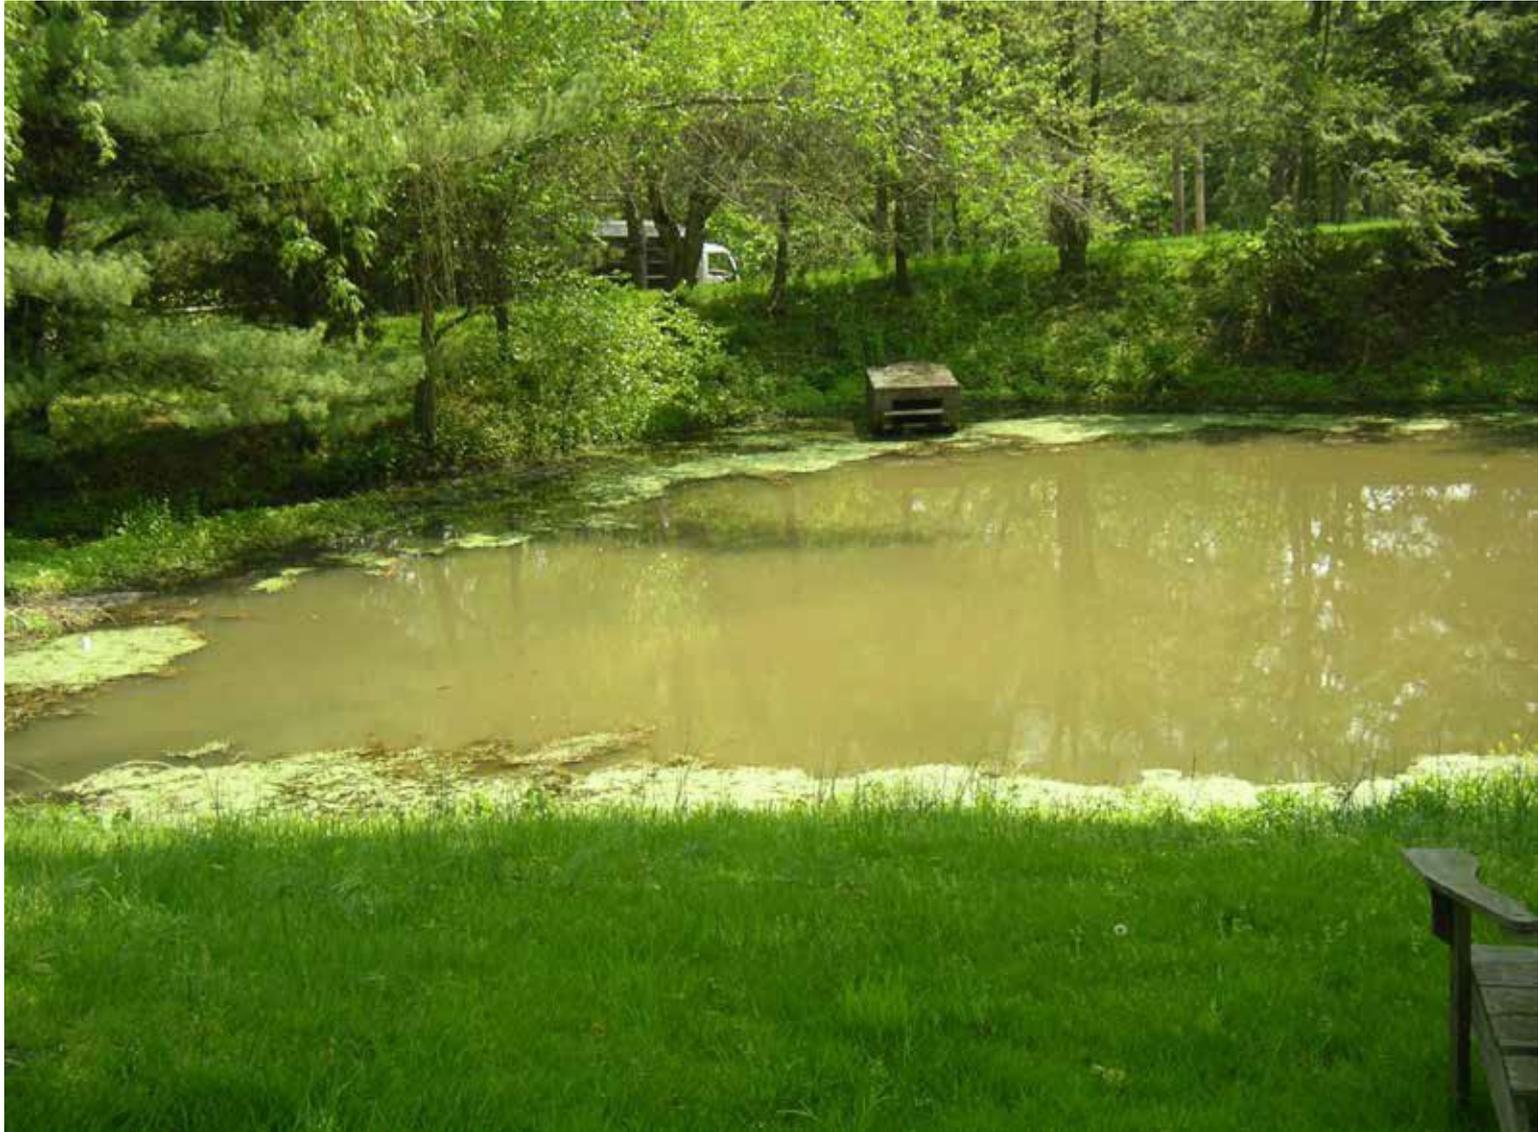
# Typical Retention Basin
