# **MS4 Permit Requirements and Inspection/Maintenance of Stormwater Management Facilities**

**Presented to Hamilton Township**

Rutgers Cooperative Extension Water Resources Program  
Chris Obropta and Matt Leconey

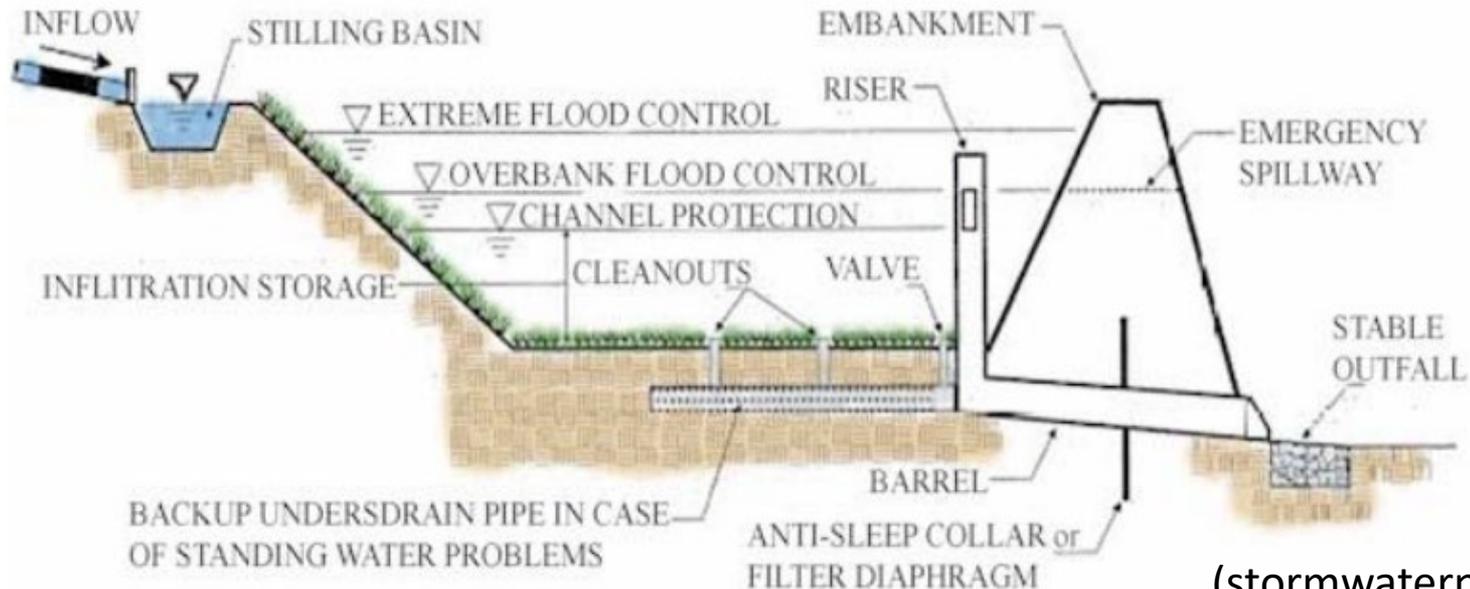
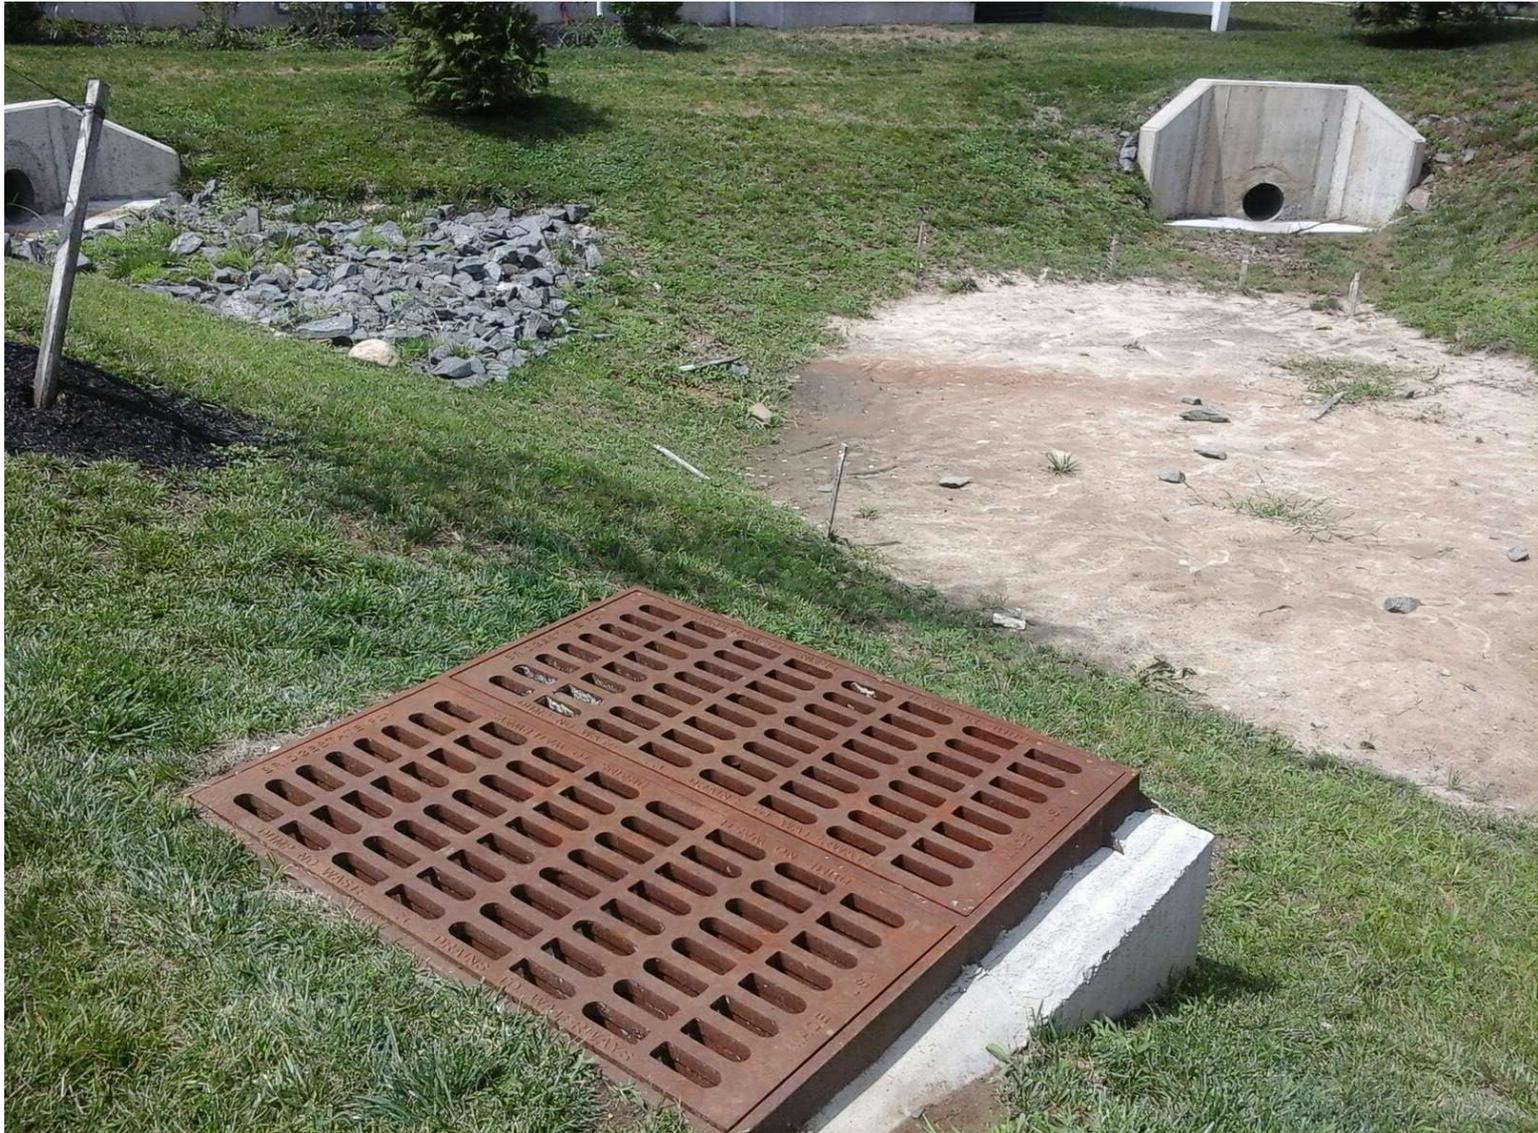
# Typical Infiltration Basin

Infiltration basins have a raised outlet structure to allow infiltration with the intention of the system fully draining

- Prevents downstream flooding
- Removes pollutants through infiltration
- Typically dry 48 hours after storm
- Follow more modern regulation standards, but now largely replaced by bioretention systems (similar but with vegetation)

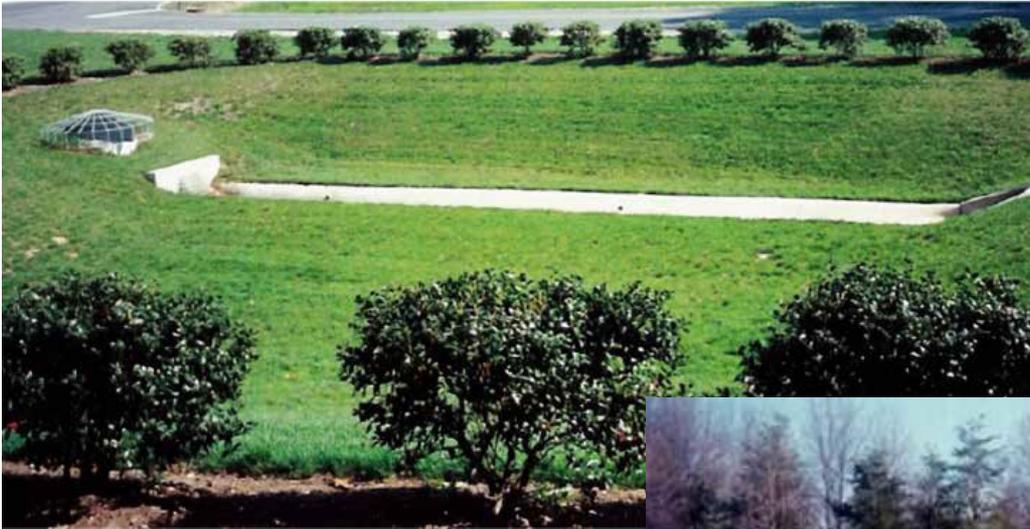
# Detention/Infiltration Basin vs. Retention Basin

NO – Detention/Infiltration

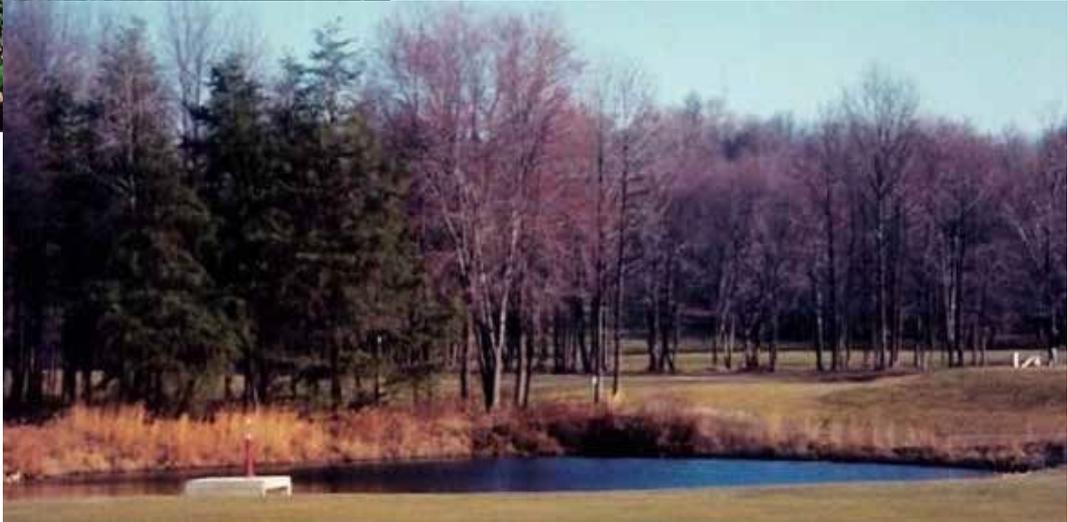
YES – Retention

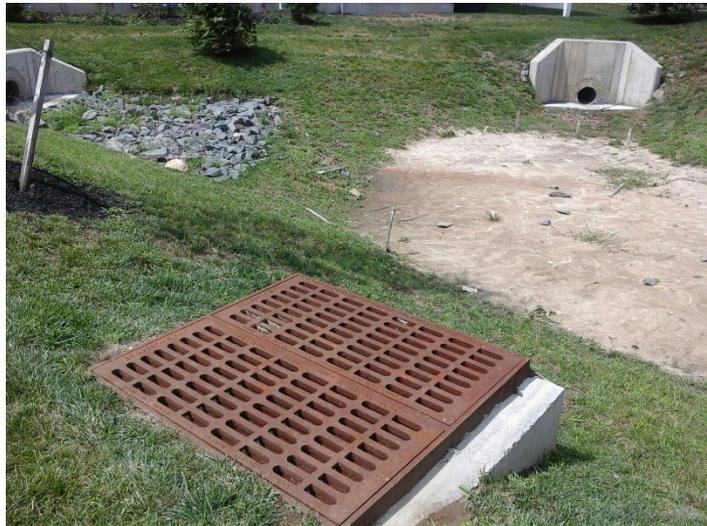
# Detention Basin vs. Infiltration Basin

Is the basins primarily outlet at the bottom of the basin or does the basin have a low flow channel?

NO – Infiltration

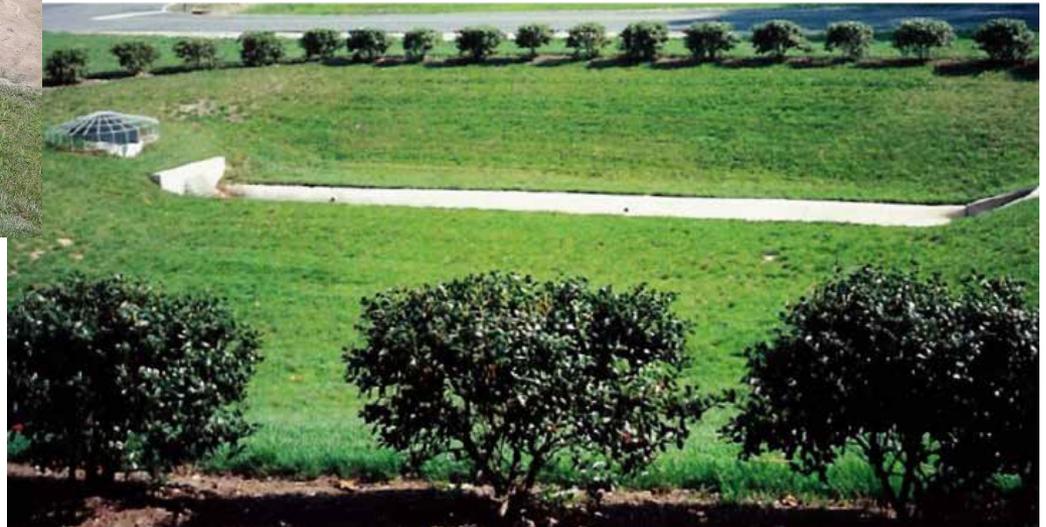
YES – Detention

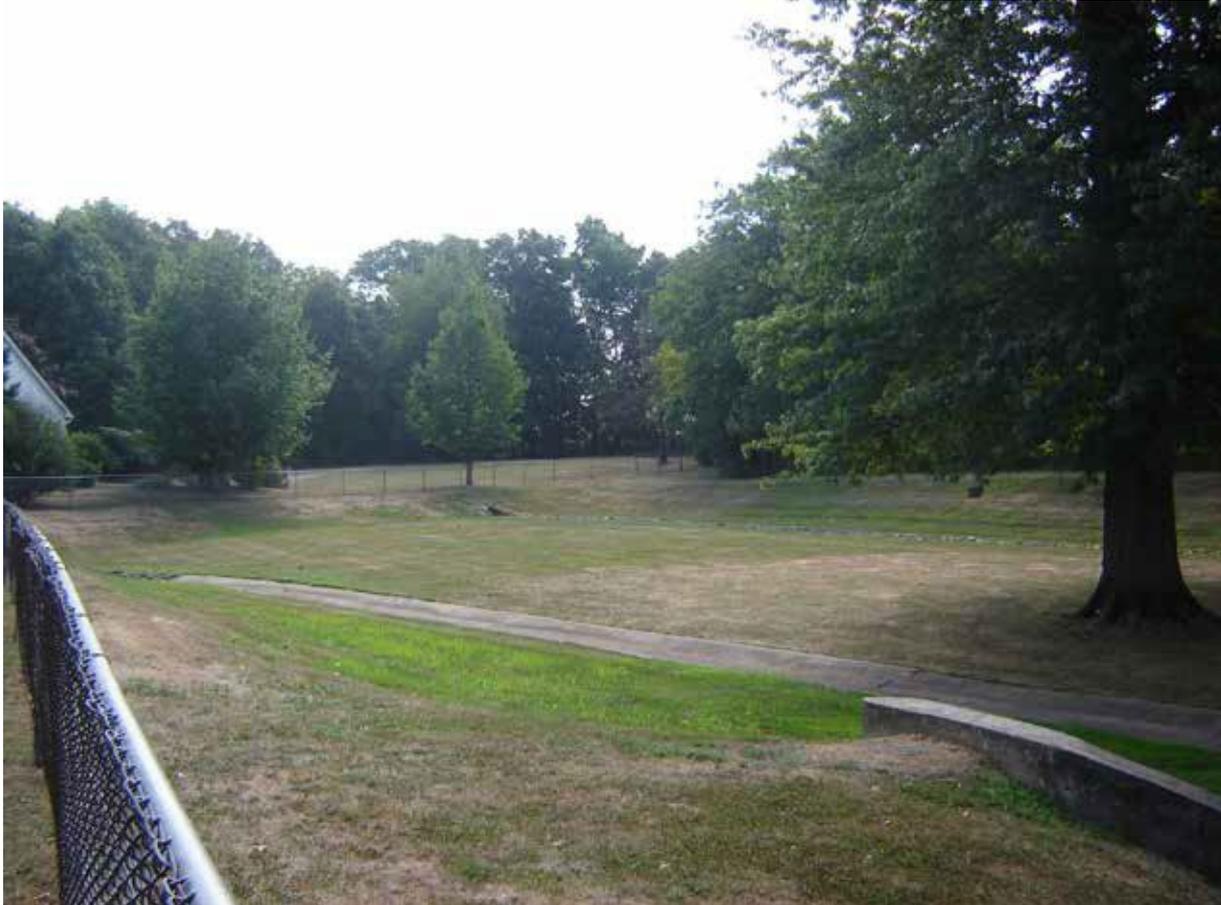
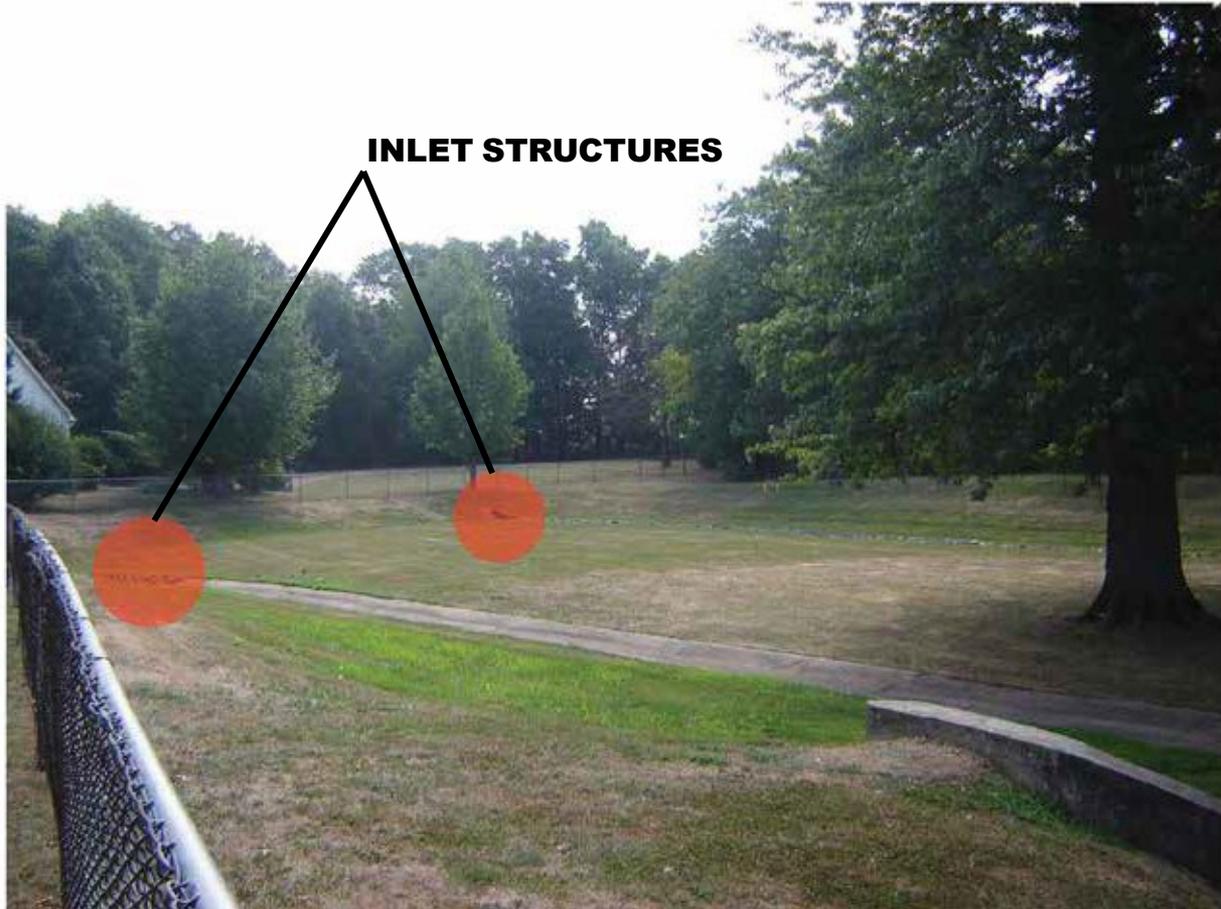
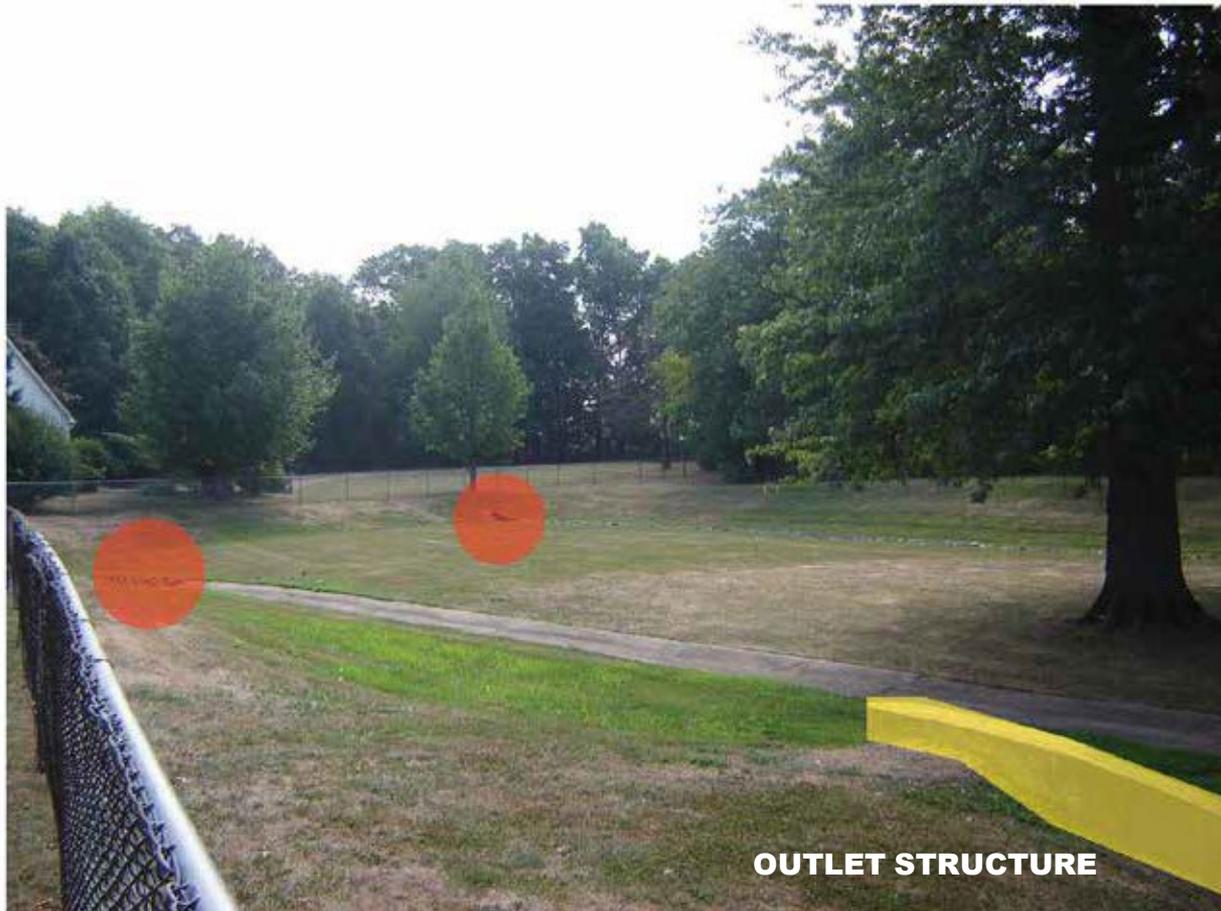
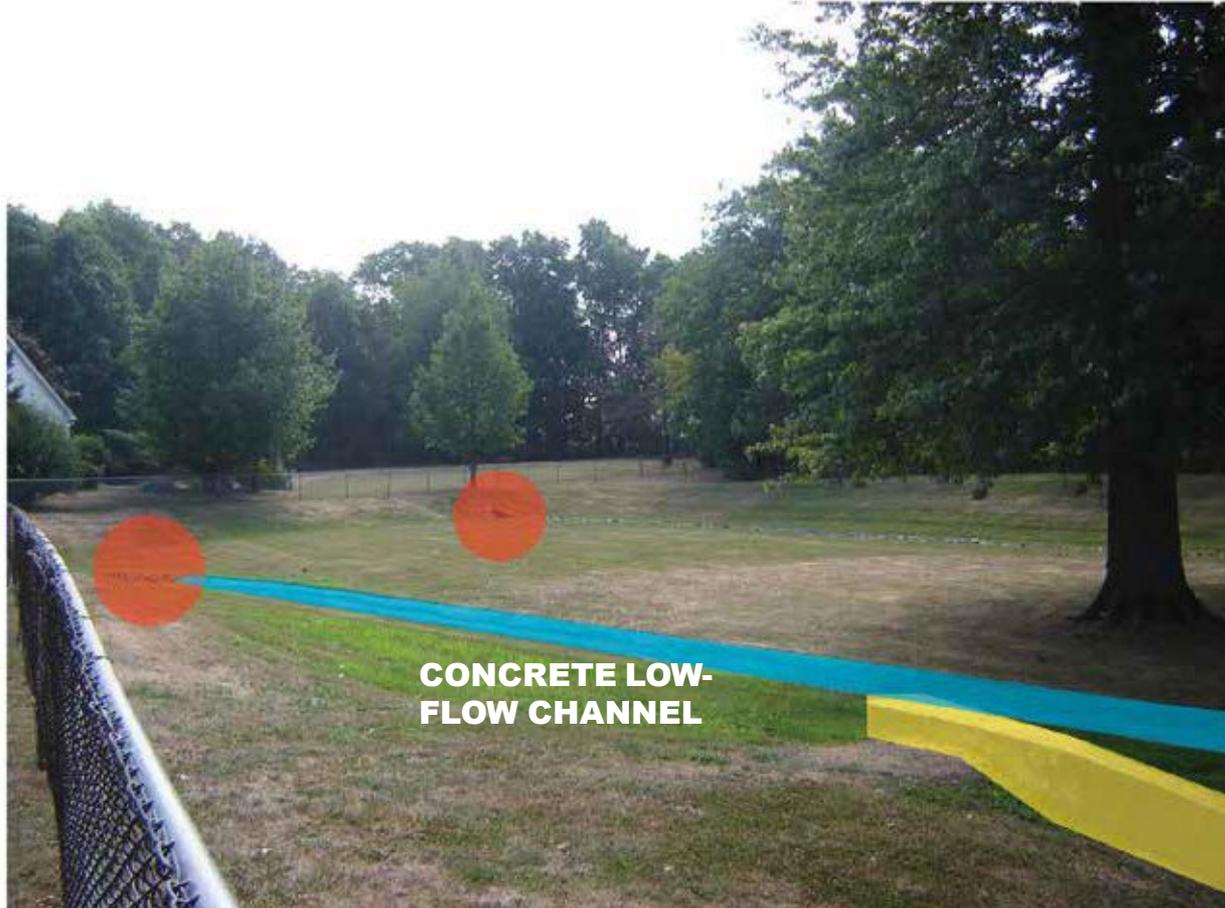
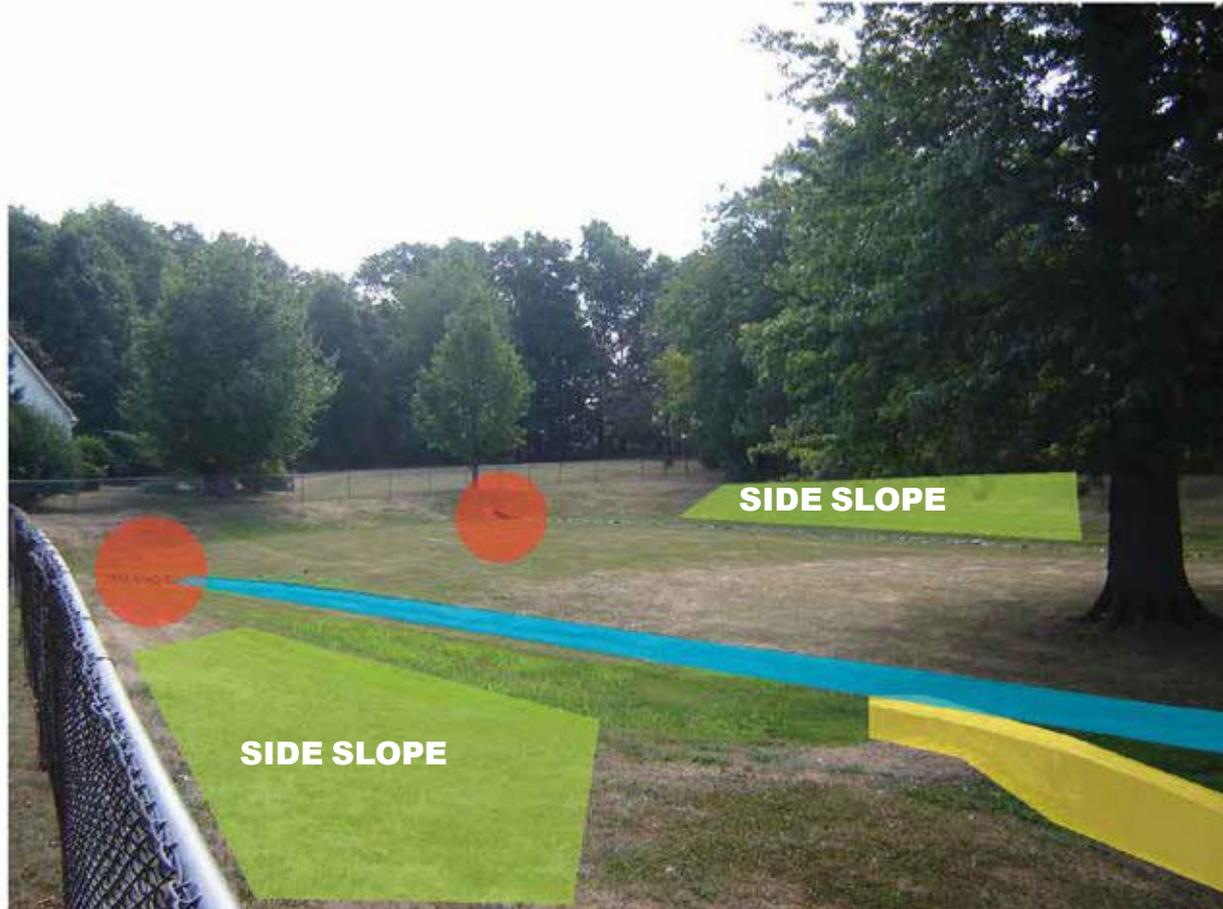
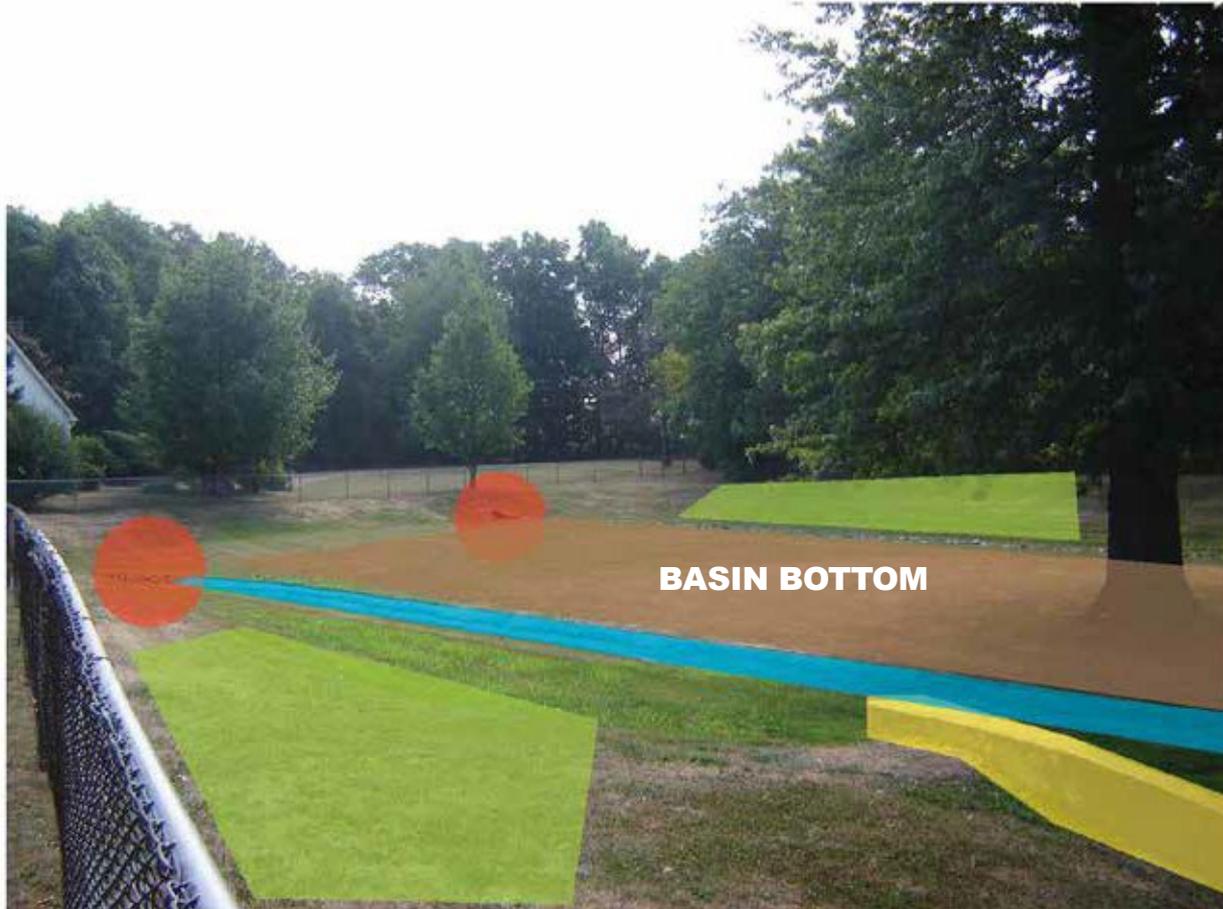
# Detention Basin Anatomy

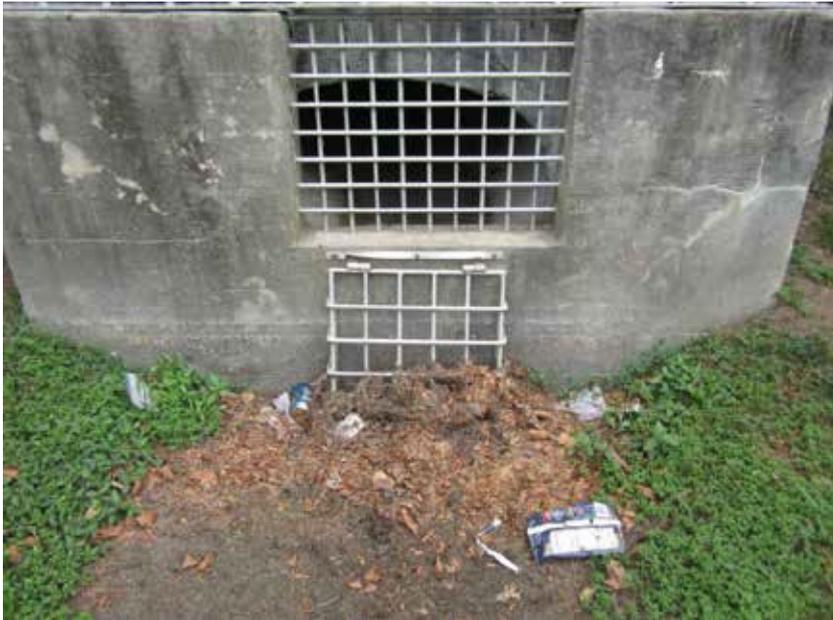
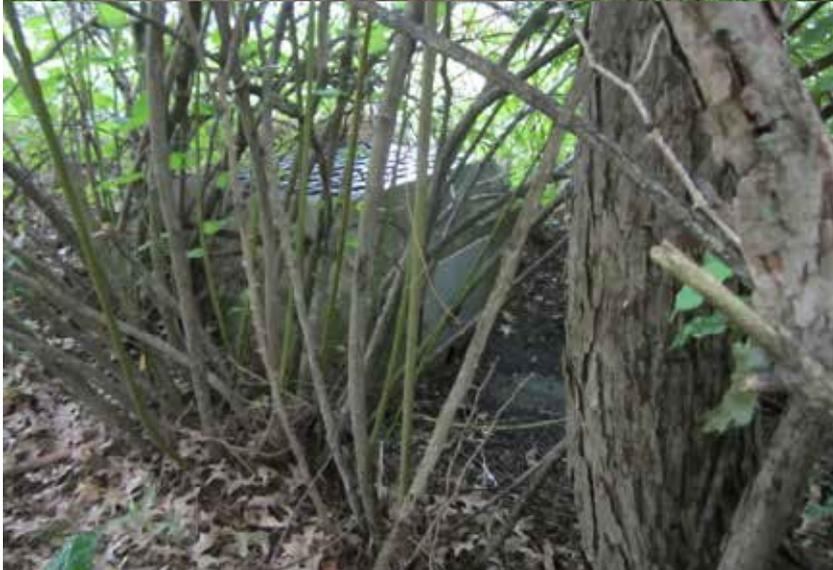
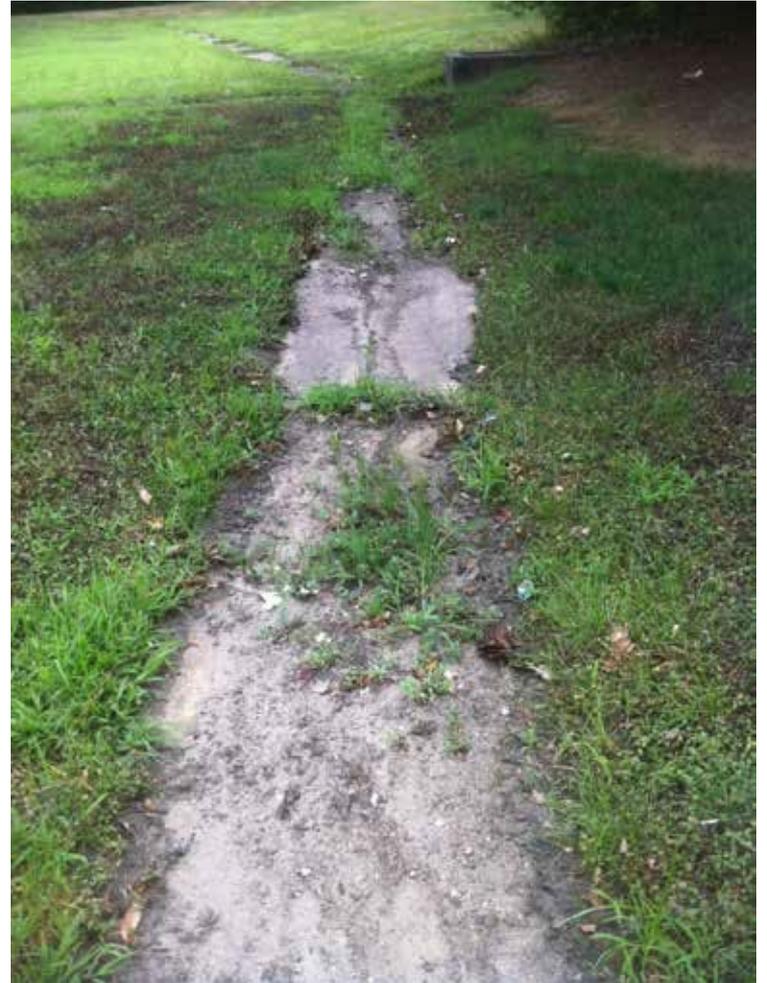
# Routine Maintenance

- **Vegetation management**
  - Mowing should be done where/when it is needed (traditionally, 10-14 times per year)
  - Effective groundcovers must be kept healthy to prevent erosion and damage to the system
- **Debris and litter removal**
  - Inlets and outlets should be regularly cleared of debris and litter to prevent obstructions and reduced efficiency of the system
- **Mechanical components maintenance**
  - All mechanical equipment, such as gates, valves, locks, or other components must be kept in working order should an emergency arise

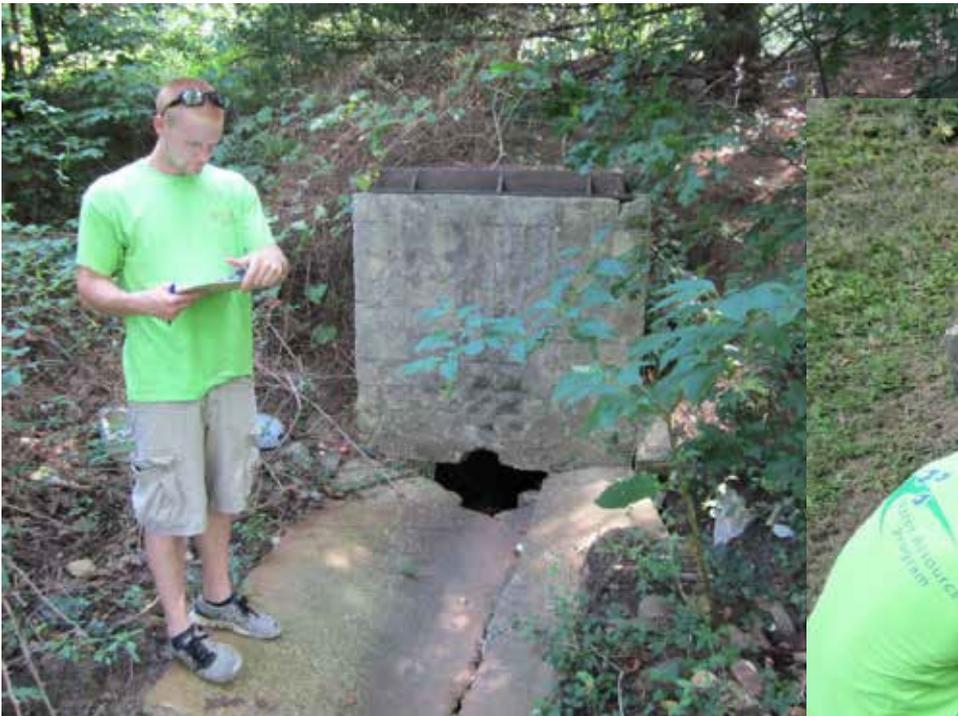
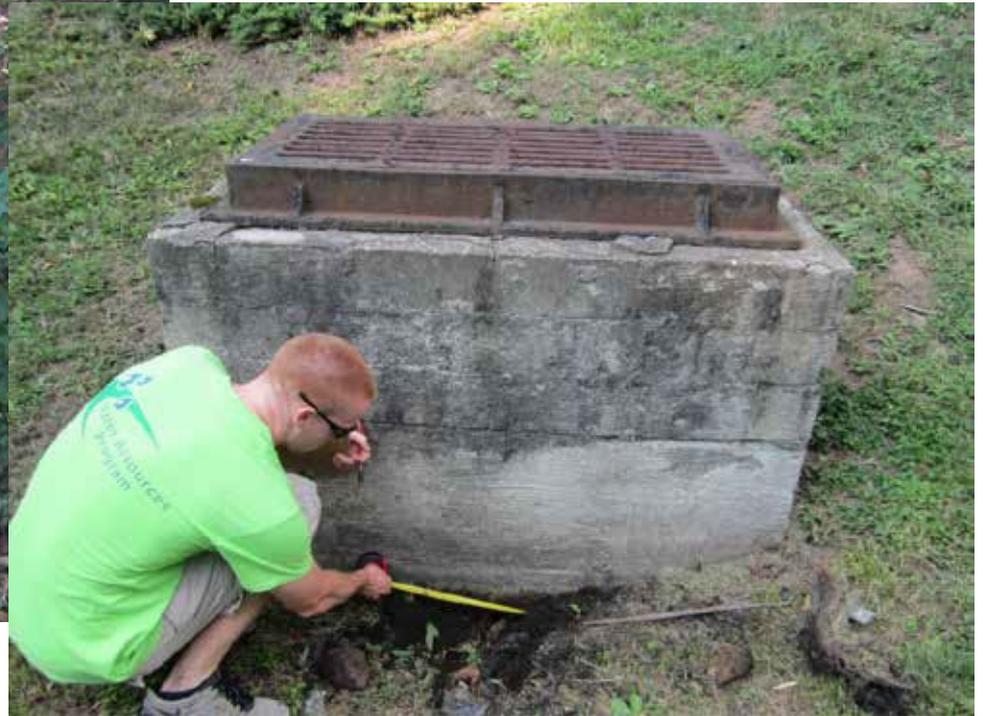
# Routine Maintenance for Mechanical Components

- Regular inspections will reduce need for major replacements

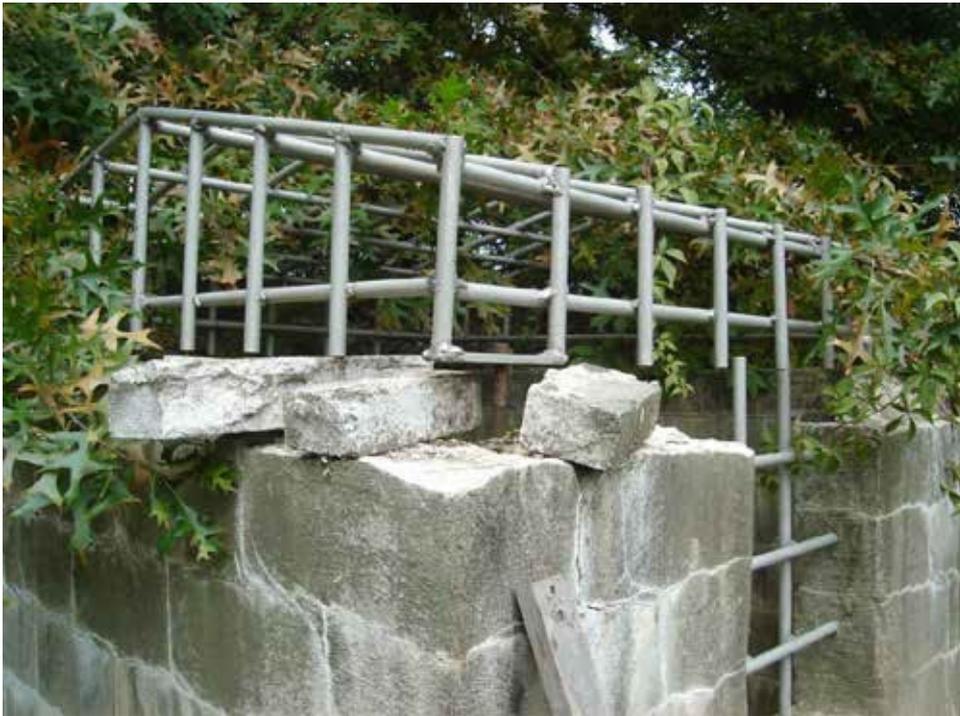
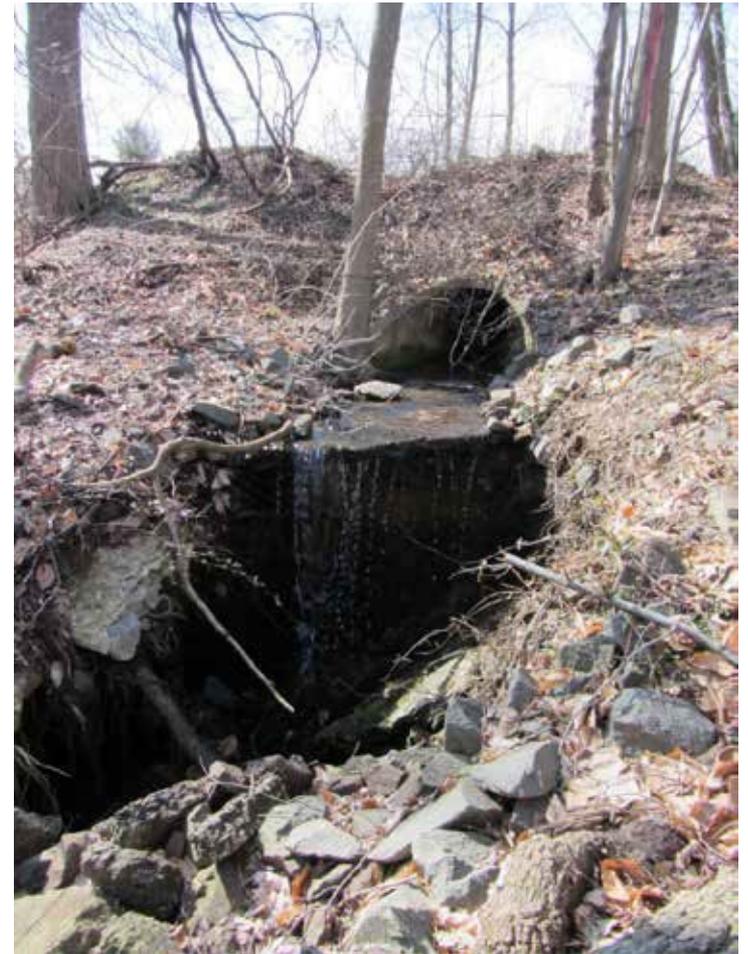
# Non-Routine Maintenance

- **Stabilization and erosion control repairs**
  - If vegetation fails on embankments or in the basin, soil replacement, reseeding and stabilization should occur immediately
- **Sediment removal**
  - During the establishment of a new basin, the basin should be inspected for excessive sedimentation. After establishment, the basin should be inspected twice a year and excessive sediment accumulated in the basin should be removed.
- **Outlet repair or replacement**
  - Should the system stop functioning as designed the outlet structure may require repair or replacement

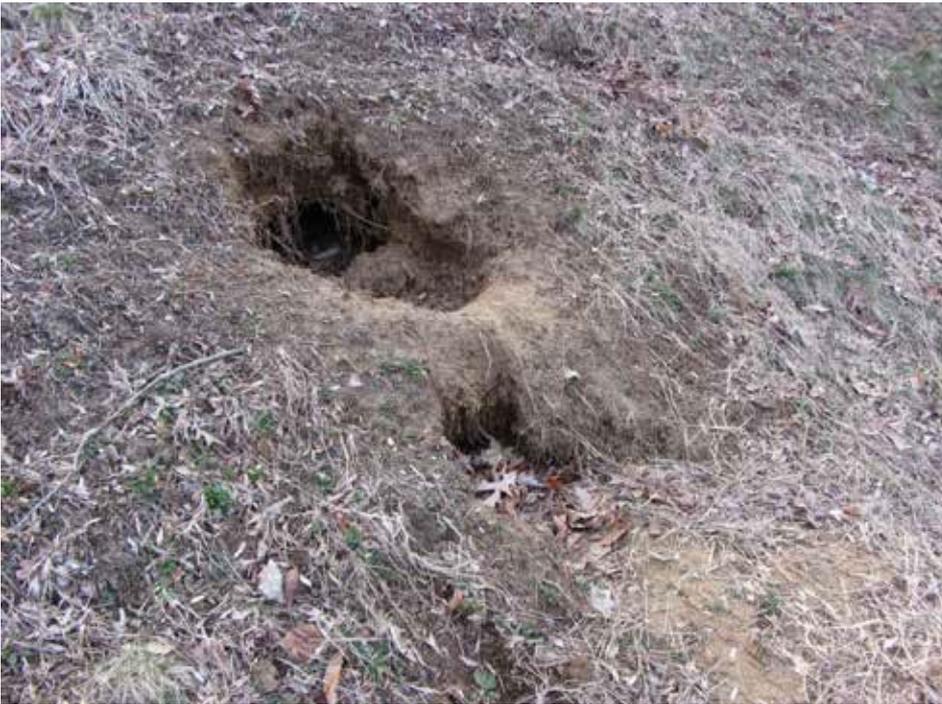
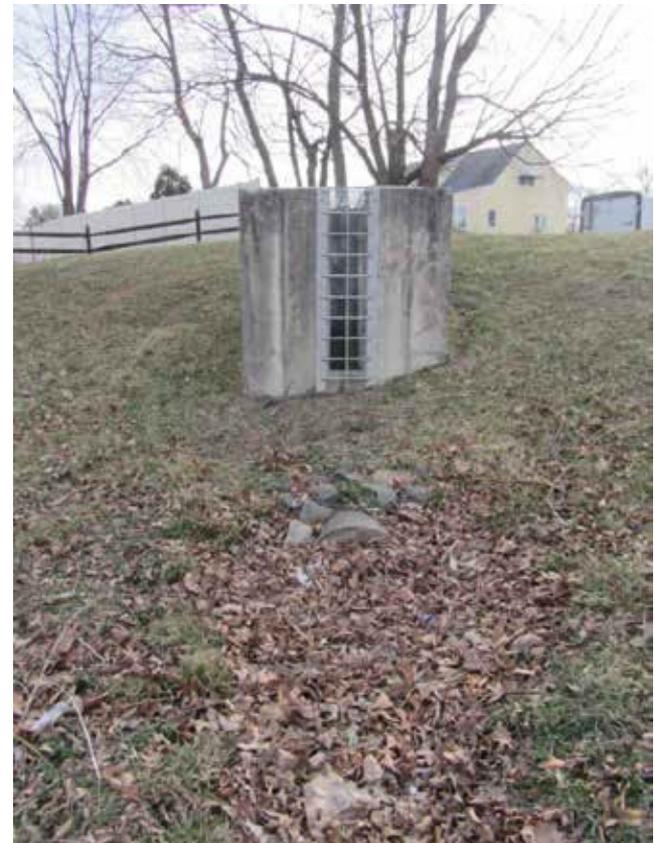
# Stabilization and Erosion Control Repairs

- Ensure basin designs due not incorporate steep embankments (greater than 3:1)
- Maintain healthy groundcovers by not mowing basin areas to less than 4 inches in height

- **Stabilization and erosion control repairs**
  - Ensure basin designs do not incorporate steep embankments (greater than 3:1)
  - Maintain healthy groundcovers by not mowing basin areas to less than 4 inches in height
- **Sediment removal**
  - Install manufactured pre-treatment device prior to stormwater discharging to basins
  - Install a settling forebay near inlets where access can be provided and reached with available excavation equipment
- **Outlet repair or replacement**
  - Conduct regular inspections to ensure system is functioning properly and debris and litter are not clogging the outlet
  - Provide and maintain clear access to all structures of the system

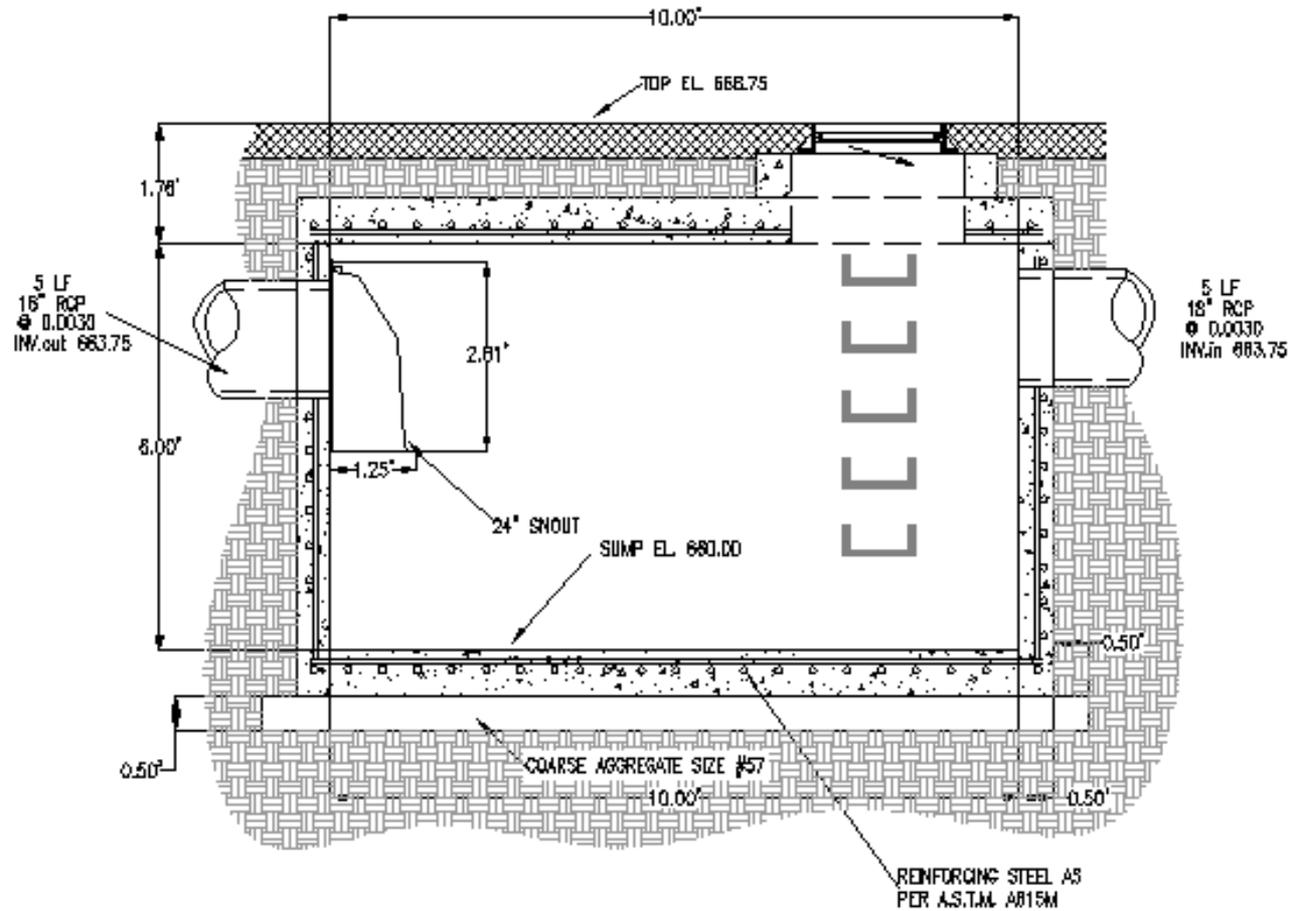
## Low Cost "Snout" Debris Separator

2  
1 VAULT W/ SNOUT -ELEVATION  
1" = 2'

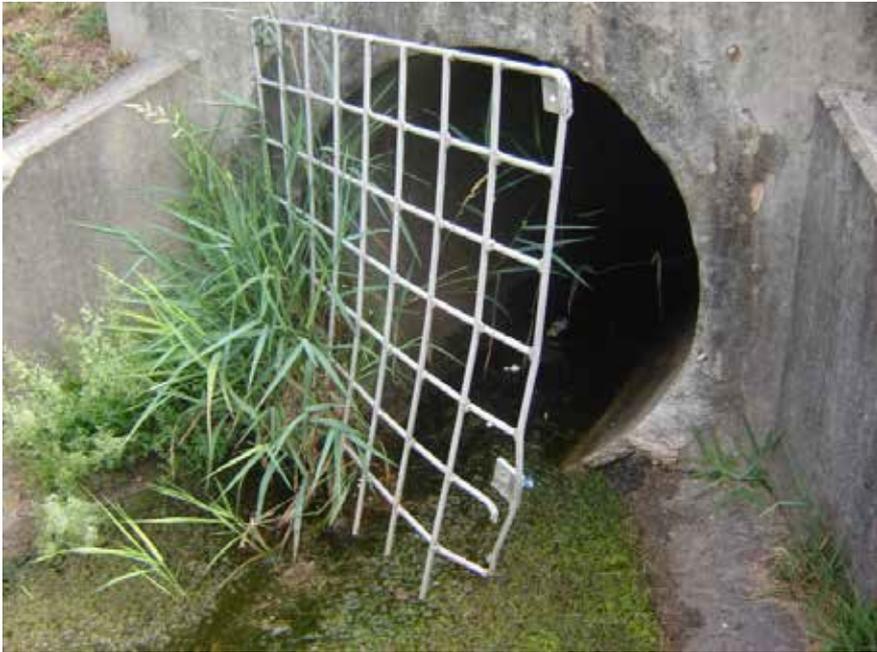
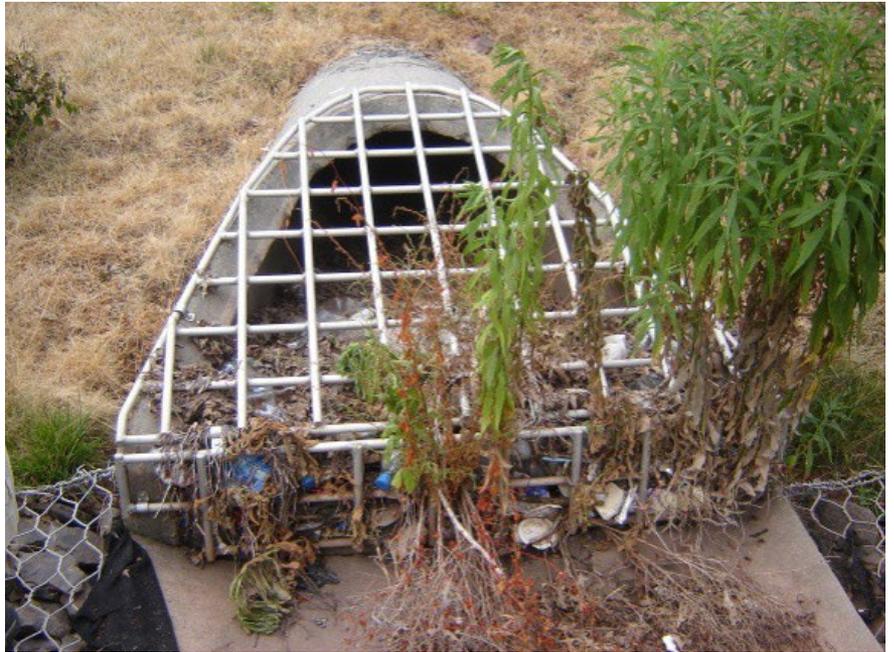
# Outlet Repair or Replacement

- Conduct regular inspections to ensure system is functioning properly and debris and litter are not clogging the outlet
- Provide and maintain clear access to all structures of the system
