Mount Arlington Borough

Introduction

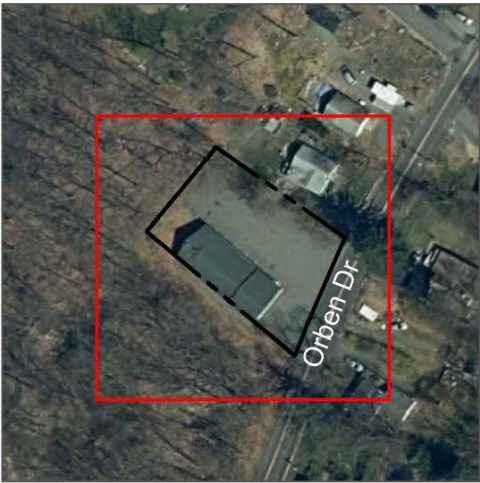
Lake Rogerene Fire Department

Cisterns can be installed to the northeast and southeast of the building to divert and detain the stormwater runoff from the rooftop for later non-potable reuse such as washing vehicles.

rainwater harvesting
-

captured drainage area
-

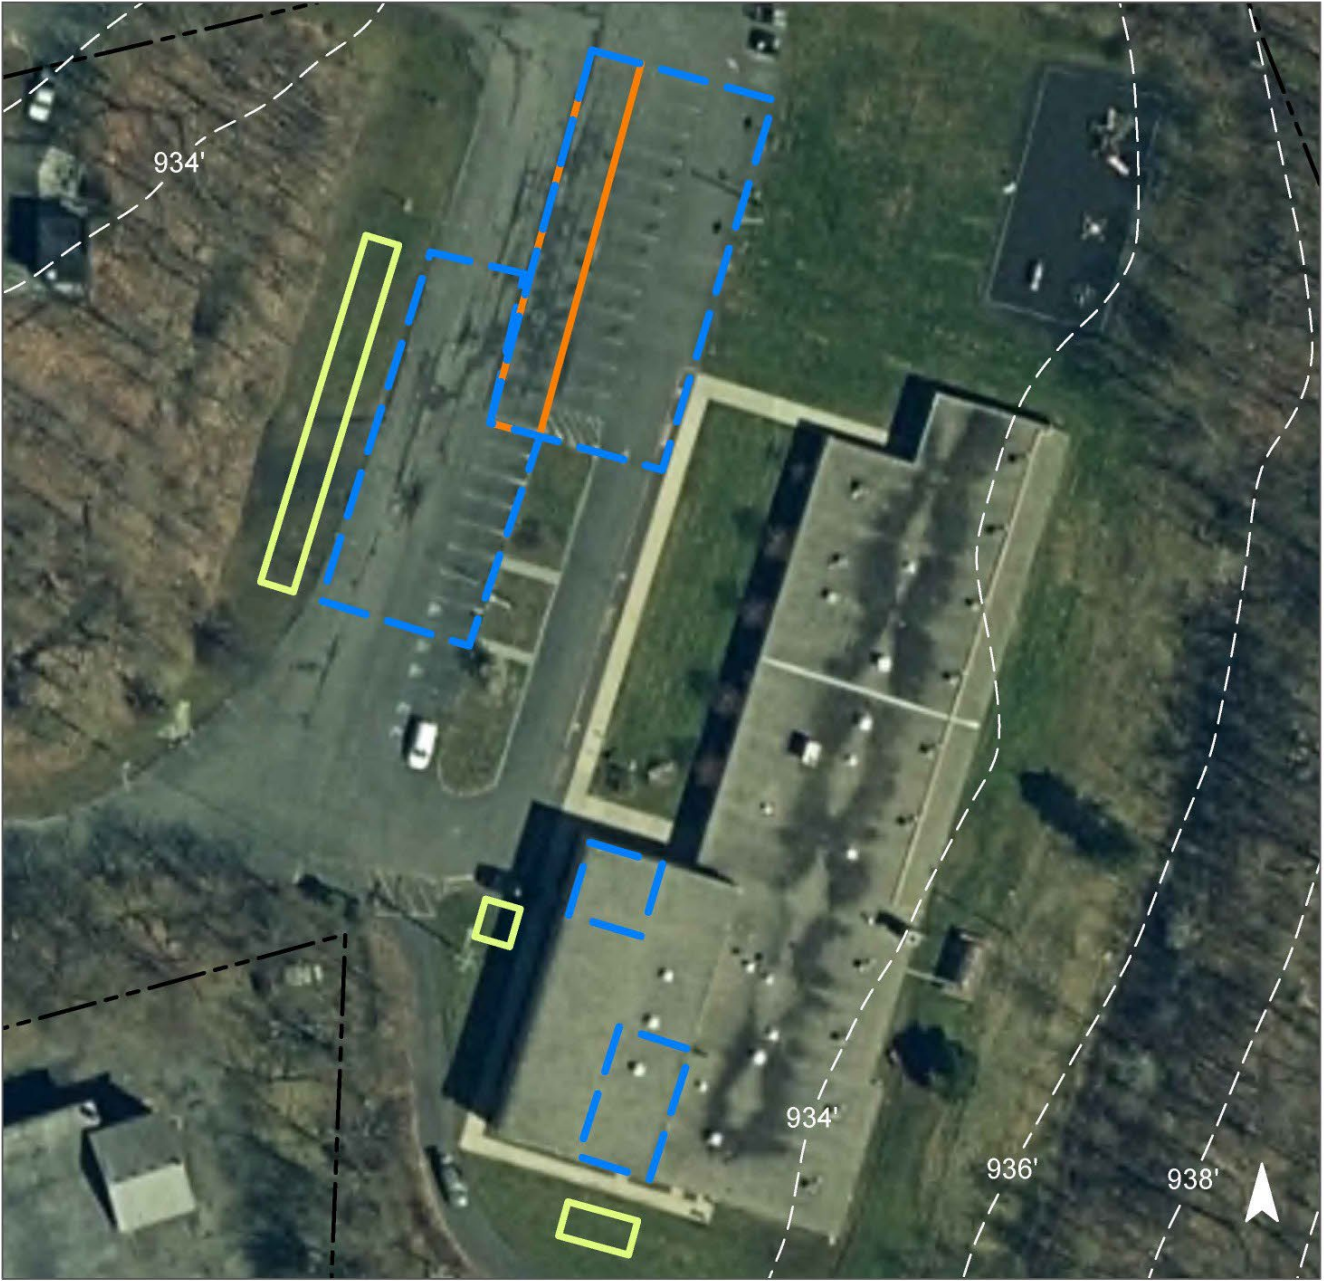
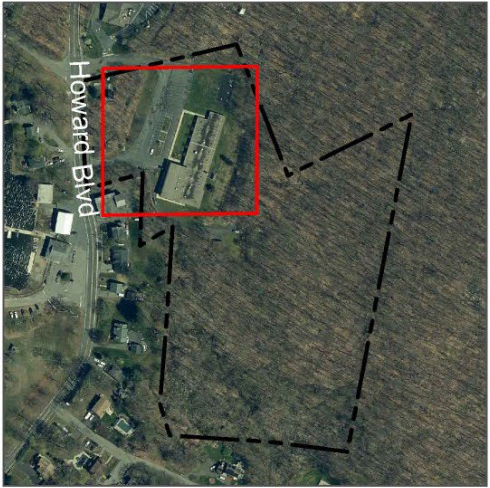
**Edith M. Decker
Elementary School**

Rain gardens can be installed to the south and southwest of the building and to the west of the parking lot to capture, treat, and infiltrate stormwater runoff from the rooftop and asphalt. The rain garden to the southwest of the school will require downspout redirection and disconnection. The rain garden to the south of the school will require downspout redirection underneath the sidewalk. The existing parking spaces to the northwest of the lot can be converted into pervious pavement to capture and infiltrate the stormwater runoff from the asphalt. A preliminary soil assessment suggests that more soil testing would be required before determining the soil's suitability for green infrastructure.

bioretention system
-

pervious pavement
-

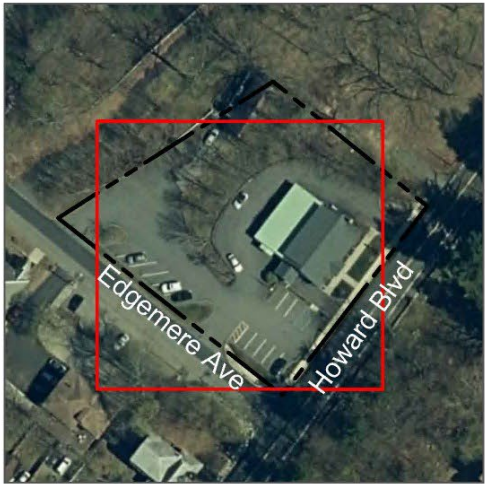
Mount Arlington Borough Hall

A rain garden can be installed to the east of the building to capture, treat, and infiltrate stormwater runoff from the rooftop. This will require a downspout redirection beneath the sidewalk. The existing parking spaces to the west of the building can be converted into pervious pavement to capture and infiltrate stormwater runoff from the asphalt. A trench drain will be required. A preliminary soil assessment suggests that more soil testing would be required before determining the soil's suitability for green infrastructure.

bioretention system
-

pervious pavement
-

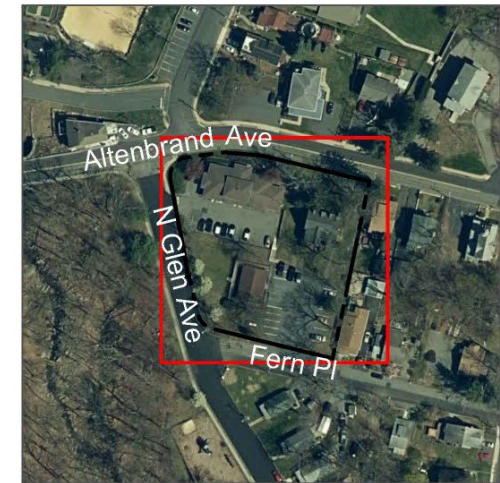
**Mount Arlington Police
Department & Civic Center**

Rain gardens can be installed in multiple grass areas around the property to capture, treat, and infiltrate stormwater runoff from the building rooftops. Many of these will require downspout redirections and disconnections. The rain garden to the west of the police department will also manage stormwater runoff from the parking lot. This rain garden will require a downspout disconnection, a trench drain, and a curb cut. The existing parking spaces to the east of the civic center can be converted into pervious pavement to capture and infiltrate the stormwater runoff from the asphalt lot. The southeastern downspout can also be disconnected to the pervious pavement to manage rooftop runoff. A cistern can be installed to the south of the police department building to divert and detain stormwater runoff from the rooftop for later non-potable reuse such as watering the landscaping vegetation or washing vehicles. A preliminary soil assessment suggests that more soil testing would be required before determining the soil's suitability for green infrastructure.

- bioretention system
- pervious pavement
- rainwater harvesting
- captured drainage area
- property line
- 2020 Aerial: NJOIT, OGIS

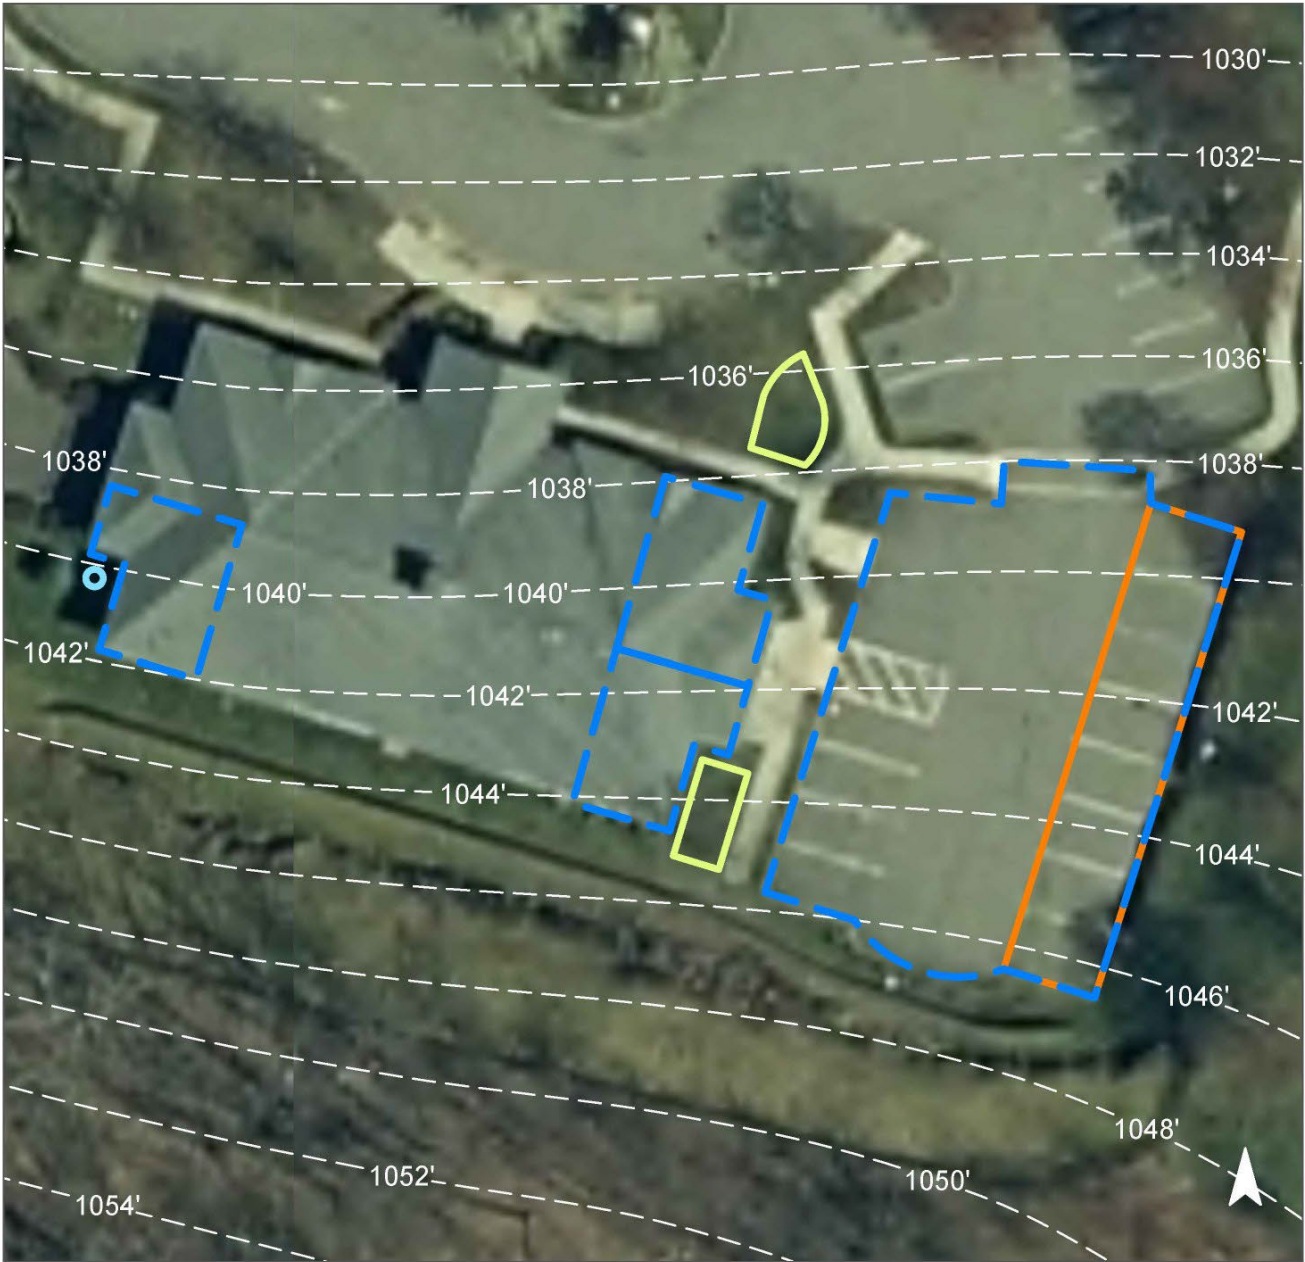
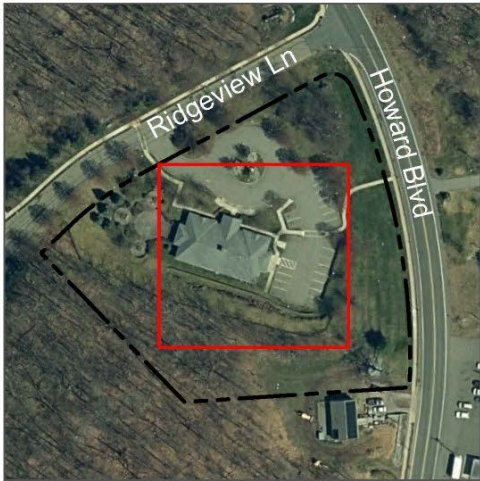
Mount Arlington Public Library

Rain gardens can be installed to the northeast and southeast corners of the building to capture, treat, and infiltrate stormwater runoff from the rooftop. This will require downspout disconnections. The northern rain garden will require downspout redirection beneath the sidewalk. The existing parking spaces to the east of the building can be converted into pervious pavement to capture and infiltrate stormwater runoff from the asphalt. A cistern can be installed to the southwest of the building to divert and detain stormwater runoff from the rooftop for later non-potable reuse such as watering the nearby garden beds. A preliminary soil assessment suggests that the soils have suitable drainage characteristics for green infrastructure.

- bioretention system
- pervious pavement
- rainwater harvesting
- captured drainage area
- property line
- 2020 Aerial: NJOIT, OGIS

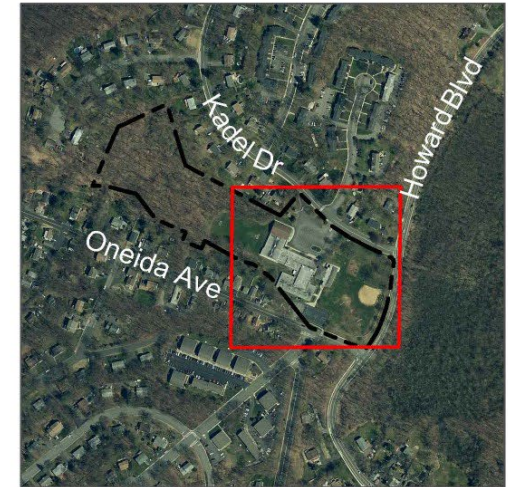
Mount Arlington Public School

Rain gardens can be installed to the northwest and southeast corners of the building to capture, treat, and infiltrate stormwater runoff from the rooftop. The southeastern rain garden will require downspout disconnections. The northwestern rain garden will require downspout redirection beneath the sidewalk. Existing parking spaces to the north and northeast of the building can be converted into pervious pavement to capture and infiltrate the stormwater runoff from the asphalt. The southern basketball court can be converted into pervious pavement to capture and infiltrate stormwater runoff from the court. A preliminary soil assessment suggests that more soil testing would be required before determining the soil's suitability for green infrastructure.

bioretention system
-

pervious pavement
-

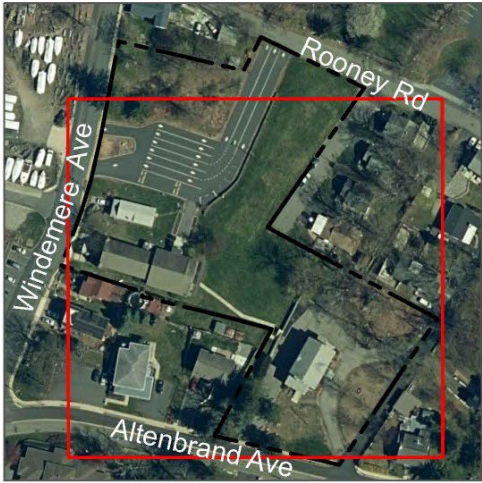
Our Lady of the Lake Roman Catholic Church

Rain gardens can be installed in multiple grass areas around the church and rectory property to capture, treat, and infiltrate stormwater runoff from the rooftops and parking lot. Downspout redirections, disconnections, and redirection beneath a walkway will be required. The rain garden to the northwest of the rectory will require a trench drain and curb cuts. A cistern can be installed to the southeast of the northern church building to divert and detain the stormwater runoff from the rooftop for later non-potable reuse such as watering the landscaping vegetation. The two nearest downspouts can be redirected to the cistern to increase the managed drainage area. A preliminary soil assessment suggests that more soil testing would be required before determining the soil's suitability for green infrastructure.

bioretention system
-

rainwater harvesting
-

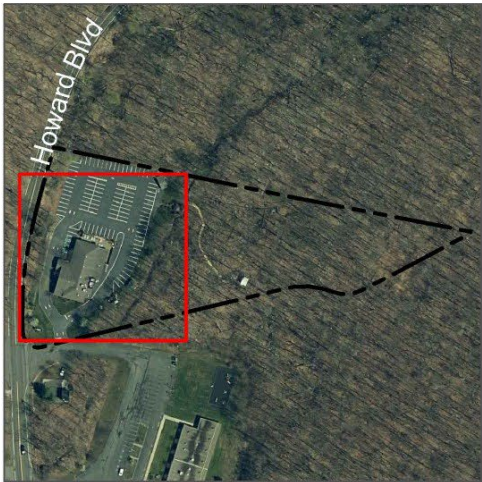
Times Square Church

A rain garden can be installed to the east of the entry driveway to capture, treat, and infiltrate stormwater runoff from the asphalt. This will require a trench drain and a curb cut. Another rain garden can be installed to the south of the manger to capture, treat, and infiltrate stormwater runoff from the rooftop. The existing parking spaces to the northwest of the church building can be converted into pervious pavement to capture and infiltrate stormwater runoff from the asphalt and the rooftop. This will require downspout disconnections to the pervious pavement. A preliminary soil assessment suggests that more soil testing would be required before determining the soil's suitability for green infrastructure.

- bioretention system
- pervious pavement
- captured drainage area
- property line
- 2020 Aerial: NJOIT, OGIS
